**HYDRAULIC FAILURE OF MICRO
EMBANKMENT DAMS AND REMEDIAL
MEASURES
(CASE STUDY: ZANA MED, AMHARA REGION)**

**By
TIGIST ANTENEH MEKONNEN**

A THESIS SUBMITTED TO THE SCHOOL OF GRADUATE STUDIES OF ADDIS
ABABA UNIVERSITY IN PARTIAL FULFILLMENT OF THE REQUIREMENTS
FOR THE DEGREE OF MASTERS OF SCIENCE IN HYDRALIC ENGINEERING

June, 2008

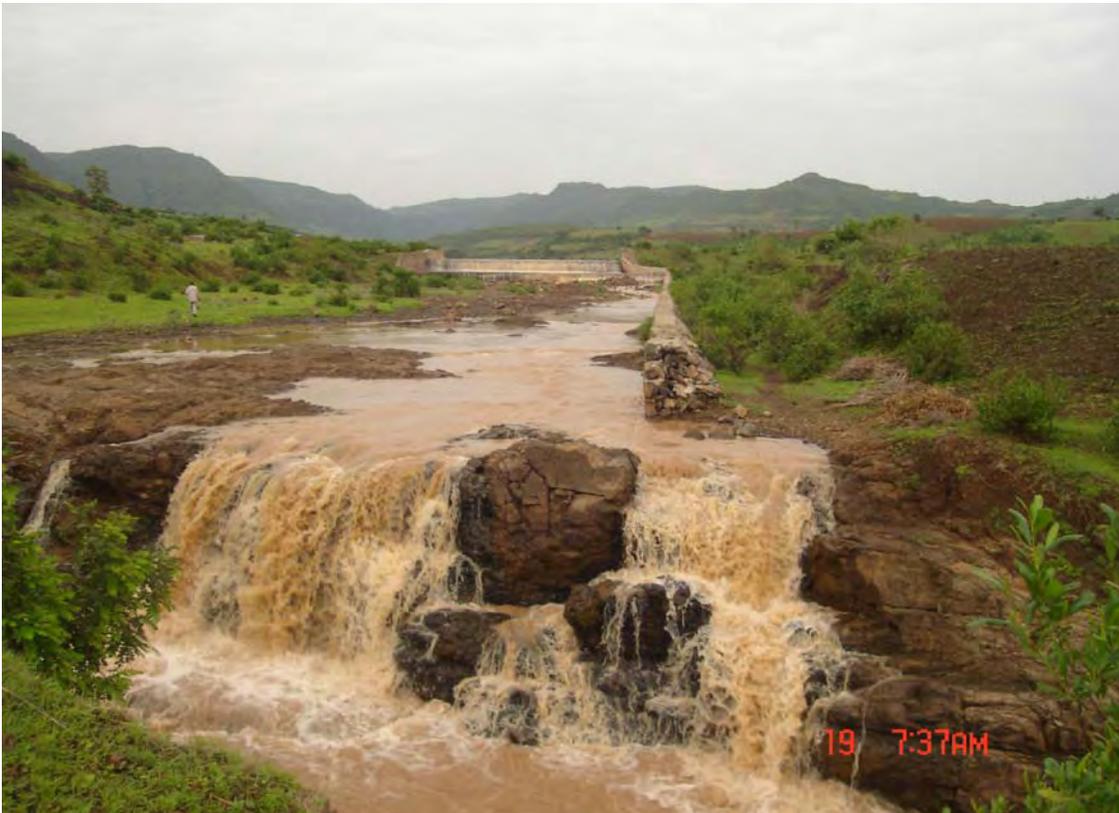
Fig1.3 Excess Water Flow over the Spillway during July, 2007

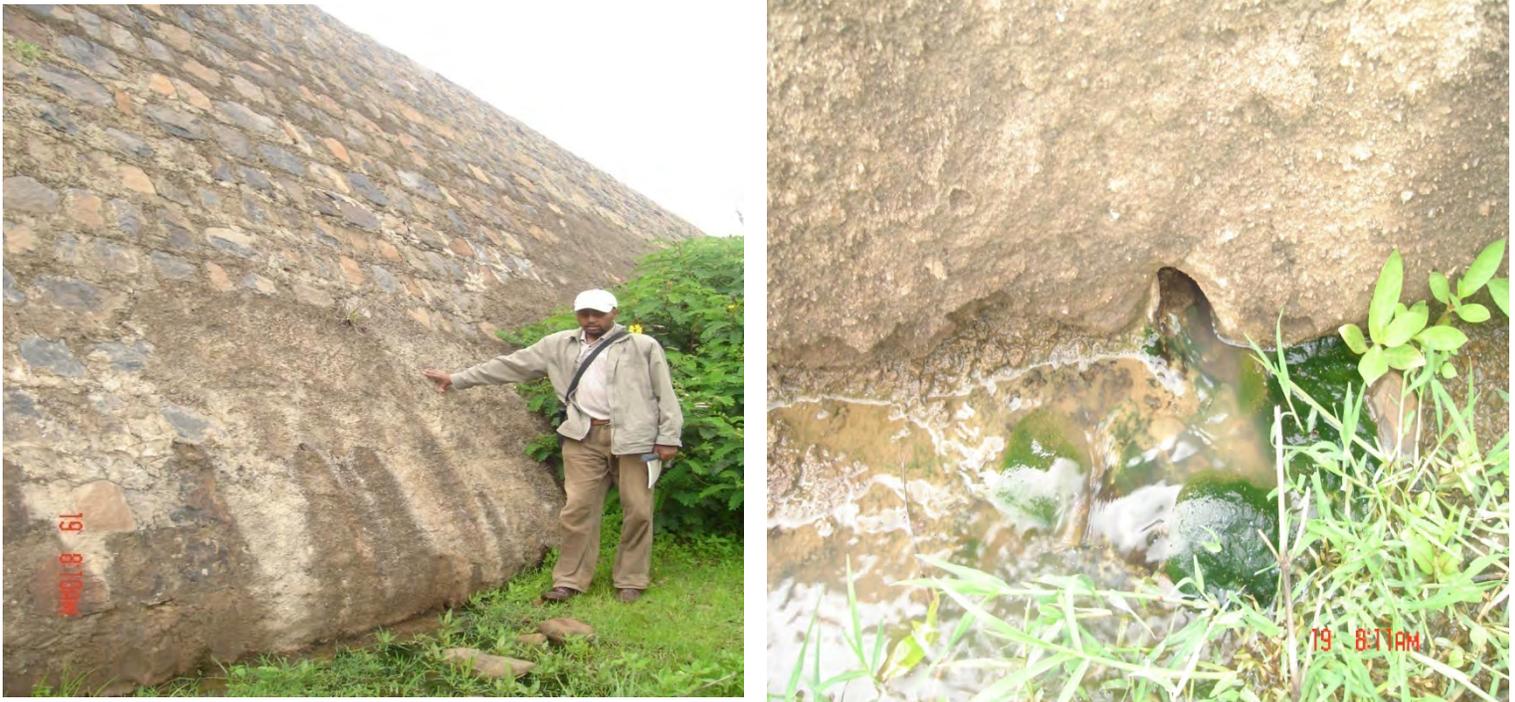
The expected quantity of seepage estimated with these different methods relatively resembles each other. The maximum seepage through the dam as per the SEEP/W software model analysis that includes foundation seepage is $7.06 \times 10^{-3} \text{ cm}^3/\text{sec}$. This value is compared with the quantity of seepage estimated at the designed document that is $7.31 \times 10^{-2} \text{ cm}^3/\text{sec}$. Therefore, the design document has no problem of quantifying the expected quantity of seepage. However, the drainage system is not properly designed at the design document. To this end, failure of seepage at the d/s face of the dam which are threatening the dam stability are expected to result from improper filter media design. Even though, the dam has a problem data on construction history, this study analyze with the help of field investigation, the cause of seepage failure at side of spillway due to poor construction quality.

Fig 4.1: Location of Leakage Area at the side of Spillway Footing

To alleviate the problem grouting, impervious blanketing and d/s berming are the proposed remedial measures for seepage and leakage failures.

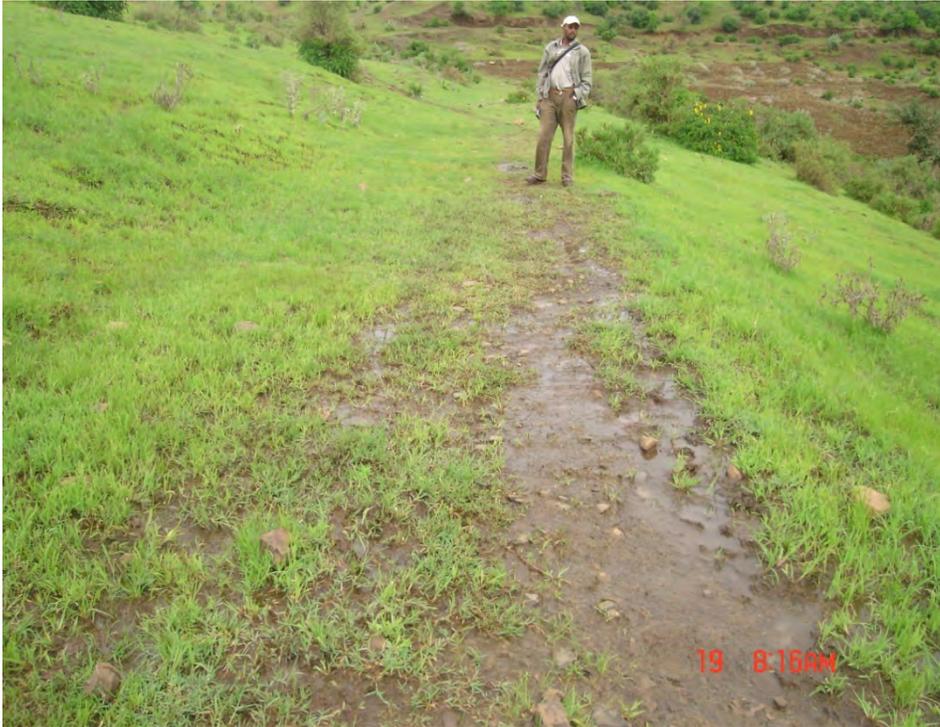
Fig 4.2 Seepage areas at the Berm of d/s Dam
