IMAGE BASED PAVEMENT CONDITION ASSESSMENT

A Thesis in Road and Transport Engineering

By Jibril Akmel Mohammed

August, 2022

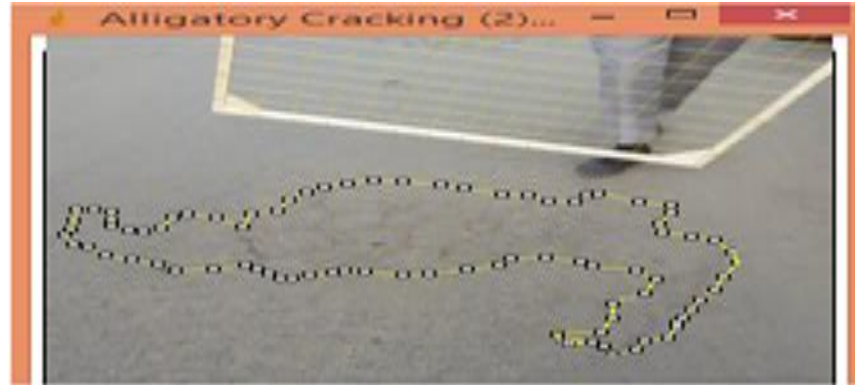
Figure 15: Digital measurement of an alligator cracking

A group of points near the location of the alligator crack were first fitted using a fin curve. The scale needs to be calibrated before performing the measurements. As seen in Fig. 15,

The result of the image measurement is shown in Fig. 17. The manual findings for the 0.634 m² alligator cracking area are quite comparable to these results.

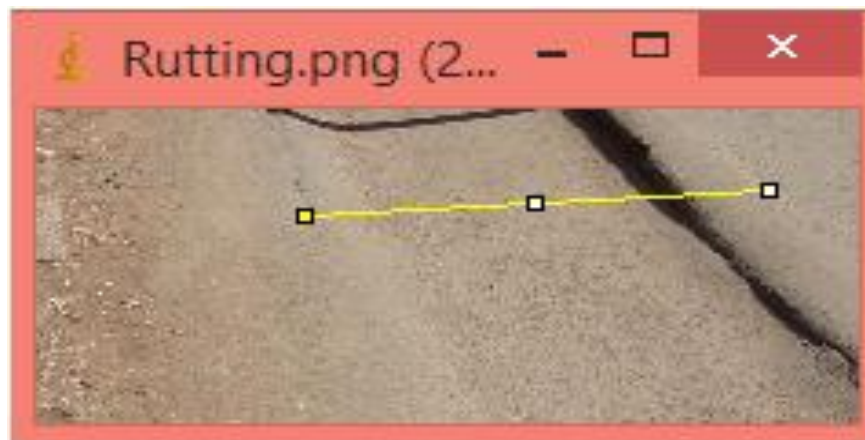
Figure 19: Rutting section

A portion of a paved road with significant rutting was chosen for this study. A 2.0 m ruler is used to manually measure 76.5 mm of wheel travel as well as the grooved length of a segment.

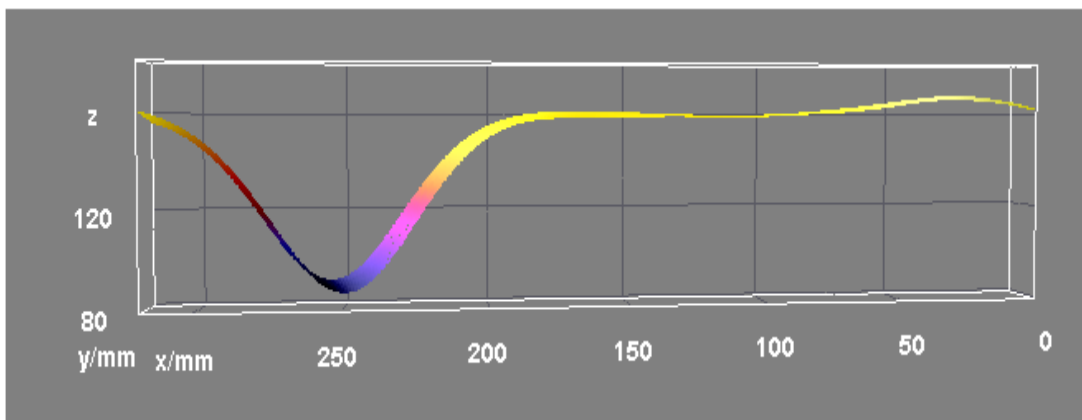
Figure 21: Measurement result for rutting

The software rutting depth shows as that, it is 78.0mm

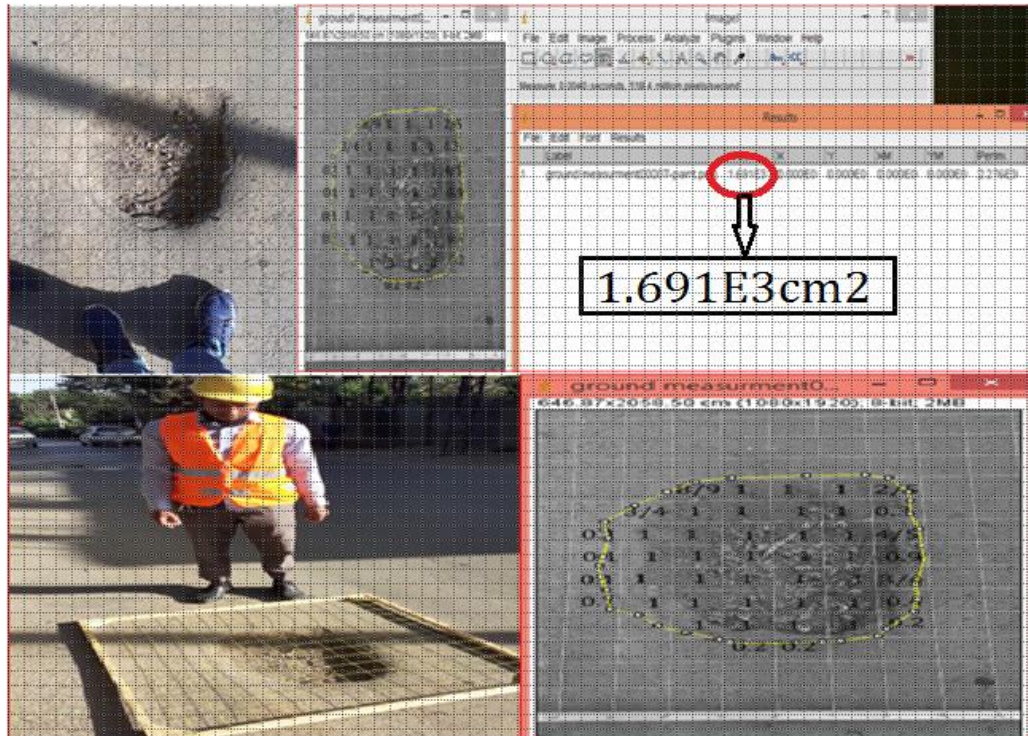
Figure 22: Pothole Manual vs. Software Measurement Comparison

✚ Pixel distance = 2.0736, Known distance = 11.5cm, Pixel ratio = 1.79, Unit of length = cm

✚ Each box area=7cm*7cm=49cm²=0.0049m²

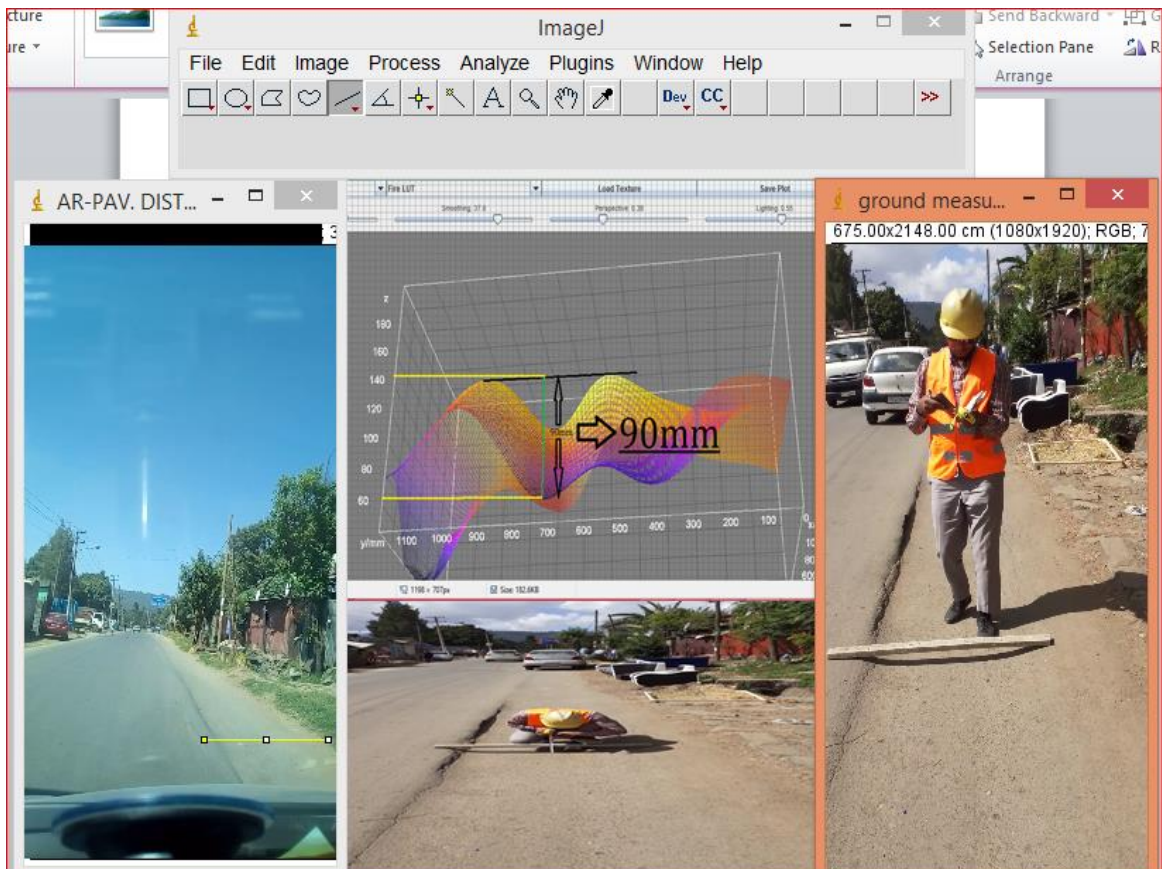
Figure 23: Rutting Manual vs. Software Measurement Comparison

Pixel distance=1.92, Known distance=1200mm, Pixel ratio = 1.79, Unit of length = mm

Rutting depth Manual Measurement =9.95cm

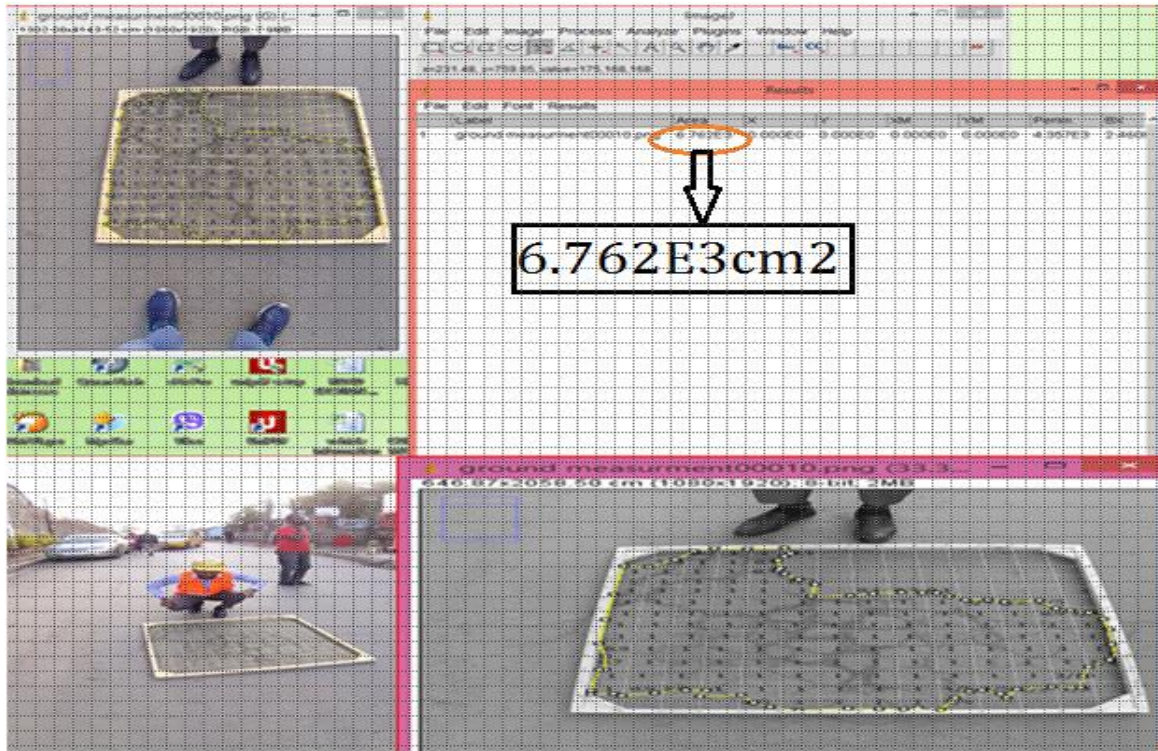
Figure 24: Cracking Manual vs. Software Measurement Comparison

✚ Pixel distance=2.0736, Known distance=250 cm, Pixel ratio=1.79, Unit of length=cm

✚ Alligator cracking Area Manual Measurement

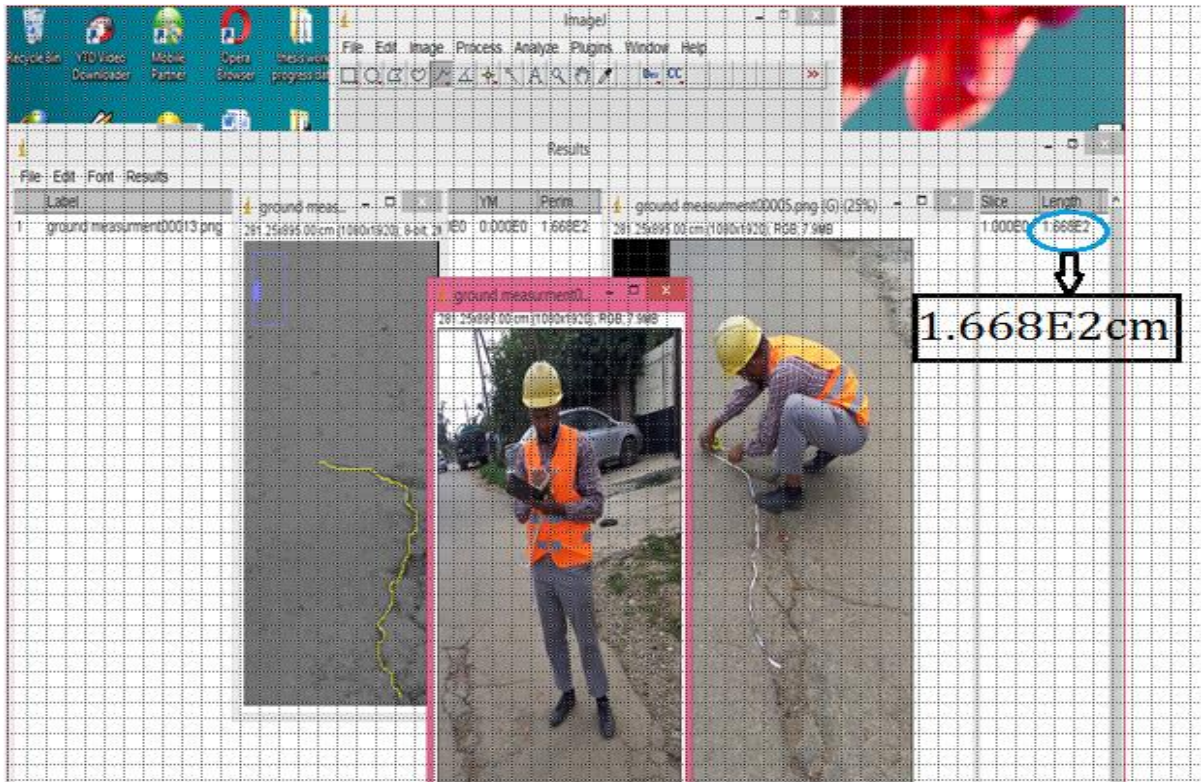
Figure 25: Longitudinal Cracking Manual vs. Software Measurement Comparison

✚ Pixel distance= 1920, Known distance= 500m, Pixel ratio=1.79, Unit of length=cm

✚ Longitudinal Cracking Manual Measurement
