# **ASSESSMENT OF ROAD PAVEMENT FAILURE ALONG ADDIS ABABA-MODJO TRUNK ROAD**

**A thesis submitted to School of Civil and Environmental Engineering  
In  
Partial fulfilment of the requirements for the degree of Master of Science in  
Civil Engineering  
(Geotechnical Engineering)**

**By: Asnake Abate**

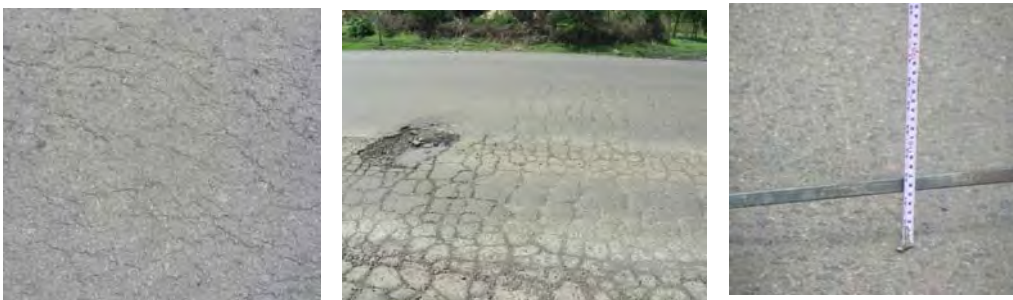
Repeated maintenance which includes removal of the asphalt surface and replacement has been done however; the same problem persisted to date. The Cracks, Ruts and Potholes are measured using Pavement Distress recording and Maintenance Manuals (Such as ERA Pavement Rehabilitation Manual).

Photo 1.1 Existing condition of the pavement and measurement

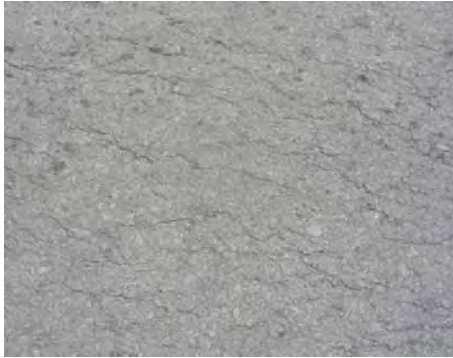
a) Dry and Brittle Surface

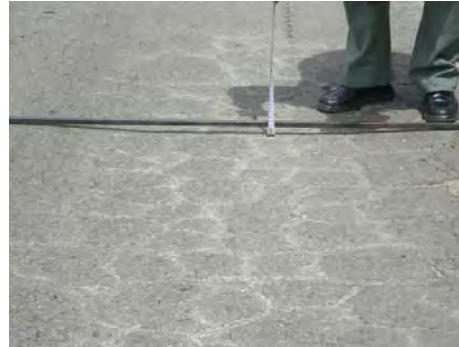
b) Ruts associated with cracks

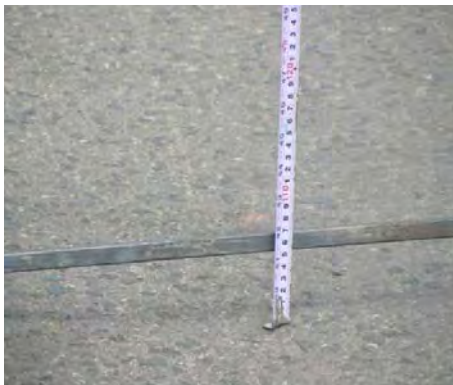
c) Rut at outer wheel path

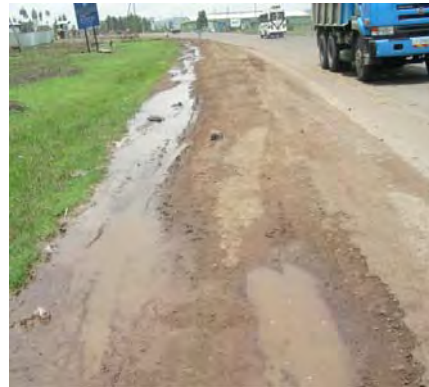
d) Side Drain Problem

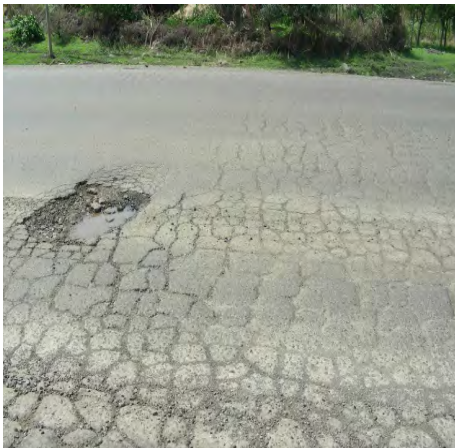
e) Potholes

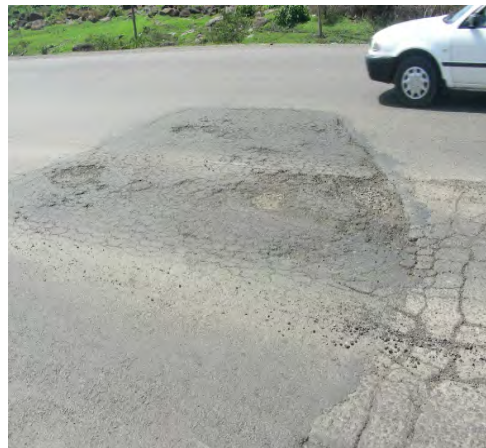
f) Repaired Section

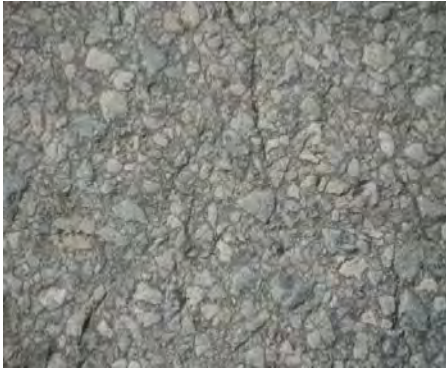
g) Raveling

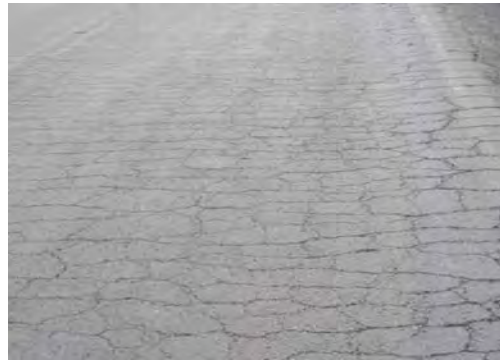
h) Crazing

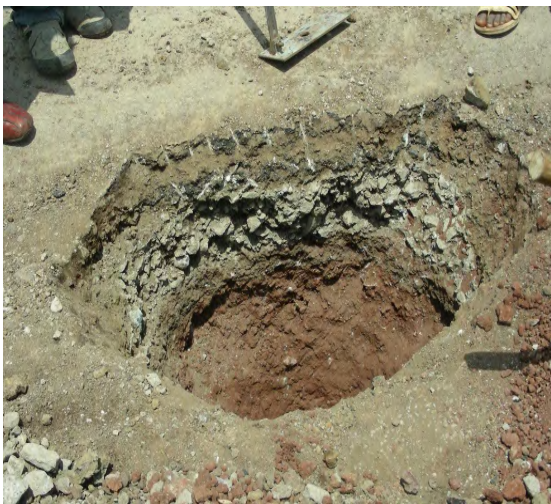
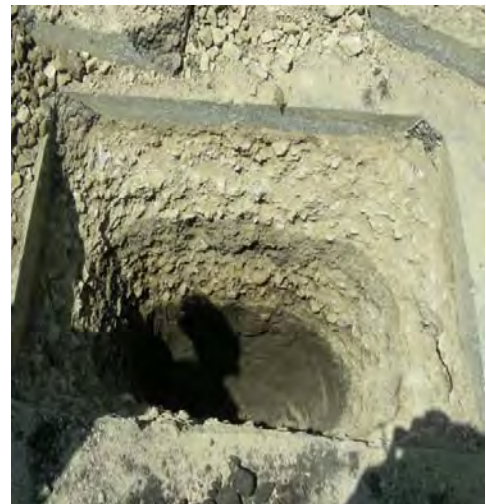
Figure 4.12: Existing pavement structure (Test pit on the Pavement) August/Sept 2012)

Three test pits were dug at each uniform section at points that represent the uniform section. A total of nine test pits were excavated and from each layer of pavement 80 kg to 100 kg samples were collected for laboratory tests. Test pit were dug to depth of insitu or native materials, i.e up to 1m at most places as shown in Figure 4.12 below.
