LANDSLIDE ASSESSMENT AND HAZARD ZONATION IN MERSA & WURGESSA, NORTH WOLLO, ETHIOPIA

A Thesis Submitted to
The School of Graduate Studies of Addis Ababa University
In Partial Fulfillment of the Requirements for the
Degree of Master of Science in
Engineering Geology

By
Jemal Ibrahim

June 2011

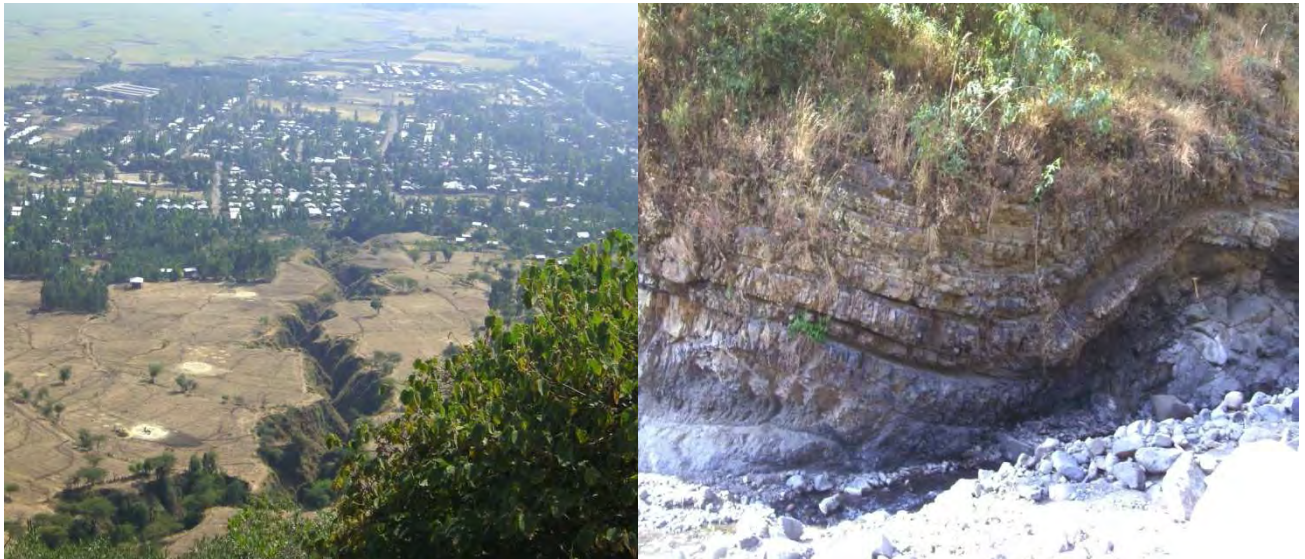
Plate 4.3 Faults and fracture in Mersa & disintegrated beds at the left bank of Golo stream Wurgessa respectively (2011).

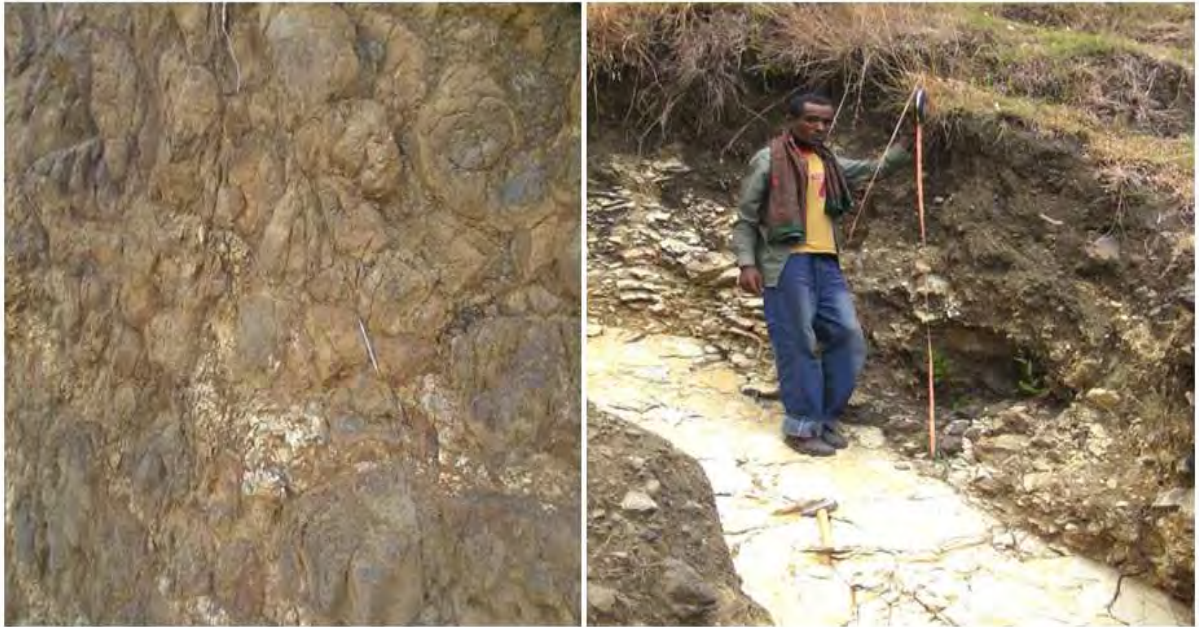
Plate 5.1 (a) Spheroidal weathering in Mersa

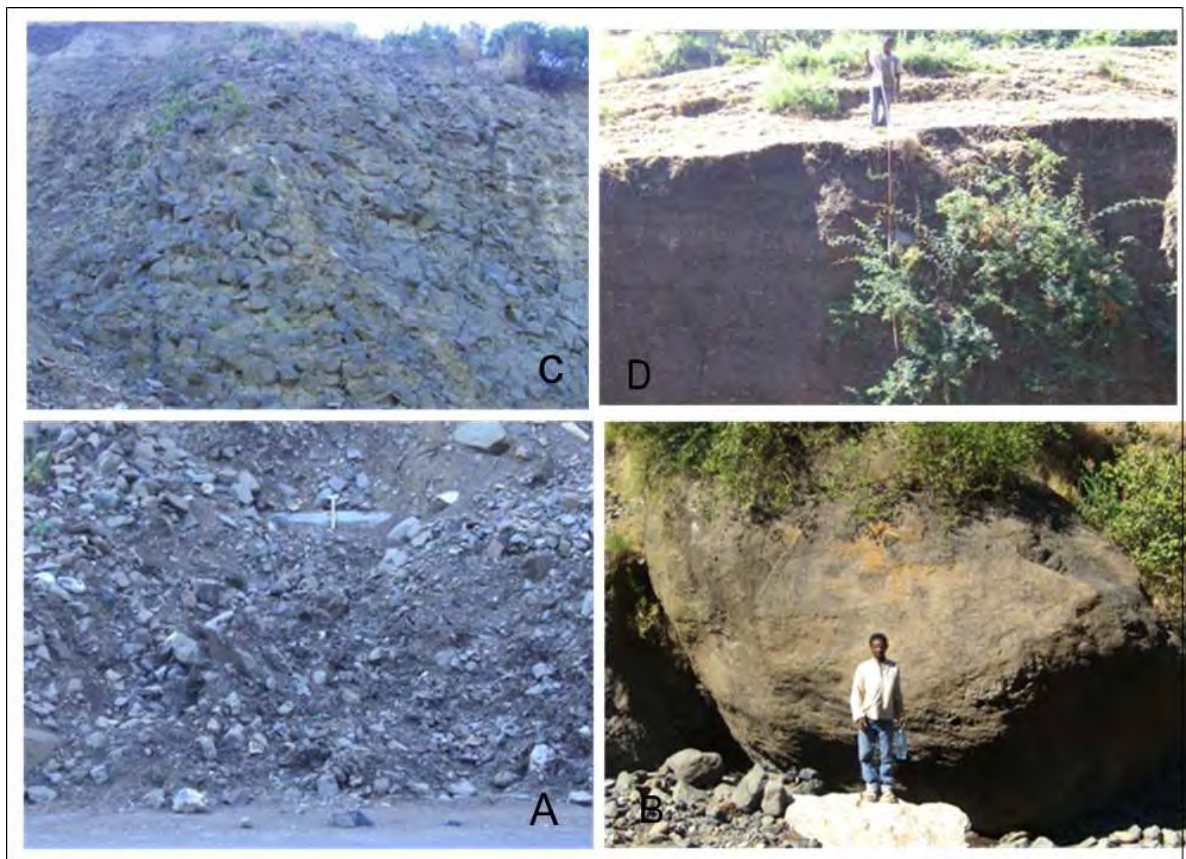
Plate 5.2 (A) Colluvial material slide with rock fragments of sharp edge. (B) Boulder slide at the foot of the slope (C) Loose rock fragments (D) Alluvial deposits (Wurgessa)

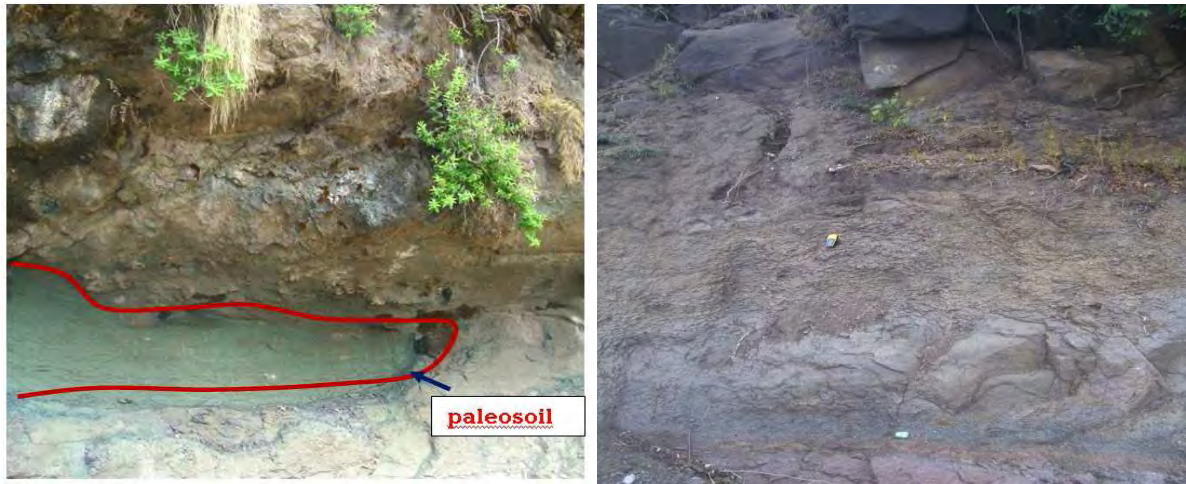
These intercalations of weak and strong rocks (competent basalt and incompetent sediments layers) may contribute to slope instability particularly in situations when other causative factors also provide favorable condition for such instabilities. Under such circumstances the incompetent layers may serve as plane or zone of failure along which mass movement can take place.

Plate 5.3 Paleosols between different flood basalt

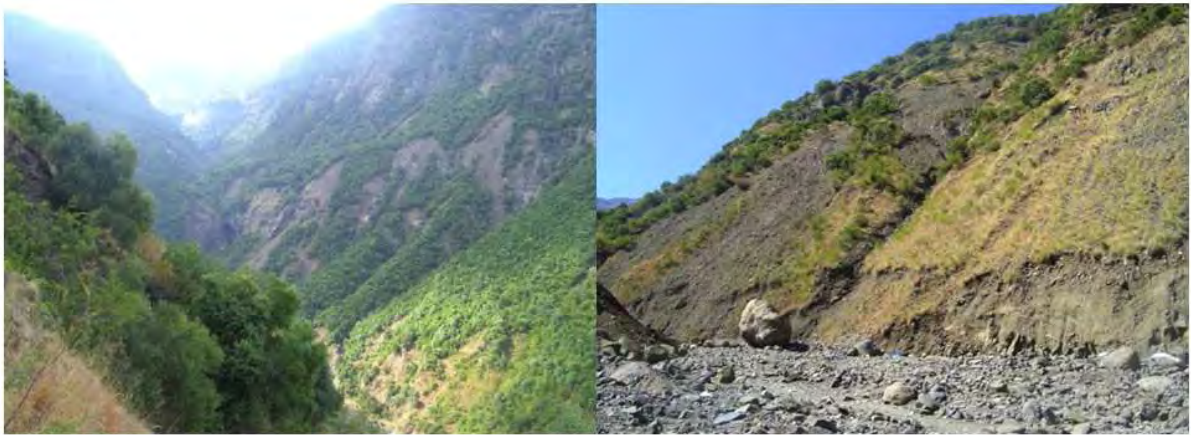
Plate 5.4 Landslide occurrences along Golo stream Wurgessa (2010).

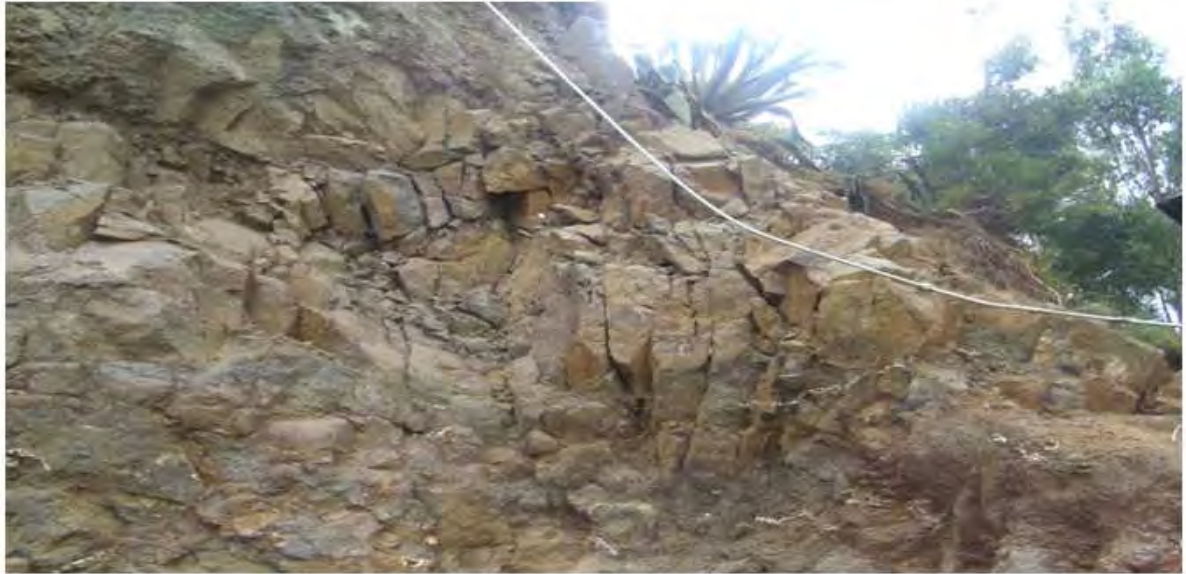
of water, which might have reduced the strength of the rock, besides facilitating the rock blocks to disintegrated and fall easily.

Plate 5.5 Rock mass comprising of Basalt in Mersa town affected by structural discontinuities

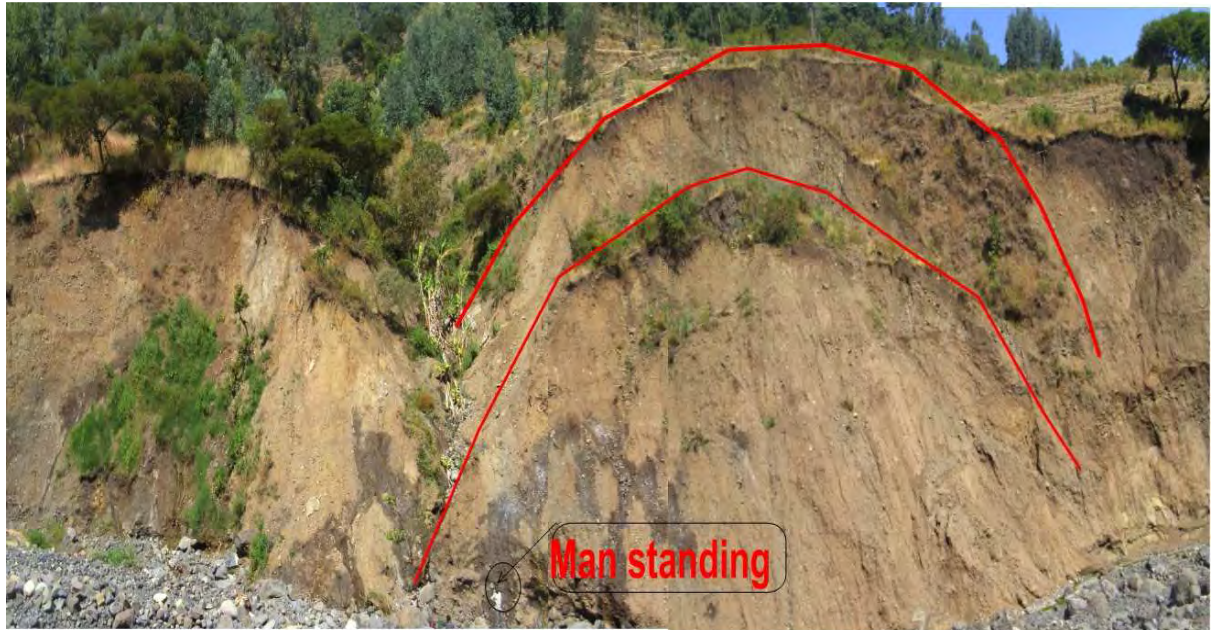
According to Kumar, (2009) flowing groundwater exerts pressures on soil particles thus impairing the slope stability. Abrupt changes in the water level cause the pore water pressure on slopes to increase, Mechanical strength of soil to decrease by washing out soluble cementing substances and this, in turn, may lead to slope instability. These effects of slope instability have been prevailed by the occurrence of large amount of landslides in association with springs and shallow ground water in the study area.

Plate 5.6 Landslide in association with Kok Wuha spring upper catchment of Tiso River (2010)

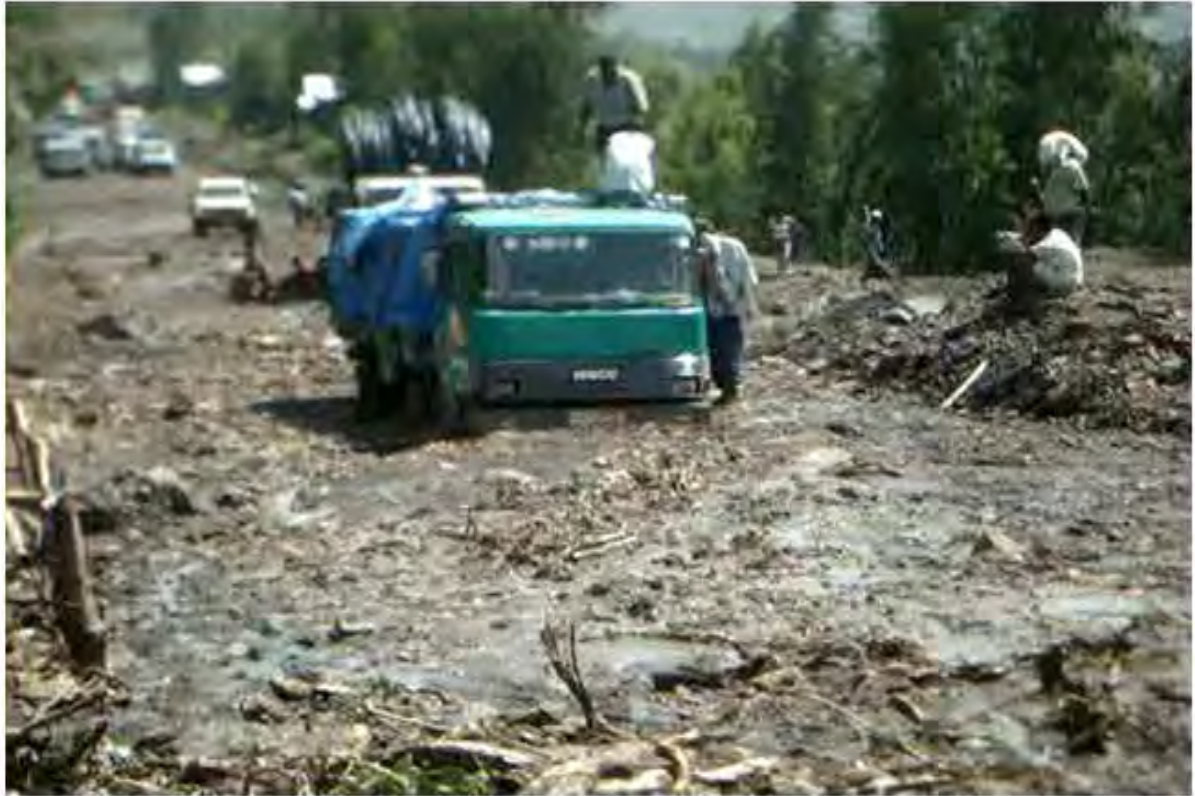
Plate 5.7 Debris flow due to Enqirt Wuha spring in August, 2010 (HWCO, 2010)

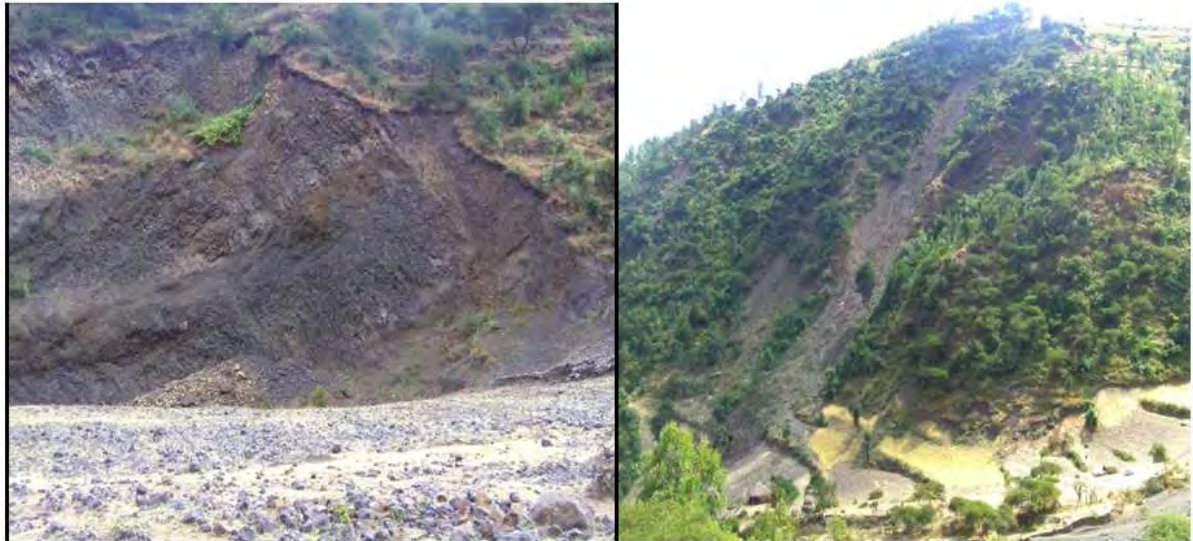
Most of the slope sections of the study area (Chapter 6, Fig 6.4 & 6.5) are characterized by steep slopes and high relative relief. However, some of the slope sections (Plate 5.9) in the study area are severely affected by the landslide not because they are steep instead the instability was induced due to weak slope material. In general, high relative relief and steep slope morphometry in the study area has facilitated increase in natural gravitational pull for poorly graded colluvial material and highly weathered, fractured and weak rock formations resting over/ or forming such slopes. In addition to this highly disintegrated rock mass and poorly graded colluvial material also facilitates more infiltration of water during prolonged rainy season which ultimately might have contributed for instability of slopes in the present study area.

Plate 5.8 steep slopes with competent rock mass. Plate 5.9 steep slopes with incompetent rock mass.

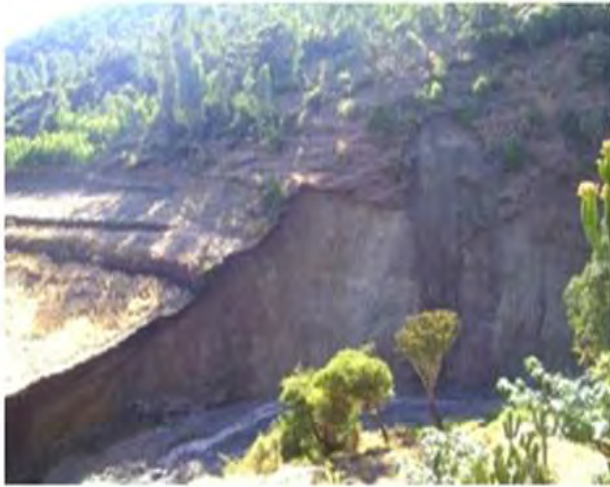
Plate 5.10 Slope toe erosion (Wurgessa)

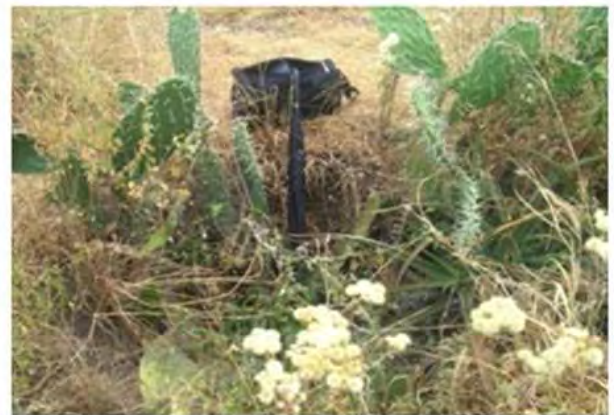
Fig 5.13 Hand dug well for crop storage (Abandoned)

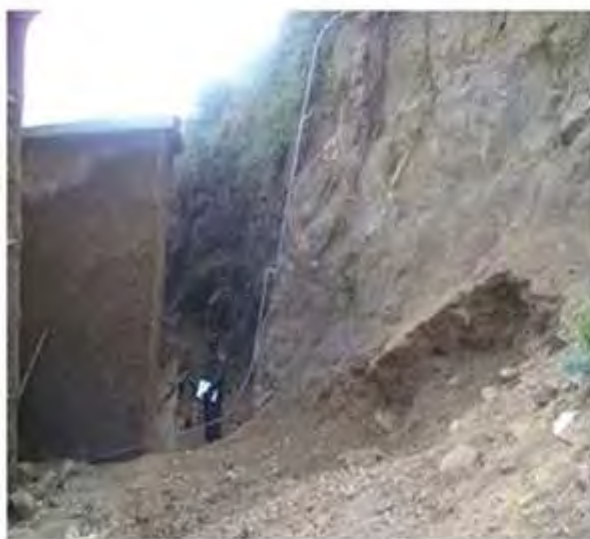
Plate 5.14 Slope cut for house construction in Mersa

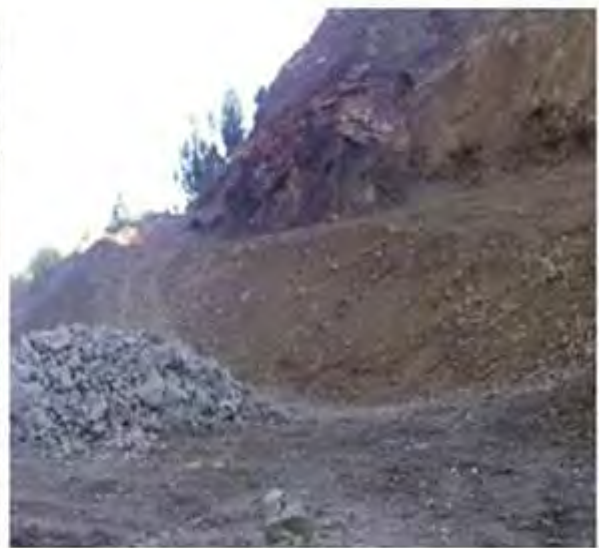
Plate 5.15 Quarry Site of ERA. (Wurgessa)

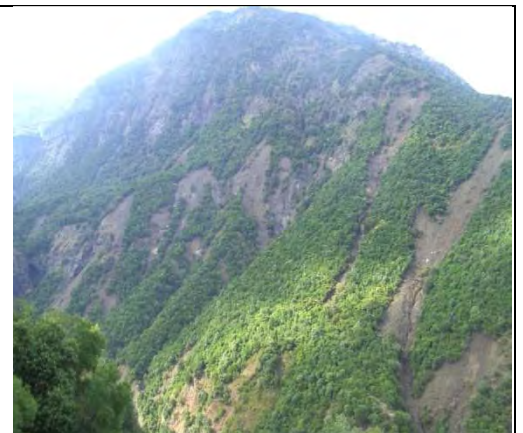
<p>Translational Soil slide</p> <p>Some of the landslides which occurred in the residual soils and colluvial materials overlying relatively less weathered volcanic rocks characterized by this kind of Landslides. Sometimes like in the figure when the impact of stream toe erosion and spring water become excessive part of slope material slide leaving scarp on the original material.</p> <p>Slides of this type show recognizable surface from which the slide begins and have translational movement.</p>

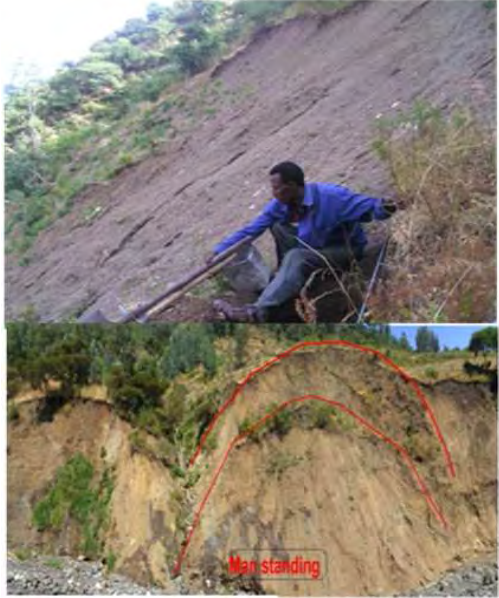
<p>Rotational Soil Slide</p> <p>This type of slide occurred in the upper portion of the slope. In this kind of slide the surface of rupture is curved concavely upward and the slide movement is roughly rotational about an axis that is parallel to the ground surface.</p>

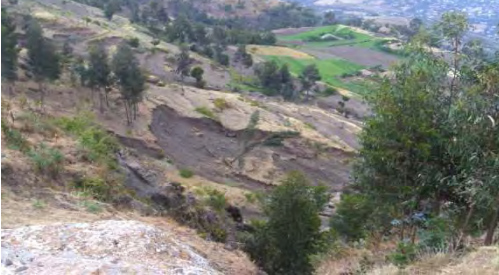
<p>Debris flow</p> <p>Debris flows which is composed of soils, sands, gravels, and boulders with plant roots and vegetations observed in the study area. At places this debris flows (fig 5.7) highly fluidized due to the high water content, with fine grained soils. This kind of debris flows moves with high speed causing many damages.</p>

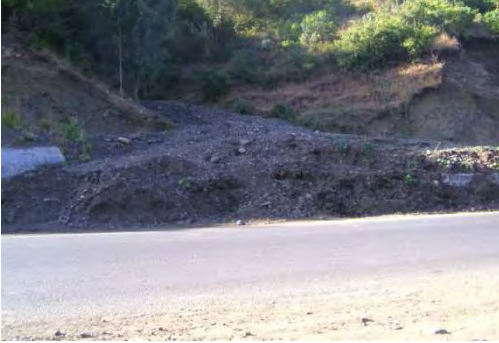
<p>Rock falls / Soil falls</p> <p>Rock falls/ Soil falls is not dominant types of landslide in the study area. However this type of slide observed at very steeply cut natural and artificial slopes of the study area, at a place called Nini-Ber near the study area</p>

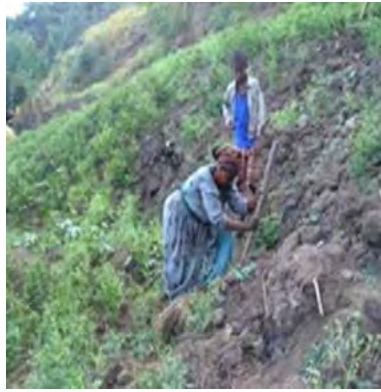
(a) Woman searching her properties which is buried by the landslide (Mersa).

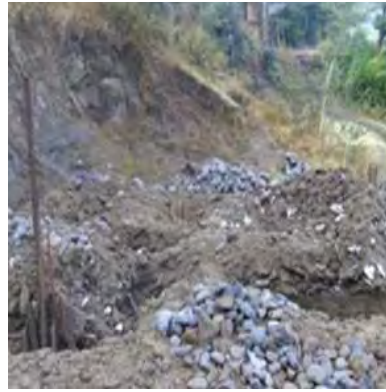
(b) Part of the houses completely damaged by the landslide (Mersa).

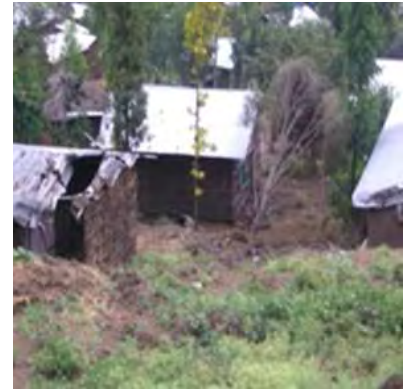
(c) Partially affected houses by the first coming rock fall before the main slide began. (Mersa).

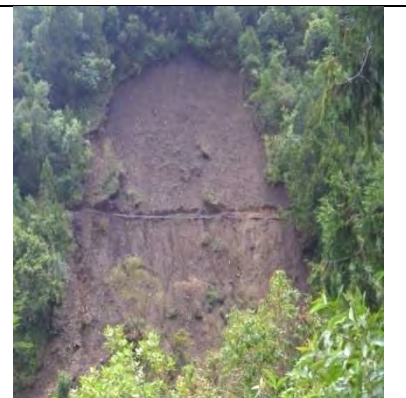
(i) Water pipeline has been damaged.

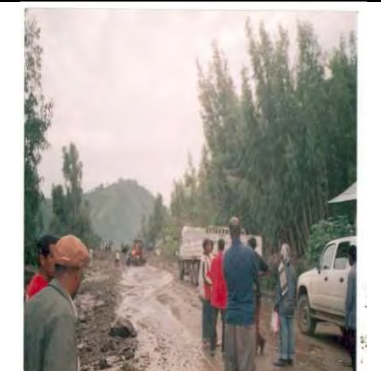
(j) People stranded until the debris removed from the road

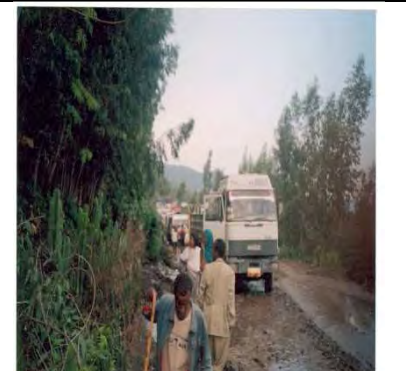
(L) people stranded until the road will be cleaned

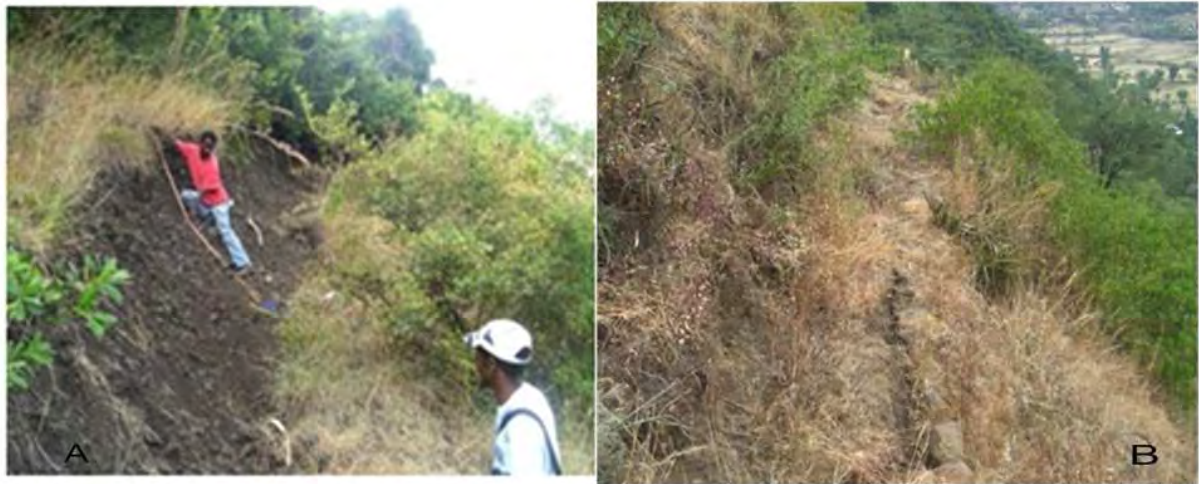
Plate 5.17 Displacement of cracked land (A) and tension crack (B) due to the 2010 Landslide Wurgessa

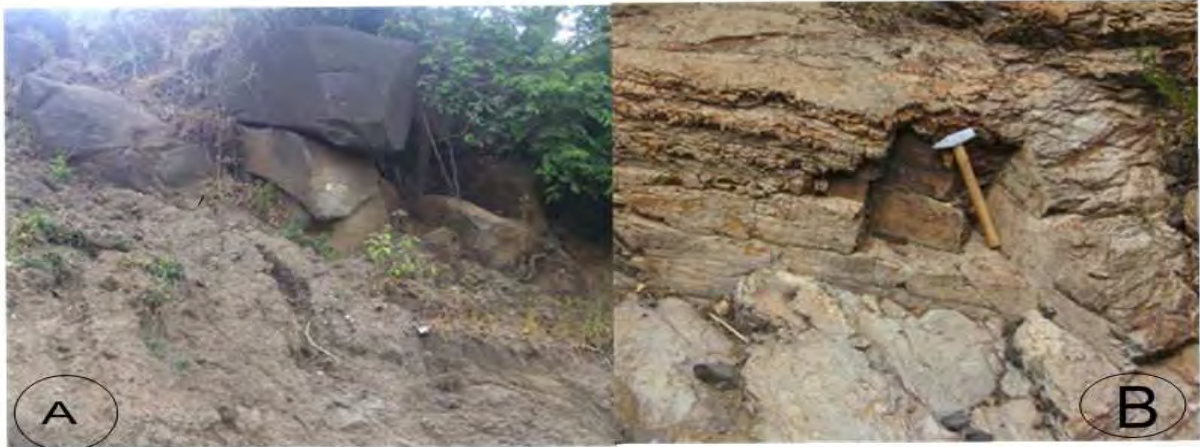
Plate 6.1 Joints dipping parallel to the slopes (A) Mersa & (B) Wurgessa

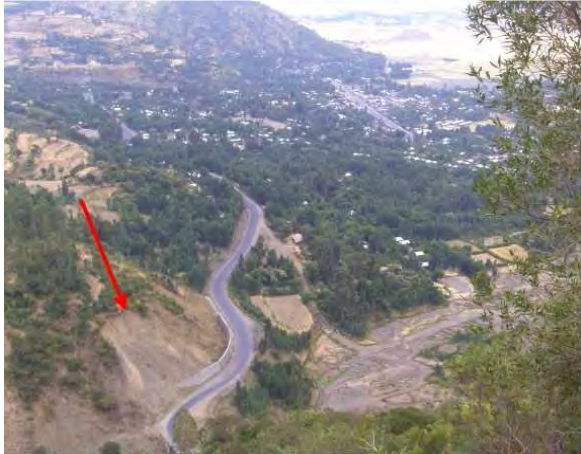
(a) Landslide which has fallen in steep slope cut (Wurgessa)

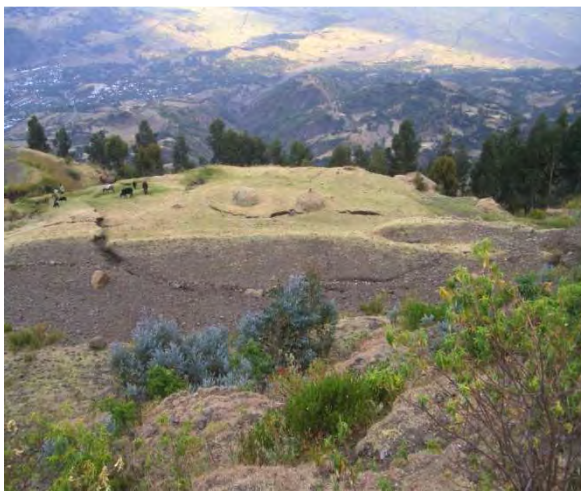
(c) Rotational Landslide in the high elevation areas. At 2643m above sea level.

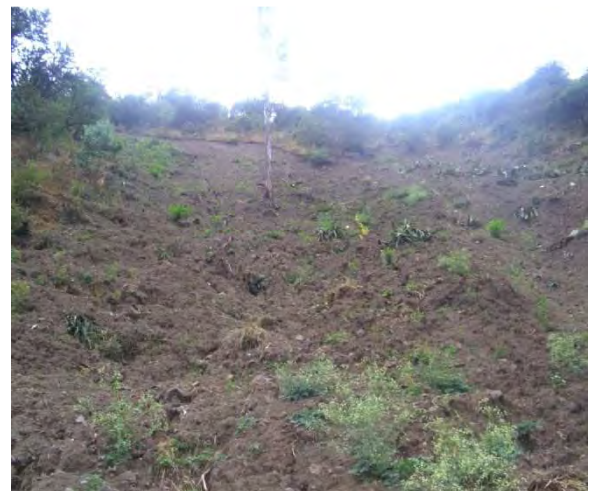
(d) The catastrophic landslide which has killed 14 people (Mersa)
