**Power Distribution System Failure and Vulnerability  
Analysis in Ethiopia  
Case Study : Kotebe Distribution System**

**A Thesis Submitted to the School of Graduate Studies of  
Addis Ababa University in Partial Fulfilment of the  
Requirements for the Degree of Masters of Science in Power  
Engineering**

November 2021

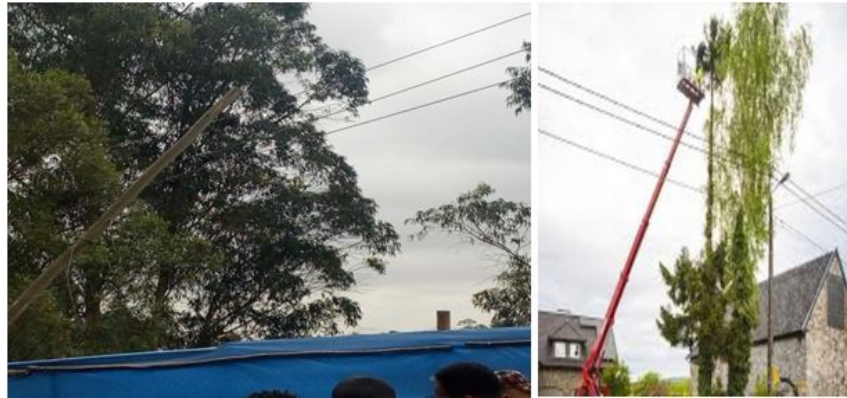
Thus, evaluation of the condition of poles is essential. The ability to predict potential damage to poles before the occurrence of weather-influenced disaster enables decision-makers to plan preventive maintenance operations promptly and helps to allocate resources effectively. So, it is necessary to understand the properties of wooden poles during weather influence.

Figure 2.1: Tilted pole (left side) and a tree risk for distribution system (right) (Source: photo from the study area (left side) and website (right))

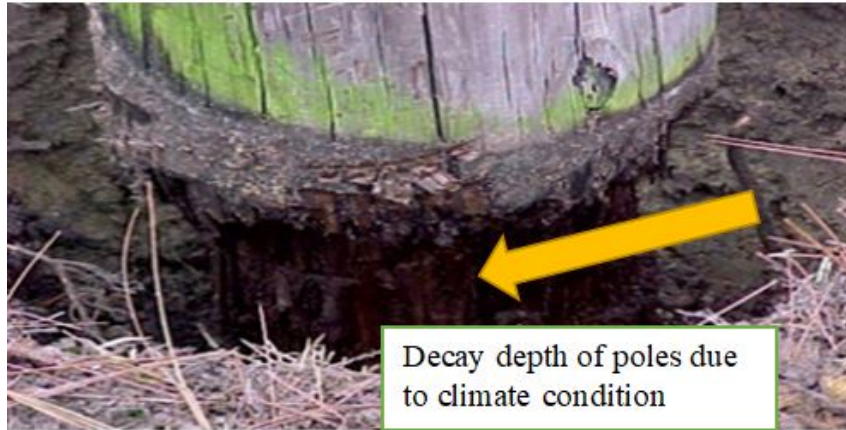
The decay rate depends on factors such as wood type, climatic conditions (temperature, rainfall, and humidity), soil properties, initial preservative treatment, termite attack, and the nature of fungal attack [15]. Climate influence is the most significant factor for the decay of wooden poles. After 50 years of installation, the residual strength under climate change could be almost 25% less than that without climate changes [16].

Figure 2.3: Decay of distribution pole due to climate influence [17]

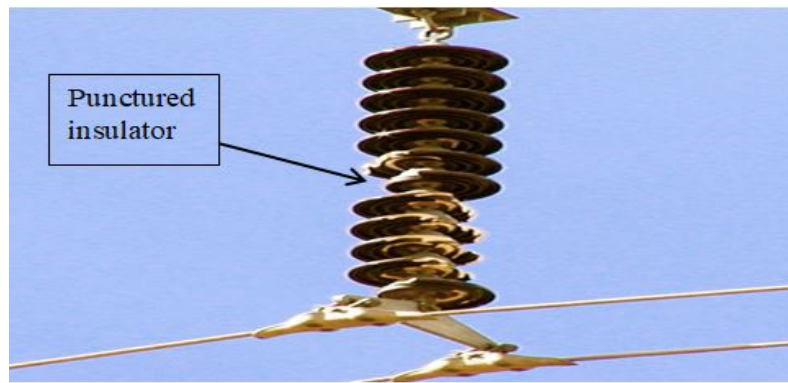
- Insulator cracking: cracking is caused by unequal expansion and contraction stress of seasonal heat cold, dryness, and dampness or heating of the insulators.
- Defective of materials: if the material is defective anywhere, it will puncture and become unfit for further use.
- Porosity of materials: porcelain manufactured at lower temperatures will absorb moisture from the air or cement and becomes porous.
- Improper glaze: if the material is not properly glazed, the water will stick to it, which will result in the deposition of dust. This reduces the flashover distance and causes the insulators to damage.
- Flashover: If there is a flash from one metal part to other, it will cause over-heating and shattering.
- Mechanical Stress: The pulling of insulators may sometimes cause mechanical stress for it.

Figure 2.4: Damaged insulator due to flash over

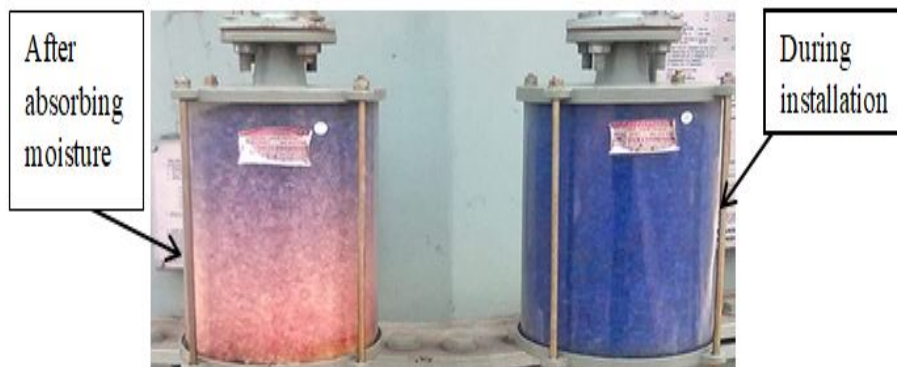
The too much absorption of moisture in silica gel breather tends it to stop working. It will be useless as the transformers will not be able to absorb any moisture in the transformer. As a result, the insulation in the transformers will be potentially harmed.

Figure 2.5: Color of silica jelly before and after absorbing excessive moisture

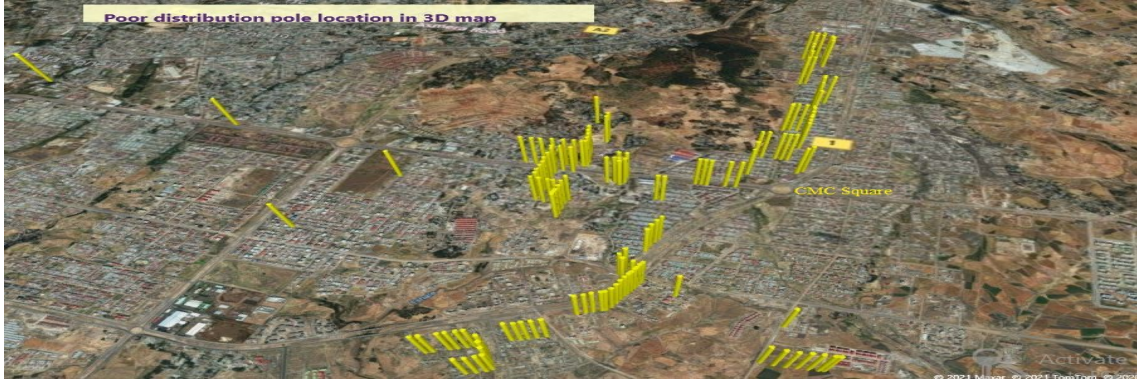
From the data noted above, wooden distribution poles with both tilted and poor foundations are identified. Typical poles with these problems are 205. Special attention needs to be given to cracked, poor foundation and tilted wooden poles to take serious measures. About 149 poles are inspected with these problems. Using GPS data, the area where these poles are located is inspected and depicted using 3d Google map, as shown in figure 3.7. Locating and visualizing those poles with the problems helps to make it easy for quick repair and maintenance. Also, the area that EEU should give more attention for

Figure 3.7: Location of cracked, poor foundation and tilted wooden poles around CMC and Ayat area

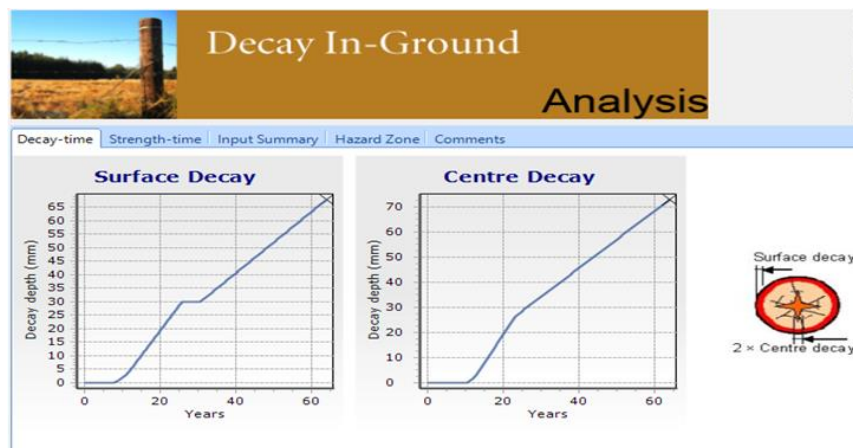
Considering the parameter of EEU wooden poles and the weather condition of the selected region, its decay characteristics are simulated. Both the surface and Centre decay of in-ground poles part is indicated by the software.

Figure 4.6: Surface and Centre decay of the inground distribution poles

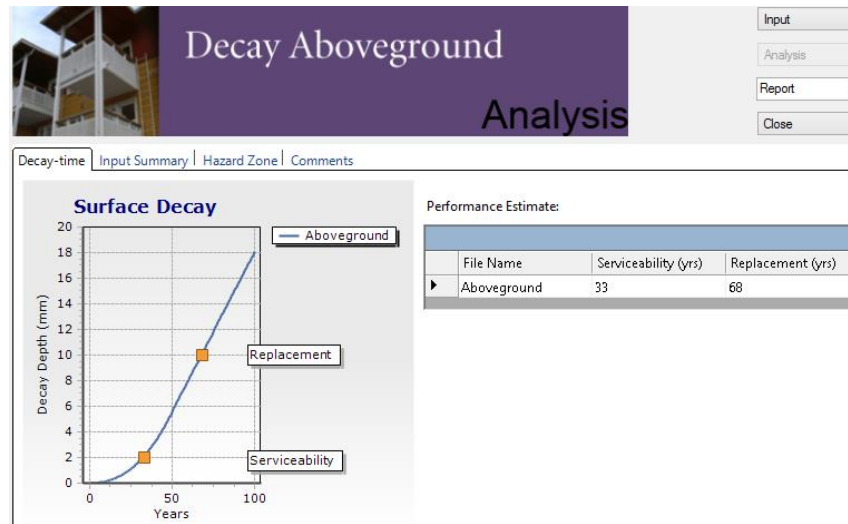
The surface decay of above-ground distribution poles is relatively slower. The result indicates that poles need service after 33 years and need replacements after 68 years of their installation. Its effect for failure is relatively low and not considered during simulation.

Figure 4.7: Surface decay of distribution pole above ground
