**GEOTECHNICAL INVESTIGATION OF
SOME FAILED SECTIONS ALONG OMO
RIVER-TERCHA ROAD PROJECT**

A Thesis in Geotechnical Engineering

By
Biniam Yihun
April, 2024
Addis Ababa

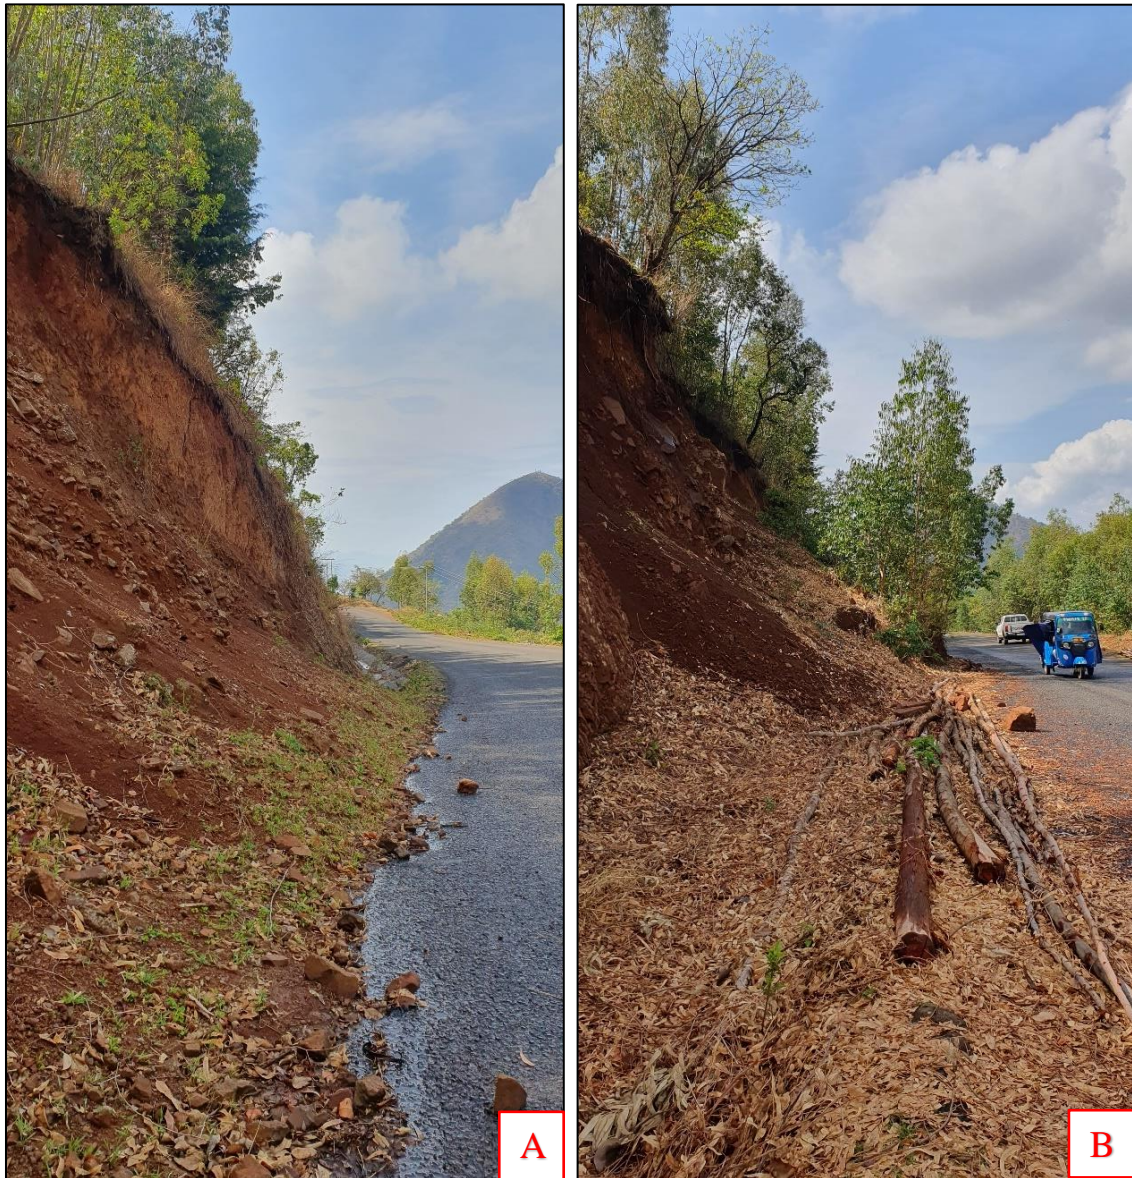
Figure 3-2: A) Slumping of soil mass B) Accumulation of displaced soil mass from the surface of cut slope @ km 100+300 RHS

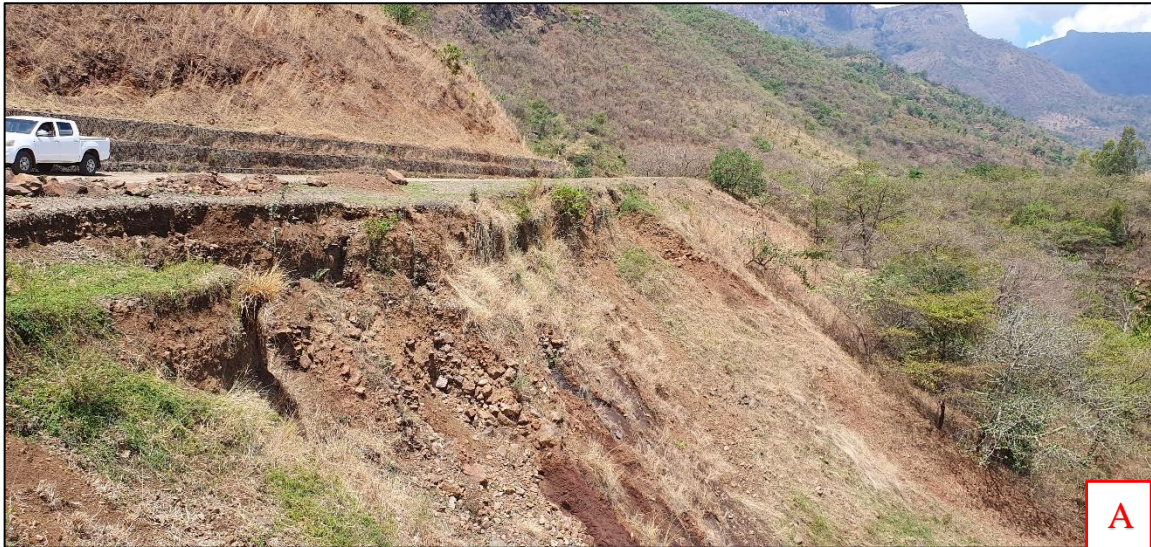
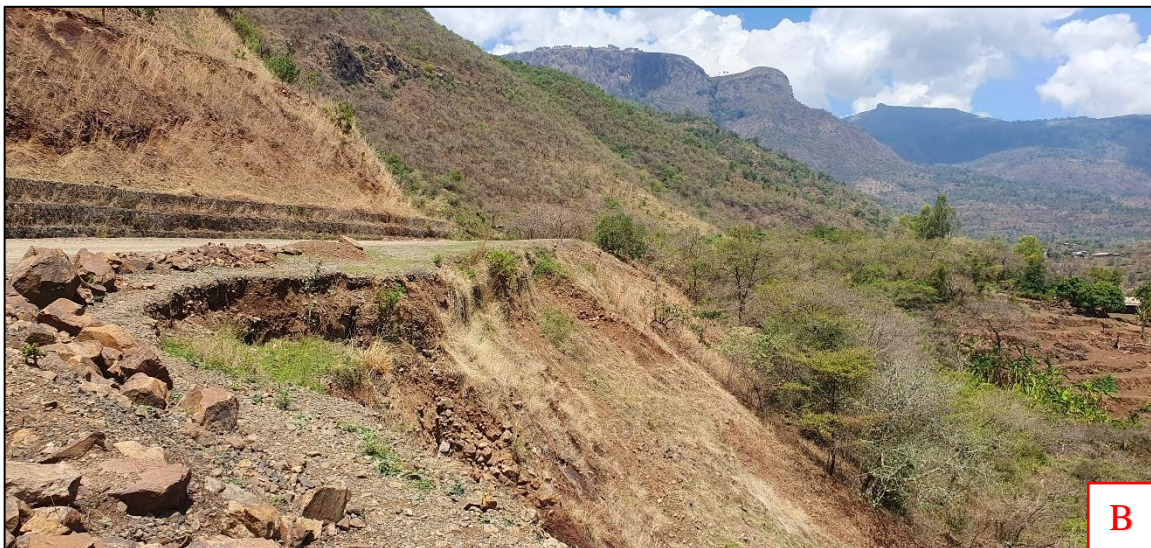
- This failed section has created a traffic disruption by a lane closure which adjacent to the fill and leading to traffic congestion.
- It is also creating hazards due to a potential for land slide.

Figure 3-3: A) Visible significant cracks on the surface of fill slope B) Bulging & deformation on the surface of fill slope @ km 126+000 RHS

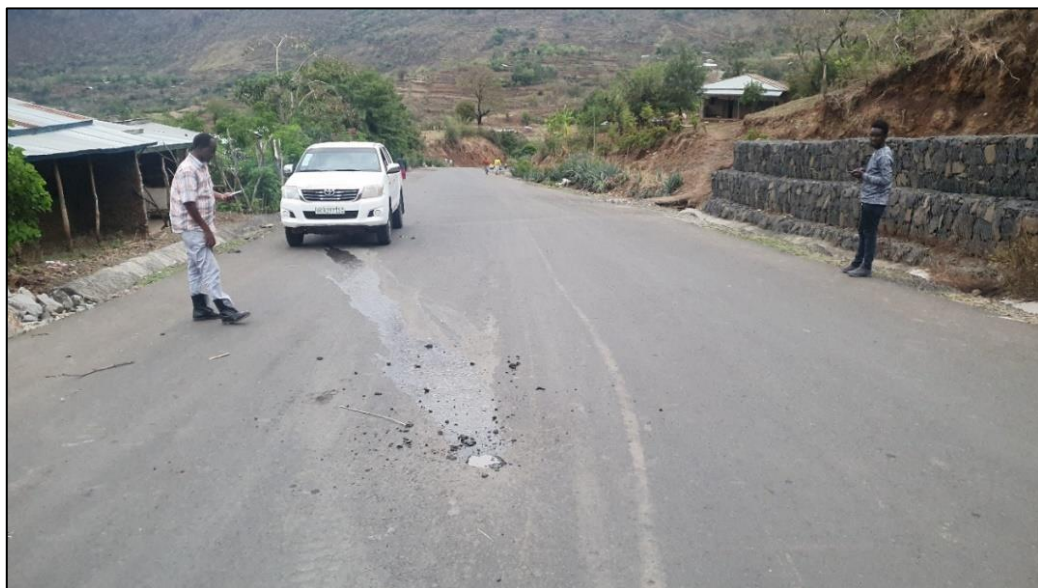
- Generally, the following major problems were observed during site investigation: softening of the pavement layers and subgrade by becoming saturated and remaining so for prolonged periods, degradation of the quality of pavement and subgrade material due to interaction with moisture and loss of bonding between pavement layers due to saturation with moisture.

Figure 3-4: Pumping of water through new placed asphalt concrete road @ km 105+000

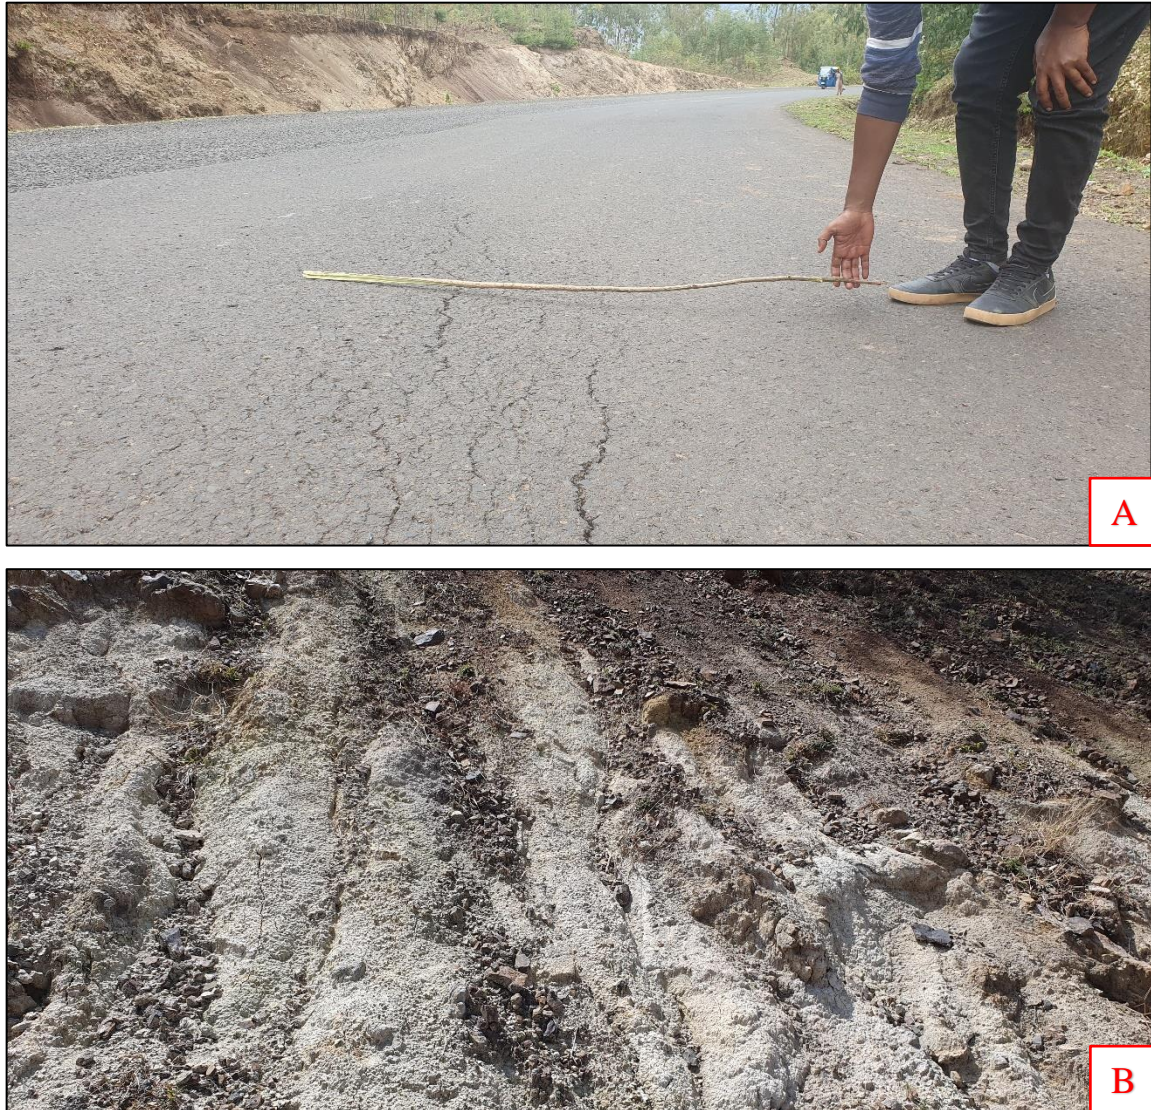
progressively increasing settlement which is resulting differential settlement where one part of the road settles more than the other this in turn leads to uneven pavement, roughness and cracking as shown in Figure 3-6.

**Figure 3-6: A) Cracks and uneven surface on newly placed asphalt B)
Problematic/Unsuitable subgrade soil @ km 114+100 LHS**

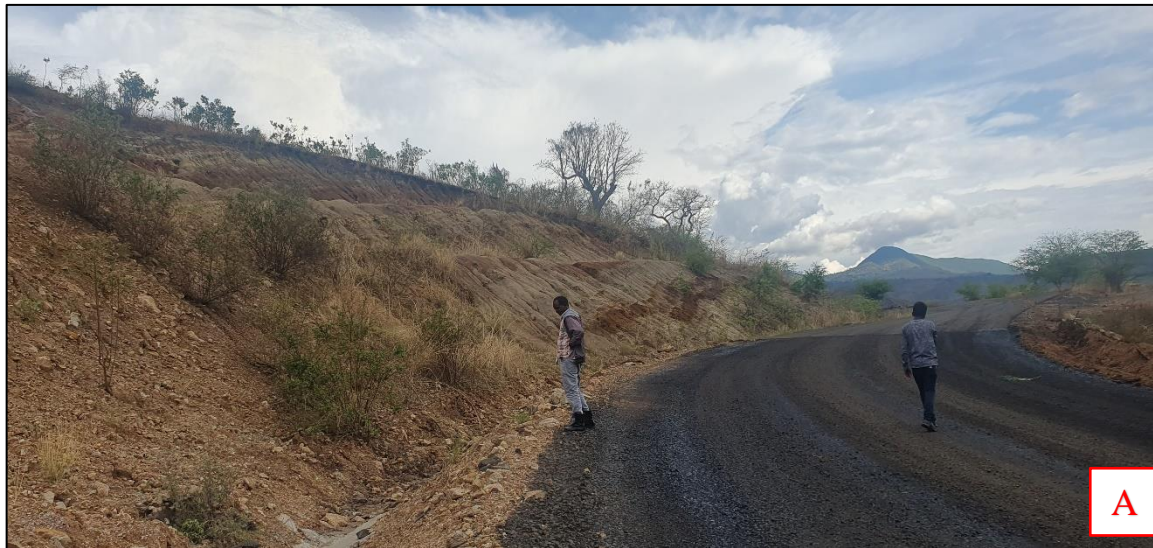
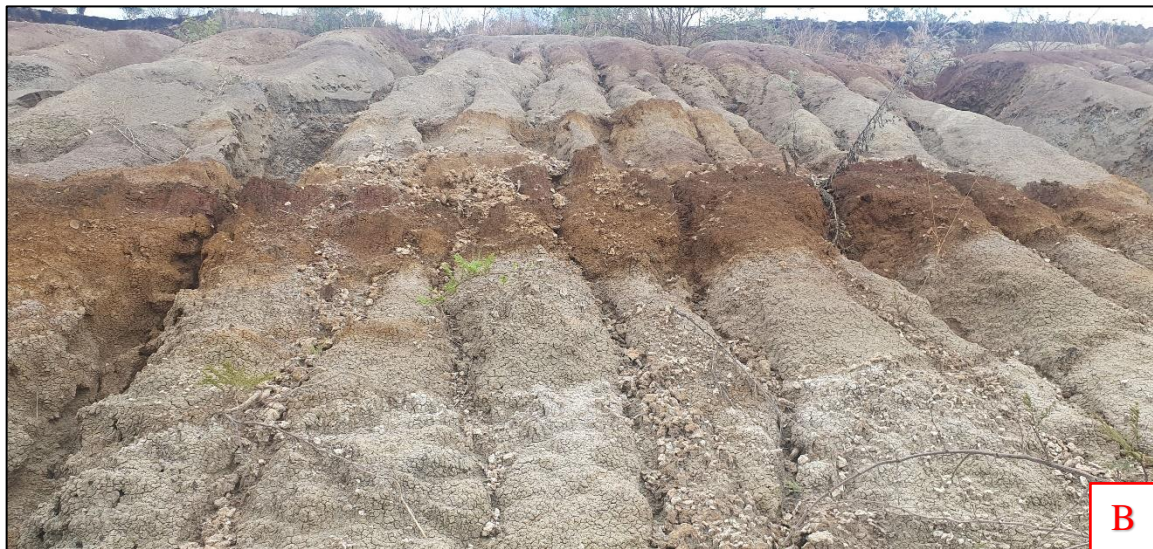
pavement, damaging the pavement structure (this side slope erosion is damaging the pavement structure particularly at the edge of the pavement adjacent to the slope) and increasing maintenance cost specially for repairing drainage systems as shown in Figure 3-7.

Figure 3-7: A) Accumulation of eroded soil in to the side ditch of the road B) Formation of gullies and channels on the surface of cut slope @ km 134+760 RHS

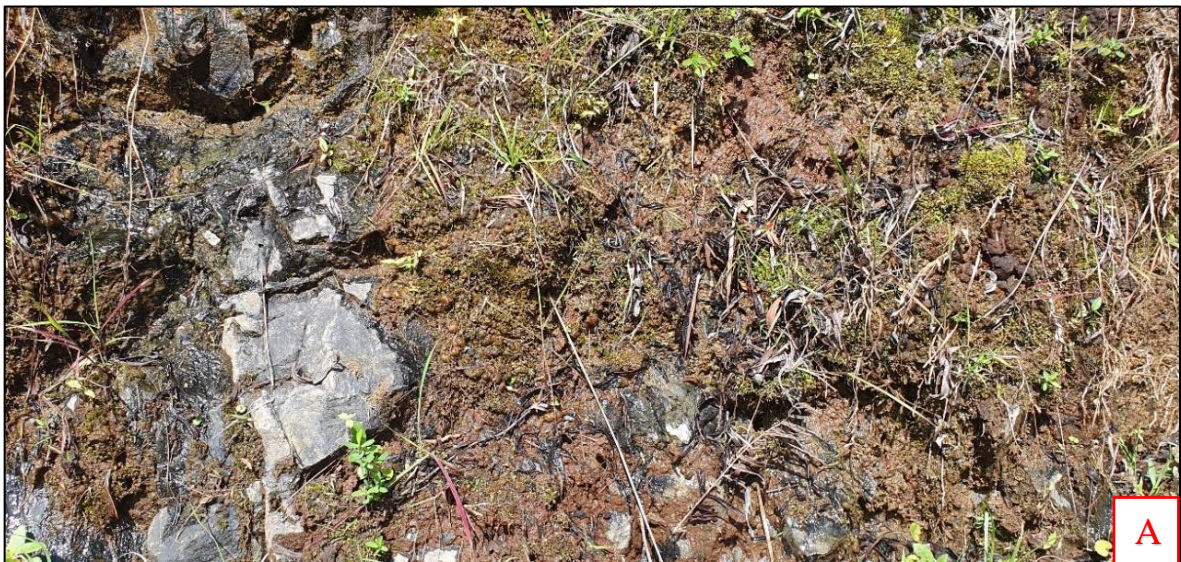
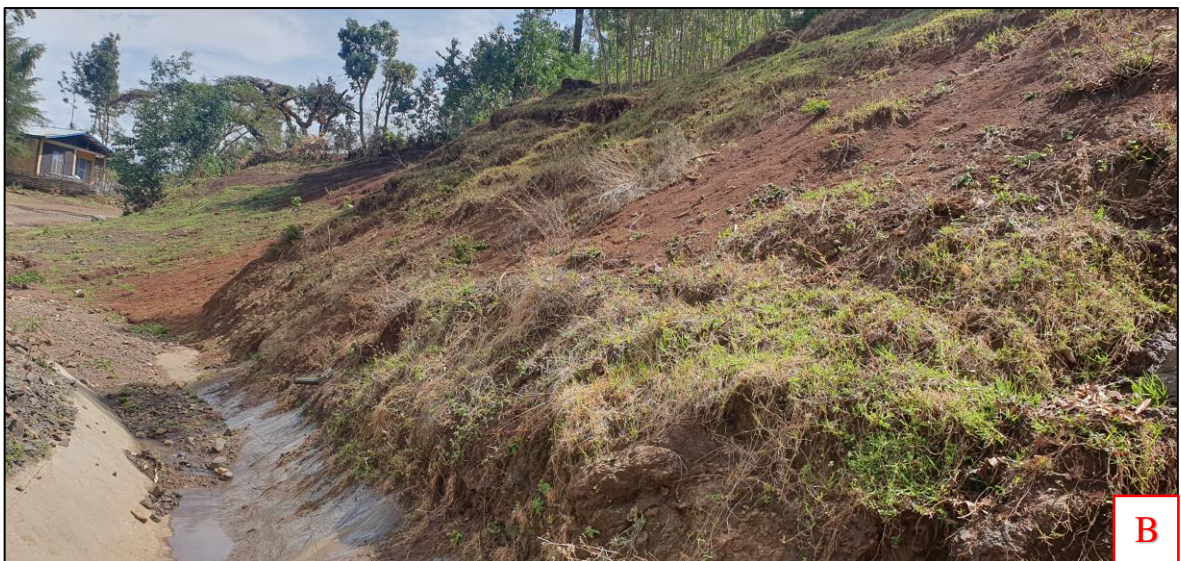
- The infiltration of water into the road cut face, caused by a high-water table or groundwater flow in the vicinity, has resulted in the gradual formation of wet patches.
- Due to the high permeability of the soils in the road cut face, water can easily pass through, resulting in the formation of wet patch.

Figure 4-1: A) Wet patches exposed on the surface of a road cut B) Out flow and seeping of water from high ground in the pavement and side ditch

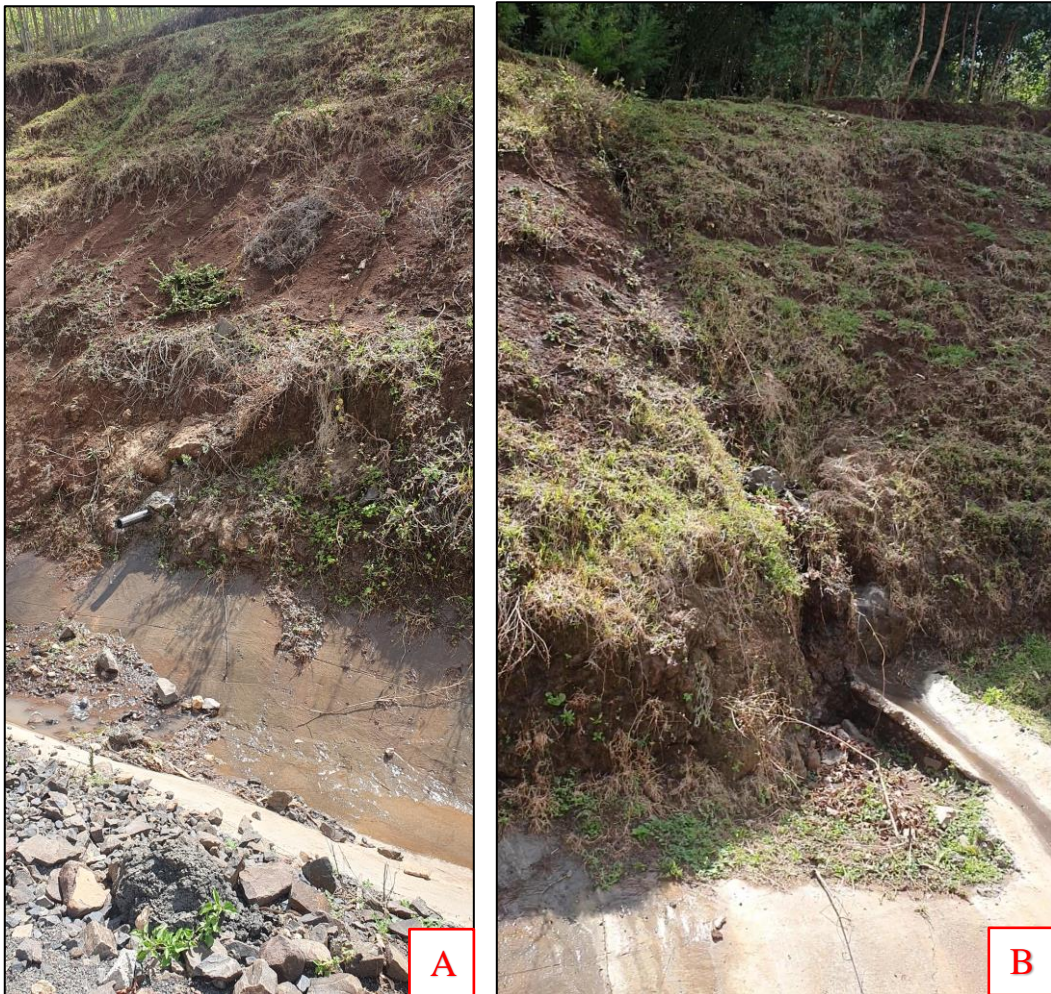
- This visible outflow typically originates from subsurface water within the road cut. The presence of outflows suggests a higher water pressure or hydraulic gradient within the road cut, leading to water actively escaping through openings.
- The flow range from a gentle trickle or seepage to a more forceful or concentrated stream as shown in Figure 4-2 A & B.
- Visible outflows highlight the importance of effective subsurface drainage measures in road cut design and construction.

Figure 4-2: A) Visible outflows on the side of road cut B) Presence of hydrophilic vegetation on the surface of high ground

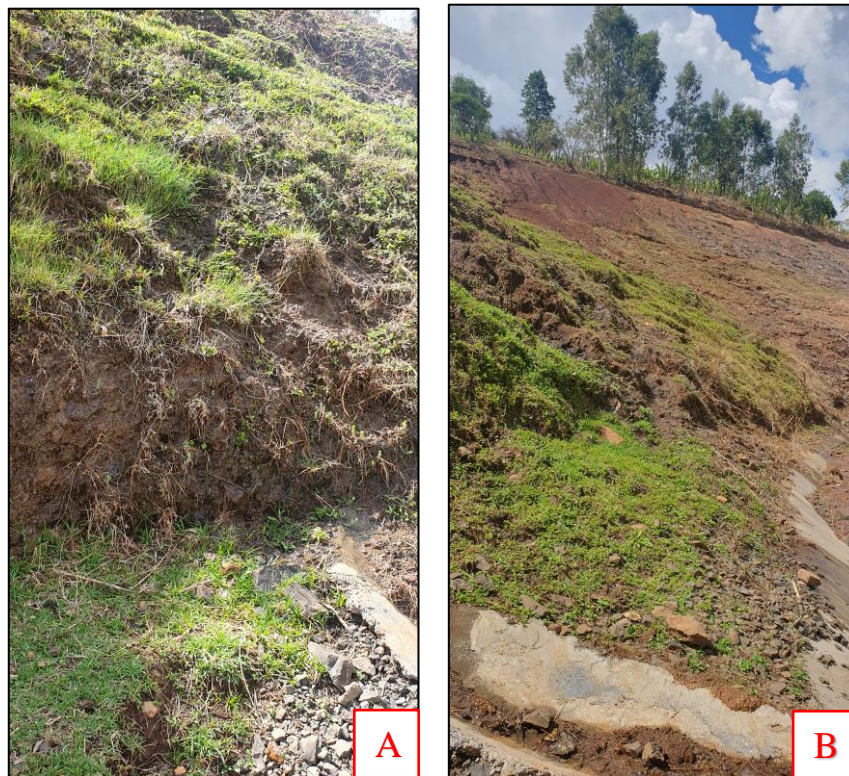
The variations in color and progressive growth of vegetation also provide insights into the hydrological dynamics within the road cut. They serve as indicators of localized water sources, such as seepage from higher ground. These signs are valuable in assessing the potential for water accumulation and the necessity for appropriate subsurface drainage measures to prevent the infiltration of water into the pavement structure at the investigated station along the roadway.

Figure 4-3: A) The road face cut exhibits the growth of hydrophilic vegetation B) Wet patches

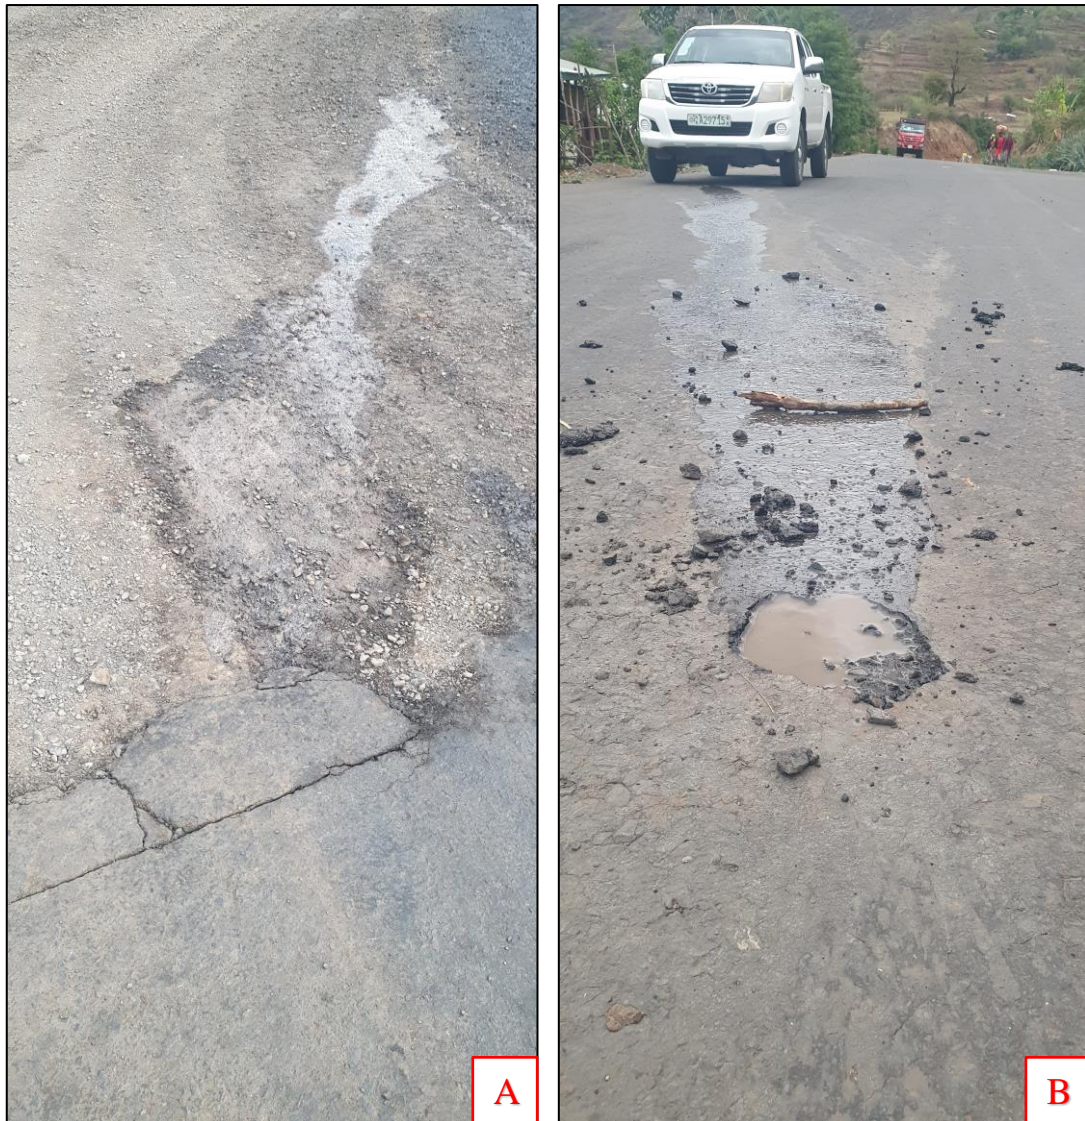
Additionally, tension cracks have been observed at the same station as shown in Figure 4-4 A. These cracks are typically longitudinal and develop on the road surface due to the stress and strain imposed by external forces. When subsurface water seeps into the pavement layers, it causes a loss of support and uneven expansion or contraction of the layers. This differential movement generates tensile stresses, leading to the formation of tension cracks on the road surface. These findings have been noted at station km 105+000 along the roadway.

Figure 4-4: A) Road surface pre-mature failures B) Pumping out of water on the surface of the pavement

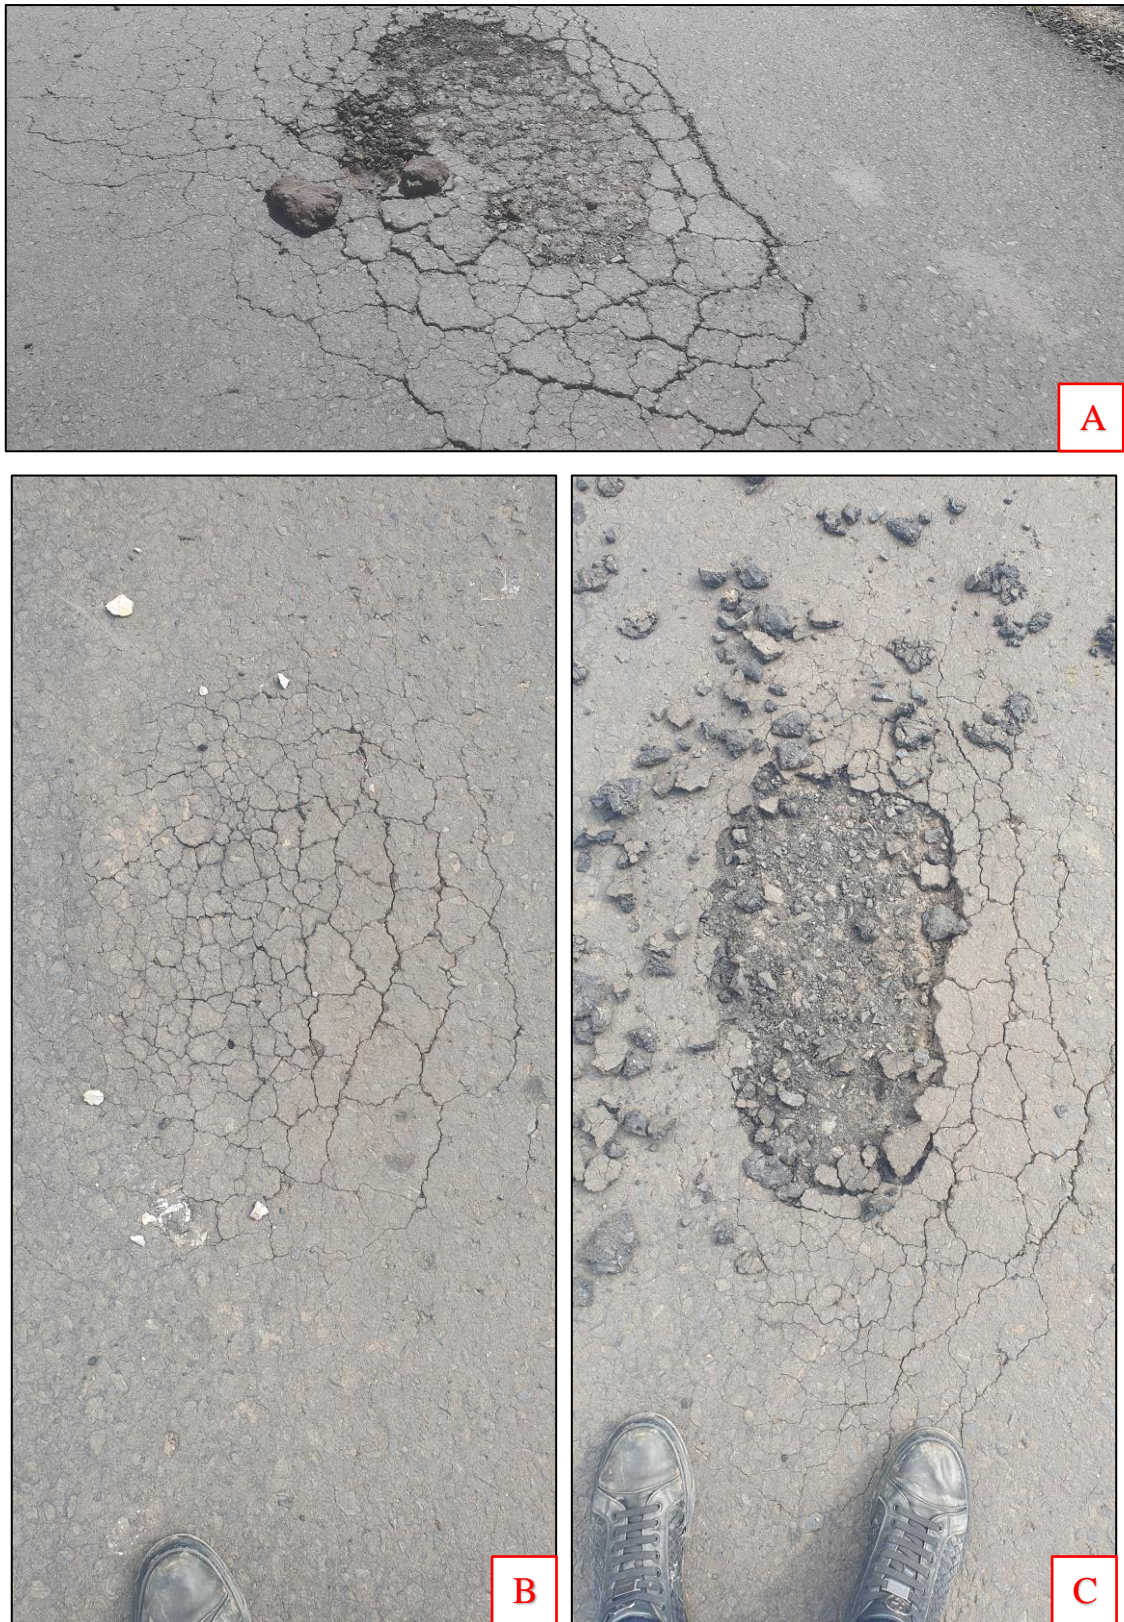
The repetitive occurrence of this phenomenon can result in the stripping of asphalt from aggregates that have been stabilized with asphalt cement. It causes the loss of cohesion and contributes to the development of shrinkage cracking in Asphalt Concrete pavements. These effects have been observed progressively in the selected section of the road project as clearly shown in Figure 4-5 A, B & C.

Figure 4-5: A&B) Cracking on newly placed asphalt C) Stripping of asphalt from aggregates

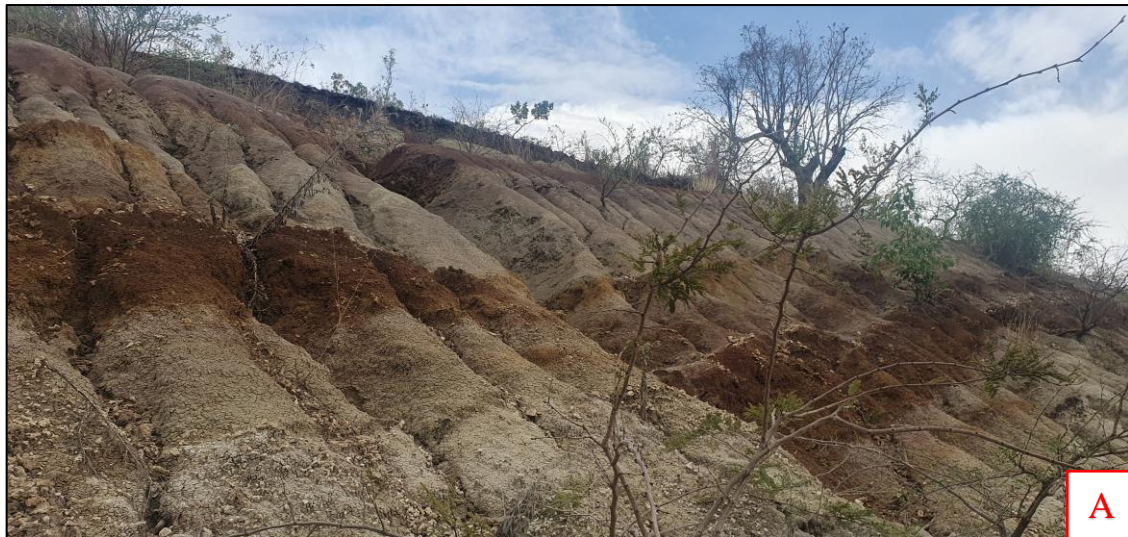
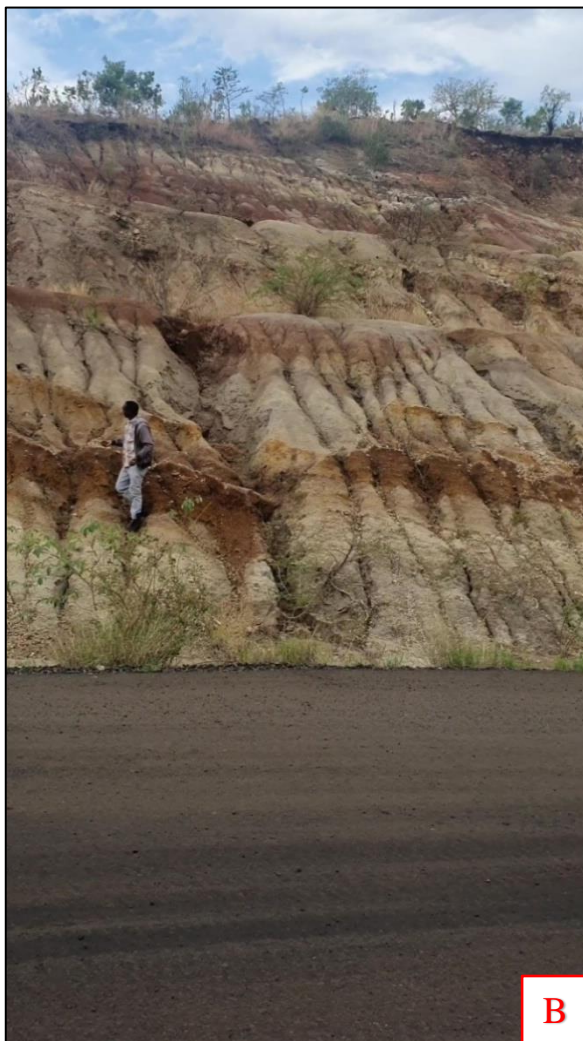
At the designated station along the roadway, the presence of rills and gullies on the slope surface has been observed. These formations range from small channels (rills) to larger, deeper channels (gullies) as shown in Figure 4-8 A & B. The existence of these channels indicates the concentrated flow of water, which is progressively causing erosion and soil removal Figure 4-8 C.

Figure 4-8: A & B) Formations of rills and gullies on the surface of slope C) Crack and fissures on the surface of slope soil

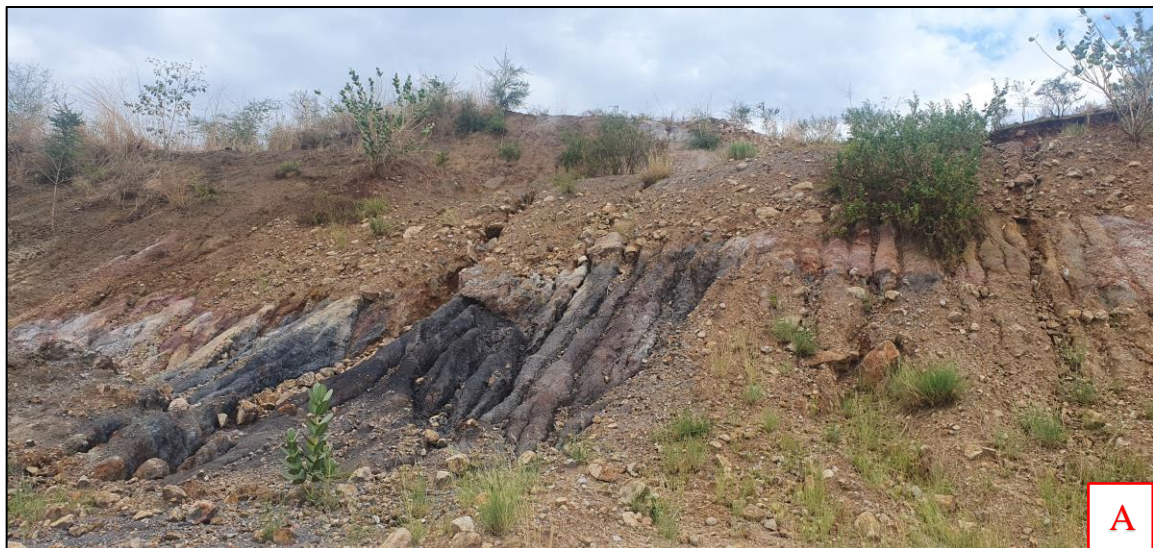
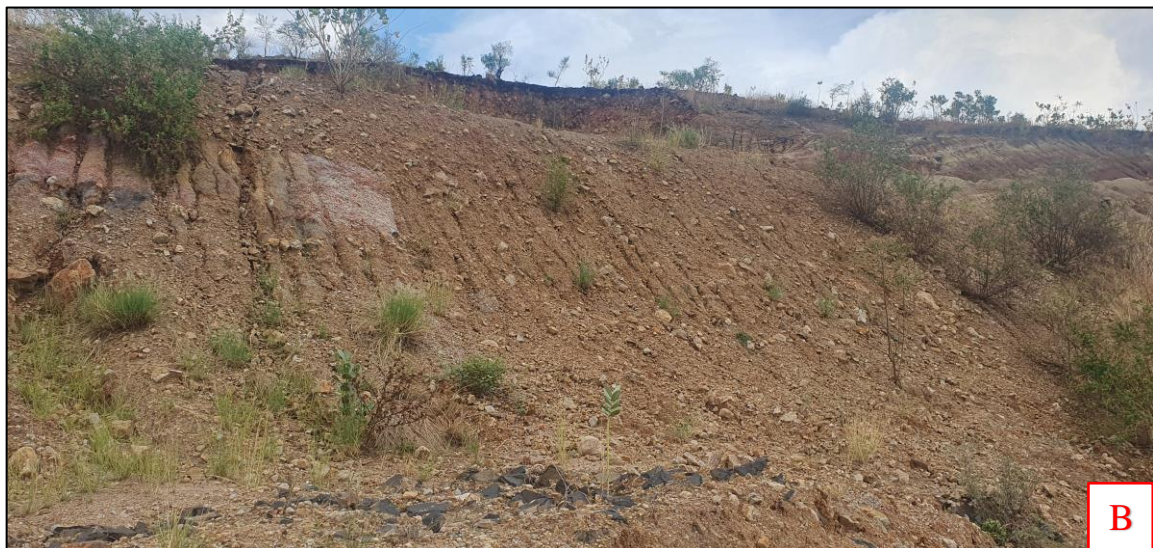
At this specific station, a significant number of exposed plant roots have been observed. These roots were initially covered by soil but have become exposed as a result of soil erosion along the surface of the roadway side cut slope. This condition progressively compromises the stability of the slope and exacerbates the erosion process. And also it has been observed that there is progressive loss of vegetation cover on the slope, including the disappearance of grass, shrubs, or trees, due to erosion washing away the topsoil and affecting the growth and stability of vegetation as shown in Figure 4-9 A & B.

Figure 4-9: A) Exposed plant roots and vegetation loss on the surface of a slope B) Disappearance of grass, shrubs and trees due to erosion washing away the topsoil

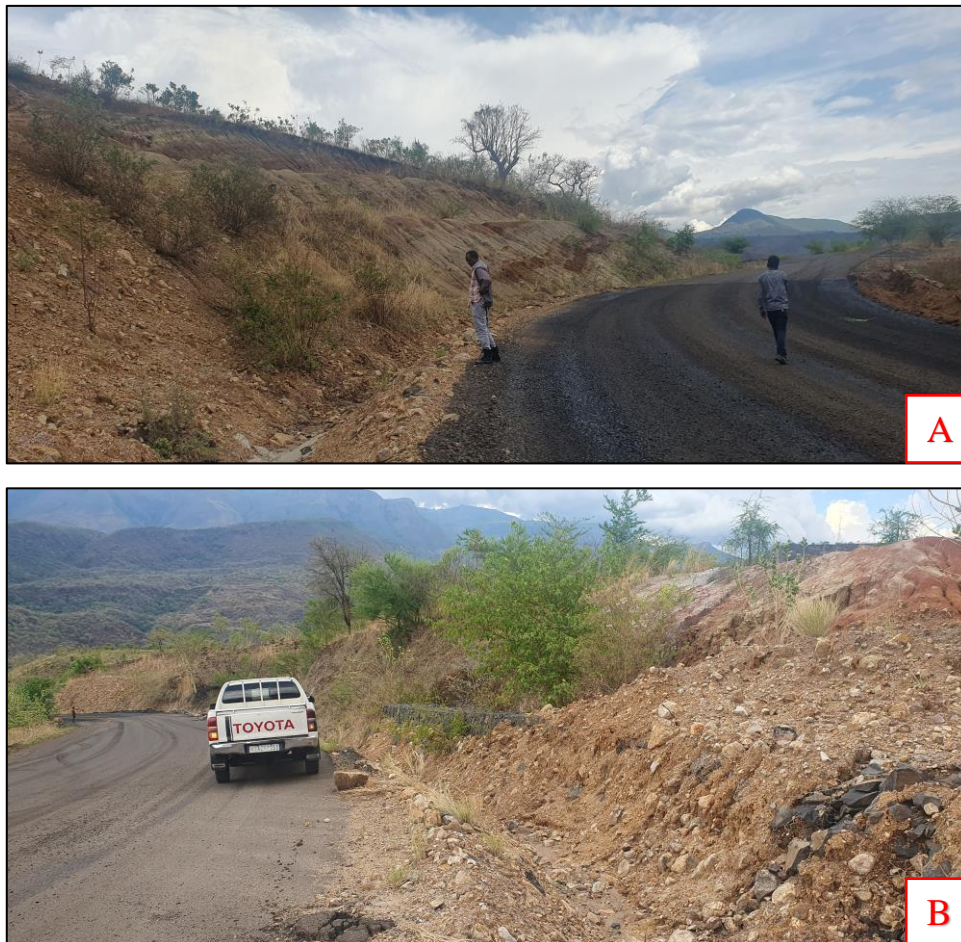
At the site it has been observed as shown in Figure 4-10 A & B, that the ongoing soil erosion along the side slope is adversely affecting the drainage patterns surrounding the gabion wall constructed at the base of the slope. The uncontrolled buildup of sediment and debris behind the wall is obstructing the natural flow of water, resulting in pooling and potentially compromising the foundation of the wall. It has been also observed that leaning and tilting of the constructed gabion wall due to erosion-induced instability.

Figure 4-10: A) Accumulation of sediments B) Tilting of adjacent structure (gabion wall)

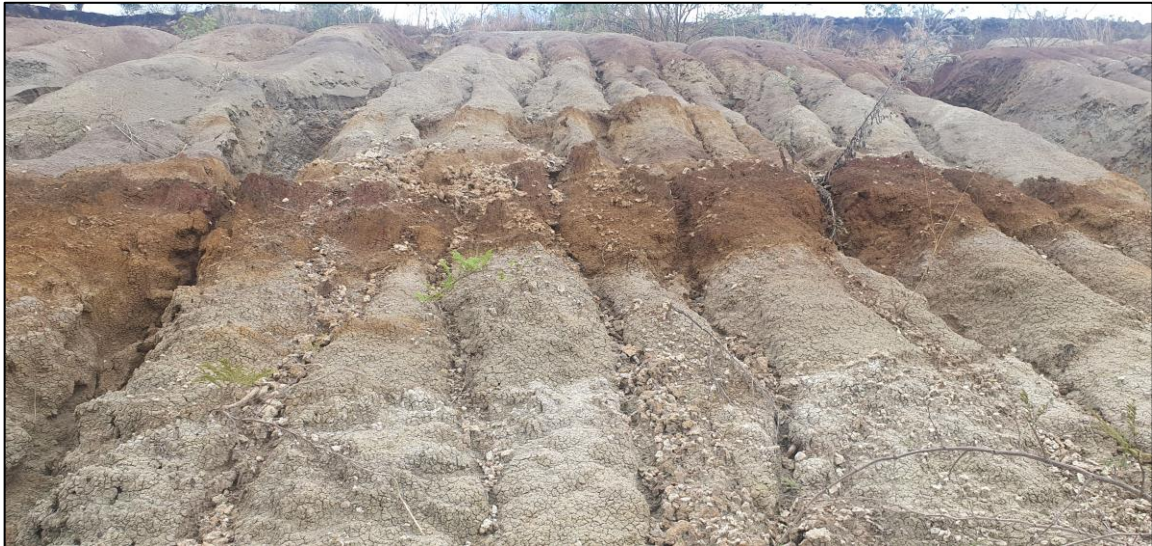
At the specified station, additional indicators of soil erosion from the sloping surface include the formation of cracks or fissures on the slope as shown in Figure 4-11. These cracks or fissures have occurred due to the drying and shrinking of eroded soil. Additionally, the soil on the slope may become loose, crumbly, or saturated, which are clear signs of erosion and a reduction in soil stability.

Figure 4-11: Formation of cracks, fissures, looseness and crumbliness of soils on the slope surface

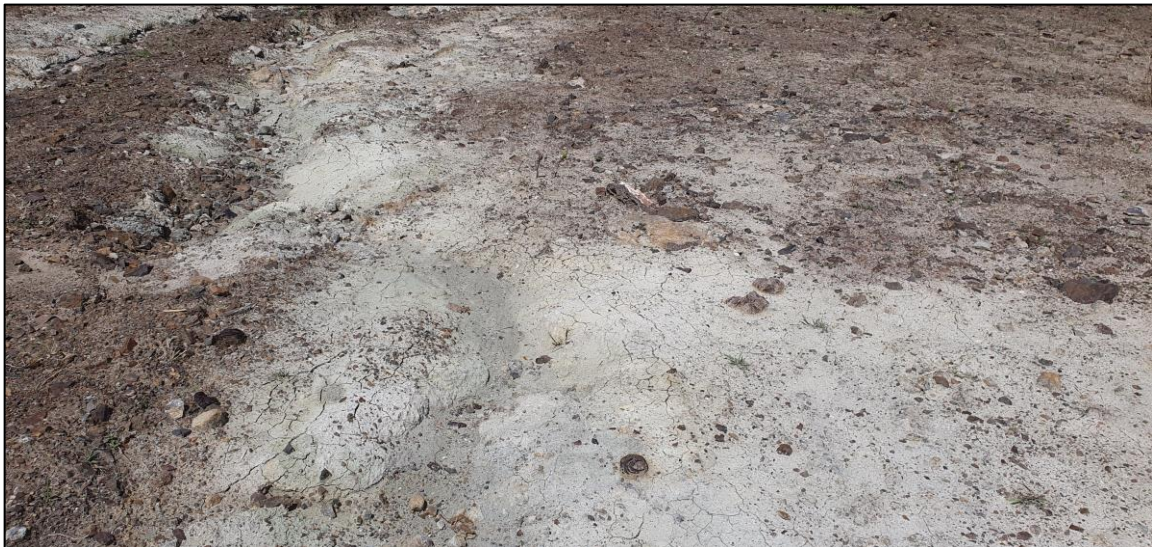
As a consequence of these overlooked issues, premature pavement failures occurred shortly after the project was completed and opened for traffic.

Figure 4-18: Problematic/unsuitable subgrade soil (Yellowish to whitish silty clay soil)

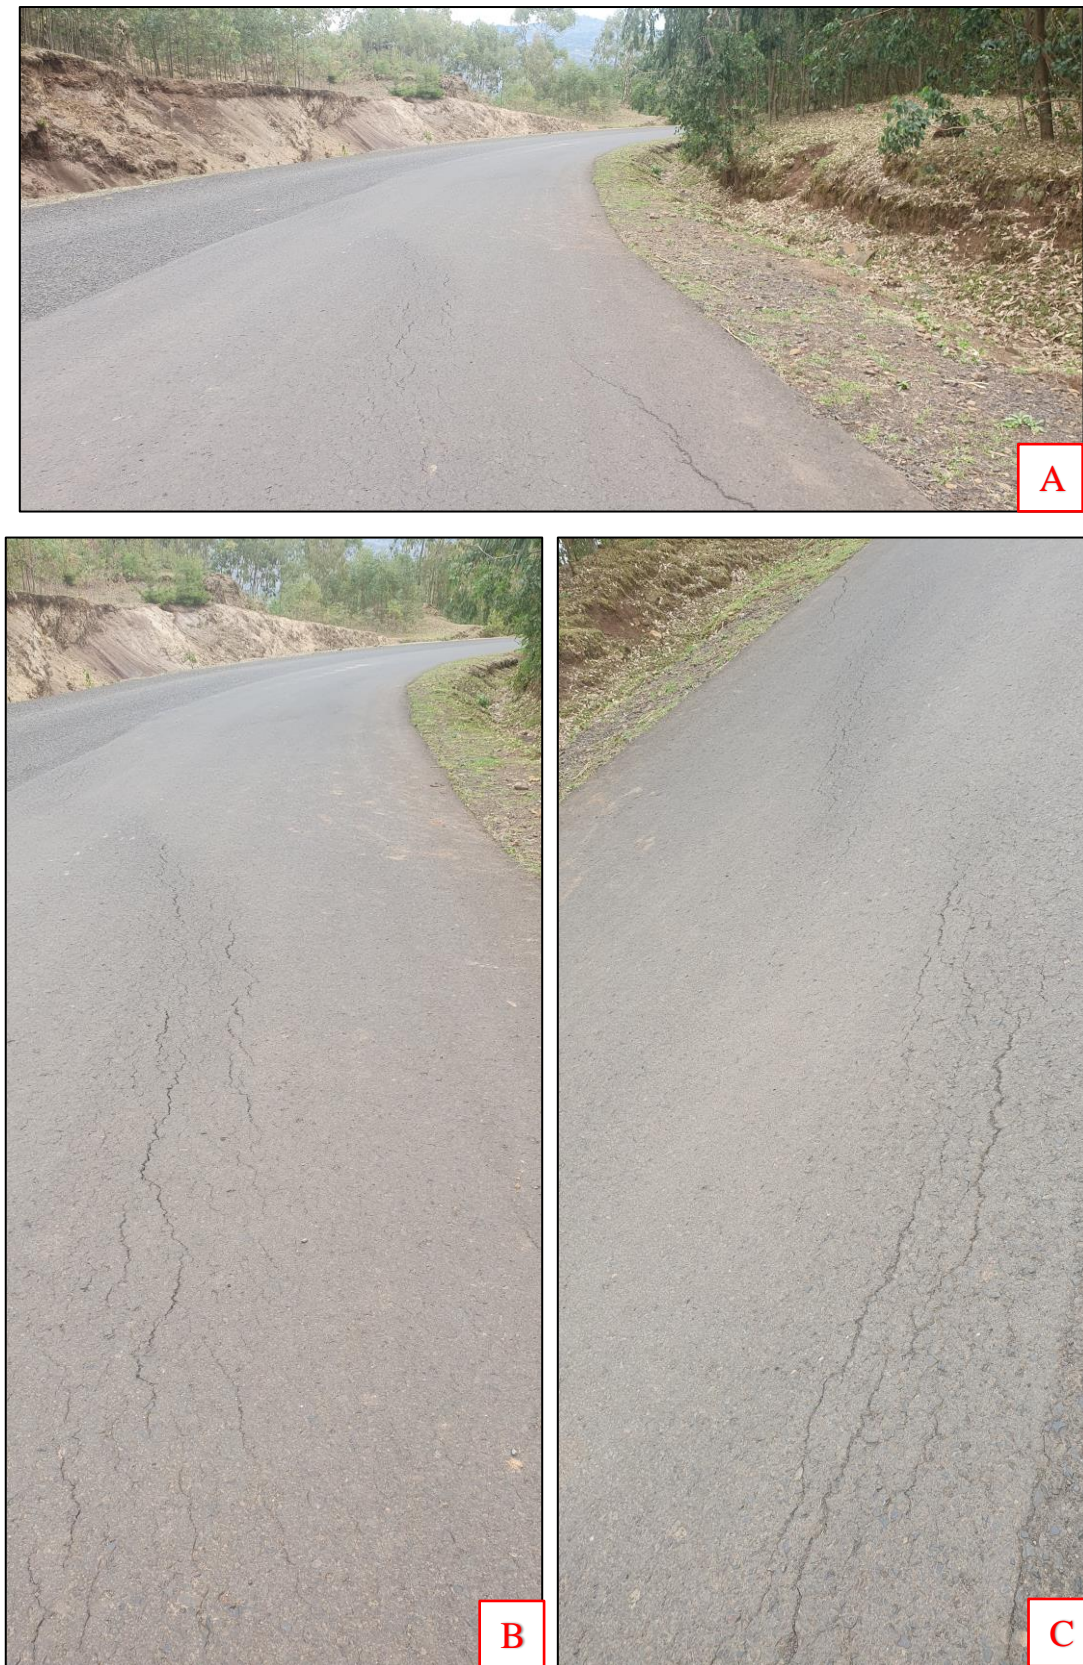
The in situ subgrade soil's insufficient supporting strength leads to ongoing settlements, resulting in an uneven pavement surface with varying elevations in adjacent driving lanes. The surface deformations, such as bumps, waves, and undulations, are evident on the road surface as shown in Figure 4-19 A & C. These deformations are caused by the subgrade soil's inadequate supporting capacity, creating an uncomfortable and uneven driving experience for road users.

Figure 4-19: A) Surface undulation B) Surface cracking C) Settlement and depression

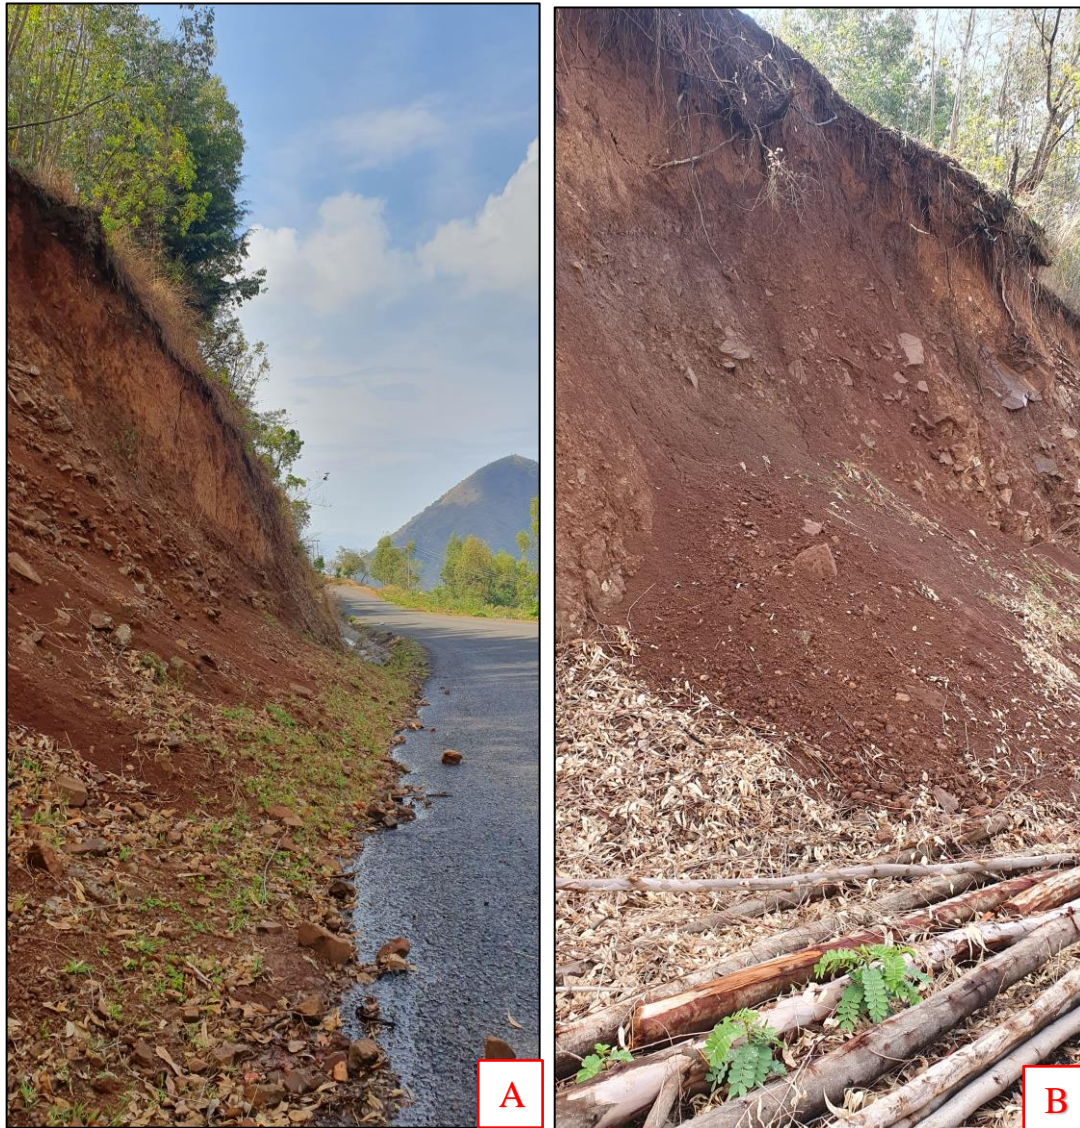
Figure 4-22: A) Slumping B) Accumulation of displaced soil from the surface of slope

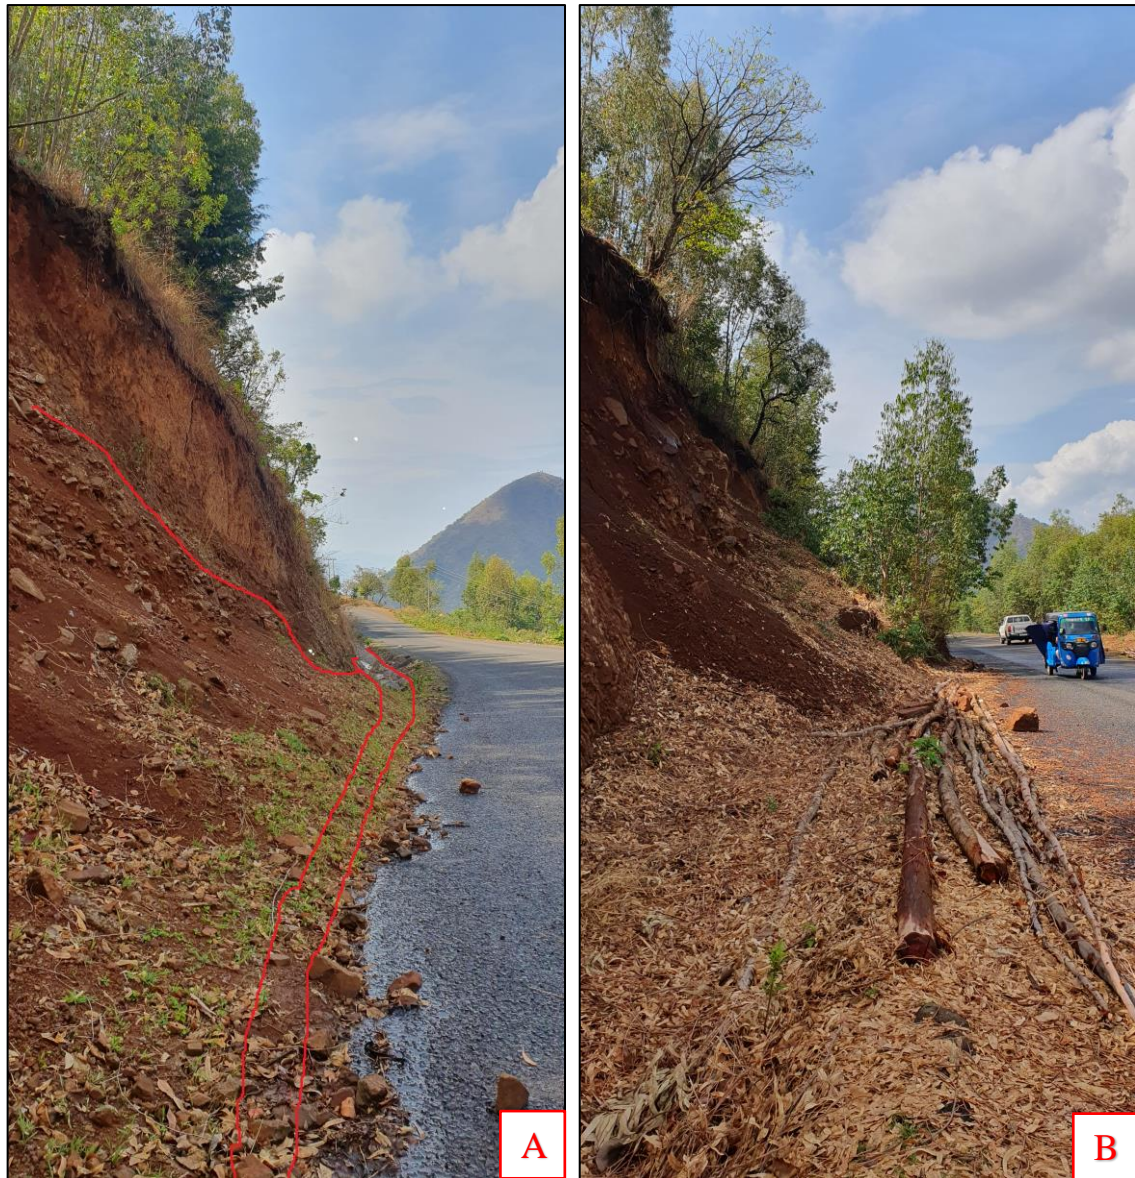
Figure 4-23: A) The side ditch adjacent to the road has been filled by sliding material B) A section of driving lane has been covered by the sliding material @ km 100+300 RHS
