**GEOTECHNICAL INVESTIGATION OF
SOME FAILED SECTIONS ALONG OMO
RIVER-TERCHA ROAD PROJECT**

A Thesis in Geotechnical Engineering

By
Biniam Yihun
April, 2024
Addis Ababa

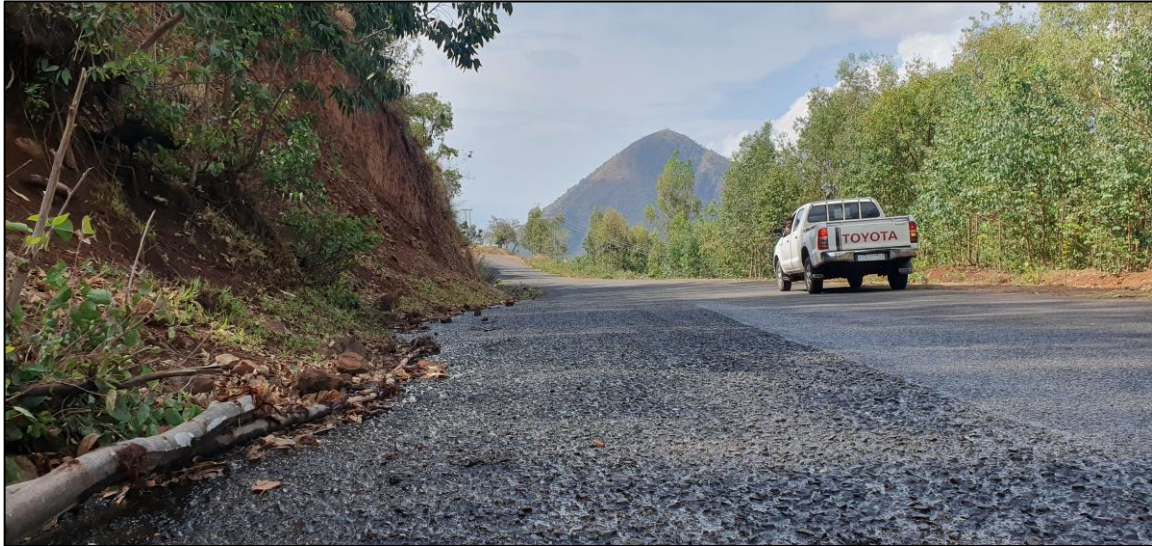
Figure 4-24: Debris flow near the toe of the failed slope @ km 100+300 RHS

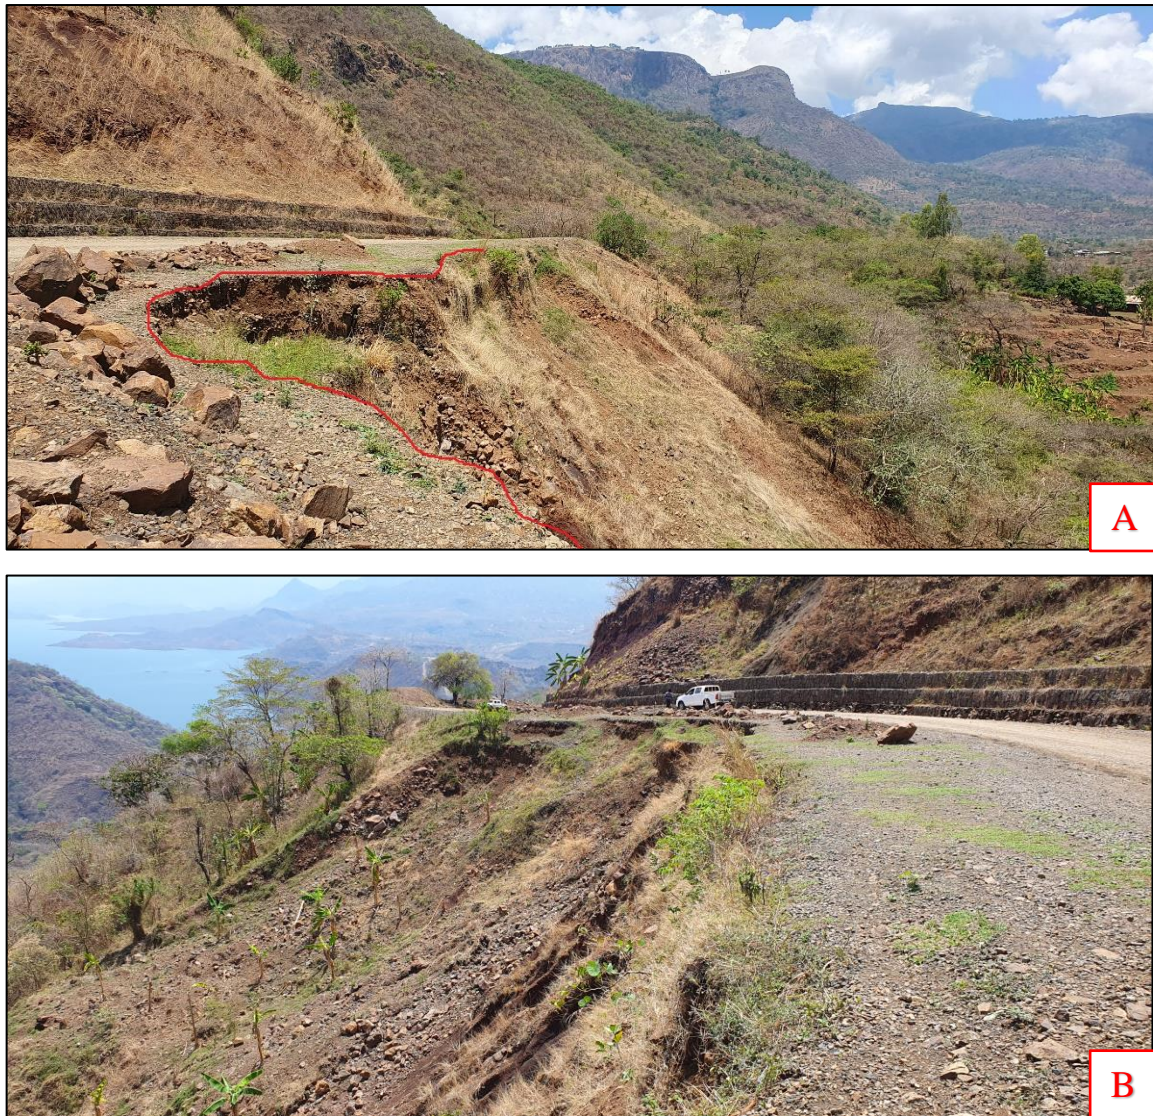
Figure 4-36: A) Visible cracks on the surface of roadside fill slope B) Bulging on the surface of fill slope

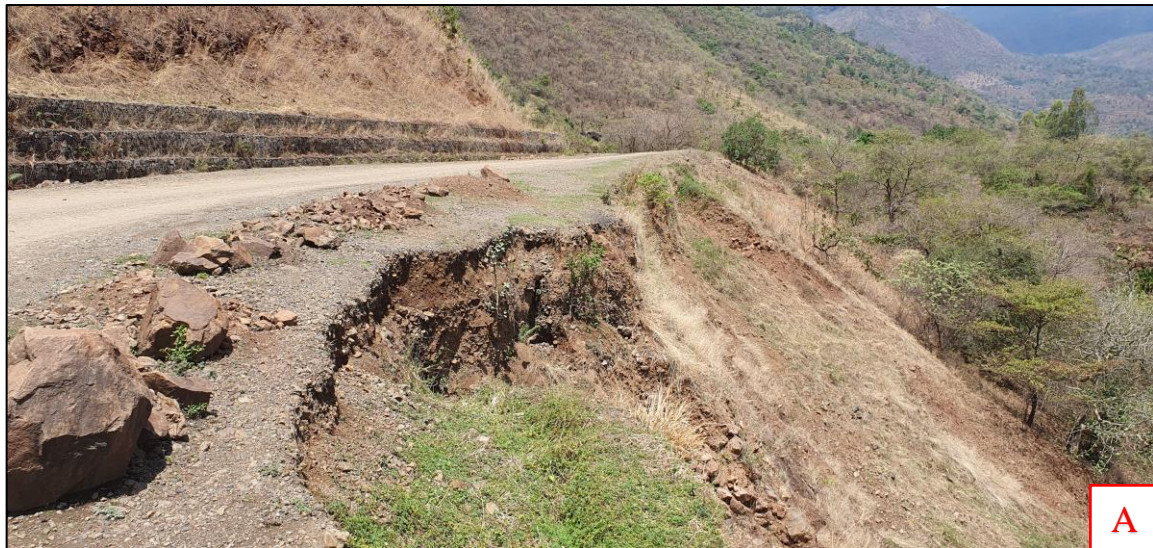
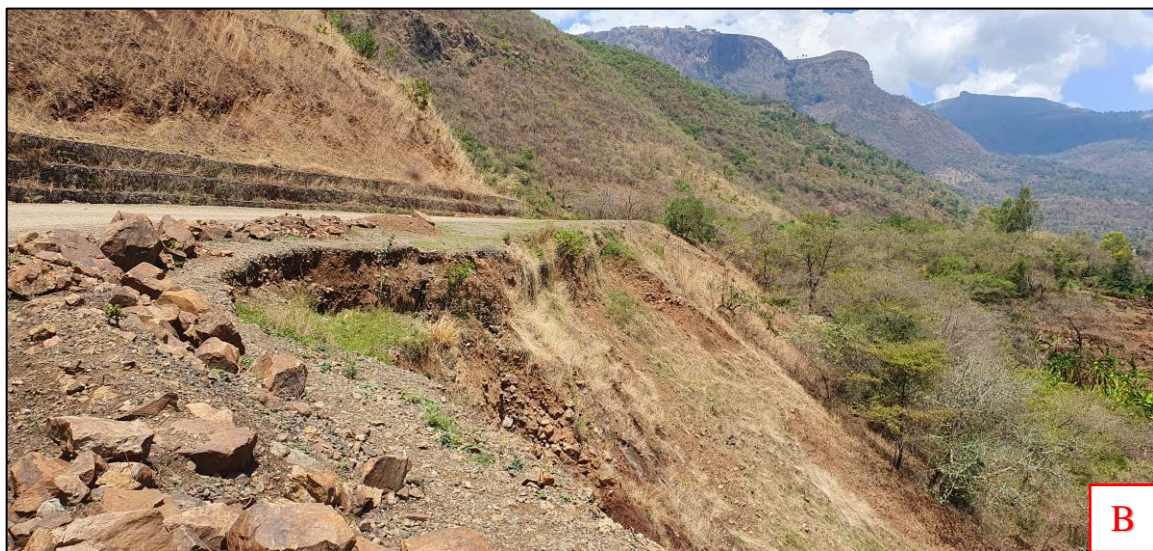
Figure 4-37: A) Deformations on the surface of fill slope B) Bulging on the surface of roadside fill slope

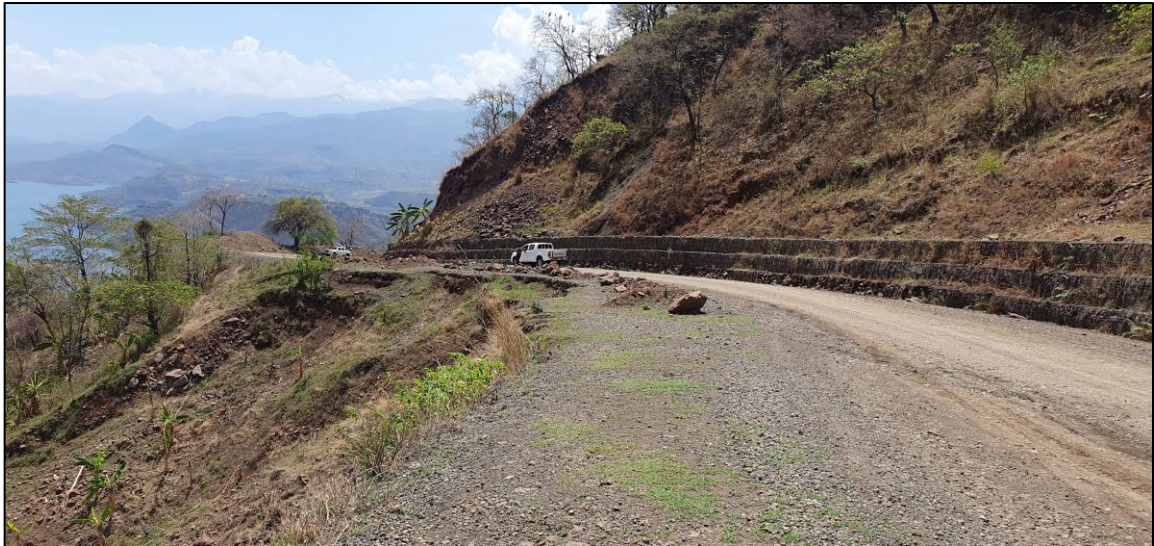
Figure 4-38: Significant signs of extensive cracking and settlements on the surface of road

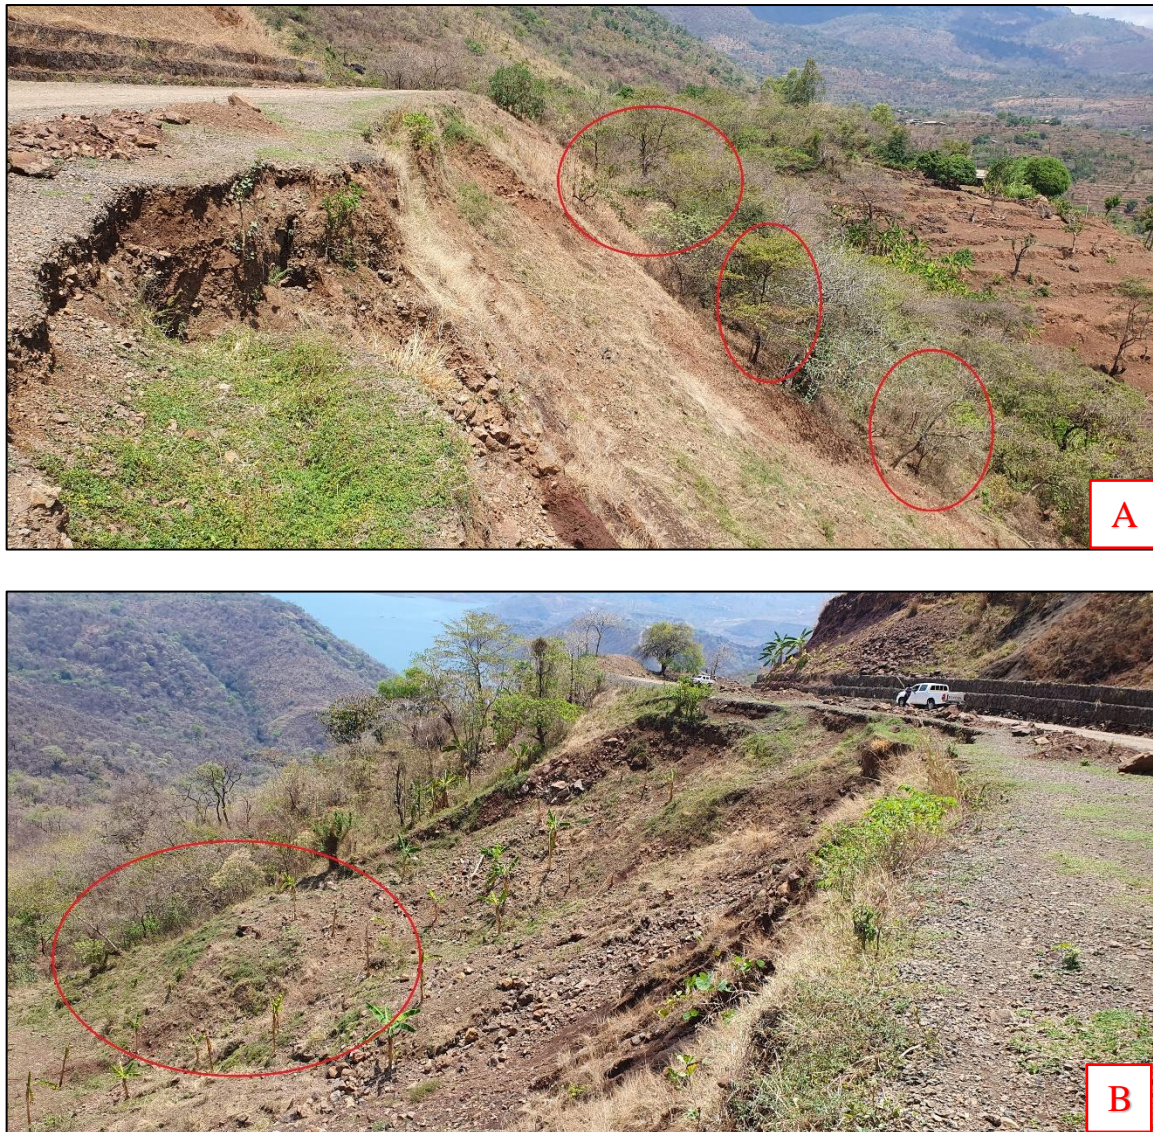
Figure 4-39: A) Leaning of trees B) Accumulation of debris
