***ASSESSMENT OF PIPE FAILURE CAUSES (CASE STUDY ON CHIRO  
TOWN WATER SUPPLY DISTRIBUTION SYSTEM), ETHIOPIA***

A thesis submitted and presented to the school of graduate studies of Addis Ababa University in partial fulfillment of the degree of Masters of Science in Civil and Environmental Engineering (Major in Water Supply & Environmental Engineering).

**By**  
Masho Dekamo

September, 2021  
Addis Ababa, Ethiopia

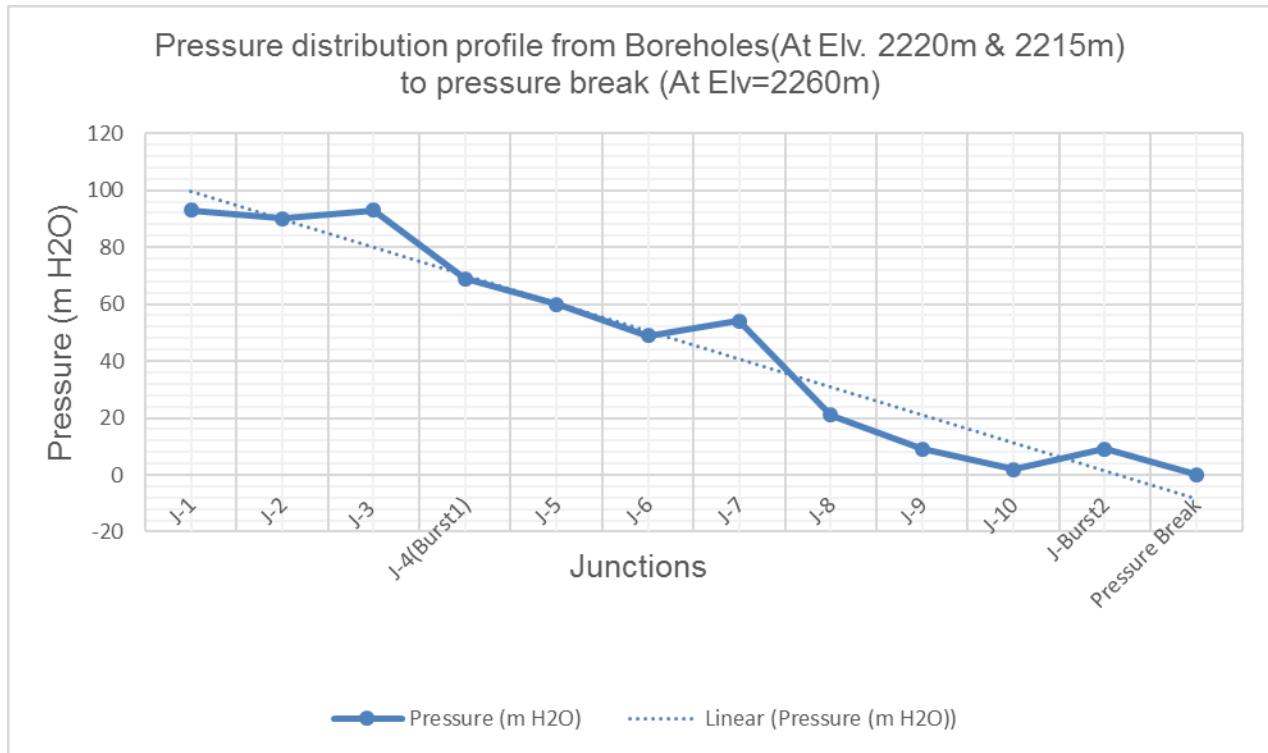
Figure 4.3.1 Pressure distribution profile from two wells to pressure break

Frequently bursting of uPVC pipe (250mm diameter, PN10) was appeared between two wells and pressure break at two places along the laid pipes. The pressure appeared at these places were 69 m and 9m at junction 4 (B1) and junction B2 respectively. But, when compared to the normal operating pressure(60m-70m) both pressures happens are less than the operating pressures (69m<70m & 9m <60m).

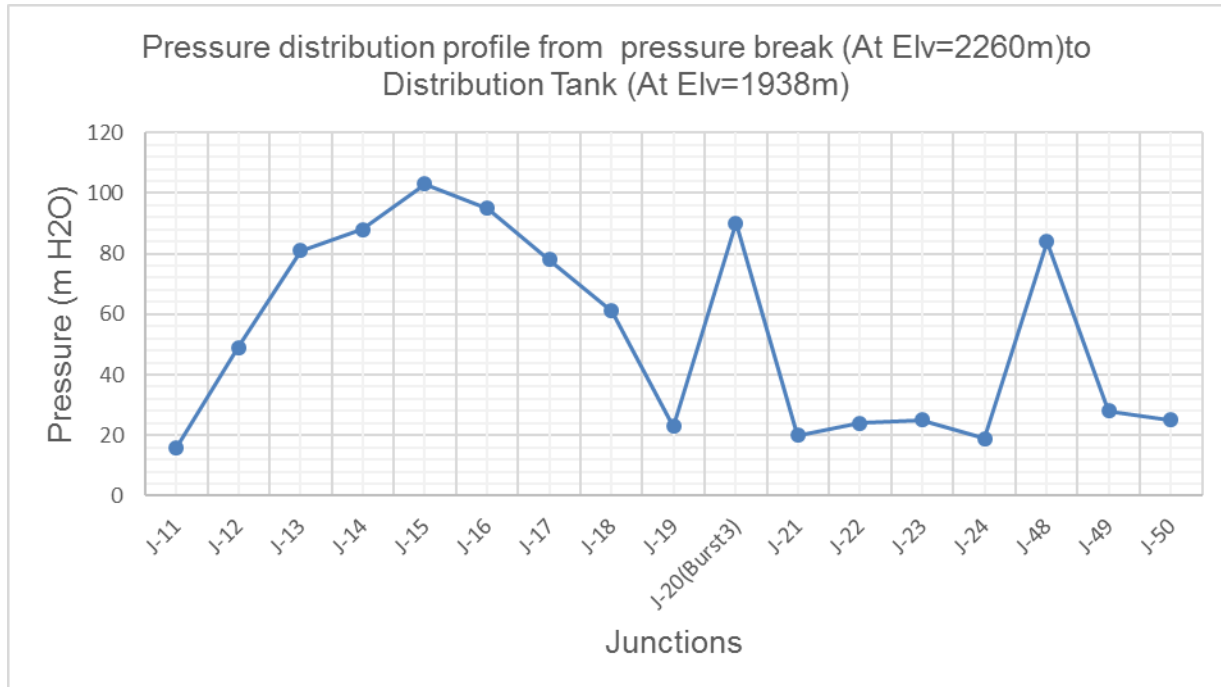
*Figure 4.3.2 Pressure distribution profile from pressure break to Tank 1*

Frequently bursting of uPVC pipe (300mm diameter, PN10) was appeared between pressure break and distribution tank (tank 1). The pressure appeared at this place was 90 m at junction 20 (B3) and when compared to allowable operating pressure, the pressure event was greater than the operating pressure (90m>70m). So, hydraulic condition could be one of the factors which leads to a pipe burst at this junction.

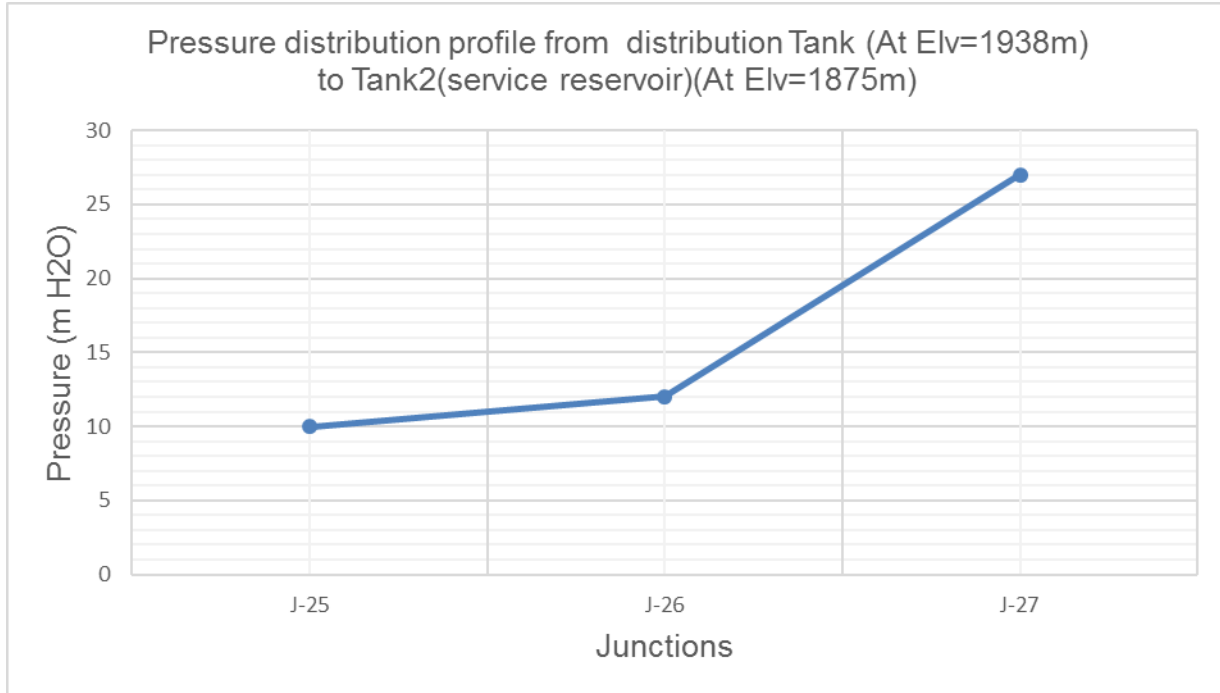
*Figure 4.3.3 Pressure distribution profile from Tank1 to Tank 2*

All pipe laid between these two points distribution tank (tank 1) and service reservoir (tank 2) are uPVC pipe (250mm diameter, PN16). At this area there is no pipe burst found from installed year to this day (15/01/2020) or has no pipe burst history and also low pressure appeared at these areas (i.e 10,12,27mH<sub>2</sub>O).

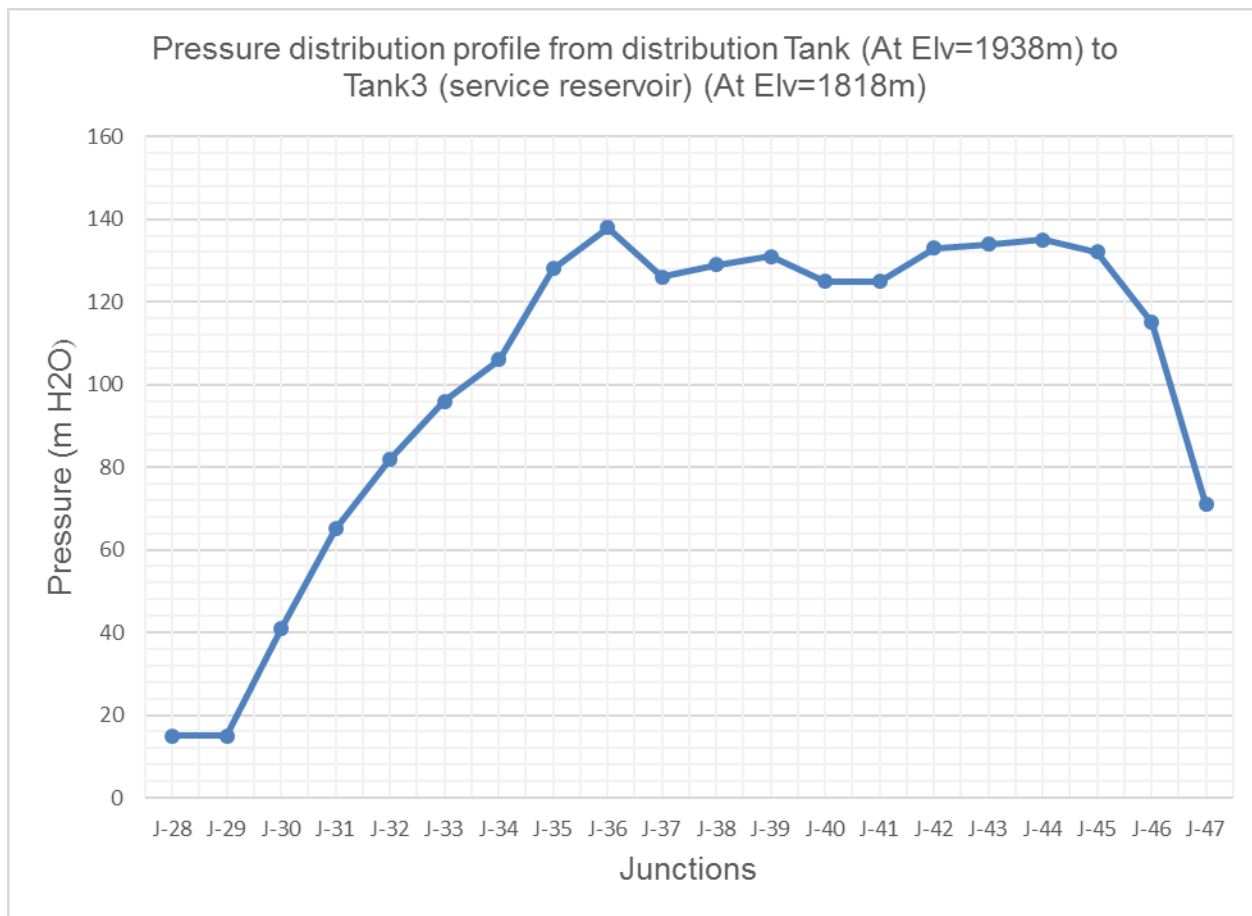
Figure 4.3.4 Pressure distribution profile from Tank1 to Tank 3

All pipe laid between these two distribution tank (tank 1) and service reservoir (tank 3) are DCI pipe (250mm diameter, PN16). At this area there is no pipe burst found from installed year to this day (15/01/2020) or has no pipe burst history.

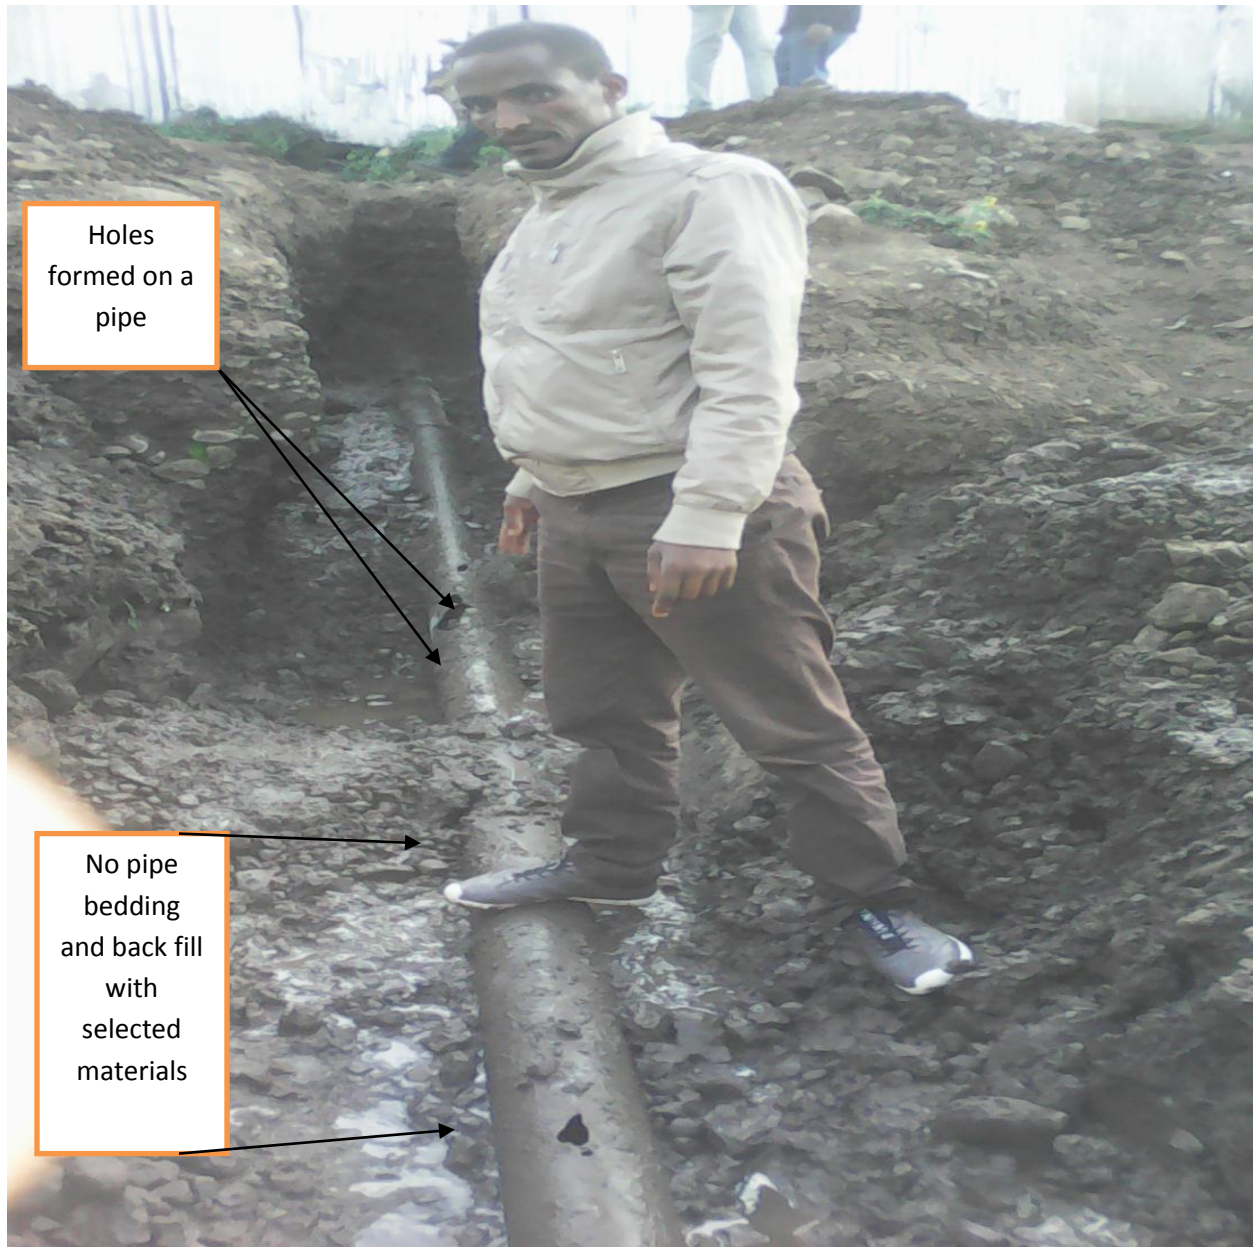
In Chiro town water supply distribution system, there is a poor pipe installation practice on a rocky area. Among these absence of pipe bedding and backfill with selected material is one which leads to a pipe burst. Such events were appeared at different locations along the pipe distribution line. Example at (X=705096, Y=1002477, Z=1811) on uPVC pipe (150mm diameter and PN10) due to poor installation practiced on a pipe line (no pipe bedding and backfill with selected materials). The situations of pipe burst at this locations, some formations of holes on a pipe laid as shown on the figure 4.4.1. And also pipe burst appeared on the HDPE pipe at location (X=704591, Y=1006126 and Z=1771m) on a distribution line (100mm diameter and PN16) as shown on the figure 4.4.2. So, absence of pipe bedding and backfill is one of the factor that leads to pipe burst in the system.

*Figure 4.5.1 uPVC Pipe burst due to the absence of a pipe bedding and backfill with selected materials*

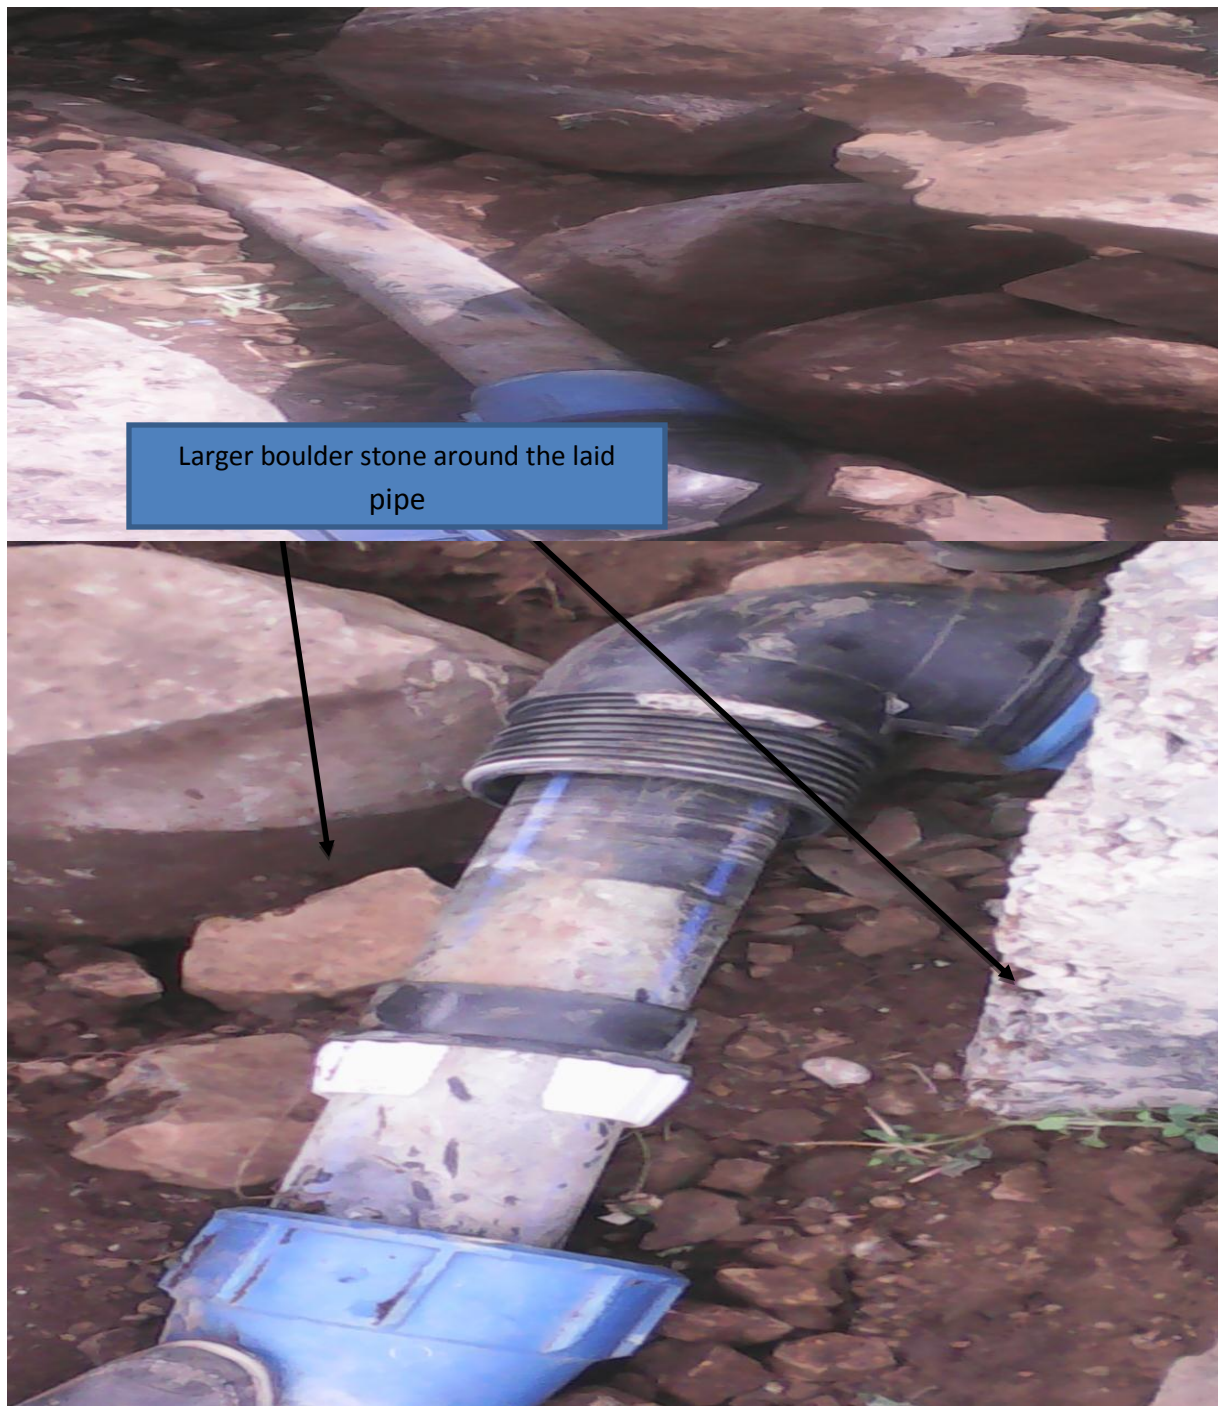
Backfill provides the primary support against lateral pipe deformation. Pipe backfill /cover materials should be free from a large rocks and debris. According to the FDRE, MoWR,2006, urban water supply design criteria and ministry of water and environment of Uganda, 2013, the minimum of the pipe cover at rock area is 0.6m ( at under foot path or normal conditions) and 0.9m /1m (under carriage (traffic load) conditions) for every type of water supply pipe layout in the town. In Chiro town water supply distribution system, poor backfill/pipe cover practiced was one of the problem appeared in the system for pipe burst/break factor as shown on the figure 4.5.2. At this location or area the type of pipe laid was HDPE pipe (100mm diameter, PN16) and this pipe burst was found at the out let of the service reservoir two (Tank-3) at location (X=704591, Y=1006126 and Z=1771m) which was appeared frequently. At this point the pipe cover was 0.3m which is more less than the normal water pipe cover ( $0.3m < 0.6m$ ). Even though a present cover pipe, it is not selected material which prevent pipe from burst/break rates. It was large boulder stone laid over and around the pipe as a pipe cover or back fill. This leads to pipe burst due to external load was exerted on the laid pipe having internal water pressure exerted on the laid pipe.

*Figure 4.5.2 HDPE pipe burst due to poor installation condition*

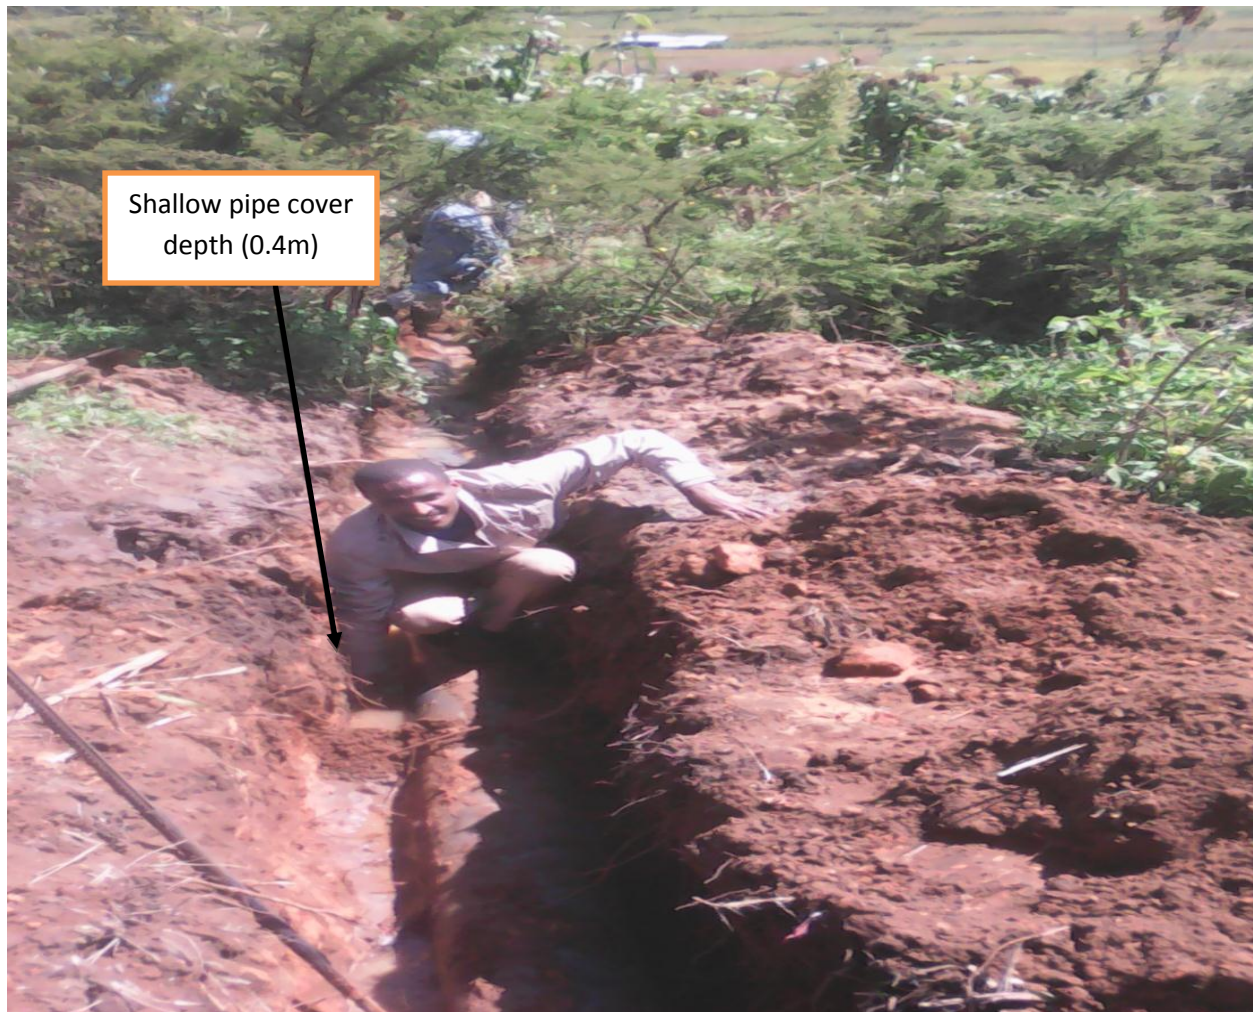
Total pipe buried depth is one of the factor that contribute the pipe failures in this system. Since most transmission pipelines was laid in the agricultural land and having low pipe cover, example the pipe laid covered by small (shallow) depth (0.4m), suddenly the farmer was penetrated or burst/break the pipe during ploughing their land. Such example was as illustrated on the figure 4.5.3 at location (X=710813, Y=998995, Z=2230m) and type of pipe used was uPVC pipe (pipe diameter 250mm, PN10) at just the outlet of the junction of the two pipe lines which rise from two bore holes. The two lines come from its specified well was connected (combined) by fitting called Y. From history of running time of the two pumps from the two wells were usually at the same time in every days. So, at this point there is the disturbance of flow water occurs in the pipe and this point found just at the out let of the two combined lines which rise from the two wells. Due to the disturbance of water flow in the pipe, also disturb the base foundation of the pipe laid over because of the absence of proper pipe bedding. Unfortunately, the pipe laid at this area was uPVC pipe with no pipe bedding and the geological area (soil type) of this area is soil mixed with boulder stone and with shallow pipe cover depth. At this point/area, there is some movement due to low pipe cover to attach the laid pipe to the ground and this movement leads to friction between pipe and boulder stone which found in the base soil of the pipe due to the absence of proper pipe bidding and gradually form holes on a pipe like as shown on the figure below.

*Figure 4.5.3 uPVC pipe burst insufficient buried depth*

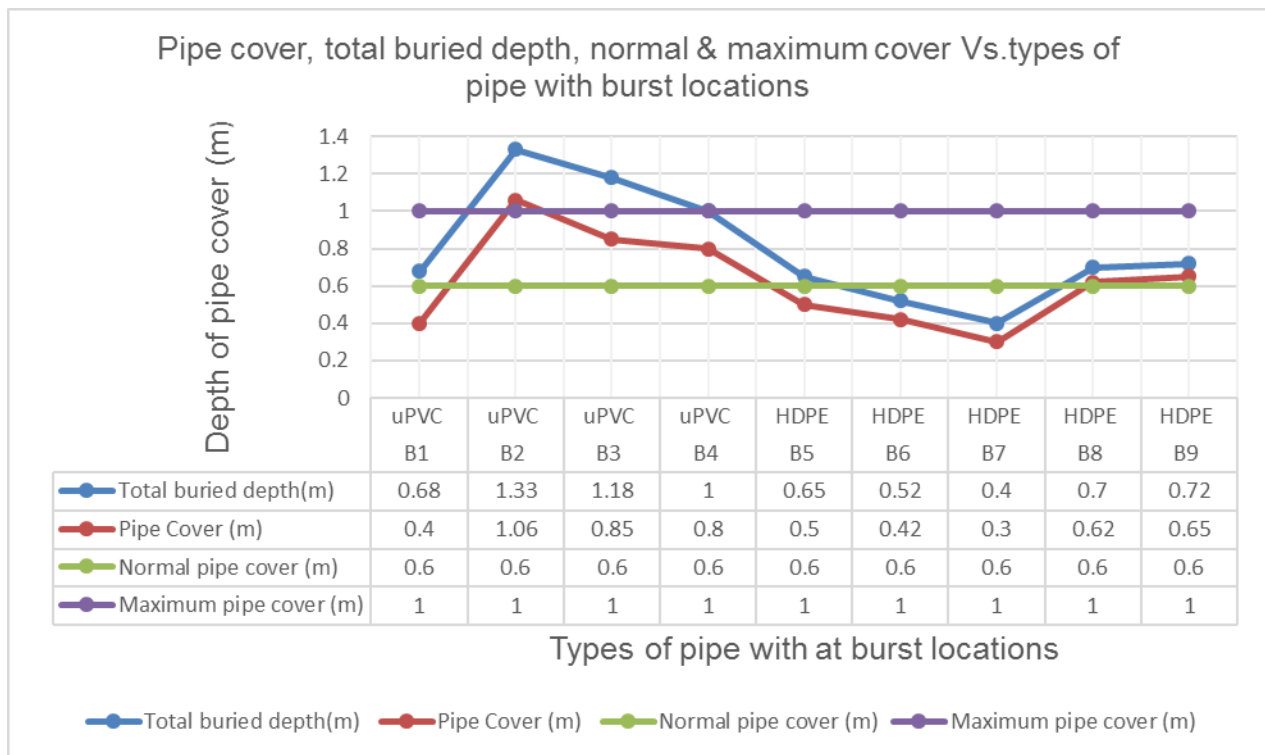
Since, there is no pipe bedding practiced in this area, total buried depth of pipe is the total depth of the trench excavation reduced by thickness of pipe bedding which is the sum of the covered pipe above pipe buried (above crown pipe) and the diameter of laid pipe. When compared pipe cover with standard pipe cover under different conditions (normal path and carriage path) of different points (at pipe burst points and at not pipe burst points) as shown on the figure 4.5.4 and figure 4.5.5.

Figure 4.5.4 Pipe cover, total buried depth at pipe burst points

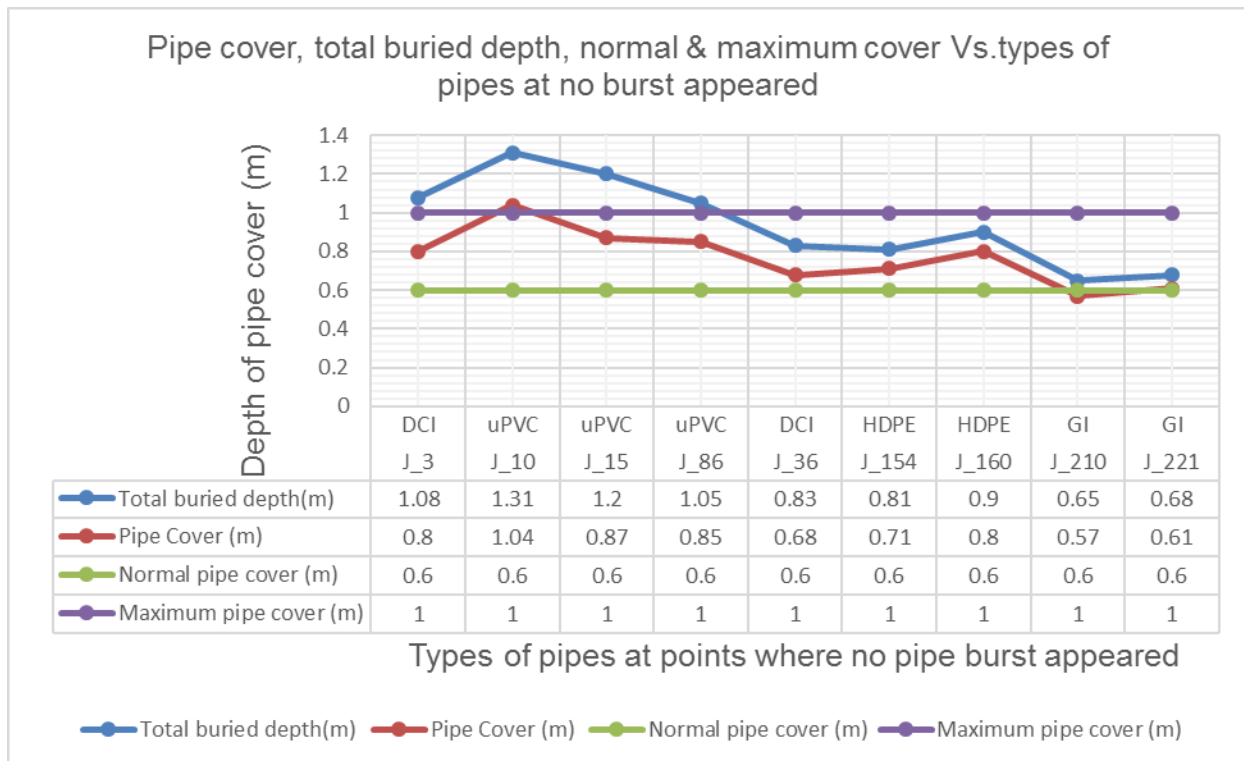
Figure 4.5.5 Pipe cover, total pipe buried depth at no pipe burst points

Almost at all points the pipe cover is satisfy the normal pipe cover depth (under normal conditions or path).

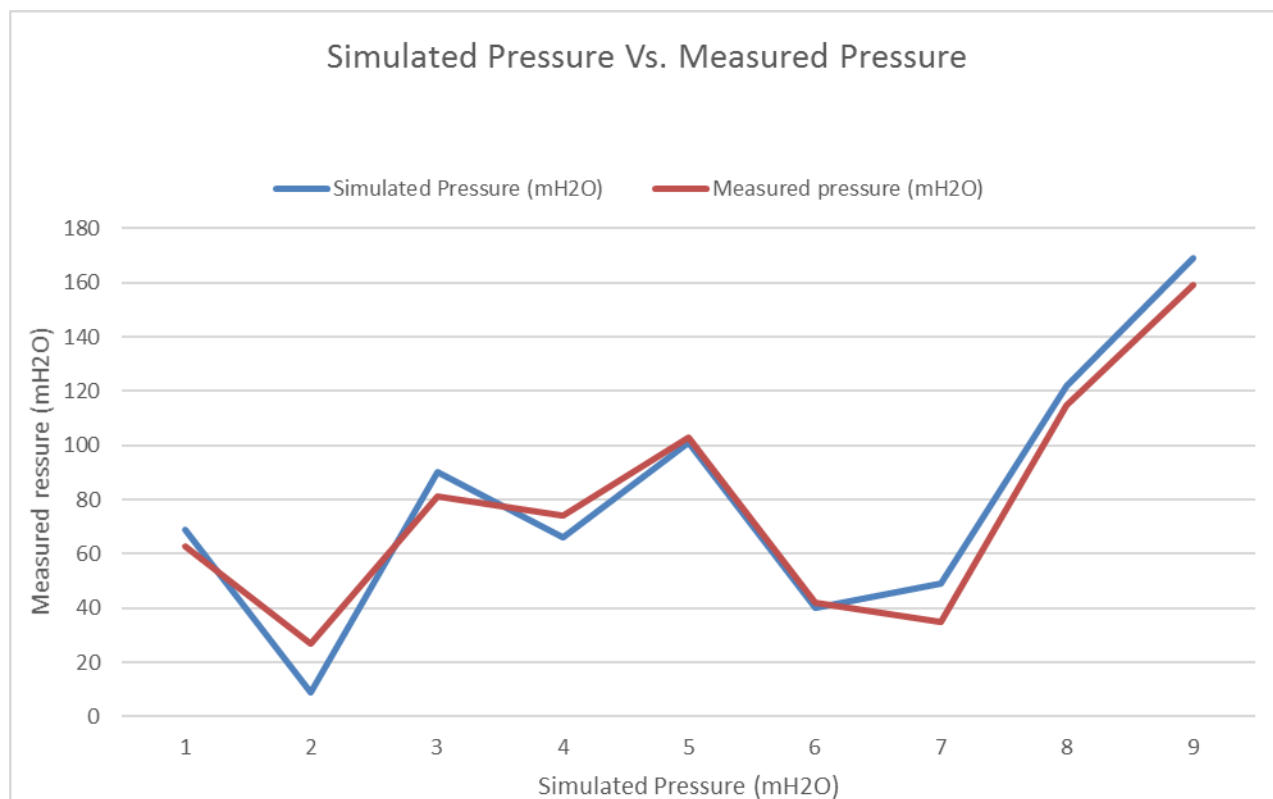
Figure 4.5.4.1 Relation between simulated pressure and measured pressure at where pipe failure was appeared

When compared the pressure appeared in the system (simulated and measured pressure) at these points where frequently pipe failure appeared to the allowable pressure, pressure appeared in these points are (B4, B5, B8 and B9) greater than allowable pressure (70m). So, at these points internal water pressure is one of the factor that contribute the pipe burst at these points. And points (B1, B2, B3, B6 and B7)
