## **INVESTIGATION ON CAUSES OF LAND SLIDE IN THE BLUE NILE BASIN (GOHATSION-DEJEN ROAD AS A CASE STUDY)**

A Thesis Submitted to the School of Graduate Studies of Addis Ababa University  
in Partial Fulfillment of the Requirement for the Degree of Master of Science in  
Civil Engineering

**July 2013**

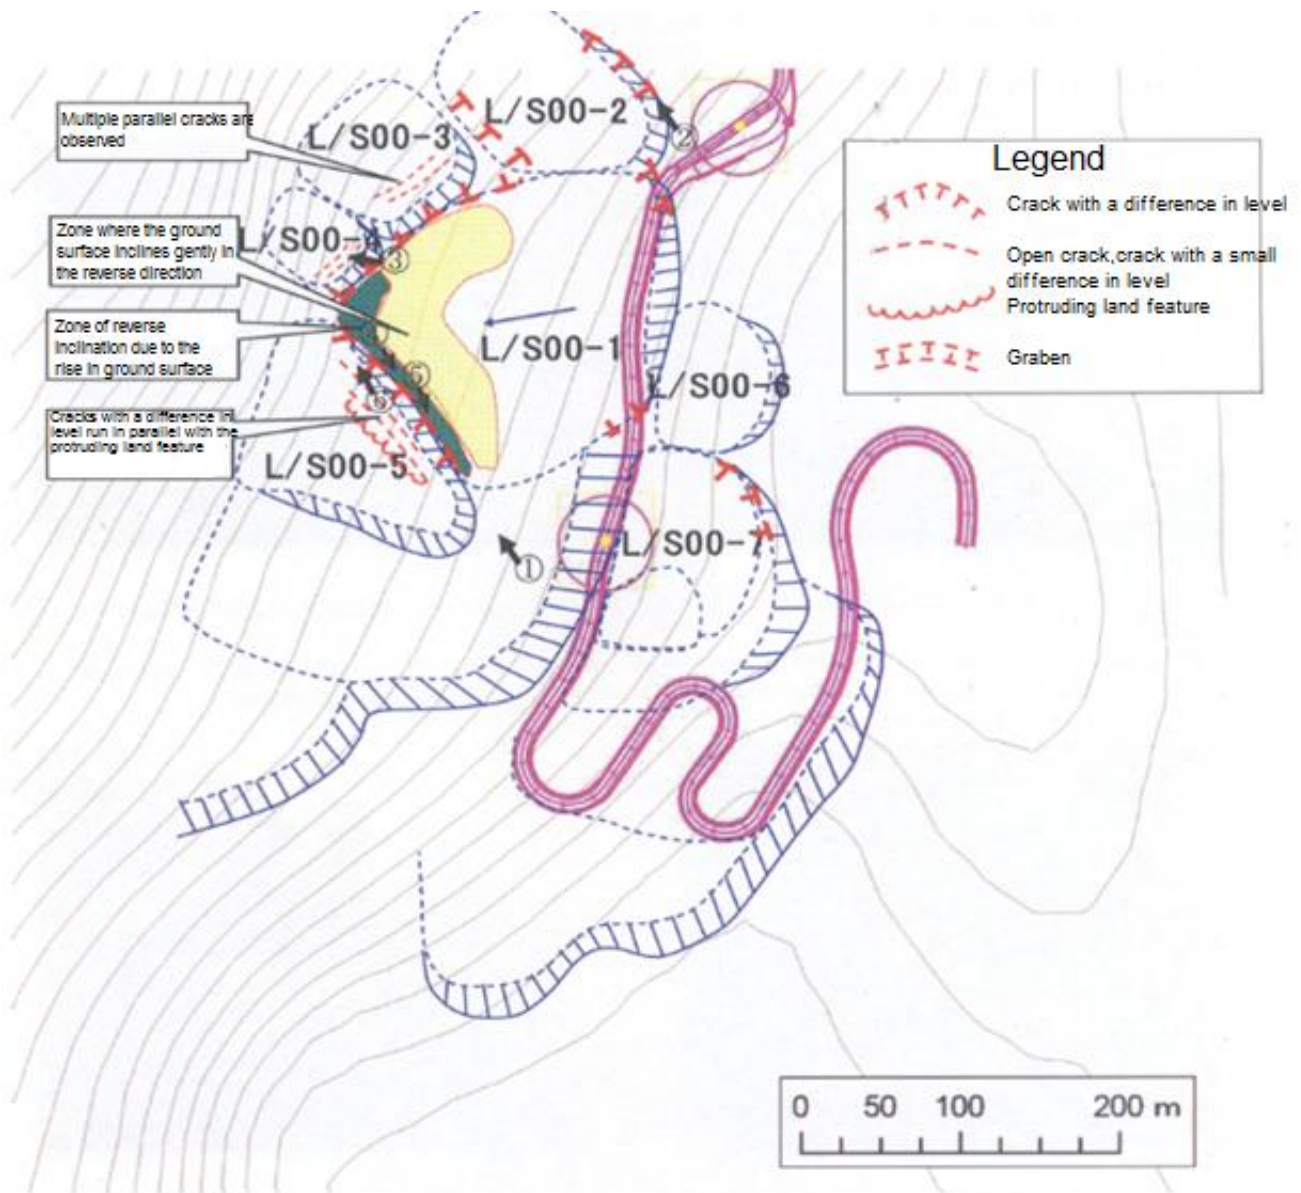
In this area, several small landslide blocks which can be classified as shown in Figure 1.3 are observed.

Figure 1-3 Surface anomalies in L/SOO (ST.0+200 to 1 + 100) (3)

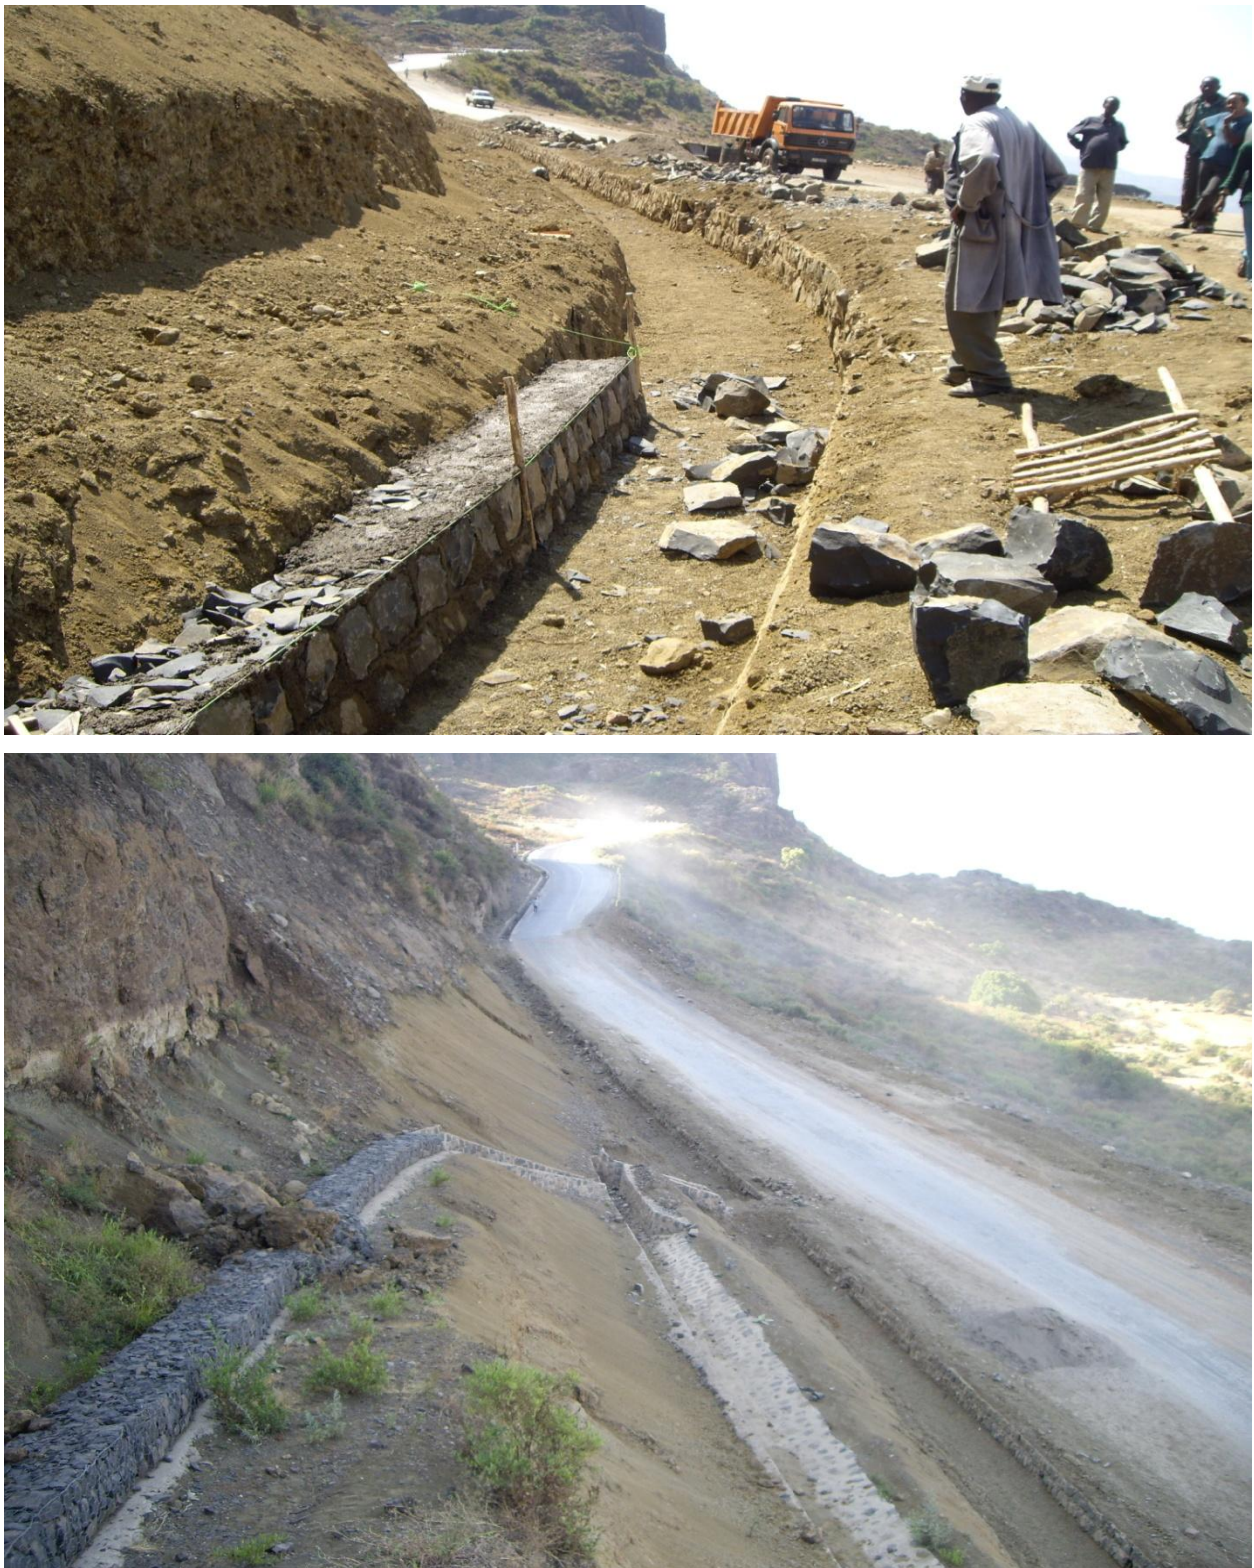
Figure 1-4 View of the land slide at ST-1

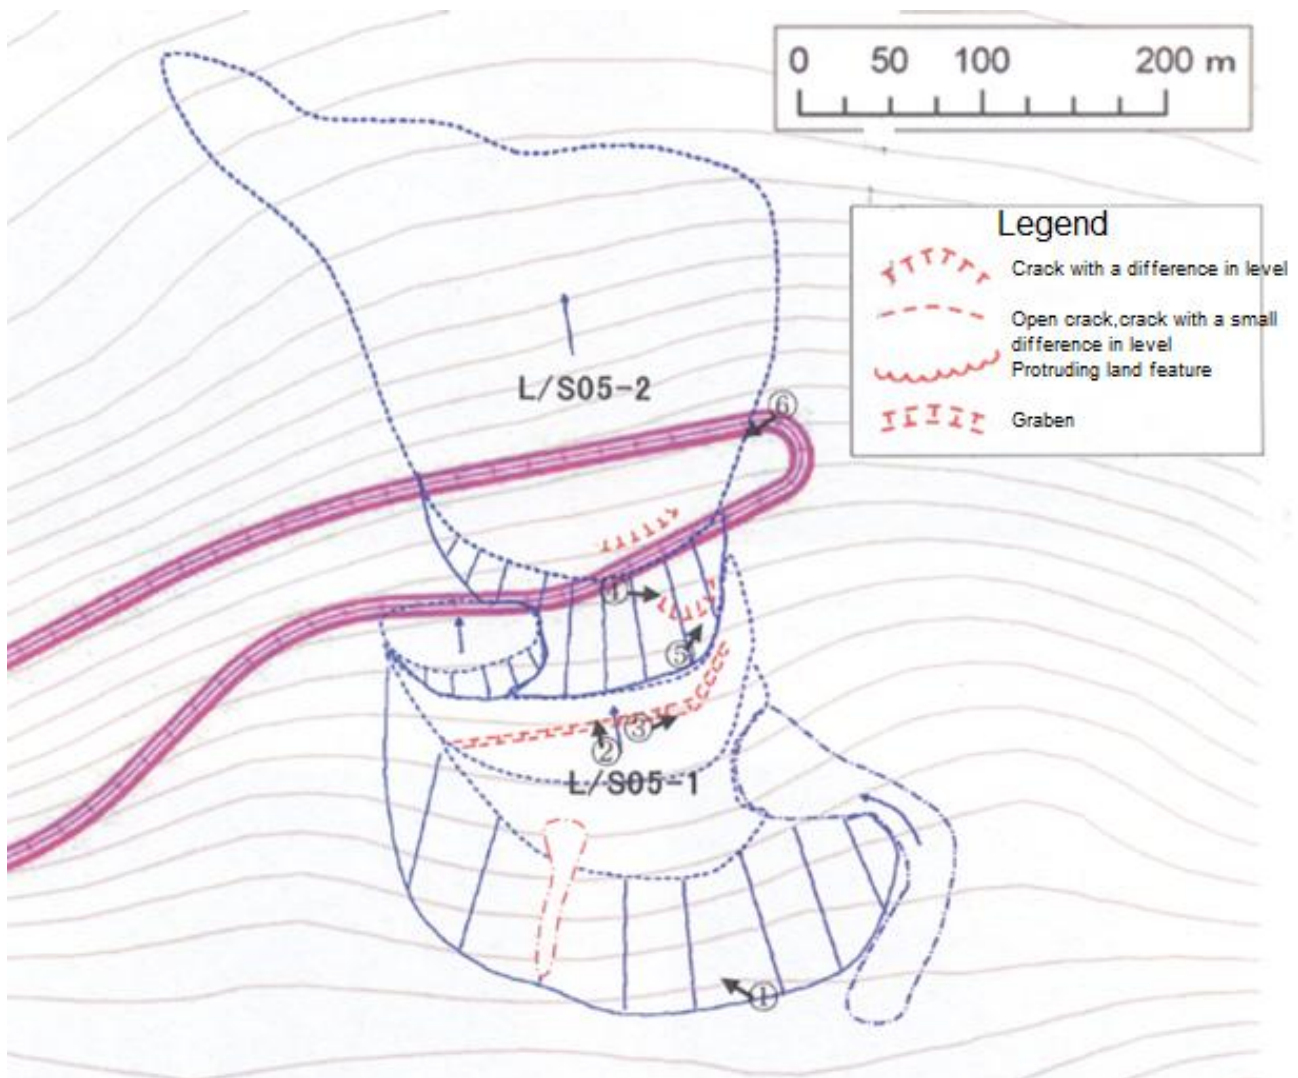
In this area huge volume of debris flow from the hill side makes the road risky. The sliding in the hill side is aggravated by seeping water which may result from percolation of rain water. The retaining wall constructed is incapable to control sliding since the sliding covers large area and deep cited in its nature.

Figure 1-5 Surface anomalies in L/SO5 (ST.4+800 to 5 + 600) (3)

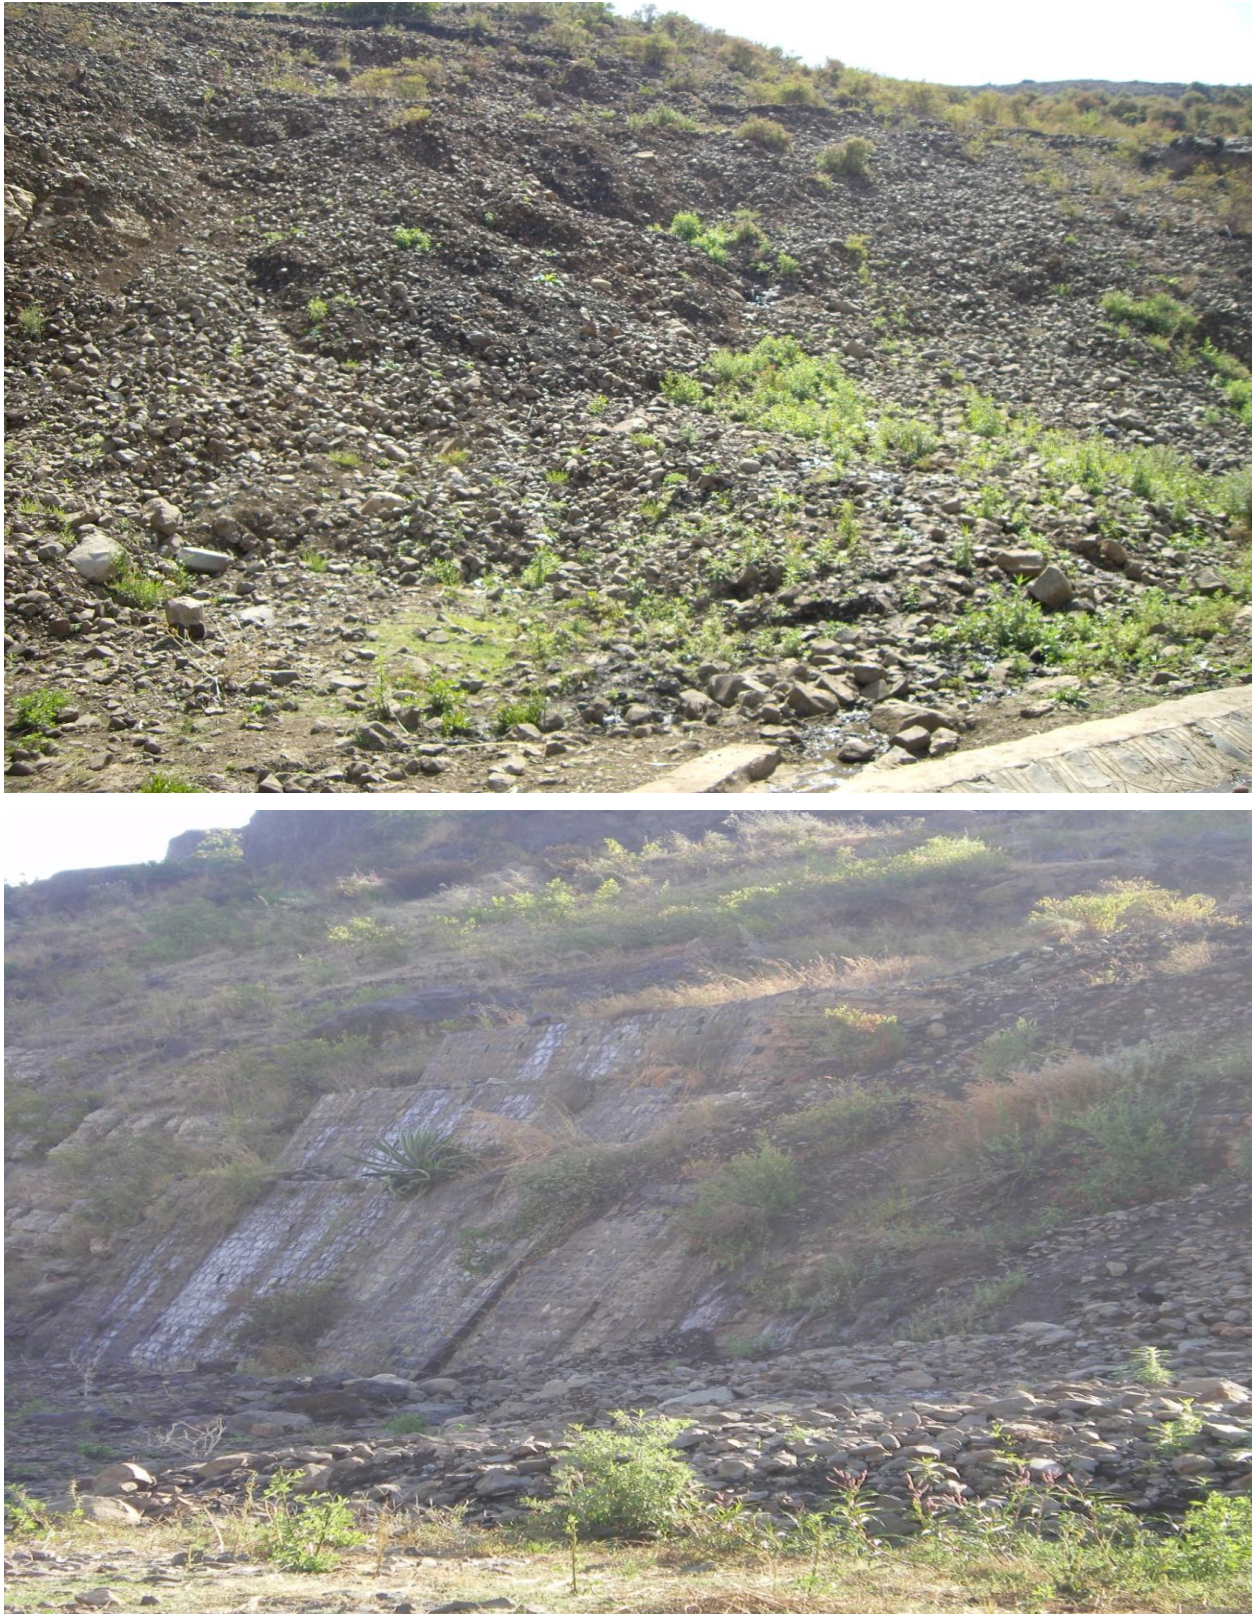
Figure 1-6 View of the land slide at ST-05

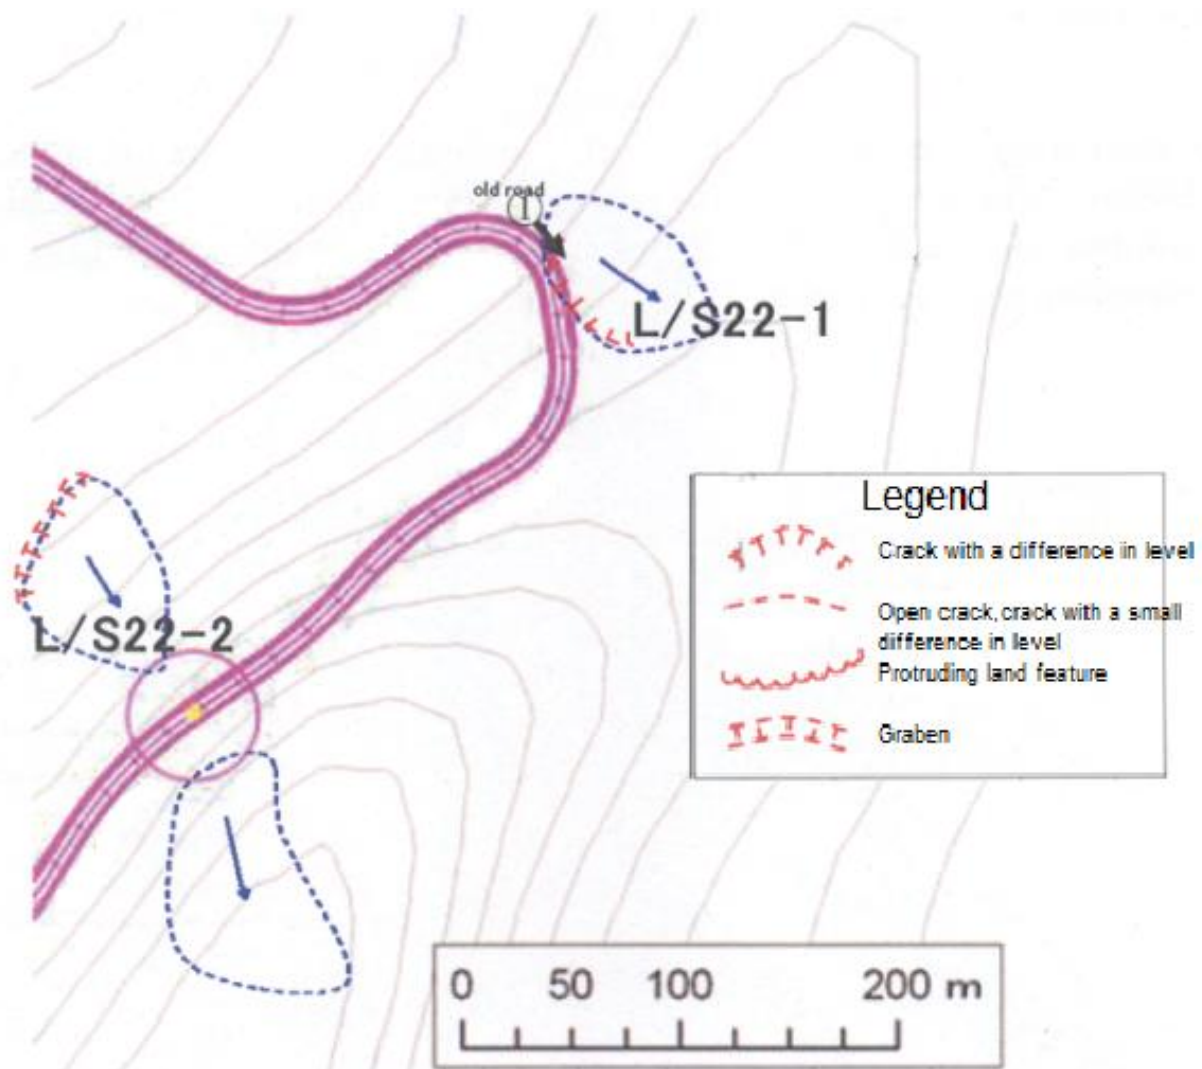
In this area, there are two blocks that are believed to have been active in recent years; a predominant displacement is the L/S22-1. This block could have resulted from events that Occurred when the toe of the block has been eroded by surface water. The initial Italian Route is washed away by erosion and reroute by Kajima construction but still the new route is just on the sand stone cliff and it is under extreme damage state.

Figure 1-7 Surface anomalies in L/S22 (ST.21+600 to 22 + 300) (3)

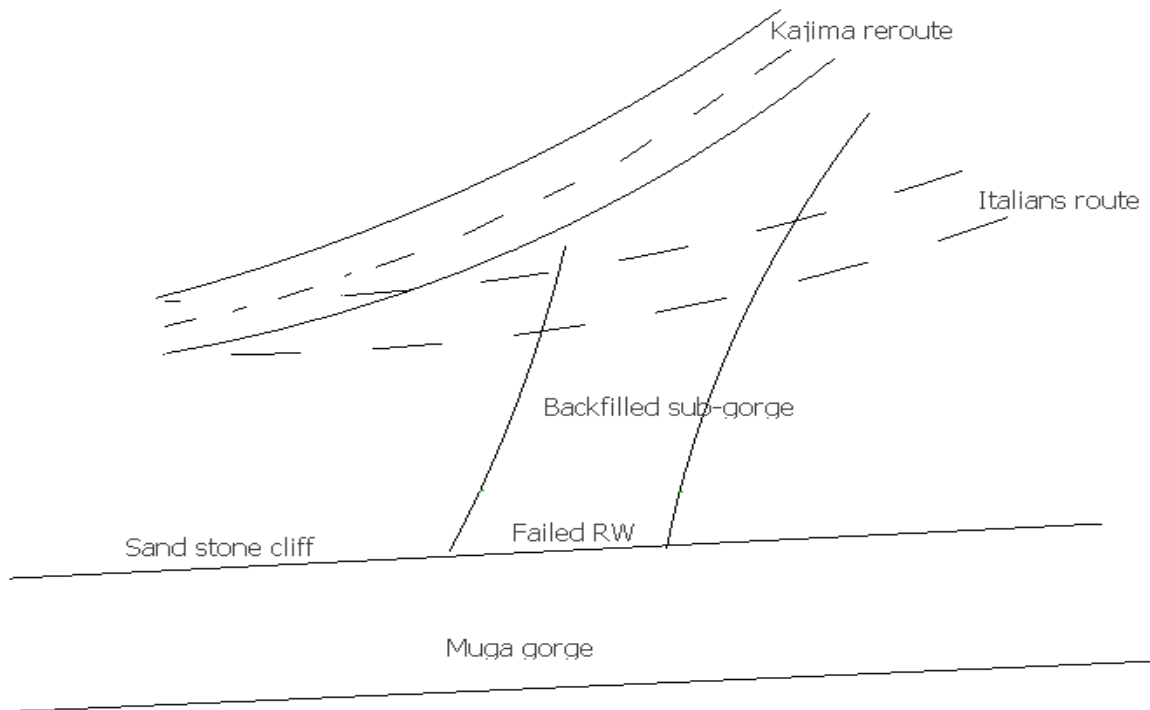
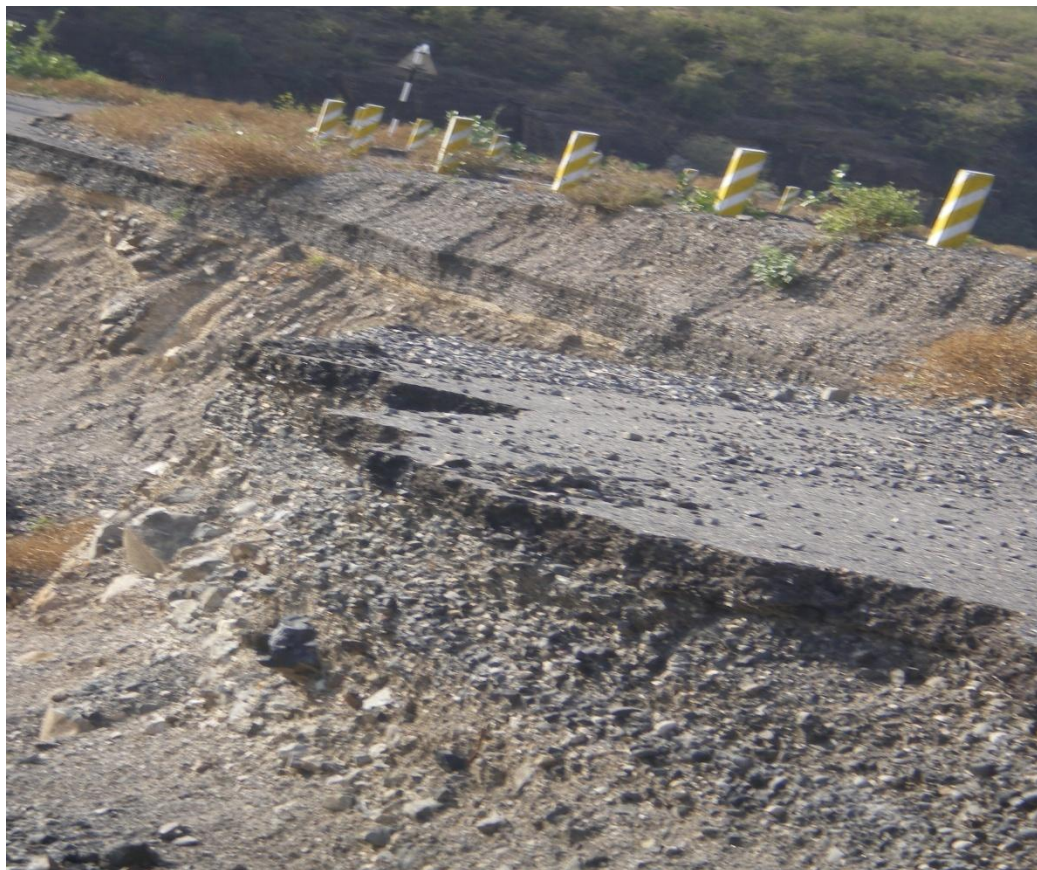
Figure 1-8 View of the land slide at ST-22

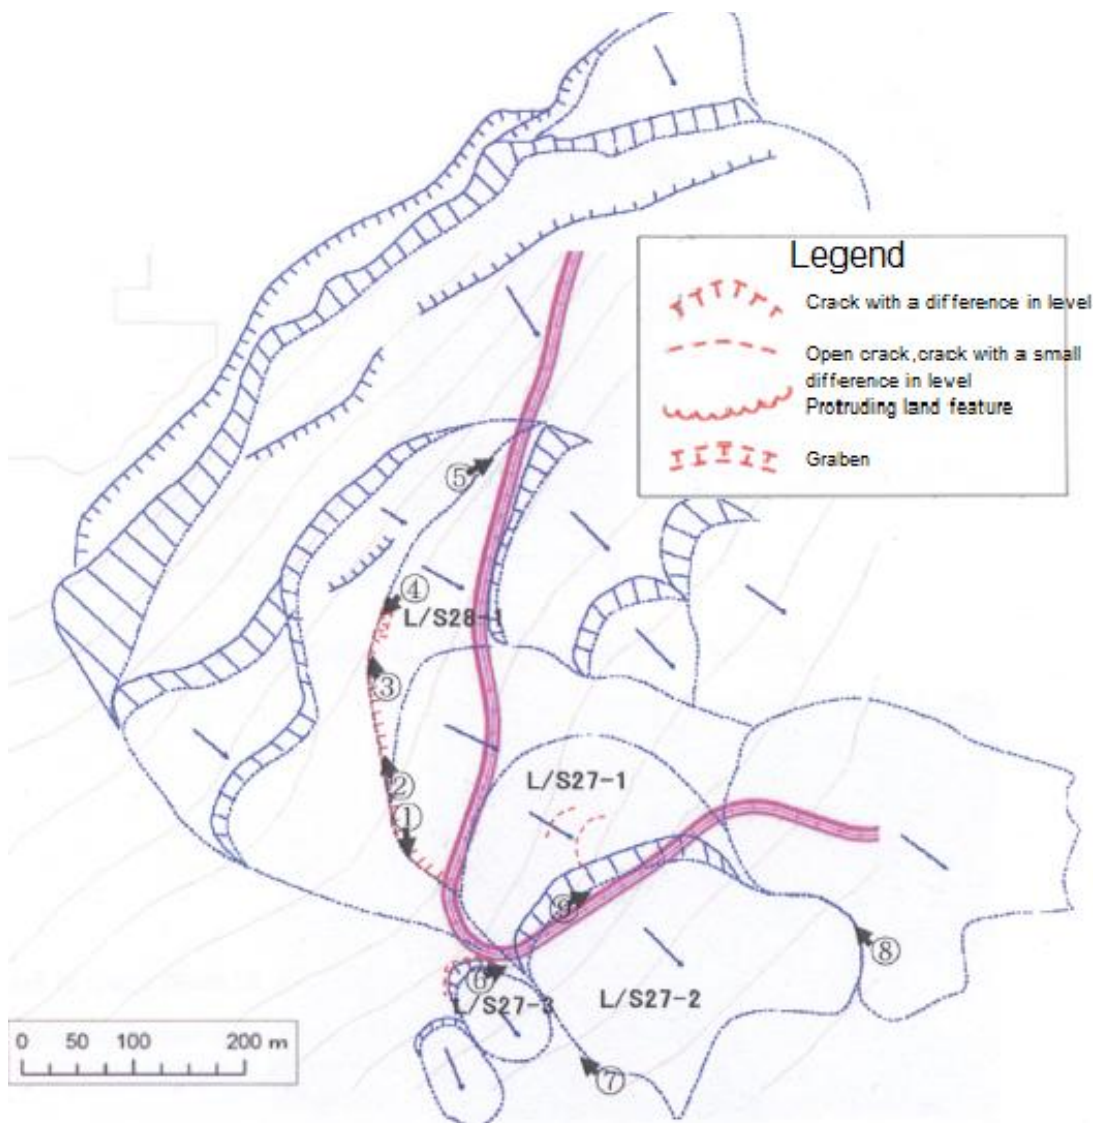
In this area, multiple landslide blocks overlap. As indicated by the significant subsidence of the road in recent years, the activities in the L/S27-2 are most conspicuous in this area. In the L/S27-1, where there is a cracked church and a new church under construction, multiple displacements consisting of cracks by landslide activities are developing; however, the cracks are not new or clear. In contrast, a new continuous crack, as well as the main scarp and graben, can be observed in the L/S28-1, a subsidence on the road can also be an extension of the deformation direction. The active dip sided land slide crushes the existing retaining wall.

Figure 1-9 Surface anomalies in L/S27 (ST.27+200 to 28 + 400) (3)

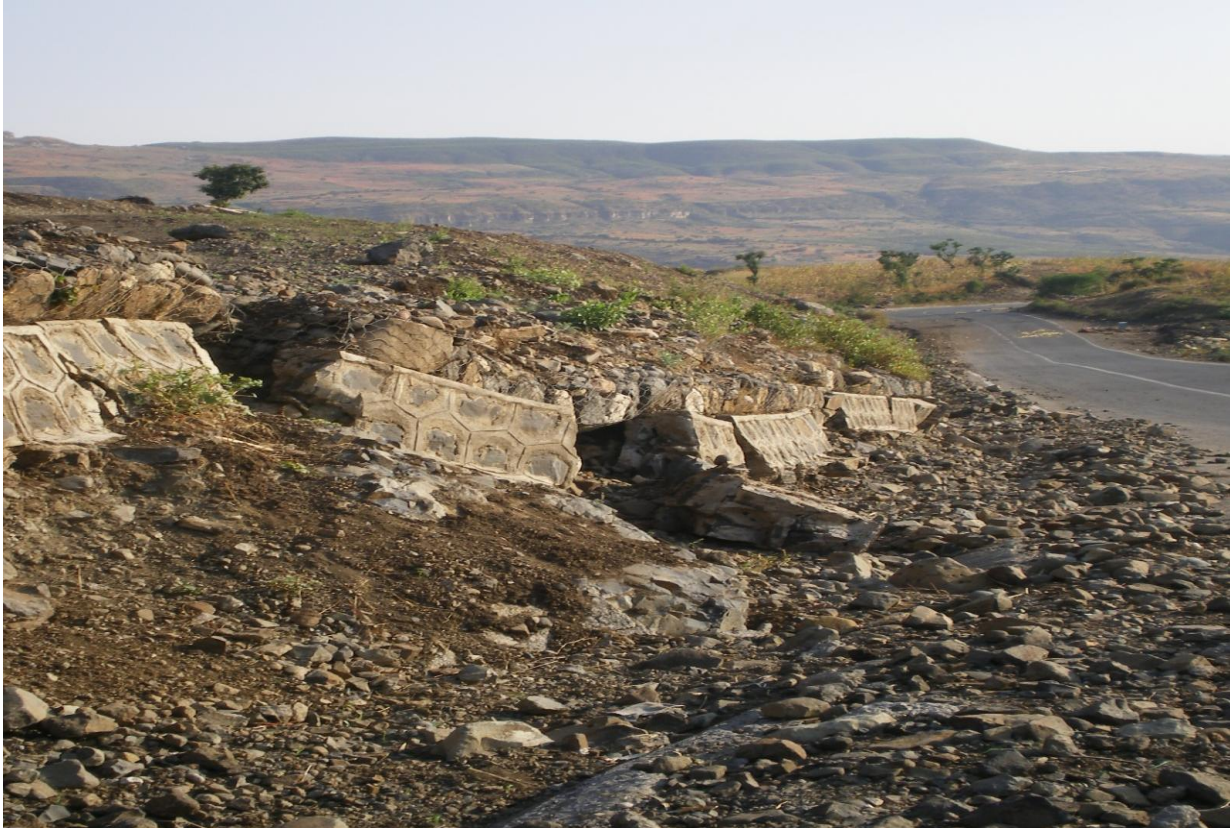
a) Falling masonry retaining wall

Figure 1-10 View of the land slide and its effect at ST-27

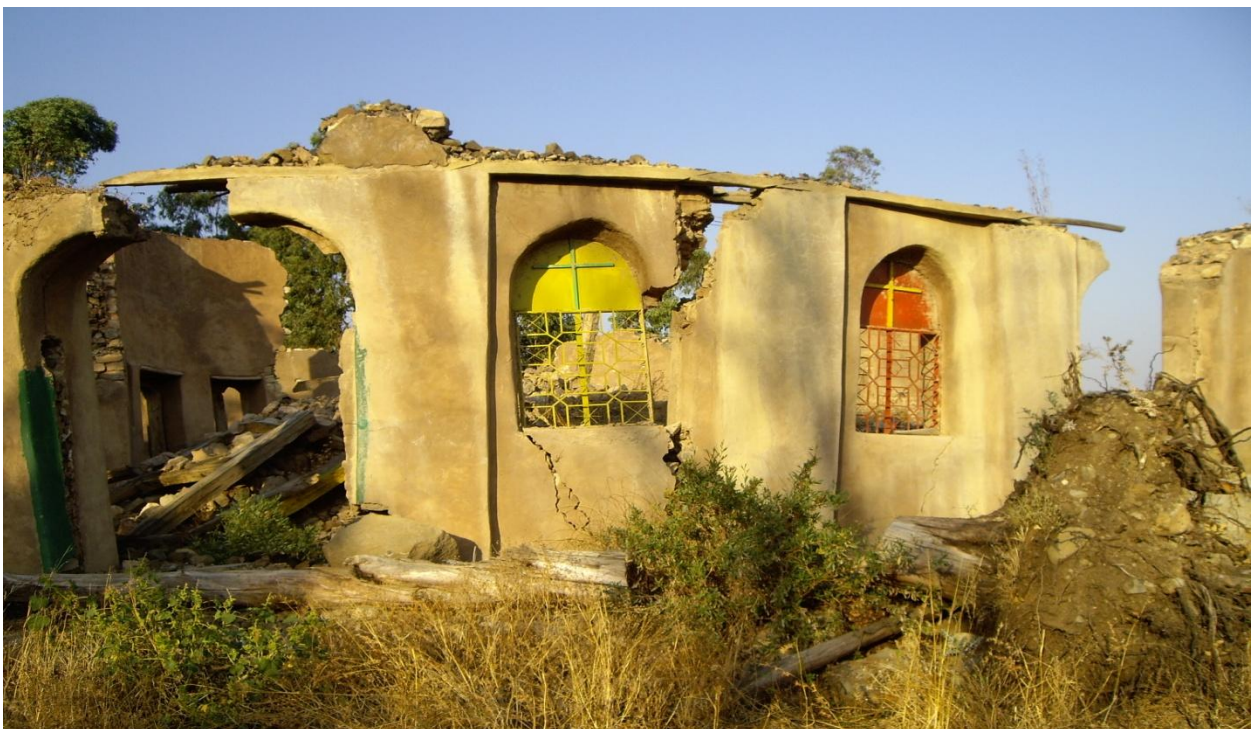
b) Collapsed church

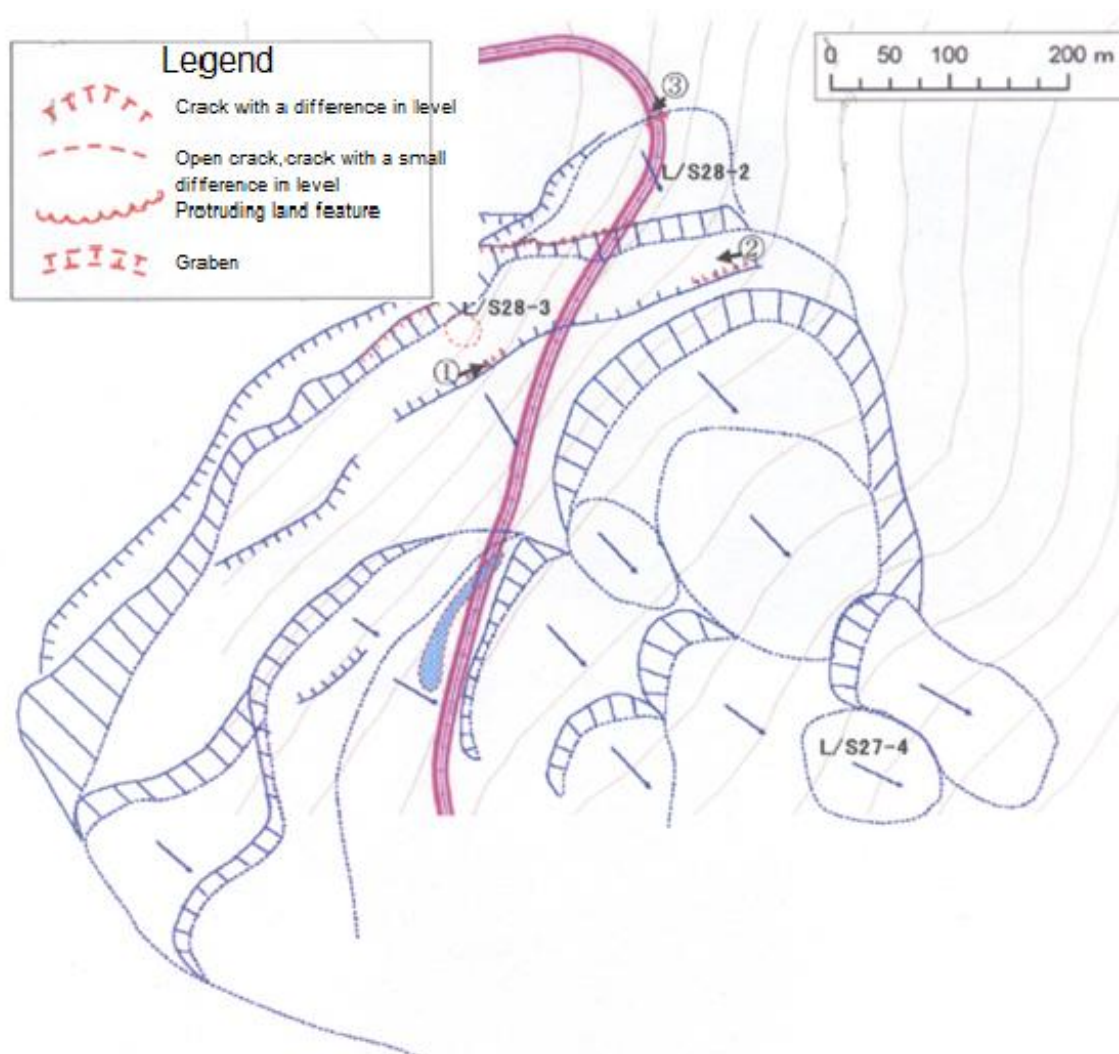
This area is positioned at the head of a large landslide covering the whole region. There are continuous clear main scarps, and cracks, whose mountain side is sinking, that runs roughly in parallel with the main scarps. L/S28-2 is one of the multiple landslide blocks in the area. Considering the size of the subsidence, it can be estimated that the current L/S28-3 moving block is at least 300 m wide. At this point big transverse subsidence is currently hindering the traffic movement.

Figure 1-11 Surface anomalies in L/S28 (ST.28+400 to 28 + 800) (3)

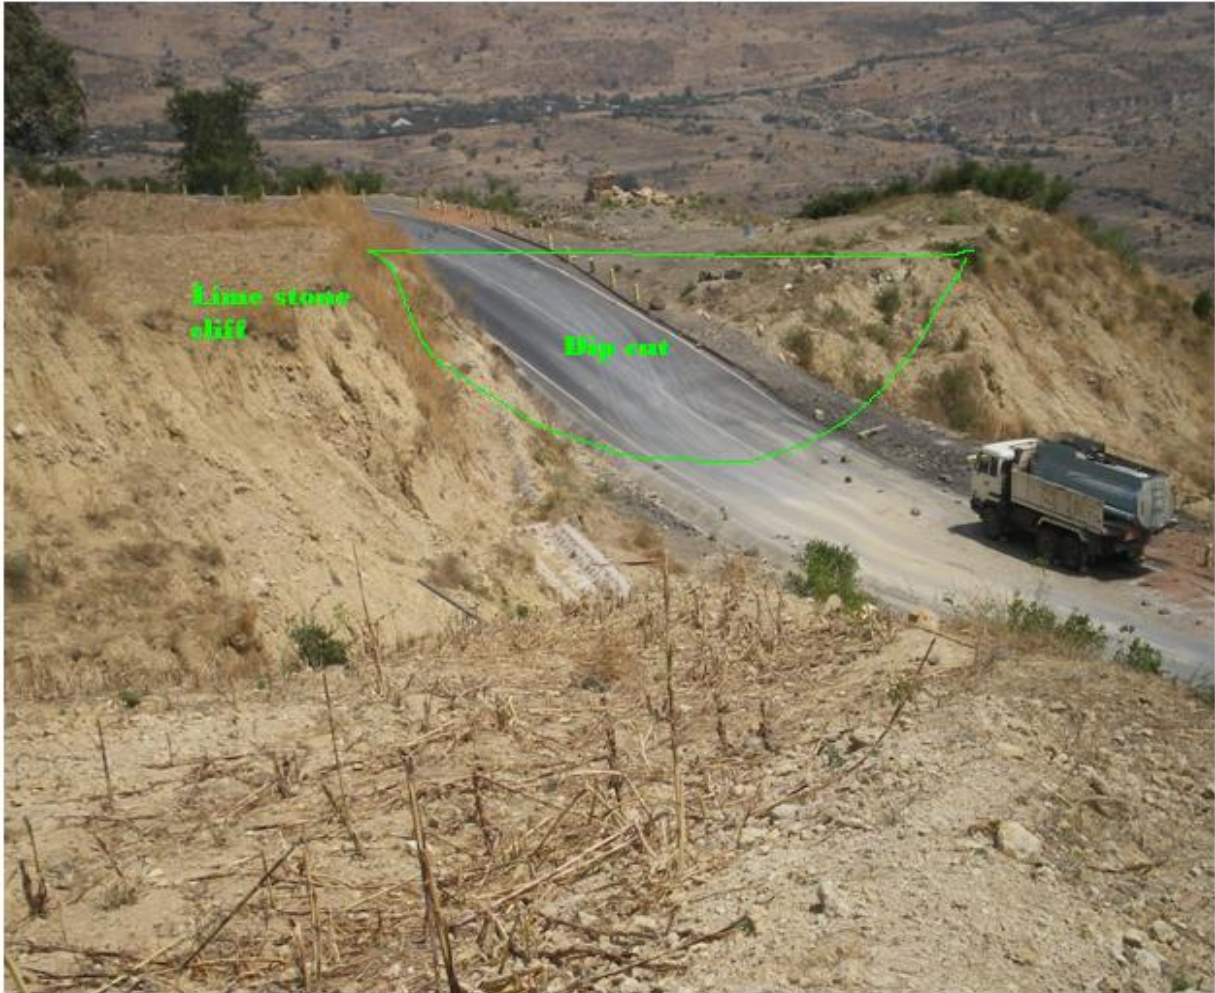
a) Results steep slope

Figure 1-12 View of the land slide and its effect at ST-28

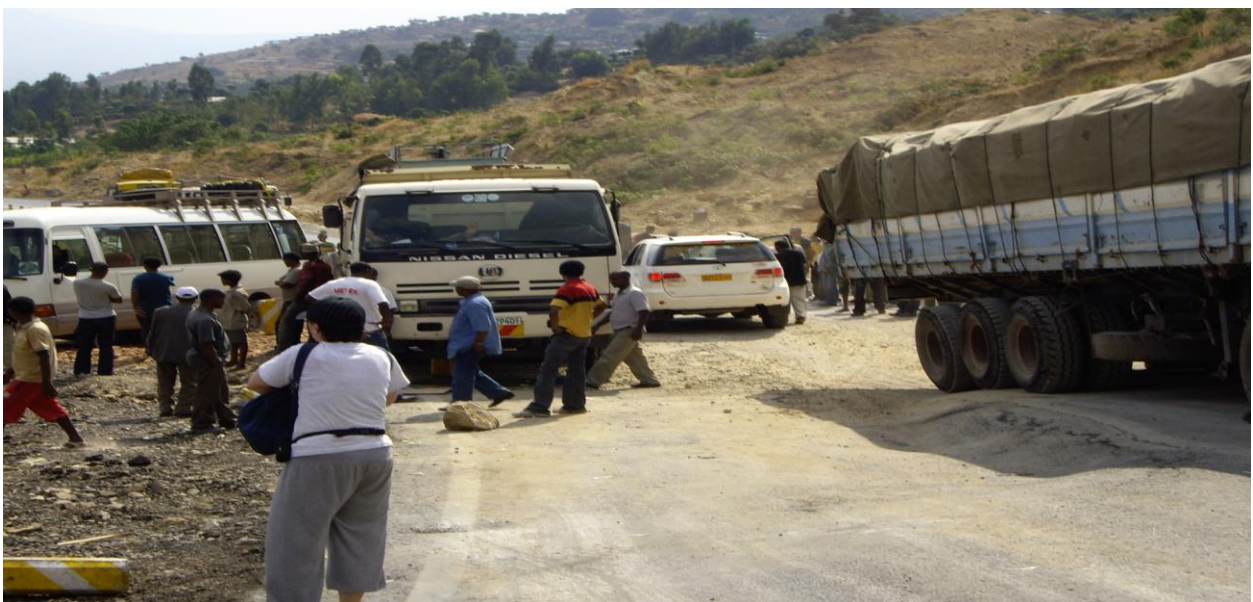
b) Hindering traffic movement

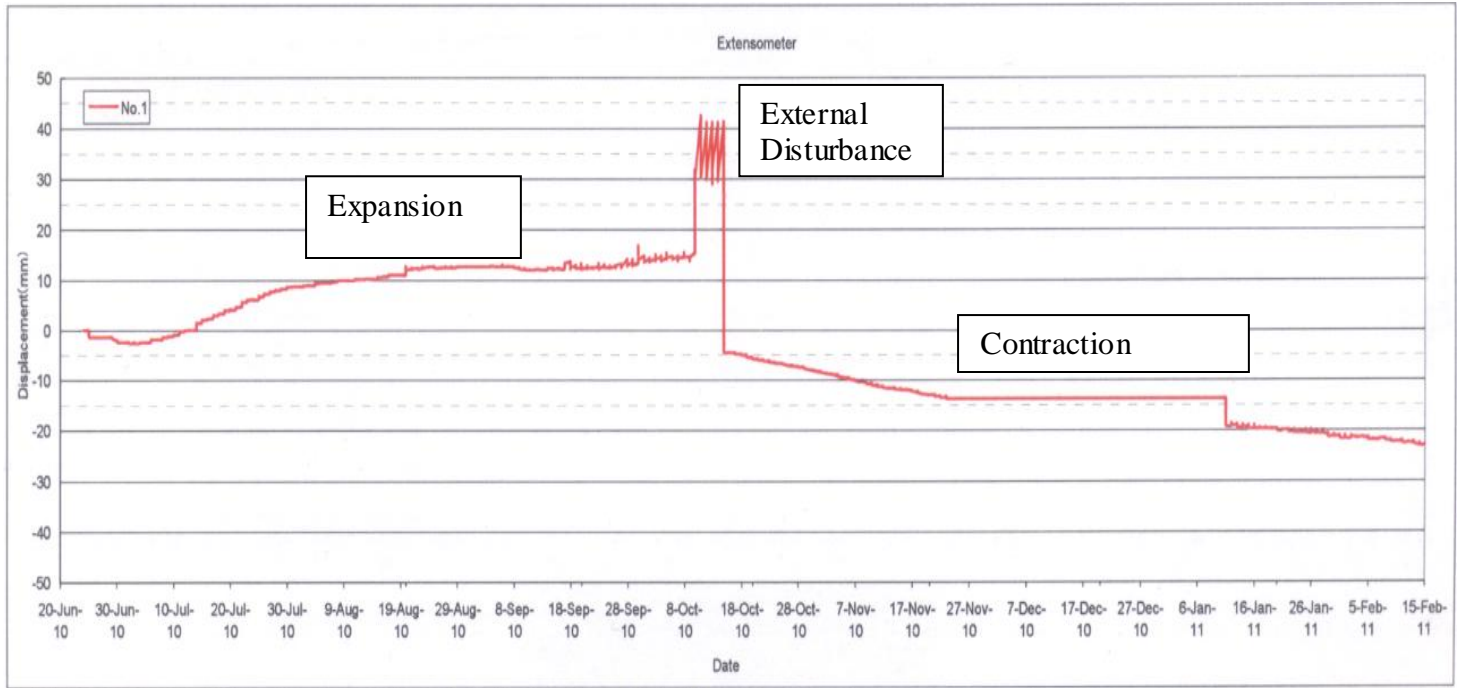
Figure 3-2 Horizontal Extensometer Reading at L/S00 (3)

From the Extensometer reading it has been observed that there is expansion in displacement around 15mm this also corresponds to the rainy season June to October as i have seen from rain fall data. At the middle of October it is observed that magnificent increment of displacement is recorded this is due to external disturbance of the Invar Line (wire) of the extensometer because there is no visible change in the cracks.

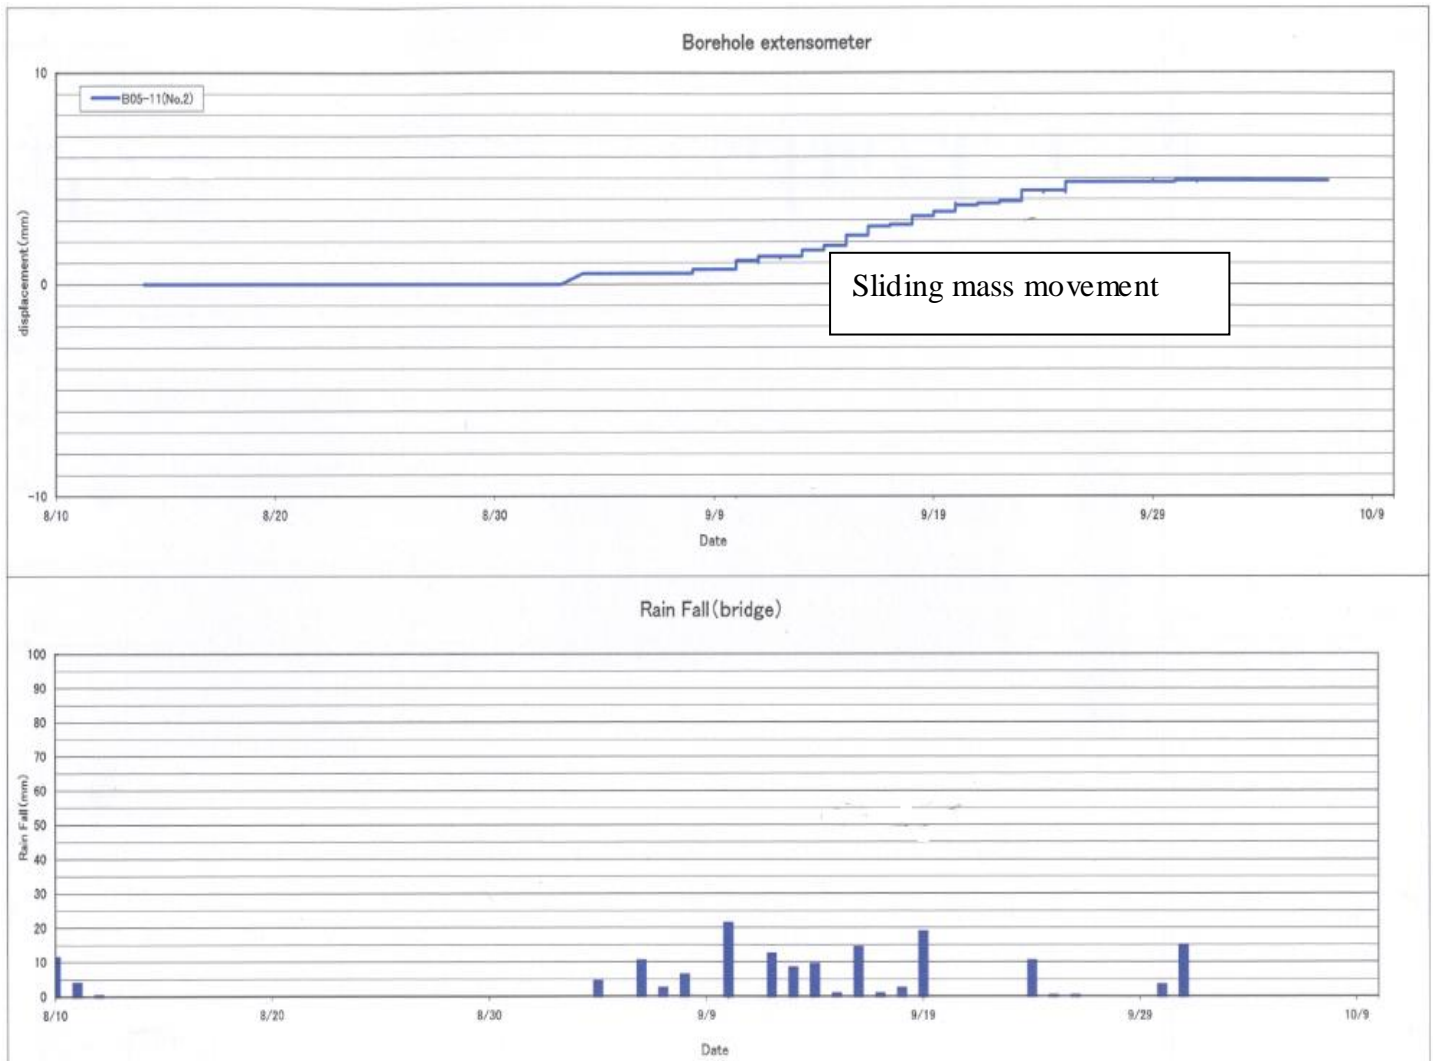
Figure 3-5 Vertical Extensometer Reading at L/S05 with Rain fall data at Bridge station (3)

The Vertical Extensometer reading shows displacement around 5mm corresponding to the rainy season. This implies the occurrence of sliding mass movement. In other vertical extensometers movement is not detected this is may be the installation of the instrument is late to the rainy season.

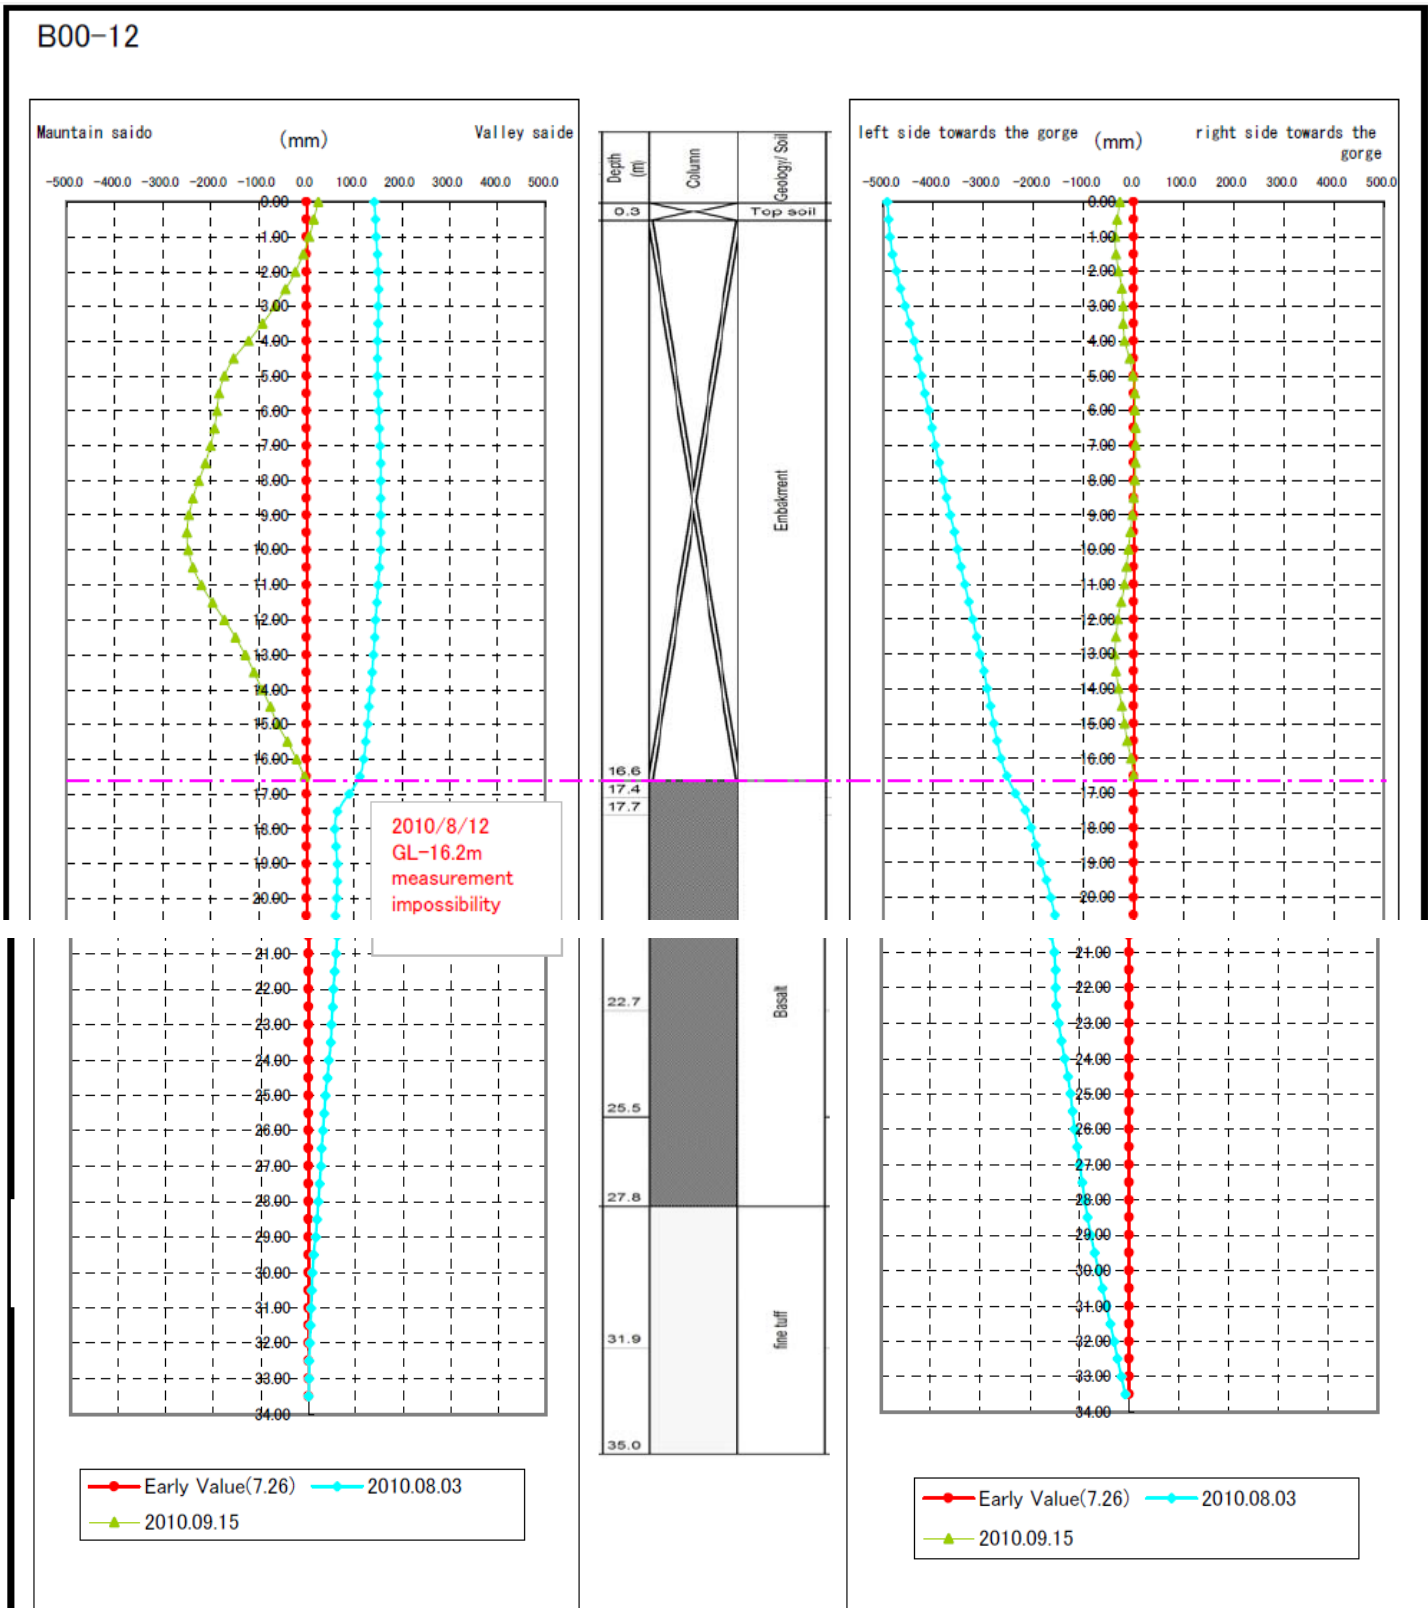
As it has been seen from the reading below the impossibility of measurement at a depth of 16.6m is due to the collapse of inclinometer tube which is also the interface of Embankment and Basaltic layer. Similarly in other inclinometers also the interface of Colluvial deposit and Limestone, Colluvial deposit and Sand stone, Colluvial deposit and Tuff with Silt and Shale boundaries are mainly sliding interfaces.

Figure 3-8 Vertical Extensometer Reading at L/S00 (3)
