## **INVESTIGATION ON CAUSES OF LAND SLIDE IN THE BLUE NILE BASIN (GOHATSION-DEJEN ROAD AS A CASE STUDY)**

A Thesis Submitted to the School of Graduate Studies of Addis Ababa University  
in Partial Fulfillment of the Requirement for the Degree of Master of Science in  
Civil Engineering

**July 2013**

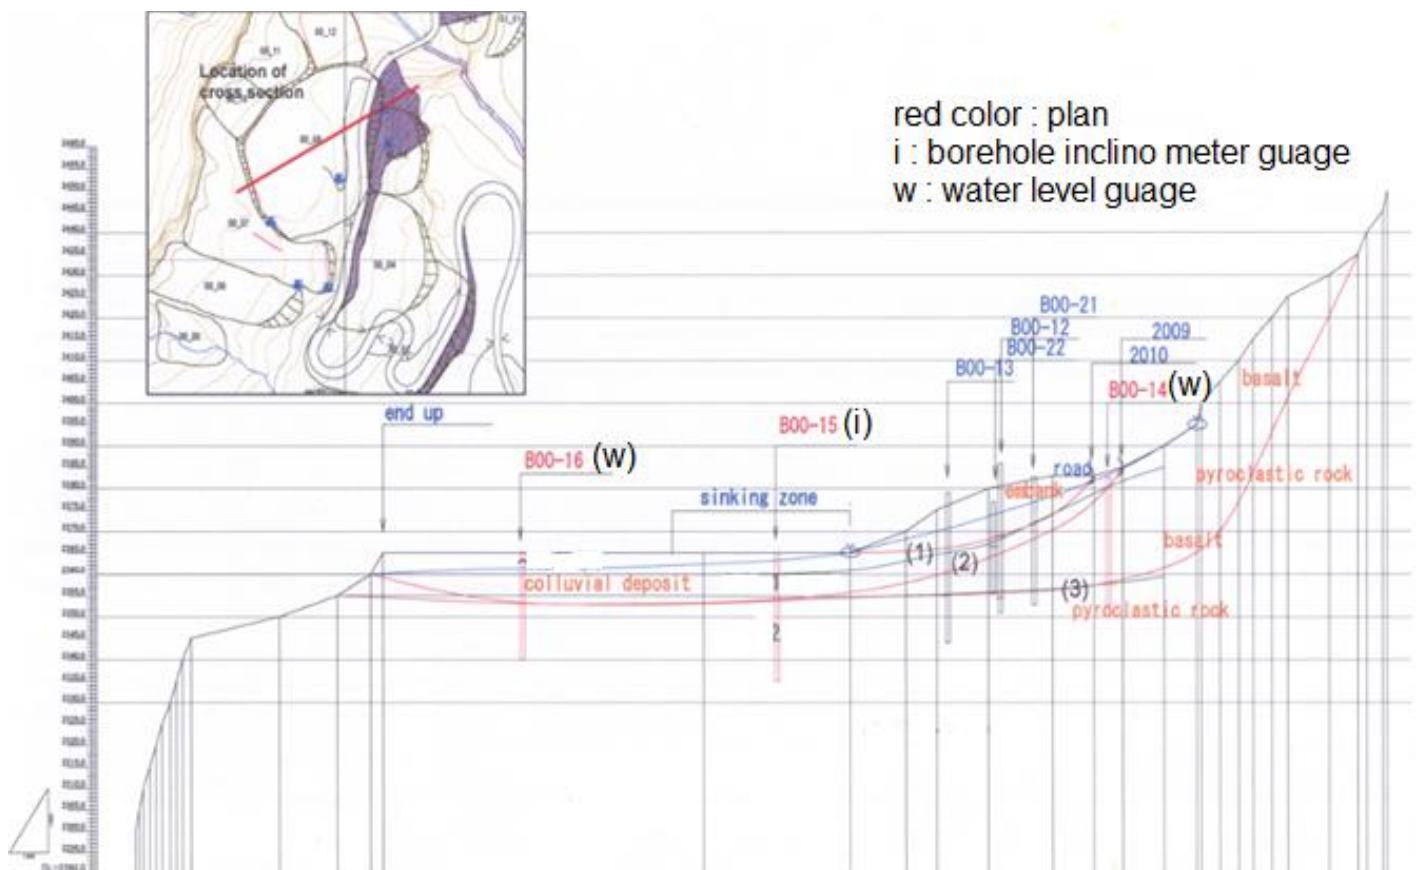
Displacement of block 00-08 was detected at a depth of 17.0m depth by a borehole inclinometer in 2010. This displacement is assumed to have occurred at the inner embankment of the road; however, it could also extend to the entire block 00-08. In consideration of above mentioned results of the investigation and the monitoring, slip surfaces were discussed. The thick red line in Figure 4.4 denotes the possibility of the slip surface. Slip surface (1) is a landslide of the embankment which is the smallest volume in the area; slip surface (2) is a landslide continuing from the road to the end of the field plane; and slip surface (3), which is few possible, is a landslide continuing from the upper part of the basalt slope to the end of the field plane.

Figure 4-4 Landslide cross-section of L/S00 (3)

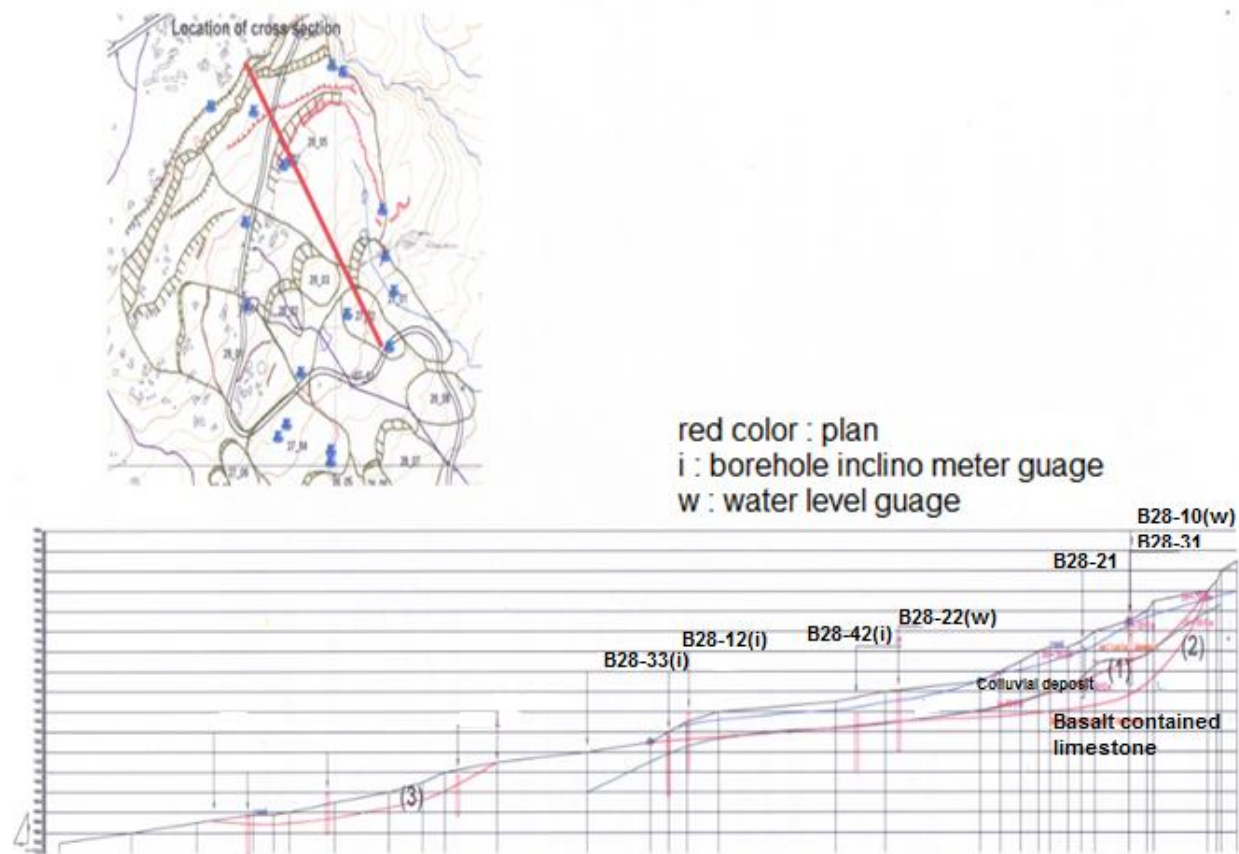
In consideration of above mentioned investigation and the monitoring, slip surfaces were discussed. The thick red line in Figure 4.5 denotes the possibility of the slip surface. Slip surface (1), which was identified by drilling survey, is a landslide from the upper slope to the end of the field; slip surface (2), which is needed to be identified on additional surveys, is a large landslide deeper than (1); and slip surface (3) is a landslide on the lower slope

Figure 4-5 Landslide cross-section of L/S28 (3)
