**ADDIS ABABA UNIVERSITY  
INSTITUTE OF TECHNOLOGY  
SCHOOL OF CIVIL AND ENVIRONMENTAL ENGINEERING**

**GEFERSA II EMBANKMENT DAM HYDRAULIC FAILURE AND  
REMEDIAL MEASURE**

**BY: KENBON HORDOFA**

**A PROJECT SUBMITTED TO THE SCHOOL OF GRADUATE STUDIES OF ADDIS  
ABABA UNIVERSITY IN PARTIAL FULFILLMENT OF THE REQUIREMENTS  
FOR THE DEGREE OF MASTERS OF SCIENCE IN HYDRAULIC ENGINEERING**

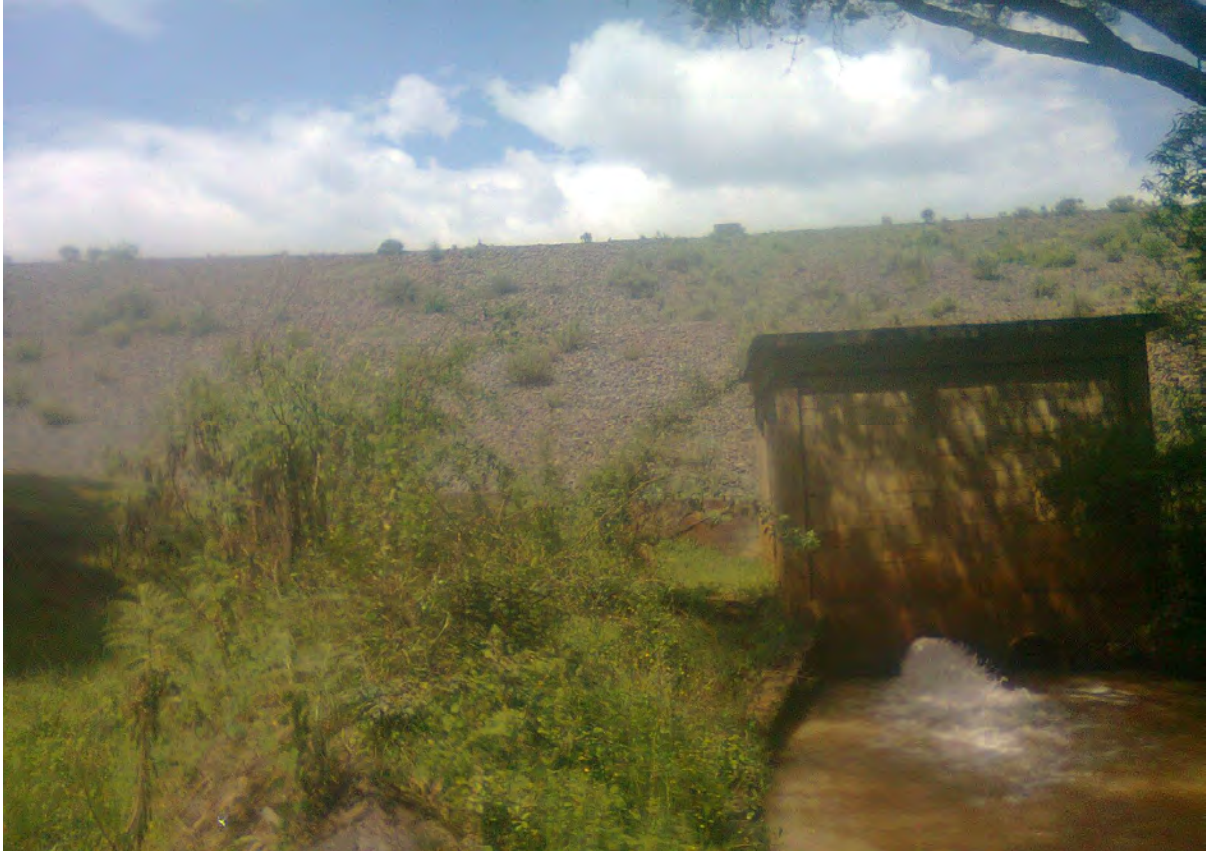
Fig 1.3 Excess water flow through the shaft spillway

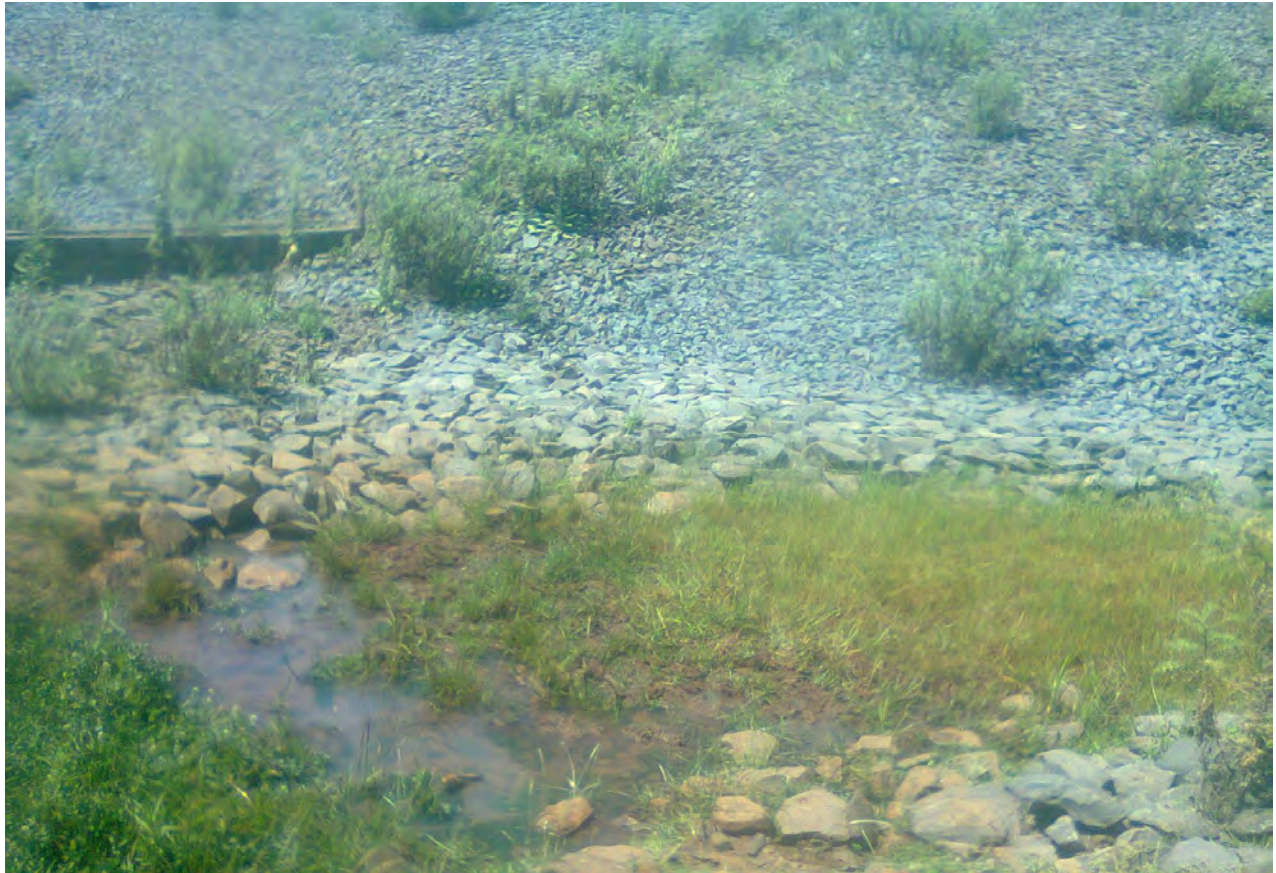
Fig 1.5: Seepage areas at downstream berm.
