**ASSESSMENT OF THE IMPACT OF DRAINAGE STRUCTURES ON  
ROAD ASSET IN ETHIOPIA; THE CASE OF BURAYU TOWN**

A Thesis Submitted to School of Graduate Studies in Partial Fulfillment of  
the Requirement for Degree of Master of Science

Road and Transport Engineering

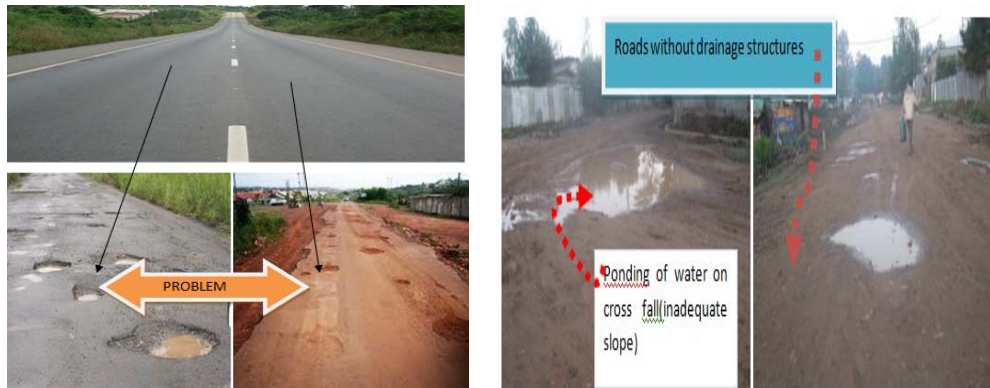
**Figure1.2** Some deteriorated roads (lack of proper drainage)

the outlined projects, very few of these projects were undertaken and these constraints were attributed to the lack of funds in the roads sector. Although governments, past and present, have made some effort, roads are still plagued with potholes, cracks, eroded sections of the roads, amongst others.

In addition the existence of deteriorated bridges due to drainage, that have now become death traps in the town.

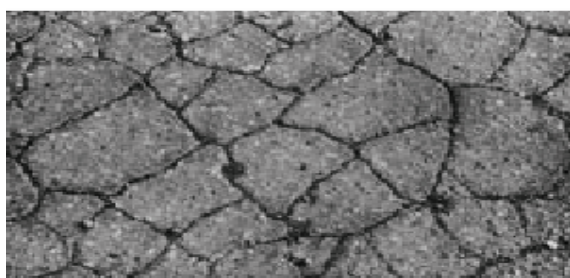
1. Damaged layer of asphalt concrete as a result of damage to the substrate due to repeated traffic loads.
2. Instability of the foundation layer of asphalt case or layer under the foundation because of the drop surface.
3. Double layer foundation stone, making it unable to land resulting from excessive loads of traffic.
4. Aging of asphalt materials by the time.
5. Insufficient thickness of the pavement.
6. Poor drainage in the base layers and under the foundation.

Figure 2.3 Alligator cracking from site survey & severity level as per (GTC, 1998)

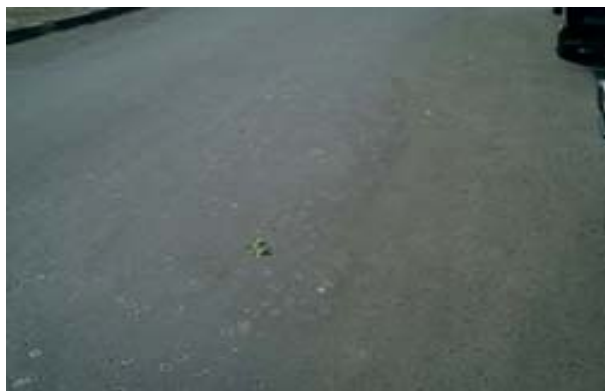
*Figure 2.4 Bleeding*

Bleeding occurs due to the increasing quantities of asphalt or increases the binding of asphalt in the mix asphalt, and increases the spraying of asphalt materials (paint layer and adhesive layer) or the lack of air spaces resulting in hot weather to extend the asphalt and fill in the blanks and then grows out of the surface. Therefore, the bleeding process does not have reflection or effect in cold climates and pool are on the asphalt surface.

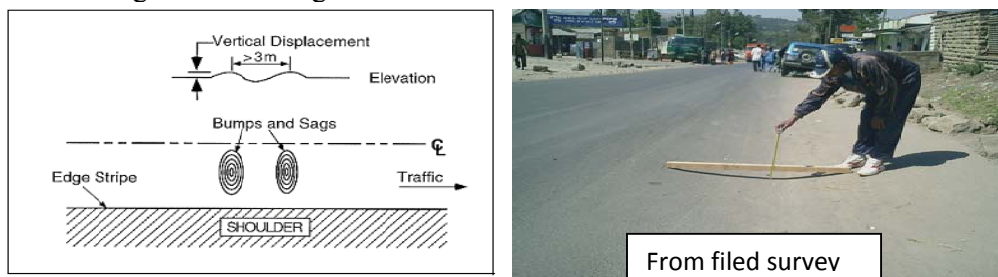
- i. Bulge or curvature of the concrete slabs of concrete under the asphalt surface.
- ii. Leakage and higher materials in the cracks due to traffic loads.

Figure 2.6 Bumps and sags from site survey & severity level as per(GTC, 1998)

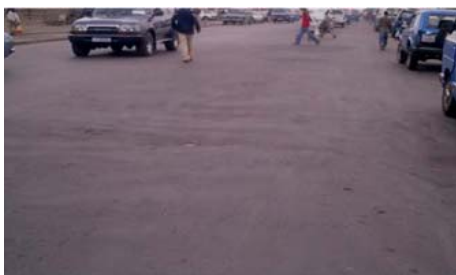
- I. Poor stability of asphalt concrete mixture or weak foundation.
- II. Excess moisture in the lower soil layers.
- III. Increase in asphalt and/or increase the soft material in the mix, or use a round pebble mixture.
- IV. Pollution mixture Contamination of mix.

Figure2.7 Corrugations from site survey & severity level as per (GTC, 1998)

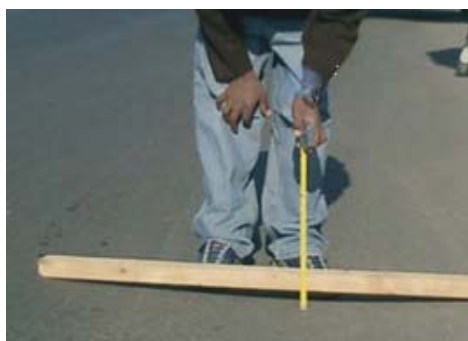
- I. Depression occurs due to falling base layers or arise during construction.
- II. Basis because of the drop, as a result of excess loads, which is pressing basis or because of the decline that occurs during the immediate implementation of the rate of movement of the upper lower classes. Inadequate compaction of hard cores and the inability of the substrate to withstand loads of reasons depression.
- III. Traffic loads, temperature, materials and disadvantages of implementation are all factors that contribute to the emergence depression and accelerate the deployment.

Figure 2.8 Depression from site survey & severity level as per (GTC, 1998)

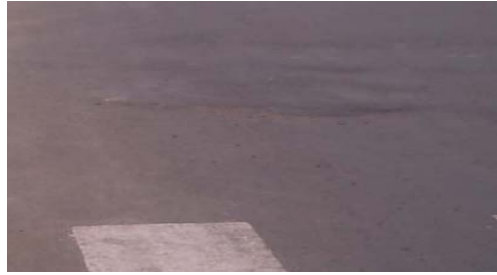
*Figure 2.16 Rutting*

of low stability asphalt mix or unsatisfactory compacted asphalt mix is leading causes for the deformation in the pavement layers.

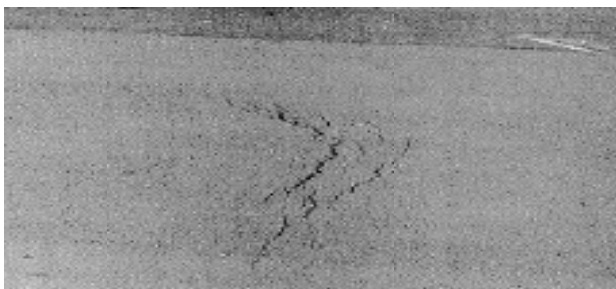
*Figure 2.18 Slippage cracks*

Slippage cracks are usually crescent shaped cracks that normally point in the direction of the thrust of the wheels during braking (Figure 2.18). Allow strength surface mix or alack of bond between the surface layer and the course beneath causes this distress. This slippage or delaminating can cause failures on the pavement surface under traffic. The slippage can be caused by poor drainage, which could aggravate a stripping problem, or by construction.

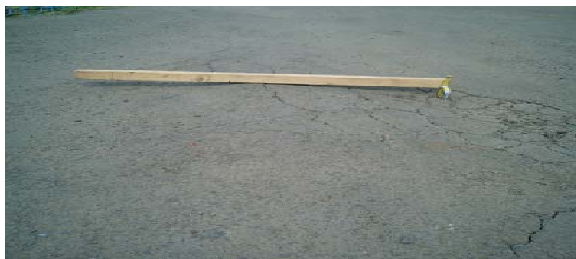
*Figure 2.19 Swelling*

Swell is the localized upward displacement of a pavement due to the upheaval of the sub-grade or some portion of the pavement structure (Figure 2.19). Swell or heave is commonly caused by infiltration of moisture into an expansive-type soil.

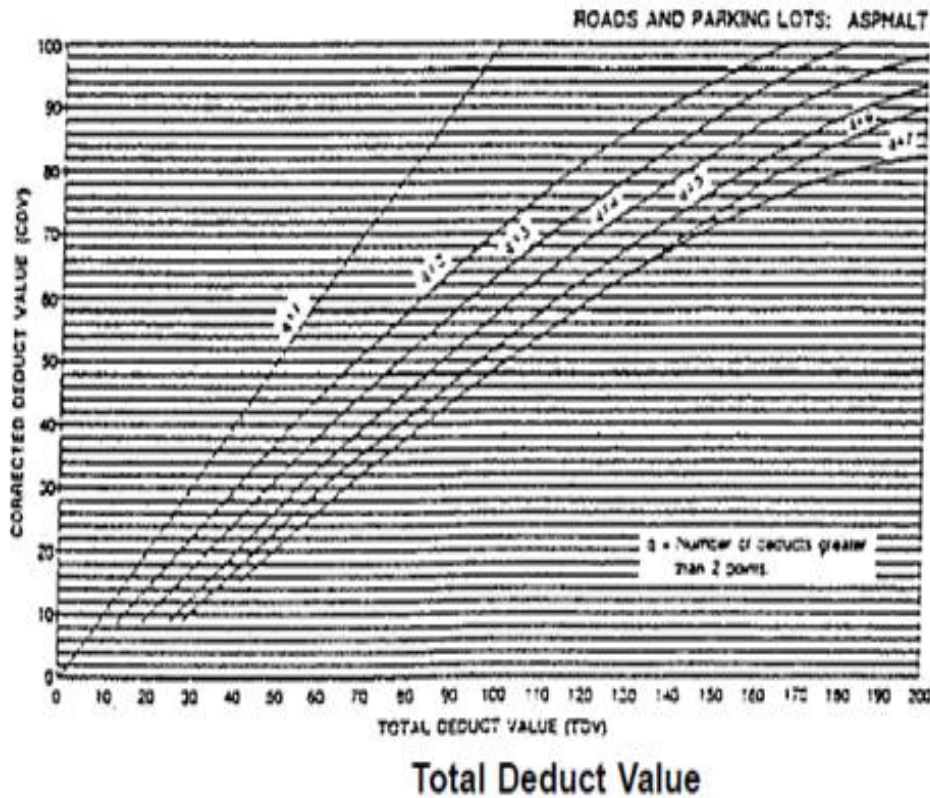
- d. The number of individual deduct values is reduced to the (m) largest deduct values, including the fractional part if less than (m) deduct values are available, all of the deduct values are used.
- e. Determine maximum CDV iteratively.
- f. Determine total deduct value by summing individual deduct values.
- g. Determine q as the number of deducts with a value greater than 2.0.
- h. Determine the CDV from total deduct value and q by looking up the appropriate correction curve for AC pavements in **figure 3.4**

**Figure 3.4** Corrected deduct values (ASTM standard D 6433)

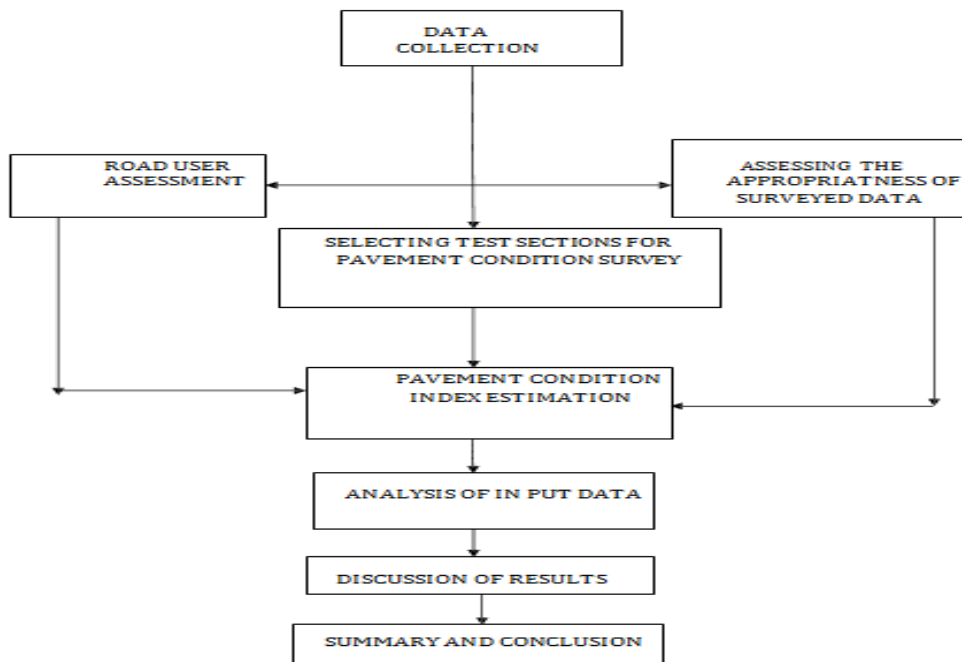
**Figure 3.5:** Flow chart showing the major activities carried out during the research work

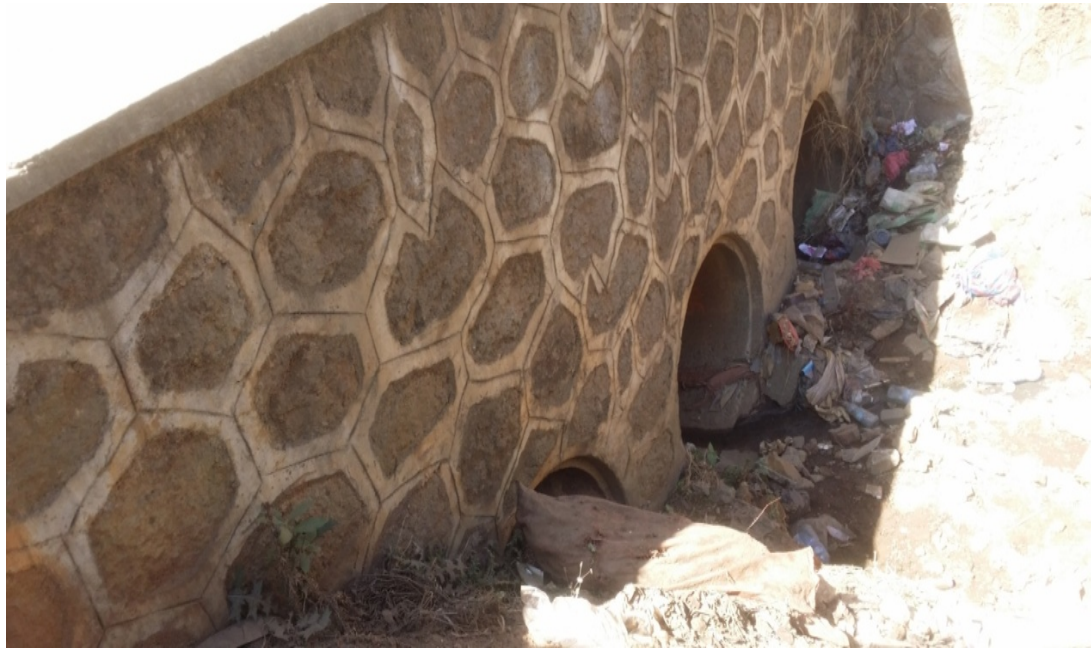
- From twenty five surveyed existing pipe culverts siltation problem in eleven of the existing pipe culverts as the area is located in town section; some of the crossings are clogged with debris in the downstream as shown in picture below.

Figure 4.1 Siltation of existing Culvert

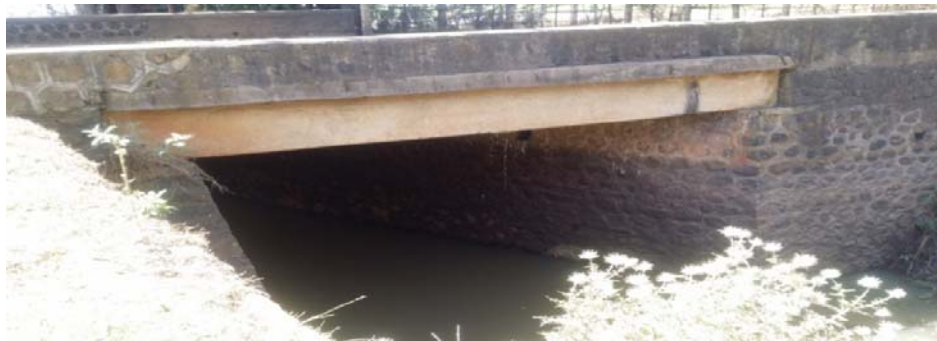
- Three of the crossing channels are missing which requires proper crossing
- Overtopping problems in some major & minor crossings from local consultation & observed flood mark during the study as shown in picture below

Figure 4.2 Improper site selections

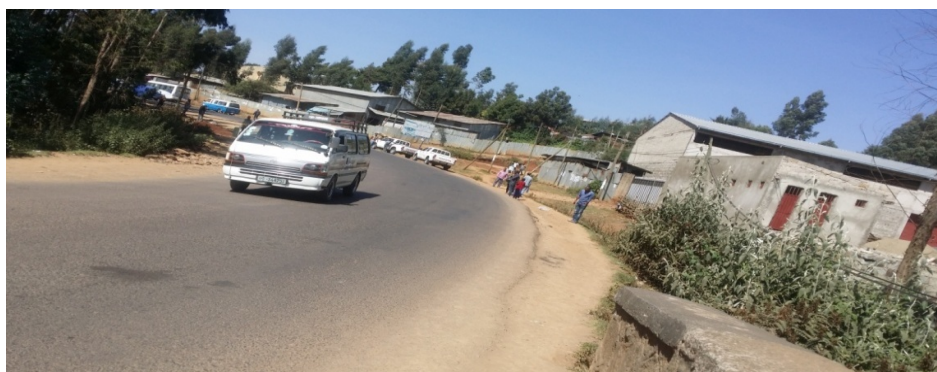
- Four crossings in a valley with respect to both approach roads in steep topography which requires rise of the structure opening height for the sake of the geometry.
- Additional cut off ditch for the first test section of 4km for the right side cut section for properly intercepting the flow from the right side hill as shown below

Figure 4.3 Few crossing structures of existing Culvert

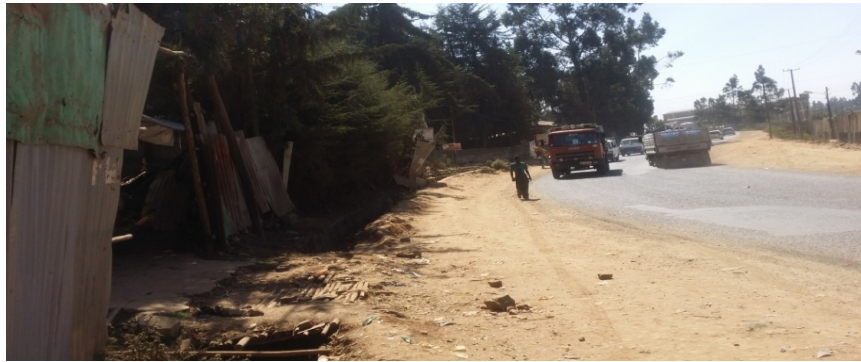
- Proper Drainage problem in all town sections of the project as shown in picture below

Figure 4.4 Proper drainage problems
