A CONSERVATION - RESTORATION STUDY ON THE OF HISTORIC
PREMISES TEFERI MEKONNEN OF SCHOOL, ADDIS ABEBA

JUNE, 2018

A THESIS SUBMITTED TO THE SCHOOL OF GRADUATE STUDIES,
ADDIS ABABA UNIVERSITY

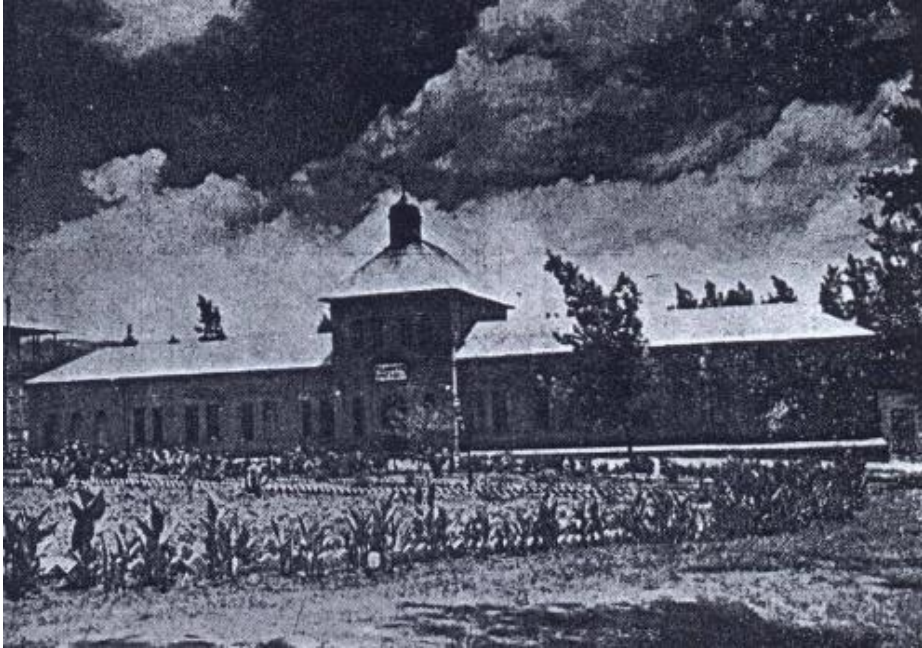
FIGURE 4 TEFERI MEKONNEN SCHOOL- SOURCE MIRROR OF ADDIS ABEBA

The materials used and method of construction of most of the buildings of the 1920's shared some similarities. This includes Teferi Mekonnen school building. Most of the buildings with stone masonry used Ignimbrite pyroclastic rocks and ashlar masonry technique of construction. This type of stone is a very hard which is durable and also expensive due to its quality for construction and durability.

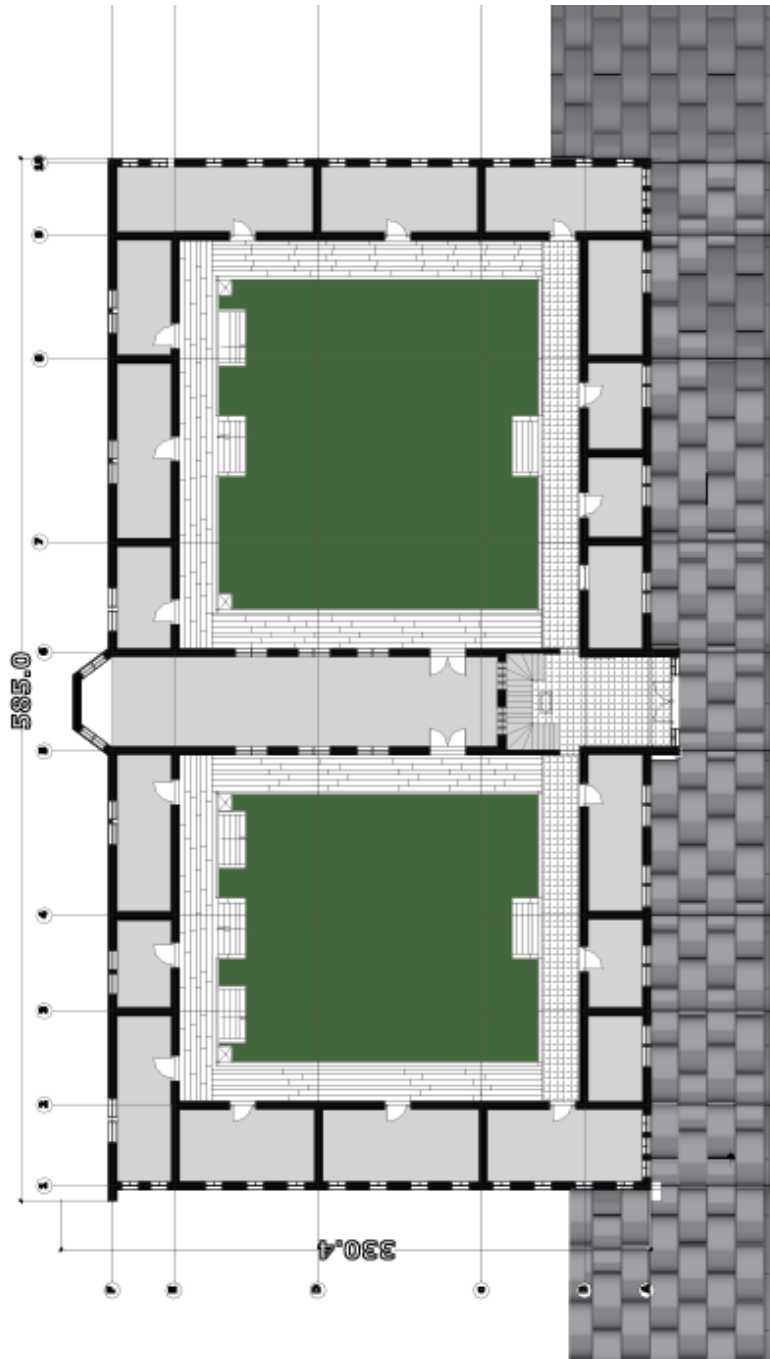
Figure 23 AS BUILT GROUND FLOOR PLAN OF TEFERI MEKONNE SCHOOL

Floor plan of the building shows that circulation was easy inside the building and a symmetric two courtyards are connected by datum block in the middle which is the entrance of the building. Having a semi basement and taking 1930.5 area of the compound. The semi basement and the first floor are accessed from the inside which made it suitable for students and staffs working in the building. The foyer right at the entrance gave the building a grace and is a conventional circulation area.

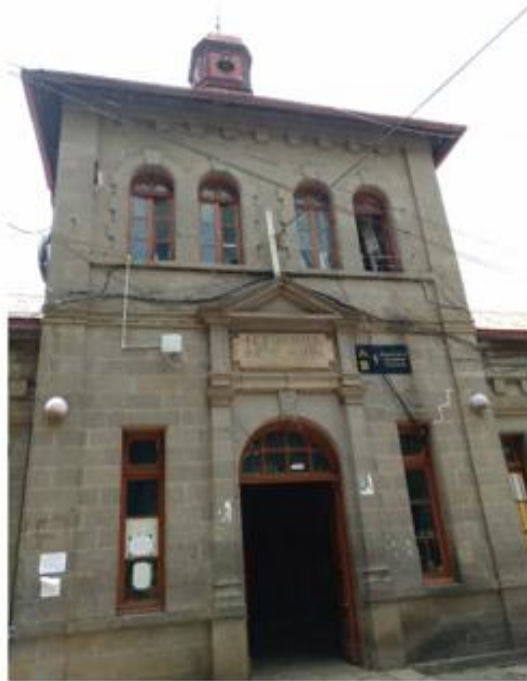
Figure 28 ARCHITECTURAL ANALYSIS 1

the height of the roof and a structure above the top of the first floor roof gave the building a taller appeal and the decorative cube stones above the windows have added a beauty to the building.

the decorative designs by stone for the windows are two types; one is arch and the other one is horizontal which are found on arch windows and rectangular windows respectively.

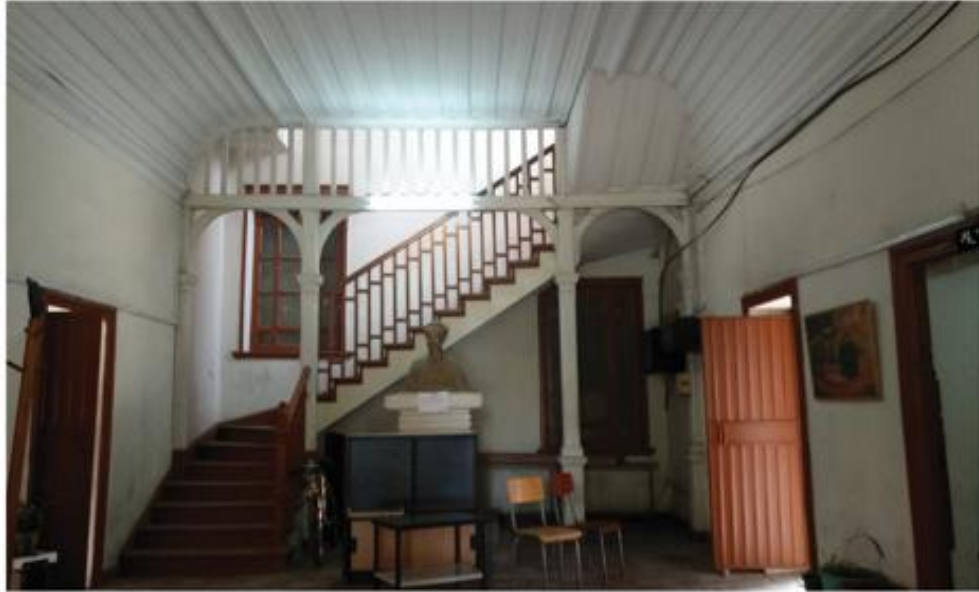
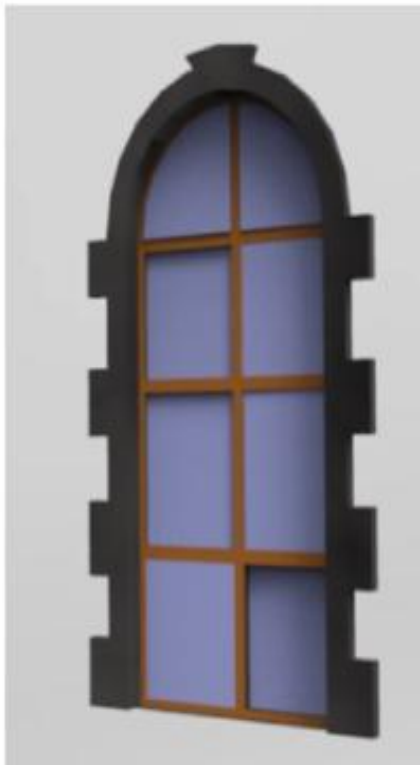
The windows are recessed and have built in arches on top of the window and the arch windows have three transoms which are made of wooden frames and glasses.

The quoins are made with similar type of stone with the wall and the stones are used to build the window sills too.

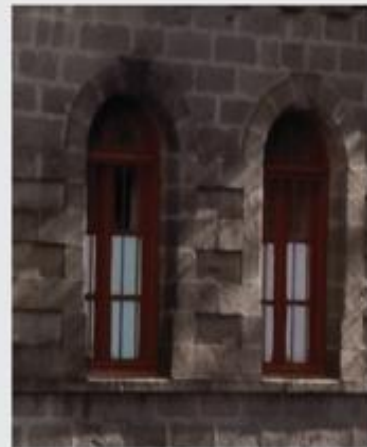
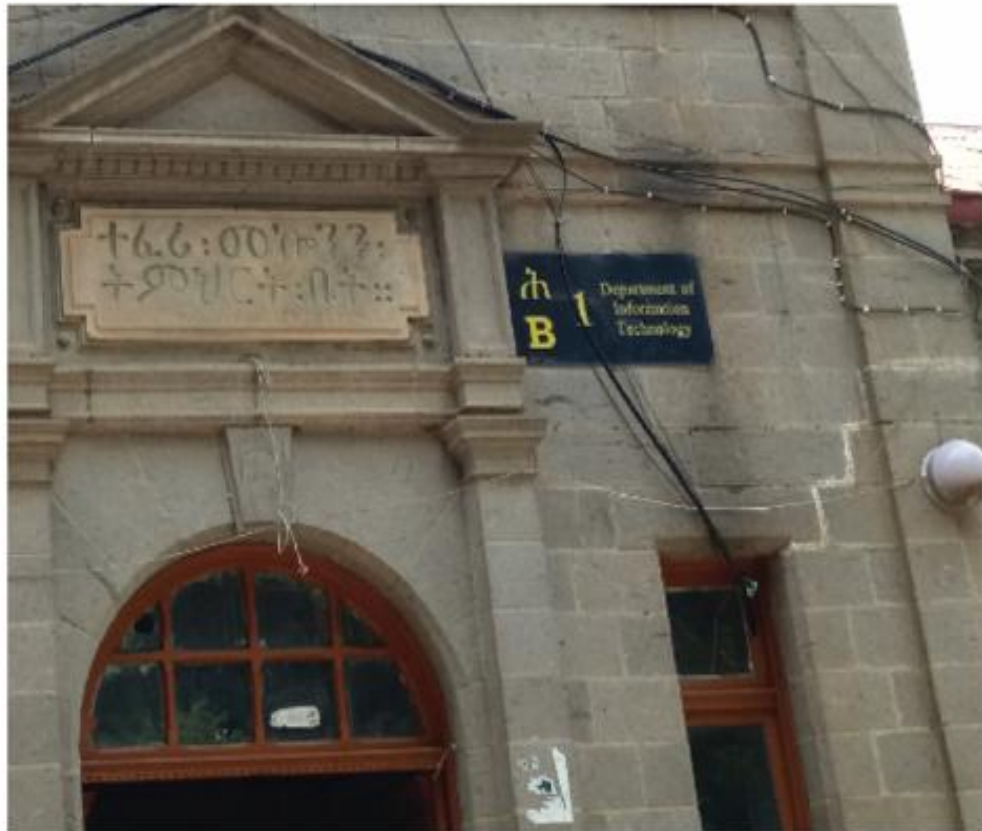
Figure 29 ARCHITECTURAL ANALYSIS 1

Use of ornaments on the door which are similar to European style buildings. The use of quoin at the corners and windows and doors show that the building is made with European style.

The construction method used for the walls is ashlar masonry. Which is a very expensive due to cost of material, cost of dressing stone and the wall thickness is 50 Cm which means it is double masonry since it is stone. Not only that the decorative chamfers of the wall also gives the building to have a nice appearance and the height of the structure made it appear high than-it already is and gave it a grace.

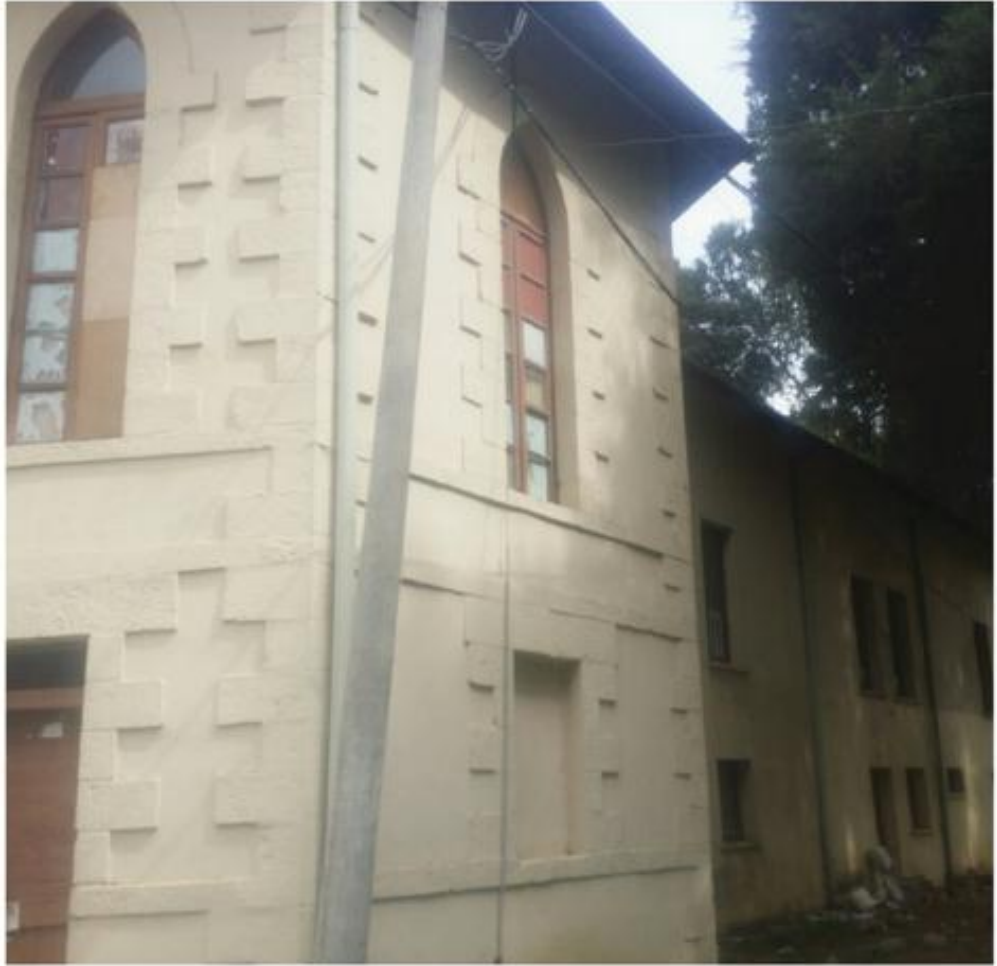
Location – front entrance left

the walls on the rear of the building are plastered and painted but the original walls were stones which are hidden underneath due to wrong restoration practice. The stones which are used to build the building are ignimbrite stones which are non-porous and the plaster and paint on the wall made the walls of the painted part to have no point where the walls will let out vapour.

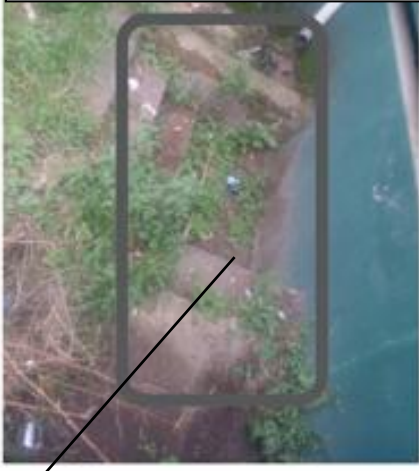
Location – right courtyard stair

biological decay - broken and disintegrated tiles

uncleaned stair

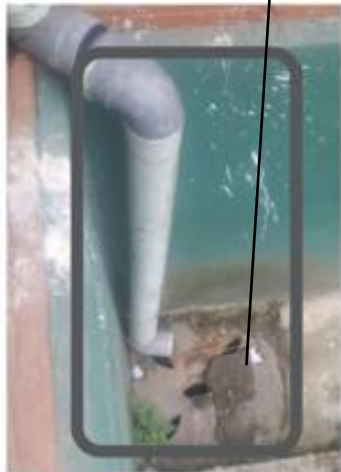
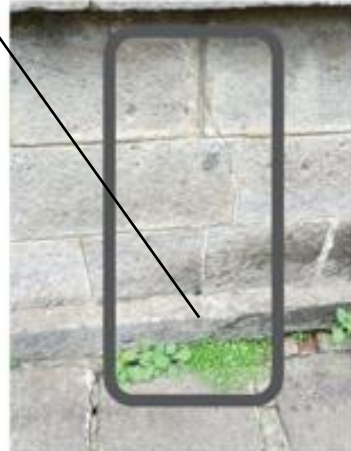
Figure 35 DAMAGE ANALYSIS 5

crack noticed on the stone due to settlement

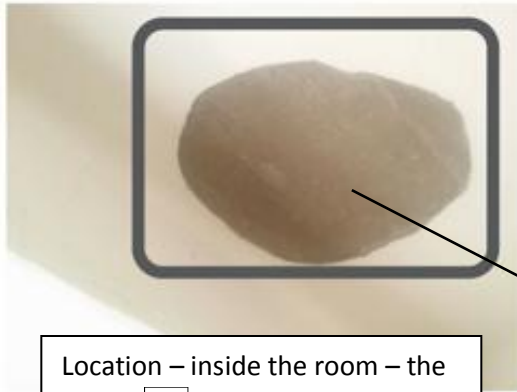
Location – inside the room – the ceiling 1

flacking of the plaster and the paint - due to ack of adhesive and vibrationa nd impropr construction.

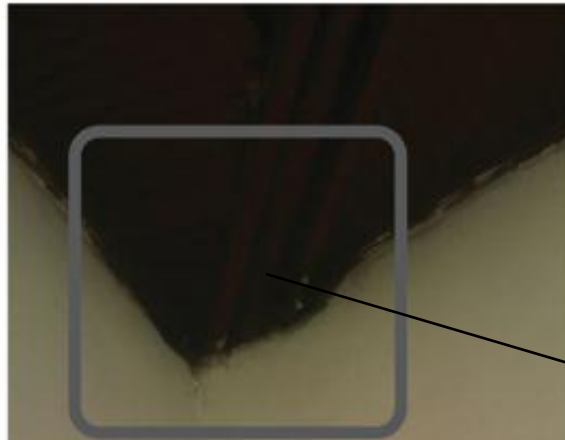
Location – connection between the veranda and the room wall 1

improper joint between the roof and the wall and the plaster of the wall

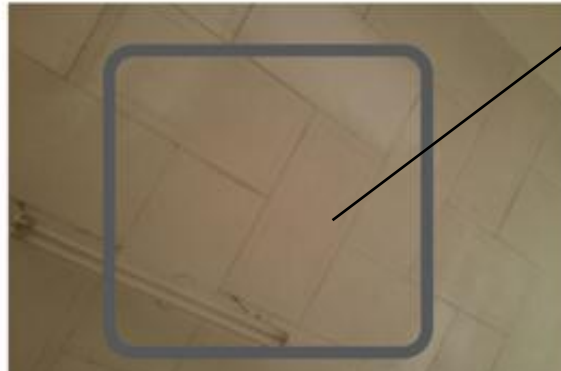
Location – inside the right corner room on the right side of the courtyard

unleached ceiling and saging due to missed nails .

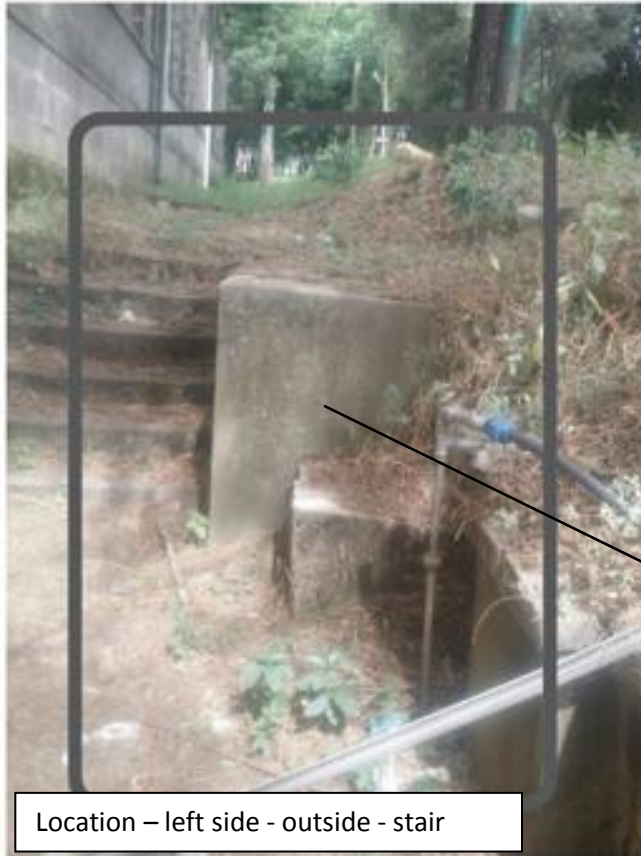
Location – left side - outside - stair

dirt - since the stair is not used and was not clead for a long time it has collected organic dust and plants are growing in between the mortars.

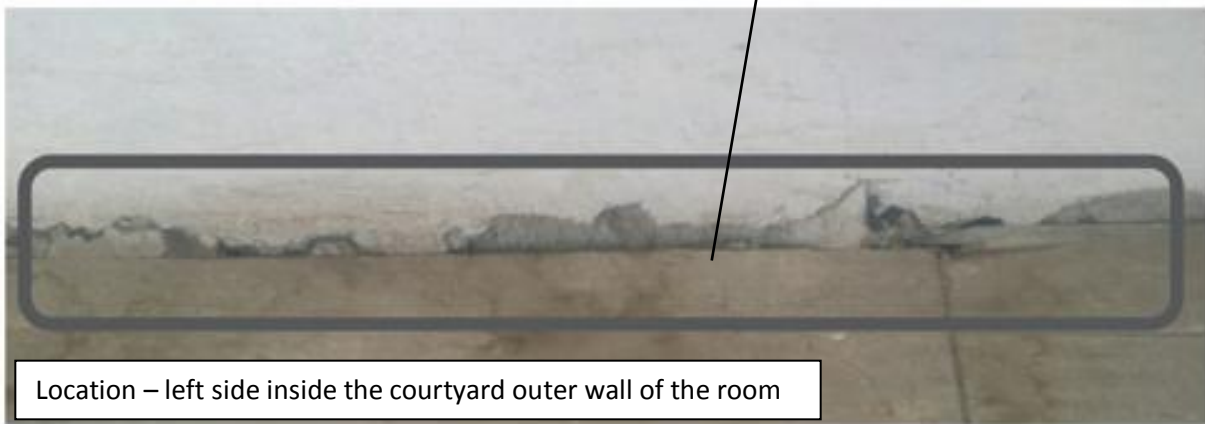
Location – left side inside the courtyard outer wall of the room

lack of connection between the plaster and the wooden floor which is a result of improper restoration in the past trying to cove the stone with plaster on top of plater and since it is not well attached with the wall and the floor its a matter of time for two materials to stay part if there is no strong connection.

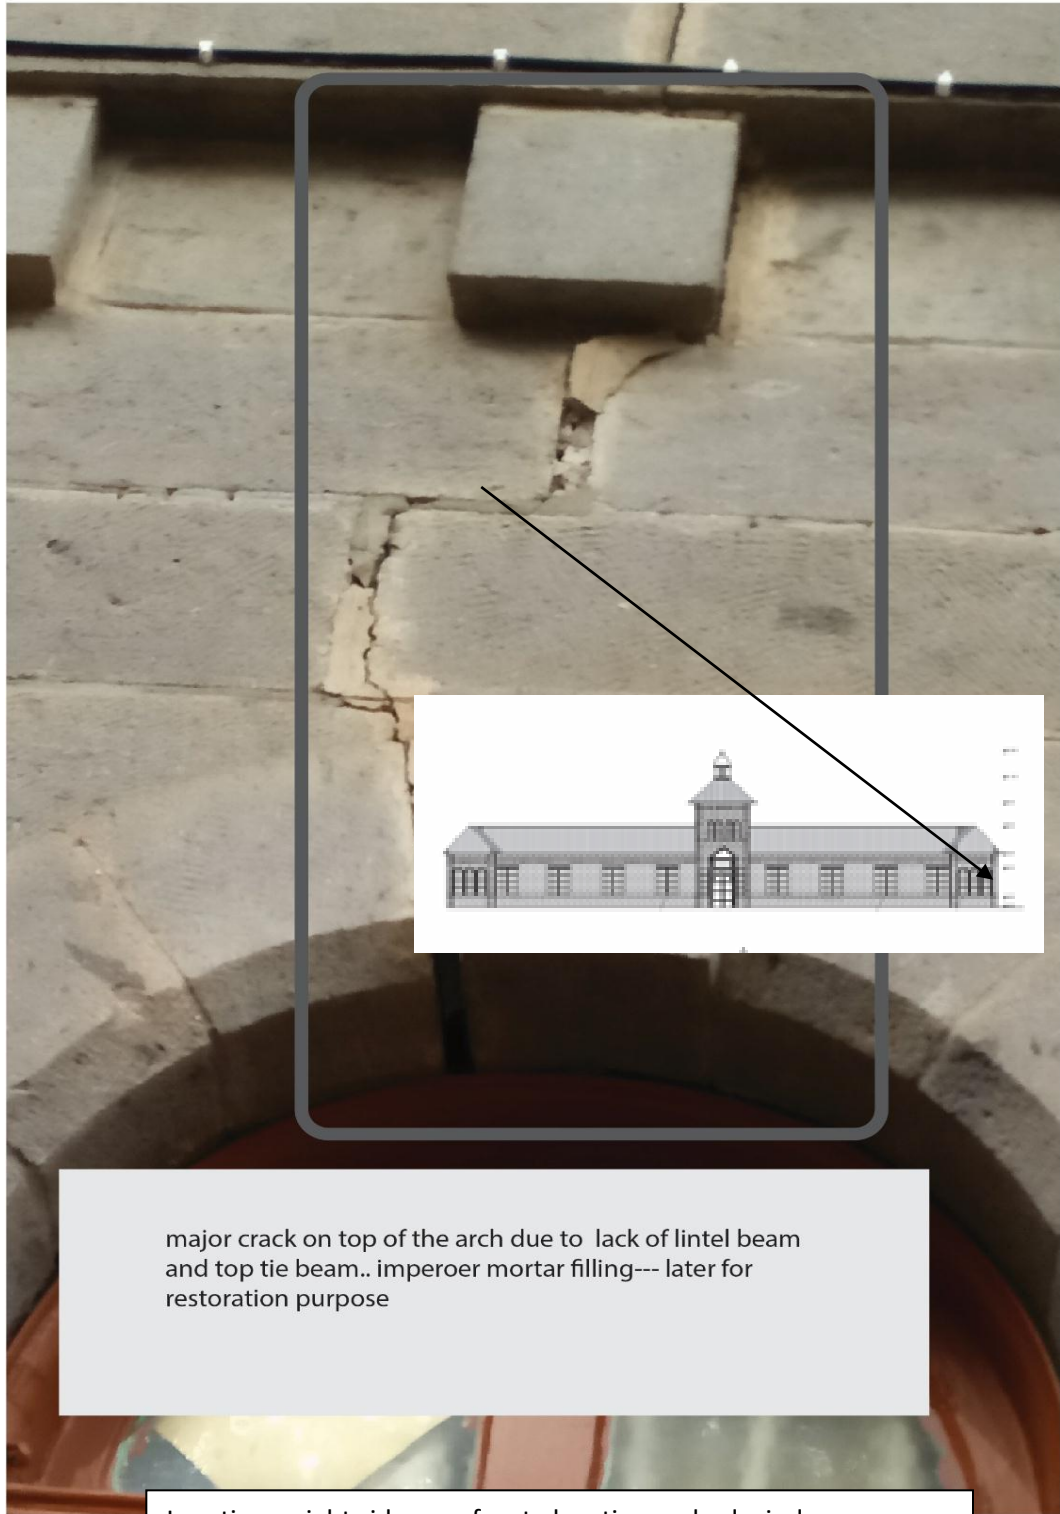
Location – right side – on front elevation arched window.

major crack on top of the arch due to lack of lintel beam and top tie beam.. impenetrable mortar filling--- later for restoration purpose

- Substitute the removed masonry with reinforced concrete top tie beam and light weight mass concrete which is reinforced with wire mesh
- Plaster the beam and paint with lime
- Fill the cracked space with low shrinkage lime mortar using hand system
- Provide top tie beam all around the building so that the top of the wall will be tied.
- Fill the gap with non-shrinking lime mortar

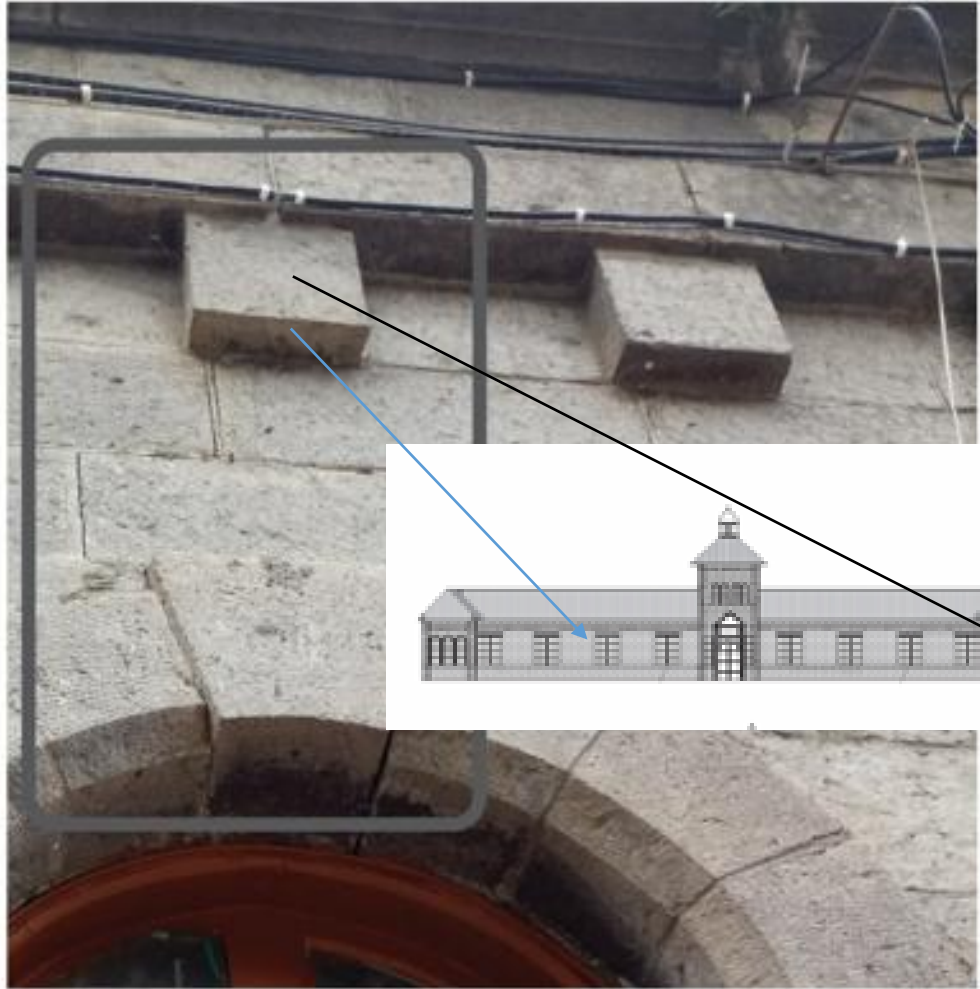
Location – right side –front elevation – above arched window

crack on top of the arch quoins made of stone and this is due to lack of tie beam and lintel beam which in turn put the stress on the mortar and on the arch. the stones are getting apart due to the stress.

electrical wire system on the walls an improper installation of the wires outside on the exterior walls.

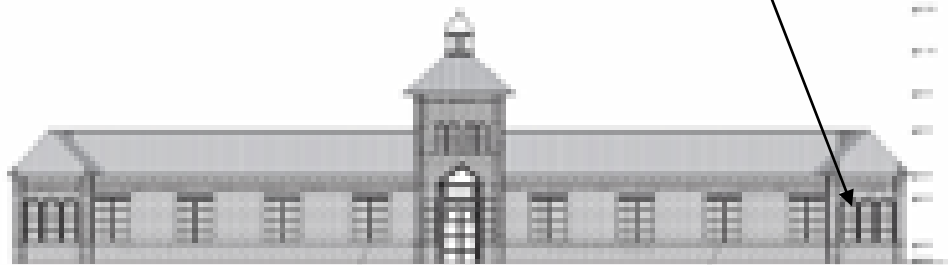
major crack on top of the arch due to lack of lintel beam and top tie beam.

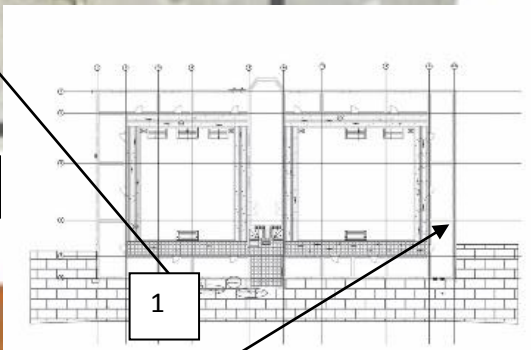
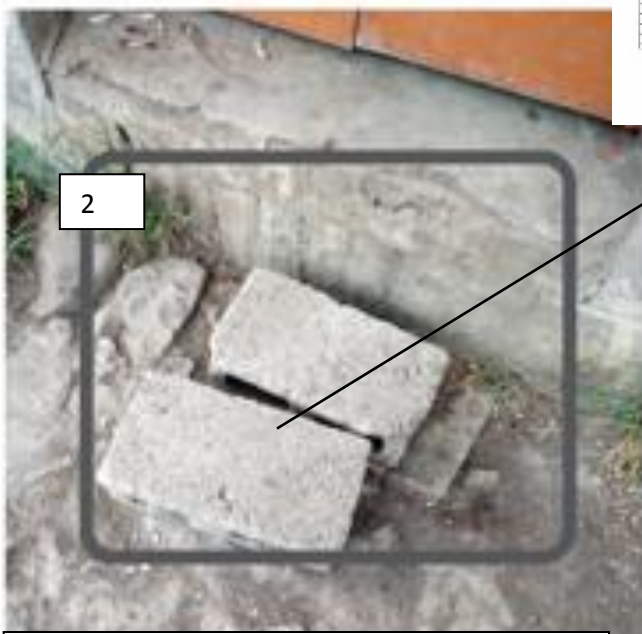
Location – right side – semi basement door

water an biological decay
destroying the wall and
changing the color .

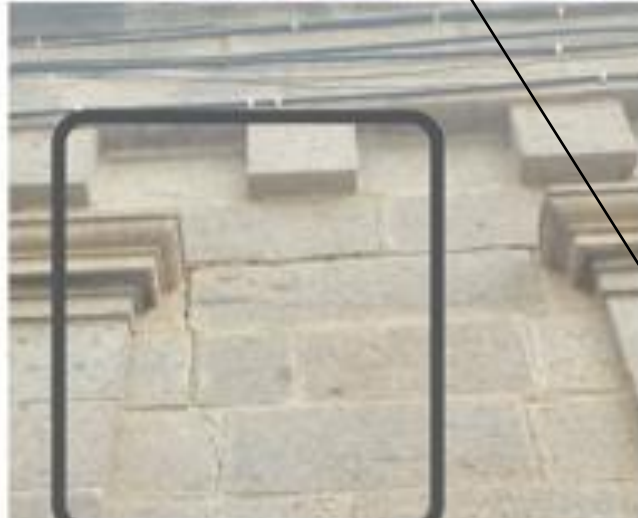
Location – front elevation right above the rectangular window

pic 2
this is a crack which is noticed on two windows of the same type which shows the bearing instability of the lintel beams and lack of top tie beam

- Dismantle two layers of masonry (the top stone masonry and the next top stone masonry)
- Substitute the removed masonry with reinforced concrete top tie beam and light weight mass concrete which is reinforced with wire mesh
- Crack on the lintel over the Arch

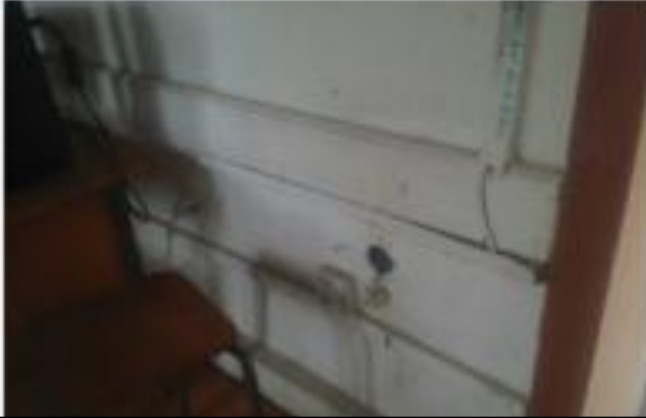
Location – inside the semi basement rooms

the first picture shows the imbalanced masonry structure which recalls for foundation settlement . due to ground water or unbalanced effect underneath in the foundation the masonry structure are disintegrating and it can cause a structural failure to the building.

- Clear the traffic in the building, relocate the residents
- Excavate the soil around the foundation carefully
- Provide 40cm working space at the bottom which widens to 100cm at the top
- Reinforce the foundation by providing concrete jacket
- Tie the concrete jacket at every meter distance
- Refill the excavated soil

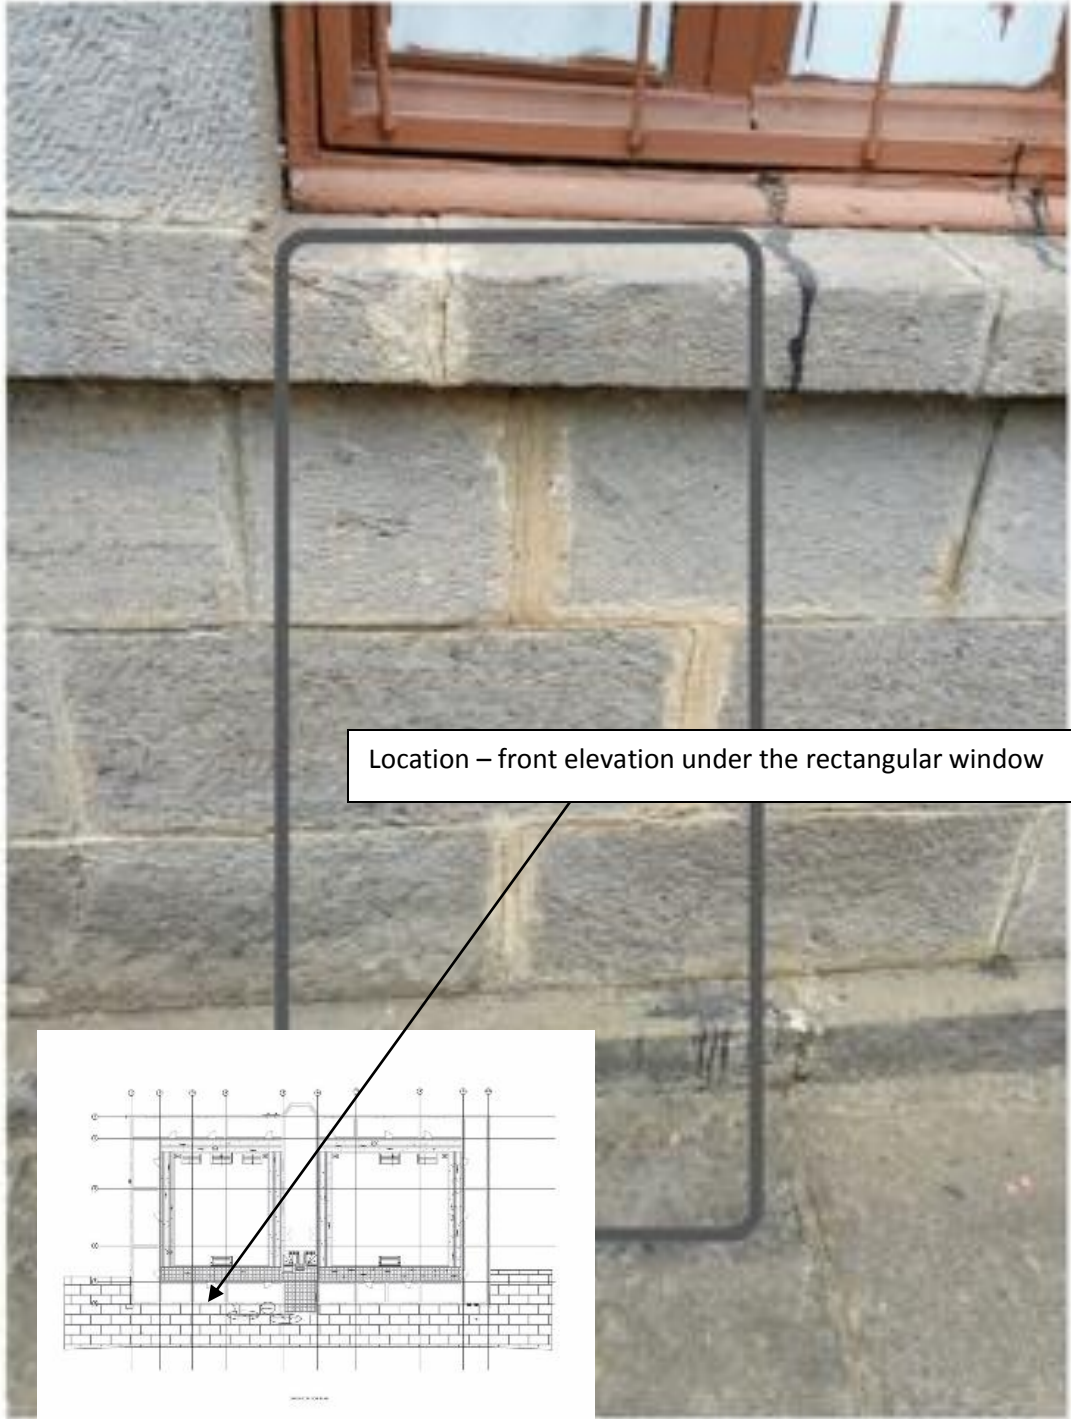
Location - front elevation under the rectangular window

improper fill of mortar and crack due to settlement along the dtone foundation underneath the ground

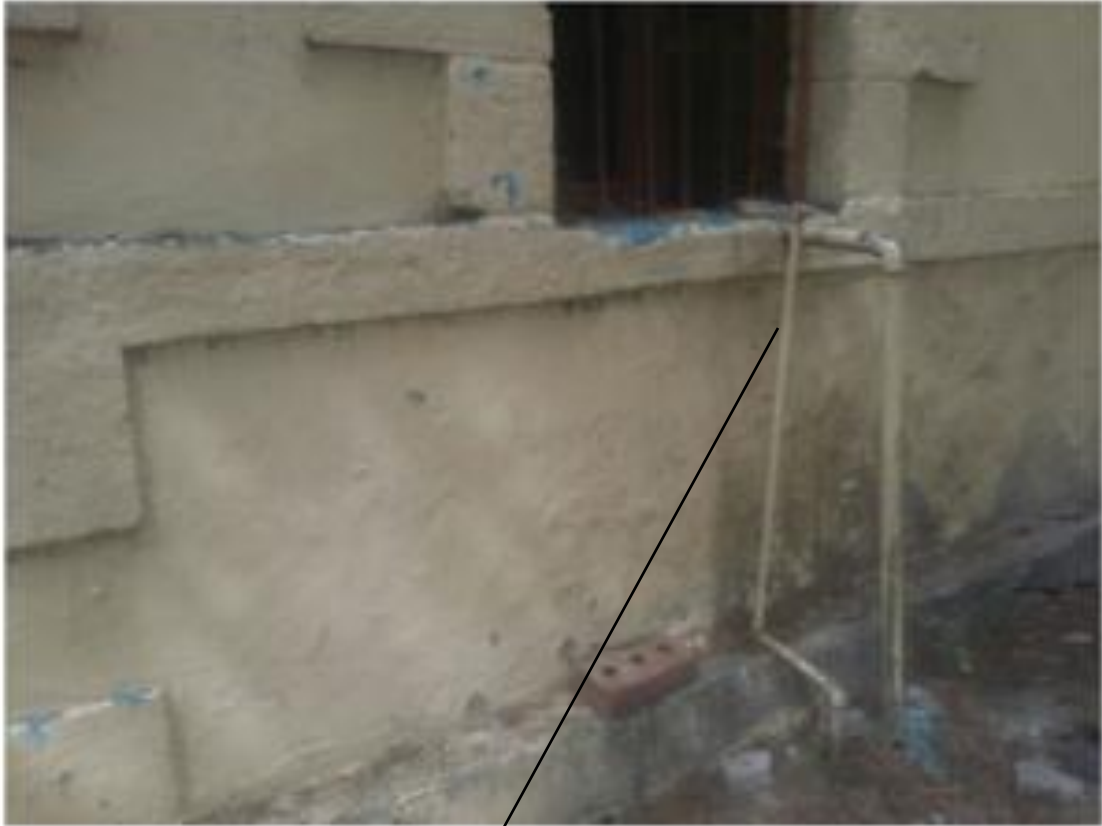
Location – back side on the walls

biological decay and vapor destroying the wall. the plaster on the wall hindering the wall to breath.

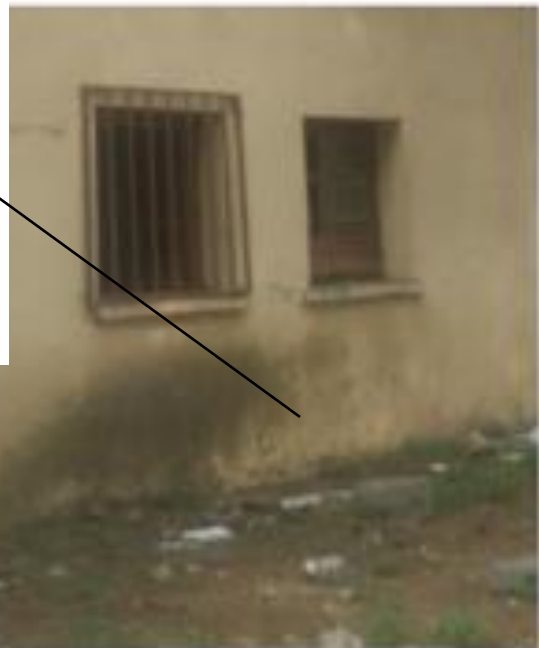
Location – stair inside the court yard

cracks on the floor due to vibration and difference in material and weak bond in between. the walls are originally constructed with stone but the plaster on top of the walls is flaking mainly due to vapor and the walls are not given a point of let out .

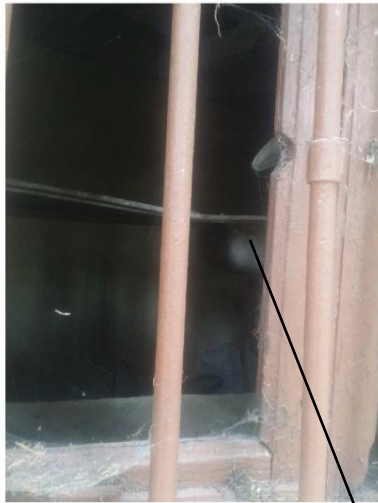
windows with wooden frames are destroyed and the color of the woods are of a different paint since they have started to flake and there are no layers.

lack of glass on the windows and broken windows.

window sill uncleaned for a long time and exposed to rain and sun radiation.

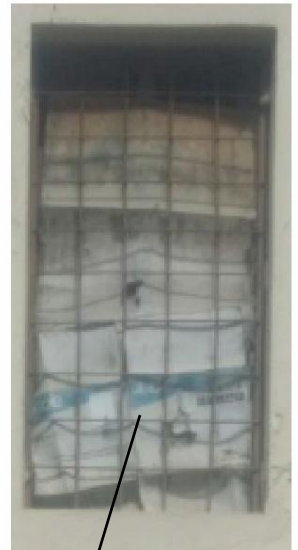
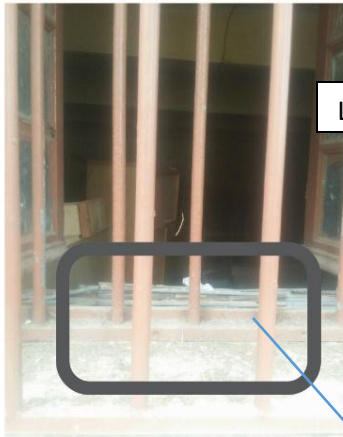
Location – all are windows at the back side

Improper restoration of the door. unplanned restoration of the door and additional elements on the door which are not similar to the frame work and biological decay destroying the plaster on the wall and the floor.

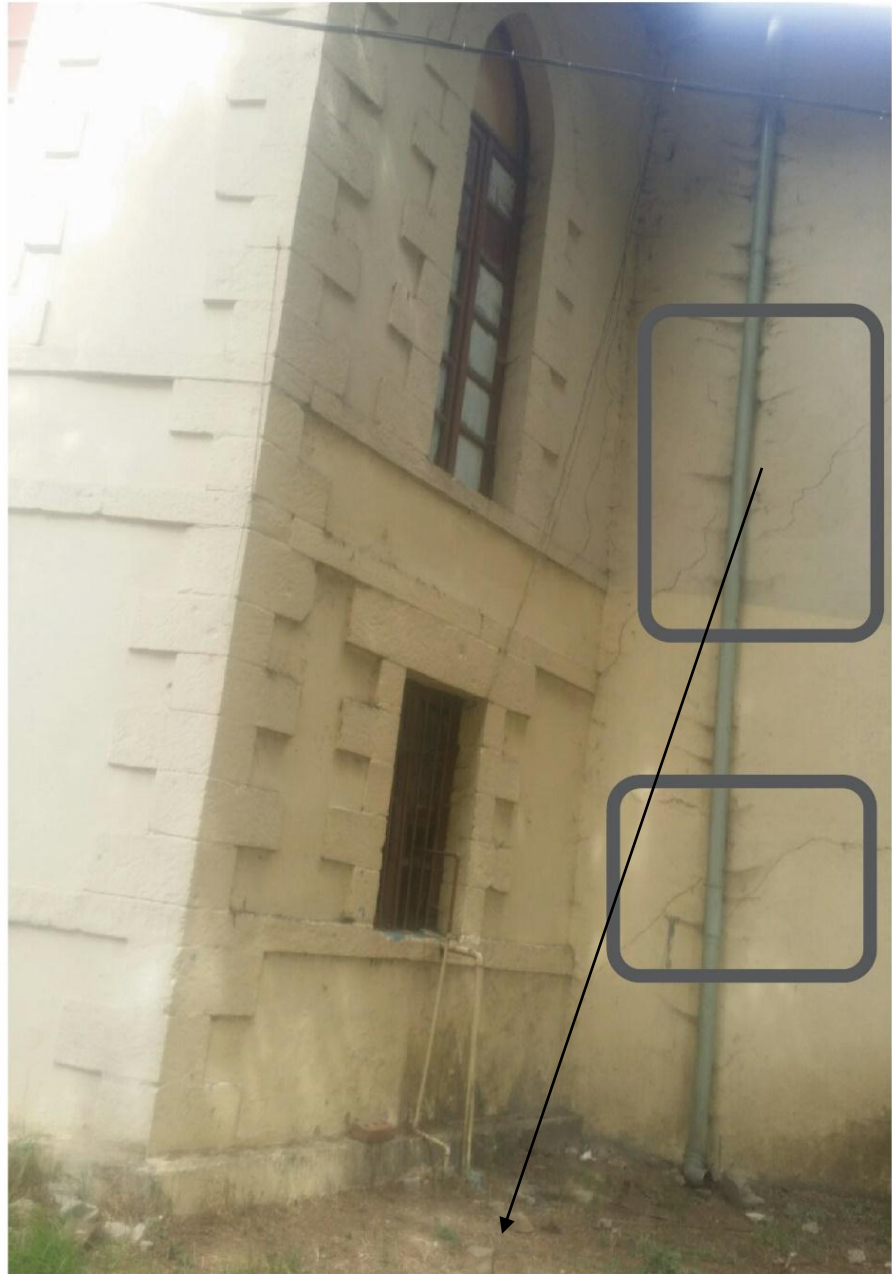
Location – front side connection between the wall and walk way

the building is having diagonal cracks on one side of the wall but two cracks which indicates for settlement of the foundation. the plaster has covered the stones but if investigation is done under the plaster most probably the stones have crack too.

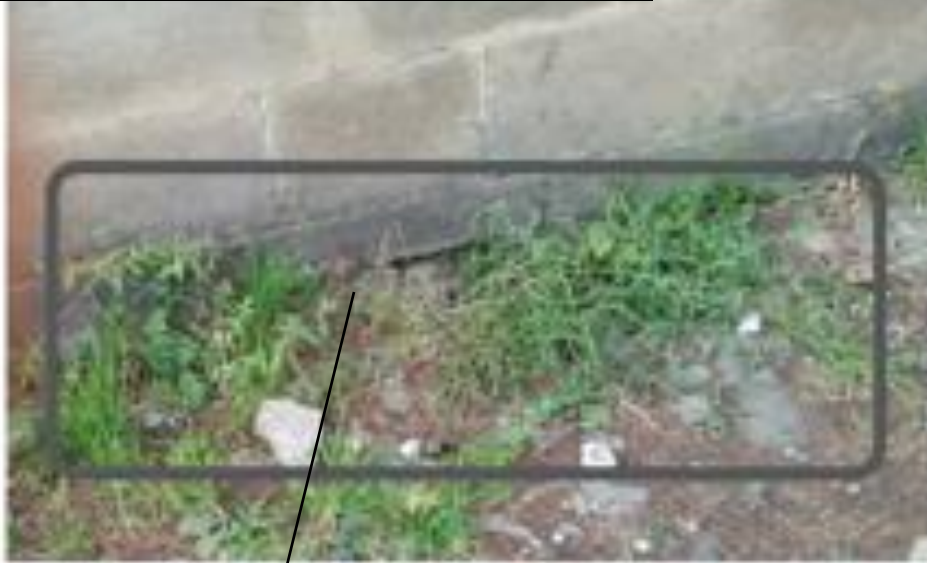
biological decay which is a result of humidity due to under ground water or water from the rain there is no metal grating for the water to pass during rain which affects the connection between the exterior wall and the ground. the material cover for the ground walk way is a means of problem since it is uncomfortable for some plants to grow and the plants keep moisture for their sake which in turn damages the walls

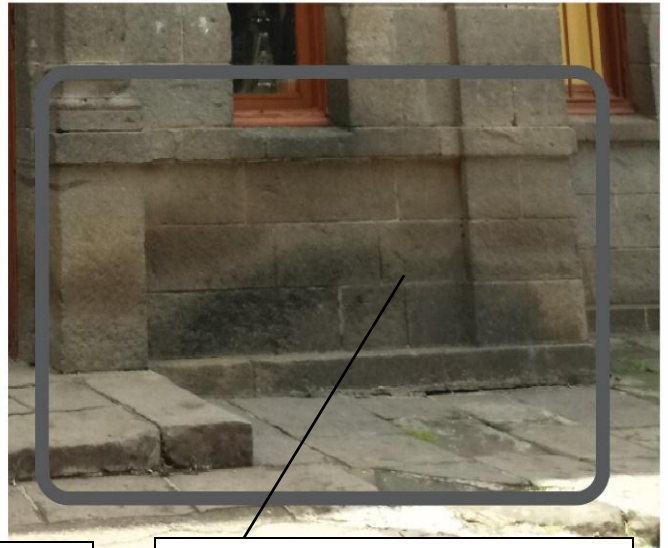
Location – front side on the wall

crack on the stone slates of the verendah

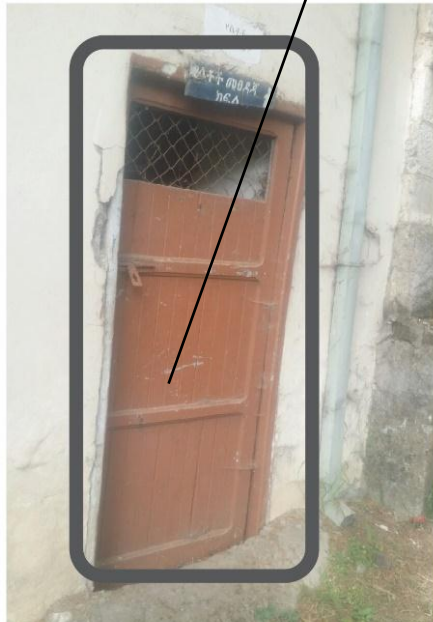
Location – back side door

biological decay , broken stones and exposure to water from the

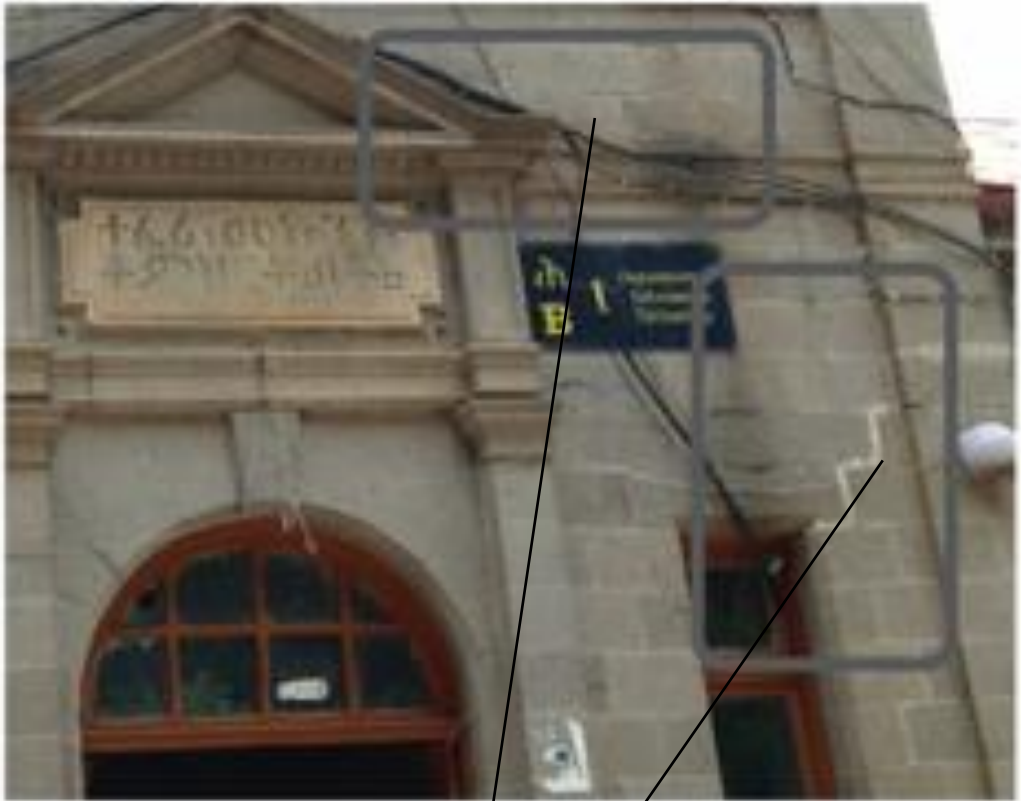
Location – front side - on the wall

major crack on top of the window and improper mortar fill

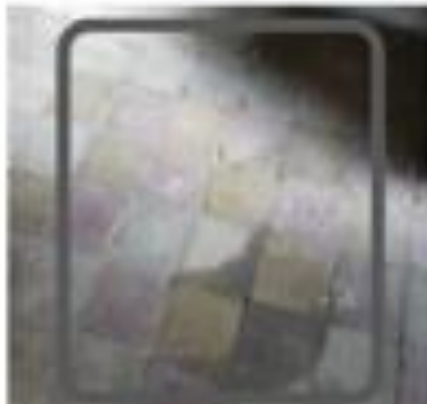
Location – inside the lobby as entered from the front entrance of the building

broken tiles

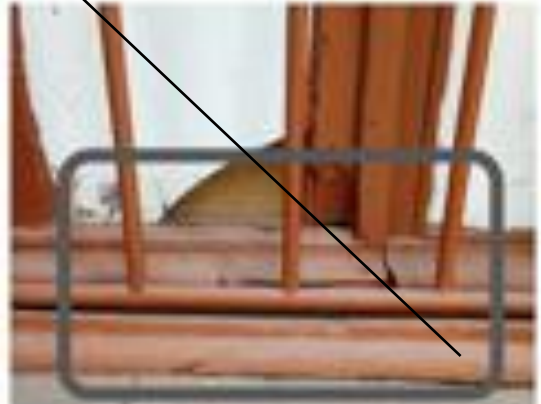
Location – window on the front side

broken window frames

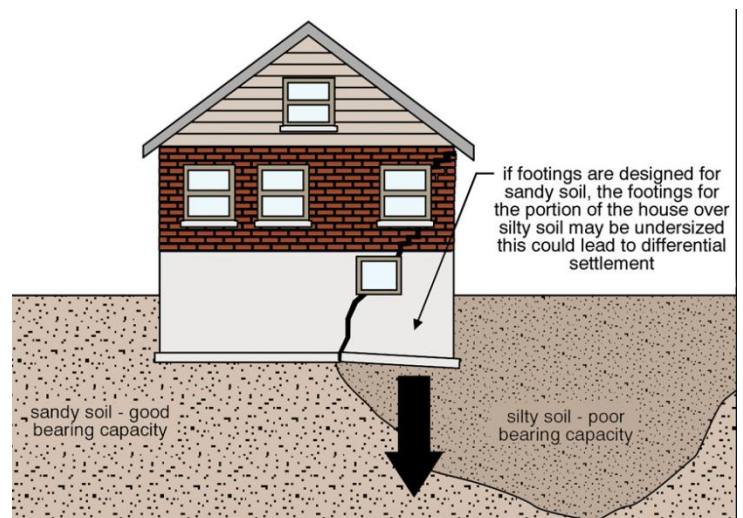
Figure 38 FOUNDATION SETTLEMENT ANALYSIS

- The cause of these cracks is buildings movement due to lateral load.
- Aging and weak bonding around the corner of doors and windows also have contribution for the crack.

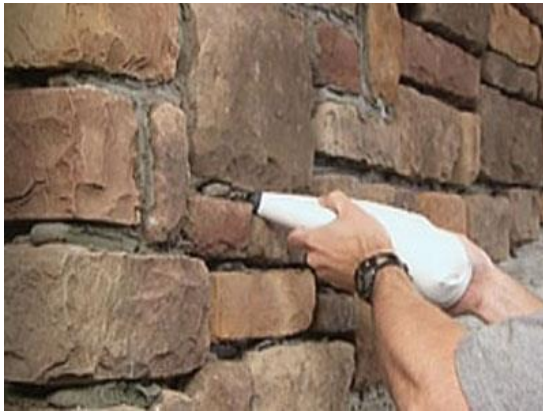
Figure 42 HAND REPOINTING

- In preserving deteriorated joints in stone cladding we must start by cutting the deteriorated joint manually using hammer or chisel to obtain a sound, compact substrate with no crumbling or unstable areas and no saline efflorescence, dust or mildew without compromising the integrity of the face of the wall.
- Clean it in low pressure hydro cleaning the surface to remove dust, traces of efflorescence and, soluble salts, micro-organisms and saturating the surface before
- Applying mortar, to improve its grip and prevent substrate drawing water from the mortar and compromising the final performance characteristics of the mortar.
- Reinforce the joint lines with Φ 6 mm bar
- Apply natural hydraulic lime and Eco Pozzolan masonry mortar with natural sand, special additives and micro fibers (such as Mape-Antique Allettamento produced by MAPEI).

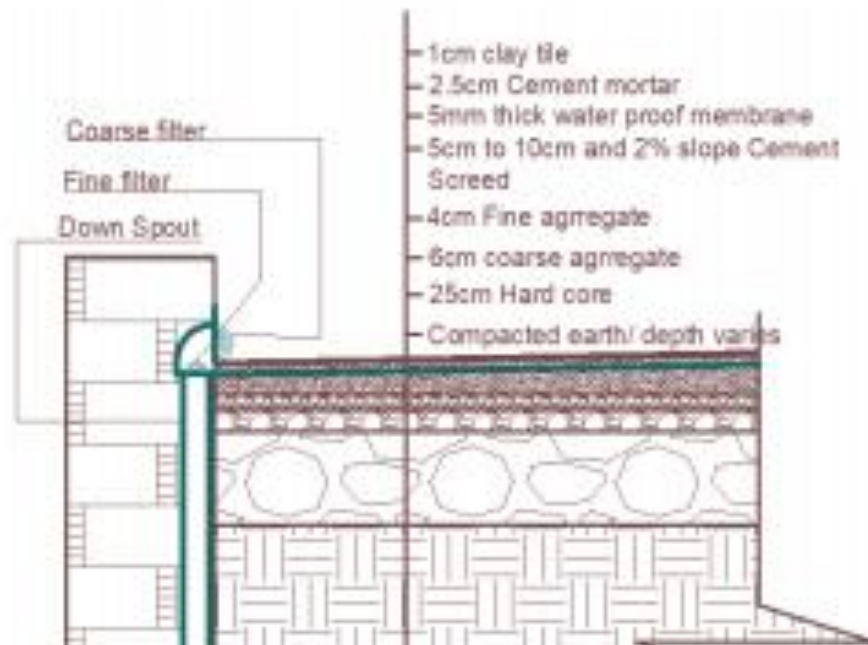
Figure 44DOWN PIPE AND SANITARY SYSYTEM RESTORATION

- Substitute the roof cover with similar high quality CIS.
- Avoid climbers and lichens around the downspouts.
- Substitute all damaged gutters and down spouts with new iron sheet gutters and downspouts.
- Clean the roof regularly at least twice a year or before every rainy season

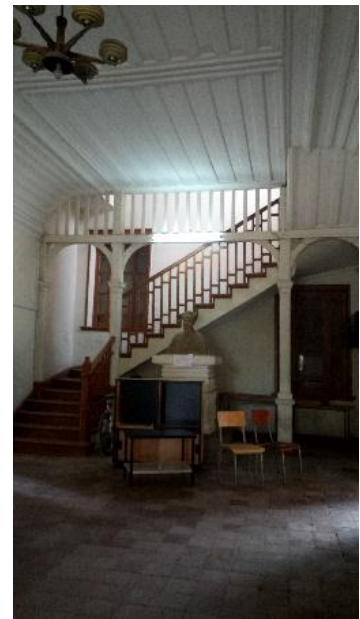
Figure 46 PICTURE OF THE INTERANCE LOBBY

- Restore highly deteriorated corrugated iron sheet by new same sheet covering.
- Fix the uplifted covers due to wind fatigue
- **Internal walls:**
 - **Plaster spalling and crack:** the same as the intervention for external defects.
 - **Ceiling:** the deteriorated canvas ceiling due to accumulation of moisture leaking from above should be restored by the same material.
 - Apply water sealant above the ceiling to protect the wetness brought from the roof.
 - Provide a wall vent that allows the condensation to escape out and even not appear.

Avoid the dampness/ leakage of water from the top – sealant between timbers

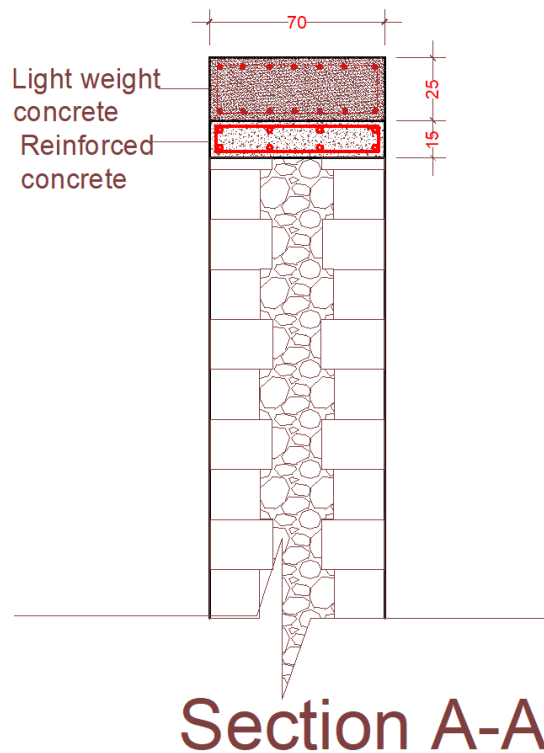
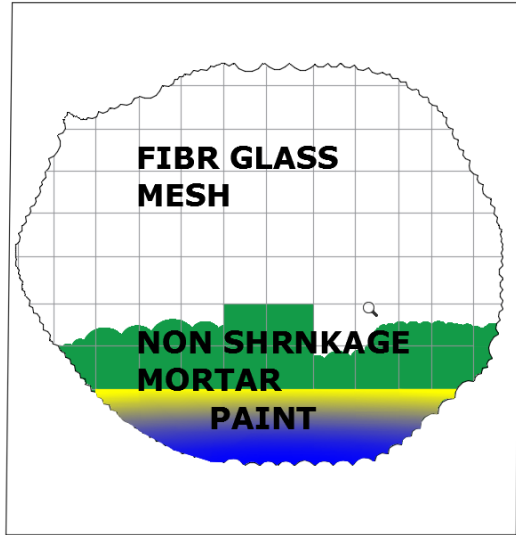
Figure 47 RESTORATION OF THE PLASTER ON THE WALL

- Disinfestation and cleaning of masonry and wood works infested with bio-deteriorating organisms
- Applying a wide-spectrum, water-based, anti-mold and anti-mildew biocide solution with a brush, roller or spray
- Flaking of surface plaster interior
- Apply fiber glass mesh and Non-shrinkage cement
