A CONSERVATION - RESTORATION STUDY ON THE OF HISTORIC
PREMISES TEFERI MEKONNEN OF SCHOOL, ADDIS ABEBA

JUNE, 2018

A THESIS SUBMITTED TO THE SCHOOL OF GRADUATE STUDIES,
ADDIS ABABA UNIVERSITY

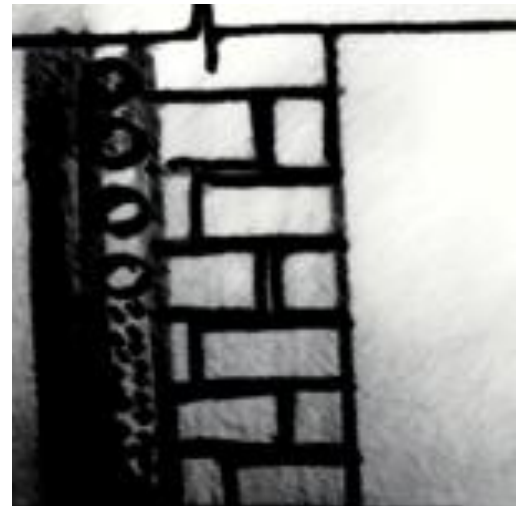
Figure 51 FOUNDATION WALLS UNDERNEATH

There needs additional perforate pipe installed in between the earth and the masonry wall to avoid further foundation damage
