**Investigation of Shear Fatigue Behavior of
Reinforced Concrete Beams Under Moving
Load**

A Thesis in Structural Engineering

By Noah Girma
January 16, 2020
Addis Ababa

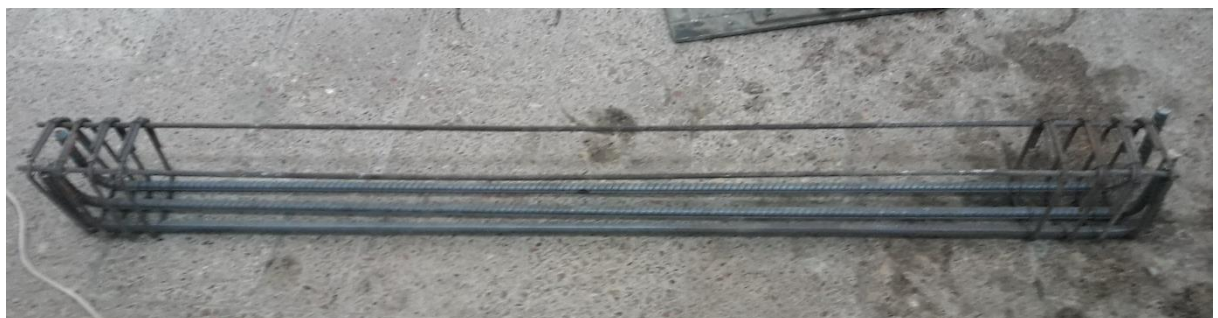
Longitudinal reinforcements were used to ensure shear failure. For the bottom reinforcements 20mm diameter rebars were installed and 10mm rebars were installed for the top longitudinal reinforcements. 8mm diameter deformed bars were used at the edges of the beam outside the effective length to avoid anchorage failure.

Figure 3.3: reinforcement cage

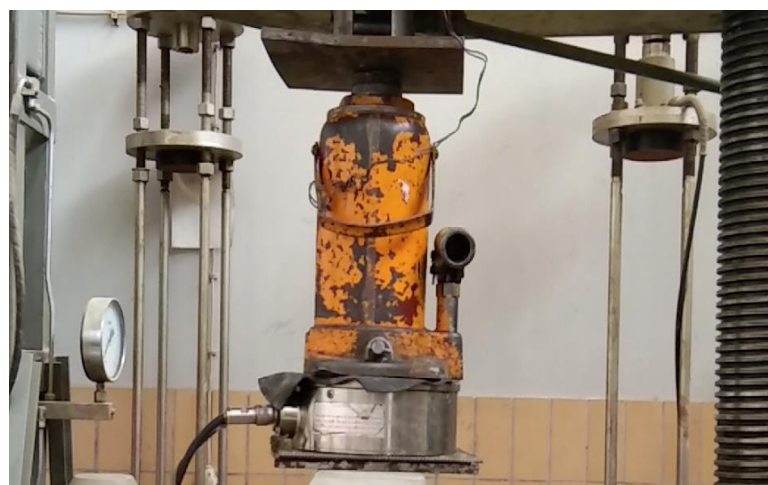
The main instruments used on the tests are the hydraulic jack which is used for applying the load, the load cell to measure the applied load, the linear variable transducers to measure the displacement of the beam upon loading and the data logger which is used for recording the load with its corresponding displacement of the beam.

Figure 3.9: hydraulic jack and load cell

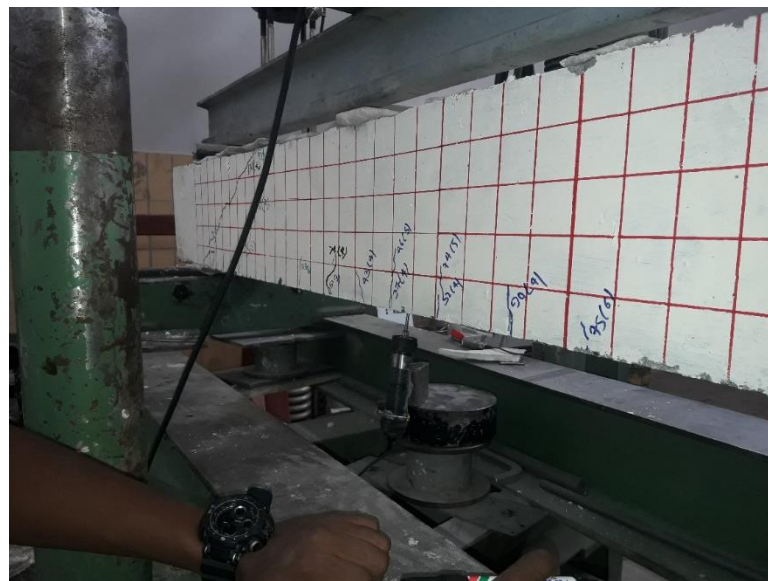
Figure 3.11: linear variable displacement transducers (LVDT) installed under the beam

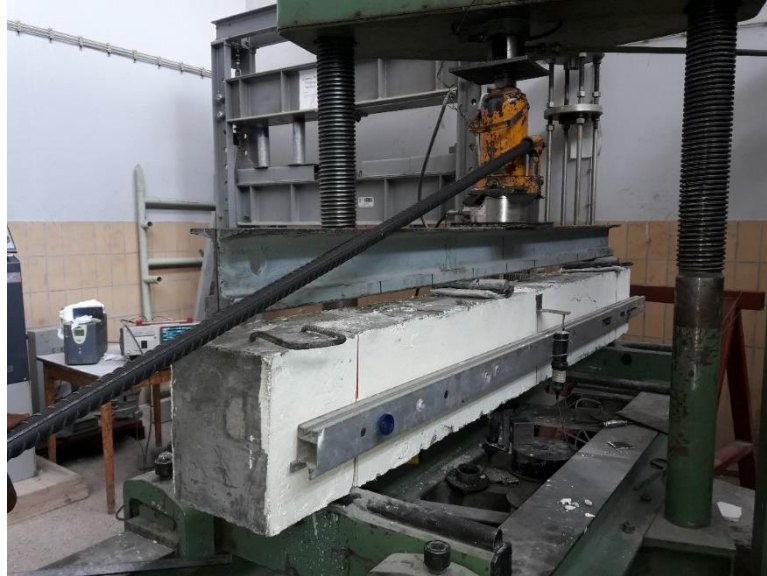
Figure 3.12: linear variable displacement transducers (LVDT) installed at the back

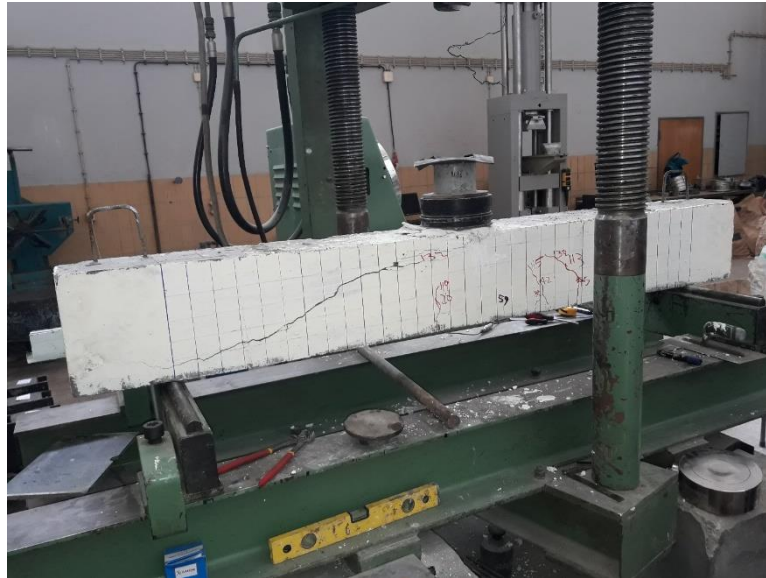
This beam was used to determine the monotonic shear capacity of the beams. Since all of the beams were casted with a material from similar source the beams are assumed to have a similar strength. This beam has an a/d of 3.86 and a concrete cubic compressive strength of 35.4MPa. After loading started, first flexural crack was observed at a load level of 59KN followed by other small flexural cracks beneath the loading point. Following the formation of the flexural cracks, a major diagonal shear crack developed and became visible at a load level of 132.55KN. The beam failed in shear, in a brittle manner.

Figure 5.1: MB after failure

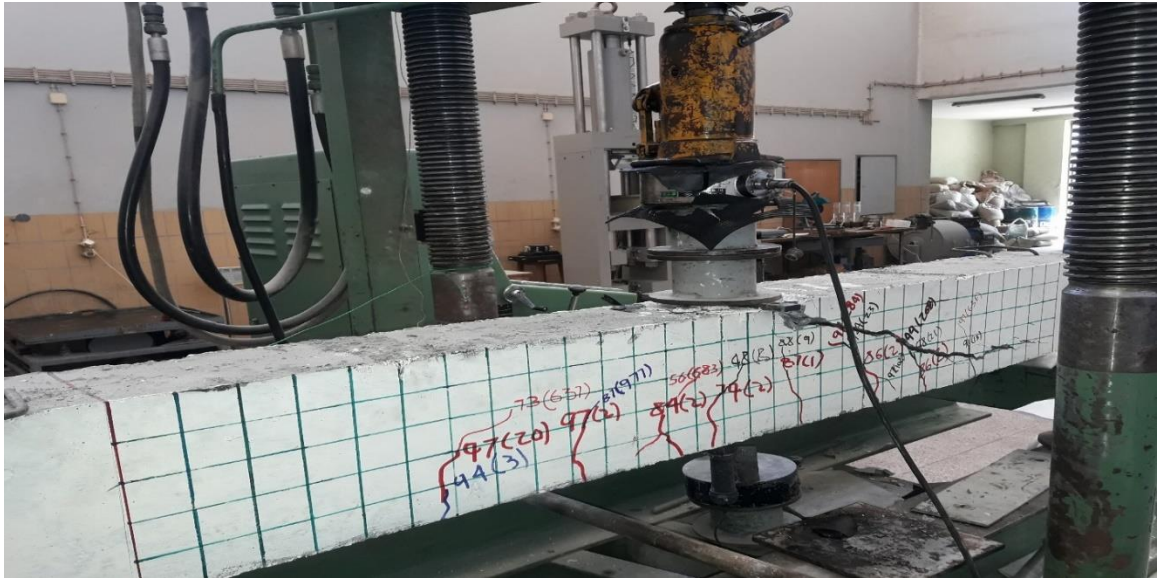
On the first loading cycle vertical flexural cracks developed near mid-span. Further loading cycles produced more flexural cracks that extended towards the point of load application in each cycle. But these cracks didn't widen throughout the test. Cracks tend to get wider when the beam is loaded and the cracks immediately closes after the beam is unloaded. After the first cycle this beam displayed almost a constant deflection with increasing number of cycles. The fixed-point pulsating load continued up to the 1000 cycle. After the 1000 cycles it was decided to load the beam monotonically since it's hard to continue cyclic loading manually until the beam fails. The beam was loaded monotonically and inclined crack formed very suddenly and was associated with the shear flexural cracks that formed due to the fatigue loading. Failure was sudden and occurred soon after inclined cracking. The beam failed in shear with a maximum load of 146.06KN in a brittle manner. The maximum load carried by this beam exceeded the control beam maximum capacity by 10.2%. This increase in shear capacity after fatigue loading was also observed in a previous research. (Getachew, 2018).

Figure 5.2: FCB75 after failure (front side)

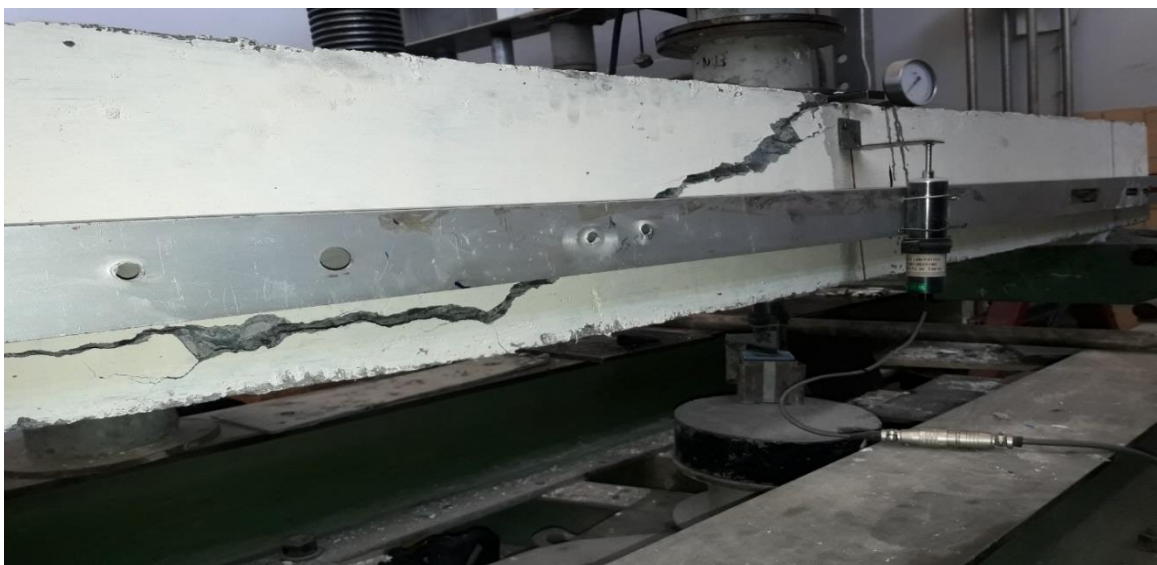
Figure 5.3: FCB after failure (rear side)

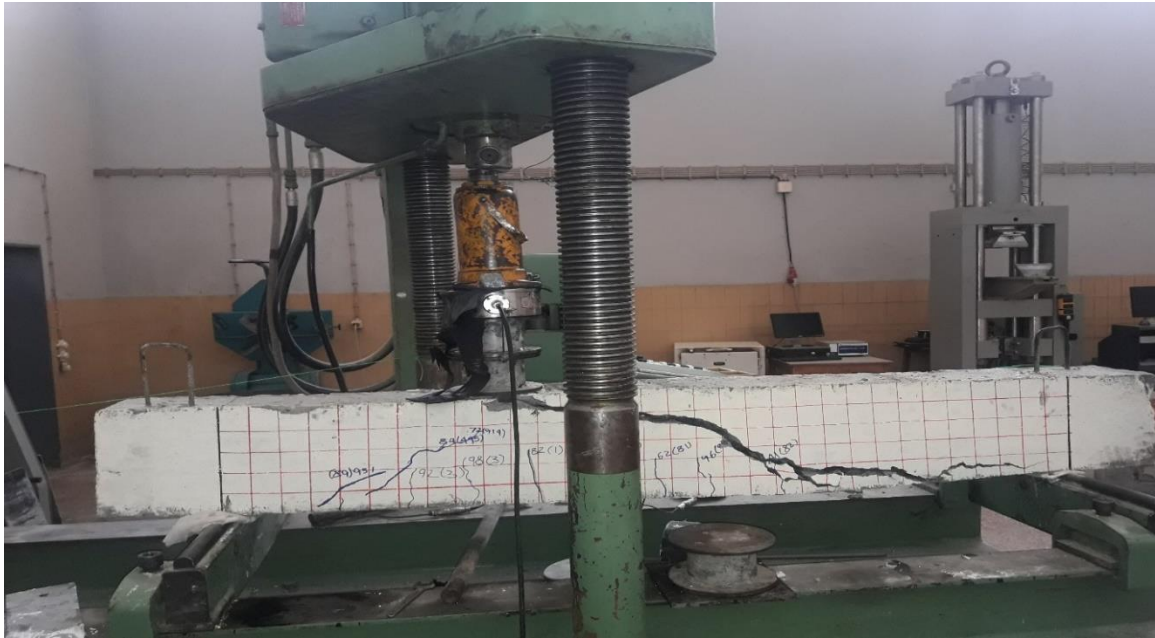
Using the above equation, the maximum shear force to capacity ratio was found to be 0.49m away from the support. Specimen FCB75c was used to test that fatigue at this point would be critical. Testing was done by applying a fixed-point pulsating load (one sided cyclic loading) at 0.31m away from midspan to the left support, after 64 days of casting. This beam was loaded up to 75% of its maximum capacity by a pulsating load. It took three days to reach 1000 cycles and after that the beam was made to fail monotonically. It was planned to show that fatigue at this point was critical but since the load range is small 1000 cycles were reached without a significant sign of failure. On the first loading cycle small flexural cracks started around the loading point and extended towards the point of load application in each cycle. Shear flexure cracks started developing on both sides of point of load application. After the first cycle this beam displayed almost a constant deflection with increasing number of cycles. Cracks tend to get wider when the beam is loaded and the cracks immediately closes after the beam is unloaded like the previous beam. The fixed-point pulsating load continued up to the 1000 cycle. Then the beam was loaded monotonically and inclined crack formed very suddenly and was not associated with the shear flexural cracks that formed due to the fatigue loading. Failure was sudden and occurred soon after inclined cracking. The beam failed in shear with a maximum load of 216.34KN in a brittle manner. Unfortunately, it failed on the side which was least expected. This is due to a significant reserve strength in the beam due to arch action. The maximum load carried by this beam exceeded the control beam maximum capacity by 63.2%.

Figure 5.4: FCB75c after failure

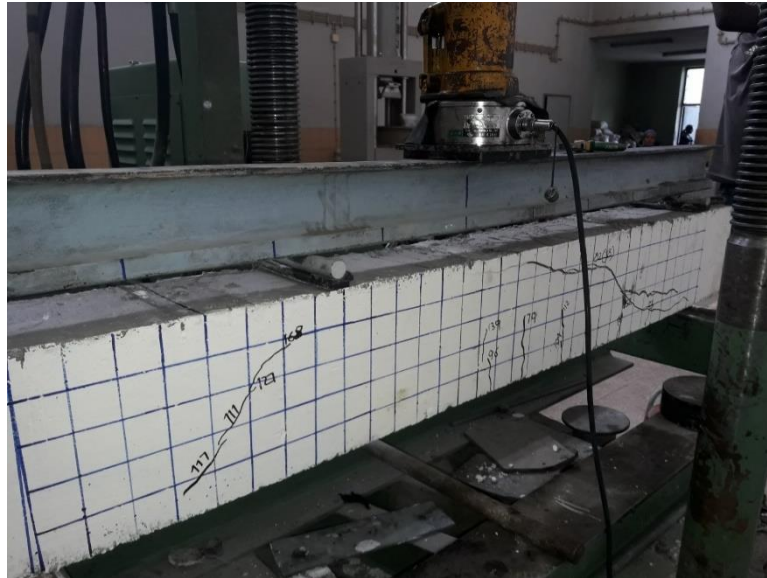
MCB85 was tested under one-side cyclic loading 33 days later from casting. This beam was subjected to a cyclic step-wise moving loads with 85% percent of its maximum capacity. The first loading is applied at an offset distance of 20 cm to the right of the left support (loading point A) with amplitude of 112.7KN. In the second loading, at an offset distance of 40 cm from the left support (loading point B), formation of diagonal cracking is observed. In the third loading (loading point C) the, diagonal crack formed during the second loading, was extended. During the fourth loading (mid span) only flexural cracks occurred. In the fifth loading (loading point E) most of the flexural cracks extended. During the sixth loading (40 cm to the right of mid span) formation of diagonal cracking is observed on this half of the beam. Until the 18th loading there was always an extension of existing cracks. In the 18th loading the diagonal crack formed during the 6th loading showed an appreciable extension to the point of load application (mid span) by propagating into the compression zone and it also extended to the support by developing a splitting crack along the longitudinal reinforcement. Lastly, the beam failed in shear during the 24th loading, which is applied at loading point C (20 cm to the left of the midspan). The already extended diagonal crack propagated towards loading point C and the beam failed at a load of 91.78KN.

Figure 5.5: Diagonal cracks in both halves of the specimen MCB85

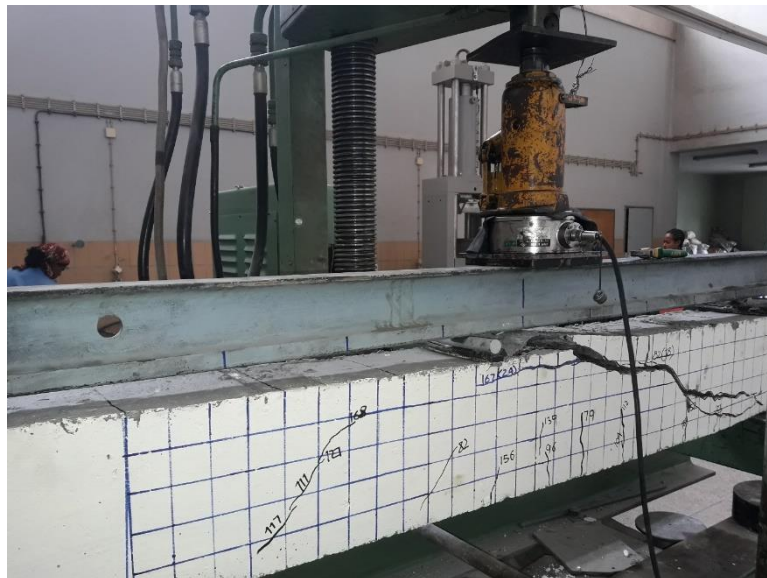
Figure 5.6: MCB85 after failure

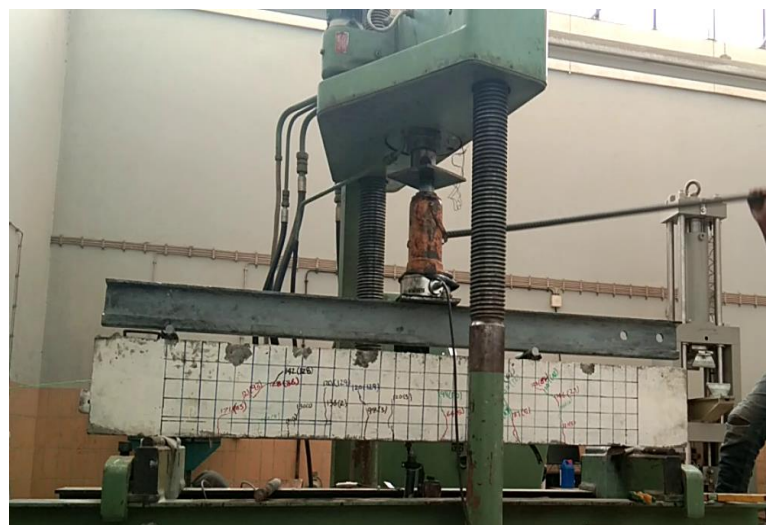
During the 208th loading (20 cm to the right of mid span) new diagonal crack suddenly occurred at a load of 96.8KN. And it was on the most damaged half of the beam. This indicates that, damage tends to accumulate on the previously damaged part due to other loading points. The new crack propagated into the compression zone and it also extended to the support by developing a splitting crack. Lastly, the beam failed in shear in the 213th loading point, which is applied at loading point C (20 cm to the left of the midspan). The diagonal crack that formed in the 208th loading propagated towards loading point C and the beam failed at a load of 93.44KN. New inclined crack also occurred towards load point C. but the beam failed along the previous winded diagonal crack. This beam failed after 30 passages, and this result do not deviate much from a previous study on RC beam subjected to a moving cyclic load with 75% of its capacity, the beam failed at 51 passages but loading points here were only at five different locations along the beam not seven as in specimen MCB75. (Gebreyouhannes & Suryanto, 2019)

Figure 5.7: diagonal cracks propagating in to compression zone in both halves of MCB75

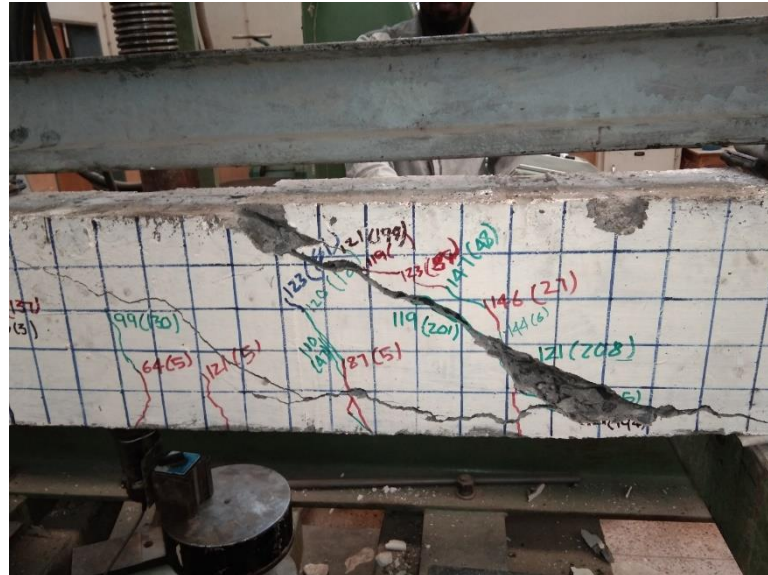
Figure 5.8: MCB75 after failure

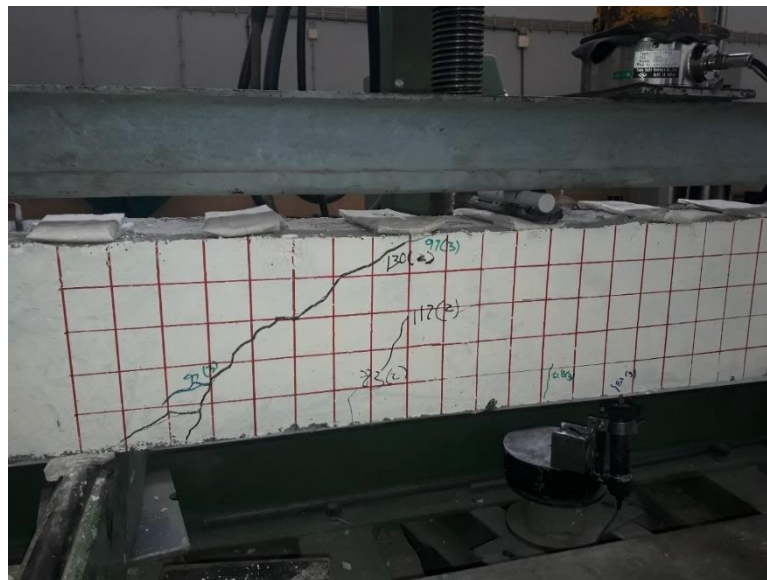
During the 165th loading (20 cm to the left of the mid span) new diagonal crack suddenly occurred at a load of 82.4KN. And it was on the most damaged half of the beam. This indicates that, damage tends to accumulate on the previously damaged part due to other loading points. The new crack propagated into the compression zone and it also extended to the support by developing a splitting crack (bond crack). Lastly, the beam failed in shear in this 165th loading, which is applied at loading point C (20 cm to the left of the midspan). The diagonal crack that formed in the 2nd loading propagated towards loading point B and the beam failed at a load of 86.4KN. New inclined crack also occurred towards load point C. But the beam failed along the diagonal crack that formed during the second loading.

Figure 5.9: diagonal crack that formed in the 2nd loading in specimen MCB68

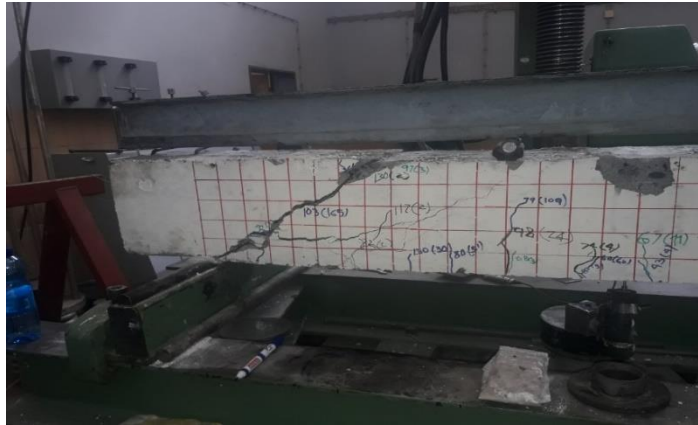
Figure 5.10: MCB68 after failure

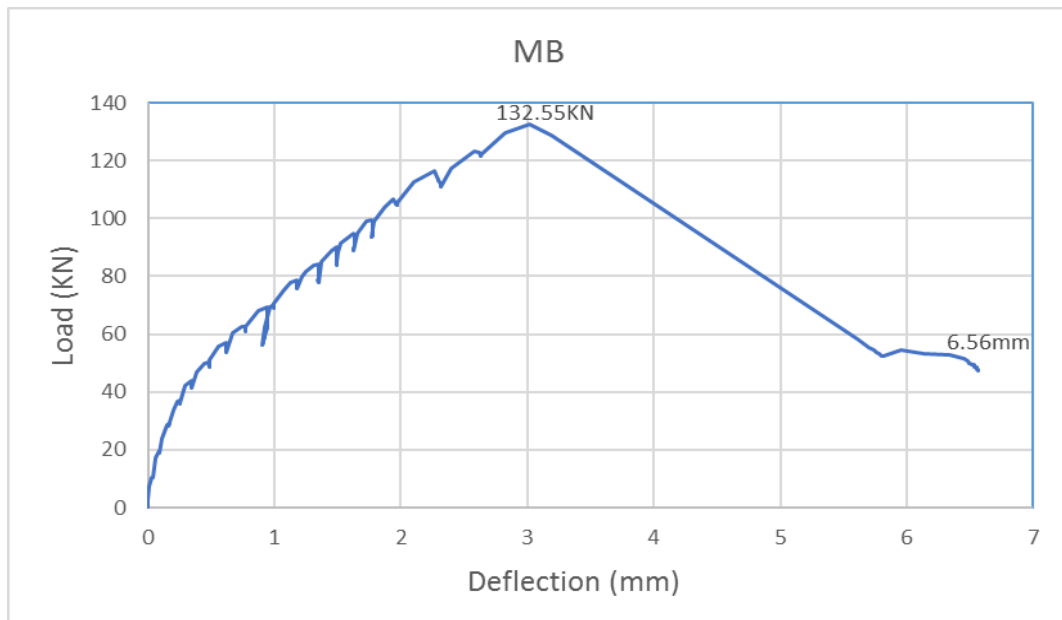
Figure 5.11: load deflection diagram for specimen MB

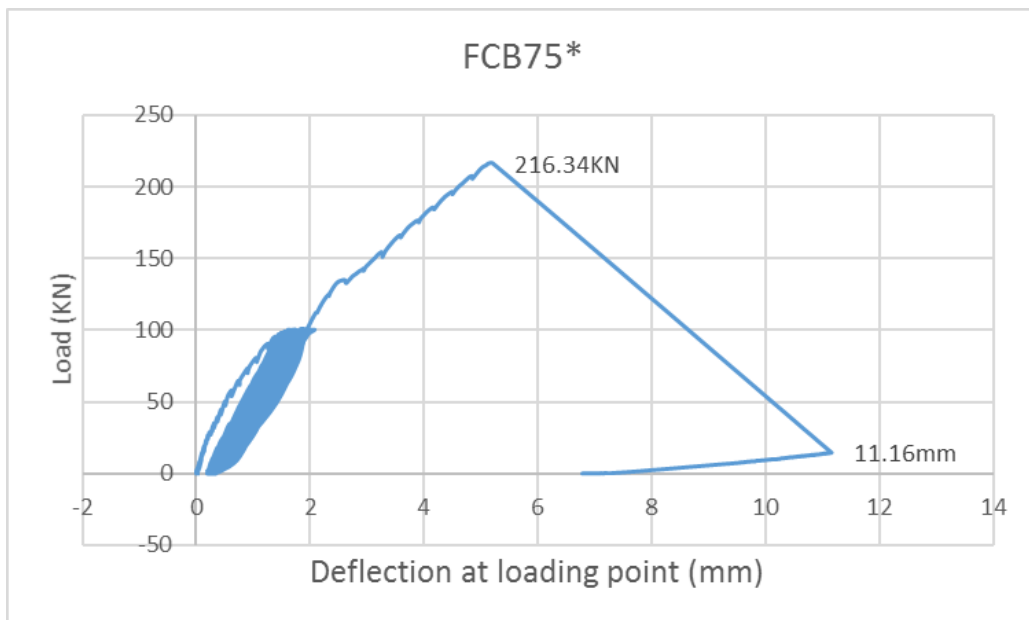
Figure 5.13: load deflection diagram for specimen FCB75c

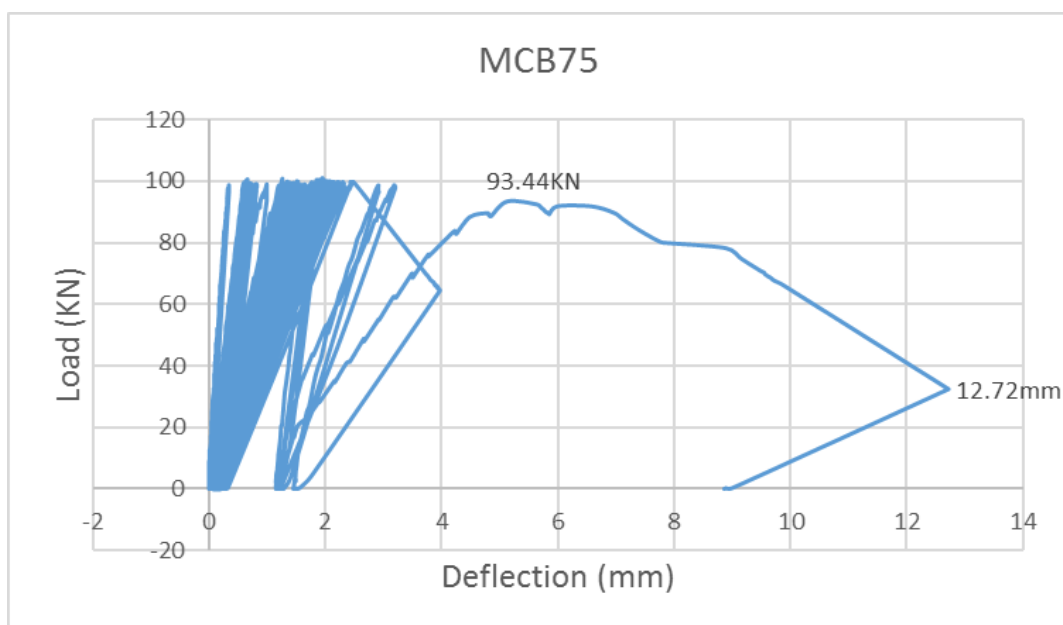
Figure 5.15: load deflection diagram for specimen MCB75

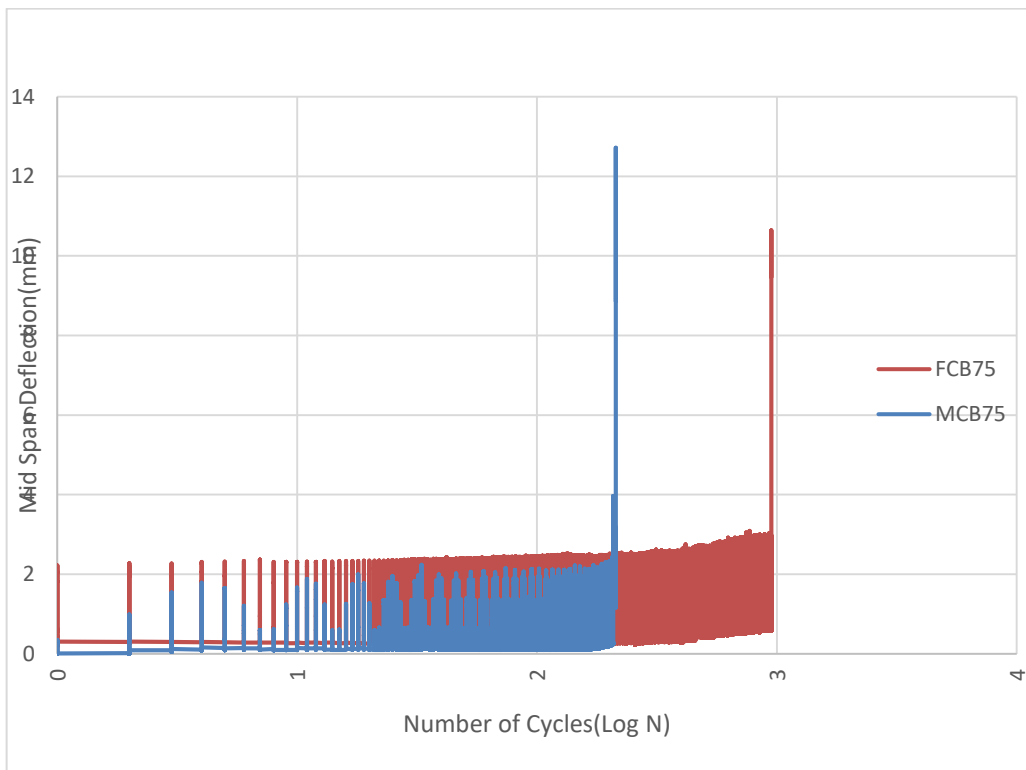
Figure 5.17: midspan deflection history of FCB75 & MCB75

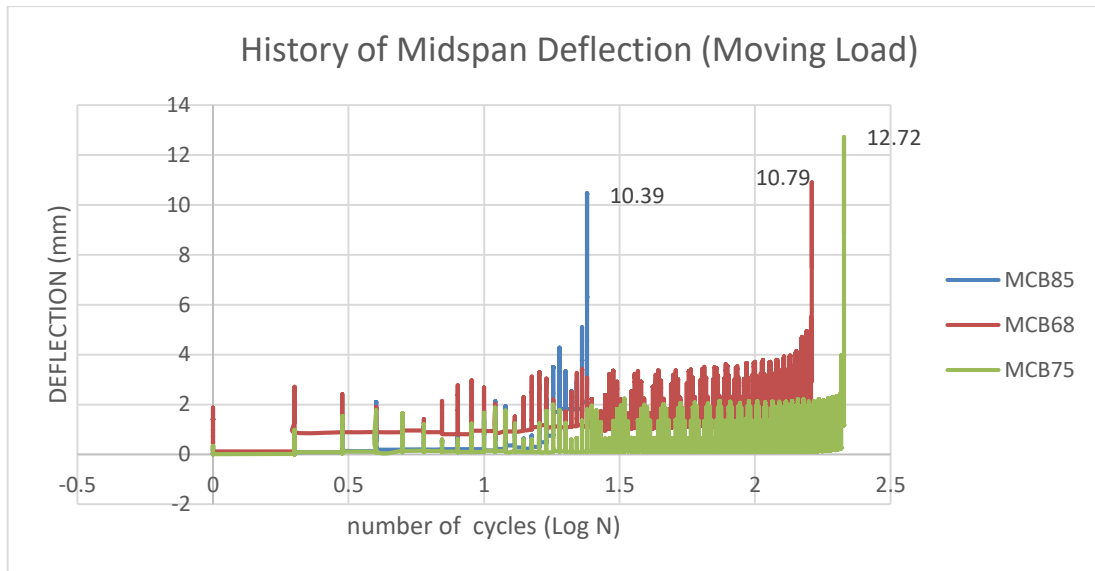
Figure 5.18: midspan deflection history of MCB85, MCB75 & MCB68

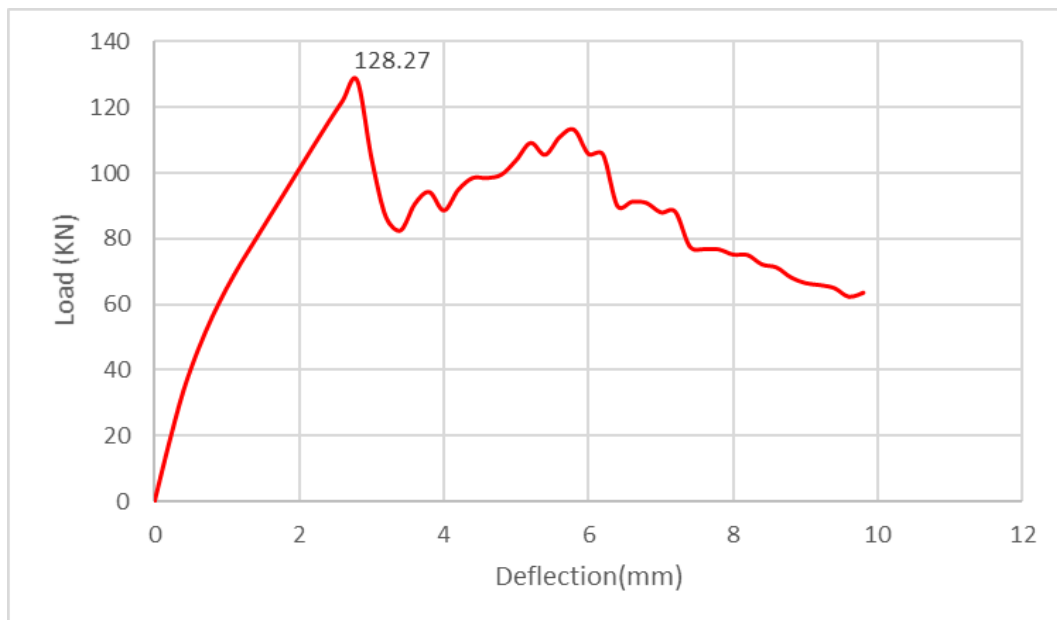
Figure 5.21: load deflection diagram of specimen A-MB

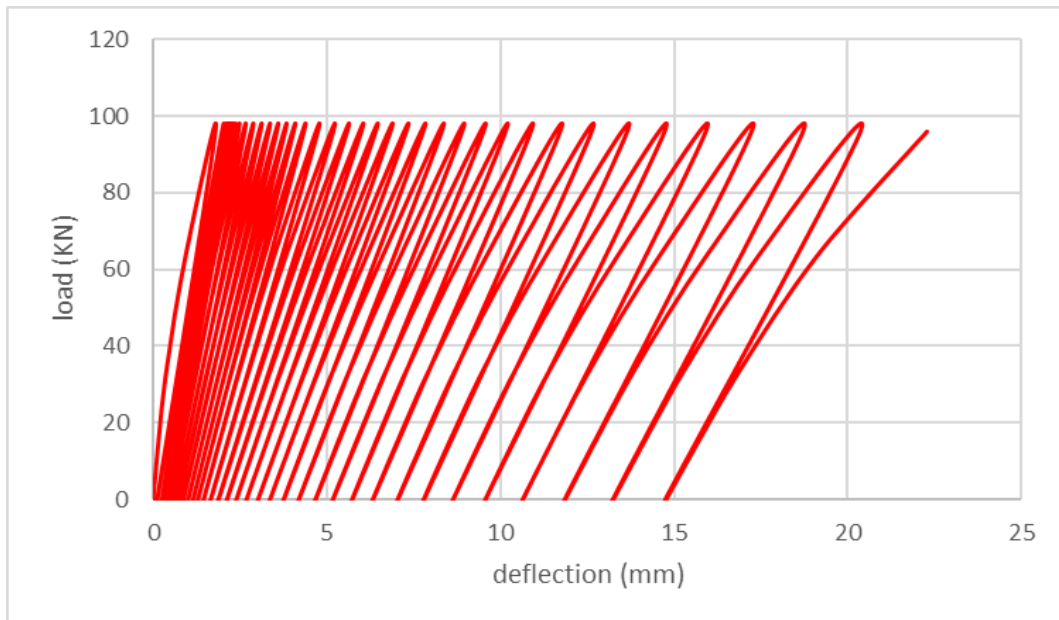
Figure 5.25: load deflection diagram of specimen A-FCB75

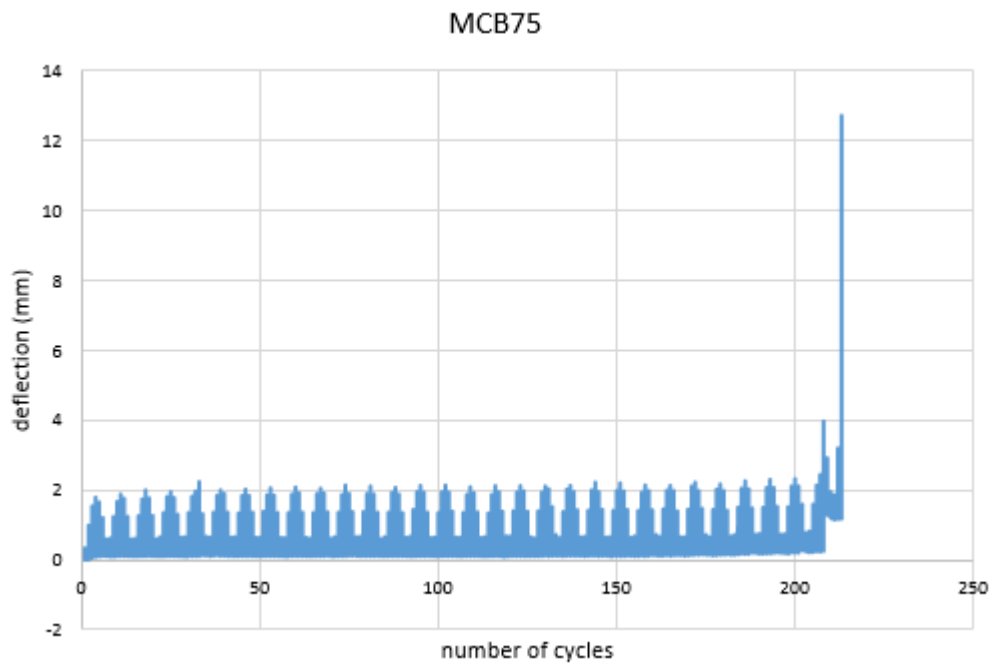
Figure 5.31: Midspan deflection versus number of cycles for MCB75

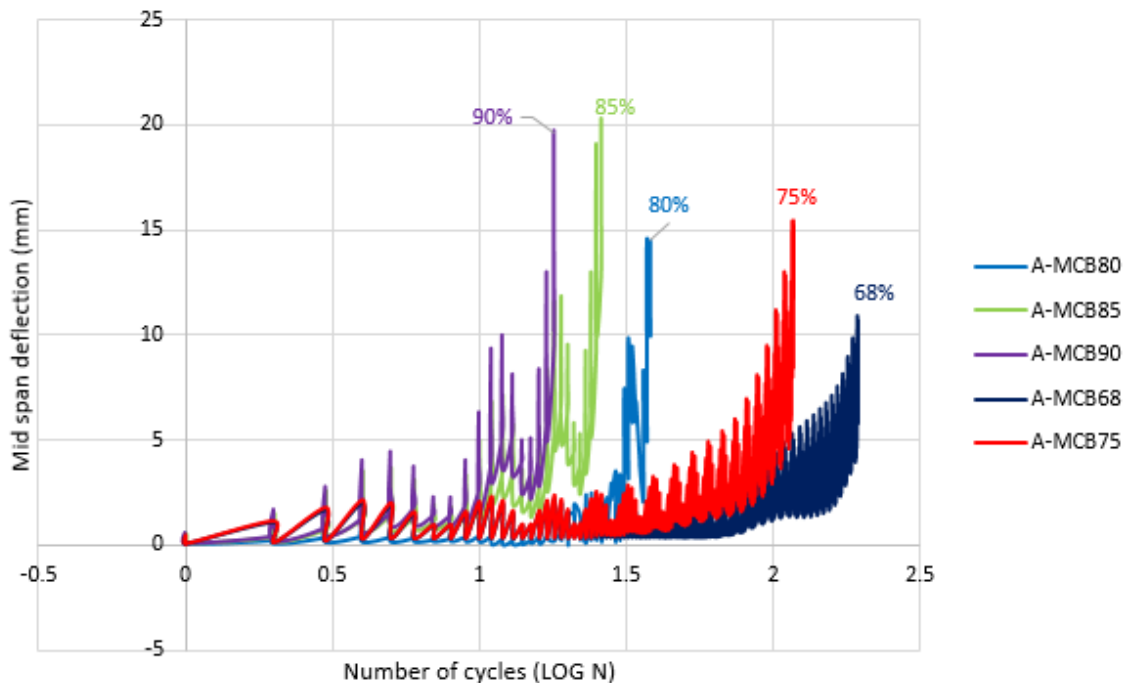
Figure 5.47: deflection-number of cycle relation

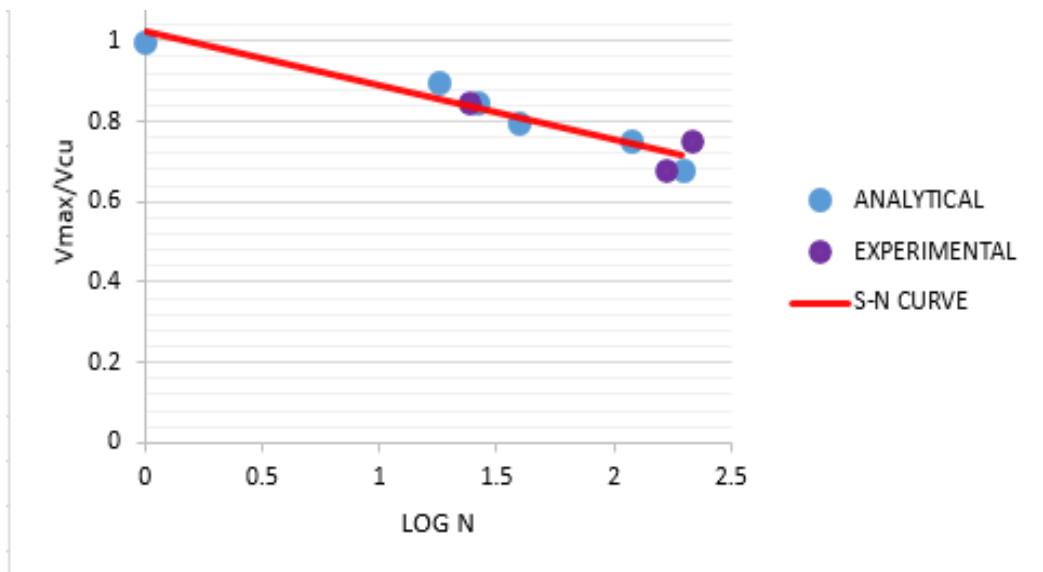
In high-cycle fatigue situations, materials performance is commonly characterized by an S-N curve, also known as the Wohler curve. The S-N curves are showing the relation between constant stress amplitude to the material and the number of cycles that leads to failure. In order to obtain the curve, each of the tested specimens is exposed to a cyclic loading with constant amplitude. Then the number of cycles until failure in the specimen is observed. The logarithm of the number of load cycles to failure, N, at the specific stress level is plotted in the diagram. Fatigue analysis was done for all the step wise moving loaded beam analytically by DuCOM-COM3D with 90%, 85%, 80%, 75% and 68% maximum amplitude of their monotonic capacity. In the figure below progress of mid-span deflection with number of cycles is shown. Increase of mid span deflection with increase in number of cycles stipulates for damage progress and strength degradation.

$$\frac{V_{max}}{V_{cu}} = 1 - 0.1354 \log N$$

Figure 5.48: S-N diagram for moving cyclic loaded beams
