**INVESTIGATION ON HARARI TRADITIONAL AGED
HOUSES MAINTENANCE WORK ENCIRCLED BY JUGOL
WALL IN HARAR**

**A Thesis Submitted to the School of Graduate Studies of Addis Ababa
University, Addis Ababa Institute of Technology in Partial Fulfillment of the
Requirements for the Degree of Master of Science in Civil Engineering**

(Construction Technology and Management)

May, 2016

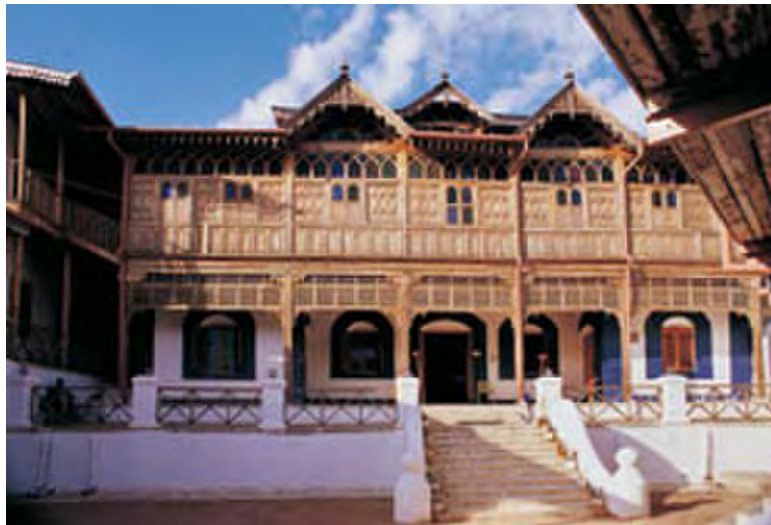
Figure. -2. Arthur Rimbaud House

Some of them are so special like "Rimbaud" house which has recently been rehabilitated and used as a cultural center and library (Figure.-2). Despite the relative newness of these houses, most of them were constructed in the late nineteenth century and early twentieth century, and

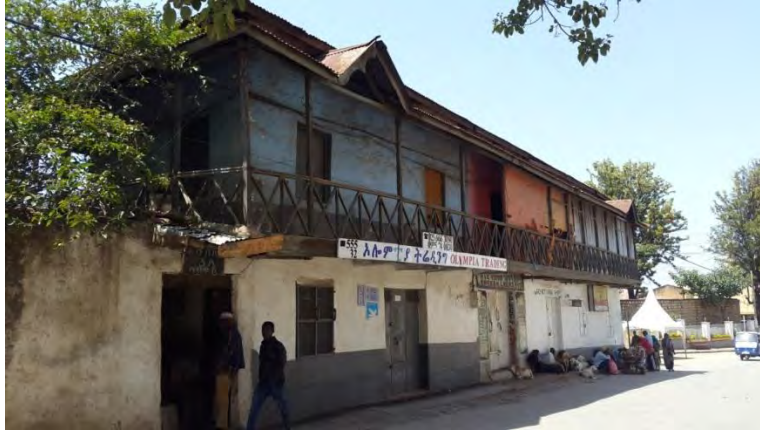
i. The Traditional Harari Houses: form the bulk of the architectural heritage of Harar city and are considered as the city's historic symbol. Harar includes around 5115 residences within the fence. They congregate a complex of several separate or connected units. In the past, combine houses were used by members of the same family. Currently, this has changed as relatives are not necessarily to reside in the same complex. The elevations of these houses are almost similar (Kamil, 2007).

Figure. -3. Mahdi Adous's house (on the straight of Jegula Hospital), an example of traditional houses

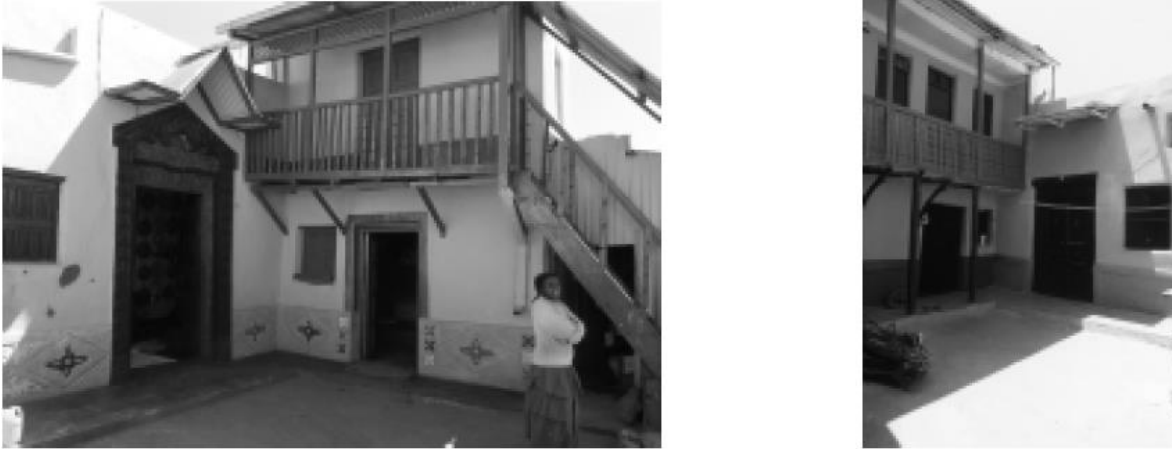
ii. Mixed House, this type combines traditional housing with later additions of the Indian style on the first or second floor. Access to the added rooms is through a wooden corridor which opens to the courtyard or street. It is the popular housing type in Harar. The added part is usually a rectangular building on one side of the courtyard and includes rooms' stack side by side overlooking the courtyard through the windows. The mixed house does not have the same degree of architectural quality of the original house. The upper floor has the same pattern of distribution of rooms that has access via an external wooden corridor through a wooden ladder (Figure.-4).

Figure.-4. Khadija Ahmed's house (near to the residence of Ras Tafari), an example of mixed house

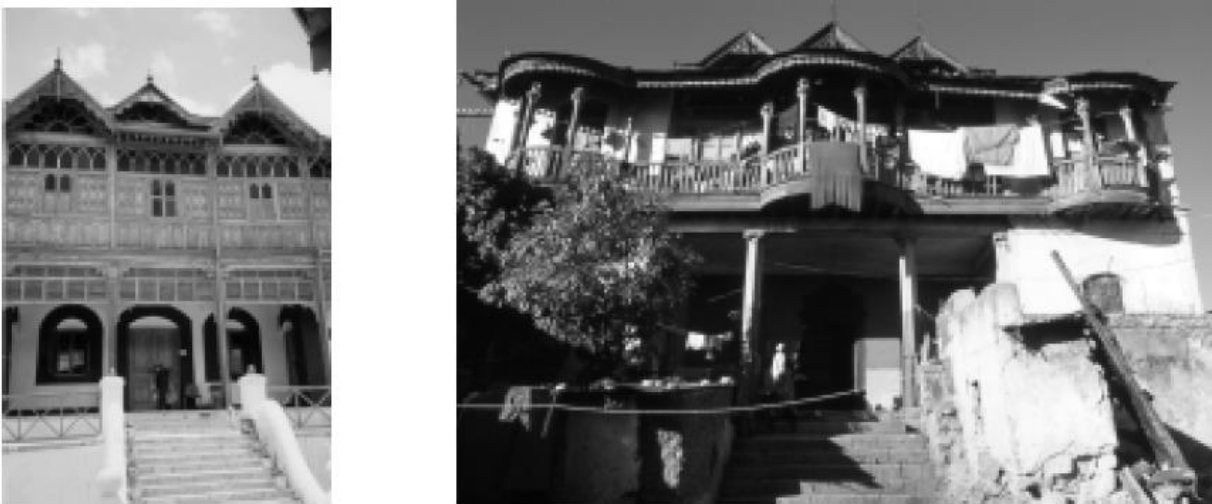
iii. Indian House, Indian traders brought this style to Harar after 1887, and most of these houses were built in the highest areas of Harar city, which then dominate the city landscape. A house of this type consists of a simple rectangle of two floors characterized by a cover with wood porch in the first floor facing the courtyard or street. One of the most famous and beautiful Indian houses is Rimbaud house which was constructed in the early twentieth century. The local authorities recently renovated it with the assistance of France. Nowadays, the house is used as a cultural center and library. Currently, there are about 12 houses of this type in Harar and they are all in the highest area of the city. The residence of Ras Tafari (Figure.-5) is one of them but needs rehabilitation. The major difference between the Indian-style and traditional style is that Indian-

style unlike the traditional, opens to the outside landscape as opposed to the Harari one which is a very introverted enclosed space (Richard, 2005).

Figure.5. Rimbaud and Ras Tafari's house respectively, an example of Indian house
(Source: Harari Cultural Heritage Conservation Library)

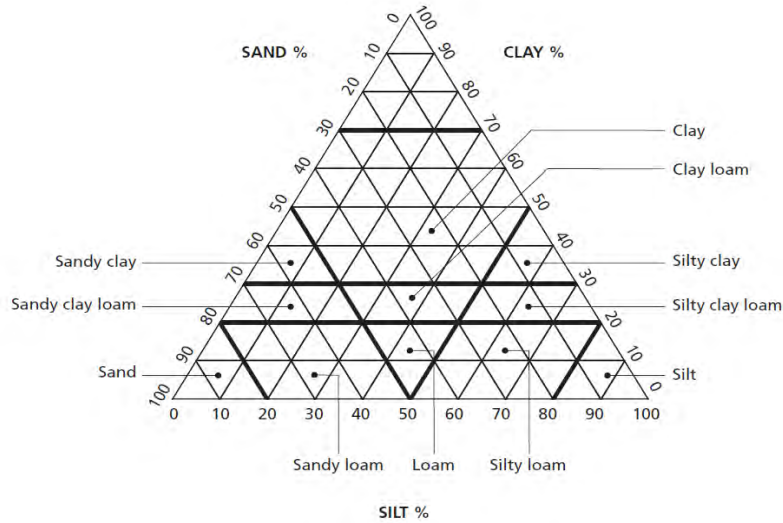
Figure 6. Soil Classification triangle

We can also classify the soil type by using the soil classification triangle (Figure. 6), which shows, for example, that a sandy clay loam is defined as soil that contains 50–80 percent sand, 0–30 percent silt and 20–30 percent clay.

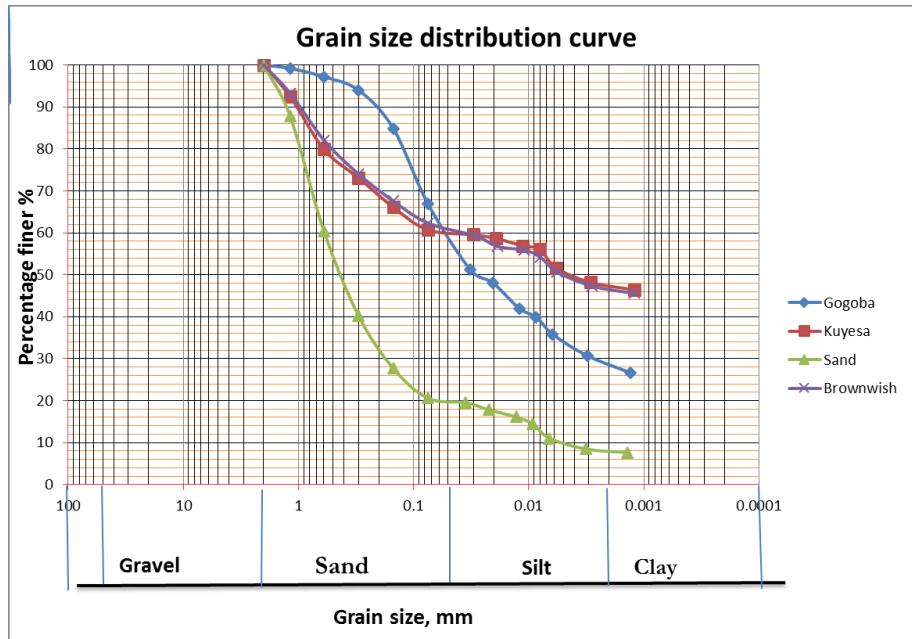
Figure 7. showing Grain Size Distribution of Four Soil Types

- ✓ Analysis for the grading test result for the four soils used for construction and maintenance work is summarized by the graph below (**Figure. 7**).
- ✓ Soils containing more than two percent organic material are usually considered unacceptable for cement treatment. So all the four types do not need any stabilization treatment.
- ✓ Kuyesa and Bunama afere (Brownish soil) is considered as gap graded soils and Gogoba and Sandy soil considered as uniformly or poorly graded soils.

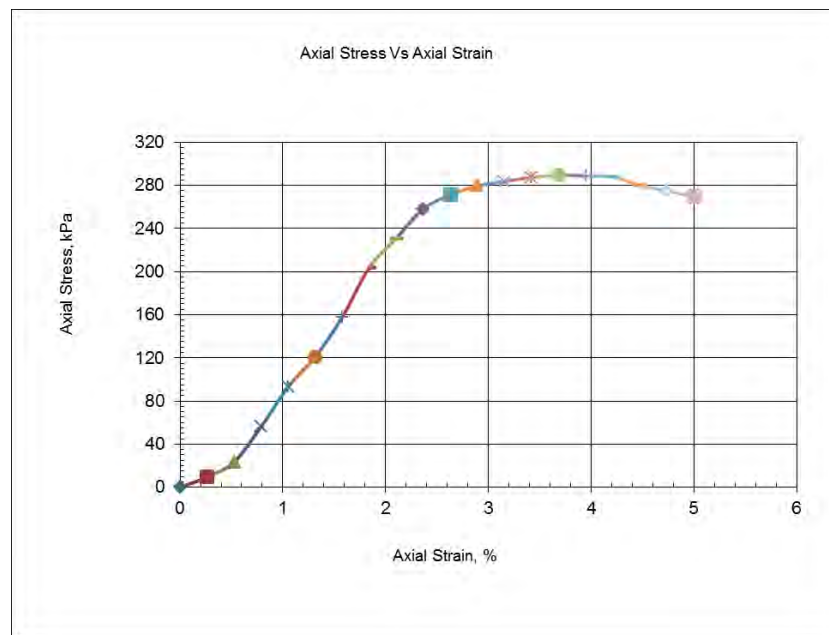
Figure. 10 UCS test result graph for the soil sample after blended

The Unconfined Compressive Strength (UCS) prepared for the blend soil sample was taken from the quarry site. The water content used is the average of the four samples determined by using Atterburg limit test, which is 42.82% of the total blend mass soil sample. The graph in Fig. 10 shows the UCS result with water content 42.82% and equal proportion of the soil sample gives a maximum value of 289.51 kpa.

The UCS test is almost similar to the compressive test of concrete. So it is possible to interrelate the corresponding result to the property of good quality cement paste and to that of the blend mud soil. Good quality cement paste needs to have properties like the maximum strength, lower permeability, increasing resistance to weathering, reducing drying shrinkage and cracking and less volume change from wetting and drying. These properties required for cement paste have great role for the durability of a building. The above cement paste properties are also required for our earthen construct buildings from mud paste. The above mentioned properties of a good cement paste depend on water content used. Similarly, the property of good mud soil has direct proportion to the water content used. That means the less water we use, the better the quality of the mud paste would be (Terre, 2001).

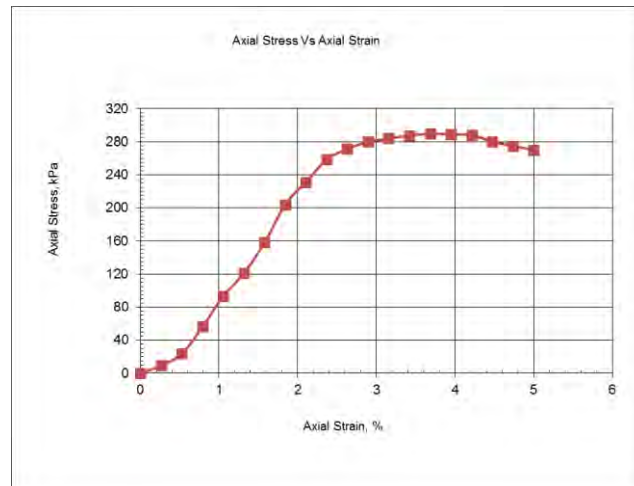
Figure-11. UCS test result graph after the adjusted water content.

The soil mud mixing preparation task is to be done for one month by making a remixing with an interval of one week. This practice is used in the olden days as well as currently. Little change is made on the practice except in the modification of their mud preparation. By using equal proportion of soils and water content of 16.43% (this amount of water brought from the plastic limit of Gogoba soil) it gives 310 kpa UCS which is shown under (Fig 11) below.

So the recommended water content for the maintenance blende soil samples mud is 16.43% (which is the least plastic limit for Gogoba soil).

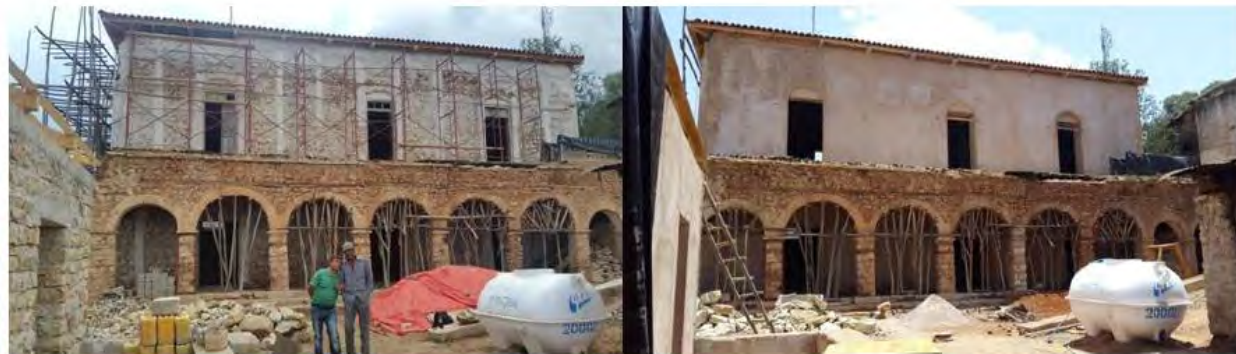
The picture below shows that some of the historic buildings that can be taken as evidences for maintenance keeping originality is being carried out after the implementation of conservation ethics (Fig.-12 and Fig.-13). This can be taken as evidence to show that the maintenance of buildings is possible without altering their historical value.

a) Maintenance on starting stage

b) First floor maintenance completed

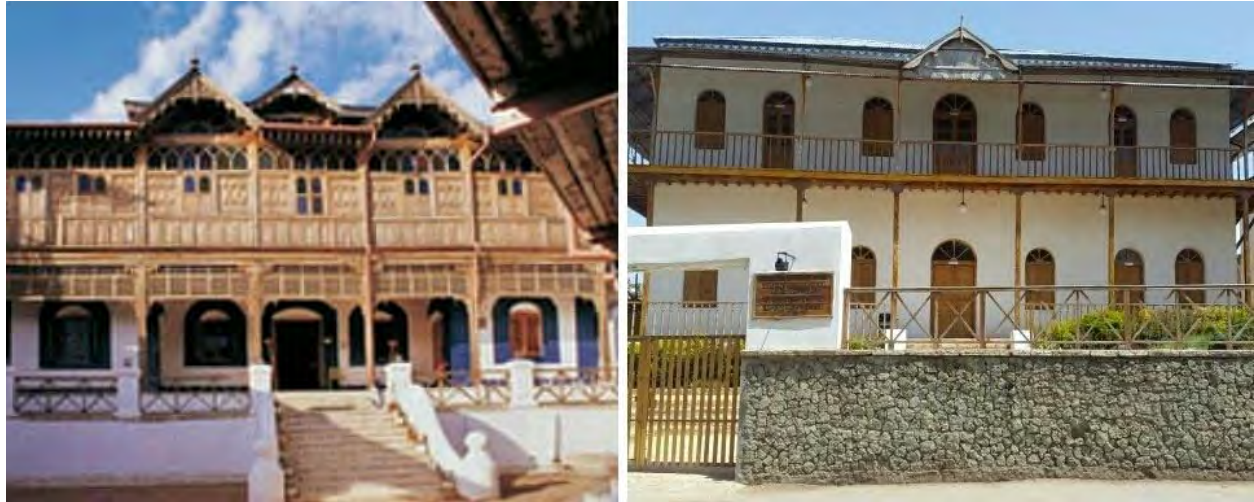
Arter Rambaud's house (Fig-13 above) was constructed around 1800. *Arter Rambaud* was a technician who came to Harar from India. The residence was designed and constructed by the Indian Architect Woli Mohammad and was therefore influenced by Indian Architecture (Harar Cultural and Heritage Database, 2009).

(a)Before

(b)After

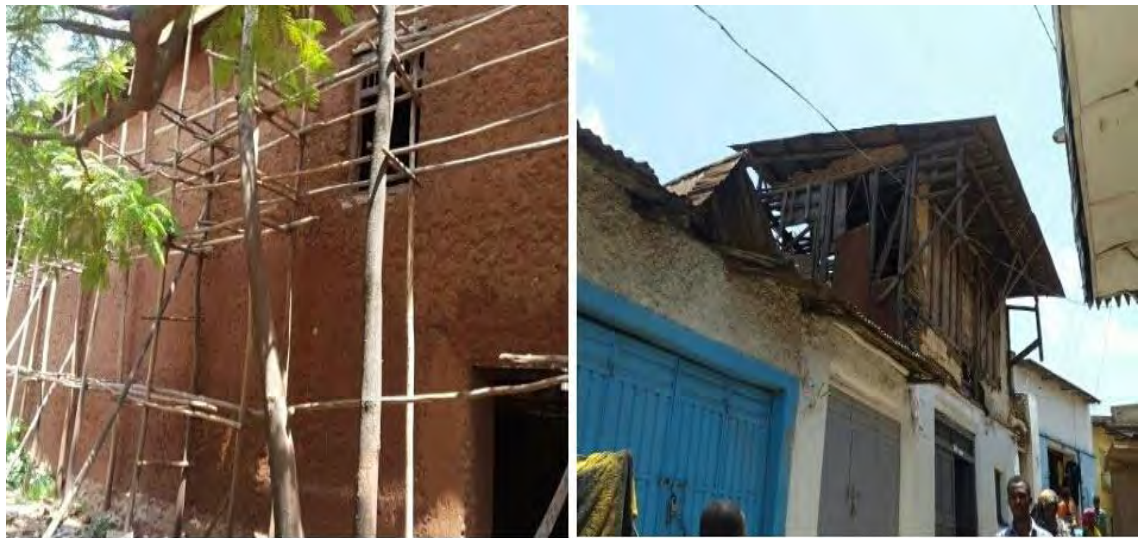
Figure. -16, Buildings under corrective maintenance and requiring corrective maintenance

i. Corrective Maintenance:

This research investigates the maintenance work according to the sampling classification. The maintenance required for building is depicted in figures Figures-16, 17, 18 & 19 below.

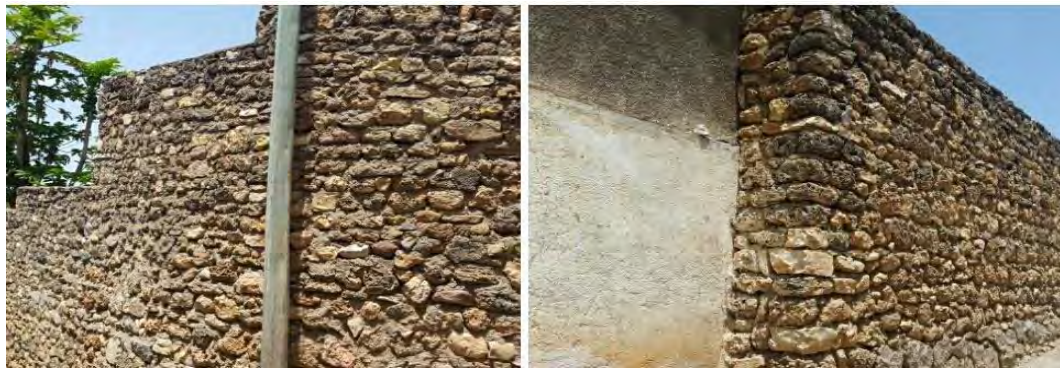
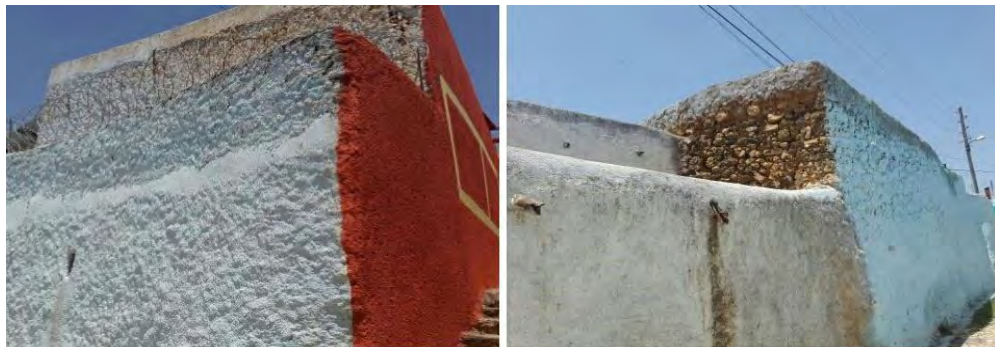
Figure. -18 (a) and (b): Building requiring Preventive maintenance

iii. Preventive Maintenance

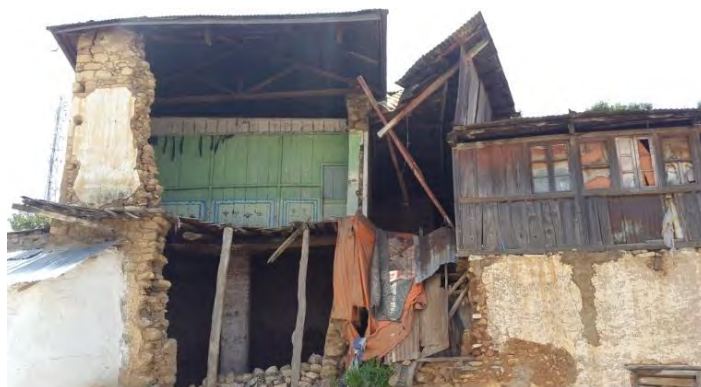
iv. Demolition

Heritage building maintenance work neglected out or given less attention faces chance of demolishing which is disastrous to the cultural heritage.
