PERMEATION GROUTABILITY ASSESSMENT
ON VOLCANI-CLASTIC -SEDIMENTS
(Particularly on Un welded Tuff and Volcanic Breccia);
A case of Kesem Dam Foundation Grouting,
In Afar regional state, Ethiopia

Msc Thesis

Master's in Engineering Geology

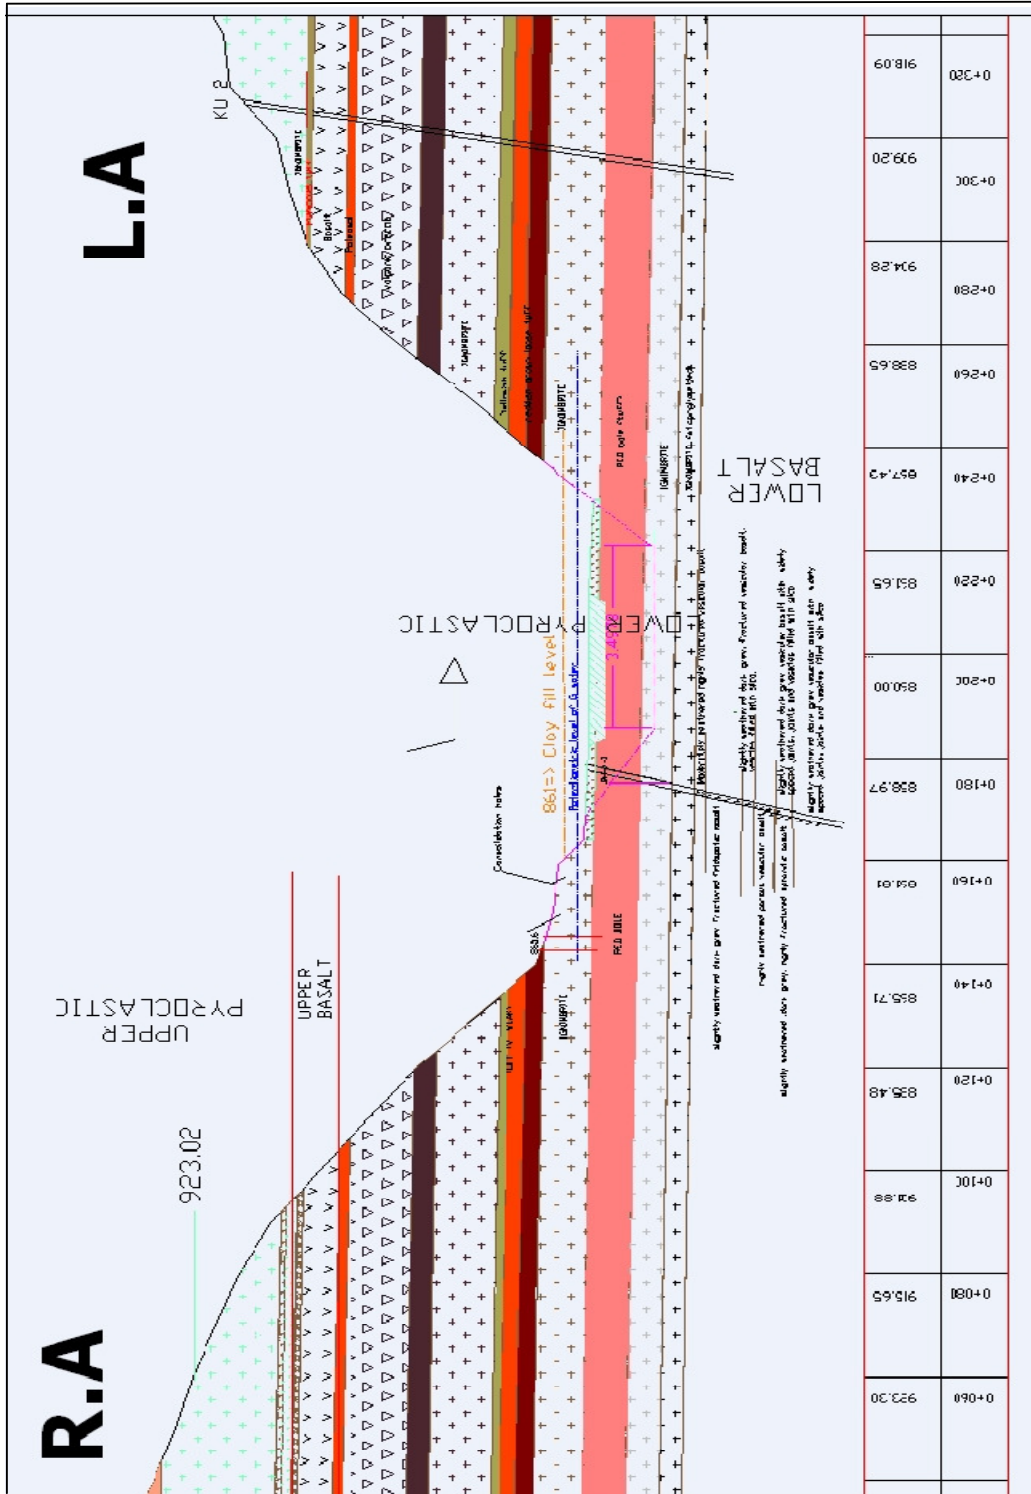
Fig. 2..5 geological cross-section along the dam axis AB (m: WWDSE, 2008)

The lower pyroclastic formation refers to the volcanic formation between the lower basalt and upper basalt, which composes the lower part of the gorge and go deep under the river bed up to 20m.

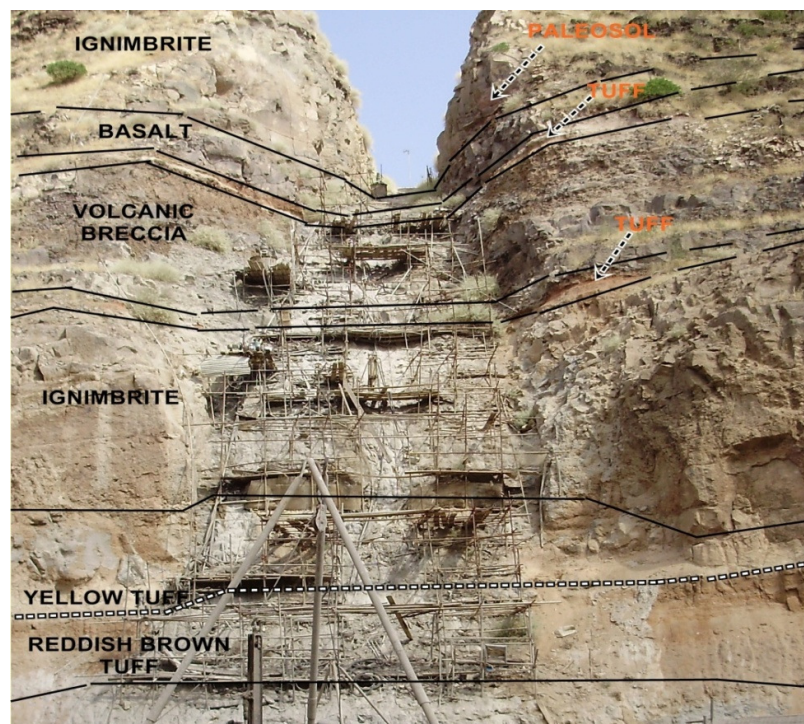
Plate 2.1 Lithology exposed at dam site (left abutment)

The upper pyroclastic unit covers the upper portion of the Kesem gorge and abutment plateau areas. It has an average thickness of 30m. It mainly comprises of strongly welded ignimbrites (grayish and greenish) containing coarser pumicious vesicles. Besides, the green ignimbrite is present which forms medium thick beds and characterized by columnar jointing. Between the ignimbrite beds very thin (0.4-0.5m) layer of loose yellowish green tuff comprise the contact. Brownish poorly welded (agglomeratic tuff) is sandwiched between the grayish and greenish ignimbrite layers. The upper pyroclastic rocks are unconformably overlain by the Kesem paleo fluvial deposits.

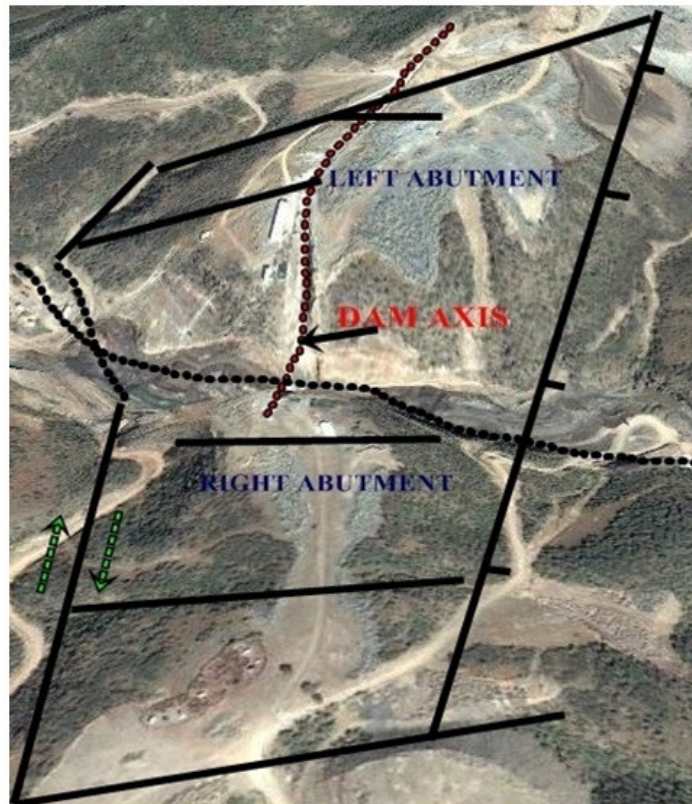
The trace of the faults revealed their interconnection thus may form potential leakage path. Faults at the river section and left abutment are within the longitudinal extent of the grout curtain, where as faults at the right abutment lie away from the grout curtain extension. Besides, except for the river bed fault, no special consideration for grout hole depth and arrangement was designed at fault zones on abutments. These faults could form potential leakage path after the reservoir impoundment unless examined in detail and treated to the required degree.

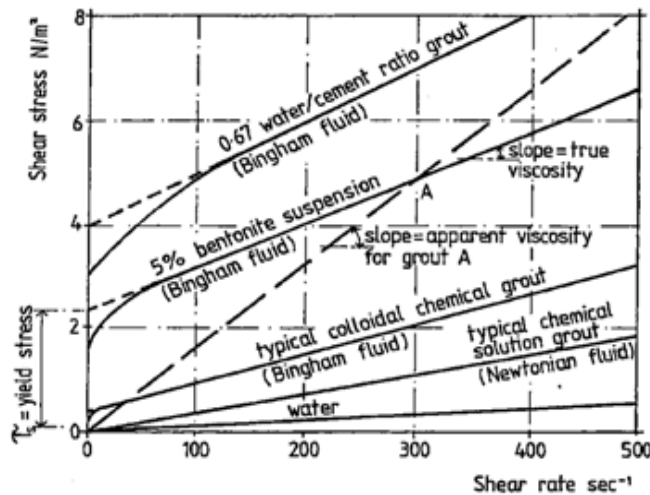
Figure 3.1 typical properties of grout types (adapted from Littlejohn, 1985)

or even with a Marsh cone. The latter two properties are closely related: the higher the cohesion, the higher the apparent viscosity. Ideally, admixtures only marginally impact on the cohesion or viscosity at moderate to high shear rates, but cause a major increase once the grout moves slowly or are at rest. These grouts are often referred to as stable suspension grouts with shear thinning rheology. Properties and characteristics of suspension grouts can be significantly altered by means of admixtures. Generally, to have a stable and durable suspension cement grout, the fluid characteristics are required to fall within acceptable ranges proposed by various Authors (Houlsby, 1986; Deere and Lombardy, 1993) based on their practical experience and Laboratory testing. As per their suggestion, water : cement ratios 3:1 (by weight) or thicker are preferred, bleed percent in 2hrs should not exceed 5%, the viscosity (measured in marsh cone funnel) should be 29-32 seconds and the relative cohesion (measured using Lombardi's plate cohesion meter) should be in the range of 0.08-0.15mm.

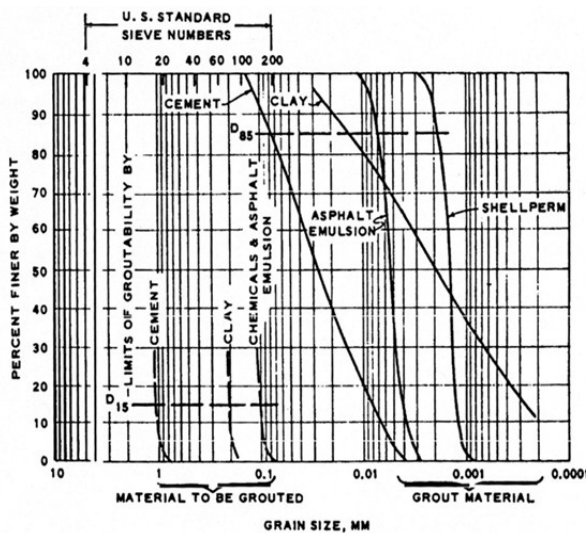
Figure 3.2 soil and grout materials grain size curves (adapted from U.S. ACE, 1984)

groutability correlating the size and number of fractures, the grain size and permeability of soil with the grain size distribution of grout material. As cited in Fell et al (1992, 2005), when considered in conjunction with the relation between Lugeon Value and fracture width along with the experience of Littlejohn (1982), it is found convincing to adopt the groutability limiting fracture width equals $3D_{100}$ where D_{100} is the sieve size for which all the grout particles are finer (Kennedy, 1958; Mitchell, 1970; Karol, 1985; Tjandrajana, 1989). Based on the relation between D_{15} or D_{10} of soil with D_{85} or D_{95} of grout respectively, “groutability Ratios” _____, has been suggested as a criteria to evaluate the injectability of suspension grout in soil (Mitchell 1981, USACE, 1984, Verfel 1989) permeation would be achieved.

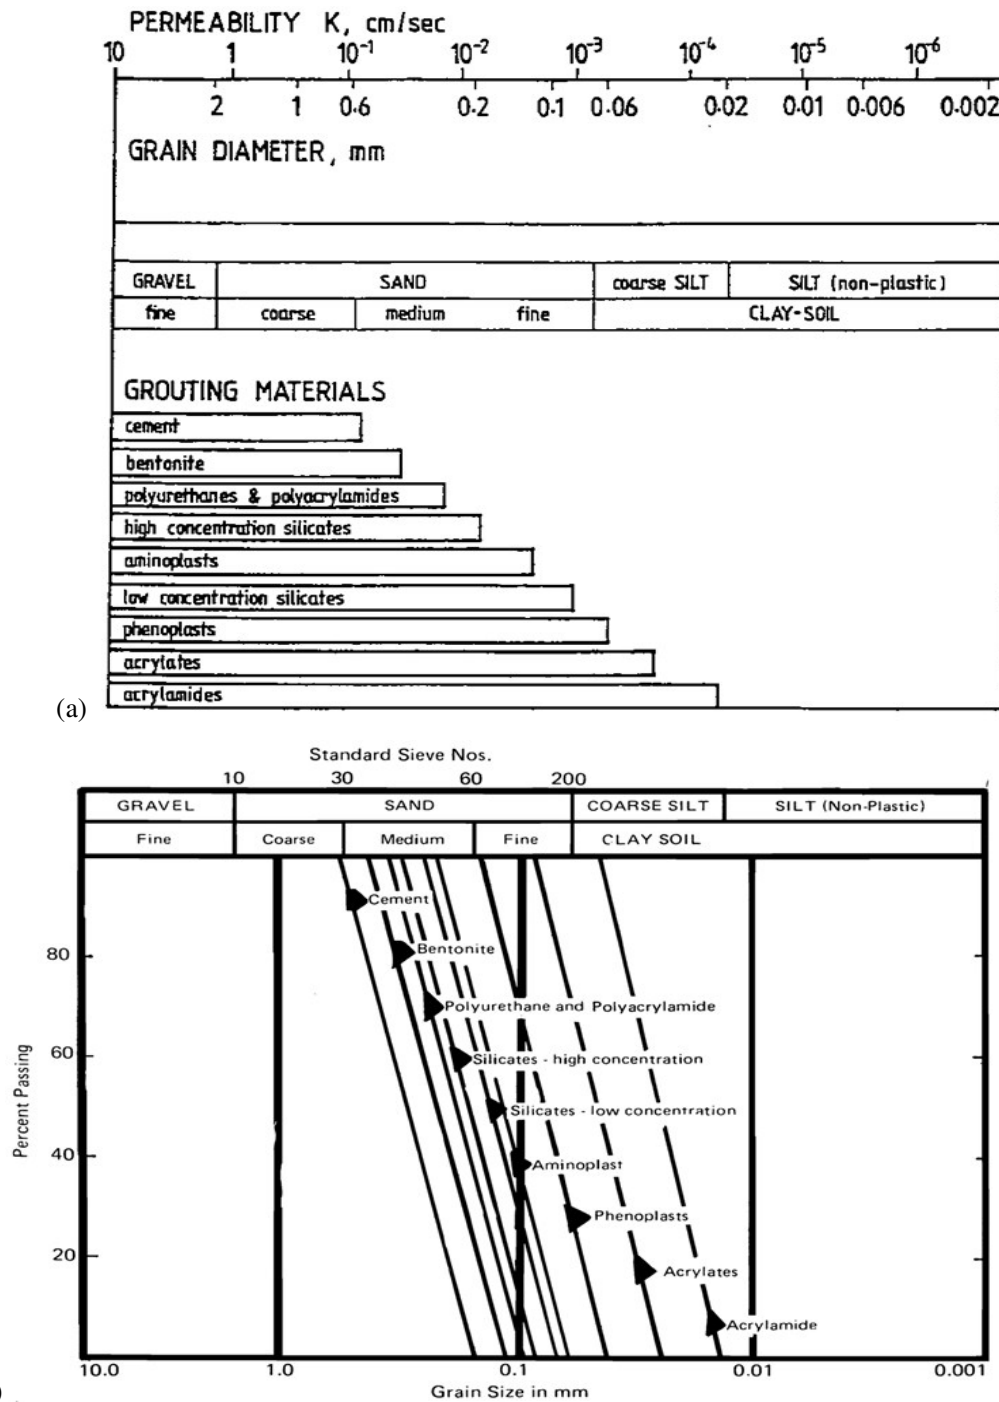
Figure 3.3 (a&b) limits of groutability based on Karol, 1985 (source: Fell R. et al, 2005)

Fell et al (1992, 2005) has adapted limits of effectiveness of a particular type of grout for permeation grouting of a soil from Karol (1985, Fig.3.3). The same concept has been modified by Haut (2009) with some additions such as the Jumbo eco pile system grouting technique (a type of jet grouting), mortar grouting and indicating the feasible range for application of ultrafine and chemical grouting (Fig. 3.4).

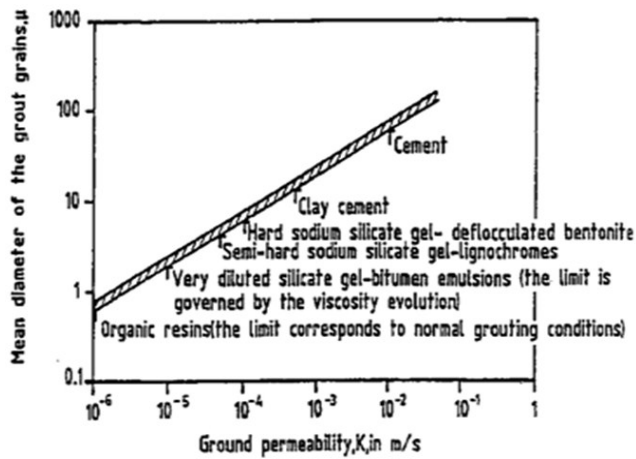
Figure 3.5 Limits of injectability of grouts based on the permeability of sands and gravels (Littlejohn, 1985)

Littlejohn (1985) has shown graphically the limits of injectability of grouts by correlating the mean diameter of grout and permeability of soil (Fig. 3.5). Besides, he has indicated that penetrability of Bingham suspensions is not warranted where D_{10} of soil is less than 0.5mm, and permeability coefficient $K < 10^{-3} \text{ m/s}$ (these agree with the opinion of Caron, 1982 and Karol, 1985 and Baker, 1982).

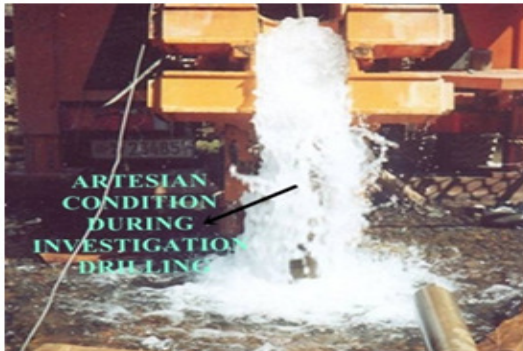
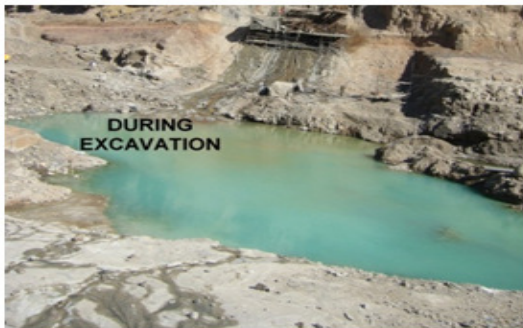
Plate 4.1 Artesian groundwater at the dam site

The groundwater at Kesem dam site possesses an artesian condition (Plate 4.1). Both springs and seepages are commonly found on the lowest level and both banks of the Kesem river valley. Those springs discharge hot water with temperatures in the range of 35° to 53 °C, signifying the existence

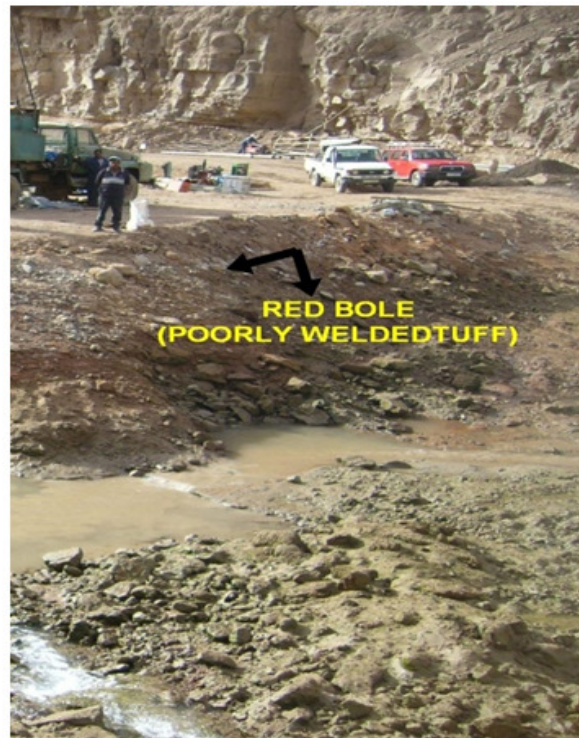
Plate 4.2 Red bole at the river bed channel section of the dam foundation

According to WWDSE (2008), the dispersivity, relatively low shear strength and excessive settlement potential of the red bole is mentioned as its main geotechnical problems. The report, as a counter measure, has suggested the complete removal of the red bole in the river channel section of the core

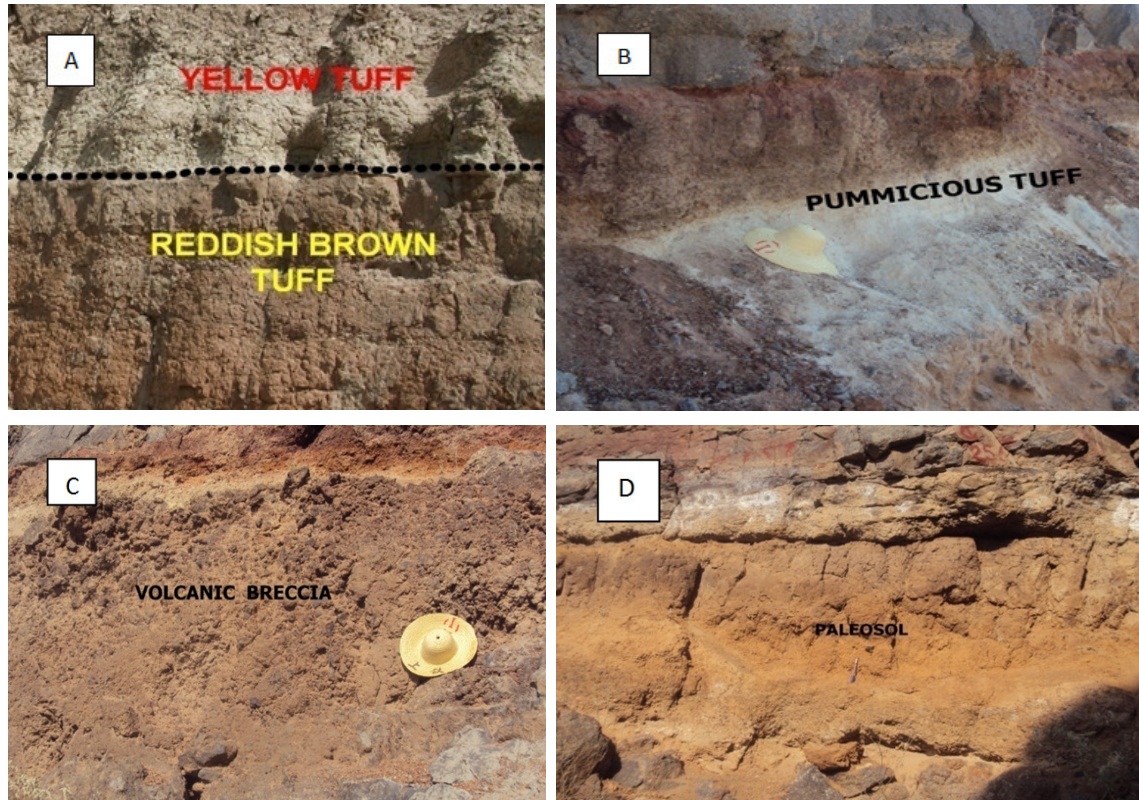
Plate 4.3 Incompetent layers exposed on abutments (A= yellowish and reddish tuff, B= Pummicious tuff, C= Volcanic breccia and D= paleosol)

requirement (< 3 Lugeon) has not been fully satisfied (KDIPR, 2008). The main reason mentioned in the report is the difficulty of grouting inter-granular pore spaces on incompetent layers probably due to permeation difficulty and hydro-fracturing with small grouting pressures (< 1 bar/meter). Moreover, the loose nature of the deposit could bring excessive settlement when loaded and may lead to differential settlement with subsequent cracking on the dam clay core.

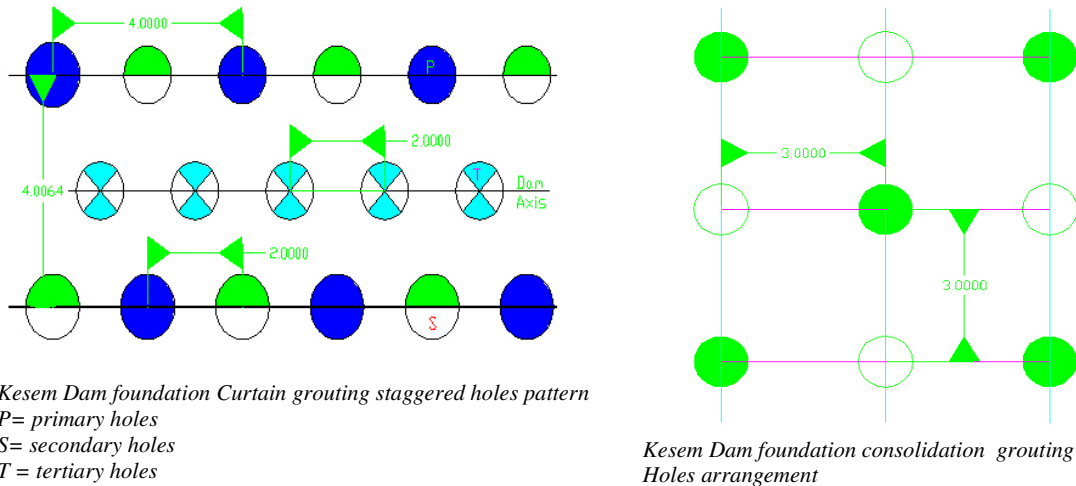
Figure 4.1 Kesem dam foundation grouting holes pattern

pressure zones 20-25m and in high pressure areas 35 to 50m deep with single, double and triple line grout holes patterns, respectively (Fig. 4.1& 4.2). Curtain grout holes are oriented inclined 15-20 degrees from the vertical dipping in to the abutments.

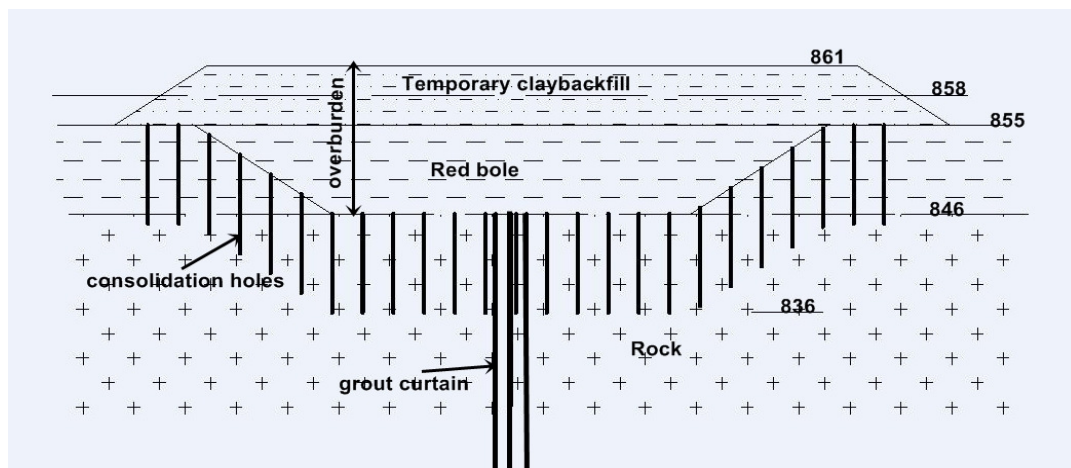
Fig. 4.3 Temporary Claybackfill at the riverbed section for grouting before excavation
(modified from WWDSE, 2008)

consolidation grouting operations are in progress at the river channel section of the dam foundation. The presence of artesian groundwater and limitation on dewatering conveniences has long been the constraint to the dam foundation excavation and grouting work delay (KDIPR, 2008). Since 2009, river bed grouting has been continuing after partial excavation to elevation of 855m and placing temporary compacted clay back filling up to elevation of 861m (Fig.4.3). The consolidation grouting is planned to serve a double objective; firstly for foundation strength improvement, secondly temporary objective is to confine the groundwater so that excavation to design foundation level would be possible (KDIPR, 2009). Thus, the method incurs extra cost for additional drilling and relatively wider zone adopted for consolidation grouting.

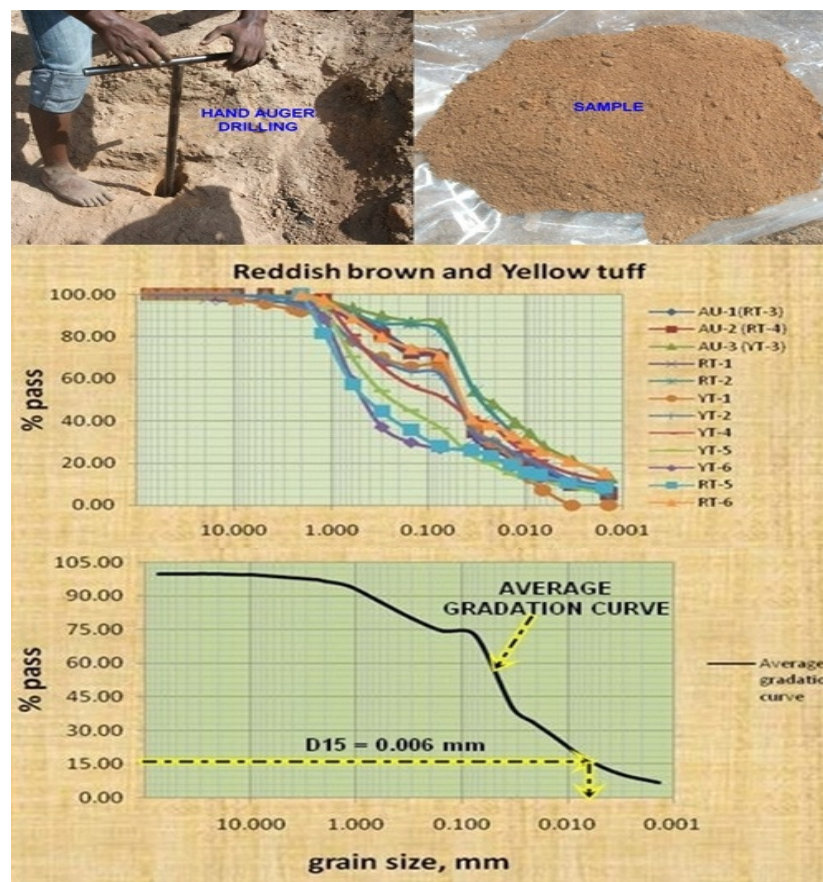
Fig. 5.1 Gradation summary of reddish brown and yellowish tuff samples

Grain size distribution, permeability, density and porosity properties of tuff and volcanic breccia deposits were determined from insitu and laboratory tests conducted during the present research.

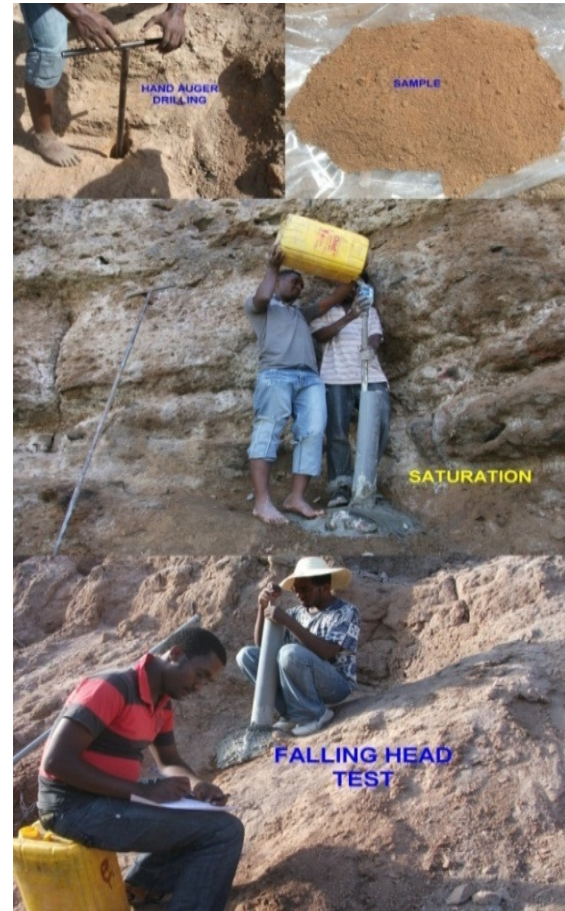
Plate 5.2 In situ falling head permeability test on tuff

A minimum of 24 hrs of continuous saturation, and one meter water head was provided using an extended anchored plastic casing placed just above the test section (Plate 5.2). The raw data records for laboratory and insitu tests are presented in Annexure 1 to 8 with appropriate recording sheet formats. Tabulated summary of laboratory and insitu tests (porosity, permeability and density) and the corresponding results are Summarized and presented in Tables 5.1 and 5.2, respectively.

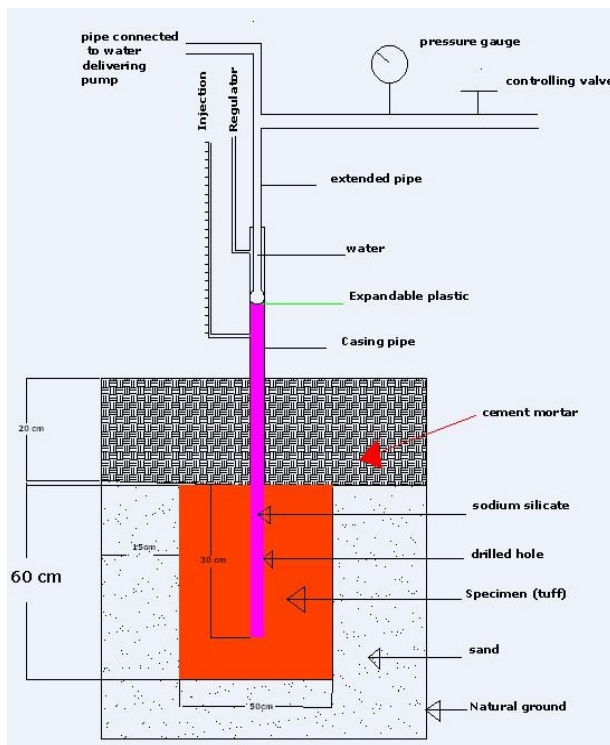
Fig. 5.4 Insitu permeation test model

If it had not been for the constraint of cost and shortage of the chemical grout, a full circulation of chemical grouting with pressure application would have been possible (Fig. 5.4).

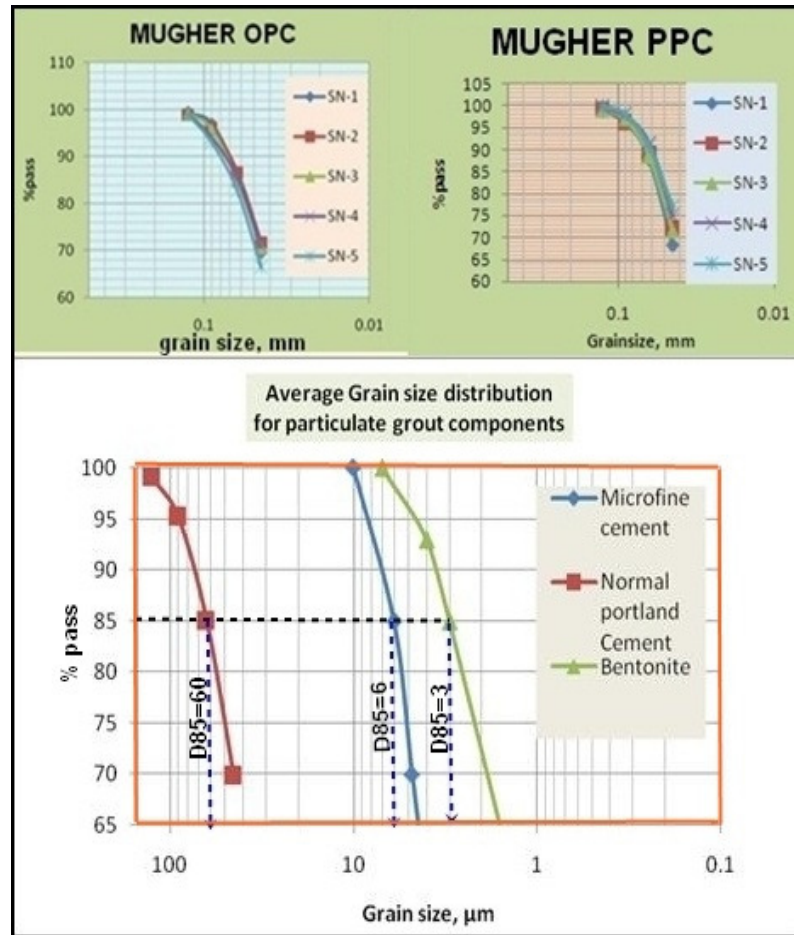
Fig. 5.5 Grain size distribution of suspension grout components

The present research has considered three types of particulate/suspension grouts (normal Portland cement, Microfine cement and bentonite grouts) while analyzing permeation groutability of the tuff and volcanic breccia.

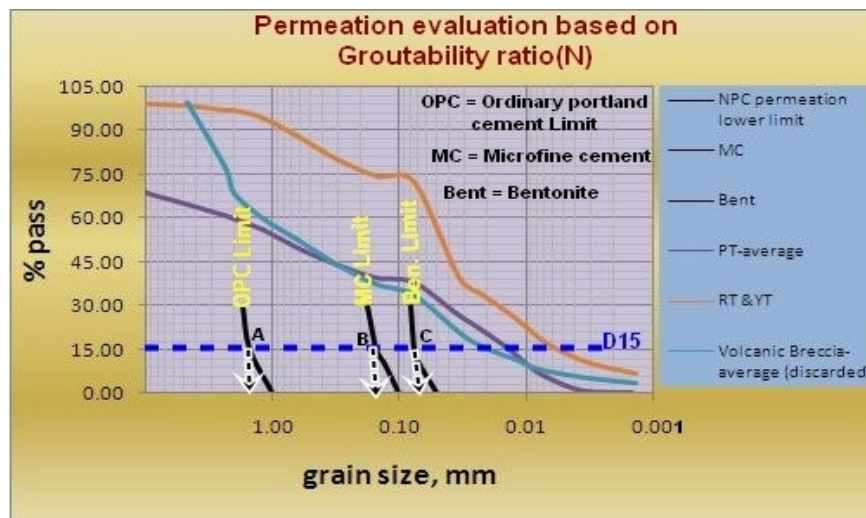
Fig. 6.1 permeation evaluation based on N

N = groutability ratio, D85= the 85 percent finer grain size in suspension grout, D15= the 15 percent finer grain size for grouting medium.

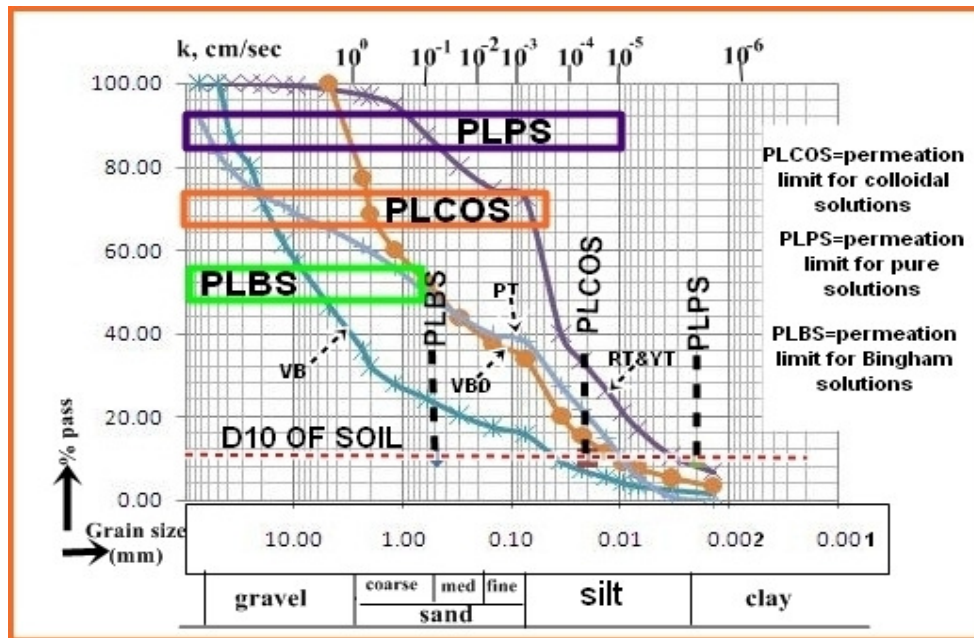
Fig. 6.2 Permeation groutability evaluation based on Karol (1982) and Littlejohn (1985)

Consideration	Bingham Suspension	Colloidal solutions	Pure solution
Soil class	Coarse sands	Fine silt	Fine silts /non-plastic clay
The effective grain size (D_{10})	Greater than 0.5mm	Between 0.5 and 0.02 mm	Less than 0.02
Permeability (cm/sec)	$> 10^{-1}$	10^{-1} & 10^{-4}	10^{-4} to 10^{-5}

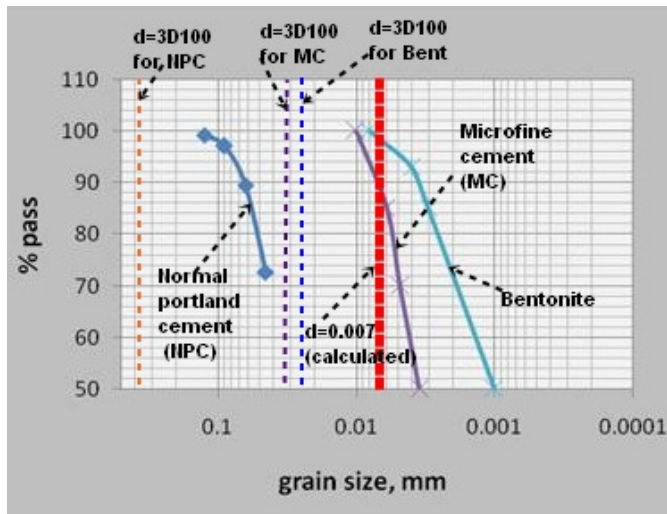
Fig. 6.3 Graphical interpretation of groutability for void size and grain size compatibility

Average, mm	D100	3D100
Normal portland cement	0.125	0.375
Microfine cement	0.01	0.03
Bentonite	0.008	0.024

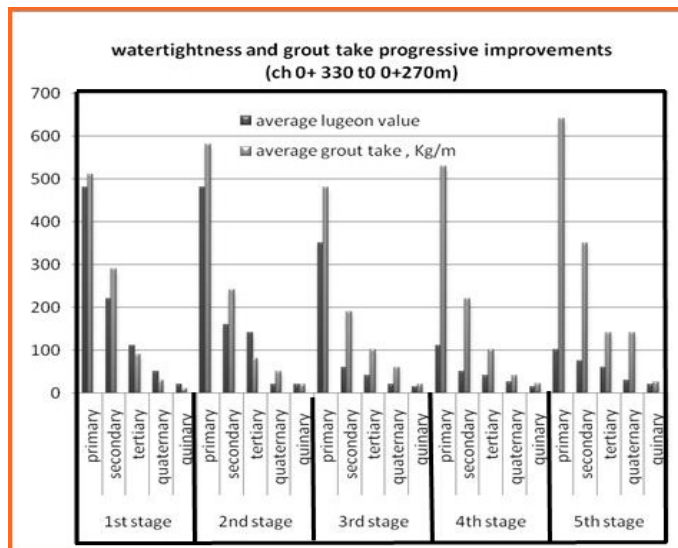
Fig. 6.4 Lugeon and grout take improvements for progressive sequences

after completion of primary and secondary sequence of holes revealed satisfactory improvement in watertightness and grout take conditions of the foundation (Fig 6.4). However, grouting on the tertiary and further sequences has encountered reverse condition of grout take compared to previous sequences, although water intake was high (up to 146 lit/ min), quick refusal of adjusted grout mixes was a common phenomenon. Consequently, more closely spaced holes were adopted for the grouting, to compensate the limited radius of influence of penetration. The grouting was beyond the design (onwards from tertiary) continued up to quinary sequence. This happened where the adjacent hole spacing and line spacing reached upto 0.75m with a little improvement on watertightness in each case. However, even with this arrangement the anticipated watertightness requirement were not fully attained. This indicates that grouting of primary and secondary holes was successful in filling wide fractures and cavities in the foundation, however fine fractures on rocks and porosities on incompetent layers were left un-grouted in that stage. Thus, further grouting with additional sequence of grout holes was necessary; however this also did not provided required results.

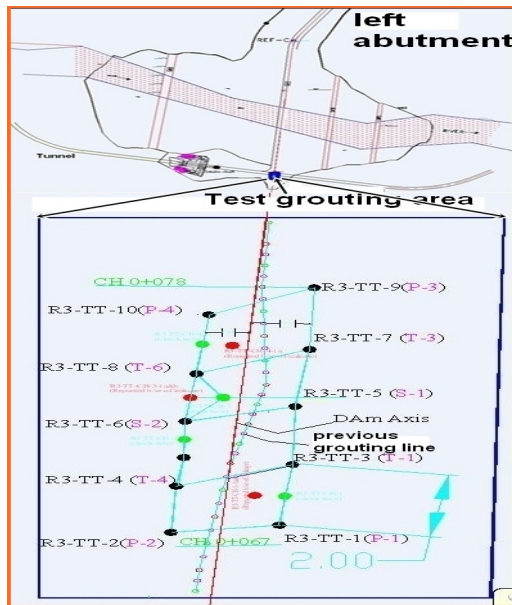
Fig. 6.5 Location of test grouting at the right Abutment

Very thin cement grouts, diluted to 10:1 water cement ratio by volume along with progressive increment of grouting pressure (up to 35 bars) were tested. Besides, wet mill grinding of the cement grout was made in order to reduce the size of cement grain size in grout. However, the grinder used for this purpose did not have appropriate specification record to indicate the achieved amount of size reduction. According to Lombardi and Deer (1993), dilution does not reduce the grain size of cement in grout. It reduces the viscosity of grout to favor penetrability; conversely however, increases rate of sedimentation which would result into reopening of filled joints. Correspondingly, dilution of mix did not bring satisfactory results for the groutability problem encountered at Kesem dam project site.

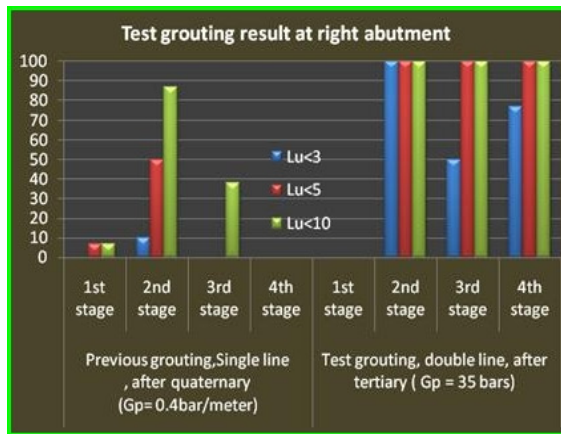
Fig. 6.7 Right abutment test grouting Lugeon achievement summary

Figure 6.7 presents the Lugeon achievement reached by the previous grouting (after quinary sequence) and test grouting (after tertiary) conducted at the right abutment. As can be inferred from the graph, previous grouting did not fully satisfy the project watertightness requirement ($\text{Lu} < 3 \geq 90\%$ and remaining $10\% < 5\text{Lu}$, WWDSE , 2500c) to each stage. On the other hand, the test grouting has shown better results comparatively; however, the groutability problem still remained. For the test grouting, Lugeon requirement was satisfied only for 2nd stage. Whereas, 3rd and 4th stages, though showed improvement compared to previous grouting, still did not satisfy the watertightness requirement of the project.

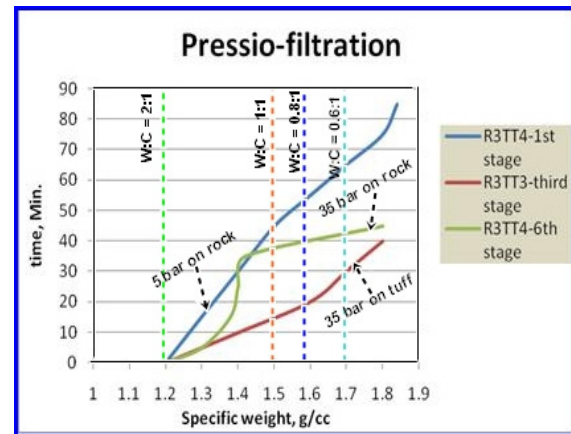
Fig. 6.8 Pressure filtration evaluation

The improvement however was not by the effective permeation as there was considerable grout filtration, formation of filter cake of coarser particles around the finer voids which then results in reduction of cement content of the grout mix actually penetrating in to the voids (Fell et. al, 1992). On the other hand, the improvement could partly come from filling of some of the fine fractures by hydro-jacking which could occur in response to high applied grouting pressure.

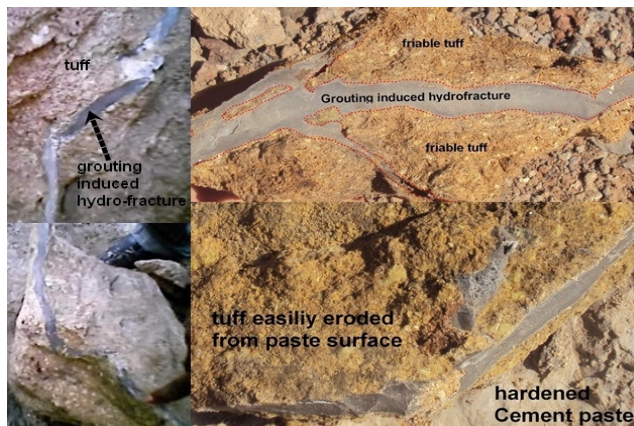
Plate 6.1 Grouting induced hydro-fracturing on tuff (left abutment)

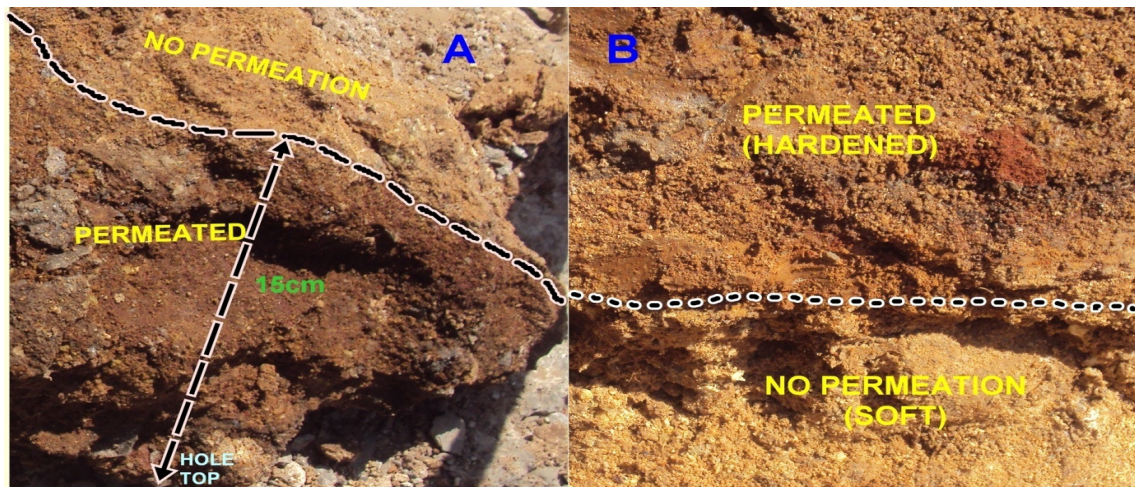
Sample was recovered from the test section on the fourth day since test grouting, and visual observation was made for the radius of influence of grout penetration and improvement in engineering performance of grouted tuff. The test block (tuff) was obtained in two conditions: for the zone penetrated by the grout, the grains were found cemented and hardened to siltstone and appeared brownish in color compared to the soft and yellow portion where penetration did not reach (Plate 6.2).

Plate 6.2 Showing status of recovered tuff samples after insitu permeation injection of sodium silicate:
a) Permeation influence at the top of test section;
b) Boundary between permeated and non permeated zone 10 cm below bottom of test hole
