# Foundation Assessment: A case in Megech Dam Project, Northwestern Ethiopia

A Thesis Submitted to  
School of Earth Sciences

Presented in Partial Fullfillment of the requirements for the Degree of  
Masters of Science (Engineering Geology)

June, 2020

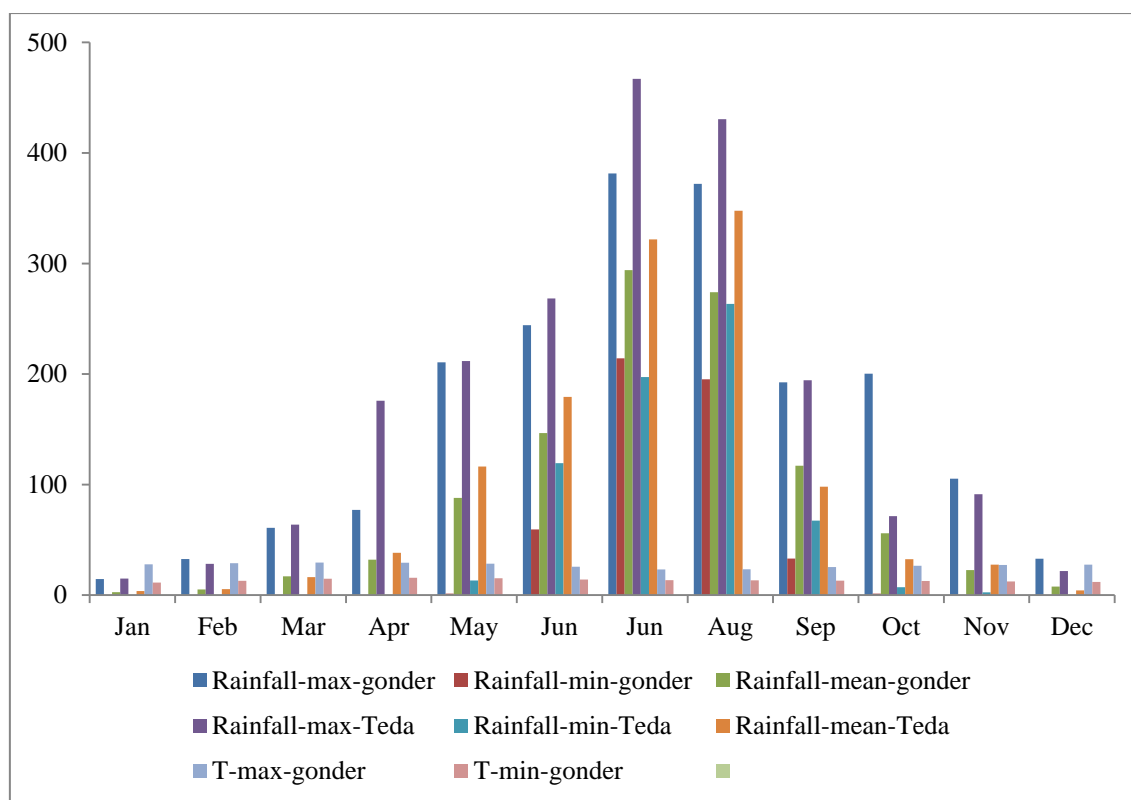
**Fig.2.3** Temperature and rainfall characteristics of Megech dam site represented by Gonder airport and Teda meteorological station based on data as shown in Table 2.2.

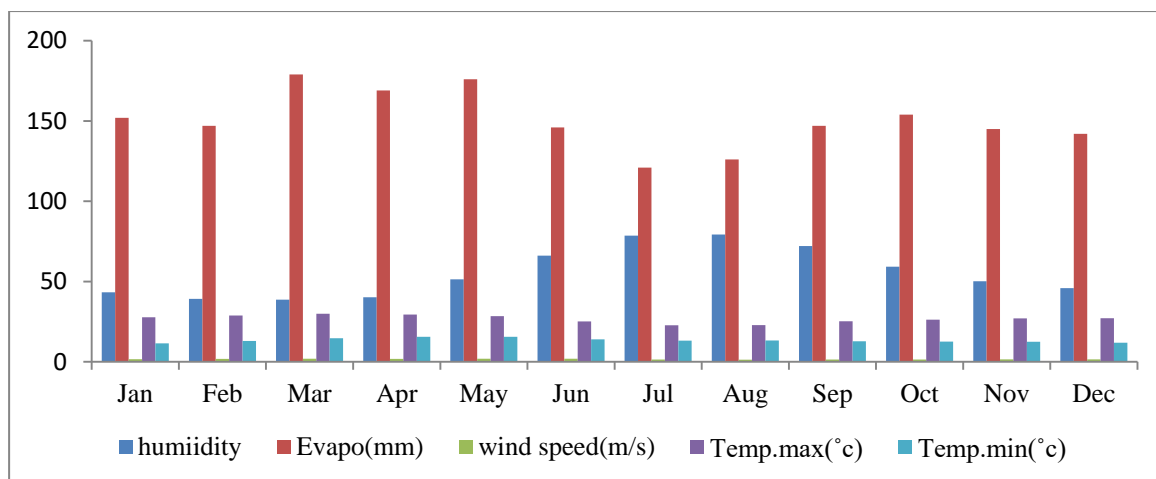
**Fig: 2.4 Evaporation and humidity characteristics of the study area at a given temperature and wind Speed conditions (Source: WWDSE, 2007)**

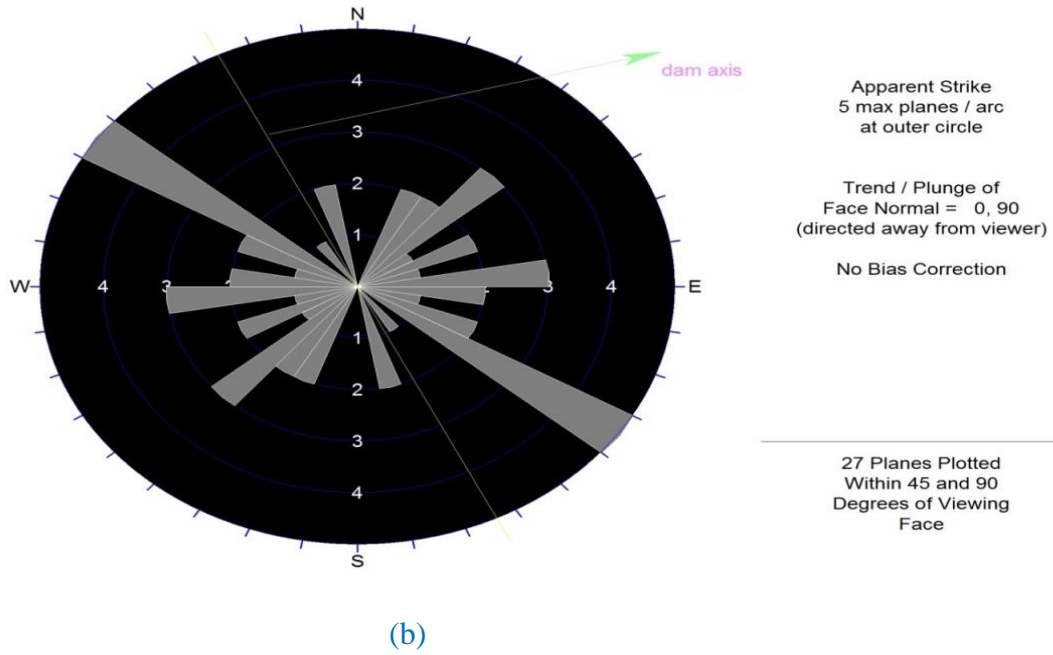
Fig. 2.8 Stereonet (a) and Rose (b) diagram of dominant joint sets at Megech dam foundation

Joints vary from slightly weathered to highly weathered, smooth-rough surfaces and mostly dipping towards the river. Joint concentration was higher in the left abutment than in the right abutment, as observed during the field data collection. Joint spacing in the three sections of the dam (left and right abutments and the river bed section) varies in range 2 to 50cm. Fig. 4.4 shows the stereo plot and rose diagrams of the dam foundation from structural data collected in the field.

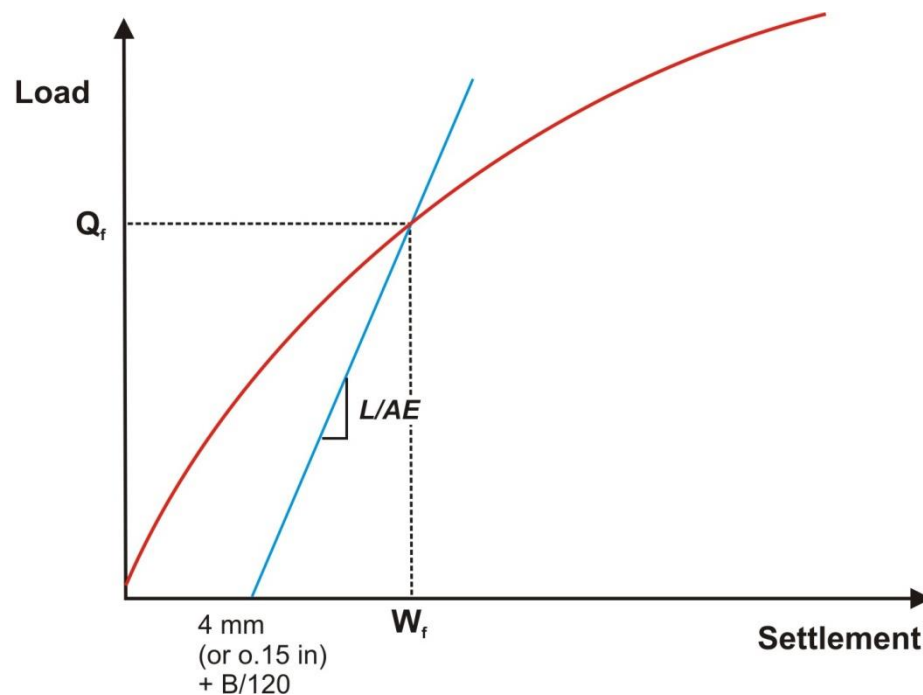
**Fig.3.2** Davisson procedure to estimate vertical bearing capacity from pile load test  
(Source: Kramer et al., 2014)

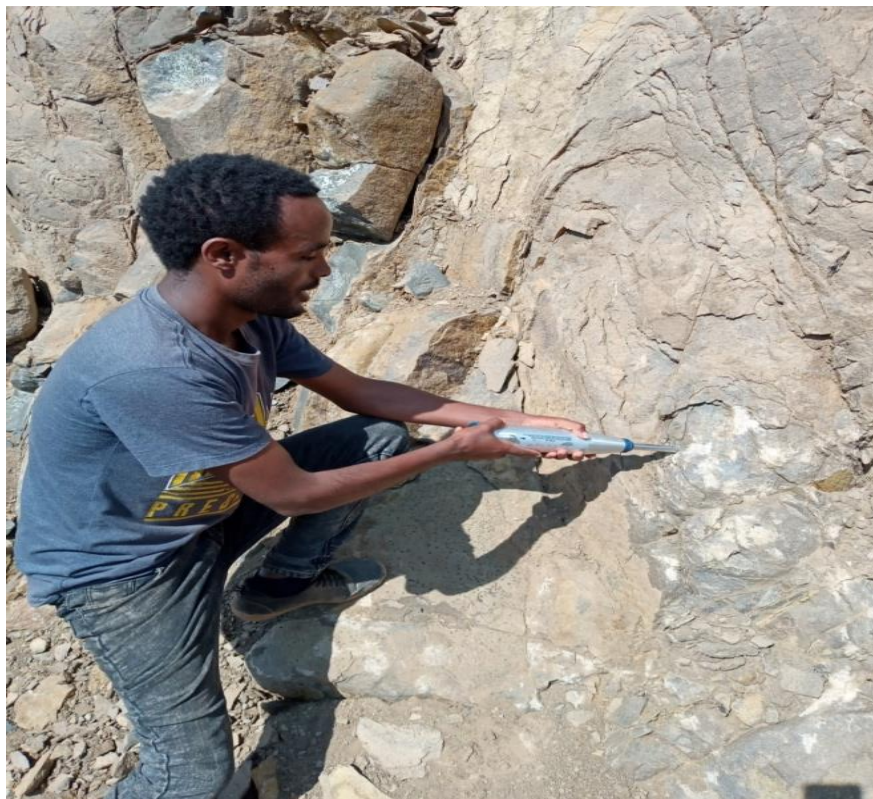
**Plate 4.1** Intact rock strength measurement by using L-type Schmidt hammer

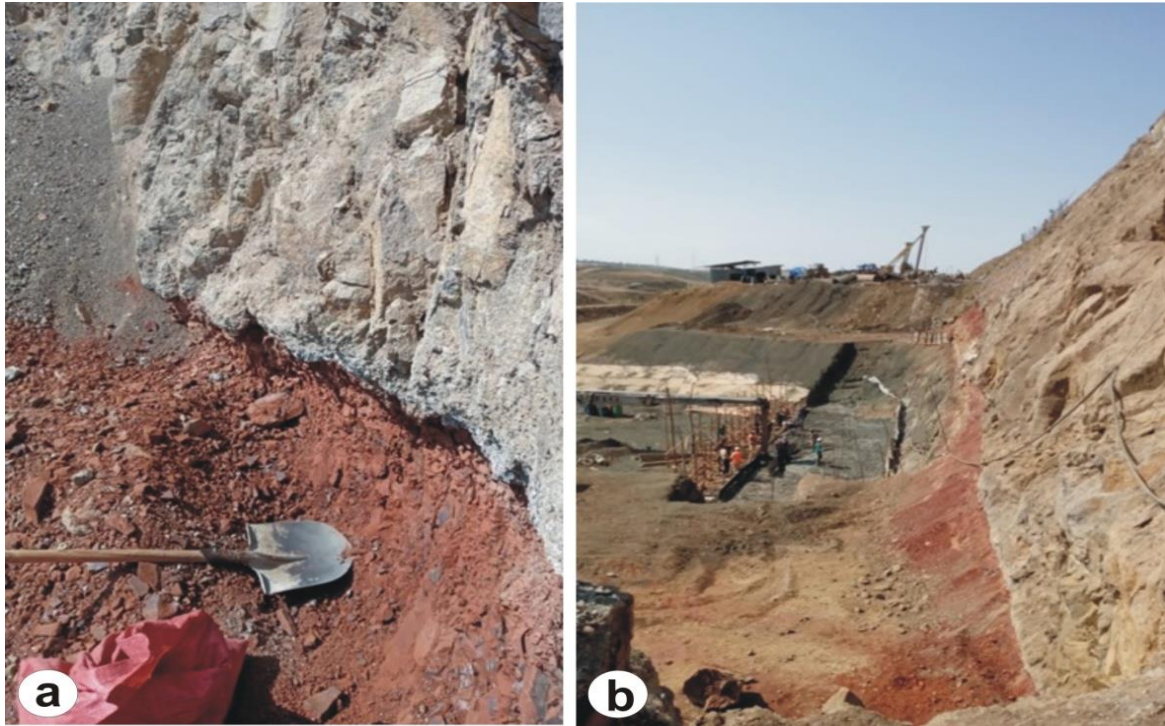
**Plate 4.2** Soil sampling locations (a) Test pit (TP-1) at the core termination in between porphyritic basalt above and aphanitic basalt below on the right abutment of the dam and (b) The core termination at the right abutment in contact with paleo-soil and line of conduit outlet work structure.

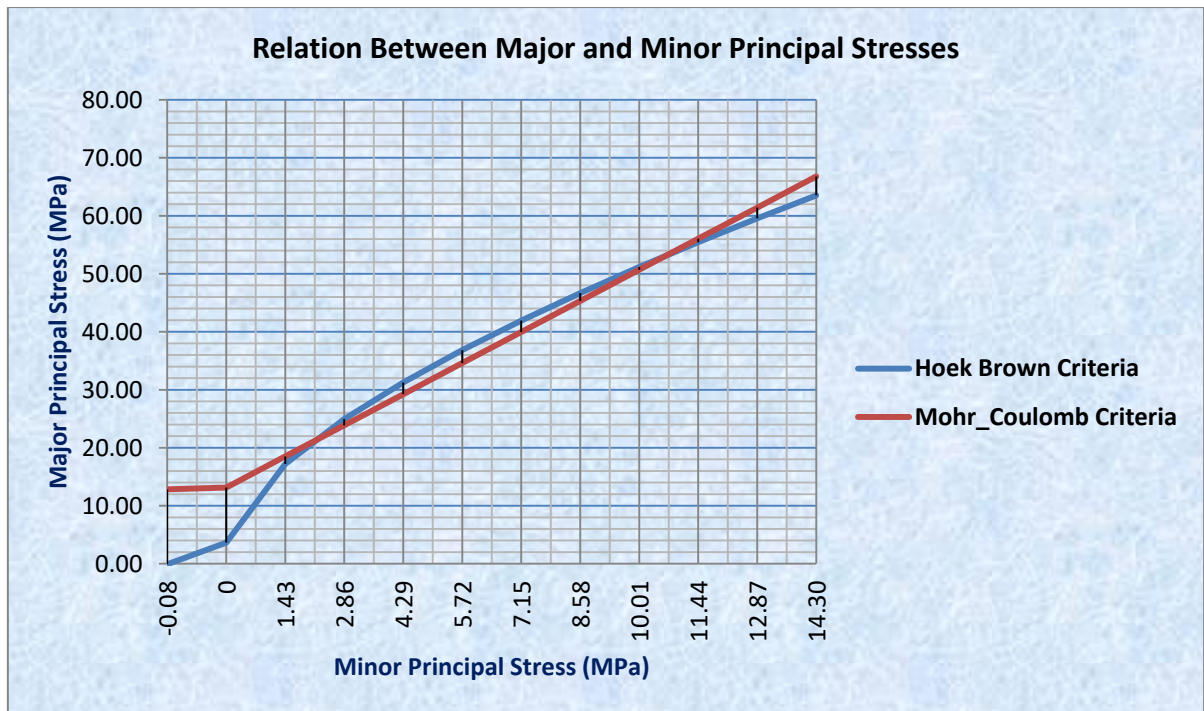
Fig. 5.1 Relationship between minor and major effective stress obtained from average RMR, UCS and  $m_i$  values showing both Hoek Brown and Mohr Coulomb criteria's for the dam foundation

The average major principal effective stress on Left abutment is 19.32 MPa and 35.83 MPa on right abutment. The rock mass characteristics of dam foundation presented in Table 7.3 were determined by using Rock Lab software and the computational sheet in MS Excel developed by Raghuvanshi (2017). The GSI was obtained from RMR (Bienwsky, 1989) presented in Table 5.2. The average UCS, RMR and  $m_i$  values were used to plot major and minor principal stress relationships. The estimated cohesion (C) from Hoek-Brown failure criteria for the rock mass at dam foundation varies from 0.82 to 11.85 MPa with an average value of 3.48 MPa (Table 5.4). Similarly, the estimated angle of friction ( $\phi$ ) for the rock mass at dam foundation varies from 21.47 to 40.6° with an average value of 34.67°.

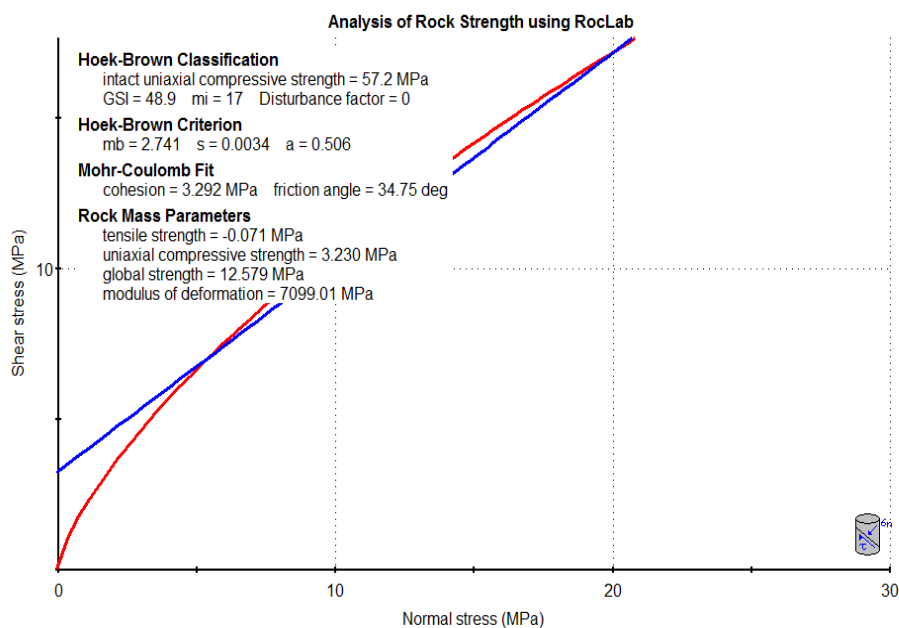
**Fig.5.2 Relationship between normal and shear stress with Mohr-Coulomb envelop using average UCS and GSI values for dam foundation for all RMR data points and  $m_i = 17$  for basalt**

Further, from Hoek Brown failure criteria by using average UCS and GSI values and  $m$  equal to 17 (for basalt) it has been found that the Mohr Coulomb Fit shows cohesion ( $C$ ) and angle of friction ( $\phi$ ) for the foundation rocks to be 3.292 MPa and  $34.75^\circ$ , respectively (Fig.5.2). The average uniaxial compressive strength for the rock mass at foundation is 3.23 MPa. Similarly, average modulus of deformation for the rock mass at dam foundation comes out to be 7.09 GPa.

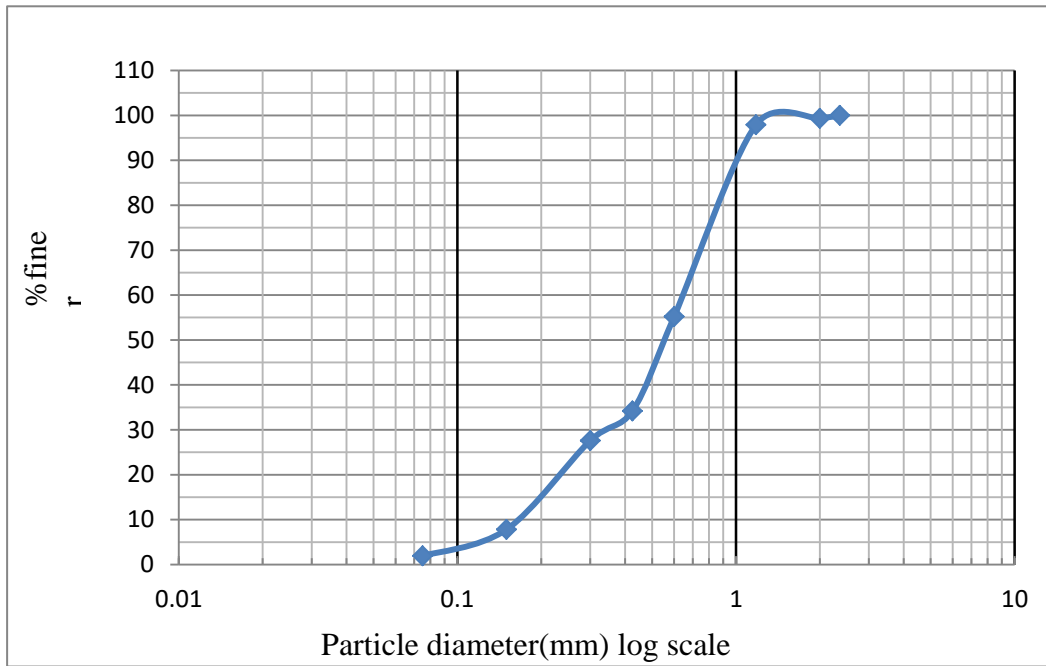
**Fig5.3**particle size distribution curve for soil sample taken from pit-2 at the core termination on the right abutment

Table 5.6 depicted both soil samples with % fines less than 5 with no gravel and to be classified as coarse grained soils typically sand with little fines (Fig 5.3 and 5.4) below.

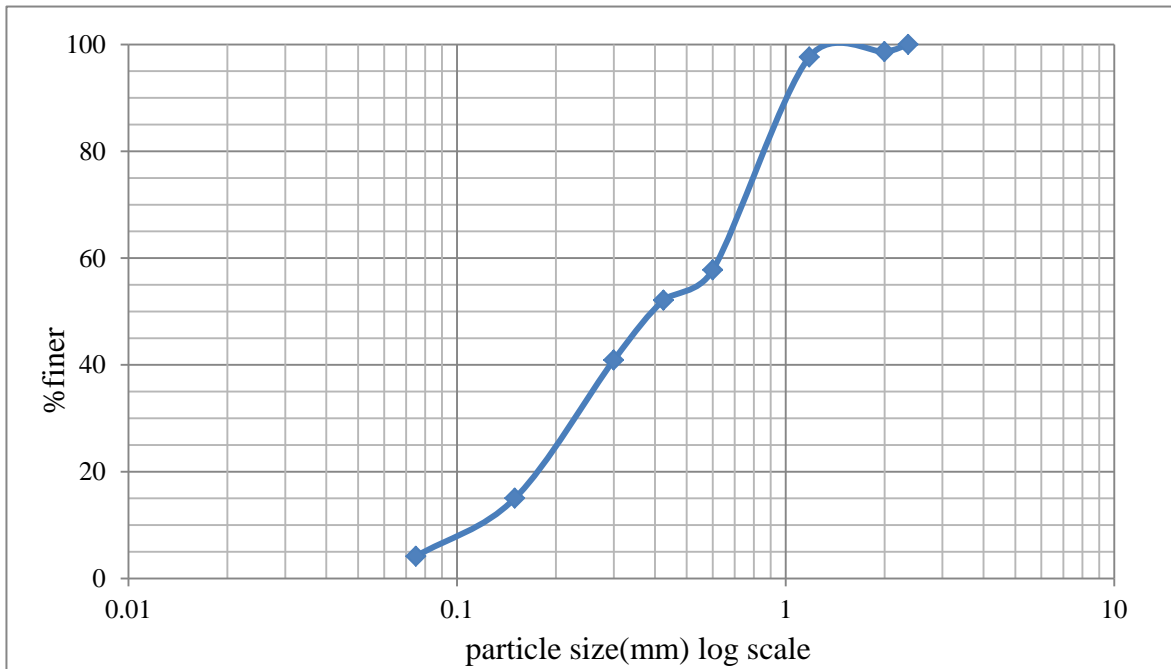
**Fig 5.4** Particle size distribution curve for soil sample taken from Pit-1 at the core termination on the right abutment

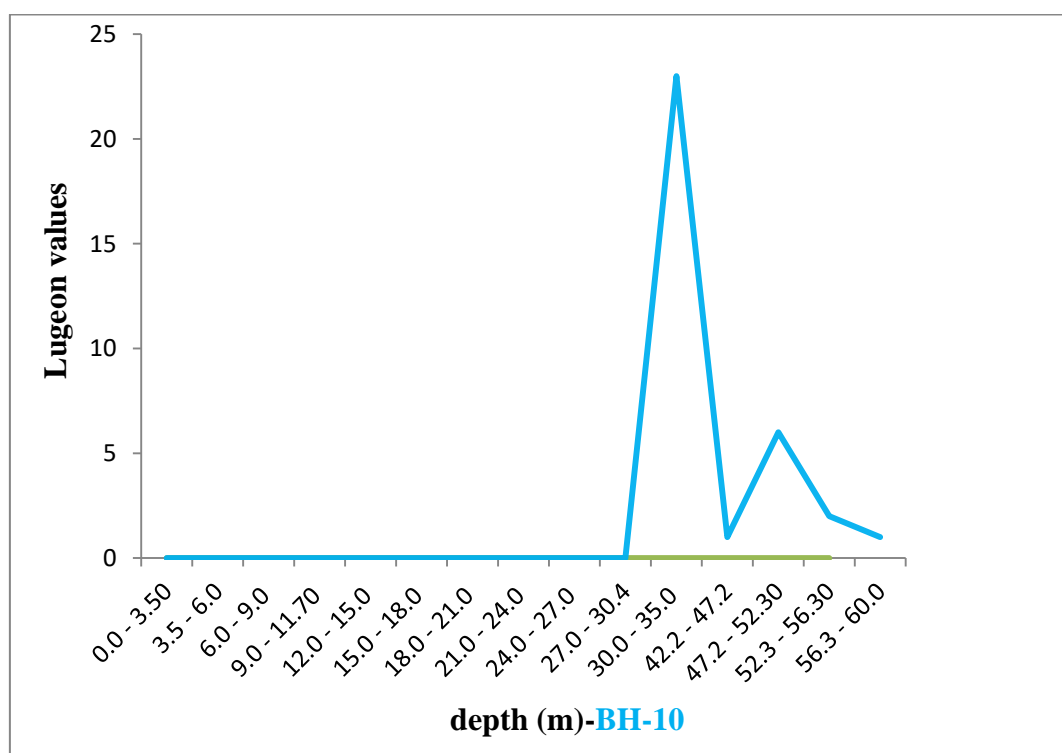
**Fig. 5.8** Variation of lugeon values with respect to depth in drill -hole NB-10 drilled at the center of the dam: 0-27m implies overburden material permeability

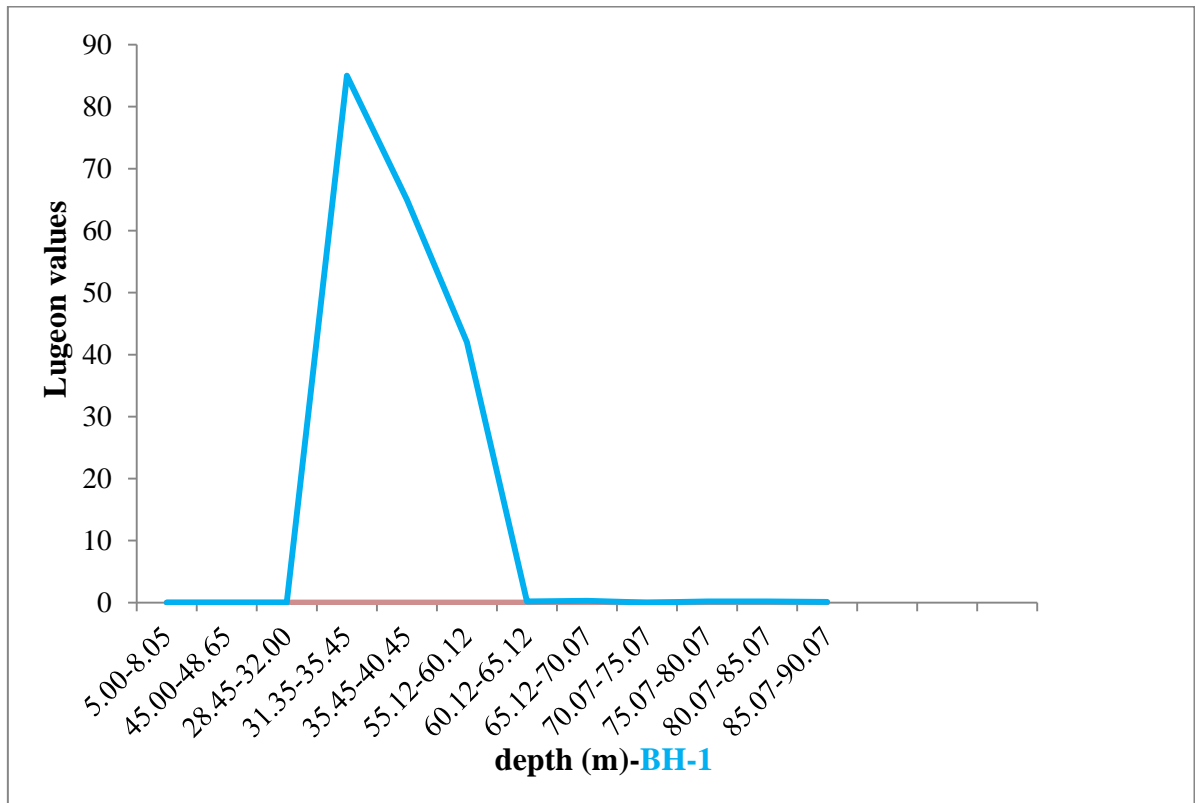
Fig. 5.10 Variation of lugeon value with respect to depth in drill hole NB-1 drilled at the left abutment of the dam: First 5 to 32m implies overburden permeability (K)

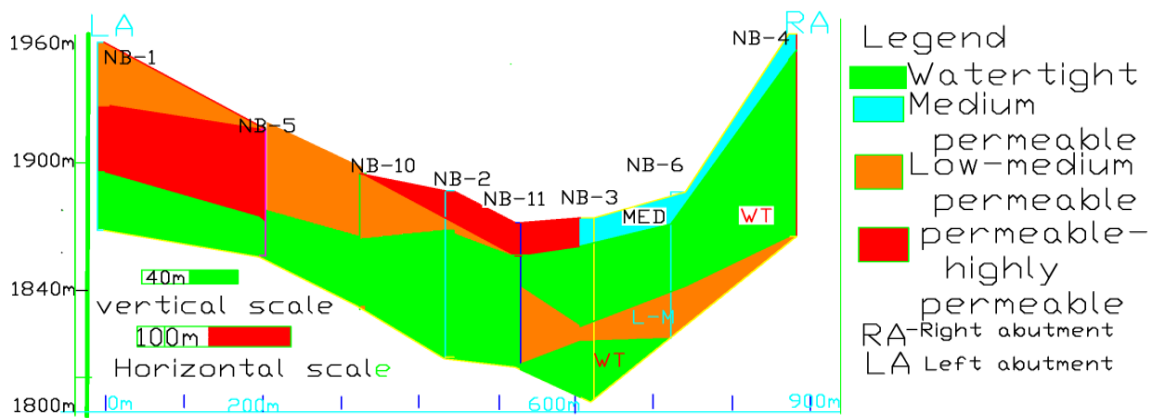
**Fig.5.11 Permeability conditions in the dam foundation and abutments**

Based on [Houlsby \(1976\)](#) classification the rock mass may be characterized as; 0-3 lugeon as water tight, 3-10 lugeon low permeable, 10-30 lugeon medium permeable, 30-60 as high permeable and  $> 60$  lugeon as very high permeable rock mass. Accordingly the dam foundation in the present study was zoned in to four classes and is presented in Fig.5.11 indicated large permeability difference in between right and left abutments. However, a general reduction in permeability with increasing depth can be observed in both abutments. Thus depth of curtain grouting has to vary from 27 to 57m along the central dam axis. The hydraulic head in this section will be 76m as per ([ICOLD , 2005](#)). As shown in Fig. 5.11 more depth of curtain grouting is required in the left abutment while in the right abutment progressive reduction in reservoir height confirms reduced of curtain grout depth as per [ICOLD \(2005\)](#). Therefore, left abutment needs special treatment with respect to permeability and [ICOLD \(2005\)](#) recommendations may not simply be adequate.

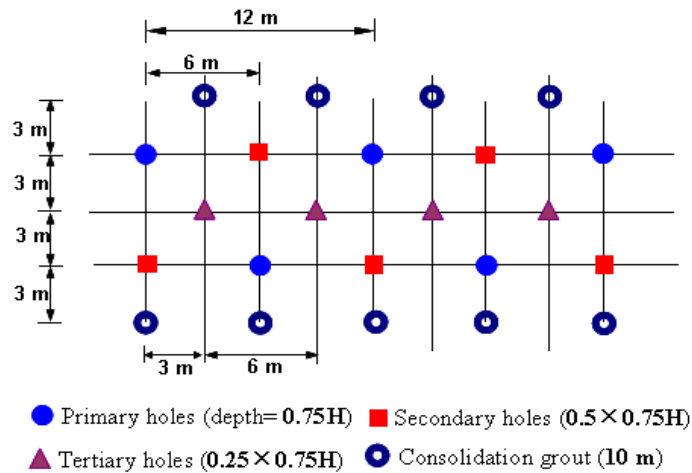
**Fig.5.12** Grouting lines along the dam axis based on permeability result adopted from Megech dam final design report (WWDSE, 2010).

In order to give intensive grouting of the upper layer in more fractured rock in the vicinity of the dam core, consolidation grouting to a maximum depth of 10m was proposed for the entire foundation by the Project authorities. The holes for consolidation grouting are proposed to be spaced 6 m apart and to ensure a highly efficient cutoff, a three-row grouting pattern is proposed by the project authorities. The general grouting scheme is presented in Fig. 5.12.

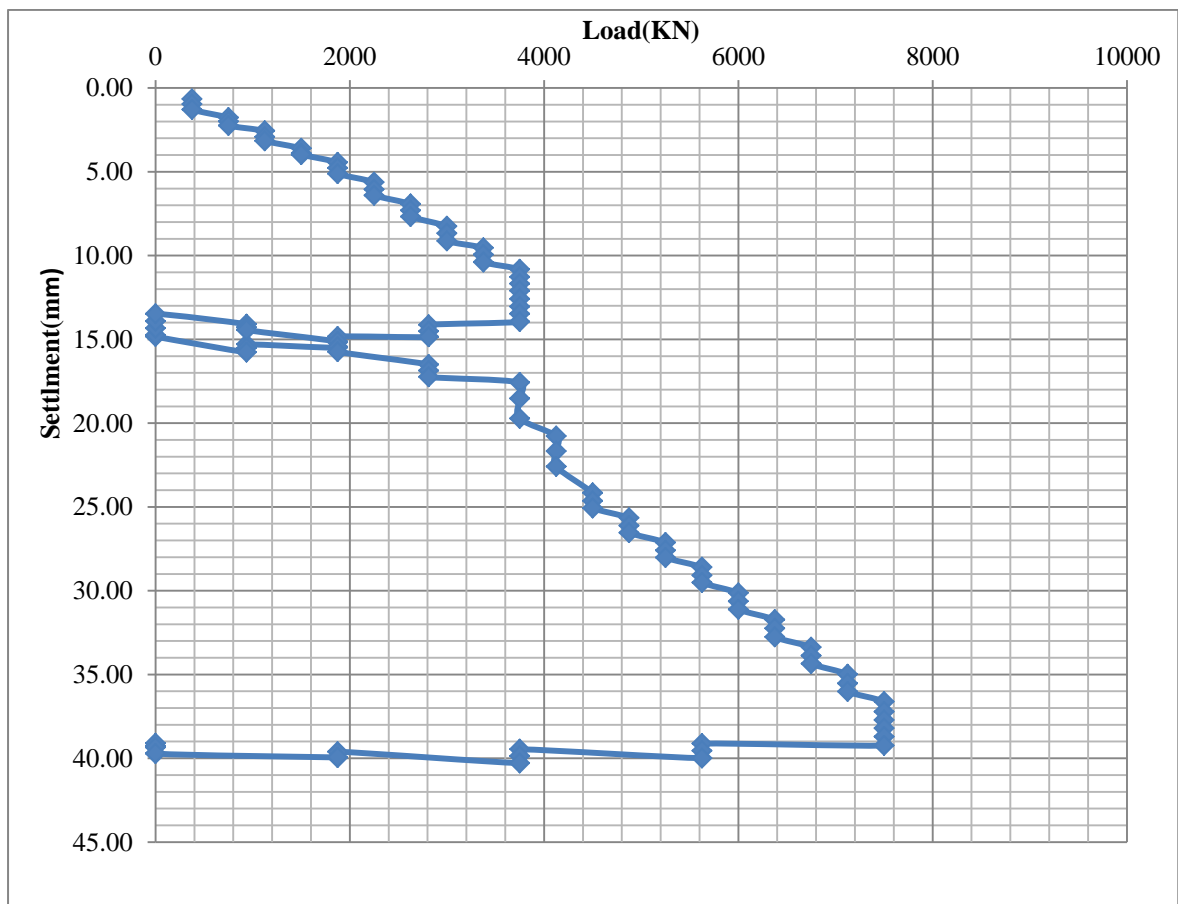
**Fig. 5.13a Load verse settlement curve for pile under intake tower - derived from working load test**

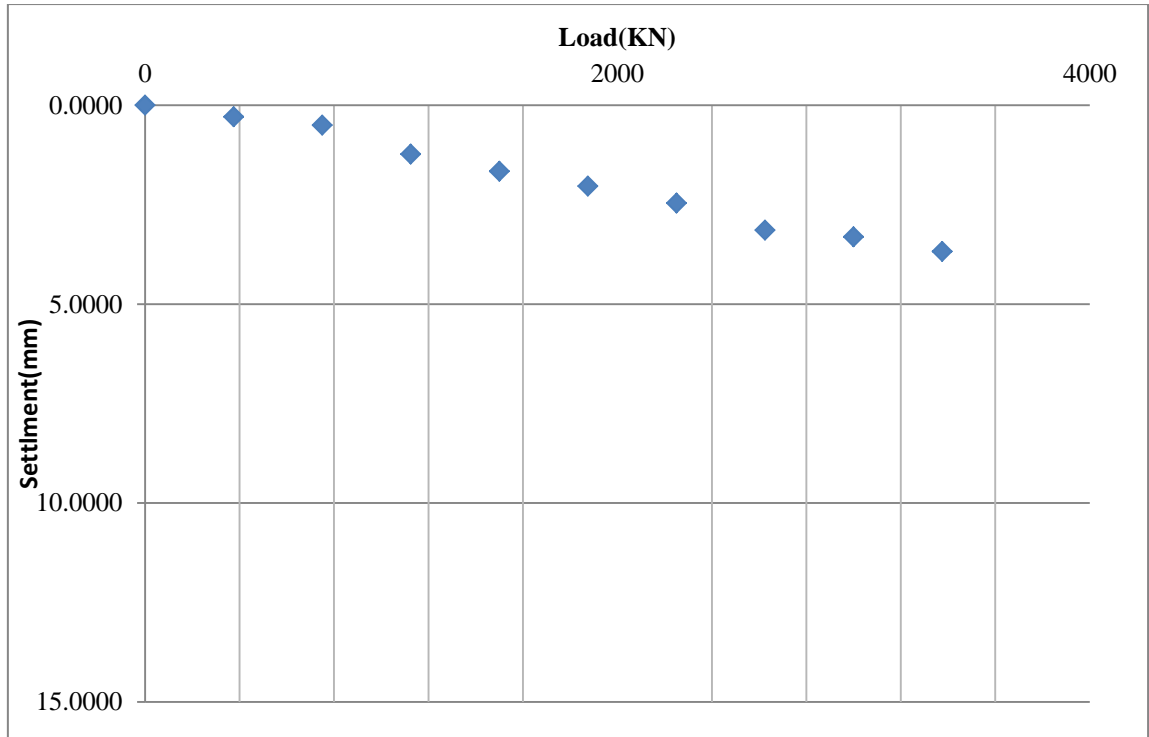
**Fig. 5.13b** Load versus settlement curve of pile under megech dam intake tower derived from preliminary load test (Pile-E-4)

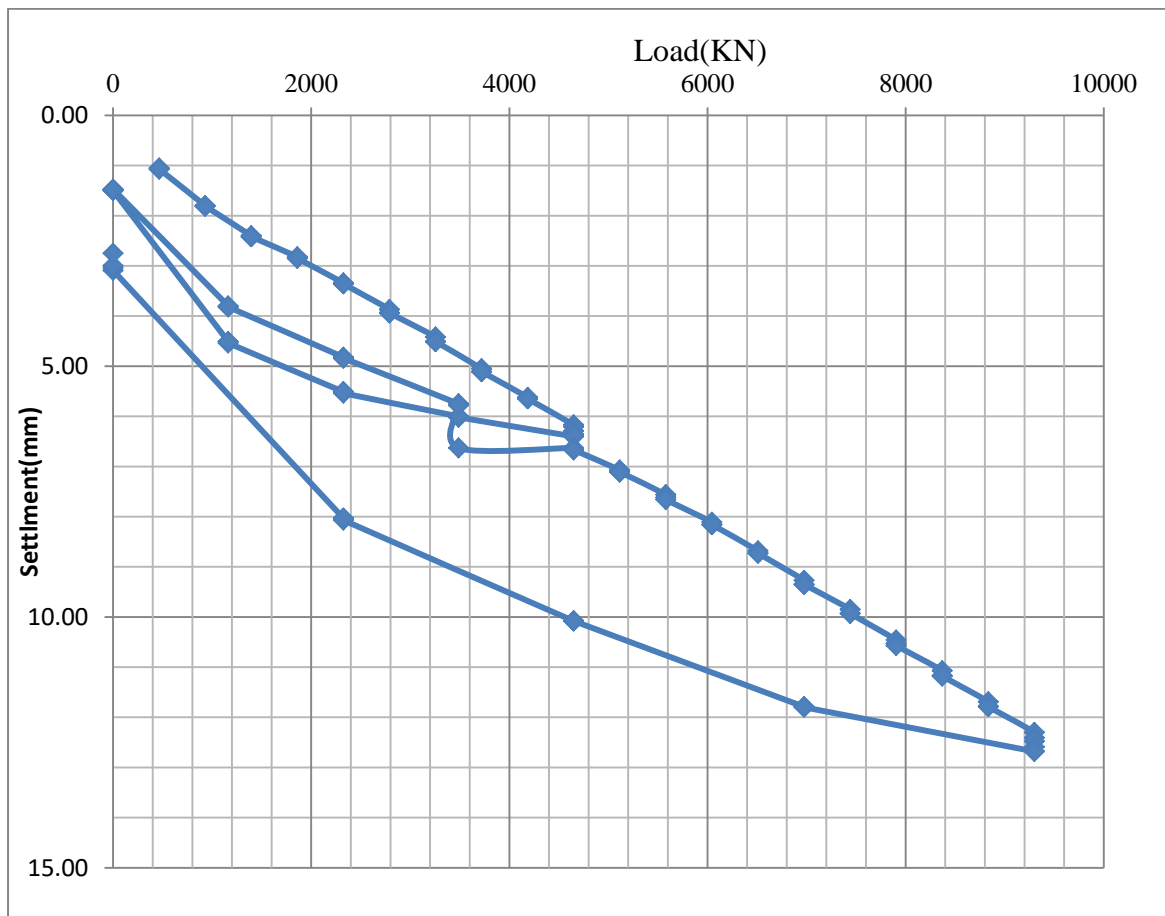
**Fig 5.14** Load-settlement curve derived from pile load test under conduit structure (P-10) working pile

The design load for the pile P-10 was 4650kN and it was tested for a maximum load of 9300kN (Fig5.14). The gross settlement for the design load was 6.4mm and the rebound settlement was 1.5mm thus, resulting net settlement of 4.9mm for first phase of loading was recorded (Fi5.14). Likewise, the gross settlement for maximum test load was 12.59mm while the rebound settlement for this load was 2.75mm thus, giving net settlement of 9.84mm. According to Singh (2016) the ultimate bearing capacity for the pile is the load at which settlement reaches 10% of the pile diameter. In the present case settlement did not reached 10% of the diameter of the pile (80mm) (Fig5.14). Further, as can be observed that settlement increases linearly with increment in load even beyond the maximum test load adopted (9300KN). Thus, it implies that the pile can bear even more than twice the design load (4650kN). Pile load test results and predicted pile bearing capacity of working pile P-10 under conduit structure is presented in Table 5.11.
