Analysis of the Causes and Consequences of Flash Flood and Design for Flood Resilient Neighborhood in Kebelle 02 of Bishoftu Town

Thesis submitted to School of Graduate Studies of Addis Ababa University in the partial fulfillment of the requirements for the degree of Master of Science in Environmental Planning and Landscape Design.

By: Biruk Tilahun

October, 2018

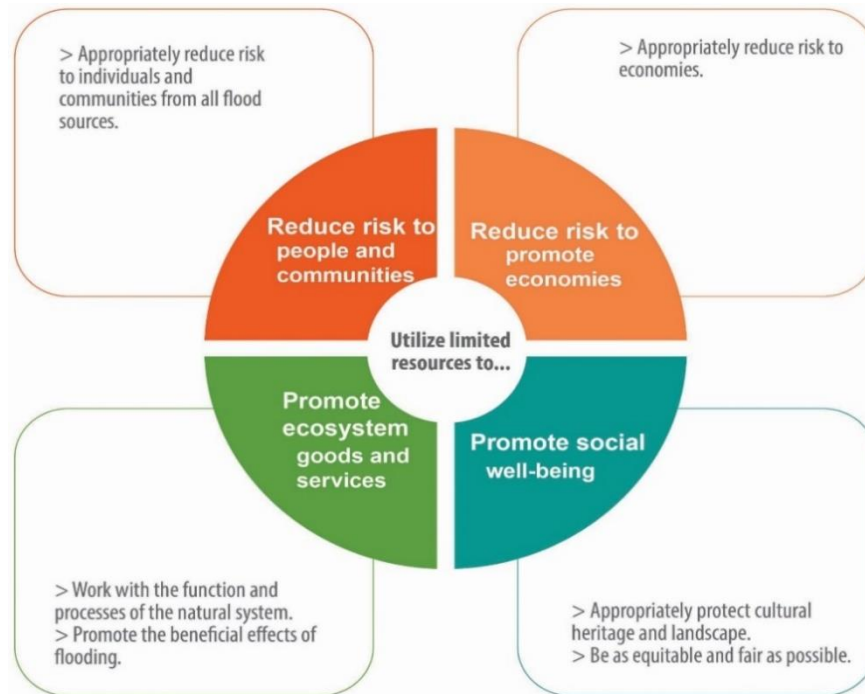
Figure 2: The primary goals of strategic flood risk management;
(Source: Sayers, et al., 2013)

Fig.2.). Achieving these relies on the development and implementation of appropriate collections of measure (where the advantages of one compensate for the disadvantages of another), a process that is complicated by the changing nature of the flooding system (through climate, geomorphologic and socio-economic influences)

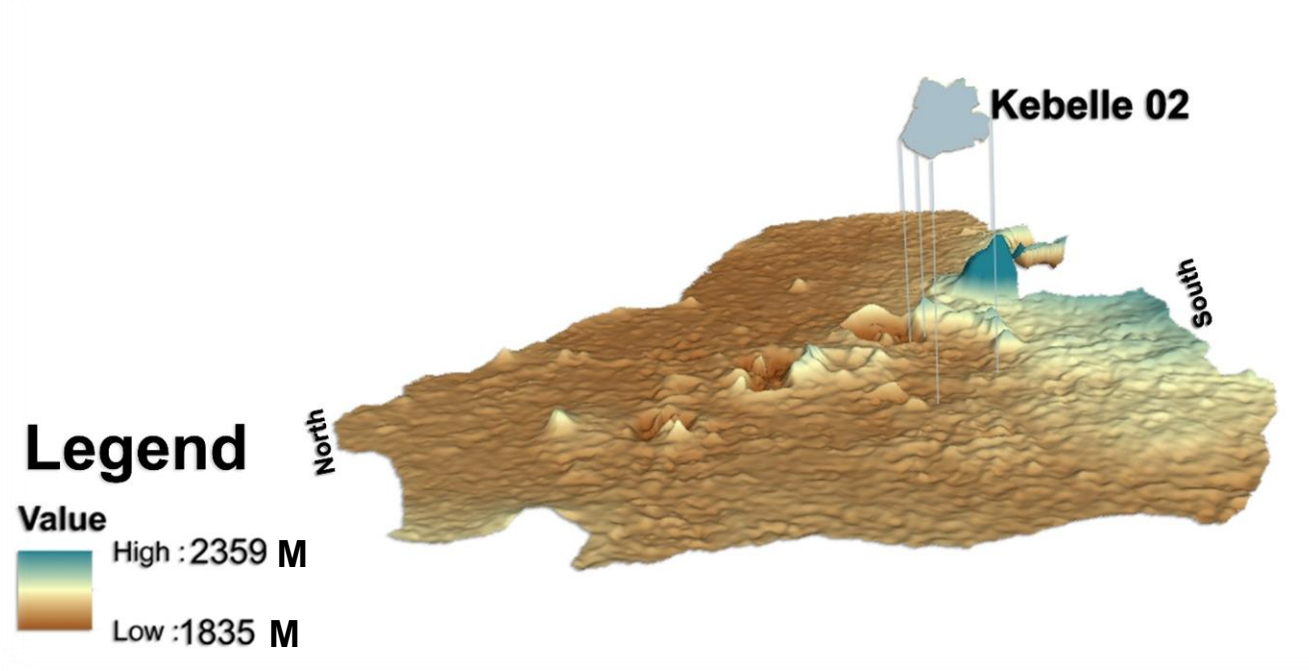
Figure 4: Topographic 3D view of Bishoftu Town

According to 30m DEM file of Ethiopia, the altitude of Bishoftu town is as low as 1835m and as high as 2359m above sea level. Therefore, the town is situated at an average elevation of 2097m above sea level. A typical description of the topography of landform of Bishoftu town and its environ comprises vast plain areas, swampy and water bodies, soft, rounded hips and hilly mountains, steep and rounded hills and associated undulating dissected areas. (See Fig.4)

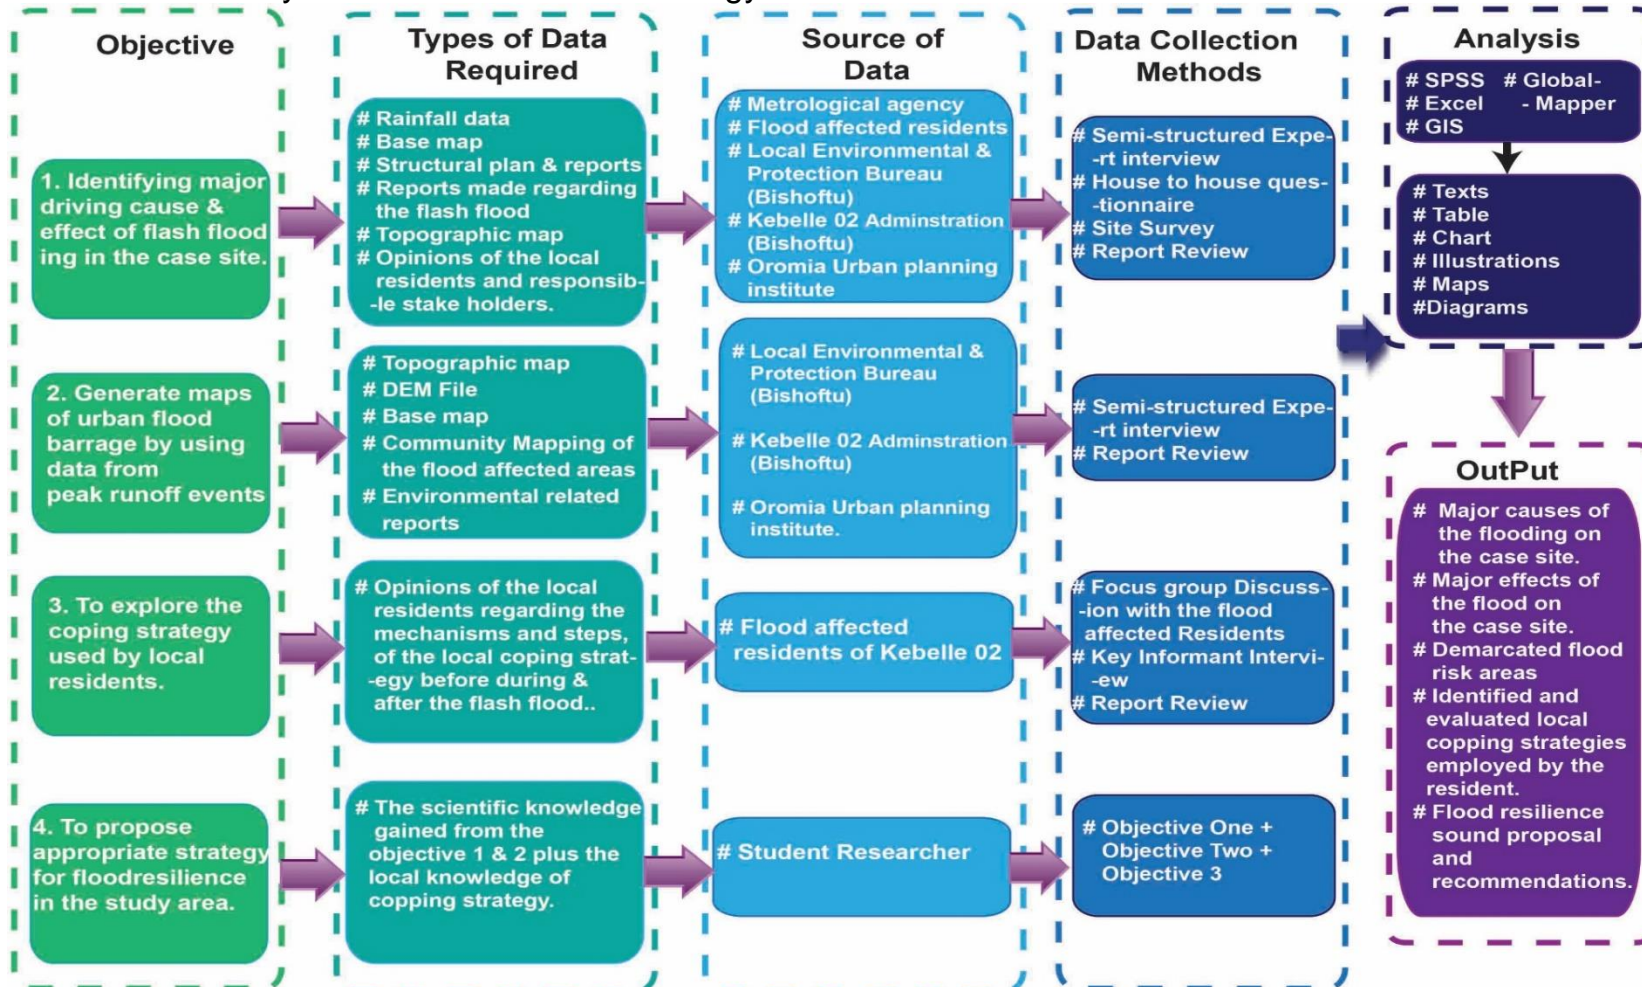
Figure 7. Summary of Research Methodology

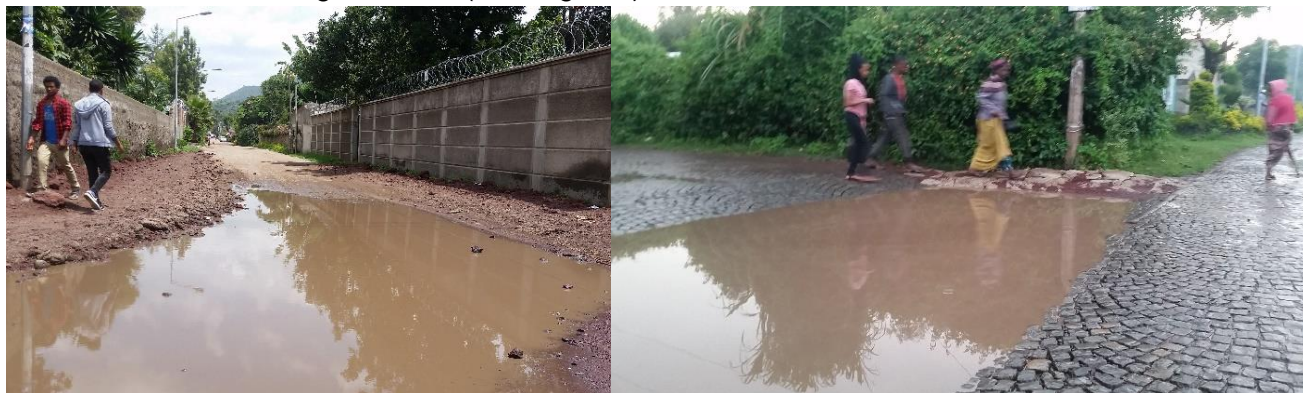
Figure 15. Lack Drainage line on the Street (Source: Field Photograph, 2017.)

Out of the total 132 respondents, the majority of the respondents around 50% believe that lack of drainage in-front of their houses causes the flood. The respondents claim that they tried to construct drainage line so that they minimize the flood during the rainy season but the Kebele administration denied the construction since the construction of the drainage may divert the water to other areas of the neighborhood (See Fig. 15.).

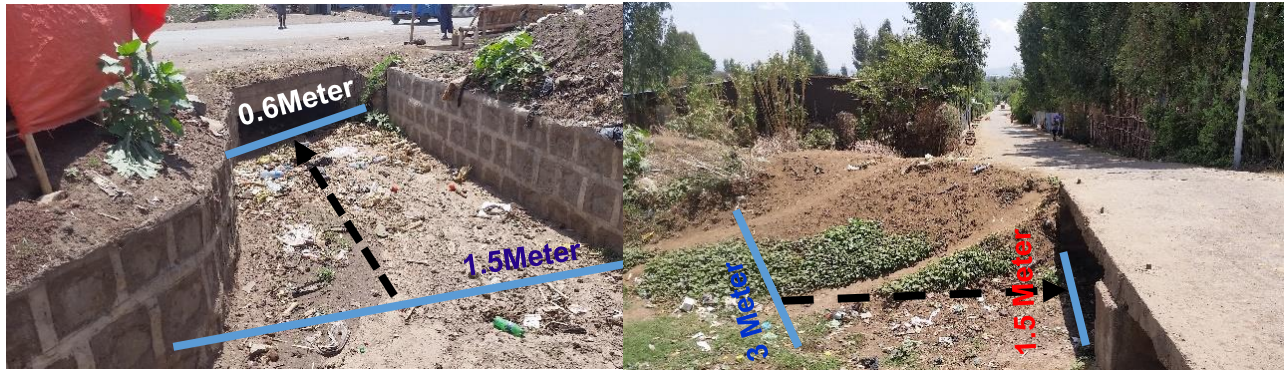
Figure 16. Incompatible drainage line Connection

drainage lines, which makes high power runoff that comes through wider size drainage overflow on the streets and cause flooding (See Fig.16.).

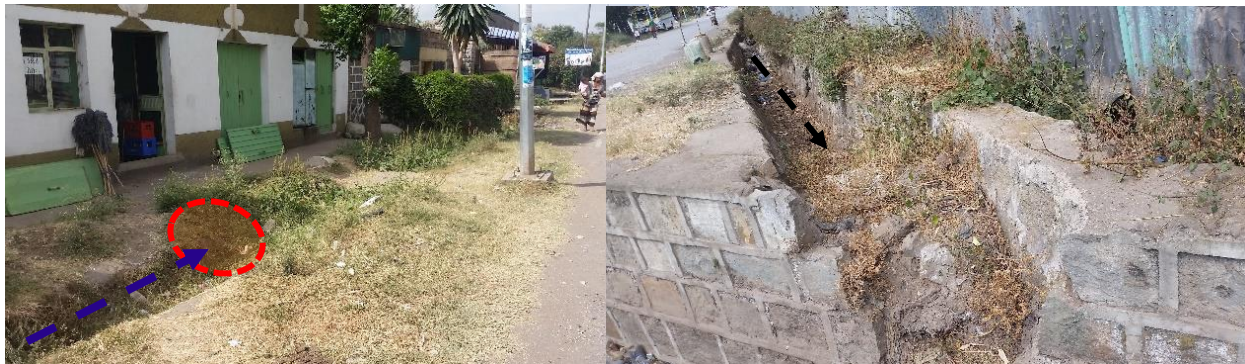
Figure 17. Dead end Drainage Lines

As it was investigated during the site survey some of the drainage lines found on the northern part constructed are against the topography. Hence the runoff cannot pass through this drainage lines. In addition, there are drainage lines that become a dead end where the water bursts out (See Fig.17.).

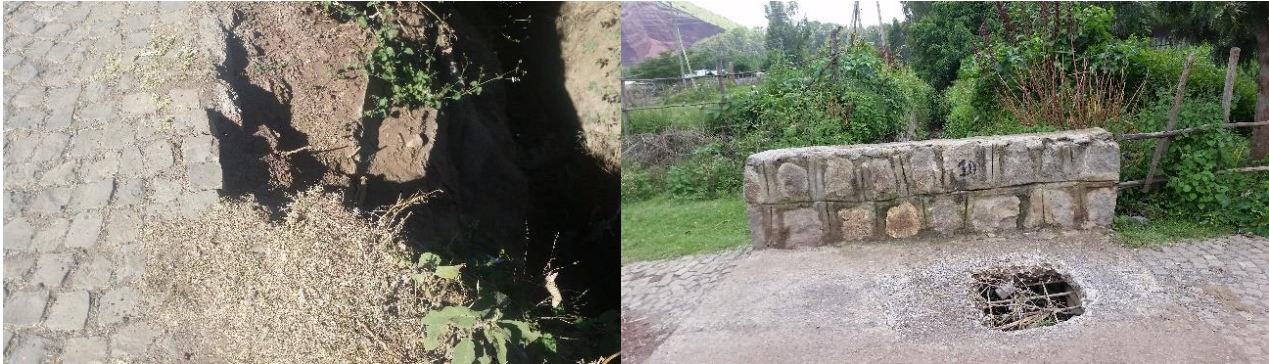
Figure 18. Poorly Constructed Drainage Lines
(Source: Field Photograph, 2017)

informants believe that the construction material of the drainage lines is very poor. As a result, some particular parts of drainage lines are currently destroyed (See Fig.18.).

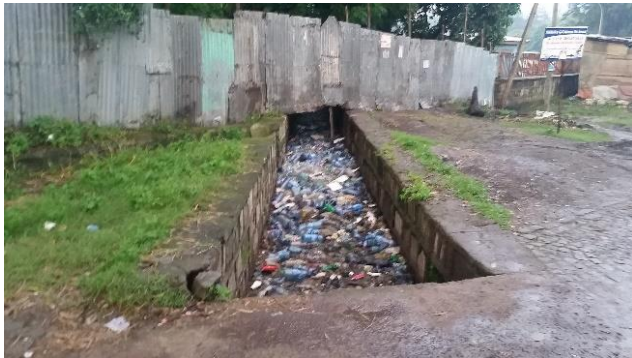
Figure 20. Clogged Drainage with Garbage
(Source: Field Photograph, 2017)

As the key informant interviewee explained, *“most of the plastic bottles dumped in the drainage comes from the bus terminal since many travelers pass through our neighborhood and they threw this used bottles into the drainage that resides with the compound of the terminal.”*

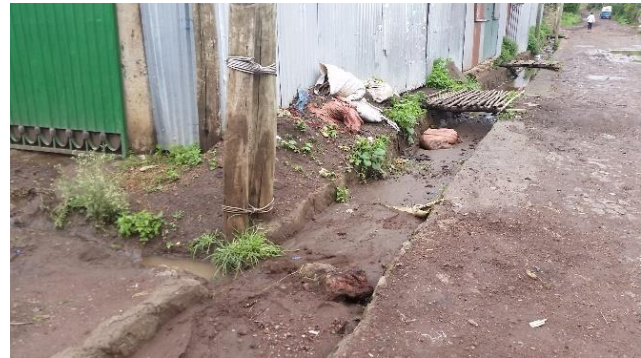
Figure 19. Sedimentation of Soil in the Drainage

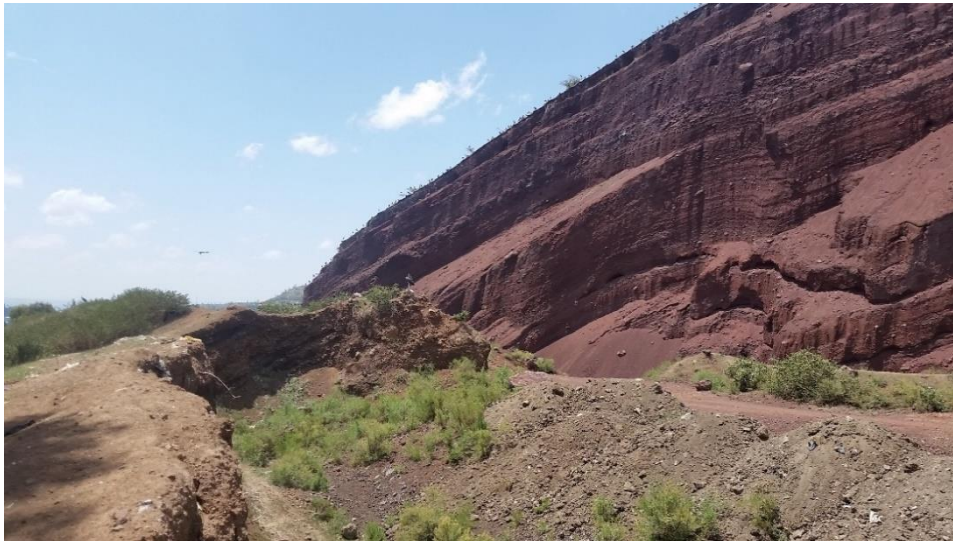
Figure 21. Quarry Site (Sofa Mountain)
(Source: Field Photograph, 2017)

the natural waterway is being disrupted and the runoff from the mountain becomes more powerful to the inhabitants adjacent to quarry and down catchment areas (See Fig.21.) With regards to the quarry the interviewee replied that *“it was 10 years ago after the quarry was started the waterway started to divert into my neighborhood, since then I started suffering because every time there is flood, the floodwater enters in my house where it reaches up to 50-60cm below the ground and I have children usually sleeping on the mattress that is found on the ground.”*

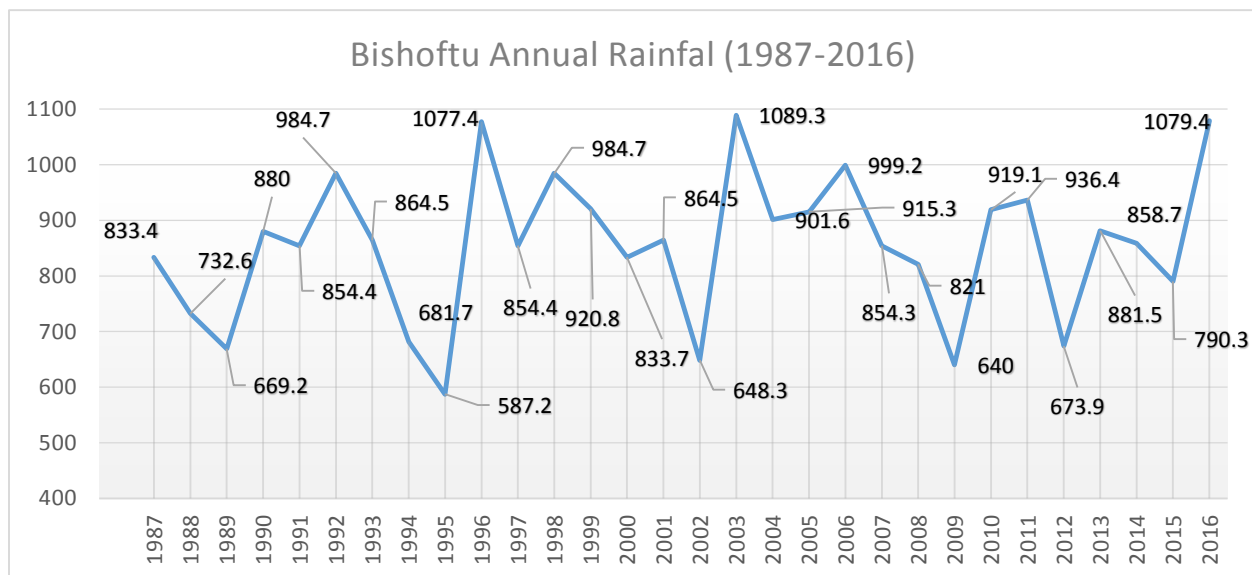
Figure 22 Bishoftu Town Thirty years Annual Rainfall

As thirty years rainfall data was gathered from the National Metrological Agency revealed that, the average rainfall occurred 854.38 mm within the past thirty years from year 1987-2016 G.C. the chart below shows that the maximum rainfall recorded annually is 1089.30mm occurred in the year 2003 G.C. while the minimum rainfall recorded annually is 587.20 mm occurred in the year 1995 G.C.. The thirty years monthly rainfall data records shows that the rainfall becomes high during the months of June, July, August, and September. This months of the year are months that rainy season starts. During the house to house survey, the informants replied that most of the flash flood occurrence are in the above stated months of the year. (See Fig.22.)

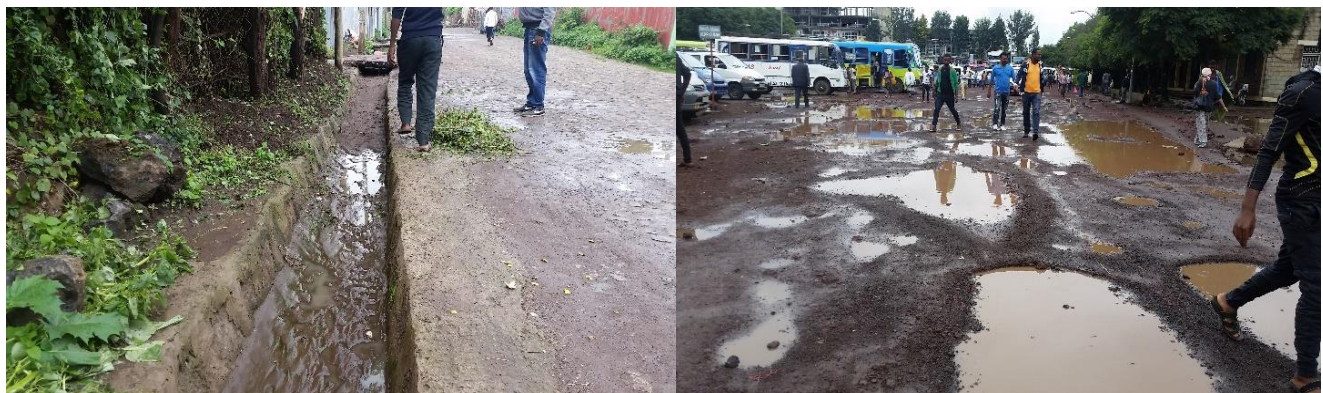
Figure 25. Deterioration of physical infrastructure

As primary effects on the study area, around 25.75% of the respondents responded that physical infrastructure gets damaged in their area whenever there is flooding. Since the storm water runoff from the upper catchment is very powerful it washes off the pavement of the street. In addition sedimentation of the soil in the few drainage lines found in the study area also decreases the quality of the drainage and the residents residing around the edges of the drainage line are forced to clean the sediment soil whenever there is a rain. (See Fig.25.)

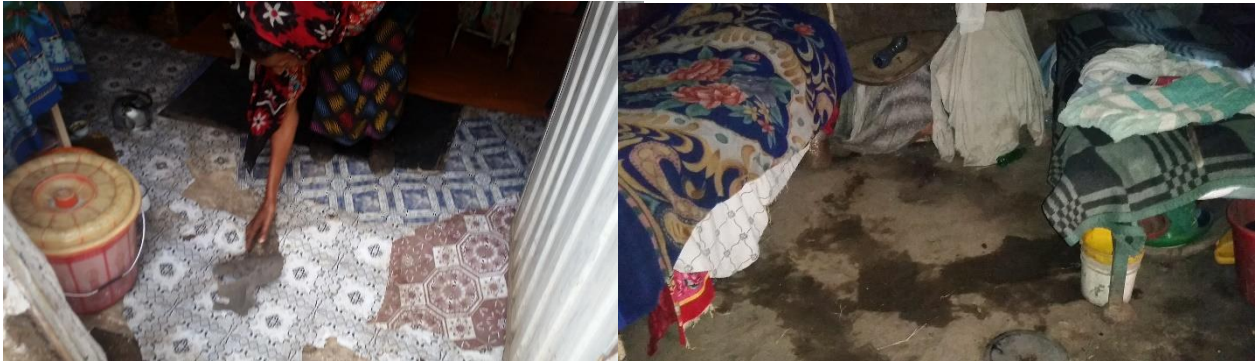
Figure 26. Housing Unit Floors Moistened from the Flooding
(Source: Field Photograph, 2017)

is very contaminated water that also gets in contact with their food and utensils, the informants claim that the flood poisons their food items and water lines.

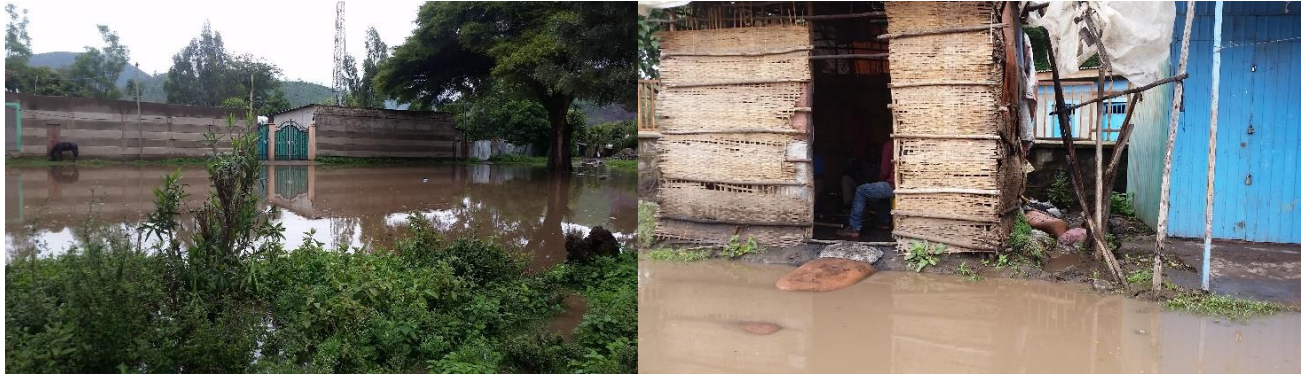
Figure 27. Blocked House Entrances Because of the Flood

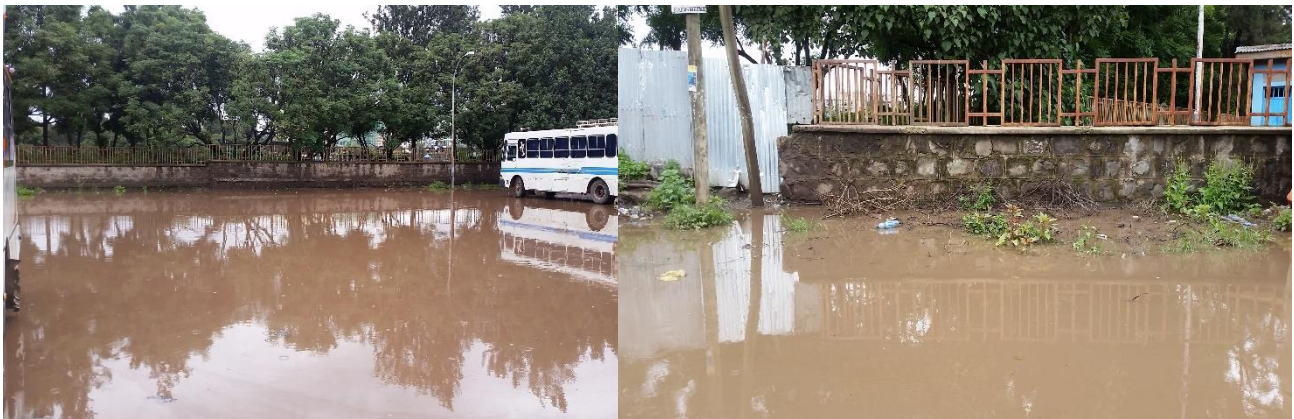
Figure 29. Swampy Area within the Bus Terminal
(Source: *Field Photograph, 2017.*)

The topographic nature of the case site is analyzed by calculating the slope and classifying it into seven categories. Out of the total area of the case site, the majority of the area coverage (38.45%) ranges with slope percentage of 2.1-5%. About 22.12% of area coverage lies between 0-2% slope percent, which implies that areas ranging in the specific slope classification are considered as swampy areas. As discovered during the field survey, during rainy seasons most of the case site areas such as, 'Sink Meda', some streets, drainage lines and individual compounds that range within 0-2% becomes inundated for longer hours or sometimes the water lasts until the rainy season is over.

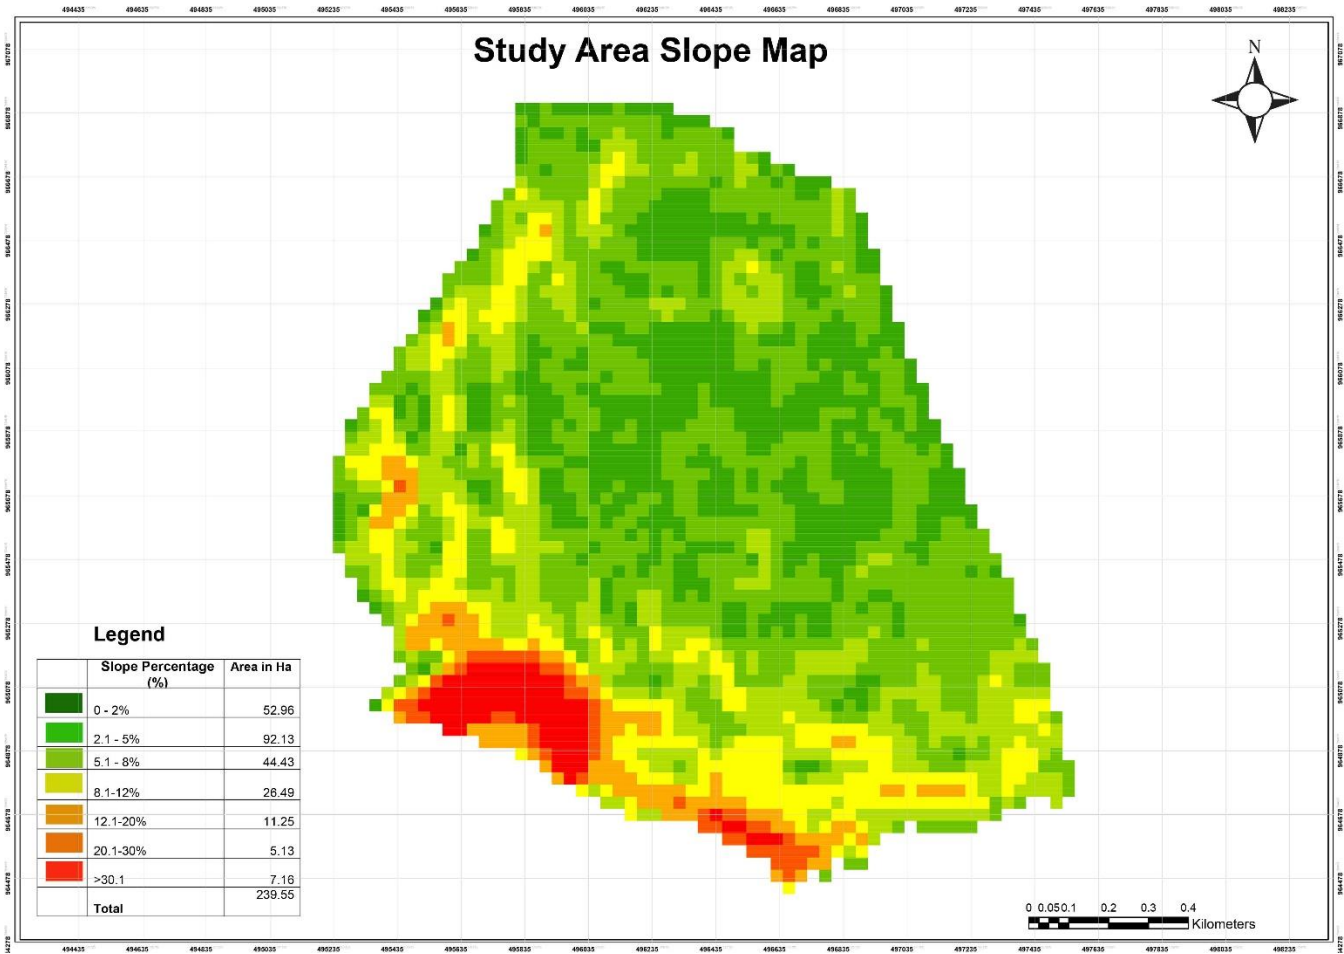
Figure 30 Classification of Relief Map of Study Area into Slope Categories

Whereas, the southern mountainous part of the case site has a slope percentage $>20.1\%$ where most of the flash flood originates (5.13%). (See Fig.30.)

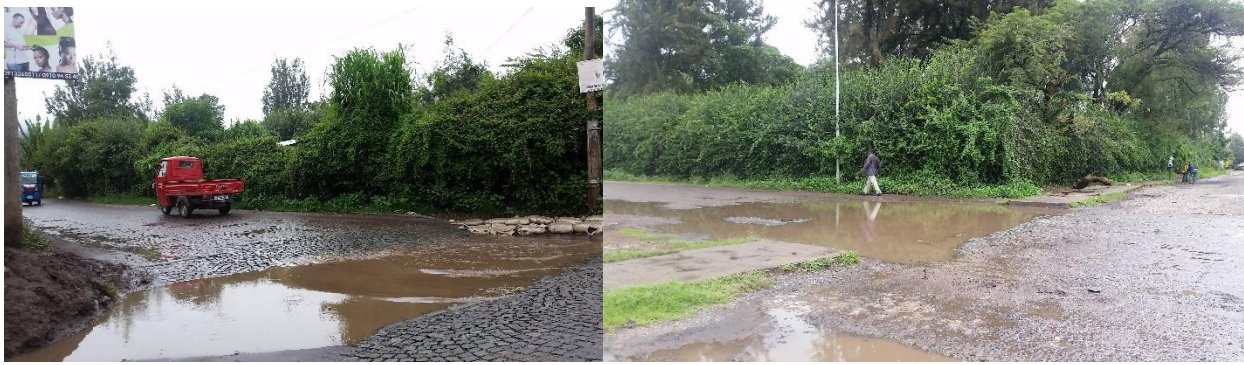
Figure 37. Poorly Constructed Cobble stone Paved Streets Promoting Inundation of Rain Water.
 (Source: Field Photograph, 2017)

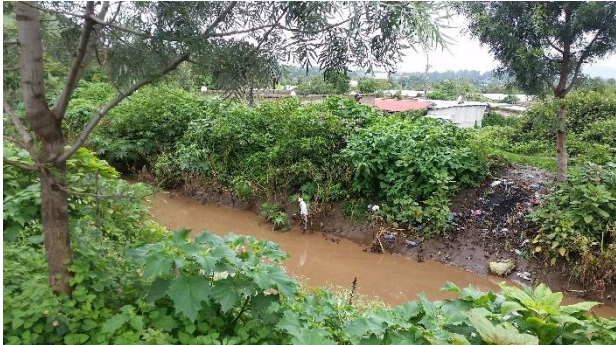
Figure 39. Non-Paved Drainage line serving as Waterway during Rainy Season

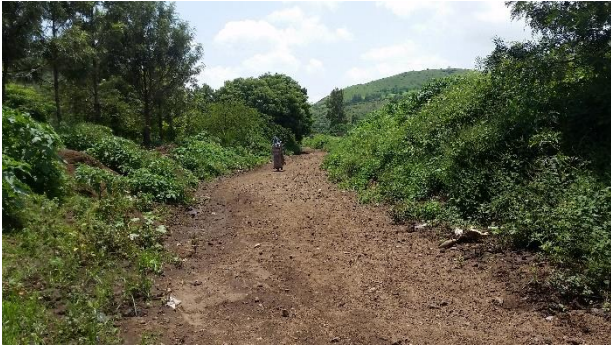
Figure 38. Non-Paved Drainage line serving as Walkway during Dry Season

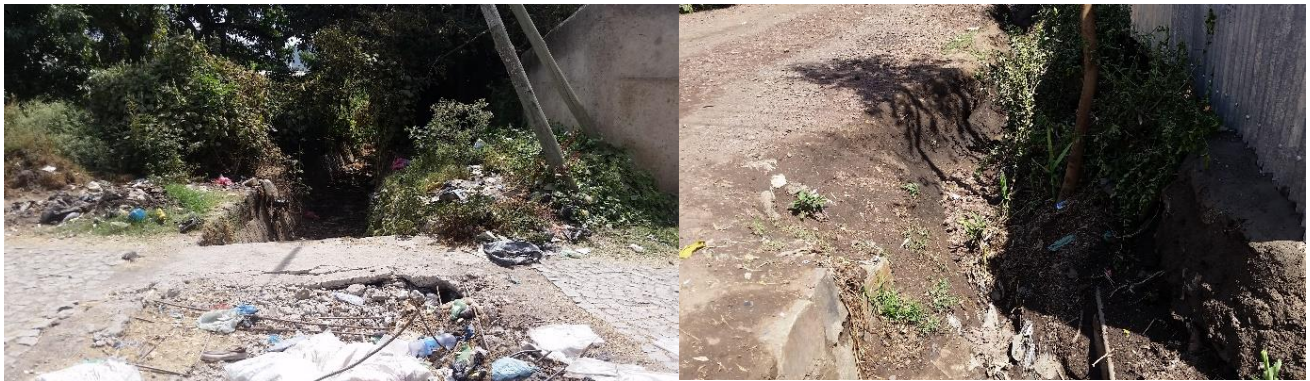
Figure 41. Deteriorating Drainage Lines
(Source: *Field Photograph, 2017*)

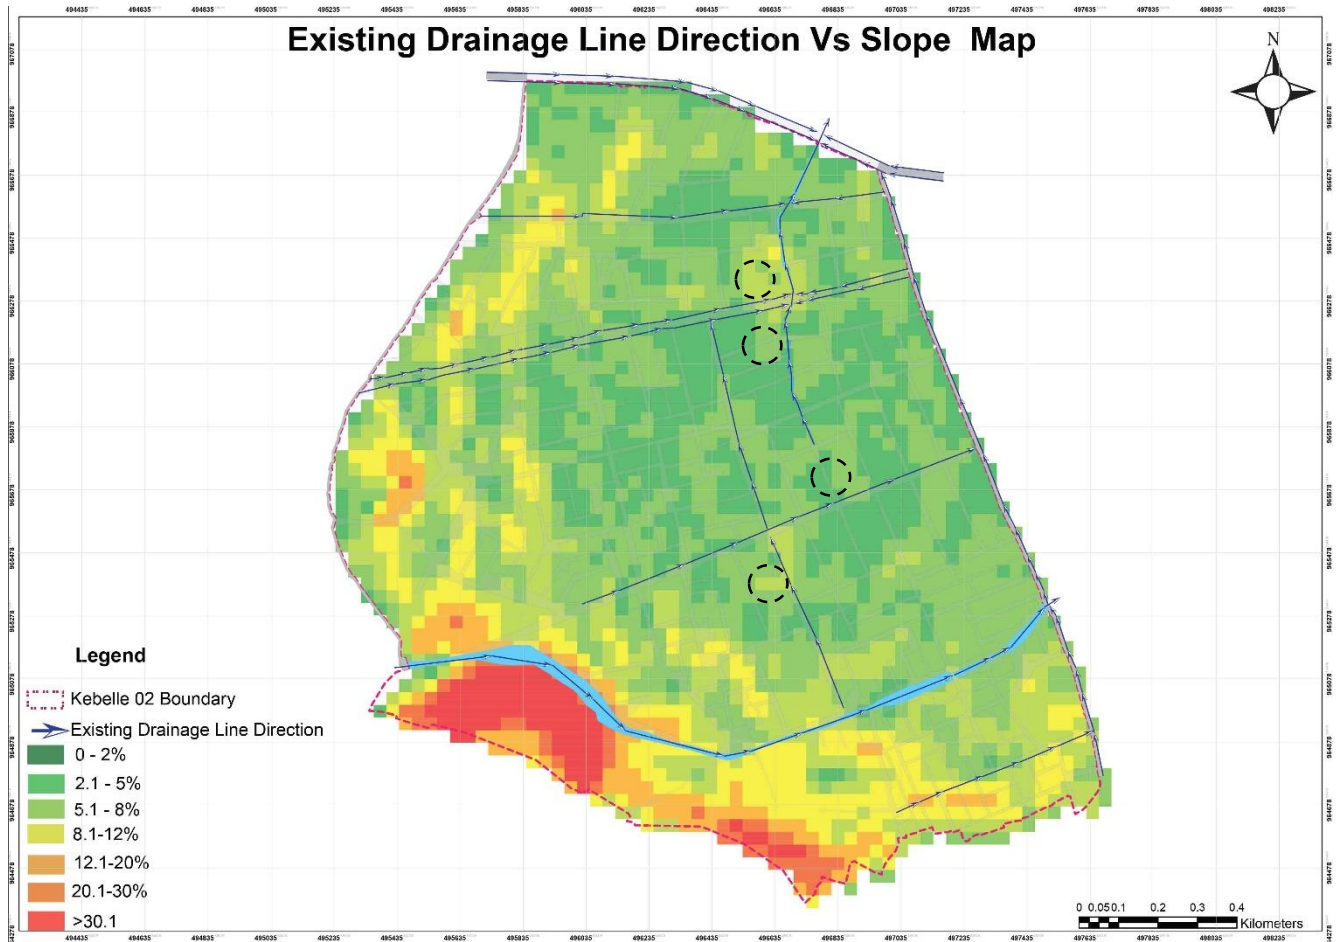
Figure 42 Existing Drainage line versus slope map of the study Area

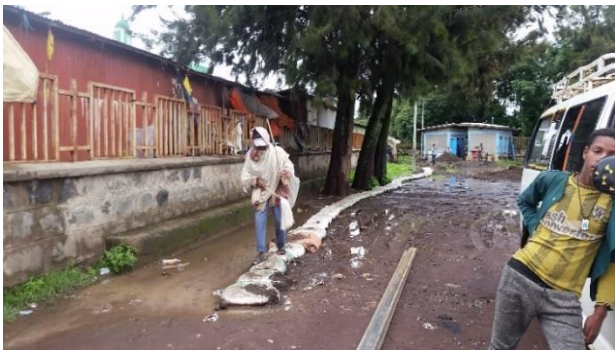
Figure 53. Sand Bags used as Walkway in swampy areas

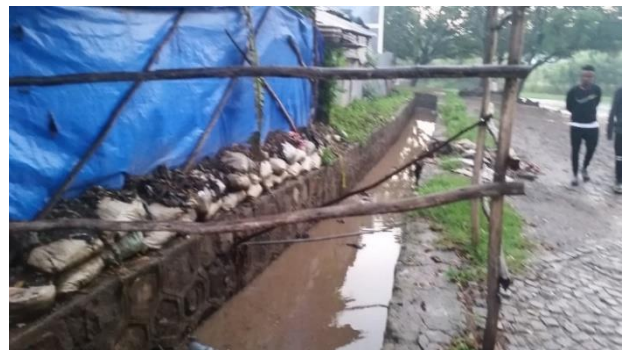
Figure 54. Sand Bags used as Blockage to Minimize the Water from Entering

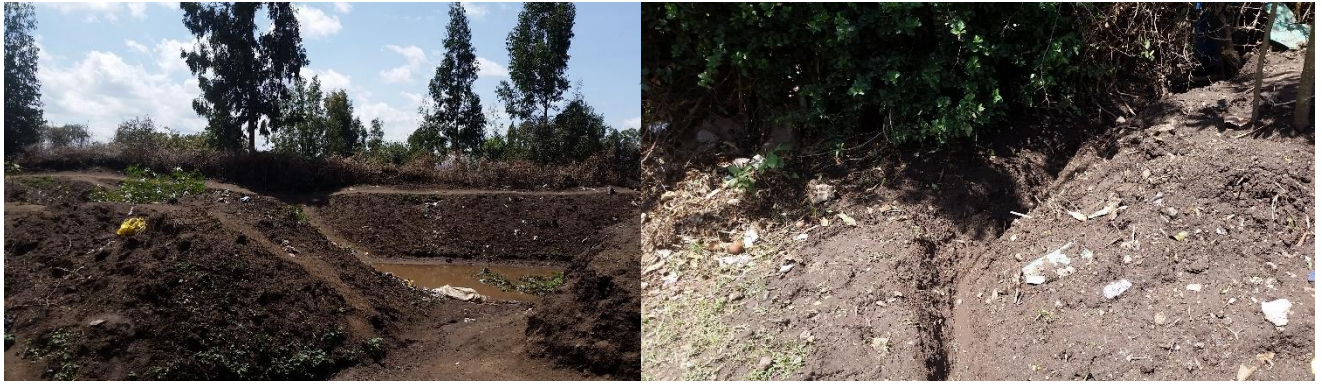
Figure 55. Diverging Waterway Strategy
 (Source: Field Photograph, 2017)

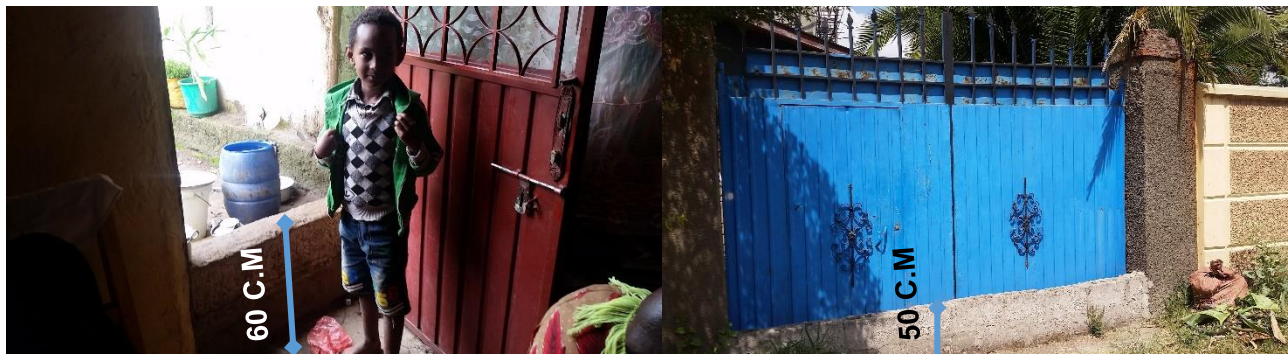
Figure 56. Hollow Block Structure
 (Source: Field Photograph, 2017)

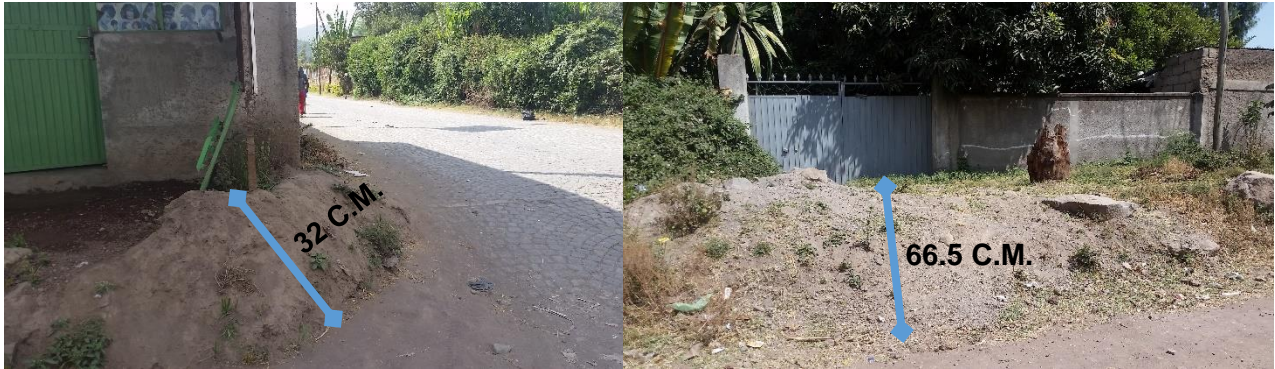
Figure 57. Soil Compacted Entrances

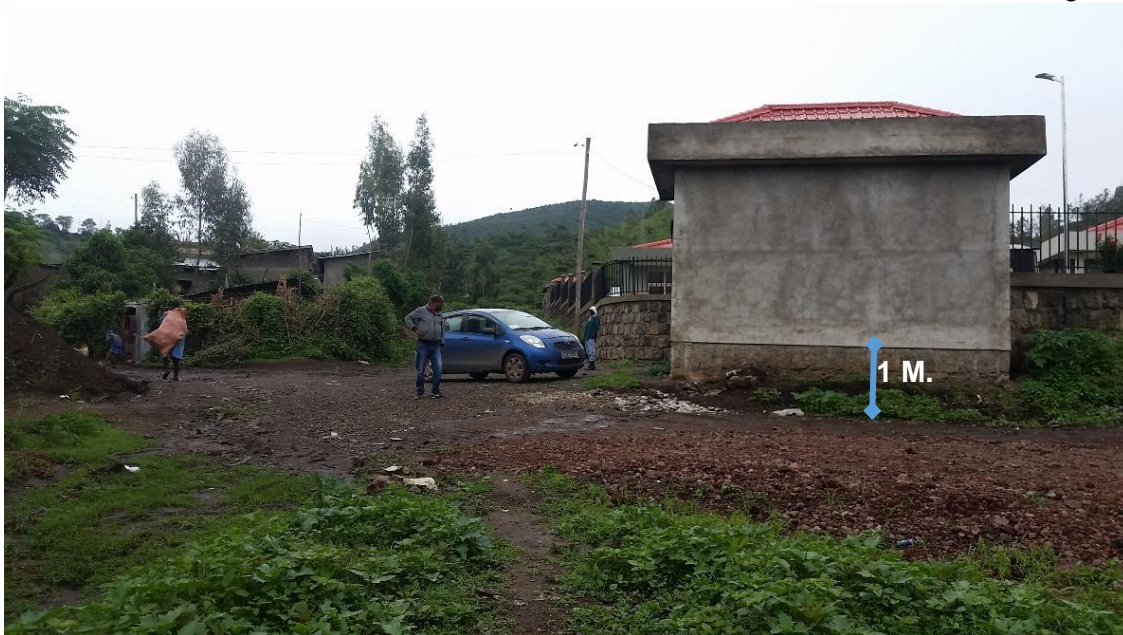
Figure 58. Housing Unit Foundations up to 1 M.

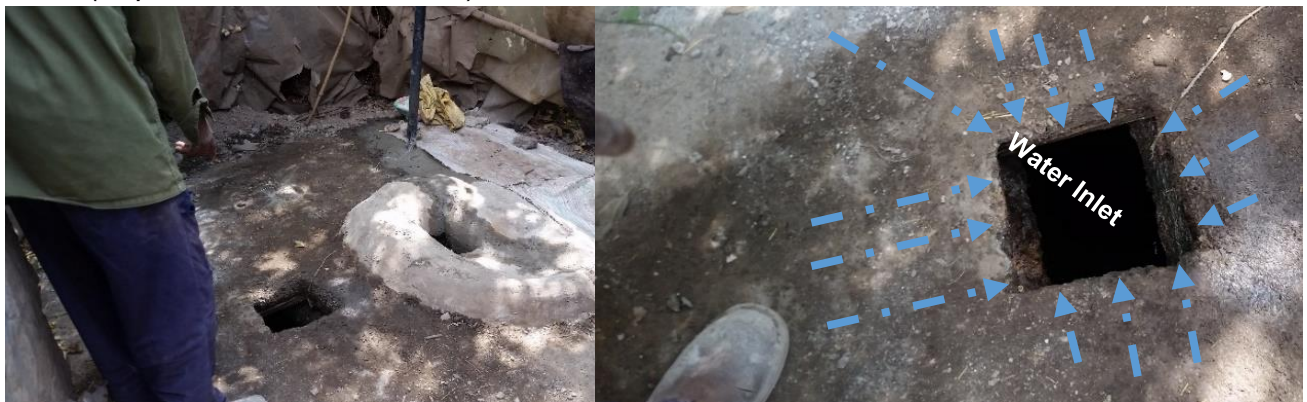
Figure 59. 2m by 3m Width with 4m Depth Hole for Flood Water Trapping
 (Source: Field Photograph, 2017)

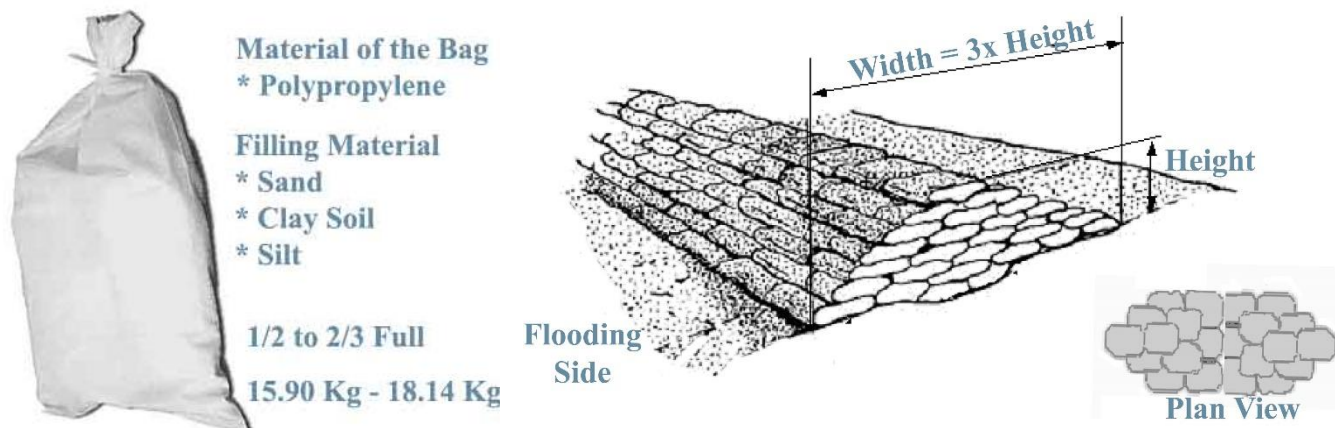
Figure 61. Preparation and proportional Placement of Sand-bags.

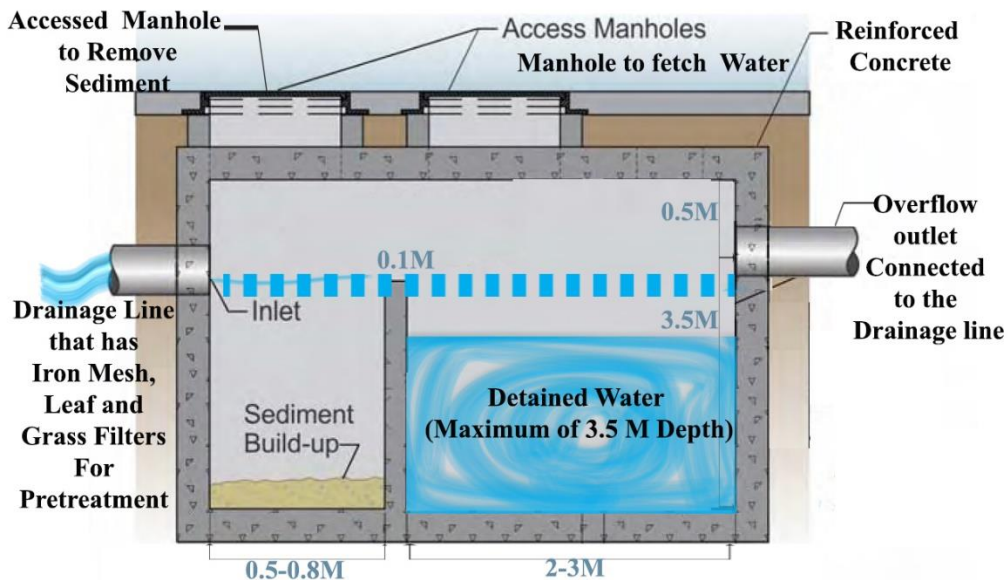
Figure 62. Flood Water Detaining Tank

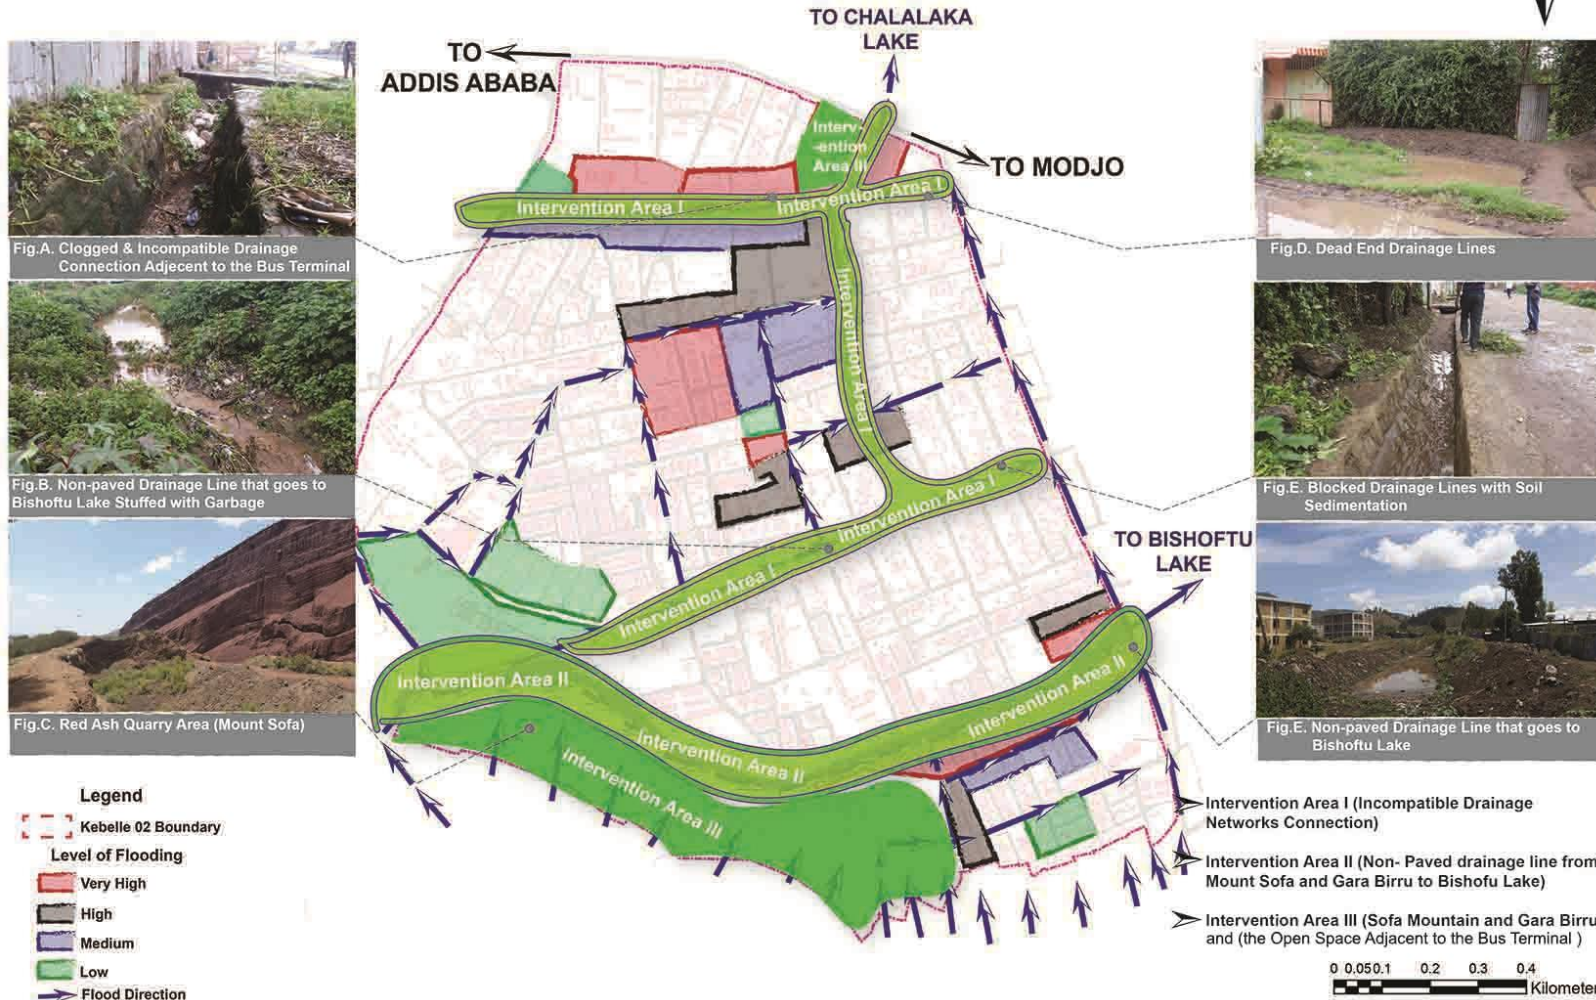
Figure 63 Possible Flood Prevention Intervention areas

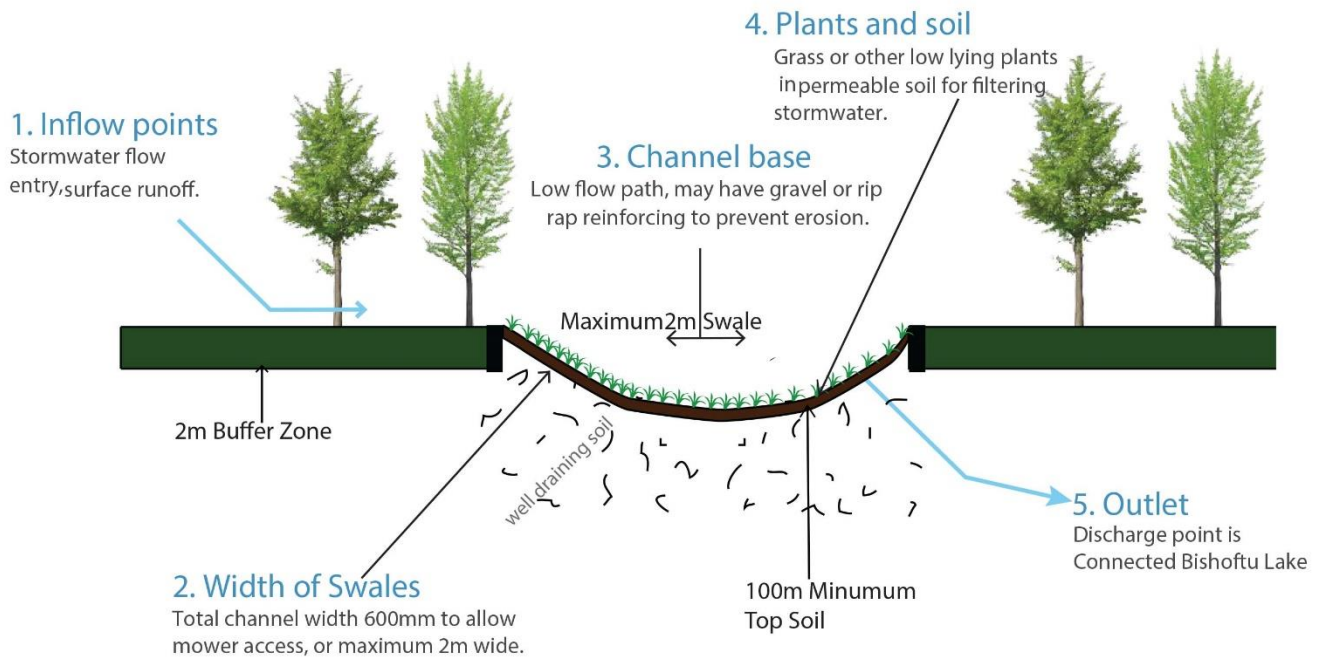
Figure 66. Non- Paved Drainage Line Design Intervention for the Case Site
 (Source: Adapted from Swales and Filter Strips Construction Guide, Auckland Council, 2017.)
