ADDIS ABABA UNIVERSITY  
ADDIS ABABA INSTITUTE OF TECHNOLOGY  
SCHOOL OF CIVIL AND ENVIRONMENTAL ENGINEERING  
INVESTIGATION OF BALLAST DEGRADATION ON  
SEBETA- ADAMA RAILWAY LINE

A RESEARCH SUBMITTED TO THE SCHOOL OF GRADUATE STUDIES OF ADDIS  
ABABA UNIVERSITY IN PARTIAL FULFILLMENT OF THE REQUIREMENTS FOR THE  
DEGREE OF MASTERS OF SCIENCE IN  
RAILWAY ENGINEERING (CIVIL INFRASTRUCTURE)

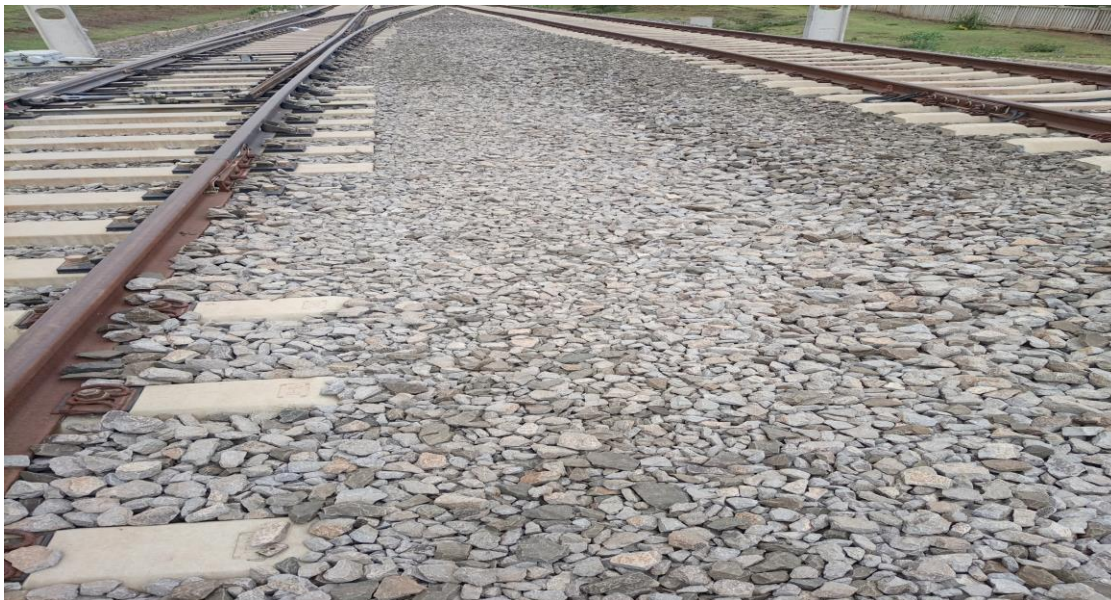
The ballast material used in this line is class one crushed rock, according to the line's as-built data, and the field examination confirms that the initial material used is proper. Certain materials, however, are new and do not match the as-built materials at various spots along the line, and the color variance is readily visible on the field. The sieve test also reveals that the grading is out of the prescribed standard in numerous places. Furthermore, the materials used for maintenance are of poor quality and do not satisfy the required grade.

Figure 5. New ballast different from the designed standard (grading, strength) around Bishoftu

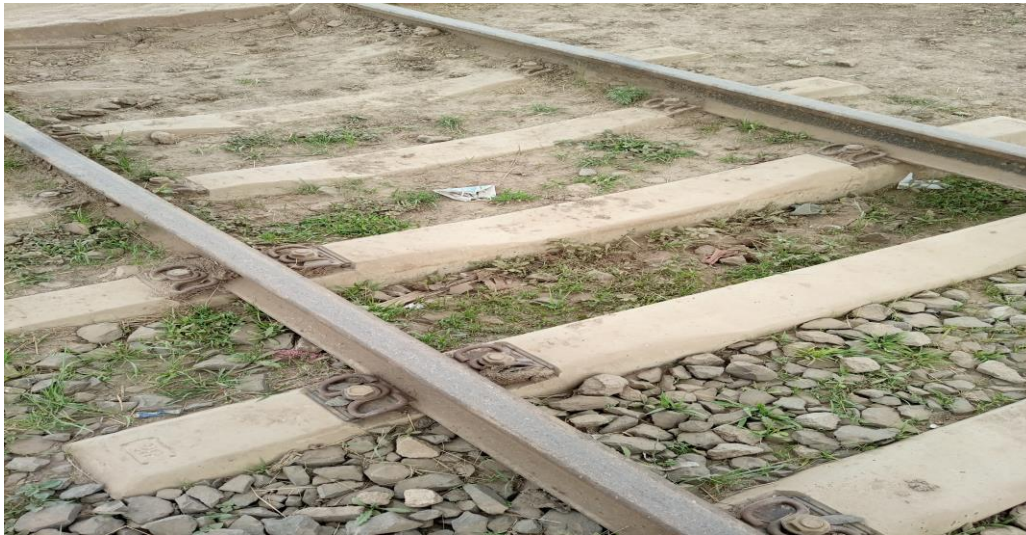
Inspection fouling can be seen at a higher level from the track. Since this line has only been operational for about three years, the ballast bed appears to be clean on most of its sections, but it has a high mud cover on the ballast in places where there are level crossings, notably near cities, where the top of the ballast bed is coated with dust and mud. This problem may be seen around Sebeta station, even on the rail portion that is not a level crossing. It has been modified to serve as a pedestrian and livestock crossing, resulting in the contamination of the ballast bed with dust, mud, and other animal wastes. The shoulder ballast is also gone in this place, and the bottom of the sleepers' edge is revealed at the shoulder's edge. This is a risk that can diminish lateral stability, and unless people are prohibited from using the main track as a crossing, accidents and losses of life and property are possible. It will also add to the cost of upkeep. Except for a few locations near the crossing, the drainage is in good shape.

Figure 6. Fouled ballast around level crossing (Furi)

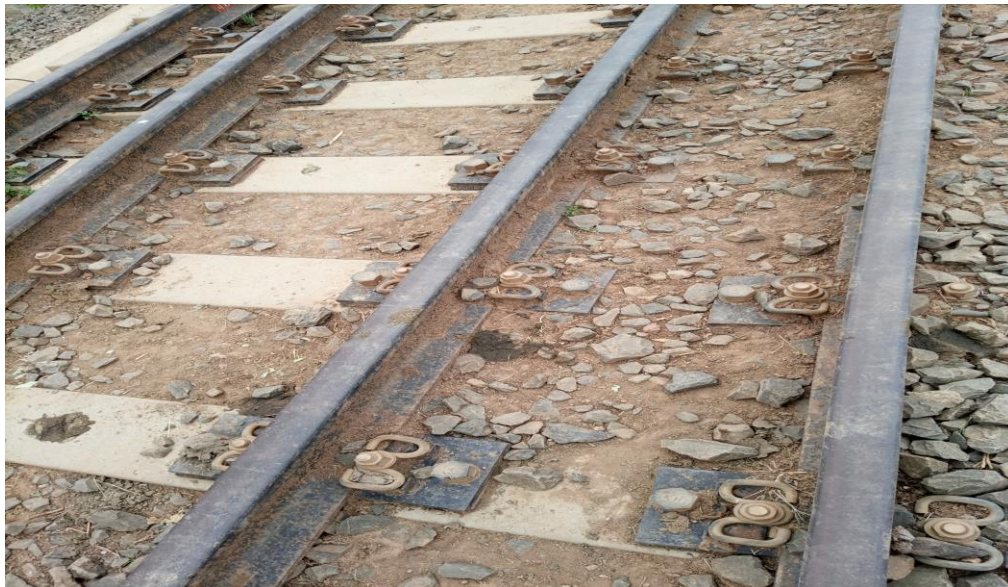
Figure 7. Fouled track ballast around undesigned crossings(Sebeta)

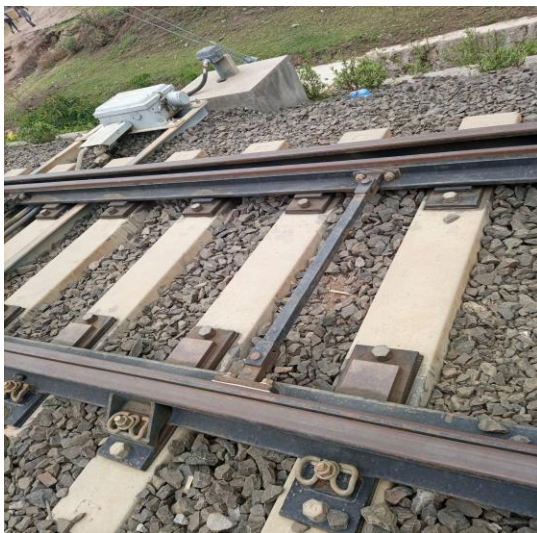
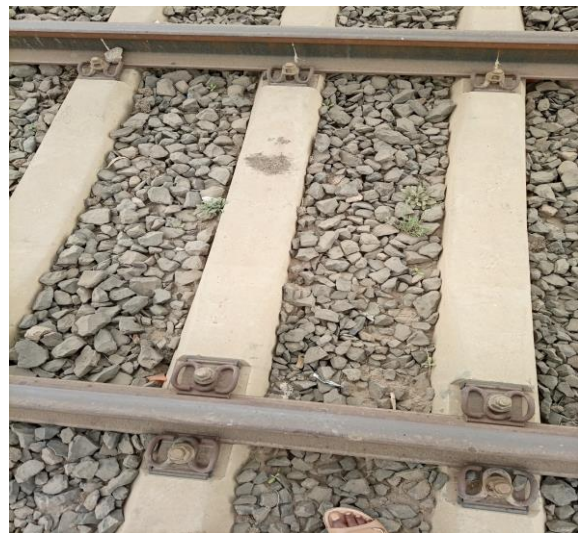
differences, such as significant fouling around the crossings, high ballast breakage around transitions and bends, and smaller grading and fines than straight lines without bridges and culvert transitions. The degradation around stations and turnouts appears to be minor, but different materials utilized for repair are of inferior quality. The ballast beds in other non-essential portions are better than those in critical sections.

Figure 8. Ballast around turnouts and transitions(Furi,Indode) (fouling)

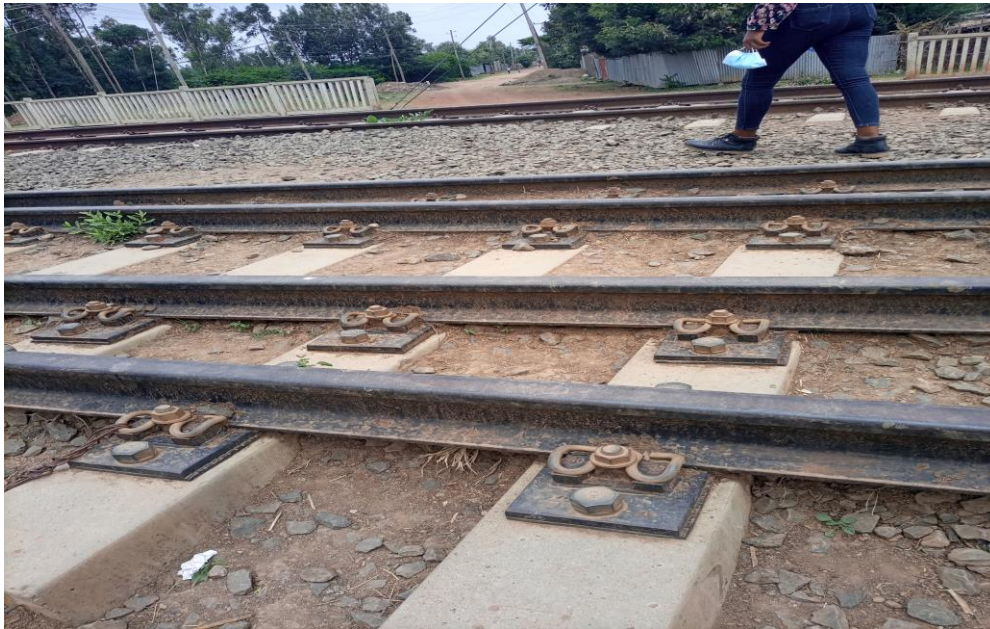
The ballast depth is 25cm all the way down the line. Except for those sections where the ballast bed is used as a crossing without being a level crossing, the depth of the ballast bed at the shoulder of the track is above the top of the sleeper, indicating that it meets the planned depth requirement. The ballast bed is also thoroughly inspected in the center of the railway. In general, the ballast depth is maintained according to the design requirements, however repair around informal crossings and level crossings is required in the future before it impairs the overall track performance and causes an accident.

Figure 9. Deteriorated ballast(Sebeta)

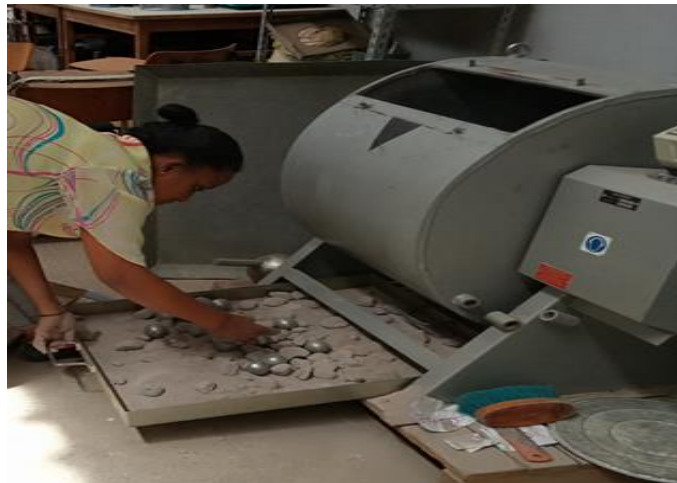
These tests were carried out as dry tests in accordance with AASHTO-T 96 protocols to determine the toughness or tendency for breaking of ballast particles. In comparison to the original sample weight, the Los Angeles abrasion value is the quantity of material finer than 1.7 mm sieve created during the test (ballast breakage). For trains with a larger axle load, this dimension is more important than the ballast used in the track. Tests were done on 8 separate locations along the Sebeta-Adama Railway Line, with a maximum of 22% and a minimum of 15% Los Angeles abrasion values reported.

Figure 13. LAA tested Material

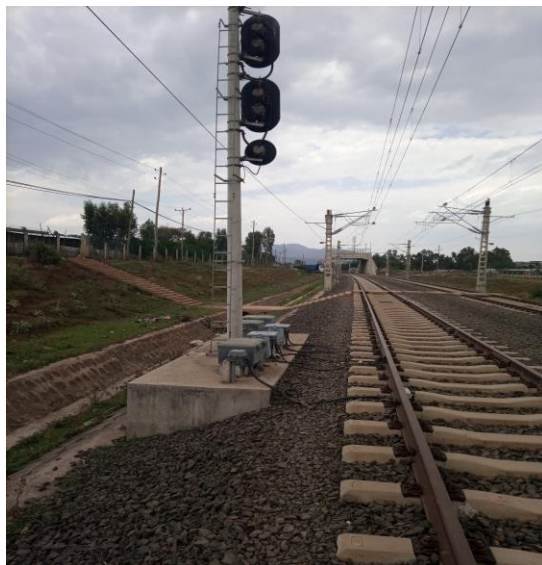
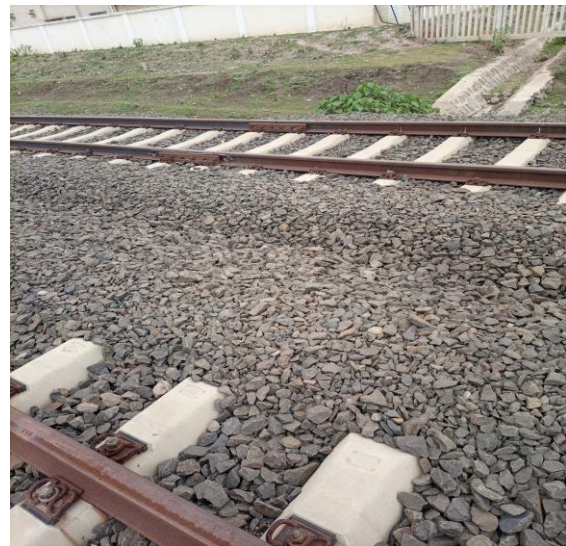
good ballast on straight line (non-critical)
