**Speed hump effect on pavement condition
(Addis Ababa City Road case study)**

A Thesis submitted to the school of graduate studies of Addis Ababa University in partial fulfilment of the requirements for the Degree of
**Master of Science in Civil Engineering
(Road and Transport Engineering)**

January, 2020

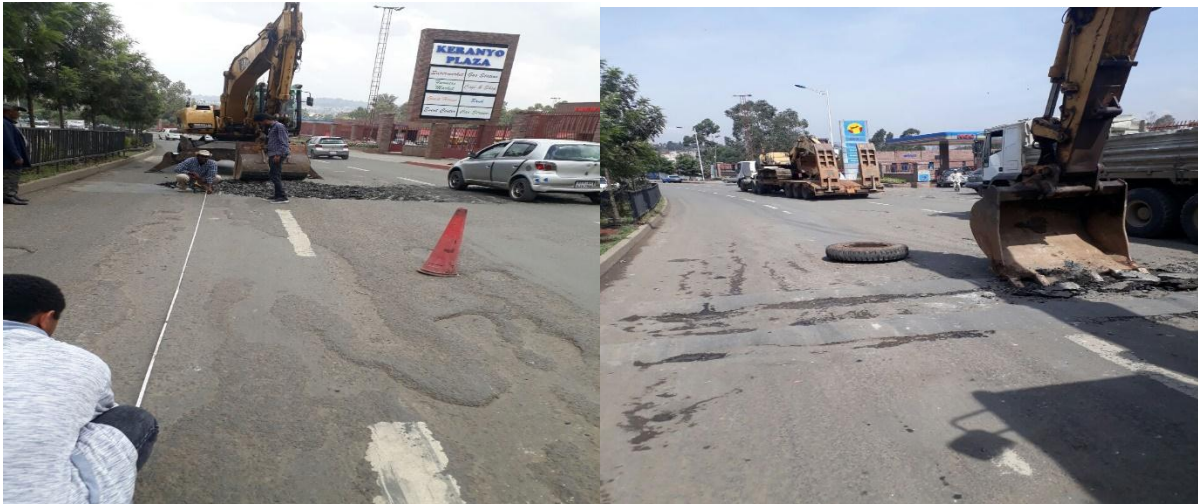
Figure 13: Torhayiloch –Mendida pavement condition measurement [2]

Use this data for pavement condition analysis by using quantitative data gathering methods, visual inspection pavement distress data collected by using ASTM standard data collection method by measure the size of failure for each section is collected from AACRA.

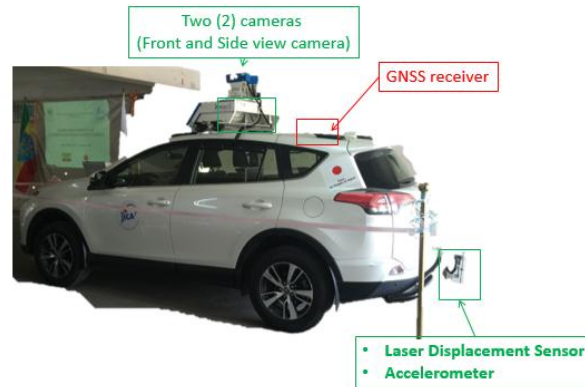
International roughness Index data are collected by AACRA by using a vehicle that measures the unevenness of a prolonged profile picture of the pavement, which is a picture of the comfort of driving on the highway. Each road segments have sections divided by 100 m long; here IRI data were a measure for each section by considering speed hump as pavement distress.

Figure 14: Vehicle measure International roughness index [2]

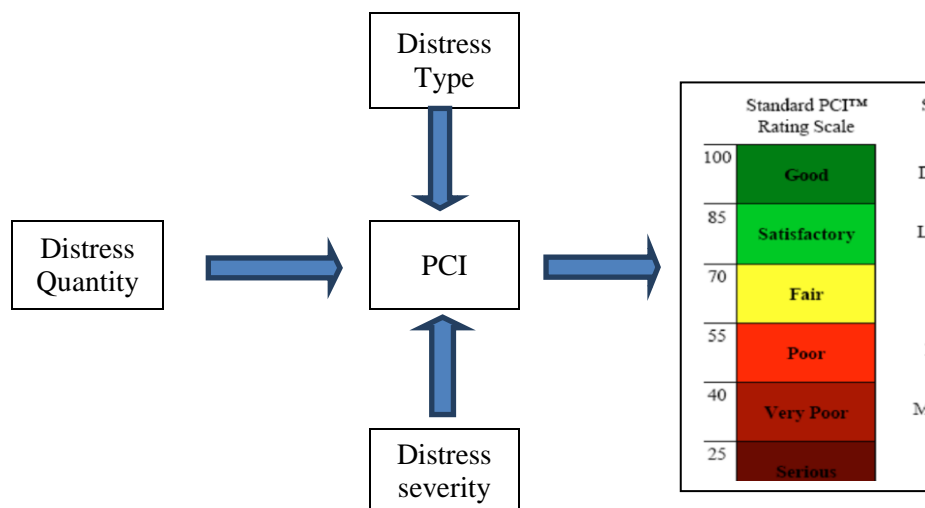
1. Inspect the sample unit, determine distress type and severity level and then measure the density.
2. The deduct values are determined from the deduct value curves for each distress type and severity.
3. A total deducts value (TDV) is computed by summing all individual deduct values.
4. Once the TDV is computed, the corrected deduct the value (CDV) can be determined from the correction curves. When determining the CDV, if any individual deduct value is higher than the CDV, the CDV is set equal to the highest individual deducts value.
5. The PCI is computed using the relation $PCI = 100 - CDV$.

Figure 15: PCI vs distress type, distress quantity and distress severity

The PCI value is calculated using the above steps, where deducted value indicates how much the pavement condition is deducted from the normal pavement condition level of existence of one failure type and total deducted value indicate the total deduction of pavement condition by the total edition of all deducted value for each distress type and severity level. Whereas not all distress type and severity level can have an equal contribution to pavement condition deduction, the total deducted value corrected by using the corrected deduct value curve. The pavement condition index calculated by deducting CDV from 100. Where 100 PCI value point is the excellent condition of the pavement.

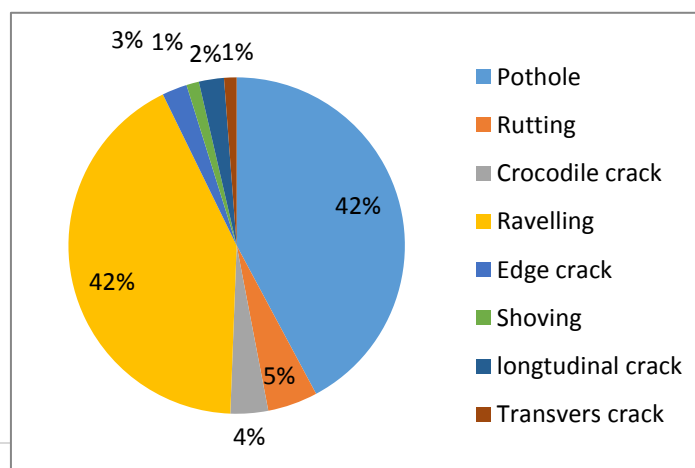
At this level of analysis, the individual pavement sections are analyzed to investigate the more frequently observed distresses. Figure 16 shows the frequency of occurrence of individual distresses in the pavement sections considered in this research, regardless of the severity level. From the analysis, the figure shows that the most widely observed distress is raveling and Pothole, which observed in 42 % of the sections considered in the analysis. While potholes are load-related crack caused by the freeze-thaw cycle. When moisture seeps into the pavement, it expands when it freezes and contracts when it thaws, this flexing of the pavement, combined with the melted water and the stress of vehicular traffic results pothole. Pothole distress type have a highest deducted value as compared to other distress types since the distress distribution here show one of the most frequently observed distress type is pothole which result lowest PCI value means that it affects the pavement condition highly. Raveling functional distress caused by the disintegration of hot mix asphalt lay from the surface downward because of the dislodgement of aggregate particles. This results in loose debris on pavement, roughness, and water collecting in the raveled location. Whereas, some distress, such as bleeding, block cracking, bumps and sags, corrugation, depression, reflective cracking, and slippage cracking were not observed in any section. On the other hand, the figure also shows that the other load-related distress was not frequently observed, where Alligator cracking, rutting, edge crack, and longitudinal cracks were observed in 3%, 4%, 2%, 1% of the sections.

Figure 16: Total Distress Distribution on total road segments.

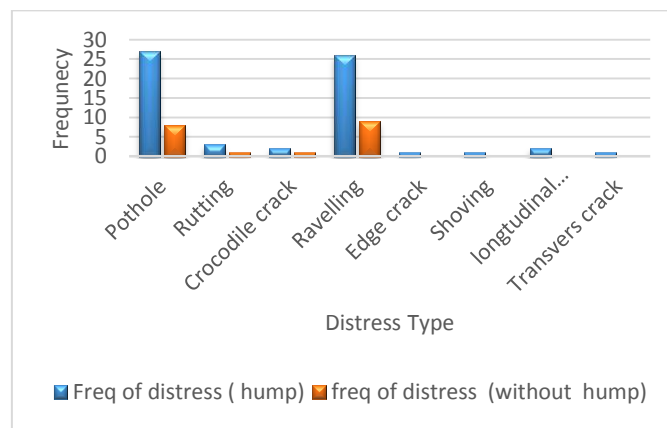
At this level of analysis distress distribution at a section with and without speed analyzed. The overall number of distress on all road segments is 83 from this 76% of distress found in sections with speed hump and 24% of distress at sections without speed hump. here the analysis show due to the presence of speed hump distressing increase by 52% from a control point that has not speed humps.

Figure 17: Frequency of distress on section with and without speed hump

From Figure 17 distress, frequency for each distress type is high for sections with hump and lower for sections without a hump.

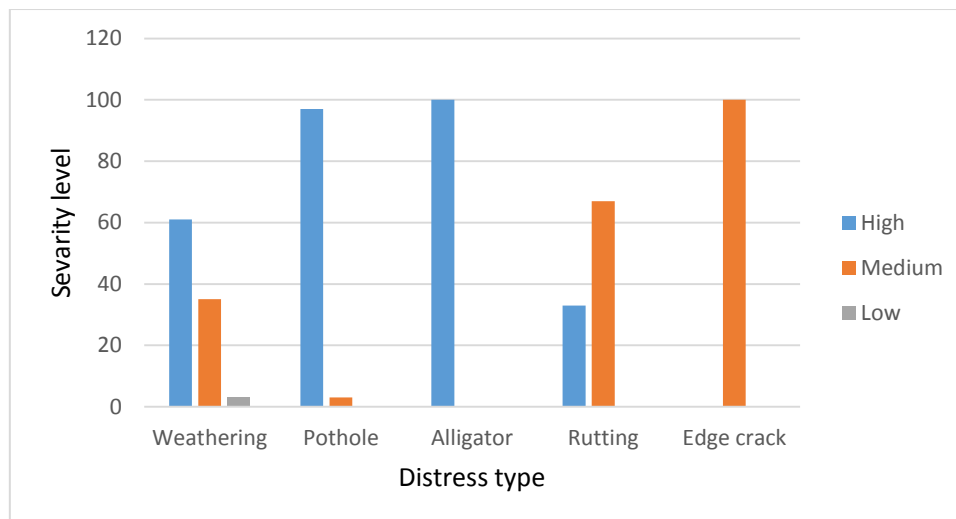
Figure :-Distress severity level

From Figure 20 for weathering type distress 61% of the distress are at a high level of severity level, 35 % medium severity and 3 % are low severity level. so the higher level of high severity means the higher the deductible value. For this particular type of distress, 61 % of distresses are at a high level of severity, which results in the lower the PCI value. For Pothole, type of distress 91 % at the highest level of severity and 3 % medium level of severity. Pothole type of distress has higher deducted value as compared to other types of distress since pothole and other types of distress cannot affect the pavement smoothness equally. In addition, the percentage of this distress severity shows that 91% of the distress are at a high level of severity so this affects the pavement condition highly. Alligator crack is about 100 % is a high level of severity level. Rutting 33% higher and 67% medium severity

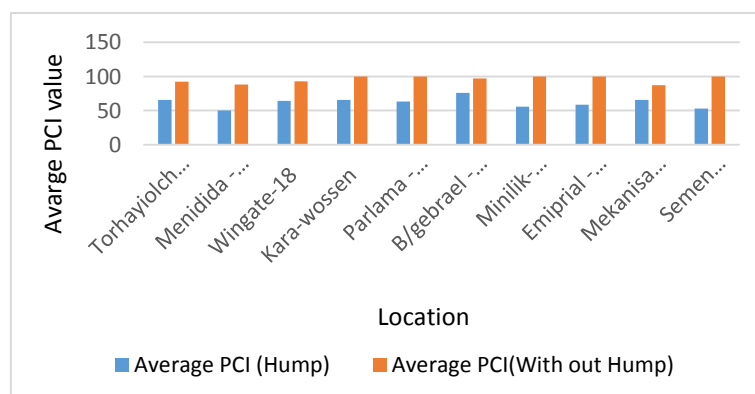
Figure 22: Average PCI values at sections with and without hump

From figure 23 The average PCI value for each road segment sections with hump show lower values as compared to the average PCI value of sections without the hump overall effect of hump in isolation to traffic, drainage, age, construction methods, etc. is the average of the change PCI values for each road segment. The change PCI value for each road segment is as the following.

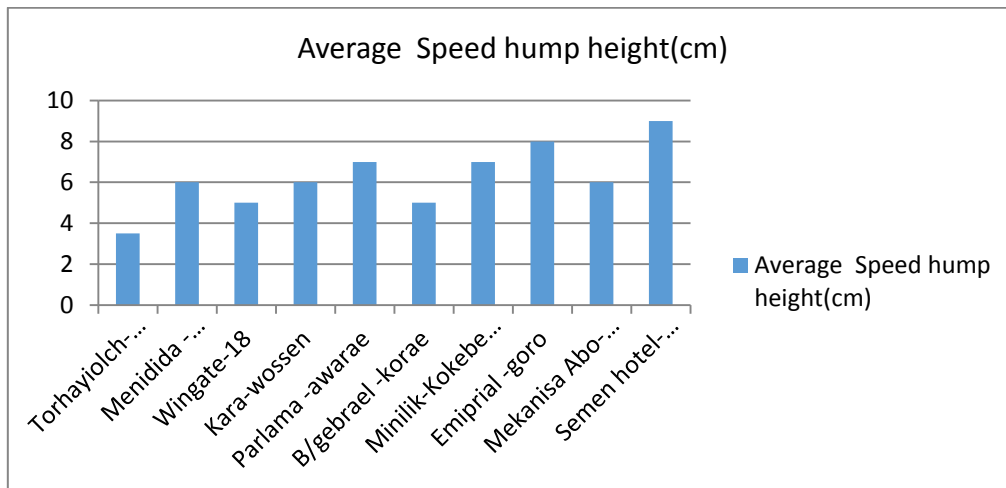
Figure 27: Average Speed hump height

The average speed hump heights vary from 3.5 to 9 cm and the height of the speed hump is equal at each width of a speed hump. Whereas, the design standard allows the height of the hump to be constructed by 0.1 slope difference in the traffic direction along the width of the hump.

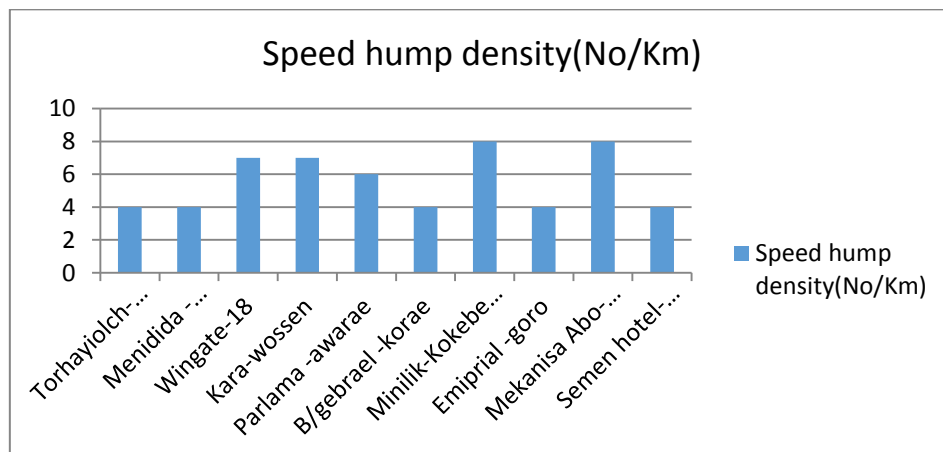
Figure 28: Average Speed hump density

From figure 29 the density or number of a speed hump on one-kilometer length of the road segment varies from 4 up to 8. Miniik to kokebtsibah and Mekanisa Abo to bridge road segments have a high number of hump on one-kilometer length.
