Landslide Assessment, Susceptibility Analysis and Recommendation of
Remedial Measures for Jimma-Chida Road Segment, South-West Ethiopia

A Master Thesis Submitted to Graduate School of Addis Ababa University
in Partial Fulfillment of the Requirement for the Award of Degree of
Masters of Science (M.Sc.)
In Civil Engineering (Geotechnical Engineering)

By
Lemenew Minale Tesfa

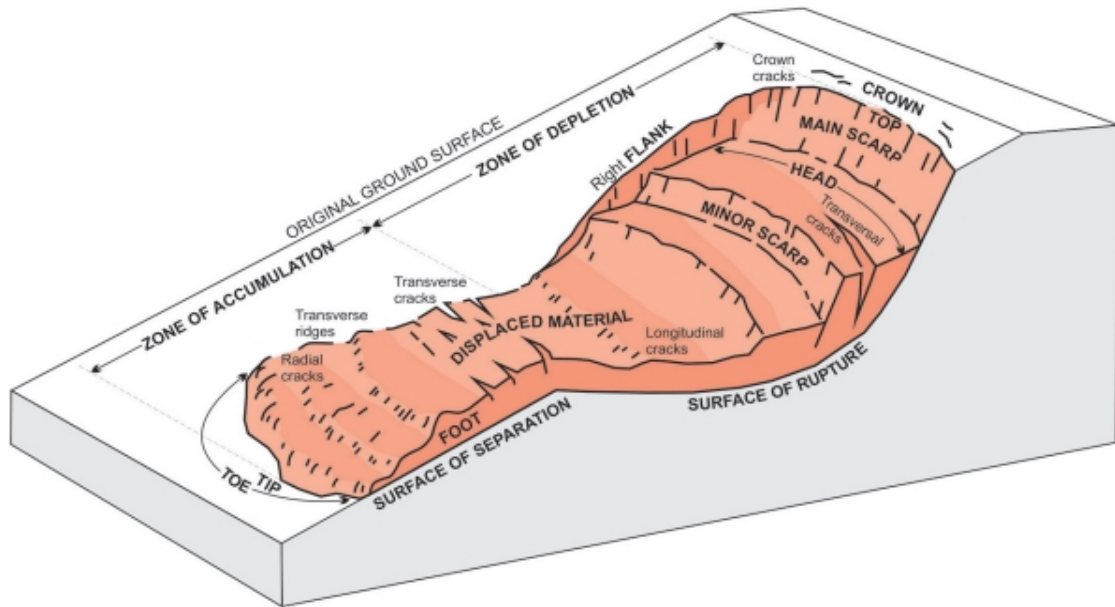
Figure 2-2: Representative diagram landslide features(Varnes, 1978) minor modification.

Proper characterization of the landslide features and geometry is very important to conduct a landslide assessment, prepare reliable susceptibility map and plan a viable remedial measure (A. Azeze, 2019; Highland (compiler), 2004). The benefit of using systematic approach for identification of landslide features and geometry extends to determining the triggering factors, severity and failure mechanism of the landslide. Most of the time the geometric features of landslide indicates the contributing factor behind, it is like a symptom for the underline health condition of the patient (Varnes, 1978). An schematic diagram indicating most of the features for a complex form of landslide is presented in Figure 2-2 (Varnes, 1978).

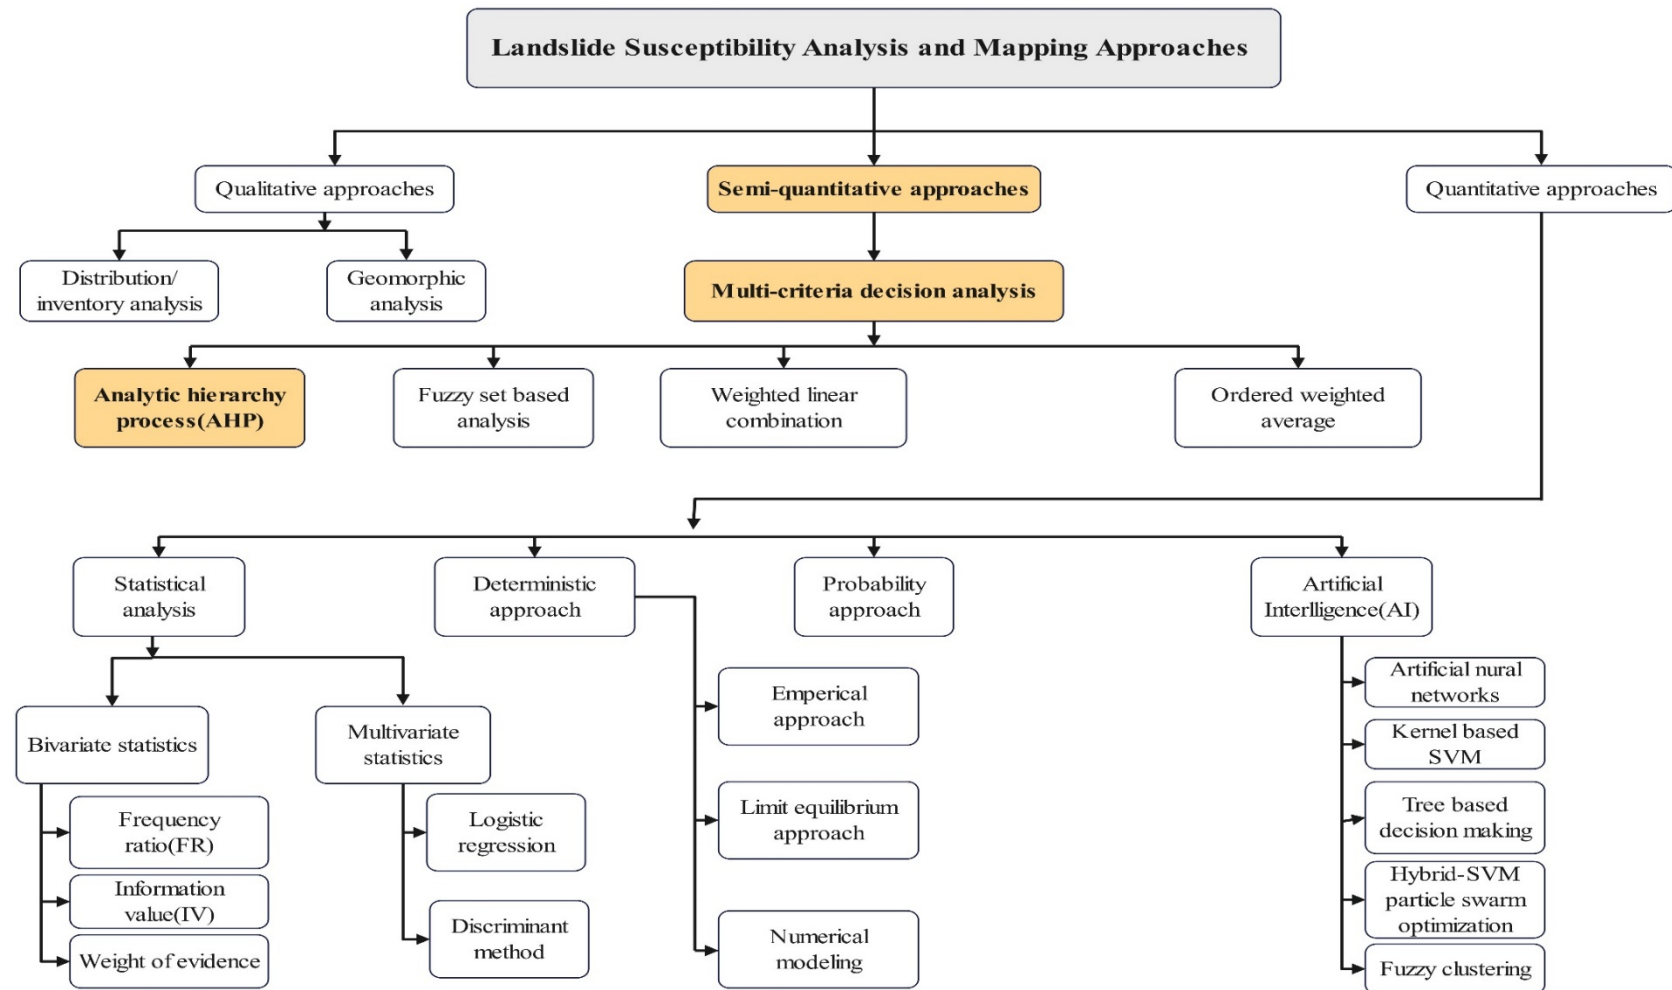
Figure 2-3: Landslide susceptibility analysis and mapping approaches(Shano et al., 2020)

On the other hand, Finite element method is capable of determining the response of the ground under stress, for this purpose the method is become more preferable by practitioners for the purpose of analyzing engineering problems in general and slope stability in particular. All the discussed approaches used for landslide susceptibility analysis is presented in the Figure 2-3.

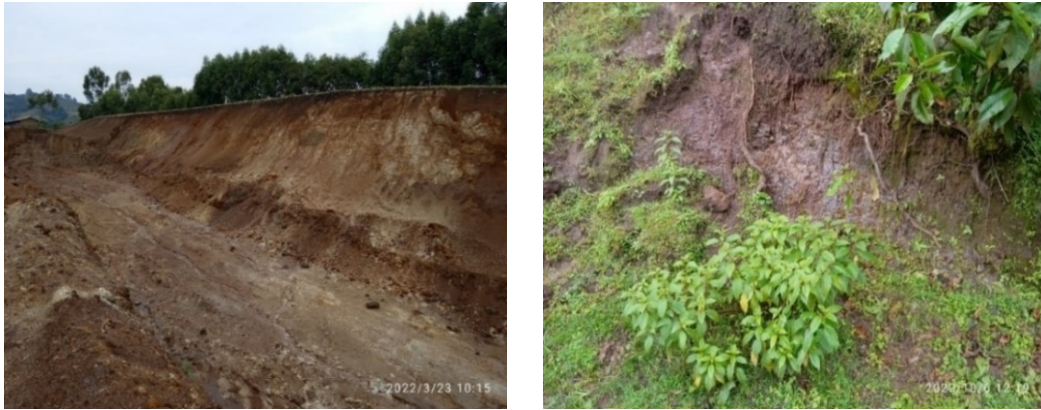
The majority of the road traverses through a highly weathered (with weak relict structures and fabric of the parent material still preserved) bed rock to completely decomposed bed rock(Figure 3-8 and Figure 3-9). The residual soils are derived from this weathered bedrock and, have not undergone transportation, i.e., they are deposited in-situ. Residual soils are an indication of high temperature and high rainfall in the area. These residual soil deposits are mostly observed along the rolling topography sections of the road corridor.

Figure 3-8: Highly weathered to decomposed rock along Jimma-Chida road section with relict structures and fabric still preserved

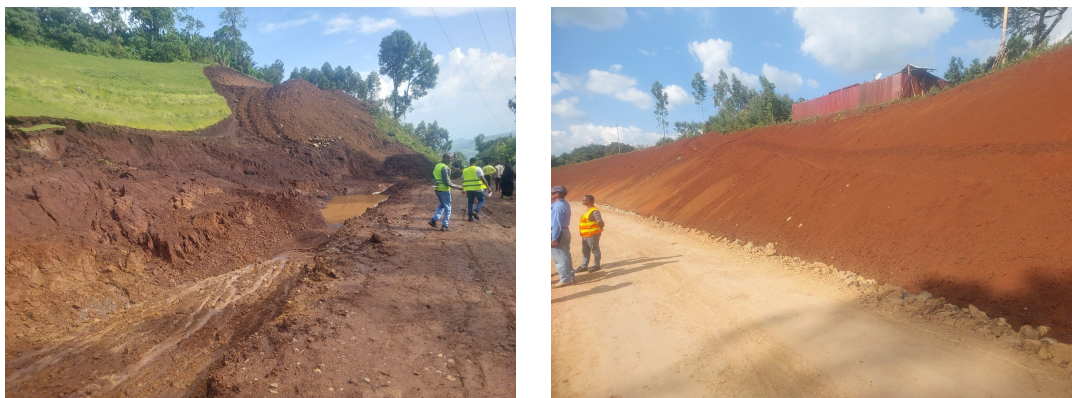
Figure 3-9: Residual soil along the road mostly covering the flat and rolling part of the corridor.

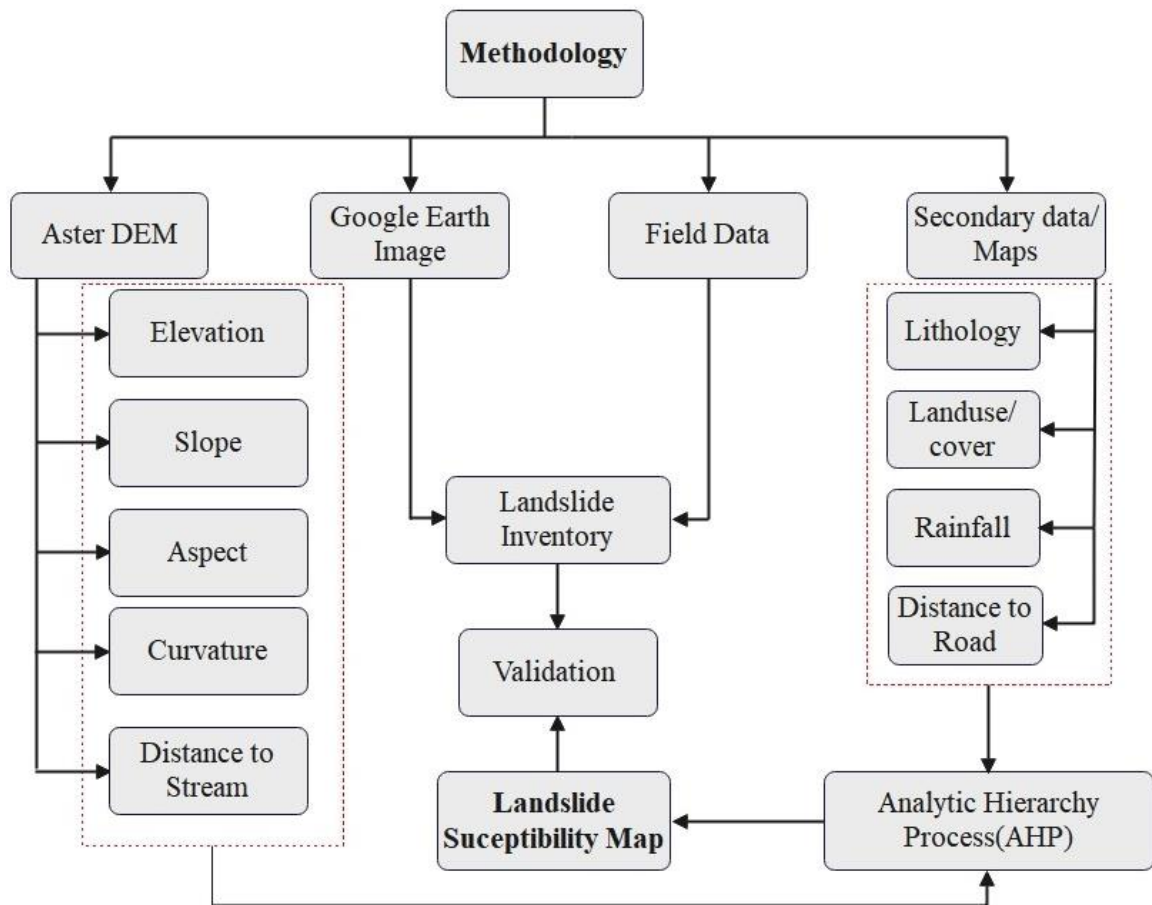
Figure 3-13: Workflow of landslide susceptibility analysis and mapping

For the landslide percent comparison method, the landslide susceptibility map is validated using active and past landslide locations which were collected during the landslide inventory work. Then the actual landslide locations are overlain on landslide susceptibility map produced to observe if the produce map using the selected analysis model really match with the actual condition on the area. For this study a total of 11 landslide locations were used as an inventory data to validate the landslide map produced. The general workflow adopted for the landslide susceptibility analysis is presented in Figure 3-13.

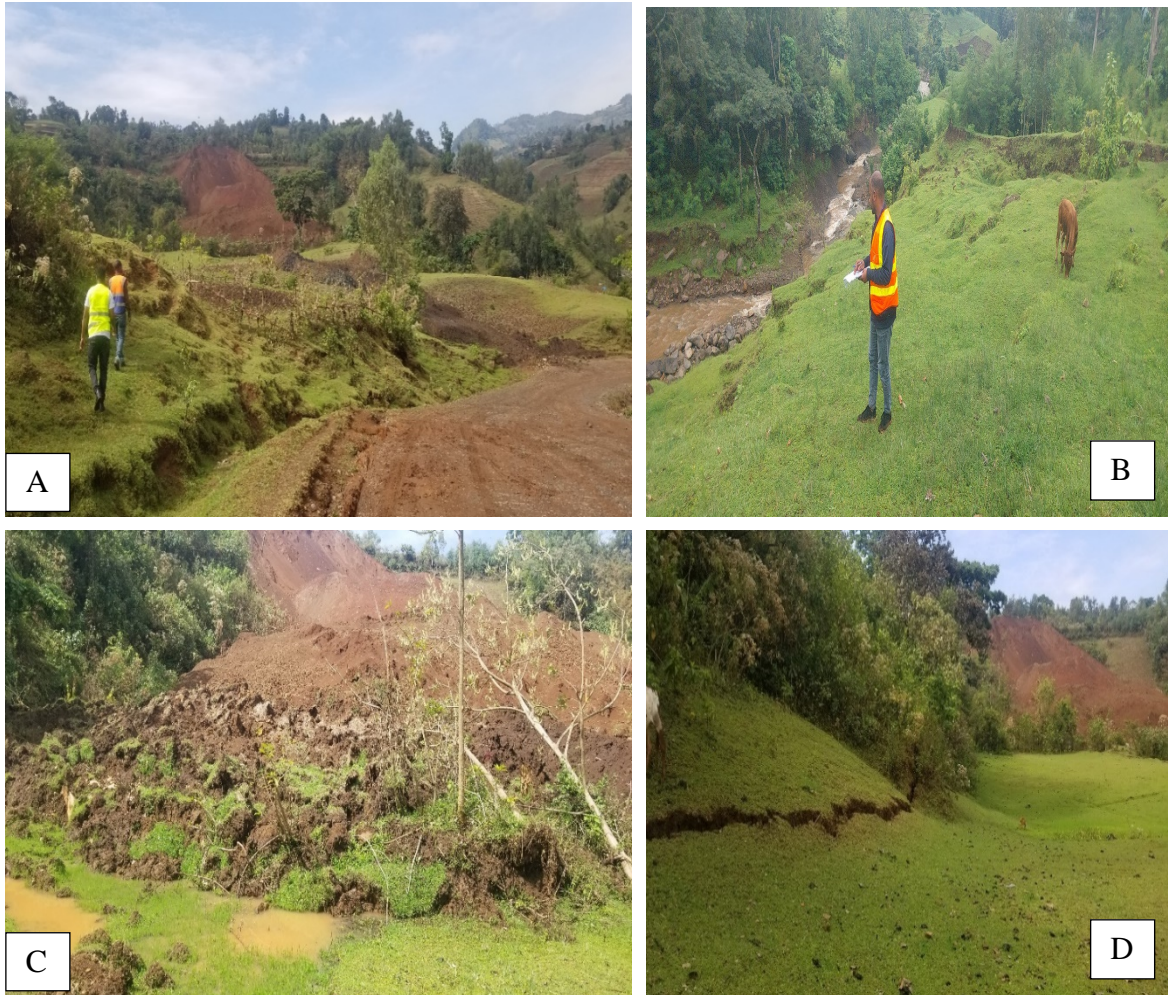
Possible Cause of Landslide: The combined effect of the spoil mass, river bank and bed erosion propagated to the slope, the steepness of the slope which marks an accumulation zone of a reactivated old landslide associated with uncontrolled surface water and shallow ground water saturation cause landslide.

Plate 4-1: Landslide at site JC/S/01 A) Spoil mass triggering the landslide B) Slide mass toward the stream at the toe C)Wet area due to multiple springs D)Long tension cracks developed by moving mass.

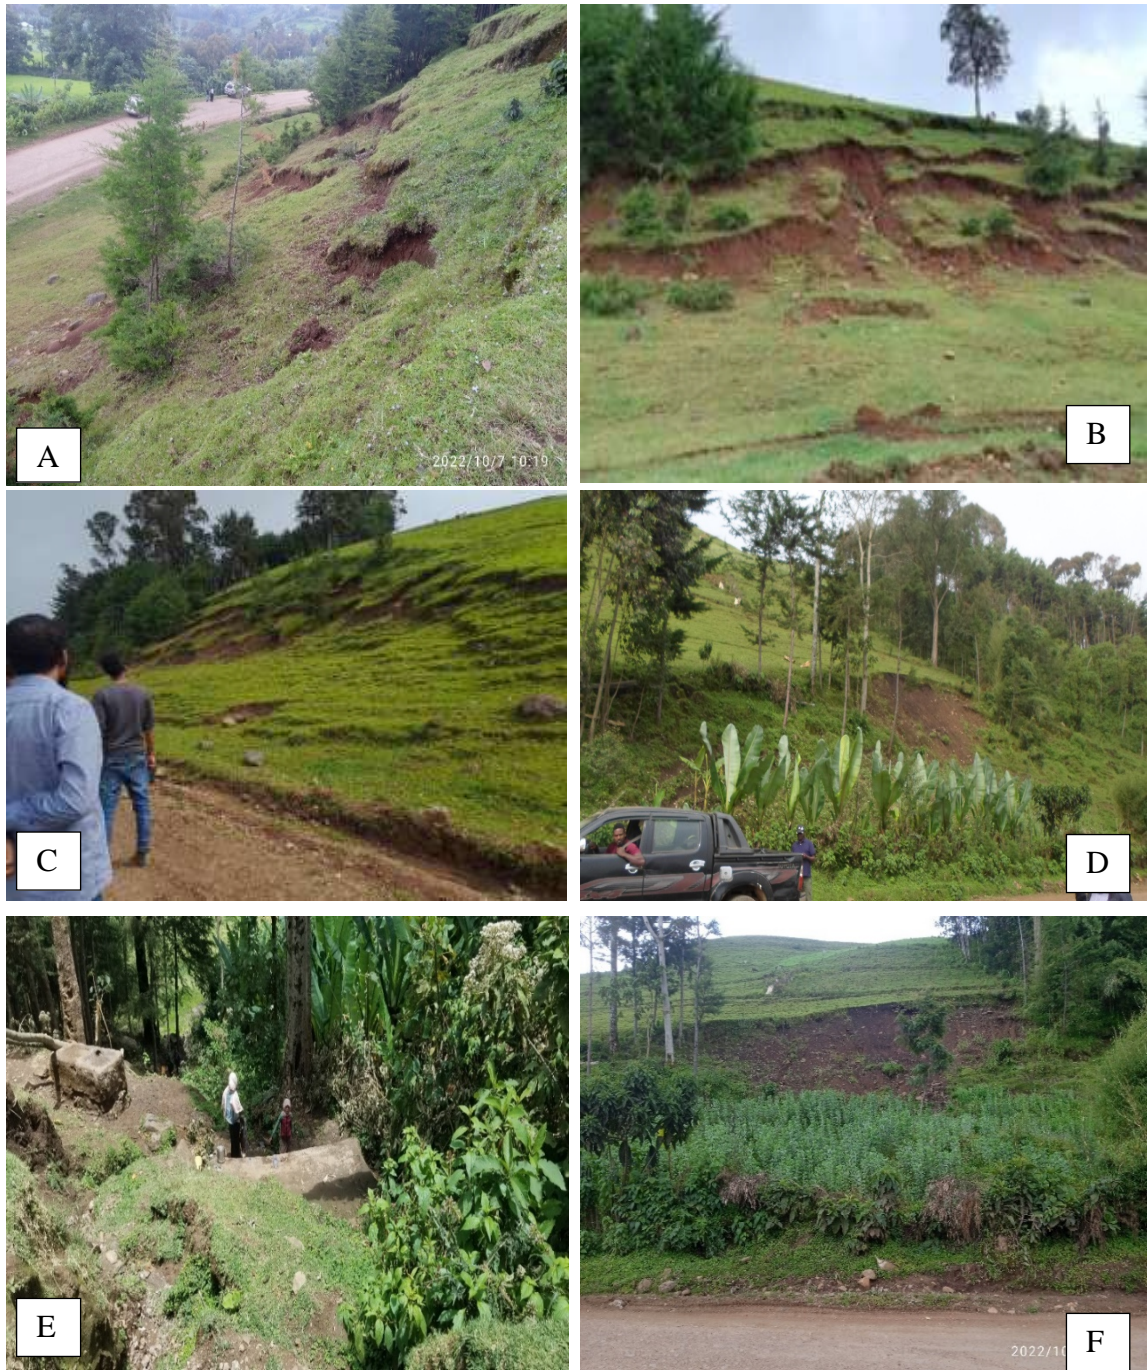
Possible Cause of Landslide: The possible causes are steepness geometry, loose material and saturated weak material, uncontrolled surface water coming from the hill side, lack of back slope drainage facilities that allows water to enter to the loose material and the presence of sub-surface water at shallow depth. The shallow sub-surface water is developed by the locals for household water source and when conducting shallow excavation work on the area the water encountered, indicating the presence of water which should be mitigate properly. In addition to that, the exposed and uncovered back slope material is eroded by surface water which diverted by settlers from the ridge of the mountain compromise the overall stability of the slope.

Plate 4-2: Landslide at site JC/S/02; A-C Slope movement of the brownish, loose silty clay soil with gravel at the back slope of the road D) Landslide at the back slope of the road E) Developed water well on the left side of the road indicating the presence of ground water at shallow depth F) Landslide of the back slope with prominent semi-circular scarp.

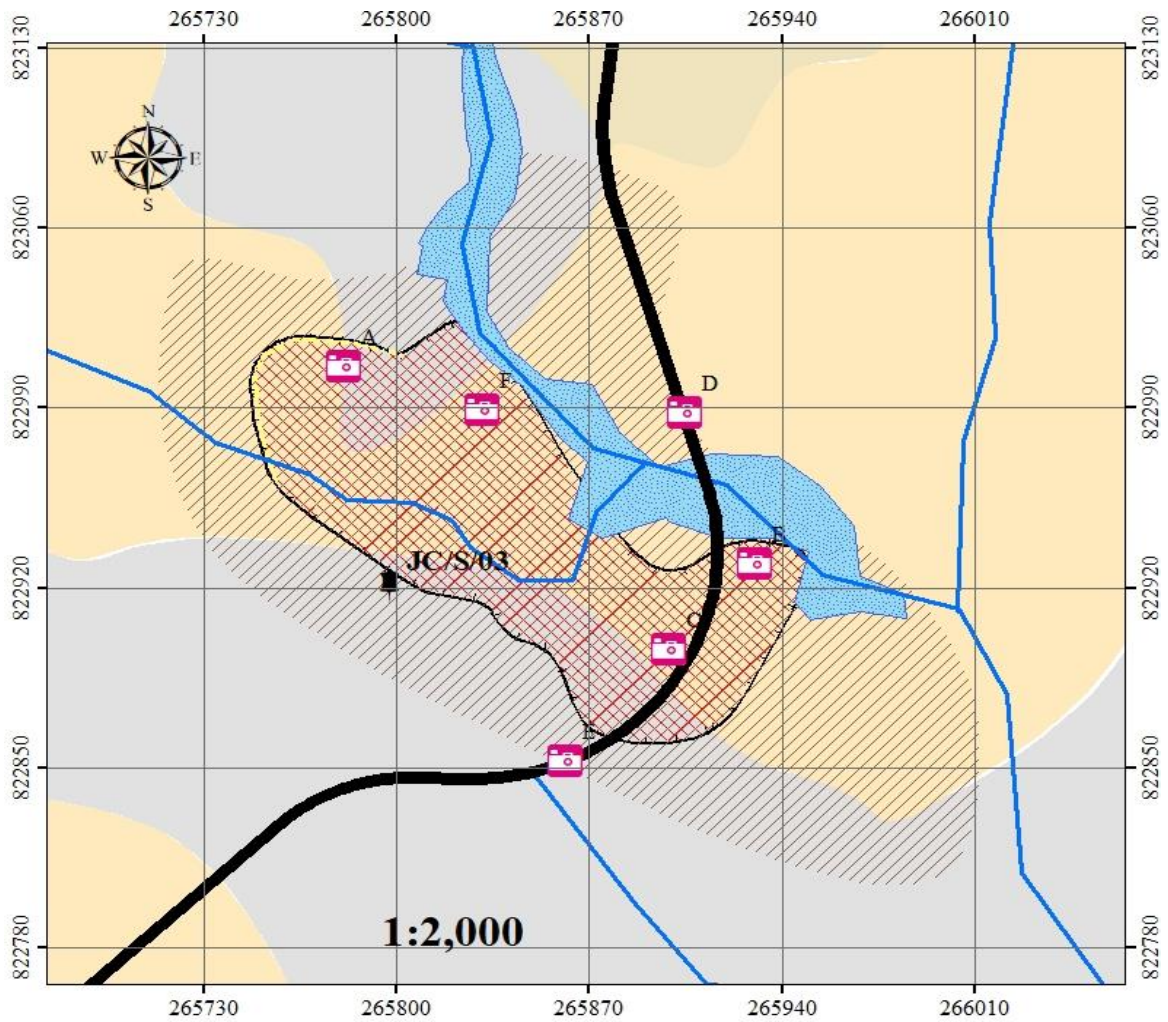
Figure 4-3: Landslide map of JC/S/03

Possible Cause of Landslide: The possible causes are weak, thick residual soil affected by valleys, various gullies, presence of sub-surface water and steep slope topography of the area.

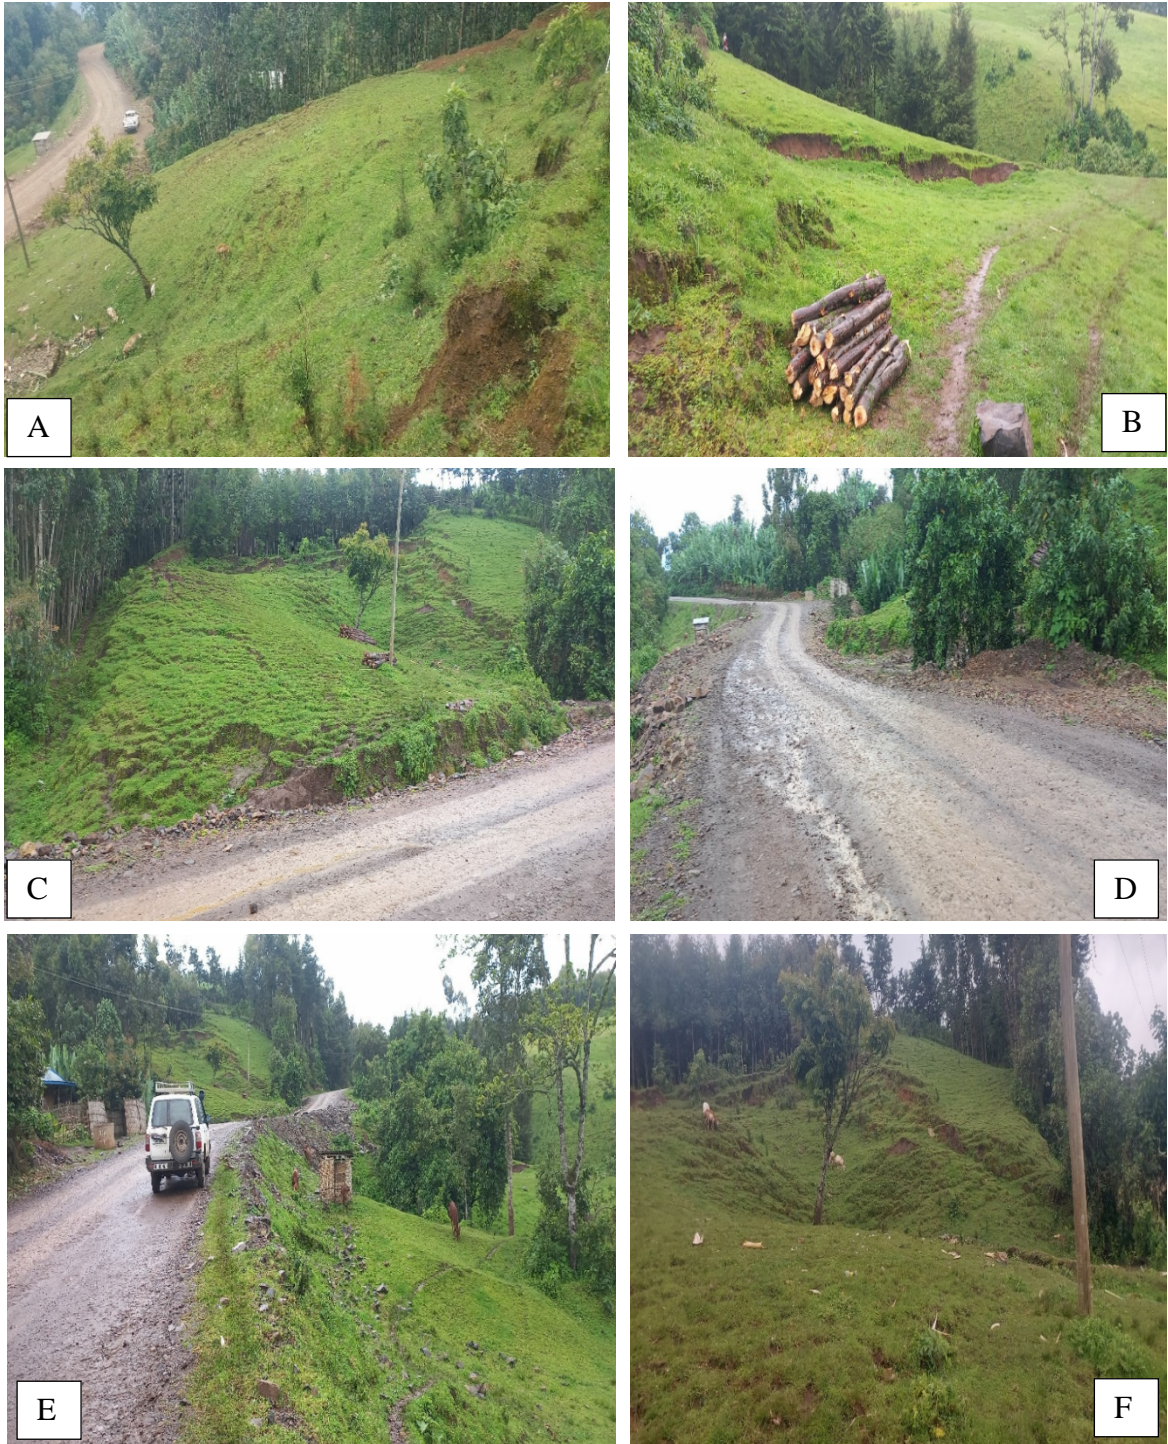
Plate 4-3: Landslide at site JC/S/03 A) Landslide from the top of the scarp) Crack on the left flank of the landslide extended to the side slope C) Depleted mass on the back slope side of the road D) The gravel wearing road near the failed section (toward Chida) E) Potentially unstable area near the active landslide F) Depletion on the back slope of the slide mass.

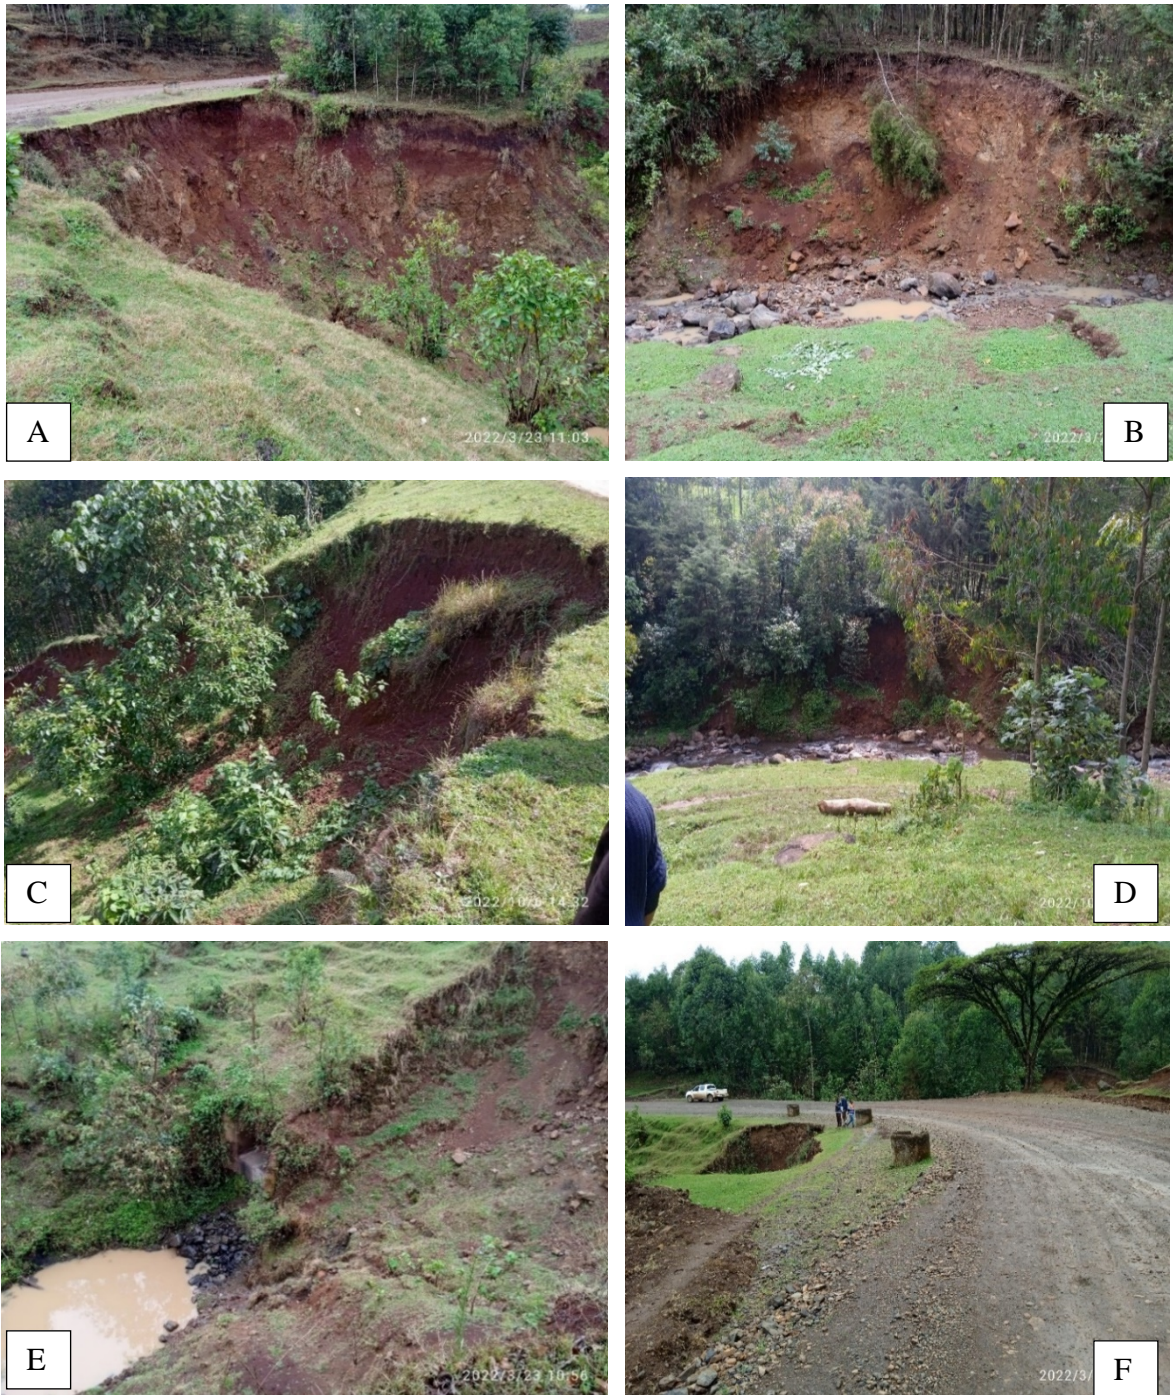
Possible Cause of Landslide: The steep side slope of the downstream and undercutting of the highly erodible silty clay soil by the stream water propagates to the road embankment. In addition, uncontrolled surface and sub-surface water plays a vital role for the initiation of landslide.

Plate 4-4: Landslide at site JC/S/04 A)Severe erosion propagated to landslide B)Erosion of river bank on the downstream direction C)Localized old landslide propagating towards the road D)Erosion of the river bank on upstream side E)Toe erosion of the side slope by the water from the drainage outlet F)Land slide initiated by severe erosion propagating to the road.

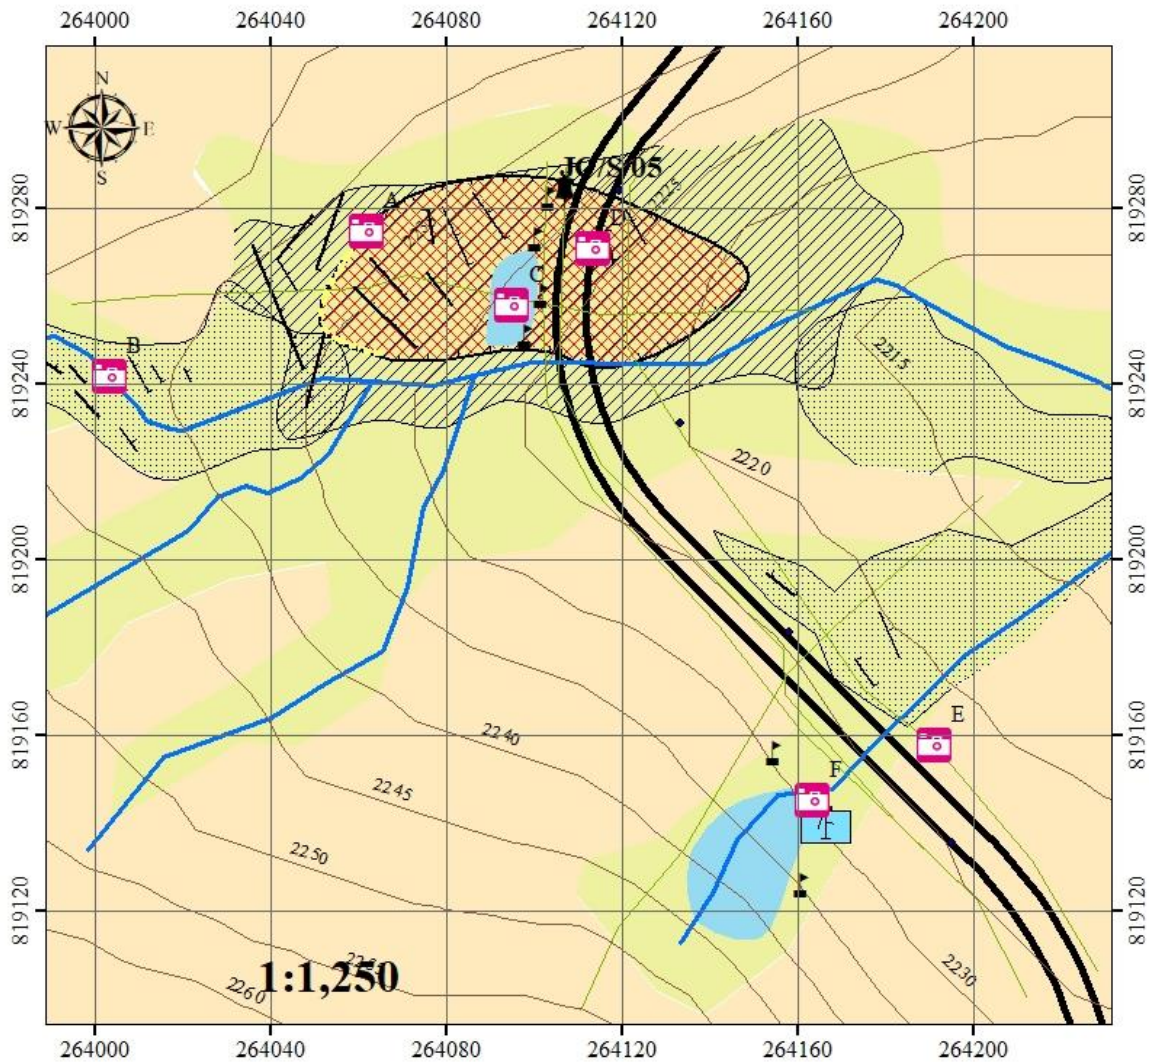
Figure 4-5: Landslide map of JC/S/05

For this location of the road multiple water wells which developed by locals for their household use were observed which indicates that there is a presence of sub-surface water at the shallow depth of the road causing the high saturation of the underneath soil stratum leading to reduction of shear strength. Any mitigation measure proposed for this location shall consider the provision of proper and integrated sub-surface drainage structures. The movement on the slope side will be more severe by the reactivation of the old landslide mass if there is any excavation work carried out at this location which could exacerbate an ongoing active landslide on the area. In addition to this, outflow from the clogged pipe culvert also contribute for the failure by saturating the road bed and foundation material of the area.

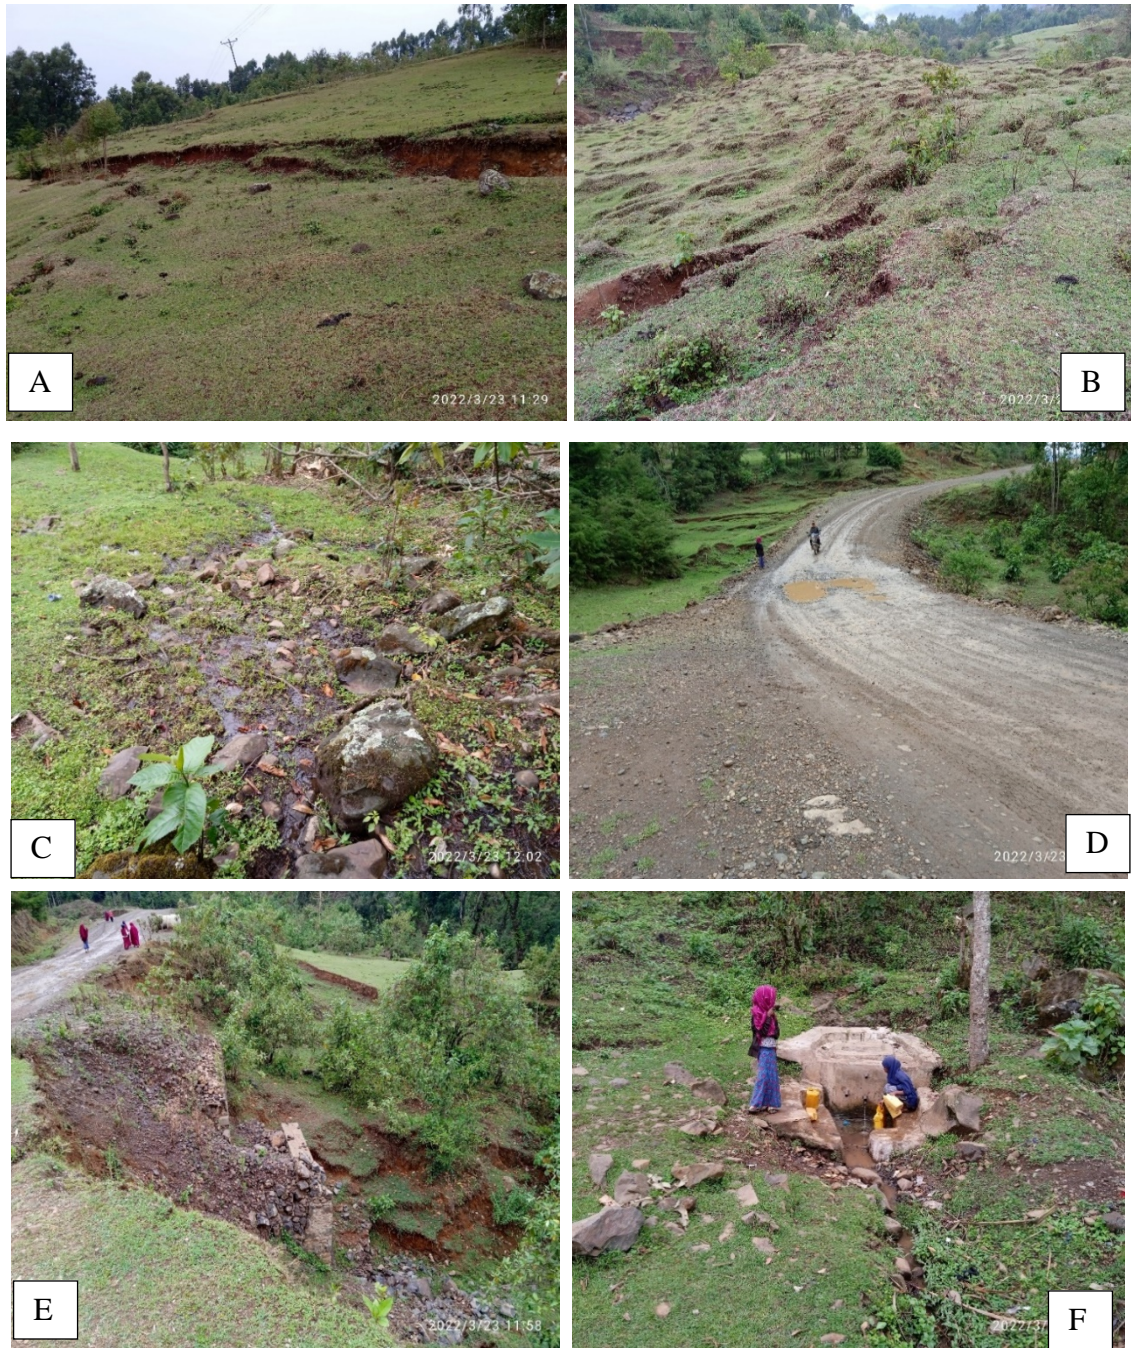
Plate 4-5: Landslide at site JC/S/05: A) Main scarp on the back slope B) Severely destabilized area of the river bank on the upstream C) Swampy area due to springs D) Sag on the existing road due to movement E) Failed drainage structure F) Water well developed from the spring indicating the presence of sub-surface water at shallow depth.

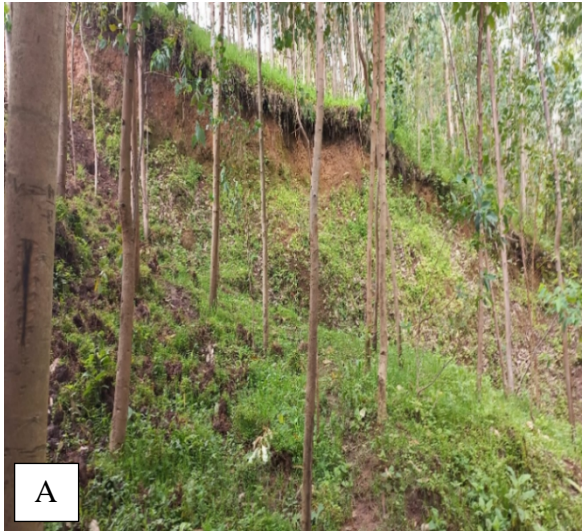
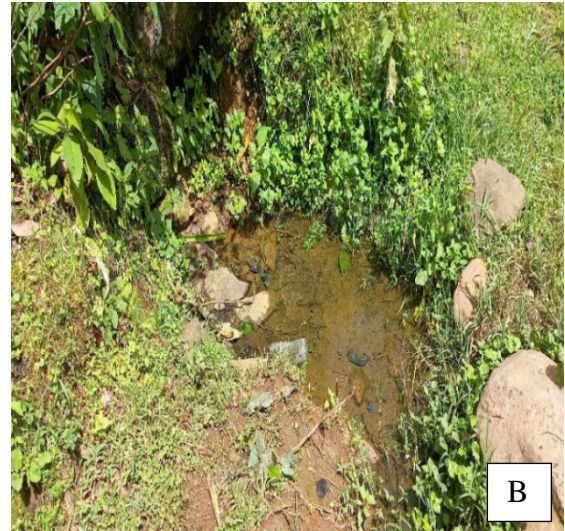
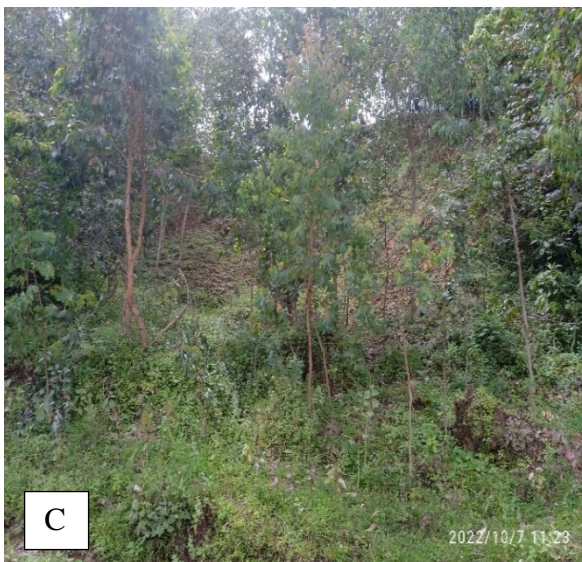
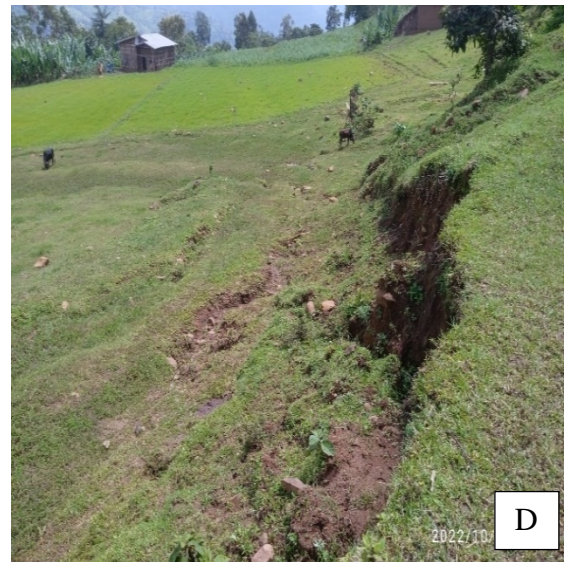
Possible Cause of Landslide: Saturation of the slope material, the presence of subsurface flow and uncontrolled surface water flow are the main causes of the landslide. The weak and saturated residual soil slope material is also plays a detrimental role for the reactivation of the landside at this section.

Plate 4-6: Landslide at site JC/S/06: A)The main scarp on the back slope B)Springs on the back slope C)Landslide area covered by trees D)Destabilized side slope on the left hand side of the road.

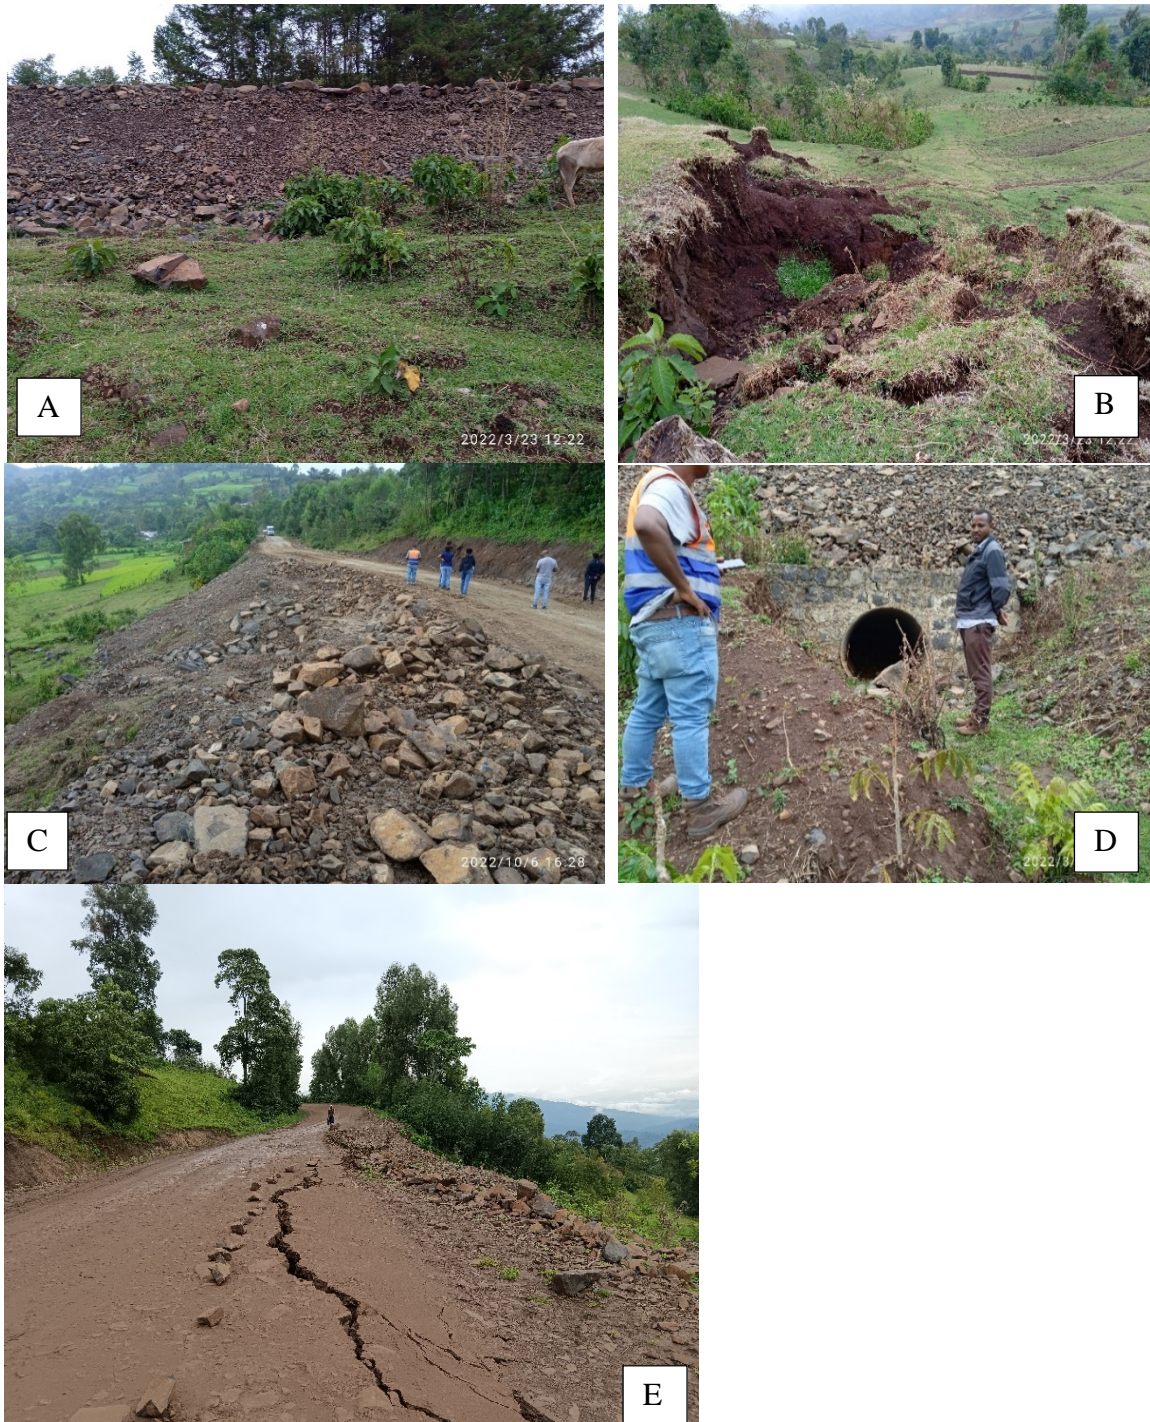
Possible Cause of Landslide: Saturation of the slope material and the presence of uncontrolled surface water flow are the main causes of the landslide. The weak and saturated residual soil slope material is also contributing for the reactivation of the landslide at this section.

Plate 4-7: Landslide at site JC/S/07: A)Backfilled material on the failed section B)Mobilized mass at the toe of the landslide C)Landslide from the side slope direction of the road D)Clogged cross drainage ditch on the downstream E)Main scarp on the road surface re-emerge on the July 31,2023.

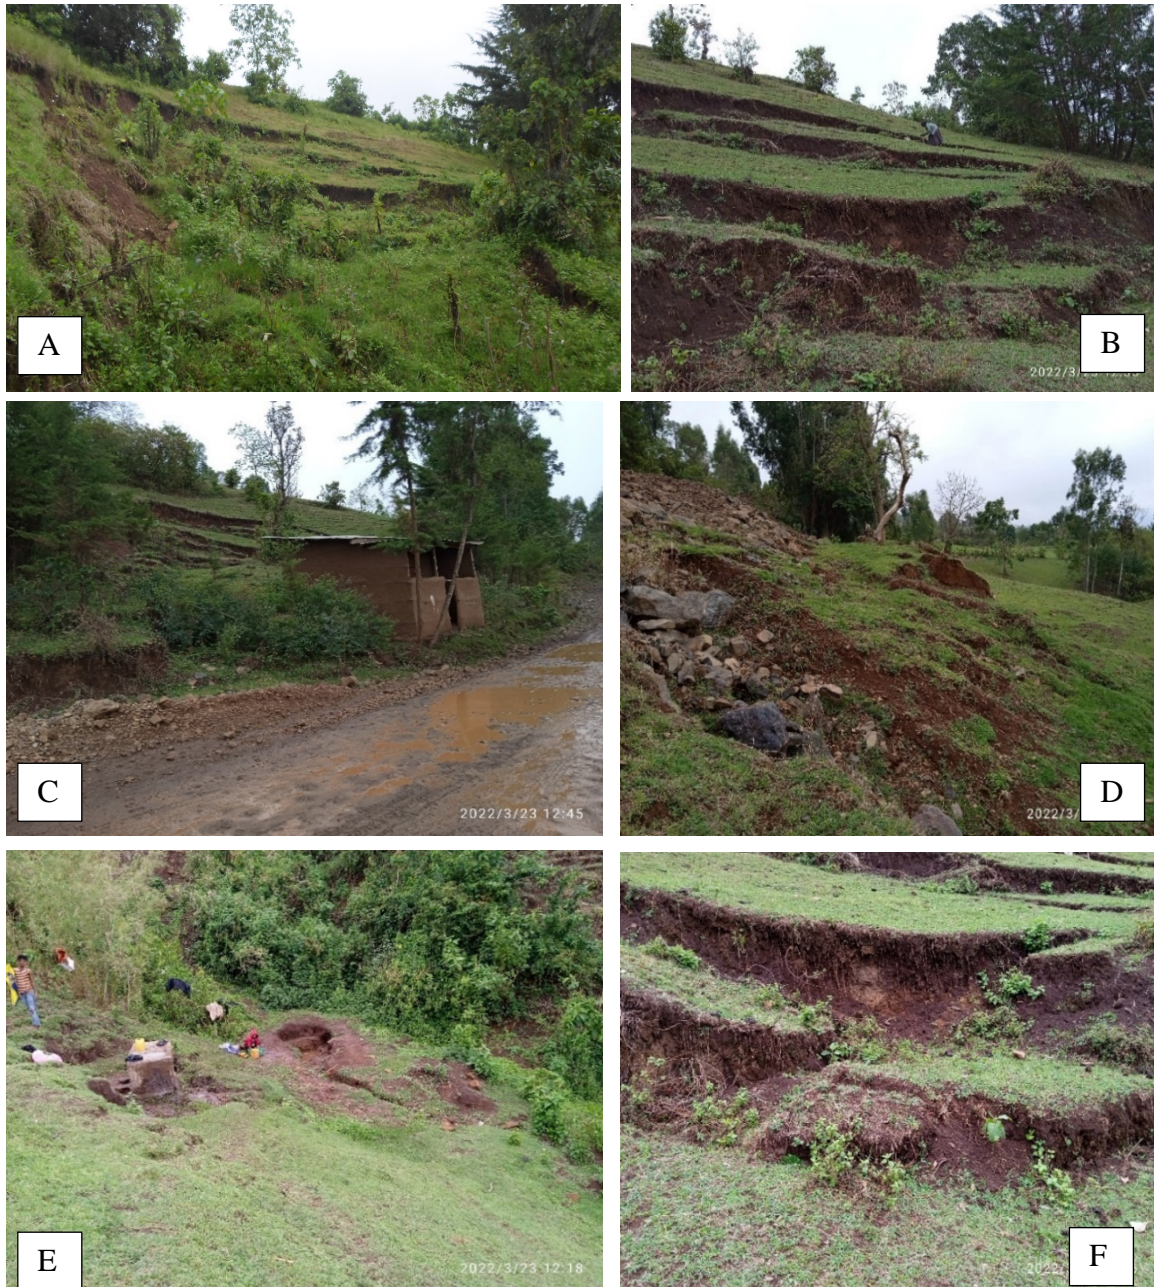
Possible Cause of Landslide: The saturation of slope material by the rainfall water and surface runoff combined with the presence of subsurface water at the toe of the slope cause the strength reduction of slope material which leads to the reactivation landslide.

Plate 4-8: Landslide at site JC/S/08 A)Landslide on the back slope of the road B) Multiple tension cracks on the slope C)House constructed on the sliding mass D)Destabilized mass on the side slope of the road E)Wet/swamp area at the toe of the side slope due to multiple springs F)Big tension cracks on main scarp on the top of the landslide.

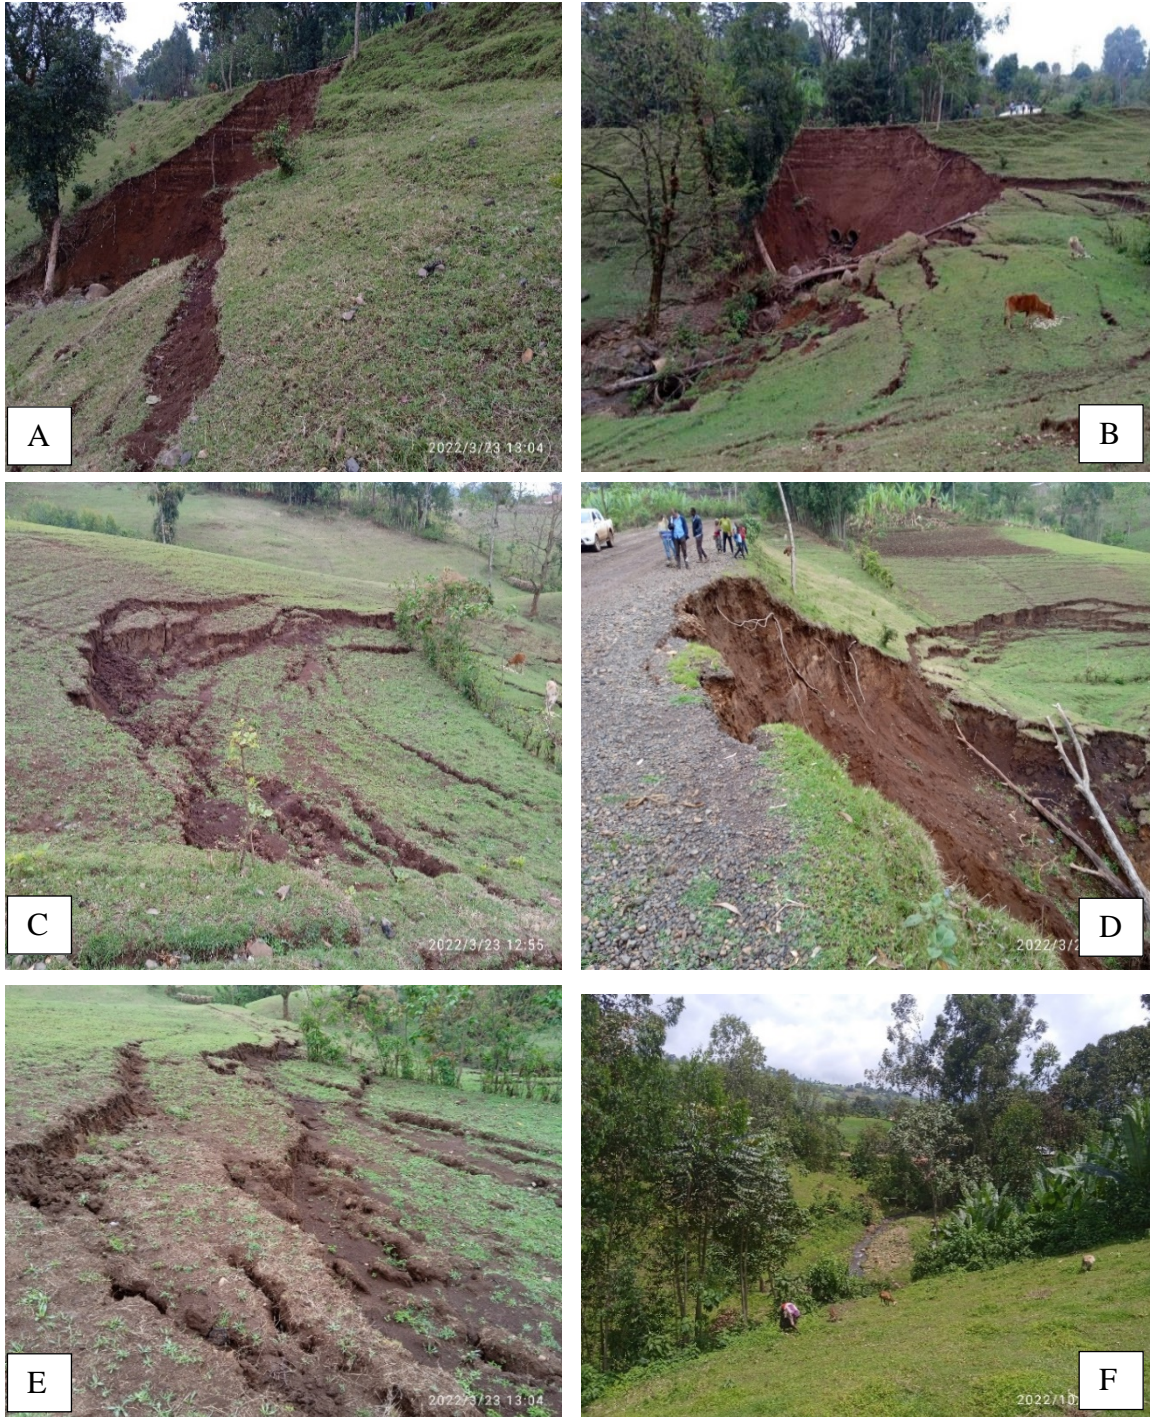
Possible Cause of Landslide: The toe erosion and undercutting of the natural slope material by the stream crossing the road is identified as the main cause of the active landslide. In addition, the saturation of the side slope material by rainfall and surface runoff water contribute for the strength reduction of the slope material which contribute for the landslide.

Plate 4-9: Landslide at site JC/S/09: A)Landslide of road side slope B)Typical rotational landslide of the slope C)Cracks developed at the side slope of the road D)Landslide propagating towards the road corridor E)Moving slope mass F)Upstream side of the landslide section.
