Landslide Assessment, Susceptibility Analysis and Recommendation of
Remedial Measures for Jimma-Chida Road Segment, South-West Ethiopia

A Master Thesis Submitted to Graduate School of Addis Ababa University
in Partial Fulfillment of the Requirement for the Award of Degree of
Masters of Science (M.Sc.)
In Civil Engineering (Geotechnical Engineering)

By
Lemenew Minale Tesfa

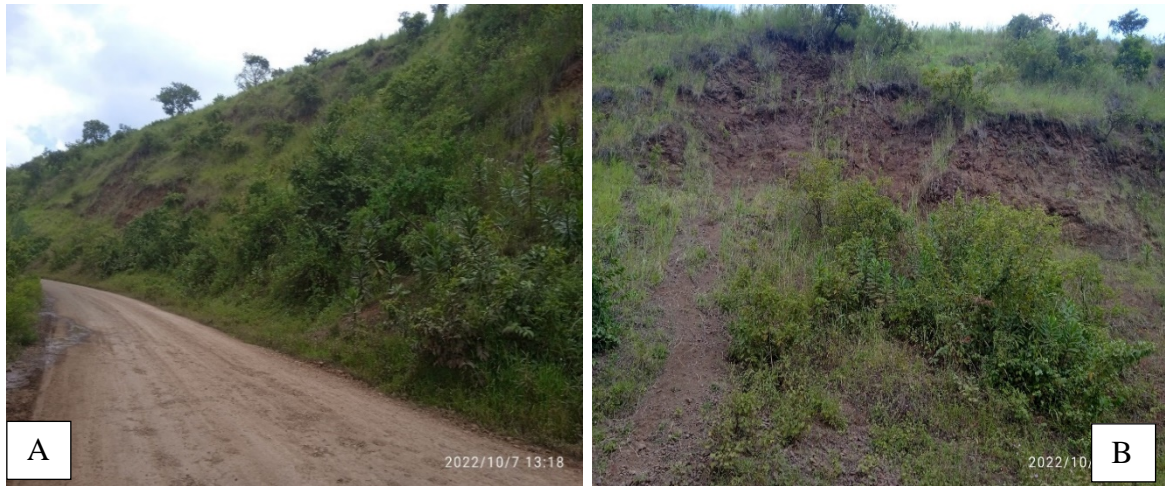
Plate 4-10: Landslide at site JC/S/10: A)Steep back slope with low severity rock fall and minor slide B)The exposed, highly weathered and fractured slope material.

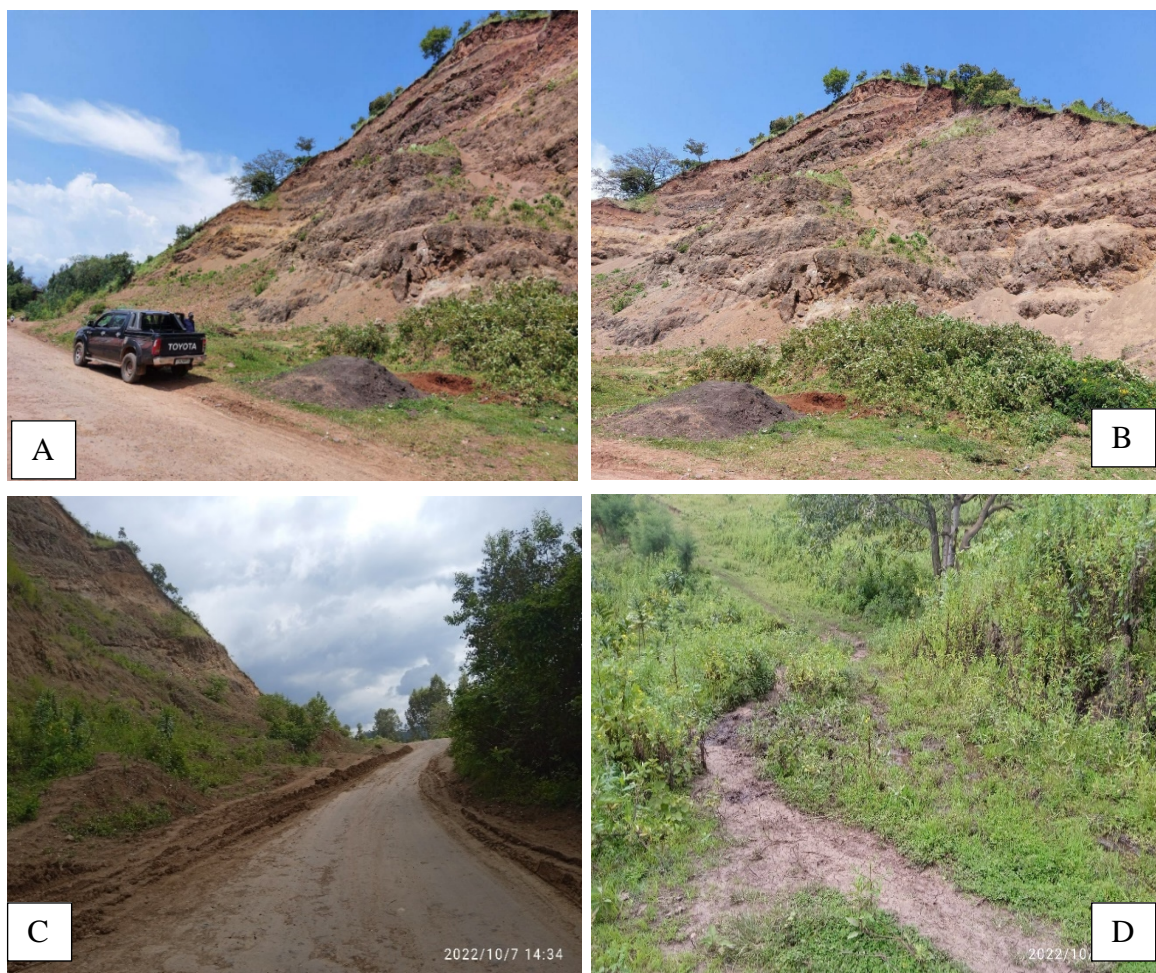
Plate 4-11: Landslide at site JC/S/11: A-C steep back slope material of highly weathered and fractured basalt. D)Swampy area at right hand side of the downslope.

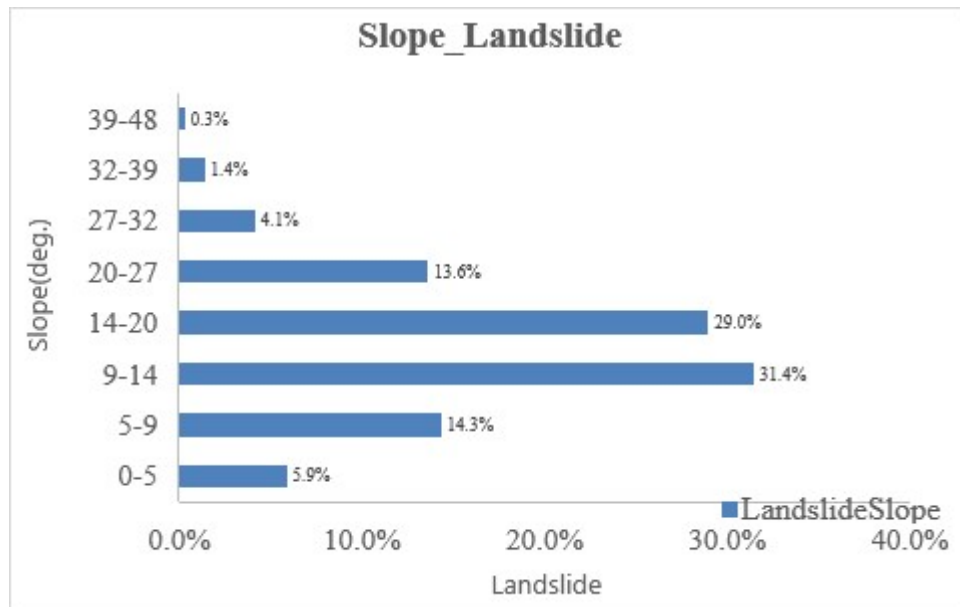
Figure 4-13: Distribution of the slope angle factor classes for the existing landslides

The topographic survey conducted along Jimma-Chida road alignment indicates that the route passes through 12.4% flat, 30.6% rolling, 52.0% mountainous and 5.0% escarpment terrain and around 70% of the route traverse along ridge top alignment section which has a favorable topographic nature for road since it optimizes the earth work and drainage structural quantities but is susceptible for the occurrence of landslide. Particularly the road section from km 20+000 to km 45+000 with a history of various occurrences of landslides is characterized by rolling to mountainous topography combined with other controlling factors like drainage, erosion gullies and intense rainfall. From Figure 4-13 it is indicated that majority of the existing landslides are occurred in a slope class 9° - 14° and 14° - 20° which composed 31.4% and 29.0% of the total landslides along the section of the road. The slope classes 5° - 9° , 20° - 27° , 0° - 5° , 27° - 32° , 32° - 39° and 39° - 48° are composed 14.3%, 13.6%, 5.9%, 4.1%, 1.4% and 0.3% of the total recorded landslides along the studied road section.
