ACCESSIBILITY ASSESSMENT AND IMPROVEMENT OF RECREATIONAL PARKS IN ADDIS ABABA FOR PEOPLE WITH DISABILITIES

THE CASE OF MOBILITY AND VISUALLY IMPAIRED PEOPLE

A thesis submitted to the school of Graduate studies of Addis Ababa University in partial fulfillment
for Master's degree in Landscape Architecture

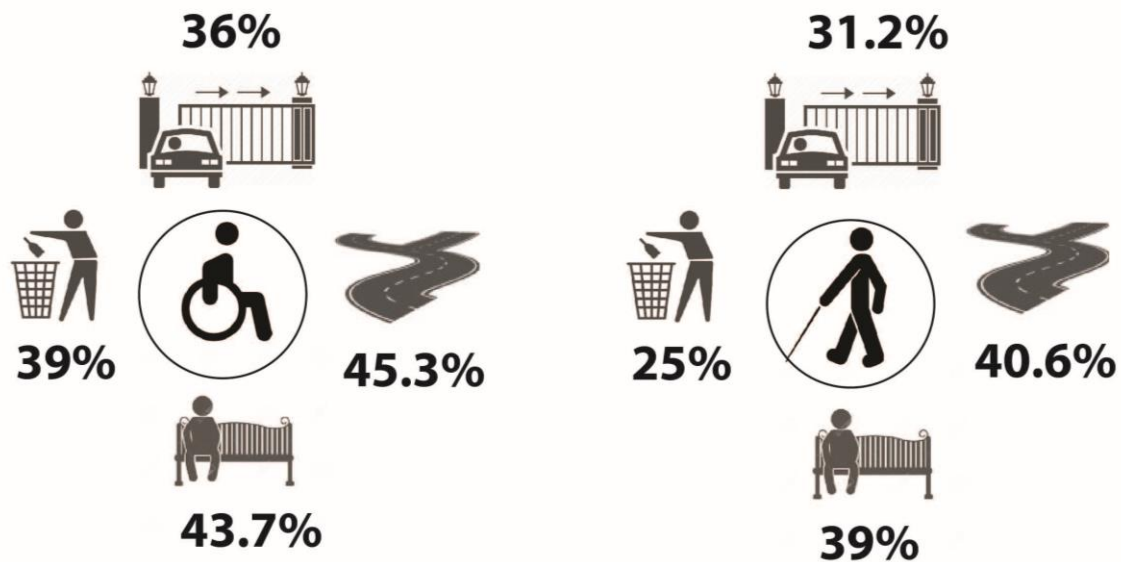
Figure 7: Barriers encountered by respondents at the different parts of the parks in Addis Ababa

All the 64 respondents who have visited recreational parks in Addis Ababa have said they have encountered barriers at the different parts of the parks in Addis Ababa. 43 respondents (36% mobility and 31.2% visually impaired people) encountered barriers at entrance spaces, 55 respondents (45.3% mobility and 40.6% visually impaired people) at circulation pathways, 34 respondents (43.7% mobility and 39% visually impaired people) at seating facilities, and 41 respondents (39% mobility and 25% visually impaired people) faced barriers in areas of waste receptacles.

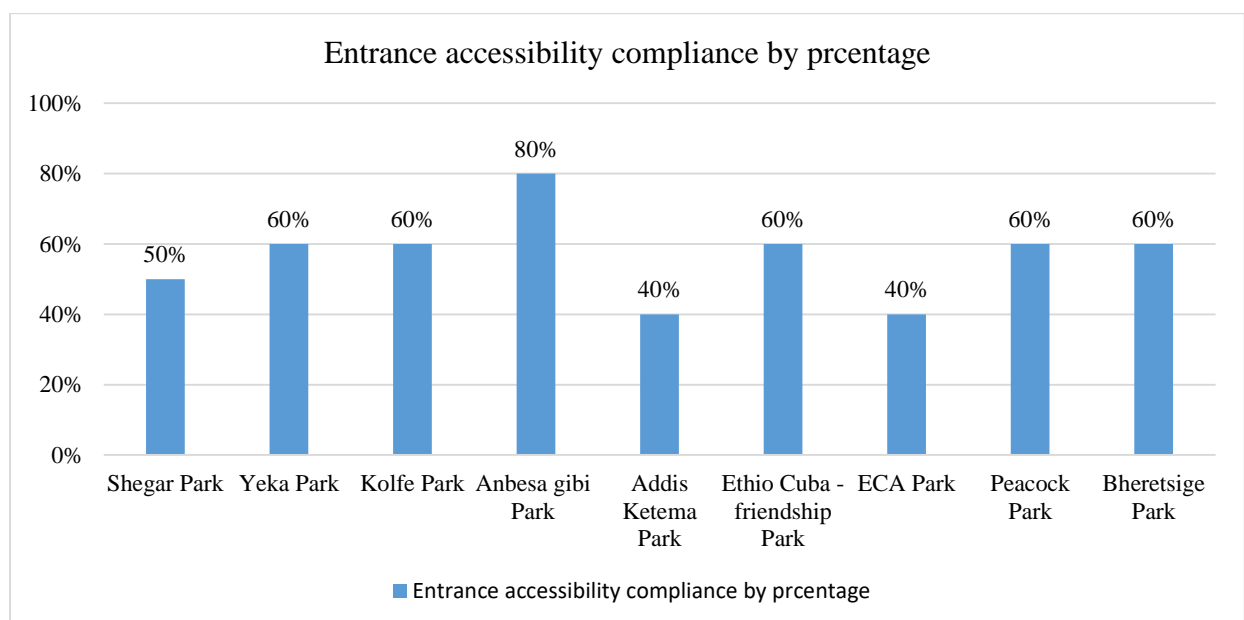
Figure 10: Entrance accessibility compliance by percentage

With a cumulative effect of the five parameters, entrance space accessibility compliance of the parks is shown in (figure 10). While the entrance of ECA and Addis Ketema parks are the lowest with 40% accessibility compliance, Entrance of Anbesa Gibe Park has the highest with 80% accessibility compliance when compared with the other parks.

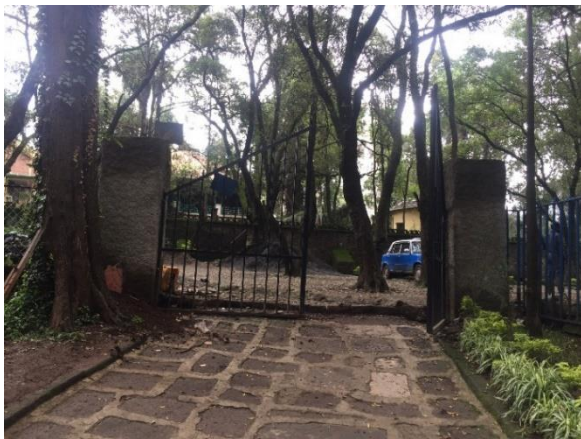
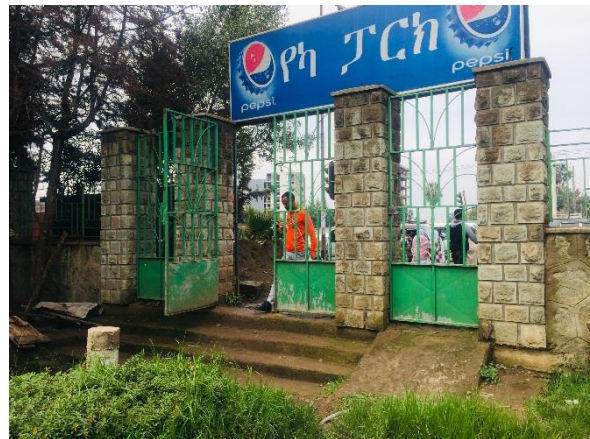
Figure 11: Entrance of Sheger Park (left) and Entrance of Yeka Park (right). (Source - Author)

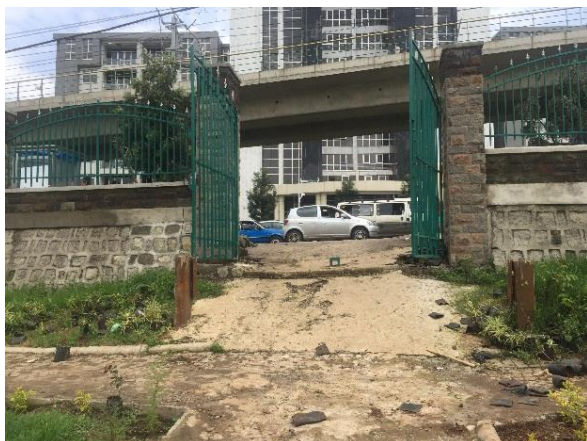
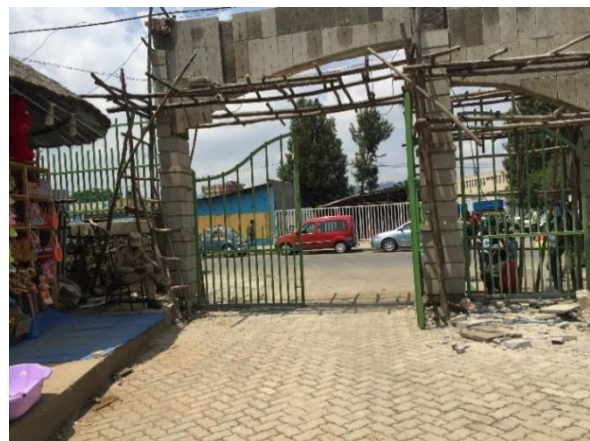
Figure 12: Entrance of ECA Park (left) and Entrance of Anbesa gebi Park (right). (Source - Author)

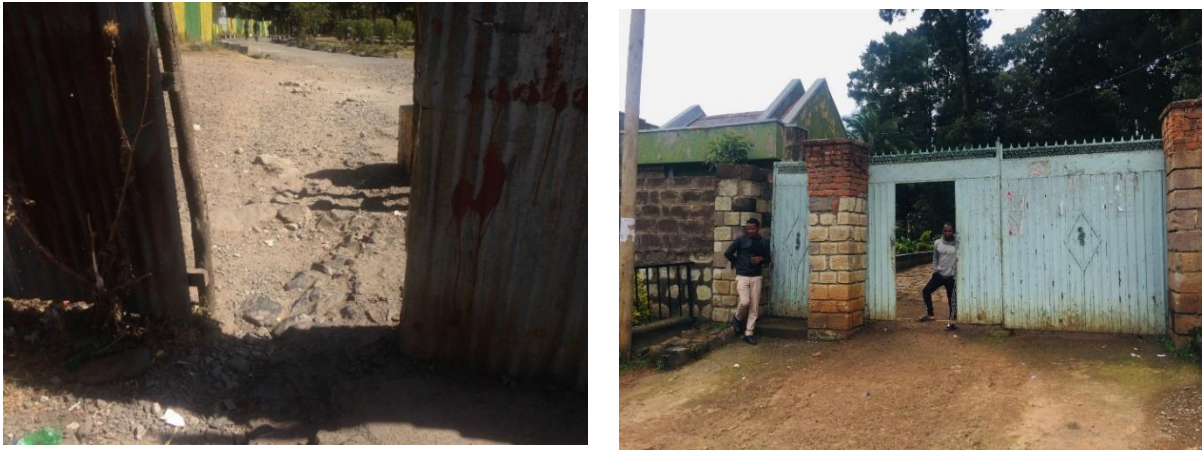
Figure 13: Entrance of Peacock Park (left) and Entrance of Kolfe Park (right). (Source - Author)

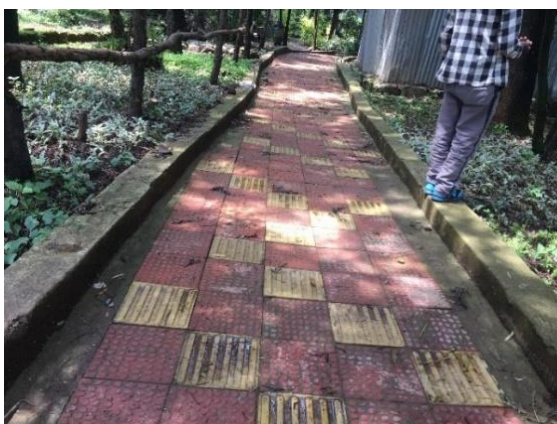
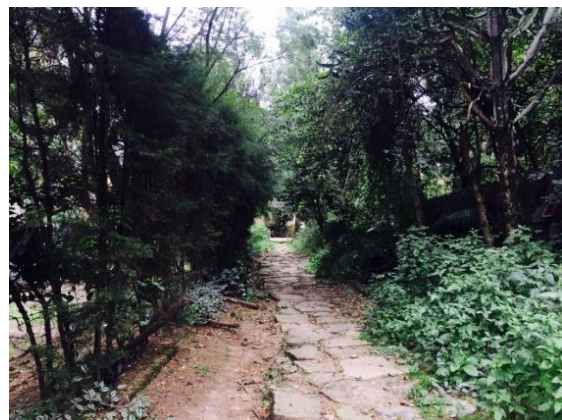
Figure 15: Misplaced tactile marking in Pathways at Yeka Park (left) and Damaged Pathways at Beheretsige Park (riahht). (Source - Author)

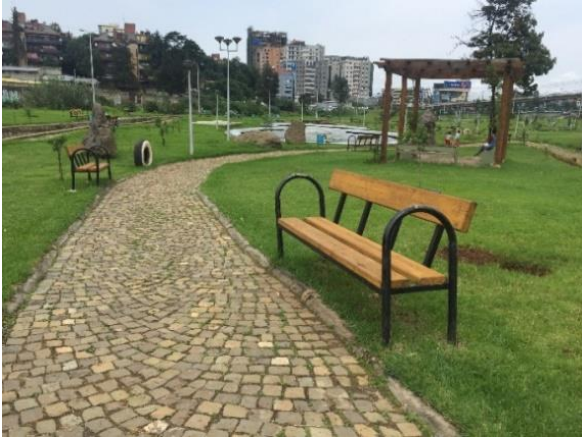
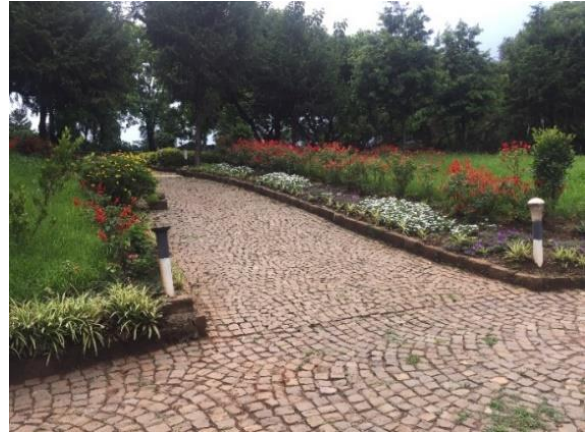
Figure 16: Obstruction free Pathways at ECA Park (left) and at Ethio – Cuba Park (right). (Source - Author)

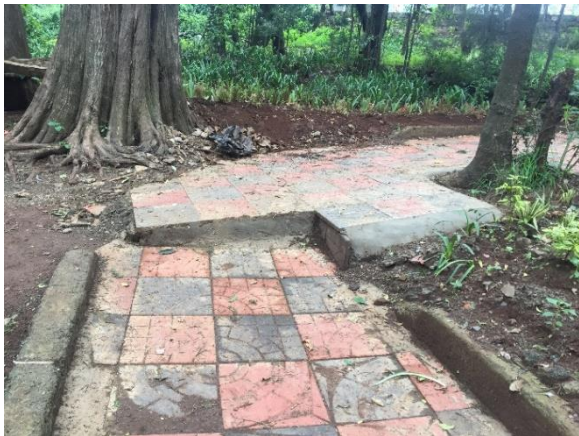
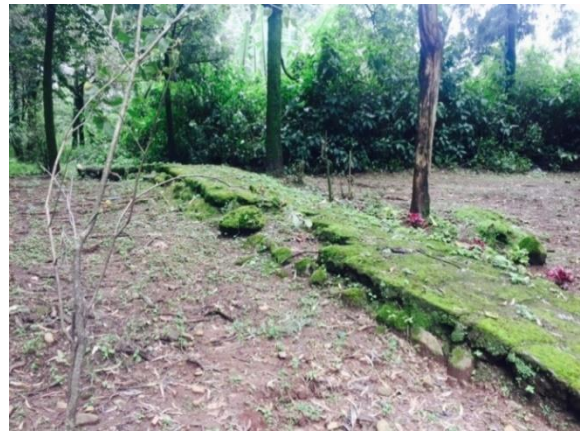
Figure 17: Steps in Pathways at Sheger Park (left) and, steep and damaged Pathways at Peacock Park (right). (Source - Author)

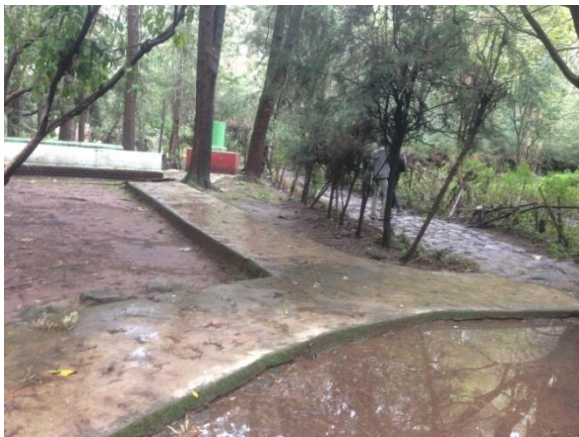
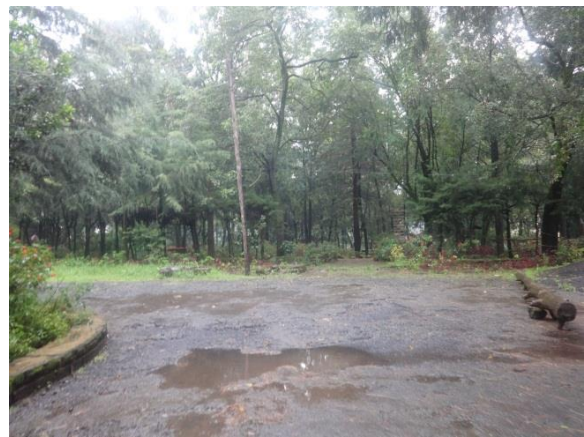
Figure 18: Sleeper Pathway at Peacock Park (left) and, damaged asphalt road at Beheretsige Park (right). (Source - Author)

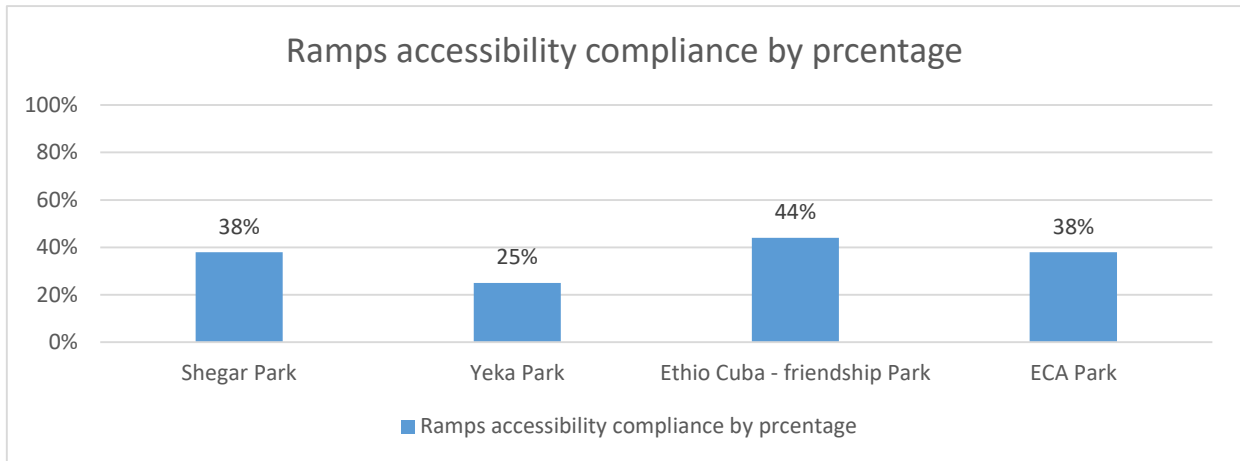
From the 9 parks that are surveyed, ramps are available in Sheger, Yeka, Ethio-Cuba Friendship and ECA Parks. In all of the four parks the accessibility compliance of the Ramps are measured by eight parameters that are shown in Appendix B section 3 of this research paper and analyzed as followed.

Figure 19: Ramps accessibility compliance by percentage

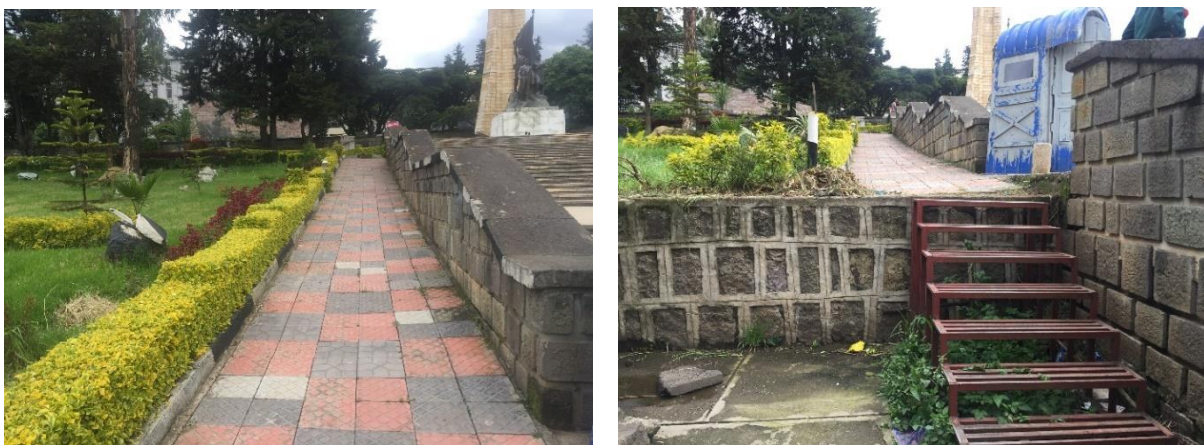
Observation of Ramps in Ethio Cuban- Friendship Park is made by categorizing the ramps according to their surface material in two types (see Section 3 of Appendix B). Type one (ramp with cobble stone surface finish) and type two (ramp with Terrazzo tile surface finish). Both ramps with cobble stone and terrazzo surface finish have a minimum width of 900mm and a gradient that does not exceed 5% slop. It is observed both types of ramps have no landing at the top and bottom or when change in direction. A stone guardrail is observed in some of the ramps but is absent in others. It is also observed there is no textural surface indicator at the top, bottom or in any surface of the ramp to alert or guide visually impaired people.

Figure 20: Terrazzo paved ramps with protective hand rail at the side but dropping to a stair with no safety consideration at Ethio - Cuba Park. (Source - Author)

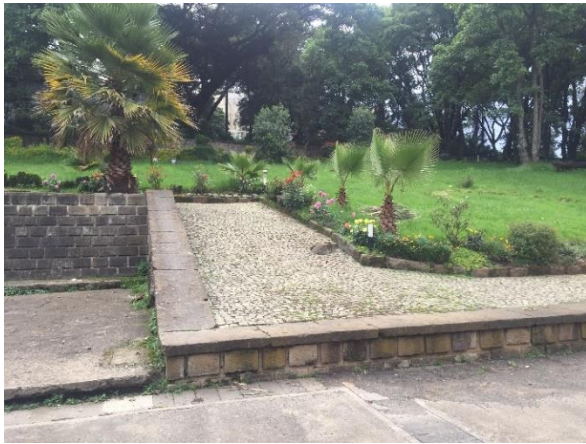
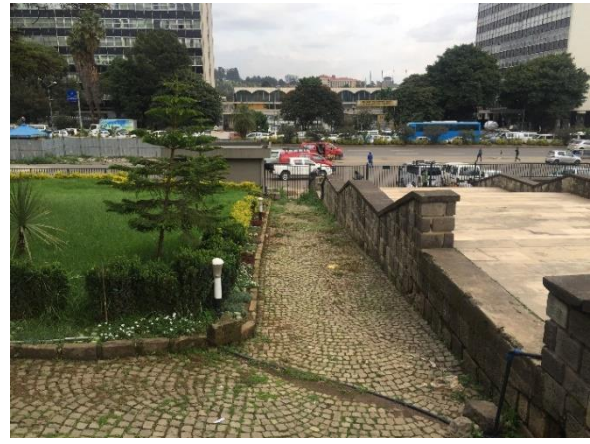
Figure 21: Cobble stone paved Ramps with no protective hand rail, no landing and damaged at Ethio - Cuba Park. (Source - Author)

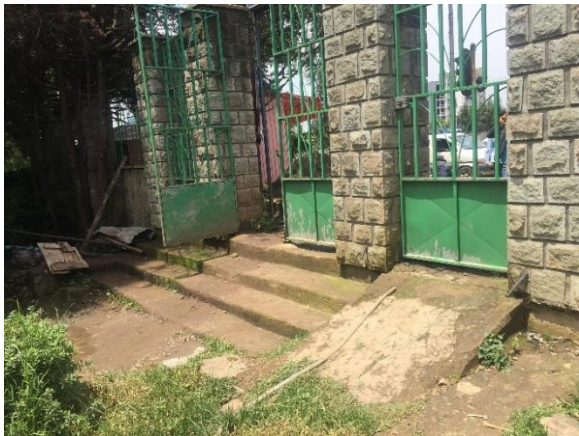
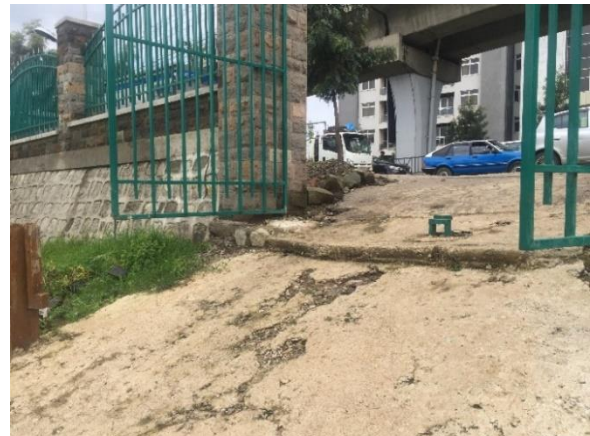
In Yeka Park a ramp is observed at the entrance space. It is 900mm wide and has a gradient that does not exceed 5% slope. It is constructed with concrete surface material that is damaged and obstructed. There is a Landings at the top of the ramp but there is no properly designed landing at the bottom. The space at the bottom of the ramp is narrow and obstructed with grown vegetation. There is no protective handrail at both side of the ramp and no textural surface indicator to alert or guide visually impaired people.

Figure 22: damaged concrete ramp at Yeka Park (left) and, ECA Park (right). (Source - Author)

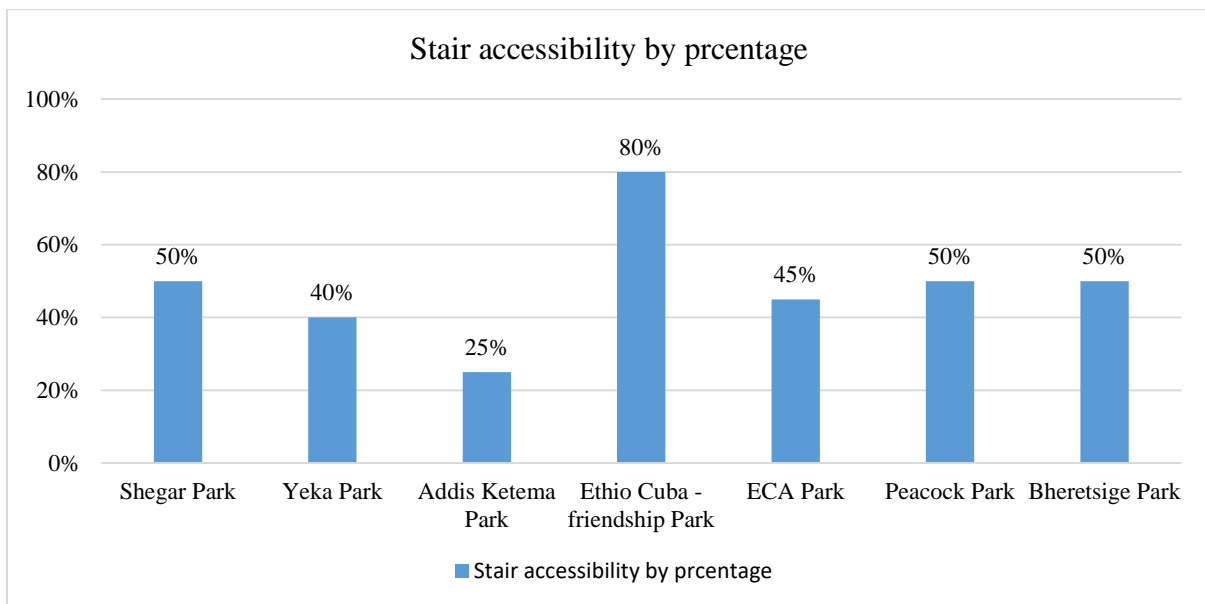
Figure 23: Stairs accessibility compliance by percentage

When measured by the stair accessibility parameters listed in (table 9), available stairs at Sheger, Peacock, and Beheretsige Park has 50% accessibility compliance, stairs in Yeka park has 40% accessibility compliance, stairs in Addis Ketema park has 25% accessibility compliance, stair in Ethio Cuba – friendship park has 80 % accessible compliance, and stairs in ECA park has complied with 45% of the accessibility measurement.

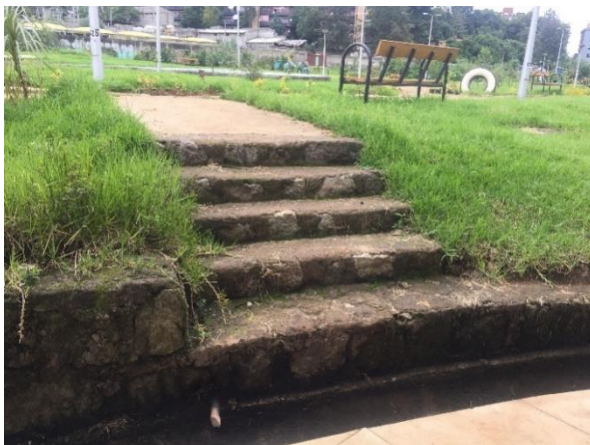
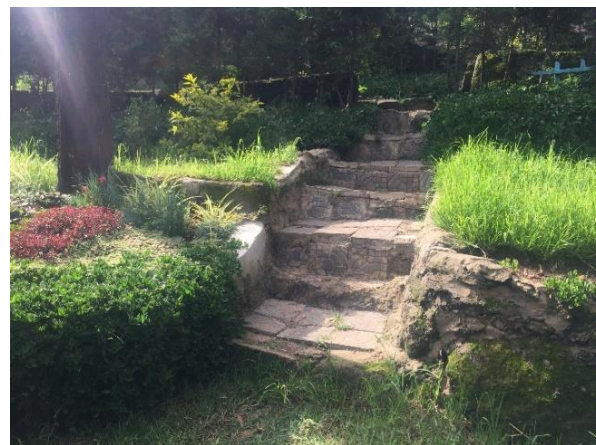
Figure 24: Stair falls into an open ditch with no proper landing at ECA Park (left) and Stair with no regular riser and trade at Addis Ketema Park. (Source - Author)

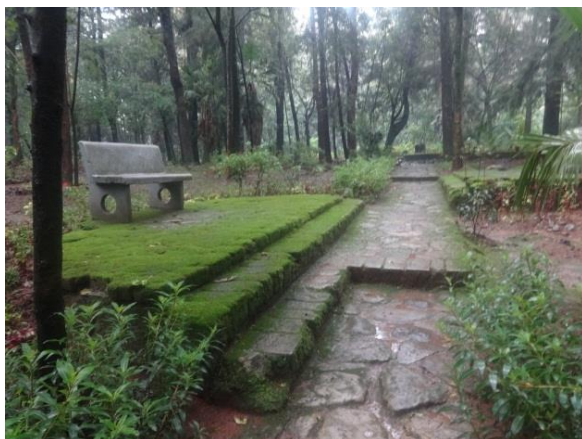
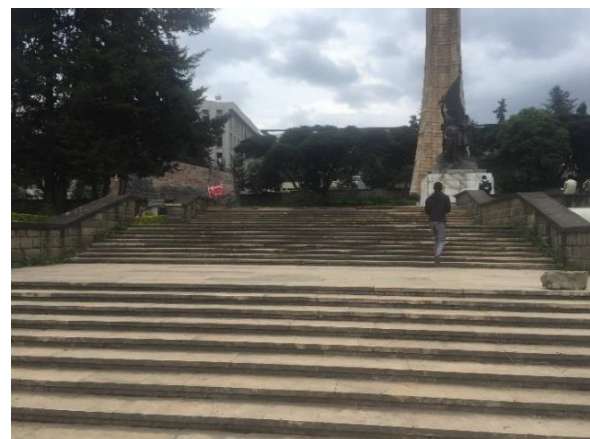
Figure 25: Stair grown alga at Peacock Park (left) and Stair with a width above 3000mm but no intermediate handrail at Ethio – Cuba Park. (Source - Author)

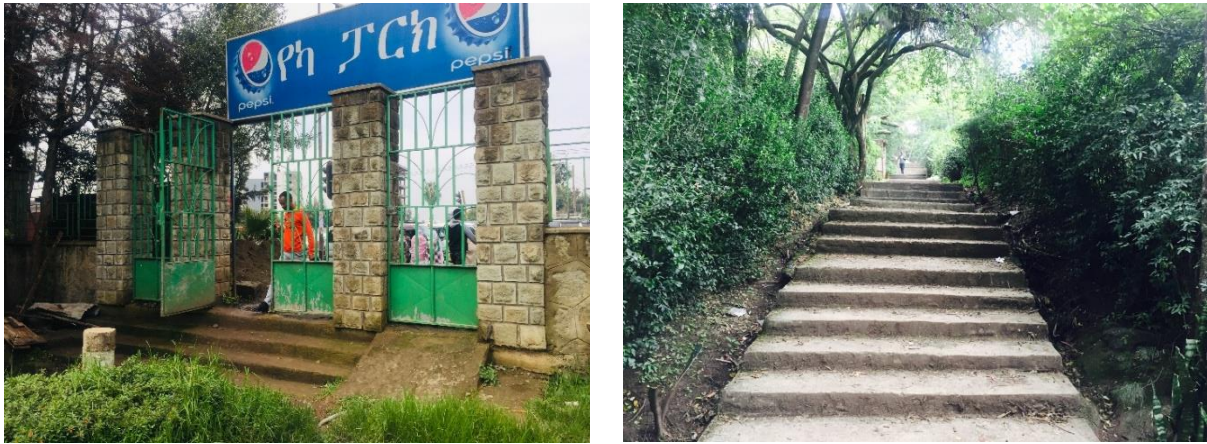
Figure 26: Stair with alternative ramp at Yeka Park (left) and, Stair with no Provision of ramp at Beheretsige Park (right). (Source - Author)

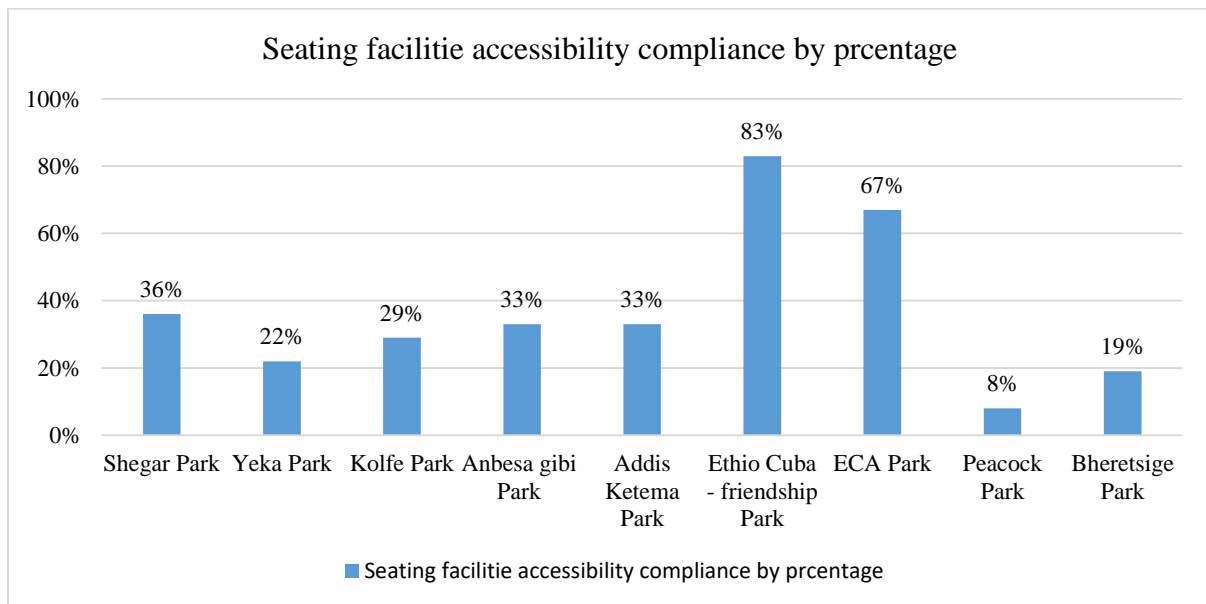
Figure 27: Seating facility accessibility compliance by percentage

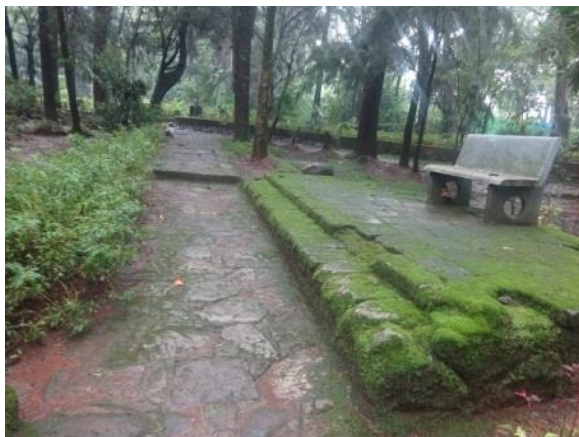
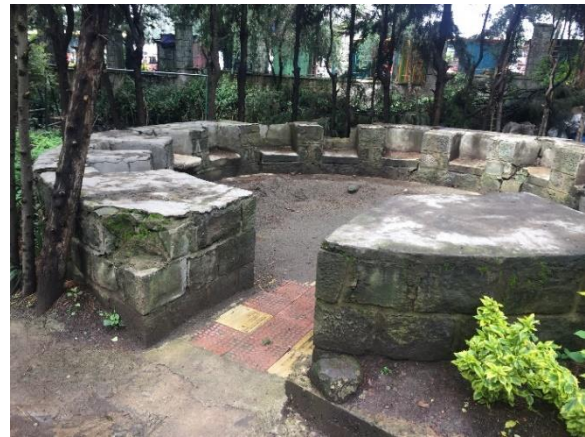
In contrary seating facilities in ECA and Ethio Cuba – friendship parks are found at one side of the main circulation paths. They are provided in a regular interval, have a suitable arm and back support and have an available space adjacent to them for wheelchair users. However, they don't have orientation or information guides in or around the seats to guide visually impaired people.

Figure 28: Seat placed in a raised platform at Peacock Park (Left) and seat with narrow entry at Yeka Park (Right). (Source - Author)

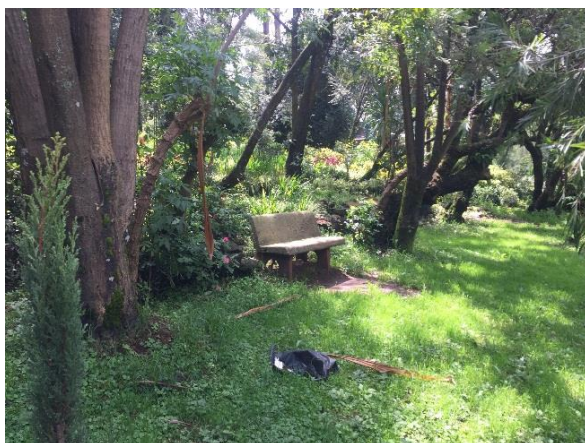
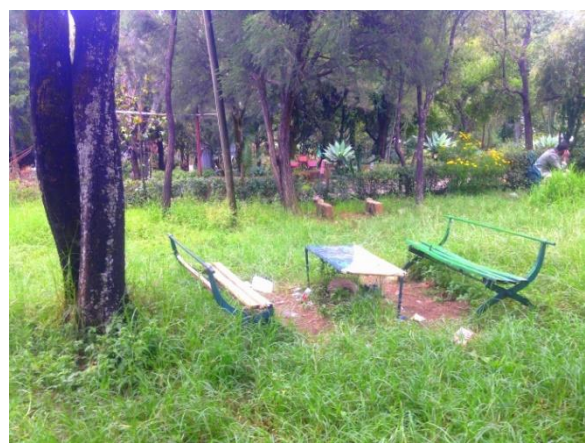
Figure 29: Seats placed on a natural ground that is not firm and leveled (left) at Sheger Park and (Right) at Ethio – Cuba Park. (Source - Author)

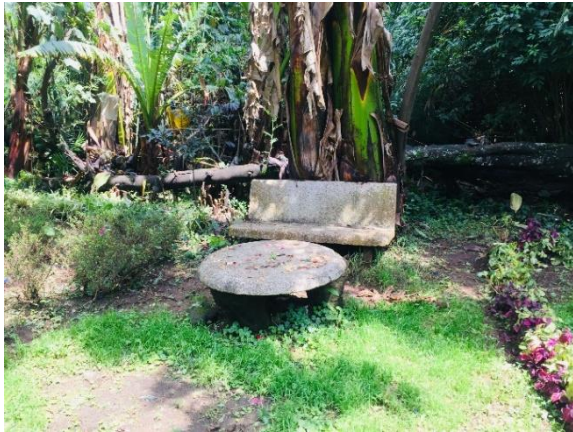
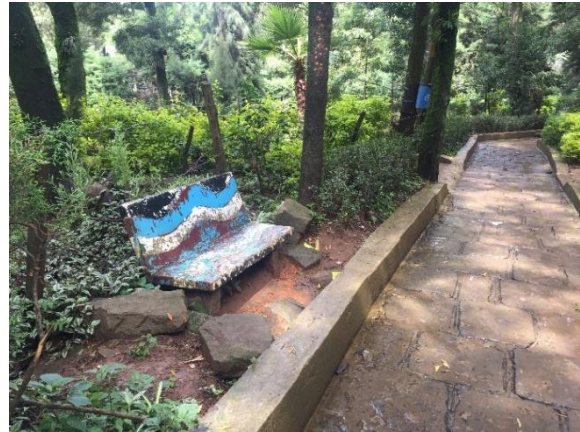
Figure 30: Seating at Yeka Park with no orientation guide. (Source - Author)

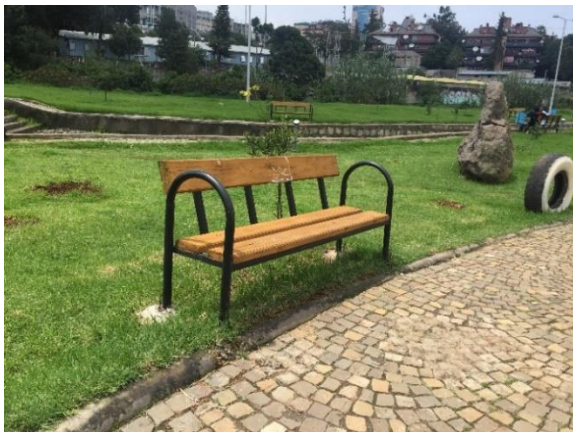
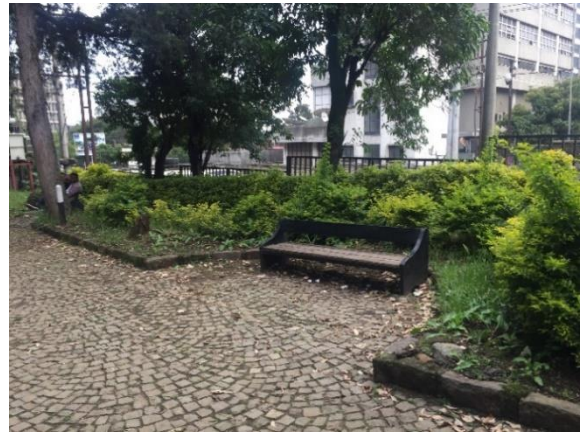
Figure 31: Seating spaces with an elevation change and no provision of ramp at Addis Ketema Park (Left) and Peacock Park (Right). (Source - Author)

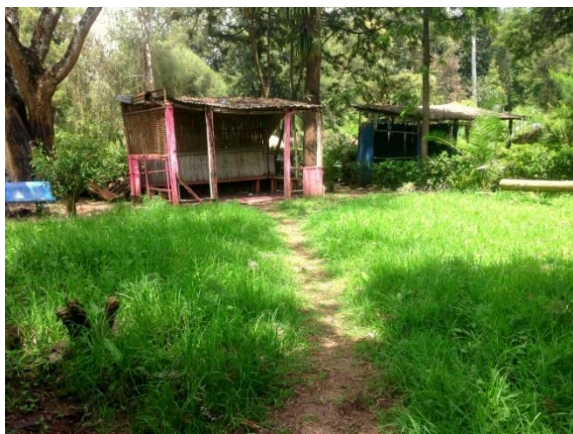
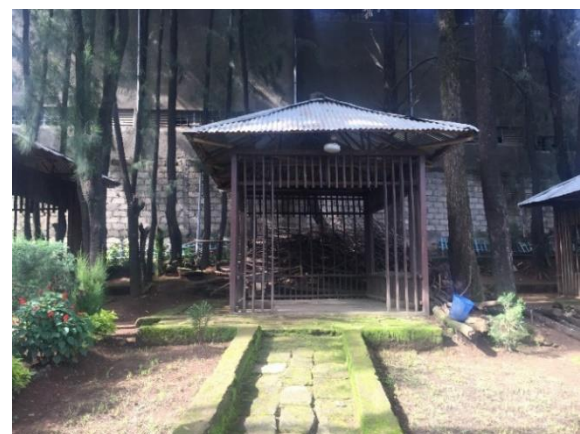
Figure 32: Shaded seating space on a natural ground with no circulation space that is properly connected with the main circulation paths (left) at Sheger Park and shaded seating space with an access with to a main circulation path but placed in a raised plat form at Addis Ketema Park (Right). (Source - Author)

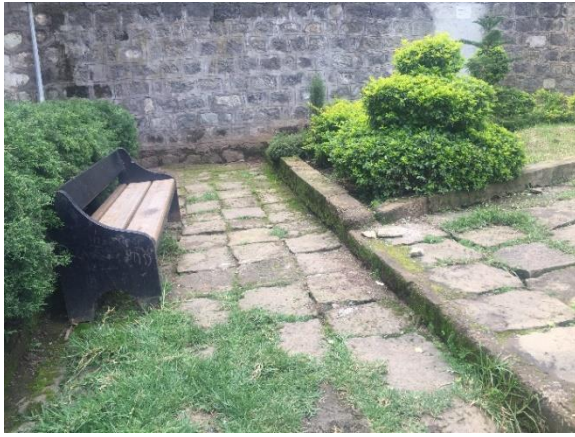
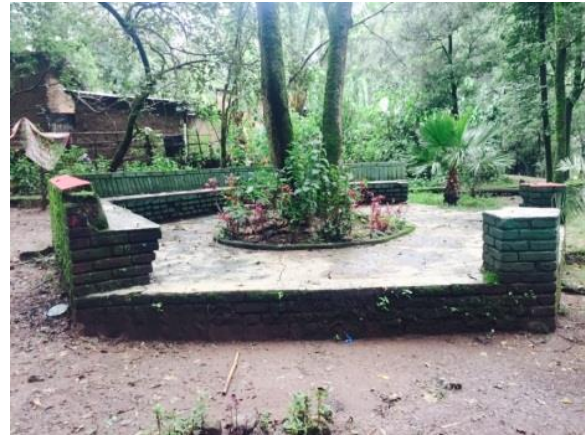
Figure 33: Seating spaces placed provided in a regular interval and outside the main circulation path at ECA Park (Left), and with an adjacent space for a wheelchair at Ethio Cuba –parks (Right). (Source - Author)

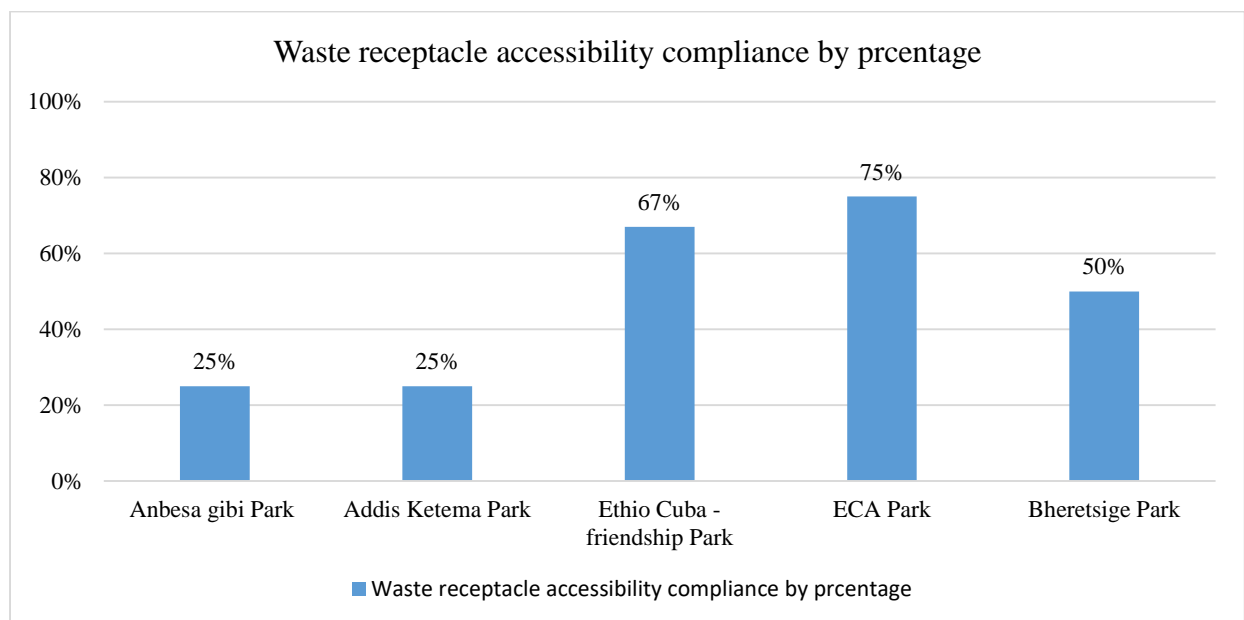
Out of the 9 parks, Waste receptacles are available only in Anbesa gebi, Addis ketema, ECA, Ethio Cuba – friendship, and Behere tsige parks. Accessibility of the waste receptacles for mobility and visually impaired people are measured by 4 accessibility parameters that are shown in Appendix B section 6 of this research paper and analyzed as followed.

Figure 34: Waste receptacles accessibility compliance by percentage

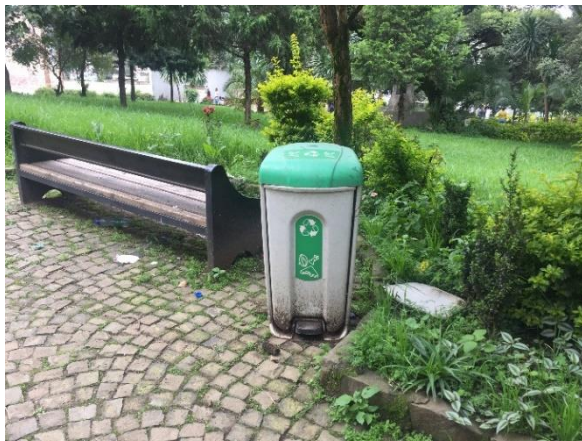
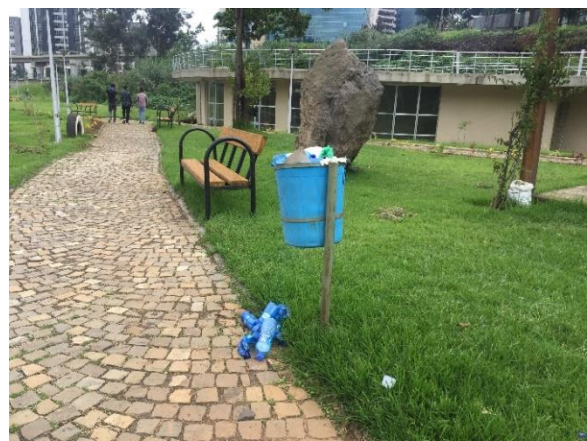
Waste receptacles in all the parks are not identified by suitable signs and contrasting color to assist visually impaired people.

Figure 35: Waste receptacles at Ethio – Cuba Park (Left) and at ECA Park (Right). (Source - Author)

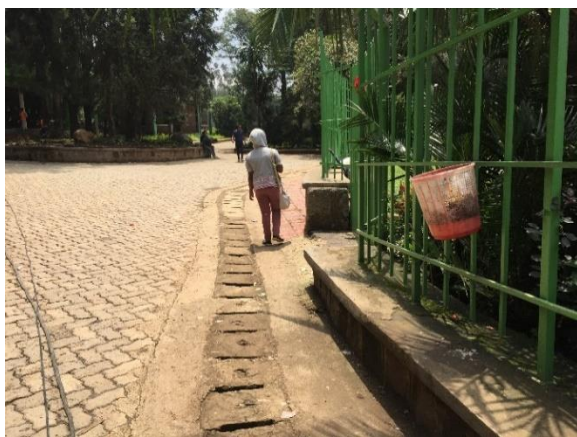
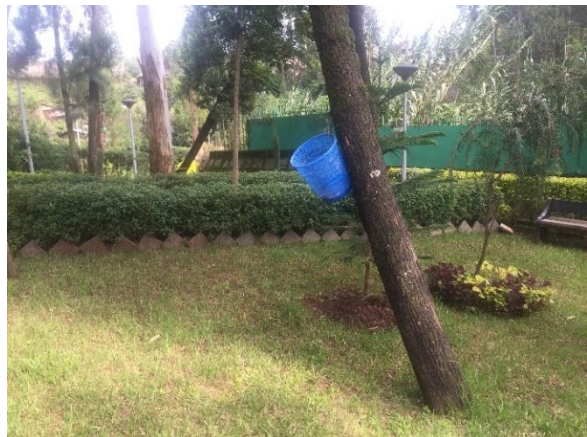
Figure 36: Waste receptacles at Anbesa Gebi (Left) and at Kolfe Park (Right). (Source - Author)

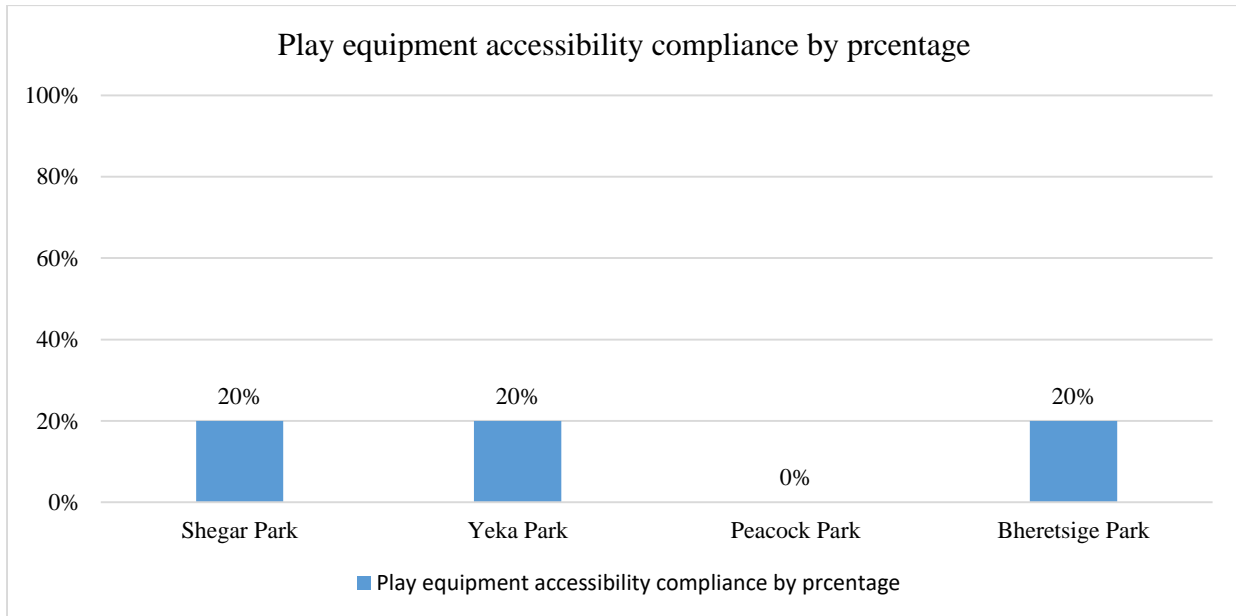
In the field observation, children play equipment is only found in Sheger, Yeka, and Peacock and Beheretsige parks. Accessibility of the play equipment for mobility and visually impaired children are measured by 5 accessibility parameters shown in Appendix B section 7 of this research paper and analyzed as followed.

Figure 37: Play equipment accessibility compliance by percentage

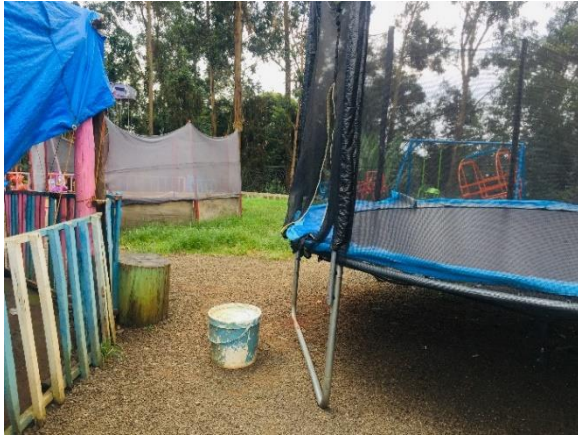
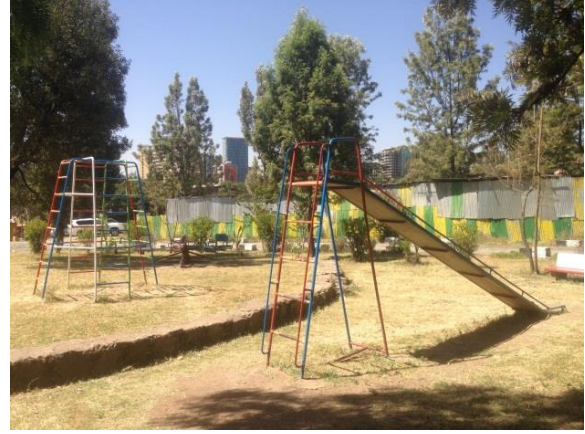
Play equipment in none of the parks have a transfer platform or grab bars to assist mobility impaired children and orientation or information guides in or around to guide visually impaired children.

Figure 38: Play equipment at Sheger Park (Left) and Peacock Park (Right). (Source - Author)

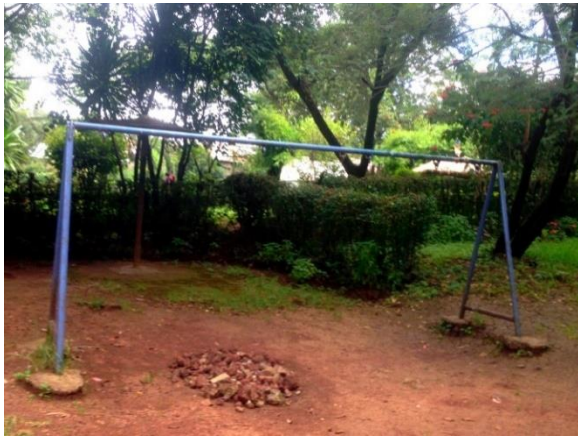
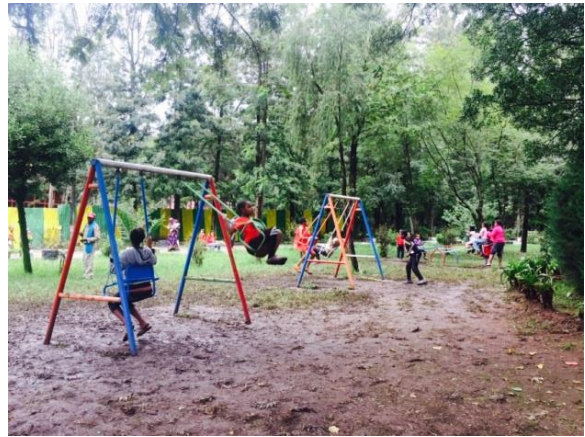
Figure 39: Play equipment placed at unconstructed platform with no circulation connected with main pathways at BehereTsigie Park (Left) and Peacock Park (Right). (Source - Author)

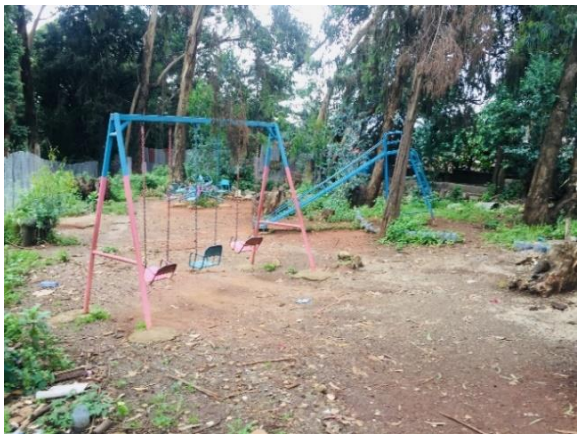
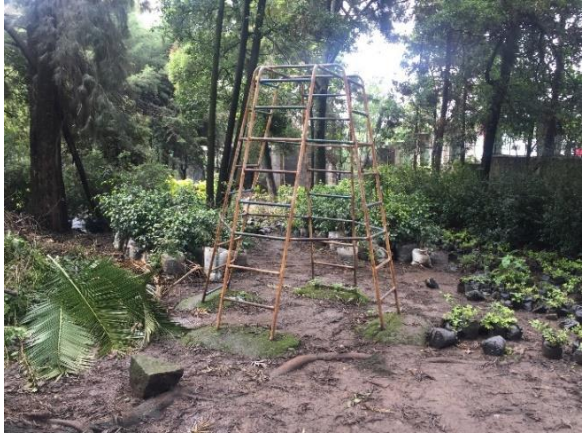
Figure 40 : Play equipment with no orientation guide and no provision of transfer platform and grab bars at Sheger Park (Left) and Yeka Park (Right). (Source - Author)

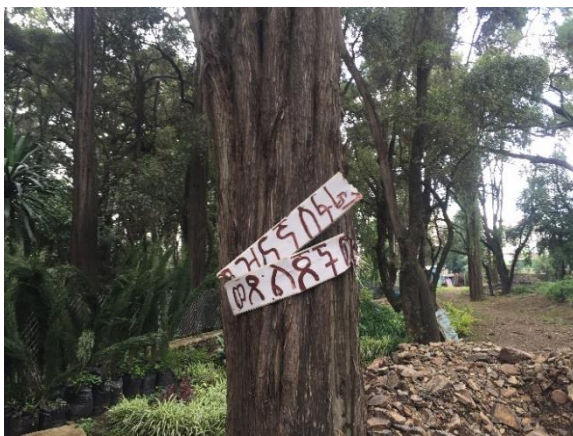
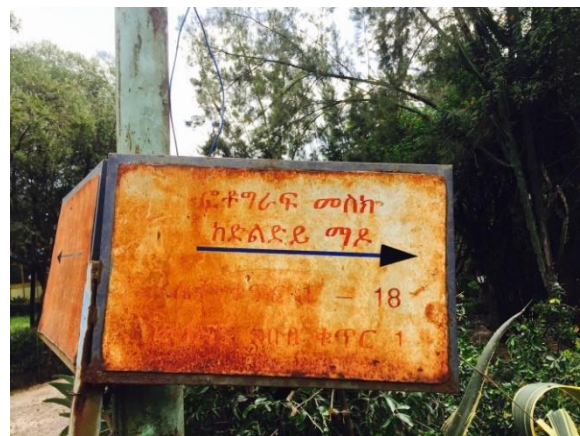
When the available signage in Shege, Yeka, Kolfe and Beheretsige parks are evaluated, they have only complied with 13% of the accessibility parameters.

Figure 41: Directional signage at Sheger Park (Left) and Beheretsige Park (Right). (Source - Author)

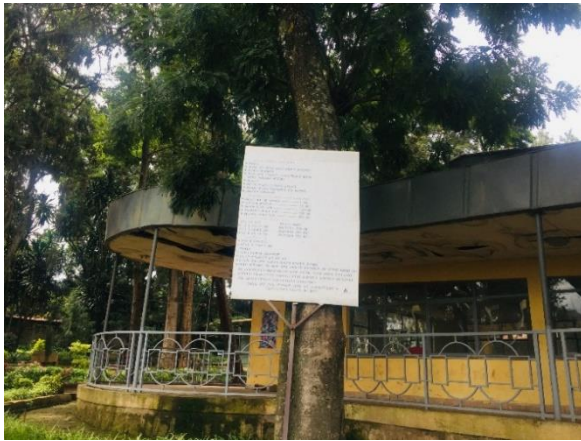
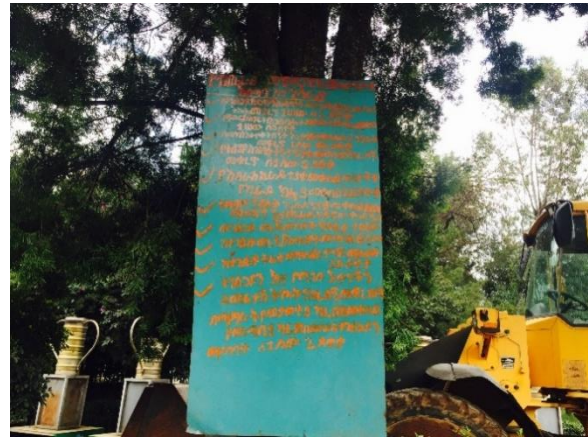
Figure 42: Information Signage at Kolfe park (Left) and Beheretsige Park (Right). (Source - Author)

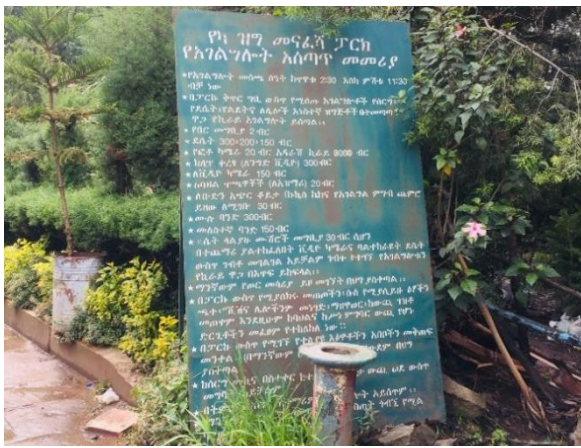
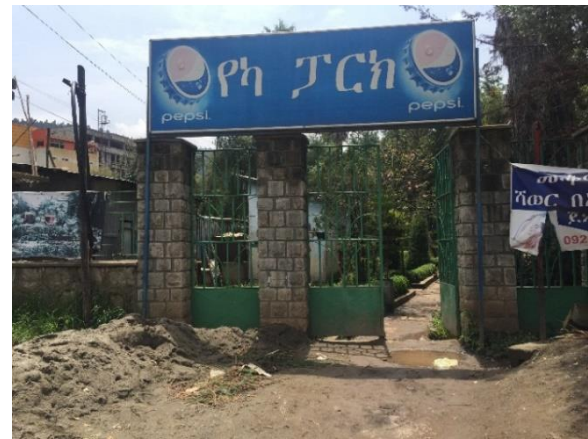
Figure 43: Information Signage at Yeka park. (Source - Author)

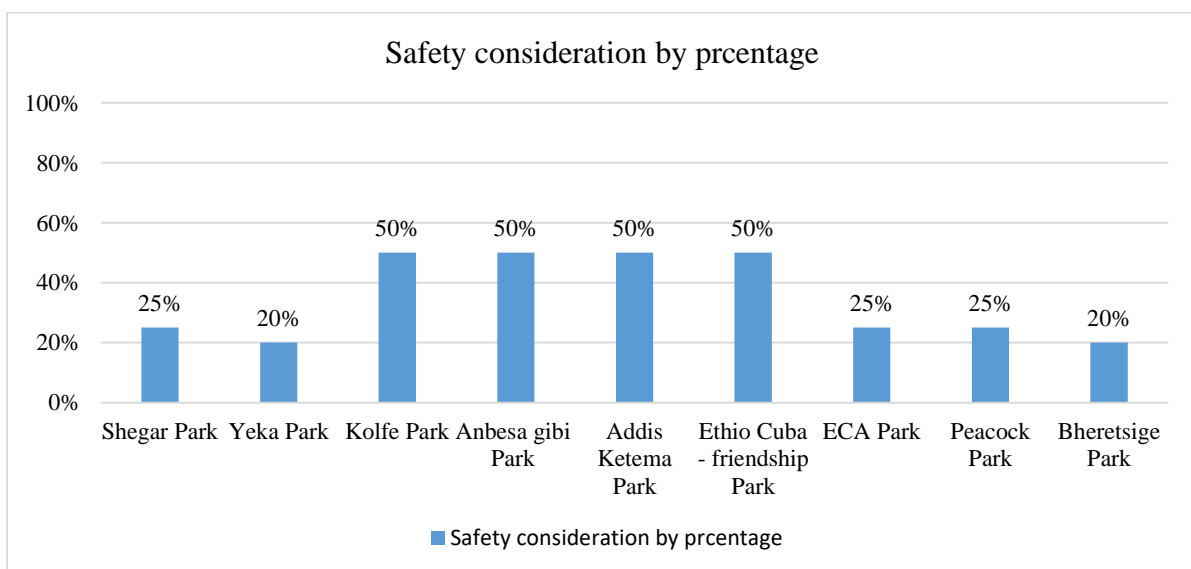
Safety considerations in the different parks are measured by five parameter shown in Appendix B section 9 of this research paper and analyzed as followed.

Figure 44: Safety consideration by percentage

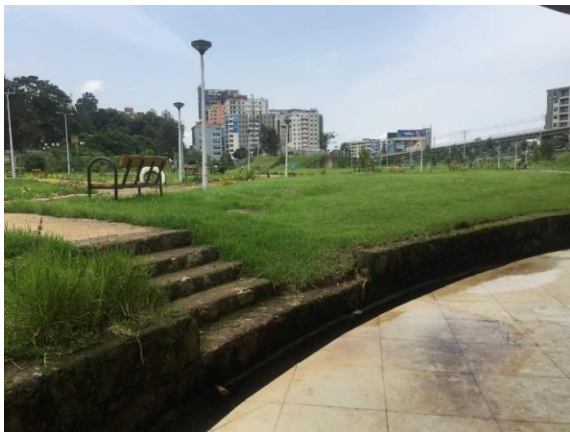
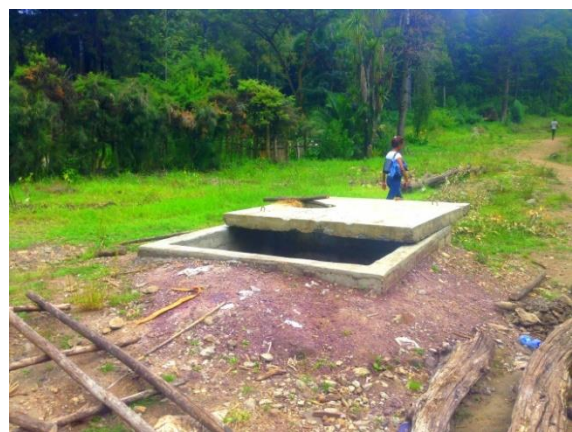
Figure 45: Stair with no landing and leading to an open drainage at ECA Park (Left) and open manhole on the travel path at Beheretsige Park (Right). (Source - Author)

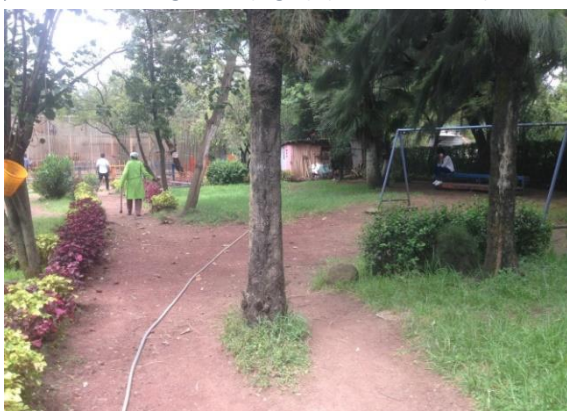
Figure 46: Tree planted on path of travel at Beheretsige Park. (Source - Author)
