ACCESSIBILITY ASSESSMENT AND IMPROVEMENT OF RECREATIONAL PARKS IN ADDIS ABABA FOR PEOPLE WITH DISABILITIES

THE CASE OF MOBILITY AND VISUALLY IMPAIRED PEOPLE

A thesis submitted to the school of Graduate studies of Addis Ababa University in partial fulfillment
for Master's degree in Landscape Architecture

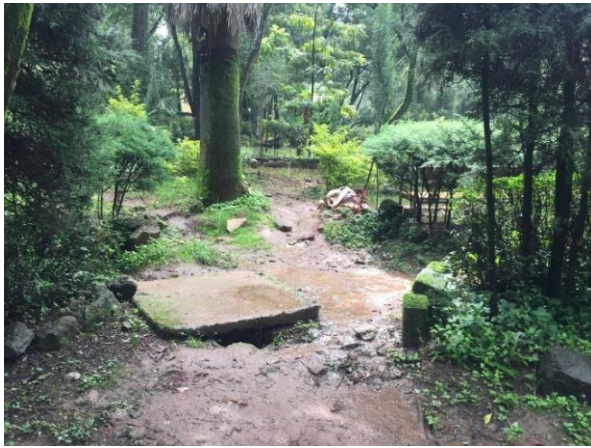
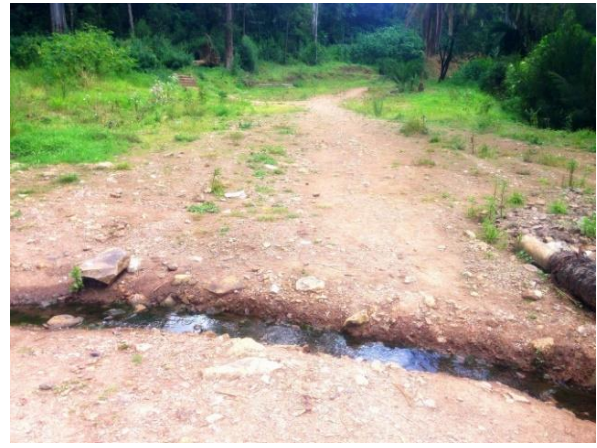
Figure 47: Open manhole on the travel path at Yeka Park (Left) and open drainage on the travel path at Beheretsige Park (Right). (Source - Author)

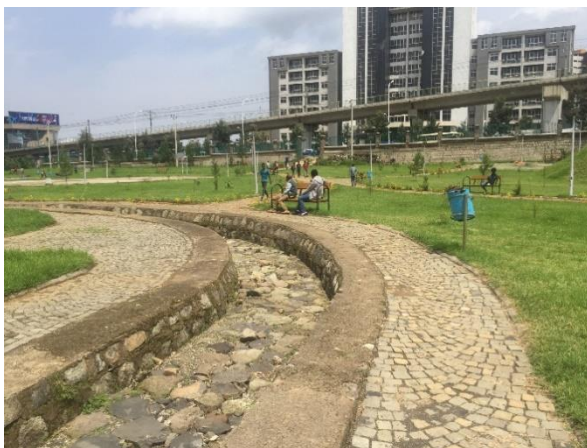
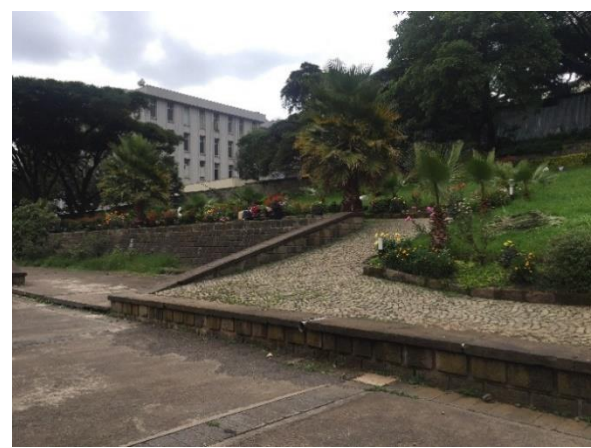
Figure 48: Elevated Path ways with no Protective rail or curb at Peacock Park (Left) and Ethio Cuba Park (Right). (Source - Author)

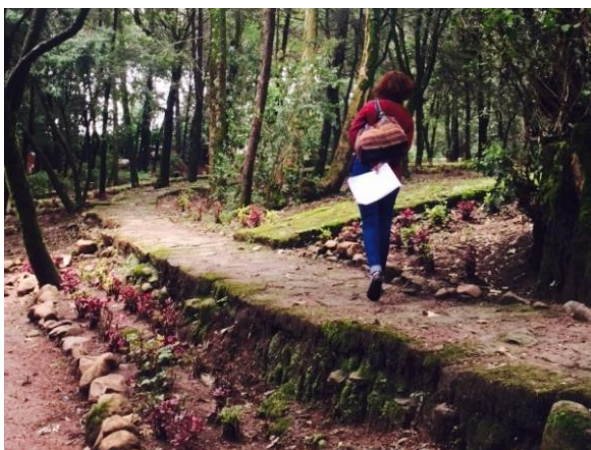
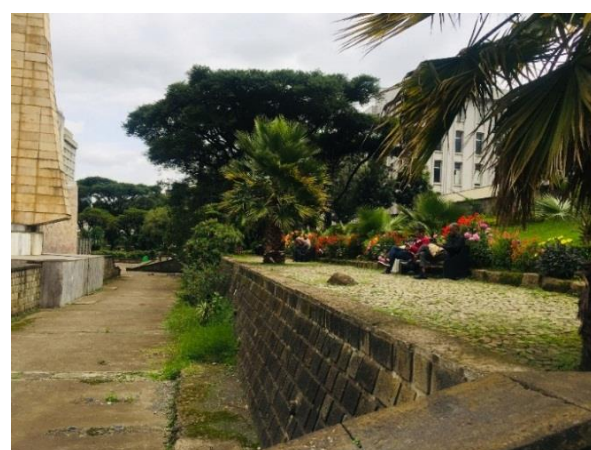
Figure 49: Elevated Path ways from adjacent landscape with no Protective rail or curb at ECA Park (Left) and ramp with no landing and protective handrail at Ethio Cuba Park (Right). (Source - Author)

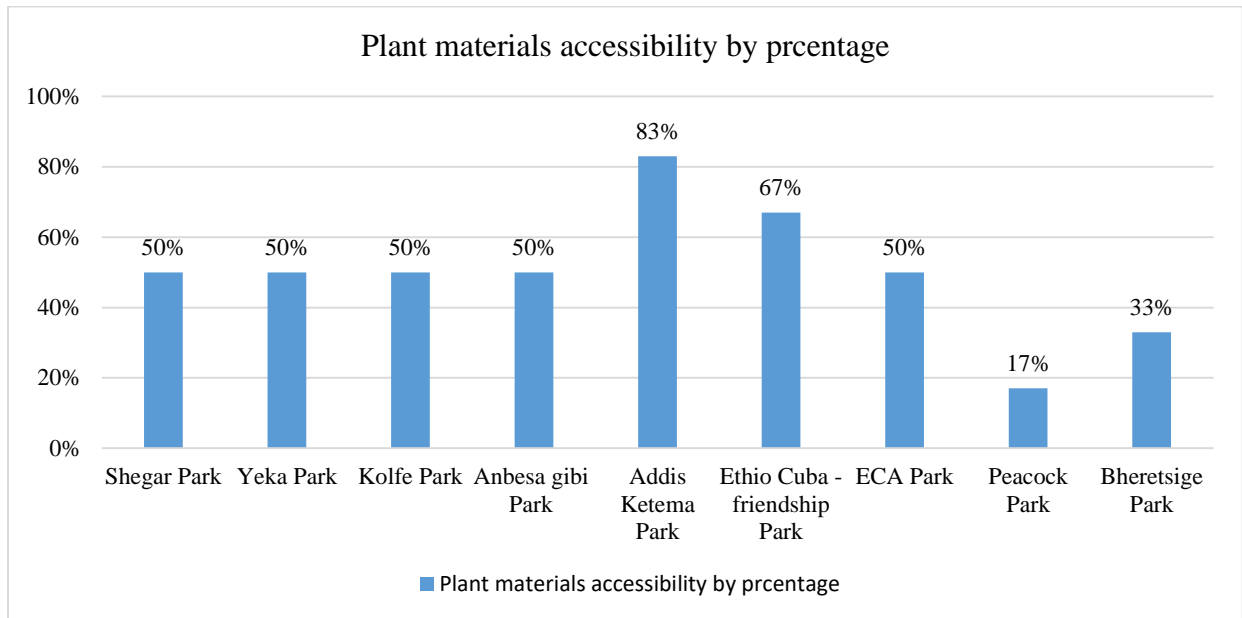
The accessibility compliance of plant materials in the surveyed parks are measured by the accessibility parameters that are shown in Appendix B section 10 of this research paper and analyzed as followed.

Figure 50: Plant materials accessibility considerations by percentage

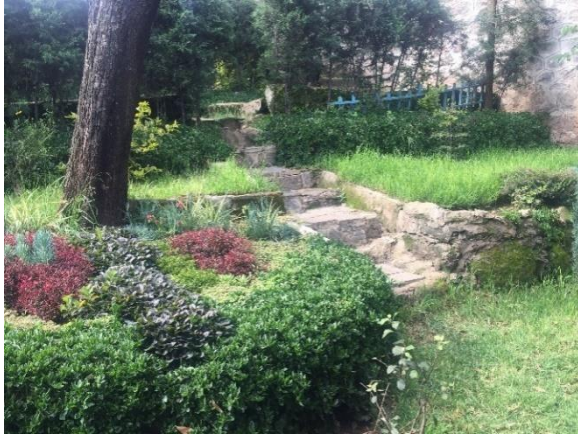
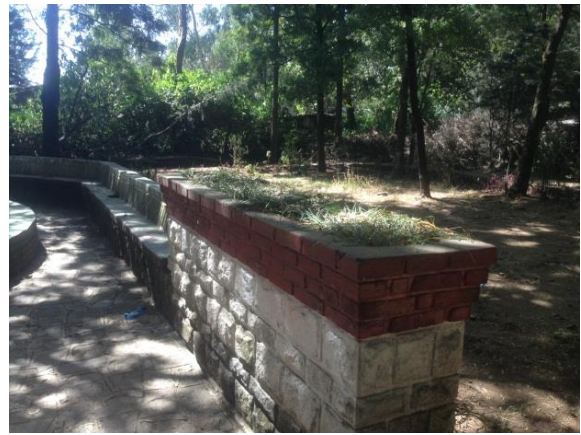
In Beheretsige and Peacock Park, plants with thorns, such as “Dovyalis abyssinica” are planted adjacent to pathways. In some of the other parks, the plants are observed but they are planted away from active areas. In Peacock Park over hanged brunches of trees over a pathway are also observed.

Figure 51: Raised planter at Addis Ketema Park (Left) and at Peacock Park (Right). (Source - Author)

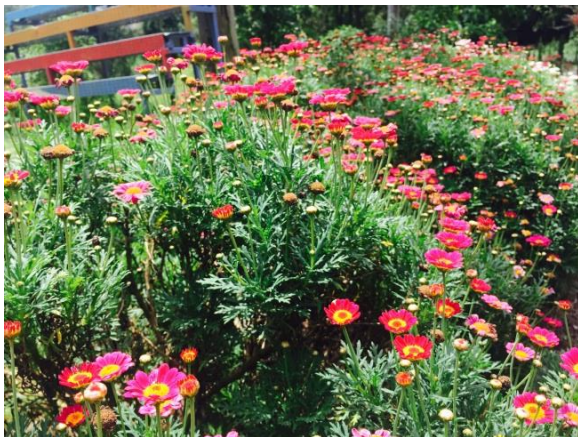
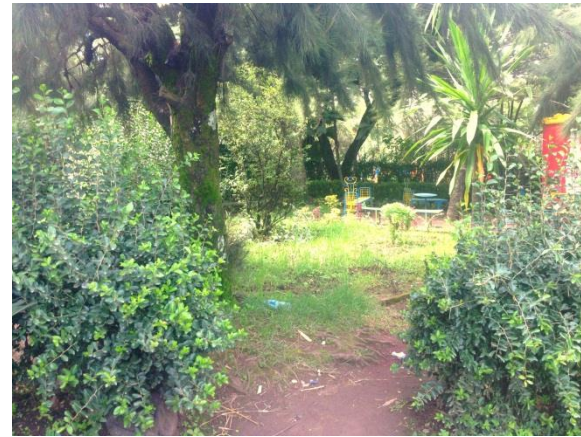
Figure 52: Plant with variety of color (Left) and plants with thorns planted adjacent to pathways (Right) at Beheretsige Park. (Source - Author)

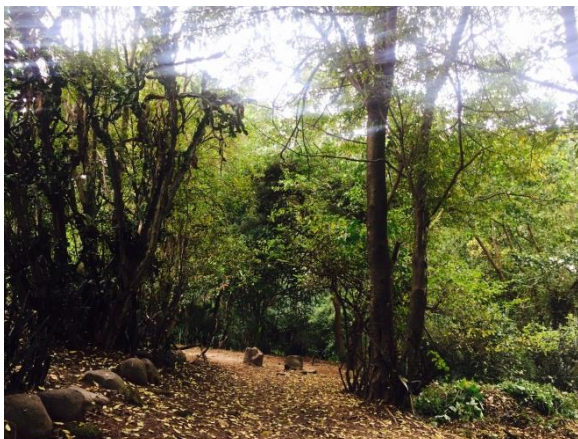
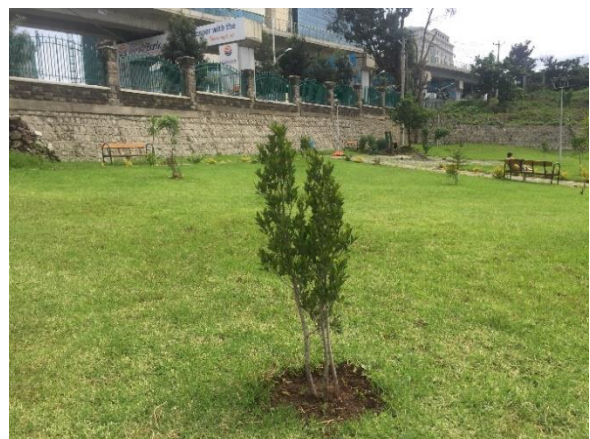
Figure 53: Fully grown Trees at Beheretsige Park (Left) and trees not fully grown (Left) at ECA Park. (Source - Author)

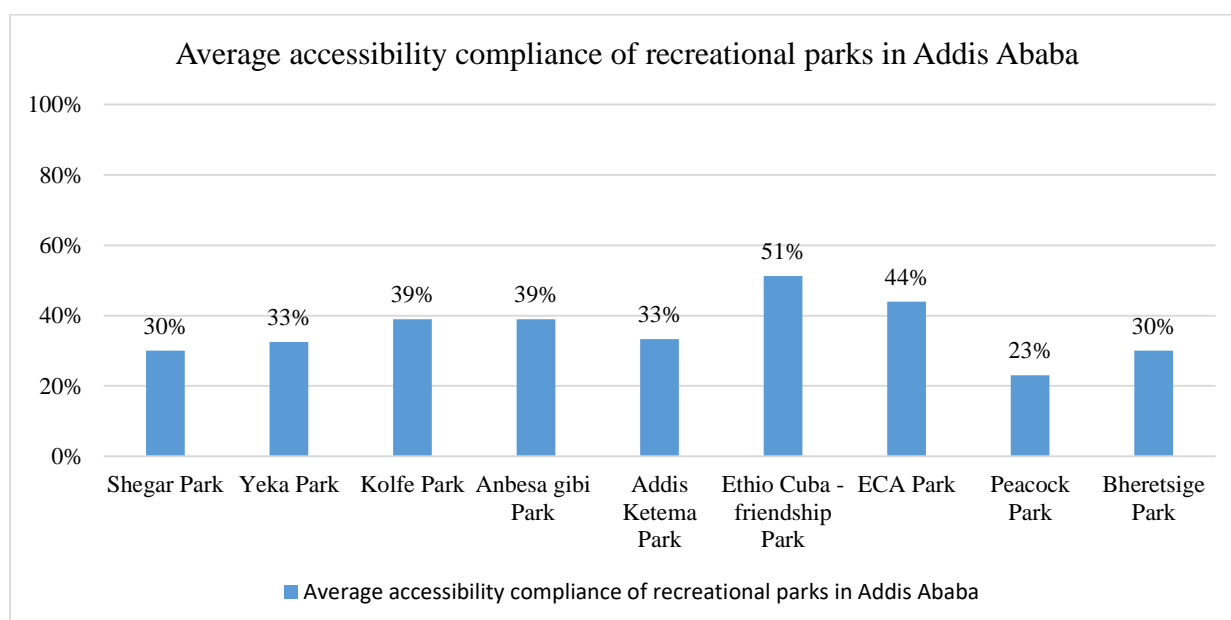
The average accessibility compliance of available park facilities and infrastructures in each recreational park under survey is summarized in the Fieger below. Where Ethio Cuba is the most with 51 % accessibility compliance, Peacock Park is the list with 23% accessibility compliance.

Figure 54: Average accessibility compliance of recreational parks in Addis Ababa

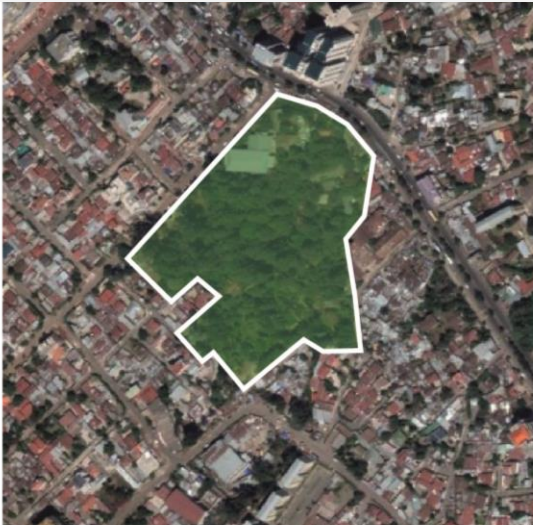
Sheger park (Scale 1:8000)

Main facilities and components – Main Entrance Ticket office, children playground, administrative offices, Toilet, wedding photograph space, sport field, indoor game space, car parking pathways, individual and group seating spaces, ceremonial spaces and plantings.

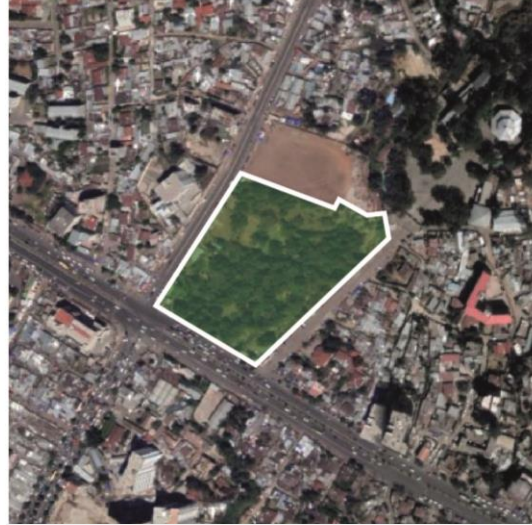
Yeka park (Scale 1:8000)

Main facilities and components – Main Entrance Ticket office, administrative offices, Toilet, play equipment, pathways, individual and group seating spaces, ceremonial spaces and plantings.

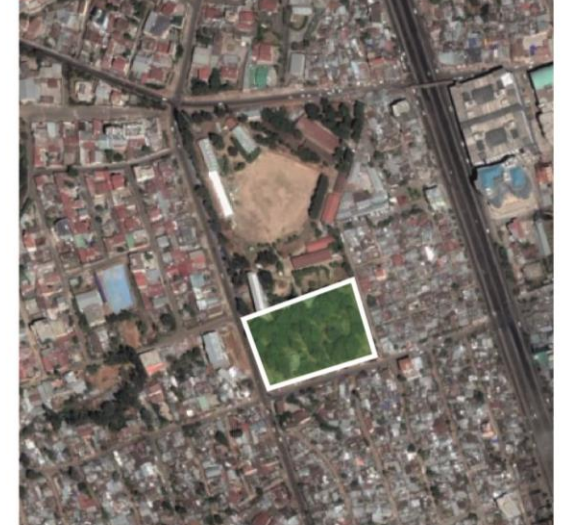
Kolfe park (Scale 1:8000)

Main facilities and components – Main Entrance Ticket office, administrative offices, Toilet, pathways, car parking, individual and group seating spaces, ceremonial spaces and plantings.

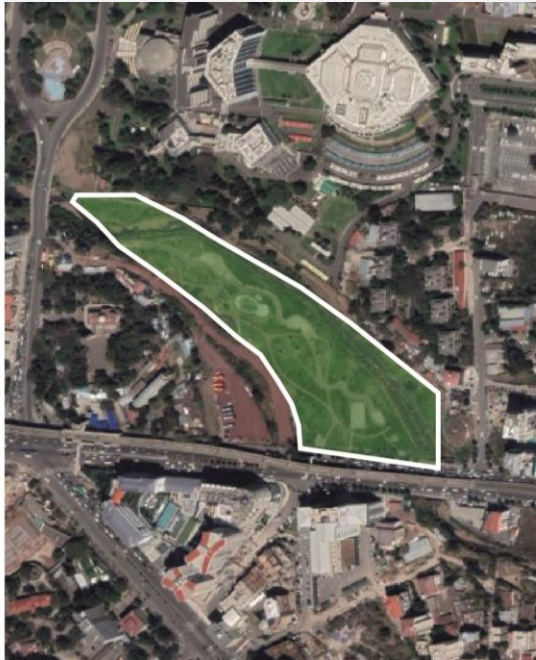
ECA park (Scale 1:8000)

Main facilities and components – Main Entrance, Building blocks (not giving service yet), site viewing roof, sport field, cascading water path, pathways, seating spaces mounds, artificial tunnel, and plantings.

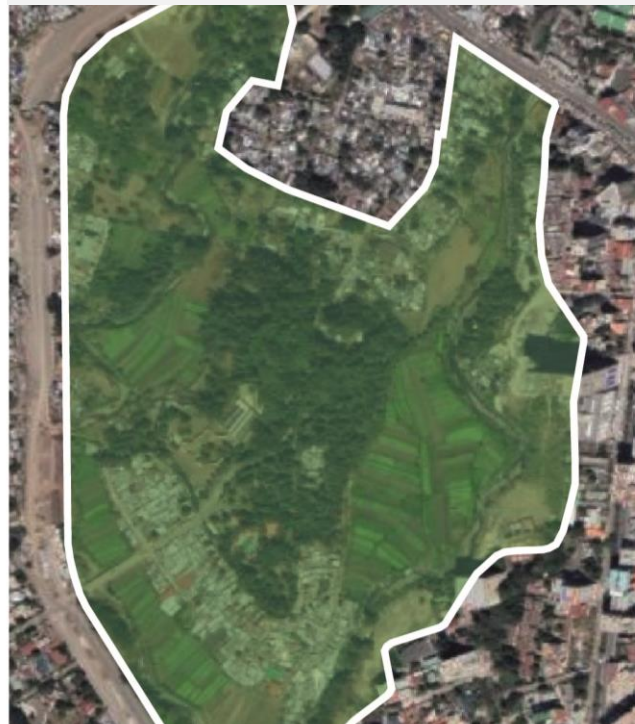
Peacock park (Scale 1:8000)

Main facilities and components – Main Entrance Ticket office, children playground, administrative offices, Toilet, car parking pathways, individual and group seating spaces, ceremonial spaces and plantings.

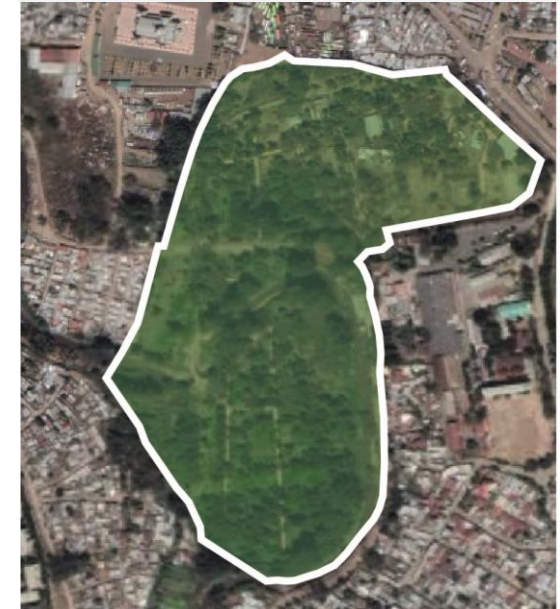
Beheretsige park (Scale 1:8000)

Main facilities and components – Main Entrance Ticket office, Animal zoo, children playground, kiosk, ceremonial and photograph space, administrative offices, rental halls, sport field Toilet, car parking pathways, open air and sheltered seating spaces and plantings.

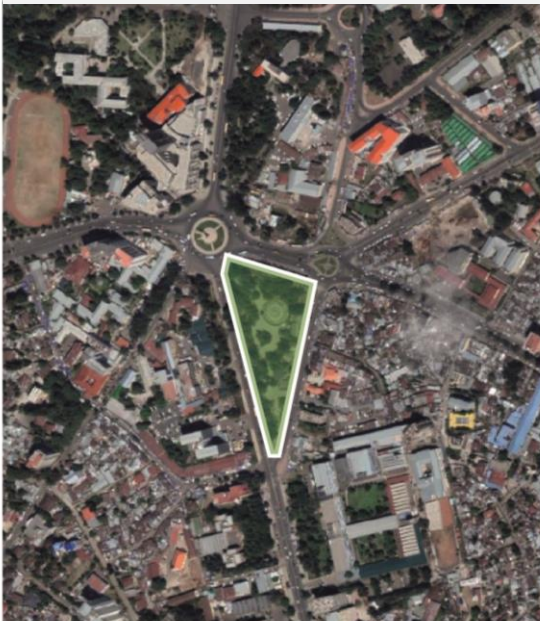
Anbes Gebi park (Scale 1:8000)

Main Facilities and components - main Entrance, Ticket office, administrative offices, car parking, pathways, seating spaces and plantings.

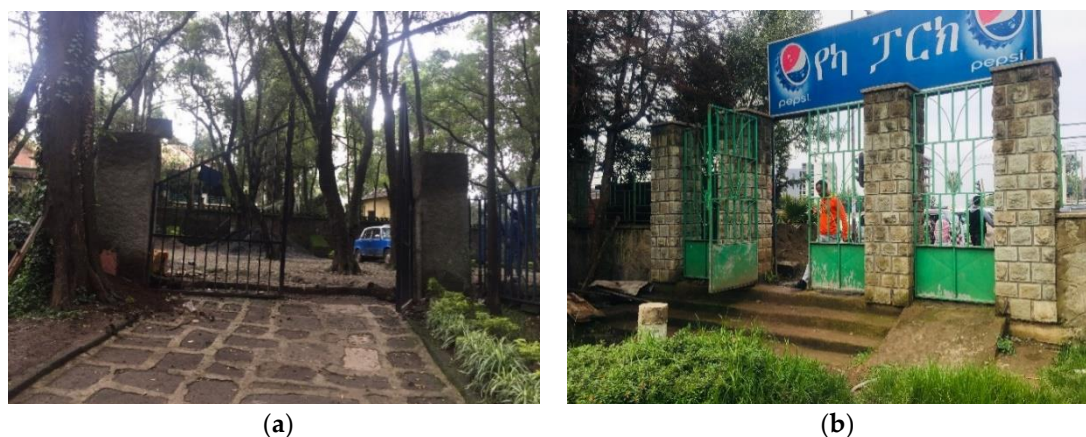
In addition, all the entrance in the 9 parks including entrance at Anbessa Gibi Park which has 80% accessibility compliance, has no tactile markings or orientation guides provided for visually impaired individuals making it difficult for visually impaired individuals to access the parks independently. As entrance spaces are the first components a person encountered to access any place including parks, it's a no brainer that the limited access to the entrance means limited access to the entire park and its facilities and components in general.

Figure 1. (a) Entrance of Sheger Park; (b) Entrance of Yeka Park. (Source - Author)

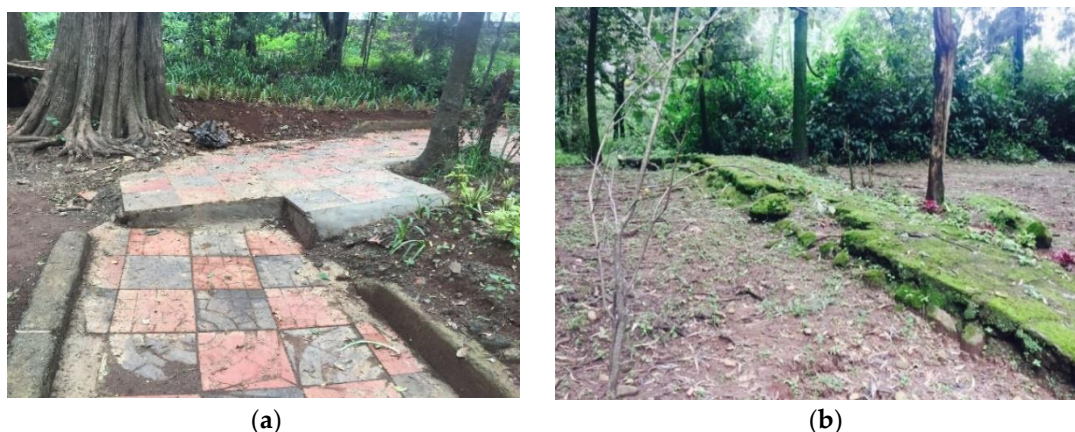
Pathways in all the 9 parks were assessed with the required pathways accessibility standard (See Appendix A) and it was found that Sheger park has complied with 33% of the requirement, Yeka and Addis Ketema 43%, Anbessa Gibi and ECA 57%, Peacock 29%, and Biheretsige has complied with 19% of the accessibility requirement. However, even with this percent of accessibility compliance, pathways in Sheger, Yeka, Addis Ketema, Peacock, and Bihere Tsigie parks are connected with a stair but no alternative ramps are provided for those using wheelchairs.

Figure 2. (a) Steps in Pathways at Sheger Park; (b) steep and damaged Pathways at Peacock Park. (Source - Author)

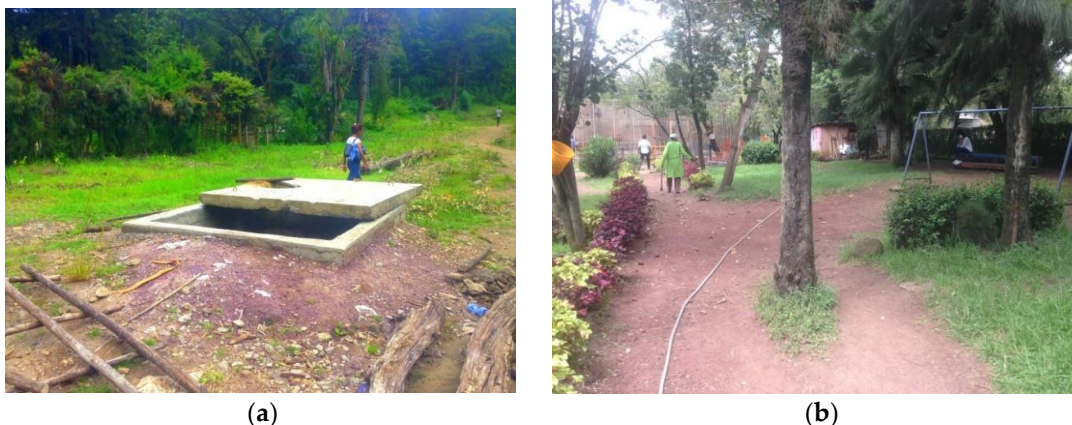
Figure 3. (a) Open manhole on the travel path at Beheretsige Park; (b) Tree planted on path of travel at Beheretsige Park. (Source - Author)

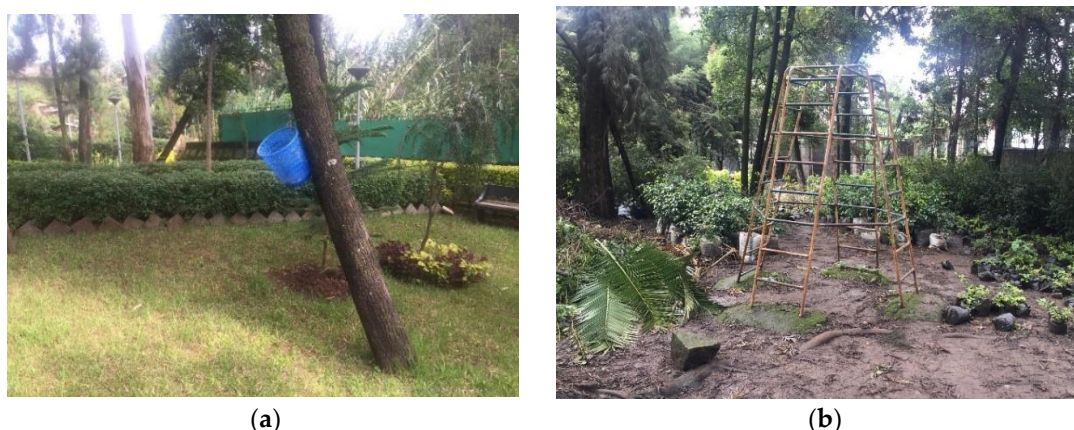
Figure 4. (a) Waste receptacles at Anbessa Gebi Park; (b) Play equipment at Sheger Park. (Source - Author)

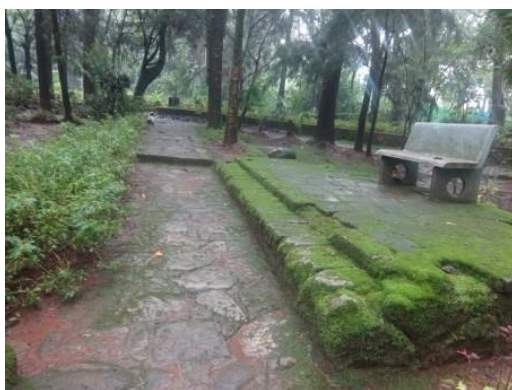
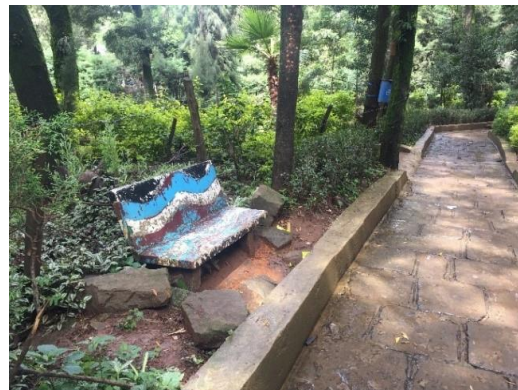
Few of the park facilities in Addis Ketema and Peacock parks are connected with main circulation pathways, but since they are observed placed in a raised platform, they cannot be reached by mobility-impaired users.

The seating facilities placed adjacent to circulation pathways in ECA Park don't have a space provided for wheelchair users but has still complied with 67% of the standard. Just because space is not provided for wheelchair users, a mobility-impaired person cannot use the spaces. This problem is observed in all the parks except Ethio - Cuba friendship Park which complied with 83% of the requirements.

Figure 5. (a) Seat placed in a raised platform at Peacock Park; (b) Seating at Yeka Park with no orientation guide. (Source - Author)

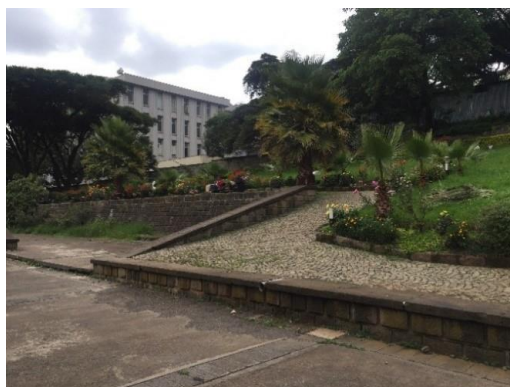
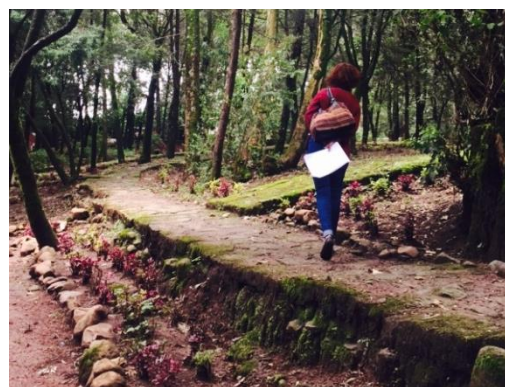
Even though available pathways in Ethio - Cuba friendship parks have better accessibility compliance next to pathways in Kolfe Park, the pathways are at an elevated level with no protection handrail and are not safe for visually impaired individuals. Though the width and gradient of ramps found in these pathways did consider wheelchair users, there is no proper landing to rest or change direction for these users. With no proper landing and no handrail on the top, the bottom and side of the ramps make it unsafe for wheelchair users.

Figure 6. (a) Elevated Path ways from adjacent landscape with no Protective rail or curb at ECA Park; (b) ramp with no landing and protective handrail at Ethio Cuba Park (Right). (Source - Author)
