ENGINEERING GEOLOGICAL EVALUATION OF EMBANKMENT DAM
FOUNDATION AND CONSTRUCTION MATERIALS CHARACTERIZATION OF
FATO DAM SITE, CENTRAL ETHIOPIA

MASTERS OF SCIENCE IN ENGINEERING GEOLOGY

ADDIS ABABA UNIVERSITY

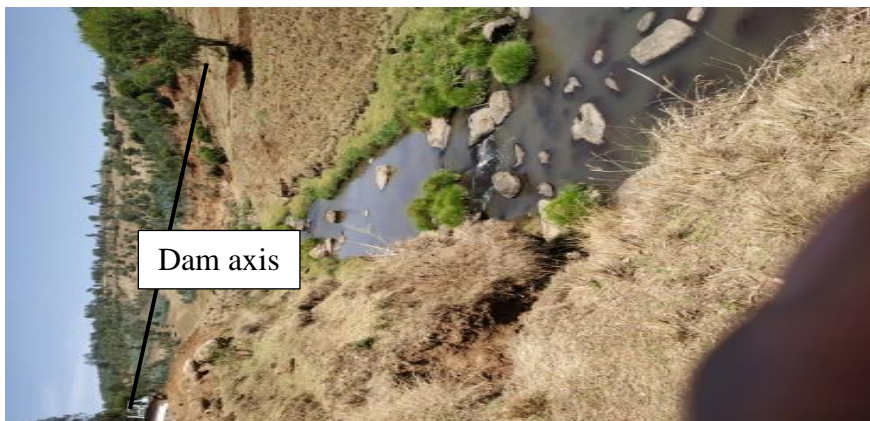
Figure 3.1 Basalt rock exposed in river bed.

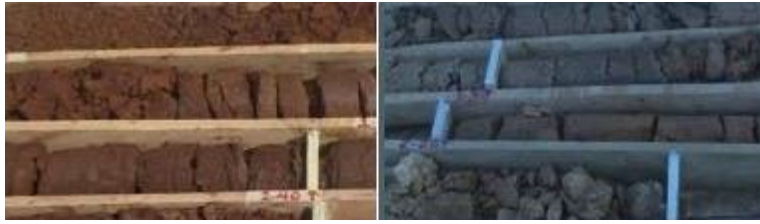
Figure Soil mass from core log foundation area.

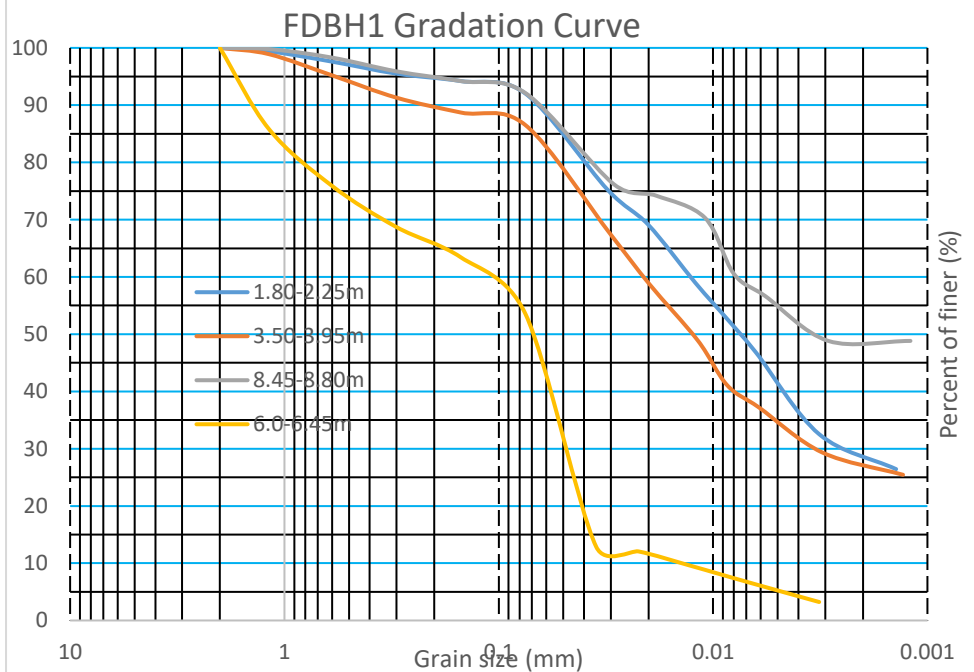
Figure 5.1 Gradation curve of FDBH1

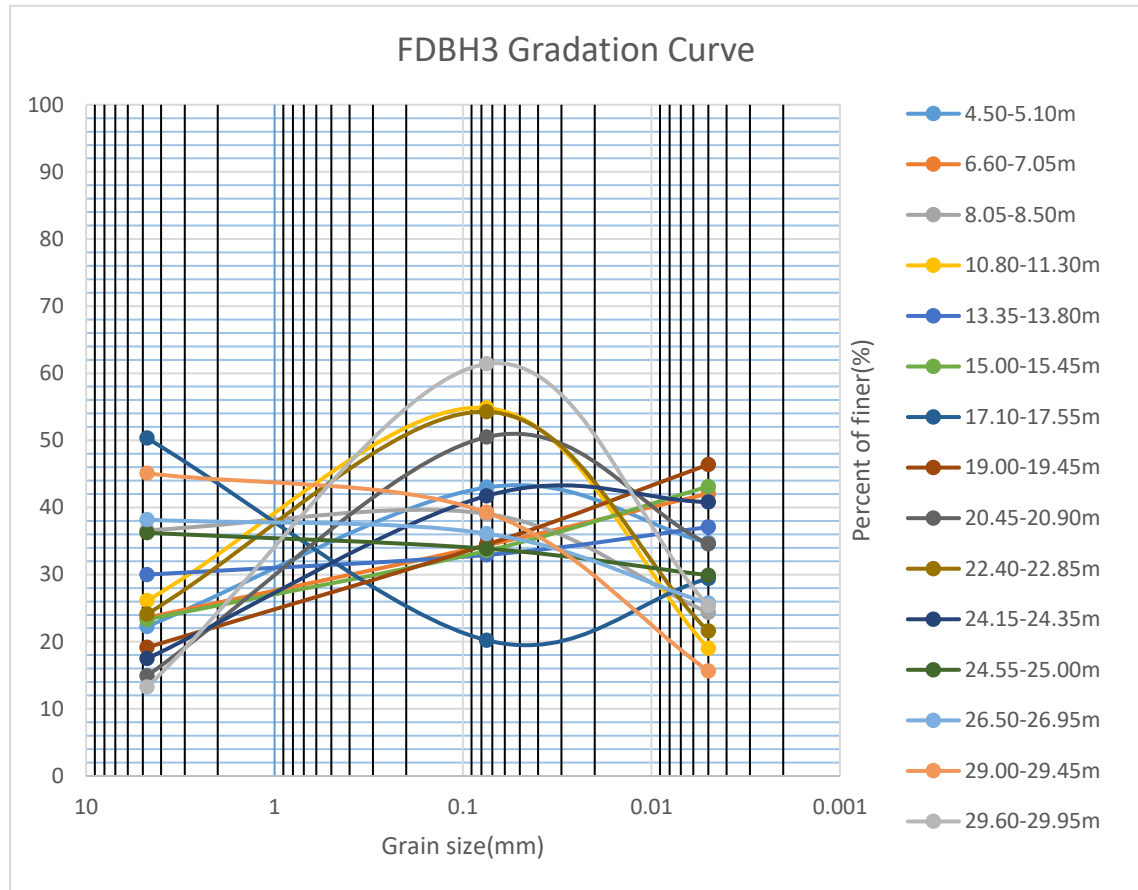
As observed from Figure 5.2, silt-sized soils were dominant in average through the different depths of the right abutment. Sand-sized soils occurred at different depths, from 13.25% to 50.3%, and clay-sized soils were from 15.65% to 46.39%. In the depths of 1.80 to 3.95m and 8.45 to 8.80 m, the percent of fines was greater than 25%. The soil from 6.0 to 6.45m

was coarser than the other three test sections. D10, D30, and D60 of the depths of 6.0 to 6.45 m, respectively, are 0.015mm, 0.05 mm, and 0.12mm. Its coefficient of uniformity, $C_u = 2.4 < 4$

Coefficient of curvature (C_c) = $(0.05)^2 / (0.015 * 0.12) = 1.4$. So it was poorly graded soil.

Figure 5.2 Gradation Curve of FDBH3

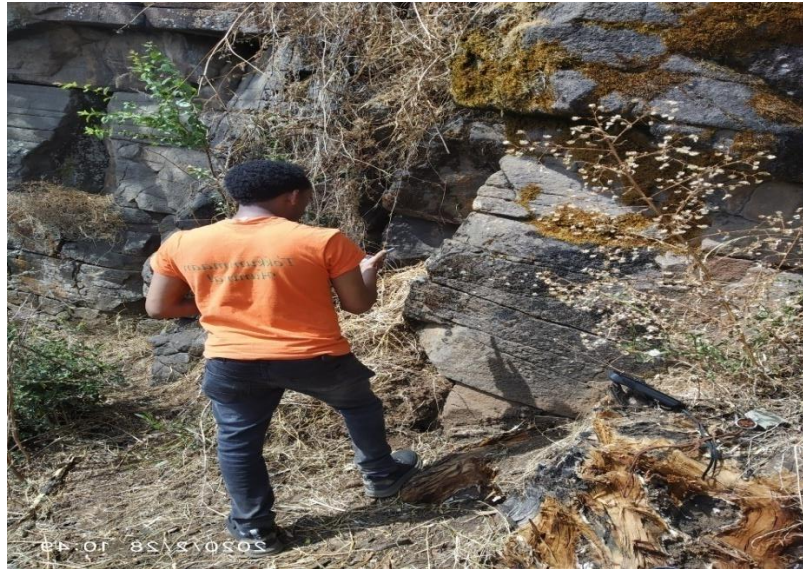
Figure 5.3 Jointed and weathered basaltic unit at top ridge of left abutment

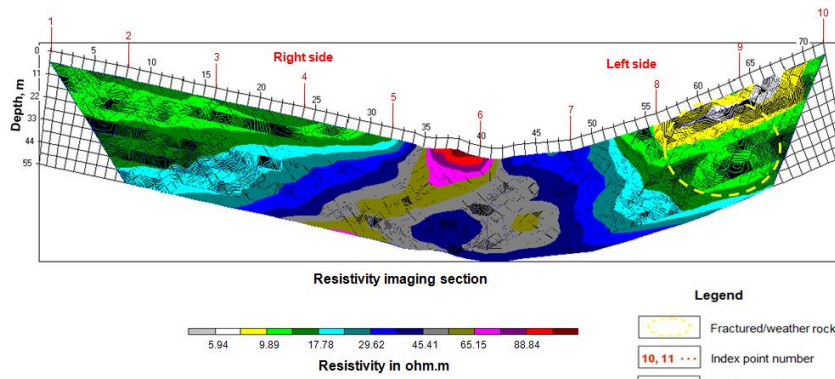
Figure 5.6 Imaging section for GPA-1

The yellow colour indicated by the image's index shows the area of weak and fractured formation at the site. By correlating the index expressed in yellow colour resistivity imaging with the weak formation boreholes (FDBH1) left abutment, the area was affected by geological structures (discontinuity). The fragment of vesicular from the core box (Figure 5.9) showed that the weathered and fractured rock formation indicated yellow index symbols of geophysical interpretation (Figures 5.6 and 5.7). This made the foundation of the dam problematic if not improved in terms of strength and seepage.

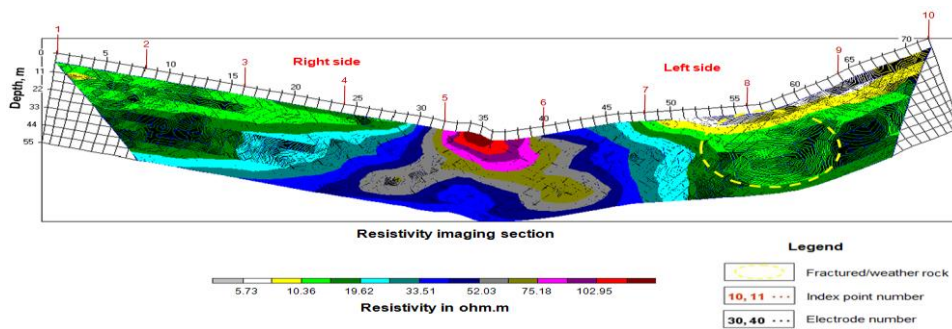
Figure 5.7 Imaging section for GPA-2

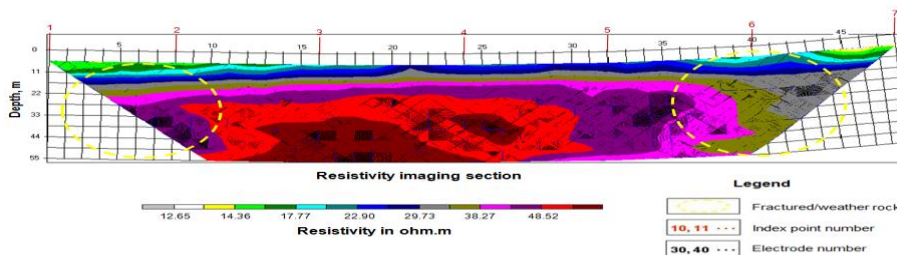
Figure 5.8 Imaging section for GPA

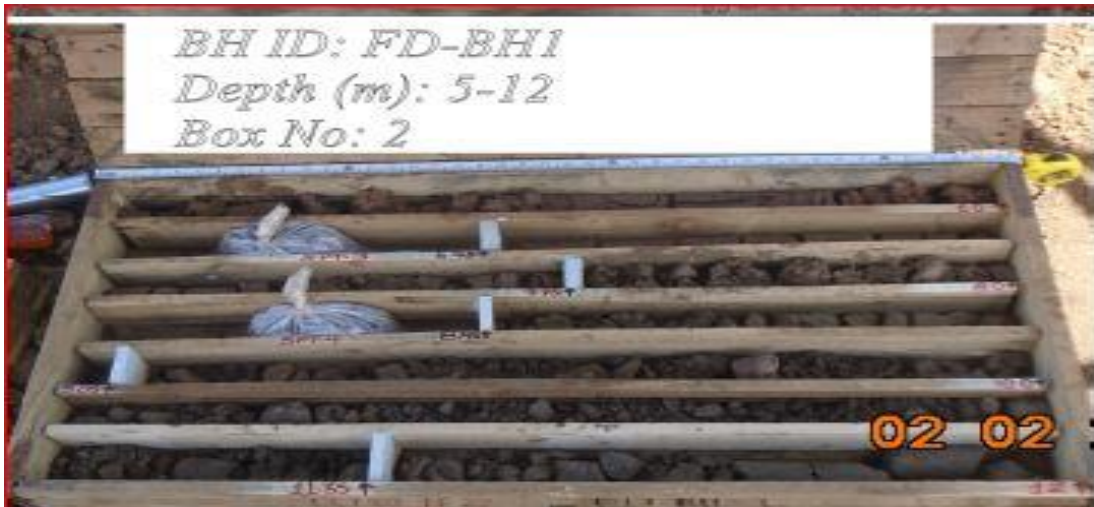
Figure 5.9 of core box shows that fractured vesicular basalt from left abutment (FDBH1)

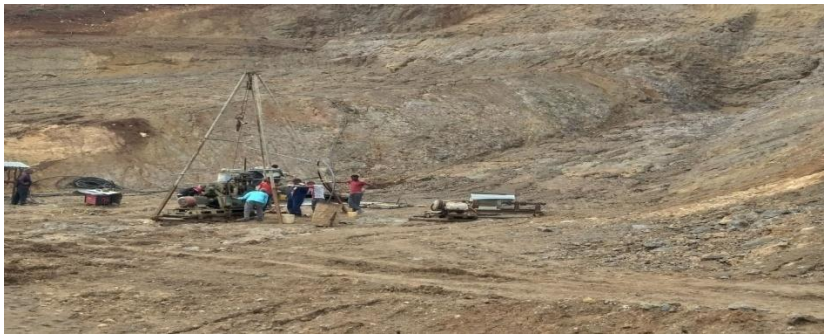
Figure 5.11 Grouting test in Weak formation at left abutment

Therefore, this treatment is good for 4.7 to 9.7m depth for weak zones extended from 12 to 32m in the left abutment.

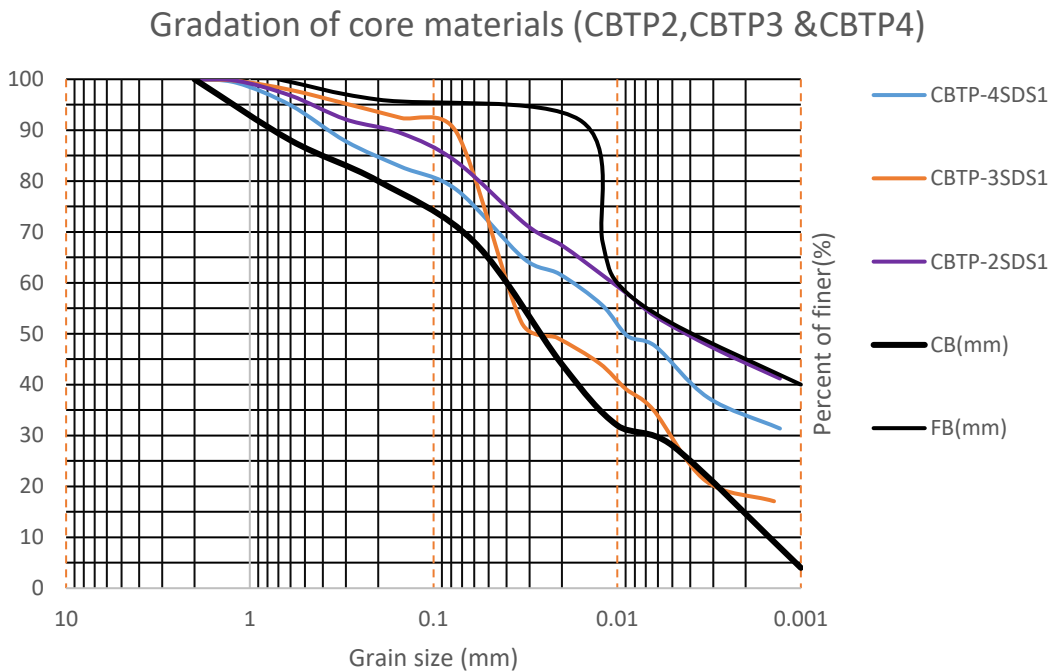
Figure 6.2 Gradation Curve of Coarse boundary (CB) and Fine boundary (FB)

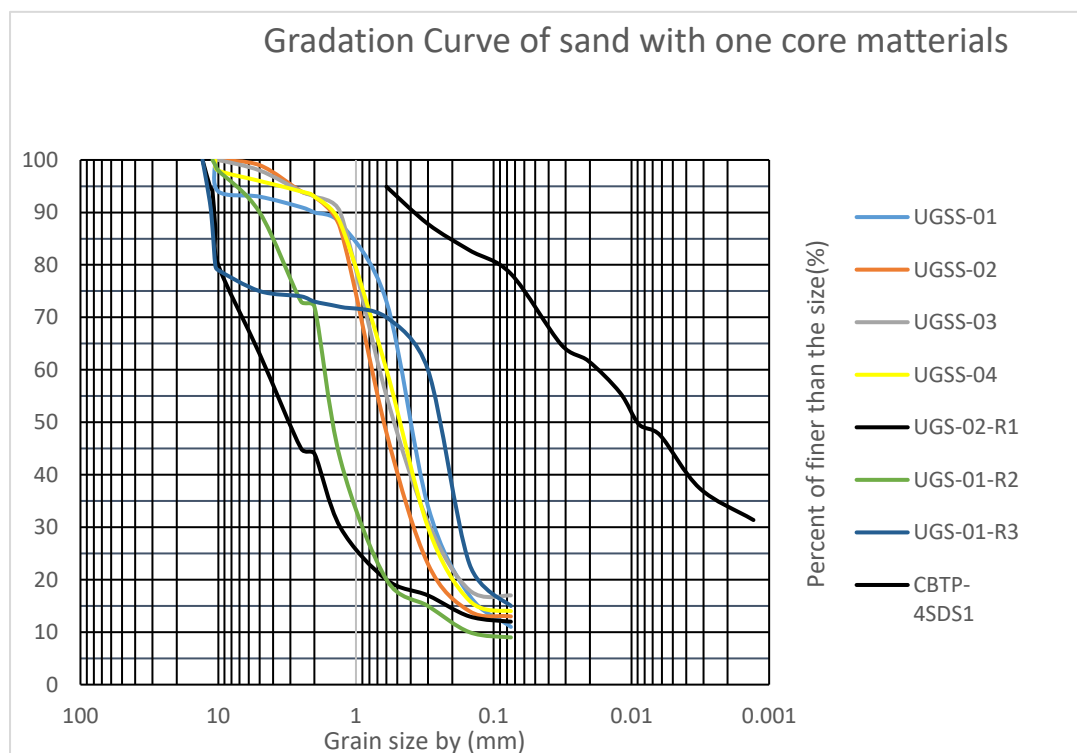
Figure 6.3 Gradation Sand proposed for filter and transition with core materials.

The filter materials of the present project include: fine filters (F1), coarse filters (F2), and transition materials (2C). From the above gradation curve and tables (6.5 and 6.6), filter criteria are interpreted as follows: The analyzed sand materials with core materials here did not satisfy even one of the three fully. Therefore, the sand material proposed from the Senkelle area was not suitable for filter and transition materials.

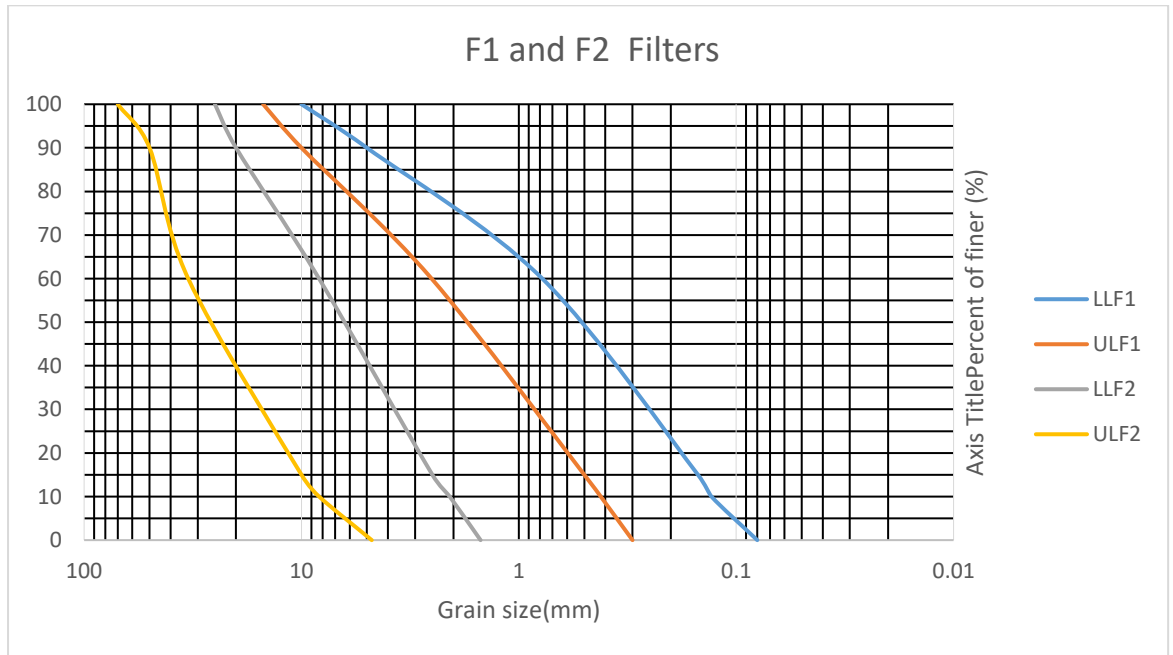
Figure 6.4 Upper and lower limits of F1 & F2

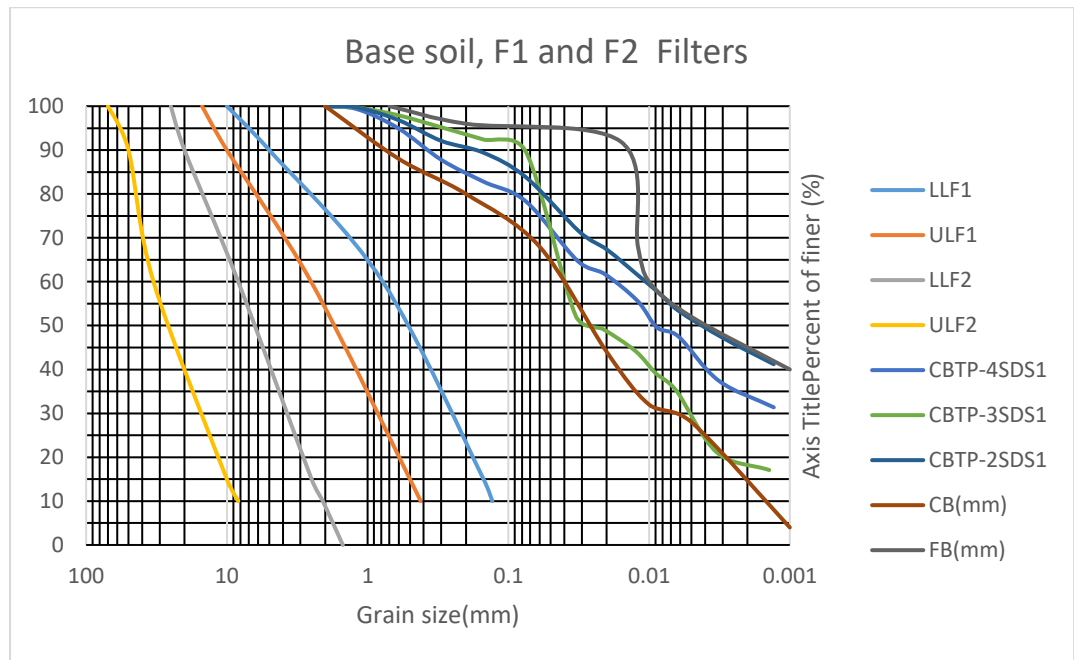
Figure 6.5 Gradation Curve of Fine F1, coarse F2 and base soil

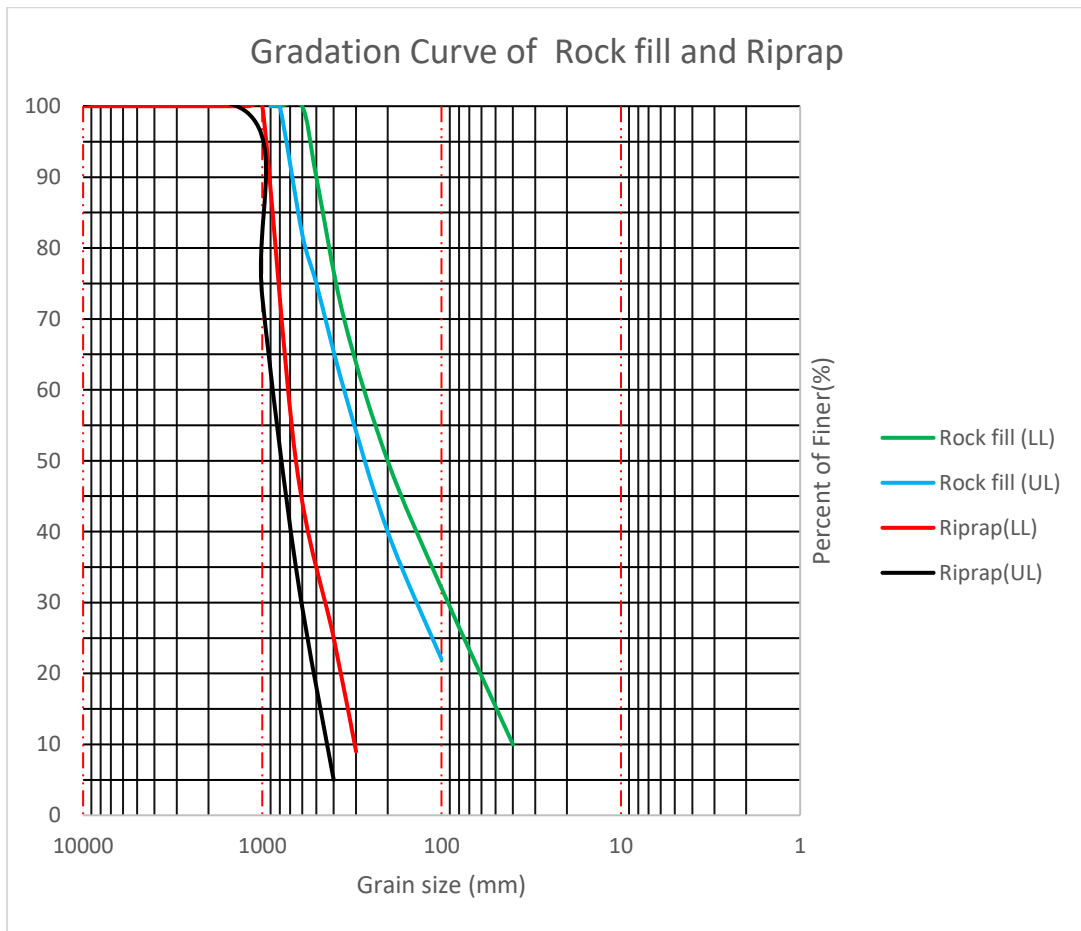
Figure 6.6 Gradation Curve of Riprap and Rock fill based on their size

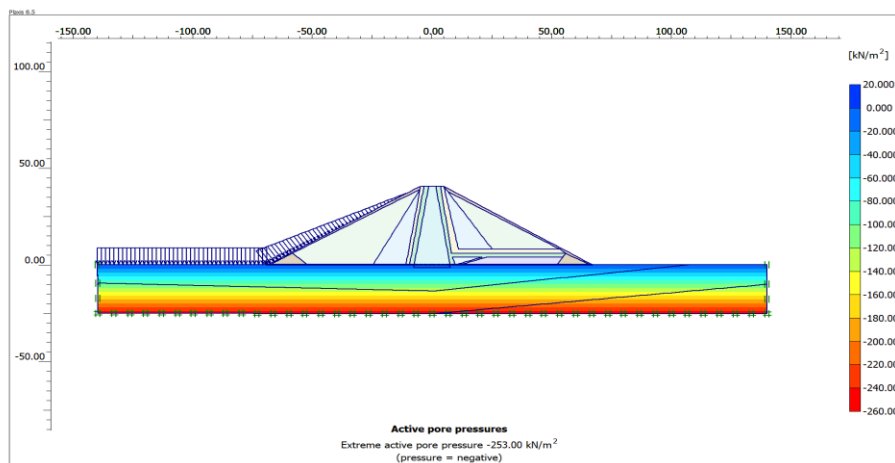
Figure 6.8 Active pore pressure distribution of foundation bed

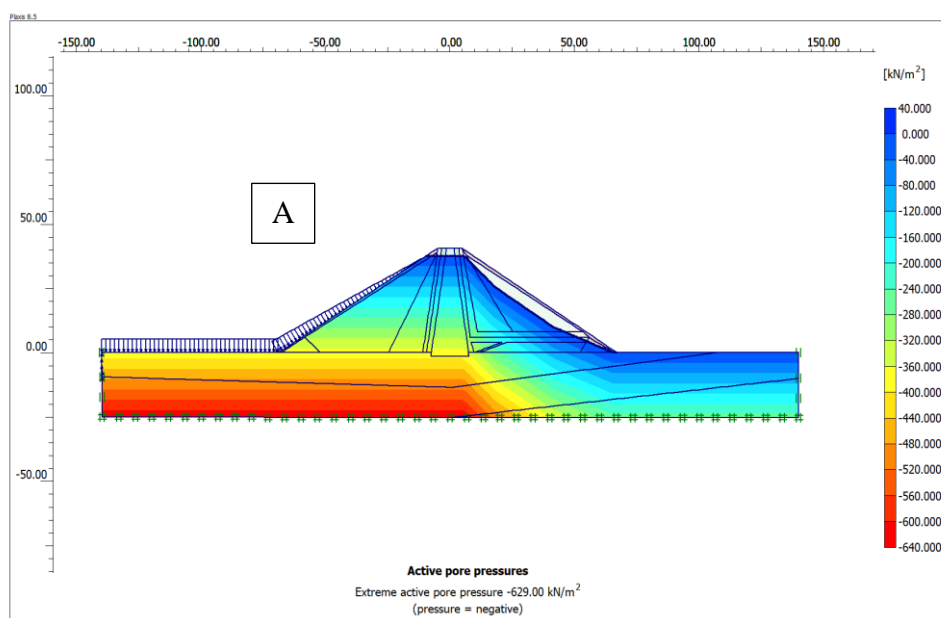
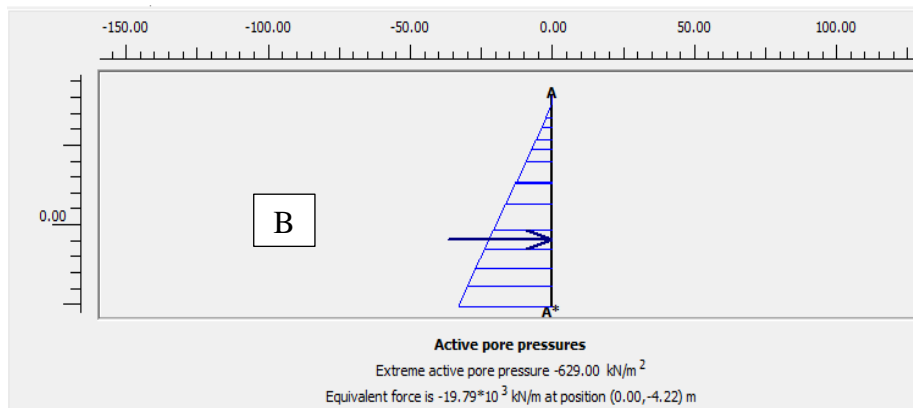
Figure 6.10 Distribution (A) and Cross section (B) of Active pore pressure at phreatic level at RFL

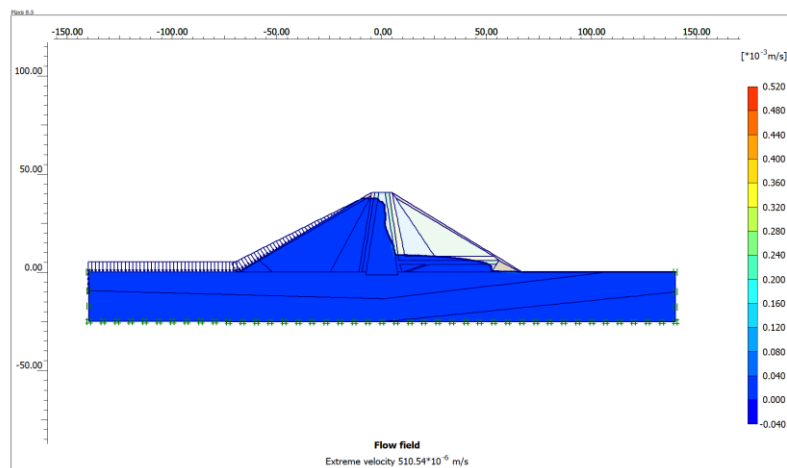
Figure 6.11 seepage flow (steady state) when phreatic line location at RFL

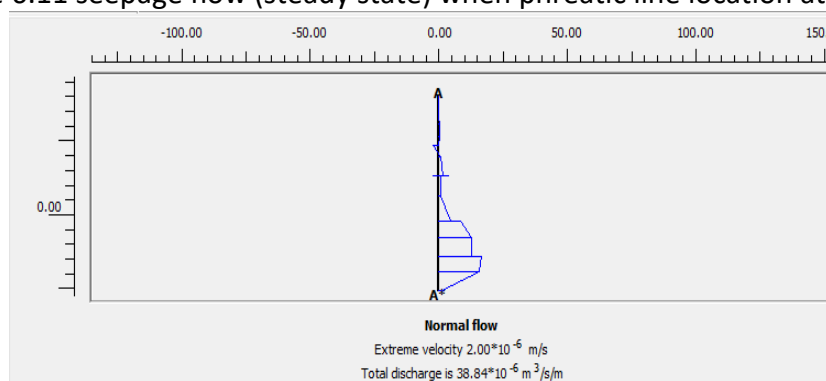
Figure 6.12 Seepage flow quantity in embankment dam body and foundation

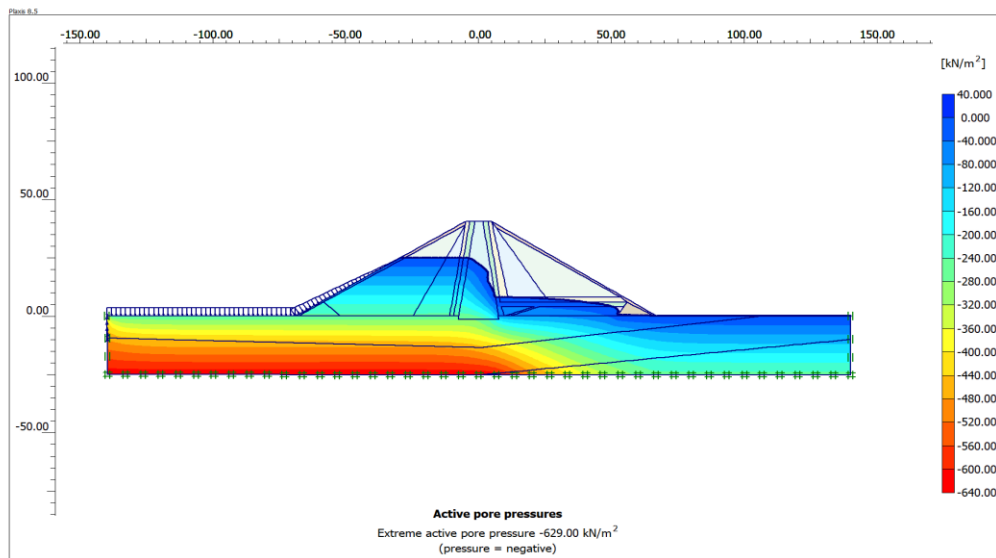
Figure 6.13 Active pore pressure distribution when phreatic line at 25m

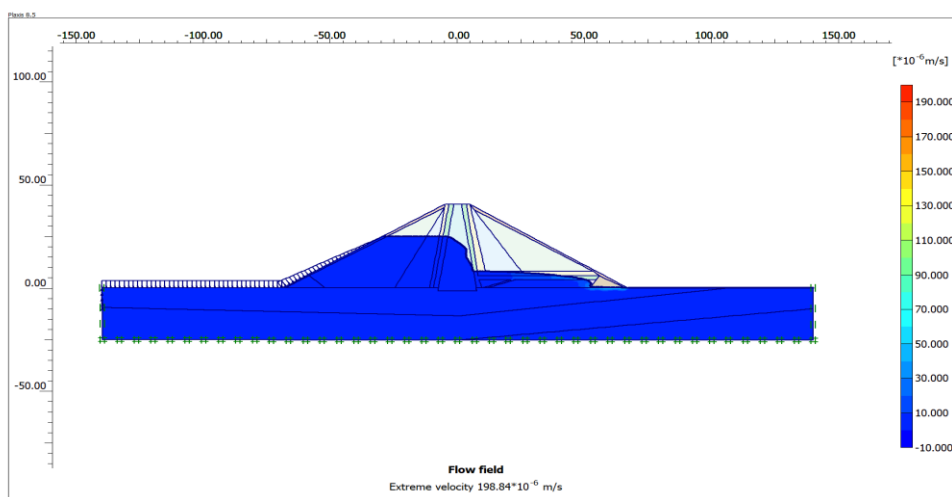
Figure 6.14 Seepage flow when GW head at 25m above foundation

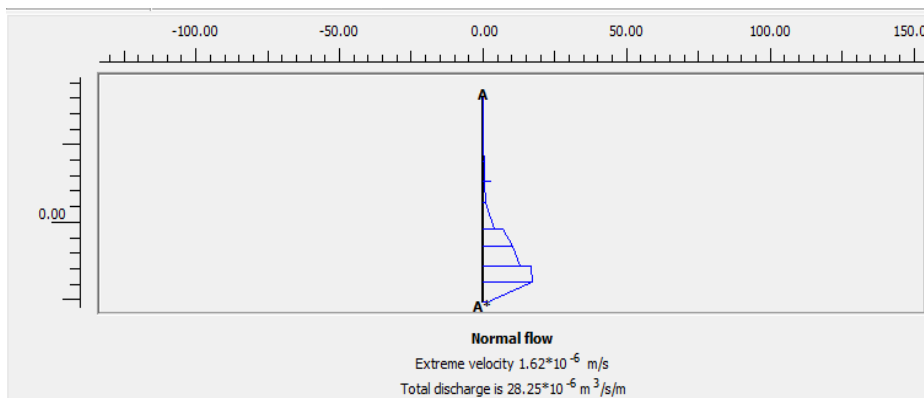
Figure 6.15 Seepage quantities for phreatic line at 25m above foundation.

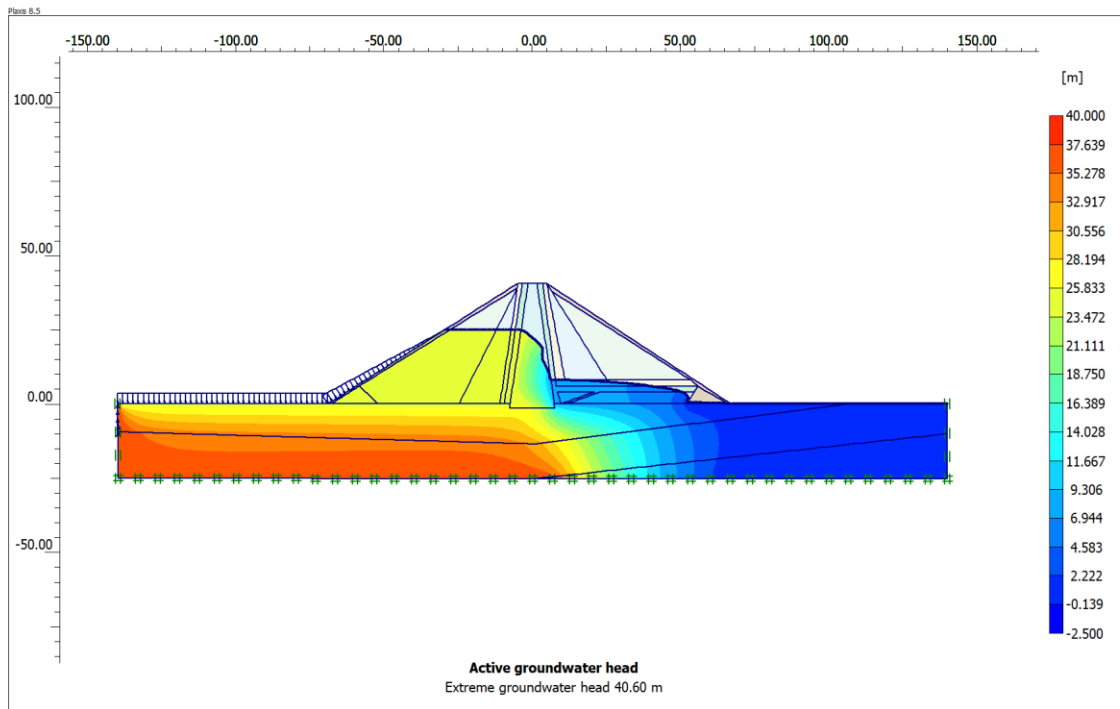
Figure 6.16 Ground water head models for phreatic line at 25m

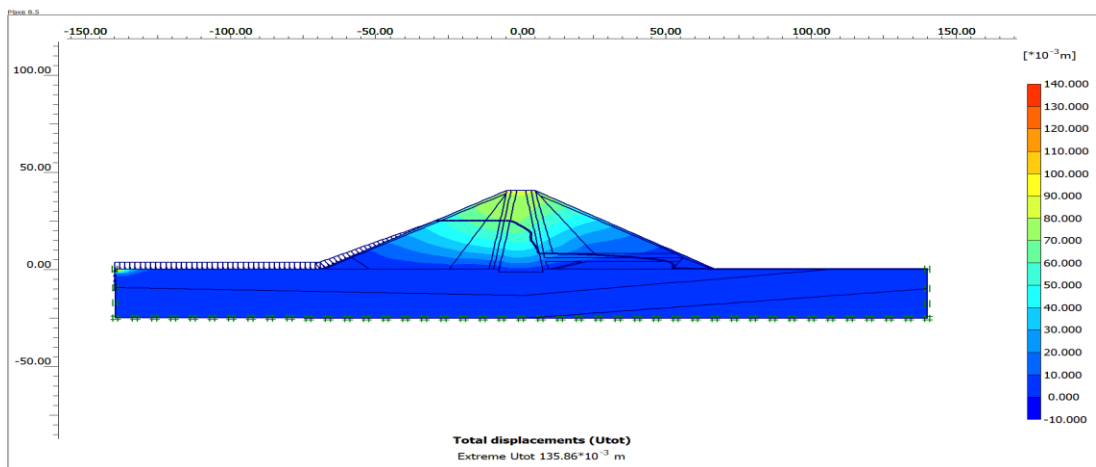
Figure 6.17 total displacement steady state Seepage when GW head at 25m

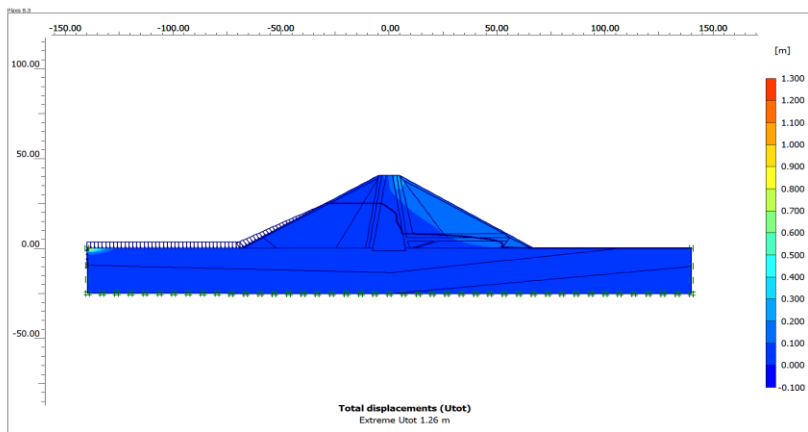
In this case flow was slowly reduced from higher (RFL) level to lower level in phreatic reduction.

Figure 6.18 Total displacements in phreatic reduction flow type

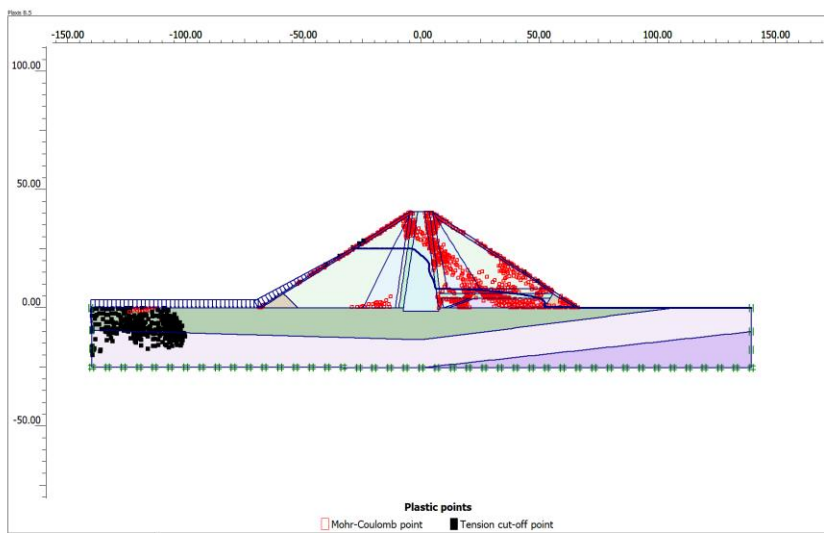
Figure 6.19 Plastic points at 25m GW head

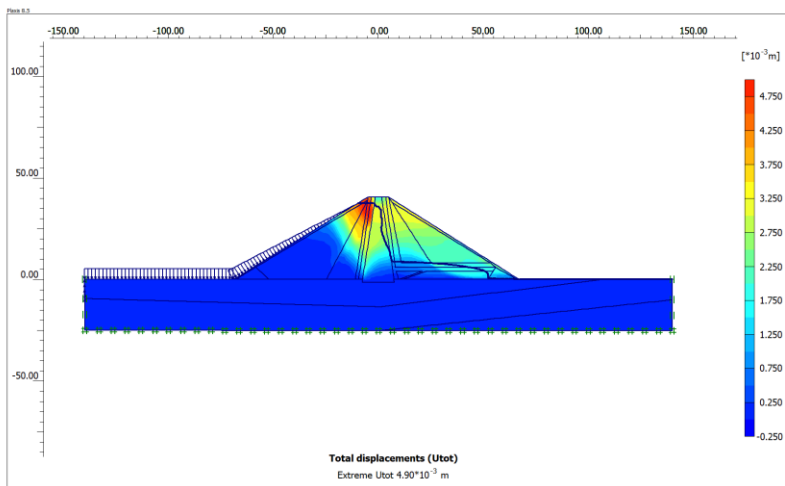
Figure 6.20 total displacement in dynamic condition

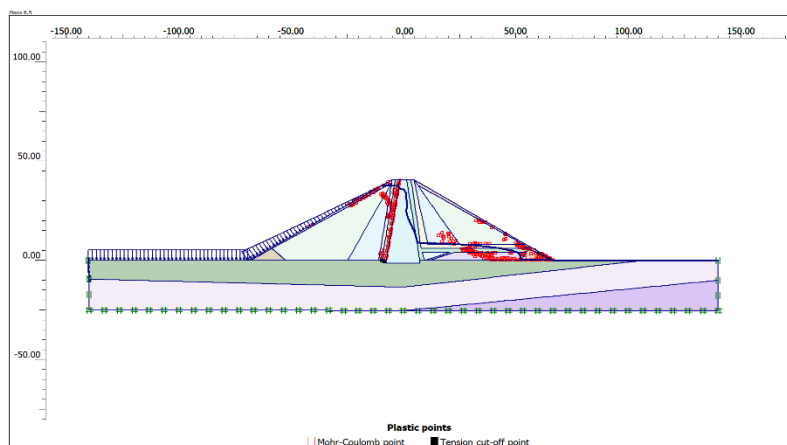
Figure 6.21 Plastic point in dynamic condition

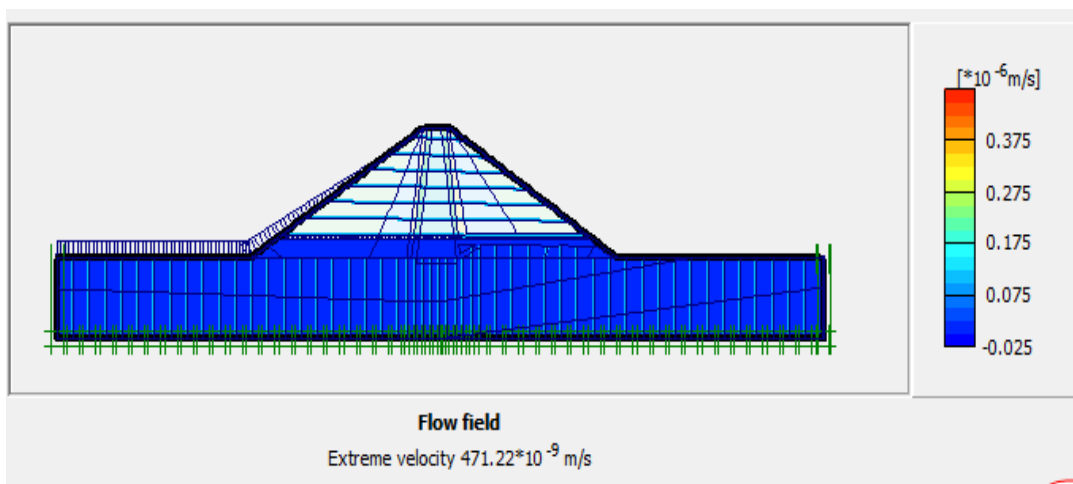
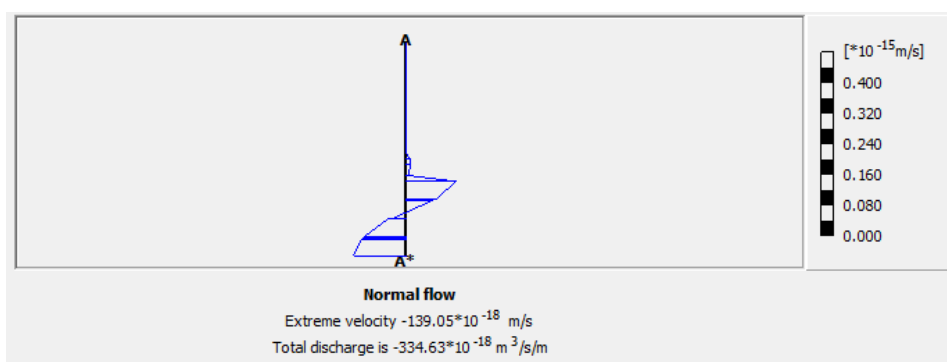
After using remedial measures of curtain grouting (secondary in less critical area, tertiary in around river bed) and consolidating grouting in some places where fractured materials were dominant. Then the discharge was reduced to 3.4×10^{-16} m³/s/m and normal flow was reduced to 4.71×10^{-7} m/s. Therefore, by using remedial measures the criteria of seepage from plaxis standard was satisfied.

Figure 6.22 Seepage flow (A) and seepage quantity (B) after using remedial measures at RFL

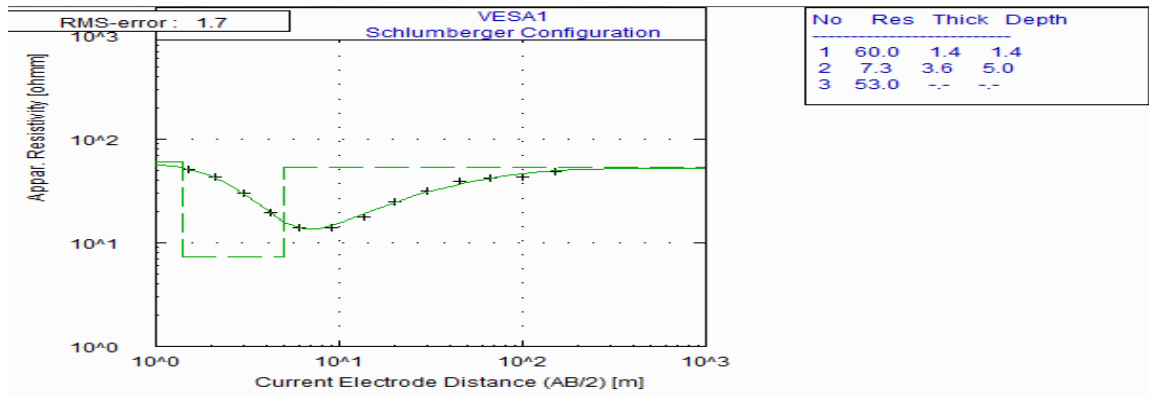
Figure Interpretation of VES model for VESA-1

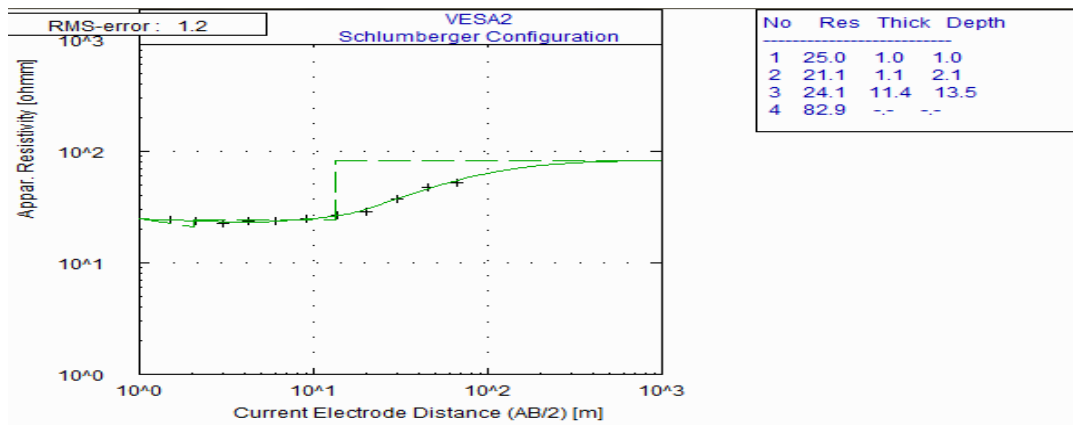
Figure Interpretation of VES model for VESA-2

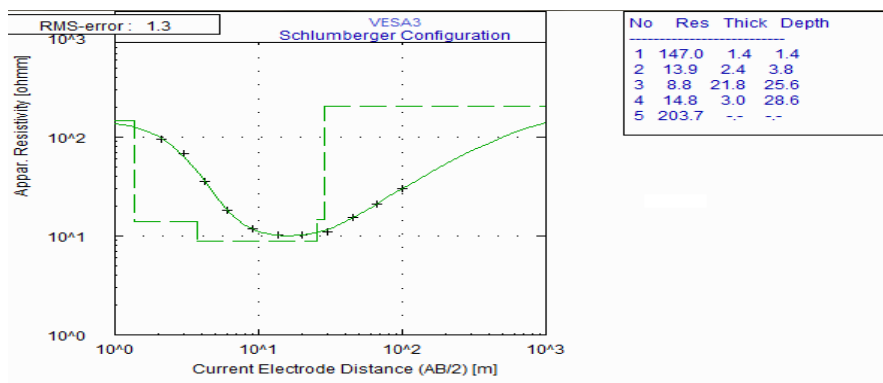
Figure Interpretation of VES model for VESA-3

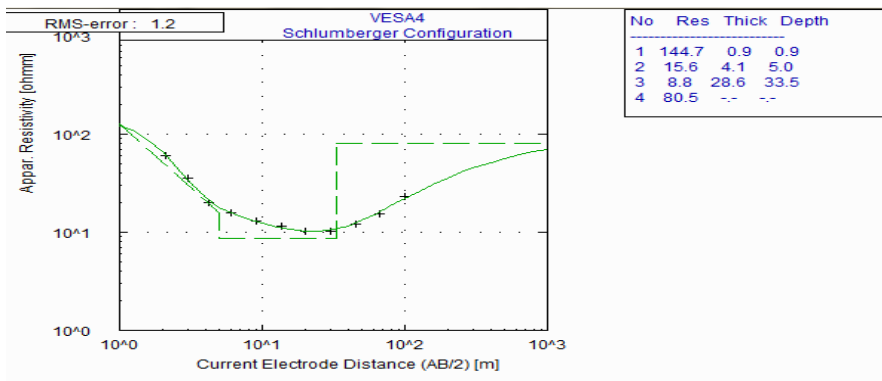
Figure Interpretation of VES model for VESA-4

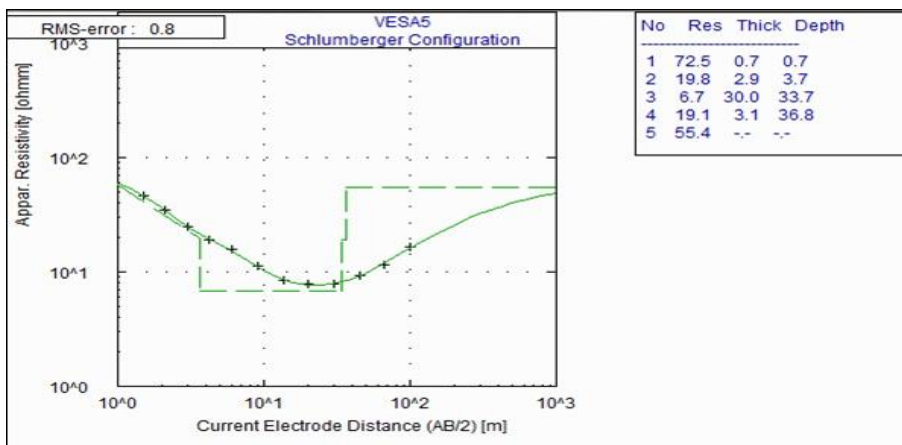
Figure Interpretation of VES model for VESA-5
