ASSESSMENT OF DAMAGE OF BUILDINGS CONSTRUCTED
IN EXPANSIVE SOIL AREAS OF ADDIS ABABA

A thesis submitted to
The school of graduate studies of Addis Ababa University in partial fulfillment of the
requirement for the degree of Master of Science in Geo-technical Engineering

By Afewerk Sisay
October 2004

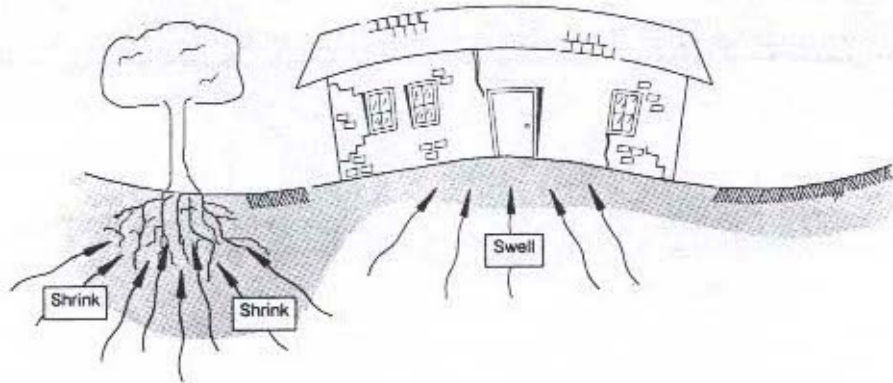
The distortion takes the shape of a plate bent with the edge down and the middle up. This type of distortion occurs as a result of the soil around the edge of the slab drying out and shrinking, or the soil beneath the center of the slab wetting up and heaving or a

combination of both. Sometimes, the combination is produced by the soil beneath the slabs center wetting up and heaving while a tree or other vegetation is removing water from beneath the slab edge during a drought. This distortion mode is distinguished by floor being distorted in a concave down ward mode and exterior slab being wider at the top than at the bottom [2]

Fig 2.1 Center lift distortion which is typically caused by heaving beneath the interior of the building, shrinking around of the perimeter of the building

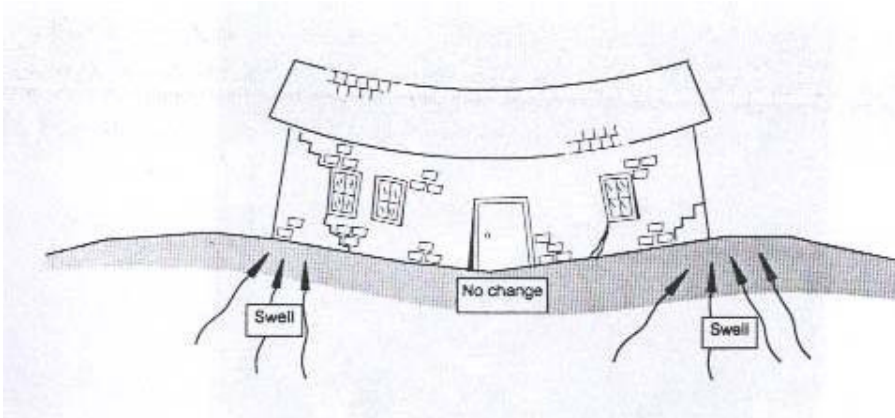
Edge lift distortion takes the shape of plate bent with the edges up and the middle down, dishing type of distortion. This type of distortion occurs because of the soil around the edge of the slab wetting up and heaving. Although it could also be caused by the soil beneath the center of the slab drying out and shrinking, this situation seldom happens. This type of distortion mode is recognized by exterior crack being wider at the bottom than at the top

Fig 2.2 Edge lift distortion which is typically caused by heaving around the perimeter of the building

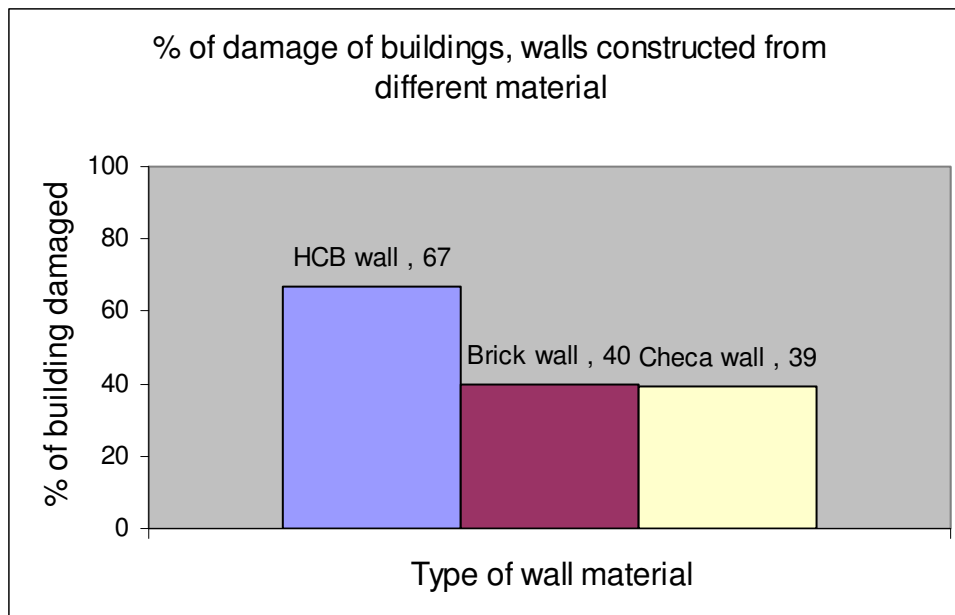
Fig 3.2 Chart showing % of building damages related with wall material

From the result of the observation data, Buildings walls constructed from hollow concrete block wall showed more damages than those walls constructed from brick and ‘checa’ wall.

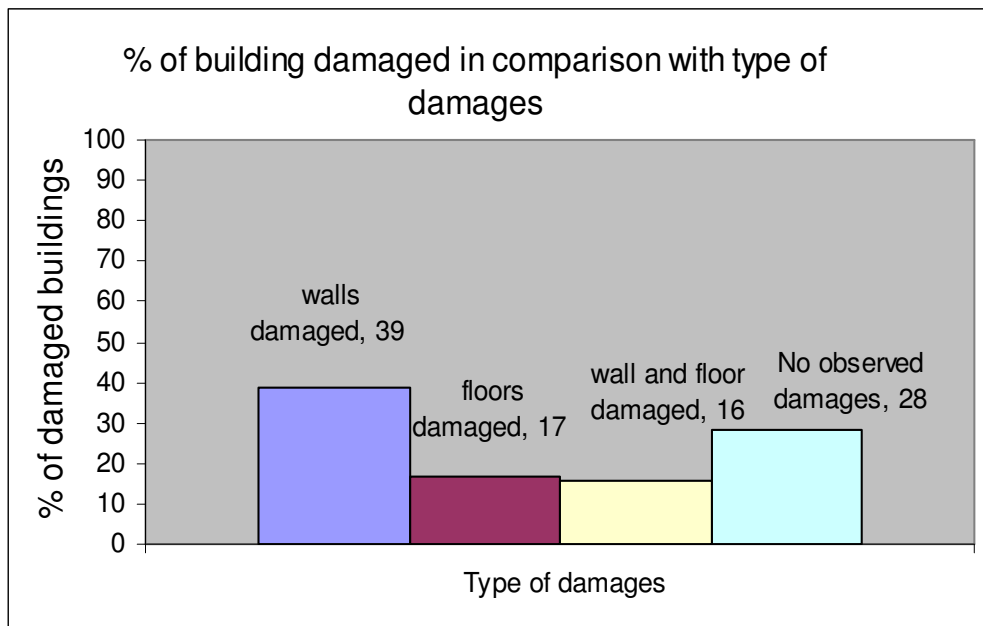
Fig 3.3 Chart showing % of building damages related with type of damages

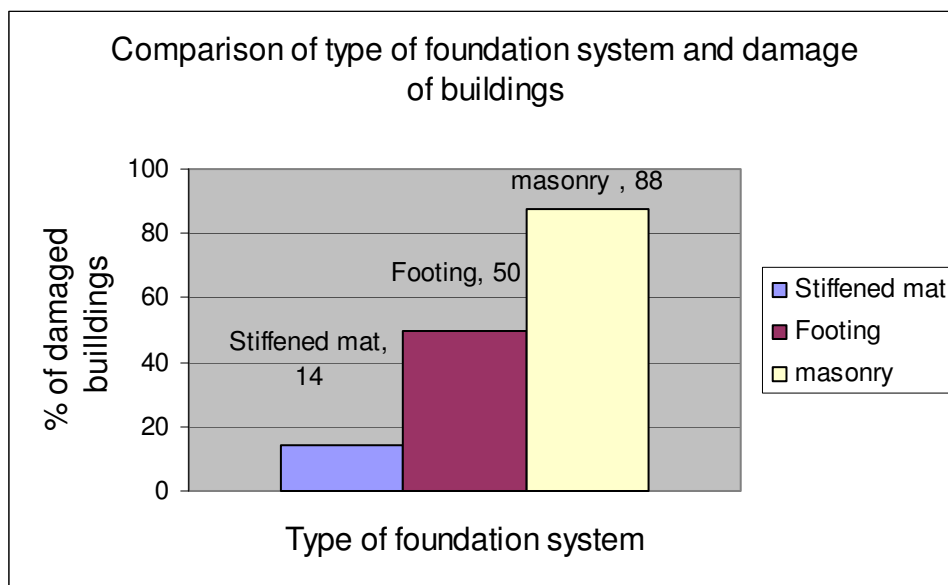
Most of the foundations of the observed buildings are masonry foundation. 88 % of the buildings with masonry foundations are damaged. A comparison is made for the performance of foundations system on expansive soil.

Fig 3.4 Chart showing % of building damaged related to foundation type

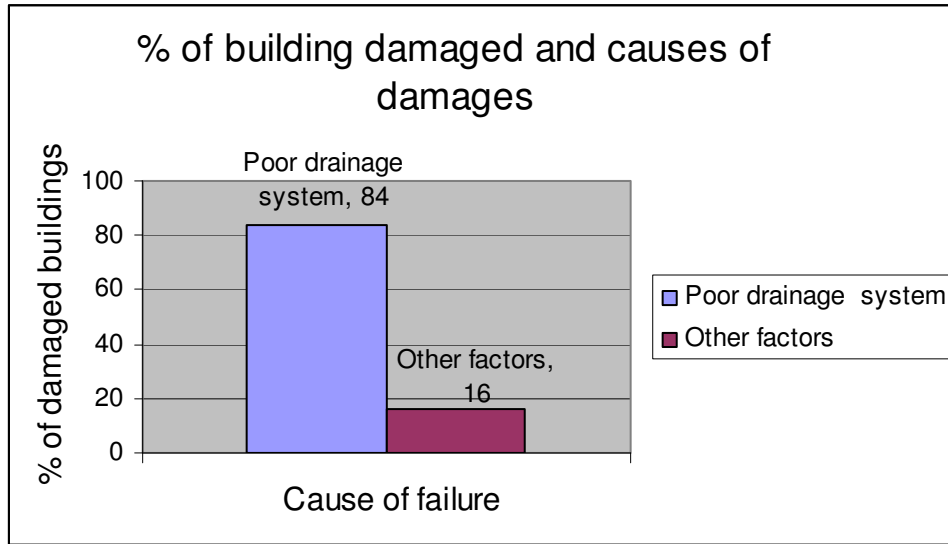
Fig 3.5 Chart showing % of building damaged and causes of damage

From the 69 buildings, that shows crack 84% lack adequate and appropriate surface and sub surface drainage system, which prevents equilibrium moisture disturbance. The other factors that cause damage are vegetations around the building, leaking of pipes, splashing of down pipes to the foundation soil and new adjacent construction.

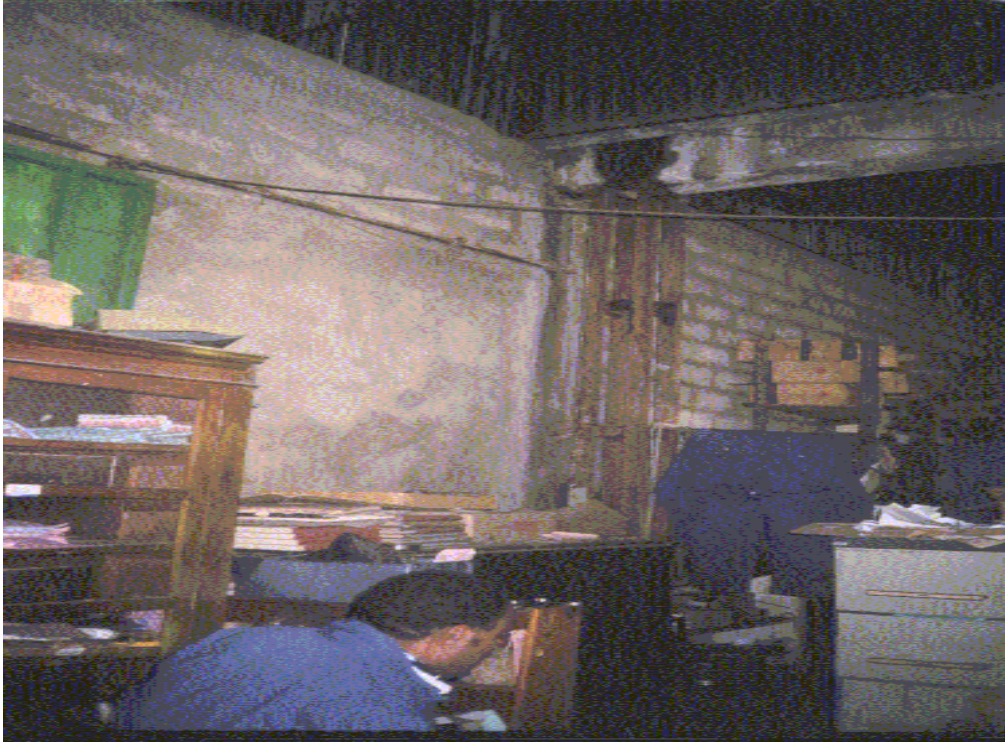
Shear of tie beams in Addis Ababa city Administration car maintenance hangar, buckling of steel column and failure of truss member in Ethiopian Airlines maintenance hangar is caused by the movement of the supporting structural element .The movement decreases the load carrying capacity of the structural element and ultimately may lead to collapse of the whole structure. Some of the observed buildings of which sever structural damages are observed are shown in Fig 3.6a and in Fig 3.6b.

Fig 3.6a Shear of tie beam in Addis Ababa city car maintenance hangar

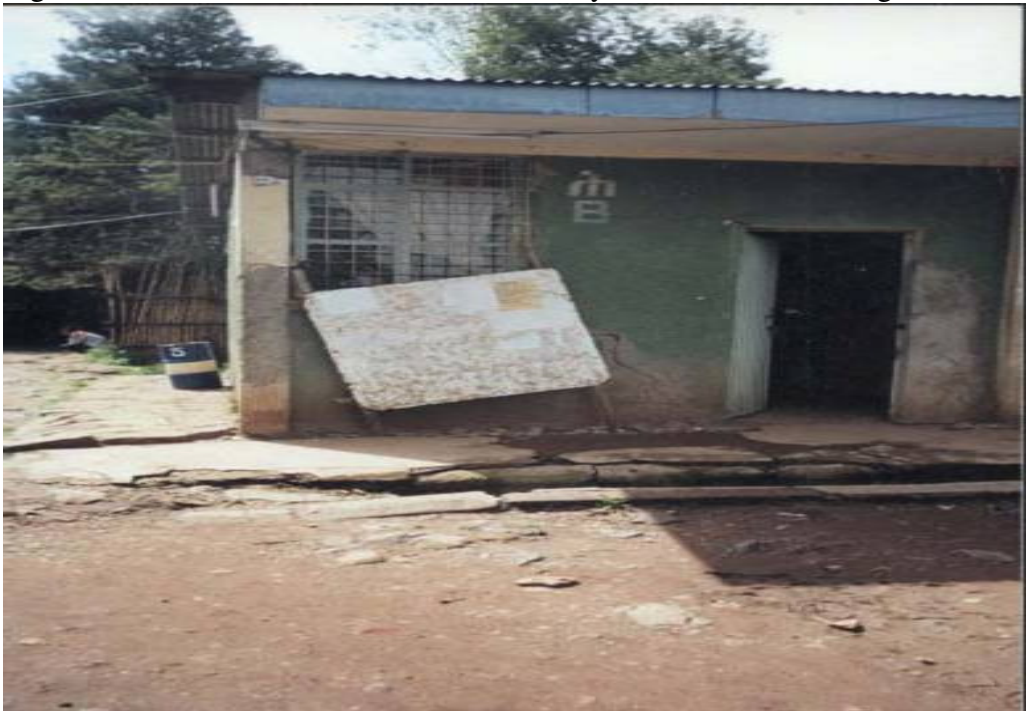
Fig 3.6 b Detachment of tie beam and column in bole senior secondary school

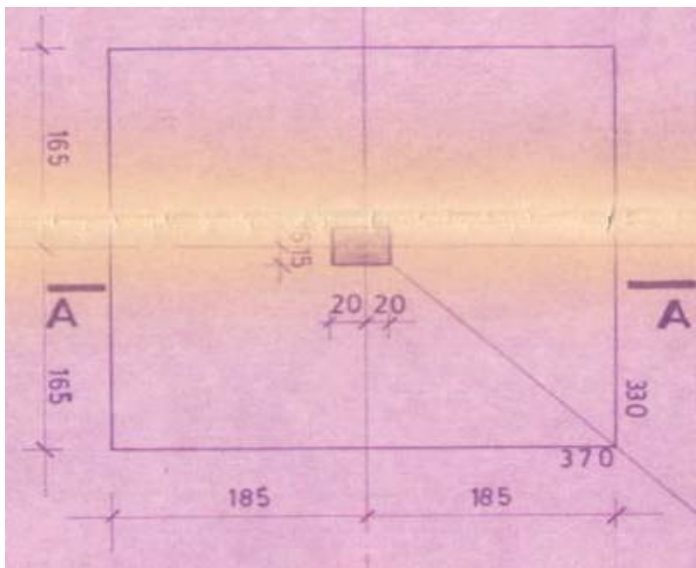
Fig 3.7b Footing size for G+1 office building in expansive soil area of Addis Ababa for the same building for which the note is shown above

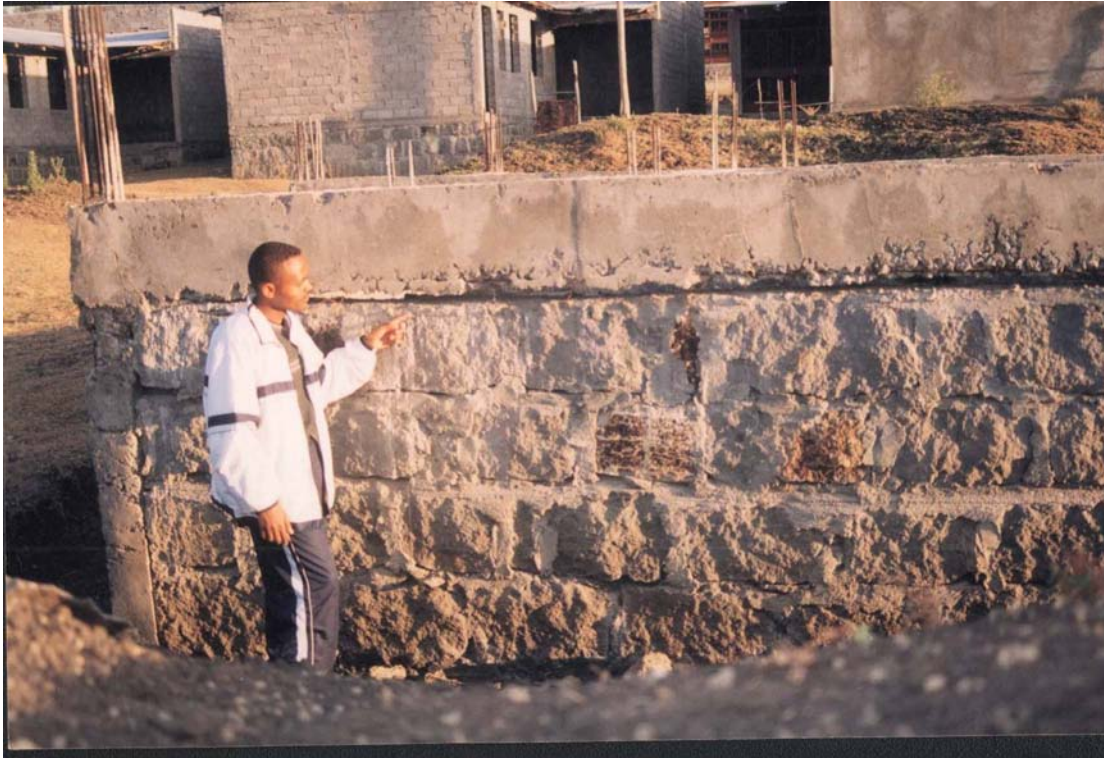
Fig 3.8 Settlement of masonry wall below grade beam in bole bulbula area

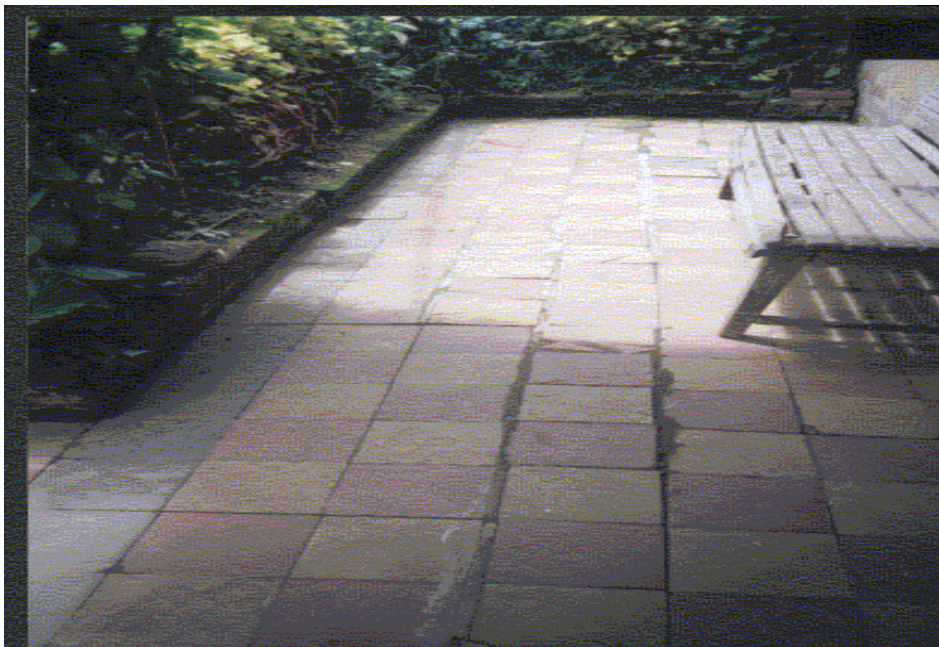
Fig 3.9a Heave of verandah floor in Olympia area due to lack of void between slab and grade beam

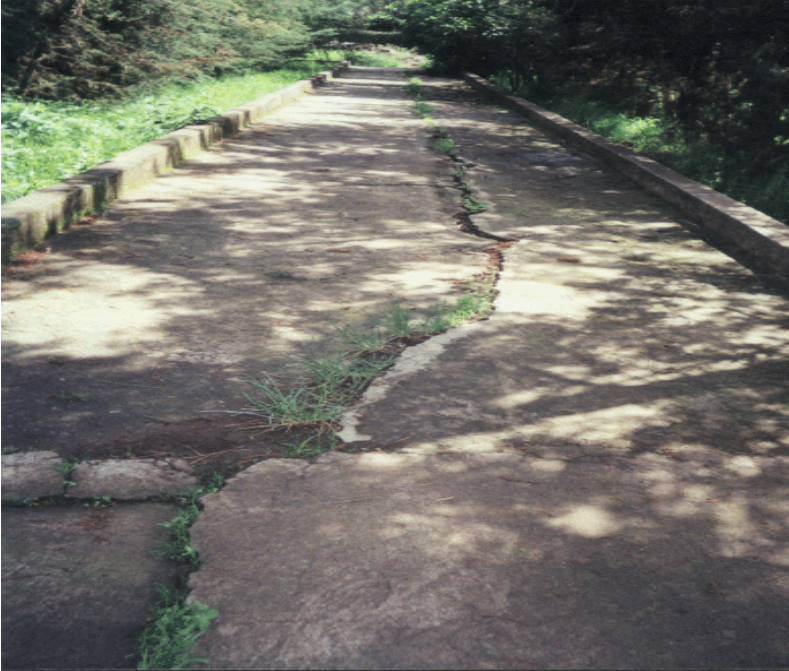
Fig 3.9b Crack of walk way in bole senior secondary school due to lack of void space between the walk way and the concrete curb stone .The source of moisture fluctuation is the surrounding vegetation

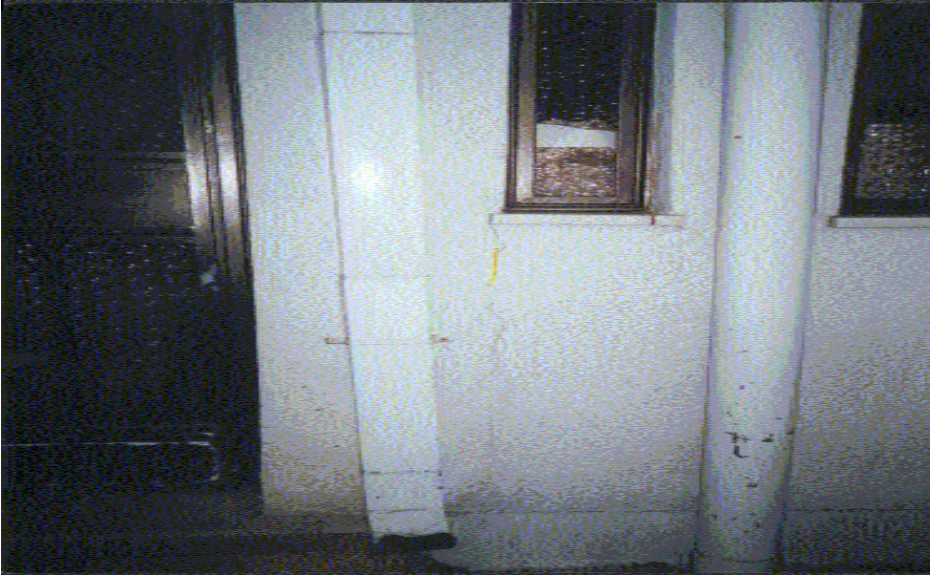
The building in Fig 3.10a built in bole area cracked at the corner of windows in the vicinity of down pipe spout. The crack appeared due to failure in maintaining the down pipe spout, which splashes to the foundation soil. It is a good practice to observe any change around the building if crack happens and to make early maintenance before the condition worsens.

Fig 3.10a Splashing of water to the foundation soil

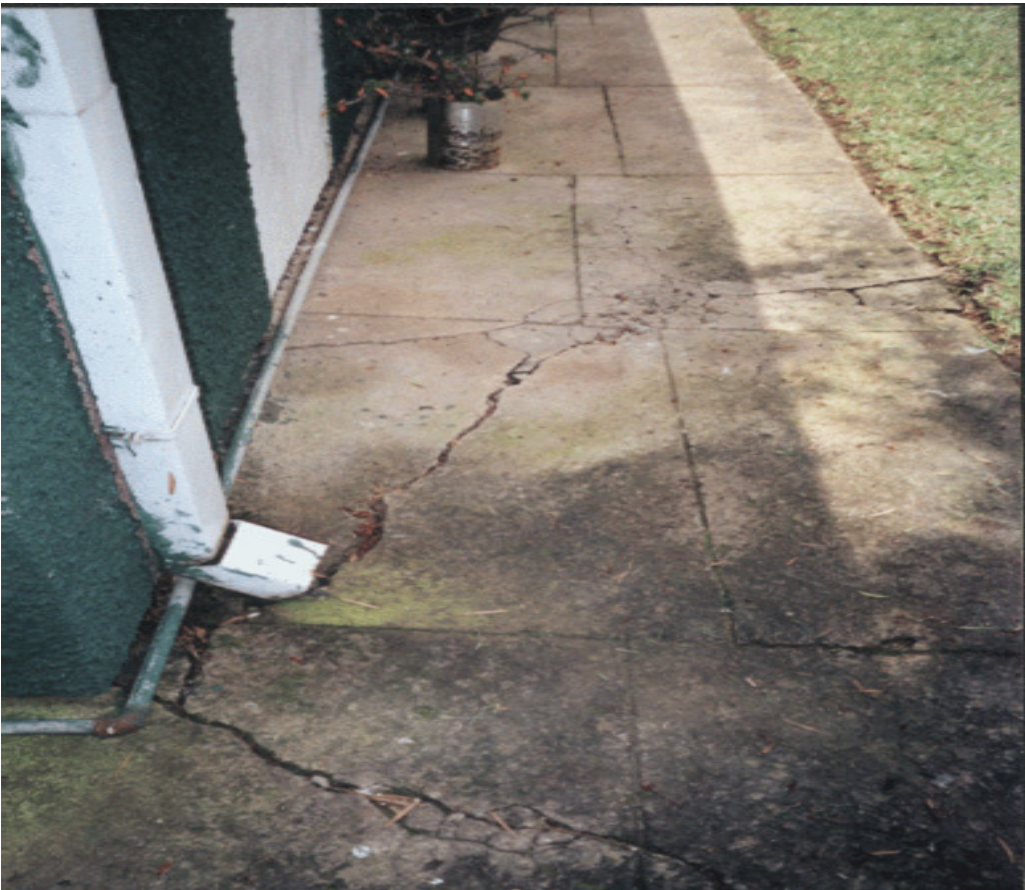
Fig 3.10b leaking of pipe around building and failure of maintaining the down pipe spout

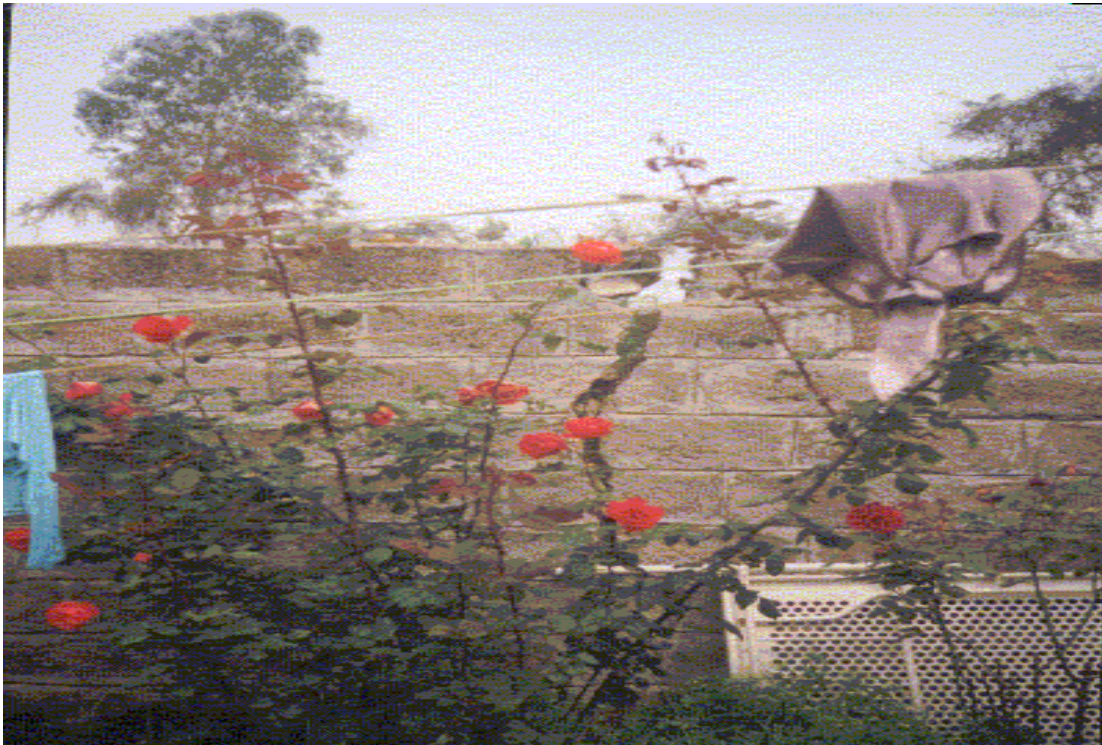
It is common to make garden in the compound. But shrubs and grass around building disturbs the moisture equilibrium of the soil. Most of the owners have garden in front of their homes and in the periphery of their fence as shown in Fig 3.11a and in Fig 3.11b. Garden watering disturbs the soil moisture and swelling pressures develops and results in crack.

Fig 3.11a Sever vertical crack of fence wall in Mekanisa area .Source of water is from garden watering

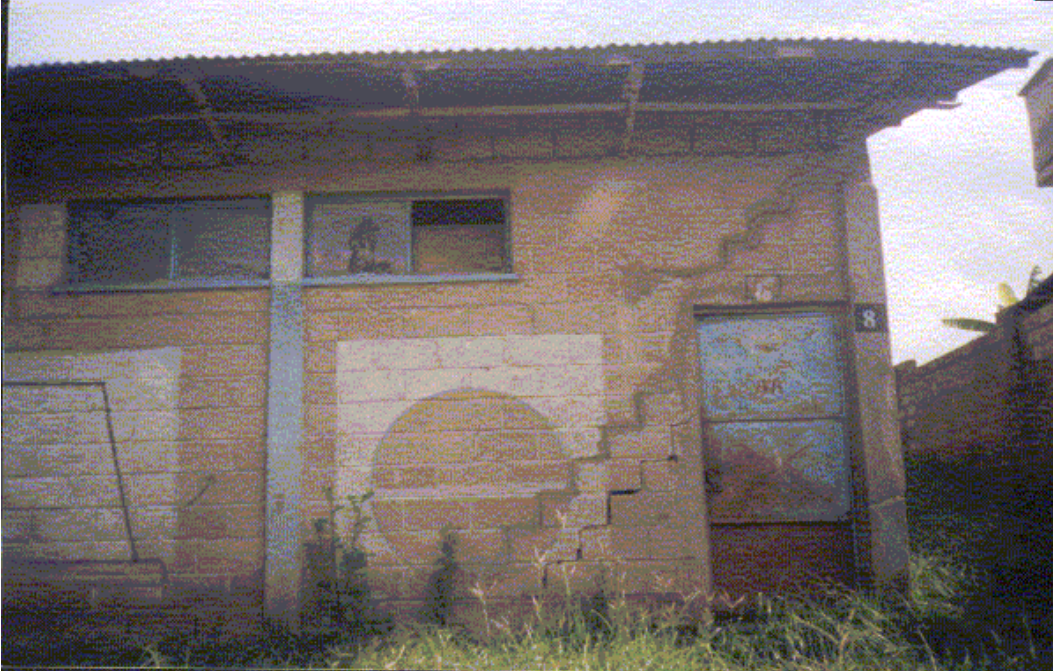
Fig 3.11b Sever diagonal crack of Nesanet public school .The building is surrounded with Shrubs and grasses

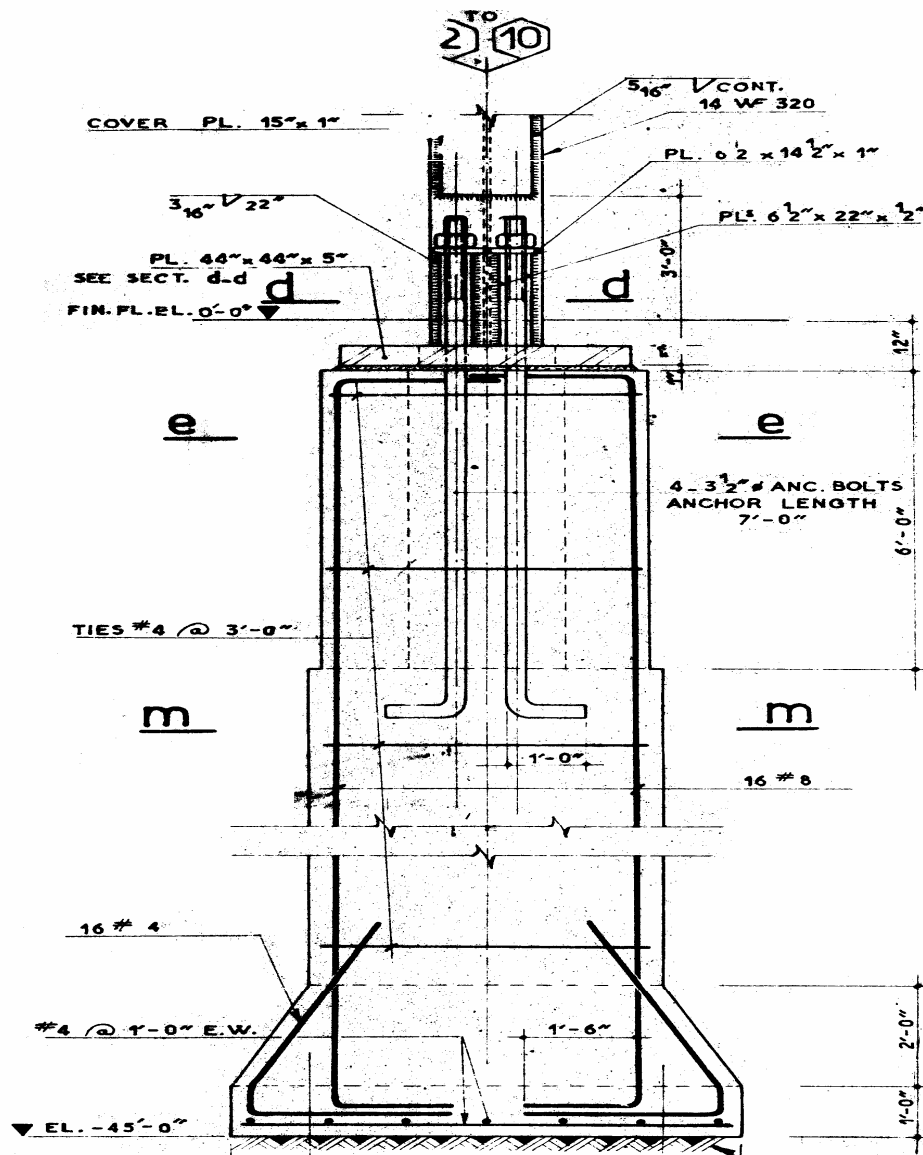
Pile foundations were adopted and the hangar building rests on 53 single piles of different pile length and pile diameter as shown in the foundation plan in Fig.4.2a and in Fig.4.2b.

The piles are interconnected by deep continuous beams. The depth of the beam varies from 1.80meter to 2.05meter. The length and dimensions of different piles used are listed on Tables 4.2

Fig 4.2a Typical pile foundation detail of Ethiopian Airlines maintenance hangar

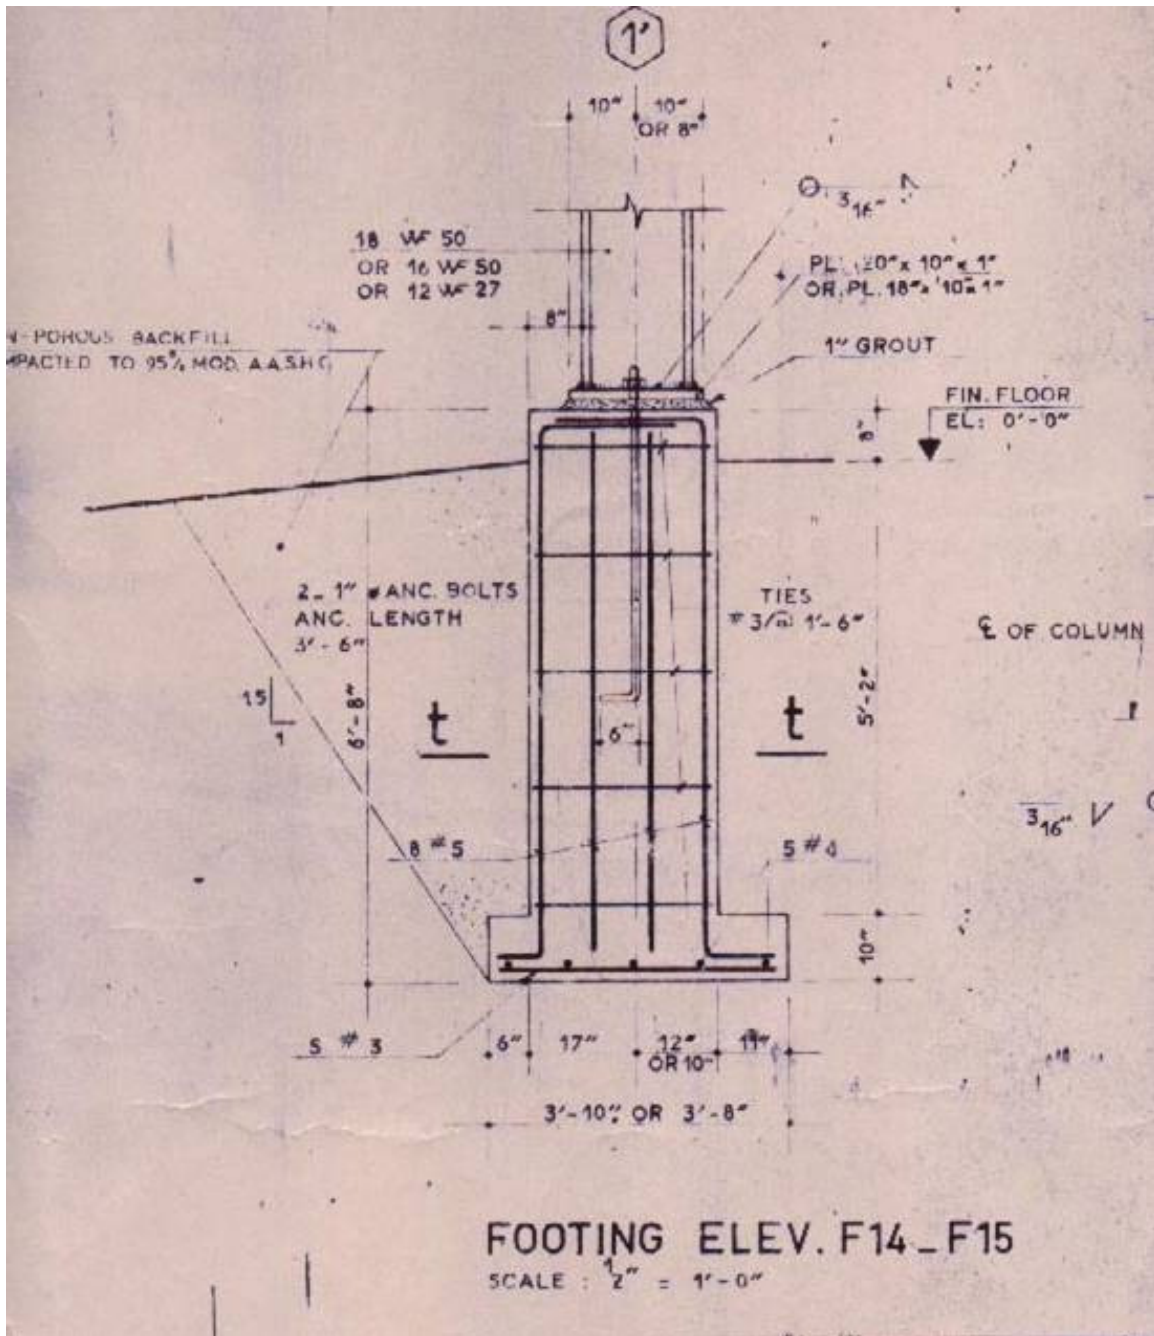
** These are foundations filled with 0.91-meter diameter cyclopean concrete to a depth Of 11m then 2.75 meter deep, reinforced concrete pile. F-14 and F-15 are Continuous footings with depth 2.05 meter and width 0.60m as shown in the Fig 4.3

Fig 4.3 Cross section of the Continues Footing on Axis – 1 of the Ethiopian Airlines Maintenance Hangar building that support the cladding member

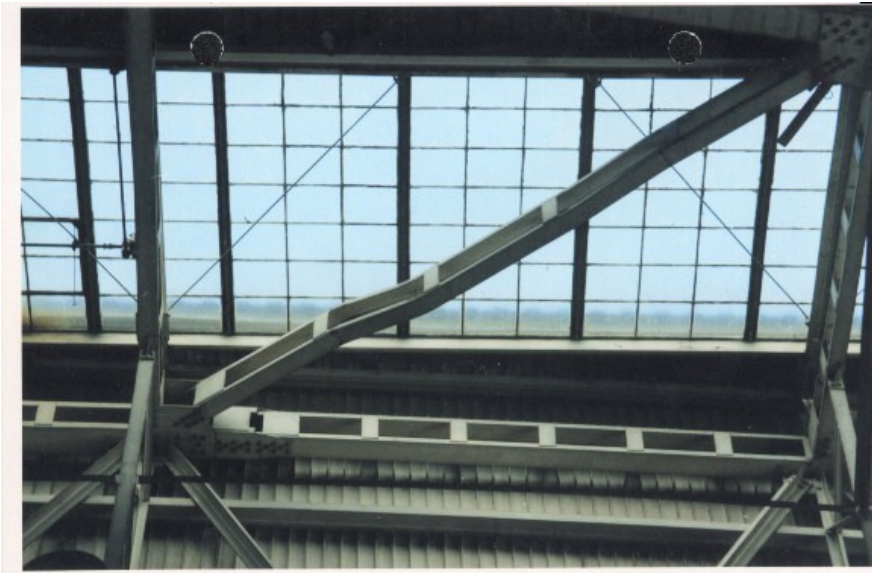
One of the truss members on axis-1 was also failed and now maintained as shown in Fig4. Generally, the problem is alarming and critical

Fig 4.4 Failed truss member of the Ethiopian Airlines maintenance hangar building on Axis-1

1/ Failure of truss member and buckling of Steel –I column Fig 4.4)

Up lift of the continuous deep beam results in pushing of the truss member through Steel column, as a result one of the truss elements failed (Fig 4.4). In the other case the other steel –I section on axis -1 which supports the cantilever truss was initially in tension and designed for tension. Pushing of the truss through the Columns placed on the continuous footing due to imperfect connection forced the columns to be in compression and buckling of the column occurred.

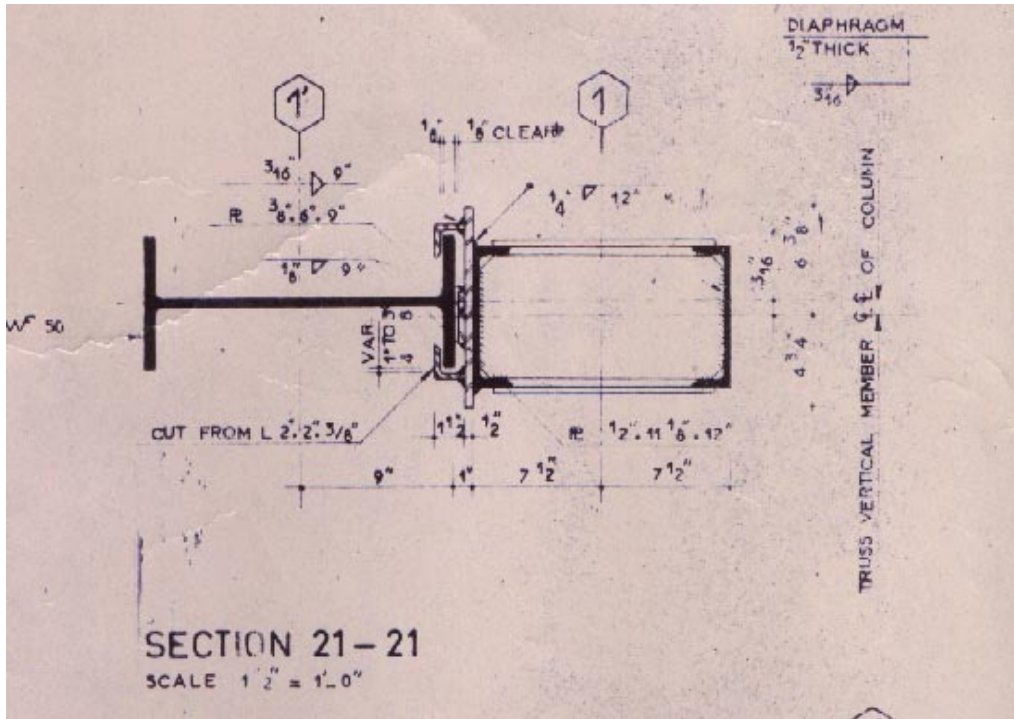
The steel I-section columns on axis-1' rested on the continuous deep beam introduced in order to support the cladding, were designed to slide vertically along the vertical member of the truss element and the truss was designed as a cantilever element (Fig –4.5).

Fig4.5 Detail of truss vertical member and column connection for vertical movement of Ethiopian Airlines Maintenance Hangar building

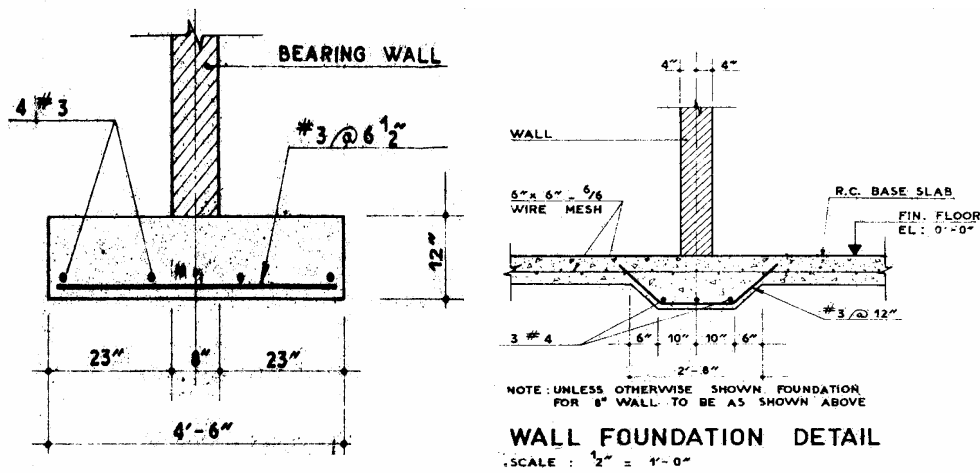
The partition walls were load bearing (Fig 4.6a and Fig 4.6b) and they rested on deep continuous beams and continuous footing. Most part of the beams is on the expansive soil. Similarly, uplift of the continuous deep beam has occurred and the load bearing brick walls between the deep beams and the first floor beams are in compression. The compressional force transmitted to the beams through the wall and the beam deflected and made slight ramp

a/ Load bearing brick wall

b/ Wall foundation detail
