# **Landslide hazard Evaluation and Zonation in Dilbe and its Surrounding area Northwestern Central Ethiopia; An Integrated GIS based Grid Overlay and Statistical Approach**

**A Thesis Submitted to  
School of Earth Sciences**

Presented in Partial Fulfilment of the requirements for the Degree of  
Masters of Science (Environmental Geology)

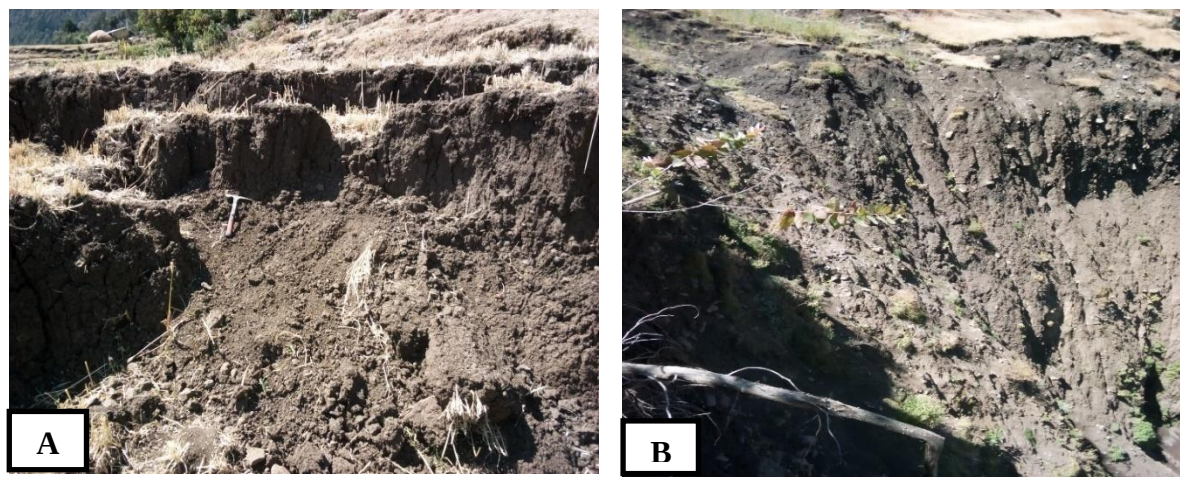
Plate 3.4 Residual soil in the area

(A) Residual soil used for agriculture in the area; (B) Residual soil comprises sand and silt

Most of the residual soils which are deposited in the study area are black in color. They are deposited in low laying/ gentle slope. It is mostly applied for agricultural practice in the area. It consist granular material comprising sand and silt (Plate 3.4.B)
