**Integrated geological and geophysical studies to investigate the landslide zones and study its impact: a case along the road section within Kurar Kebele, Dejen woreda, Central Ethiopia**

**A Thesis Submitted to School of Graduate Studies of Addis Ababa University**  
***In partial fulfillment of the requirements for the Degree of Masters of Sciences***  
***(Environmental Geology and Geo-hazard)***

**June 2017**

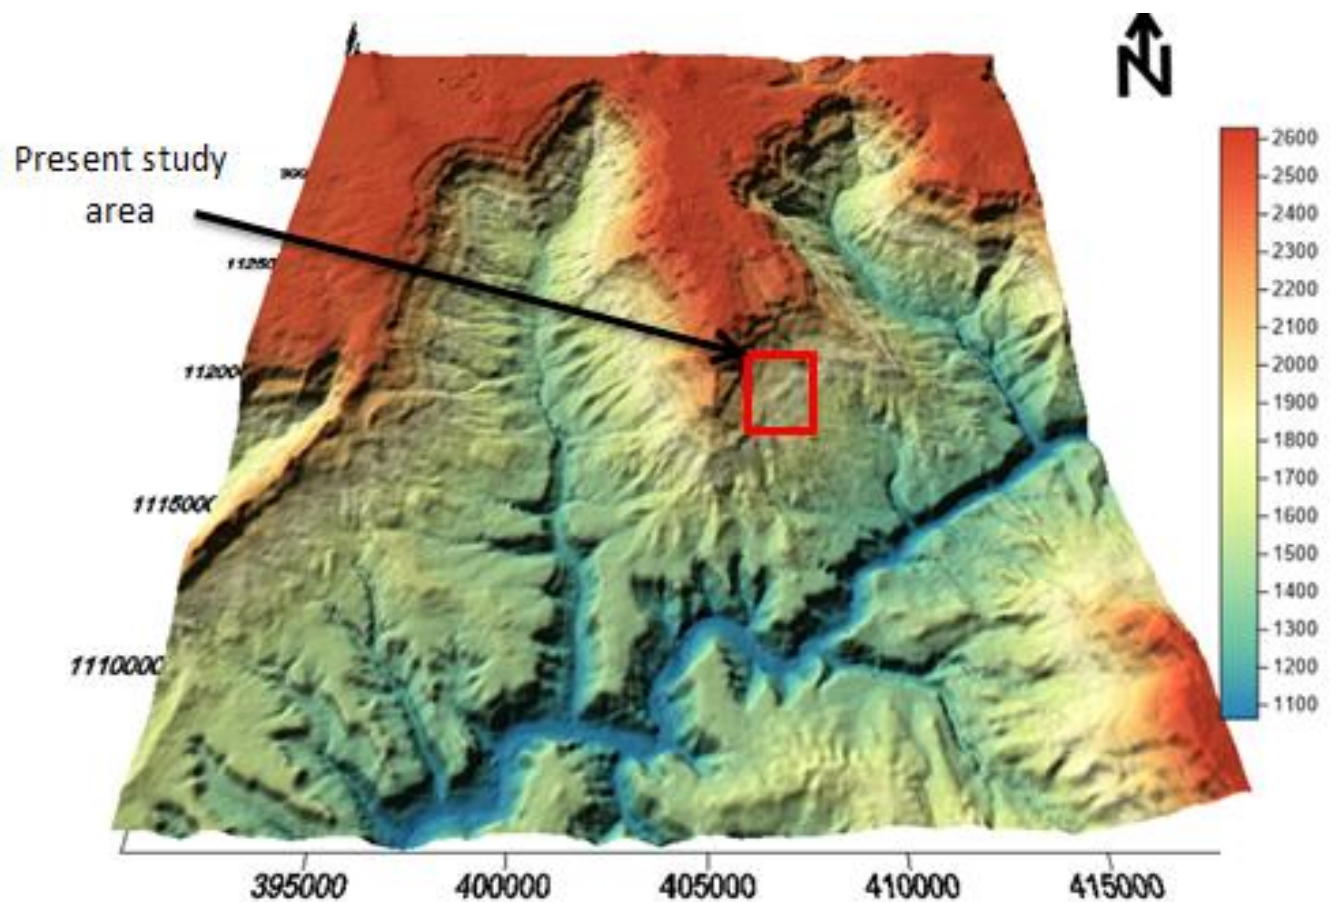
The study area is characterized by undulated landform with elevation ranging from 1700 to 2550m above sea level. The topographical features are represented by valleys, flat area and cliff with slope gradient varying from gentle to steep slope. The gentle and flat lands are densely populated and cultivated mainly by maize, teff and sorghum. Some parts of the area are also covered by bushes and the rest is a barren land. Uncontrolled drainage pattern and flood erode toes of unstable slopes and thereby facilitates the sliding process. The topographic map of the area produced from 30m resolution DEM data is presented in Figure 1.2.

Figure 1. 2 Physiography of study area

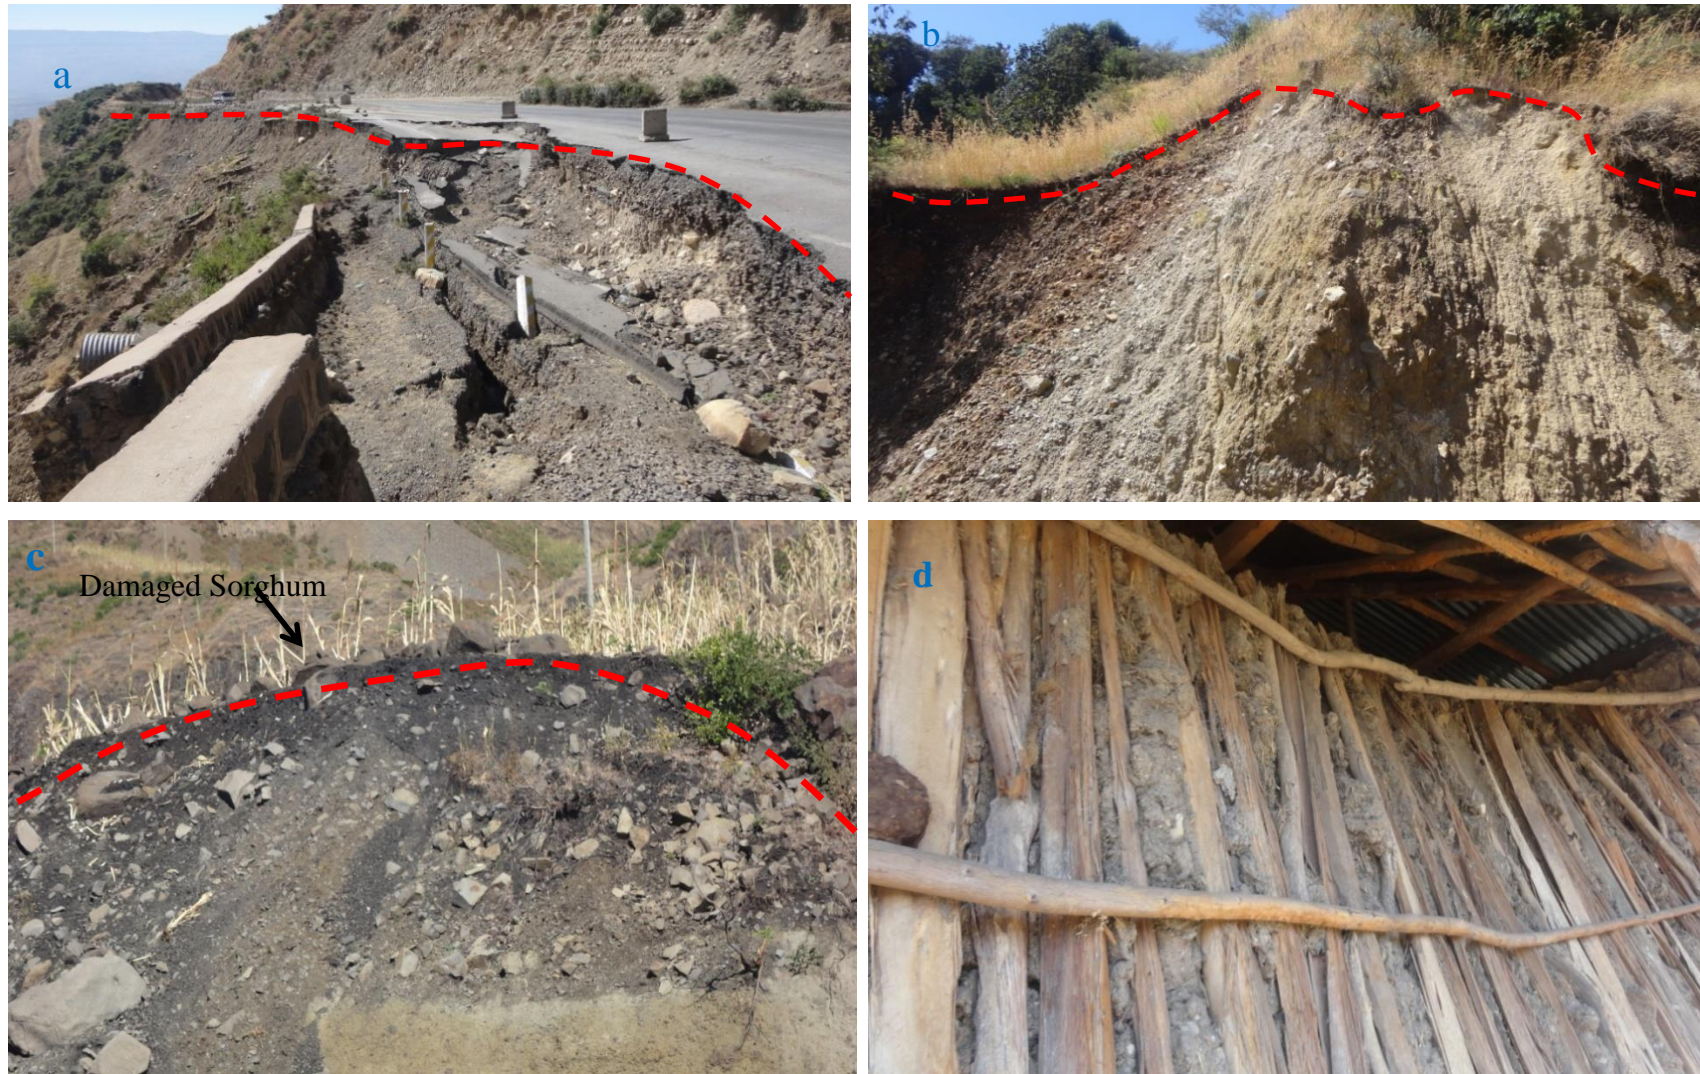
Currently in this area landslide-generated problems are becoming serious concerns to local people and administration as well as federal government bodies (Figure1.3). The frequent damage of the road and other social utilities has significantly increased maintenance costs. Besides, wastage of fertile farm lands make local people's life very difficult, even unbearable though due to lack of alternative they still live and continued farming in highly landslide-susceptible slopes. Hence, adequate understanding of the locations, extents, and landslide triggering / aggravating factors is essential to develop mitigation measures that contribute to safeguard human life and built sustainable engineering structures.

Figure 1.3 Field photos illustrating landslide problem a) completely damaged road; b) damaged grass land and soil; c) destructive agricultural land with sorghum and d) completely damaged local home

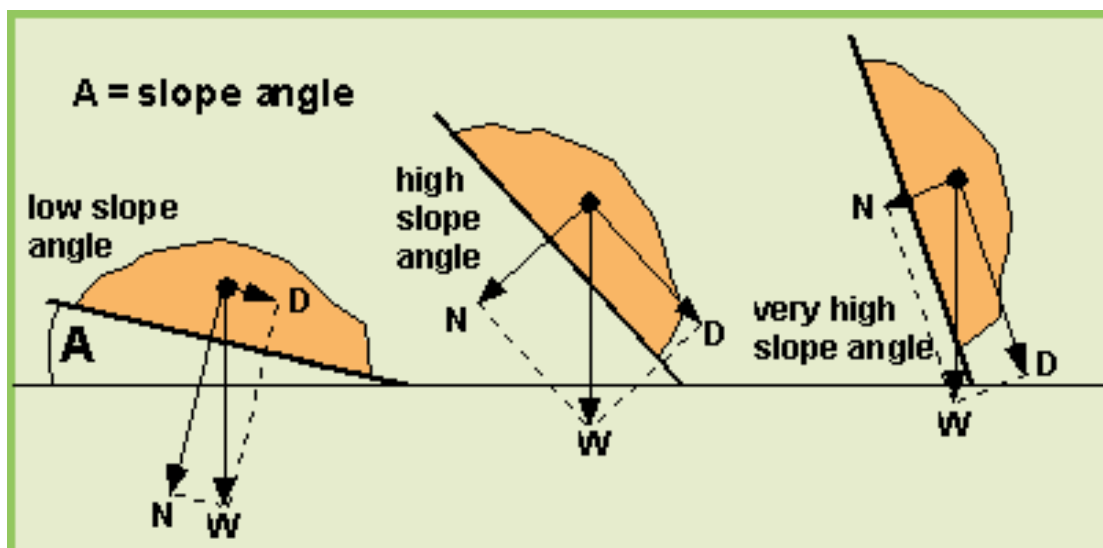
Figure 2. 2 shows an increase the slope angle “A” results increases the driving force “D” (Rai et al., 2014)

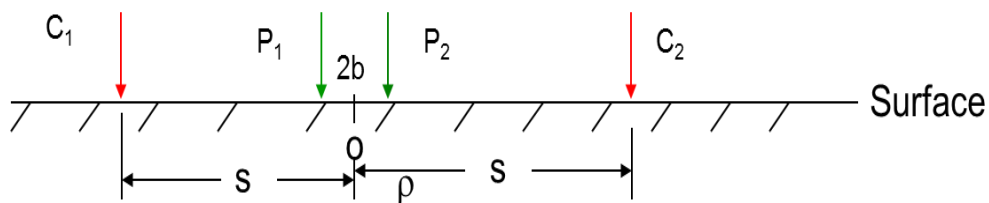
There are many ways of electrode arrangement, but common arrangements including Wenner, Schlumberger and the Dipole-Dipole. However, for the present study Schlumberger electrode configuration was selected. In this case two potential electrode (P1 and P2) and two current electrodes (C1 and C2) can be placed over the ground in symmetrical manner as the following:

Figure 2. 3 Schlumberger electrode configurations

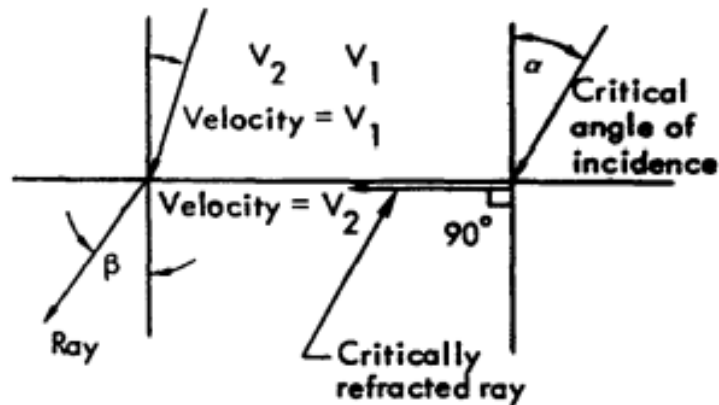
Figure 2. 4 Snell's Law and refraction of ray transmitted across boundary between two media with different velocities ( $V_2 = 2V_1$ ) (Redpath, 1973)

Where  $\alpha$  is denoting the incident angle,  $\beta$  the refraction angle of the travel path with respect to the boundary normal and  $V_1$  is the propagation velocity of upper medium and  $V_2$  is the propagation velocity of lower medium. In the important special case:

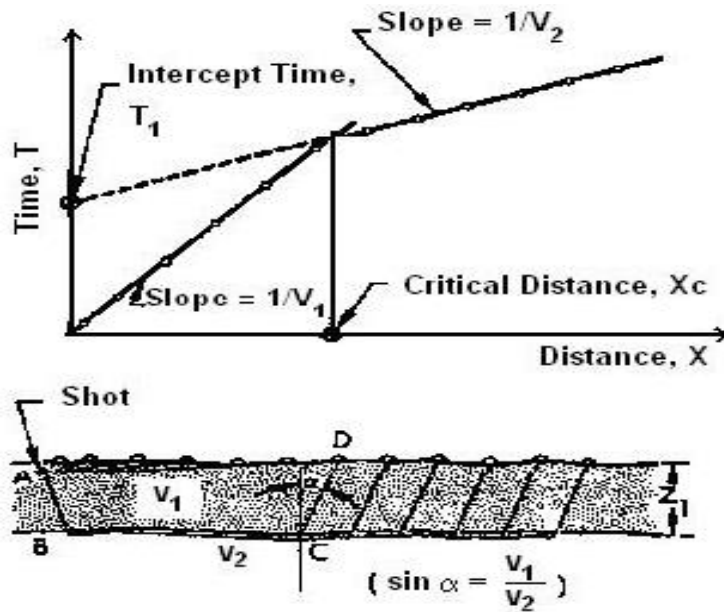
Figure 2.5 Simple two layer case with plane, parallel boundaries and corresponding time-distance curve (Redpath, 1973)

Suppose strata consist of one horizontal low velocity ( $V_1$ ) layer underlain by one high velocity ( $V_2$ ) layer on the Figure 3.12.

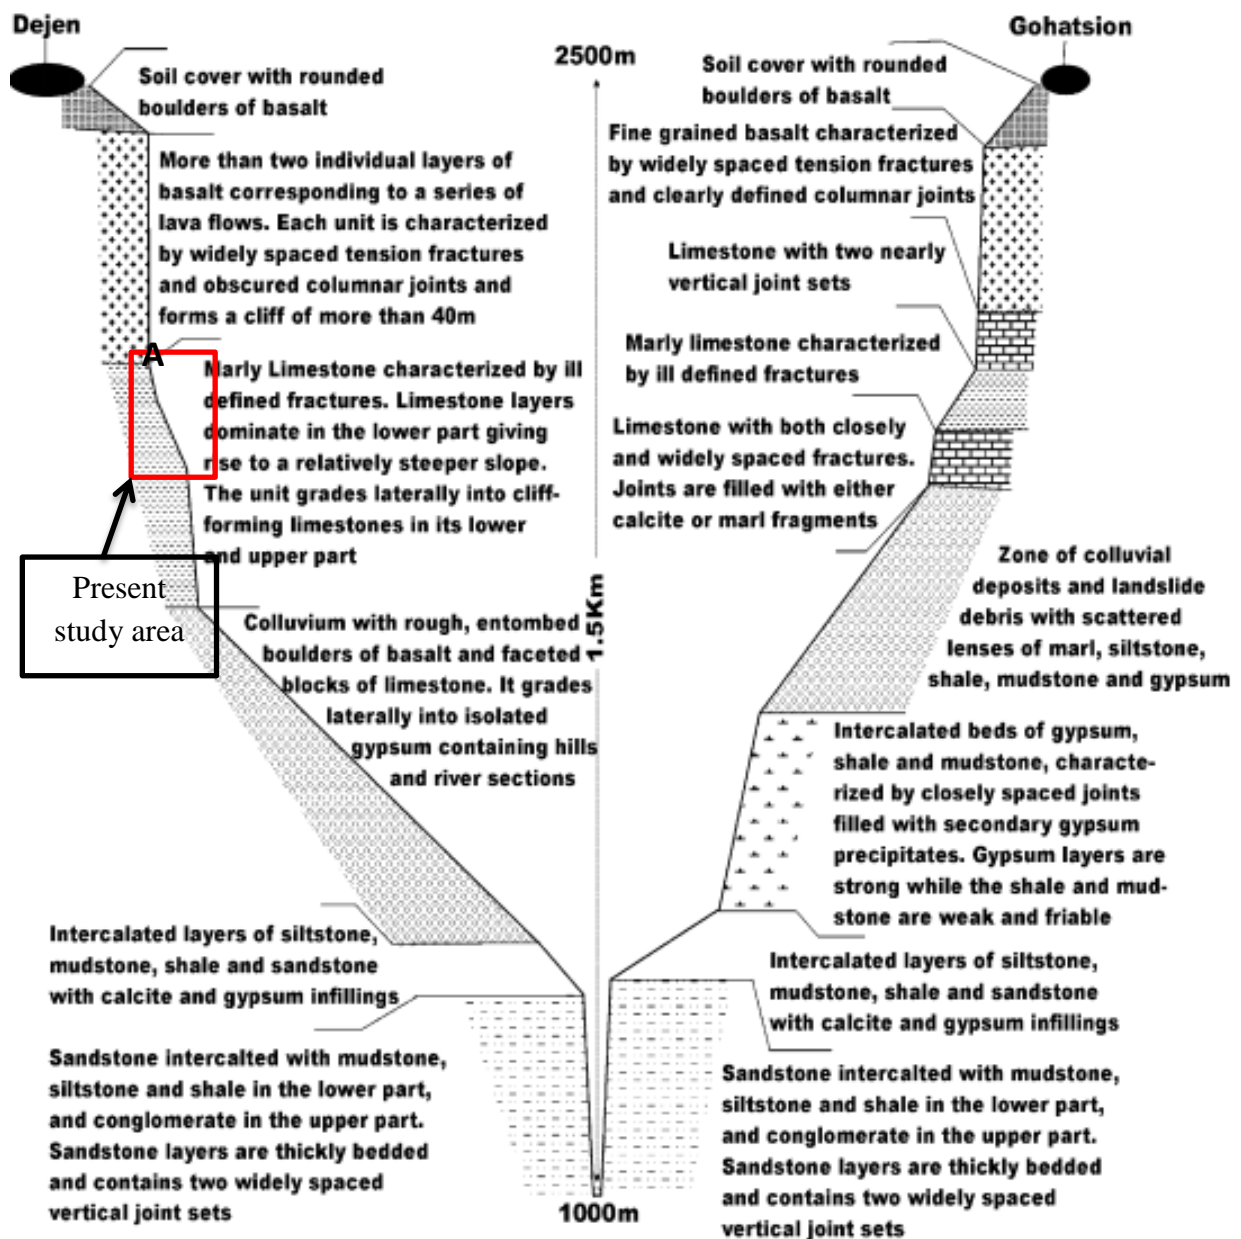
Figure 3. 2 Schematic geological section of the Abay River gorge along Gohatsion to Dejen (Lulseged Ayalew and Hiromitsu Yamagishi, 2003 after modified from Lulseged Ayalew, 2000), A) shows present study area

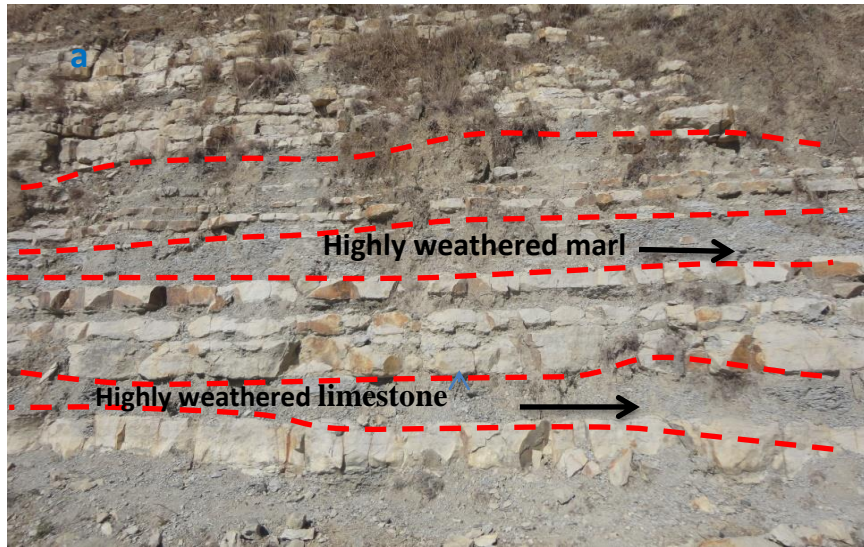
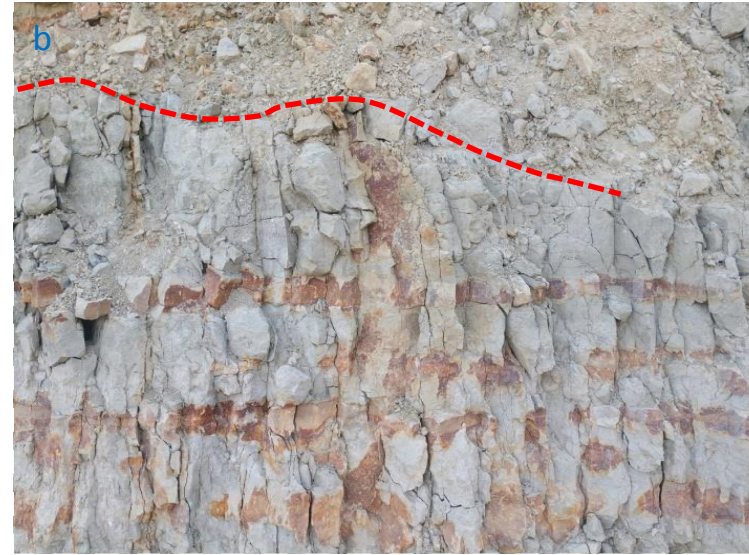
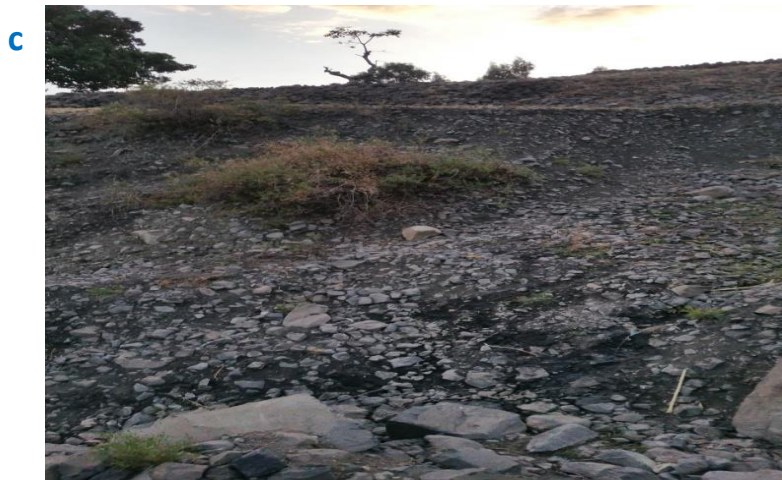
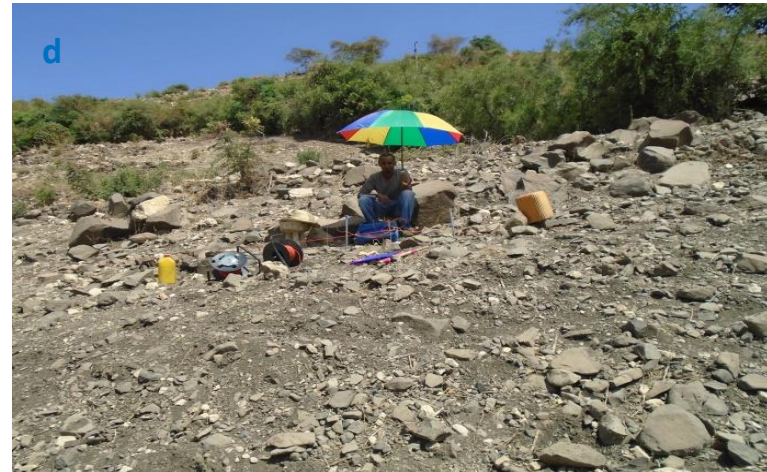
Hence, it is easily for rain water to percolate down and cause sudden fluctuation groundwater level that minimizes the shear strength of slope material. During field investigation different sizes of cracks (about 10-40cm spacing) have been observed at the toe of the sliding mass. Based on raster calculations more than 83% landslide problem was found to occur within the colluvial materials and the remaining 17% is associated with the limestone intercalated area (Table 3.1).

Figure 4. 1 Field photos illustrating lithologies a) highly weathered limestone interbedded with marl; b) Highly weathered limestone; c) Colluvial material saturated by seepage; d) dry colluvial material

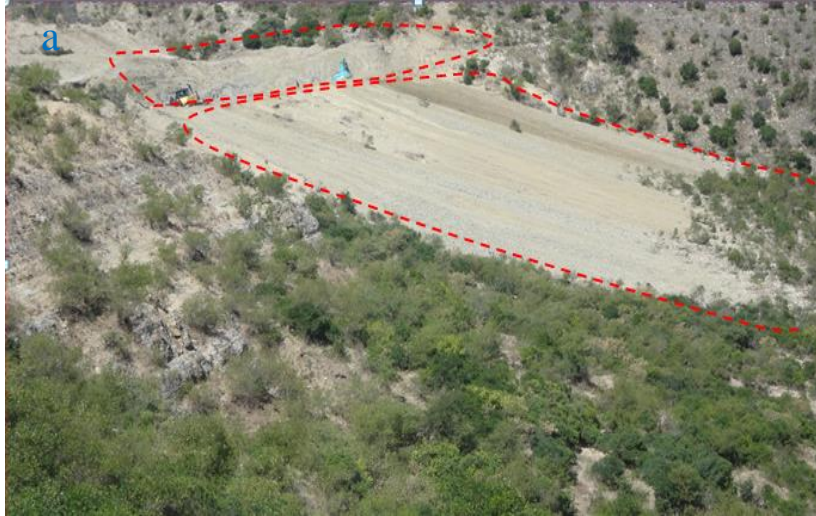
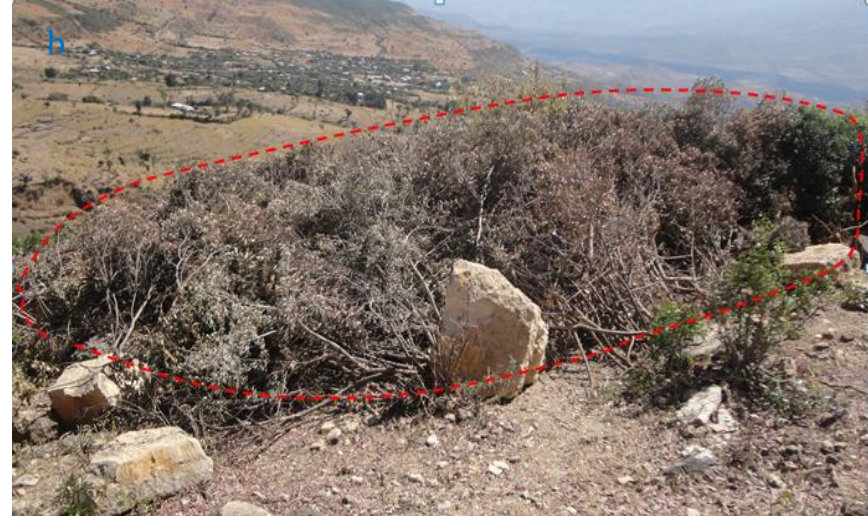
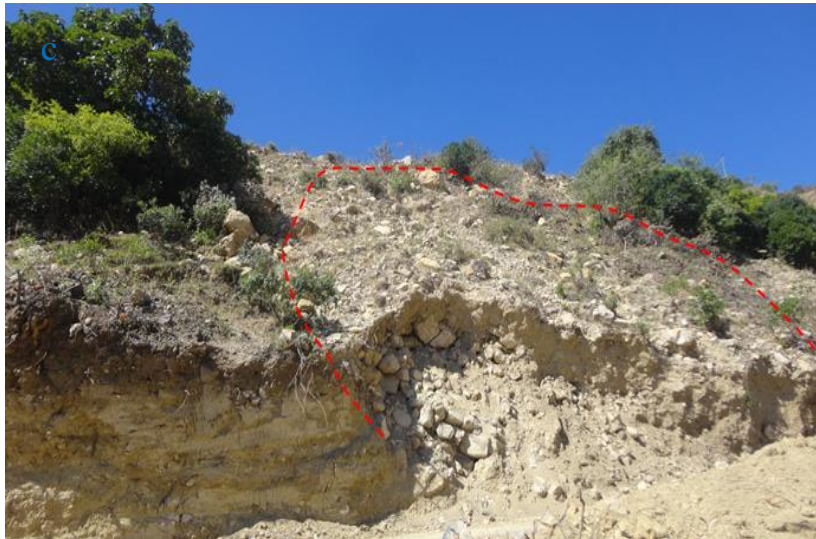
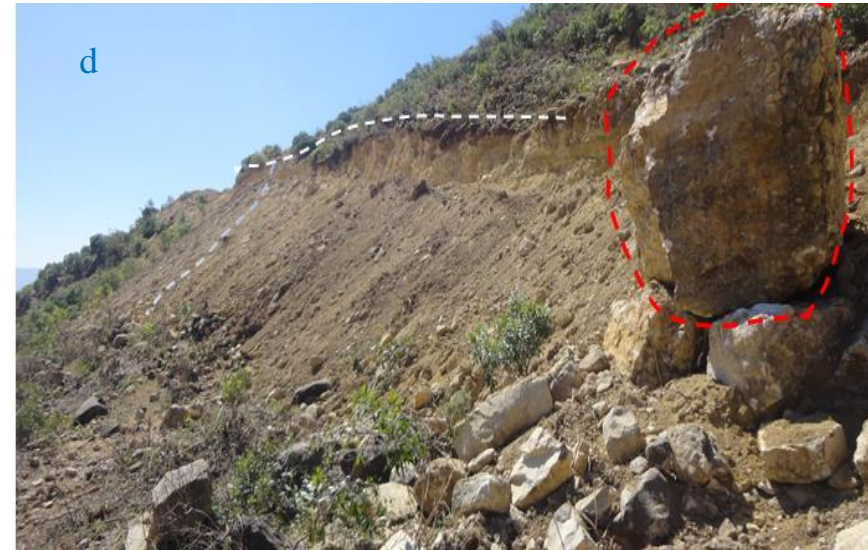
Human activities may result directly or indirectly triggering landslide phenomenon during work to modify their lives. The increasing human activities, such as intensive agriculture, removing bushes (vegetation) from slope, modify slope and land use changes, slope excavation for improper ways to repair road or maintenance were increases the potential instability of the slope (Figure 3.4). All of this activity reduces the shear strength of the slope and increases both density of slide and the amount of material moving down the slope. The increasing in number of population maximize human activity along the landslide prone area which multiple the intensity of landslide hazard and raises effect on natural environment and socio-economic at high rates.

Figure 4. 4 Field photos illustrating human activity along landslide prone area a) dumping waste down the slope; b) removing bushes from slope; c) slope excavation and d) Generate rock fall

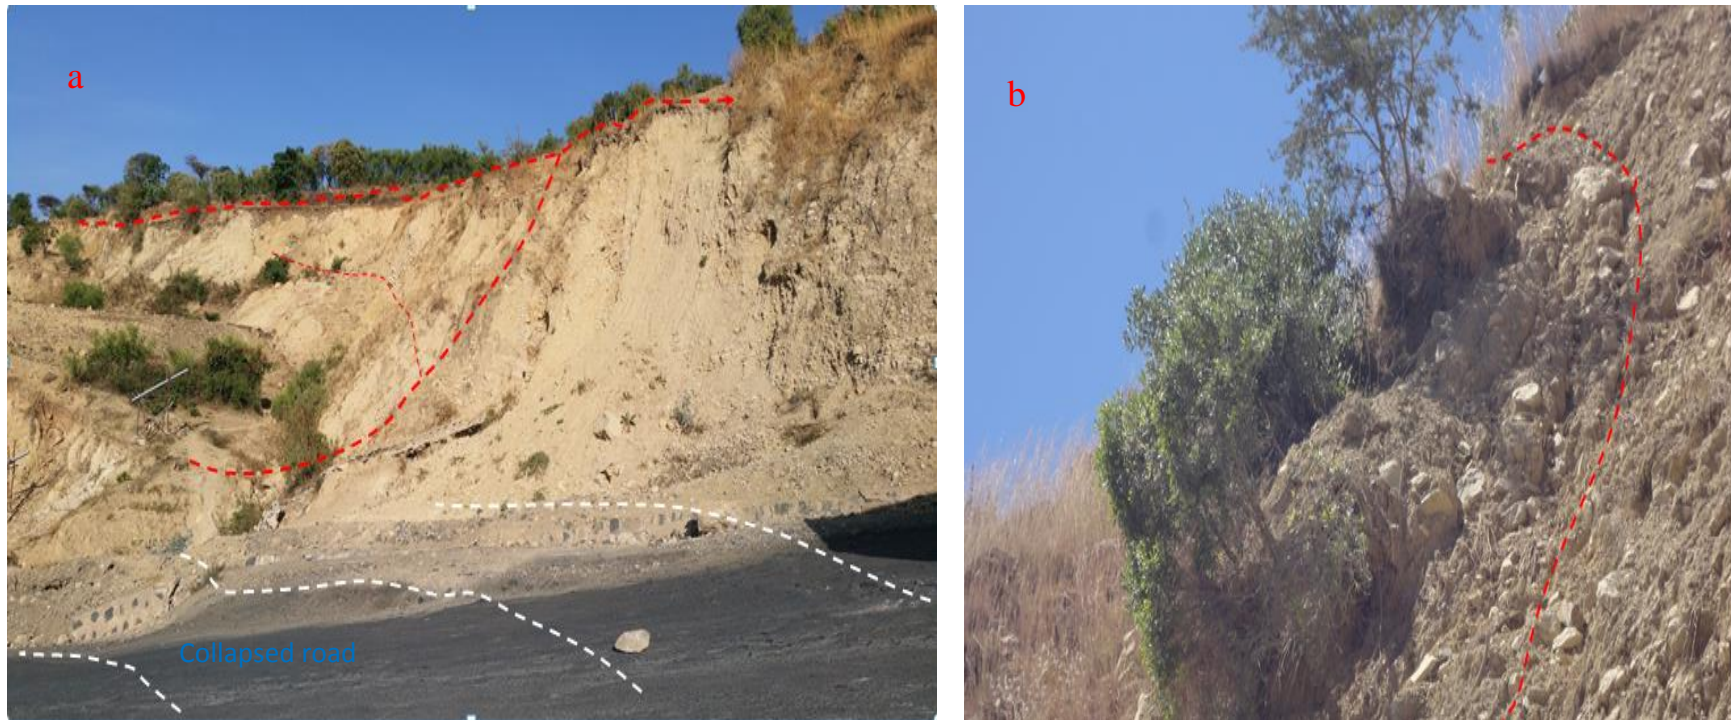
The morphological appearances characterized by main scarp, back-tilted bench at the head and concave upward, found between  $5^{\circ}$ - $25^{\circ}$  or very gentle to moderate steep slope gradient and thick colluvial material (10-14m) which moved slowly considered as rotational mechanism triggered by rain fall (Figure 3.5a). This type of movement was common in the southern margin of present study area and in some part of central.

Figure 4. 5 Field photo illustrate mechanism of landslides a) rotation slide and b) debris slide

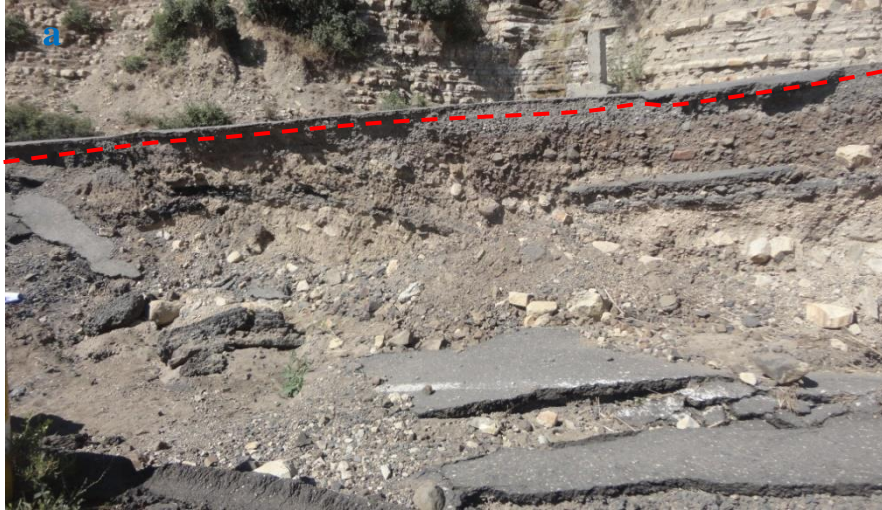
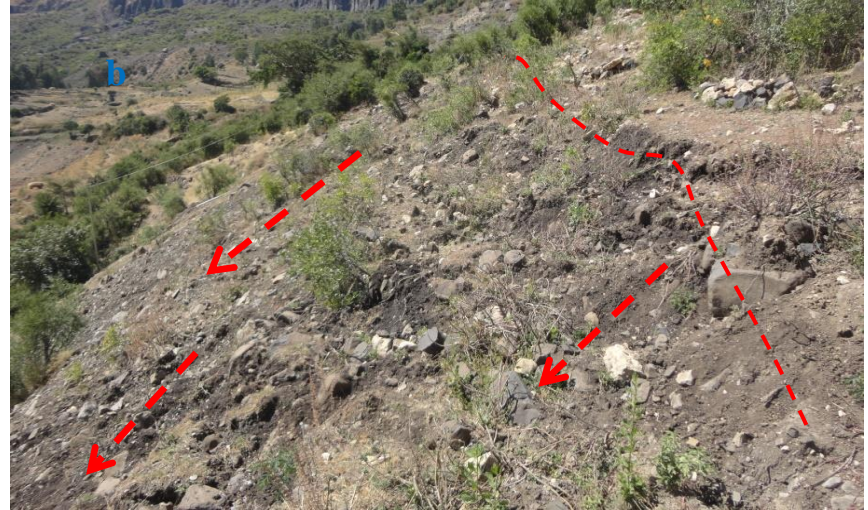
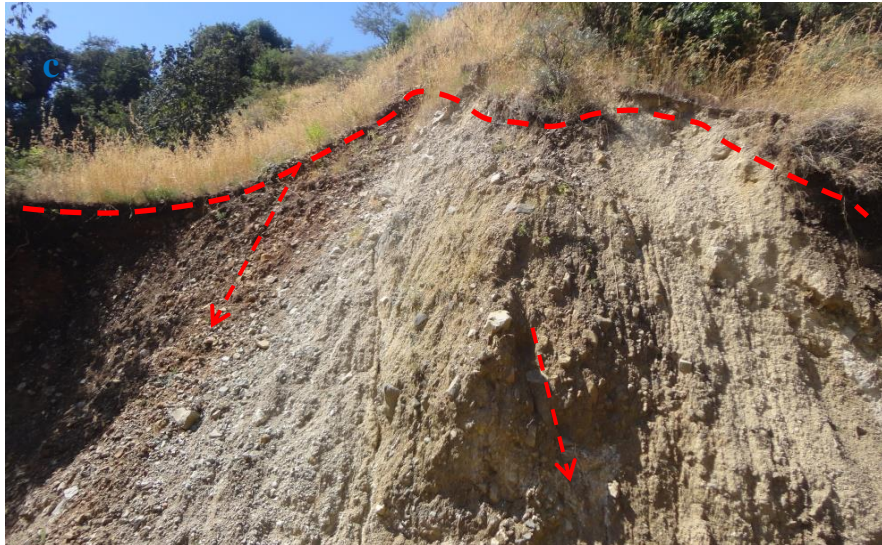
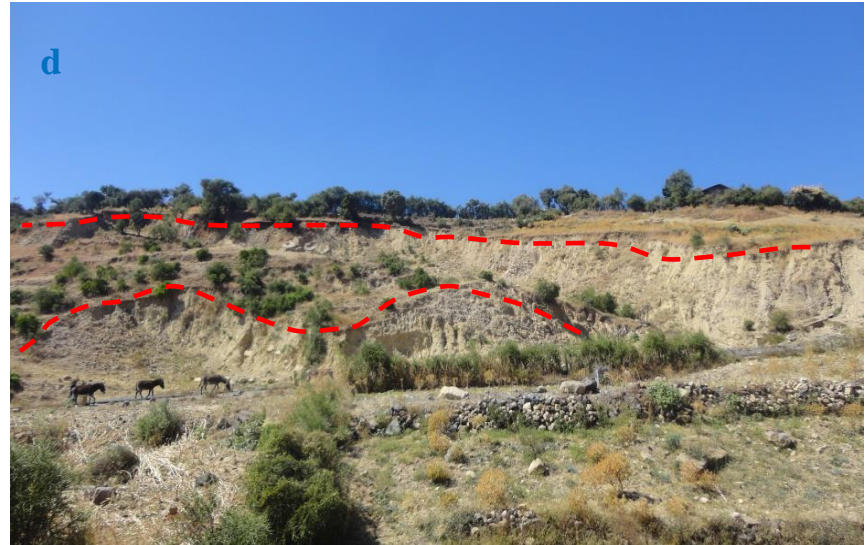
Generally, in the area of study various factors such as a growing population and extensive farming pressures encourage rapid land-cover changes; land degradation (rock and soil) movement increases and displaces local people from the area.

Figure 4.8 Field photos illustrating of landslide impact to natural environment a) completely damaged main road; b) completely damaged agricultural land; c) landslide damaged grass land and soil and d) morphological change

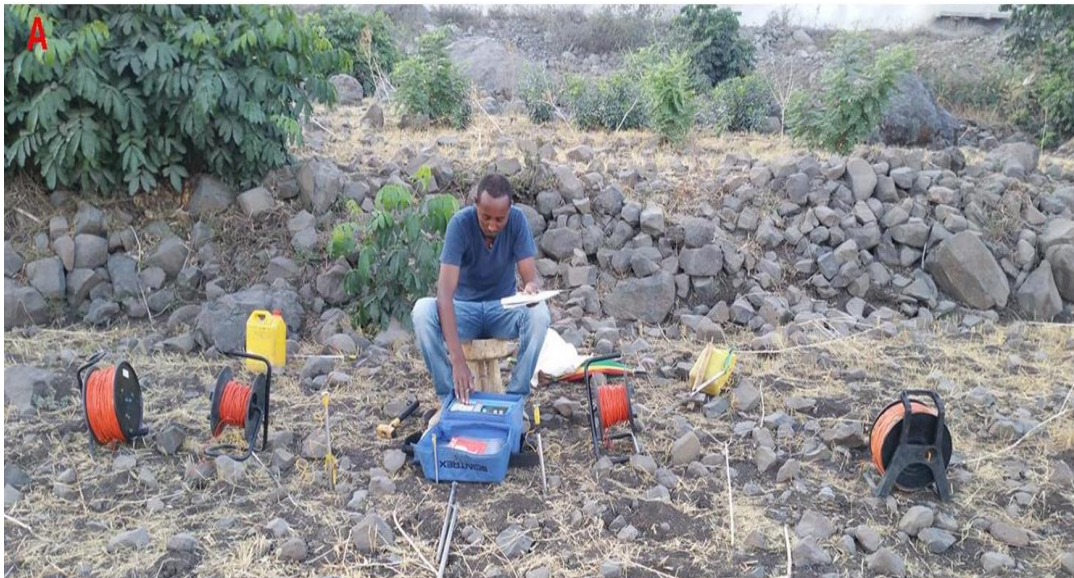
The field data acquisition using this technique has been carried out by the Schlumberger electrode configuration employing the *Scintrex Automatic Resistivity Imaging System (SARIS)* resistivity meter. For this purpose current is injected in to the ground through two electrodes (A and B) and the potential difference is measured by another pair of electrodes, M and N (Telford et al., 1990; Lowrie, 1997 as cited in Fisseha and Mewa, 2016). The maximum separation the current electrode was  $AB/2=150\text{m}$ . The measured potential difference demonstrates the effects of different geological materials within the area of current distribution. In this study four traverse lines (three lines oriented NW-SE and one line E-W) were surveyed and resistivity data has been collected from 14 stations (Figure 3.10).

Line 3 : VES-7 point 1		
easting	nothing	elevations
407541	1119410	1984
AB/2	MN/2	$\rho_a (\Omega\text{-m})$
1.5	0.5	24.07

2.1	0.5	29.25
3	0.5	24.26
4.2	0.5	16.51
6	0.5	22.23
9	0.5	16.11
13.5	0.5	12.66
20	0.5	17.87
20	6	18.61
30	0.5	25.75
30	6	19.68
45	6	19.68
66	6	14.95
100	6	15.2
150	6	66.27

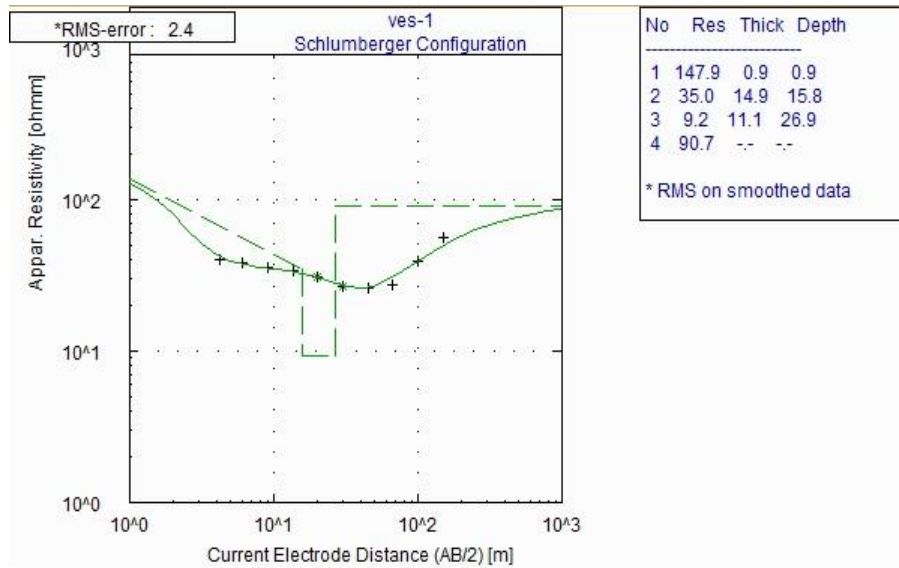
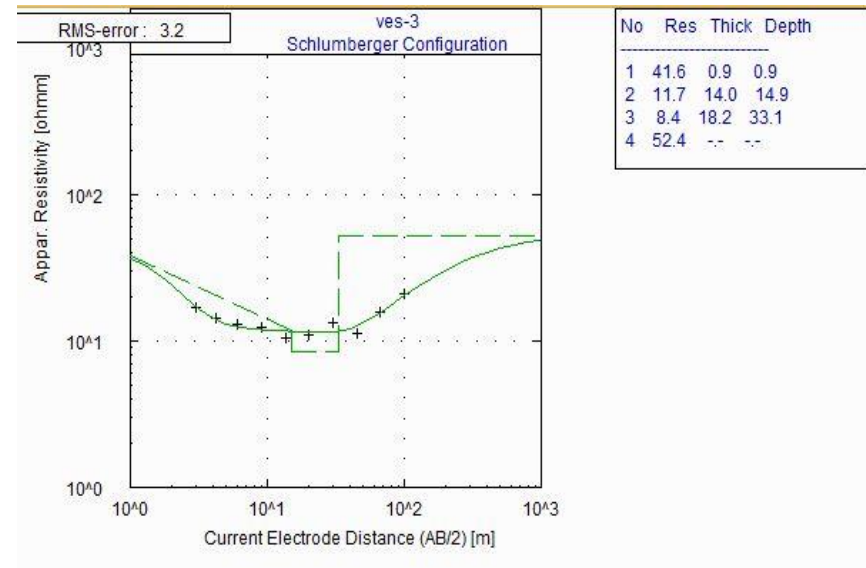
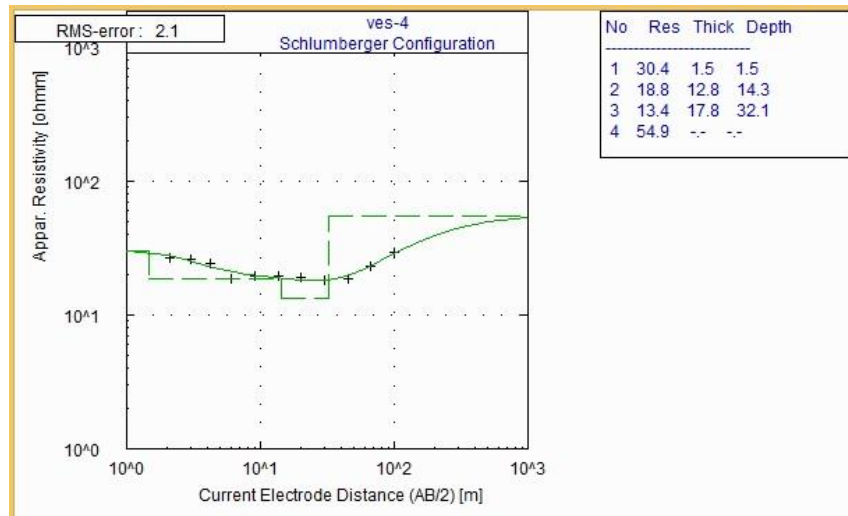
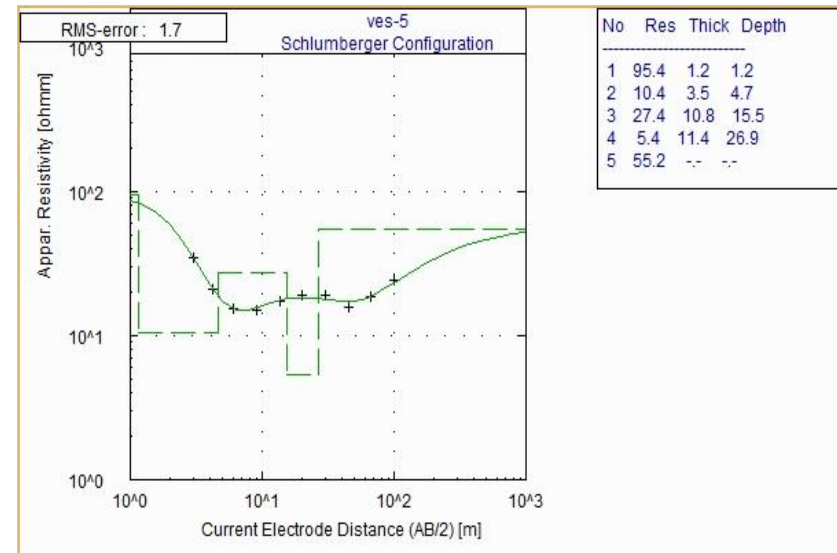
The raw resistivity data is plotted as pseudo-depth section using surfer10 software that roughly demonstrates the vertical variation of measured resistivity's as a function of AB/2 and guides the construction of geo-electrical section using MapInfo software based on which the subsurface structures are quantitatively characterized.

Figure 4.10 Electrical resistivity Model curves

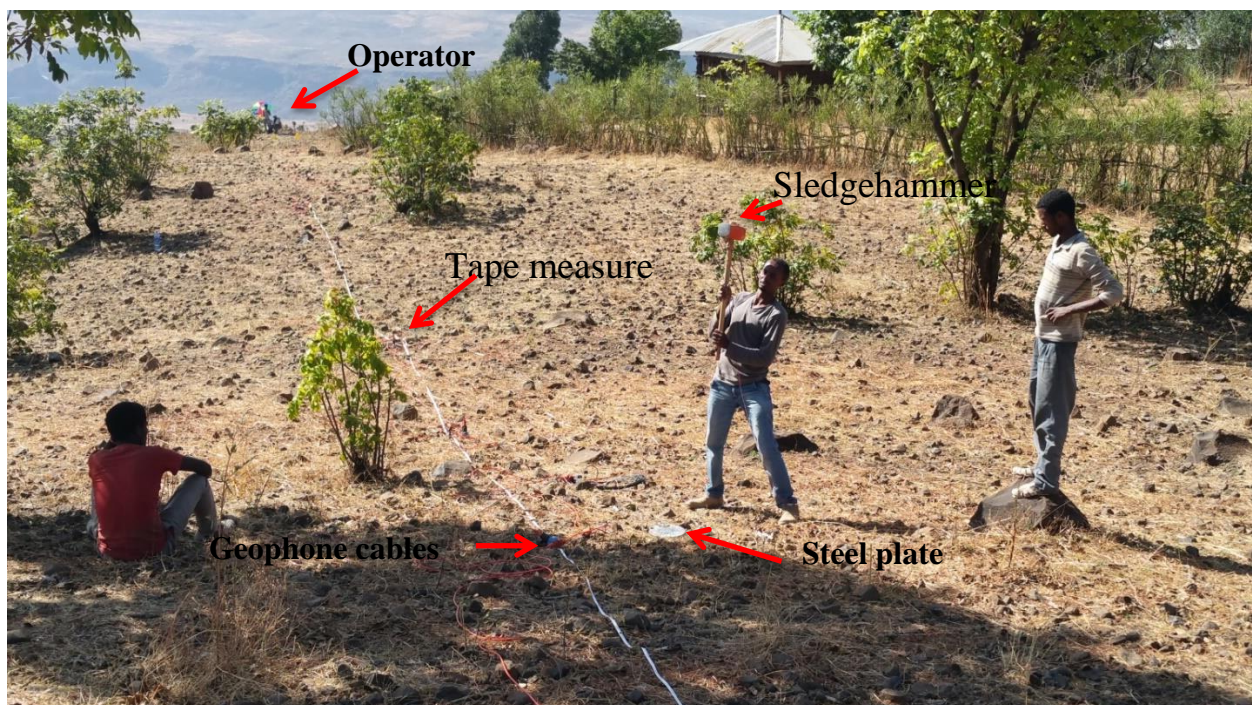
Then, to produce the vibration to the ground, a series of hammer striking the steel plate or stacking has been took place in order to enhance the signal. The seismic vibration of the wave generated was passed through the subsurface and near surface and sensed by geophone which convert this seismic vibration or mechanical energy to electrical impulse (signal) and sent to the system (portable computer). In such a way that seismic refraction helps to provide information about the depth or thickness of overburden material and velocity variation along the spread.

Figure 4. 11 Seismic refraction field measurement setup and data acquisition

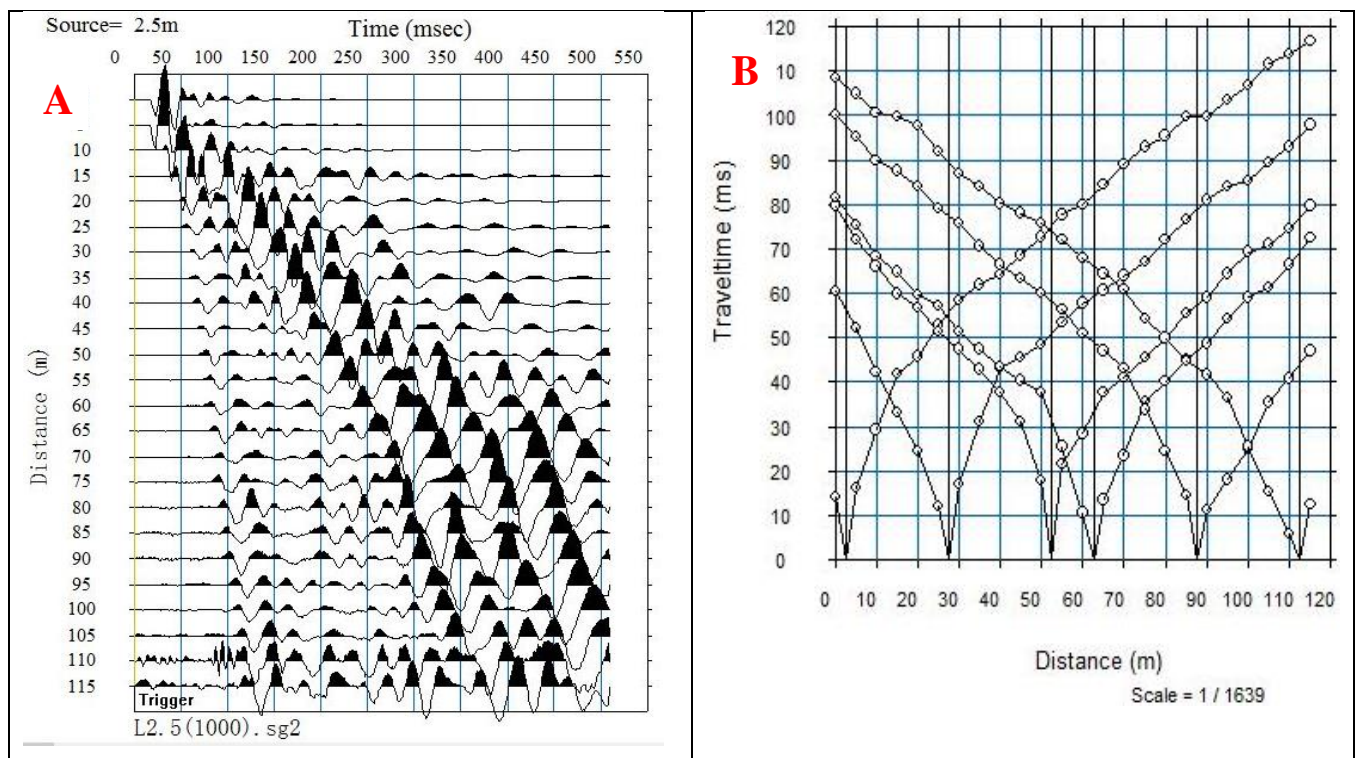
Accordingly the recorded signal data has been processed by software package SEISMAGER/2D with the pick-win (pinking of first arrivals) and PLOTREFA (concentration of dataset). This has been processed in PICKWIN, pick the first arrival time from the field recorded signal and draw time distance graph relationship between the geophone numbers versus the first arrival time of P-waves for each shooting point (Figure.3.15). Then using PLOTREFA tools with help saved pink point or arrival time, determine the general subsurface condition the thickness of loose material and possible number of layer, and strength or compactness of material which generate the intercept time graph as described in figure 3.15. Generally, field measurement, signal recording on portable computer, travel time data, packing the first arrival from each geophone, construct velocity model.

Figure 4. 12 a) Arrival times of P-waves curves for 24-channel seismic spread b) Travel-time

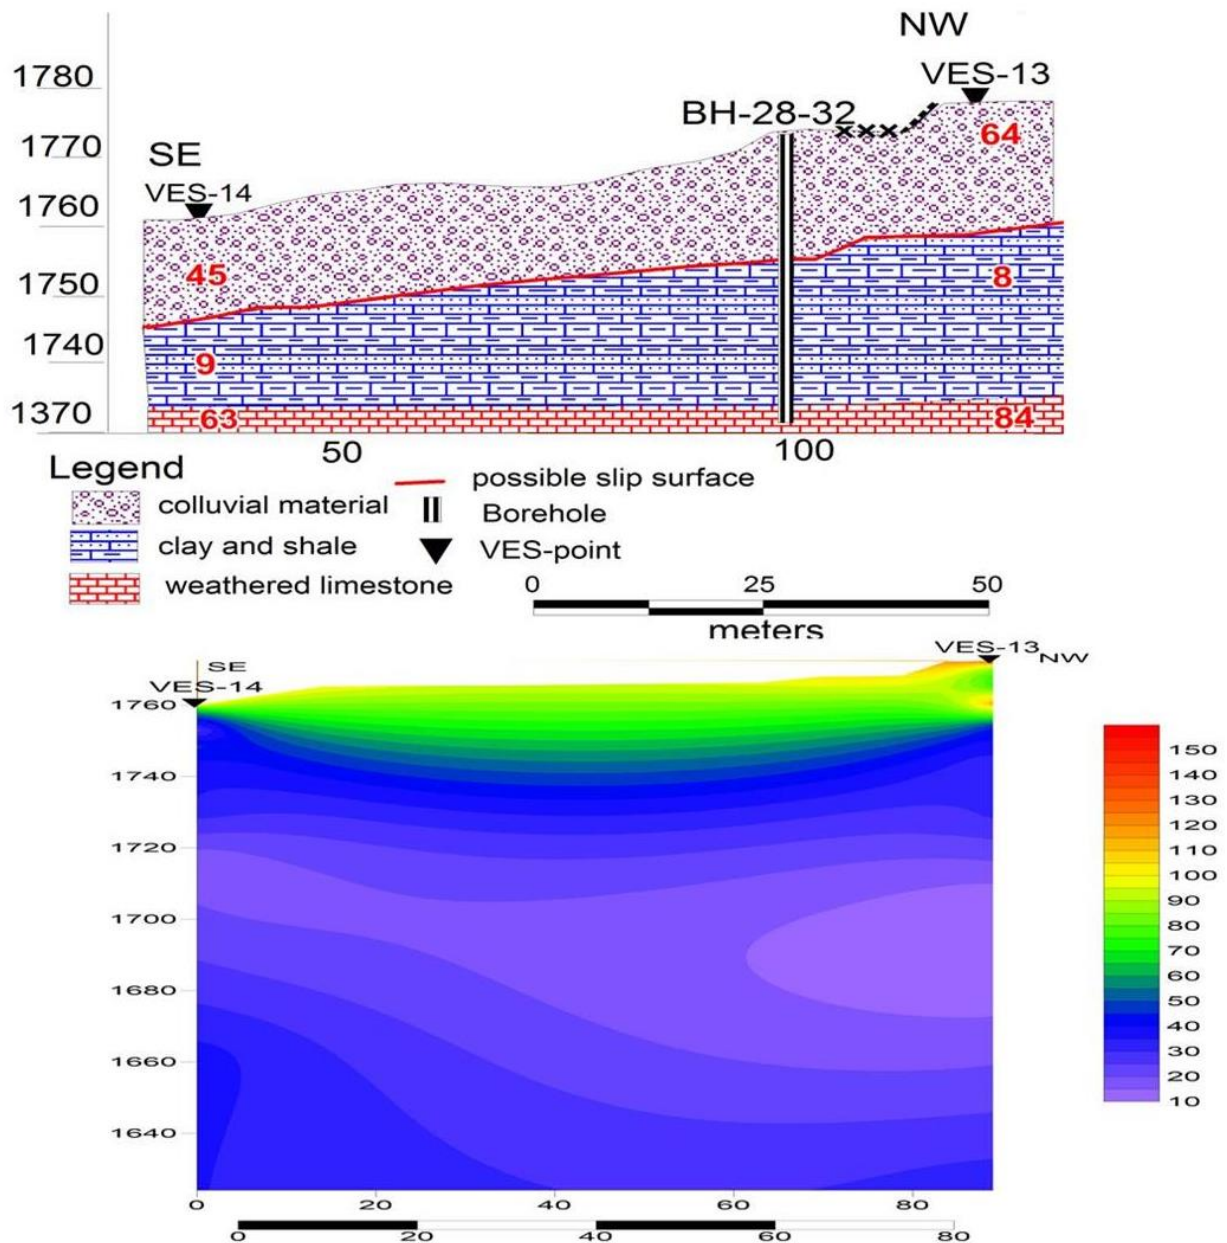
The bottom layer with a resistivity range of 63-84  $\Omega$ -m is mapped from about 25m at VES-14 to 40m depth at VES-13. This depth estimation based on geophysical data closely correlates with borehole data obtained from BH 28-31 and BH 28-32 located nearby the survey line and where fractured and weathered limestone was intercepted at a depth of 32-40m.

Figure 5. 2 Geo-electric section and Pseudo-depth section of line 2

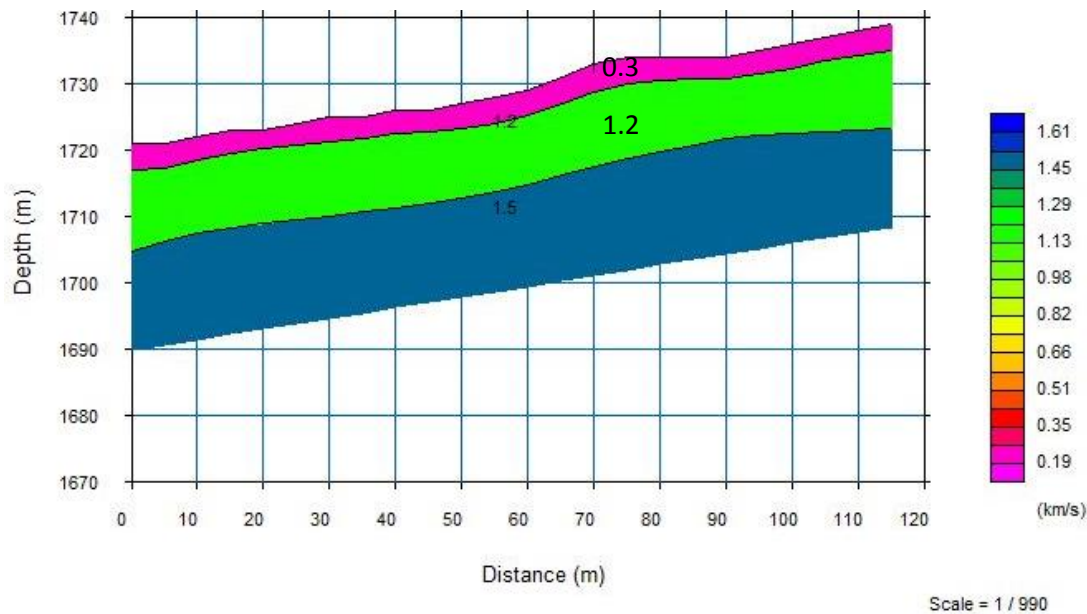
unconsolidated dry materials. As results, this layer has medium velocity ranges 1200m/s (1.2km/s). According to borehole log data this second velocity layer corresponding to saturated clay intercalated soil. The third layer has been shows higher velocity than the two layers. This may relatively massive and compacted which considered as weathered limestone comprised to borehole data.

Figure 5. 5 Velocity model of line 1

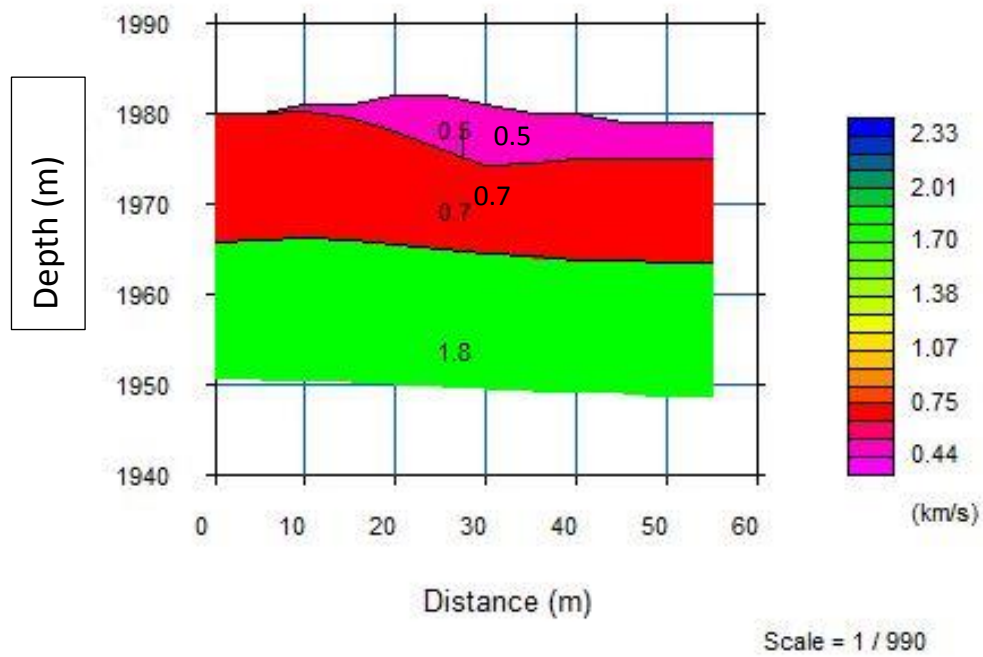
The third layer shows relatively high velocity (1800m/s) and is attributed to a limestone bed which has a moderately strong rock mass strength. This indicates the low velocity layer which corresponding to unconsolidated material underlies by relatively hard rock. During rainyseason this hard formation hold

Figure 5. 6 Velocity model of line 2
