**The Cause and Significance of Crack and Structural Defect
Assessment of School Building in Dire Dawa City (Case Study on
Legehare Cracked School Building in Dire Dawa City)**

**A Thesis Submitted to
The School of Civil and Environmental Engineering
Presented in Partial fulfillment of the Requirement for the
Degree of Master of Science in Civil Engineering
(Structures)**

This thesis focuses on investigating the cause of significant crack on a five story School Building located in Dire Dawa city. The building is constructed with reinforced concrete frame structure with infill hollow block concrete walls. Large diagonal crack is observed on many walls coupled with minor crack on some structural members. The fact that this defect is observed within three to five service years of the building brought attention for investigation.

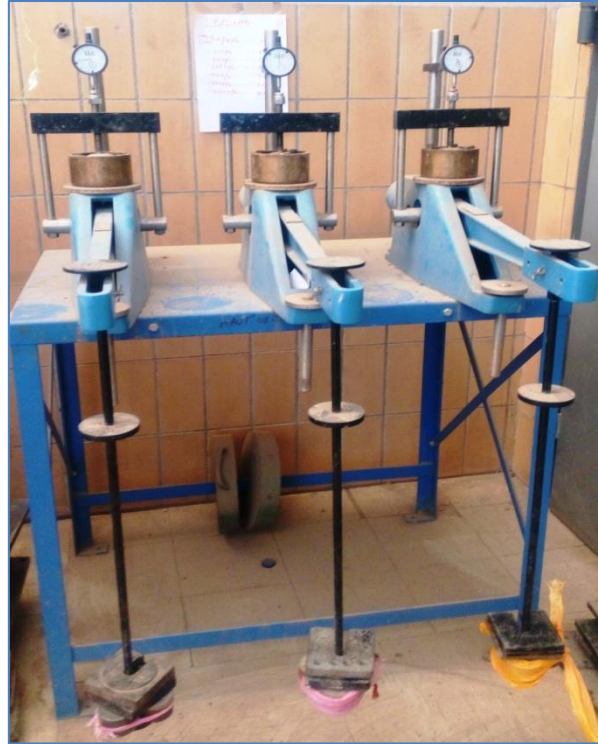
Figure 2.8 Table consolidation test apparatus

The main purpose of the consolidation test on soil samples is to obtain the necessary information about the compressibility properties of a saturated soil for use in determining the magnitude and rate of settlement of structures. The following test procedure is applied to any type of soil in the table consolidation test apparatus shown on Fig 2.8. Loads are applied in steps in such a way that the successive load intensity, P , is twice the preceding one. The load intensities commonly used 1/4, 1/2, 1, 2, 4, 8, and 16 tons/ft² (25, 50, 100,200,400, 800 and 1600 kN/m²). Each load is allowed to stand until compression has practically ceased (no longer than 24 hours). The dial readings are taken at elapsed times of 1/4, 1/2, 1,2,4, 8, 15, 30, 60, 120, 240, 480 and 1440 minutes from the time the new increment of load is put on the sample (or at elapsed times as per requirements). **Sandy samples** are compressed in a relatively short time as compared to clay samples and the use of one day duration is common for the latter. After the greatest load required for the test has been applied to the soil sample, the load is removed in decrements to provide data for plotting the expansion curve of the soil in order to learn [51]

Incremental loads including unloading sequences are applied to the platen and the settlement of the soil at various fixed times under each load increment is measured by a displacement gauge. Each load increment is allowed to remain on the soil until the change in settlement is negligible and the excess pore water pressure developed under the current load increment has dissipated. For many soils, this usually occurs within 24 hours. [37]

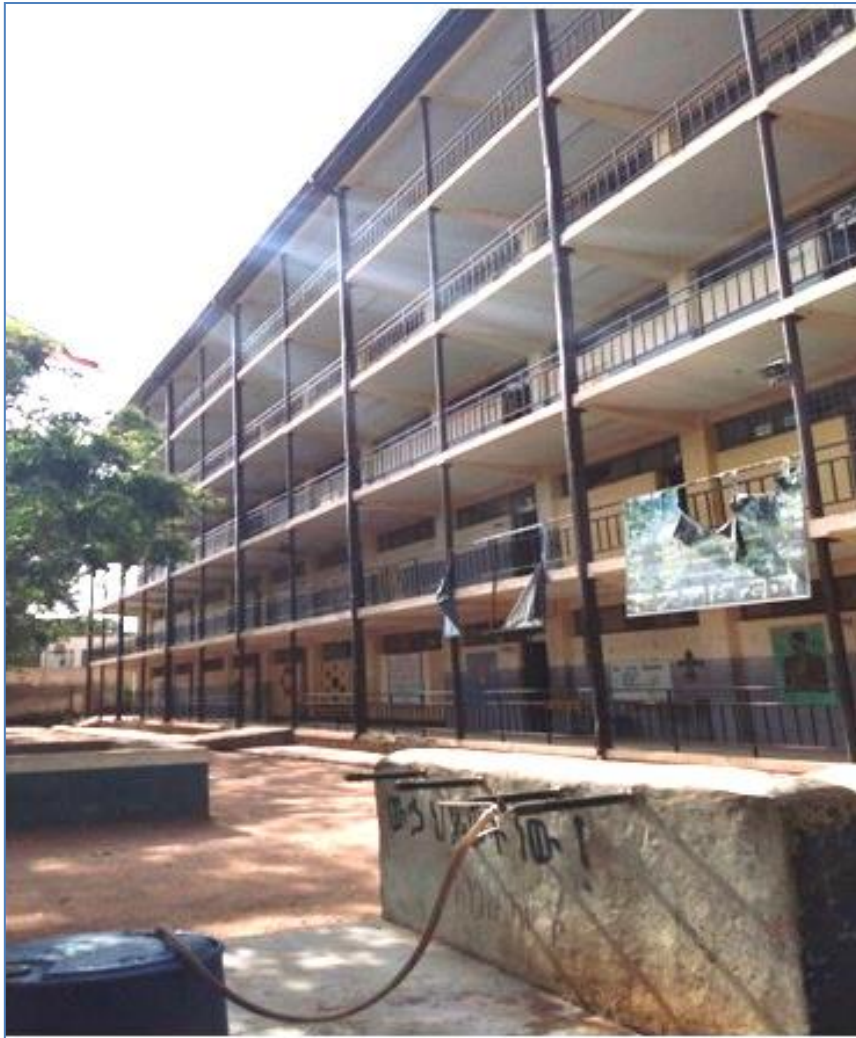
Figure 3.1 Existing building over view

Most valuable or important data are obtained from visual analysis of a building. A building itself can speak the problem underneath it. The visual observation leads to the proper methods of investigation which helps to identify the cause of a failure. Therefore multi site visits has been done to observe current situation of Legehare school building shown in Fig 3.1.

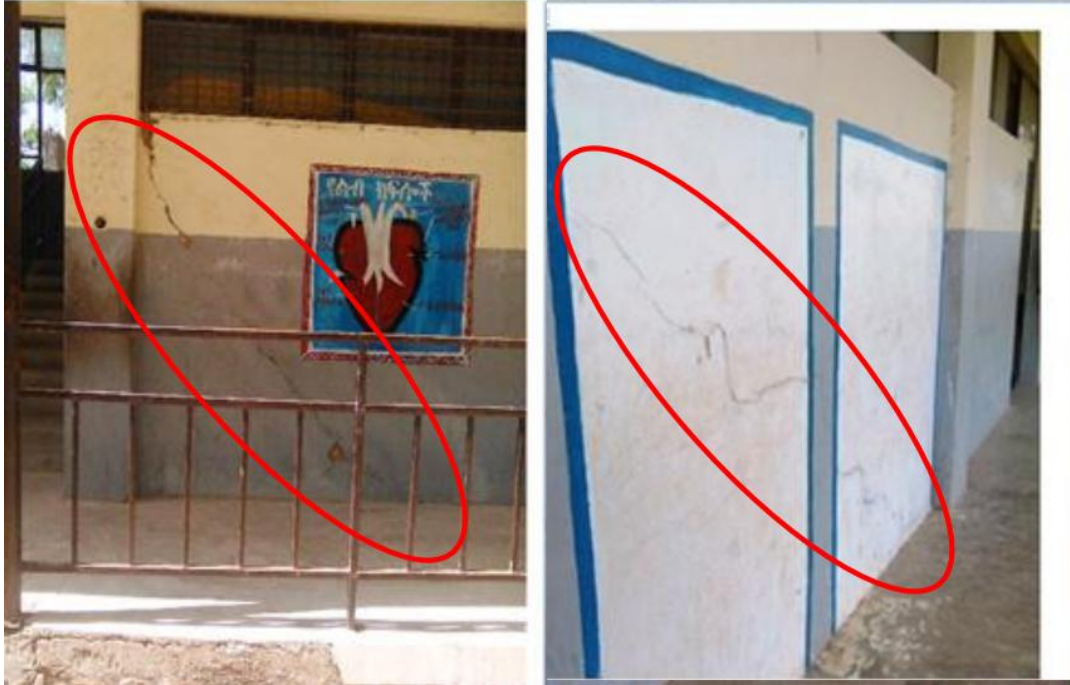
Figure 3.3 External infill walls diagonal cracks along Axis B

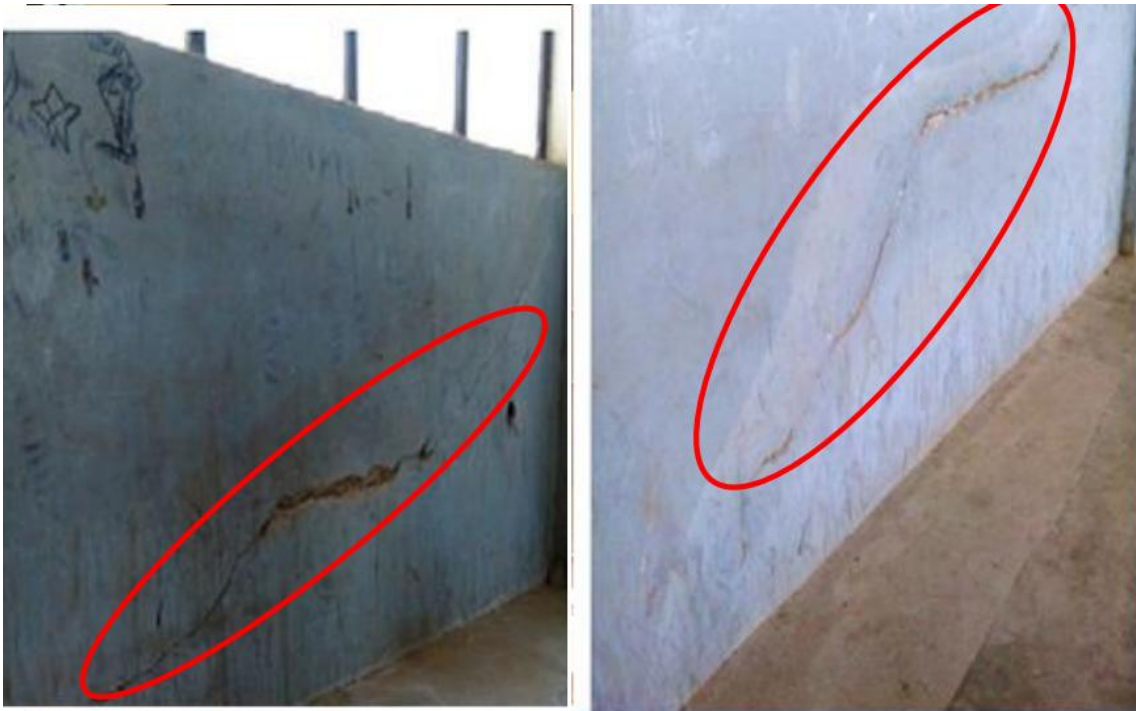
Figure 3.4 Internal infill walls diagonal cracks along Axis B

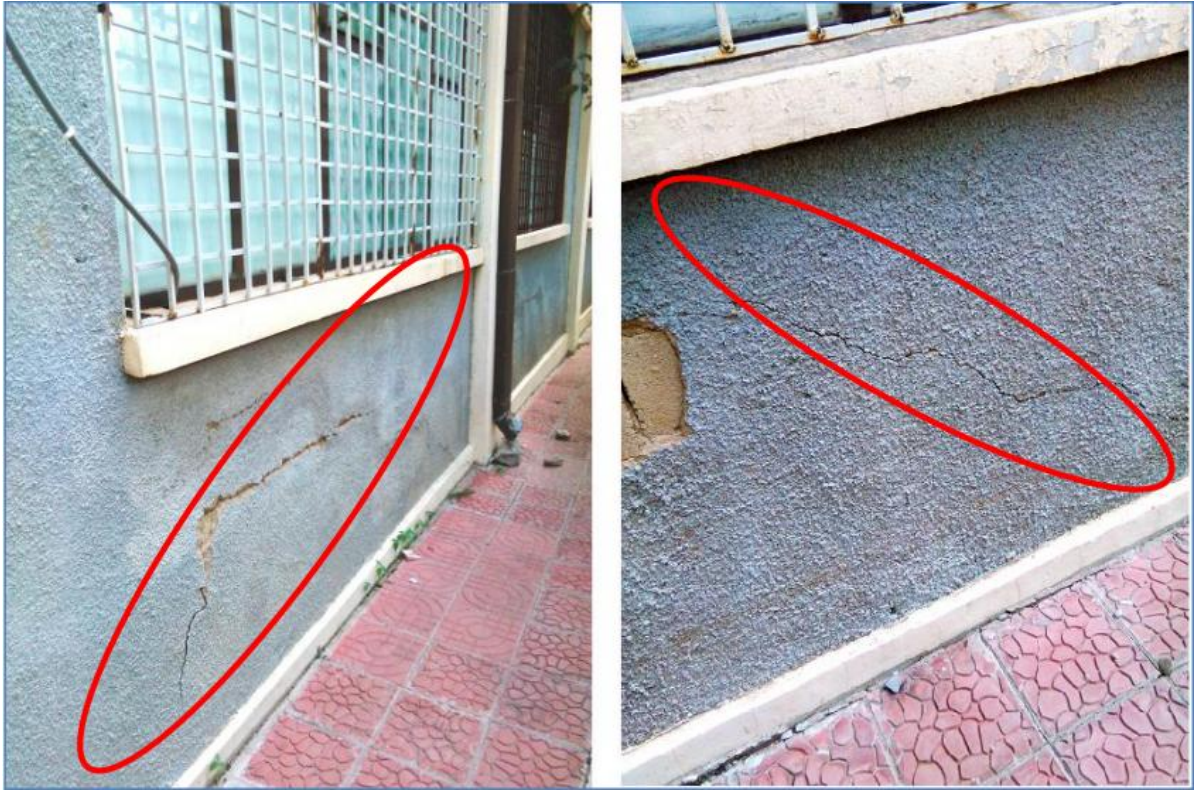
Figure 3.5 Infill walls diagonal cracks along the Axis C

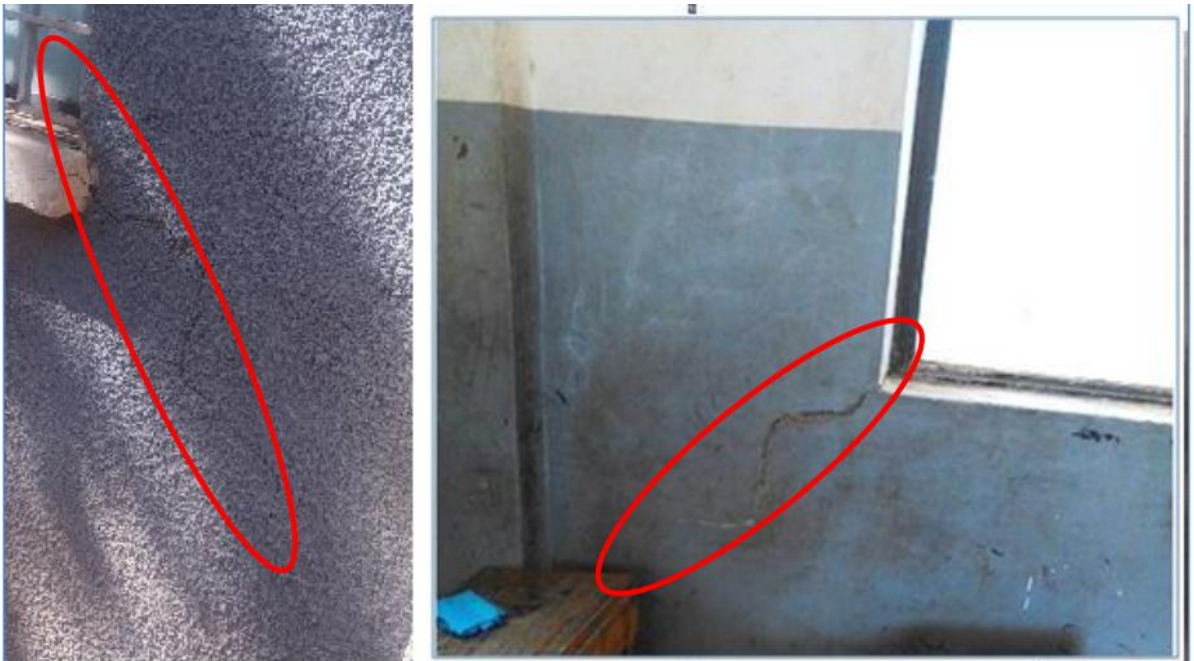
Figure 3.6 External and internal side's window corner diagonal cracks

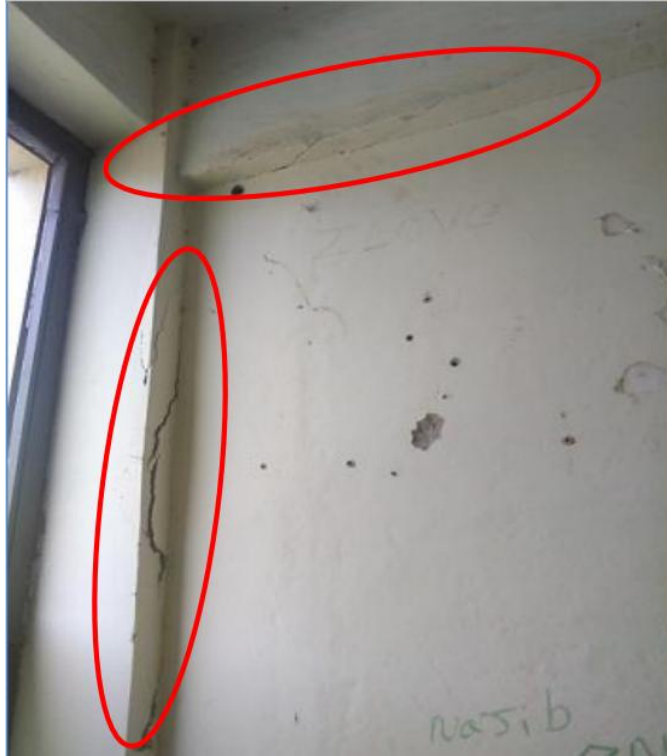
Figure 3.7 Along axis C column crack

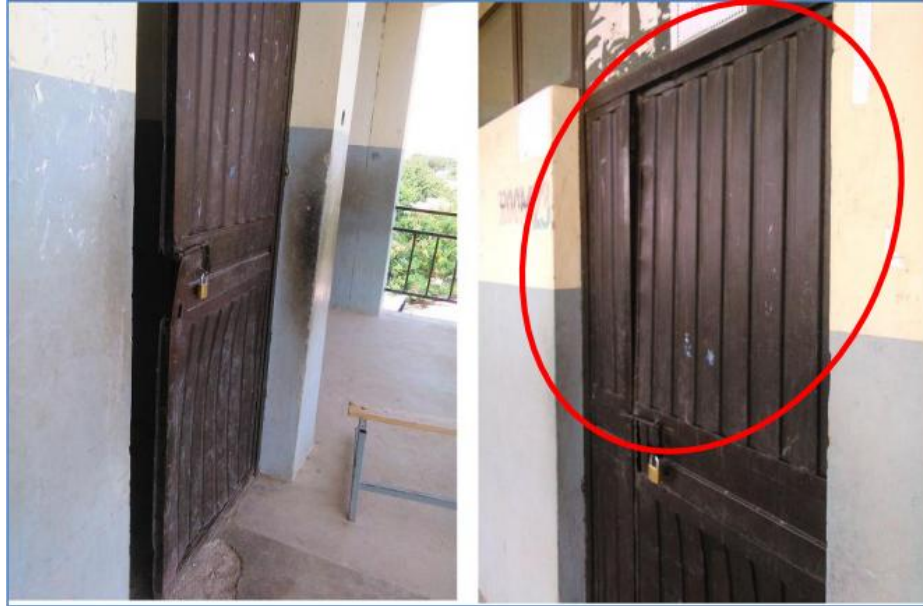
Figure 3.9 Building's steel doors distortion

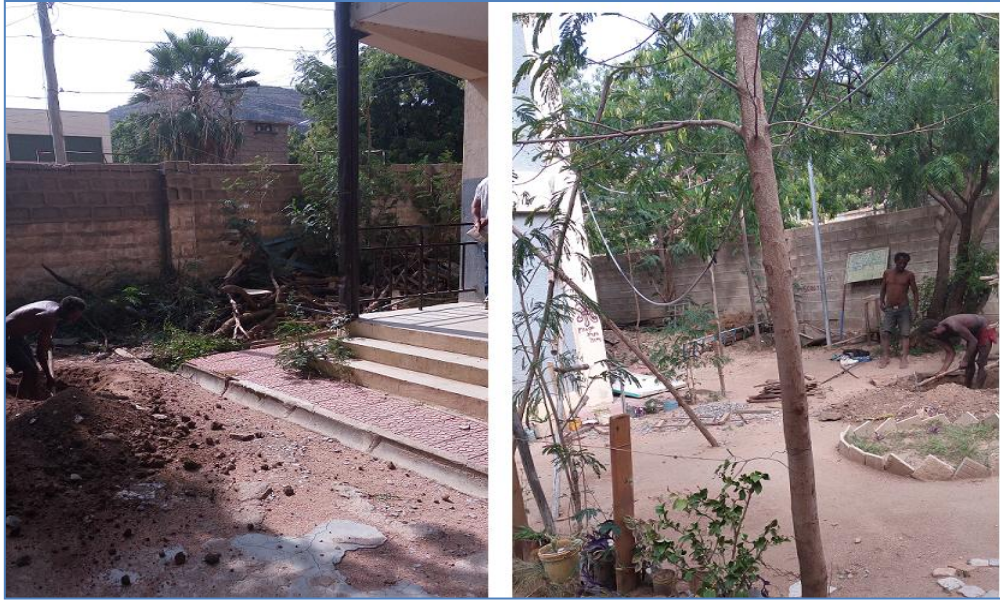
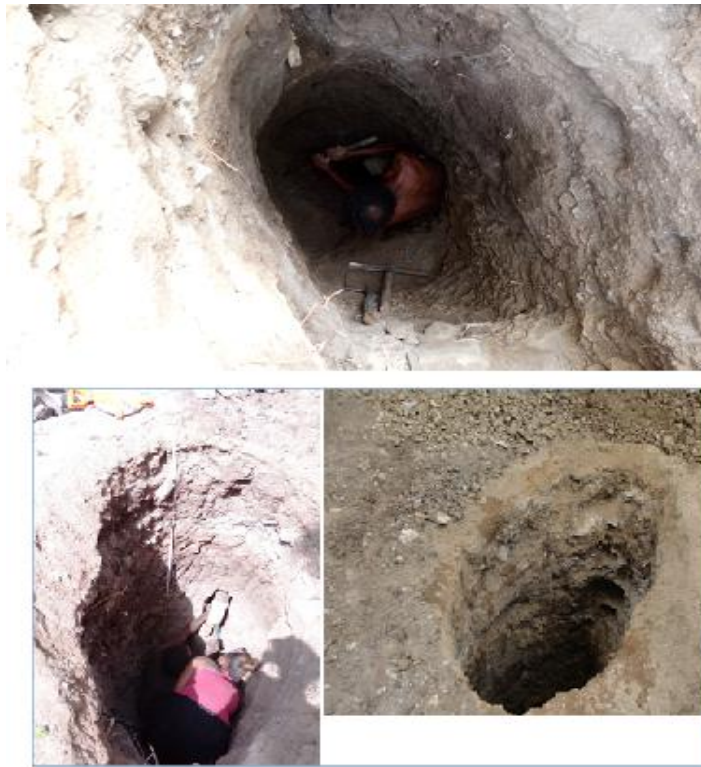
Figure 4.2 Pit 1 and 4 excavations around the building and taking soil samples

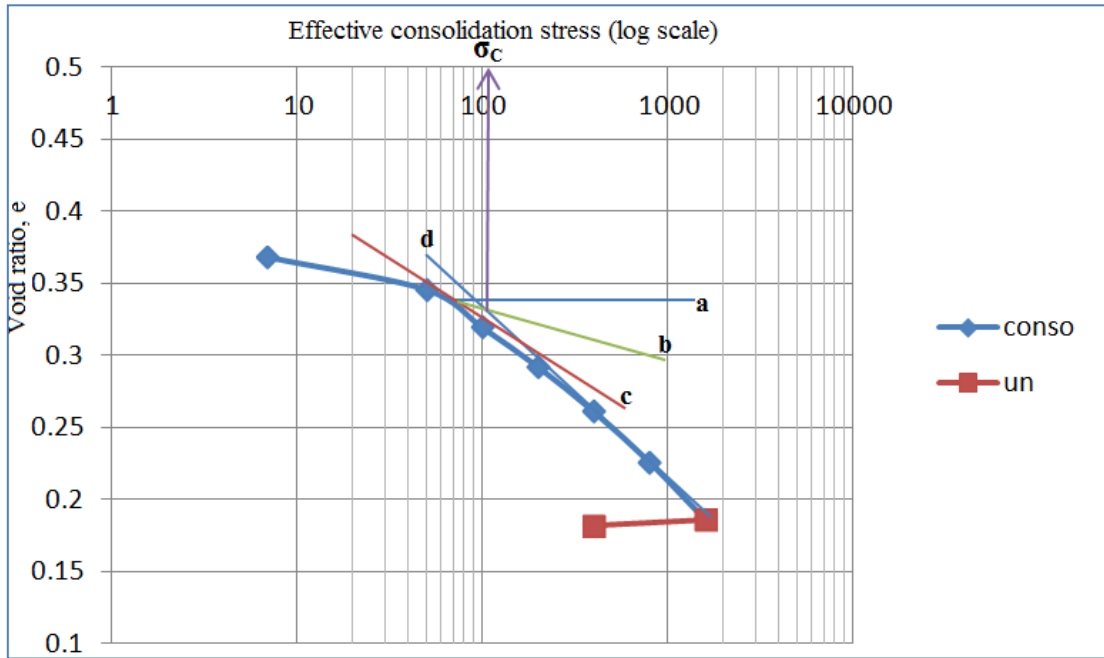
Figure 4.3 Pit 1 at 3m $e - \log P$ curve

Fig 4.3 shows $e - \log P$ of Pit 1 at 3m, Fig 4.4 shows $e - \log P$ of Pit 1 at 4.5m, Fig 4.6 shows $e - \log P$ of Pit 2, 3 and 4 at 3m and Fig 4.6 shows $e - \log P$ of Pit 2, 3 and 4 at 4.5m.

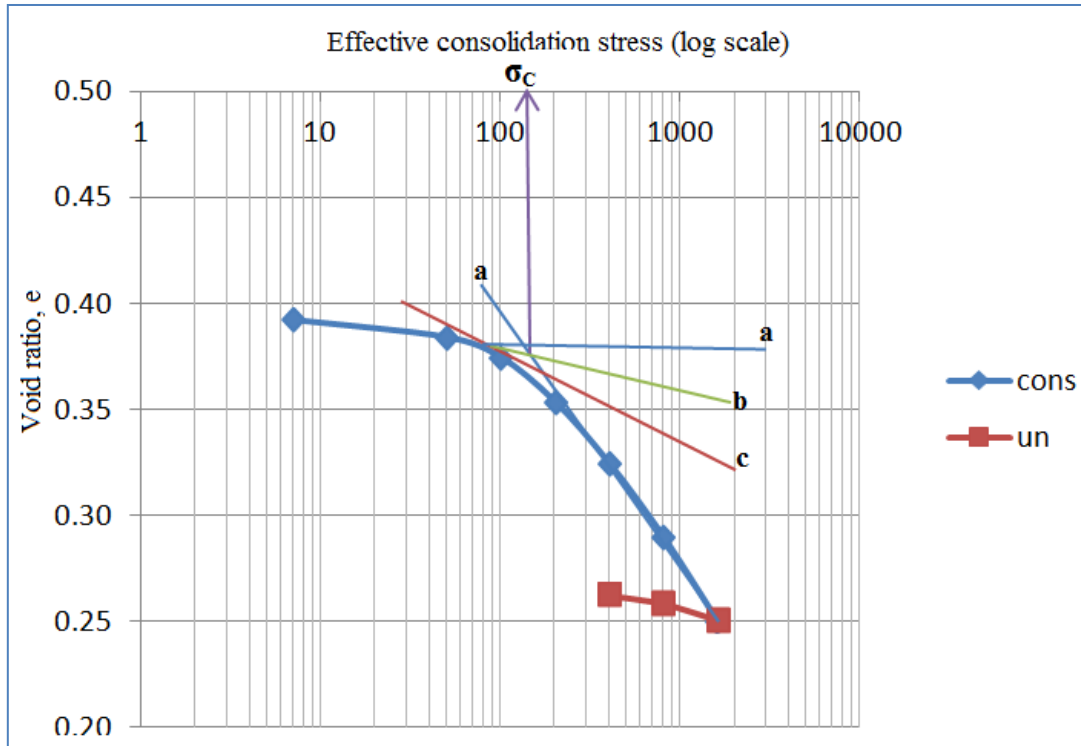
Figure 4.6 Pit 2, 3 and 4 at 4.5m e -log P curve

The soil layers observed in pits 2, 3 and 4; specifically below 4m from ground level show significantly varying property as compared to layers up to -4m level.

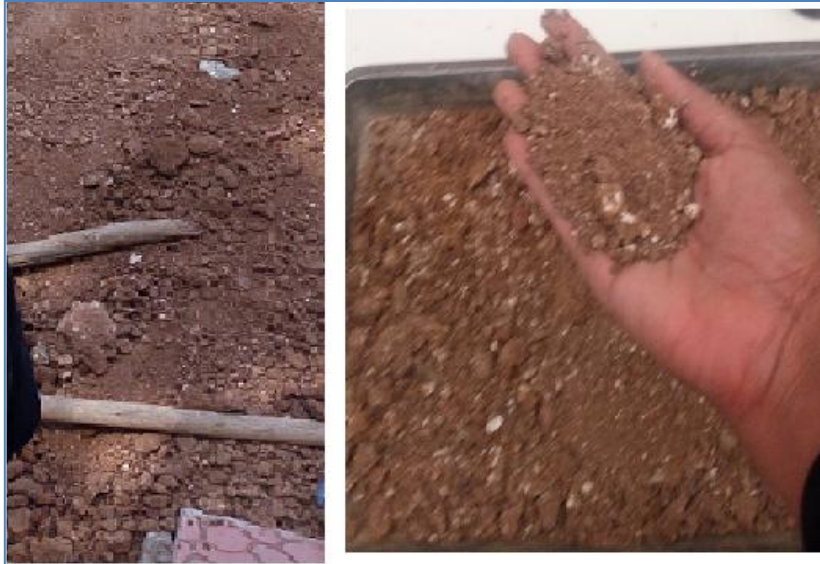
As can be seen in Fig 4.7, the color texture of soil layers observed in pits 2, 3 & 4 from NGL level 0.00m to -4m is brown with sparsely dotted white spots. Whereas for layers below -4m of pits 2, 3 & 4 as seen in Fig 4.8, the color texture is generally white and relatively stiffer than the layers found above-4m level.

Figure 4.7 Pit 1 soil at 4.5m

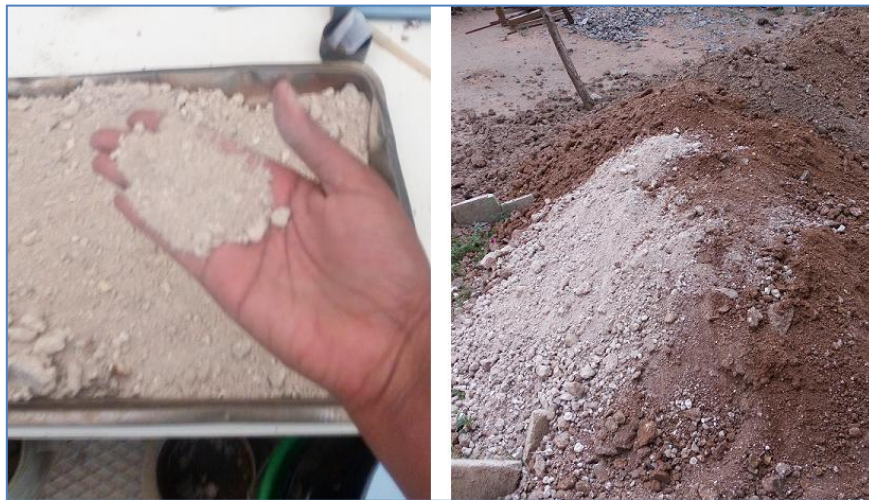
Figure 4.8 Pit 2, 3, and 4 soil at 4m up to 4.5m

Therefore, only from the visual and laboratory test, pit 2, pit 3 and pit 4 have almost similar soil type and settlement property.

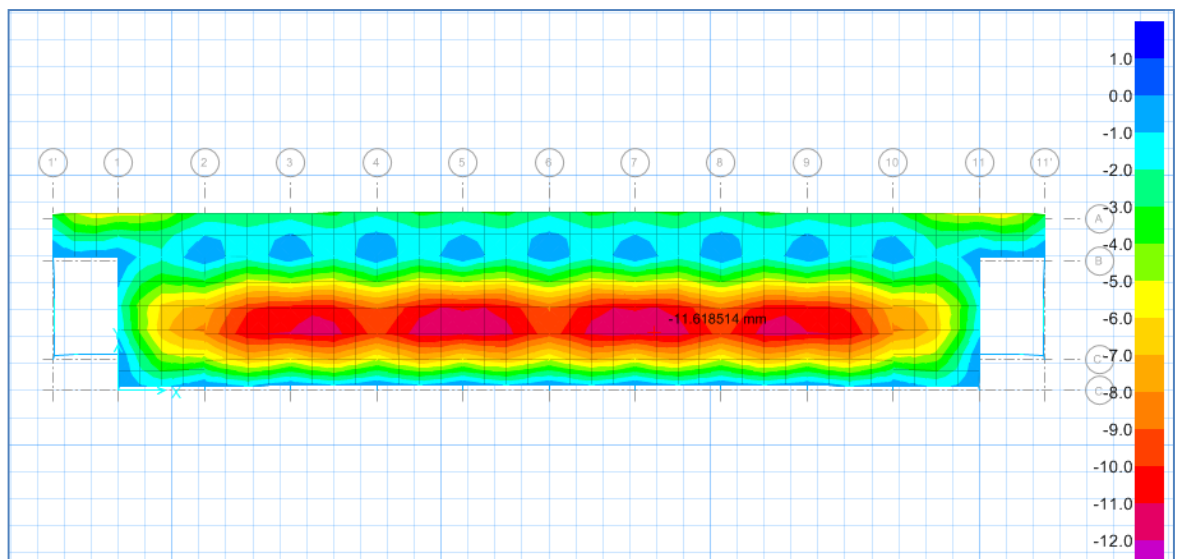
Therefore the typical slabs of the floors under the expected given loads are within acceptable deflection limit and the typical slabs are safe under the previous designed condition.

Figure 4.17 Safe 2014 deflection output

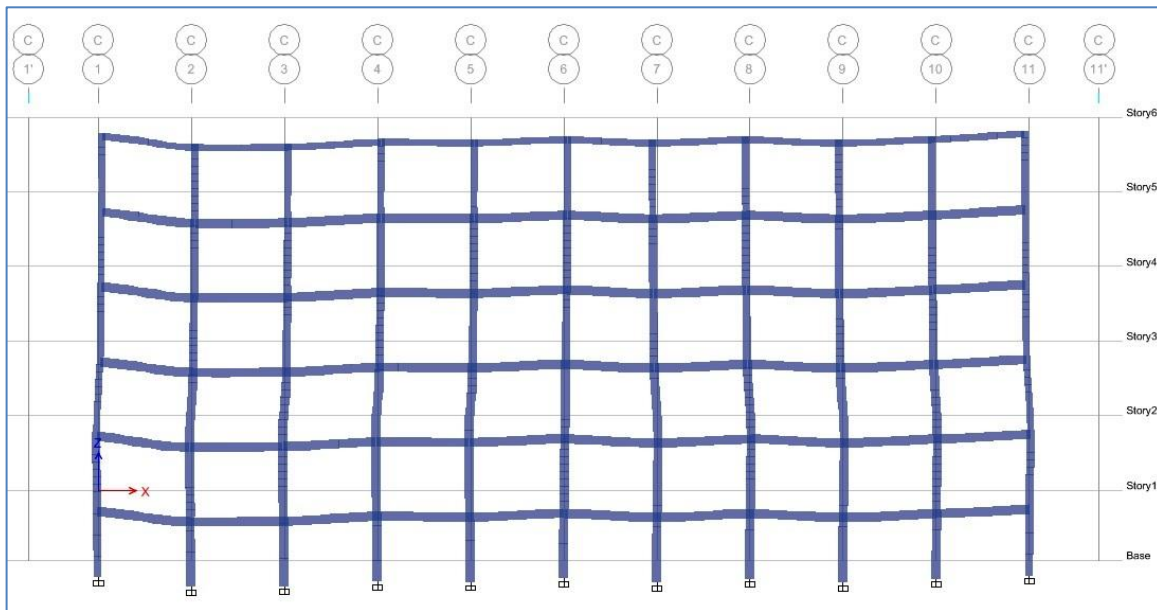
Figure 4.18 and 4.19 clearly shows the final settlement different at both sides of the building. And unlike the results from visual observation and followed by analysis, here the difference between the two sides of the building in terms of differential settlement is quite noticeable.

Figure 4.18 ETABS2016 analysis result of Axis C frame deformed shape
