Environmental Impact Assessment of Quarrying Activities on the downstream section of the Big Akaki Catchment. Addis Ababa, Ethiopia

A thesis submitted to Addis Ababa University School of Earth Sciences Graduate Studies as Partial Fulfillment of Master of Science in Geological Engineering (Environmental Geology and Geohazards) Stream.

By: Samrawit Yimame Aragaw
Advisor: Professor Asfawossen Asrat
June 2020

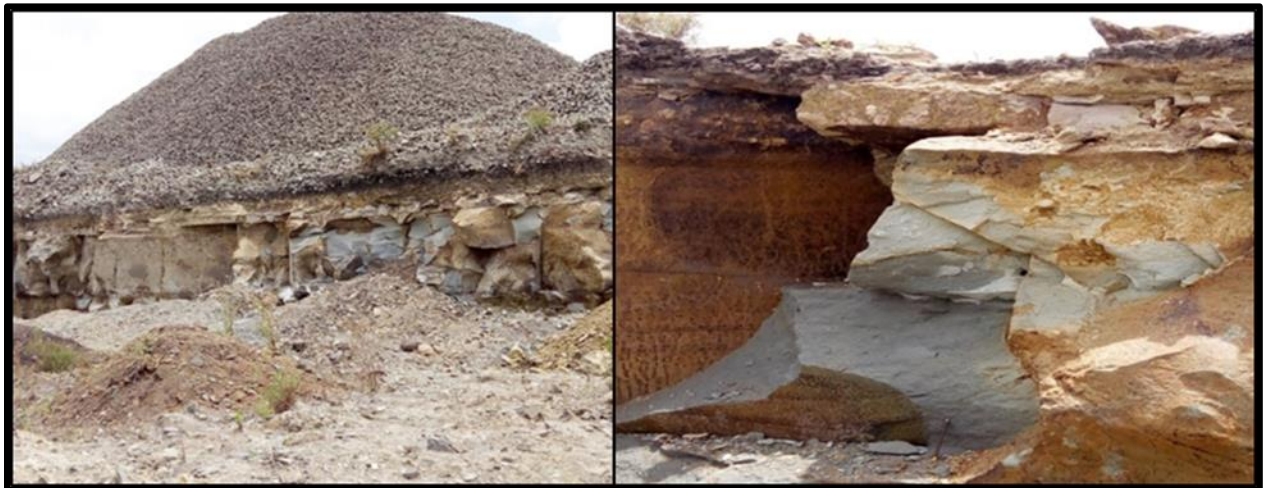
Welded pyroclastic flow covers the central to the northern part of the study area and categorized under the sin-rift unit. According to Efrem Beshawered (2010) this unit is light to dark-grey in fresh samples and reddish to yellow to pink in weathered ones. It is fine-grained, densely welded rock containing Vitrophyric Fiamme and lithic fragments with associated rhyolite lava flows interleaved with ash and un-welded tuffs.

Figure 3.1. Ignimbrite exposure in the northern part of the study area.

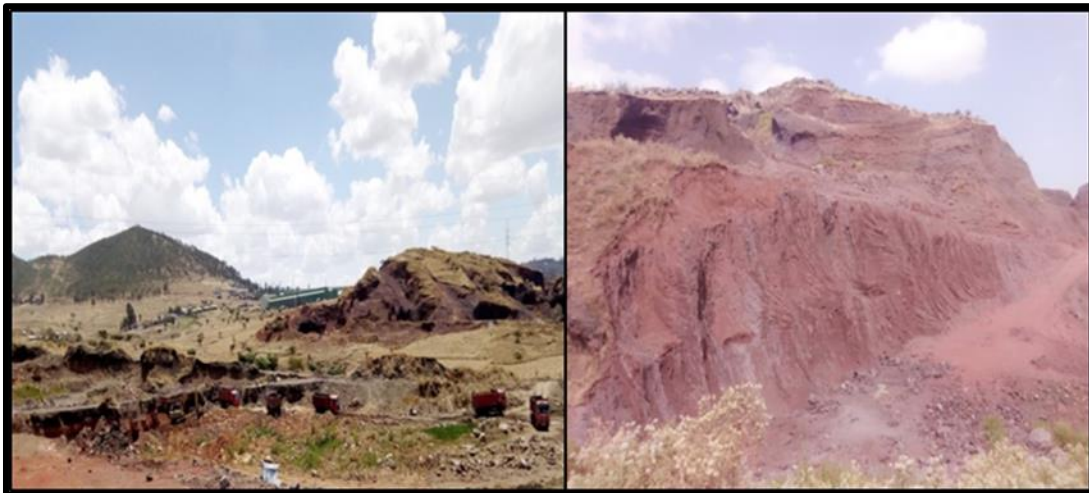
Exposure of the Scoria unit is found in the eastern and southeastern portion of the current study area. This unit usually forms unevenly distributed cinder cones and sometimes broad-based gentle-sloping circular to elliptical hills. It is dark brown, reddish grey color, vesicular coarse-grained rock; generally Akaki basalt this includes pyric basaltic flows and scoria fallout are exposed on the western rift shoulder south of Addis Ababa (Efrem Beshawered, 2010).

Figure 3.2. Scoria exposure in the southern part of the study area.

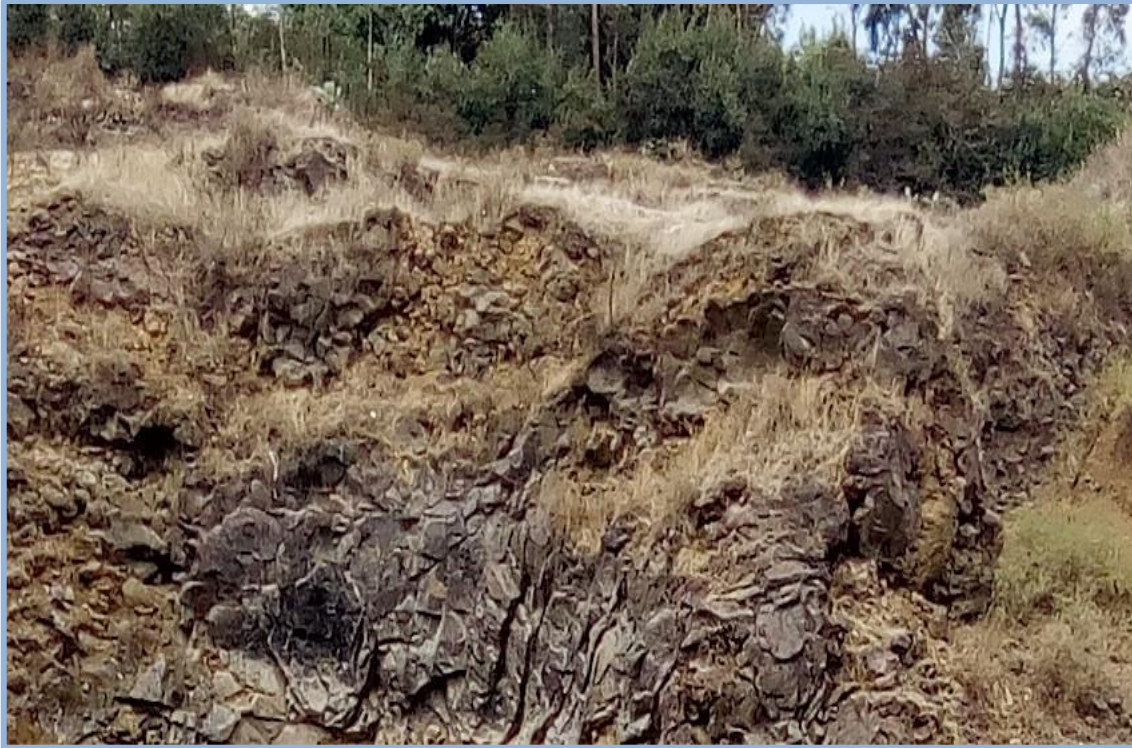
Figure 3.5. Fractured and weathered basaltic rock exposure in the northern part of the study area.

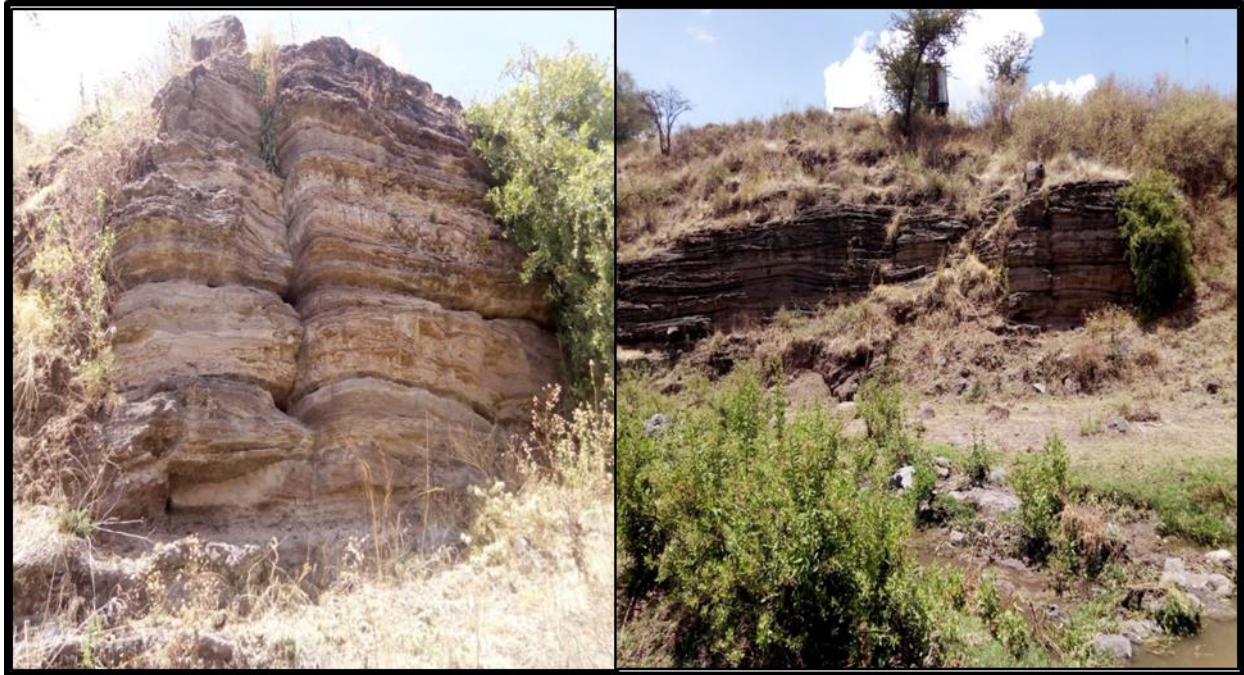
Figure 3.6. Lacustrine deposit in the southern part of the study area.

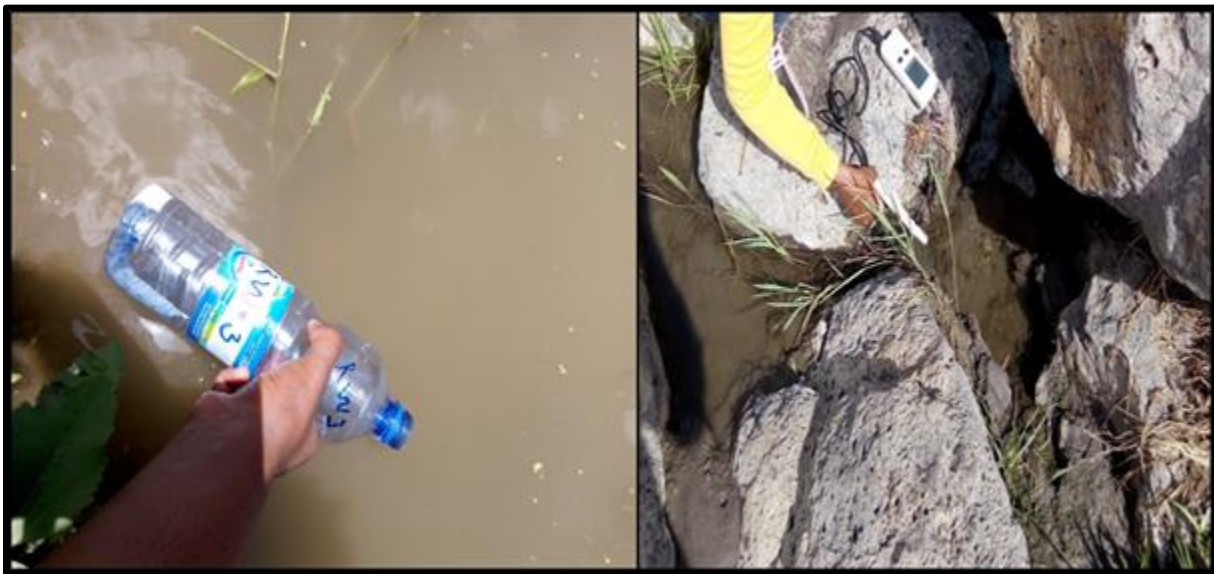
Figure 4.1. On field EC, pH measurement and surface water sampling.

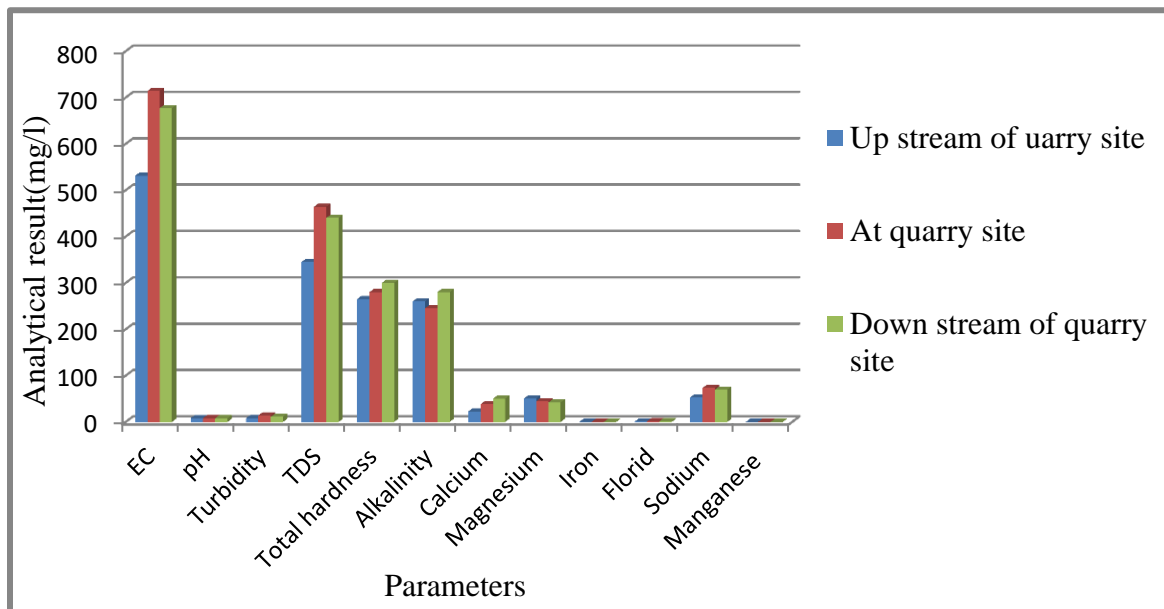
decreases away from the quarry site, hence the lower turbidities in the upper and downstream sections. The color index of the river water increased within the quarry and at the downstream section, confirming the turbidity of the water which leads to color change. This was confirmed during field observation while sampling where the river water upstream the quarry was more naturally colored than those at quarry site and just downstream the quarry site.

Figure 5.2. Physiochemical parameters change of Dengora River relative with quarry activity.

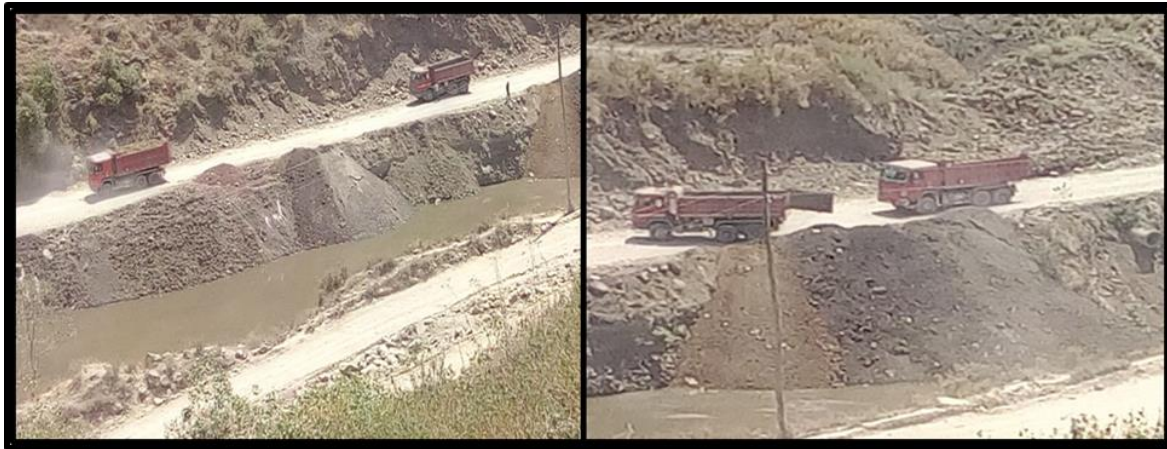
Figure 5.4. Trucks disposing cleared upper soil from quarry in to Akaki River.

Generally, in addition to other sources of pollutants Akaki River is impacted by quarrying activity, as shown on fig 5.4 the upper soils cleared from quarry sites are discharged into Akaki River this can adverse a great problem on river ecosystem and this may indirectly affect socioeconomic development. Additional to controlling other sources of pollutants in the city of Addis Ababa responsible agencies should take into consideration quarry impact on river water resources.

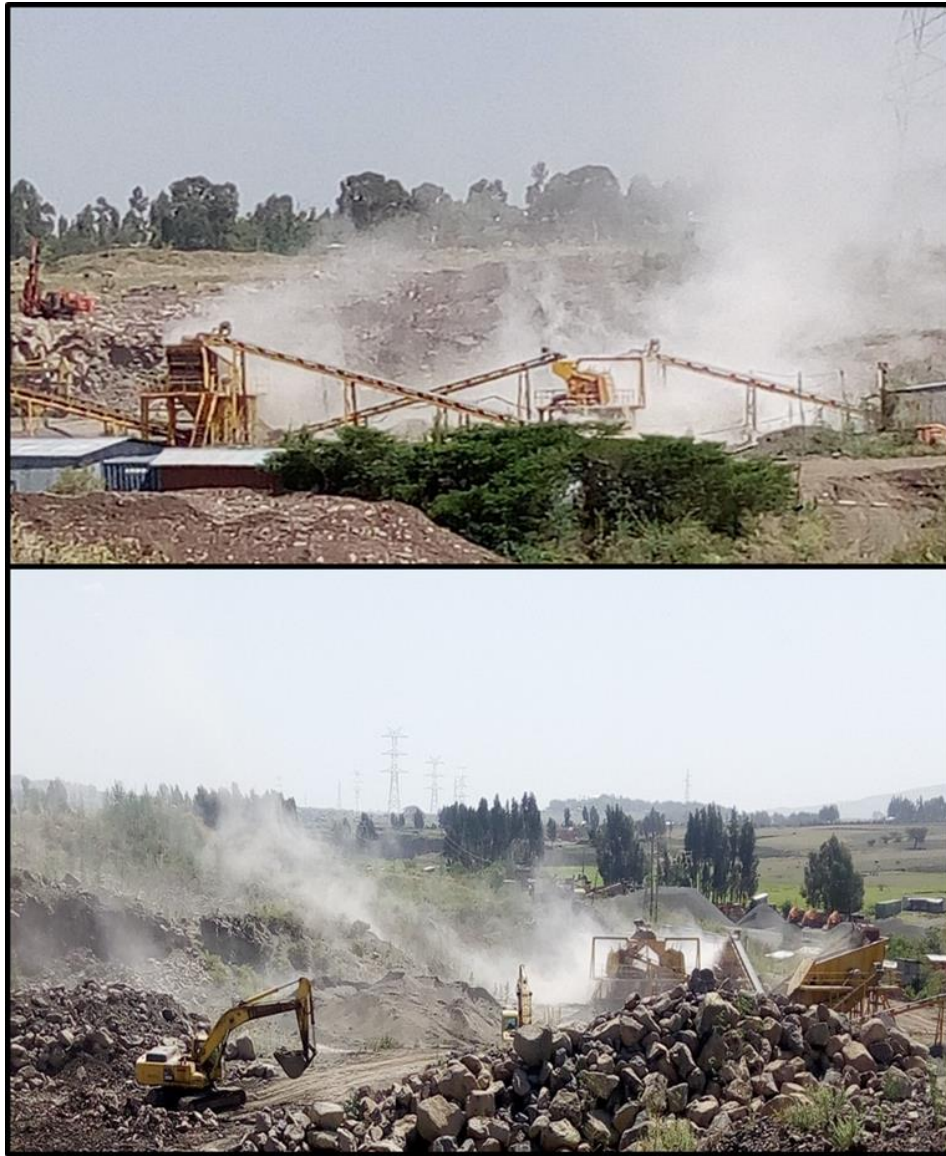
Figure 5.17. Dust impact from the quarry create hazy environment.

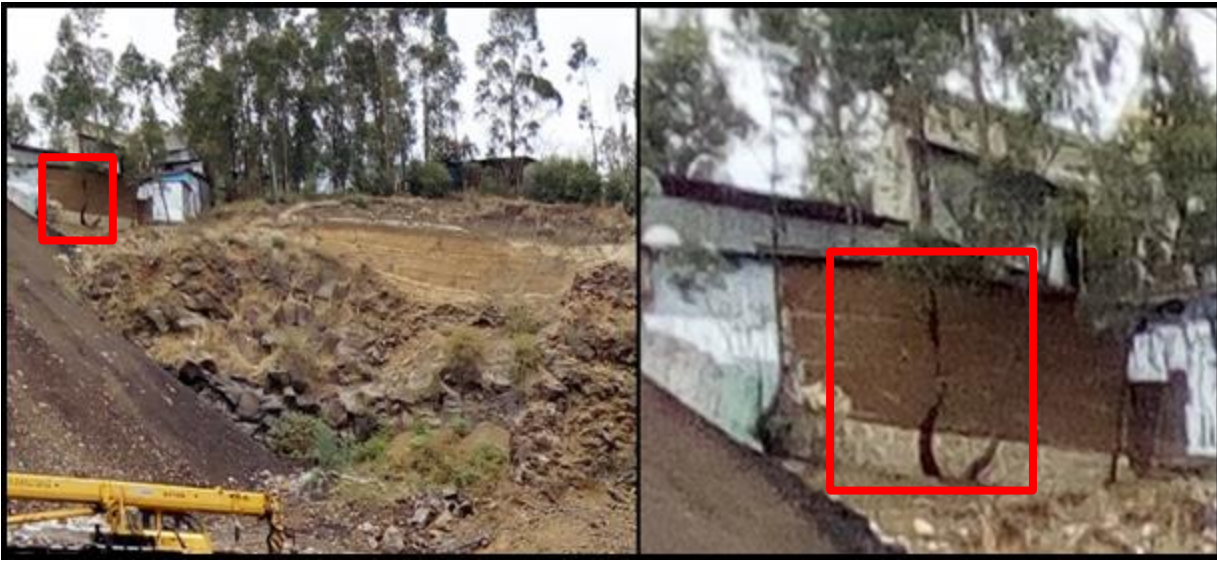
electricity cables and the communities are faced with electricity-related problems such as burning of electrical materials at home. They said their house roofs are making perforation due to flying rocks. Finally, most of the respondents are angry due to multi-impact of quarry activity in the study area.

Figure 5.19. Cracked house due to quarry blasting.

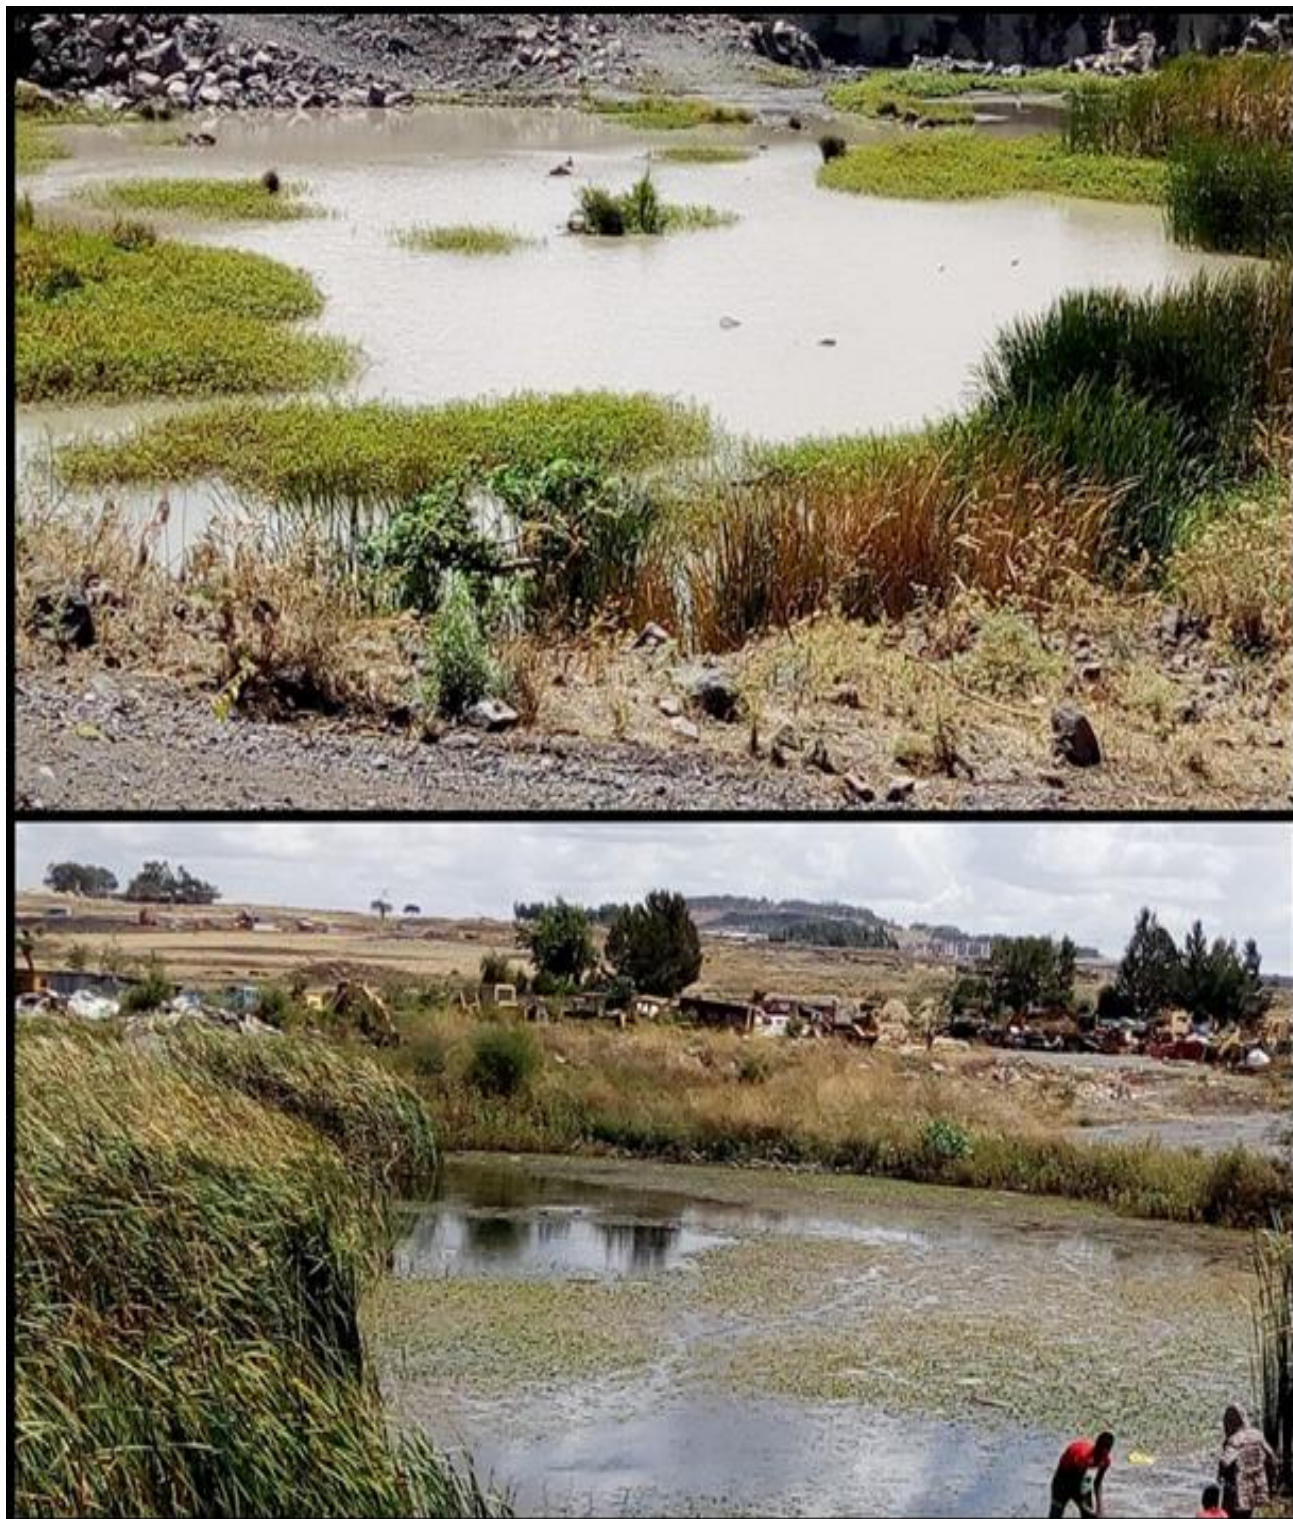
death, they said as maximum as in one season 6 friends were passed due to accumulated water in the quarry site. Most of the time boys and girls are vulnerable to this problem; because boys are trying to swim and girls are trying to fische water from the accumulated water in the quarry. Also, they expressed animals have died when they try to drink water.

Figure 5.21. Accumulated water in abandoned quarry site picture captured at winter.
