**DOCUMENTATION AND CONSERVATION STATUS OF BETE MULU
CASTLE IN WELKAIT, WESTERN TIGRAY**

OCTOBER, 2016

**A THESIS SUBMITTED TO THE DEPARTMENT OF ARCHAEOLOGY
AND HERITAGE MANAGEMENT, IN PARTIAL FULFILMENT OF THE
REQUIREMENTS FOR THE DEGREE OF MASTER OF ARTS IN
ARCHAEOLOGY**

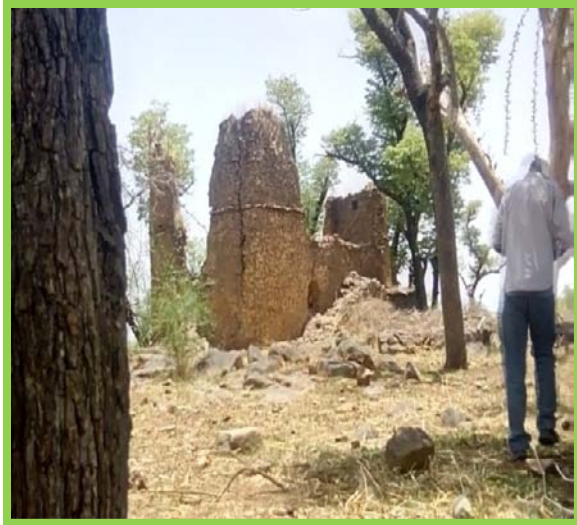
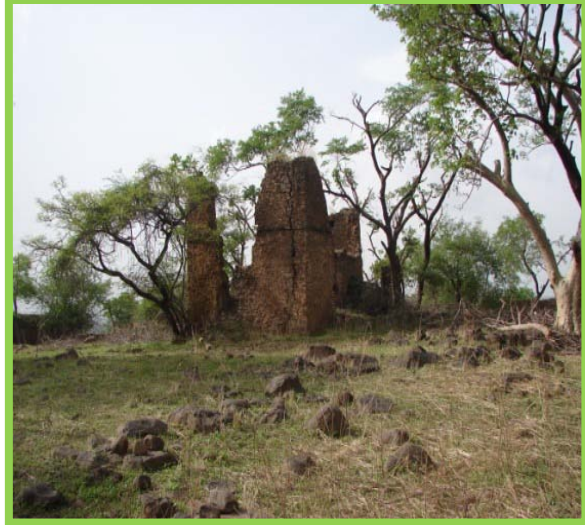
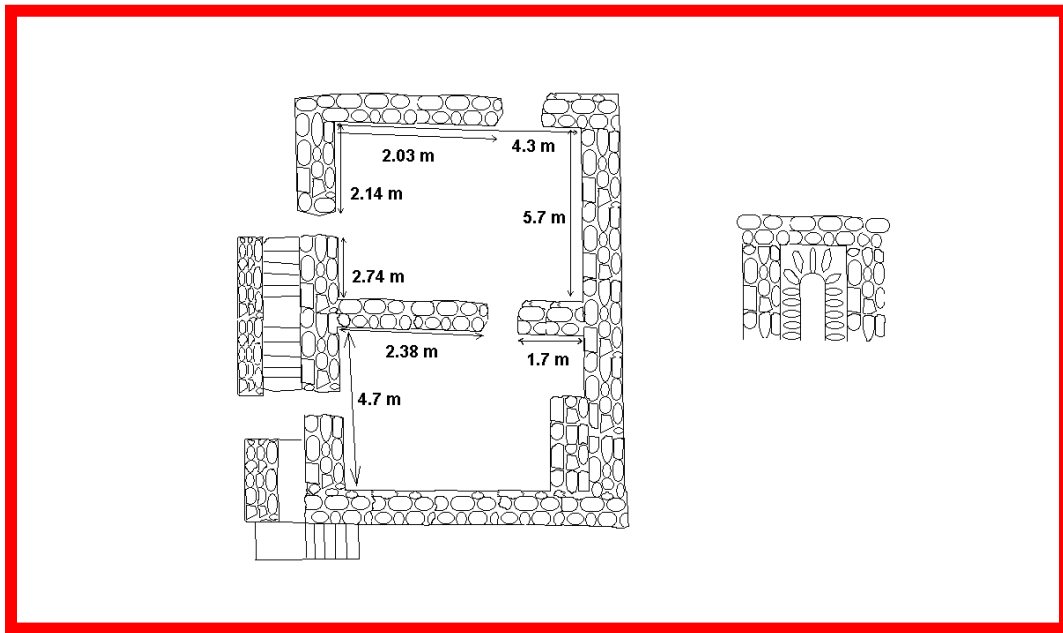
The most important parts of the building are the castle and its surrounding enclosure. Based on researcher observation, currently, the castle encompasses one storey building with rectangular shape (See fig.4 below). The building had at least one upper storey. The clues could be found from the presences of stairway. The top part of the castle has collapsed except some visible part from the southern and northern directions. The ground length and width of the castle is 12.65m and 6.33m respectively whilst its height is 6m. It was built on an area of 1.5 hectares. It is believed that the castle took about one year and six months to complete its construction. However, today, the castle is out of radar from any governmental or non-governmental bodies that do conservation work. It also seems to be crumbling due to old age.

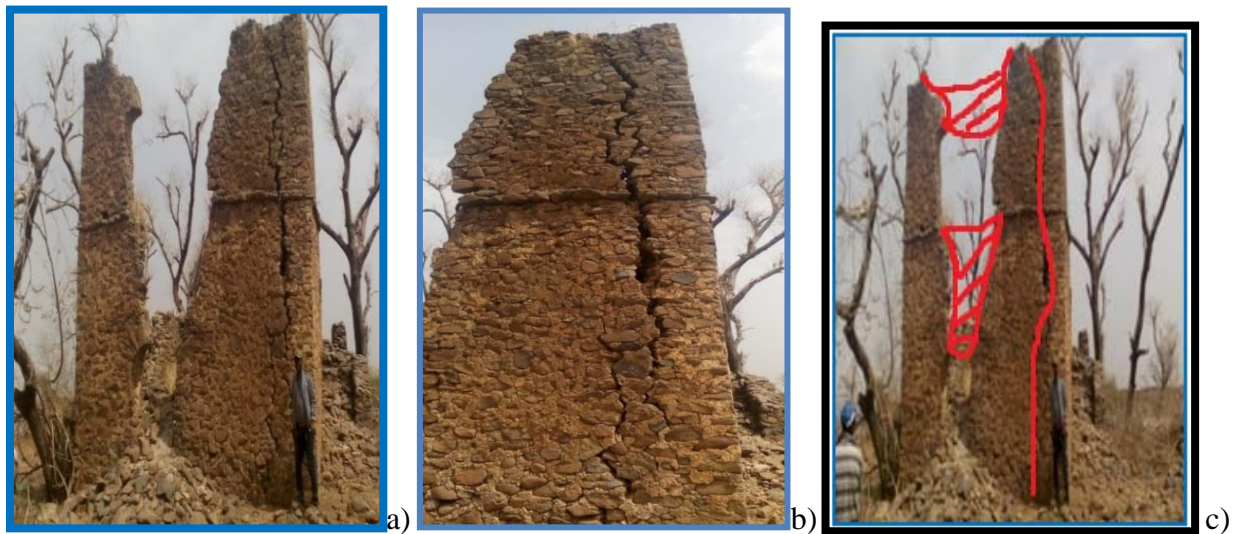
This side of the castle is almost intact as compared to the other sides of the same castle. It has width and height of 6.33m and 6.75m respectively. The thickness of this wall is 80cm. This part of the building is on the side of the main gate of the enclosure from the outside. Even though most part of it is intact, however, some part of it is collapsing with crack on the surviving wall.

Figure 6: Southern façade of the castle (a), cracking (b), and collapsed (c) (Photo by Feyissa H, 2016).

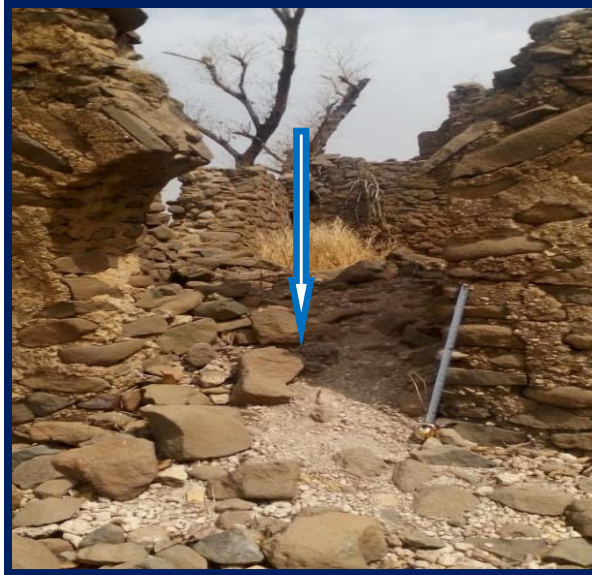
The main gate of the castle, which is arch shaped is found on the southern façade. The gate has width of 1.15m and thickness of 80cm. The height of this gate cannot be measured due to its upper limit is destroyed.

Figure 7: Main gate of the castle on the southern wall (Photo by Feyissa H, 2016).

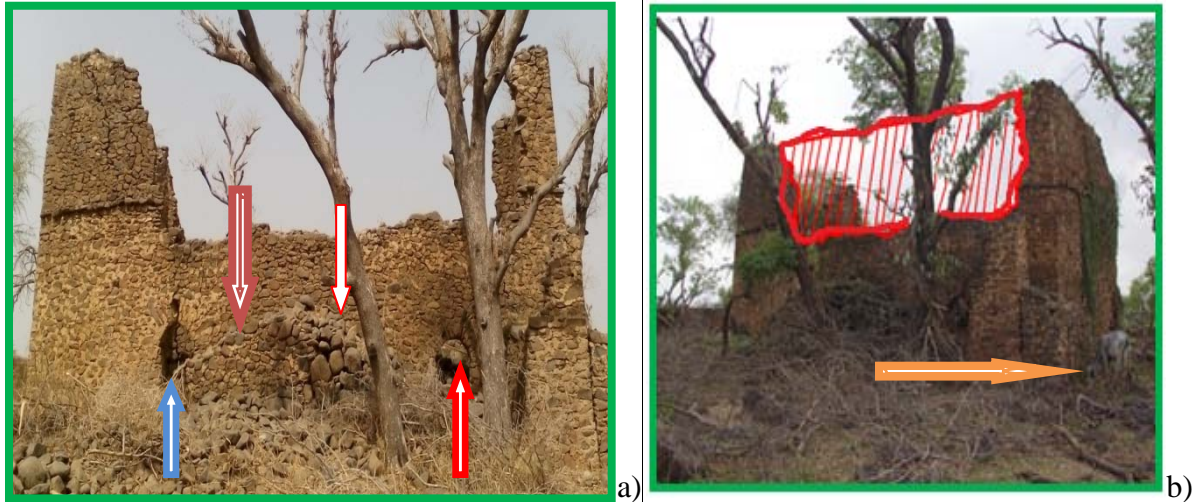
The visible height of this eastern façade is 2.55m while its length is 12.65m. The first floor of this part of the castle is totally demolished. The castle seems to have been one storey building as it can be understood from the surviving two stairways/passageway on the eastern side of the building. The stairways show that there was a passage to the castle on the first floor, at the middle of the east side. There are two an arch shaped small gate from this direction which may have been used as entrance/door, and window. The upper part on the eastern wall of the castle is totally demolished while the ground is intact.

Figure 8: Eastern side of the castle with two arched doors/windows (arrow up) and two stairways (arrow down) indicated (a), and the lost part and arrow showing cattle disturbing the castle (b) (Photo by Feyissa H, 2016).

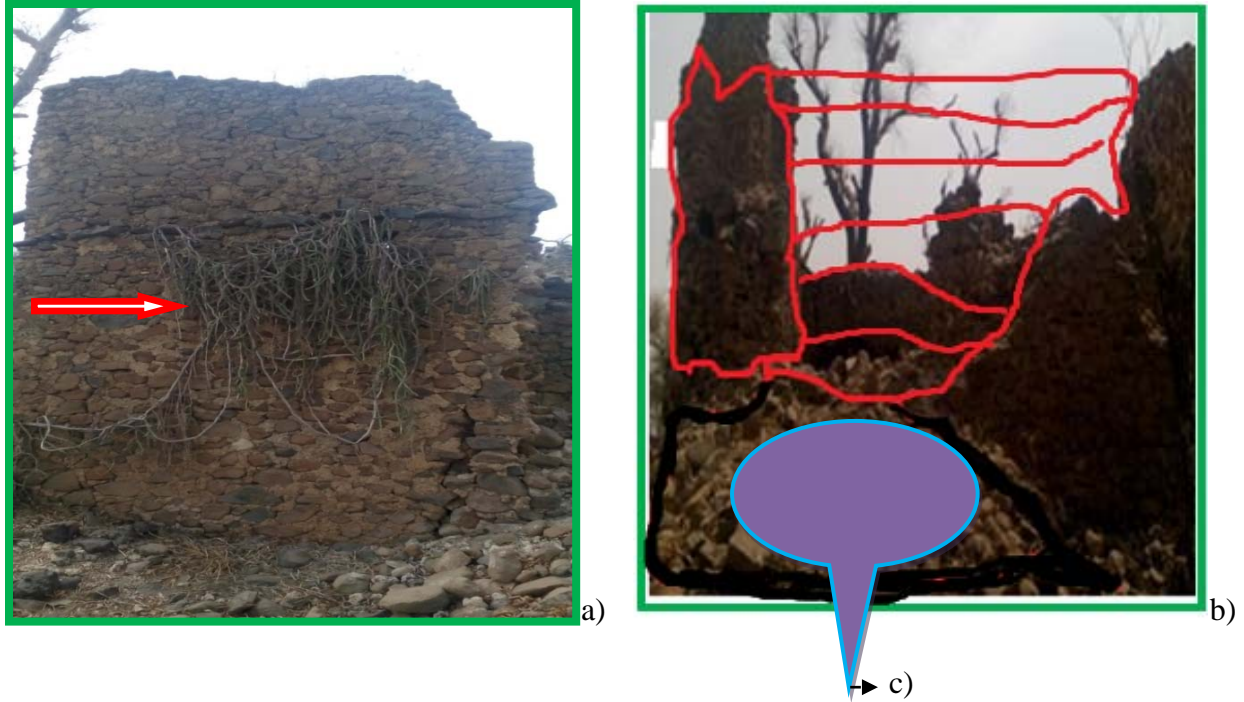
The visible height of this wall is 5.94m. There are no doors and windows on this wall. There is also no architecture visible on it. Most part of this wall is still standing except with minor wall collapsed on its northwest. The edge of the western part of the same wall is collapsed along with wall on the western part of the castle. The roots grown on this part are affecting the preservation of the wall.

Figure 9: Northern façade of the castle and vegetation grown (a), destroyed section on northwestern edge (b), and mounted of destroyed part (c) (Photo by Feyissa H, 2016).

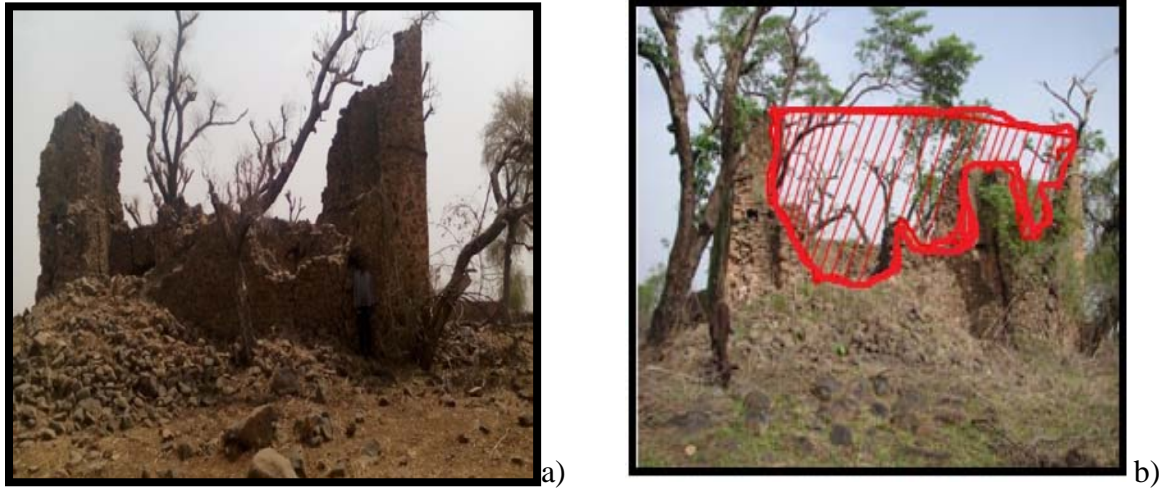
This part of the castle is almost demolished and has lost its features. Most of the wall on this side is not surviving. The reason as to why this part of the wall is compared to the other wall might have been the result of direct hit by sunlight coming after mid day. This part of the wall is used sheltering cattle during rainy season. There is pile of stones next to the castle, further indicating that the wall was destroyed recently. Based on consecutive observation of the researcher there is an increase on the size of the pile of the stone showing that the destruction of the wall is continuing.

Figure 10: Western façade of the castle (a) and destroyed section (b) (Photo by Feyissa H, 2016).

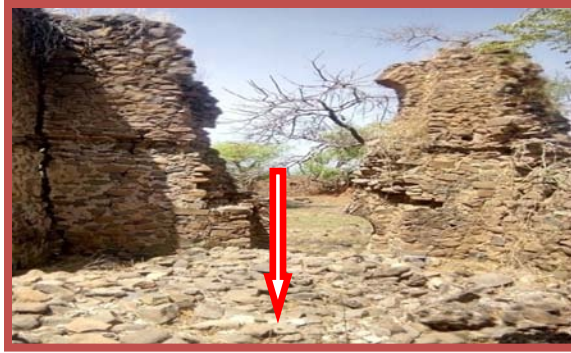
The ground floor of the castle is divided into two roughly equivalent sets of rooms each with their own structure. According to the available source (*Dejena, 2002*) the castle has four rooms; two at the ground and two others on the first storey. The rooms on the ground floor are connected by a door gate. The first room is found parallel to the main gate of the enclosure. It measures 4.38m wide and 6.4m long. There are three possible entrances to this part of the castle. One is the main gate from the southern direction whilst the second one is small arched gate from the eastern direction of the castle. The third one could be an entrance from the first room to the second one or vice versa. The floor is not clearly known since it is covered with fallen piles of stones.

Figure 11: The first room-from southern direction (Photo by Feyissa H, 2016).

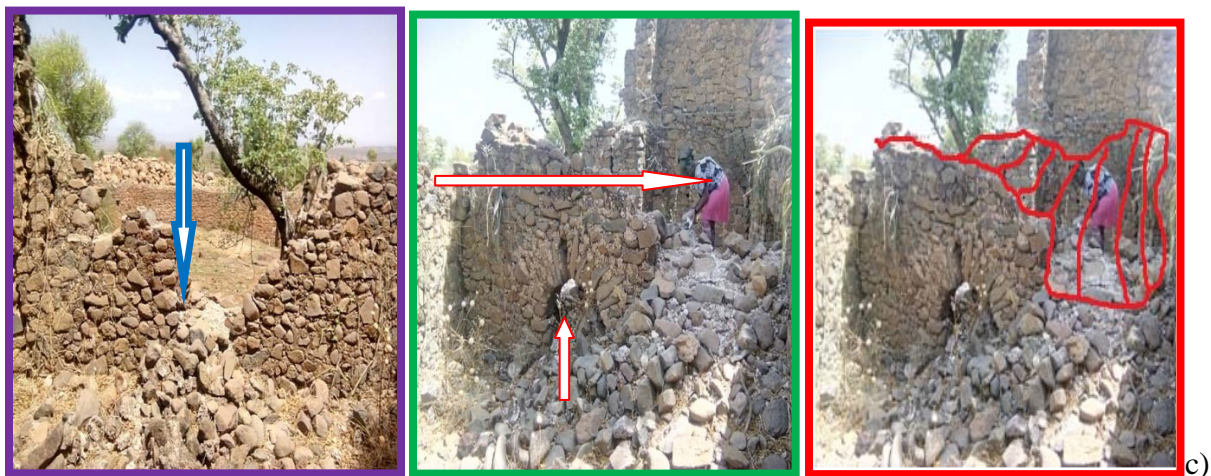
The second room is located on the northern façade of the castle i.e. to the north wall. It has two small gates; one from the east and another one from the first room- which also serve as transit from one room to the other one i.e. from the first to the second room. The width and length of this room is 4.65 and 5.43meters respectively. There is an entrance that takes to the second room and the block that separate the first room from the second room. Some part of the block, that separate the two rooms, is almost demolished. Two Small false windows are also found in this room (see fig.11b).

Figure 12: The second room (a), the wall that separates the two rooms and its entrance (b), and destroyed part (c) (Photo by Feyissa H, 2016).

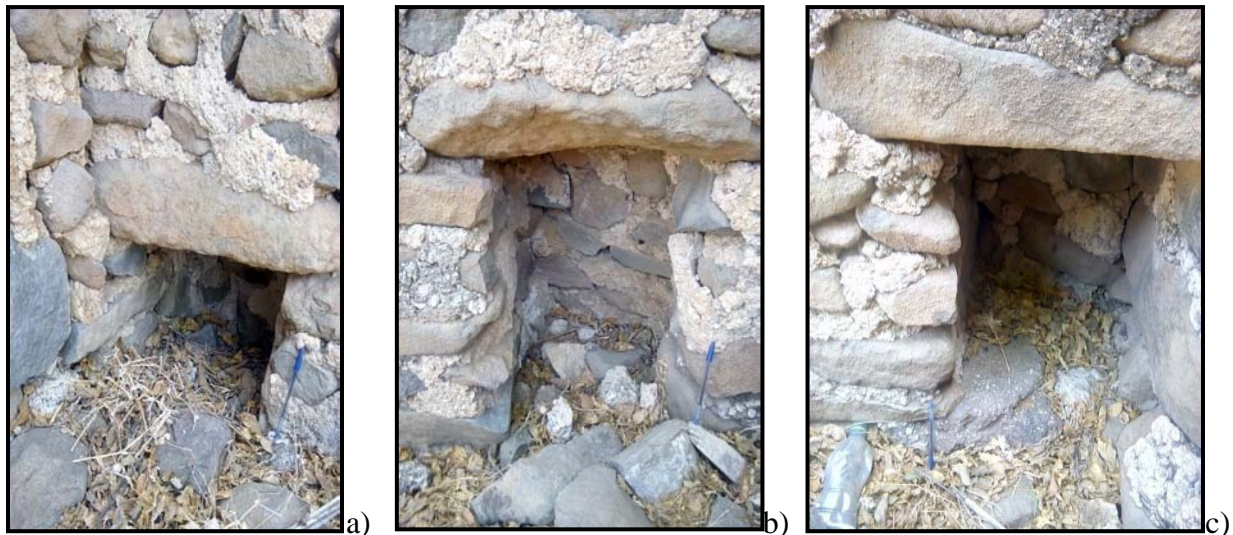
The second niche is found on the central part of the northern wall. It has the height, width, and thickness of 70cm, 40cm, and 40cm respectively (fig.12b) whilst the third niche is found at the western direction of the northern wall. Its height, width, and thickness are 54cm, 35cm, and 55cm respectively (fig. 12c). Again on the same wall, on the first storey, there are two visible niches which are too difficult to measure them due to their collapse.

Figure 13: Niches on the northern wall showing the eastern (a), central (b) and western (c) (Photo by Feyissa H, 2016).

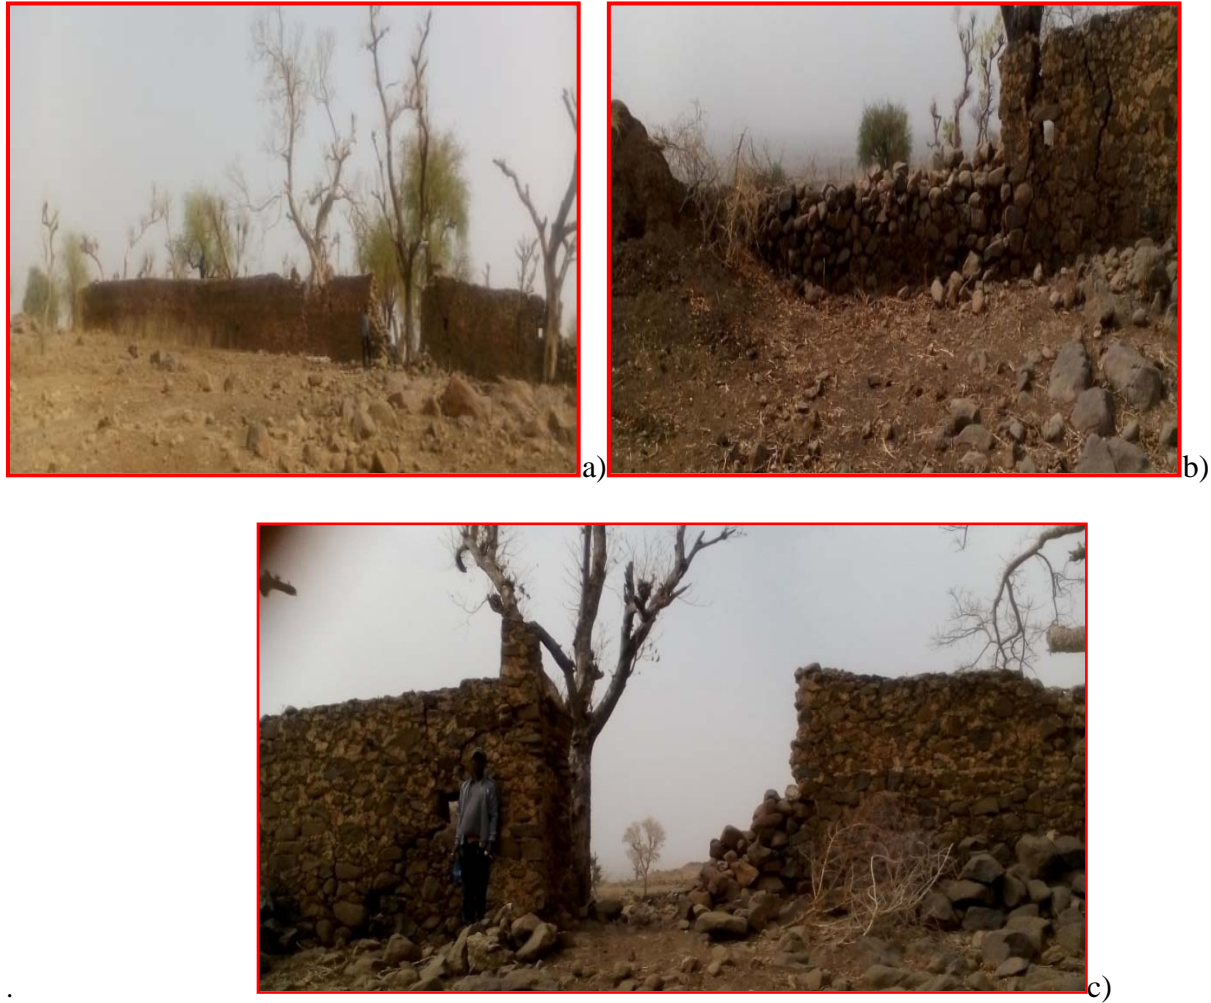
The Bete Mulu castle is encircled by big enclosure. There are two walls encircling the castle as enclosure. The first wall enclosure is well built and most part of it is still well preserved.

Figure 14: Collective view the first enclosure- best preserved (a), destroyed (b), and inside view of the main gate (c) (Photo by Feyissa H, 2016).

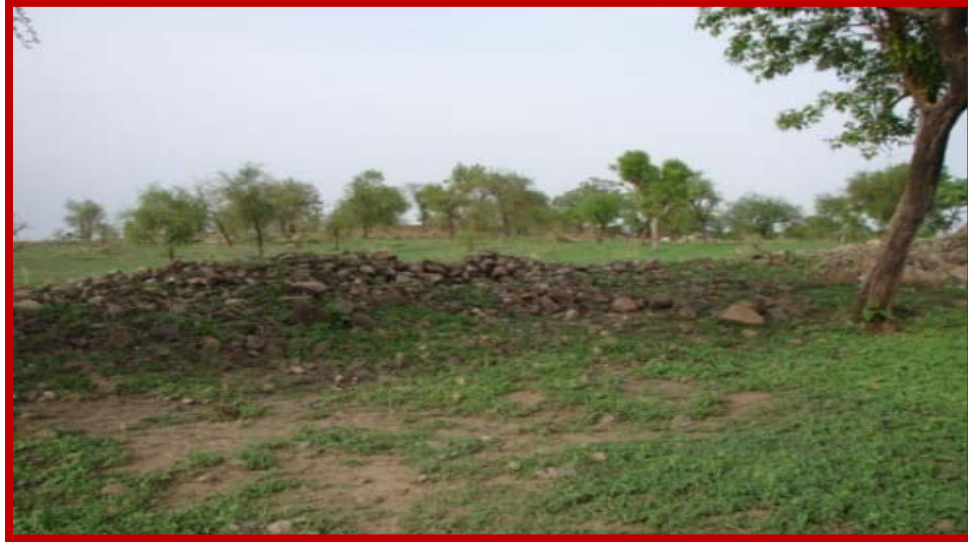
this threat is that, in fact, a crushing machine has been installed near the wall to crash piles of stones mounted over there.

Figure 15: Enclosure of Bete Mulu from the outside (the second wall and much destructed part)

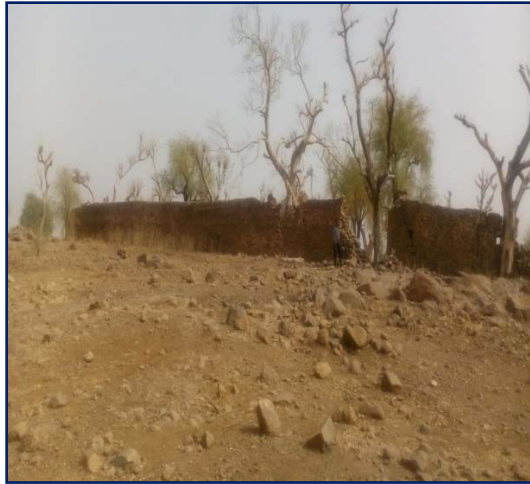
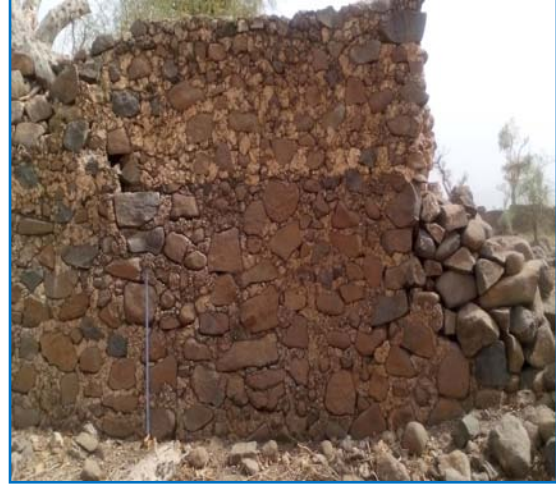
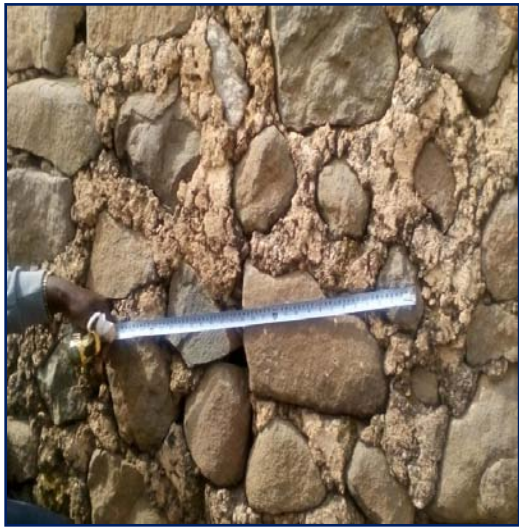
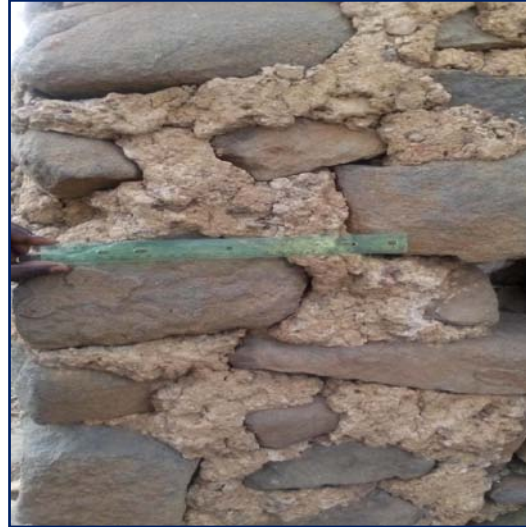
In order to evaluate the current condition of the main enclosure, it is important to divide and view from four directions. The first part of it is the southern wall. It is the enclosure where main gate is entered from the town of May Gaba. The width and visible height of this entrance is 2.5m and 2.9m respectively, while its average thickness is 70cm.

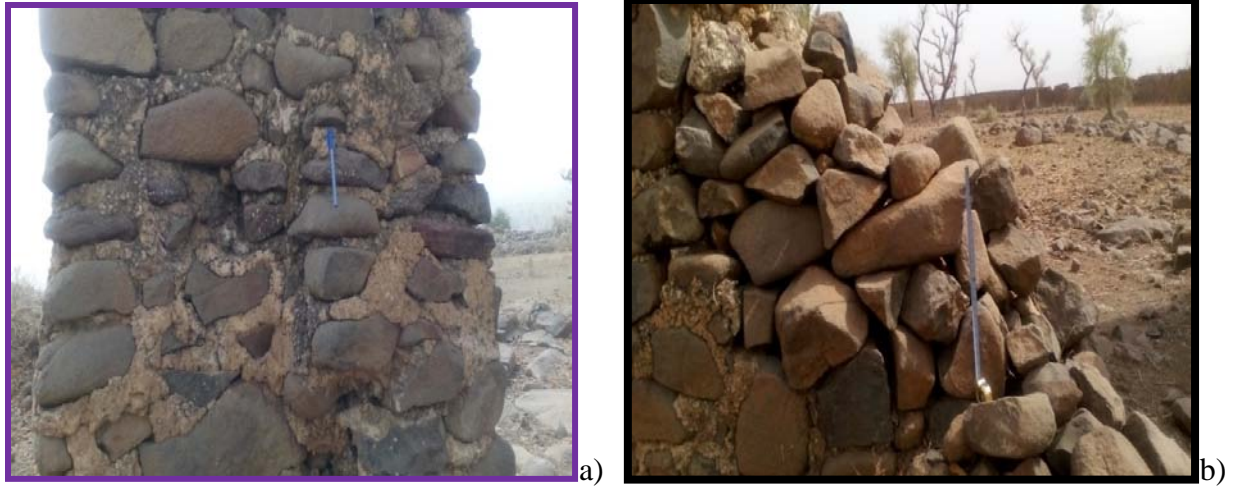
Looking at the status of the main gate of enclosure, from both side, the eastern side of the entrance is intact, while its western side partly demolished.

Figure 17: Main gate-intact from eastern side (a) and partly demolished on the western side (b) (Photo by Feyissa H, 2016).

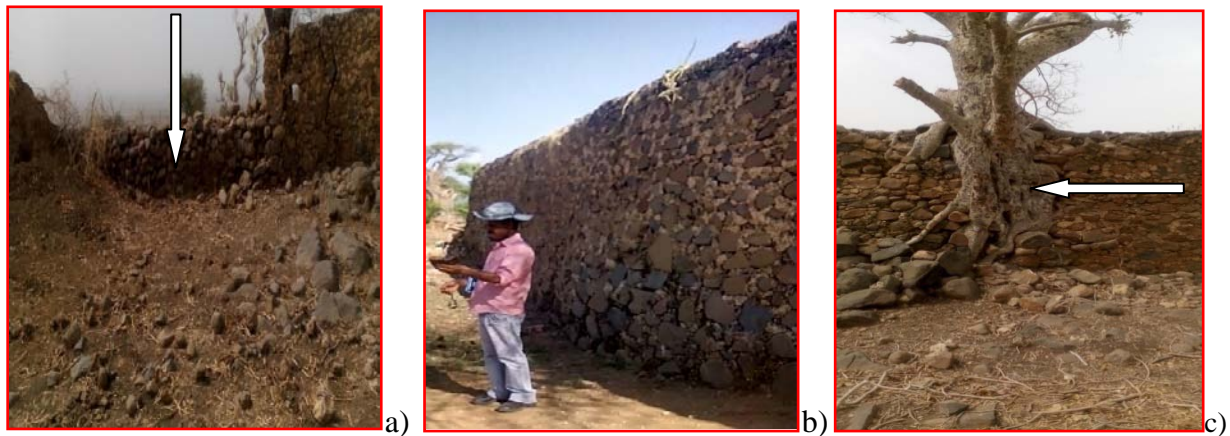
Following the main gate to the eastern direction of the enclosure, there is a partly demolished section with a maximum height of 1.5m. The wall on the western side of the enclosure is better preserved than the eastern one. However, it is also suffering from tree grown from the inside of the enclosure which is affecting the wall by creating cracks. The maximum height of the wall from this side is 2.5m.

Figure 18: View of the destroyed wall (a), maximum height of the wall to the east (b), and trees grown from the inside of the enclosure (c) (Photo by Feyissa H, 2016).

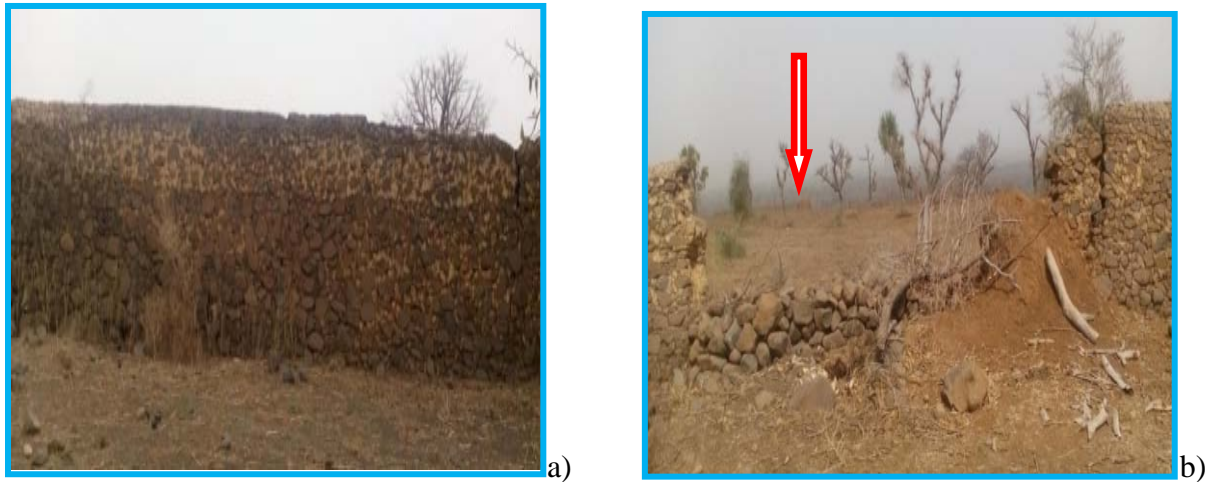
The northern side of the enclosure is well preserved as compared with the other side of the enclosure. But small section of this side is completely destroyed. This demolished section is used as another gate to the castle. The highest height of the wall from this direction is 2.42m. This can be proved that the height cannot go more than the indicated height, because of its upper part is in the plastered form.

Figure 19: Well preserved wall (a) and demolished section (b) (Photo by Feyissa H, 2016).

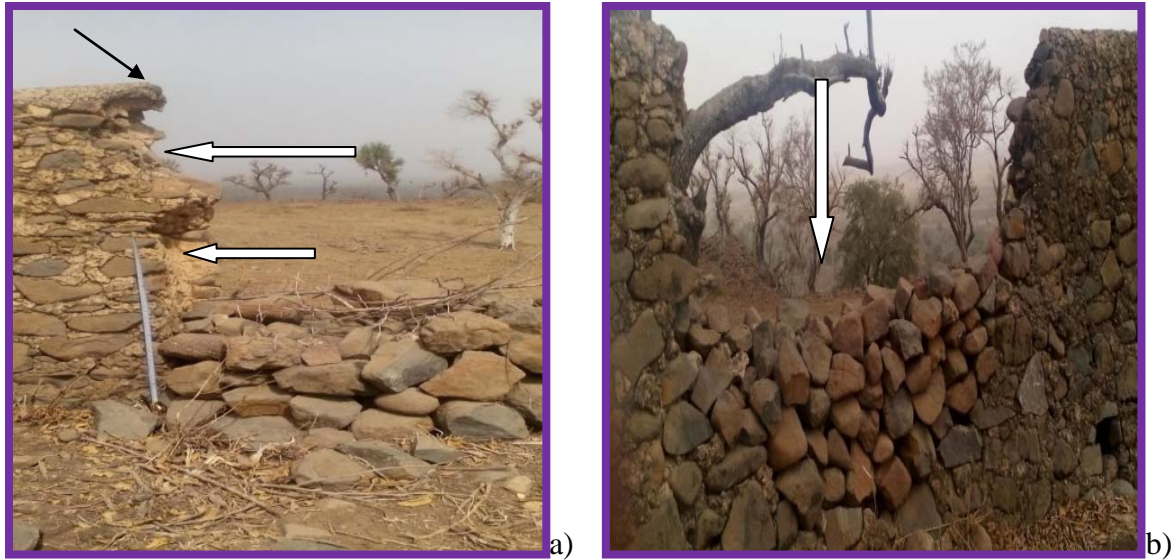
There is also another small gate on the northern side of the enclosure. The indication of the existence of the gate is, even though not completely visible, the presence of arched structure (see fig. 20a) with totally plastered beginning from the floor to the top part of the wall. We could not measure the width of this entrance as it is demolished. Next to this small main gate on the east side of the northern enclosure, part of the wall is demolished (see fig. 20b).

Figure 20: Small gate (a) and damaged part (b) of northern enclosure (Photo by Feyissa H, 2016).

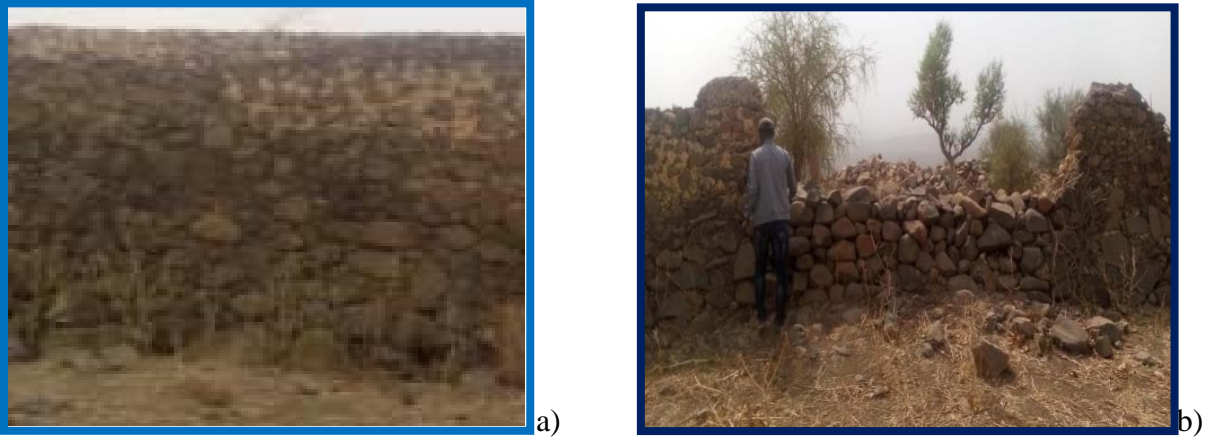
The other part of the enclosure is the one found on the eastern direction. This side is the completely standing part of the enclosure. But there is also some part of it, where it is on state of destruction. The maximum height of the eastern wall is 2.65m. Generally, the height of the enclosure varies across different directions.

Figure 21: Eastern enclosure well preserved (a) and destroyed section (b) (Photo by Feyissa H, 2016).

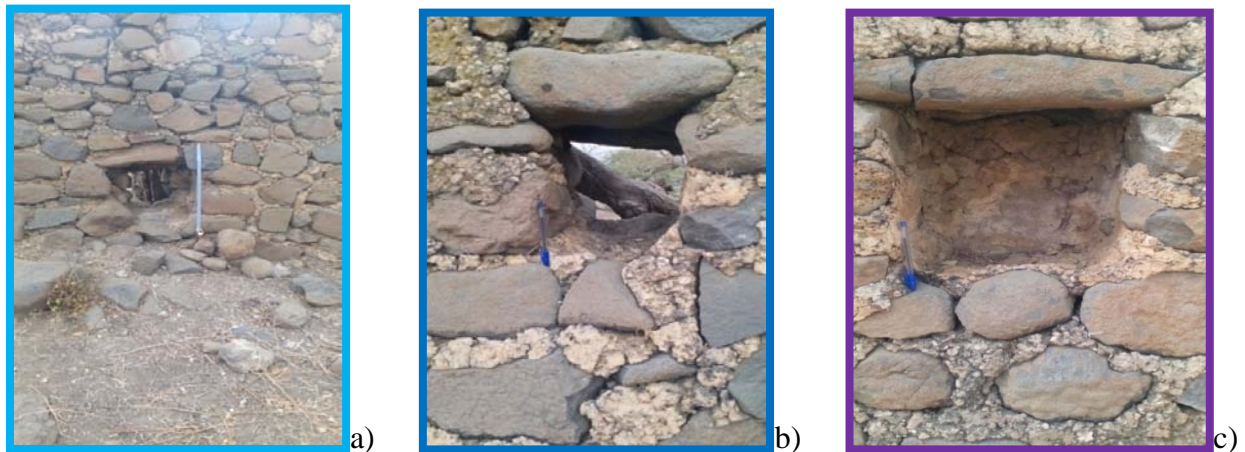
There are windows and false windows on the different parts of the enclosure. However, there is no visible window on the southern part of the enclosure. The average distance between windows is 11.6m. The width, height and thickness of one of the window that is found on the eastern enclosure are 5cm, 70cm and 50cm respectively (see fig. 22a). The northern window has a width, height and thickness of 30cm, 40cm and 50cm respectively. It is almost at the middle of the enclosure and measures 1.05m height from the ground (see fig. 22b). There are also false windows on the western and northern side of the enclosure. The window on the western side of the enclosure has width, height and thickness of 40cm, 41cm, and 30cm respectively (see fig. 22c). Generally, there are total number of twenty four windows and two false windows. There is large concentration of windows on the northern direction of the enclosure.

Figure 22: Sample view of windows on the eastern and northern enclosure (a and b), and sample of false window on the western enclosure (c) (Photo by Feyissa H, 2016).

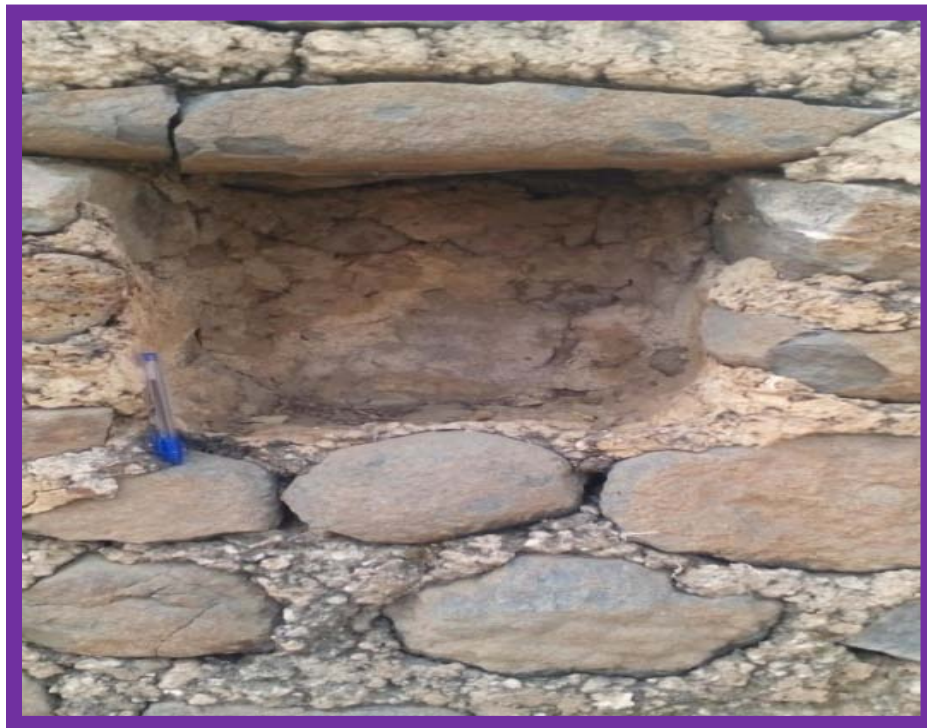
The castle is rectangular whilst its enclosure is circular. There are different arches on the castle. We find the same style of design on the windows and doors in the form of arches and barrel-vaulting. There are small size windows on the enclosure which are square shaped.

Figure 23: The square architecture on the enclosure of Bete Mulu (Photo by Feyissa H, 2016).

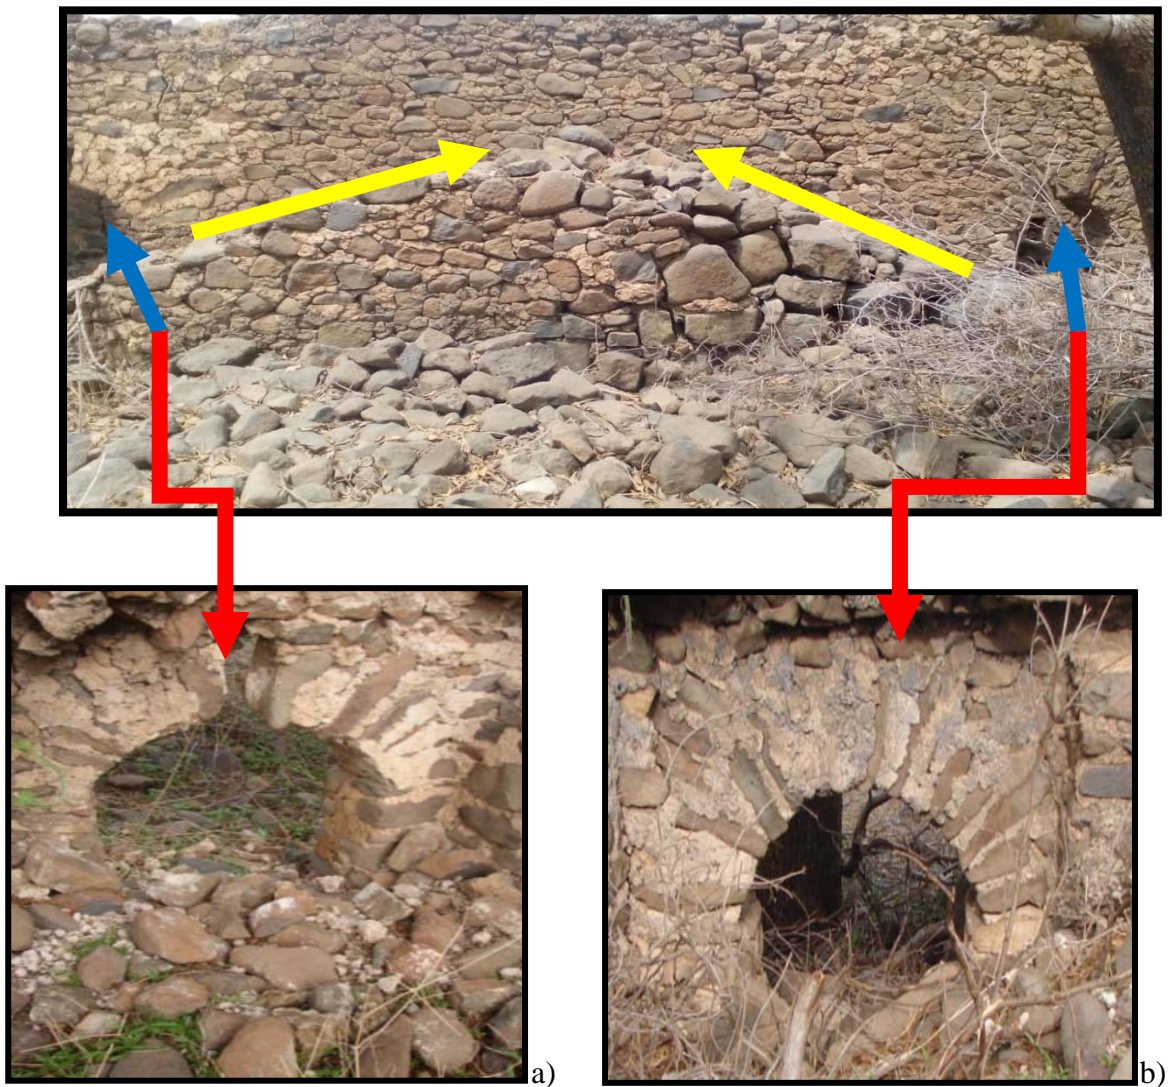
In addition to the structures on the enclosure, there are also different arch styles on the building itself. These are clearly observable from the windows of the different façade of the building. There are two arched windows on the Eastern façade of the castle. In between these two arched windows, there is also one stairway-takes to first floor (see fig. 24).

Figure 24: Windows with arch design (a and b) on the eastern façade of the castle (Photo by Feyissa H, 2016).

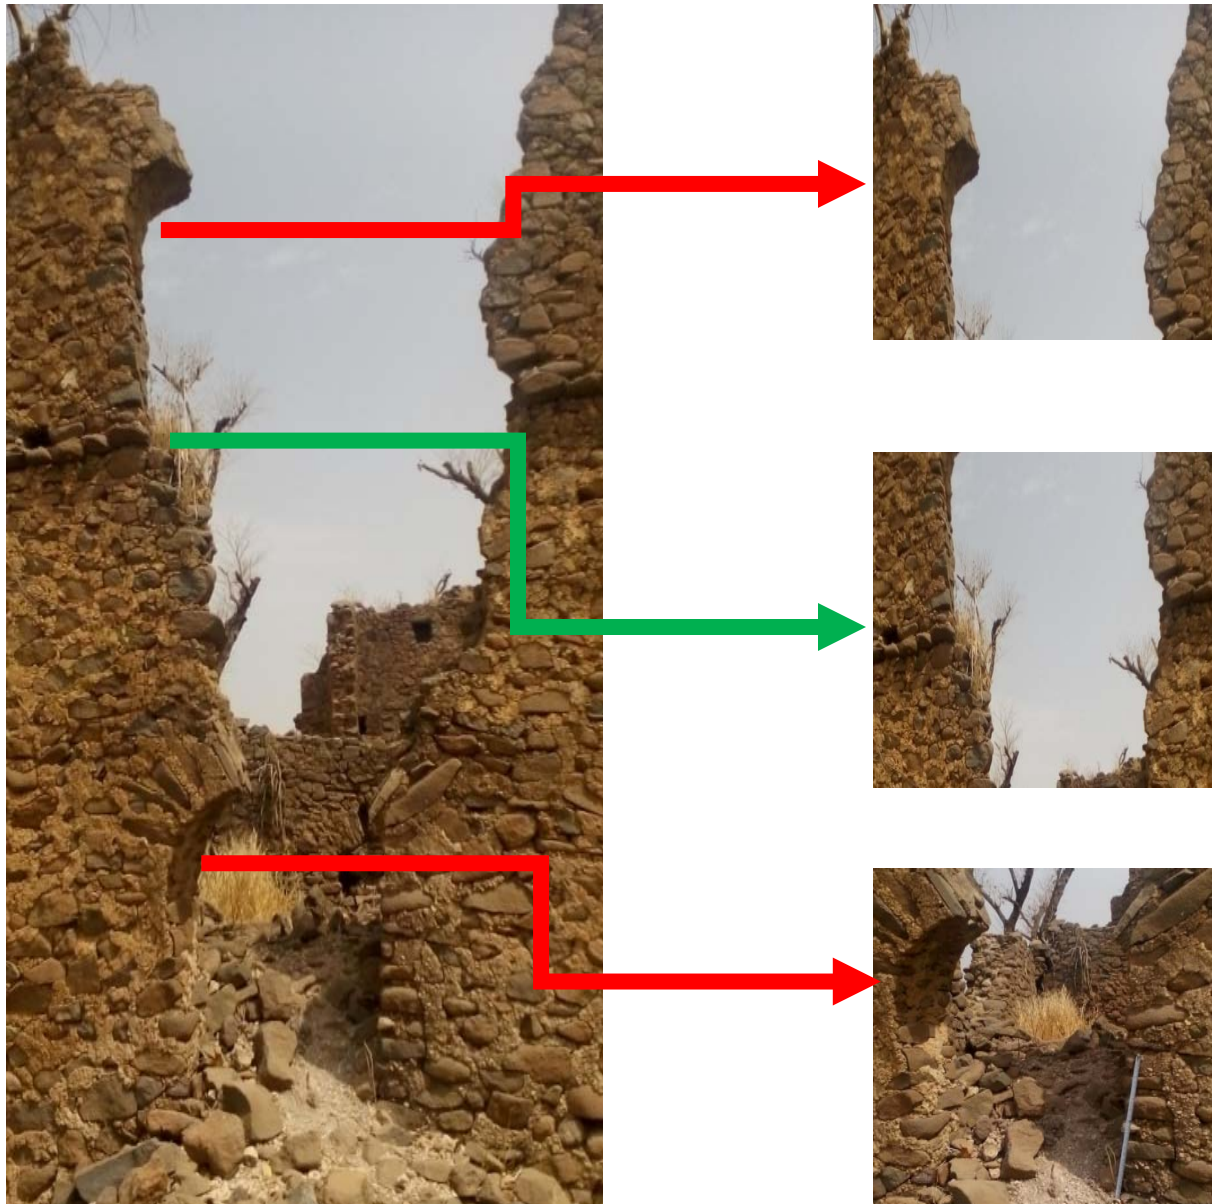
On the Southern part of the castle, there is an arch door on the ground of the first floor. There are rivet that holds together the ground with the first floor.

Figure 25: The arched structure and rivet on the southern wall (Photo by Feyissa H, 2016).

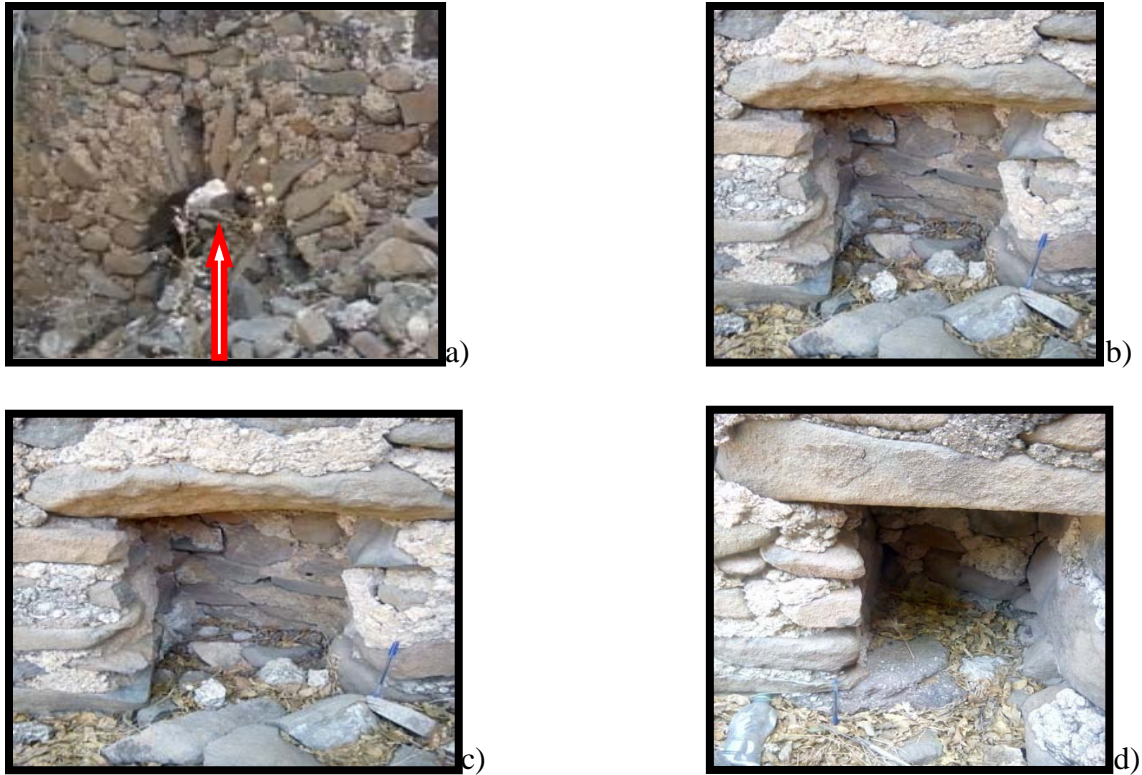
Inside part of the castle's room, consists of arched entrance from the first to the second room, and three small false windows of square design (see fig. 26).

Figure 26: The arch designs (a), and small square false windows (b, c and d) (Photo by Feyissa H, 2016).

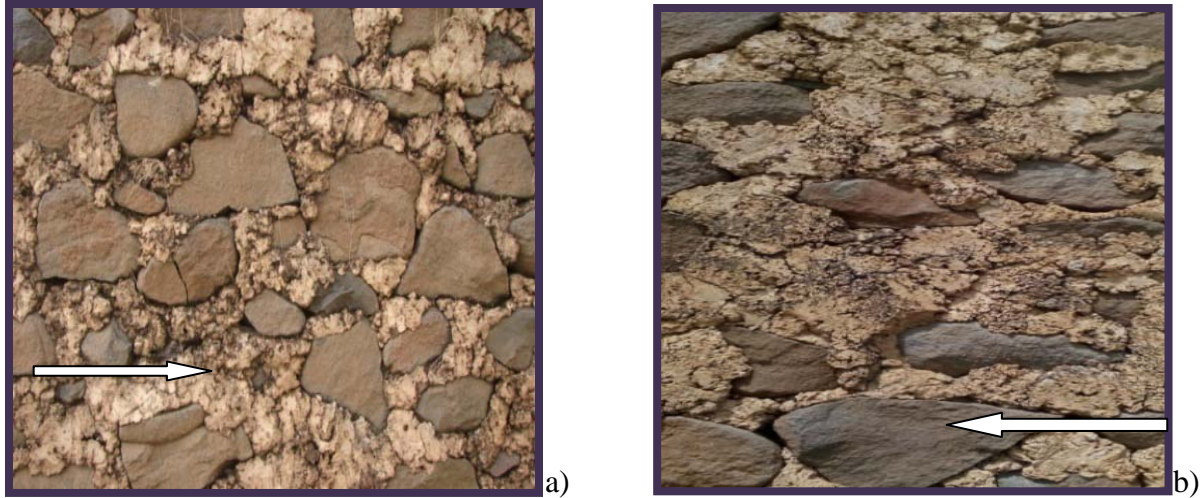
Based on field observation, the materials that were used for the construction of the castle consist of basalt rocks with white lime mortar (see fig. 27) similar to the Gondarian castles. The stones are rough with differing sizes. As a result, it is difficult to take the size of each stones. Looking at the technology of the building, castle's exterior part is almost seems plastered. According to *Dejena* (2002), raw materials like mortar and stones were used in the process of the construction.

Figure 27: Rough uncovered basalt rocks with white lime mortar (a and b) (Photo by Feyissa H, 2016).

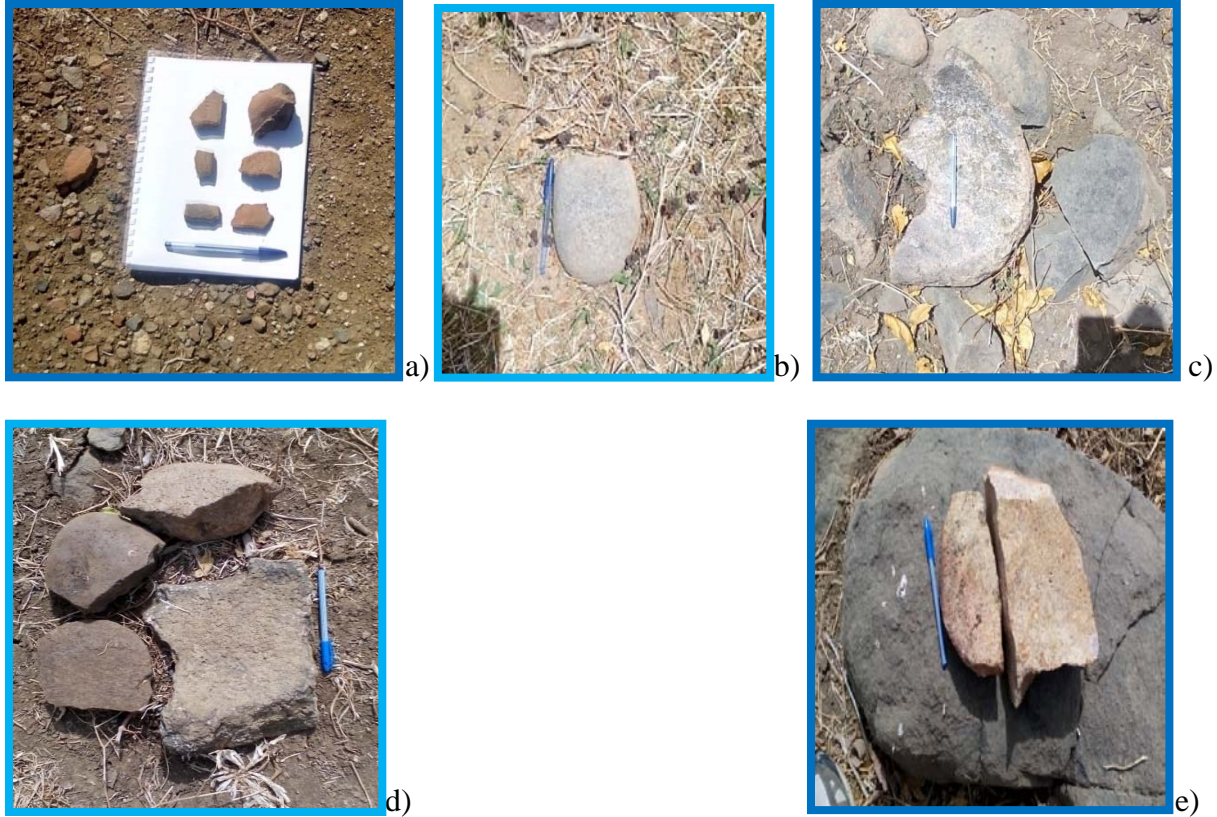
In the compound of the Bete Mulu castle, there are large numbers of grindstones and discarded pottery remains. In the area of 1x2m the discarded 280(two hundred eighty) pottery remains were counted. Even though it is difficult to date and associate with the time of Ayanaizgi, based on the local evidence (Informants: *Ato Tsehaye Ambaye* and *Ato Nigussie*, 2016), today, there is no such pottery making practices in the locality. Which means it was activity that dated to the time of King Ayanaizgi. The informant, additionally, hinted that it was to meet the need and to respect the king's interests that the servants engaged in such activities. Servants make pottery not to catch their interest rather to increase the moral of the king. It is due to this that most of the discarded pottery remains reveals as it was purposely produced for luxurious purpose. Informant (*Ato Gebremeskel* and *Ato Nigussie G*, 2016), who accessed to the better remains of pottery-justified that most remains of pottery are much decorated one.

Figure 28: The discarded pottery remains (a), and grindstones (b, c, d and e) (Photo by Feyissa H, 2016).
