**DOCUMENTATION AND CONSERVATION STATUS OF BETE MULU
CASTLE IN WELKAIT, WESTERN TIGRAY**

OCTOBER, 2016

**A THESIS SUBMITTED TO THE DEPARTMENT OF ARCHAEOLOGY
AND HERITAGE MANAGEMENT, IN PARTIAL FULFILMENT OF THE
REQUIREMENTS FOR THE DEGREE OF MASTER OF ARTS IN
ARCHAEOLOGY**

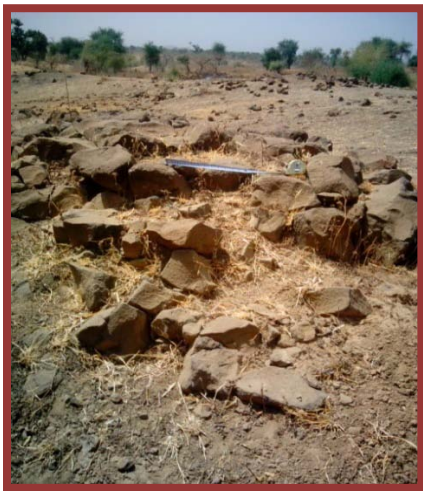
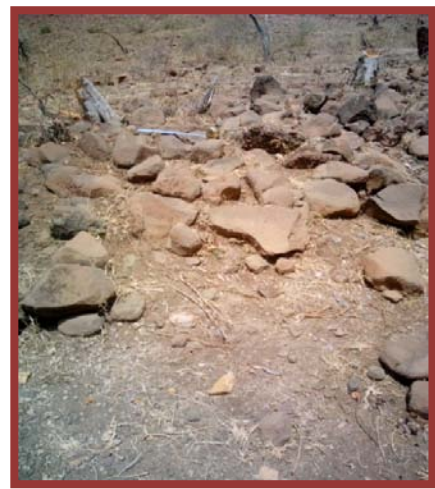
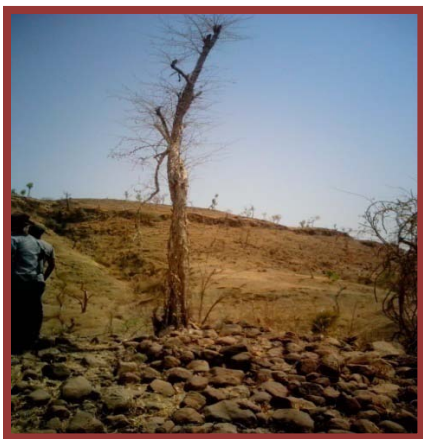
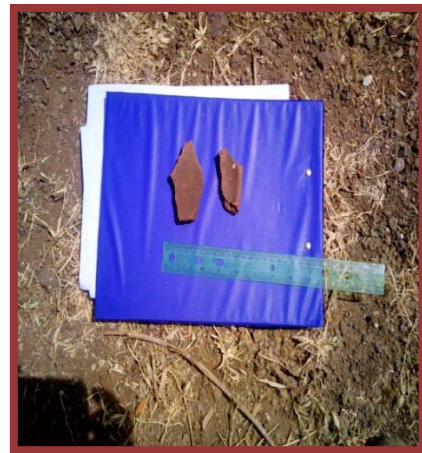
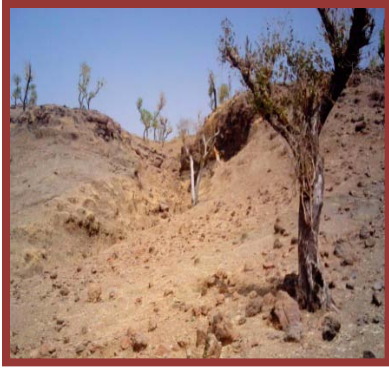
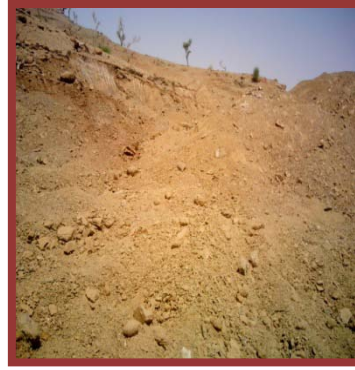
Some of those tumuli are disturbed by erosion, land slide and terracing. There are also human activities that currently disturbing those unprotected tumuli. They are also disturbed by construction purposes. On the other tumuli there are fragment of pottery remains and small rocks of different types and structures. Despite the presence of the tumuli-it is difficult to define and associate it with other tumuli from other areas and different periods. To do this was also not part of this research objective and open to further investigation (see fig. 30).

Figure 30: View of tumuli (a and c) and threats affecting it-erosion (e) and human activity (f)
(Photo by Feyissa H, 2016).

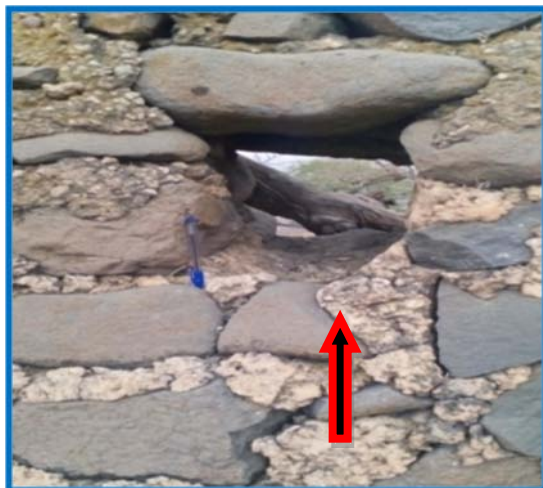
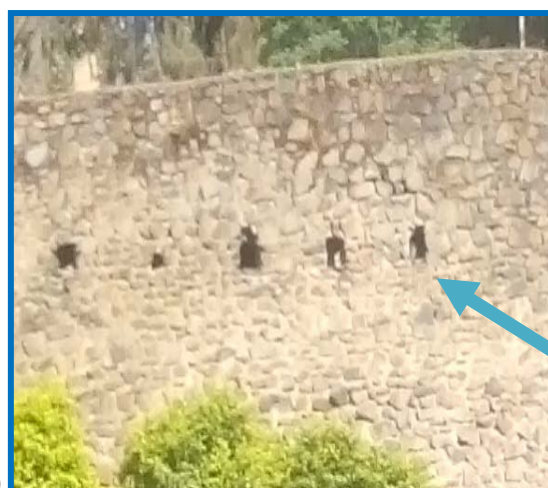
a) b) Figure 32: View of square tower on Bete Mulu castle (a) and Fasil Ghinb (b) (Photo by Feyissa H, 2016).

Therefore, the presence of observation towers on the enclosure in the form of window was the simple tactic of the day to defend and withstand possible enemies coming from different sides. Something impressive is that the positions of those observation towers on the enclosure are different. Some of the observation towers are at the middle of the enclosure whilst the other ones are at the bottom. This is meaningful for that the landscape surrounding the enclosure is not in an equally flat and plain. The observation tower is at the top when the landscape out of the enclosure is at its mounted/elevated level whilst at the bottom when the landscape out of the compound is lowered. This is very essential to closely monitor the situation over the outside environment (*Ato Nigussie and Ato Nigussie G, 2016*).

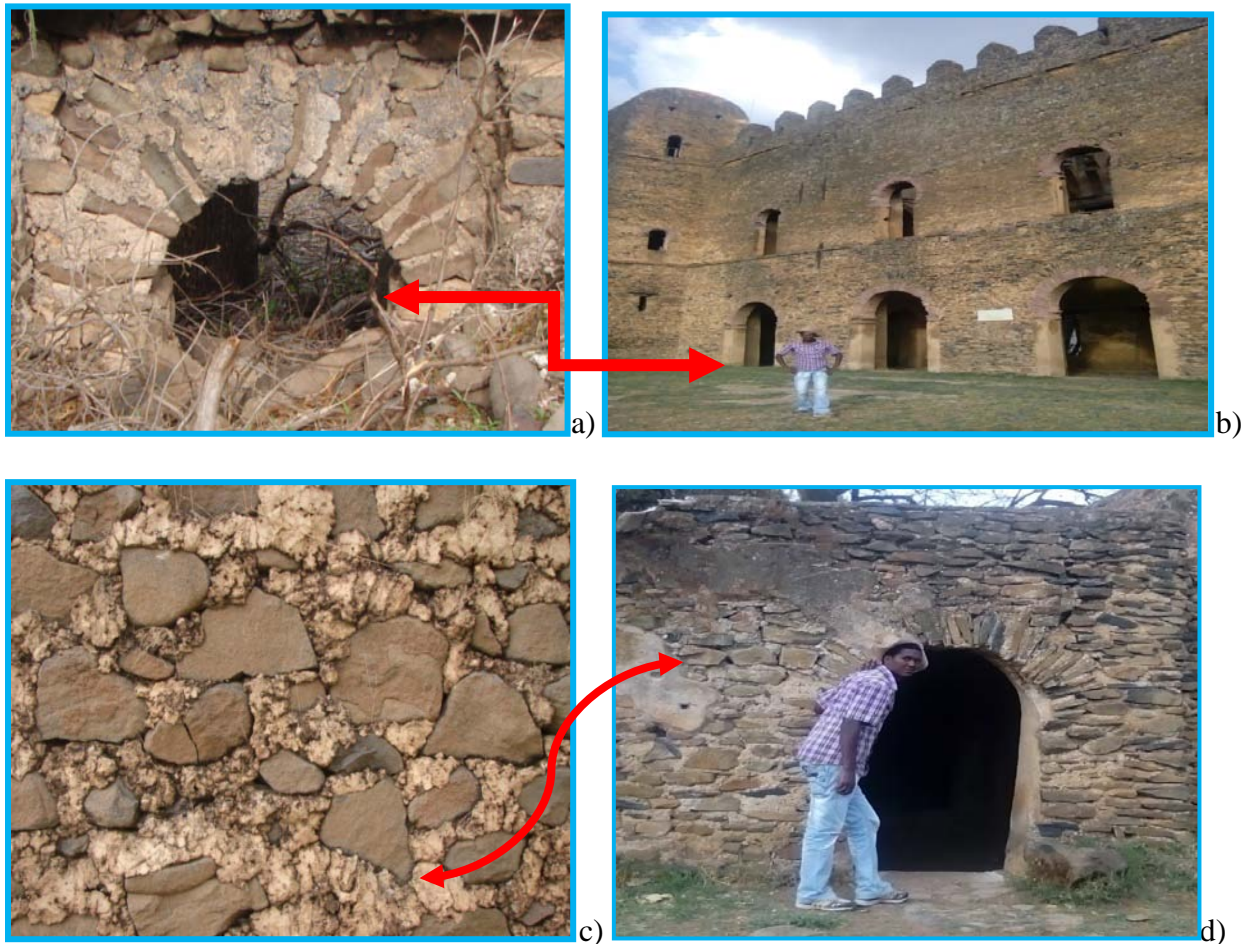
Like elsewhere, raw materials like lime mortar, basaltic rock-quite common in the May Gaba area (Ato Nigussie, 2016) were used to construct Bete Mulu castle. The advantage of using mortar is also helpful in withstanding problems coming from weathering and compactness (WBIDA, 2007). As stated above, arched design is visible on the different parts of the castle. The design and the other parts of the building are plastered with lime mortar.

Figure 34: Arch on Bete Mulu castle (a) and on Fasil *Ghinb* (b), and plastered view of the castle and *Ghinb* with lime mortar (c) and (d) respectively (Photo by Feyissa H, 2016).

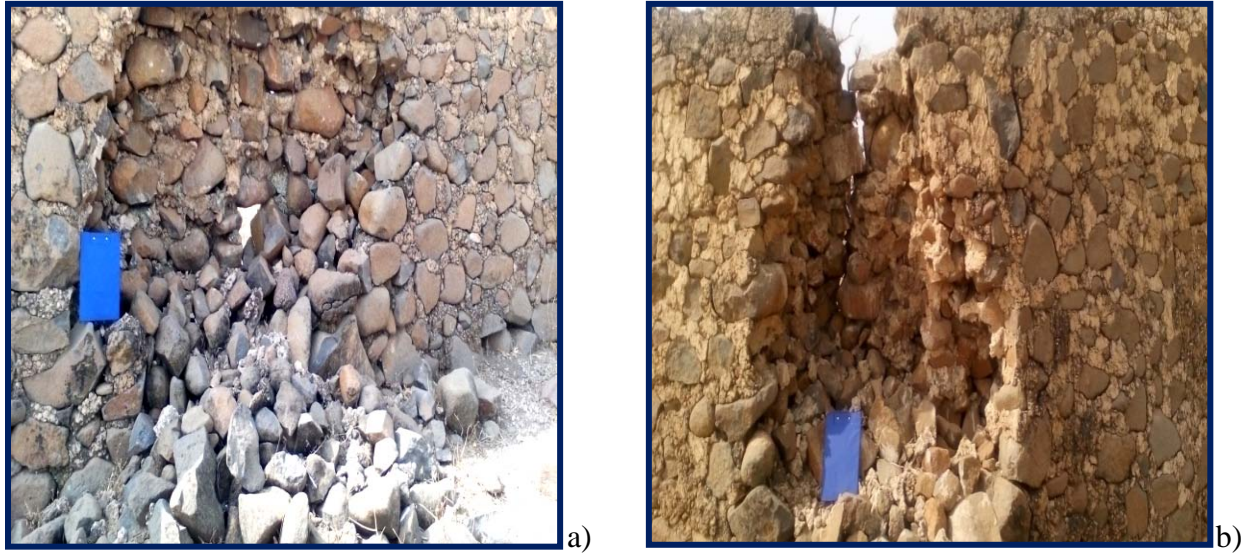
Figure 35: Small destruction before a year (a) and after a year (b) (Photo by Feyissa H, 2016).

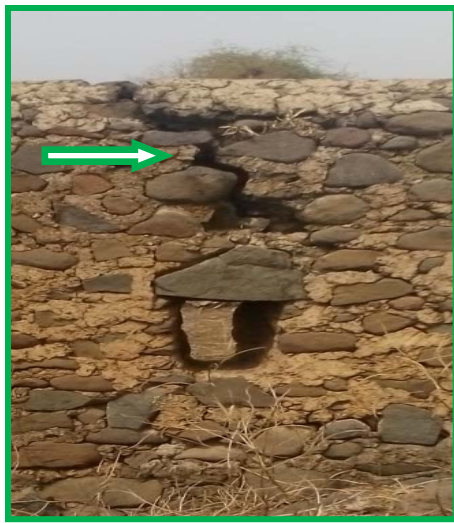
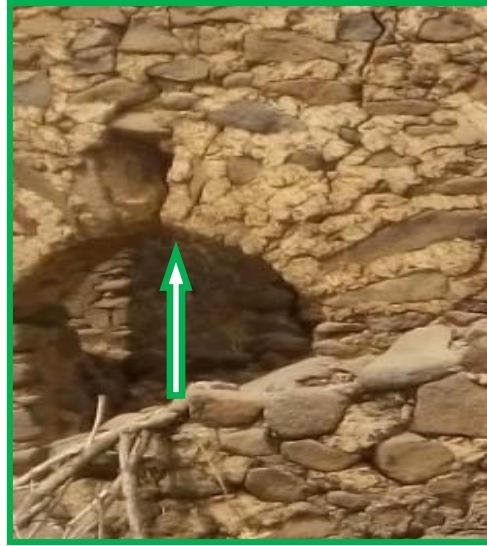
Based on researcher field work and interview with local resident reveals that natural factor like heavy solar radiation (since it is located in one of the hottest part of the country), is the most threat to the castle and its enclosure. Sun light as prime causes of decay of building (Feilden, 2003) result in expand of materials used in construction like stones. It expands when heated and contracts again when cooled. This expansion and contraction being called thermal movement is a major cause of decay in buildings. The usual outcome of sunny sunlight on building is, as a whole, cracking and loosening of the stones in their joints. This is, in fact, an adverse effect clearly visible on Bete Mulu castle (see fig. 36).

Figure 36: Sunlight cracking view on enclosure (a) and lost stones on joint part of the castle (b) (Photo by Feyissa H, 2016).

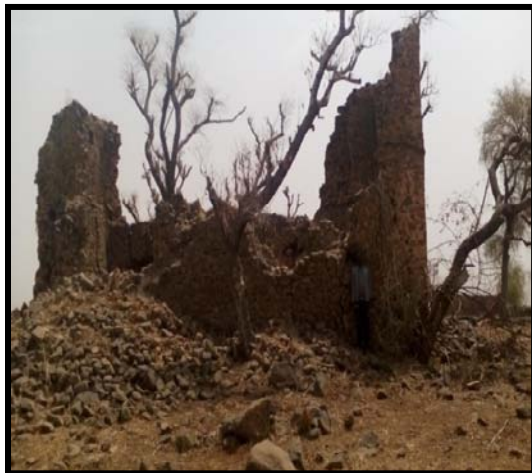
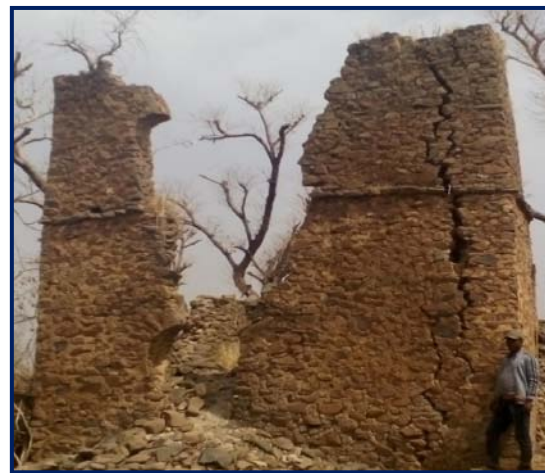
From researcher's observation, evidence that is clearly visible on Bete Mulu castle is that its western and eastern walls are almost destroyed. Such affection is happened and visible because of most extreme straight line sunlight exposure than the rest of the wall of the same castle (see fig. 37).

Figure 37: Comparison showing destroyed western wall-direct sunlight exposed (a) *versus* better saved of northern wall (b) (Photo by Feyissa H, 2016).

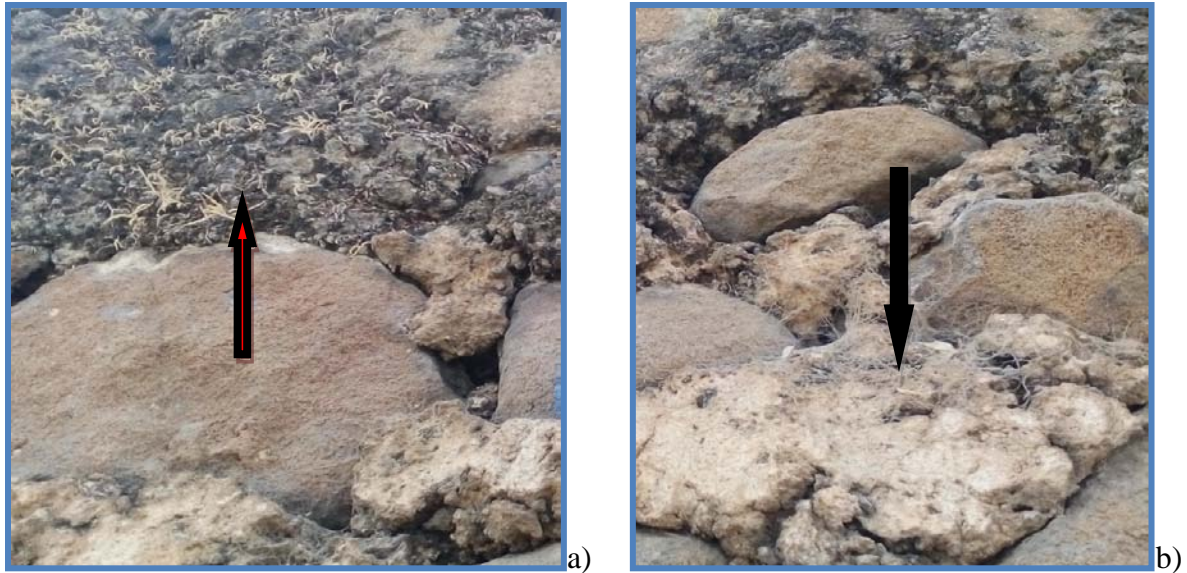
Figure 38: Blacken parts of the wall due to rain hits and plants grown (a) and eroded section (b) (Photo by Feyissa H, 2016).

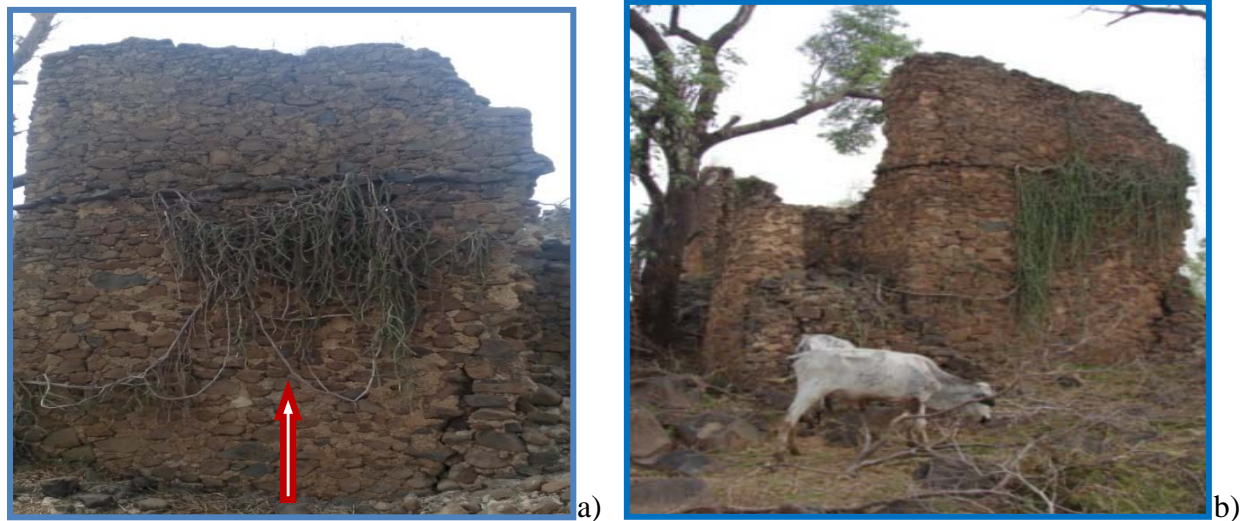
Figure 39: Biological causes of deterioration-plants and grasses grown (a) and cattle grazing (b) (Photo by Feyissa H, 2016).

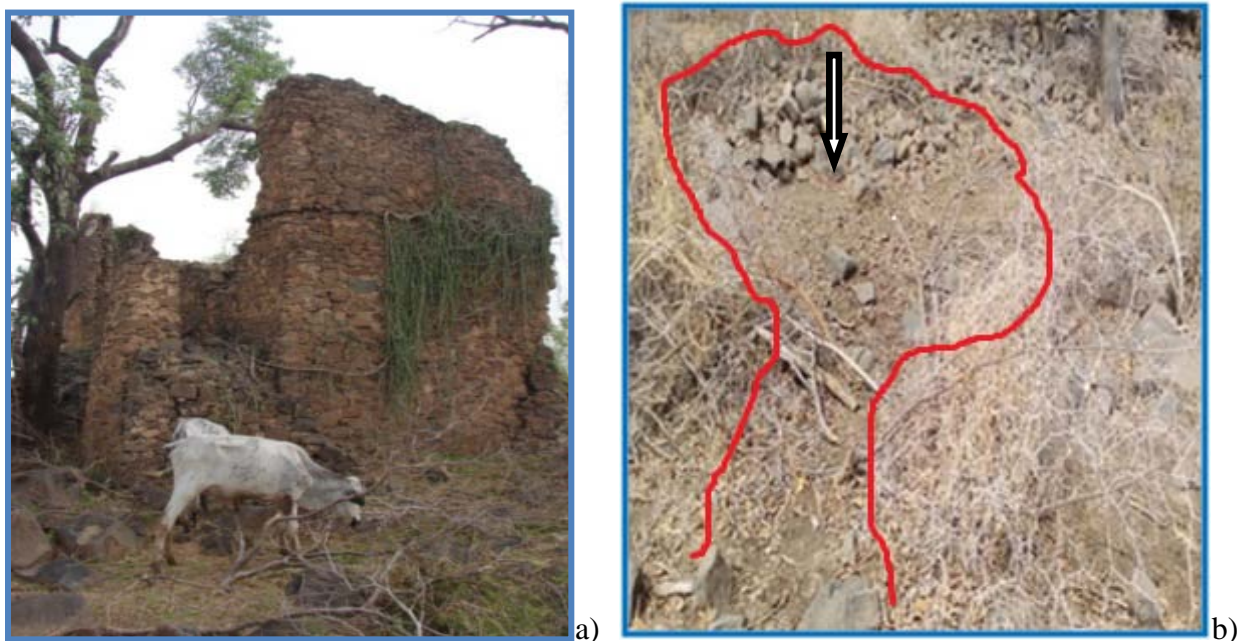
Figure 40: Cow grazing in the enclosure (a) and its fence (b) (Photo by Feyissa H, 2016).

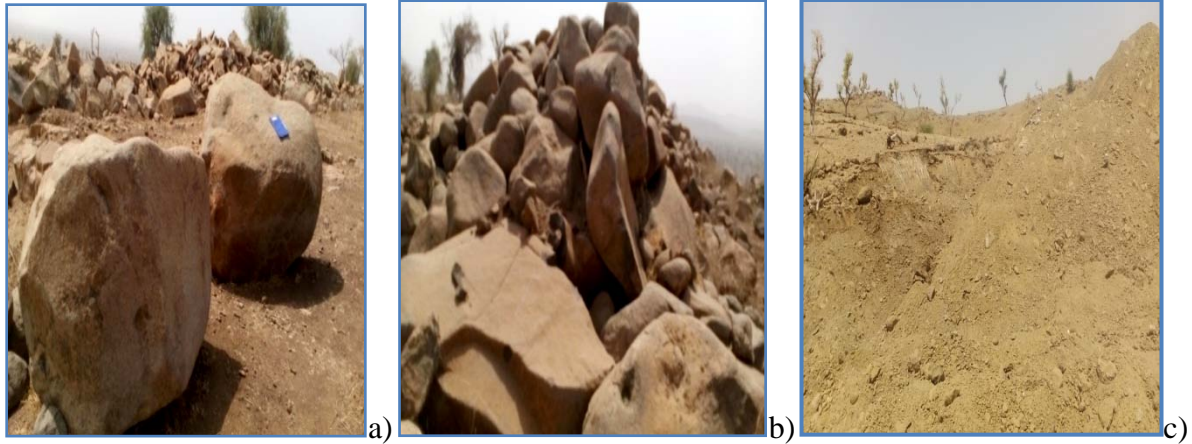
Figure 41: Stored stones ready to be cracked into pieces over the site (a and b) and site part under digging for construction purposes (c) (Photo by Feyissa H, 2016).

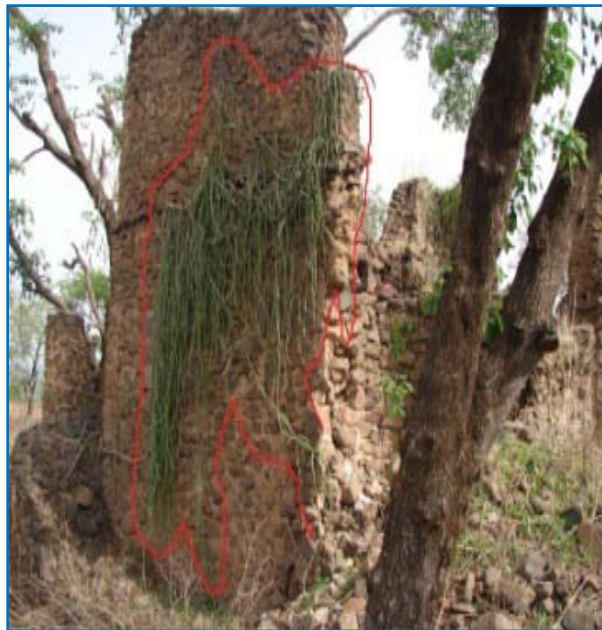
Figure 43: Vegetation and biological grown (Photo by Feyissa H, 2016).

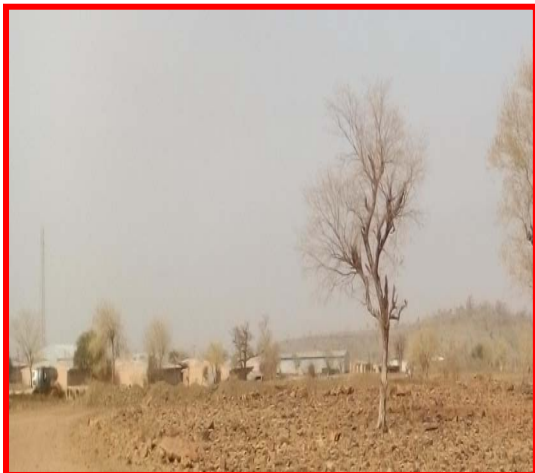
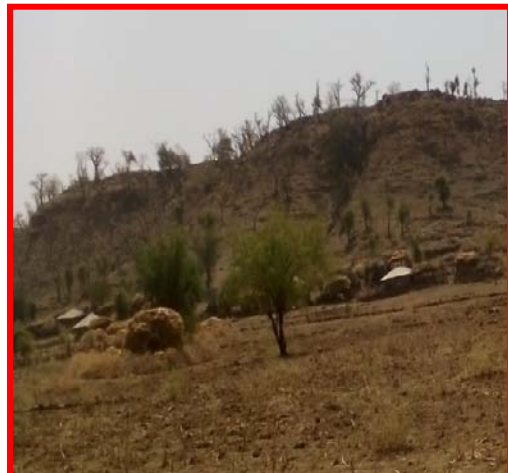
Figure 45: Settlement surrounding the Bete Mulu castle (Photo by Feyissa H, 2016).

- Moreover, the increased use of the area around the site as residential should be considered improper in view of transforming of the site as an attractive pole for tourism and other aspects of tourism.

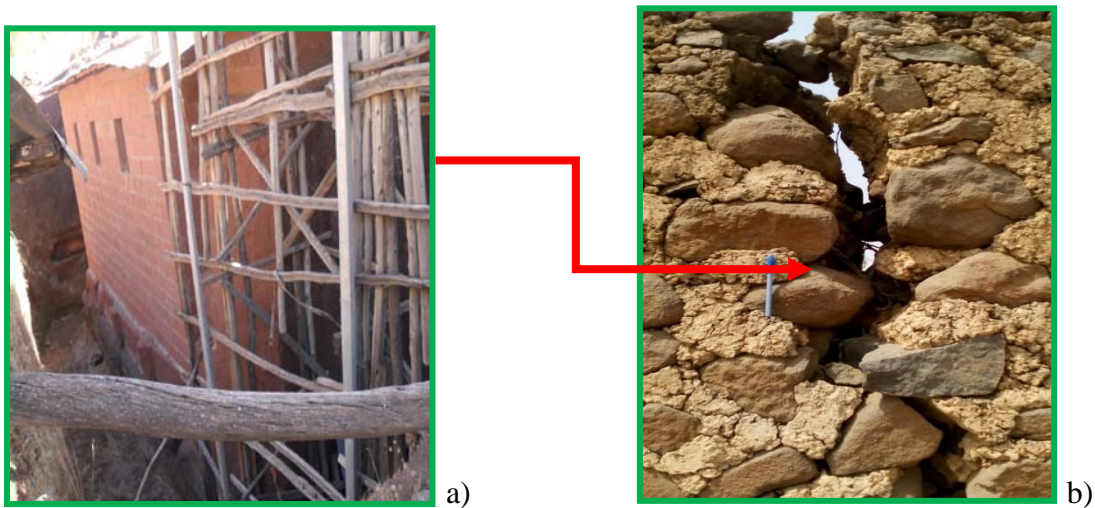
Figure 46: Sarzina Mikael-renewed part of its eastern façade (a)(Photo after Nathanael, 2012) and cracking part of Bete Mulu castle (b)(Photo by Feyissa H, 2016).
