**INVESTIGATION OF SOIL EROSION RESISTANCE ALONG
ADAMA-ITEYA ROAD SECTION (CASE STUDY)**

A Thesis in Geotechnical Engineering

By Lemma Hlefome Kassay

March 2016

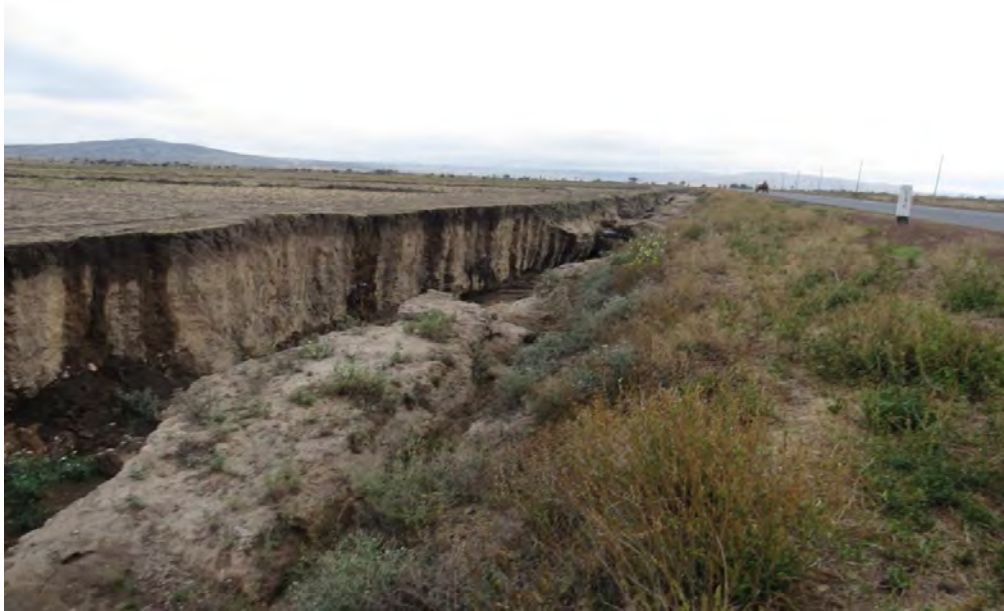
Photo 5.1 Typical topography nature of the area (flat topography)

However, according to terrain classification of the study area, Adama-Iteya road section is mainly classified as flat to rolling topography. Thus, the cause of the soil erosion and gully formation in the study area will not be due to topography of the area.

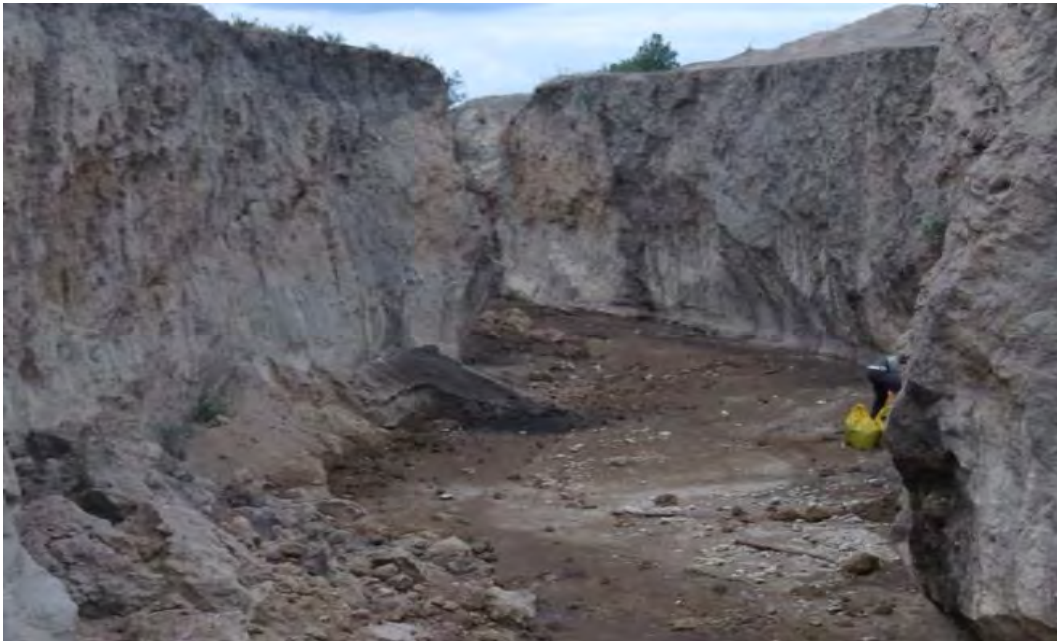
Photo 5.2 physical nature of the soil

Besides, the soil in the study area has contain relatively higher percent of sodium concentration than other four metallic cations and hence, excessive leaching will occur and the situation worsen.

Generally, the inherent properties of the soil combine with physical forces of rainfall in the area are main factors to be created erosion gully in study area.

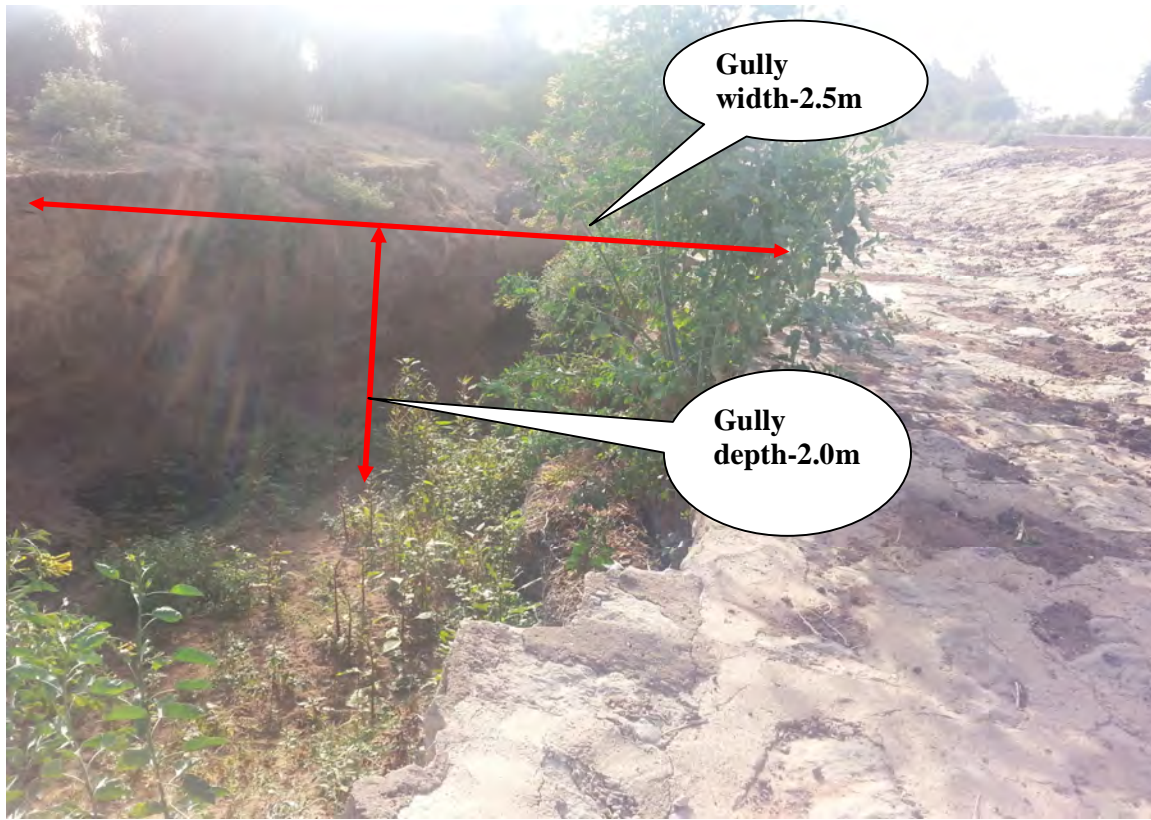
Photo 5.5 Actual condition of erosion gully site -2

The soil types found in the area is alluvial & lacustrine formation of brown silty sandy soil and it is classified as SM group according to USC system. The average depth of the gully reaches up to 2m and its width is about 2.5m and it is categorized as medium gully. The length of gully has extends to 150m and has low level hazard. The gully has trigger due to improper surface rain water management.

Currently, the erosion gully has less effect on the existing asphalt road however; there will be problem in the future if it is not protected well.

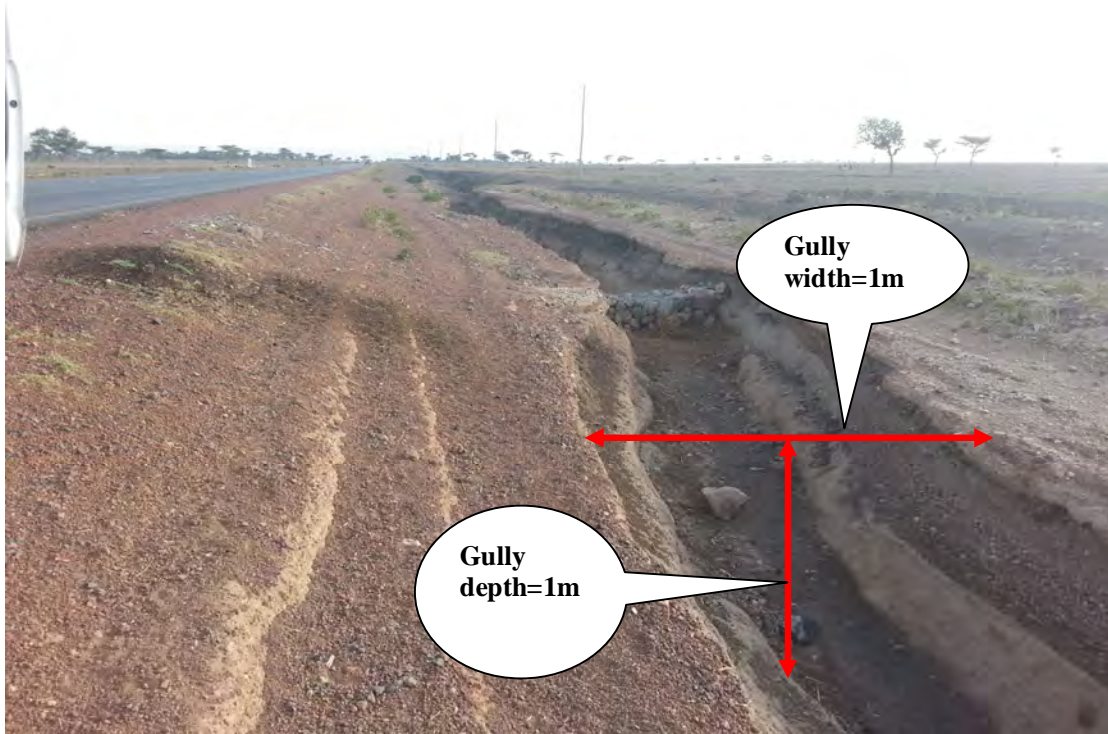
Photo 5.9 Actual condition of erosion gully site-6

The erosion gully in this section of the road is located on both side of the road. The gully in this section of the road is very minor and has an average depth of 1m and width of about 1m. The gully is developed due to improper surface rain water management. Besides, during construction period, it was not properly provided concrete or masonry ditch along the road stretch. The length of the gully extends to 1km and currently, it has less hazard level on the existing asphalt road.

The soil types found in the area are lacustrine & alluvial formation of whitish silty sandy soil and it is classified as ML according to USC system. The slope of the road alignment in this section ranges from flat to rolling. The UTM coordinate of the erosion gully is E533528.800 and Northing 915429.656

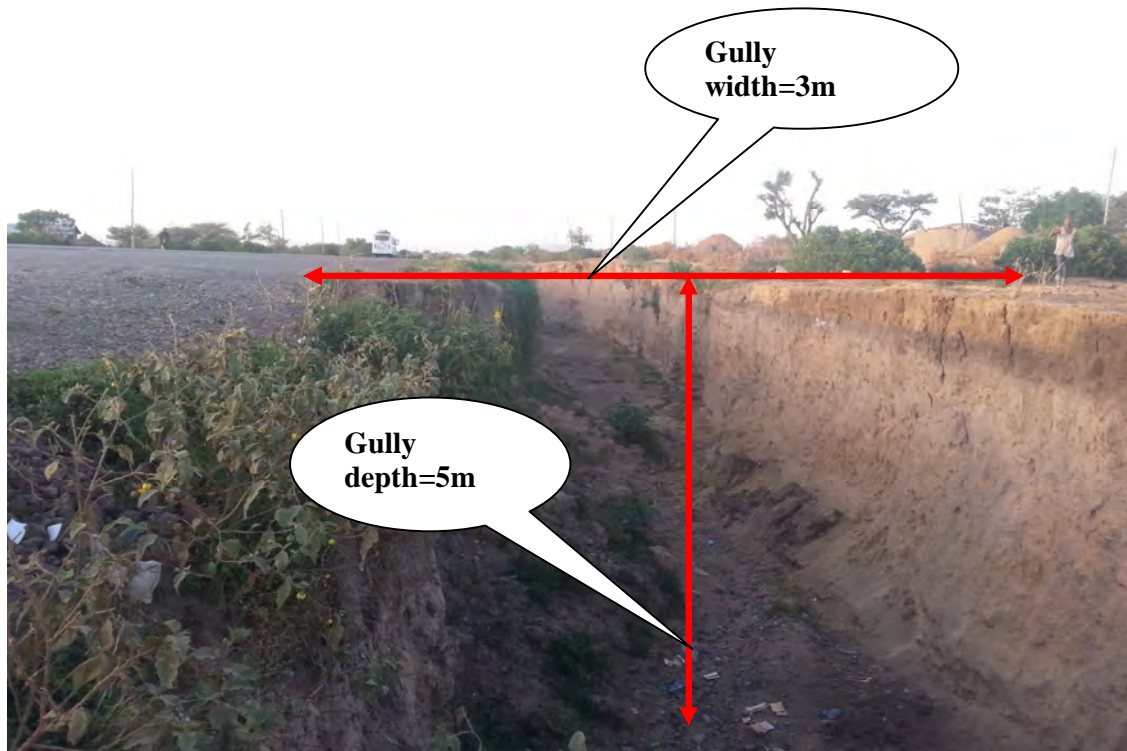
Photo 5.12 Actual condition of erosion gully site-9

The erosion gully in this section of the road is located on the left hand side of the road (LHS) and has UTM coordinate of E526341.532 and Northing 905731.702. Similarly, the cause of the gully in this area of the road is associated with improper surface rain water management i.e, during construction period it was not provided appropriate concrete or masonry ditch along the side of the road. Gully erosion present within this section of the road has an average length of 1600m. The soil types found in the area are lacustrine & alluvial formation of greyish to whitish silty sand soil and classified as SM according to USC system. The gradient of the road alignment in this section has rolling topography. The depth of the gully reaches up to 5m and its width is about 3m.

Currently, the erosion gully will greatly affect the newly constructed asphalt road and away from it if immediate remedial measure is not provided the problem will worsen.

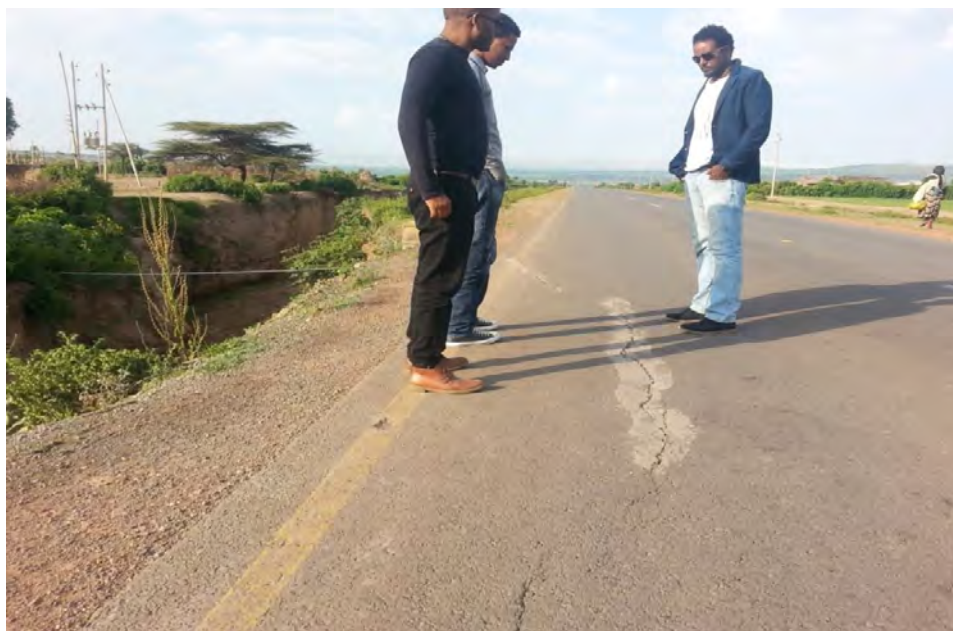
Photo 5.14 Road starts to fail because of erosion gully.

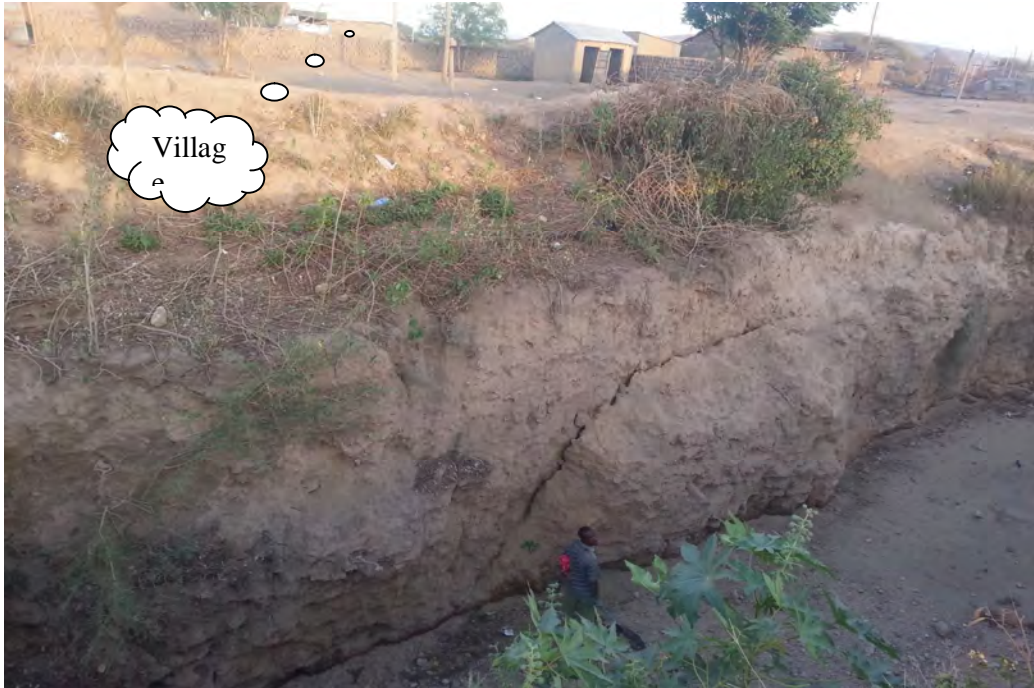
Photo 5.15. Settlement near to the gully area susceptible to land failure.

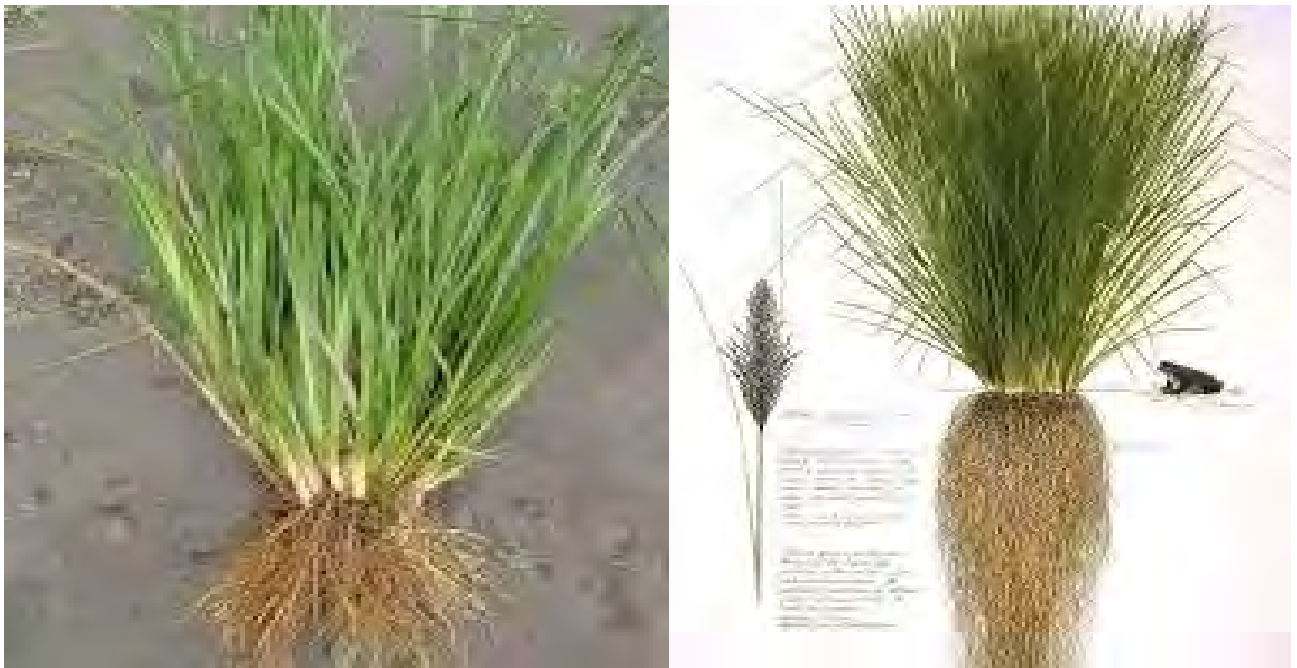
Photo 7.1 Vetiver grass (Source; internet)

Vetiver grass is one of the best species grass for erosion protection and it is unique in that it can thrive in arid and humid conditions, growing under some extreme soil conditions and survives wide temperature ranges. This grass should be planted on both sides of the road side ditch

Vetiver grass has good morphological, physiological and ecological characteristics including its tolerance to highly adverse growing conditions. This provides a unique engineering tool for land stabilisation, soil erosion control and thus it is recommended erosion protection for study area, Adama-Itaya road section.

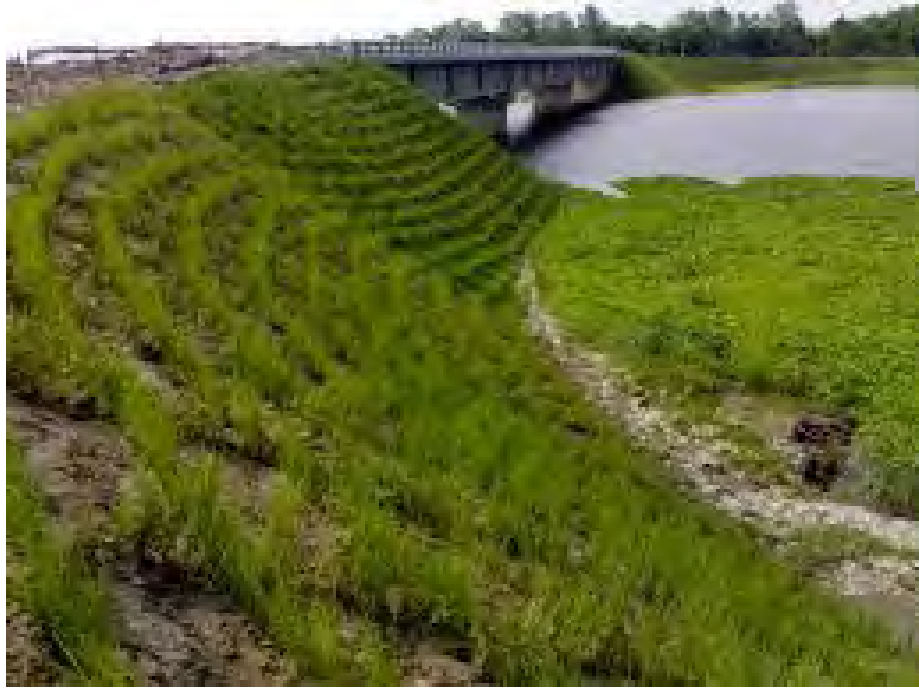
Photo 7.2 Vetiver grass for erosion protection (Source; internet)
