A Conservation Study of the Italian Consulate Building in Adwa and an Adaptive reuse proposal for its up keep

This thesis is submitted to the Department of Architecture (DARCH), School of Built Environment, College of Technology and Built Environment (CTBE), Addis Ababa University for partial fulfillment of all requirements of Master of Science Degree in Conservation of Urban and Architecture Heritage.

Beza Alemu Asgedom – GSR/2618/15

Jan, 2026

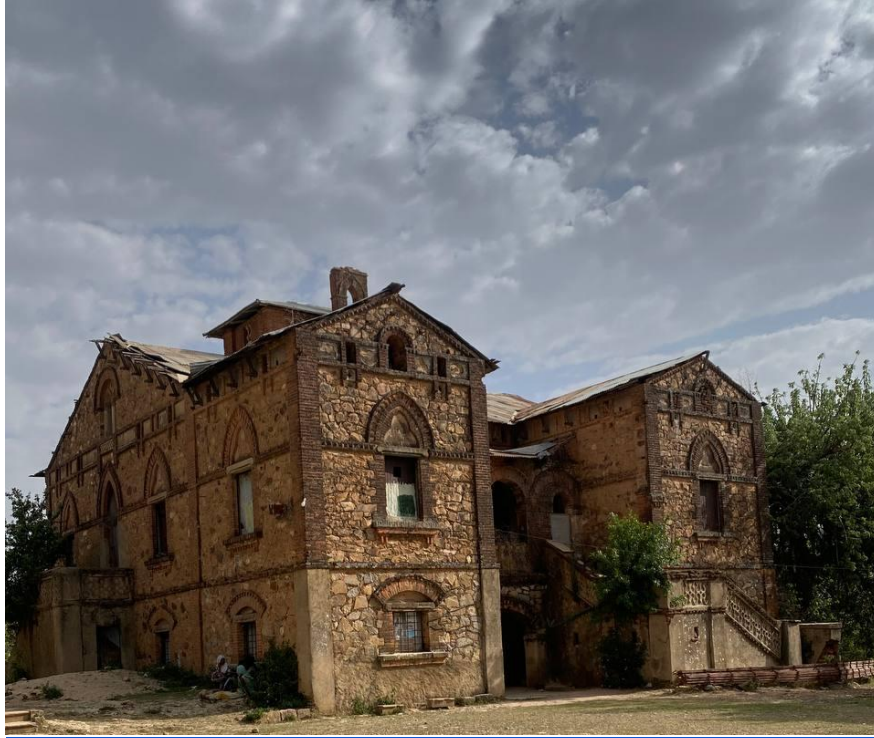
Figure 4. Italian consulate building (source: Adwa culture and tourism bureau)

Finally, the building's evident **conservation imperative** makes it a critical subject. The visible state of deterioration, including decay and neglect, signals a pressing need for immediate intervention. This physical condition presents an opportunity: a well-planned adaptive reuse strategy, combined with proper conservation, could rescue and preserve the structure for future generations, transforming a neglected heritage asset into a sustainable development (Ethiopian Ministry of Culture and Tourism & Tigray Culture and Tourism office, n.d.). Thus, the project aims to address a dual purpose: to rescue the structure through comprehensive documentation and to demonstrate the transformative potential of **adaptive reuse** in fostering sustainable development.

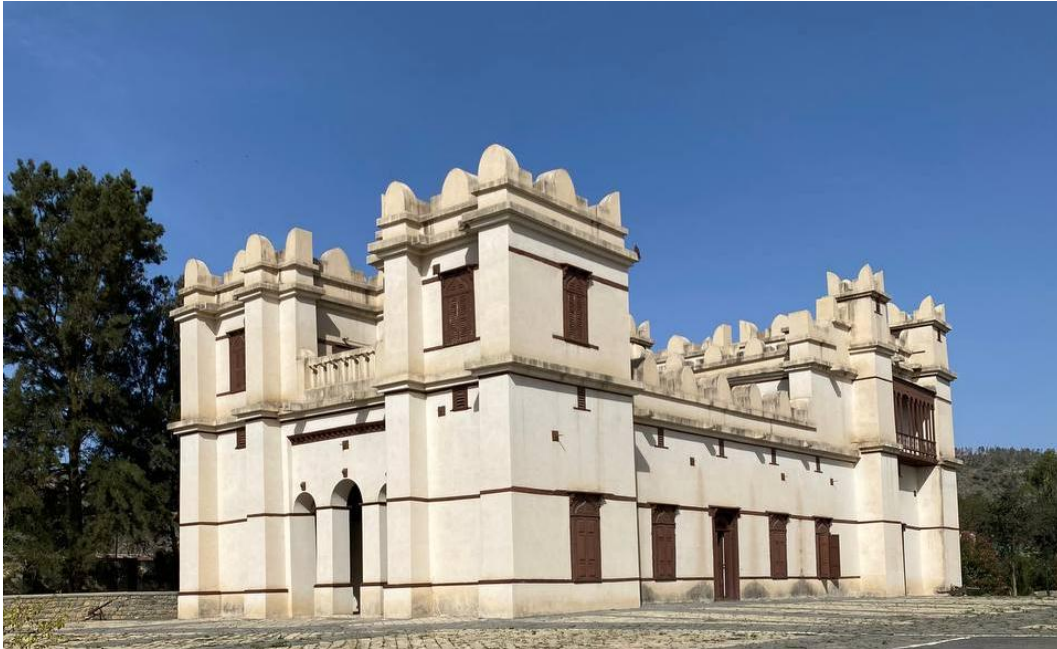
The exterior view is characterized by **thick masonry walls** finished with a pale, earth-toned plaster. Architecturally, the composition is marked by a deep archway leading to an external space, crowned by simple, fortress-like parapets that suggest the imperial and defensive purpose of the original structure.

Figure 5. Exterior image of Atse Yohannes IV Palace

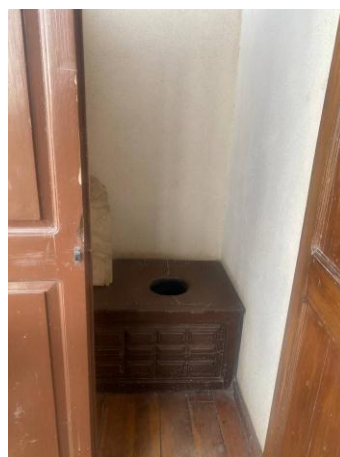
A notable feature representing the private, domestic side of the imperial residence is the historic sanitary installation, housed within a small, dedicated alcove or closet space . This chamber features a built-in wooden structure that serves as the toilet, distinguished by decorative paneled casework and a circular aperture at the seat level. The dark, heavily finished wood of this utilitarian fixture contrasts sharply with the plain plastered walls. Its enclosed, minimalist design reflects the early forms of sanitary engineering available in the 19th century, predating modern plumbing standards and offering a tangible insight into the daily life and infrastructure of the palace's original occupants. A notable feature representing the private, domestic side of the imperial residence is the historic sanitary installation, housed within a small, dedicated alcove or closet space . This chamber features a built-in wooden structure that serves as the toilet, distinguished by decorative paneled casework and a circular aperture at the seat level. The dark, heavily finished wood of this utilitarian fixture contrasts sharply with the plain plastered walls. Its enclosed, minimalist design reflects the early forms of sanitary engineering available in the 19th century, predating modern plumbing standards and offering a tangible insight into the daily life and infrastructure of the palace's original occupants. This is still open as part of the exhibition for visitors to get a better understanding of sanitary system of the time.

Figure 7. Images showing Atse Yohannes IV Palace original toilet

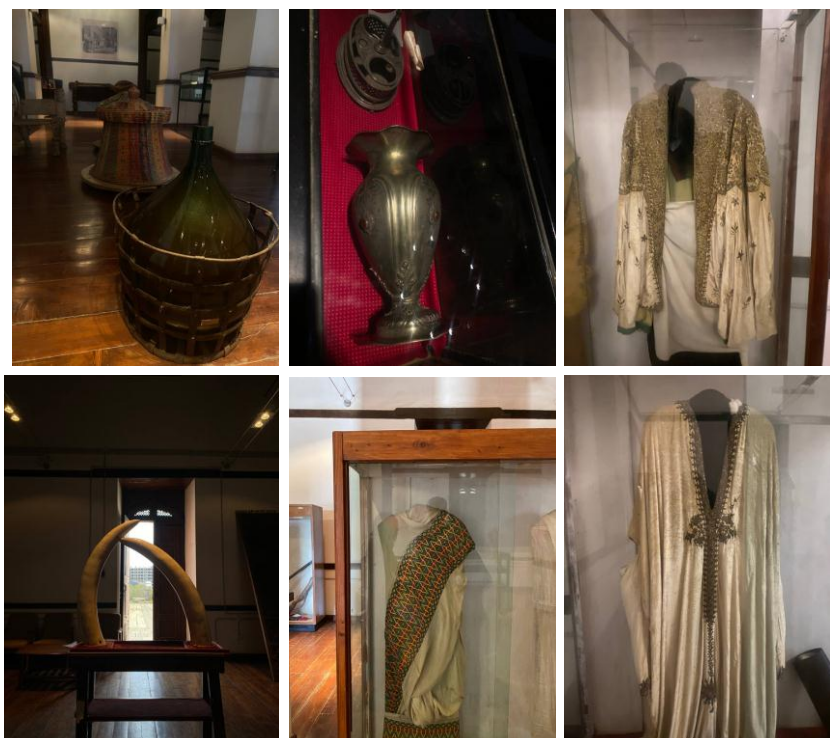
The adaptive reuse strategy of the Atse Yohannes IV Palace interior involved a functional re-zoning to transition from a private imperial residence to a public museum. Key primary spaces, notably the former reception halls, have been formally designated as **Exhibition Galleries**. These areas leverage the existing structural grid of monumental interior columns and high ceilings to define expansive verticality, allowing for the display of large-scale artifacts, such as the ceremonial elephant tusks, without compromising sightlines or circulation volume. The design employs a sequential, linear flow, using the original architectural features the deeply coffered timber ceiling and the substantial column shafts as inherent elements of the museological narrative. Exhibition components consist primarily of freestanding, perimeter, and central vitrines, which maintain a deliberate separation from the historic plaster walls, thereby adhering to crucial **non-invasive conservation principles** during display configuration. Lighting control is managed through exposed surface-mounted track systems, providing adjustable task illumination for artifacts while supplementing the limited natural light entering through the deeply recessed historical fenestration, effectively balancing preservation requirements with required visibility and user experience.

Figure 8. Images showing Atse Yohannes IV Palace various artifacts displayed in the adaptively reused museum

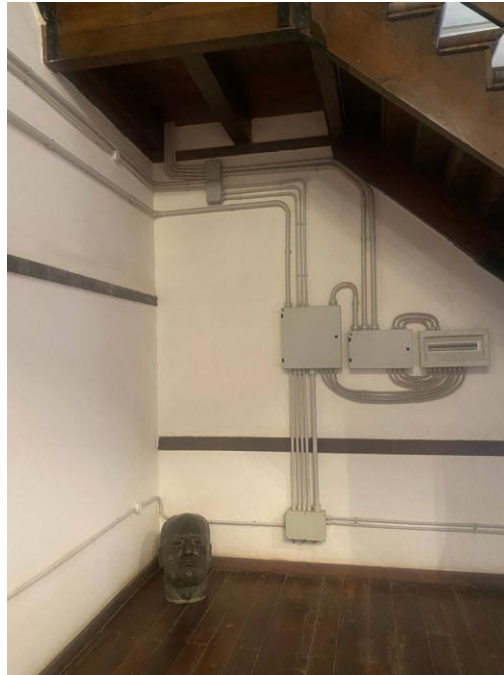
Figure 9. Images showing Atse Yohannes IV Palace electrical installations in the adaptive reused museum

stone and mortar walls, though the exposed gray PVC conduit runs follow complex paths, highlighting the difficulty of routing modern systems in this archaic structure

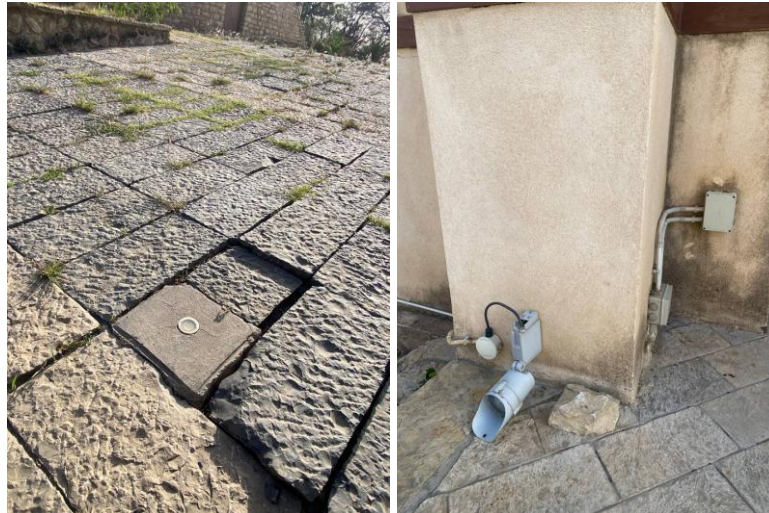
Figure 10. Images showing Atse Yohannes IV Palace pavement and walkway light fixtures installations

Observations of the pathways and exterior lighting within the palace compound reveal necessary compromises for security and visitor accessibility. The pathways feature large, irregularly shaped flagstones typical of **traditional masonry paving**, but the rough, uneven surface and intrusive vegetation suggest deferred maintenance. To facilitate evening circulation, a modern, **low-voltage recessed light fixture** is installed, but it is embedded into a new, geometrically cut concrete square that is clearly inserted into the rough, historic flagstone matrix; this **invasive intervention** prioritizes functional ground illumination over the consistency of the historical texture. Furthermore, exterior fixtures, such as a large floodlight mounted near a stone step, show less aesthetic consideration for the required utility runs, with exposed cabling indicating a less refined approach to installation than seen indoors, and a missing lens element on the fixture suggests current **maintenance deficits** impacting the planned illumination scheme.

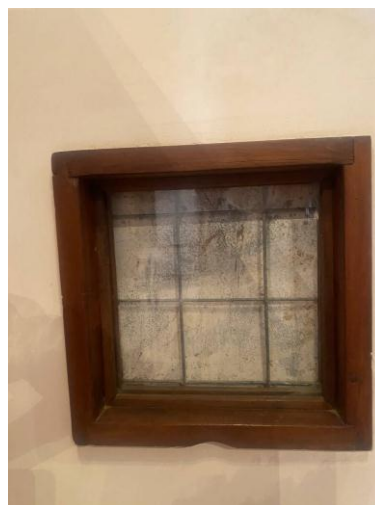
Figure 11. Images showing Atse Yohannes IV Palace material revelation window as part of the museum display

The interior utilizes a focused **material revelation window** as a key didactic display element. This common heritage interpretation technique involves cutting a clean, square aperture into the finished plastered wall and framing it with dark, stained wood trim. The primary purpose is to expose the **underlying structural components** typically the original plaster finish with the added mesh for the new plaster to bind providing visitors with direct, tangible insight into the palace's earliest finishing. By transforming a section of the building wall itself into an **educational artifact**, this feature effectively bridges the gap between the finished architectural appearance and its hidden plastering without requiring the wholesale removal of historic finishes.

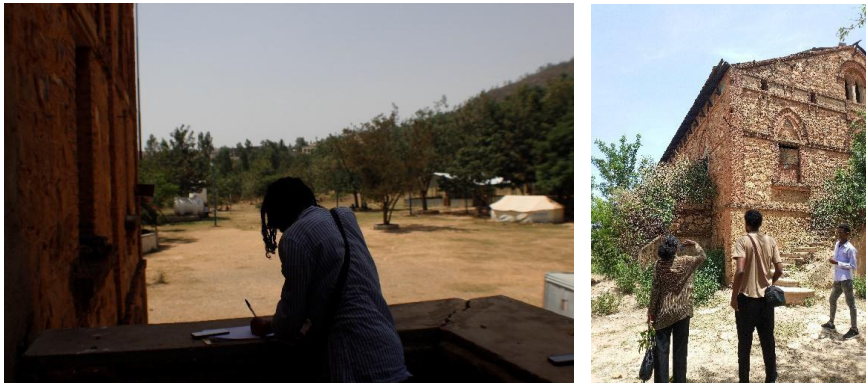
A Visual Technical Investigation is a systematic approach focused on the visual examination of a building's structure and components. The primary goal is to accurately assess the overall condition and pinpoint any existing damage or defects. Following the established methodology, this investigation is generally divided into three sections

Figure 12. On-site Technical Investigation

The Visual Technical Investigation process, as the name suggests, is a methodical approach to visually examining a building's structure and components to assess its condition and identify any damages or defects. As mentioned before, this process typically consists of three sections

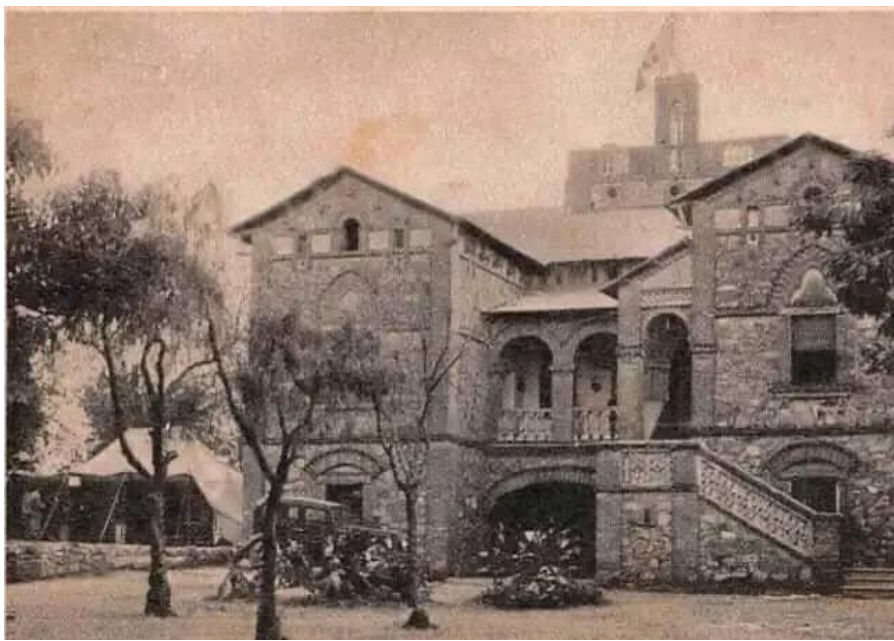
The Italian Consulate Building in Adwa was constructed as part of Italy's broader diplomatic infrastructure in Ethiopia. While the exact architectural style of the consulate building in Adwa is not widely documented, it is likely that the building exhibited typical colonial Italian architectural features, such as the use of masonry and neoclassical elements. These buildings were designed to project Italian authority and were typically characterized by symmetrical facades, columns, and large windows, often integrating elements of European design with local building techniques Pankhurst (2001).

Figure 18. Italian consulate building old photograph (Source: Adwa culture and tourism office)

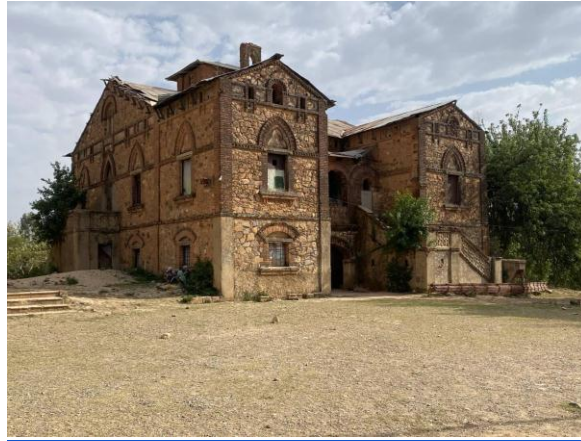
Figure 20. picture showing Italian consulate building (2024)

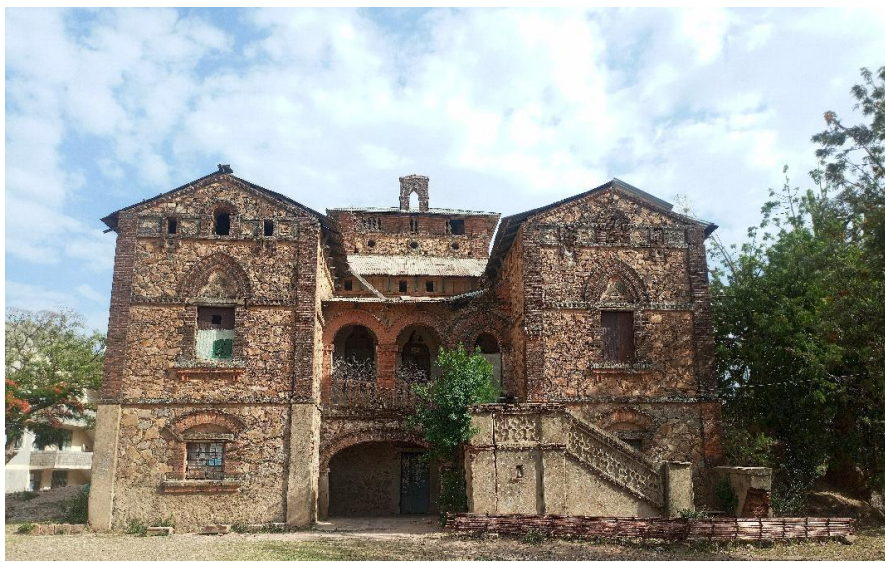
Figure 22. Italian consulate building

Constructed primarily from indigenous stone, the façade of the building is not only sturdy but also aesthetically pleasing, enhanced by a striking assortment of red brick embellishments. These brick accents add depth and texture to the surface, creating a dynamic interplay of materials that draws the eye and invites closer inspection. The careful craftsmanship involved in the integration of these materials speaks to the skill and artistry of the builders, who sought to create a lasting monument.

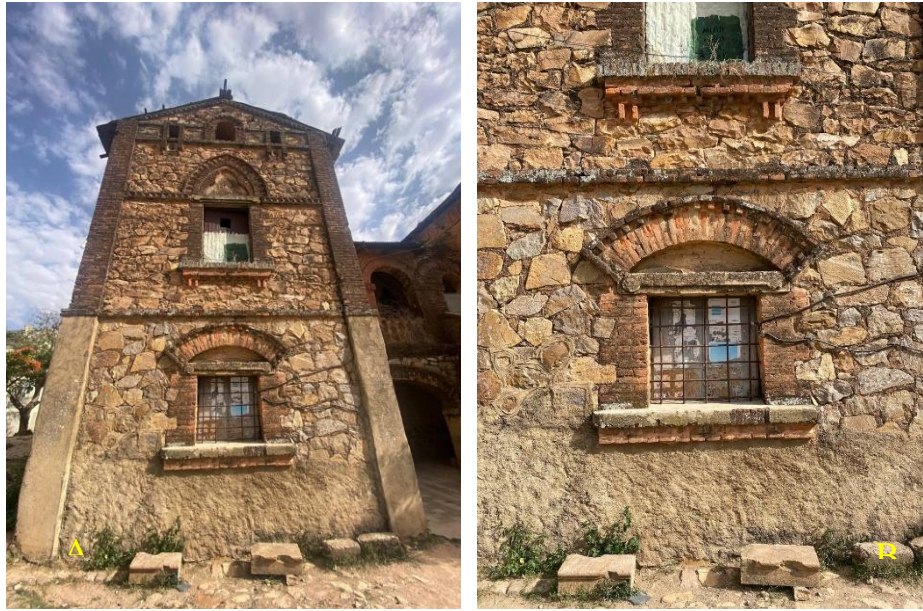
Figure 23. Image A showing the overall facade features of one side of the building, Image B showing a closeup details of one of the arched windows

The symmetrical layout of the building is a classical design, providing a sense of balance and harmony. This is further emphasized by the numerous arched windows that punctuate the façade, each one serving as a frame for the light that filters into the interior. These windows are not merely functional; they are also ornamental, featuring intricate designs that enhance the overall aesthetic appeal of the structure. Above the entrances, elaborately carved details add a touch of elegance, showcasing the meticulous attention to detail that characterizes the building's design.

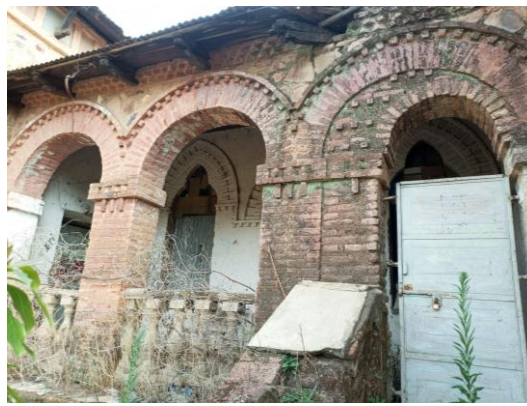
Figure 24. image showing arches in the balcony

At the heart of the structure lies a balcony, which serves as a focal point and is supported by sturdy columns. This feature not only underscores the vertical emphasis of the building but also invites visitors to appreciate the view from above, creating a sense of connection between the interior and the surrounding landscape. The balcony, with its graceful lines and proportions, exemplifies the architectural sophistication of the era.

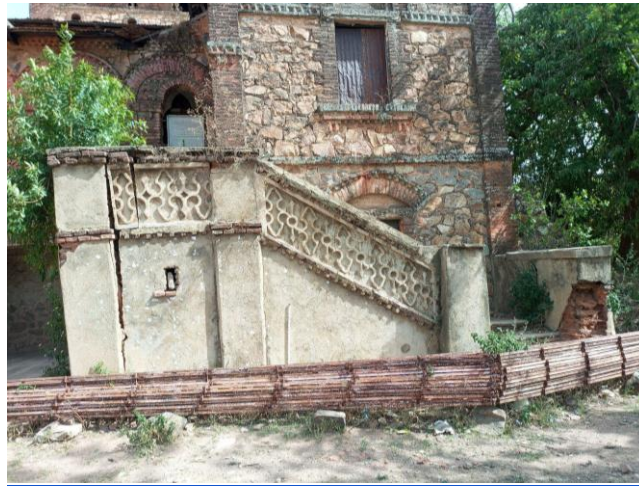
Figure 25. image showing details of the front stair

ascend and experience the beauty within. The staircase, with steps and supportive walls, serves as a transition from the outside world to the historical significance of the interior.

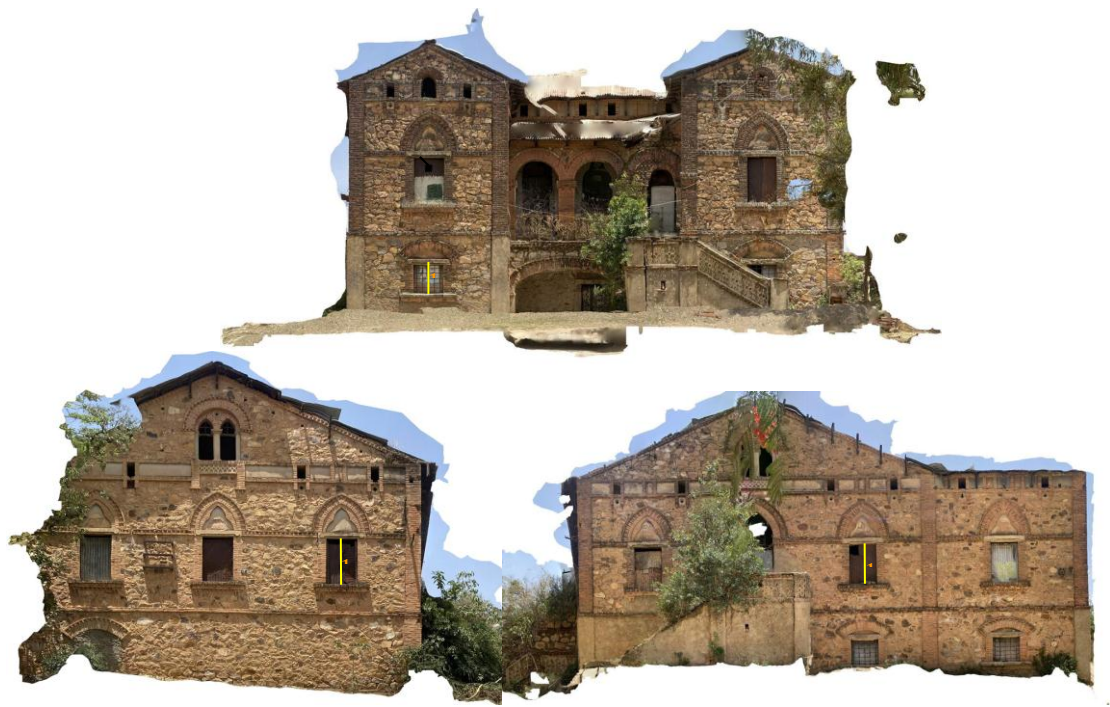
Figure 35. photogrammetric result three elevation (prepared by: Natneal Firew)

The current conditions at the site, including the presence of birds occupying certain rooms, inaccessible due to excessive clutter, and areas of complete darkness, made the photometric survey method impractical for mapping the cracked areas and assessing the internal damages within the building. However, the research study attempted to conduct a photogrammetric documentation of the building's external elevations, and the results are presented in the images below.

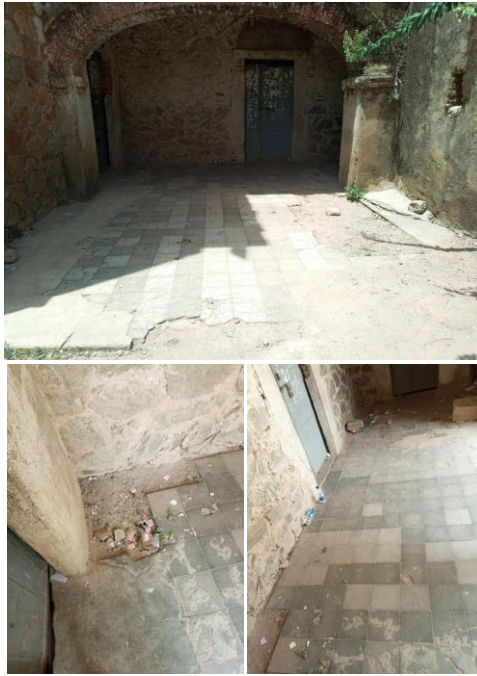
Figure 39. Images showing the floor damages

The flooring depicted in the image is evidently in a deteriorated condition, necessitating immediate attention. A notable concern is the absence of several tiles, which results in gaps and uneven surfaces that pose a tripping hazard. Additionally, numerous remaining tiles exhibit cracks, further undermining the integrity of the flooring. The presence of dirt, leaves, and other debris contributes to the overall appearance of neglect and unsanitariness. The combination of missing and cracked tiles leads to an uneven walking surface, which can be uncomfortable and hazardous. The flooring is in a state of disrepair and requires substantial repairs to restore its safety and functionality.

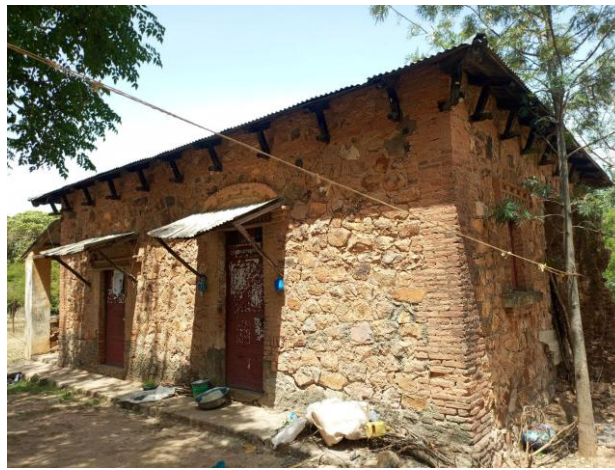
Figure 47. Image showing the other historic part of building in the compound

The image shows a smaller, more utilitarian building compared to the main structure. It is a single-story edifice with a distinct architectural style that, while related to the main building, is less ornate. The building features a series of arches that form an open-air corridor or loggia along its facade. This design is both functional, providing shade and shelter, and aesthetically pleasing, creating a sense of continuity with the arched details found elsewhere in the compound. The arches are well-proportioned and appear to be constructed from the same masonry or rendered material as the other structures, reinforcing a cohesive architectural language.

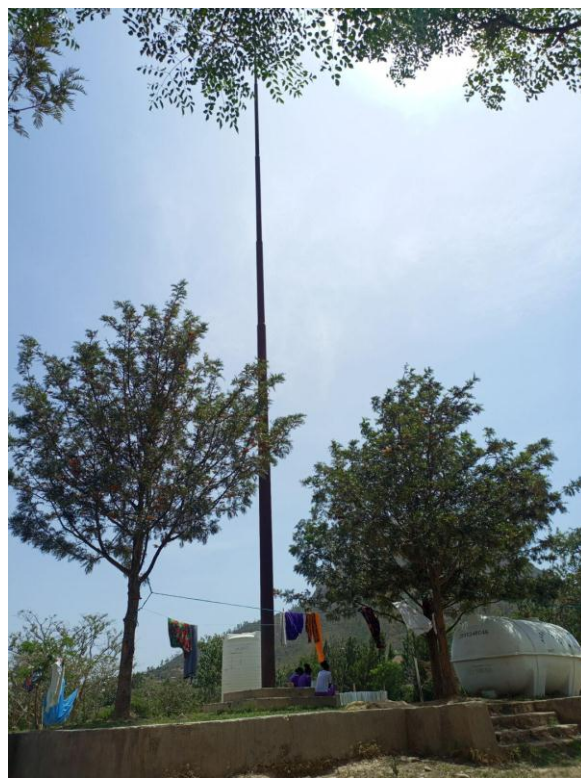
The image captures the flagpole's imposing height, which suggests its intended purpose was to be visible from a distance, making a clear statement about the consulate's status. Its extreme length, dwarfing the surrounding buildings and trees, is a deliberate design choice that speaks to the pride and authority of the nation it represents. The pole itself appears to be made of a sturdy material, possibly metal, and is anchored firmly to the ground with a robust base, ensuring its stability and permanence.

Figure 48. Images showing the flag pole

The placement of the flagpole is particularly noteworthy. It is situated in a central, open area of the compound, away from the main building but still a focal point. This careful placement ensures that the flag, when raised, would have been the most prominent feature of the entire site. The flagpole's prominence is a physical manifestation of the concept of sovereignty; it is a sentinel, a silent guardian that declared the presence of the Italian state in Adwa.

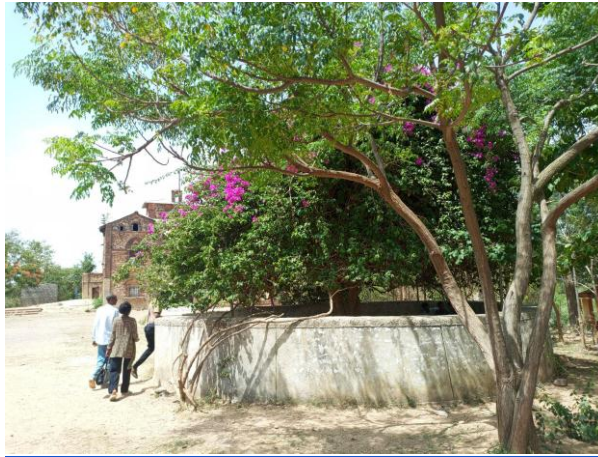
Figure 50. Sitting space

The seating area itself is defined by a circular arrangement of masonry benches. These benches are constructed from the same type of stone or rendered material found in the compound's other structures, ensuring architectural continuity. The circular layout encourages conversation and social interaction, creating an intimate and communal atmosphere. The simple, robust construction of the benches is both practical and durable, designed for long-term use.

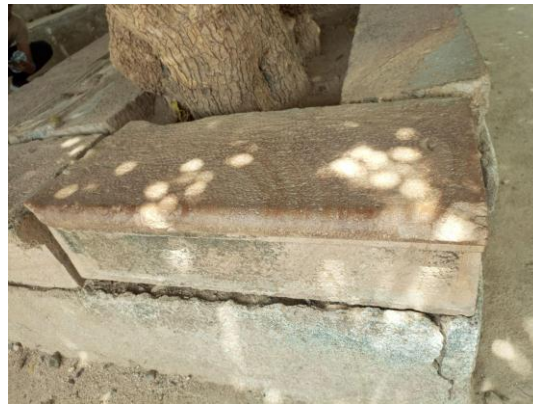
The images also show a rectangular raised planter bed or a decorative fountain basin at the very center, encircling the tree's base. This detail further accentuates the tree's importance and frames it as a central monument. While the planter or basin appears to be in disrepair, its original design suggests a past commitment to creating a beautiful and serene environment.

Figure 52. Image showing the rectangular planter at the center

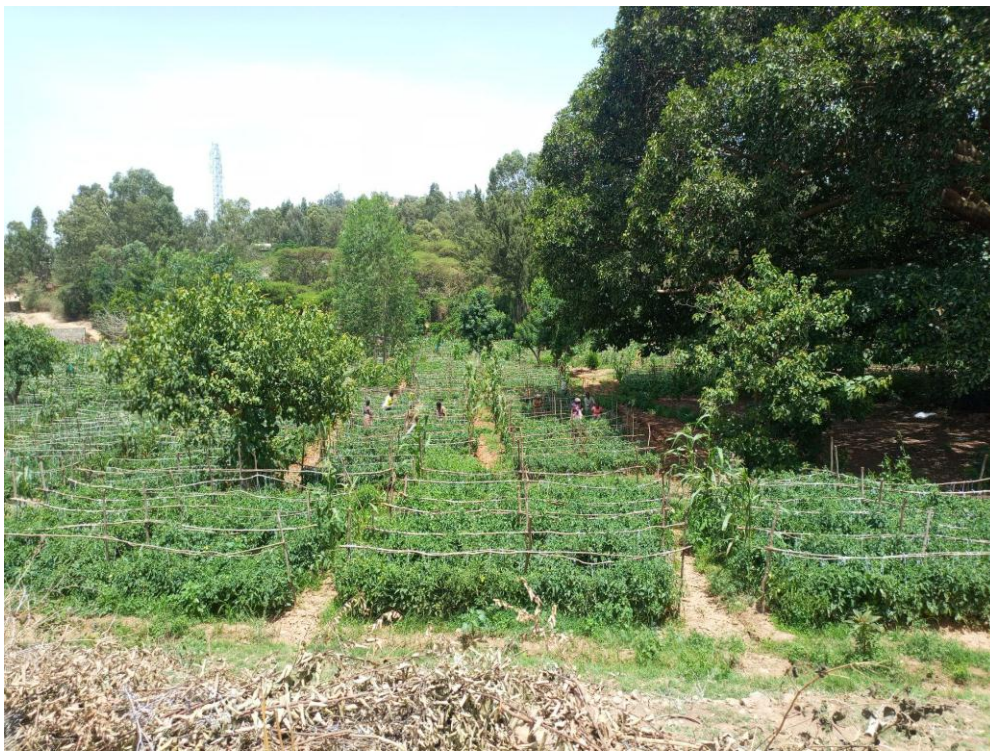
The Italian Consulate compound in Adwa also contains a small farm area since it is in close distance with a river passing by, emphasizing potential self-sufficiency and resourcefulness. The image shows a structured agricultural plot, with a series of organized rows of plants. The rows are separated by raised earth, which likely serves as a form of furrow irrigation, a common and efficient method in arid and semi-arid regions. This demonstrates a thoughtful and practical approach to cultivation, designed to conserve water and maximize crop yield.

Figure 55. Image showing the small-scale farm inside the site

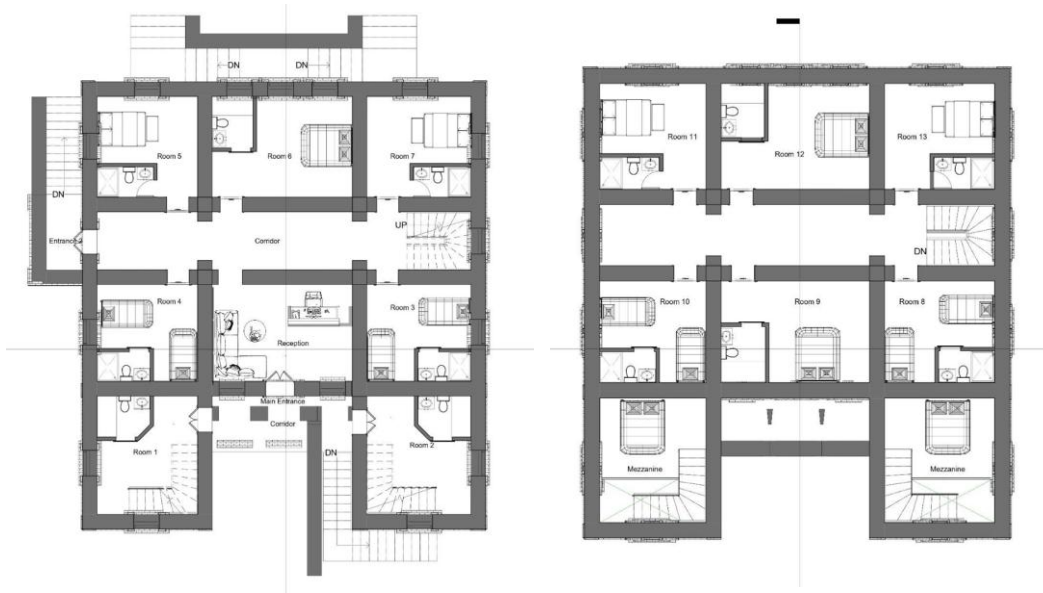
Figure 57. Images showing the proposed first and second floor plan

2. Guest Inn: The existing rooms on the first and second floors can be restored and converted into comfortable guest rooms, maintaining the building's original spatial configuration where feasible. The incorporation of modern amenities, such as en-suite bathrooms and Wi-Fi, is crucial to meet the expectations of contemporary travelers.

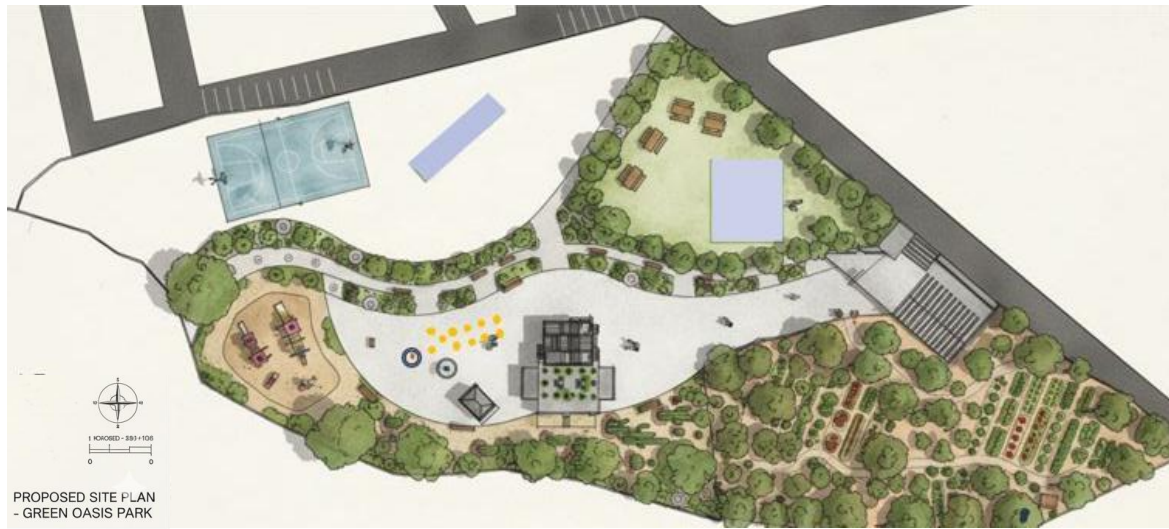
Figure 58. Image showing the proposed site floor plan

3. Outdoor Space: The building's surrounding compound offers opportunities for creating an attractive courtyard or outdoor dining/lounging area. Landscaping and the integration of local flora will enhance the ambiance and create a welcoming environment. Presenting a wider, comprehensive view of the entire site, [image 62](#) site plan for the compound. The design introduces new amenities that complement the historical structure without

overshadowing it. A dedicated camping area, featuring a series of stylish and comfortable tents, is proposed to attract tourists and provide a unique accommodation experience. A central fire pit acts as a focal point for gatherings and evening relaxation and entertainment. The intentional variety of seating arrangements from informal benches to elegant patio transforms the once-vacant grounds into a versatile and dynamic leisure and event space. The design also strategically incorporates the existing farm, which can be revitalized for educational or agricultural purposes, creating a self-sustaining element within the compound. Additionally, a designated parking space and a new entrance has been thoughtfully included to ensure better access for all visitors.

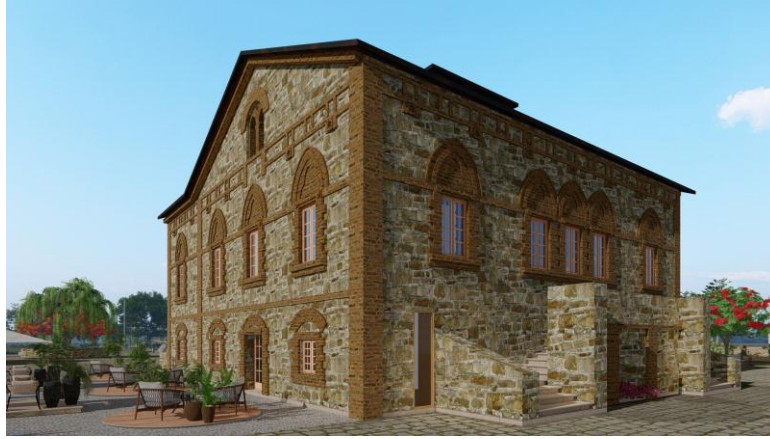
Figure 61. Image showing the proposal in 3D

Restored Main Facade This rendering showcases the restored main facade of the Italian Consulate building. The design emphasizes the preservation of the original stone and brickwork, highlighting the unique arched windows and symmetrical architecture. The proposed landscaping and paved courtyard create a welcoming entrance, setting the stage for the building's new life as a public space.

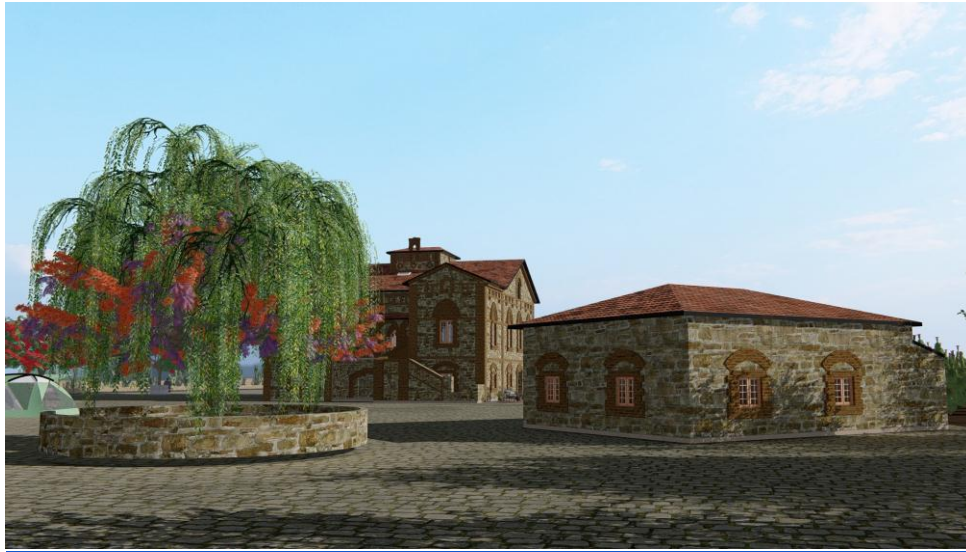
Figure 63. Image showing the proposal in 3D in relation to the other historic buildings

Site Overview with Proposed Amenities This wider view of the site shows the main building and its surrounding landscape. The design introduces new amenities, including a dedicated camping or glamping area with stylish tents, a fire pit for community gatherings, and a variety of seating arrangements. This transforms the grounds into a versatile leisure and event space, inviting both locals and tourists to engage with the site.

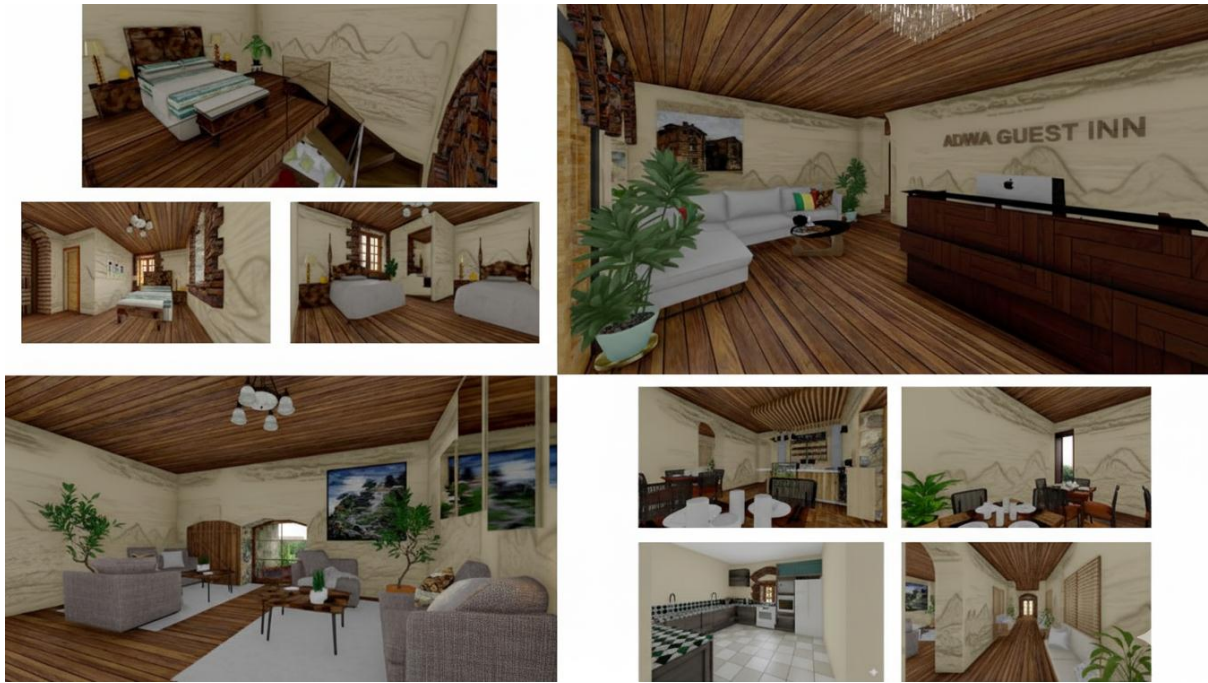
Figure 67. Images Showing the theme of the interior spaces

The proposed interior design for the **Adwa Guest Inn** blends a **rustic, natural aesthetic** with modern comfort, creating a cozy and unique theme. This is achieved primarily through the extensive use of **natural wood finishes**, seen in the dark-stained plank flooring and the exposed beam or slatted ceiling, which provides a warm, cabin-like feel. This warmth contrasts with the **rough, textured, light-colored walls** that appear to mimic ancient mud or carved stone, suggesting a connection to local or historical architectural elements. The furniture is contemporary—featuring plush gray sofas and simple, dark wooden pieces—while indoor greenery and unique artwork add splashes of color and life, resulting in a theme that is both **earthy and invitingly modern**.
