**MANAGEMENT OF LOAD BALANCE AND ITS IMPACT ON
PAVEMENT CONDITIONS
A CASE STUDY ON ADAMA – MILLE ROUTE**

A Thesis in Road and Transport Engineering

Hiwot Mesele
December 2016
Addis Ababa, Ethiopia

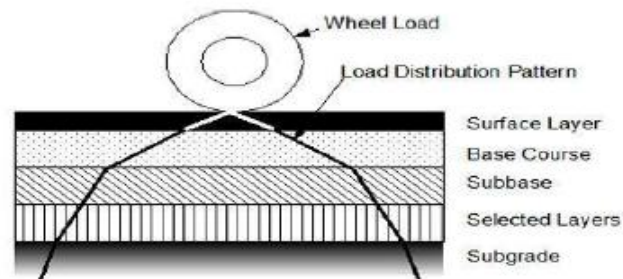
Flexible pavements are constructed of superimposed layers of natural granular material with different layer strength. The strength difference between the pavements layers are used to change the load distribution pattern from layer to layer. If the applied load on the pavement is higher, the flexible pavement will flex (bend) and it causes pavement failure [5].

Figure 2. Load Distribution of Flexible Pavement [5]

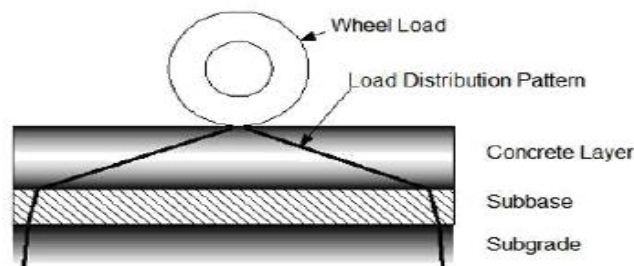
Rigid pavements are made with a Portland Cement Concrete (PCC) surface course and it is stiffer than flexible pavements due to high modulus elasticity of the PCC material [5]. The wheel load applied on the rigid pavement is transferred to sub grade by flexural strength and the rigid pavement is acts like a rigid plate [4].

Figure 3. Load Distribution of Rigid Pavement [5]

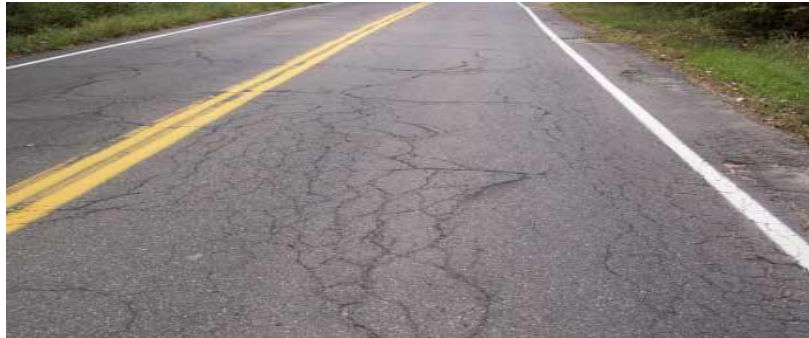
bitumen at the top of asphalt wearing course oxidizes rapidly and the material become brittle. Alligator crack which occur out of the wheel path area or not associated with the rutting is caused by construction problem.

Figure 4. Alligator Cracking^[8]

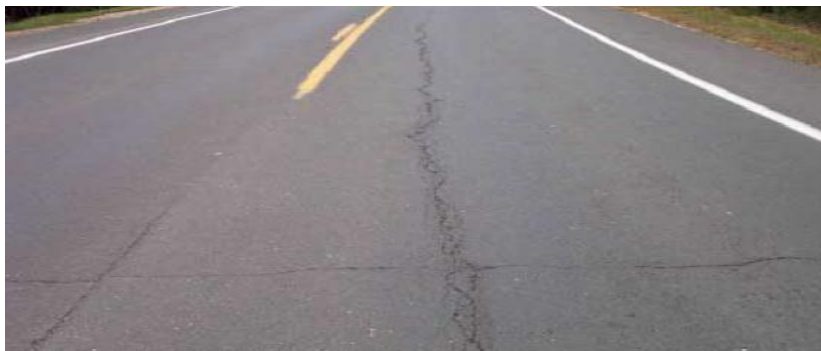
According to ERA Pavement Rehabilitation and Asphalt Overlay Design Manual, 2013, short irregular longitudinal cracks in the wheel paths are the first stage of traffic induced fatigue of the surface and by further trafficking these cracks will interconnect to form alligator crack. Long longitudinal cracks are the result of subgrade movement.

Figure 5. Longitudinal Cracking^[8]

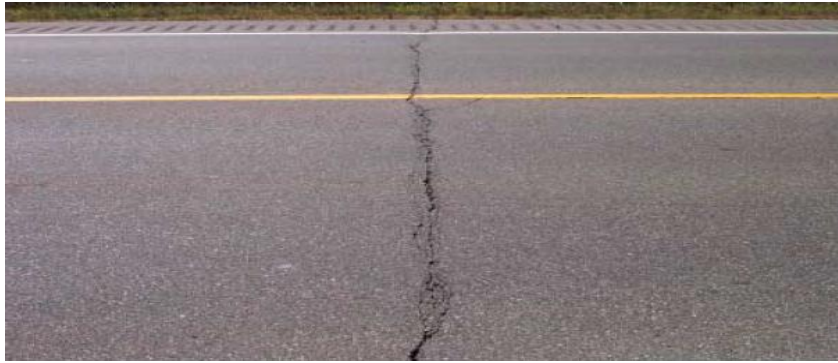
Transverse crack is a type of crack which runs approximately perpendicular to the centerline of the road. Transverse cracking has the same cause with longitudinal cracking. Moreover, low temperature cracking can exist due to thermal issue if the asphalt cement is too hard^[5]. Poor compaction at drainage structures can also cause transverse crack^[9].

Figure 6. Transverse Cracking ^[8]

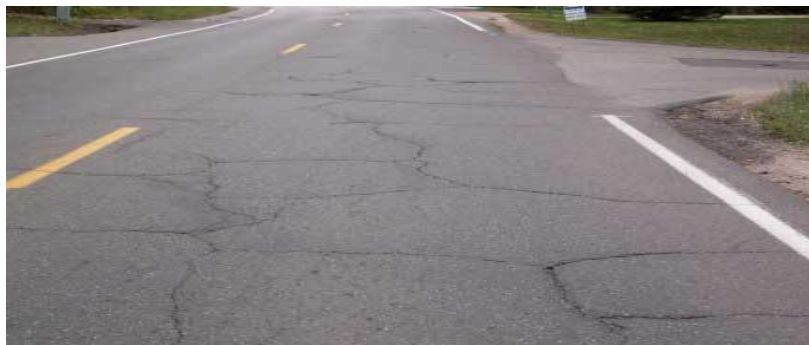
Block crack is an interconnected series of cracks which divide the pavement in to irregular pieces. Block crack is the intersecting of transverse and longitudinal cracks and lack of compaction during construction is the cause of this type of crack ^[5]. Shrinkage of treated (stabilized) pavement layers due to thermal stress also the main cause of block cracking ^[9]. Even if, the severity of crack increases from low to medium to high due to traffic loading, it is not a load associated failure ^[10].

Figure 7. Block Cracking ^[8]

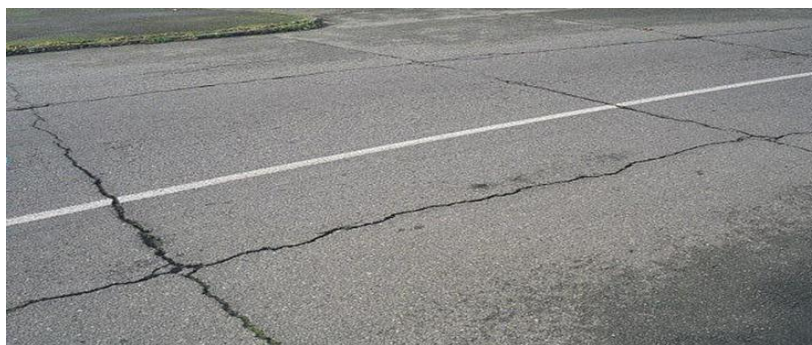
Reflective crack is any type of crack which reflects up through the overlaid (repaired) surface with hot mix asphalt concrete ^[5].

Figure 8. Reflective Cracking (www.pavementinteractive.org)

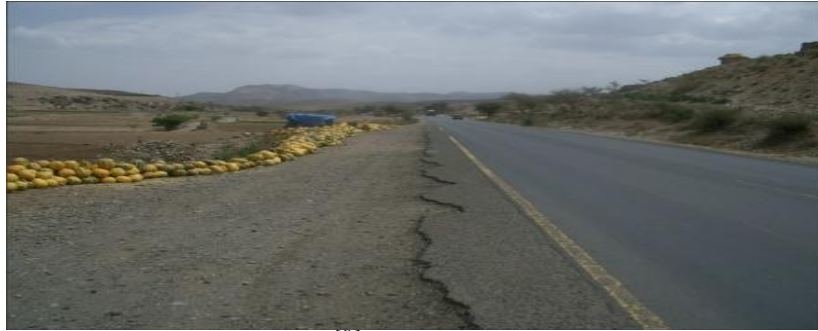
Edge crack is a type of crack which starts at the edge of the pavement with crescent shape and expand until it begins to resemble alligator cracking ^[5]. Inadequate pavement width, inadequate edge support, traffic traveling on shoulder edge and weak seal coat or loss of adhesion is the possible causes of edge cracking ^[11].

Figure 9. Edge Cracking ^[9]

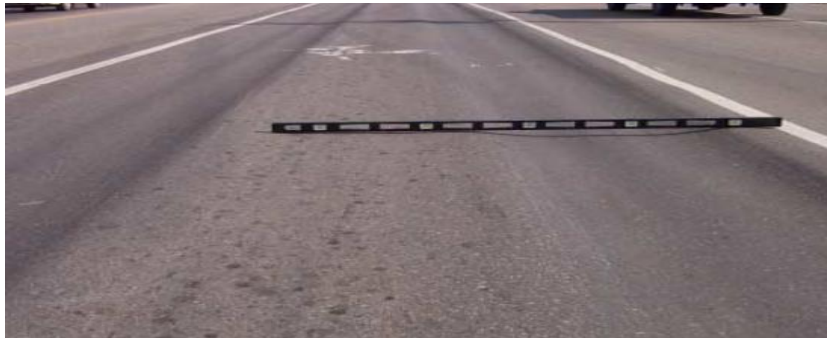
one or more of the pavement layers by traffic and the increasing of rut will decrease after the initial compaction phase ^[12].

Figure 10. Rutting without Shoving ^[8]

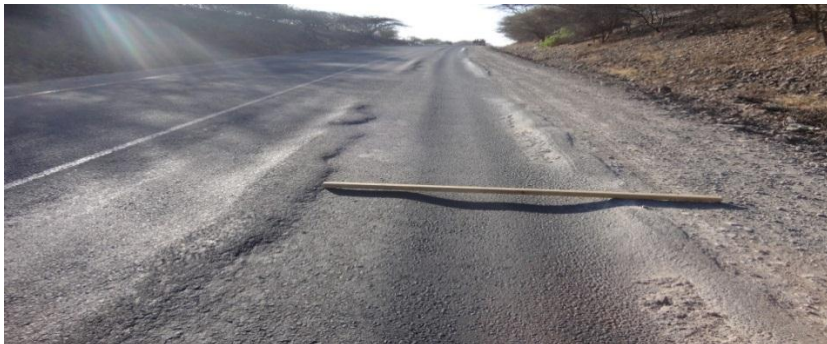
In this case shoving is occurred at the edge of the ruts and it is the indicative of shear failure in one of the pavement layers. The main cause of this type of rut is inadequate shear strength of the pavement to resist the applied traffic stress at that particular depth of the pavement due to poor quality surfacing material and inappropriate surfacing material for temperature and/or loading regime. The failures are usually to the upper pavement layers which have high traffic stress and unlike the rutting without shoving, it is not related to the overall strength of the pavement ^[12].

Figure 11. Rutting with Shoving (NET Consult Consulting Engineers and Architects Plc)

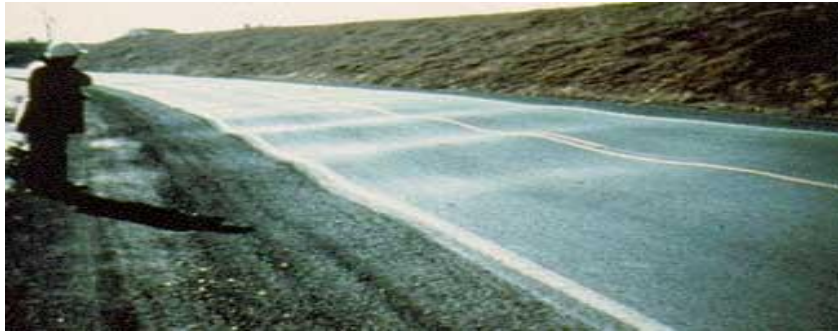
Corrugation is a shallow and evenly spaced ridges of the pavement surface material which existing transverse to road axis. It results from a lack of cohesion in the surface material and displacement by moving vehicles ^[13]. Too much asphalt cement, too much fine aggregate or rounded or smooth textured course aggregate may cause the lack of cohesion or instability of the asphalt concrete surface. Corrugation mostly occurred at the places where vehicles accelerate or decelerate ^[5].

Figure 12. Corrugation (www.fhwa.dot.gov)

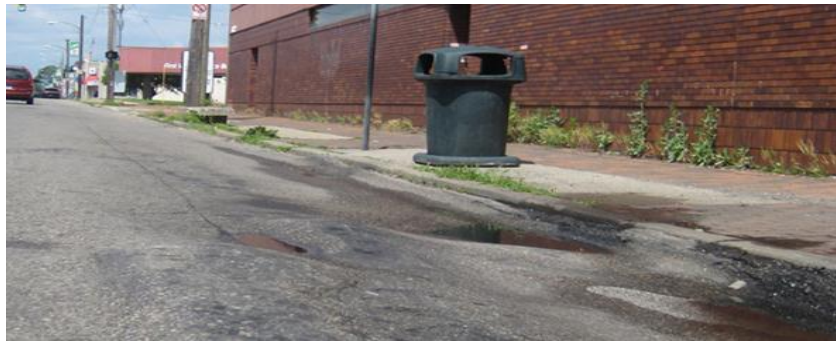
Shoving is a longitudinal and associated vertical displacement of a localized area of the pavement surface. This type of deformation mostly occurred on hills, curves and at intersections due to braking and accelerating of vehicles ^[14]. Poor bond between layers, Lack of edge containment and inadequate pavement thickness may also be the possible causes of shoving ^[11].

Figure 13. Corrugation (www.fhwa.dot.gov)

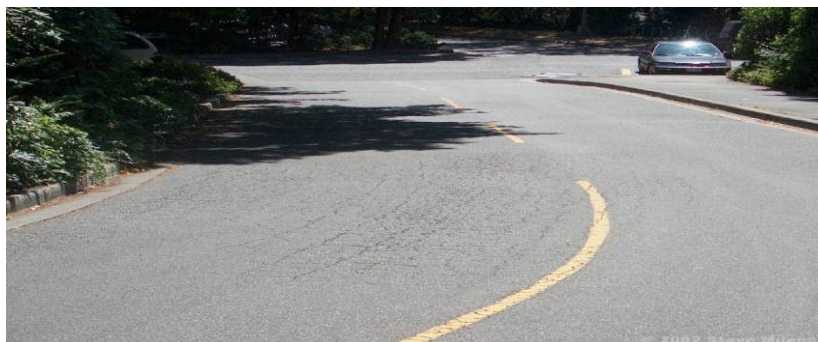
Depressions are small, localized and bowl shaped areas that may include cracking which cause roughness and allow water to collect. Localized consolidation or movement of the supporting layers under the surface course due to instability is the major cause of depressions ^[5].

Figure 14. Depression (www.pavementinteractive.org)

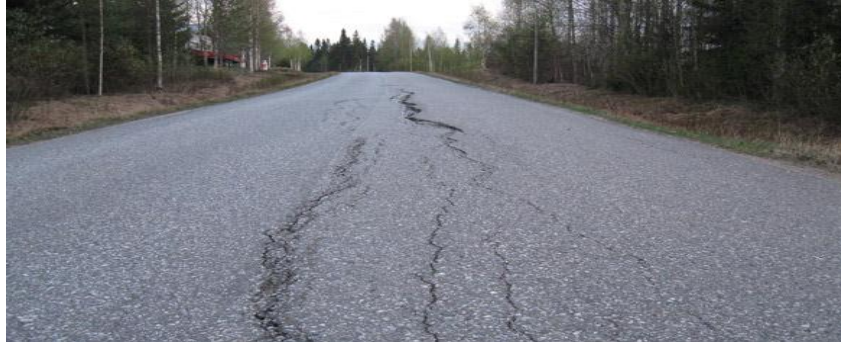
Swell is a localized hump on the pavement surface caused by an expansion of the supporting layers under the surface course or the subgrade. Moisture and subgrade with highly plastic clay are the major causes of expansion ^[5].

Figure 15. Swelling (www.pavemanpro.com)

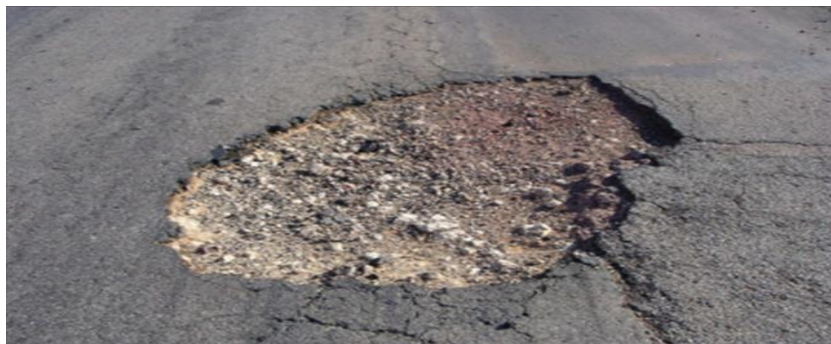
Potholes are bowl-shaped holes similar to depressions. The failure starts with a small fragment at the top of layer and it will progress downward into the lower layers of the pavement over time. Potholes are caused by moisture (area of poor drainage), pavement disintegration under traffic loading and due to inadequate strength in one or more layers of the pavement ^[5].

Figure 16. Potholes ^[10]

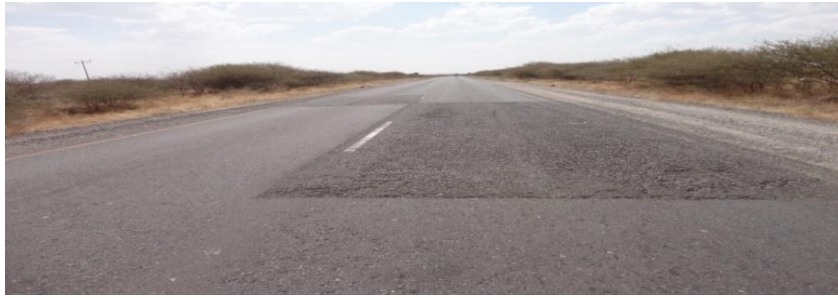
Patches are used to repair defects which are applied on a portion of pavement. However, patch failure can lead to a more widespread failure of the surrounding pavement ^[5]. Patches may be caused by inadequate cleaning or inadequate tack coat before placement of upper layers, seepage of water or moisture and weak or loose layer ^[15].

Figure 17. Patching (NET Consult Consulting Engineers and Architects Plc)

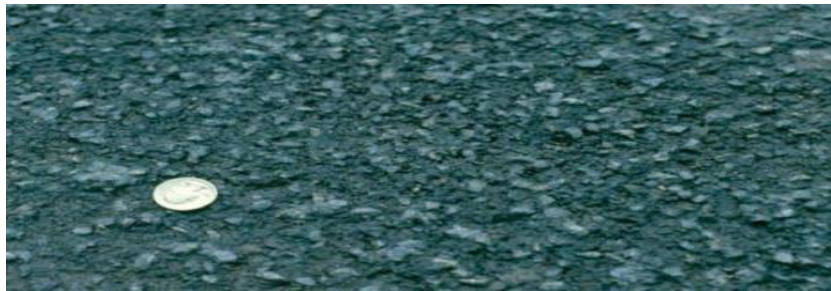
Raveling is the loss of material from the pavement surface due to insufficient adhesion between the asphalt cement and aggregate. Raveling can be accelerated by traffic and freezing weather^[5].

Figure 18. Raveling^[5]

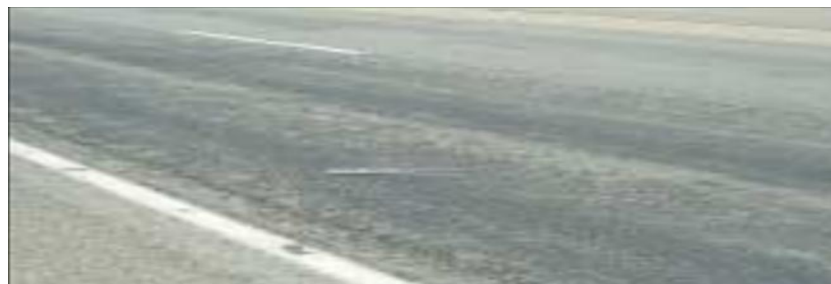
Bleeding is the presence of excess asphalt on the road surface which creates patches of asphalt cement. It reduce the skid-resistance of a pavement, and it can become very slippery when wet, creating a safety hazard. Excessively high asphalt cement content in the mix, asphalt cement with too low a viscosity (too flowable), too heavy a prime or tack coat and improperly applied seal coat are the causes of bleeding. Bleeding occurs more often in hot weather when the asphalt cement is less viscous (more flowable) and the traffic forces the asphalt to the surface^[5].

Figure 19. Bleeding^[14]

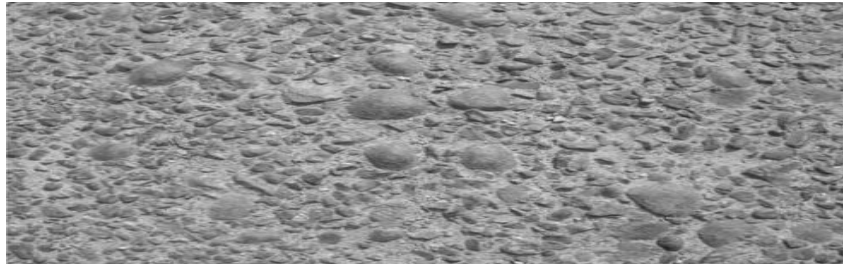
Polishing is the presence of aggregate with either small or no rough or angular aggregate particles extending above the asphalt binder due to heavy traffic movement. Inadequate resistance to polishing of surface aggregates, use of naturally smooth uncrushed aggregates, inadequate cleaning or inadequate tack coat before placement of upper layers, seepage of water through asphalt and weak layer are the possible causes of polishing ^[15].

Figure 20. Polishing ^[11]

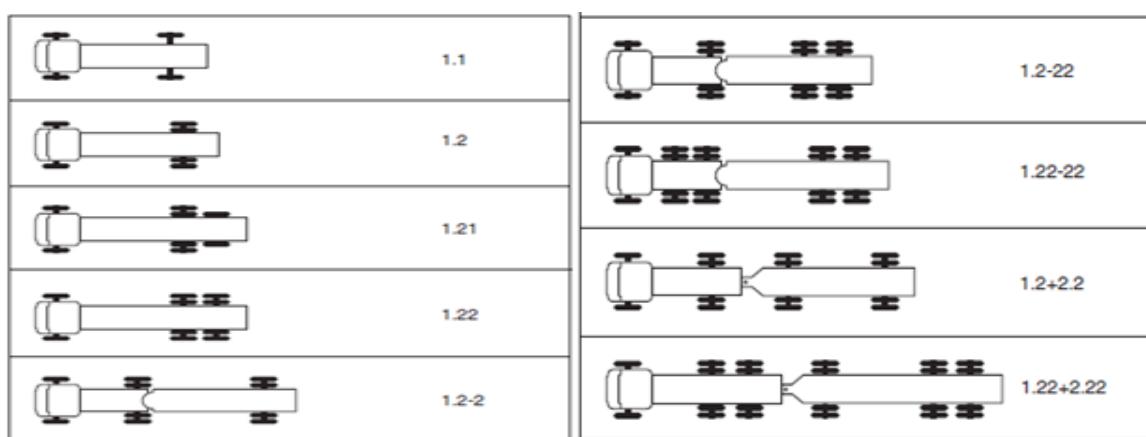
The information about axle configuration of the vehicle is important during the time of axle load survey. The classification system of axle configuration is based on a code, each axle is represented by '1' or '2' depending on the number of wheels (tyres) at each end of the axle. To separate the front and rear axles, a decimal point is placed between the codes. Tandem and Tridem axles are also represented by recording these codes directly after each other without any decimal point. A trailer and Semi-trailers or articulated vehicles can be denoted by a '+' and a '-' sign respectively^[20].

Figure 22. Axle Configuration^[20]

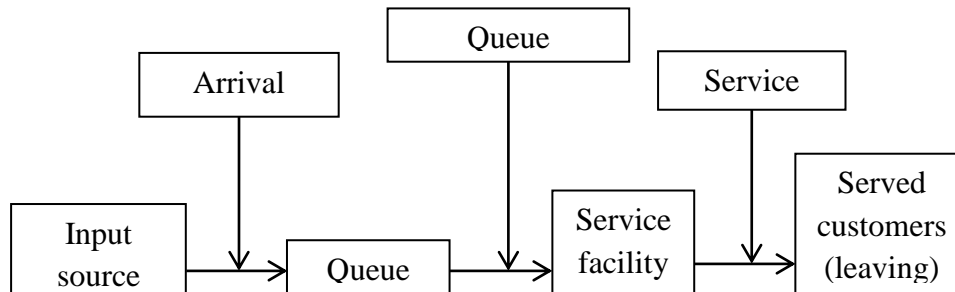
The component of basic queuing system is shown in Figure 23 ^[27].

Figure 23. Components of a basic queuing system ^[27]

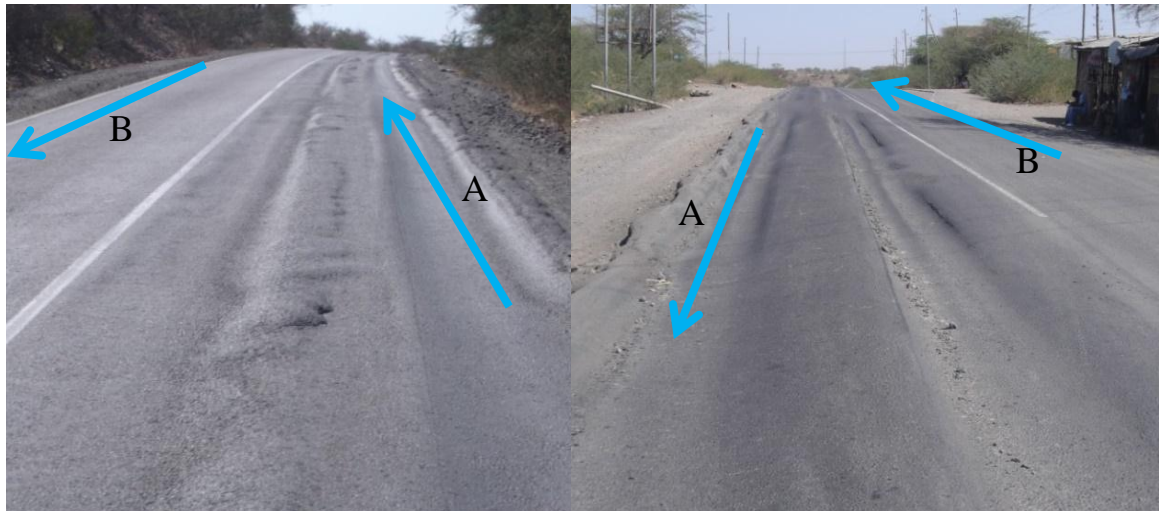
Figure 25. Sample Pictures (A represent Djibouti-Addis Ababa lane and B is vice versa)

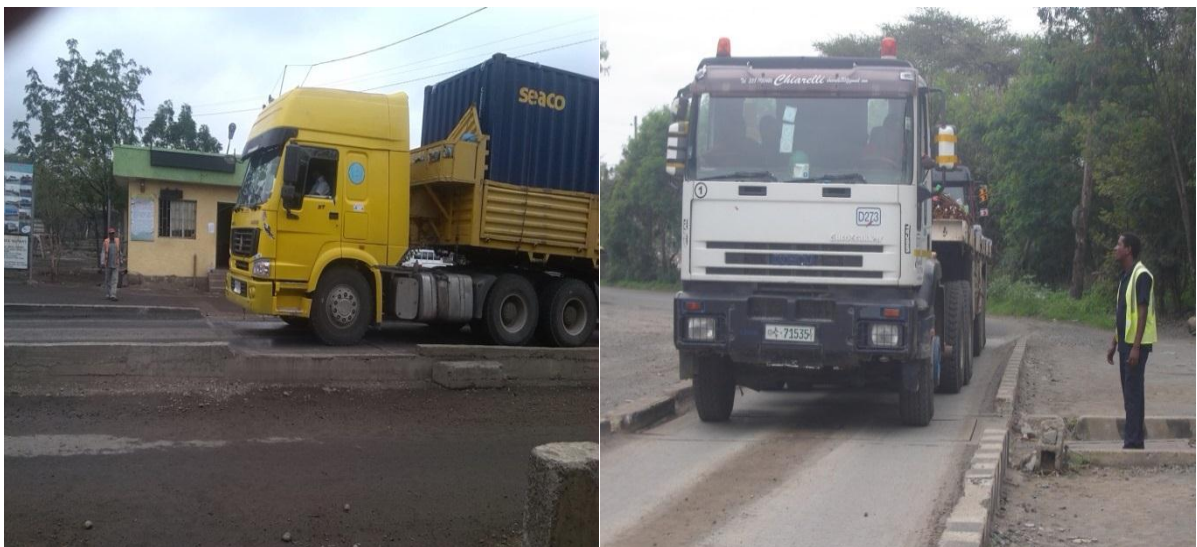
Axle load survey was conducted in July, October and November at Awash Vehicle Weight and Size Control Stations; and August, September and October at Modjo Vehicle Weight and Size Control Stations for seven days on each month and stations. To collect axle load survey data, data collection form which is attached as annex 1 was prepared.

Figure 26. Vehicles under Examination at Awash and Modjo Control Stations

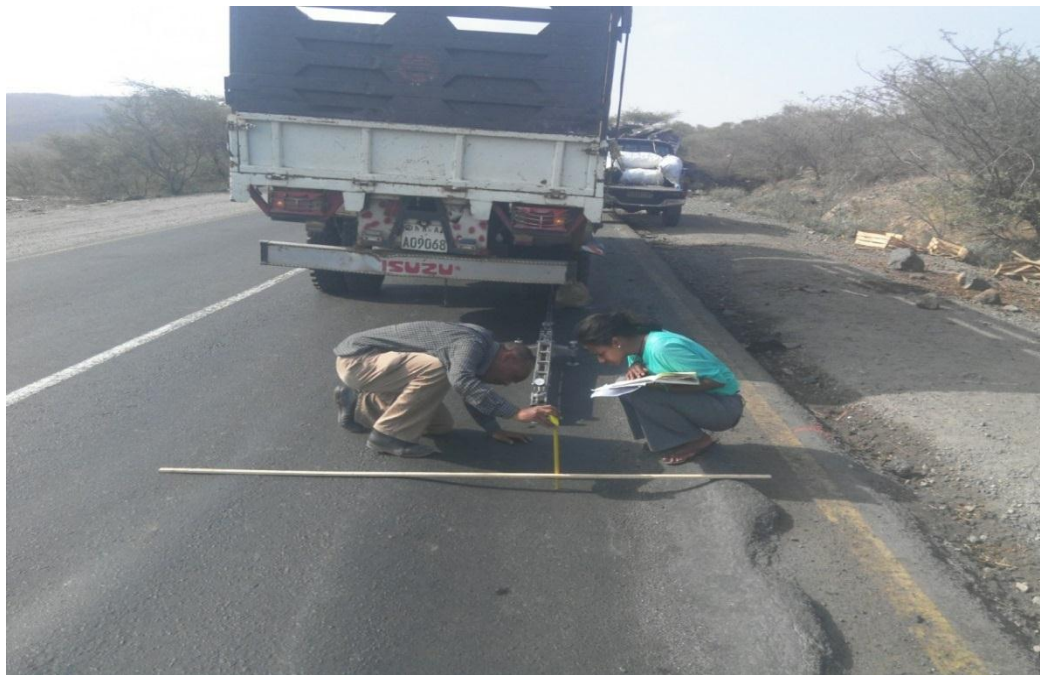
Pavement condition survey has been carried out on December 12 and 13, 2015 from Adama to Awash Arba, which is around 137 km. During the time of survey, measurement on rutting and potholes on more damaged sections has been taken due to time and cost constraint.

Figure 27. Rut Depth Measurement during Pavement Condition Survey

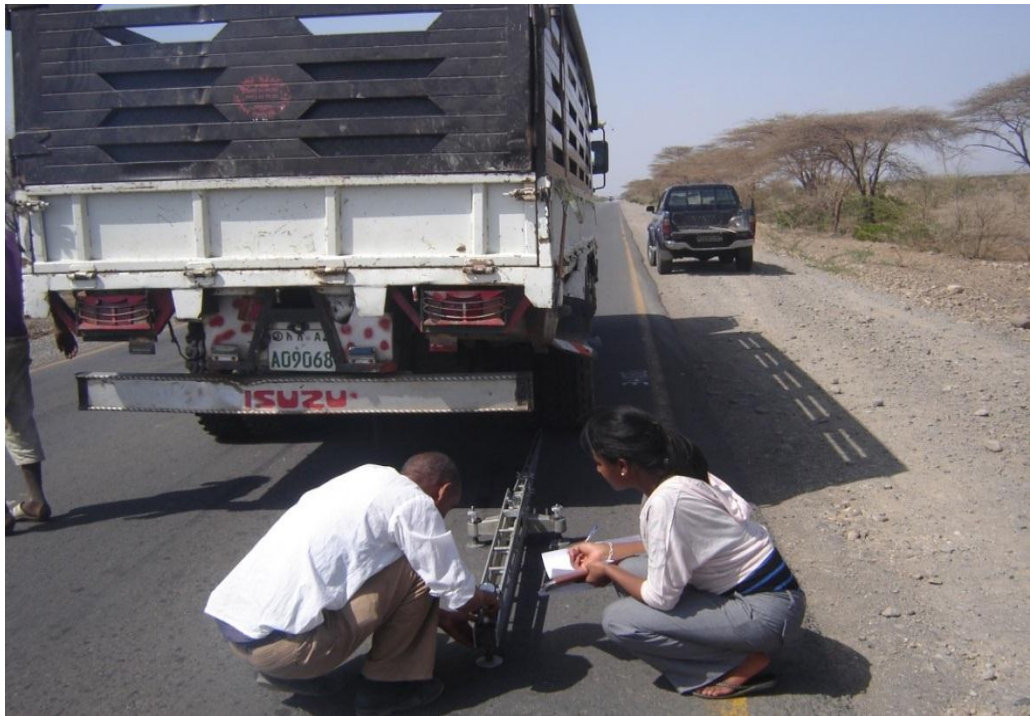
The pavement deflection test was collected at the same time with visual pavement condition survey using Benkelman beam. The truck used to measure deflection has dual rear wheels and loaded 8.2 tonnes which is a standard rear axle load recommended for deflection test.

Figure 28. Deflection Data Collection

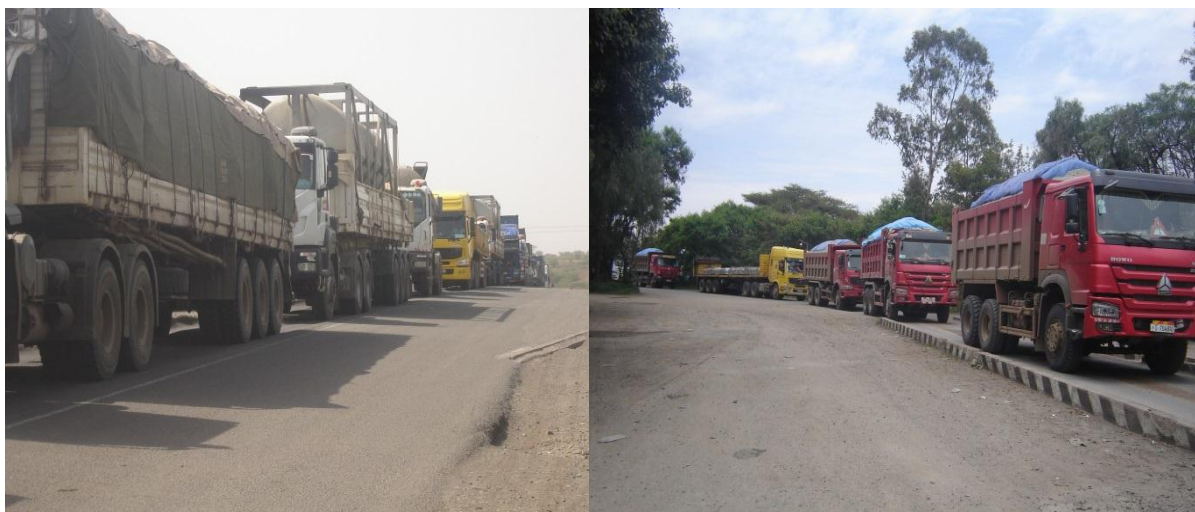
The arrival and service time of vehicles were collected from December 20-26, 2015 at Awash Vehicle Weight and Size Control Stations and from August 25-29, 2015 at Modjo Vehicle Weight and Size Control Stations.

Figure 29. Vehicles on Queue at Awash and Modjo Control Stations

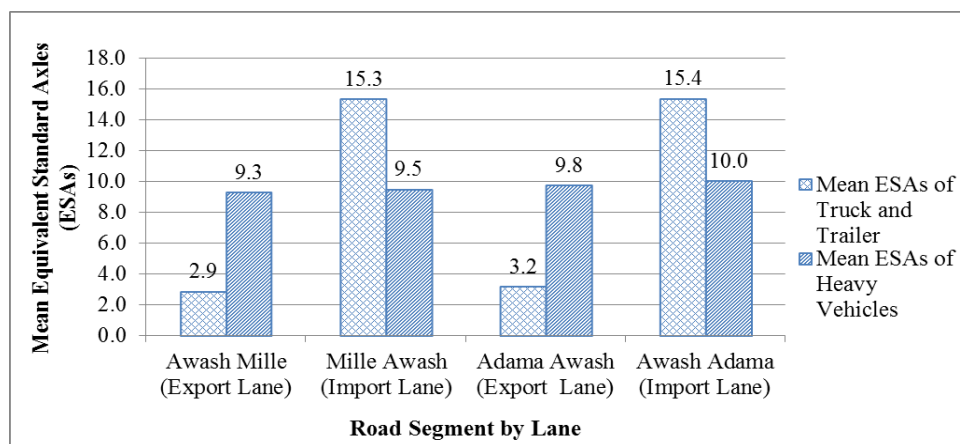
The summary of Mean ESAs per lane and road segment is shown in Figure 30.

Figure 30. Mean Equivalent Standard Axles (ESAs) per Lane and Road Segment

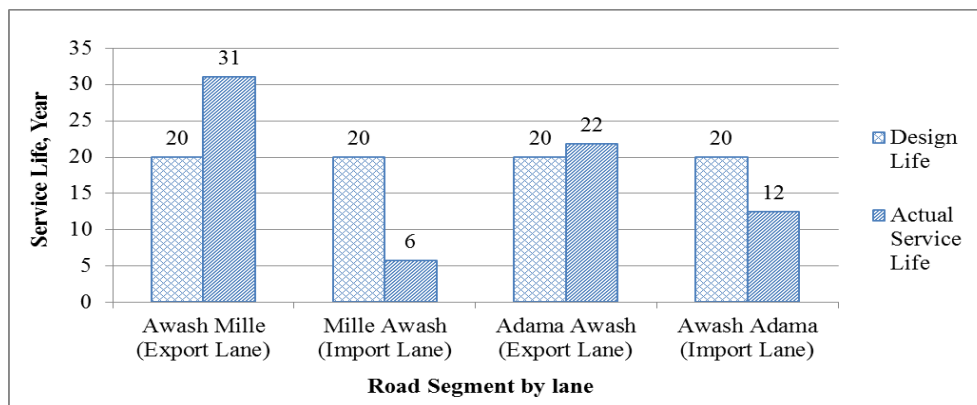
The summary of actual pavement service life per lane and road segment is shown in Figure 31.

Figure 31. Design Vs Actual Service Life of Pavement per Lane and Road Segment

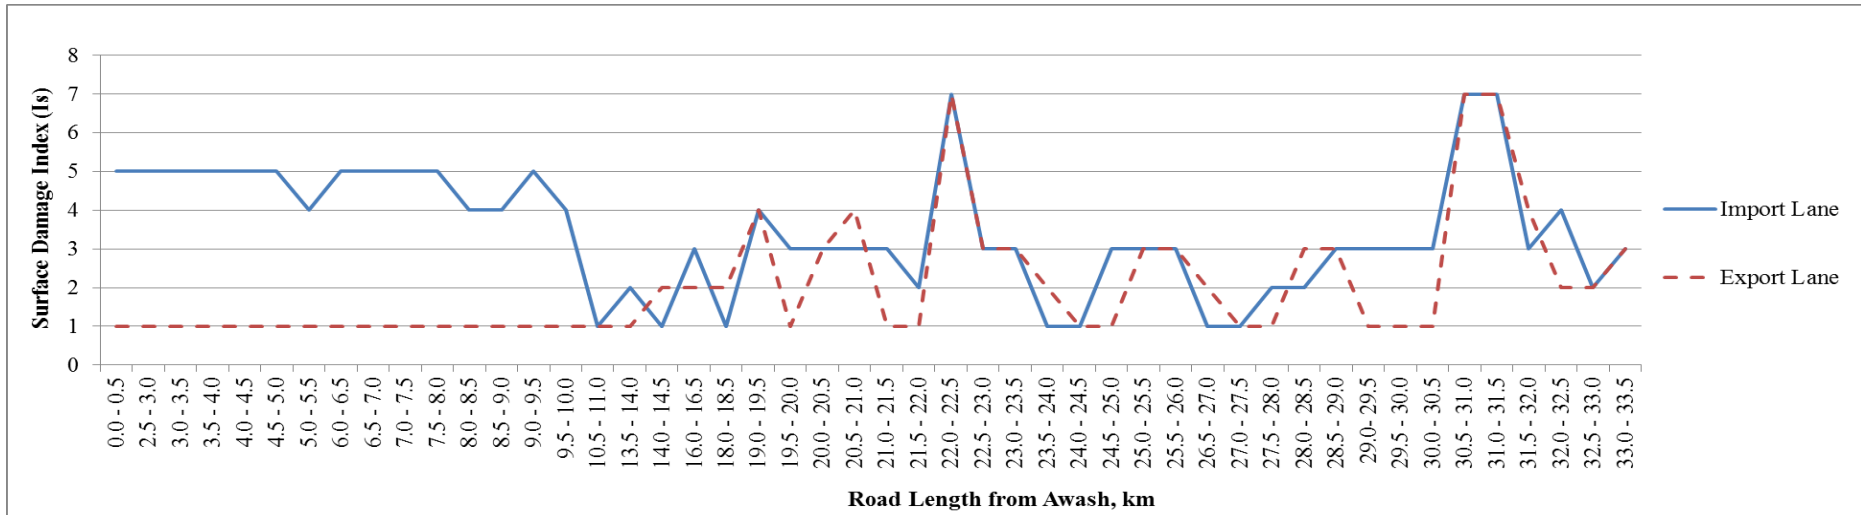
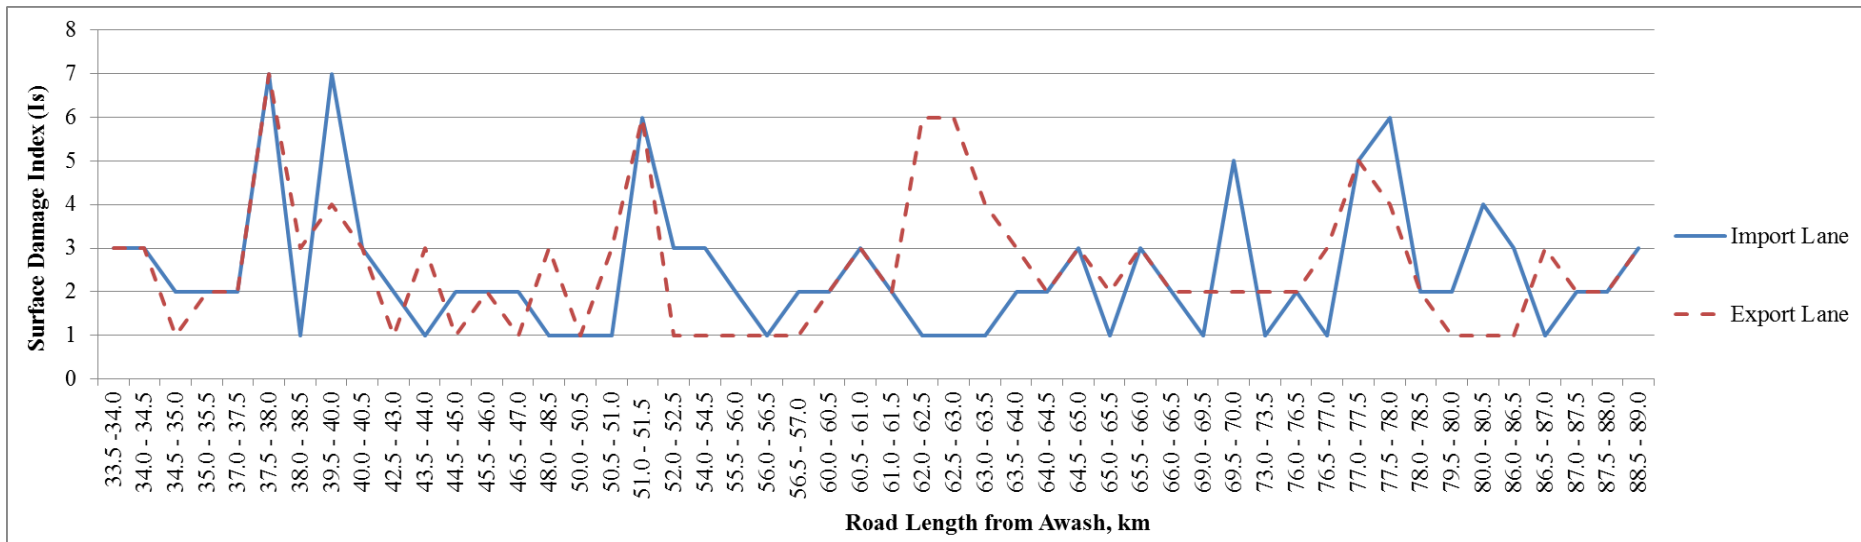
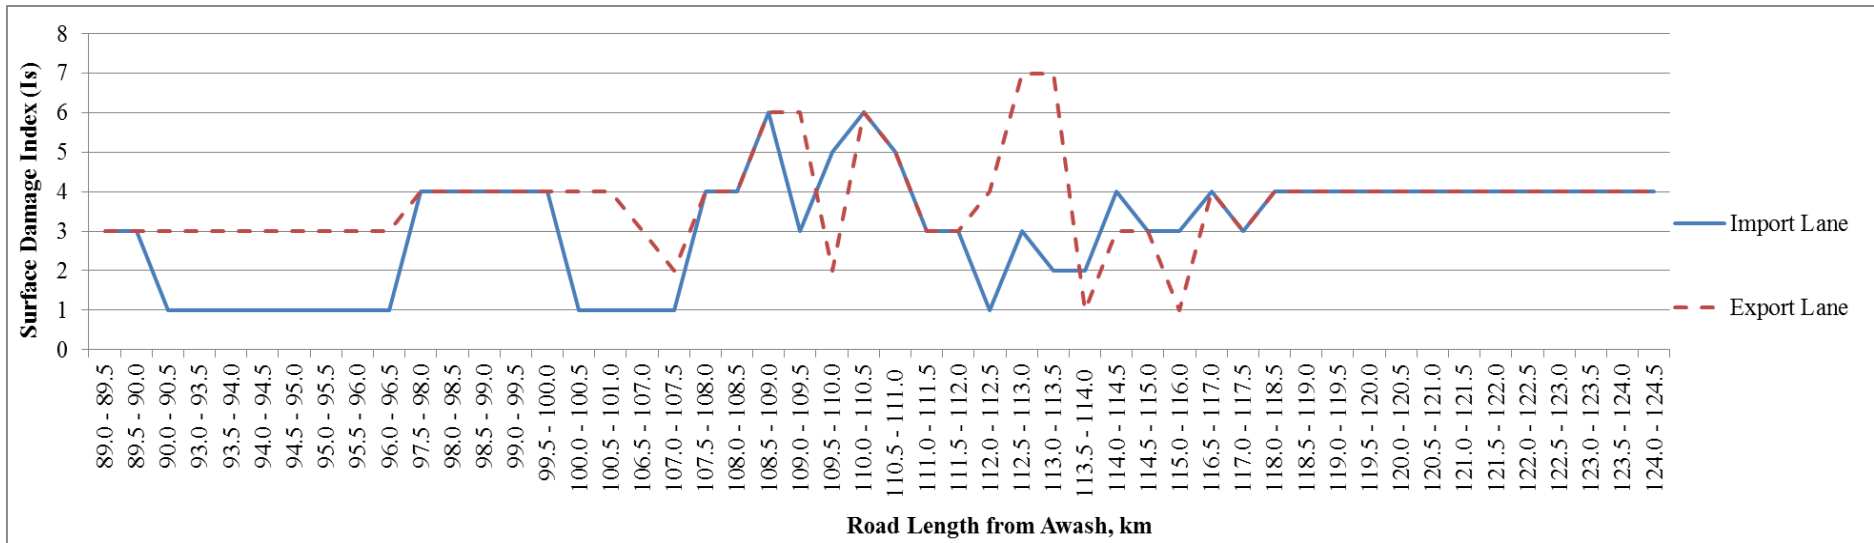
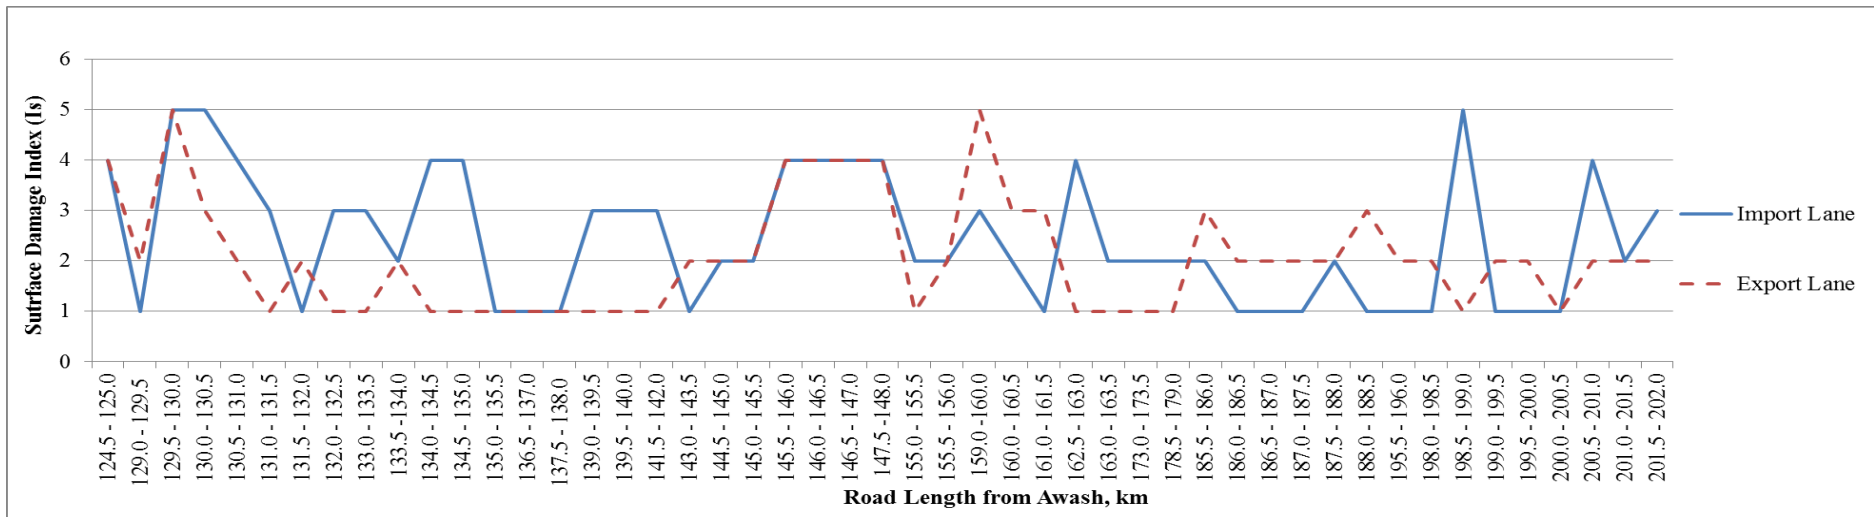
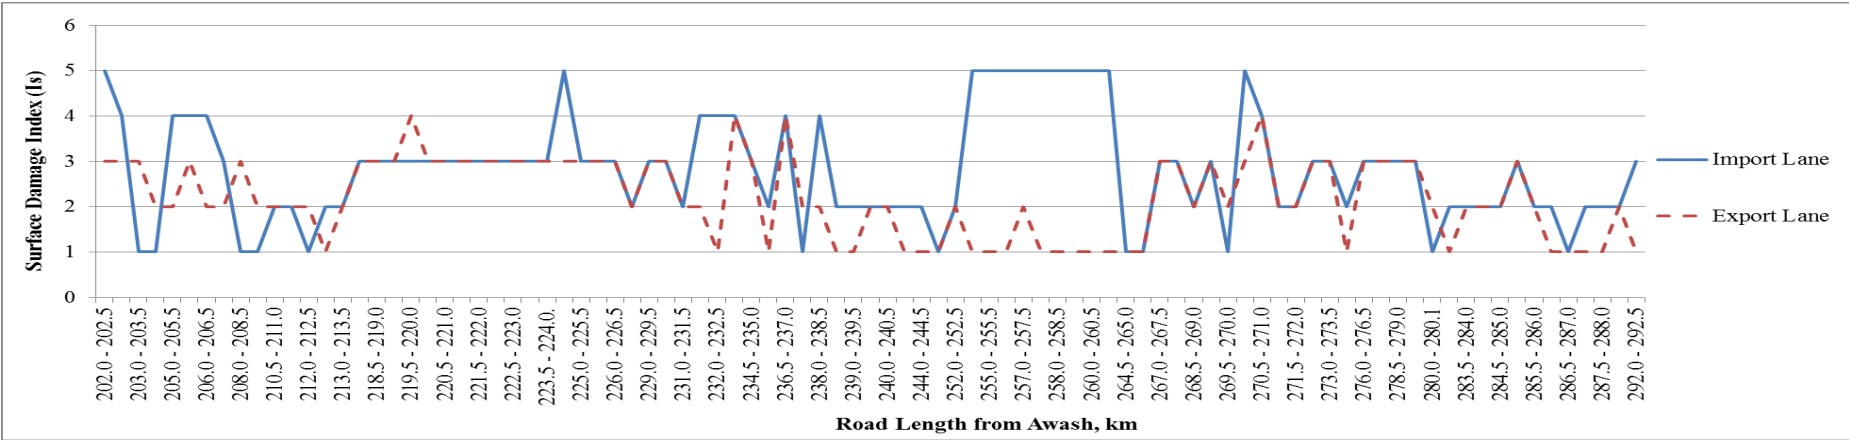
To identify the pavement surface condition along Awash-Mille road segment, surface damage index per 500m road length for both lanes was calculated separately and the result is shown in Figure 32-36. The result of surface damage index 1 and 2 represent good surface condition, 3 and 4 represent intermediate (fair) surface condition and; 5, 6, and 7, represent very poor surface condition.

Figure 32. Surface Damage Index per lane (0.0-33.5 km)

Figure 33. Surface Damage Index per lane (33.5-89.0 km)

Figure 34. Surface Damage Index per lane (89.0 – 124.5 km)

Figure 35. Surface Damage Index per lane (124.5 – 202.0 km)

Figure 36. Surface Damage Index per lane (202.0-292.5 km)

The above result from calculation of surface damage index shows that 55% of the import lane and 45% of the export lane along Awash-Mille road segment is under fair and poor surface condition. The summary of pavement surface condition is shown in Figure 37.

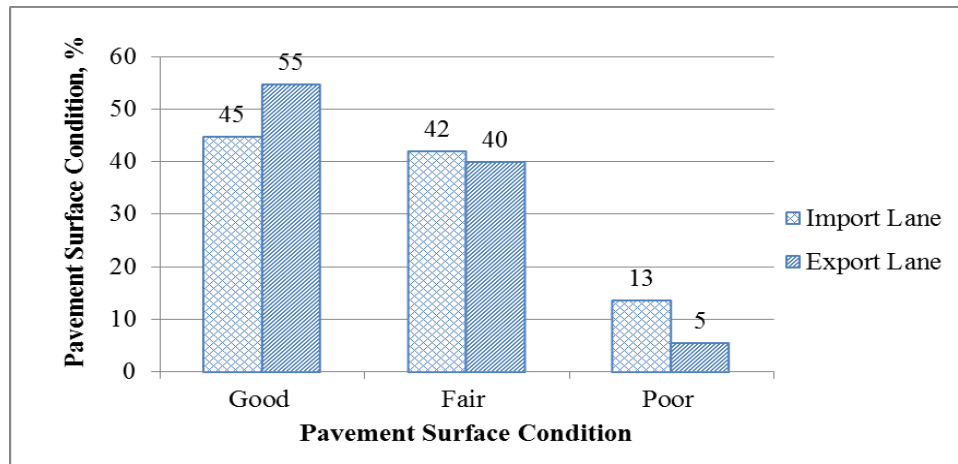
Figure 37. Pavement Surface Condition per Lane

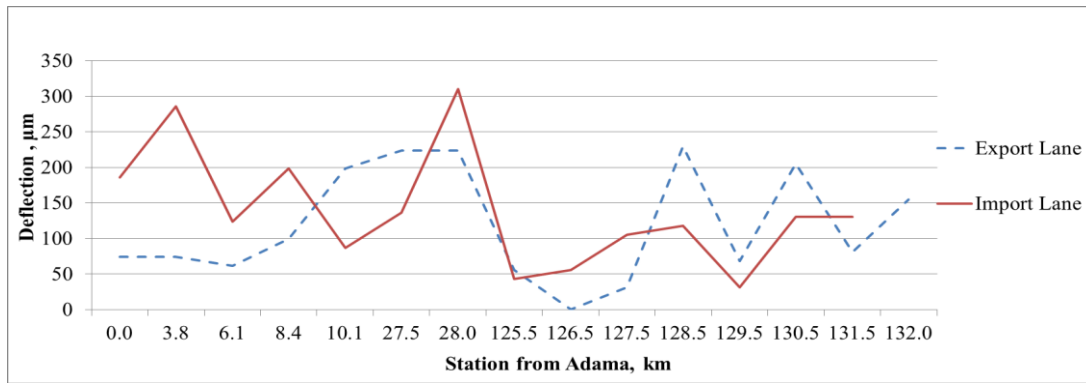
Even if, the structural condition of the selected road is sound, the deflection between the two lanes and along the road segment is not uniform as shown in Figure 38.

Figure 38. Deflection difference between import and export lanes

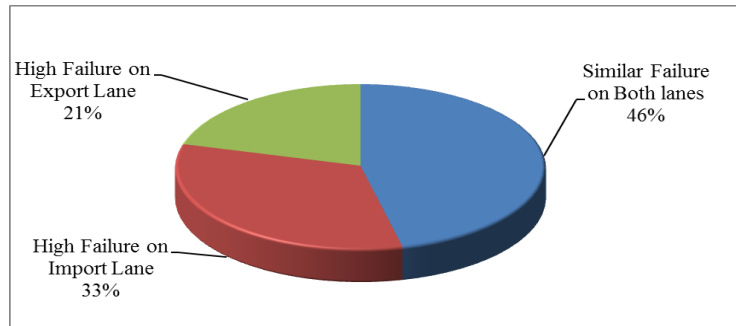
To identify the cause of failures easily, the common and different locations of failures was separated based on the result from surface damage index. The summary of failure location from 144.5 Km damaged section is shown in Figure 39.

Figure 39. Identified Pavement Failure Location per Lane

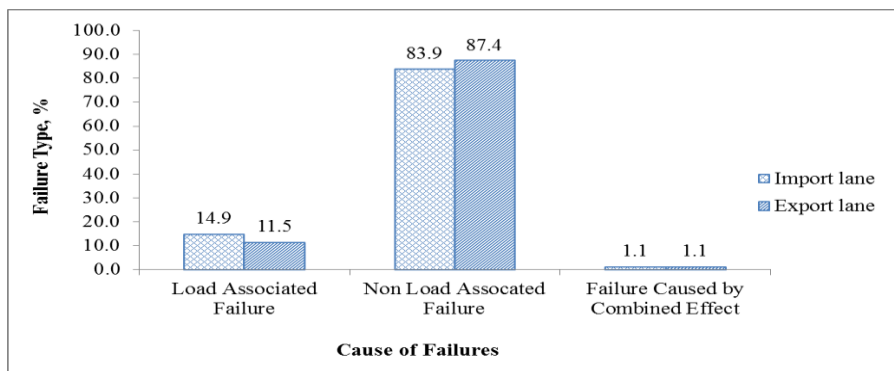
The summary of causes of failures related with traffic load under sections which have the same pavement surface condition on both lanes is shown in Figure 40.

Figure 40. Cause of Identified Failures per Lane, Case I

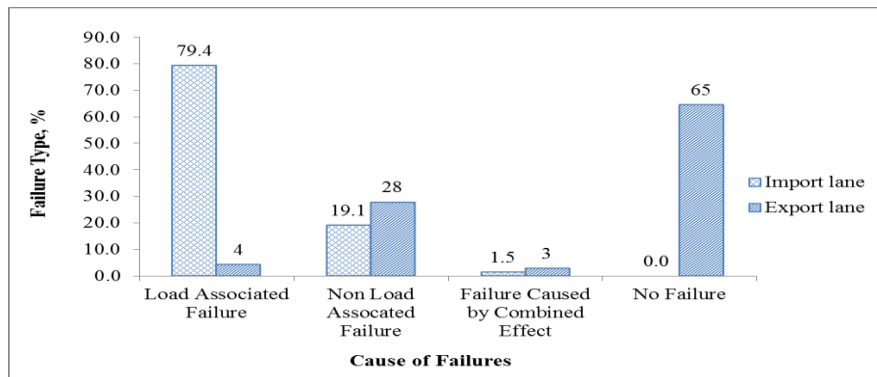
The summary of causes of failures related with traffic load under sections which have high failures on the import lane is shown in Figure 41.

Figure 41. Cause of Identified Failures per Lane, Case II

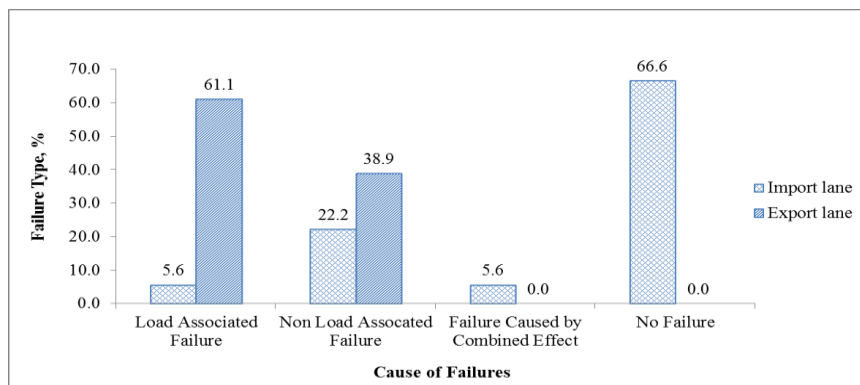
The summary of causes of failures related with traffic load under sections which have high failures on the export lane is shown in Figure 42.

Figure 42. Cause of Identified Failures per Lane, Case III

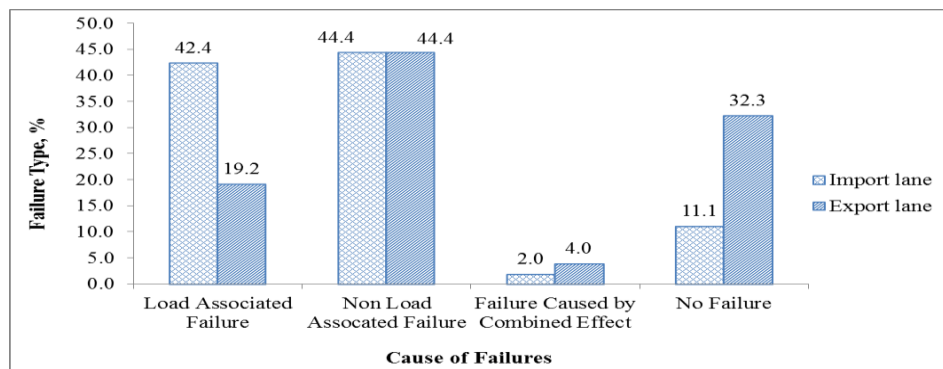
The summary of causes of failures related with traffic load under sections which have high failures on the export lane is shown in Figure 43.

Figure 43. Cause of Identified Failures per Lane, Case IV

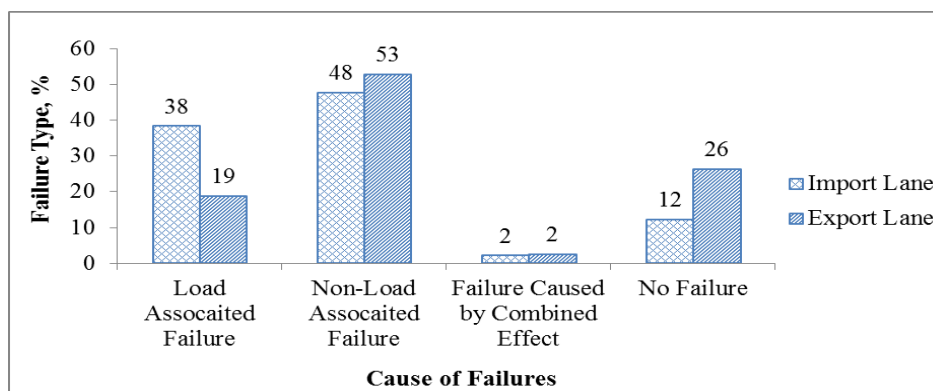
Figure 44. Summary of Cause of Existing Failures per Lane

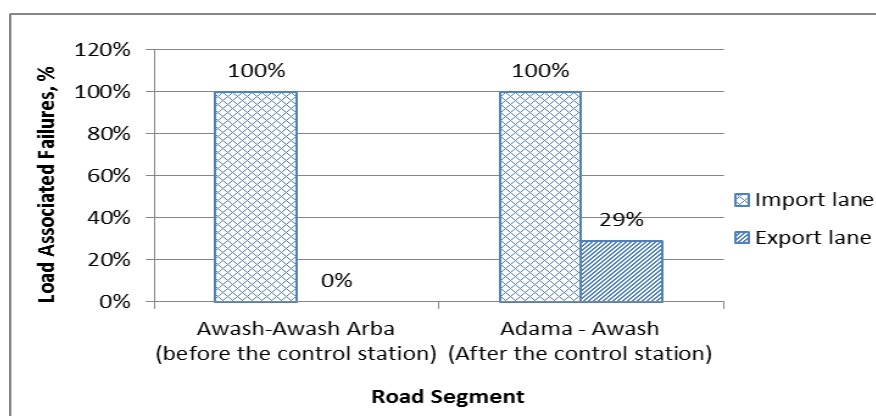
Figure 46. Summary of Load Associated Failure Per Road Segment

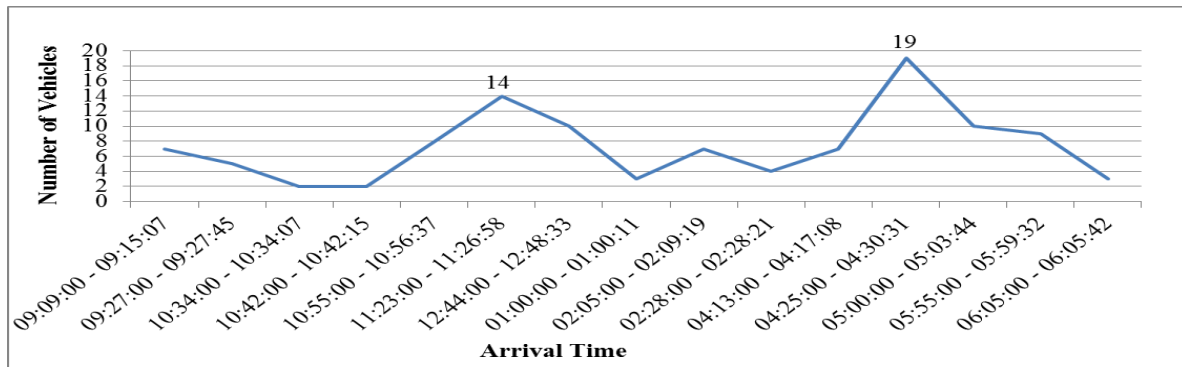
Figure 53. Queue Variation per time at Awash vehicle weight and size control station

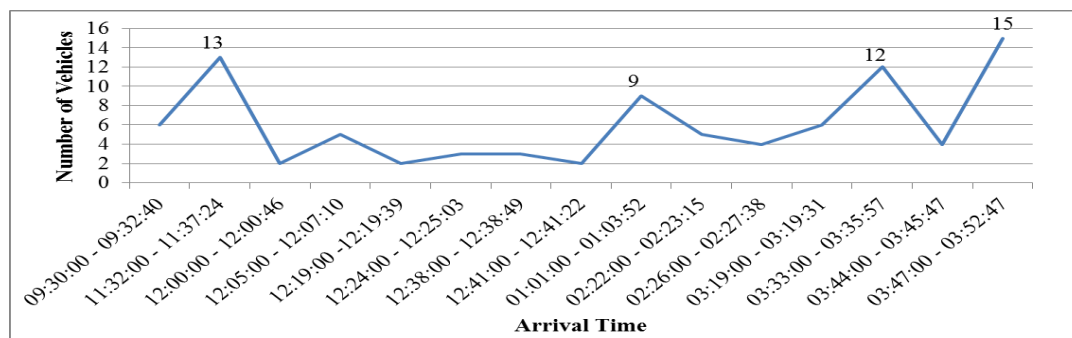
Figure 54. Queue Variation per time at Modjo vehicle weight and size control station
