INVESTIGATE THE CAUSES OF PAVEMENT DISTRESSES AND ITS REMEDIES

**(Case Study: Dessie - Hayk Road Segment)**

**A Thesis in Road and Transport Engineering**

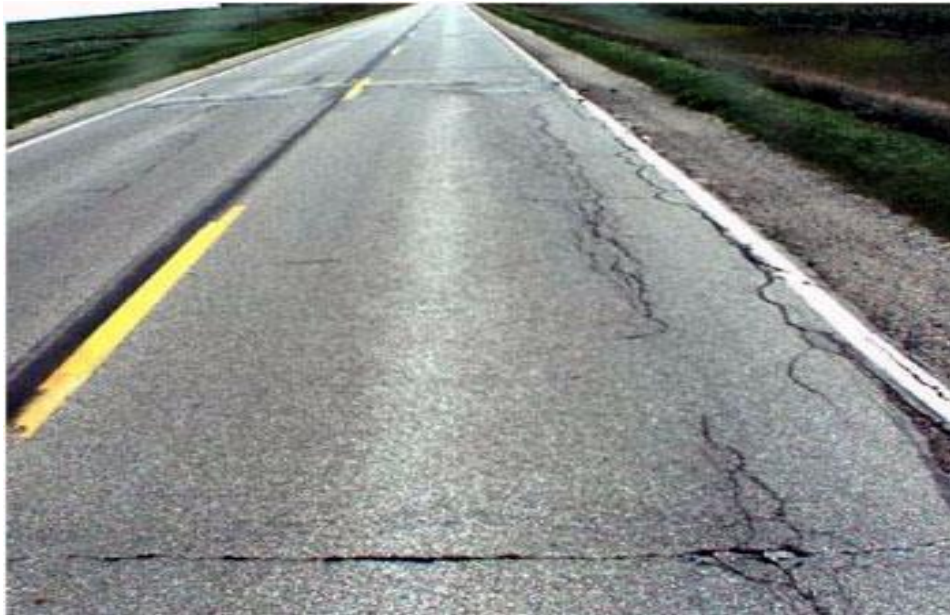
caused by failure of the surface layer or base due to repeated traffic loading (fatigue). Eventually, the cracks lead to disintegration of the surface. The final result is potholes. Alligator cracking is usually associated with base or drainage problems. Small areas may be fixed with a patch or area repair. Larger areas require reclamation or reconstruction. Drainage must be carefully examined in all cases. Figure 2.1 below illustrates fatigue cracking in flexible pavement.

**Figure 2.1** Fatigue Cracking in Flexible Pavement

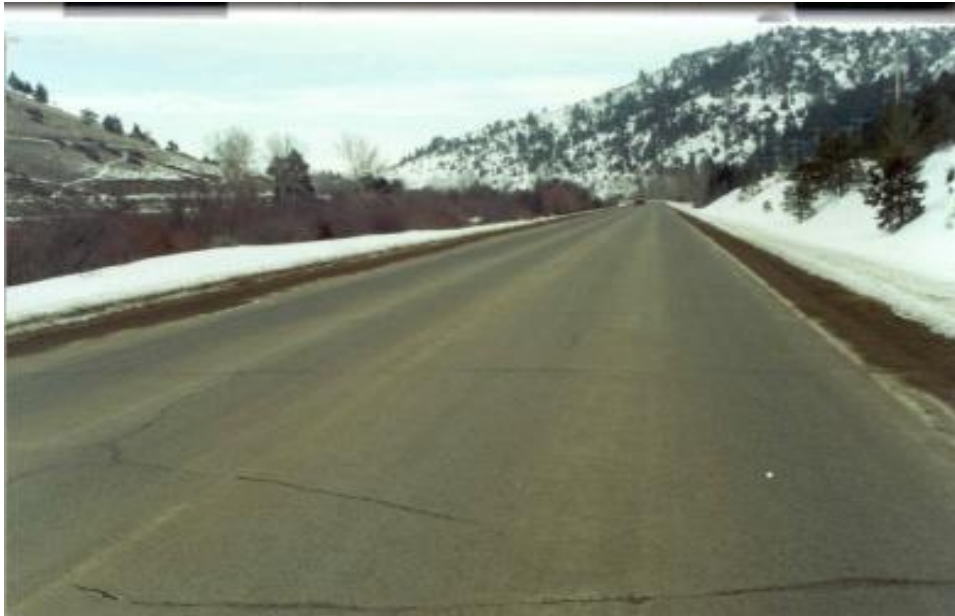
issues can lead to low-temperature cracking if the asphalt cement is too hard. Figure 2.2 below shows transverse cracking in flexible pavement.

**Figure 2.2** Transverse Cracking in Flexible Pavement

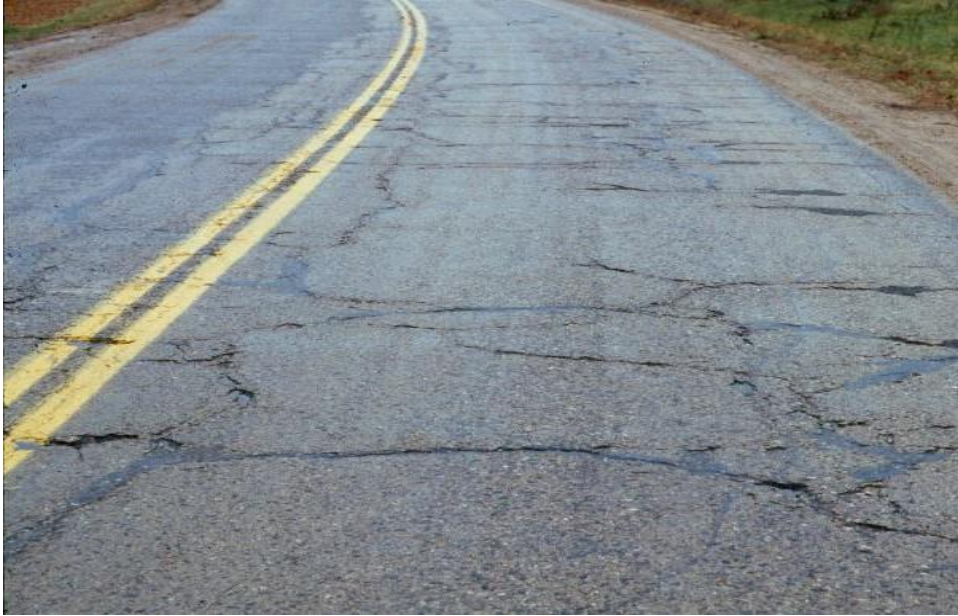
- **Block cracking:** Block cracking is an interconnected series of cracks that divides the pavement into irregular pieces. This is sometimes the result of transverse and longitudinal cracks intersecting. They can also be due to lack of compaction during construction. Low severity block cracking may be repaired by a thin wearing course. As the cracking gets more severe, overlays and recycling may be needed. If base problems are found, reclamation or reconstruction may be needed. Figure 2.3 below shows Block Cracking in Flexible Pavement.

**Figure 2.3** Block Cracking in Flexible Pavement

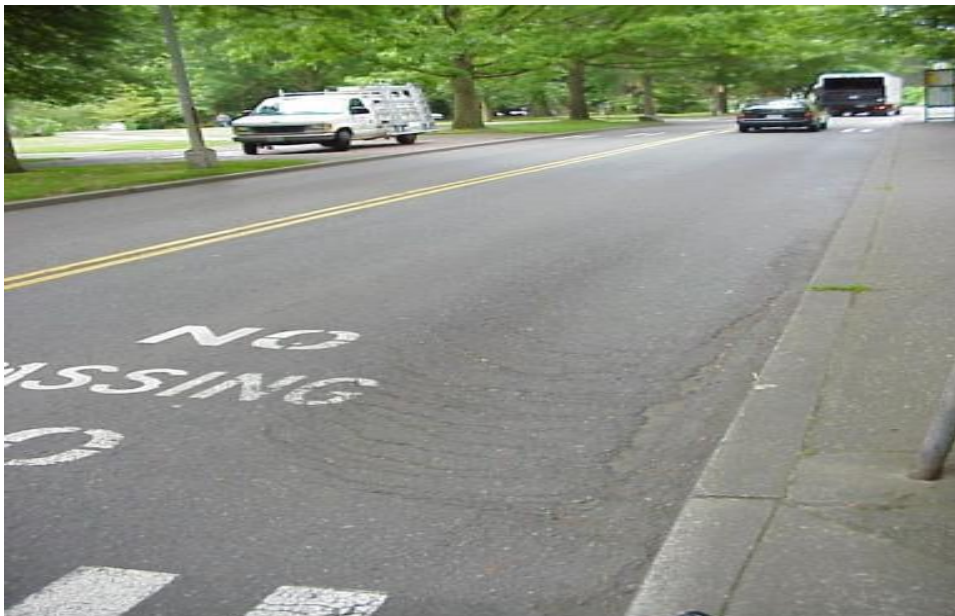
- **Slippage cracks:** These are half-moon shaped cracks with both ends pointed towards the oncoming vehicles. They are created by the horizontal forces from traffic. They are usually a result of poor bonding between the asphalt surface layer and the layer below. The lack of a tack coat is a prime factor in many cases. Repair requires removal of the slipped area and repaving. Be sure to use a tack coat in the new pavement. Figure 2.4 below shows slippage cracks in flexible pavement.

**Figure 2.4** Slippage Cracks in Flexible Pavement

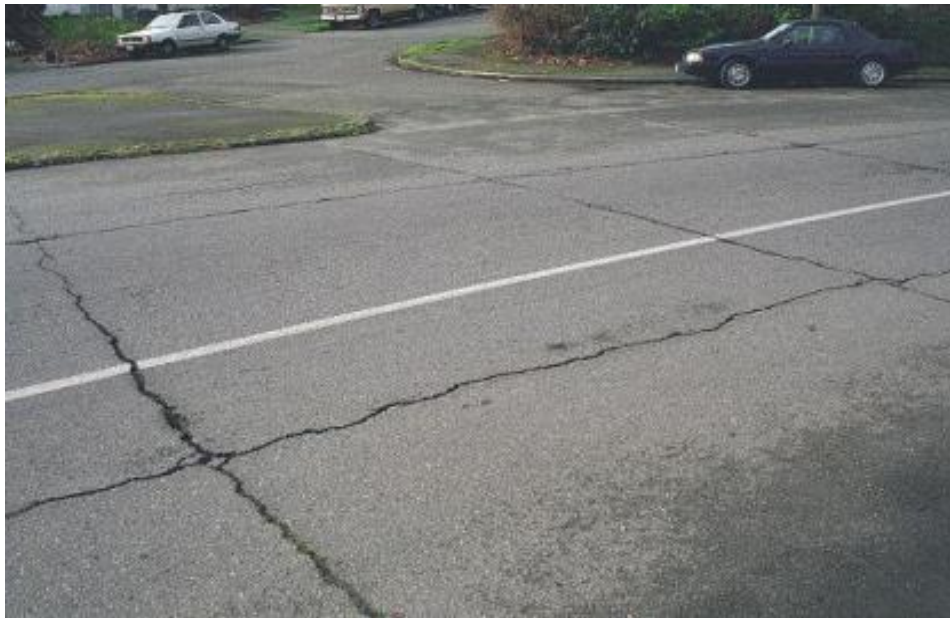
- **Reflective cracking:** Reflective cracking occurs when a pavement is overlaid with hot mix asphalt concrete and cracks reflect up through the new surface. It is called reflective cracking because it reflects the crack pattern of the pavement structure below. As expected from the name, reflective cracks are actually covered over cracks reappearing in the surface. They can be repaired in similar techniques to the other cracking noted above. Before placing any overlays or wearing courses, cracks should be properly repaired. Figure 2.5 shows Reflective Cracking in Flexible Pavement.

**Figure 2.5** Reflective Cracking in Flexible Pavement

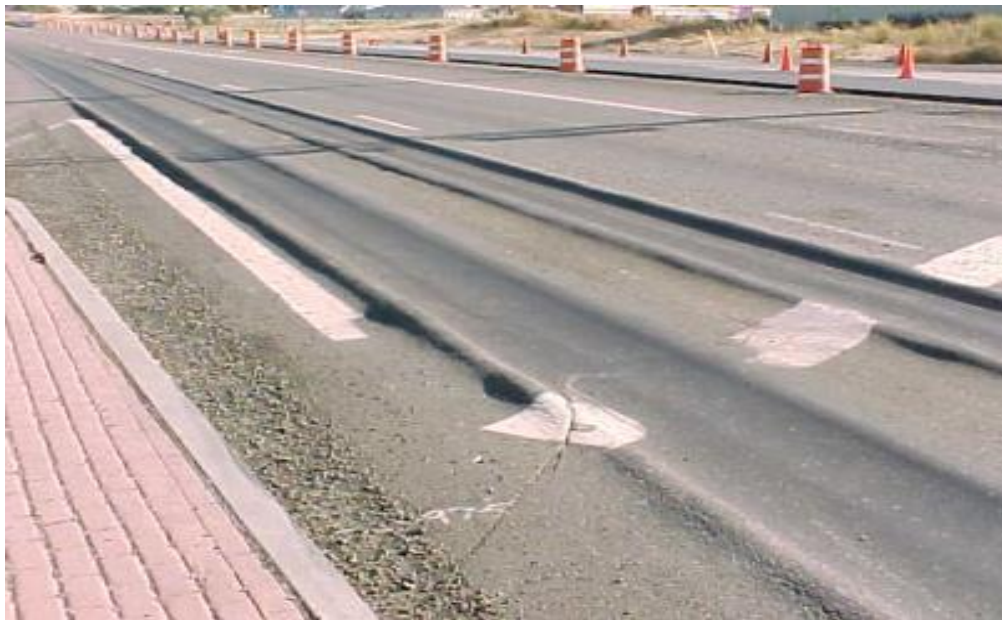
- **Rutting:** This is the displacement of pavement material that creates channels in the wheel path. Very severe rutting will actually hold water in the rut. Rutting is usually a failure in one or more layers in the pavement. The width of the rut is a sign of which layer has failed. A very narrow rut is usually a surface failure, while a wide one is indicative of a sub-grade failure. Inadequate compaction can lead to rutting. Deeper ruts may be shimmed with a truing and leveling course, with an overlay placed over the shim. If the surface asphalt is unstable, recycling of the surface may be the best option. If the problem is in the sub-grade layer, reclamation or reconstruction may be needed. Figure 2.6 below shows rutting type surface deformation in flexible pavement.

**Figure 2.6** Rutting Type Surface Deformation in Flexible Pavement

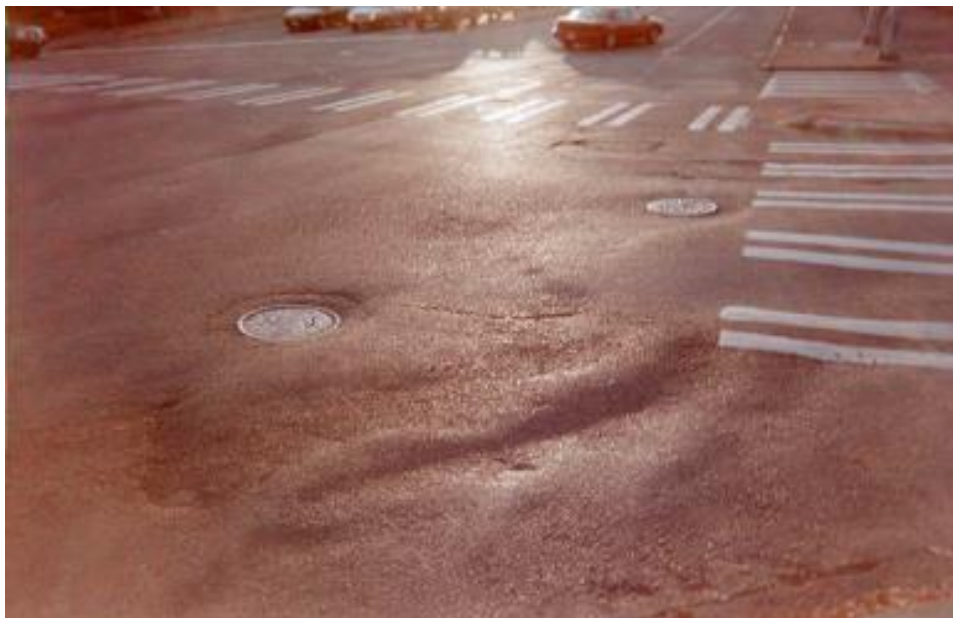
- **Shoving:** Shoving is also a form of plastic movement in the asphalt concrete surface layer that creates a localized bulging of the pavement. Locations and causes of shoving are similar to those for corrugations. Repair minor shoving by removing and replacing. For large areas, milling the surface may be required, followed by an overlay. Figure 2.7 below shows shoving type surface deformation in flexible pavement.

**Figure 2.7** Shoving Type Surface Deformation in Flexible Pavement

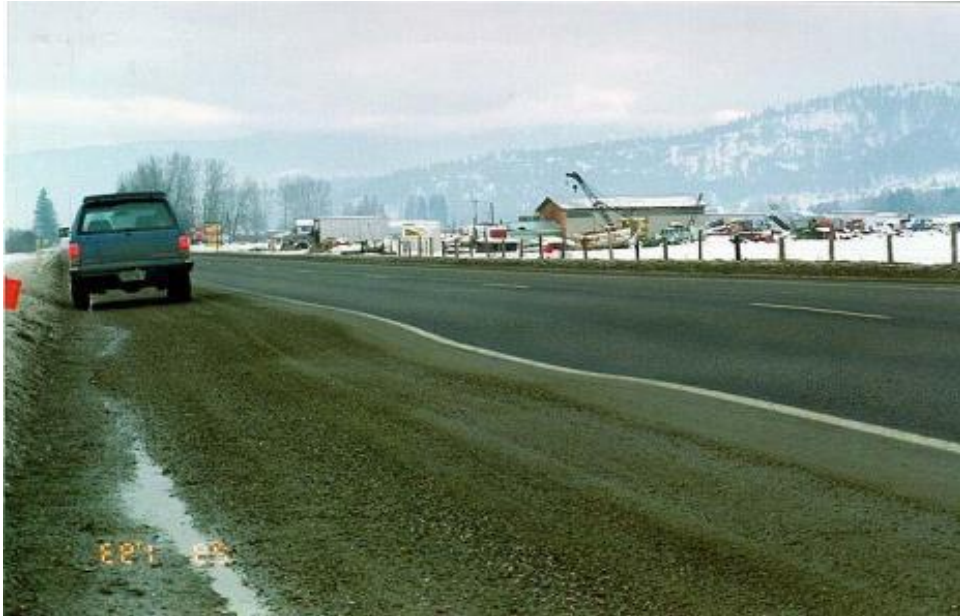
- **Depressions:** Depressions are small, localized bowl-shaped areas that may include cracking. Depressions cause roughness, are hazard to motorists, and allow water to collect. Depressions are typically caused by localized consolidation or movement of the supporting layers beneath the surface course due to instability. Repair by excavating and rebuilding the localized depressions. Reconstruction is required for extensive depressions. Figure 2.8 below shows depressions type surface deformation in flexible pavement.

**Figure 2.8** Depressions Type Surface Deformation in Flexible Pavement

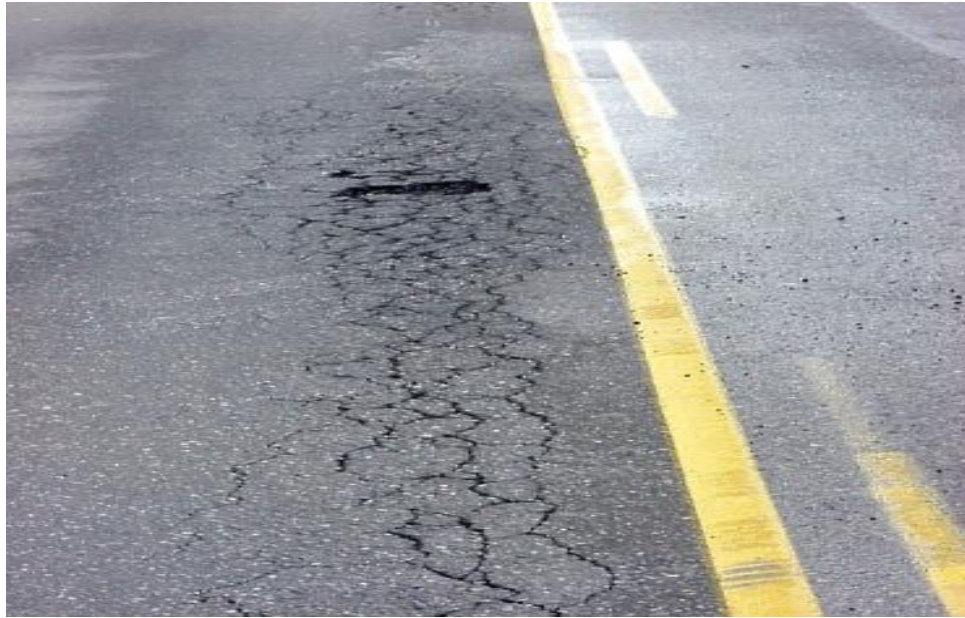
root cause was repaired before development of the pothole. Repair by excavating and rebuilding. Area repairs or reconstruction may be required for extensive potholes. Figure 2.9 below shows potholes type disintegration in flexible pavement.

**Figure 2.9 Potholes Type Disintegration in Flexible Pavement.**

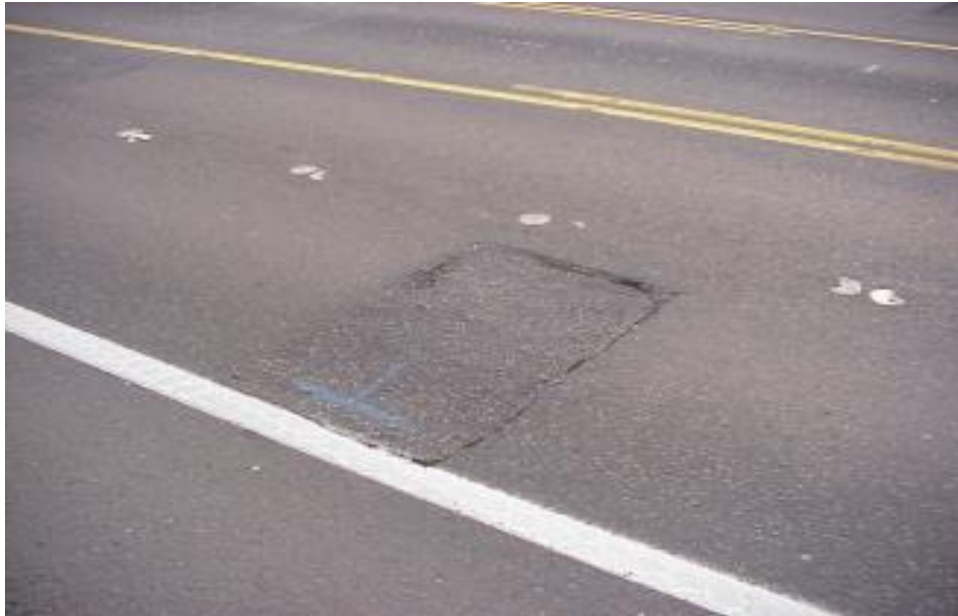
- Patches: This is defined as a portion of the pavement that has been removed and replaced. Patches are usually used to repair defects in a pavement or to cover a utility trench. Patch failure can lead to a more widespread failure of the surrounding pavement. Some people do not consider patches as a pavement defect. While this should be true for high quality patches as is done in a semipermanent patch, the throw and roll patch is just a cover. The underlying cause is still under the pothole. To repair a patch, a semi-permanent patch should be placed. Extensive potholes may lead to area repairs or reclamation. Reconstruction is only needed if base problems are the root source of the potholes. Figure 2.10 below shows patches type disintegration in flexible pavement.

**Figure 2.10** Patches Type Disintegration in Flexible Pavement

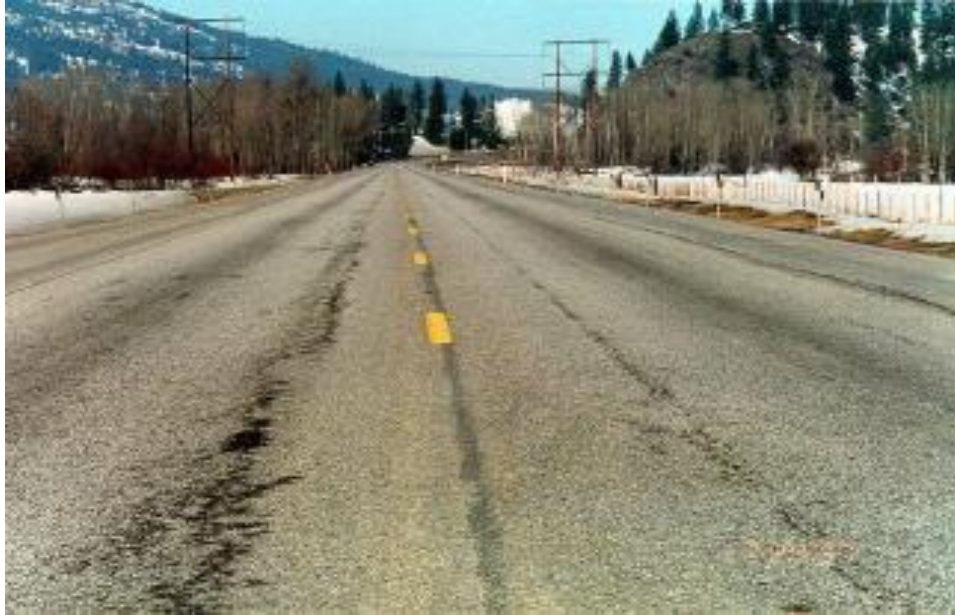
- **Raveling:** This is the loss of material from the pavement surface. It is a result of insufficient adhesion between the asphalt cement and the aggregate. Initially, fine aggregate breaks loose and leave small, rough patches in the surface of the pavement. As the disintegration continues, larger aggregate breaks loose, leaving rougher surfaces. Raveling can be accelerated by traffic and freezing weather. Some raveling in chip seals is due to improper construction technique. This can also lead to bleeding. Repair the problem with a wearing course or an overlay. Figure 2.11 below shows raveling type surface defects in flexible pavement.

**Figure 2.11** Raveling Type Surface Defects in Flexible Pavement

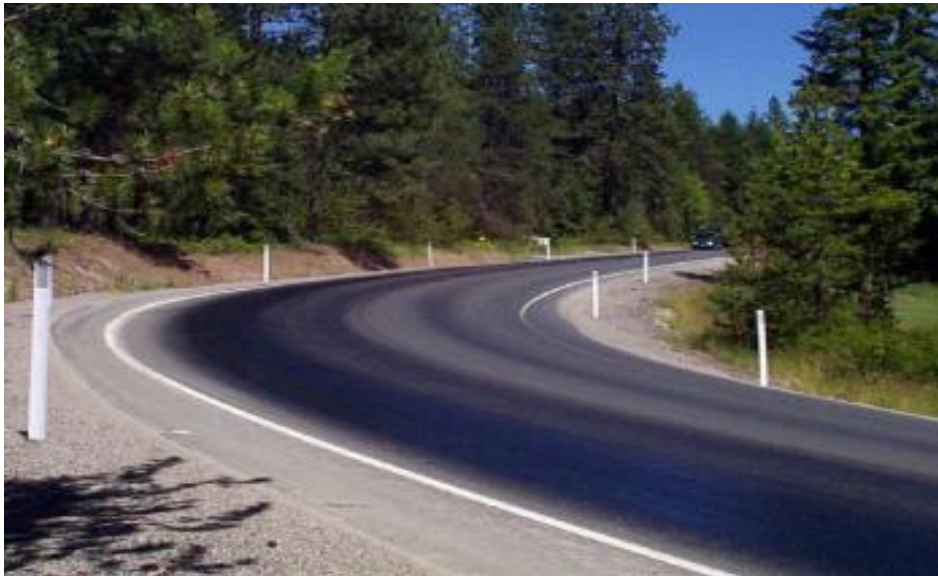
- **Bleeding:** This is defined as the presence of excess asphalt on the road surface which creates patches of asphalt cement. Excessive asphalt cement reduces the skid-resistance of a pavement, and it can become very slippery when wet, creating a safety hazard. This is caused by an excessively high asphalt cement content in the mix, using an asphalt cement with too low a viscosity (too flow able), too heavy a prime or tack coat, or an improperly applied seal coat. Bleeding occurs more often in hot weather when the asphalt cement is less viscous (more flow able). Figure 2.12 below shows bleeding type surface defects in flexible pavement.

**Figure 2.11** Bleeding Type Surface Defects in Flexible Pavement

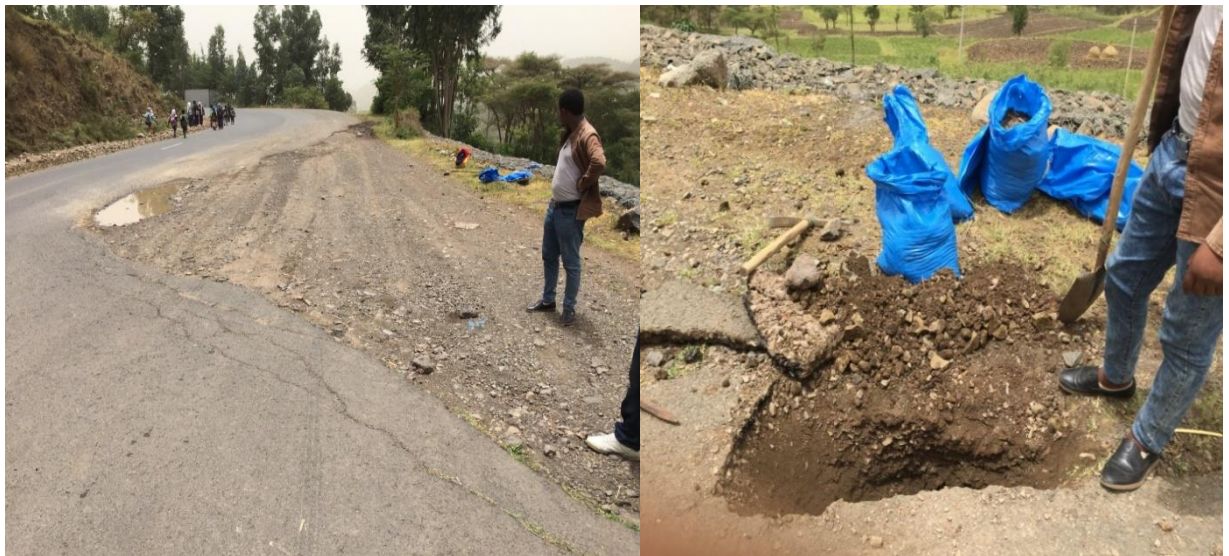
- Problem: Loose debris on the pavement, roughness, water collecting in the ravelled locations resulting in vehicle hydroplaning, loss of skid resistance.
- Possible Causes: Several including; loss of bond between aggregate particles and the asphalt binder as a result of a dust coating on the aggregate particles that forces the asphalt binder to bond with the dust rather than the aggregate. If fine particles are missing from the aggregate matrix, then the asphalt binder is only able to bind the remaining coarse particles at their relatively few contact points. Inadequate compaction during construction. High density is required to develop sufficient cohesion within the HMA (paving in cold weather). Mechanical dislodging by certain types of traffic (studded tyres or tracked vehicles). Figure 3.1 below shows representative raveling damage.

**Figure 3.1** Representative Raveling Damage and their Sample (19/09/2010E.C)

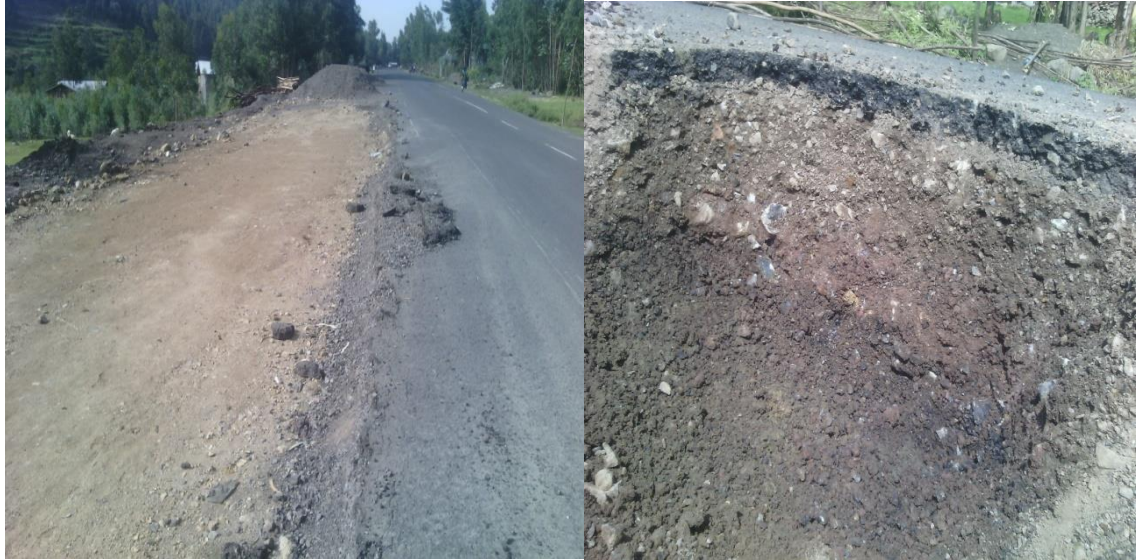
**Sample Three:** patching type of failure mode which is the dominant failure on Dessie - Hayk road segment. Its description, problem and possible cause are:

- Description: An area of pavement that has been replaced with new material to repair the existing pavement. A patch is considered a defect no matter how well it performs.
- Problem: Roughness.
- Possible Causes: Previous localized pavement deterioration that has been removed and patched. Figure 3.2 below shows representative patched damage.

**Figure 3.2** Representative Patched Damaged and their Samples (27/09/2010 E.C)

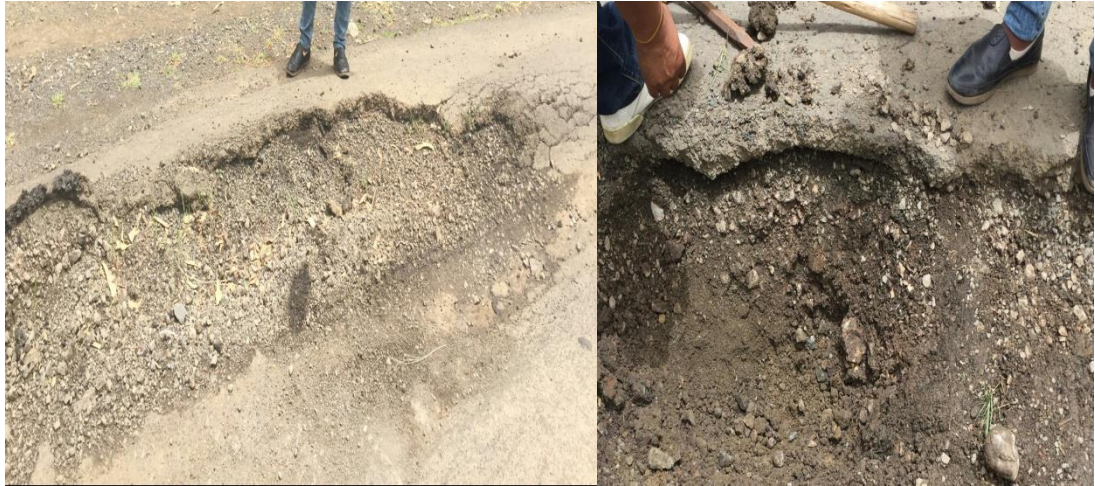
**Sample Four:** Corrugation types of failure mode which is also a failure on Dessie - Hayk road segment. Its description, problem and possible cause are:

- Description: A form of plastic movement typified by ripples (corrugation) or an abrupt wave across the pavement surface. The distortion is perpendicular to the traffic direction. Usually occurs at points where traffic starts and stops (corrugation) or where HMA abuts a rigid object.
- Problem: Roughness
- Possible Causes: usually caused by traffic action combined with: an unstable (i.e. low stiffness) HMA layer (caused by mix contamination, poor mix design, poor HMA manufacturing, or lack of aeration of liquid asphalt emulsions) and excessive moisture in the pavement structure. Figure 3.3 below shows representative corrugation type damaged.

**Figure 3.3** Representative Corrugation Type Damaged and their Samples (27/09/2010 E.C)

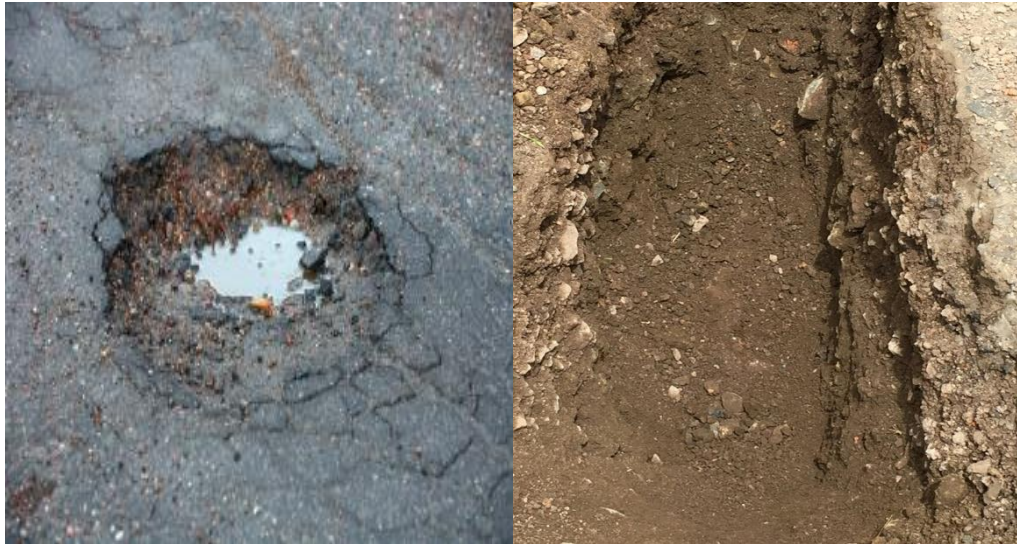
**Sample Five:** pothole types of failure mode which is a failure on Dessie - Hayk road segment. Its description, problem and possible cause are:

- **Description:** Small, bowl-shaped depressions in the pavement surface that penetrate all the way through the HMA layer down to the base course. They generally have sharp edges and vertical sides near the top of the hole. Potholes are most likely to occur on roads with thin HMA surfaces (25 to 50 mm) and seldom occur on roads with 100 mm or deeper HMA surfaces.
- **Problem:** Roughness (serious vehicular damage can result from driving across potholes at higher speeds), moisture infiltration.
- **Possible Causes:** Generally, potholes are the end result of alligator cracking. As alligator cracking becomes severe, the interconnected cracks create small chunks of pavement, which can be dislodged as vehicles drive over them. The remaining hole after the pavement chunk is dislodged is called a pothole. Figure 3.4 below shows representative potholes damage.

**Figure 3.4** Representative Potholes Damages and their Samples (27/09/2010 E.C)
