**Evaluation of Factors Responsible For Landslides
In Haro Village And It's Surrounding, North Shoa of Oromia,
Central Ethiopia**

***In Partial Fullfillment of the requirements for the Degree of
Masters in Geo-Hazards and Disaster Management***

July 2007

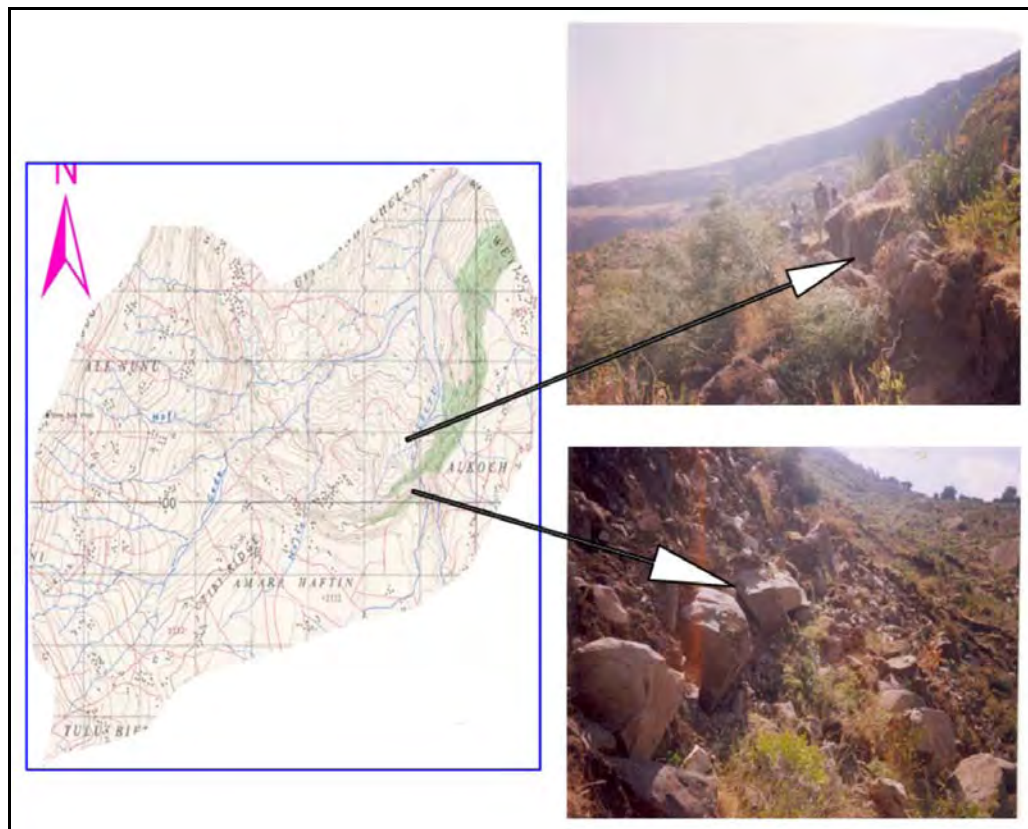
Fig. 1.2 Most of the study area shows such kind of instabilities

Most of the landslides in the area are characterized by shallow and deep seated process with different characteristics of slope materials. The slope materials include weathered, heterogeneous rocks and soil sediments. These landslides are defined as being of four types: falls, topples, slides and recent flows. Continuously moving rock fragment deposits comprise basalts on upper slopes; limestone & sandstone on the middle and lower slopes with different sizes and with angular, semi-angular and rounded in shapes.

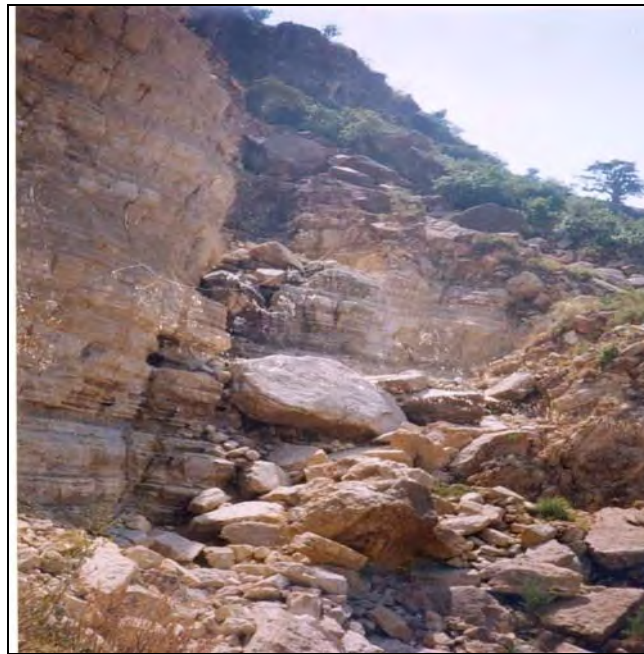
Fig. 1.3 Sample view of rock toppling and falling in the study area

Rock toppling and falling: Shallow topples and falls consisting of individual rock blocks become detached from a steep slope and descending by falling or rolling and coming to rest on gentler slopes in the village. Where these occur frequently, the

bedrock is usually moderately to highly fracture with parallel and intersecting discontinuities with slopes. Toppling and falling of rocks vary in size mostly as a single block, by fracturing and often occur rapidly without warning.

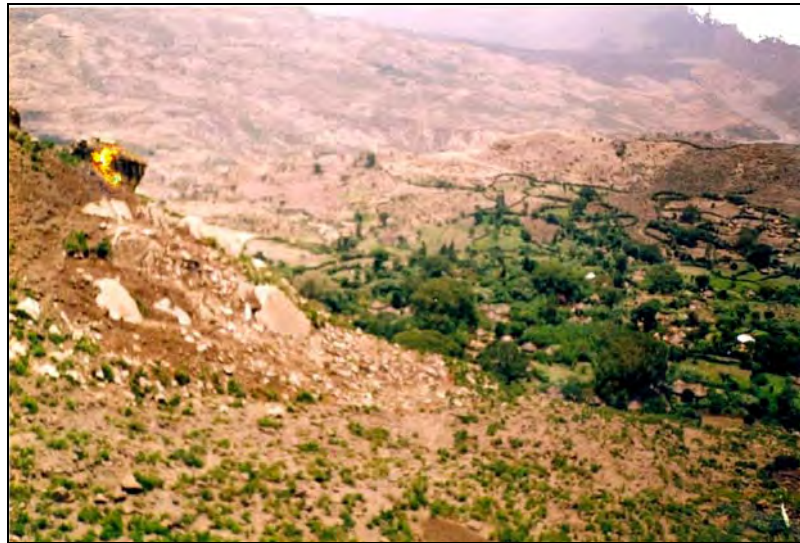
Fig. 1.4 Recent debris slides and flows in the study area

Debris slides: debris slides in the area are the recent phenomena and common on steep slopes especially during the periods of intense rainfall. They tend to be deep failures and occur along planes of weakness between looser, overlying colluvial soils and highly weathered rocks. Recently, these have started to move rapidly on steep slopes and slowly on gentle slopes then become developing into debris flows very near to the villages.

Debris flows: debris flows are also newly occurring phenomena on open slopes and in pre-existing falls and slides, which are predominantly loose, heterogeneous and initiated by tension cracks at the start of the failure. As these are newly creating

Geographical location of 9°55'00" to 9°59'4"N and 38°22'8" to 38°27'6"E and falls in the Gebre-Guracha top sheet N₀ 0938A₂, edited in 1982. The study area forms a part of the Abay basin from the northwest, Jema River valley from the North and Selale highlands from east and south with the total area of about 50km² (Figure 1.4).

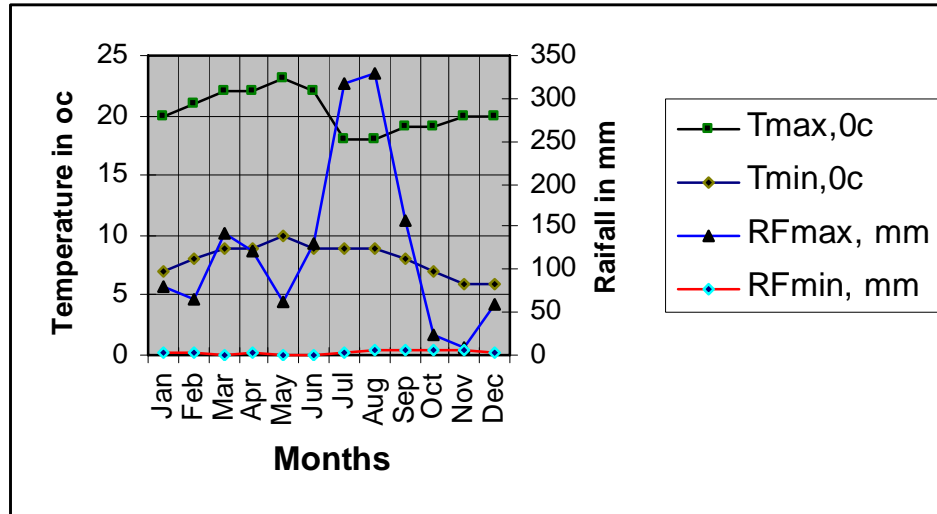
Fig. 1.6 Graph showing the mean monthly maximum and minimum Rainfall and Temperature of the study area

Temperature: The analysis of this data reveals that the daily average temperature varies between 7.0⁰C to 25.0⁰C and the annual average temperature ranges between 6.0⁰C to 23.0⁰C with a maximum daily temperature variation recorded during the low rainy season from December to May.

Rainfall: Rainfall is one of the most important factors in triggering landslide conditions. The consideration of this factor was based on the assumption that wet conditions are more likely to occur at areas of higher mean areal rainfall. The rainfall of the study area is characterized mostly by one long rainy season that last from June to September.

The Fitch rain guage station, approximately measured indicates that the average annual rainfall in a period of 20 years varies between 980 and 1530mm with maximum in 1996. The highest average monthly rainfall value of 330mm is mostly in August and the average minimum monthly rainfall of even less than 6mm was recorded in the month of November over the 20 years (table 1.2). The average annual number of rainy days varies from 93 to 126 days per year. In this period, heavy intermittent rains, lasting from few minutes to several hours even the whole day is common.

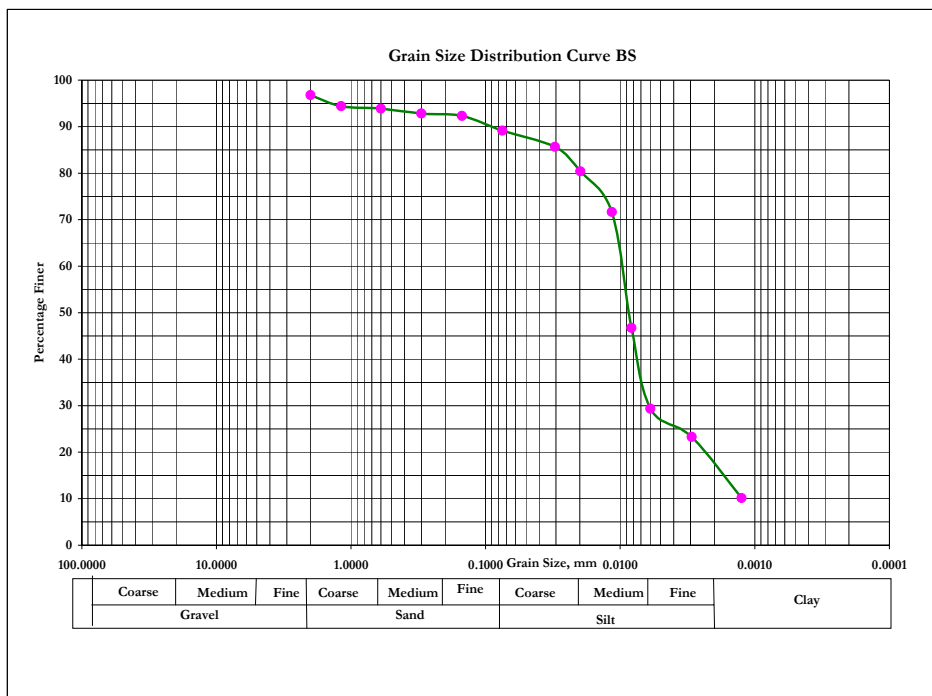
Fig. 5.1: Gradation curve of the soils present in the study area

However, the values for cohesion and angle of shearing resistance have been taken from USBR, 1982 standard table based on the index properties of soil (Bowles, 1996). According to this, the cohesion, angle of friction and the dry unit weight of the soils for the area are found to be 5.0lb/in², 33.9⁰ and 115.6lb/ft³, respectively that used in stability analysis for the unstable slopes.
