Effects of Earthquake in Hosanna Town Selected buildings

Aklilu Tadesse

A thesis submitted to the school of graduate Studies of Addis Ababa University

Master of Science in Civil Engineering

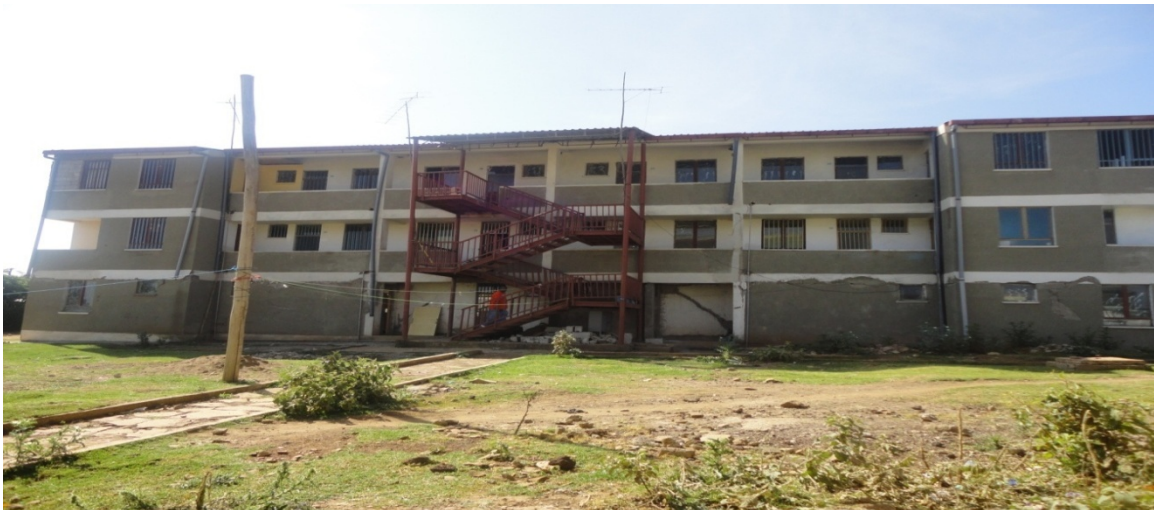
**Figure 4.1: Front view of case study 01**

It is a two storey reinforced concrete residential building which is built in 2008 and has a floor of 286.2m<sup>2</sup>. It is located seismic zone 4.

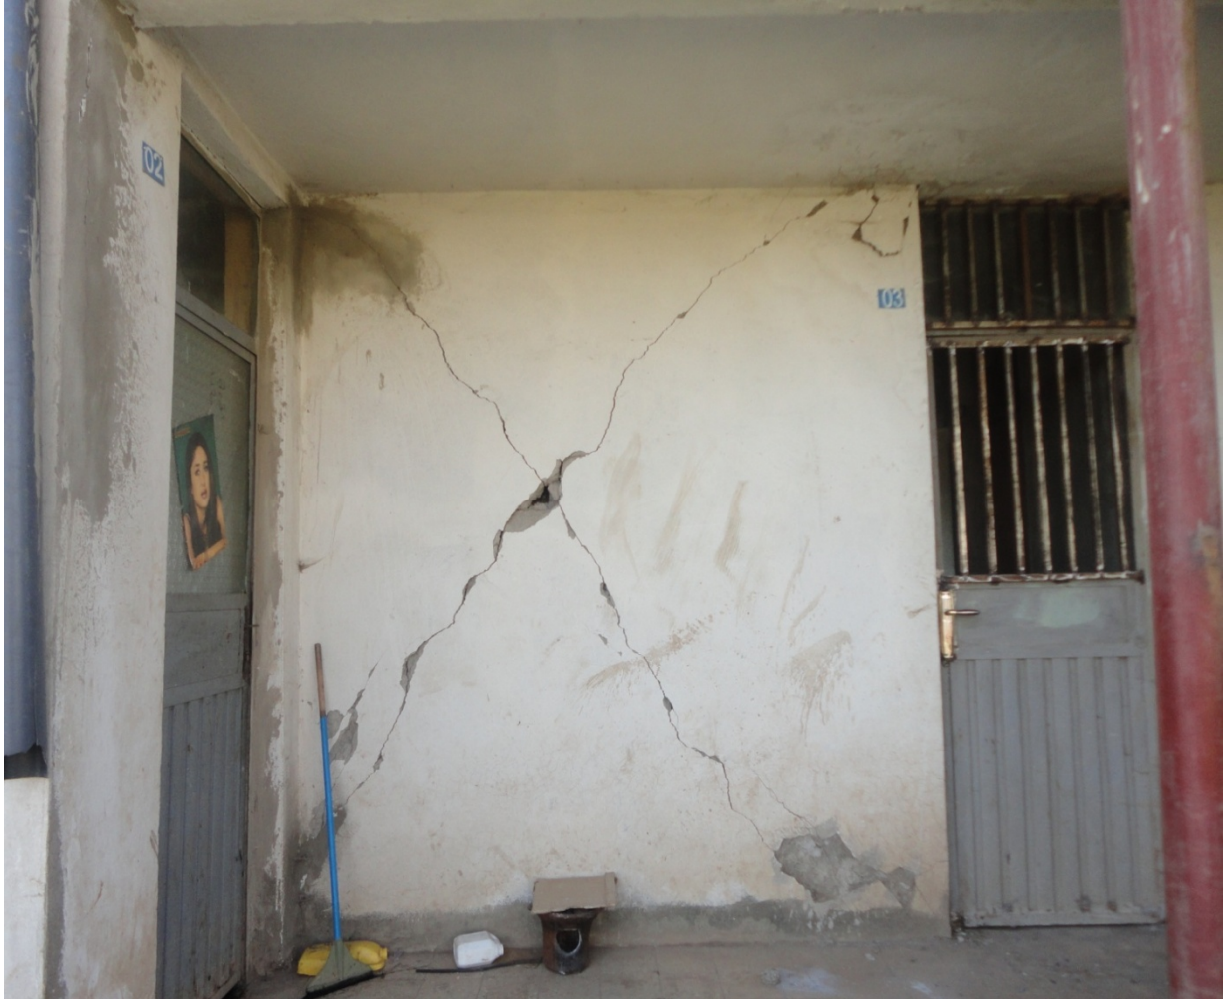
**Figure 4:2: Case study 01 actual damage photo**

Damage incurred: Diagonal cracks on the wall between axis B and C in the exterior wall of the ground floor, which is on the longer direction. The damages are large and extensive, but not all of them penetrate the whole wall thickness of the wall. Moderate non-structural damage and categorized on damage grade2 as per EMS-98.

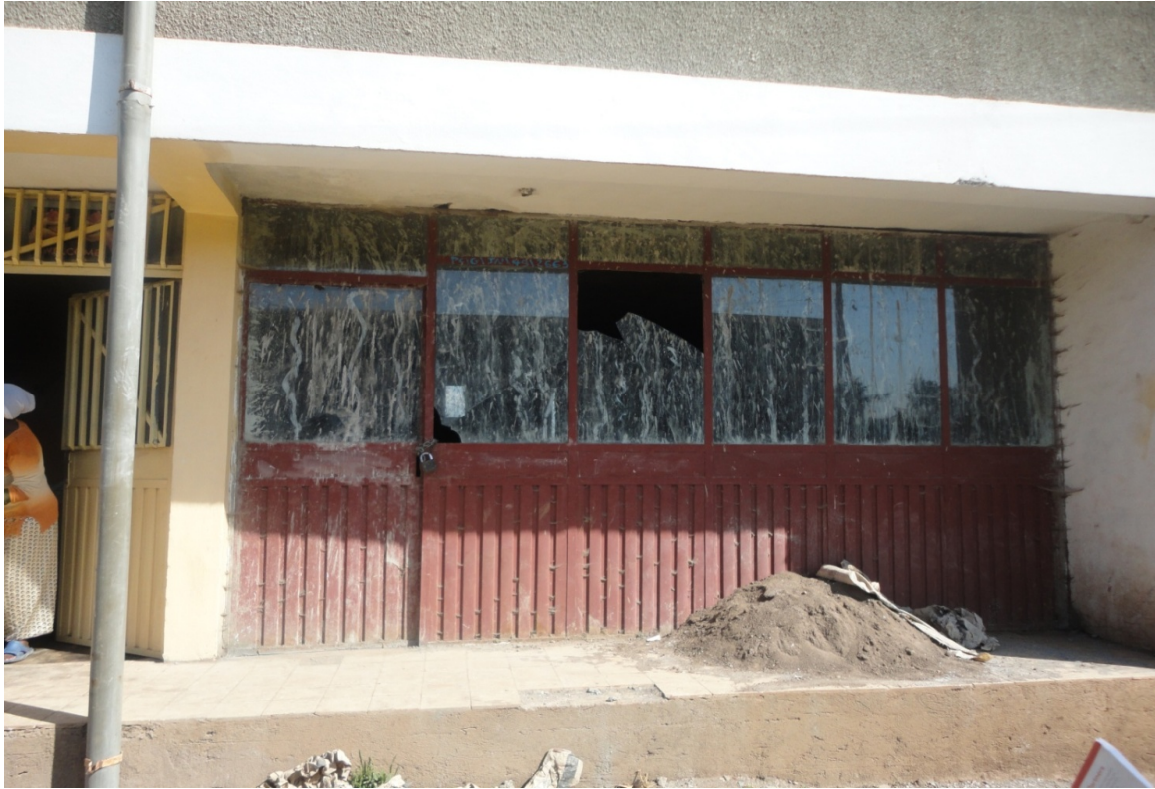
**Figure 4:3: Case study01 damage view photo**

Damage incurred: damage of window glass on the ground floor. Slight non structural damage categorized grade1 as per EMS-98.

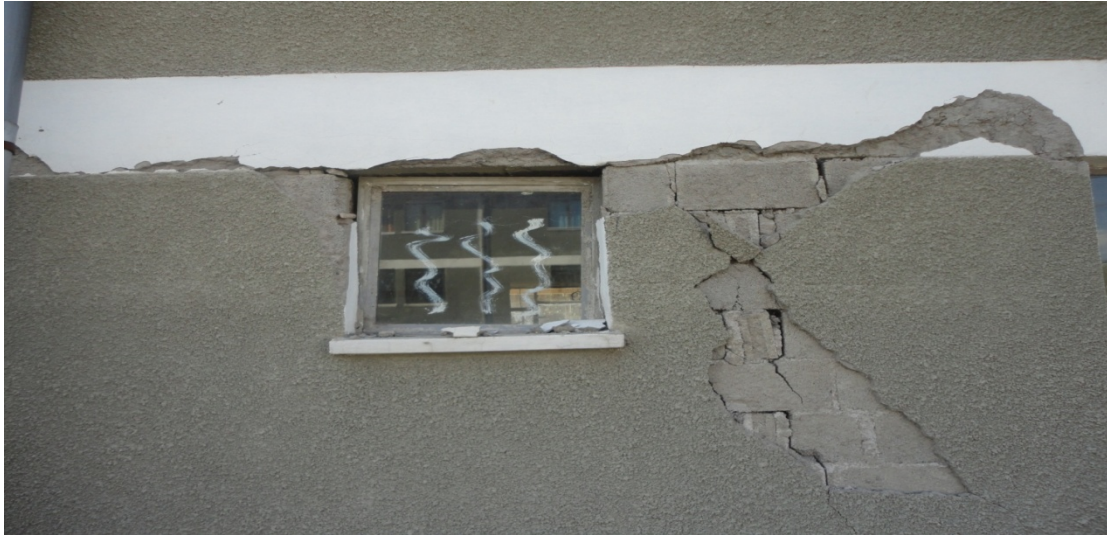
**Figure 4:4: Case Study 01 actual damage photo**

Damage incurred: removal of clear cover from floor beam and bulging of window frame.

Moderate non- structural damage categorized grade 2 as per EMS-98.

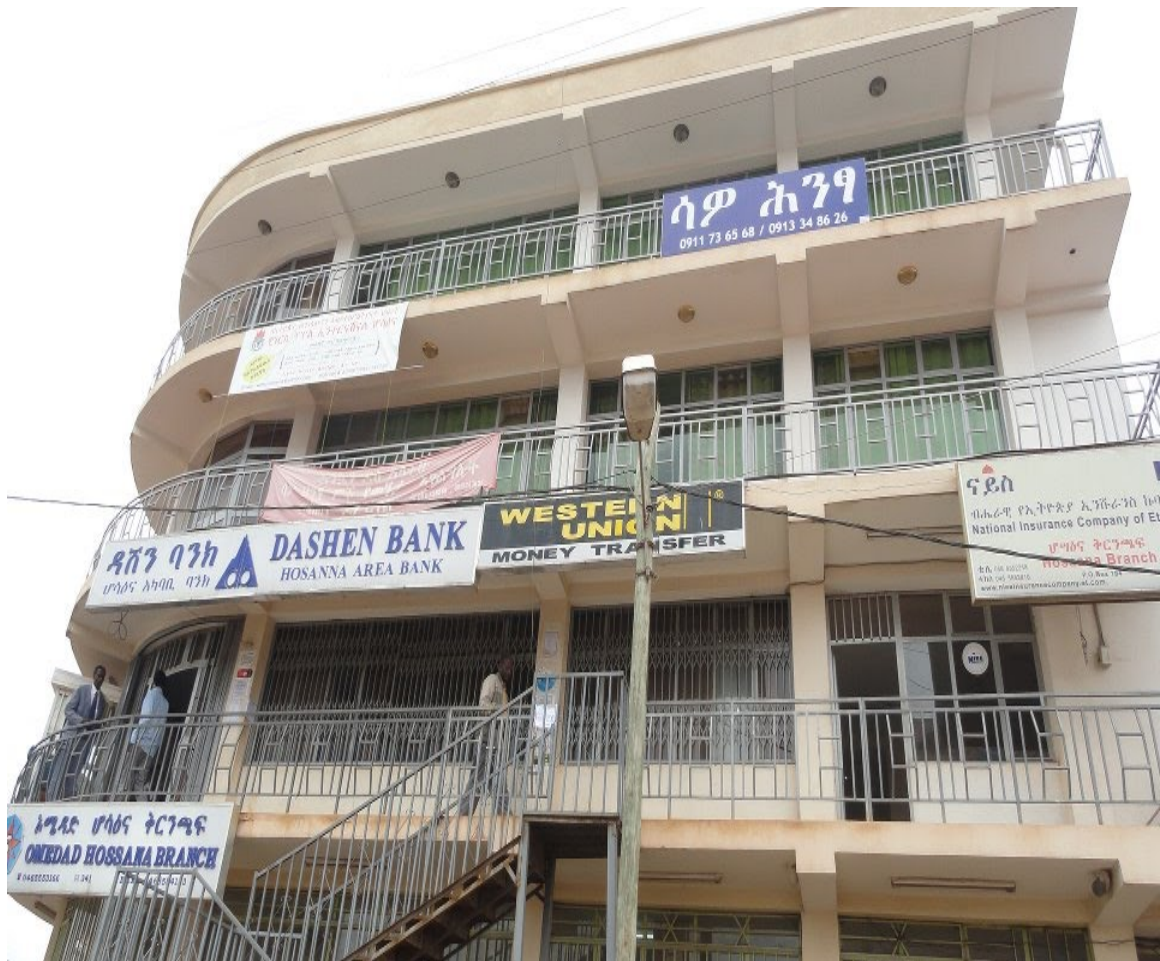
Figure 4:5: Case study 02 Front view

It is a three storey reinforced concrete mixed use building which is built in 2009 and has a floor of 380m<sup>2</sup>. This structure is occupied by the commercial units at ground story and by residential units at the upper three stories. It is located seismic zone 4.

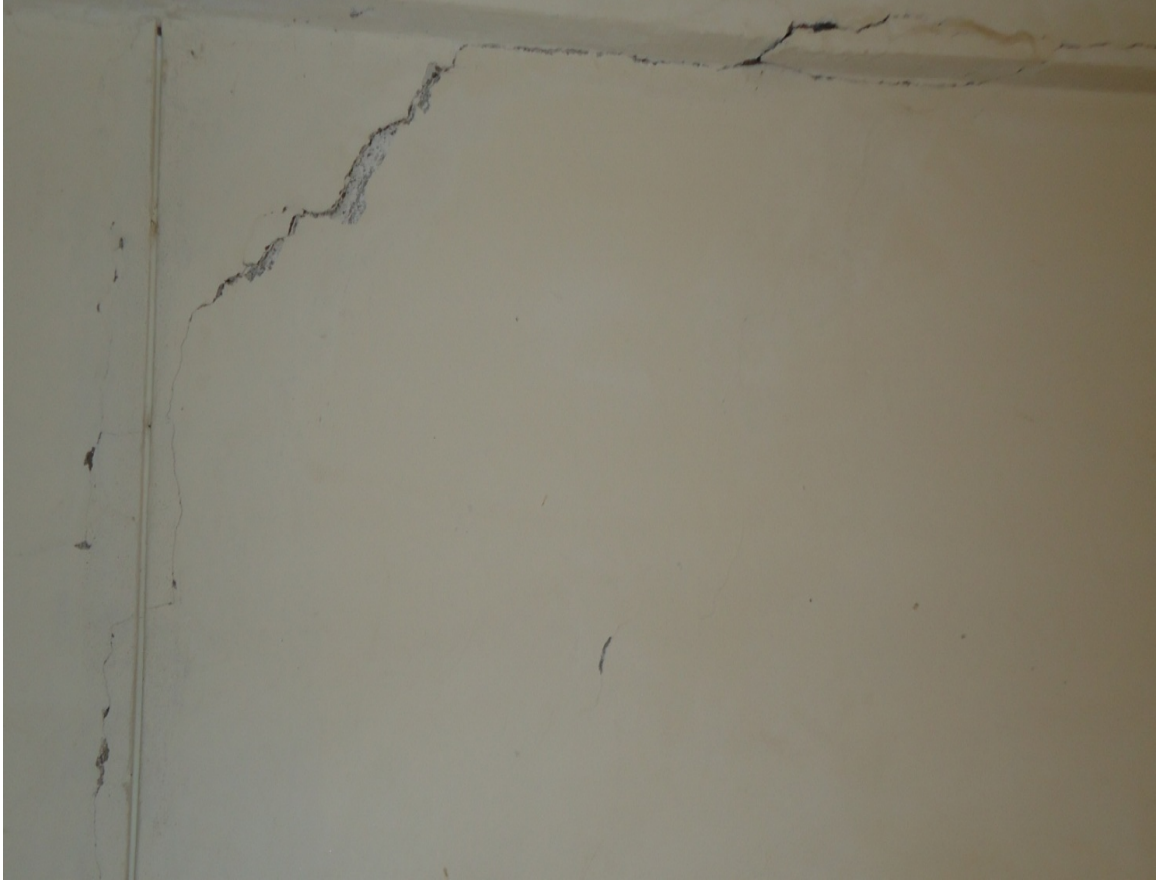
**Figure 4:6: Case study02 actual damage view photo**

Damage incurred: from the ground to third floor cracks on infill wall and partial removal of clear cover on floor beam. Slight non -structural damage categorized grade1 as per EMS-98.

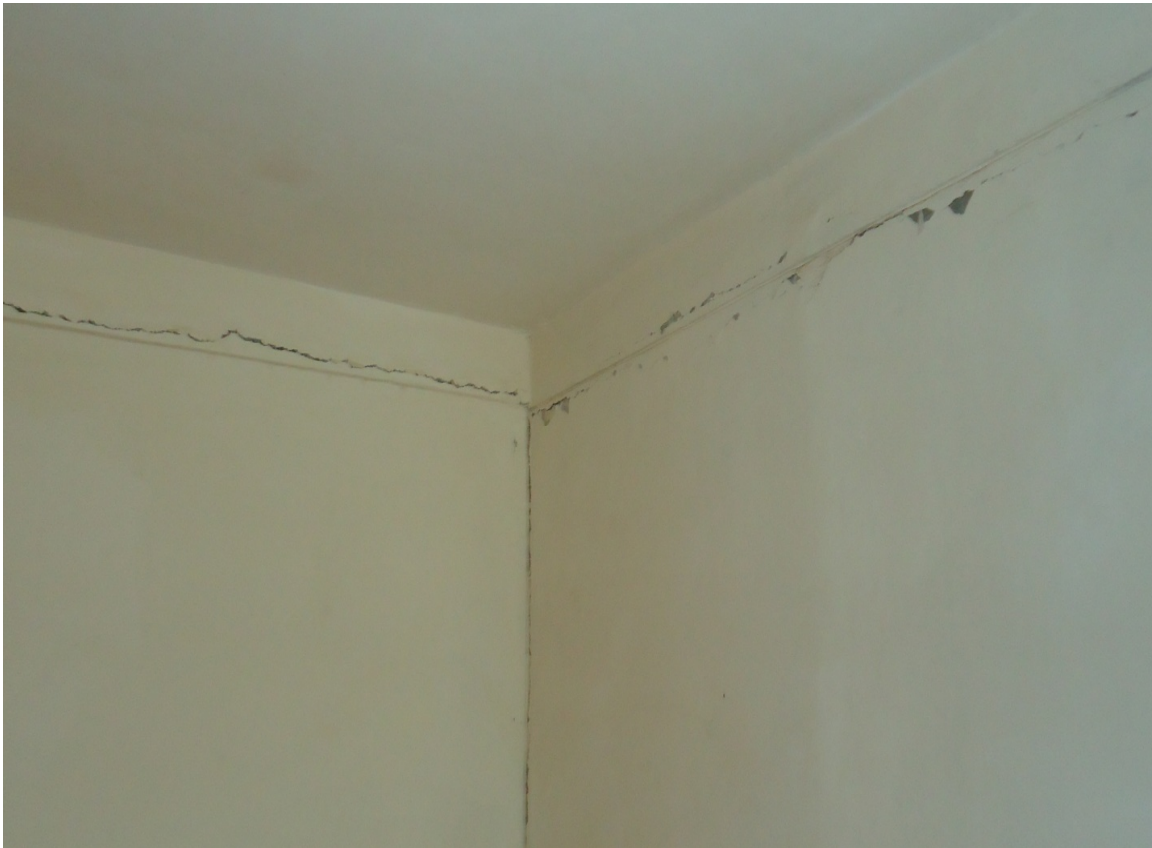
**Figure 4:7: Case study02 actual damage view photo**

Damage incurred: from the ground to third floor slight cracks between infill wall and reinforced concrete beam. Damage categorized grade1 as per EMS-98.

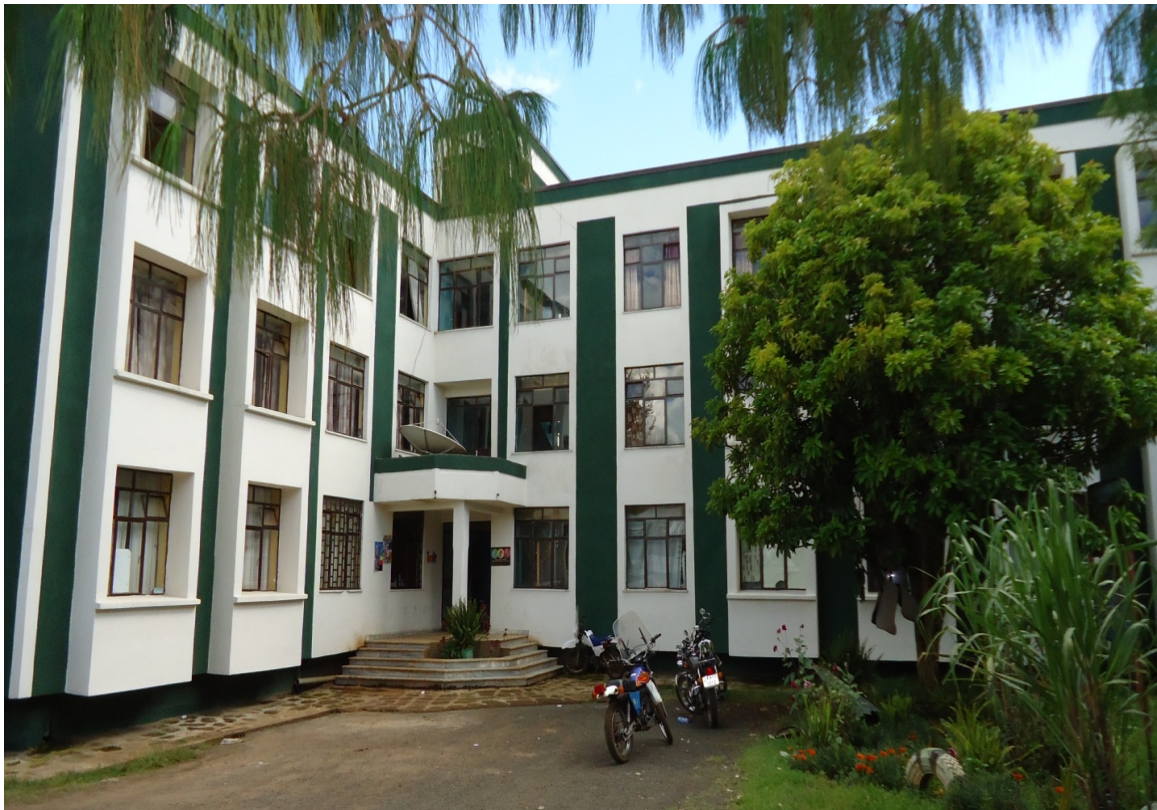
**Figure 4:8: Figure Front view of Case study 03 building**

Case study 03 building is office building which is two stories reinforced concrete frame building. It is L-shaped in plan but has construction joint between two parts and located in zone 4. It is the one of the building which is affected by Hosanna earthquake 2010.

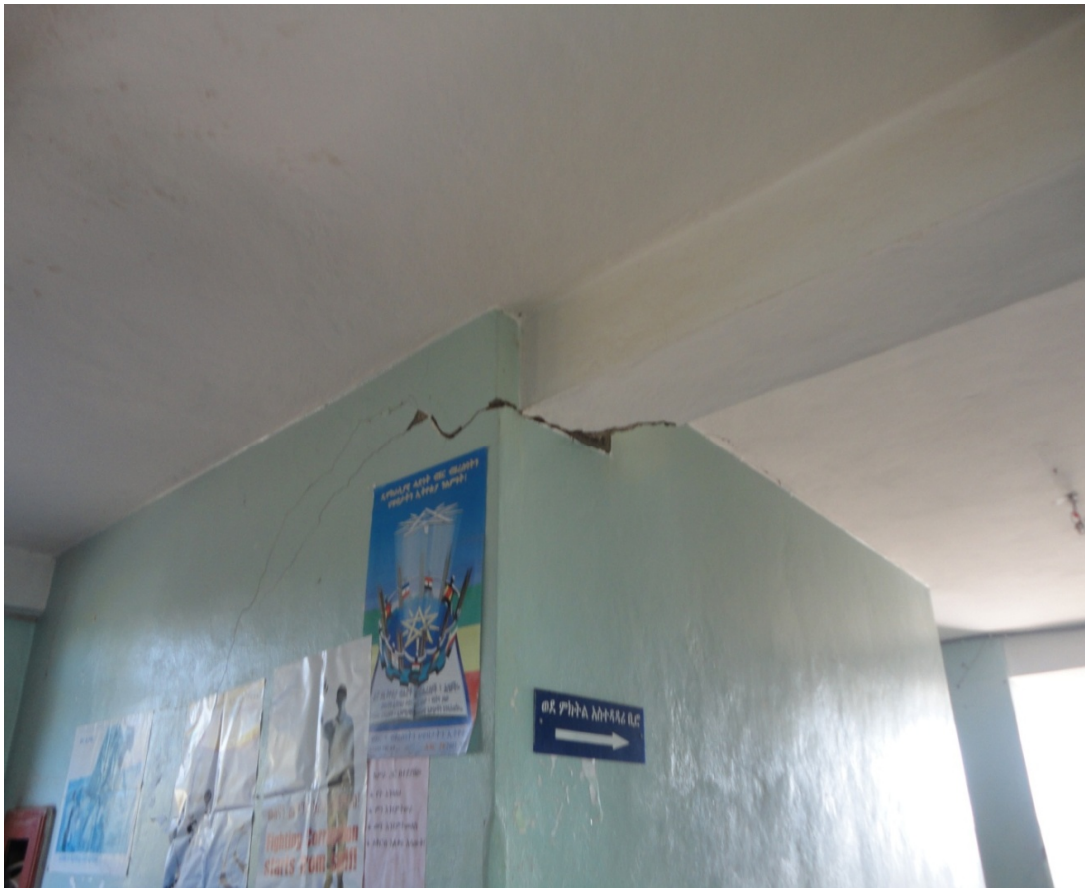
**Figure 4:9 : Actual damage view photos of case study 03 building**

Damage incurred: from the ground to third floor, cracking at the beam and wall interface of infill walls. Damage categorized grade2 as per EMS-98

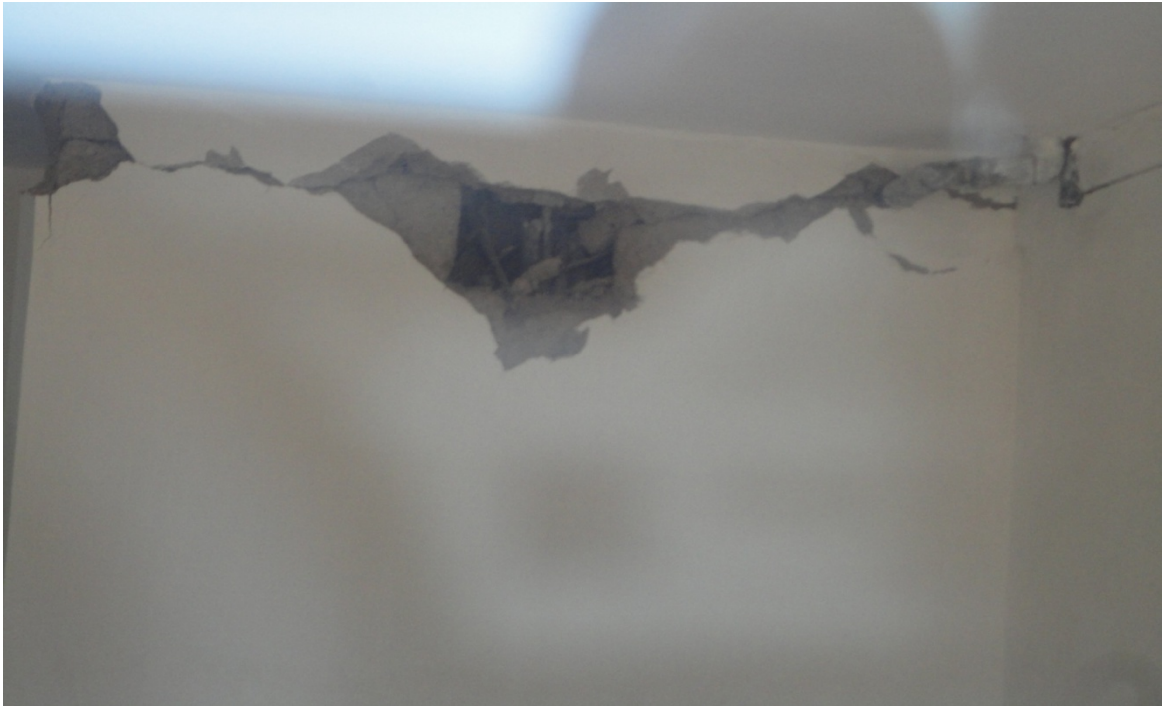
**Figure 4:10: Actual damage view photo of case study 03 building**

Damage incurred: Large cracks in partition walls. Damage categorized grade2 as per EMS-98.

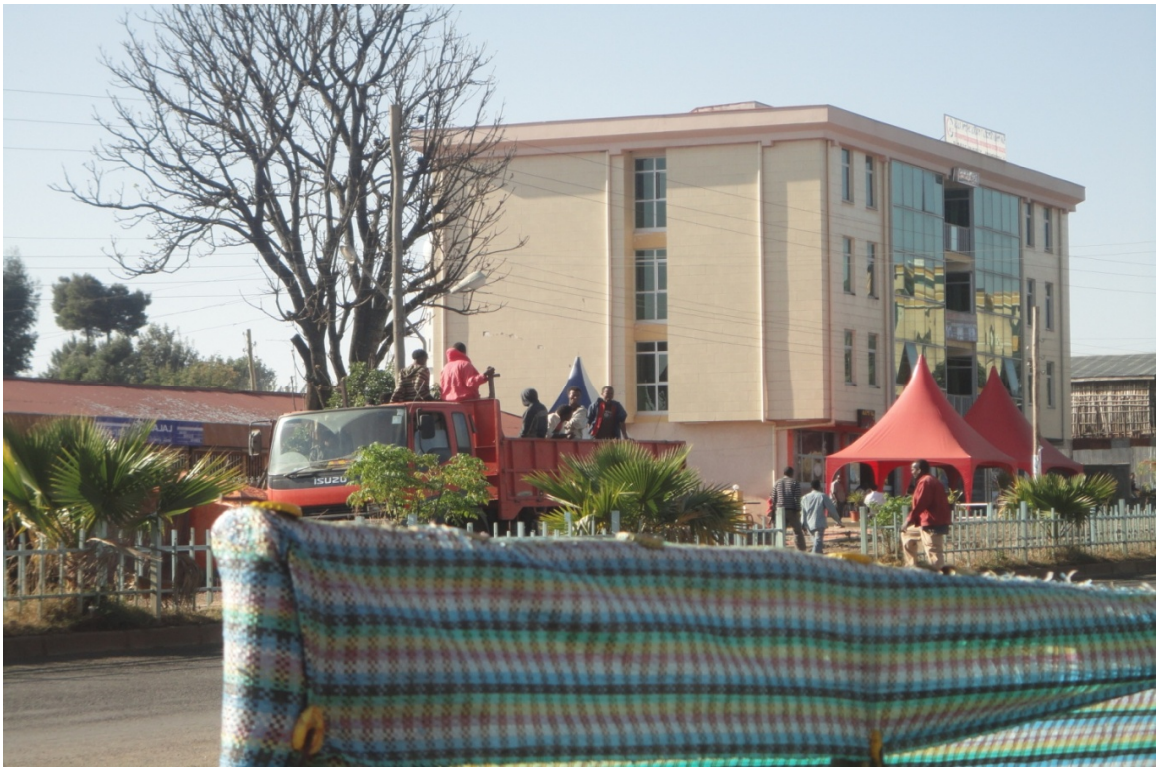
**Figure 4:11: Front view of Case Study 04 Building**

It is a commercial building with three story reinforced concrete frame building. It is rectangular-shape in plan and located on zone 4. It is the one of the building which is affected by Hosanna earthquake.

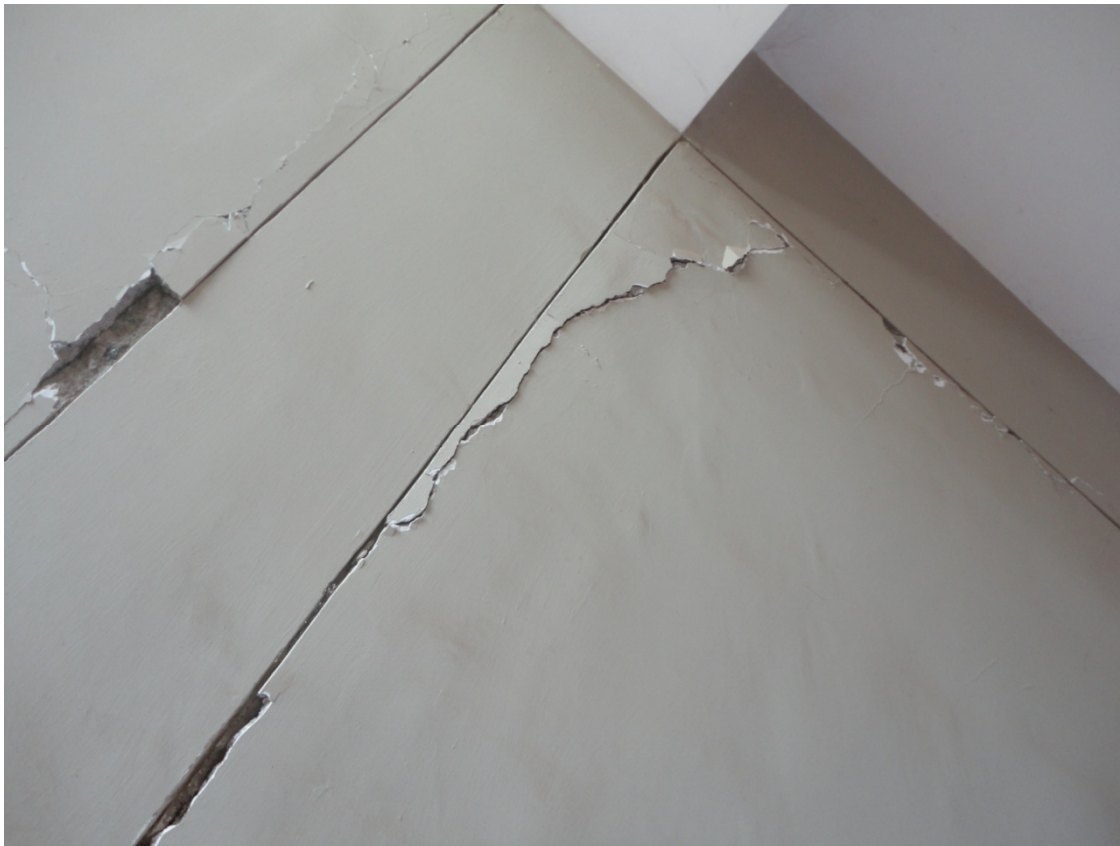
**Figure 4:13 : Damage photo of Case study 04 Building**

Damage incurred: from ground floor to third floor partial removal of the plastering from walls. Damage categorized grade2 as per EMS-98.

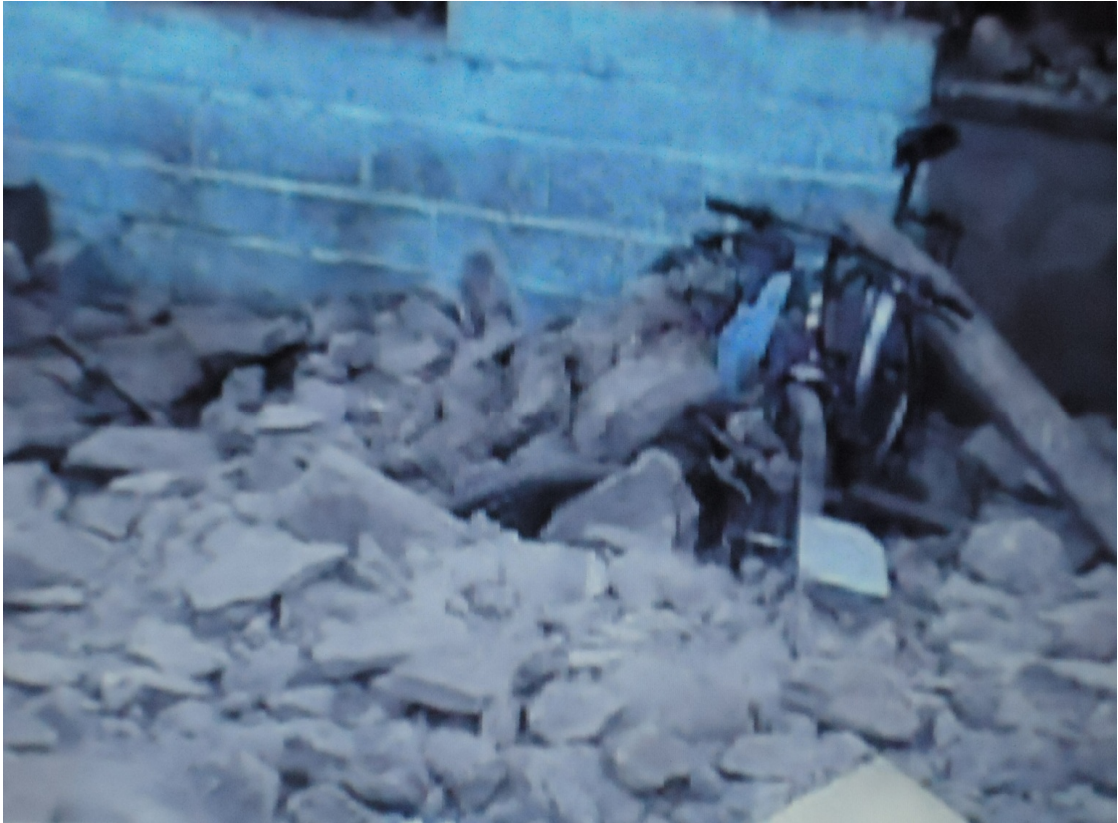
**Figure 4:15: Damage photo of case study 05**

Damage incurred partial collapse of building. Damage categorized grade3 as per EMS98
