**Analysis on Road Safety Inspection using Analytical Hierarchy
Process (AHP) Method**

A case study in Addis Ababa city

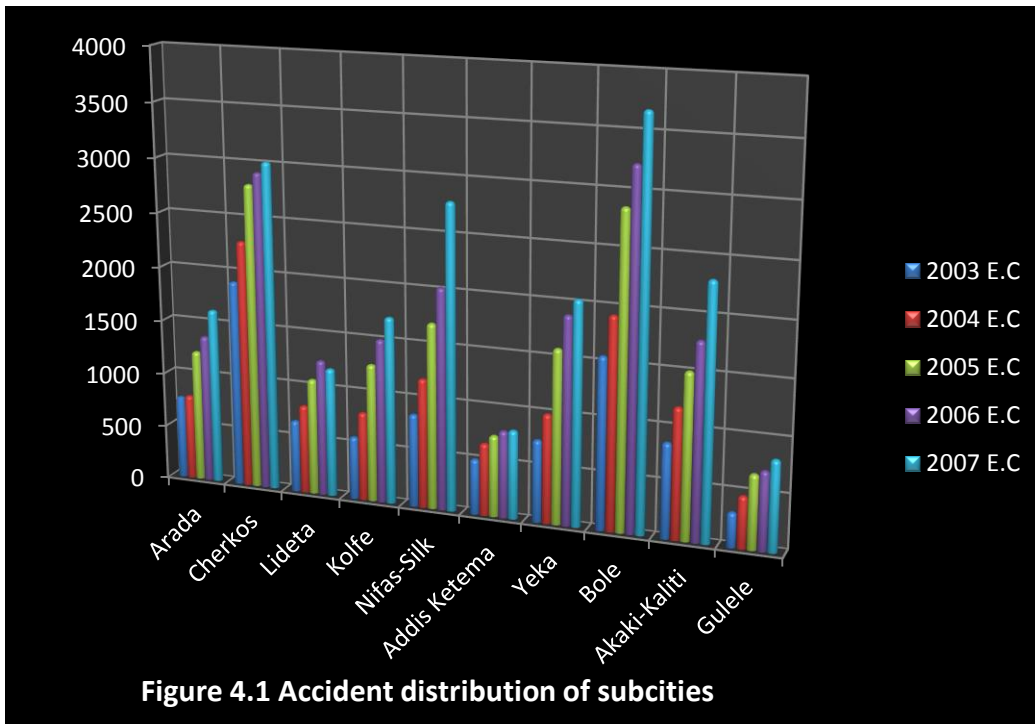
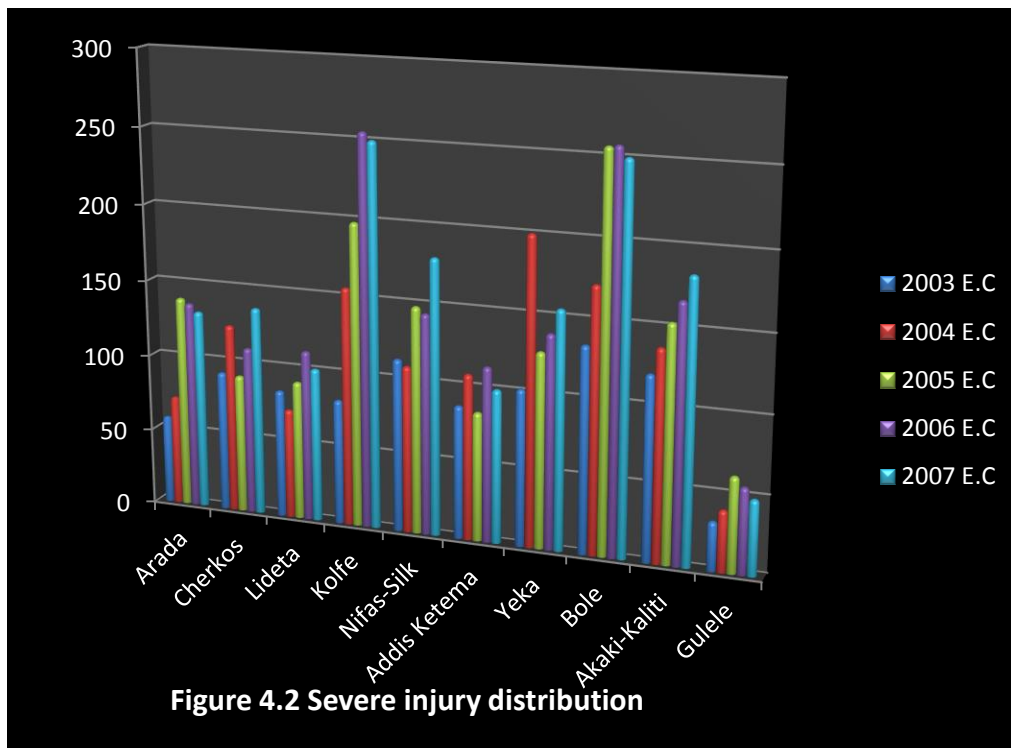
4.2.1 Accident Density of the Road Sections

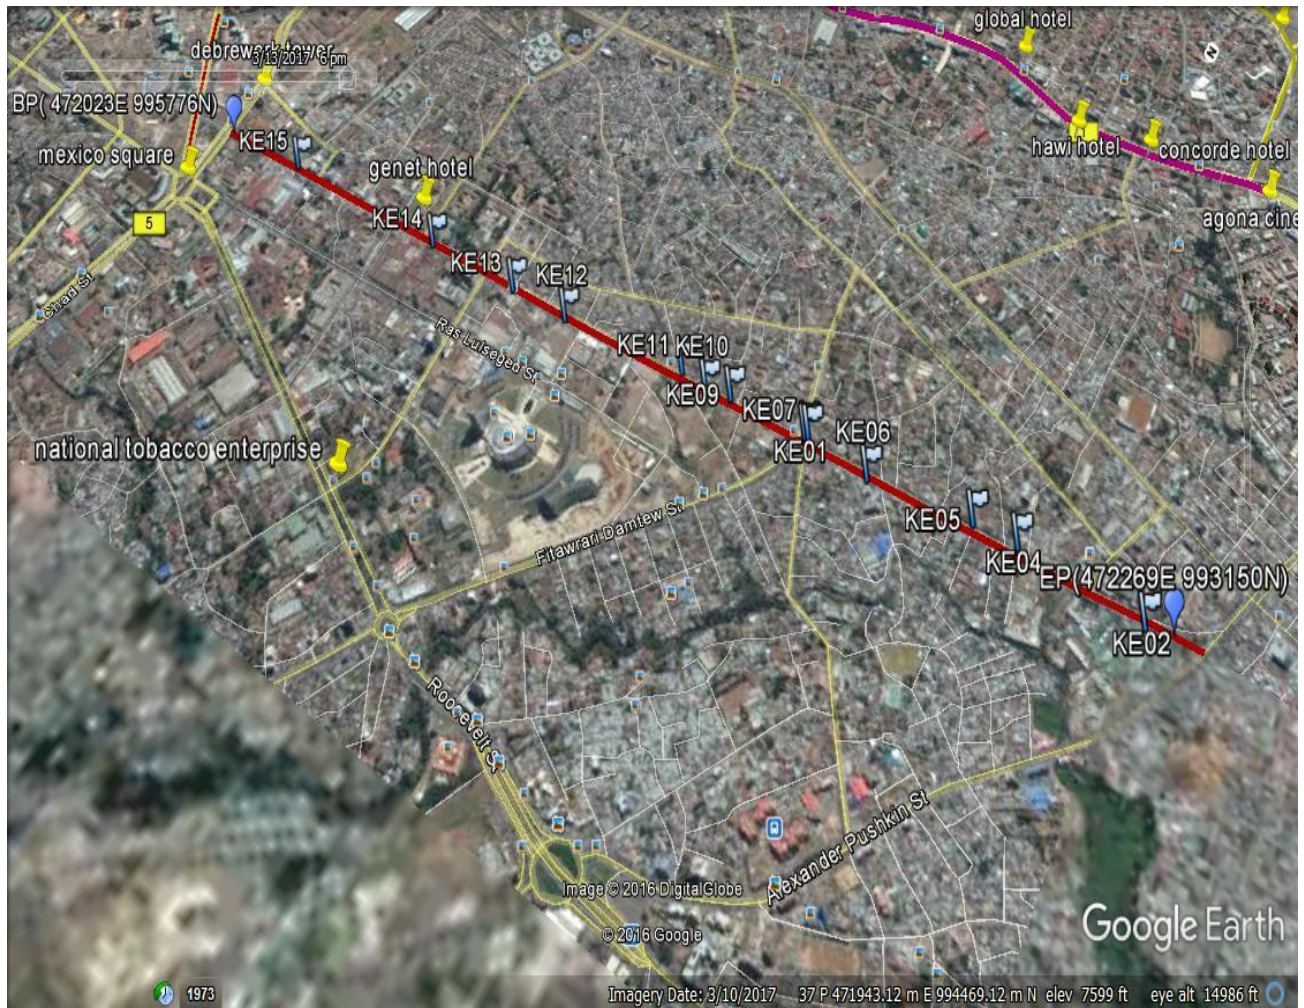
Figure 4.7 Topographic views and coordinate points of Kera road.

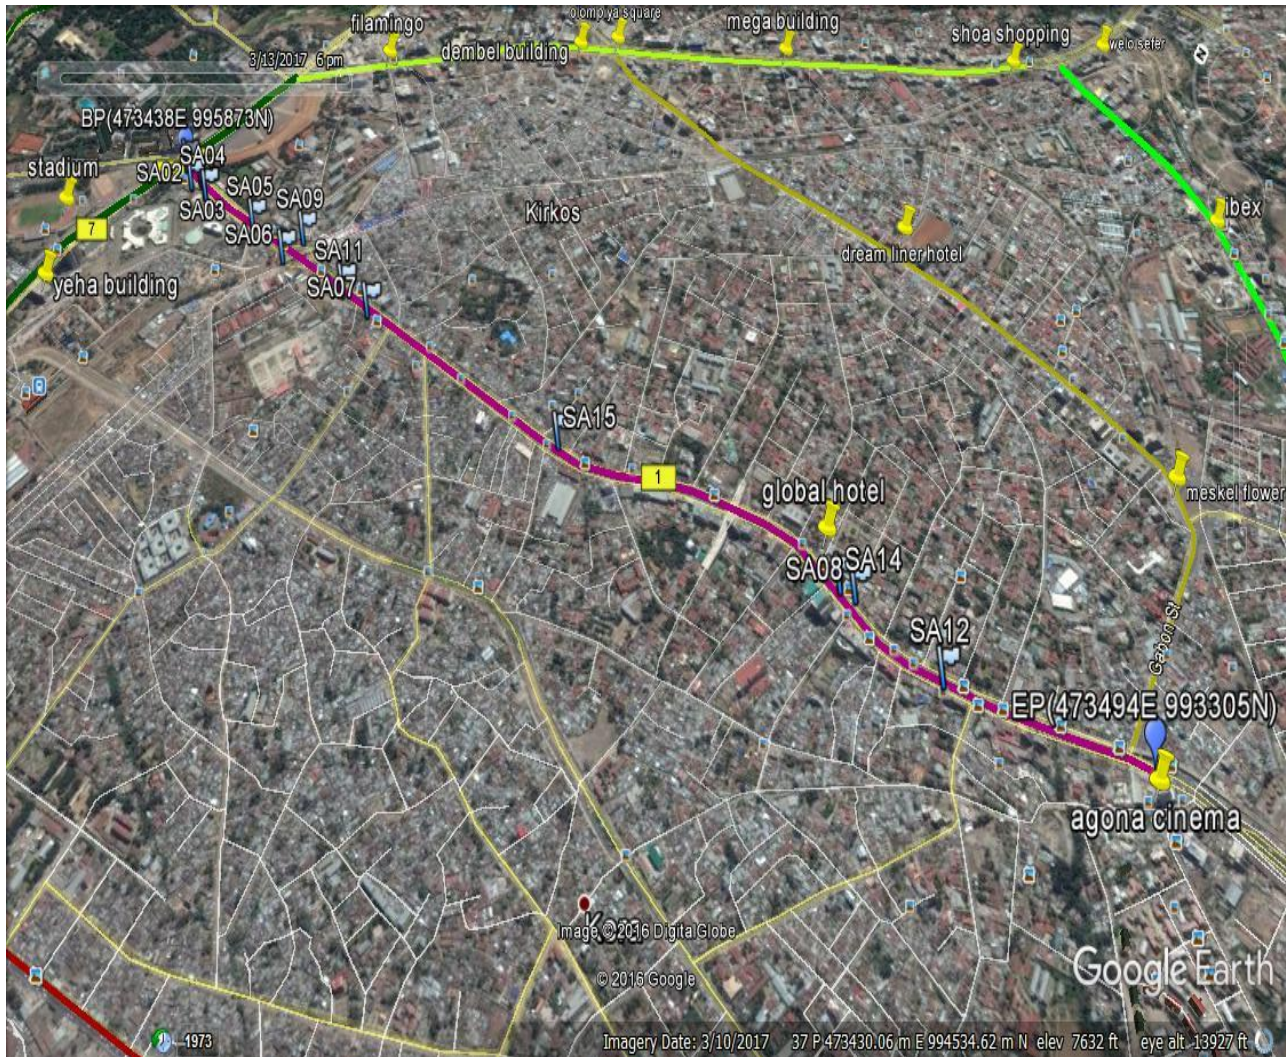
Figure 4.8 Topographic views and coordinate points of St. Joseph- Agona road.

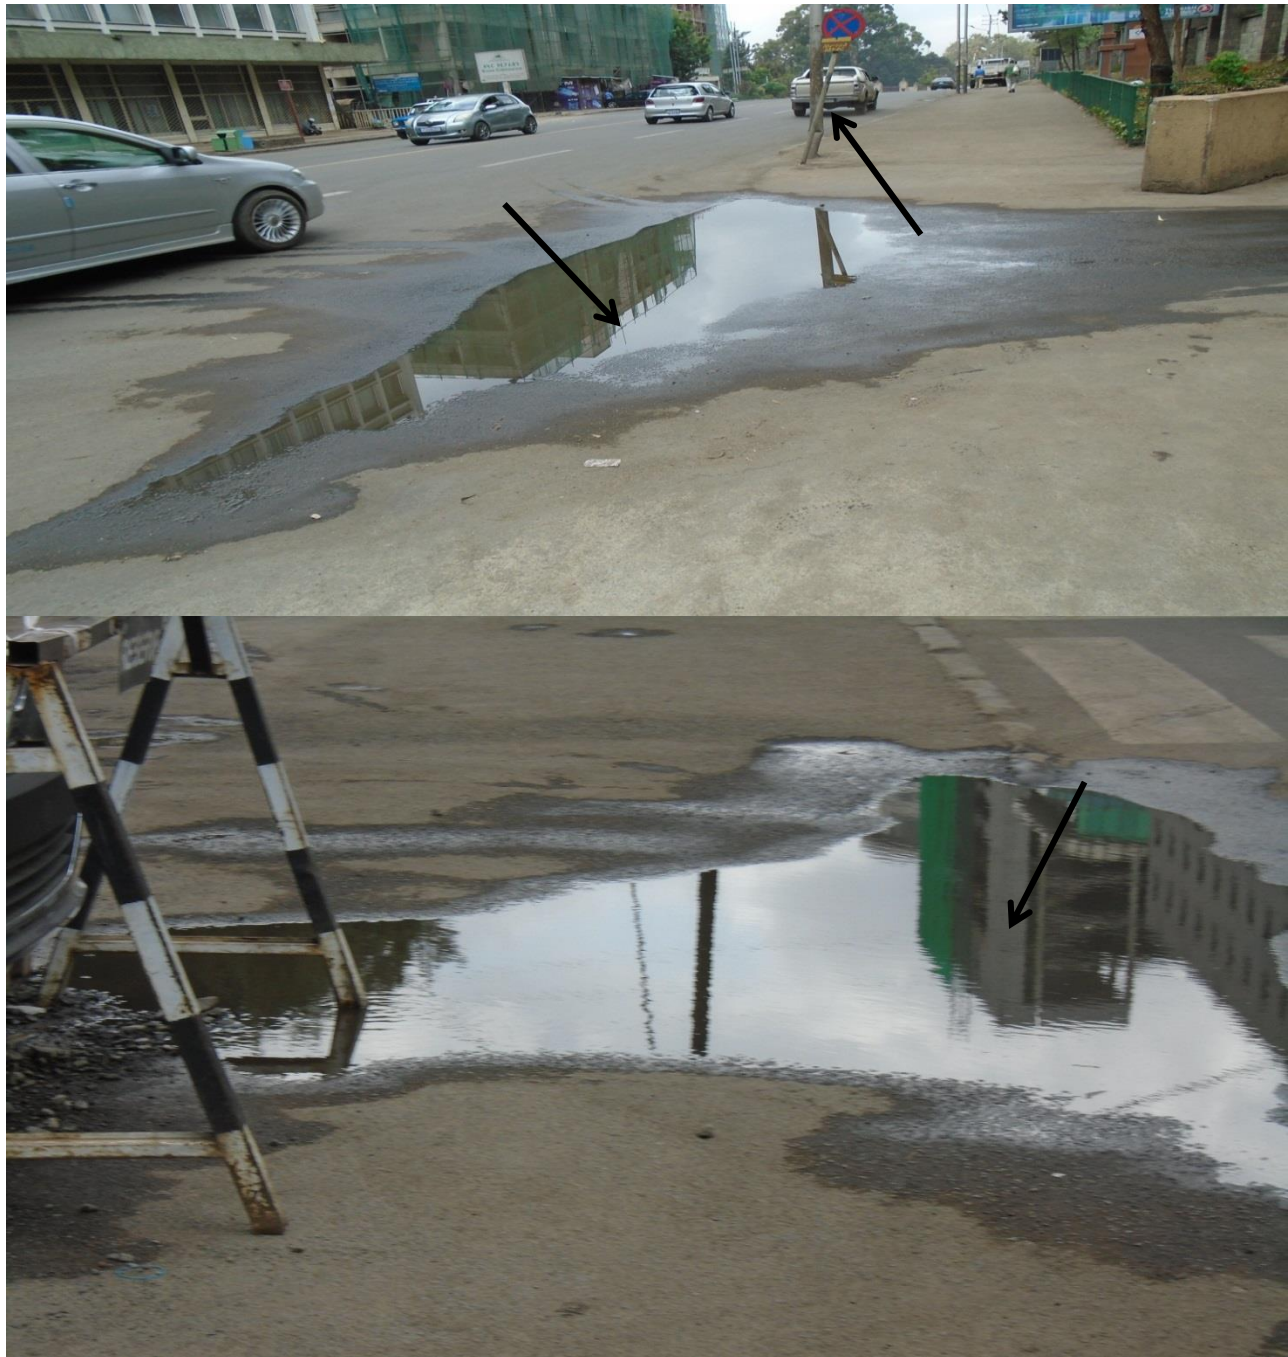
Figure 1. Photo. Water ponding on the walk way & pavement edge, damaged traffic sign & Lighting pole

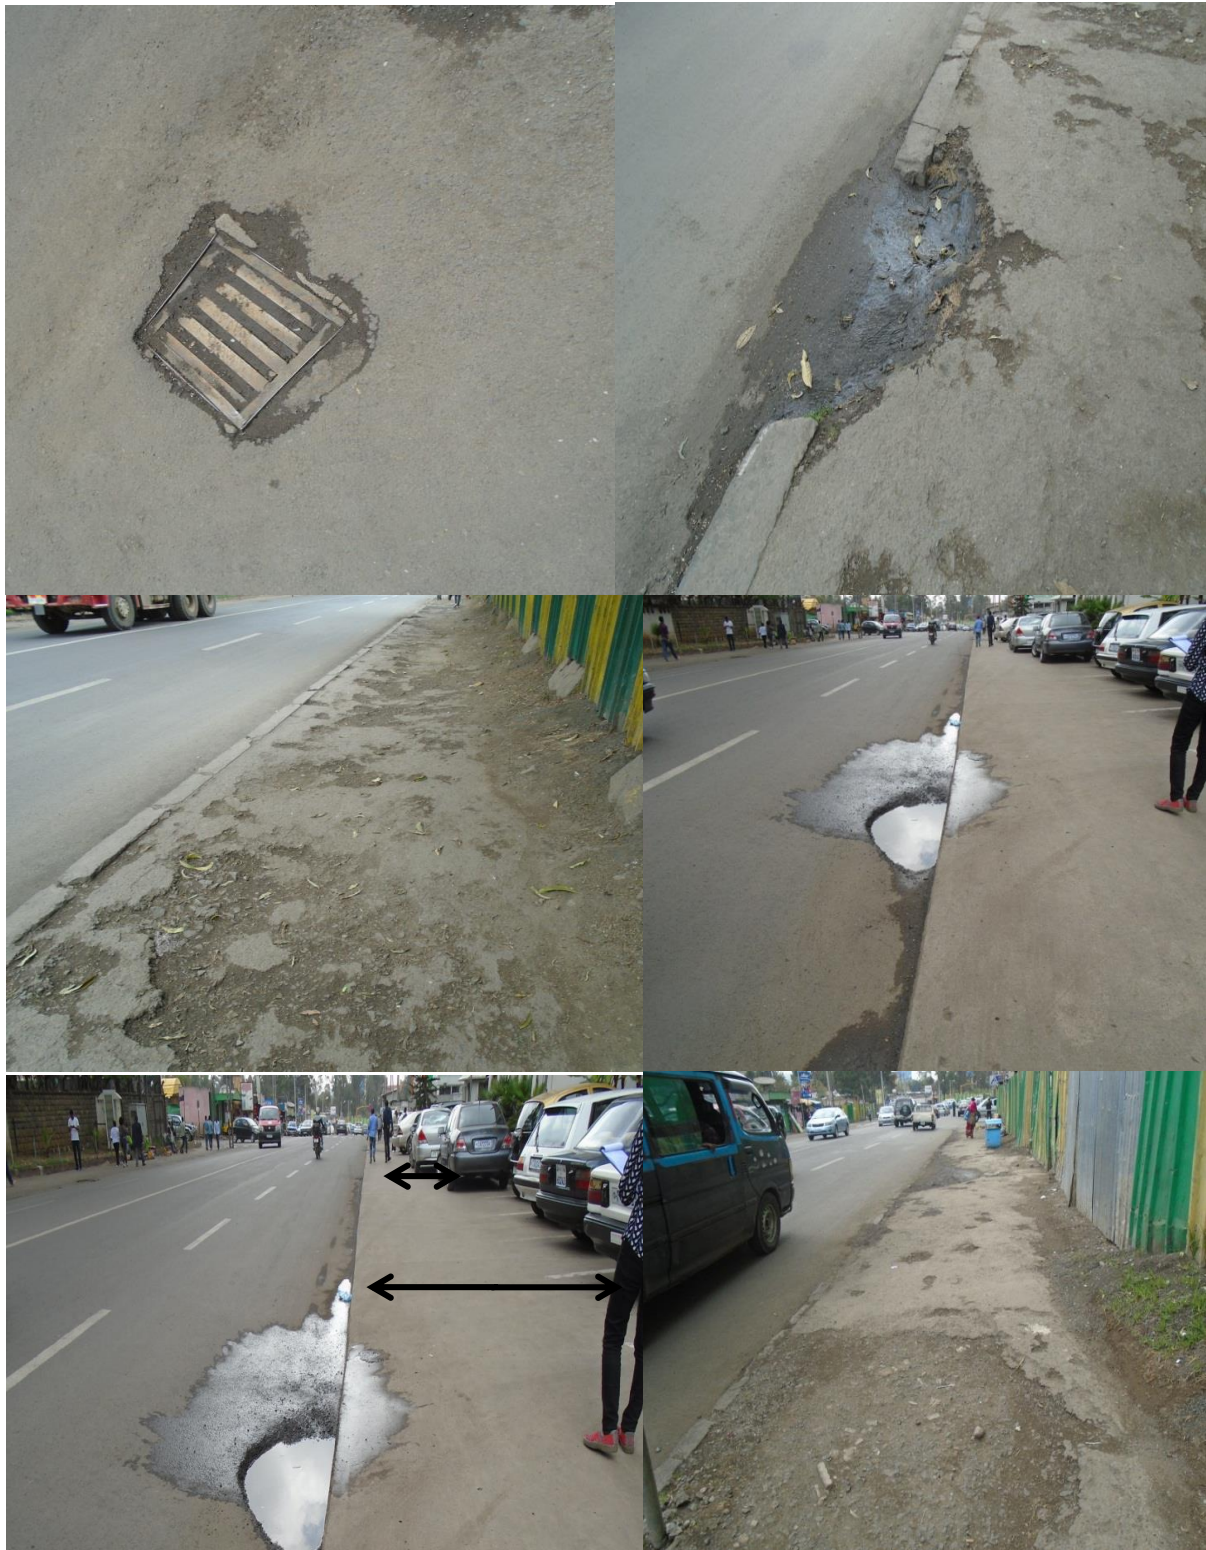
Figure 2. Photo. Blocked road side drainage, deteriorated walks way and walk way reduced by parked vehicle.

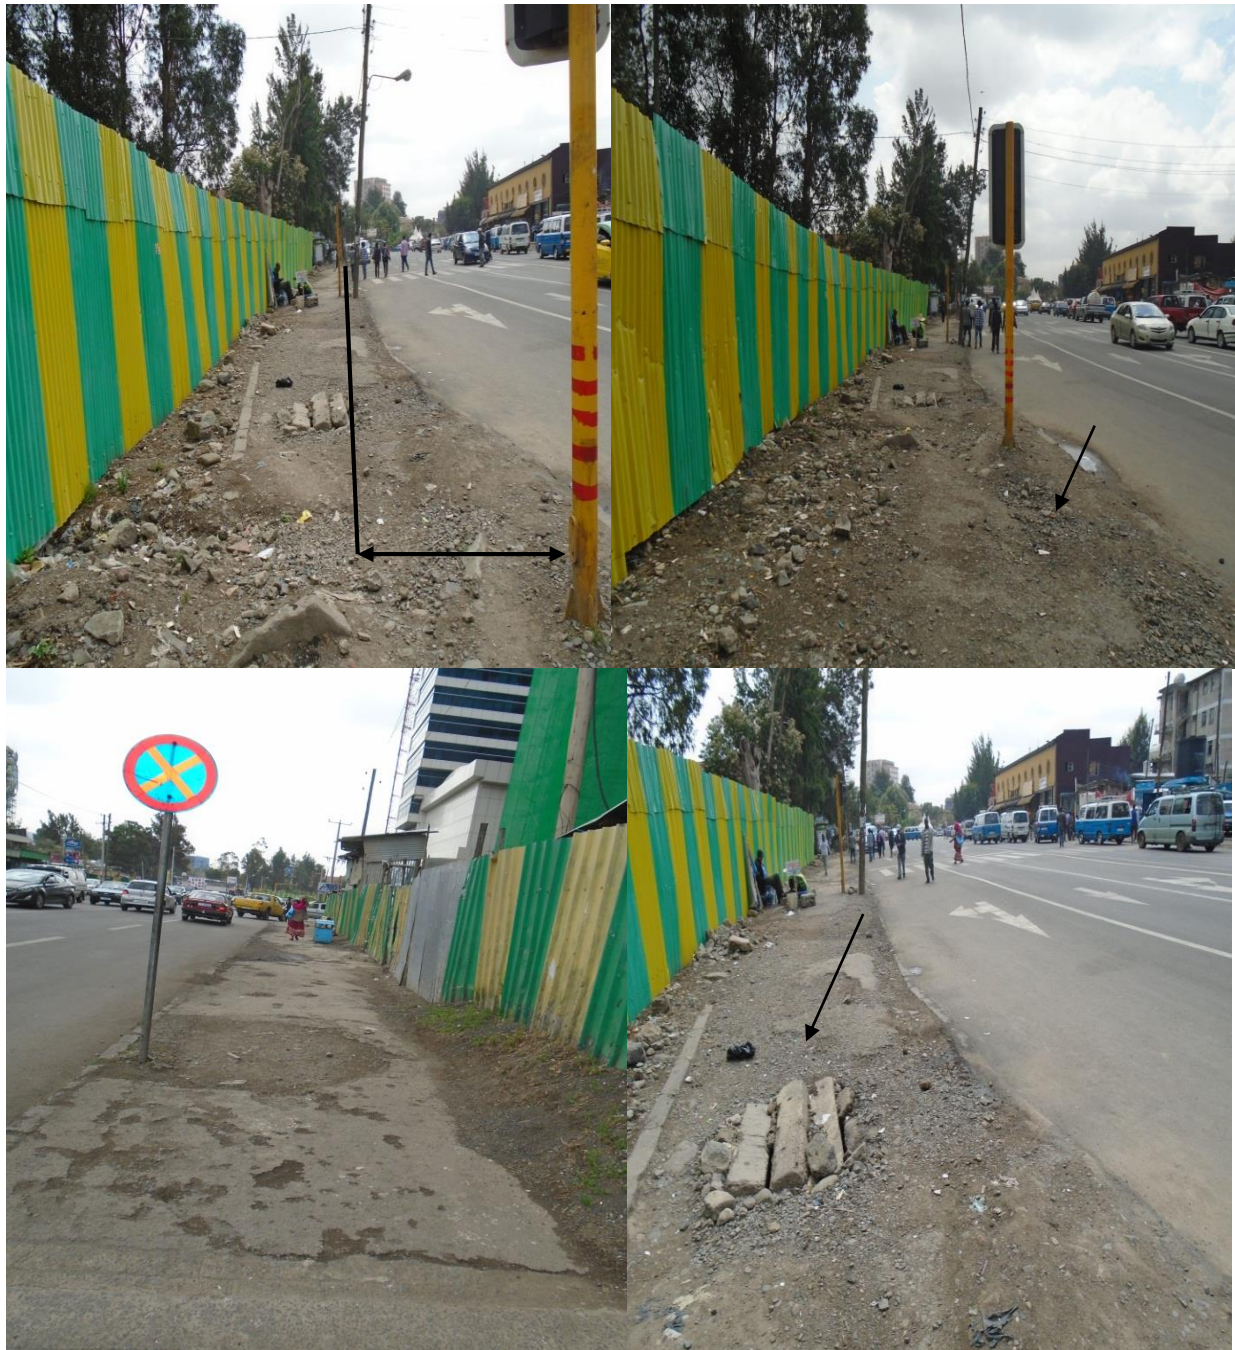
Figure 3. Photo. Signals at the wrong position and are not functional, missing kerb, surface defect of walk way

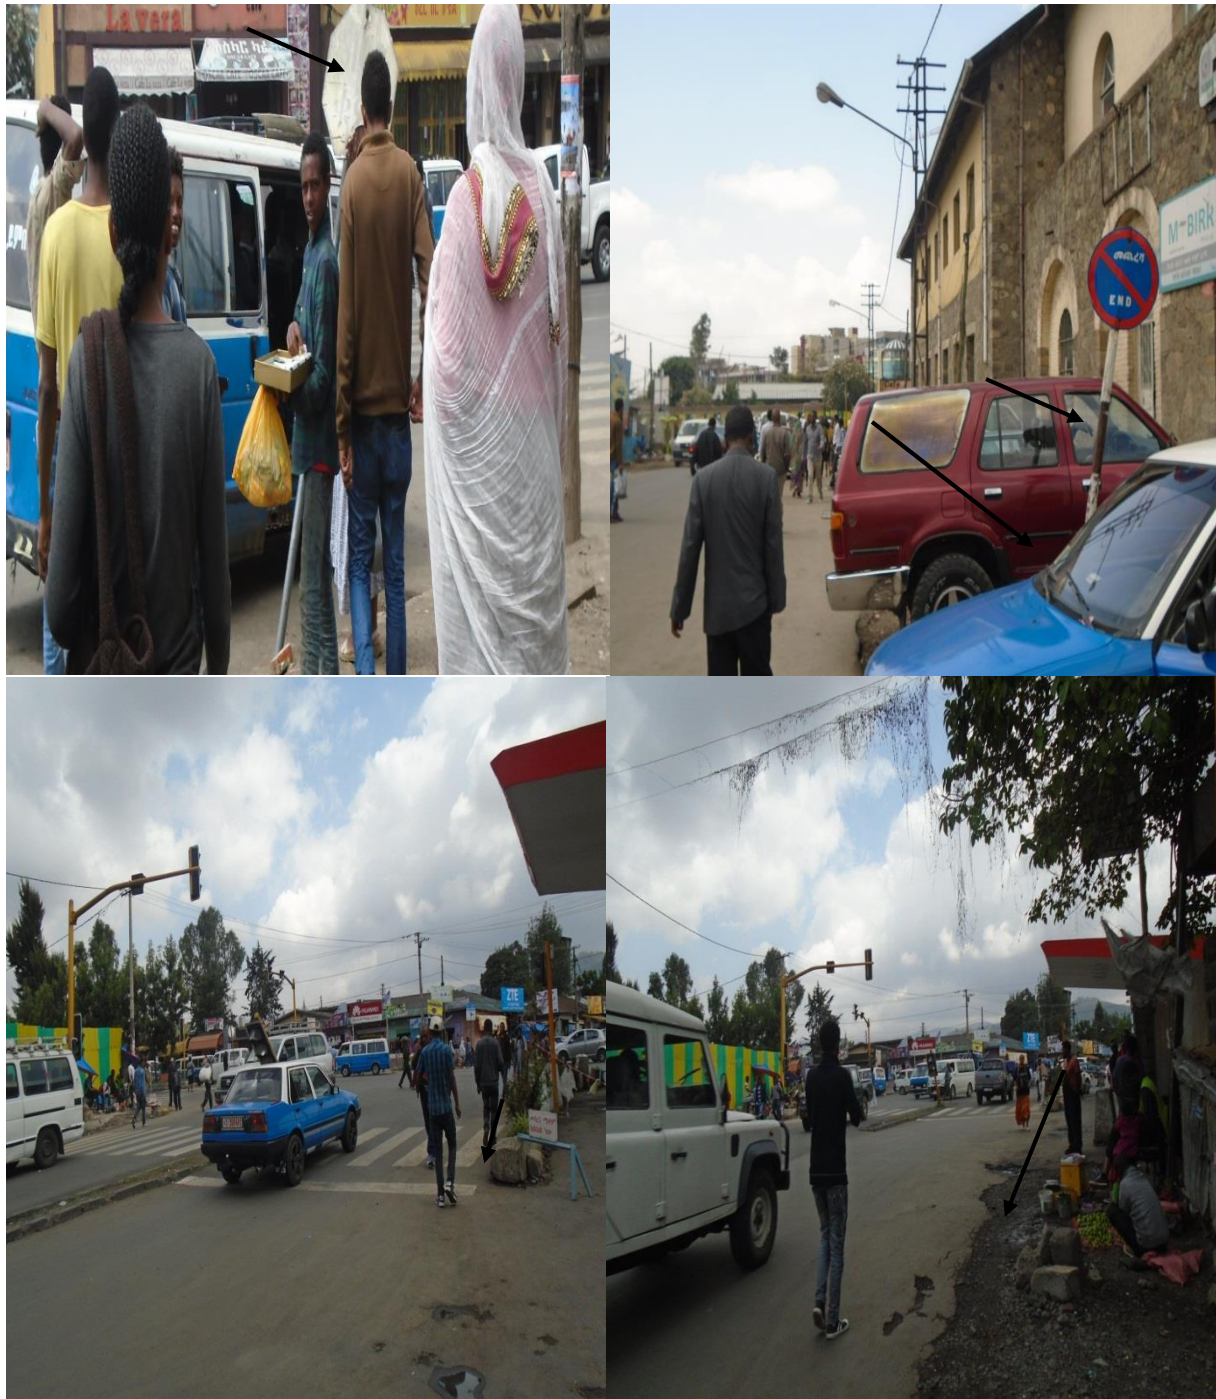
Figure 4. Photo. Poor visibility of sign and damaged traffic sign, missing kerb, vehicles parked on the walkway

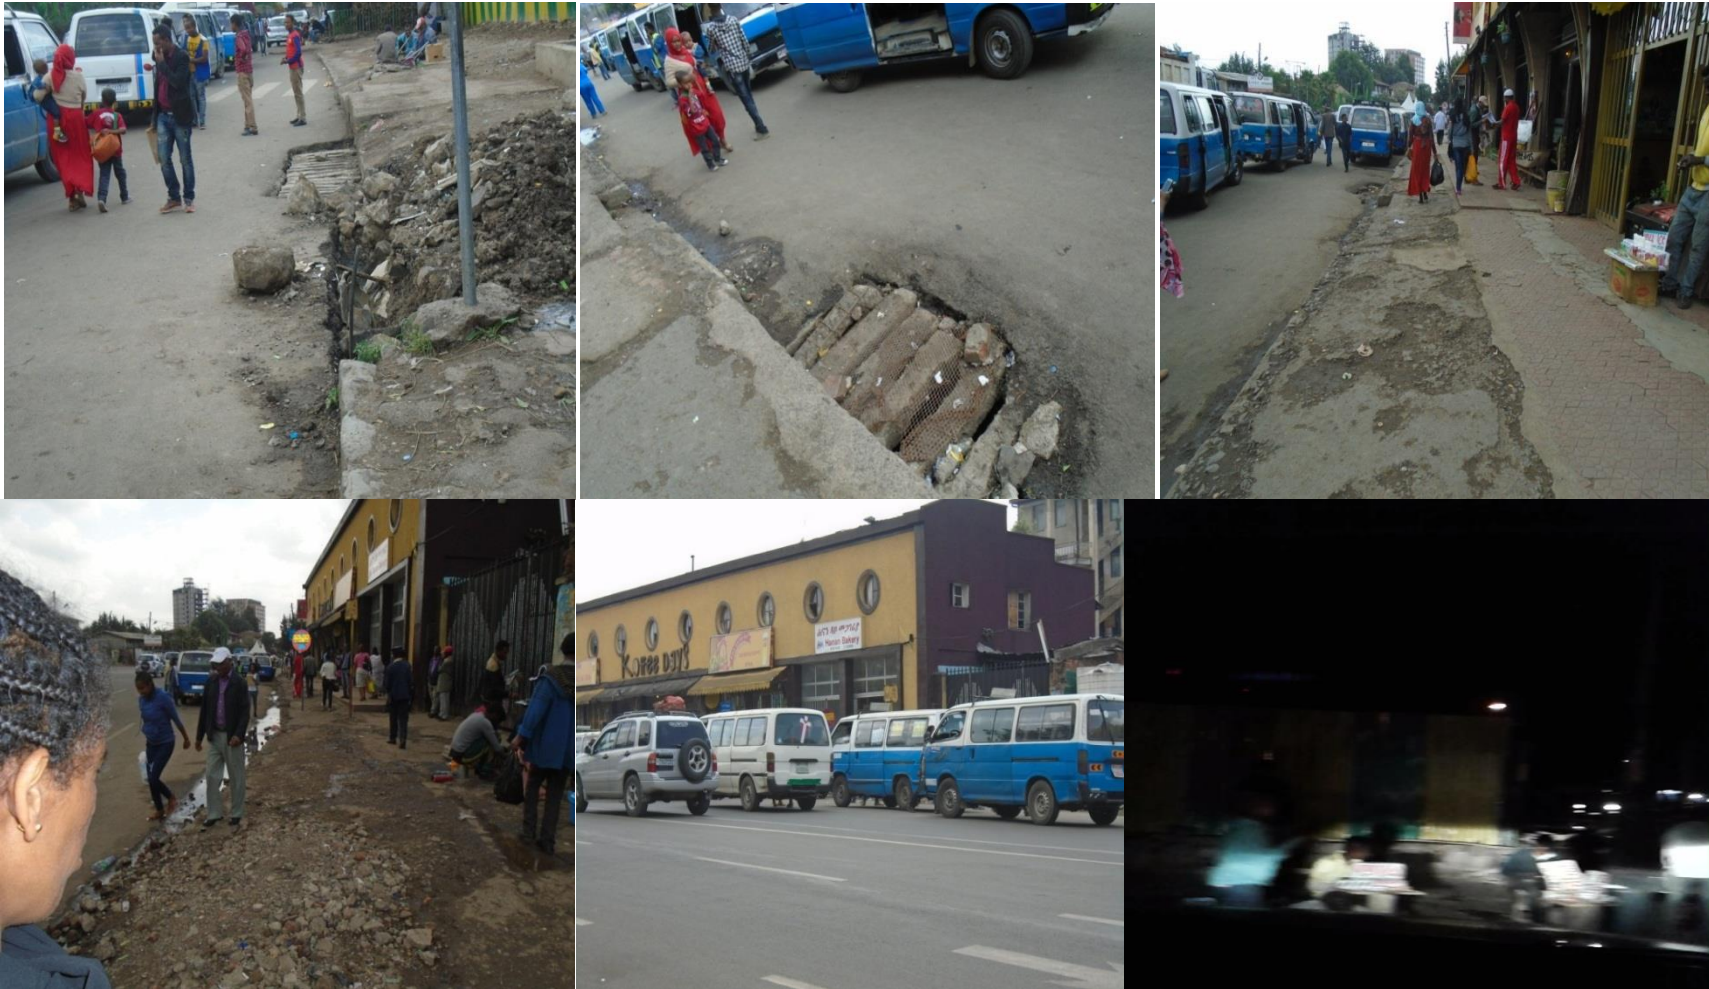
Figure 5. Photo. blocked drains, Insufficient pedestrian and passenger facility, the service area and taxi station very close to each other, worn walk way, insufficient parking space for taxis, road side vendors at night, no road side lighting.

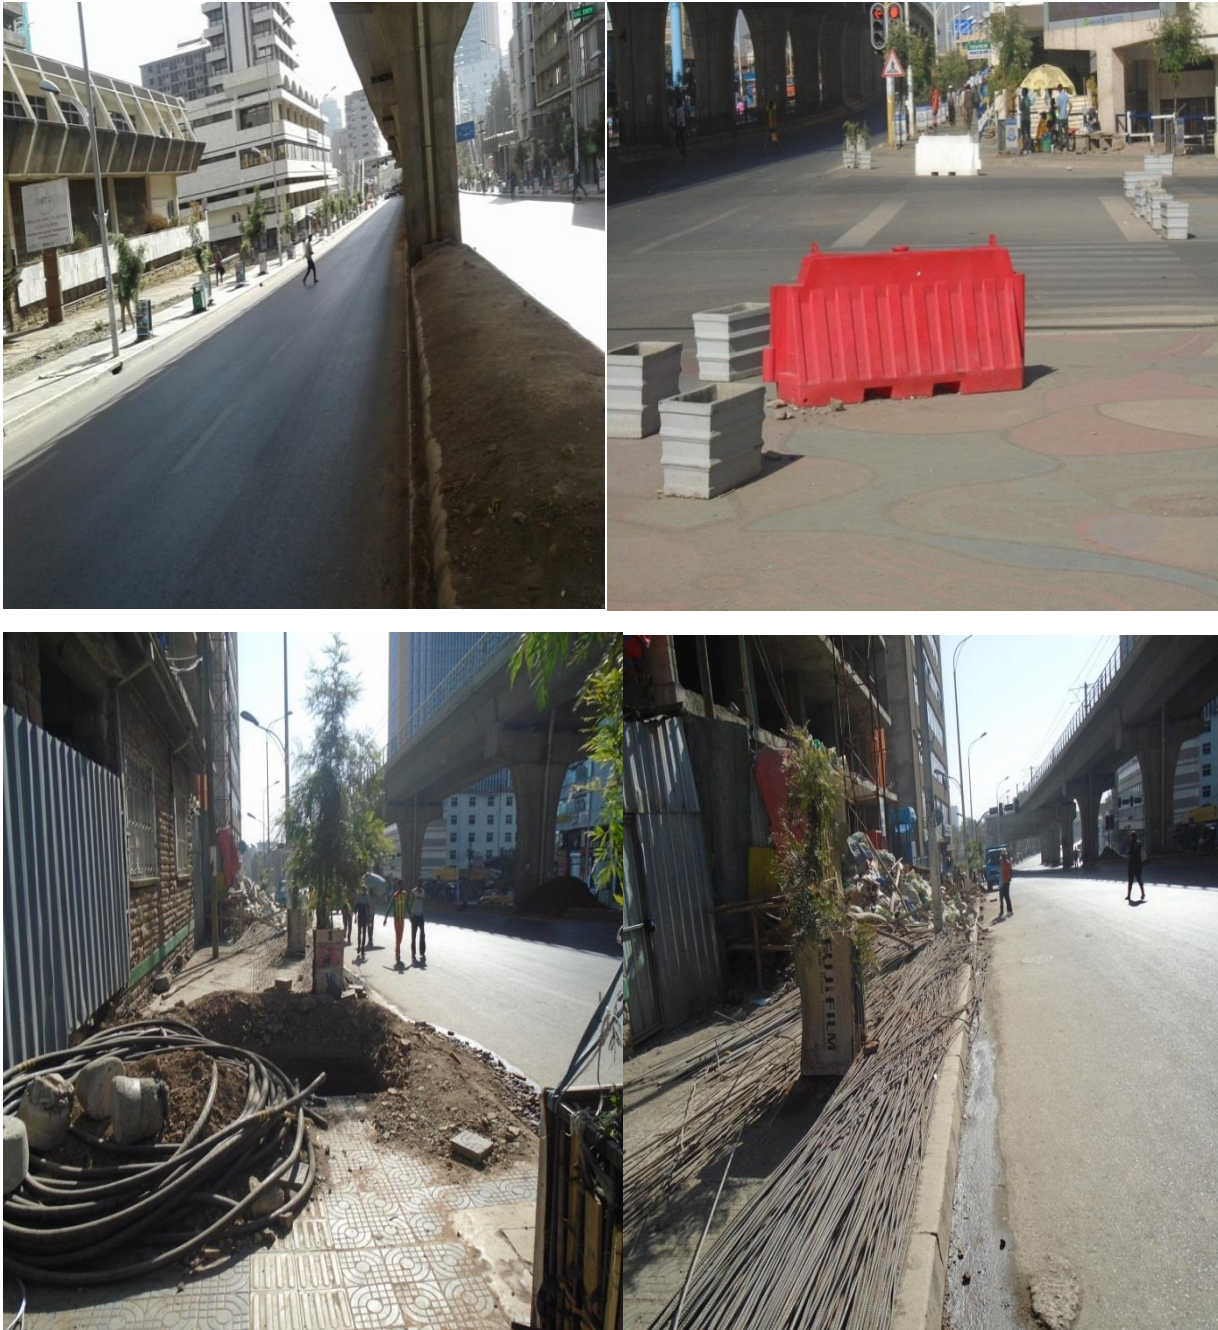
Figure 6. Photo. Faded longitudinal and pedestrian cross markings, unprotected utility line burrow, construction materials on walkway.

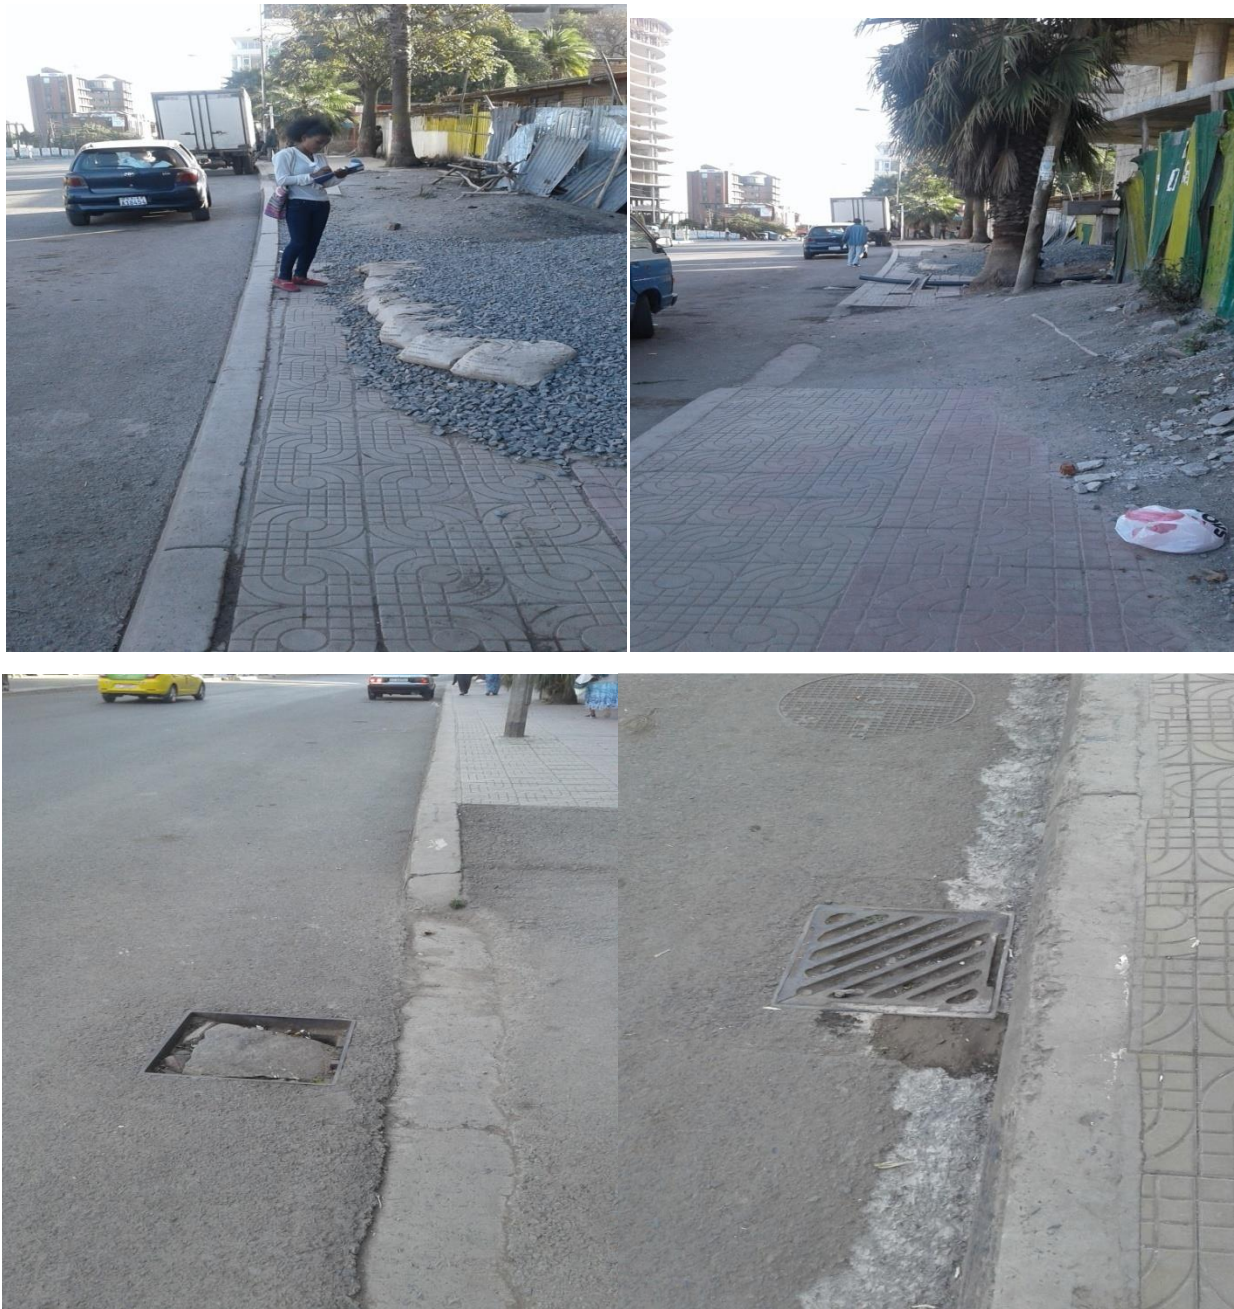
Figure 9. Photo. Construction material on the walkway, blocked inlet, improper inlet cover

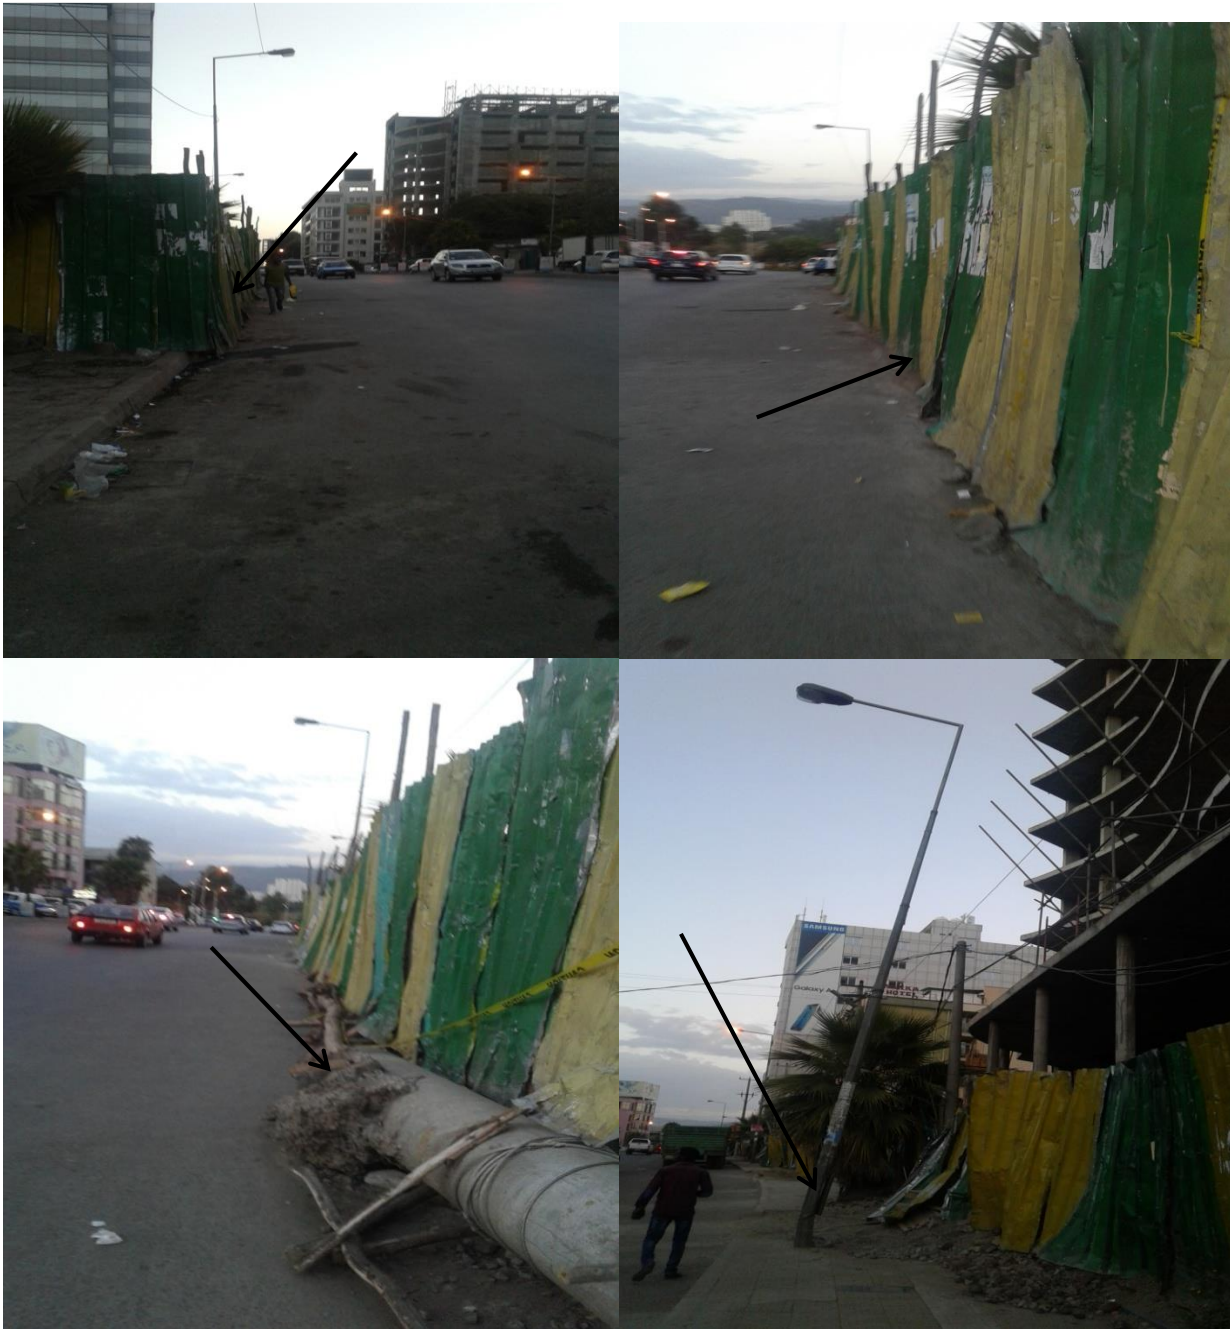
Figure 10. Photo. Construction fence block the walk way and obstruct both pedestrian and vehicle movement, damaged lighting

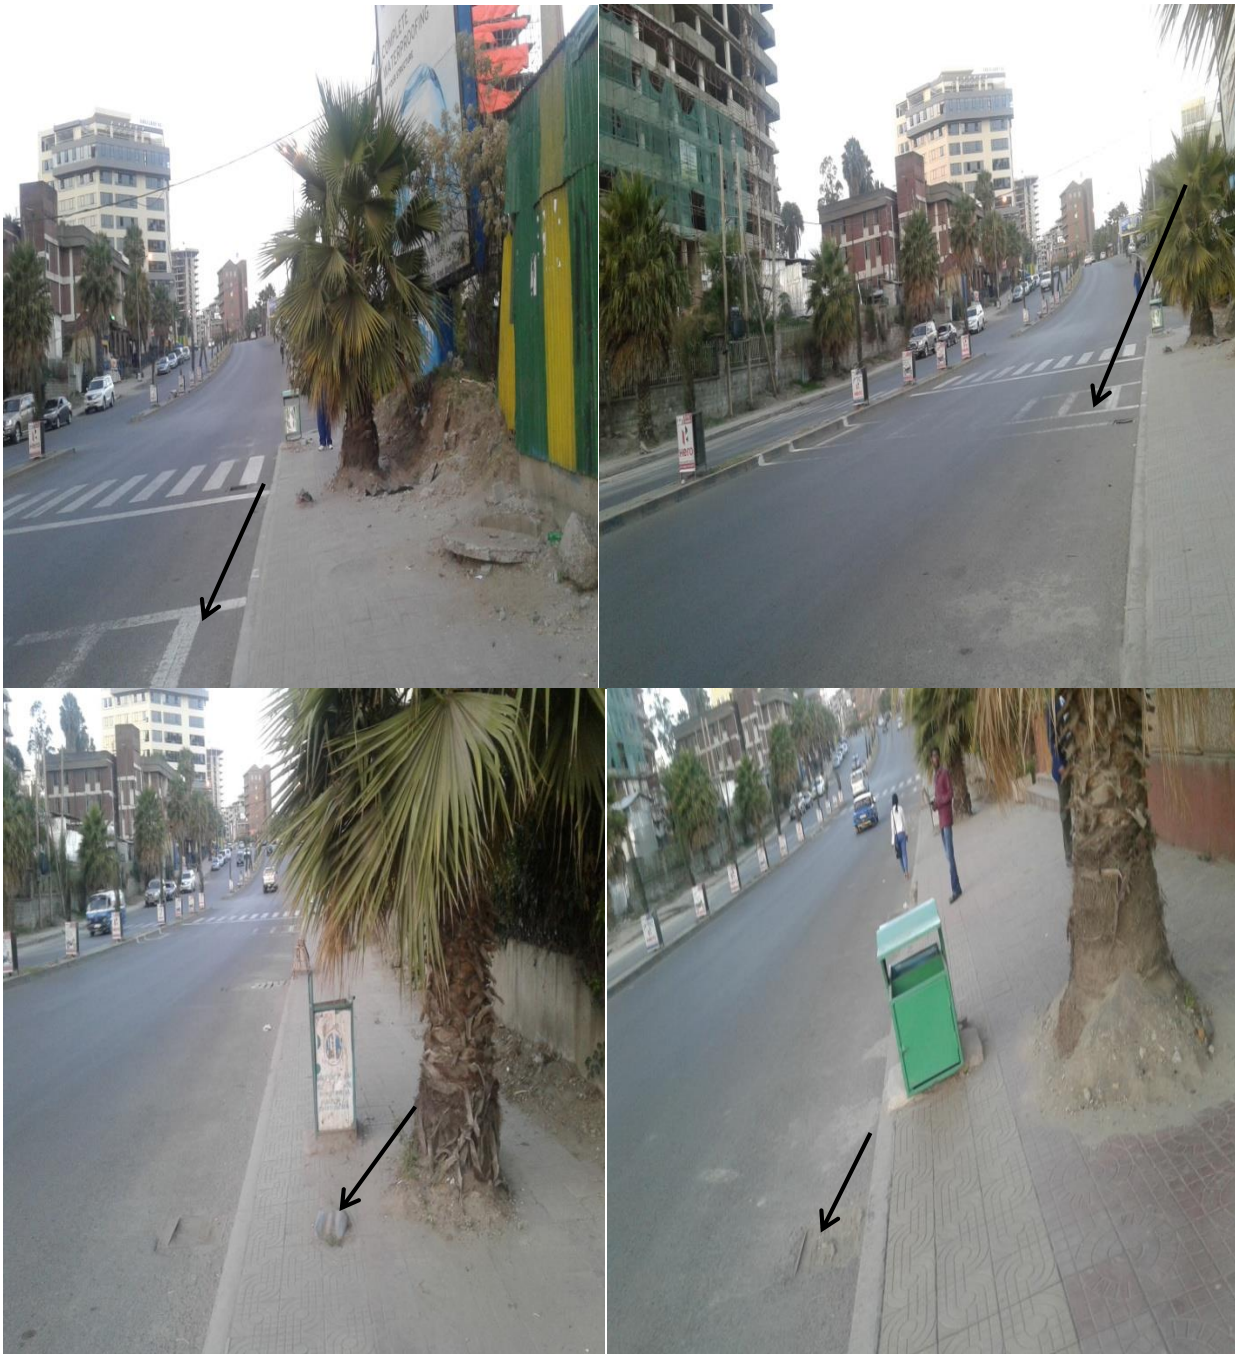
Figure 11. Photo. Old cross marking is not removed, damaged lighting, blocked inlet

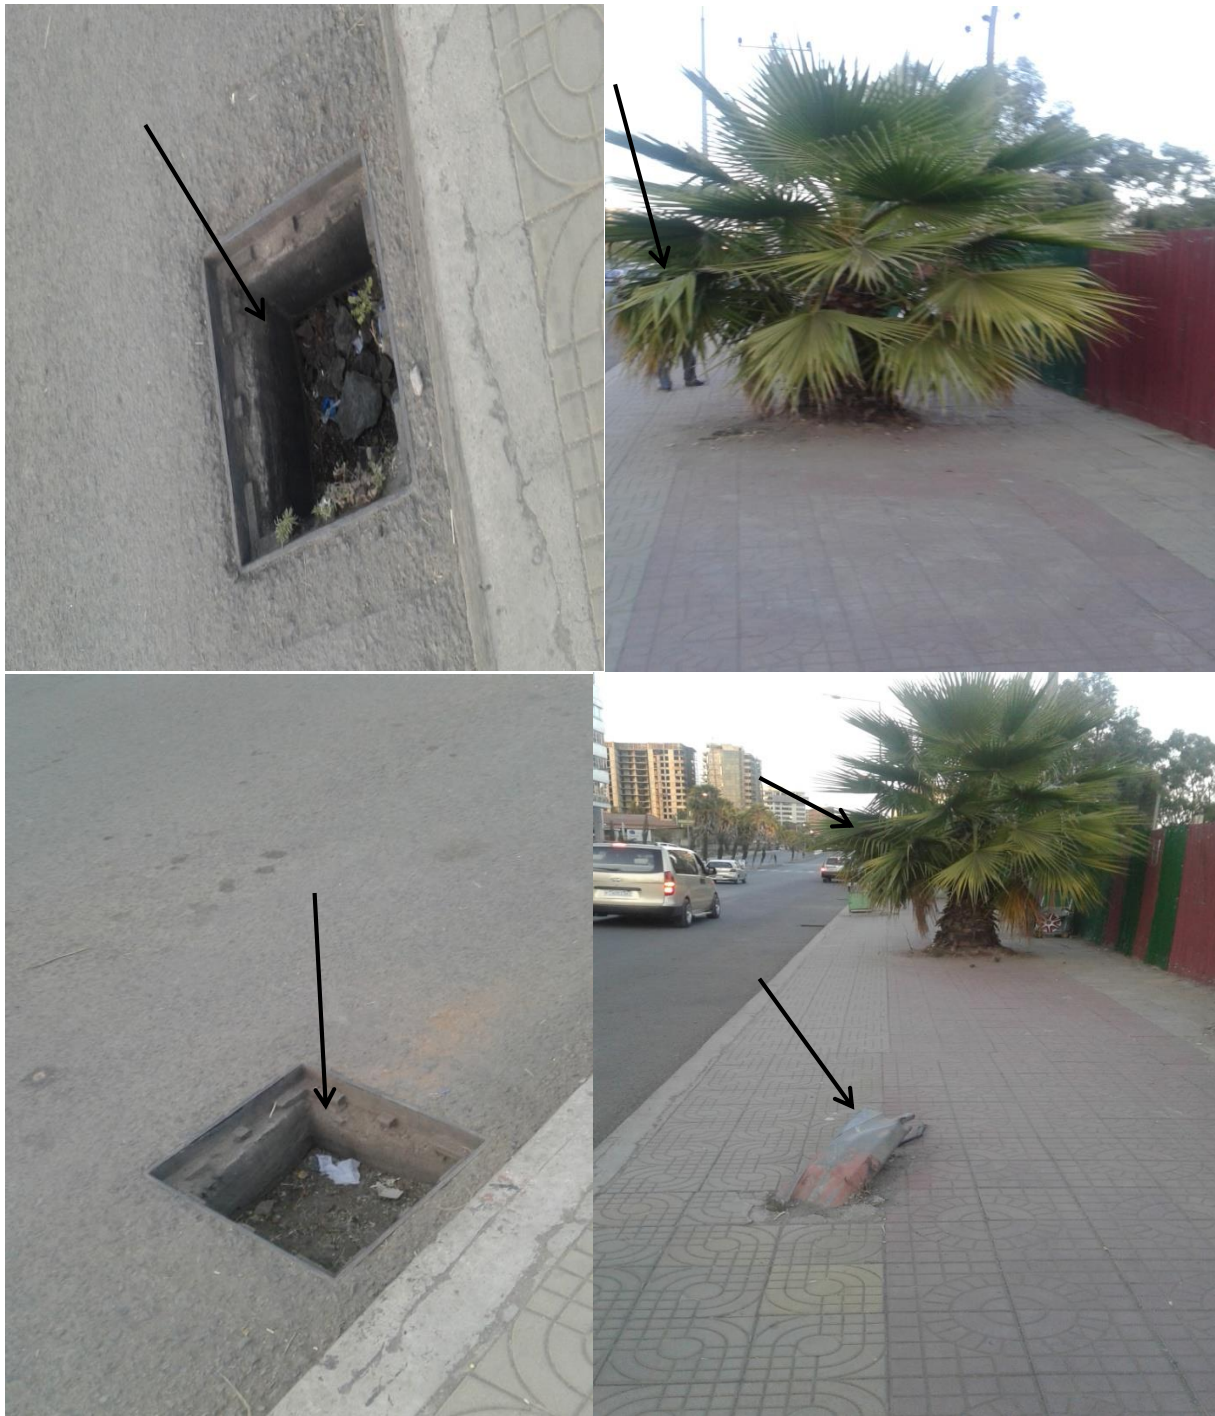
Figure 12. Photo. Uncovered ditch filled by mud and dirt, damaged lighting, branch of vegetation obstruct pedestrian movement.

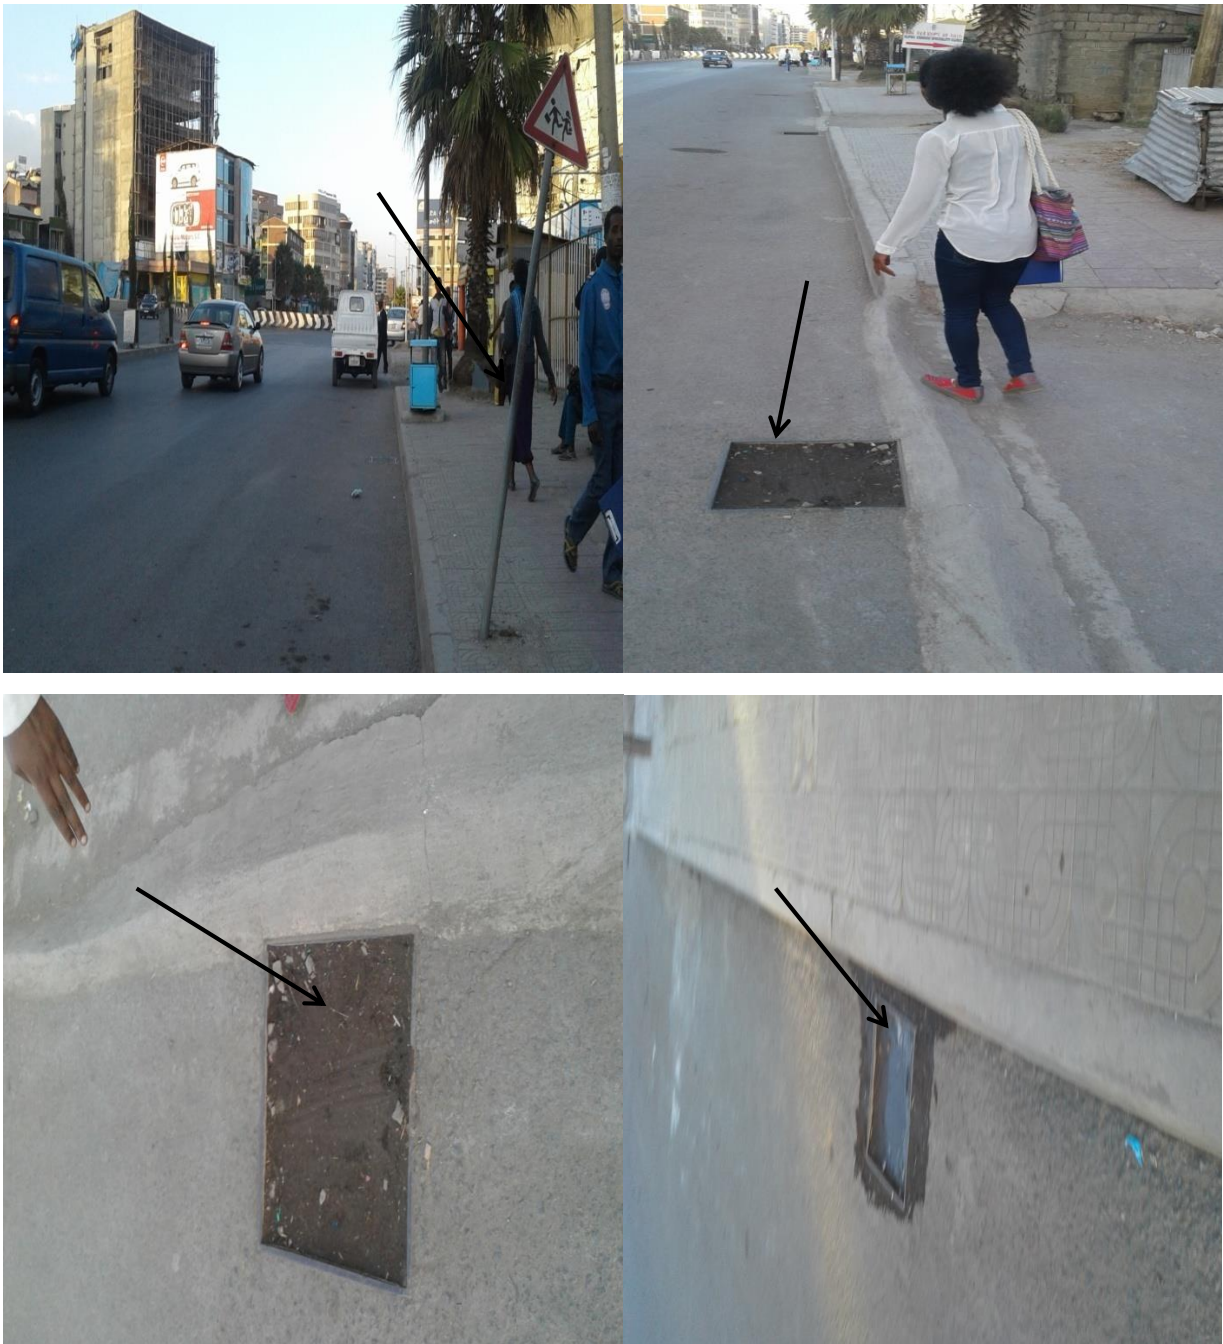
Figure 14. Photo. Damaged traffic sign, blocked ditches.
