**Analysis on Road Safety Inspection using Analytical Hierarchy
Process (AHP) Method**

A case study in Addis Ababa city

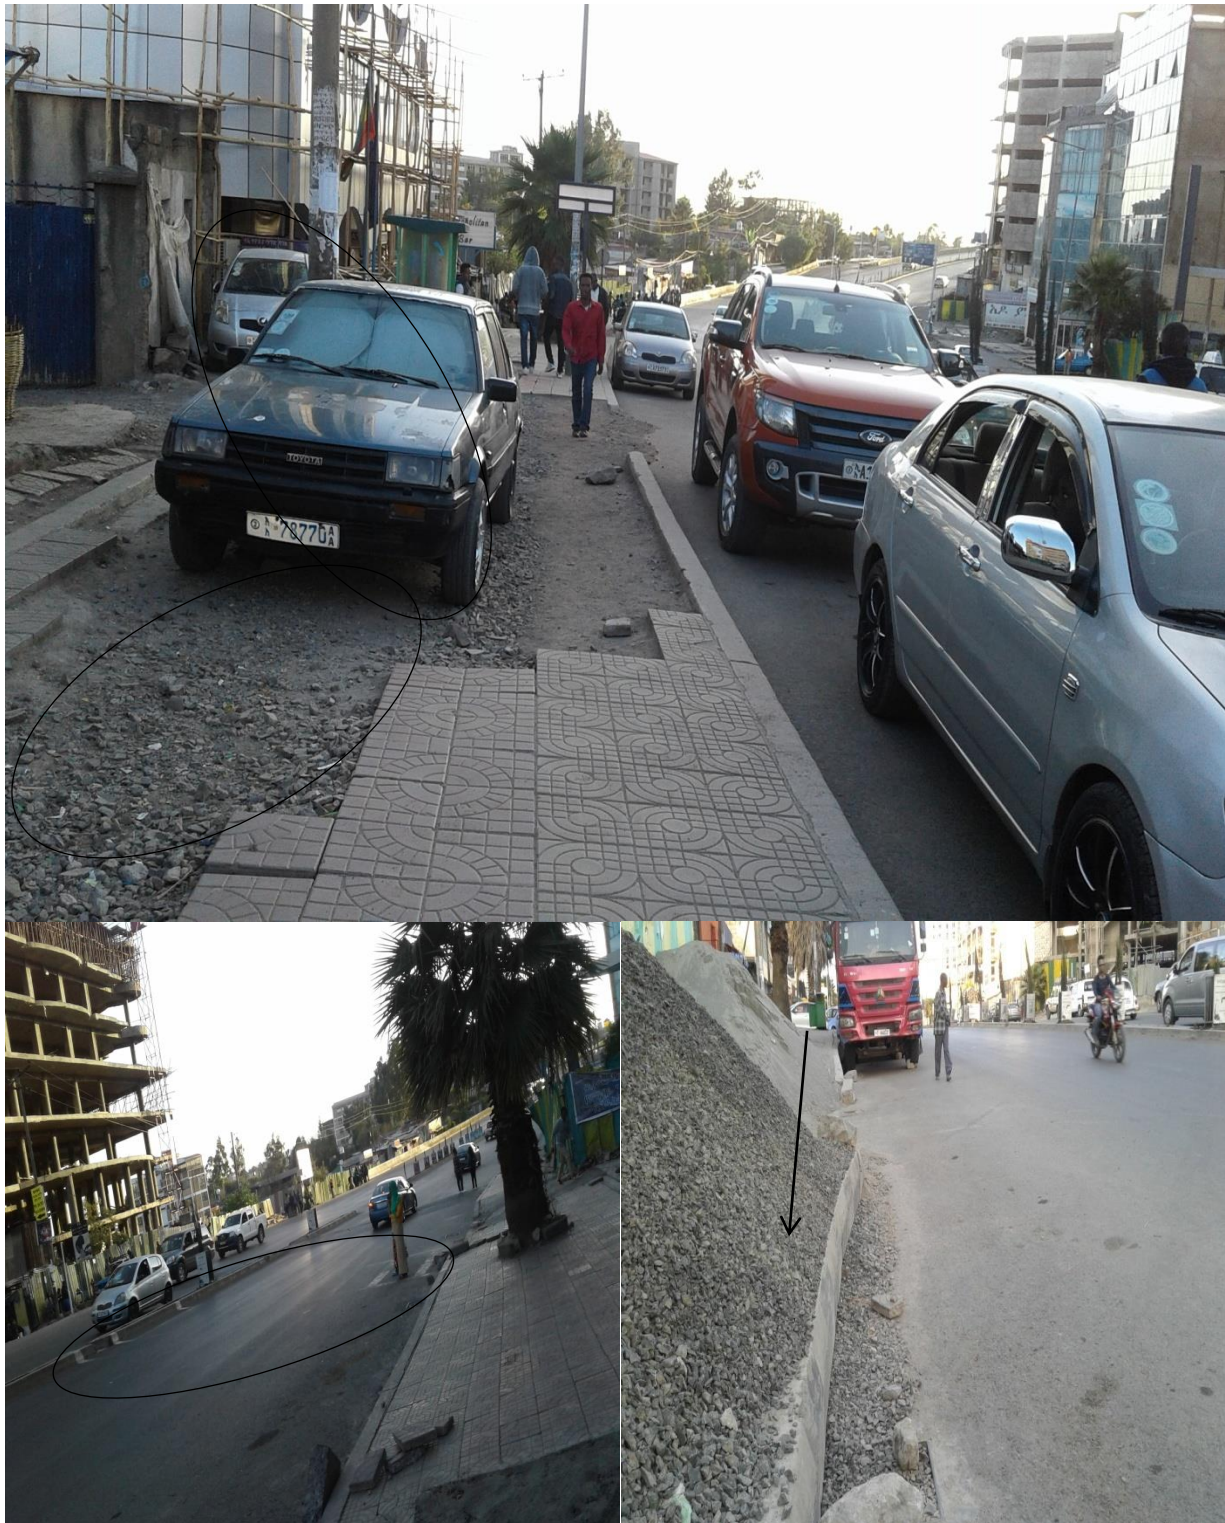
Figure 15. Photo. Damaged walk way, vehicles parked on walkway, faded pedestrian cross marking and dumped construction material on walkway

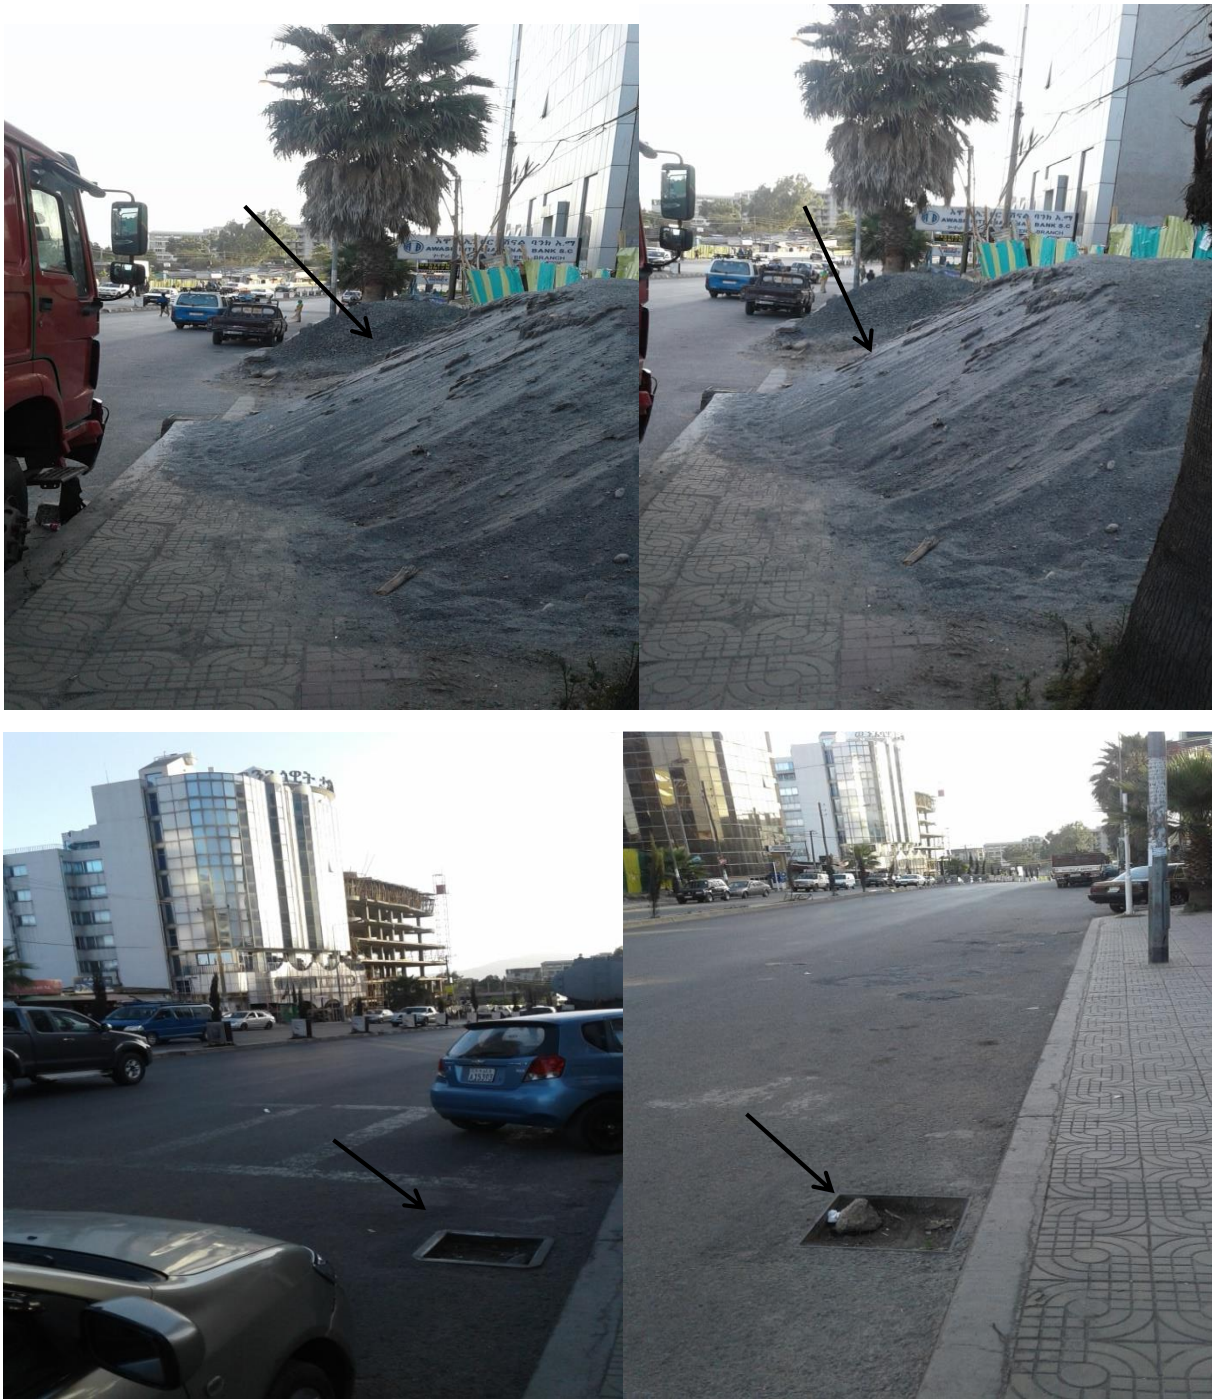
Figure 16. Photo. Construction materials dumped on the walkway, blocked ditches

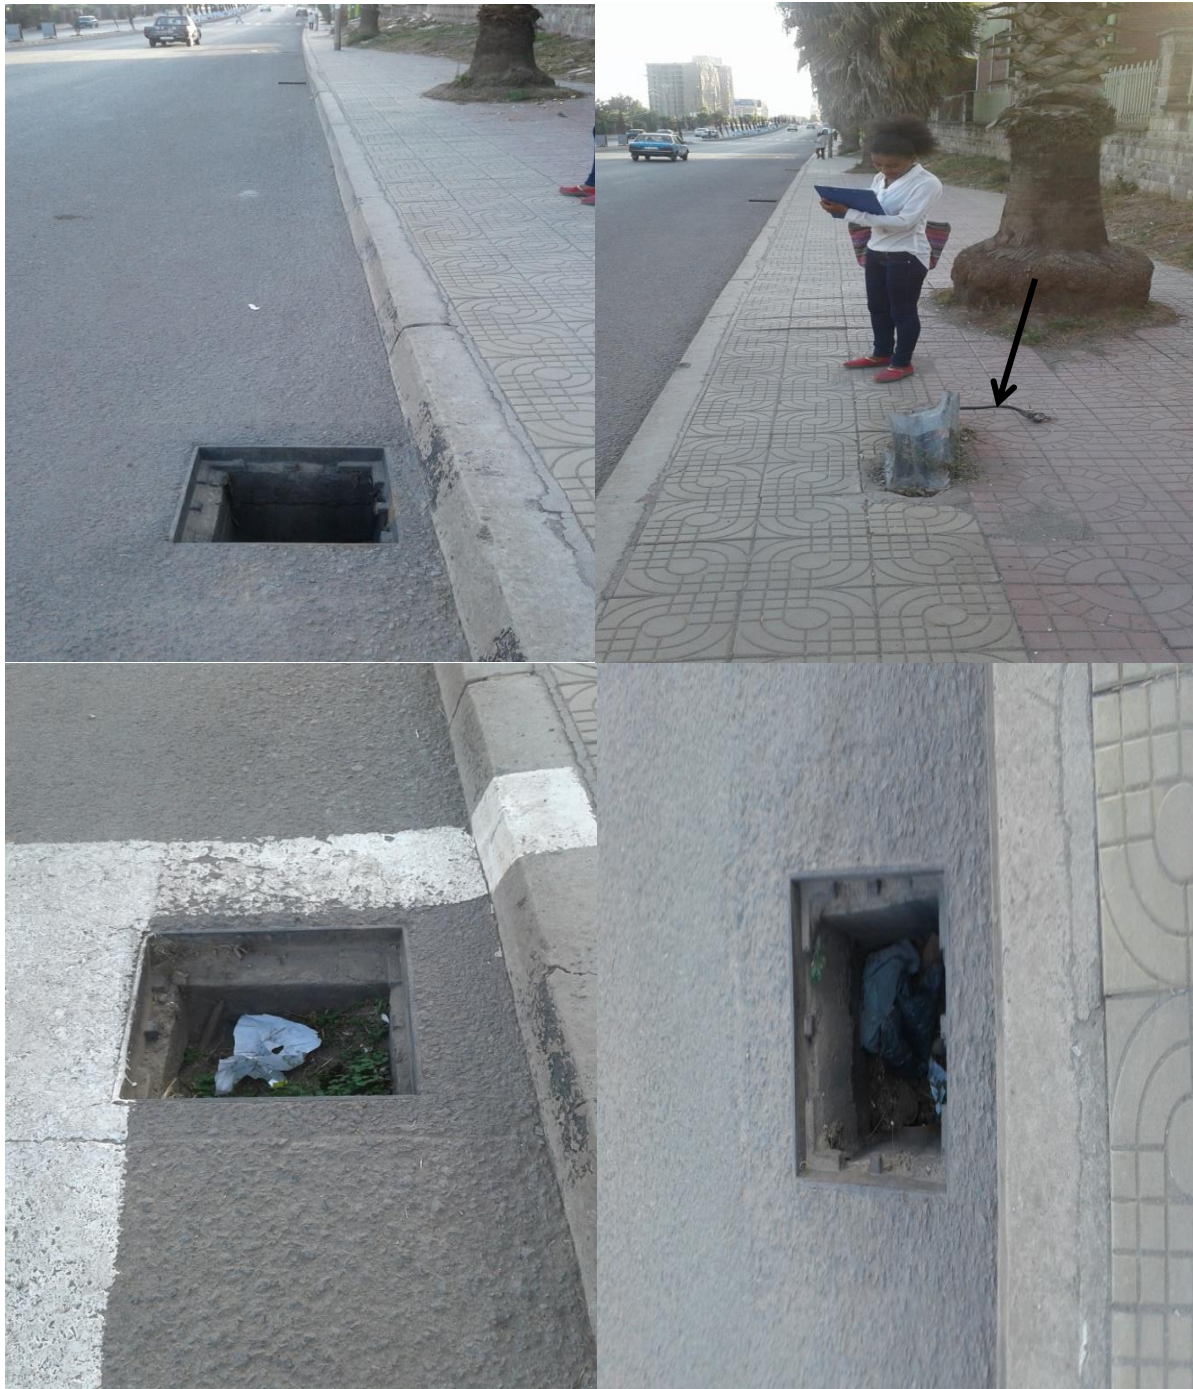
Figure 19. Photo. Uncovered ditch filled with dirt, damaged lighting

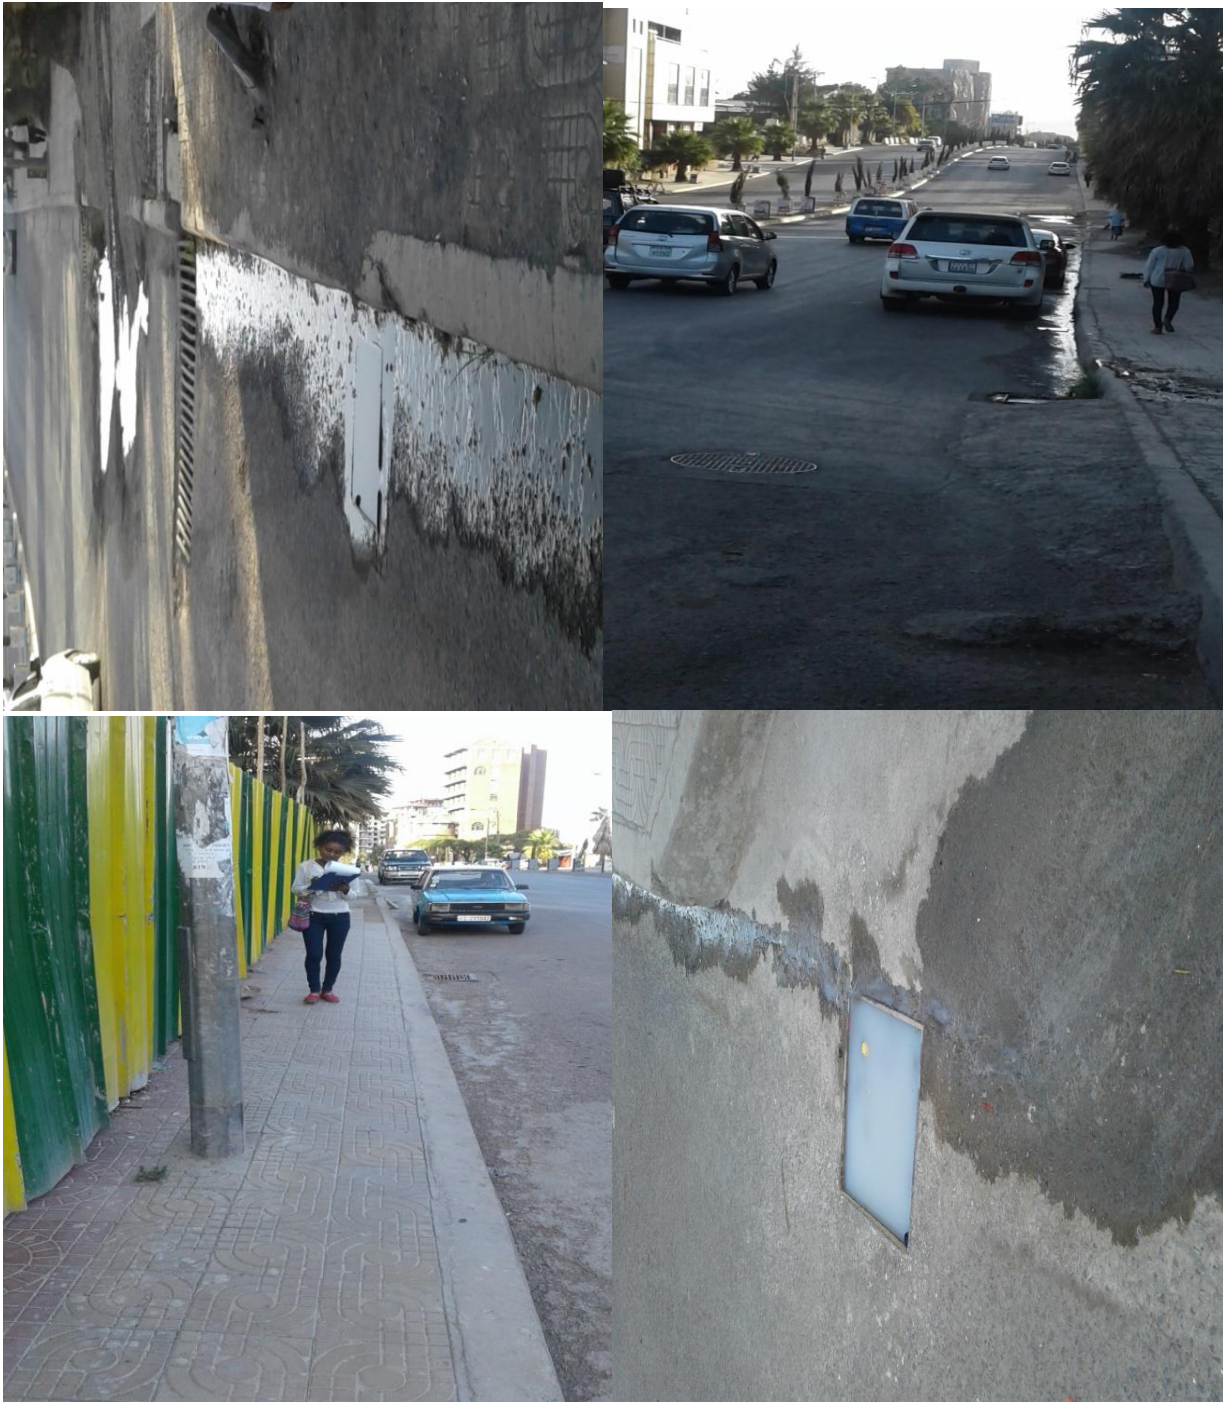
Figure 20. Photo. Ponding water on the pavement surface due to poor drainage, steep vertical alignment, construction fence reduce walkway width

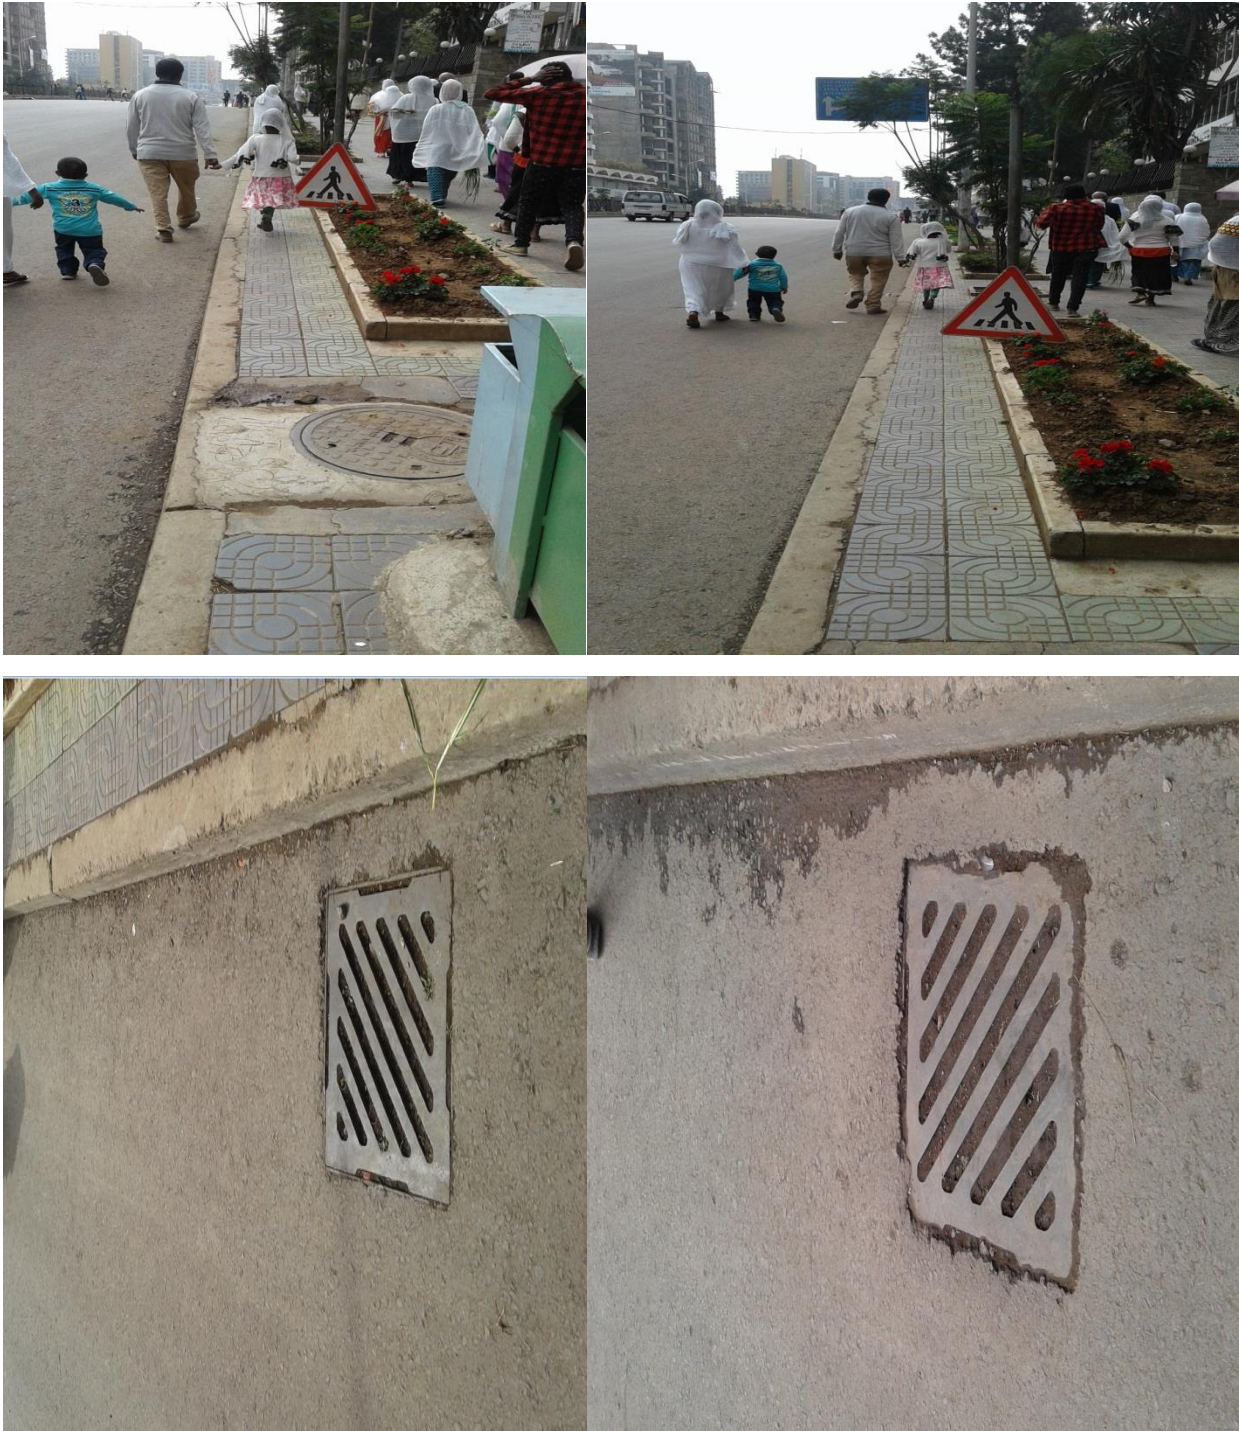
Figure 21. Photo. Damaged traffic sign, blocked inlets

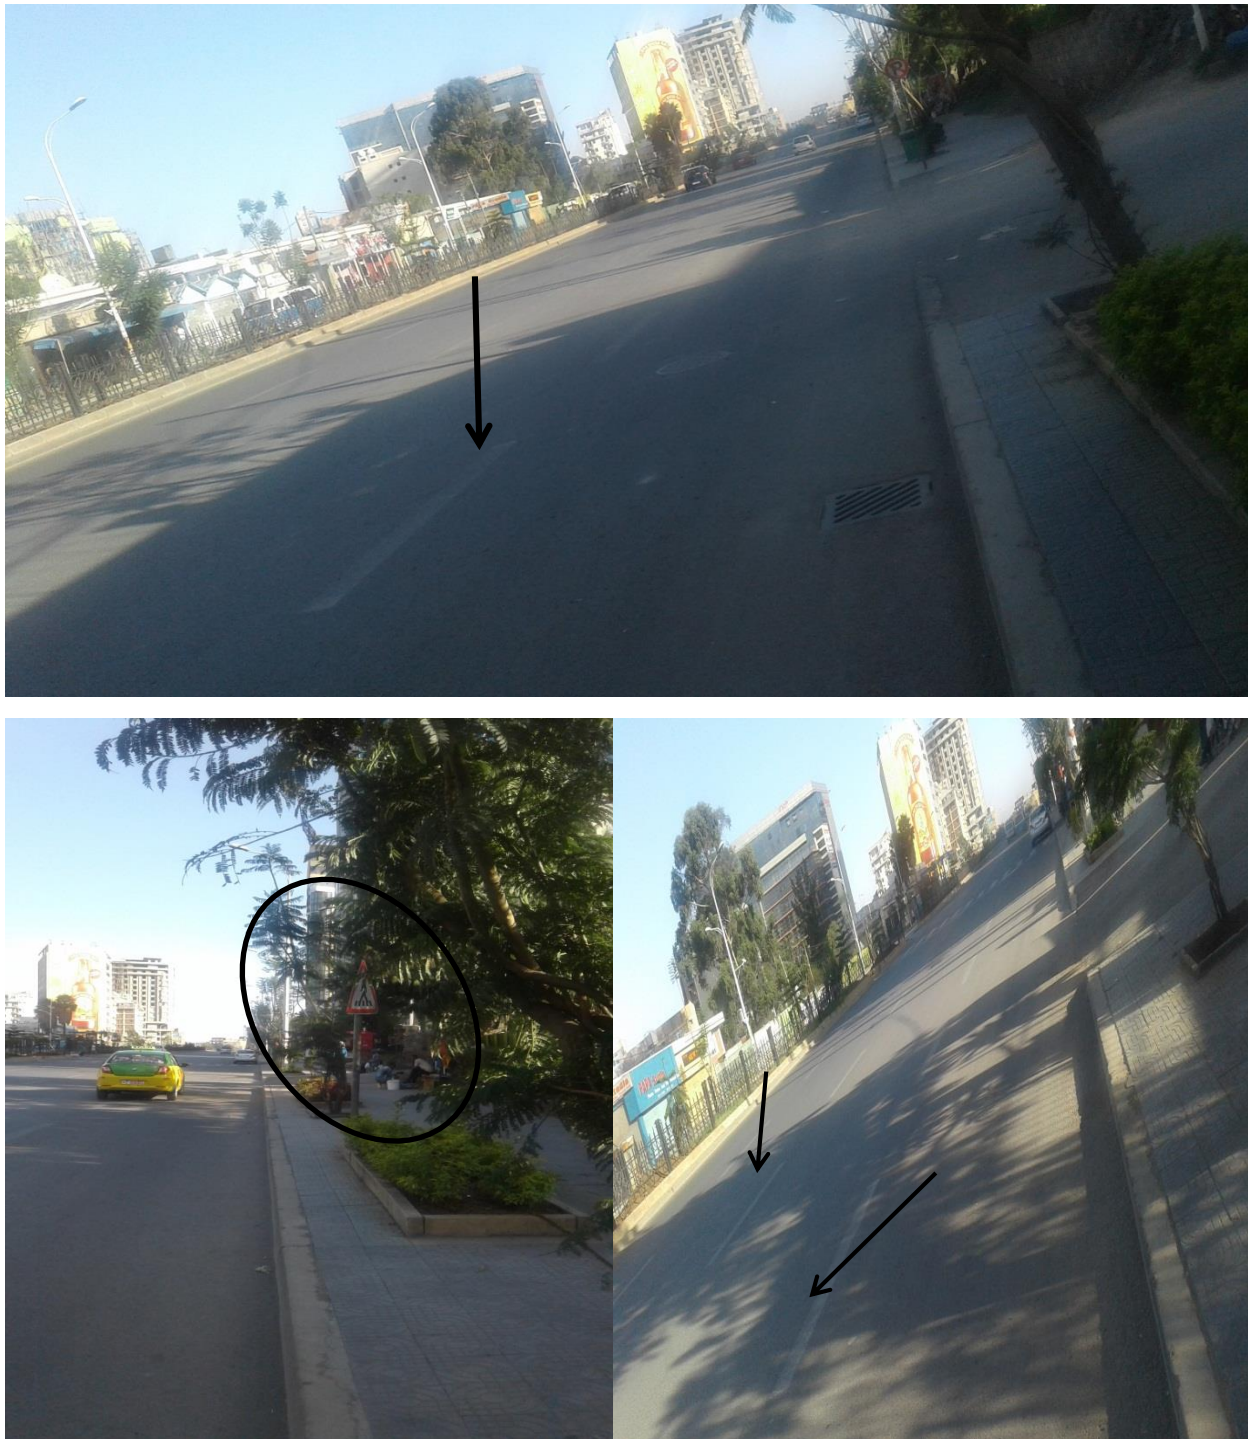
Figure 22.Photo.Faded road marking, road side vegetation obstruct visibility of traffic sign

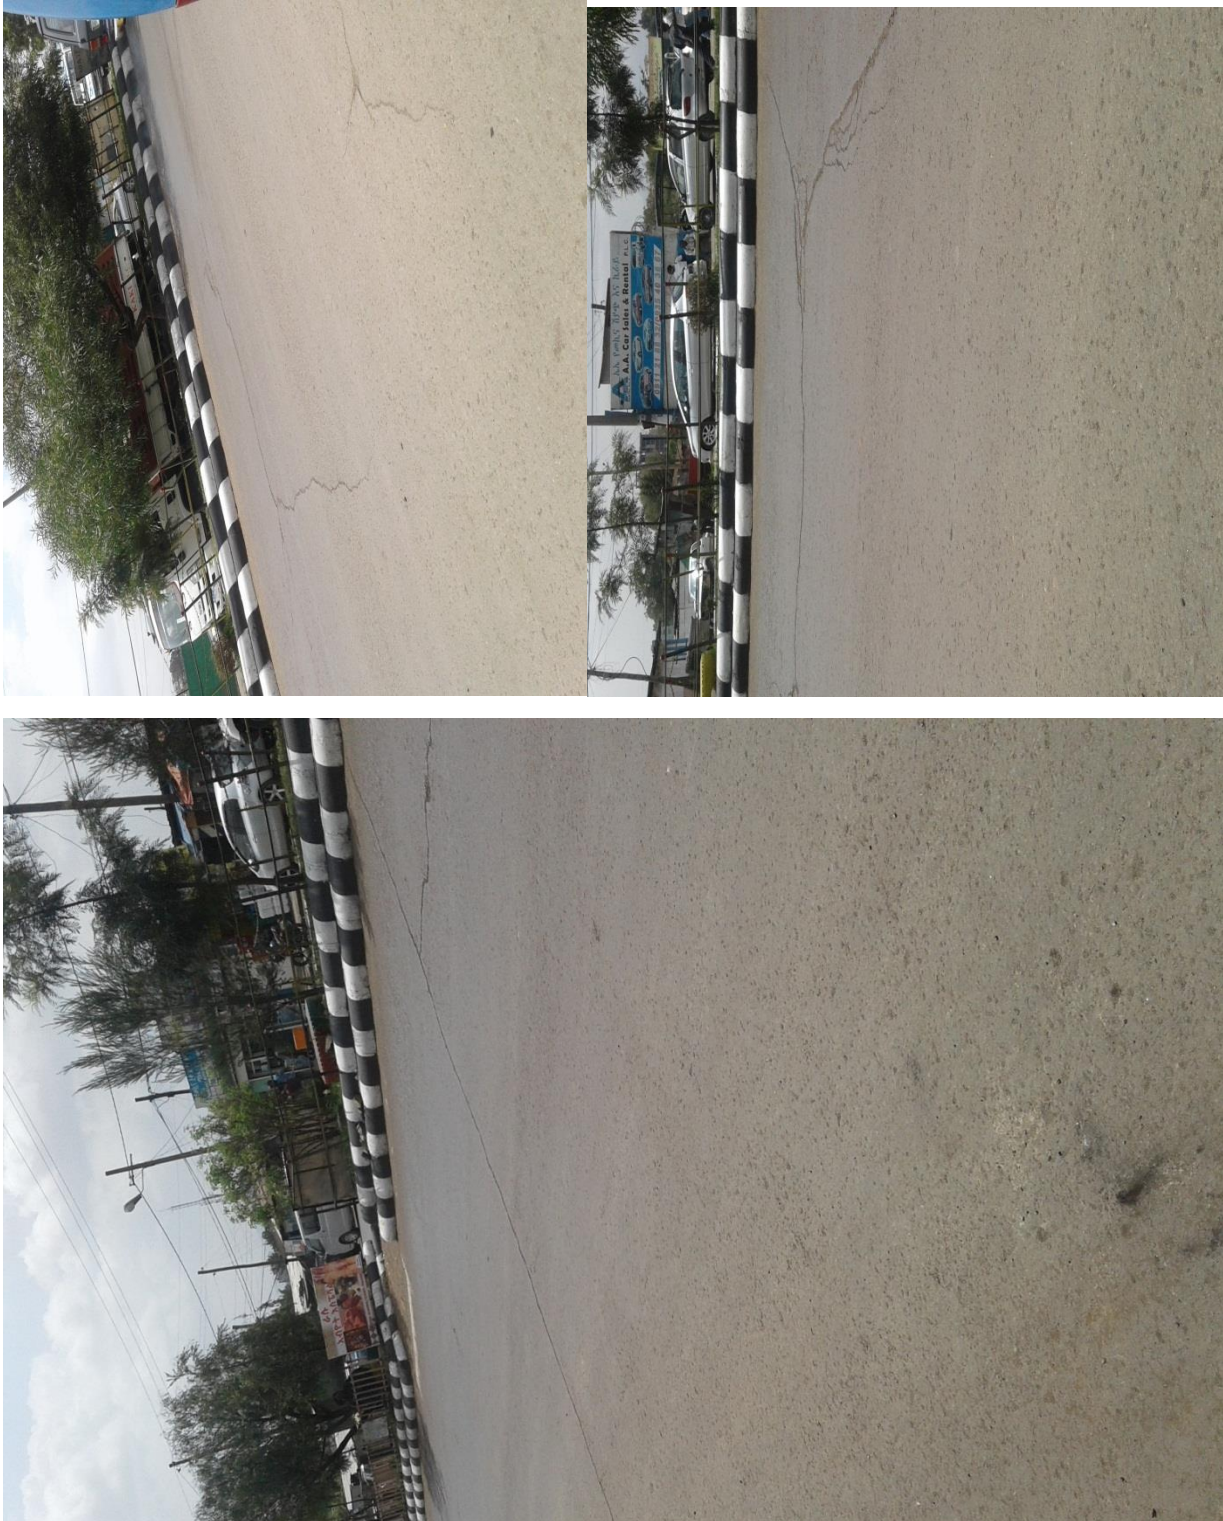
Figure 28. Photo. Longitudinal and transverse pavement crack

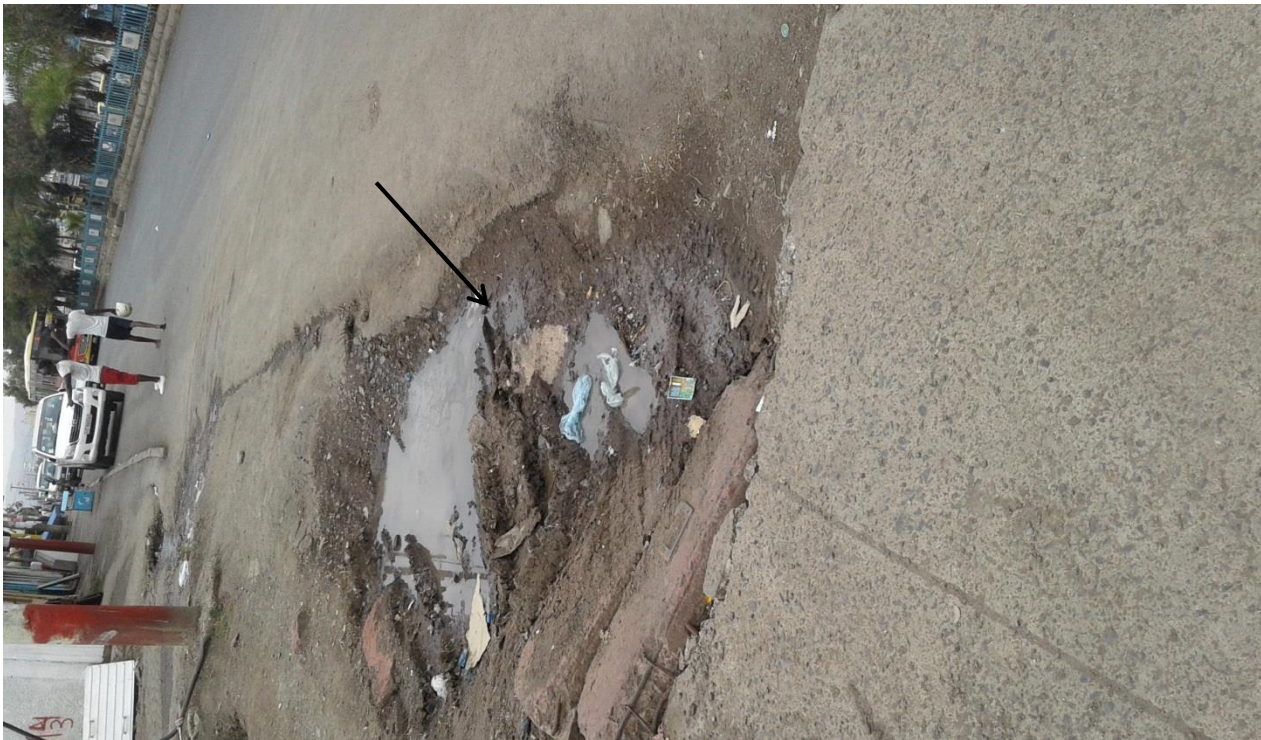
Figure 29. Photo. Pavement crack and blocked roadside drainage inlet

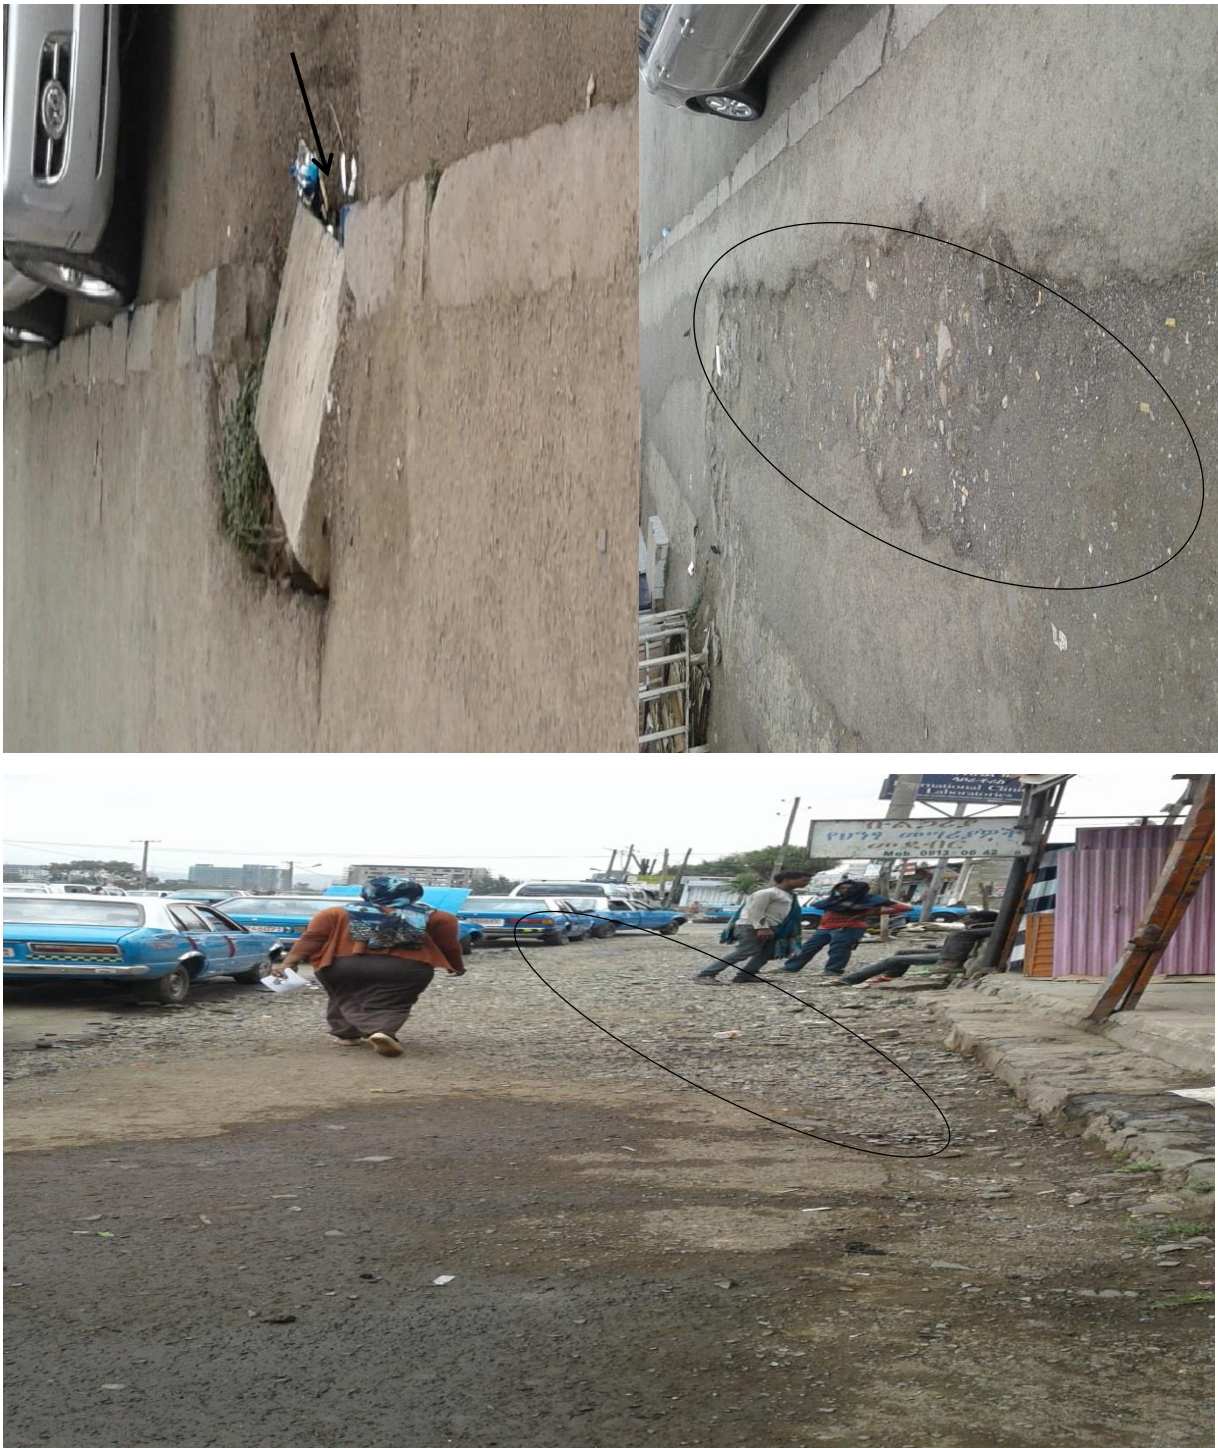
Figure 30.Photo.Deteriorated walk way, blocked inlet

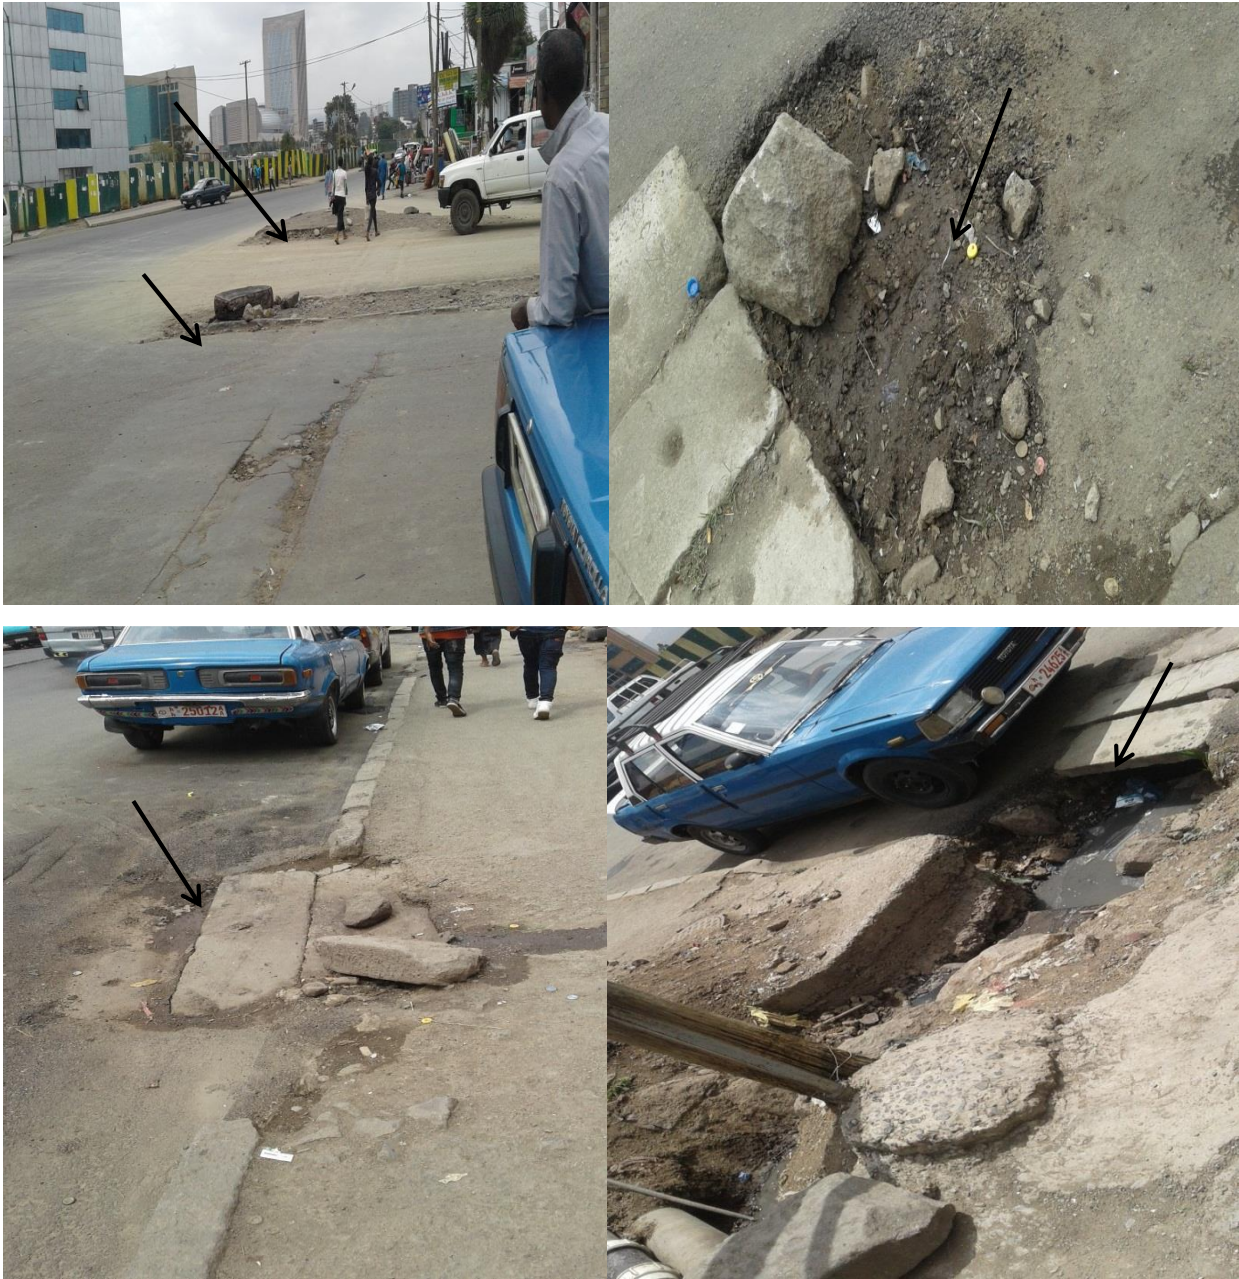
Figure 31. Photo. Deteriorated Island, blocked poor drainage

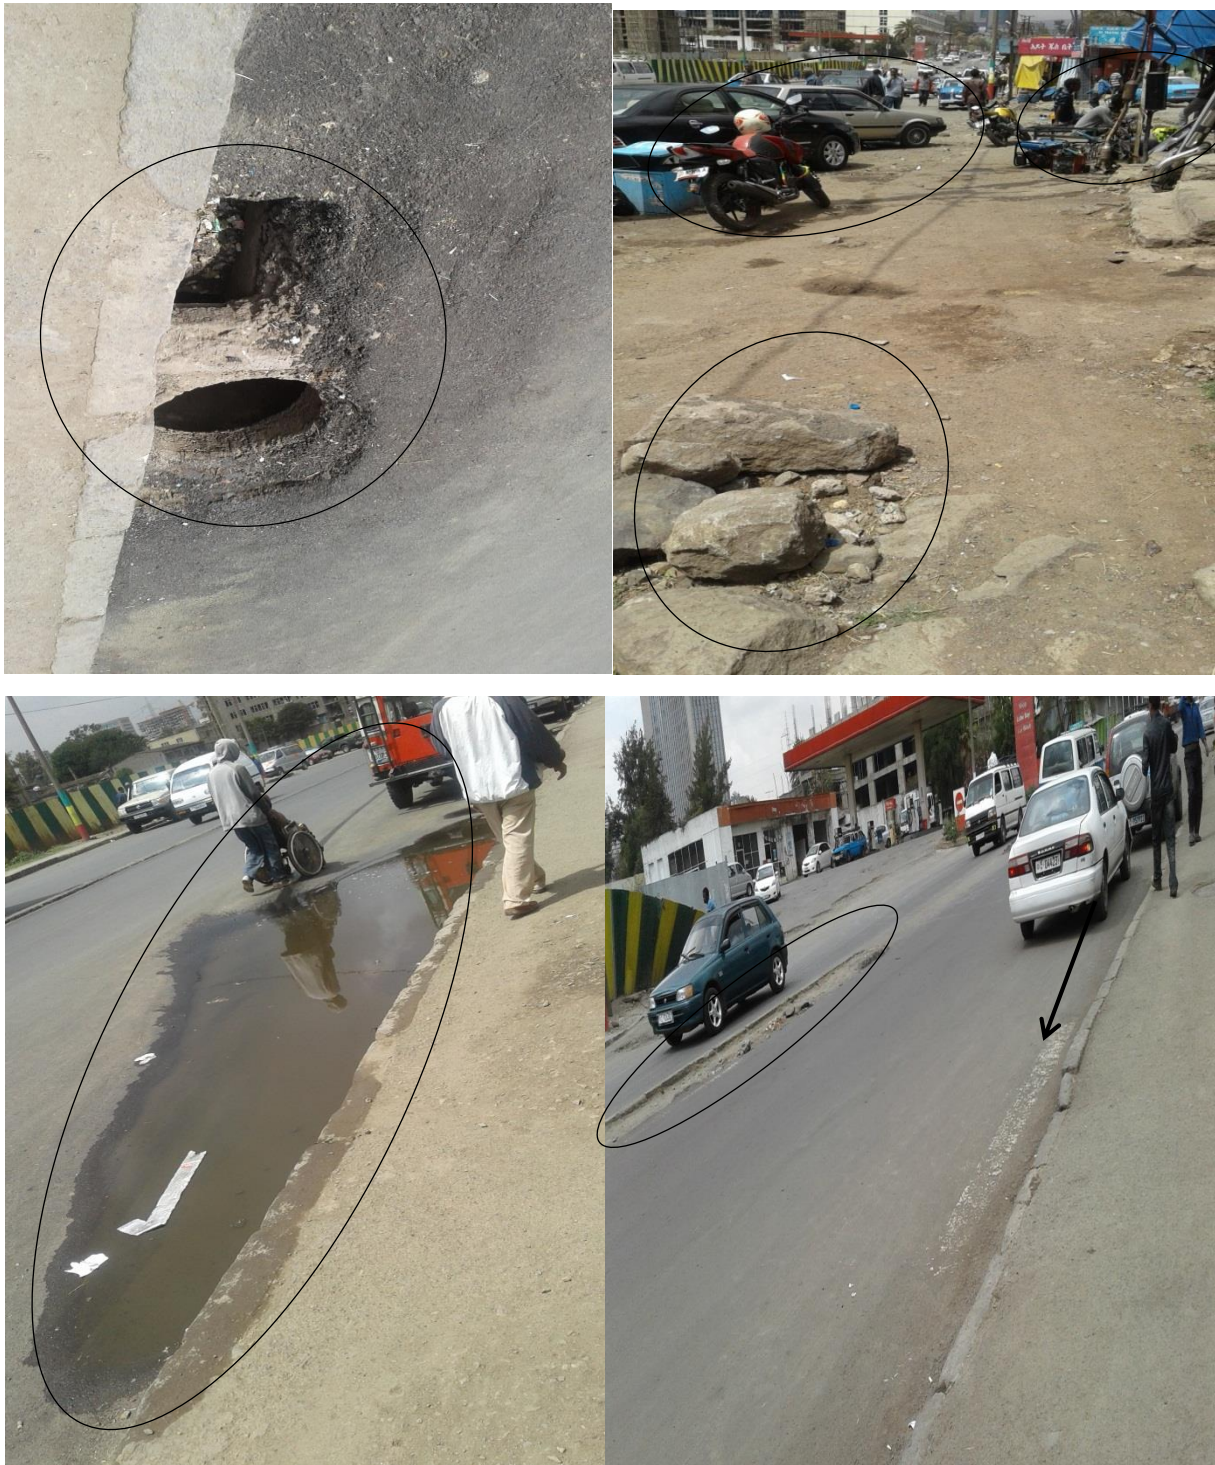
Figure 32. Photo. Uncovered ditch, ponding of water on the pavement surface, faded pedestrian cross marking, damaged median, obstructed walkway

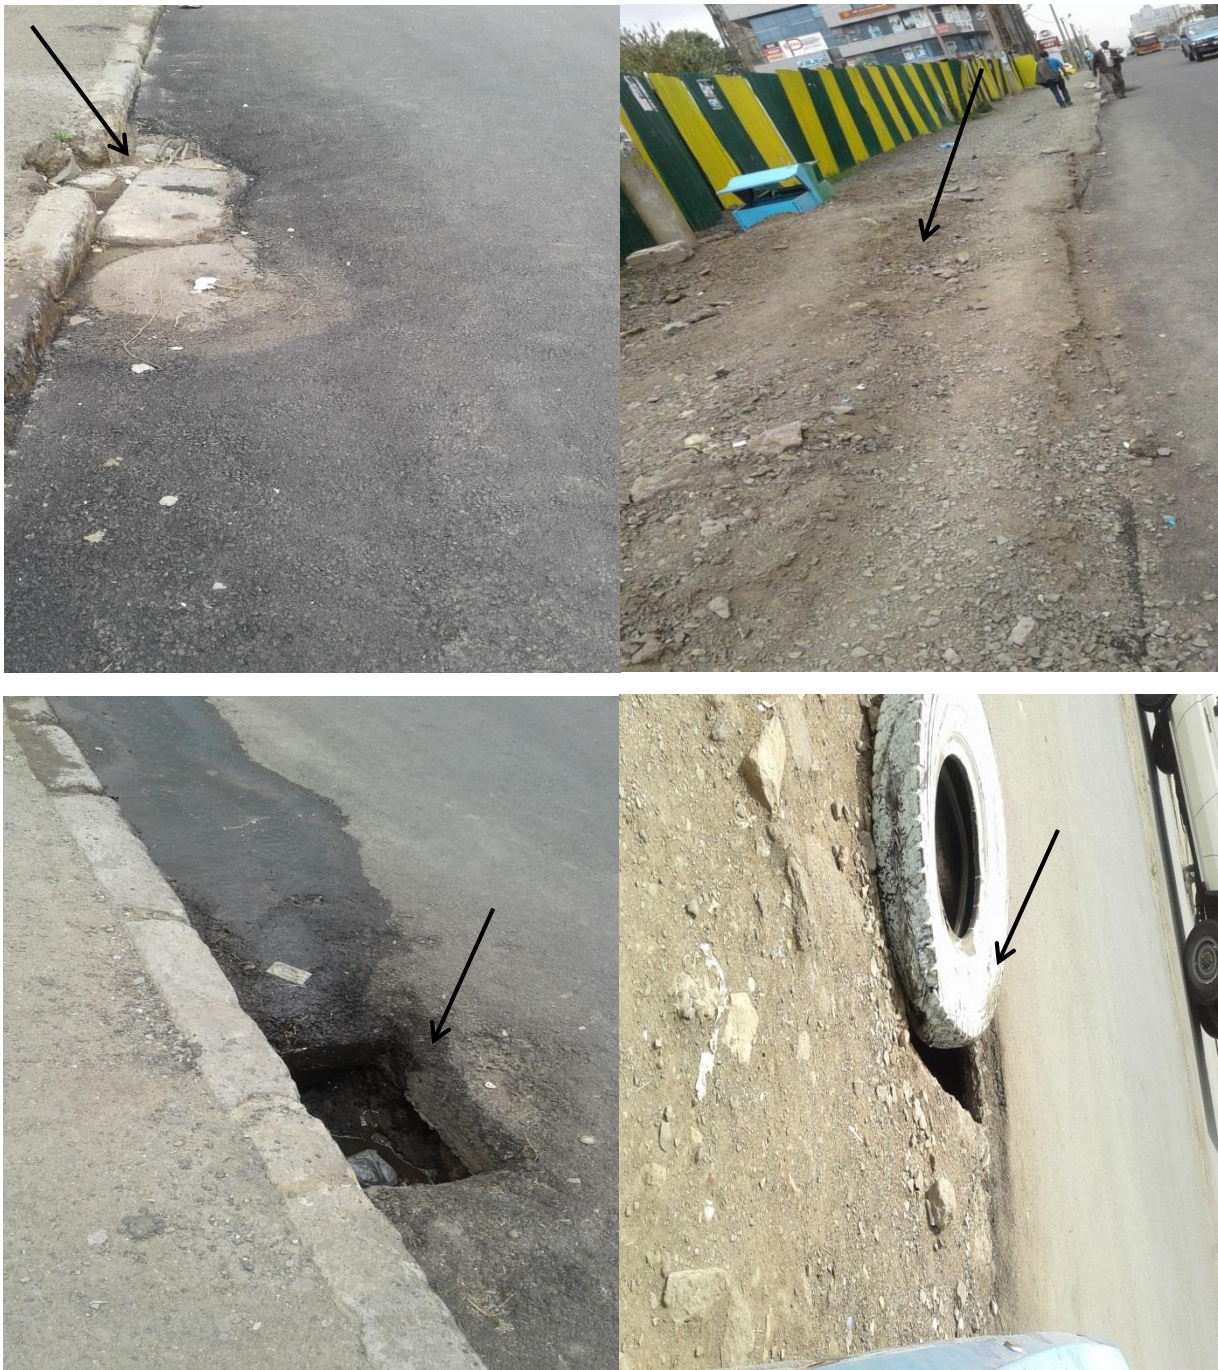
Figure 33. Photo. Blocked road side inlet, construction debris on walkway, uncovered ditch, and improper drainage cover

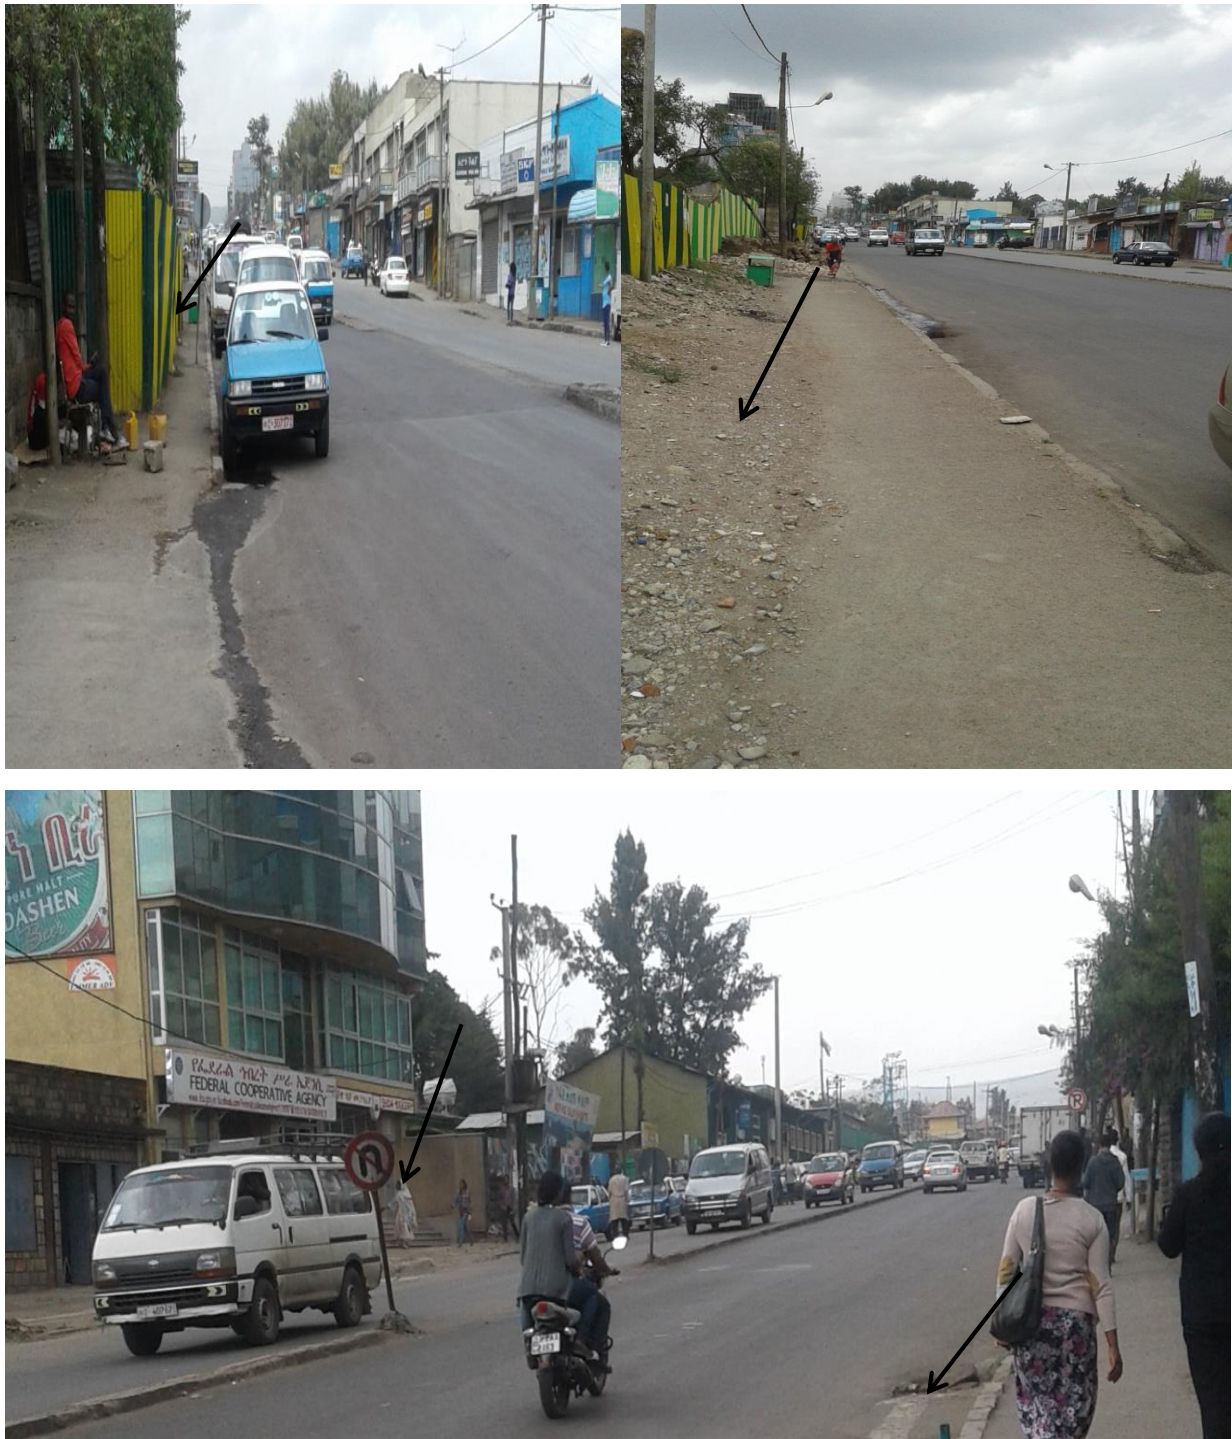
Figure 34. Photo. Construction fence and debris reduced walkway width, damaged sign, faded marking
