**Analysis on Road Safety Inspection using Analytical Hierarchy
Process (AHP) Method**

A case study in Addis Ababa city

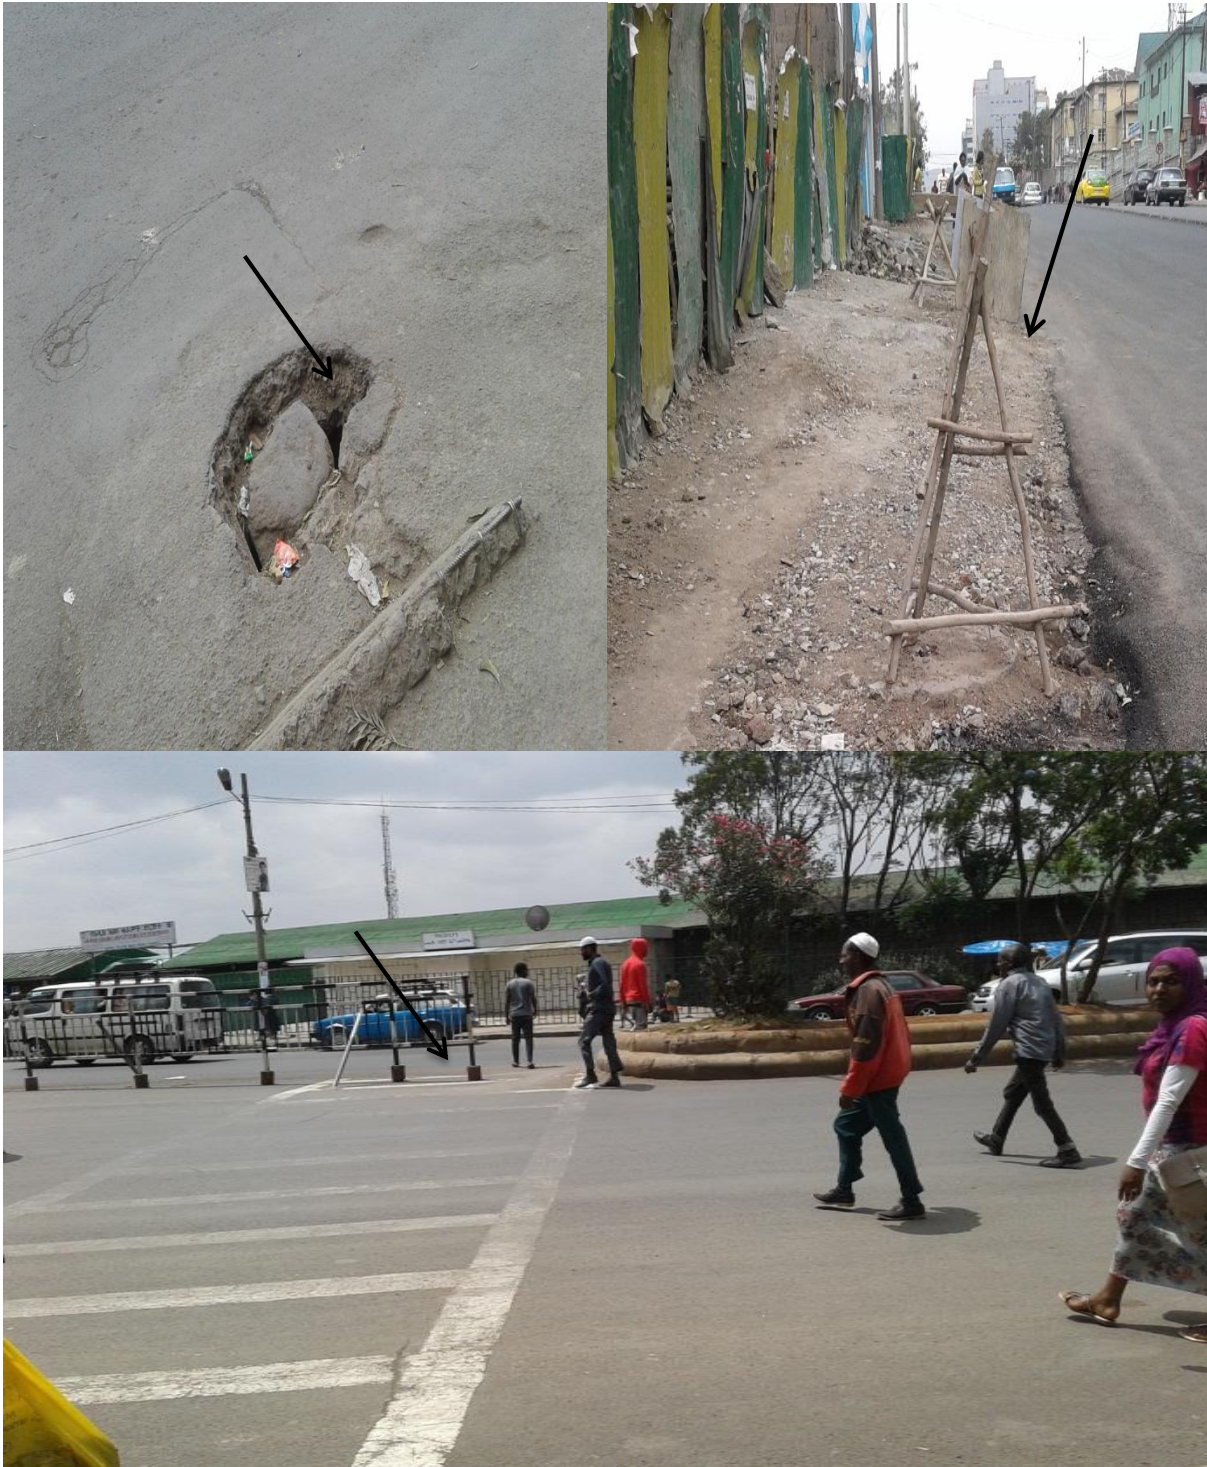
Figure 35.Photo.Incorrect drainage cover, blocked walk way, pedestrian cross marking is not continuous up to full width of the road

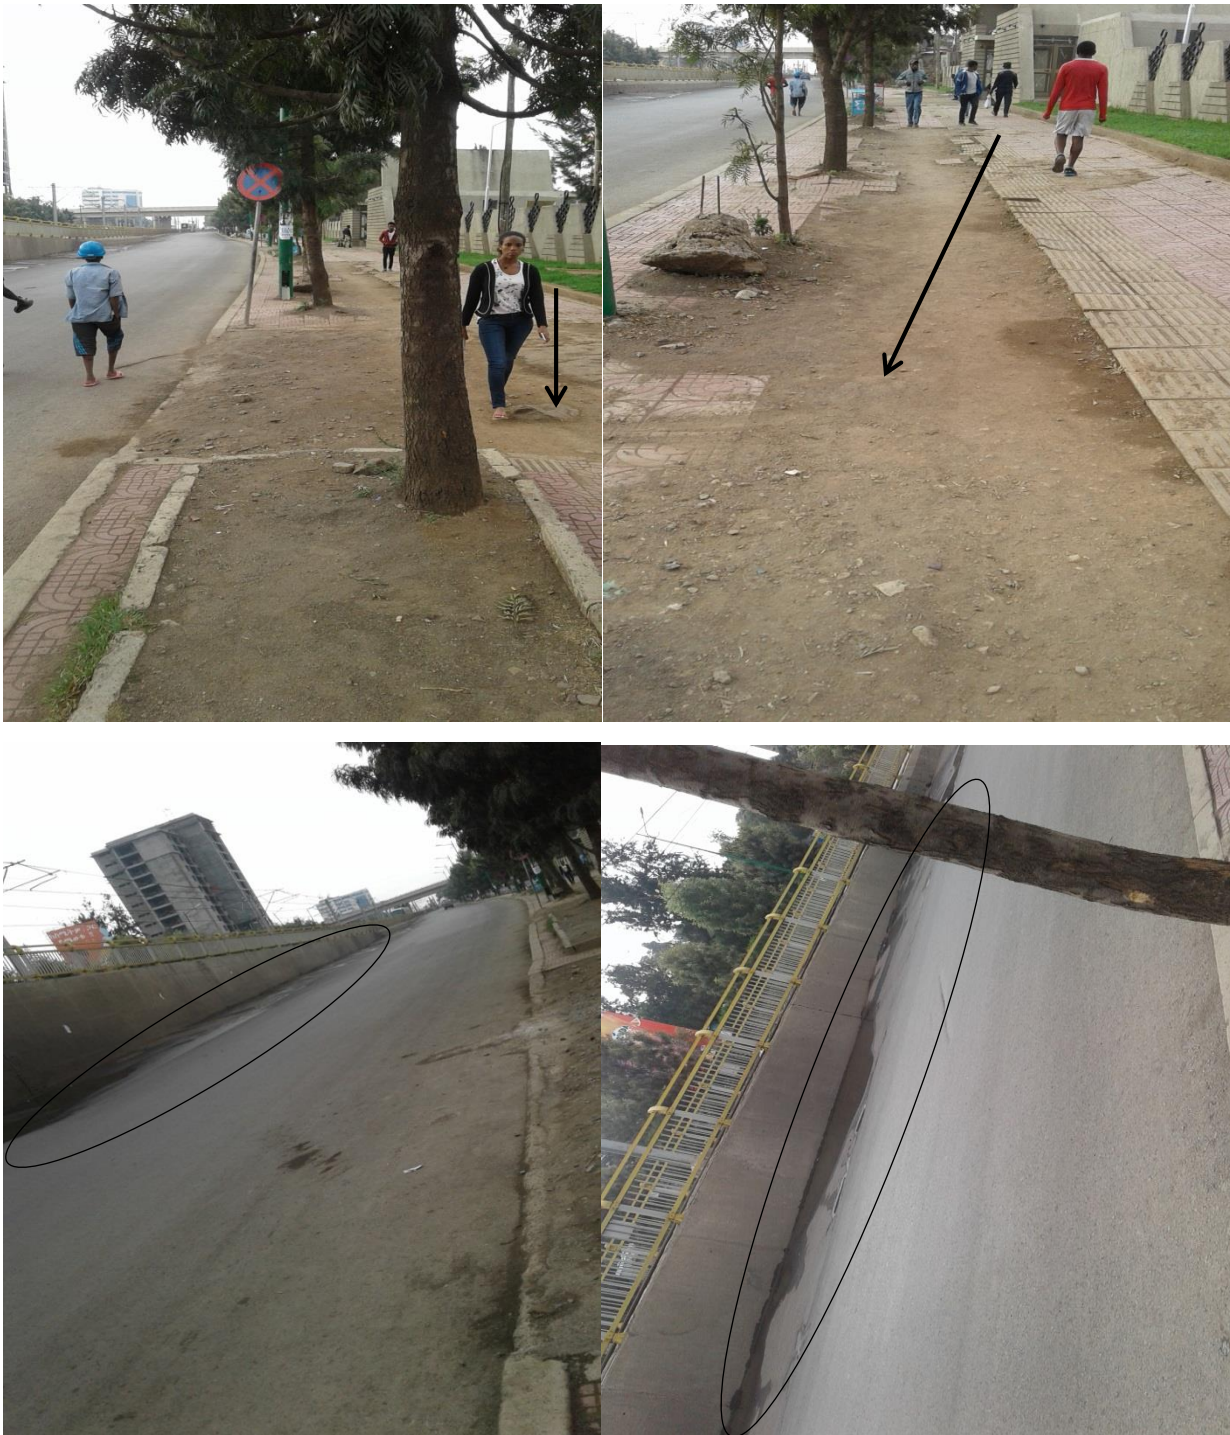
Figure 38. Photo. Damaged walk way, pavement depression, water ponding on the pavement surface

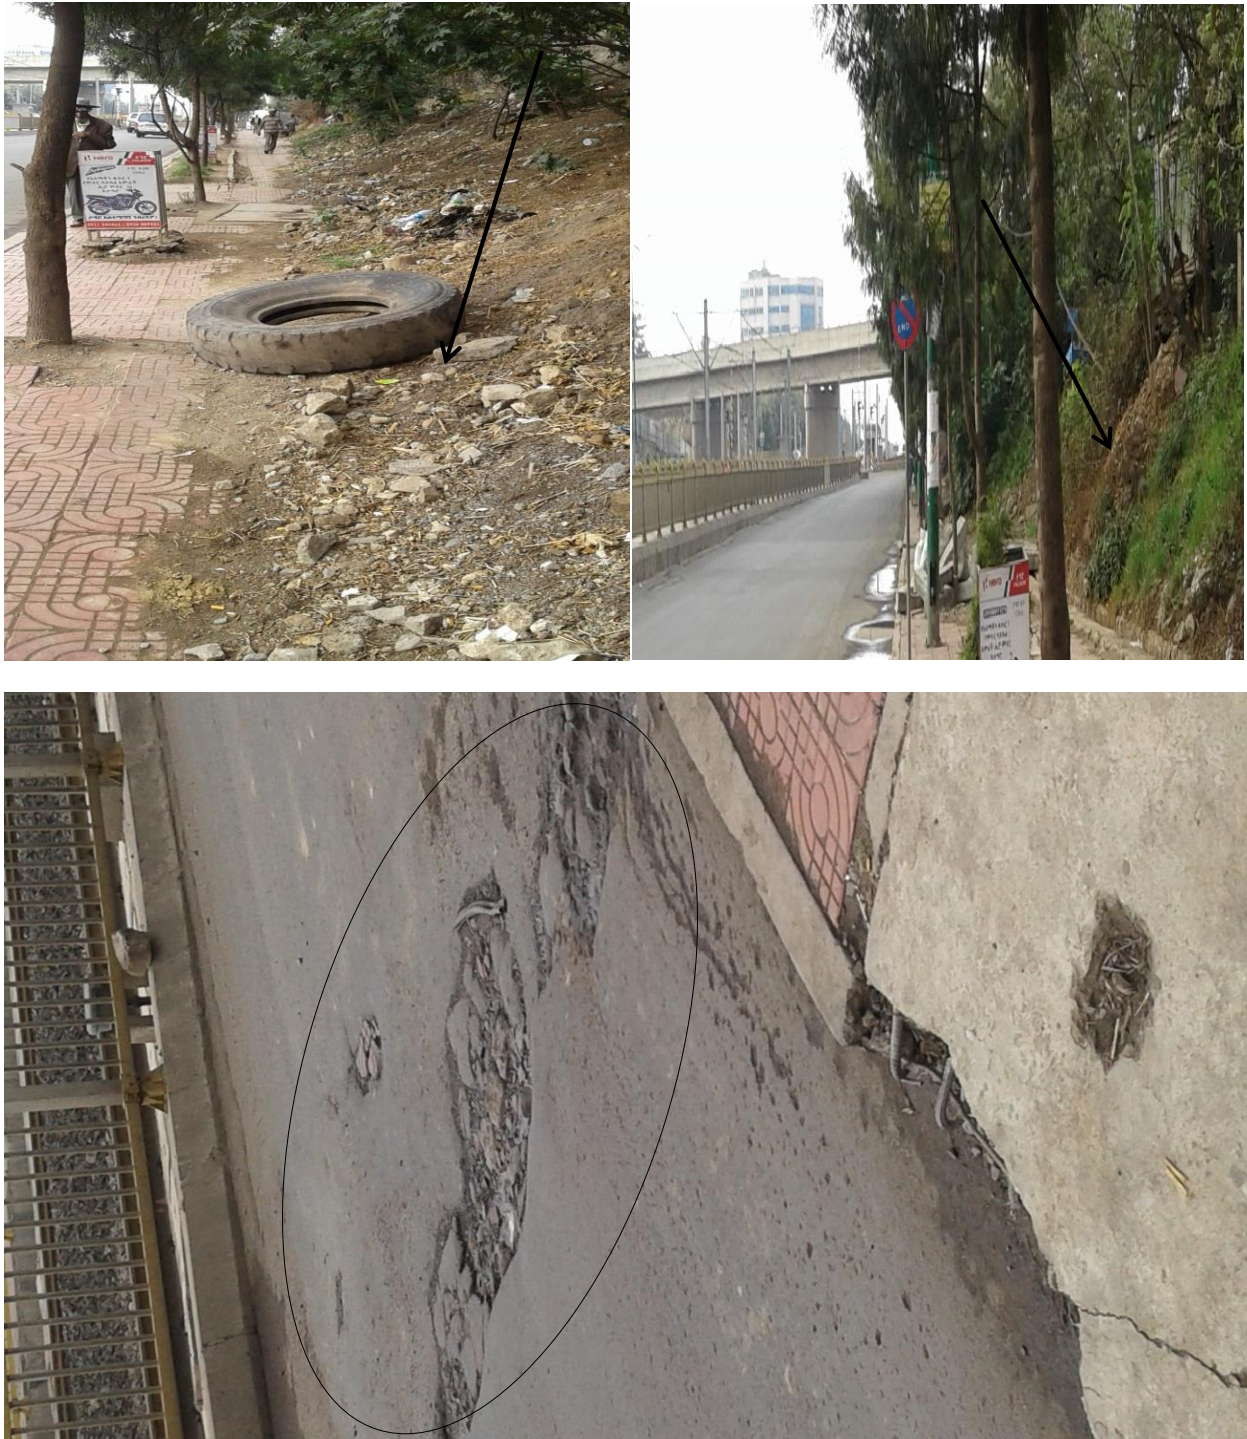
Figure 39. Photo. Trashes and vegetation reduced walk way width, Pavement surface deterioration

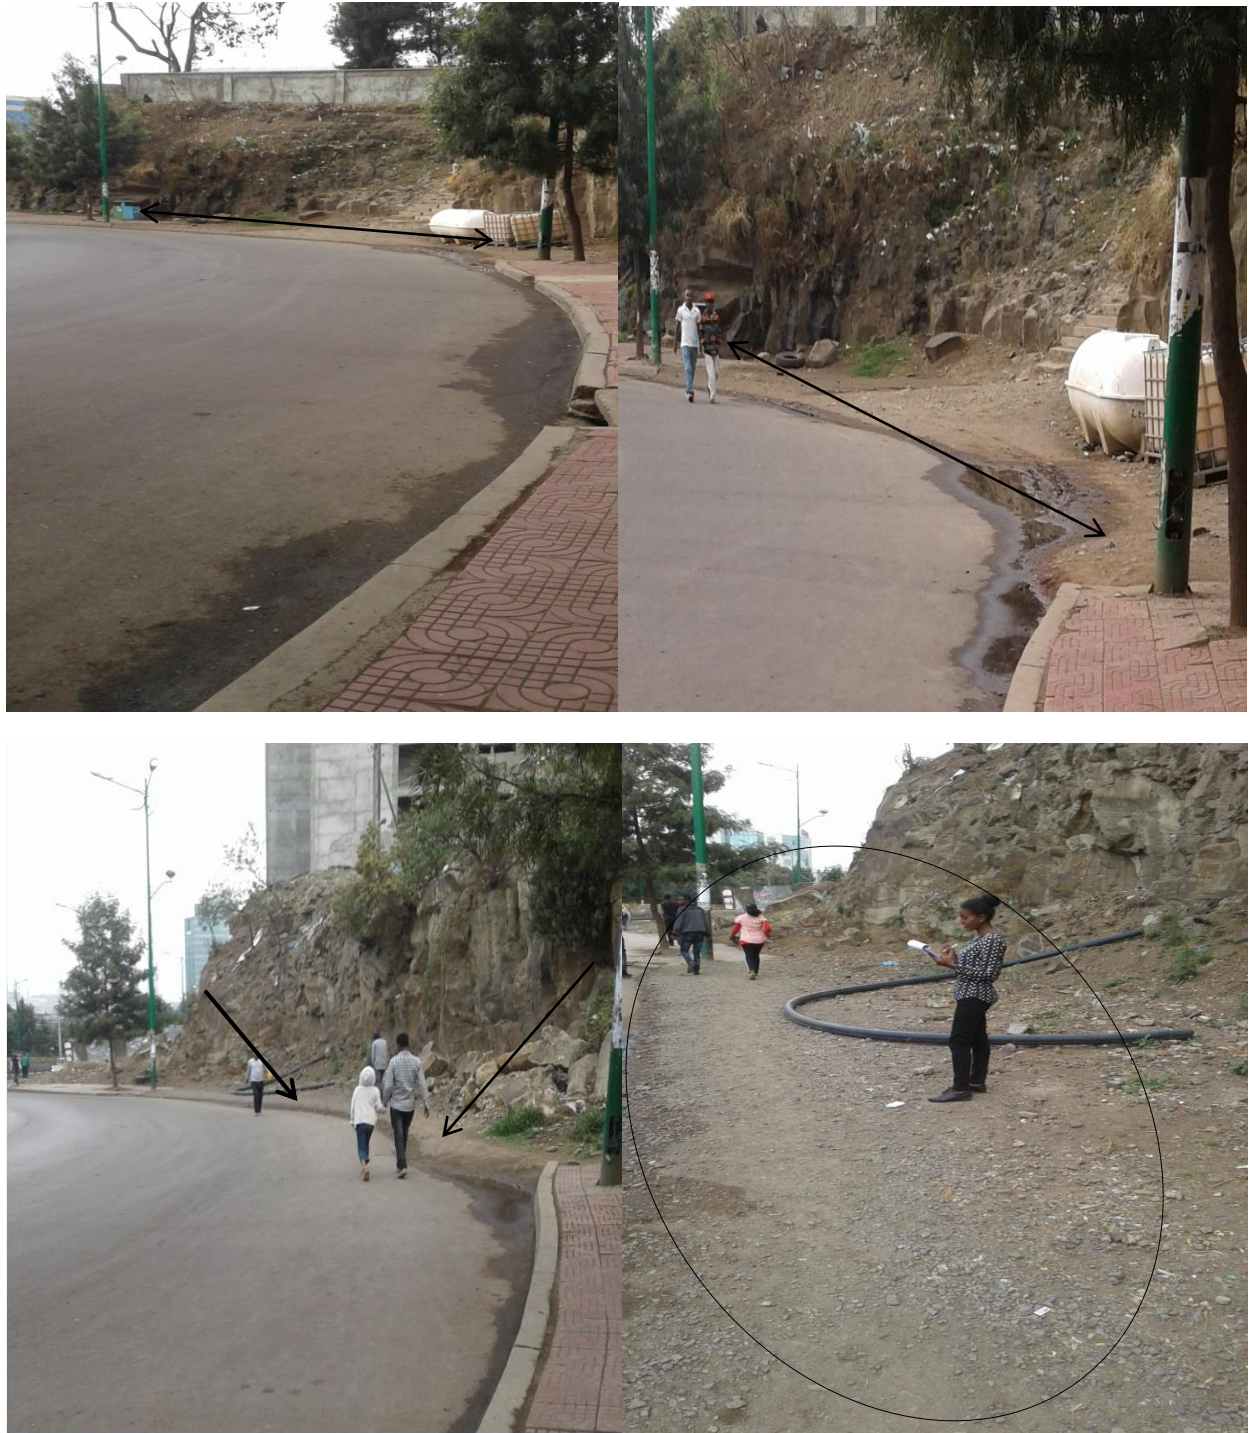
Figure 40. Photo. Provision of pedestrian walkway is not continuous on both sides of the road

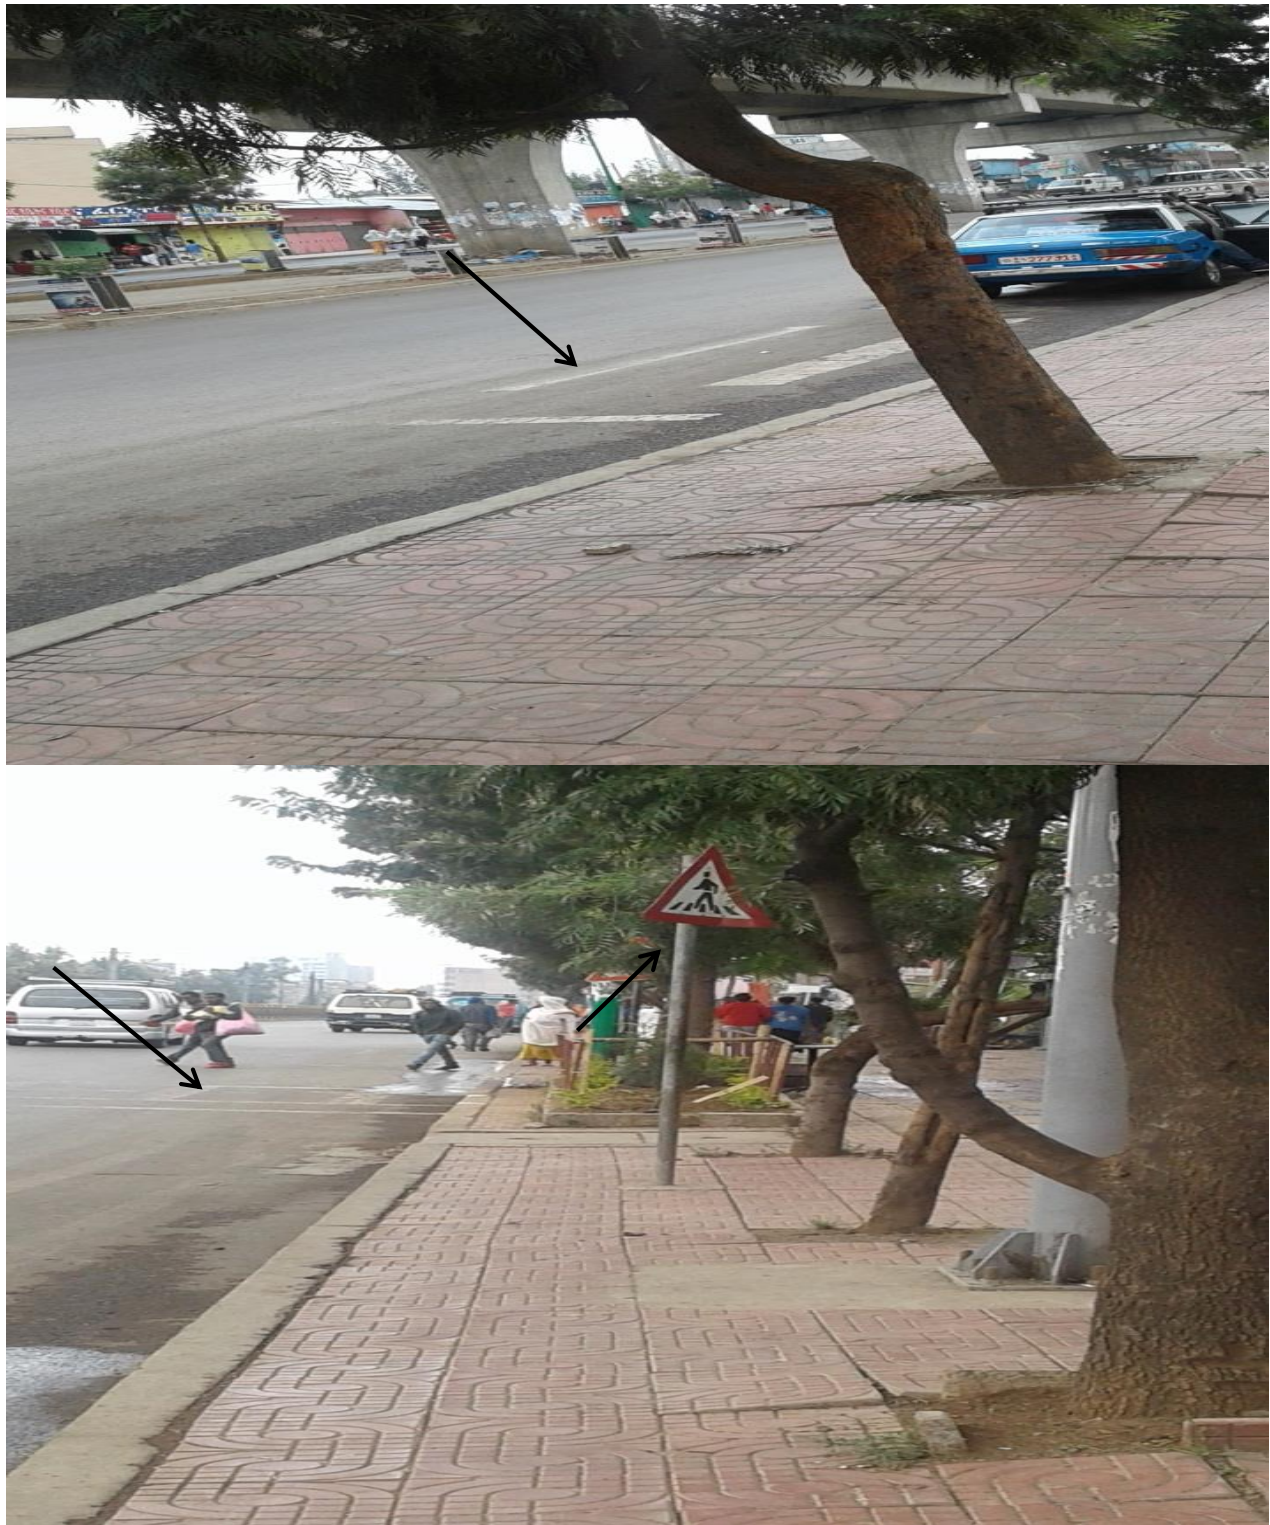
Figure 41. Photo. Faded pedestrian cross marking, damaged traffic sign, Long Branch of road side trees.

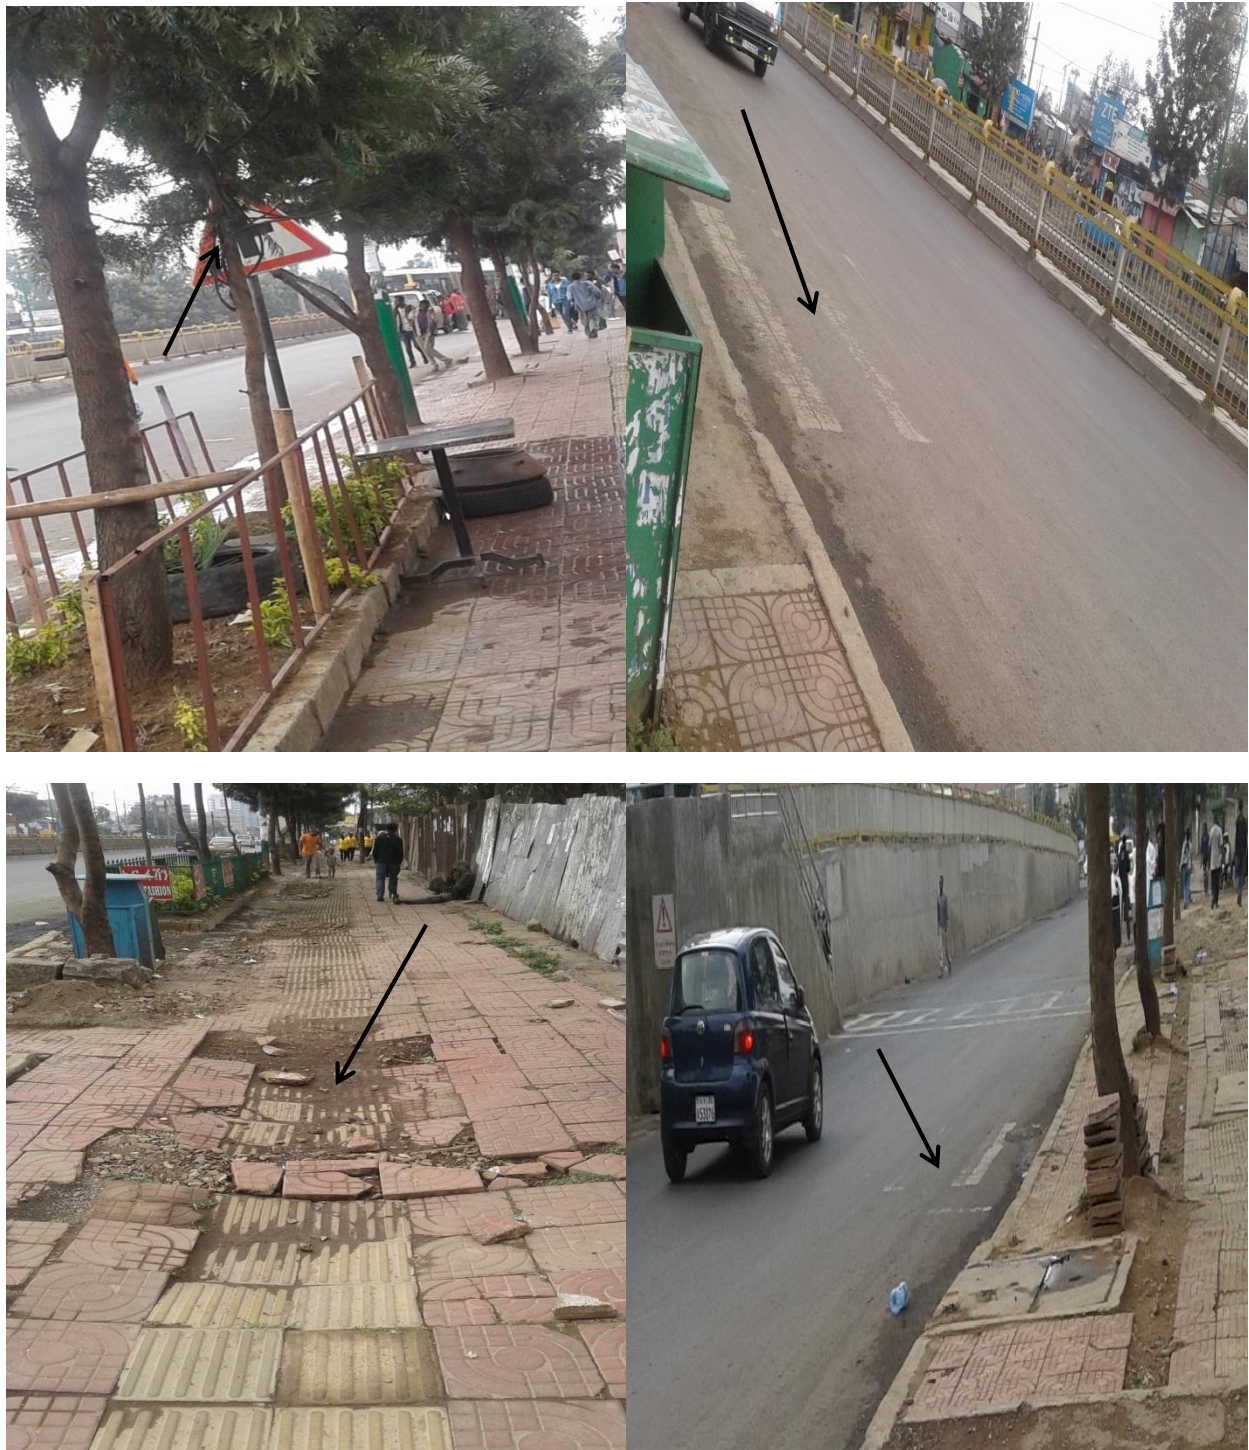
Figure 42. Photo. Traffic sign obstructed by road side trees, deteriorated walk way, old pedestrian cross marking are not removed

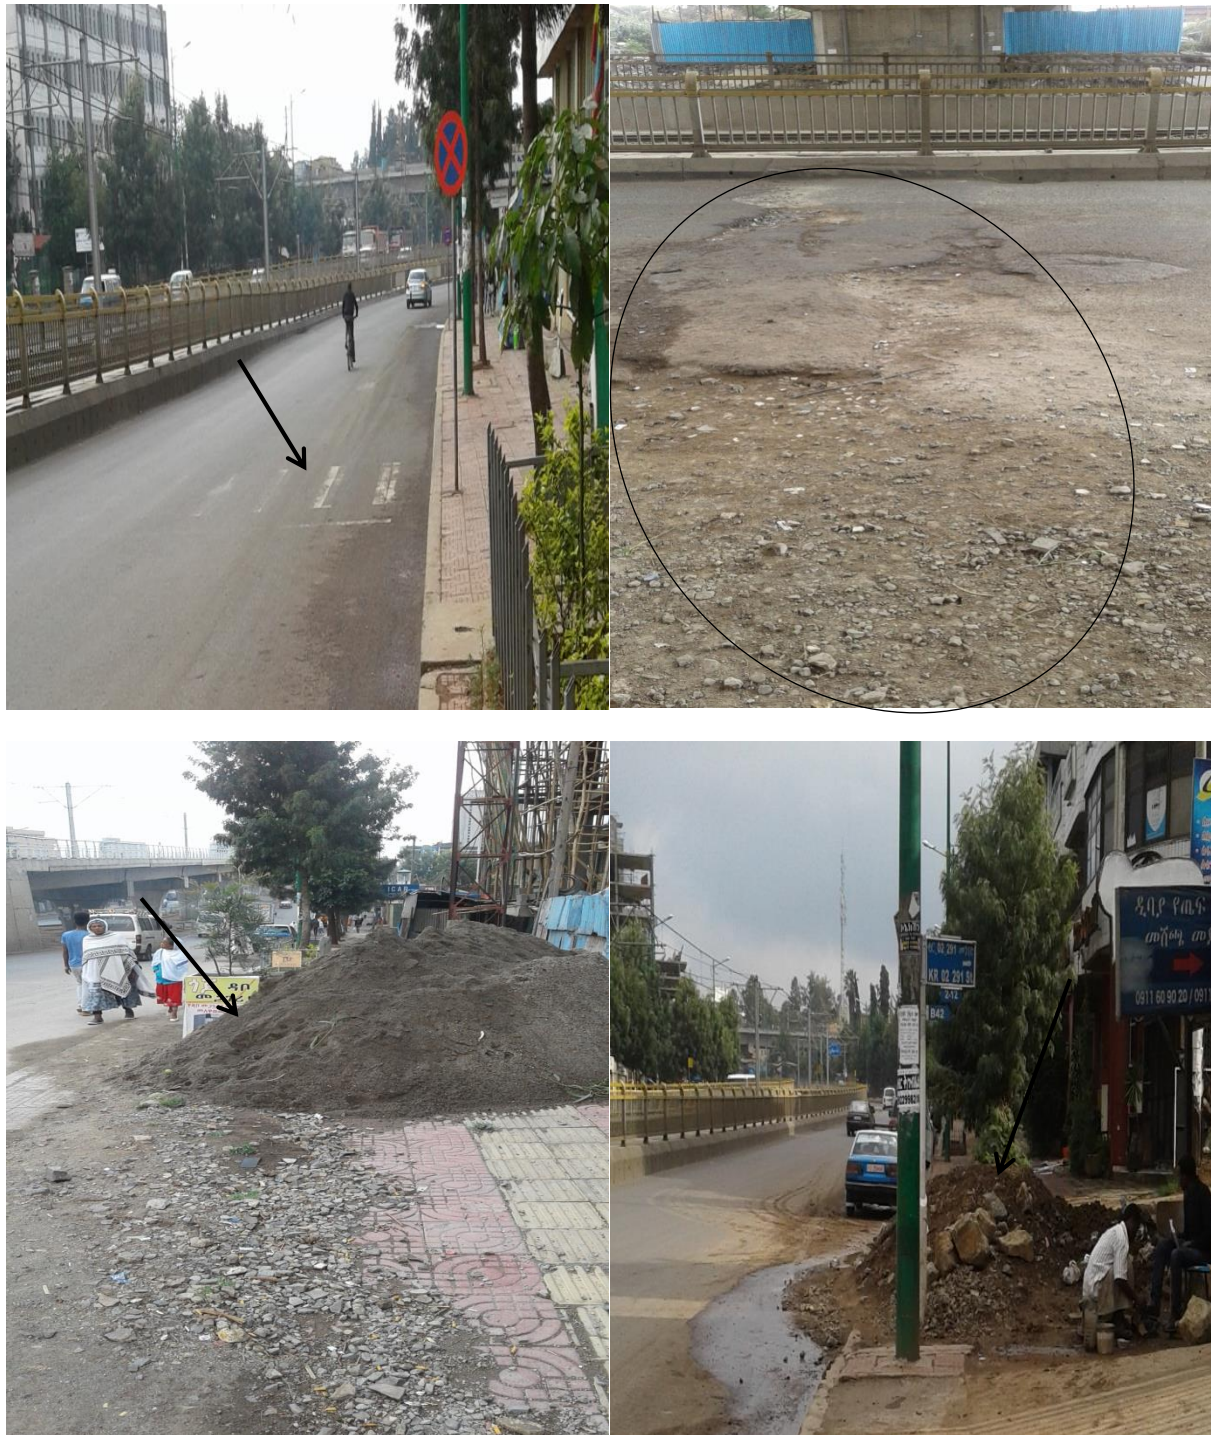
Figure 43. Photo. Unremoved pedestrian cross marking, Deteriorated pavement surface, dumped construction material on walkway, excavated material on walk way

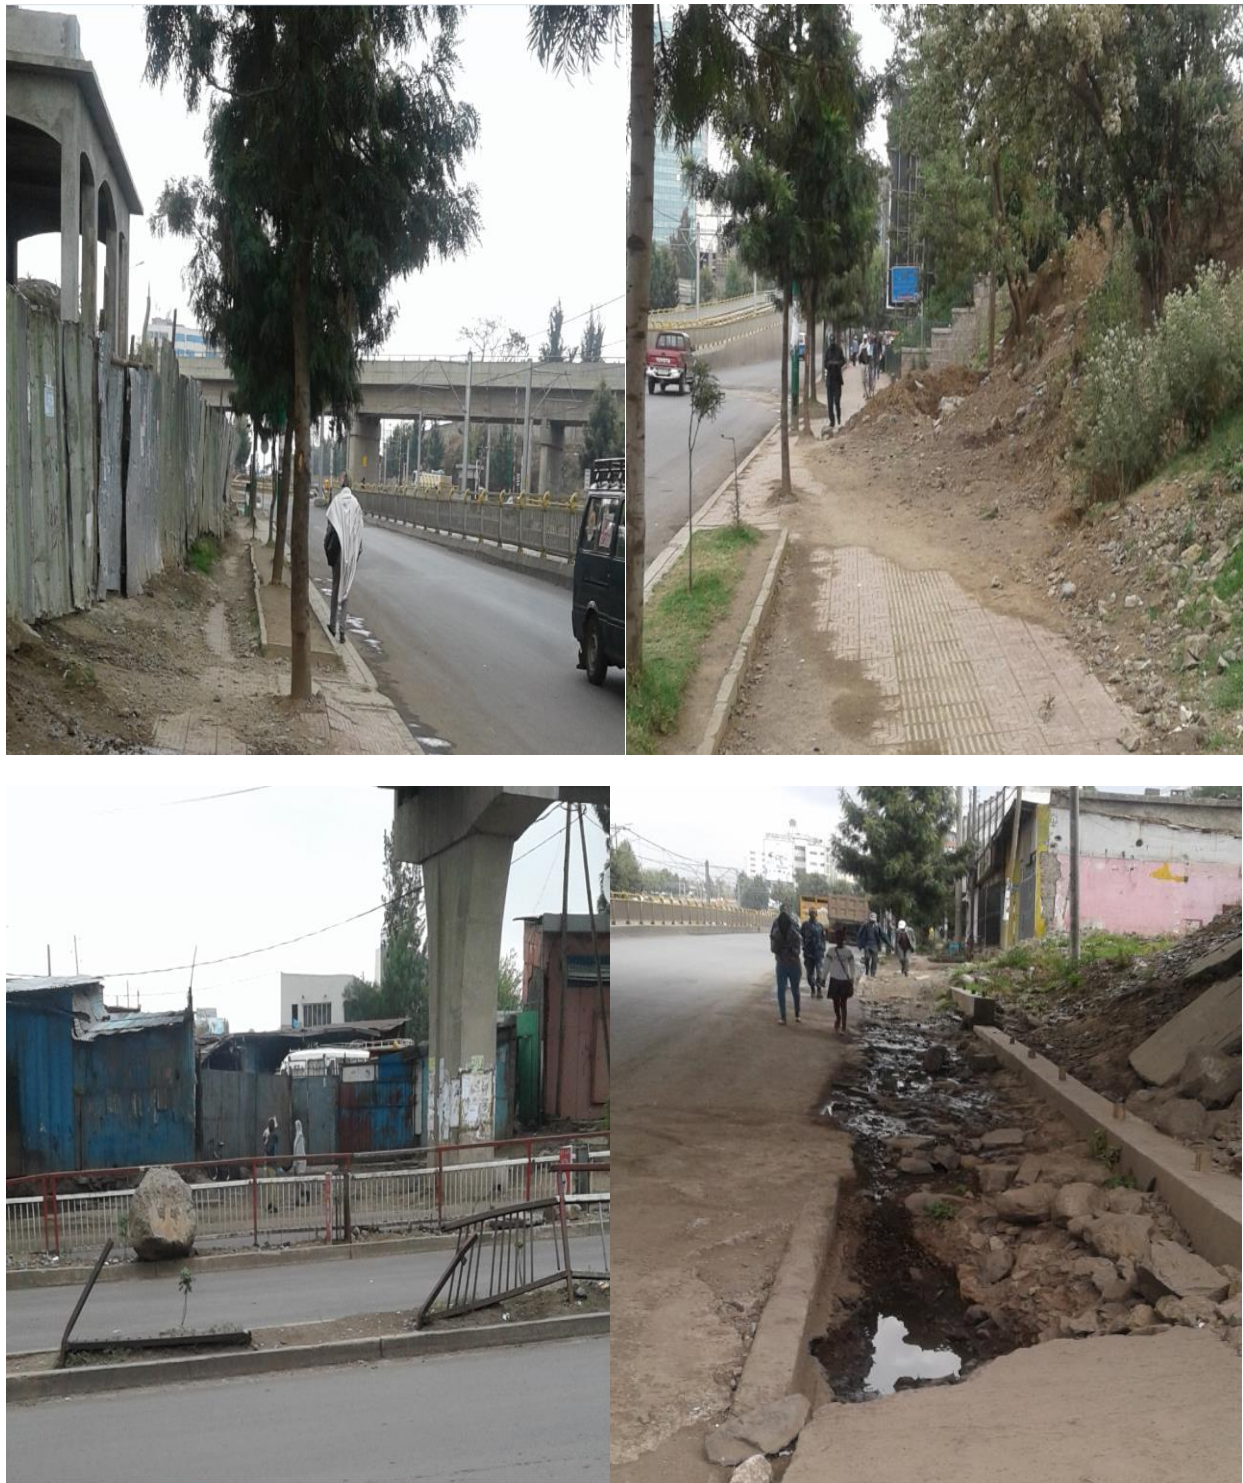
Figure 44. Photo. Walkway width reduced by construction fence, roadside debris on the walk way, damaged guard rail and hazardous object in the median, poor drainage and damaged walk way

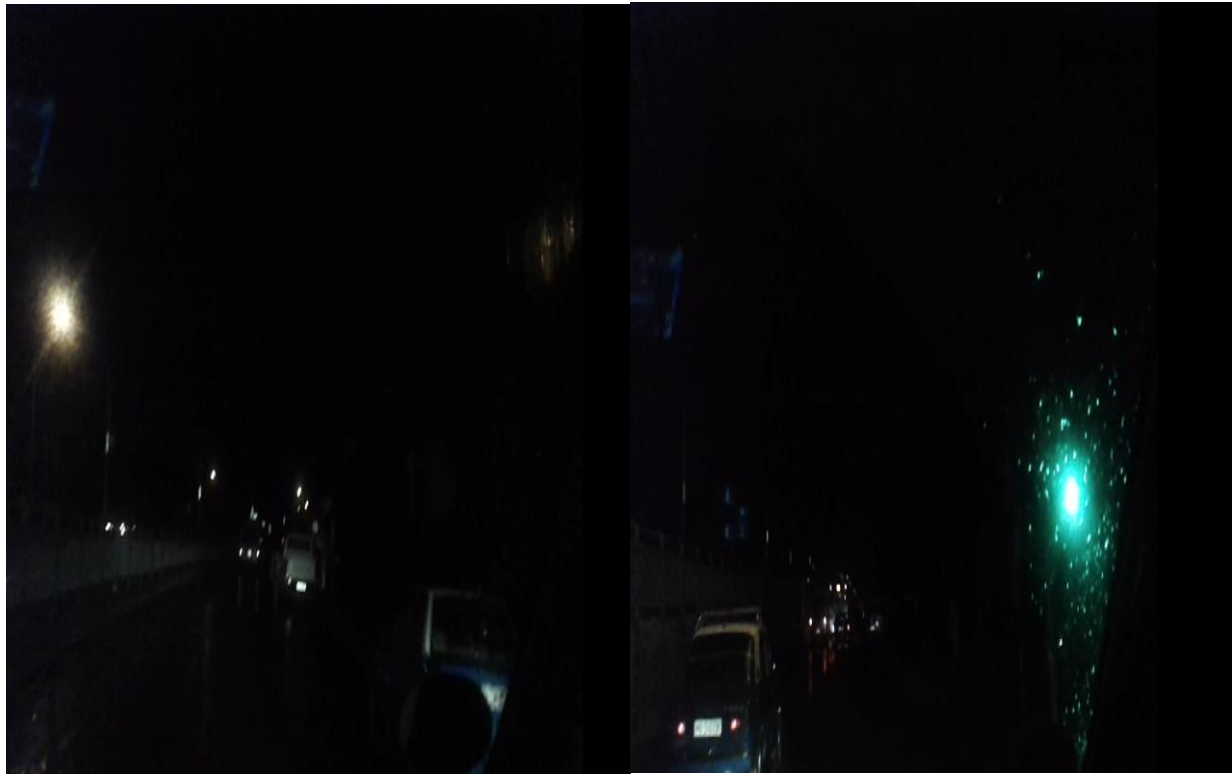
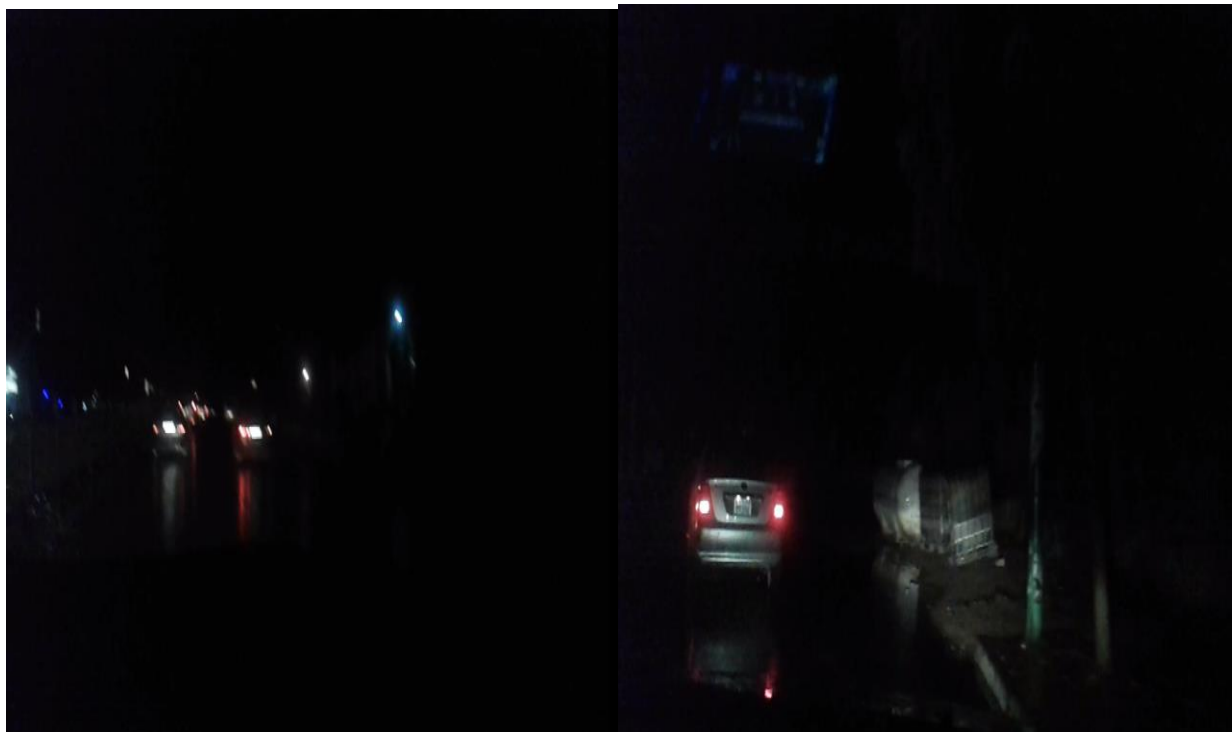
Figure 45.Photo.Poor night time visibility due to non-functional road side lighting
