**THE WATER QUALITY OF FLORICULTURE EFFLUENT AND ITS EFFECT ON
Oreochromis niloticus AND *Cyprinus carpio* IN AQUARIA: THE CASE OF LAKE
ZIWAY, ETHIOPIA**

**MSc. Thesis Submitted to Graduate Program in Partial Fulfillment of the Requirement for
Masters of Science in Zoological Sciences (Aquatic Sciences, Fisheries and Aquaculture)**

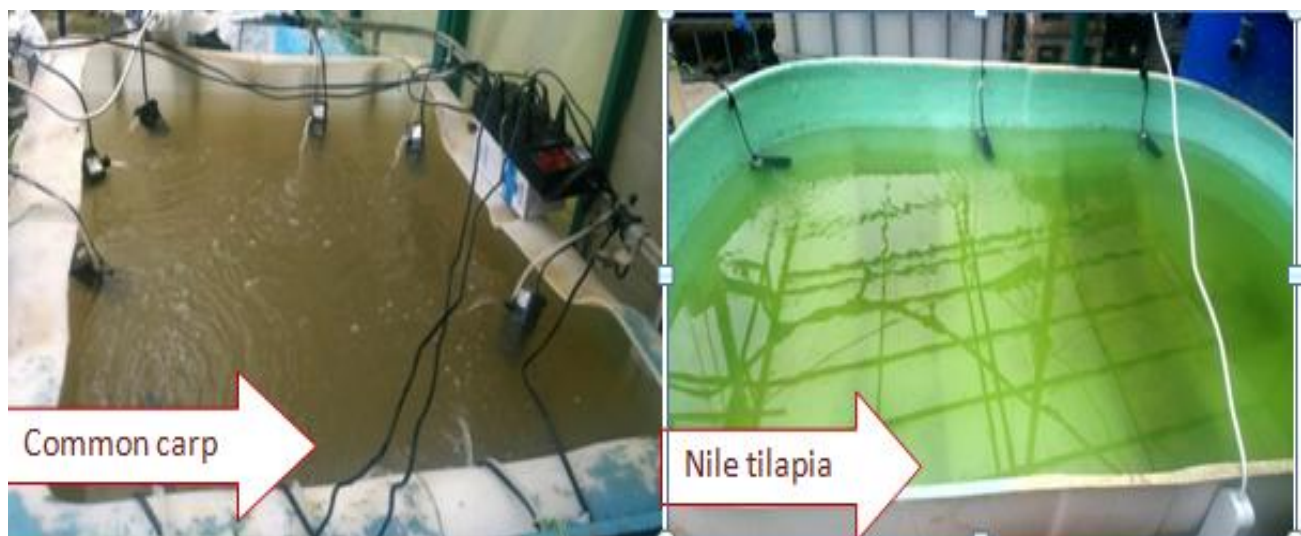
Plate.3.1. Acclimatization tanks for common carp and Nile tilapia

Continuous aeration was maintained in each tank using electric air pumping compressors. Fishes were fed daily on formulated fish diet at 6% of their body weight twice daily. The behavior of fishes was monitored daily and recorded and any dead fish was removed.

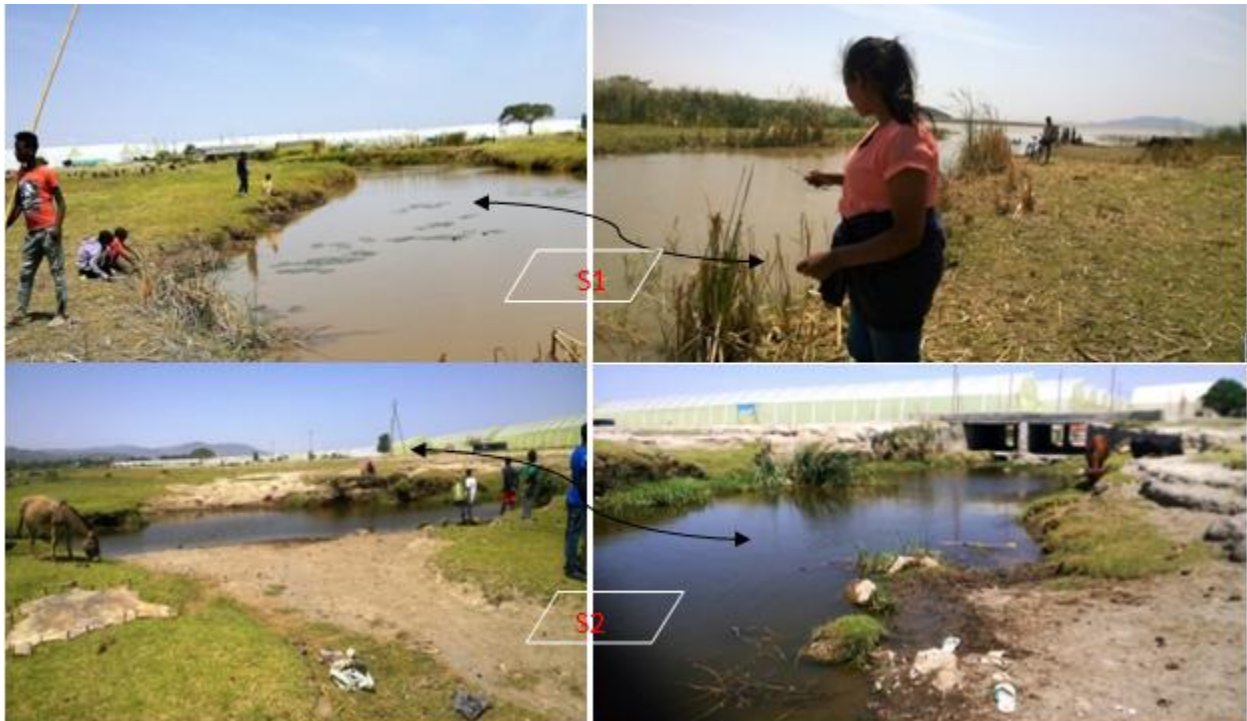
Plate.3.2. Floriculture effluent sampling sites discharged in to Lake Ziway

A total of 2000 liter (19 samples containing 60L) of effluent were collected two times from the discharge or out fall of floriculture farm which is located at the shore of Lake Ziway to perform the required tests.

Then the physicochemical parameters such as pH, temperature (Temp.), electrical conductivity (EC) and dissolved oxygen (DO) were measured at the sampling site by using a portable multimeter probe model (HQ40d); all the nineteen (19) sample containers were completely filled leaving no air space between the contents in order to minimize the loss of toxicity due to volatilization of toxic constituents and transported with a truck to the experiment place which is located in the greenhouse of Addis Ababa University.

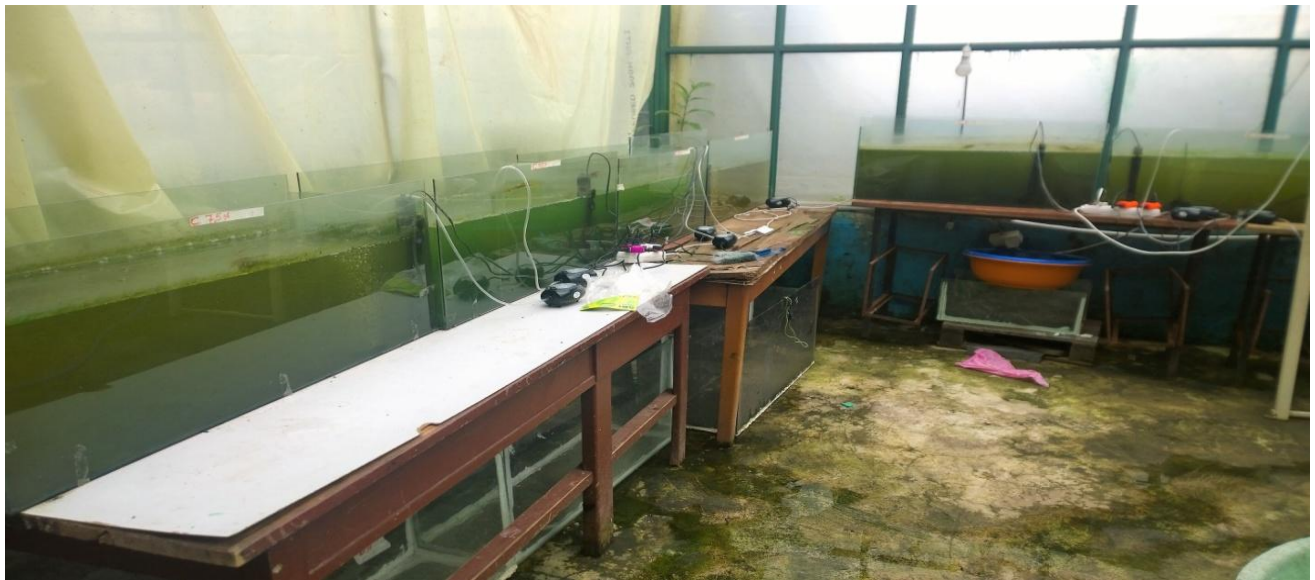
Plate.3.3. Experimental set up of effluent test

A series of duplicate nine glass aquaria with size of 100cm x 30cm x 42cm for each of the two fish species was labeled and placed in two sides. One of the aquaria was assigned as control and the other eight were treatment aquaria with different concentrations of the effluent. One electric air pumping compressor and one heater were set into each glass aquarium for the required aeration and heat. Tap water was added in a proportion of 0%, 25%, 50%, 75% and 100% for dilution two days before addition of the effluent to remove the chlorine. Then, 100%, 75%, 50%, 25% and 0% of effluent was dispensed into each aquarium, respectively with two replicates for each test concentration. The 0% effluent was set as control for both fishes. Then, the heat and aeration system was adjusted and allowed for 30 minutes. The physicochemical parameters such as pH, Temperature (T), Electrical conductivity (EC), Dissolved Oxygen (DO) and % saturation were measured with a portable multimeter probe.

10 fingerlings each of *O. niloticus* and *C. carpio* were collected from the acclimatization tank and transferred into separate aquarium by using a hand net. This was also repeated for juveniles. Continuous aeration and heat was maintained in each aquarium. Both fingerling and juvenile fishes were fed twice daily 6% of their body weight on fish diet formulated from 45% and 30% crude protein, respectively. Then, the time when the first fish was transferred into the test

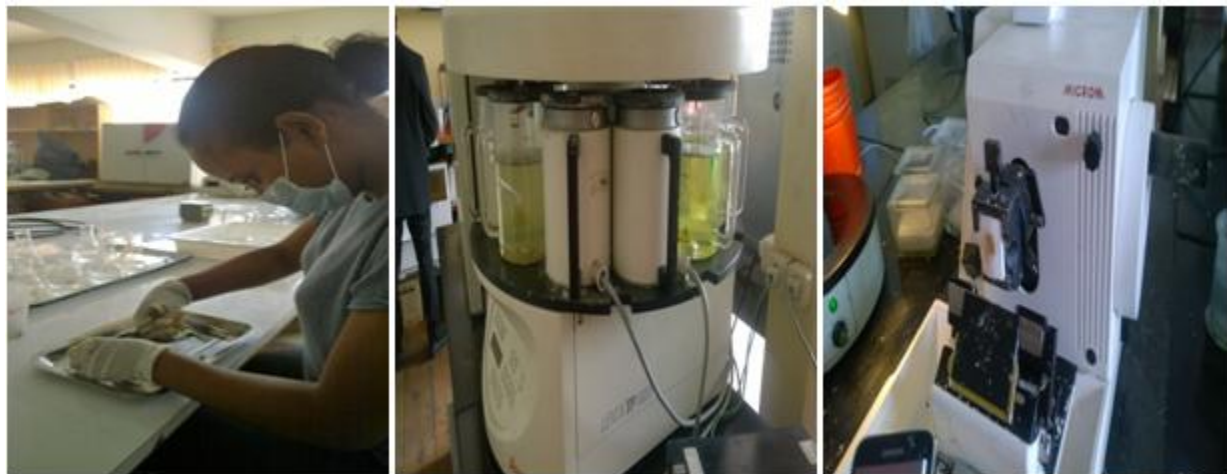
Plate.3.4. Tissue preparation for histology test

At the end of exposure period, two (2) fishes were taken from each replicate aquarium. The gill arches of the fish were excised quickly from both sides and the abdominal cavity was operated and the liver and kidney were excised and fixed in 10% formalin as a histological fixative for 24 hr (Tao *et al.*, 1999).

The specimens were prepared at Ethiopia Public health Institute (Pastor Hospital) and processed as usual in the recognized method of dehydration, cleared in xylene and finally embedded in paraffin wax before being sectioned at 5 μm using a rotary microtome (Leica TP 1020 USA) According to Humason (1967). The specimens were stained with hematoxylin and eosin. Finally, the prepared sections were examined and photographically enlarged using light microscopy.

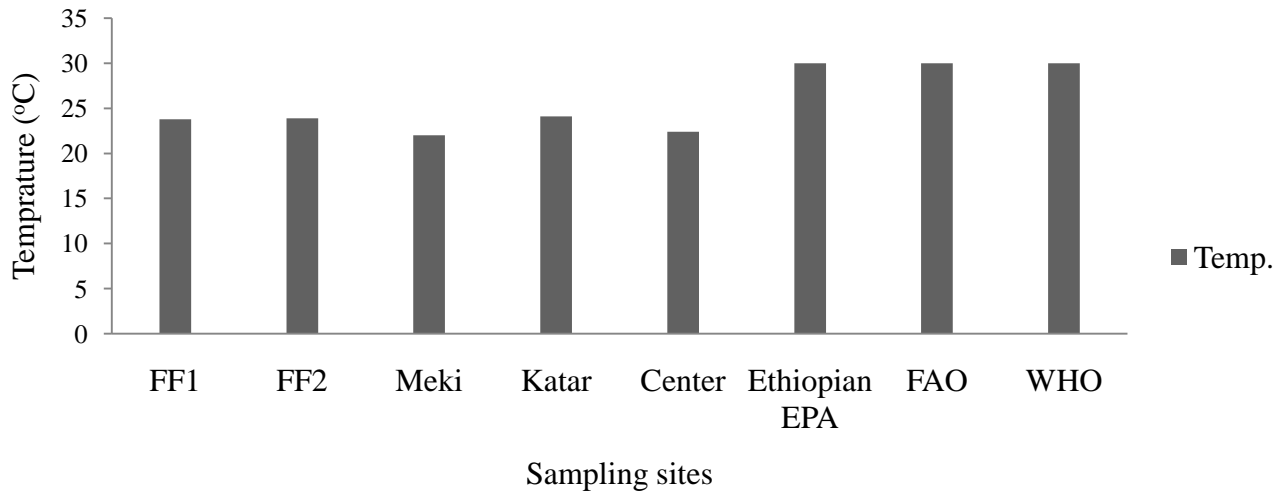
Fig.4.2. Mean values of temperature as compared to EPA, FAO and WHO standards

In this study, the mean values of temperature did not show significant difference between sampling sites ($p > 0.05$). The values were also compared with Ethiopian EPA, FAO and WHO standards and the level of temperature in all sites were within the ranges of the standard values for maintenance of fisheries and aquatic life. In this case, there is no indication of thermal pollution and this may be due to the sampling time which is in the morning around four and five o'clock. Water temperature is a controlling factor for aquatic life (Carr and Neary, 2006). It controls the rate of metabolic activities, reproductive activities and life cycles. If water

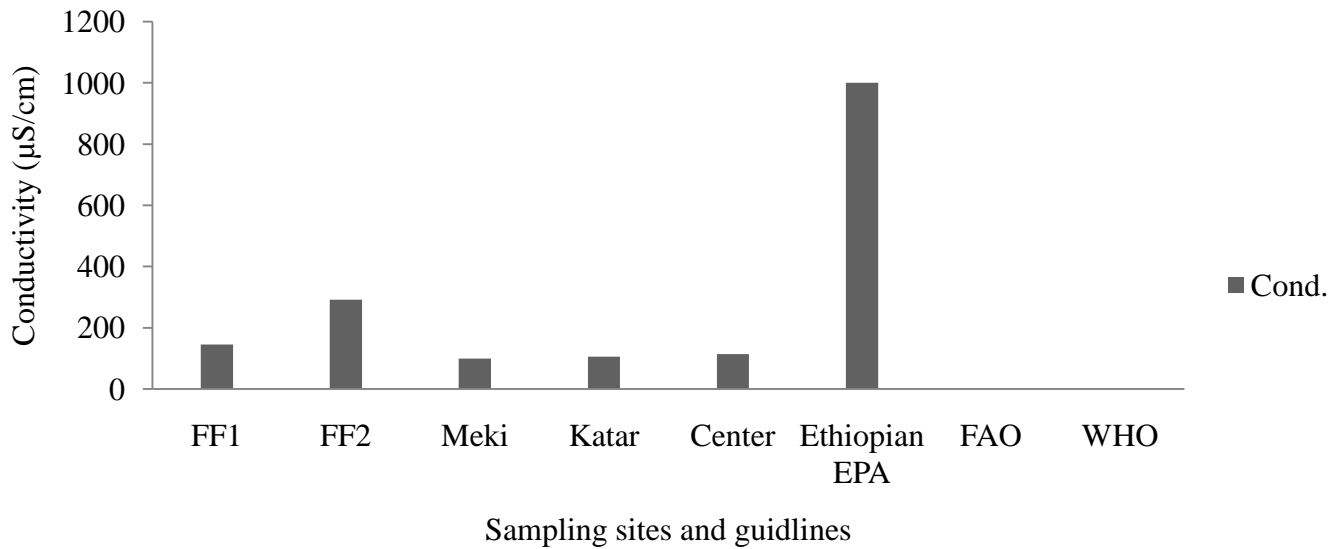
Fig.4.4. Mean values of Conductivity as compared to EPA, FAO and WHO standards

The work of Malefia Tadele (2009) also agreed with this; the farms around Lake Ziway discharged untreated effluents in-to the lake which led to a negative effect on the lakes water quality. Similar result was also obtained by Birhan Teklu *et al.* (2016) the higher EC values were found for sampling points near the floriculture area of Lake Ziway. An increase in conductivity indicates that there is a slight increase in dissolved ions, which is an indicator for the pollution status of Lake Ziway and may have an impact on aquatic life and water quality. In an aquatic environment, EC is an important and simple indicator to characterize the pollution status of b

surface water, a sudden increase in conductivity can indicate the presence of more dissolved ions, which have an impact on aquatic life and water quality (Birhan Teklu *et al.*, 2016).

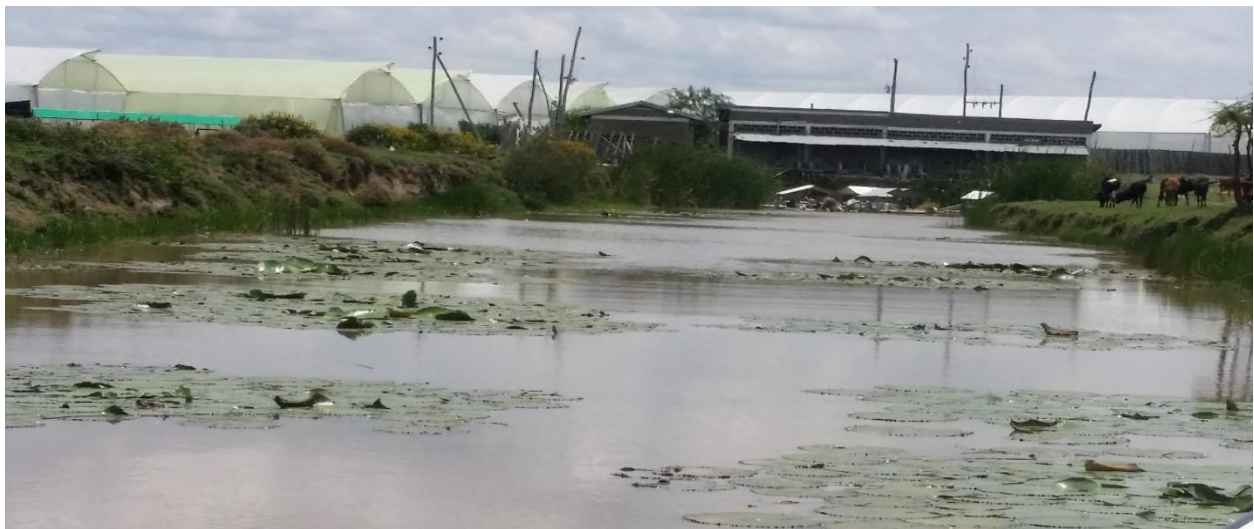
Plate 4.1: Image showing floating macrophyte of the effluent discharge
