**Engineering rock mass characterization -
An integrated approach through Rock Mass Classification
and Seismic Refraction - A case of TAMS Hydroelectric Power
Dam Project in Gambella, Ethiopia**

**A Thesis Submitted to
School of Earth Sciences**

Presented in Partial Fullfillment of the requirements for the Degree of
Masters of Science (Engineering Geology)

ADDIS ABABA UNIVERSITY

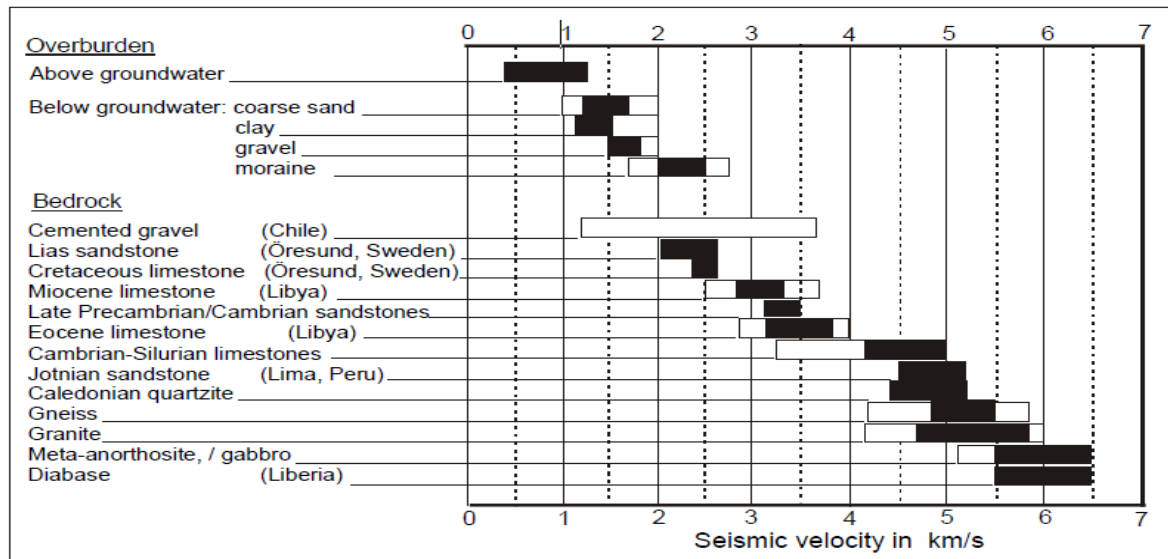
Fig. 3.3 Typical ranges of longitudinal seismic velocities for intact rocks (Sjögren, 1984)

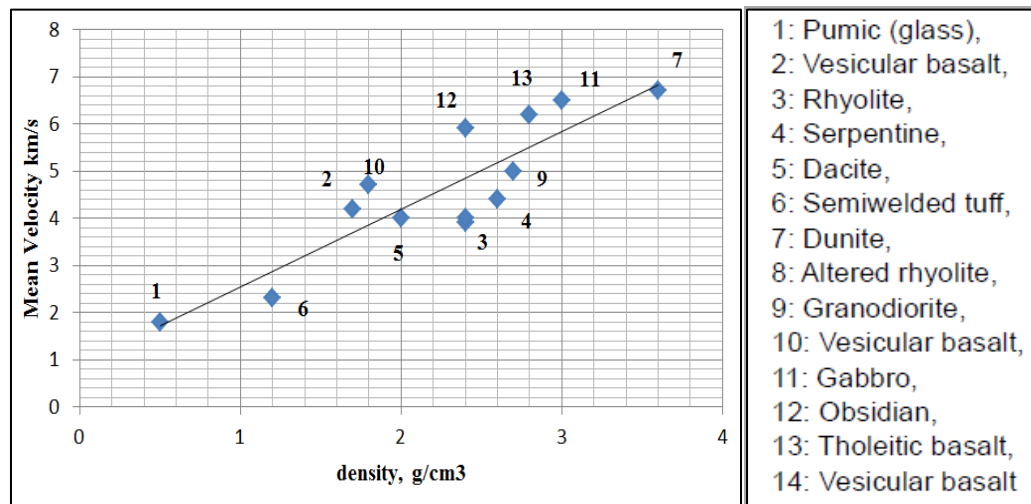
Fig. 3.4 Mean longitudinal pulse velocity versus density of the rock. (After Sjögren et al., 1979)

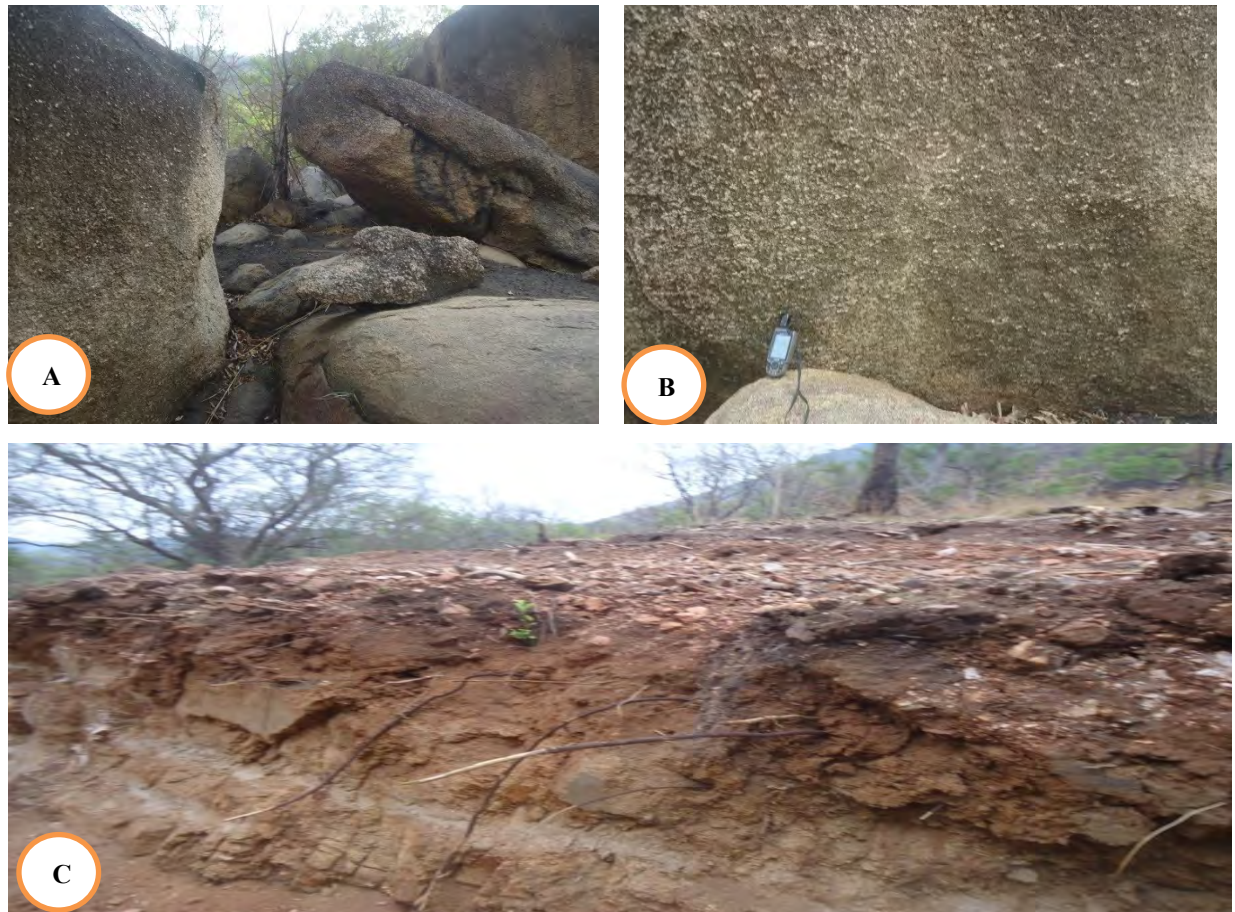
Plate 4.1 Photo showing Granite exposure on the left side of the study area (A&B), Residual soil found at the right bank (C)

Plate 4.1 shows an exposure of granite on the left side of the study area. The granite is found in boulder size.

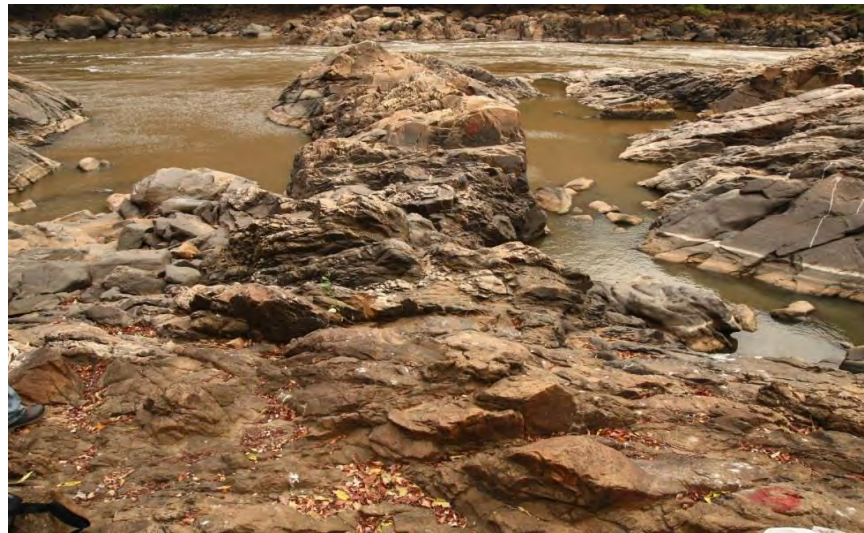
Plate 4.2 Structural discontinuity at the Baro River, downstream of the dam axis

Plate 4.2 shows a rather solid and compact rock, whose mechanical discontinuities are arranged in three families, forming cubic blocks. The rock-mass conditions in this place are hence considered as good.

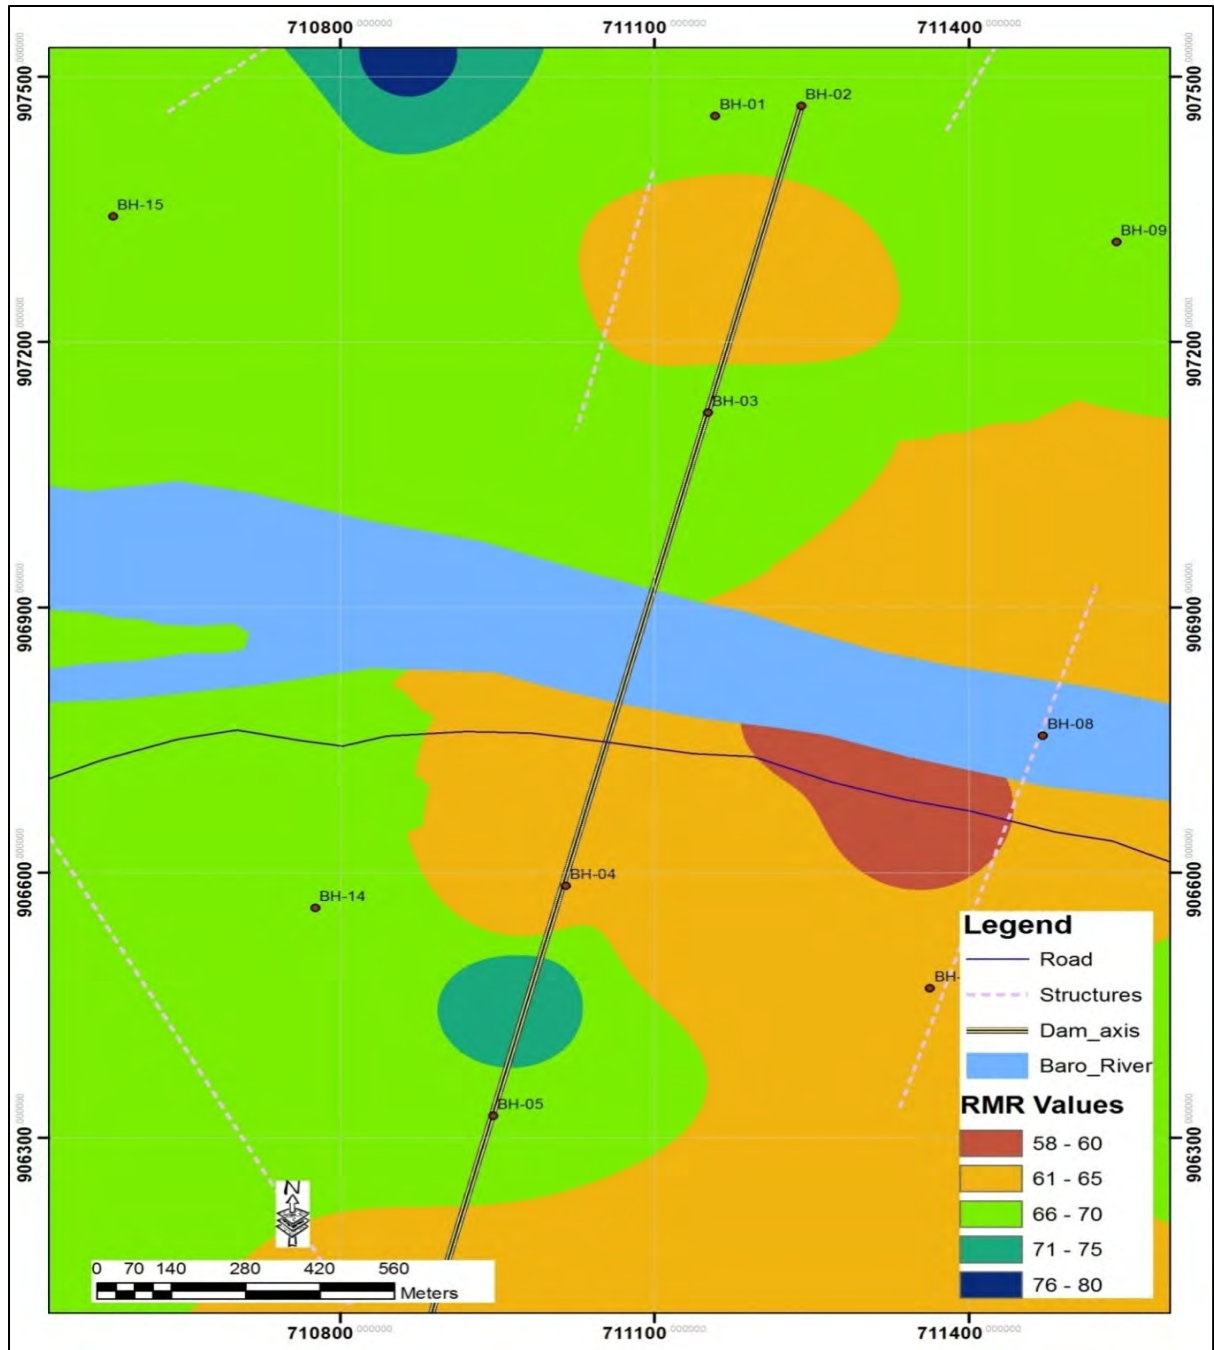
Fig 6.1 RMR zone map at the Dam Site

Geomechanics classification (RMR) was used for classifying and interpreting the quality of the foundation rocks at the proposed Dam site through bore holes data. For the purpose of classification the rock mass at dam foundation was first divided in to structural regions, based on fracture density and evenness as displayed by weighted RQD. These regions are assumed to be more or less uniform in certain geotechnical features.

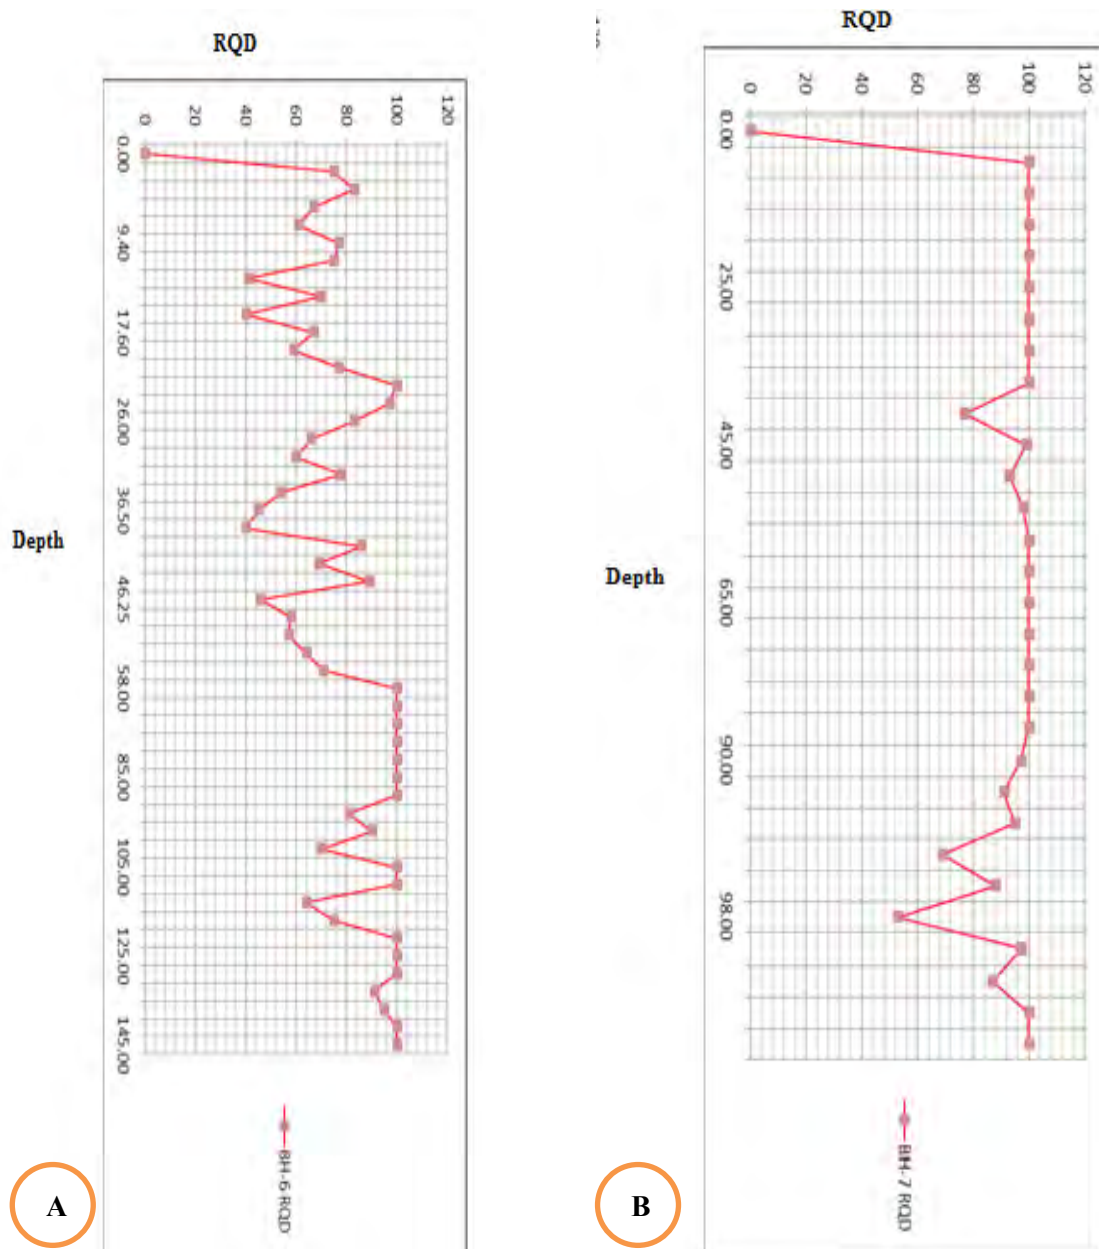
Fig 6.2 RQD value at selected boreholes A) BH-6 & B) BH-7

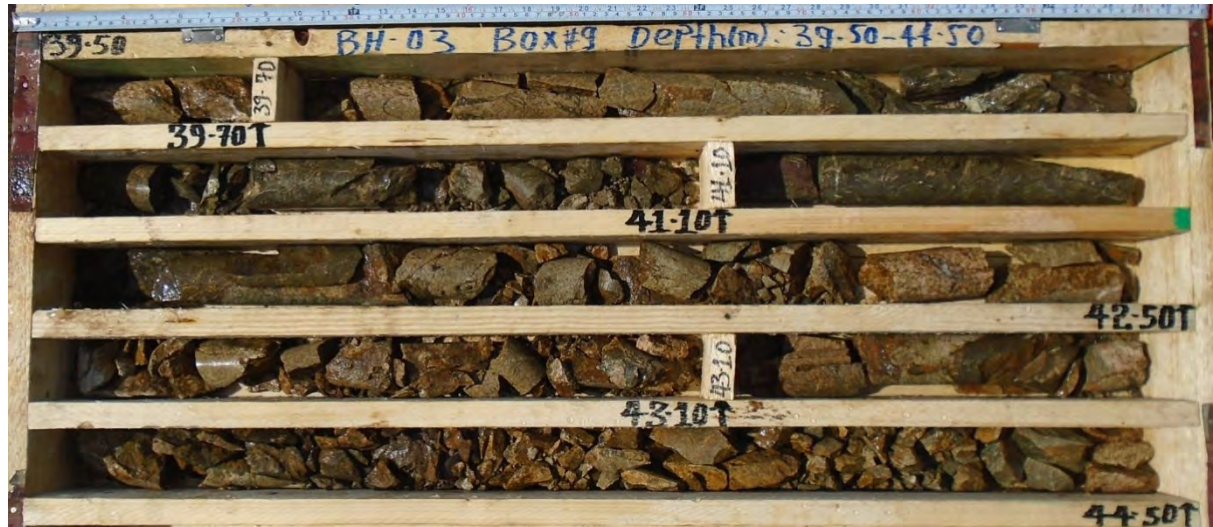
Plate 6.1 Rock core showing zone of weakness, decomposition at the contact zone (Borehole 3)

Plate 6.1 shows the weak formations on biotite-hornblende schist formation on the right bank of the dam site. These weak zones are associated with high foundation permeability as observed during insitu packer permeability test results.

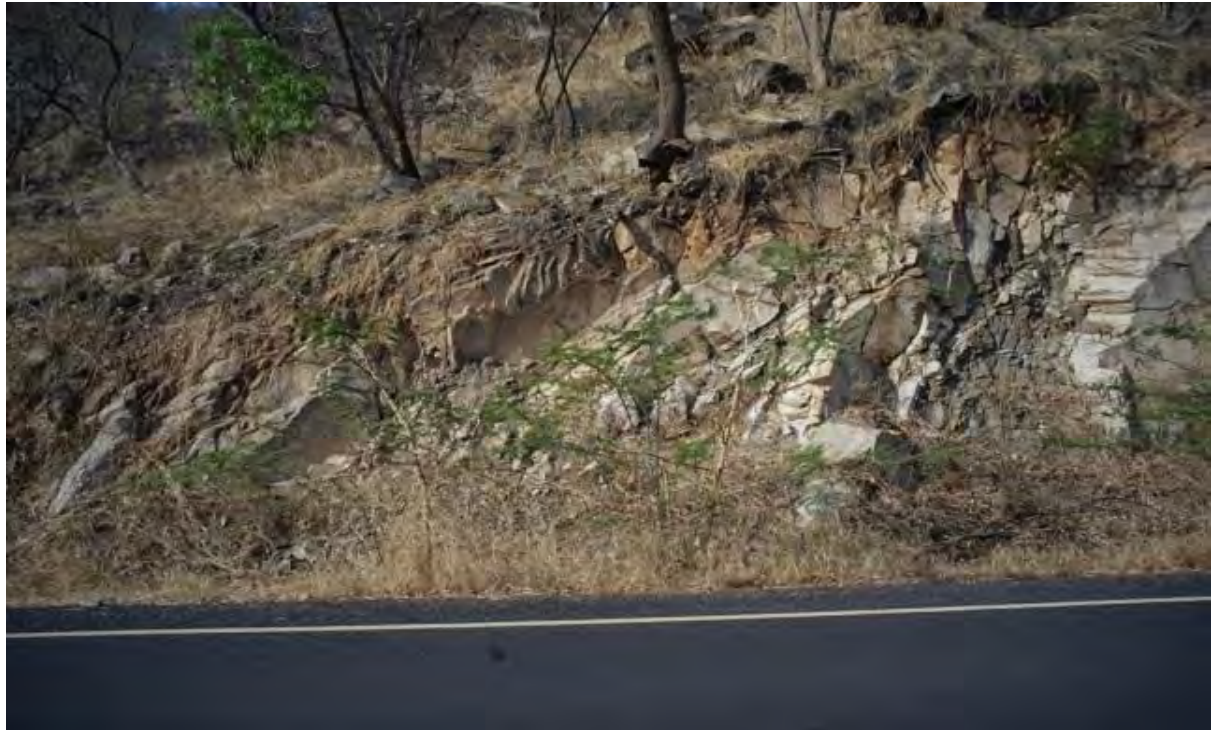
Plate 6.2. RMR point 8, left side of the outcrop left abutment

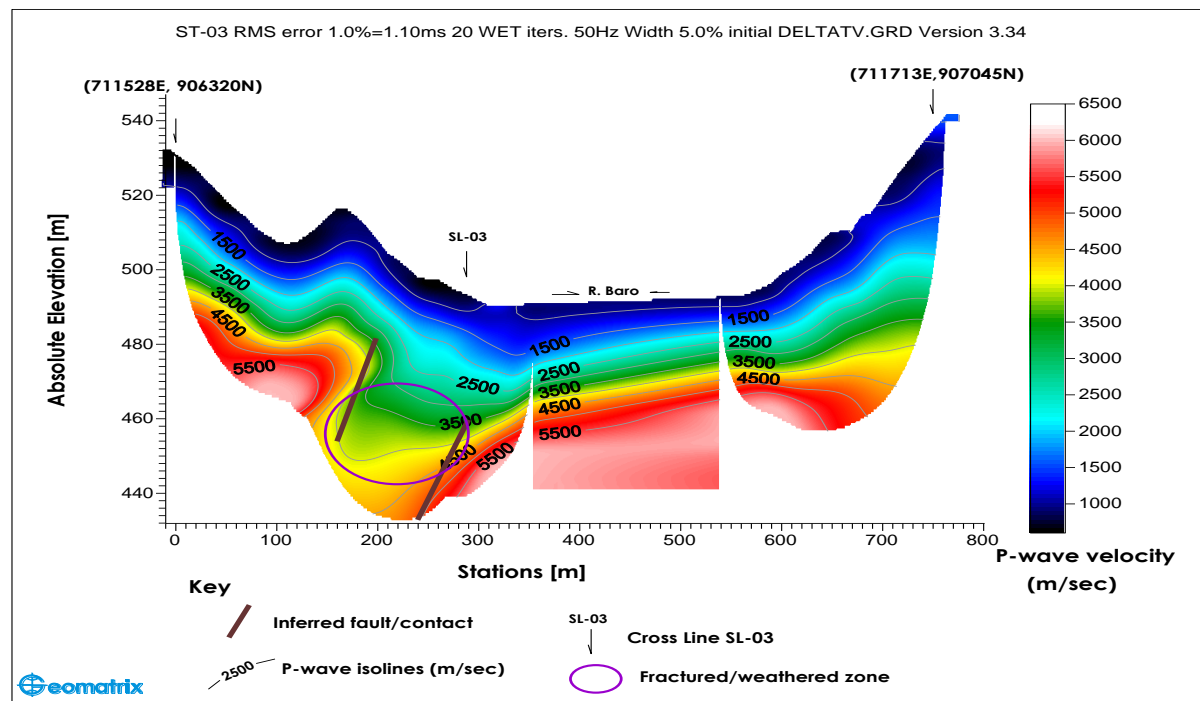
6.17 P-wave Velocity Tomography, ST-03, TAMS HP (Geomatrix, 2016)
