**ADDIS ABABA INSTITUTE OF TECHNOLOGY
SCHOOL OF CIVIL AND ENVIRONMENTAL ENGINEERING
POST GRADUATE STUDIES**

**Assessment of Pedestrian Overpass Facilities along the
Addis Ababa Ring Road**

A Thesis Submitted to the School of Civil and Environmental Engineering in Partial
Fulfillment of the Requirements for the Degree of Master of Science in Civil Engineering
(Road and Transport Engineering)

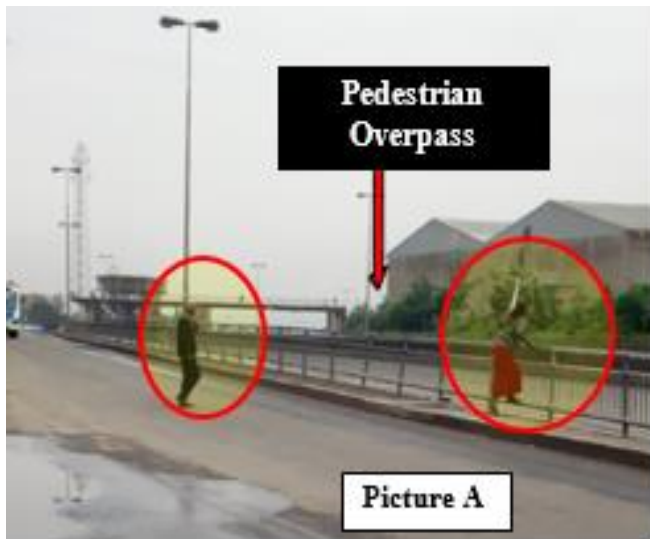
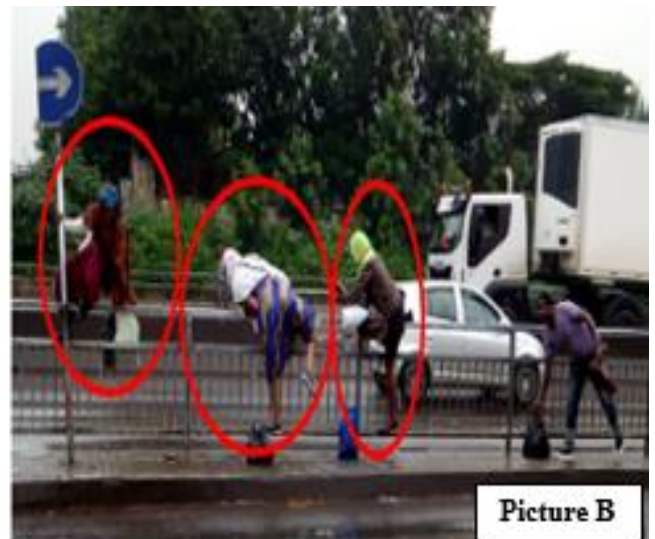
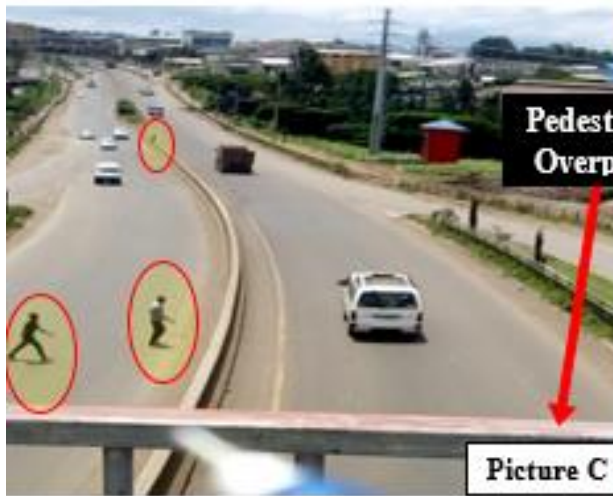
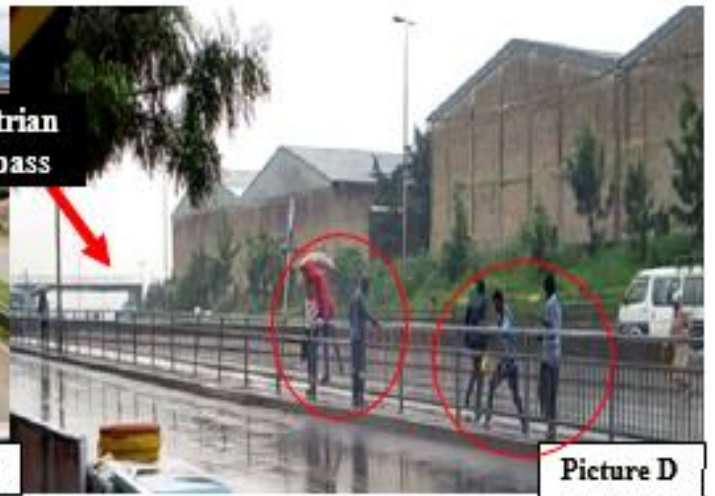
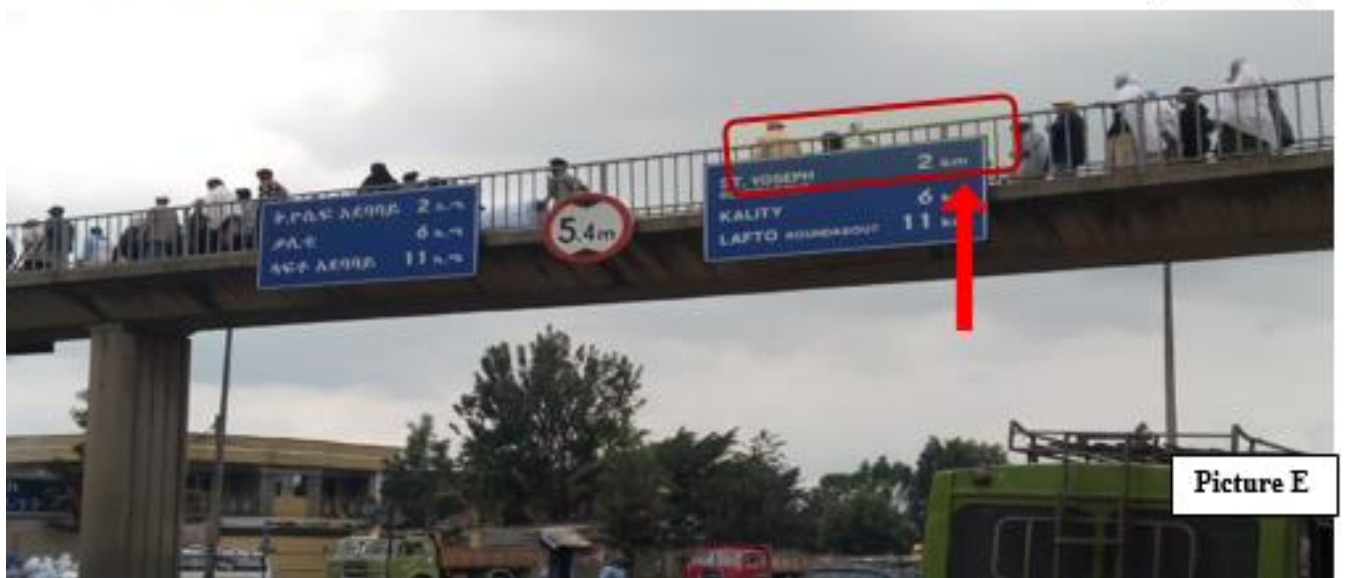
Figure 1.1: Pictures to Exhibit the Problem along the Study Route (Addis Ababa Ring Road)

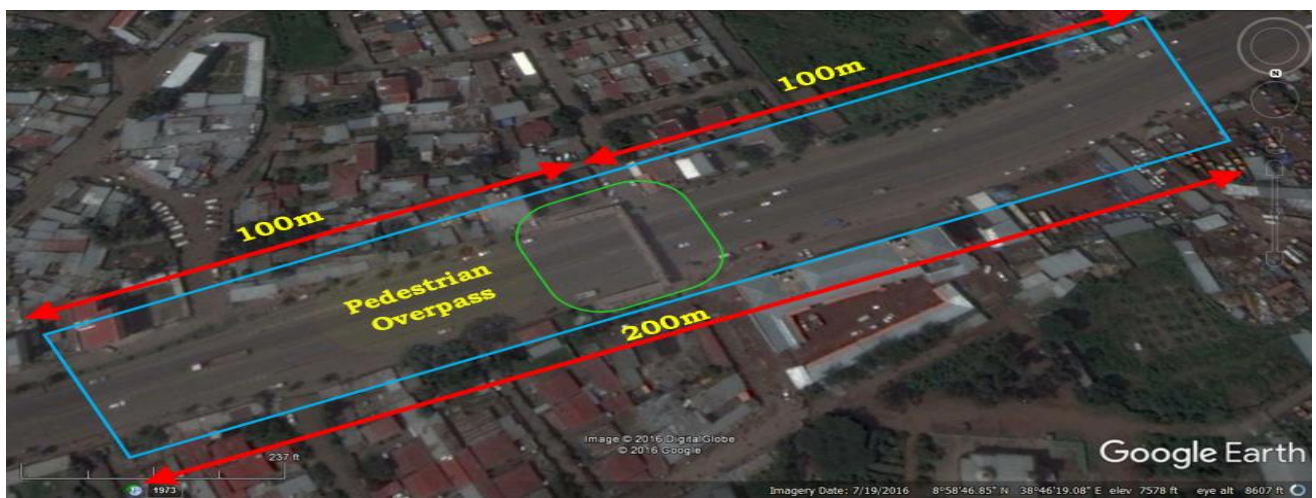
Figure 3.2: Ranges of Distances Considered During Pedestrian Counting (Picture from Google Earth)

The physical dimensions of the overpasses such as width and length were measured in the field using measuring tape to be used as inputs for the computation of average pedestrian area (space), density and flow rate. Measuring tape was used to locate 200m ranges of distances properly and measure distance between important locations and spacing between pedestrian facilities.

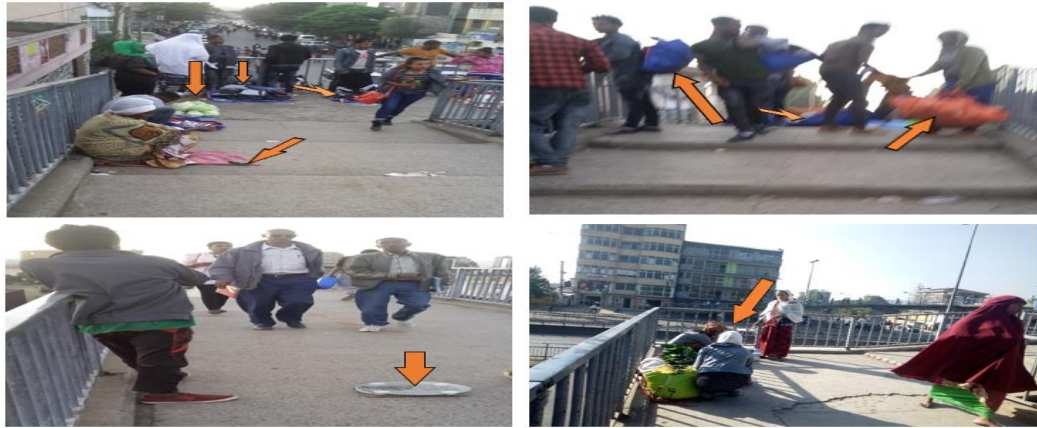
Tremendous amount of street vendors and beggars are noticeable in the city especially where pedestrian volume is high such as market areas, transport stations and religious centers. The effect is noteworthy even on pedestrian overpass facilities where a lot of commodities are wide spread for sale.

Figure 4.7: Illegal Vendors and Beggars Over Pedestrian Overpasses along The Addis Ababa Ring Road

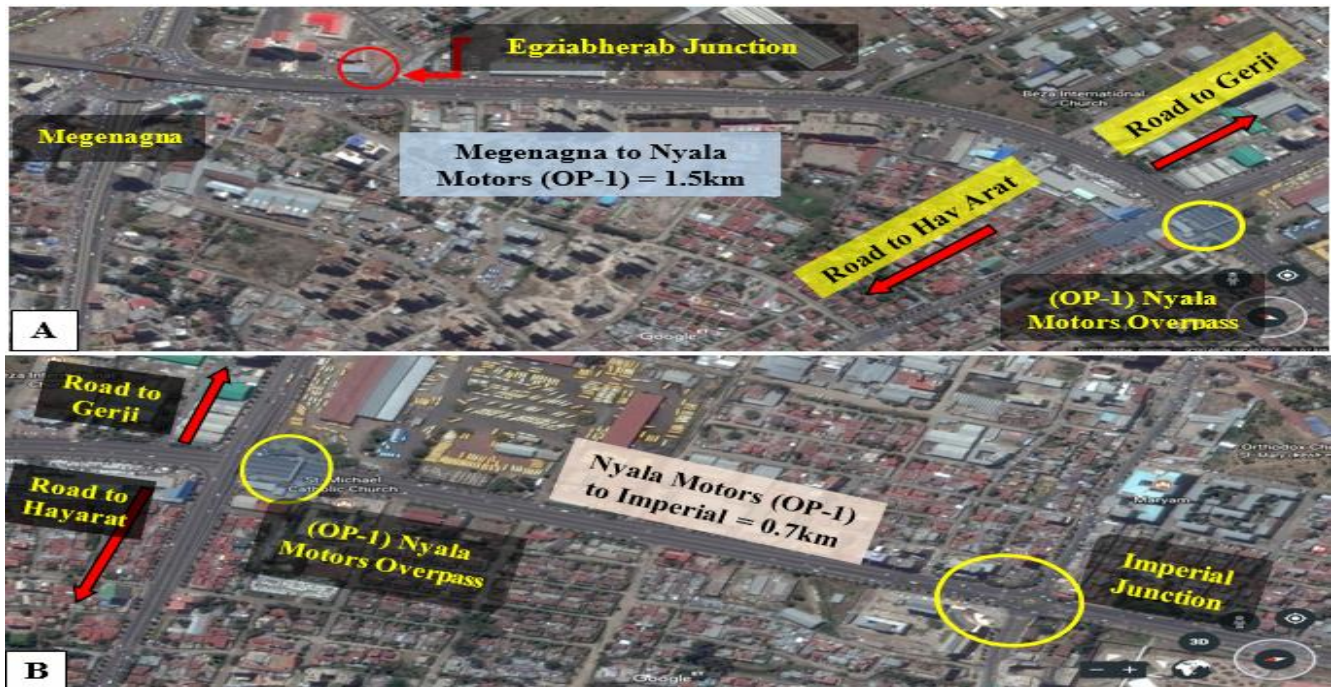
Nyala Motors (OP-1) is located between *Megenanga* and *Imperia Junction* (formerly called *Bob-Marley* square). It is located at 1.5km from *Megenagna* and 0.7km before *Imperial* junction. It mainly serves pedestrians travelling to and from *Gerji to Haya Arat*.

Figure 4.10 (A&B): Location of Nyala Motors (Anbessa Garage) overpass (OP-1)

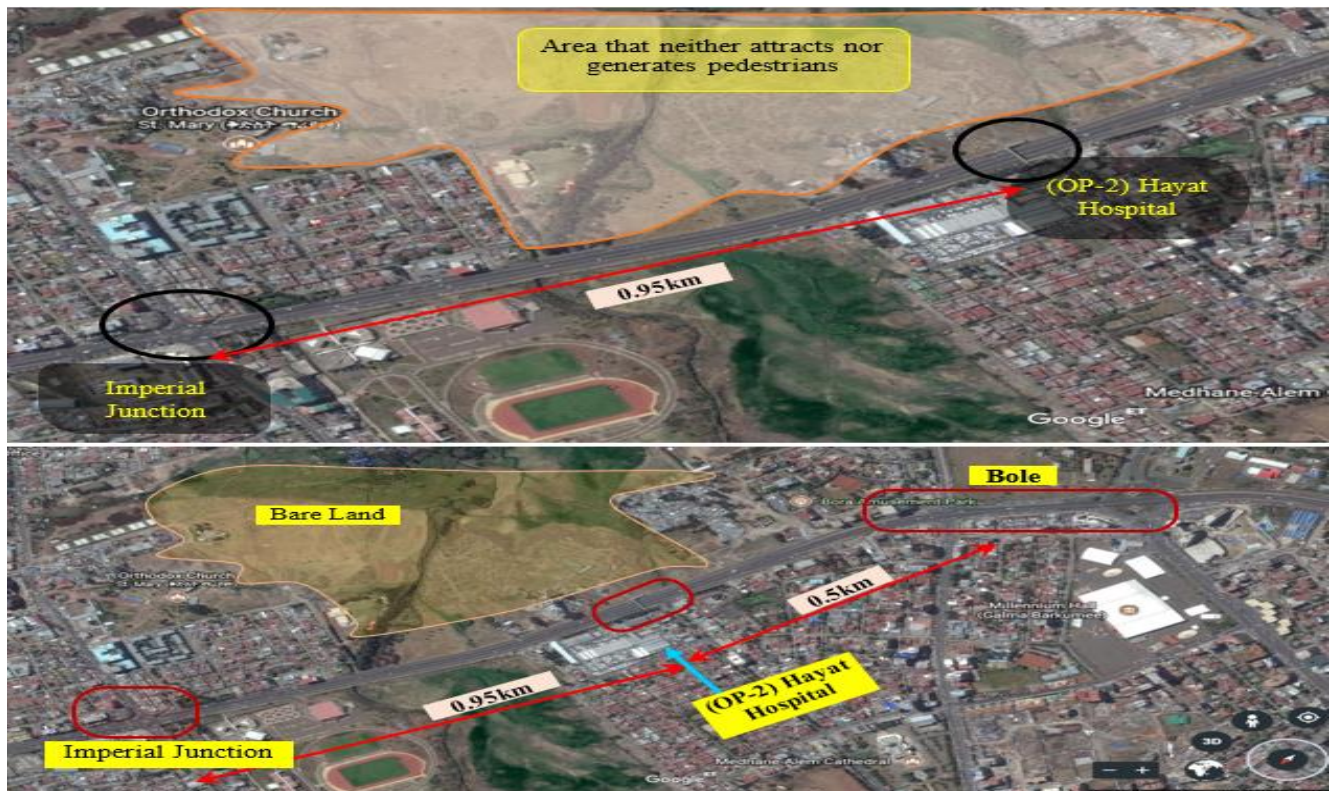
This facility is located between *Imperia Junction* (formerly called *Bob-Marley square*) and Bole International Airport. It is at 0.95km from *Imperia Junction* and 0.5km before *Bole International Airport*. It is provided where one side of the road is a bare land where there is no settlement and does not attract or generate pedestrians.

Figure 4.11: Location of Hayat Hospital Overpass (OP-2)

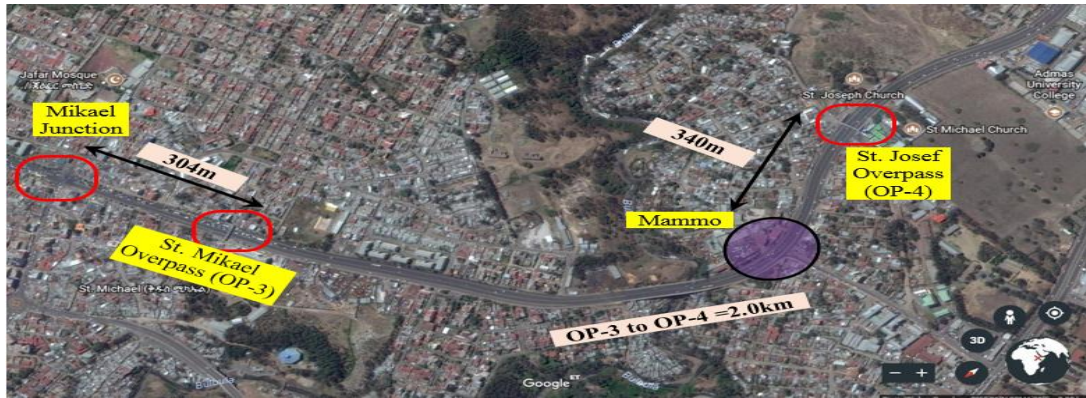
Bole Mikael Overpass (OP-3) is located in front of St. Mikael Church between *Bole Mikael Junction* (formerly roundabout & currently operating with traffic light) and St. Yosef Overpass (OP-4). It is located at about 0.3km from *Bole Mikael Junction* and 2.0km before *St. Yosef Overpass (OP-4)*.

Figure 4.12: Location of Bole Mikael Overpass (OP-3)

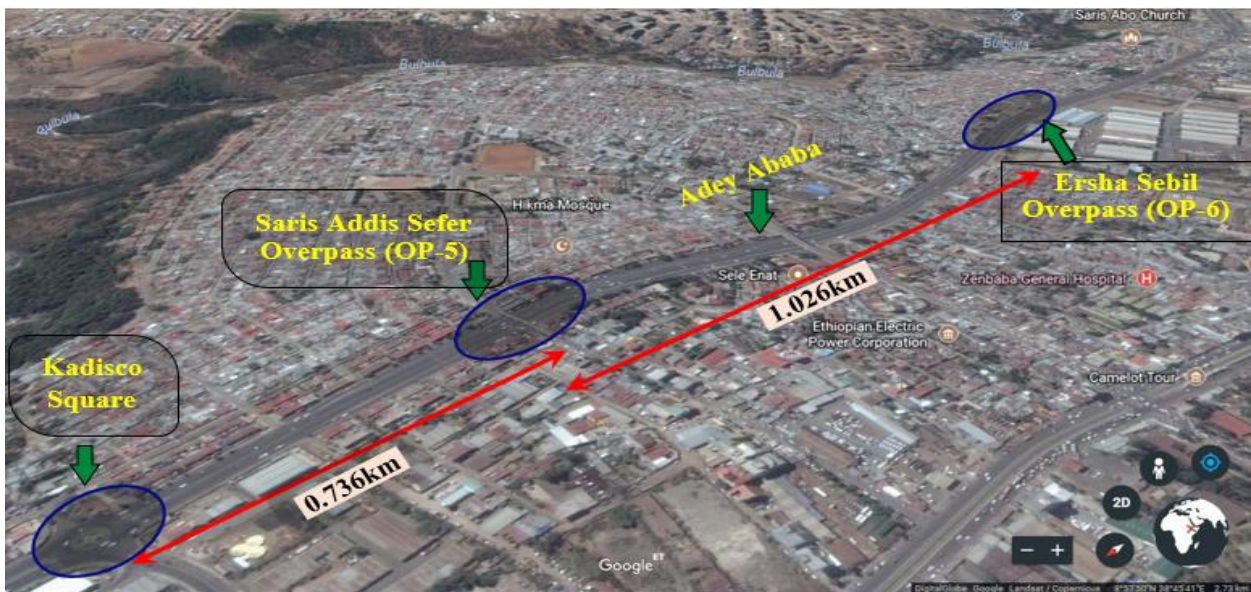
Saris Addisu Sefer Overpass (OP-5) is located between *Kadisco* square and *Ersha Sebil Overpass (OP-6)*. It is located at about 0.376km from *Kadisco* square and 1.026km before *Ersha Sebil Overpass (OP-6)*. This facility is located at a densely populated area where a large volume of pedestrian movement exists.

Figure 4.14: Location of Saris Addisu Sefer Overpass (OP-5)

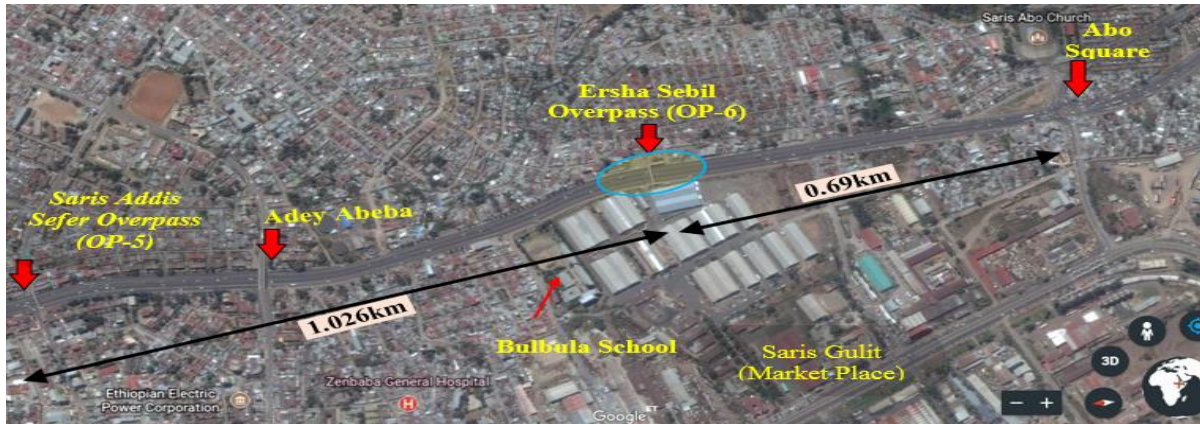
This facility is located between *Saris Addisu Sefer* overpass (OP-5) and *Abo square*. It is located at about 1.026km from *Saris Addis Sefer Overpass (OP-5)* and 0.69km before *Saris Abo Square*.

Figure 4.15 (A): Location of Ersha Sebil Overpass (OP-6)

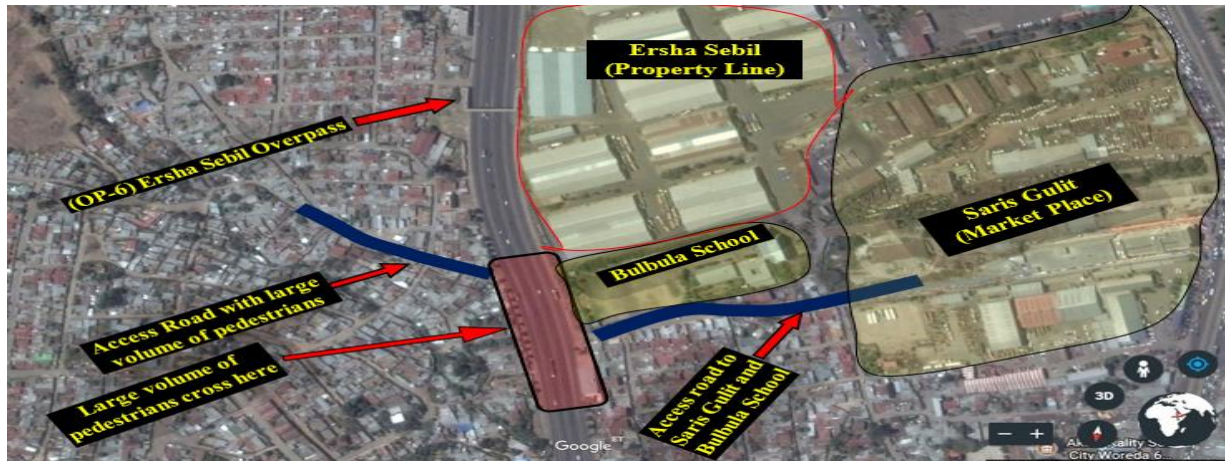
overpass. The peak 15-minute volume of users and non-users (at 212m from the facility) are 213 to 172 respectively. Hence, from the survey response and comparison of volume at the two alternatives, the location of Ersha Sebil overpass is wrong/inappropriate. Therefore, a pedestrian crossing facility shall be provided to guarantee the safety of students and resident travelling to and from *Bulbula School* and *Saris Gult* local market.

Figure 4.15 (B): Location of Ersha Sebil Overpass (OP-6)

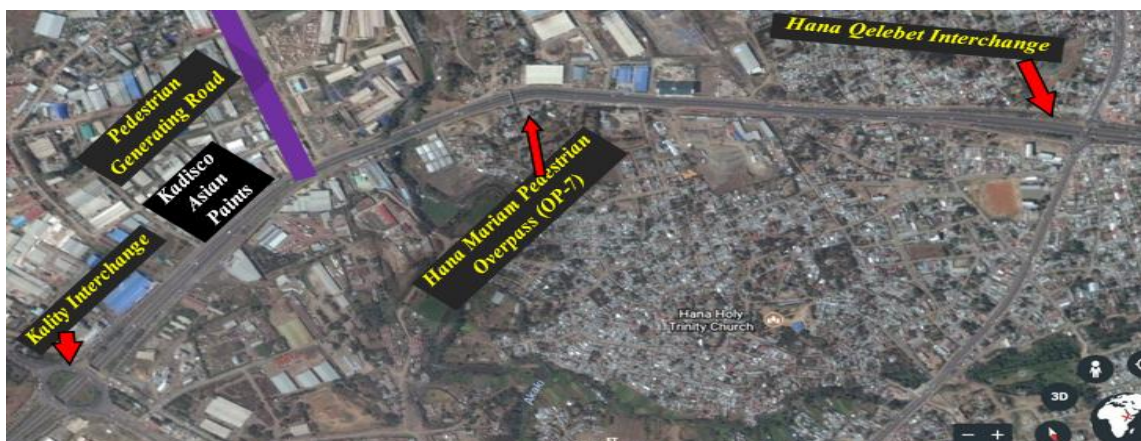
Hana Mariam Overpass (OP-7) is located between *Kality Interchange* and *Hana Qelebet Interchange*. It is located at about 1.18km from *Kality Interchange* and 1.12km before *Hana Qelebet Interchange*. The facility is located where there is no access road joining the Ring Road in both sides where one side of the overpass terminates just in front of local residents property line and the other side just in front of small shops. Illegal crossing is observed in front of *Kadisco Asian Paints* located at 430m from the facility (on the road to Kality).

Figure 4.16: Location of Hana Mariam Overpass (OP-7)

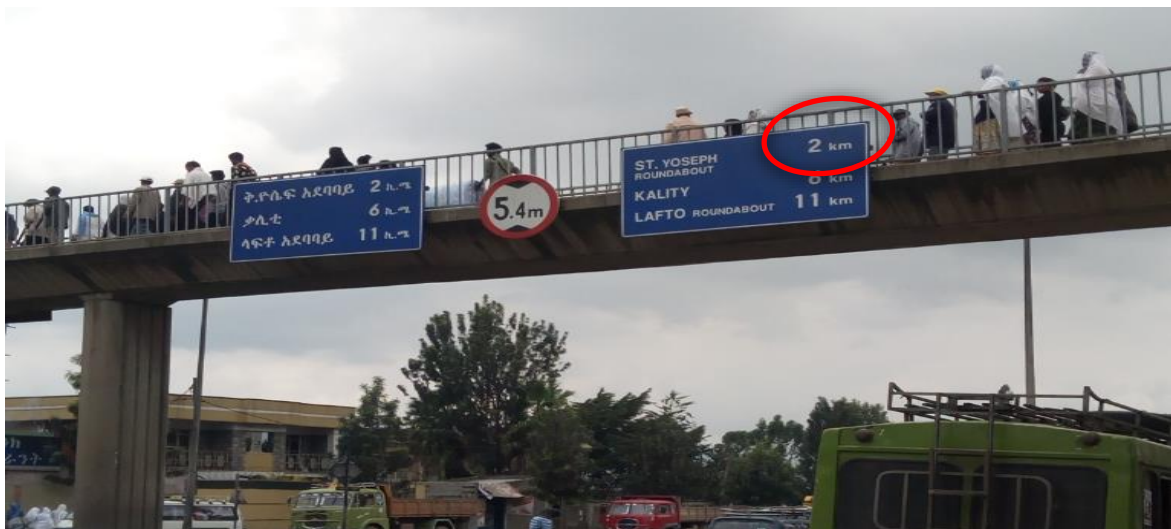
The study route is about 14km long and has a total of 12 pedestrian crossing facilities which are supposed to be legal to use. The average spacing of crossing facilities along the road is greater than 1.0km although not uniform throughout the route. For instance, the spacing between Bole Mikael overpass (OP-3) and St. Yosef overpass (OP-4) is 2.0km whereas between Bole Mikael junction and Bole Mikael overpass (OP-3) is about 300m only.

Figure 4.21: Distance (spacing) between Bole Mikael (OP-3) and St. Yosef Overpasses (OP-4) is 2km.

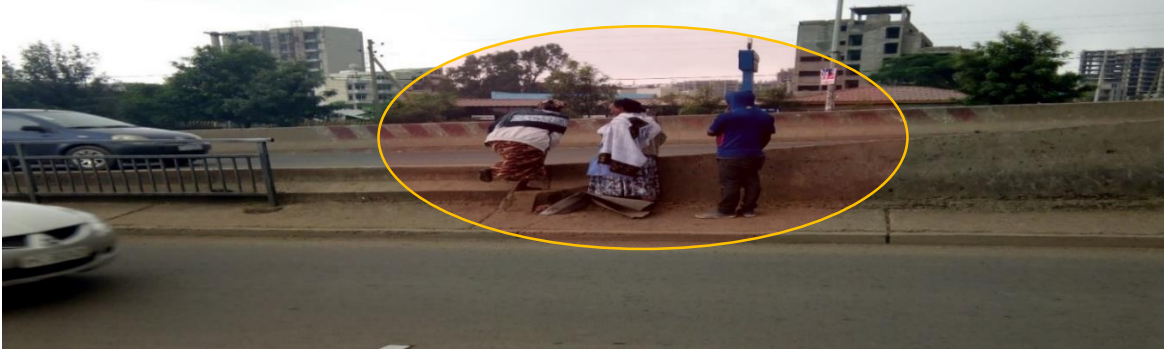
Local place names, descriptions of pedestrian attracting/ generating land uses & Pictures took During Site Visit
<p>1. Egziabherab Junction: A local textile marketplace in front of AMCE attracts large volume pedestrians. Taxis, mini-buses and auto buses drop-off passengers before reaching Megenagna Transport Station as most of the time the approach gets congested. The nearest legal and safe crossing facility is at Megenagna which is one of the most congested places in Addis Ababa as it attracts and generates a large volume of pedestrians.</p>

<p>2. Approach to Bole Dildiy: The New Taxi station at Bole attracts and generates pedestrians but pedestrians prefer to cross the Ring Road over fences to access the station.</p>
<p>3. Bole Airport Cargo Terminal: Bole International Airport Cargo Terminal entry where extremely large volume of pedestrians are left with no option to cross the Ring Road other than jumping over barriers or travel long distance in search for another crossing alternatives. The terminal, which is not only nationally but also internationally important area, has no pedestrian facility to cross the pedestrian access protected Ring Road.</p>

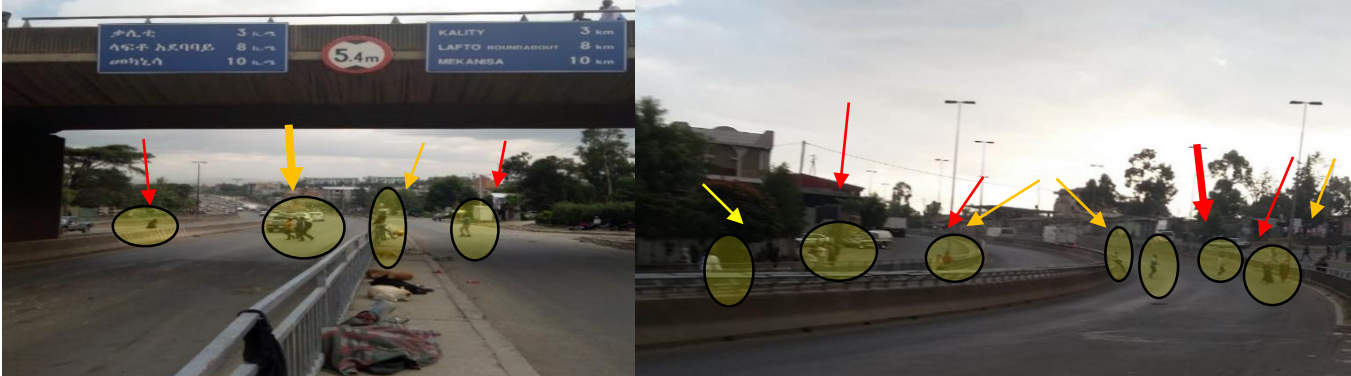
<p>4. Mammo: At Mammo where large volume of pedestrians especially students from <i>Agaziyan</i>, <i>Sibiste</i> and <i>Nifas Silk</i> schools cross the Ring Road in a risky way. Mammo is 340m before St. Yosef overpass (OP-4) where large volume of illegal crossing exists and residents and students do not have options other than jumping over barriers or travelling additional 340m (totally 680m), which is not acceptable by most of them</p>
<p>5. Adey Abeba/ Zenbaba Hospital: Just below the overhead road at Adey Abeba, taxis drop-off and pick passengers which makes pedestrians to jump over barriers.</p>

6. Approach to Abo Square: Abo church and the taxi and bus stations at this area attracts/generates a large volume of pedestrians. There is an alternative at grade crossing (Abo Square) within a very short distance and illegal crossing here is small.

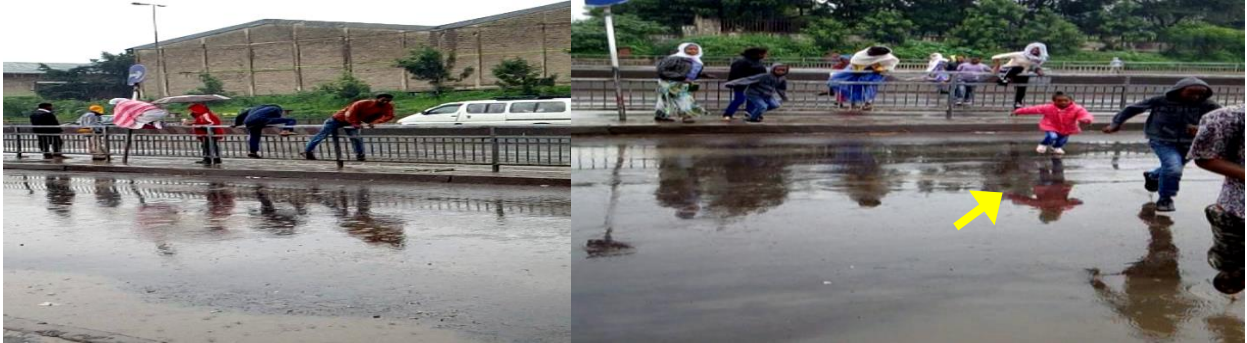
7. Saris Gulit & Bulbula School: Pedestrians travelling to and from Saris Gulit (local marketplace) and Bulbula School almost totally abandon the nearby Ersha Sebil overpass (OP-6) and cross the road over barriers rather than travelling 212m (totally 424m) laterally to the facility. Illegal crossing here is greater than legal crossings by using the facility.

8. Kadisco (in front of Kadisco Asia Paints): The area is dominantly of industrial zone characterized by low volume of pedestrians. It is at 430m from the Hana Mariam (OP-7) and 750m from Kality interchange. Hence pedestrians from the access road cross here rather than travelling 430m (totally 860m) to Hana Mariam overpass OR 750m (totally 1.5km) to Kality Interchange which are the two legal crossing facilities.

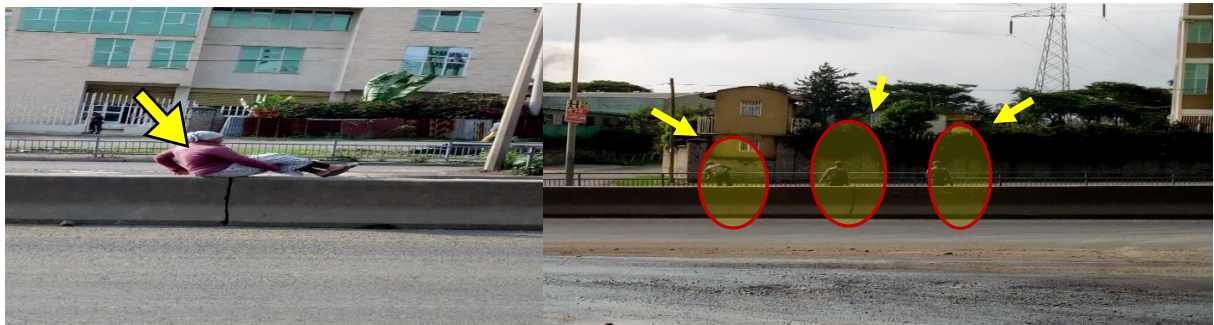
9. China Teter: Insignificant volume of illegal crossing exists here relative to the other places (but it is significant as far as it is illegal with traffic rules perspective).
