QUARRY REHABILITATION PLANNING:

THE CASE OF 'WORKU-SEFER' QUARRY PROJECTS, ADDIS ABABA

M.Sc. Thesis in Environmental Planning and Landscape Design

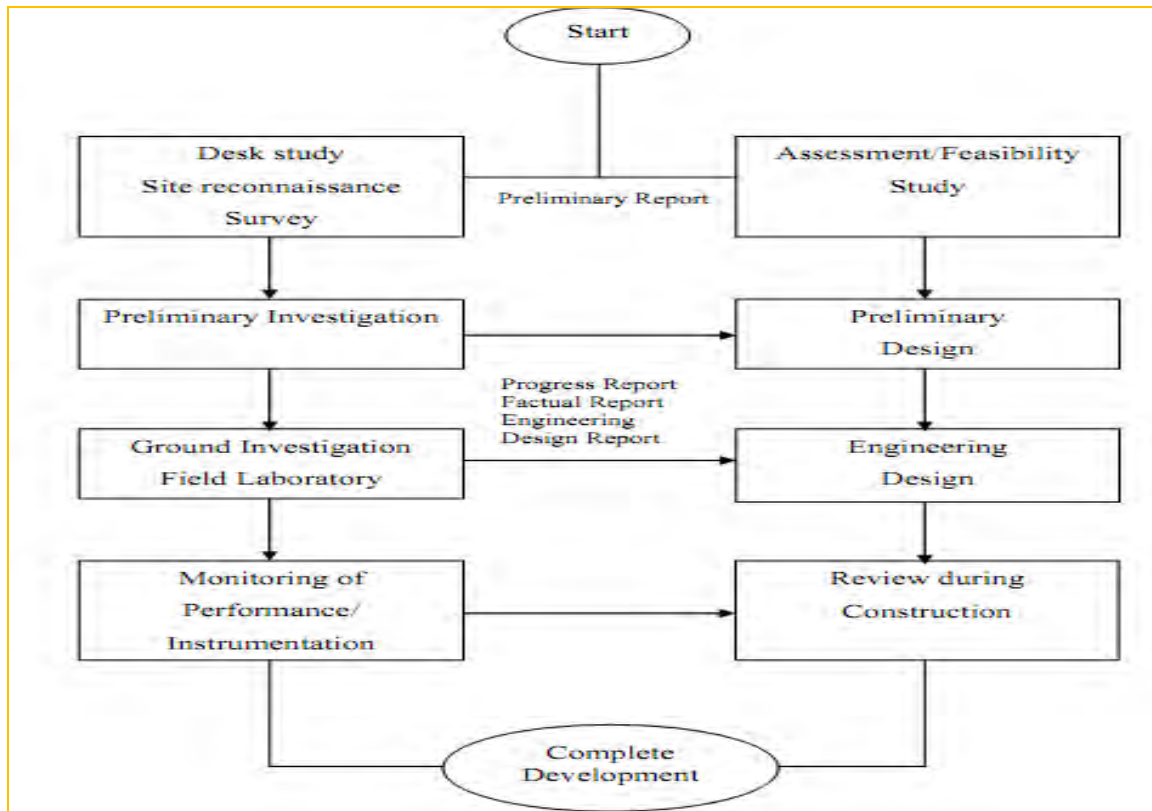
Figure 1: Sequences of ground investigation in relation with quarry design stages (Source: Nurly Gofar et.al; 2007)

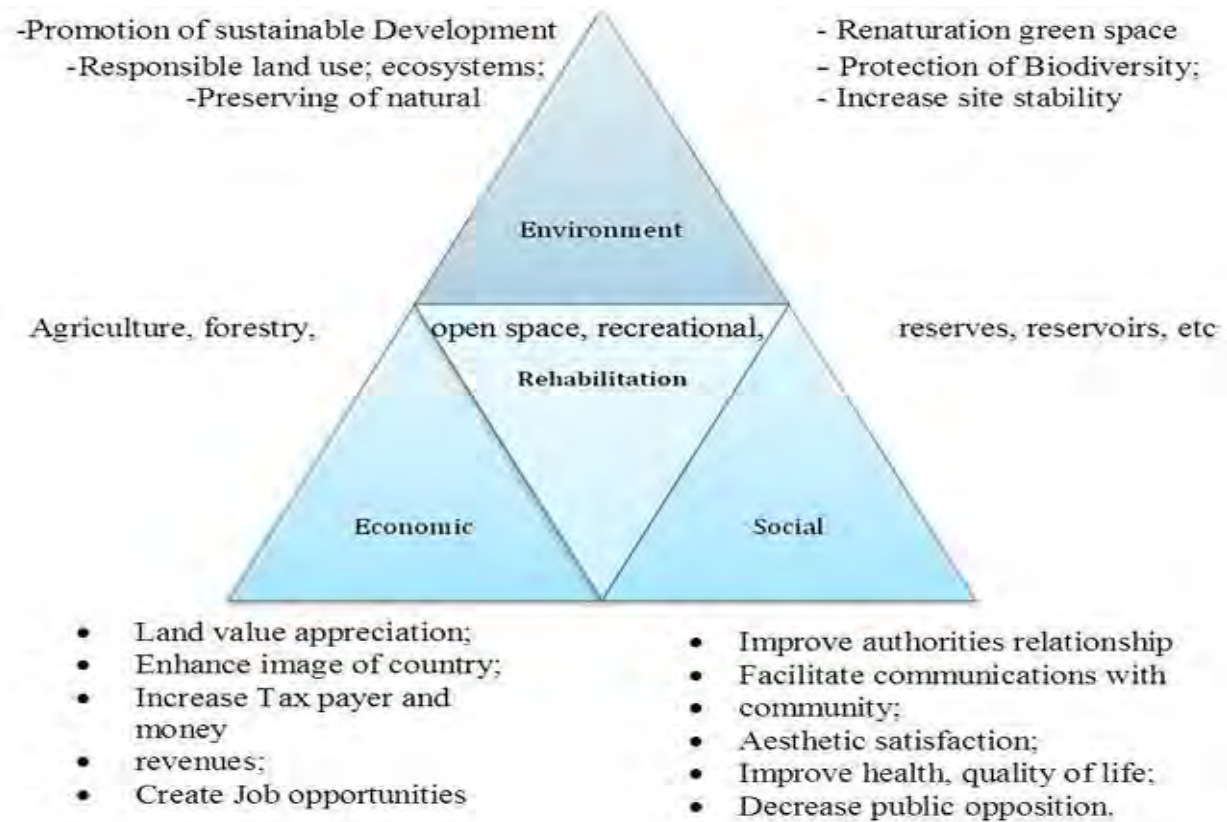
Figure 2 Rehabilitation and the three base process of sustainable development (*University of Applied Science, Switzerland, 2006*)

There are numerous environmental benefits associated with quarry rehabilitation, such as the recuperation of ecological conditions, restoration of green spaces and vegetation, and decrease in soil losses and erosion. Figure 2 describes the correlation that joins the rehabilitation process and the three main pillars of sustainable development.

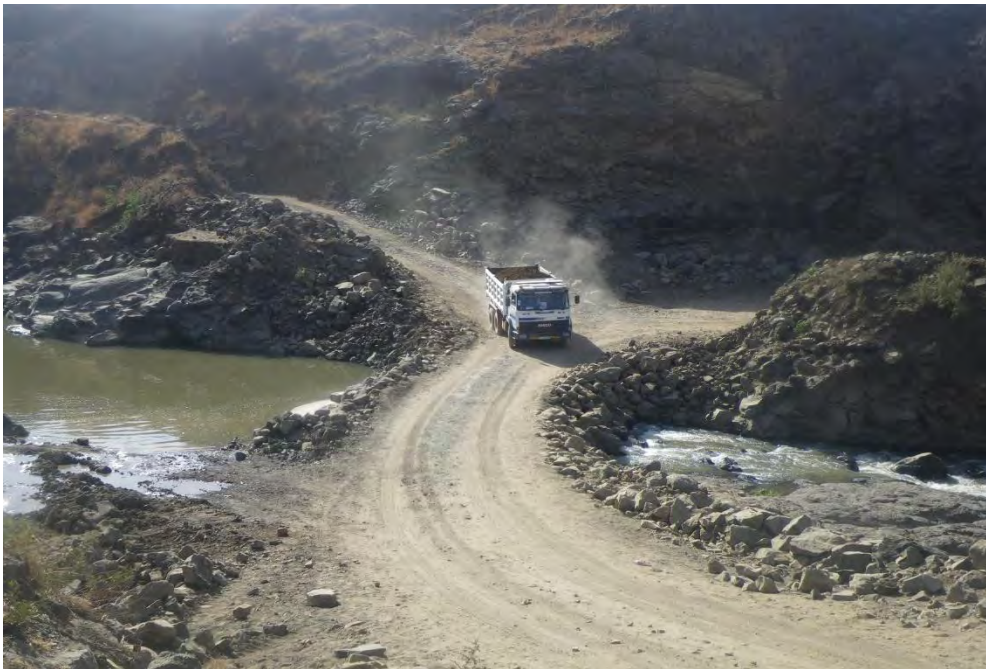
Figure 7: The current access road block the flow of water

The above figure reveals different vehicles were cross the river through poor and temporary constructed road, which pollute the river and affect the river ecosystem at the whole.

This activity includes stripping of soil and vegetation cover, surface leveling, construction of access road and site offices or camps, etc. However, the majority of access road in the study area was poorly designed and closing the natural flow of the river. In addition the roads were damaged during the rainy season through river flooding (figure 7).

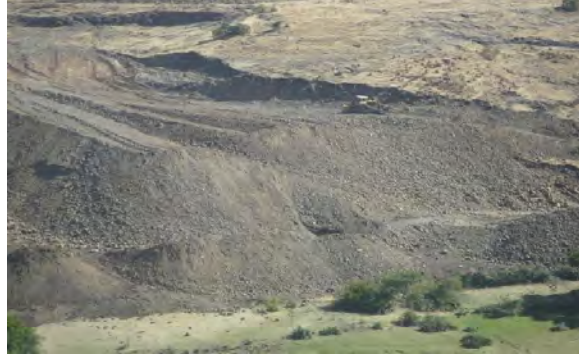
Figure 8: The stripping of overburden material in the study area

This is the operation of removing of volcanic tuffs together with black cotton soil (top soil). This material has excavated and stripped off by a dozer in order to exploit minerals with the required quality.

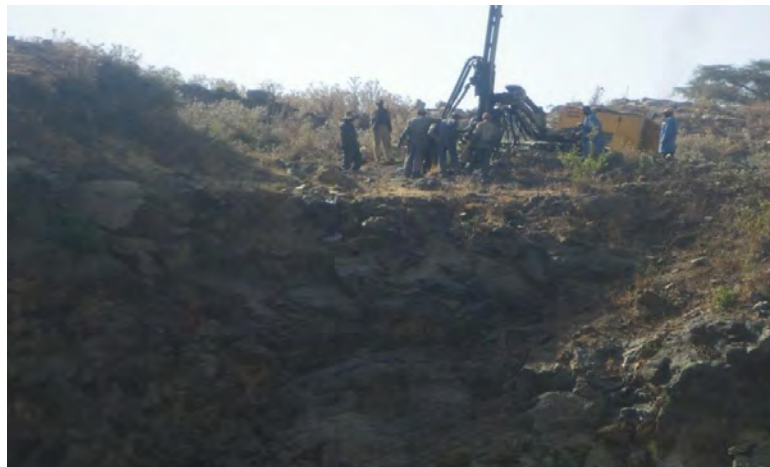
Figure 9: Drilling and blasting preparation to fragment the rocks in the study area

These explosives can induce cracks, break, open or throw away limited volumes of rock around it on exploding. However, these depths were beyond the limit and result negative impact to the surrounding environment of the study area. According to AAEP 2012 report on basalt and quarrying processing the maximum allowed quarrying depth is 10 m.

Particularly AACRA and CRBC Addis Engineering PLC used drilling and blasting methods of rock excavation in the study area. The principle of quarry drilling was to obtain blast holes and drilling operations carried out using hydraulic drills. The diameter, depth, number and spacing of boreholes require very careful considerations for getting the most beneficial results. In general, the type of the explosive being used determines the diameter of the hole. The depth of blast hole depends on the volume of rock to be broken in one shot. In this regard both AACRA and CRBC used 12 m depth hole.

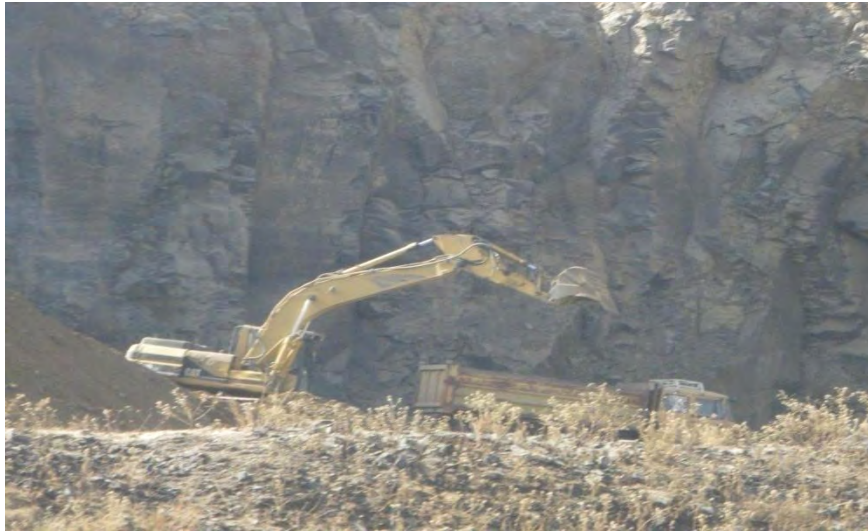
Figure 10: Excavation and loading selected materials in the study area

Following the blasting operation, the fractured rock has to be excavated prior to loading. Thus, dozers or excavators are alternatively performing the excavation activity in the study area.

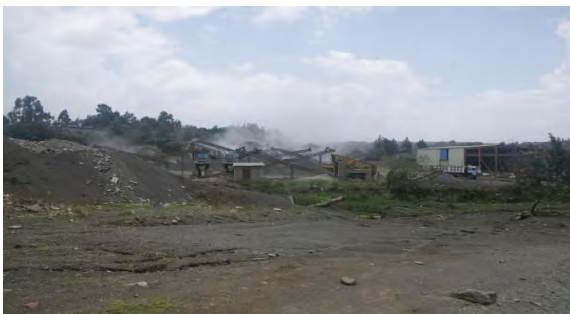
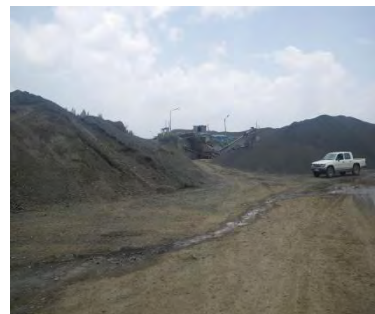
Figure 11: Crusher plantation in the study area

The objective of crushing is to accomplish size reduction and occasionally for obtaining additional requirements of different products used in various fields of applications. Specification on gradations shall be met by screening and classifying of the crushed aggregates with the use of vibrating screens. The crushing process in general starts with the feeding of blasted rock materials into the crushing unit of feed hopper by a front-end wheel loader or direct feed by a dump truck into the feeder.

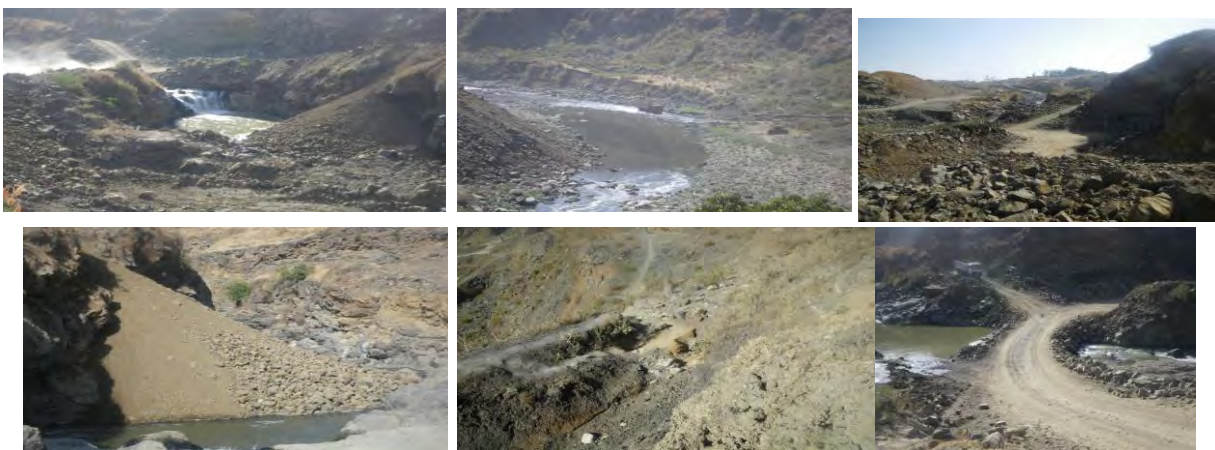
Figure12: Carelessly dumped overburden material and bridging of the river

From the definition, excavation is an act of removing, moving and depositing the surface of the earth's outmost crust. Successful excavation of solid rock necessitates preliminary determination of rock units and their boundaries or contacts, the nature of discontinuities to be encountered, the possible presence of water, and the presence of any weathering or alteration. Furthermore, the volcanic tuffs together with thick layer of black cotton soil have to be excavated and stripped off by a dozer in order to exploit minerals with the required quality. It is also strongly recommended that, the overburden debris to be excavated must be kept protected at specific sites for future rehabilitation program and get well compacted to protect pollution of the nearby stream from such loss of organic debris by erosion. According to the field observation and the respondent's explanations, however, the existing excavation and management practice of the mining activity in the study area is very poor and not consider the above listed issue. In addition the boundaries of the project area are not well demarcated to separate one project site from the other and the operation is not consider the environmental issue of the site. These are mainly the quarry projects in the study area starting without site investigation and as the sites are highly affected and left as degraded make the rehabilitation method complex and increase cost. The overburden materials were lost through erosion and it is thrown to the river carelessly. As a result it leads in diverting the natural flow of the river and highly affected the river ecosystem in general.

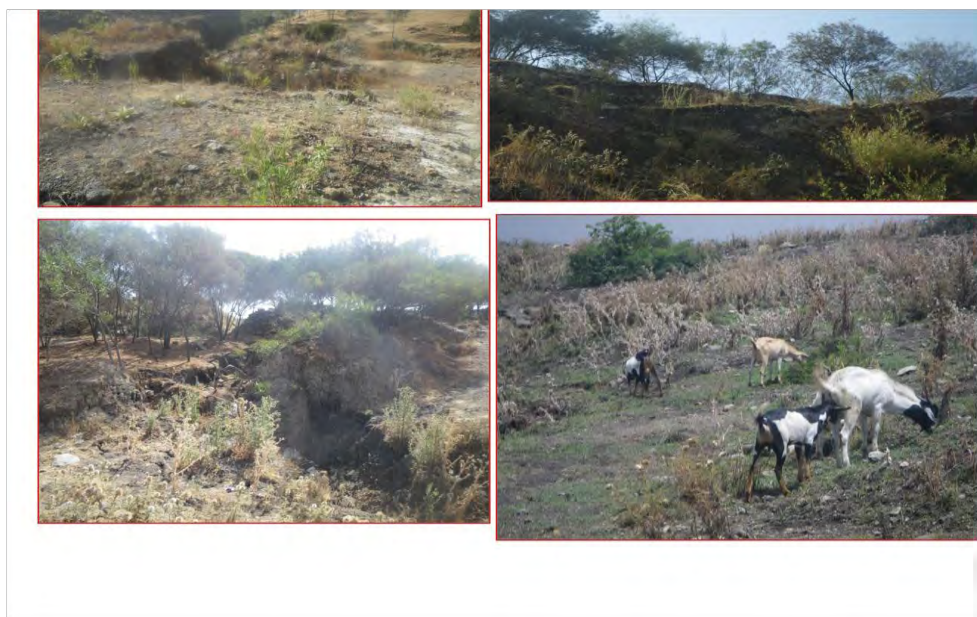
Figure 13: Poor practice quarry rehabilitation efforts in the site

The following figure shows the current rehabilitation of the site.

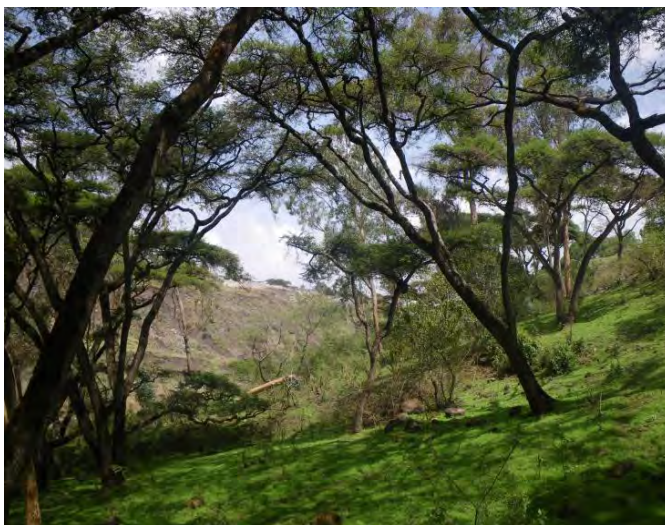
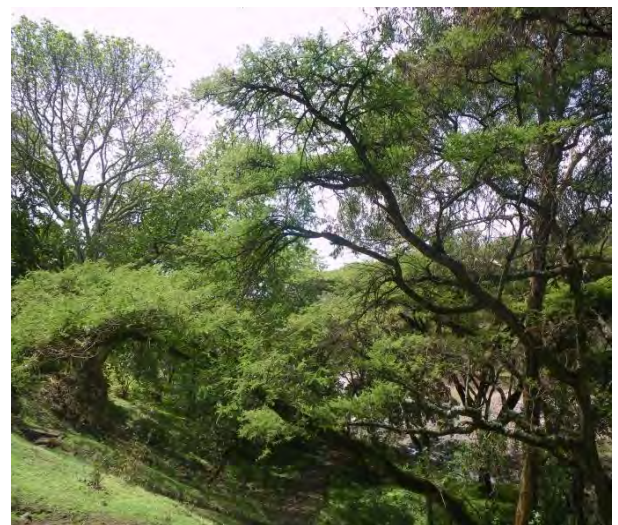
Figure 14: woody species found in the study area

The above figure shows plant species found in the study area. This was dominated by a species of *Acacia abyssinica*.

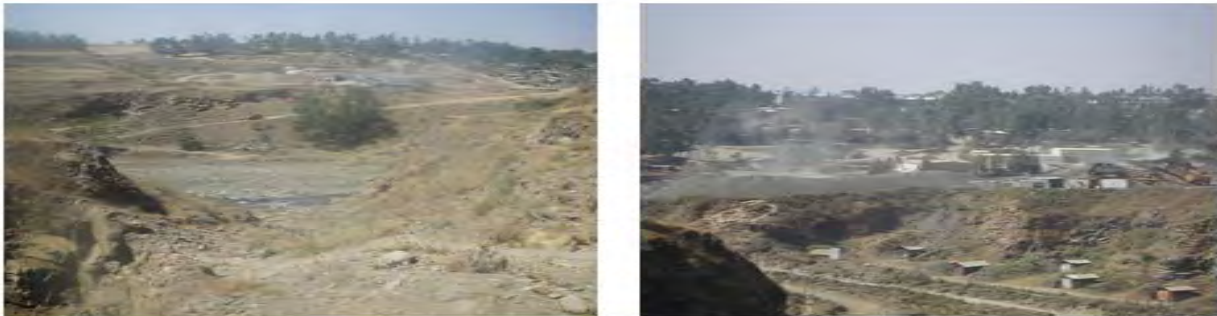
Figure 15: Abandoned /bare land in the study area

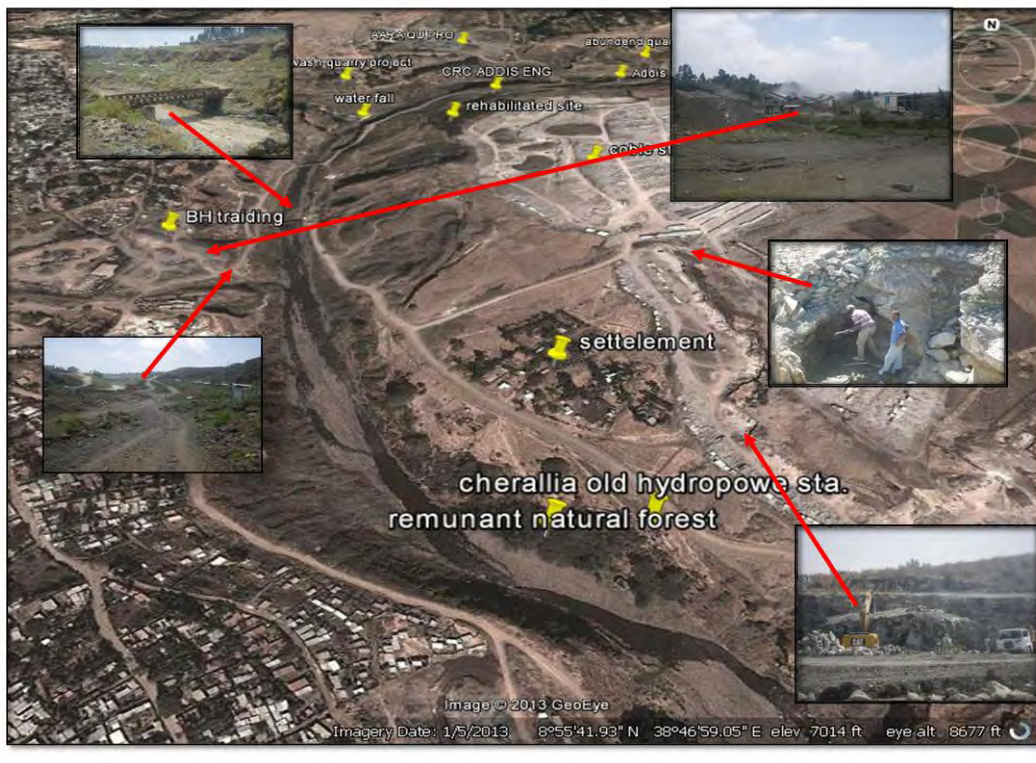
The left picture shows a quarry site owned by Berta construction Plc. This was started in 1986. This quarry is currently not operational and abandoned. While the picture in right side is a quarry site owned by BH trading, started its operation in 1987. However, the quarry has ceased its operation.

Figure 16: field photograph and Google earth image, 2013

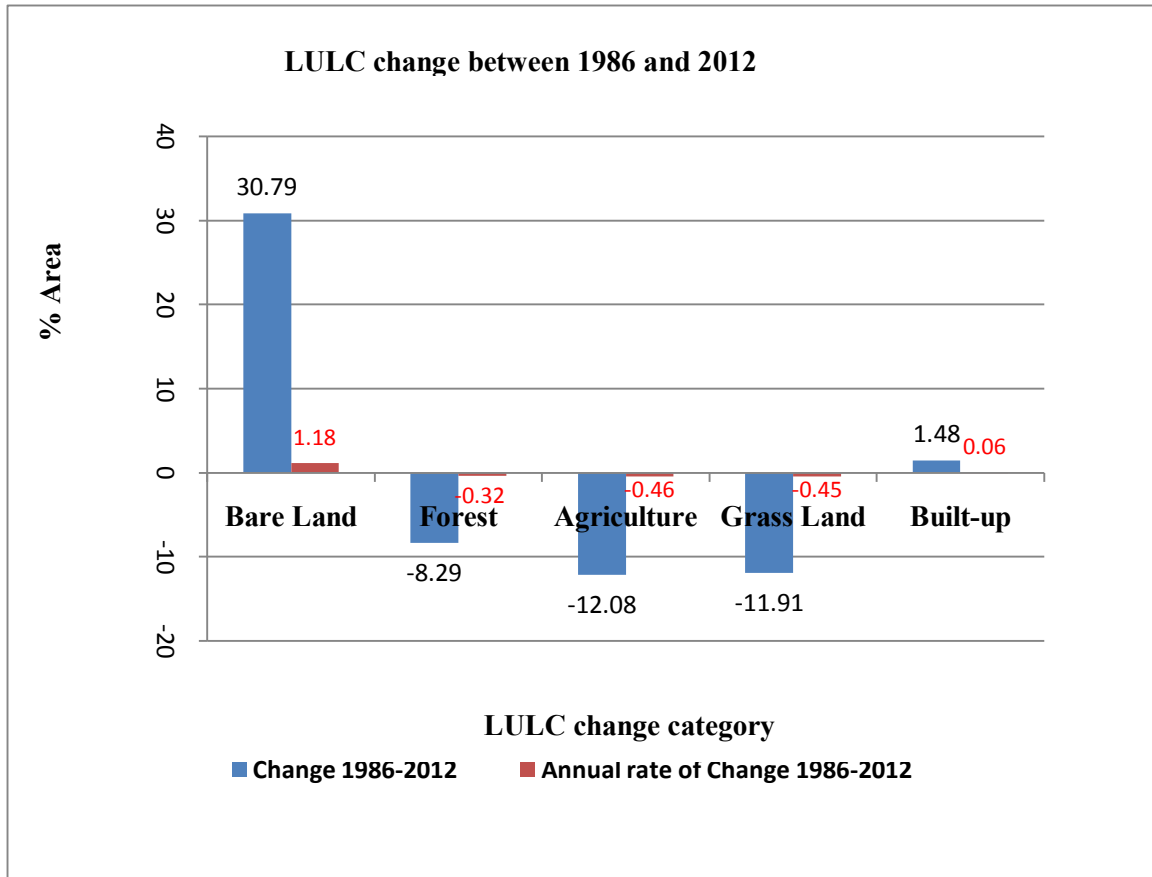
Figure 19: Land Use and Land Cover Change over the study period

The table above shows that bare land and agriculture land changed significantly; the former was increased in 101 hectares (1010949.97 m²) with 3.9 ha (38882.69m²)/yr (1.18%) rate of change, while the later one had decreased with 39.7 ha (396553.92m²) by 1.5 ha (15252.07m²) /yr (0.46 %) negative rate of change. The Forest coverage showed a major change that has declined with 1.1 ha (10467.3 m²) per year (0.32%) negative rate of change. Built-up area showed very small expansion (4.9 ha) and the rate of increase over the period has been estimated as 0.2 ha (1873.79)/yr (0.06% per year) which is relatively the lowest rate of change. (Table 8 and figure 18).

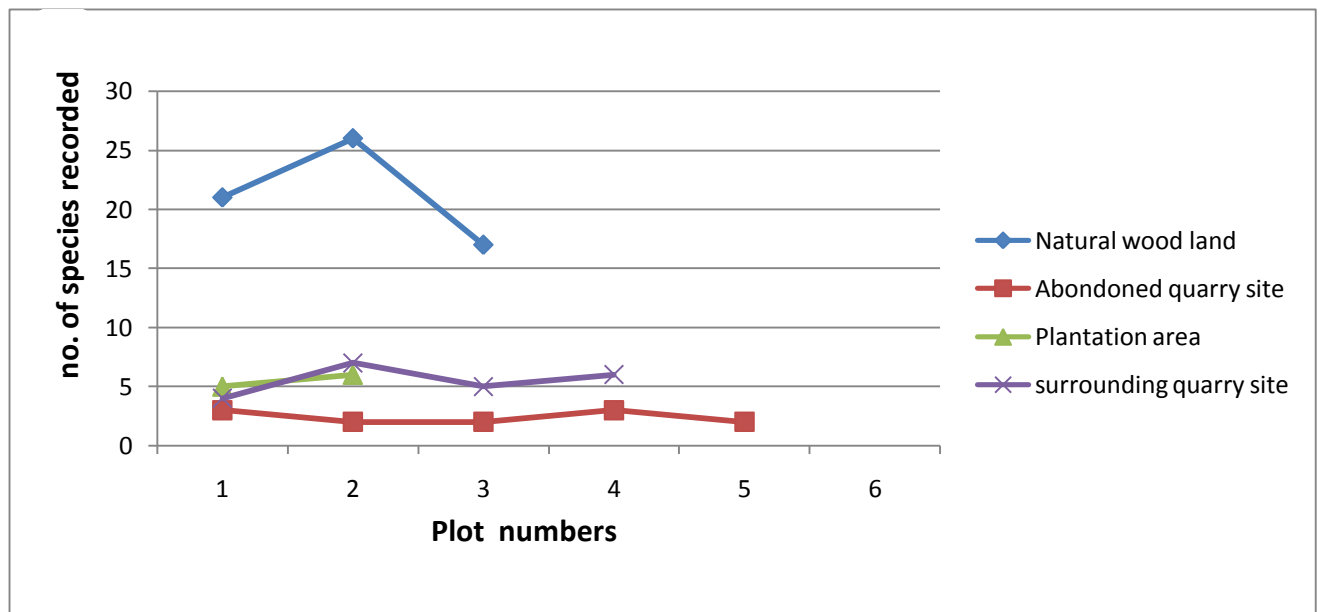
Figure 20: Number of woody plants (all trees and shrubs) for the different land uses types of the study area.

During vegetation survey different species were recorded in the sampled areas to judge the composition and related vegetation (woody species) qualities in the study area. The recorded species graphs to the four land category in the study area are given in Figures 20.

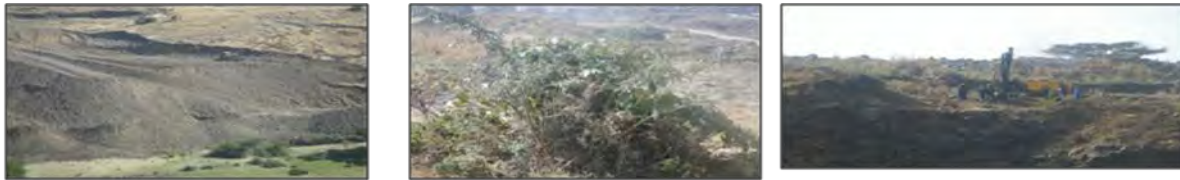
Vegetation cover around active mining site: *Rosa abyssinica*, *Croton macrostachyus*, etc.

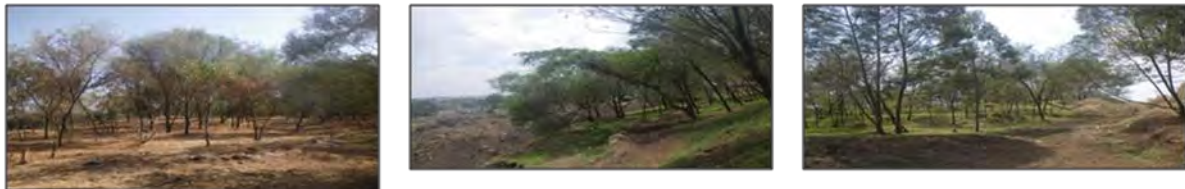
Vegetation from plantation area: mainly *Acacia decurrens* and *Acacia saligna*

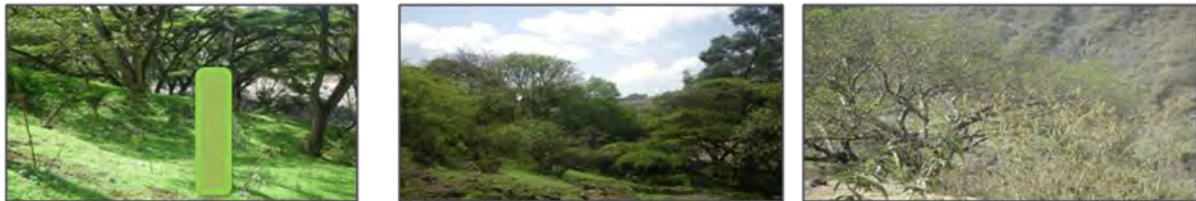
Vegetation from remnant natural wood land: *Acacia abyssinica*, *Croton macrostachyus*, *Carissa spinarum*, *Ficus sur*, *Justicia schimperiana*, etc.

Figure 21: Different vegetation covers at different category in the study site

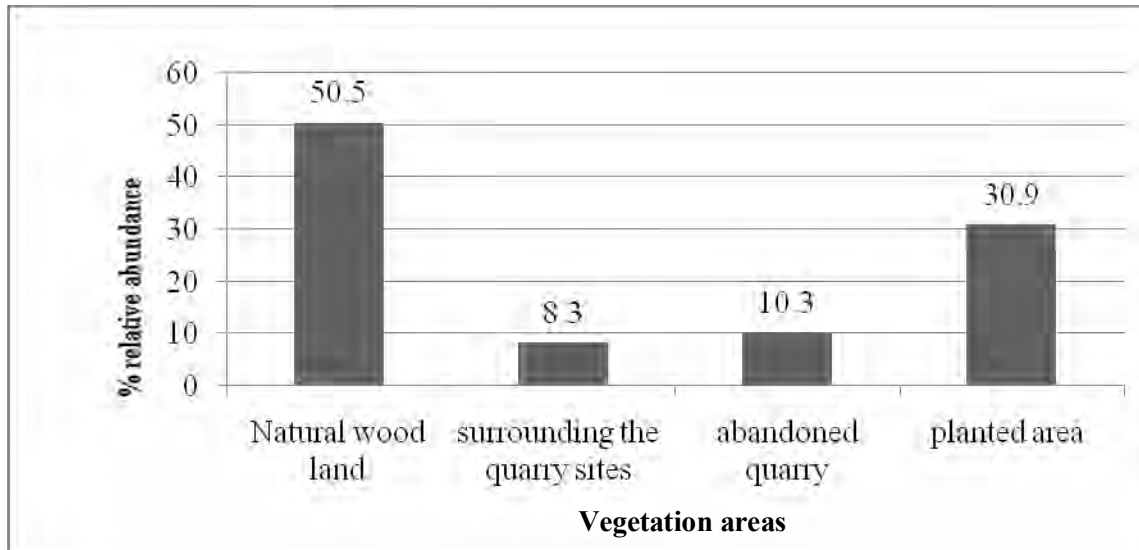
Figure 22: Total % relative abundance of all woody species across the vegetation types (calculated as the total abundance of all species in each vegetation type show as a percentage of the combined total for all vegetation types).

The abundance of woody plants of both trees and shrubs was highly varied over the four land use types (figure 22). The remnant natural wood land area has the highest abundance with 226 plants (50.5% of the total). The plots surrounding the quarry sites had 37 plants (8.3 % of the total), the abandoned quarry and spoil heaps area had 46 plants (10.3 % of total), and the planted area survey recorded only 138 plants (30.9 % of total abundance).

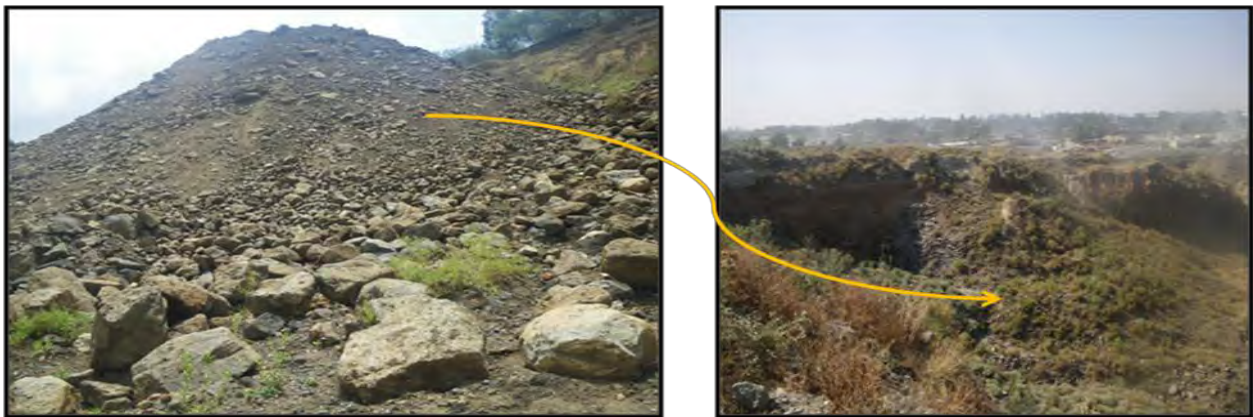
Figure 24: the stripped overburden material from the active mining site used to refilling the abandoned quarry site in the study area

Furthermore, the quarry operator should improve the plan of the extractions of material by adding the stripping of over burden material (top soil) from the active mining site to the abandoned quarry sites in the study area.

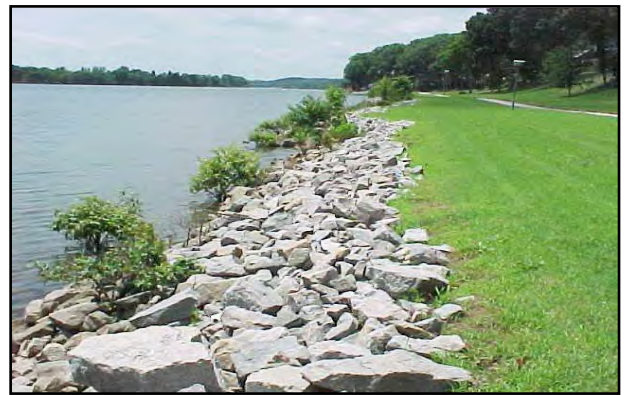
Figure29. Stone rip raping (Adapted from Tweed River Estuary Management Plan 2009)

Lining the river banks with some stone is feasible if local source of rock is available. The pits in stones and the nooks and crannies between them increase the amount of area for colonization by aquatic insects. Plants can take root between the rocks and rocks ledges can be used as resting and roosting sites by waterfowl. Stone is a relatively permanent option if the stones used are sufficiently large that they do not wash away during high flows. More angular stones will interlock and thus more stable. Placing a layer of fine gravel or stone under the larger rip-rap material will help to prevent erosion of finer bank materials from beneath the rocks. To avoid undermining at the toe of the rip-rap, stone aprons can be used which extends well out into the riverbed. An extra pile of rocks can be added to the edge of the apron which fall in and continue protecting the bed if it degrades.

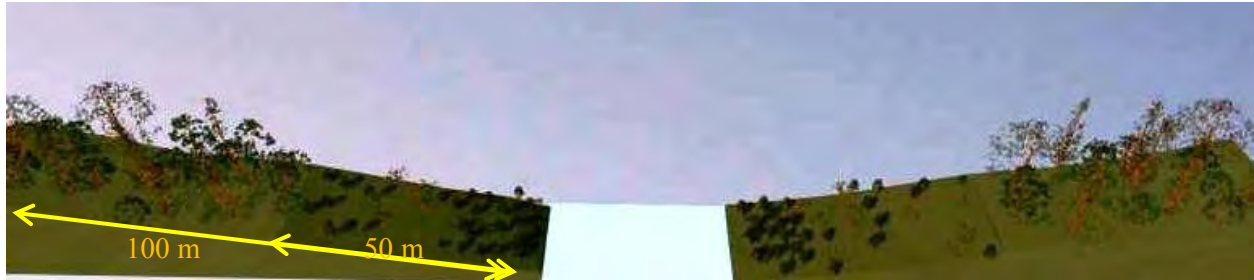
Figure 32: Proposed river buffer plantation in the study area

deep by increasing shear resistance of the soil by 40 percent and prevents landslides (Journey, W. 2003). While, the 100 meter buffer zone should be covered with a vegetation of grass and shade trees including *Acacia abyssinica*, *Casuarina cunninghamiana*, *Millettia ferruginea*, *Jacaranda mimosifolia*, *phoenix reclanata*, etc. These shade trees should be planted in a space of 2.5m x 2.5m between each other.
