**PERFORMANCE OF ROADS CONSTRUCTED ON BLACK COTTON SUBGRADE SOIL  
WITH RESPECT TO REPLACEMENT MATERIALS TYPE AND REPLACEMENT DEPTH**

**(A CASE STUDY ON MODJO - EDJERE ROAD)**

**The school of Graduate Studies of Addis Ababa Institute of Technology in partial  
fulfillment of the Requirement for the Degree of Master of Science in Road and Transport  
Engineering**

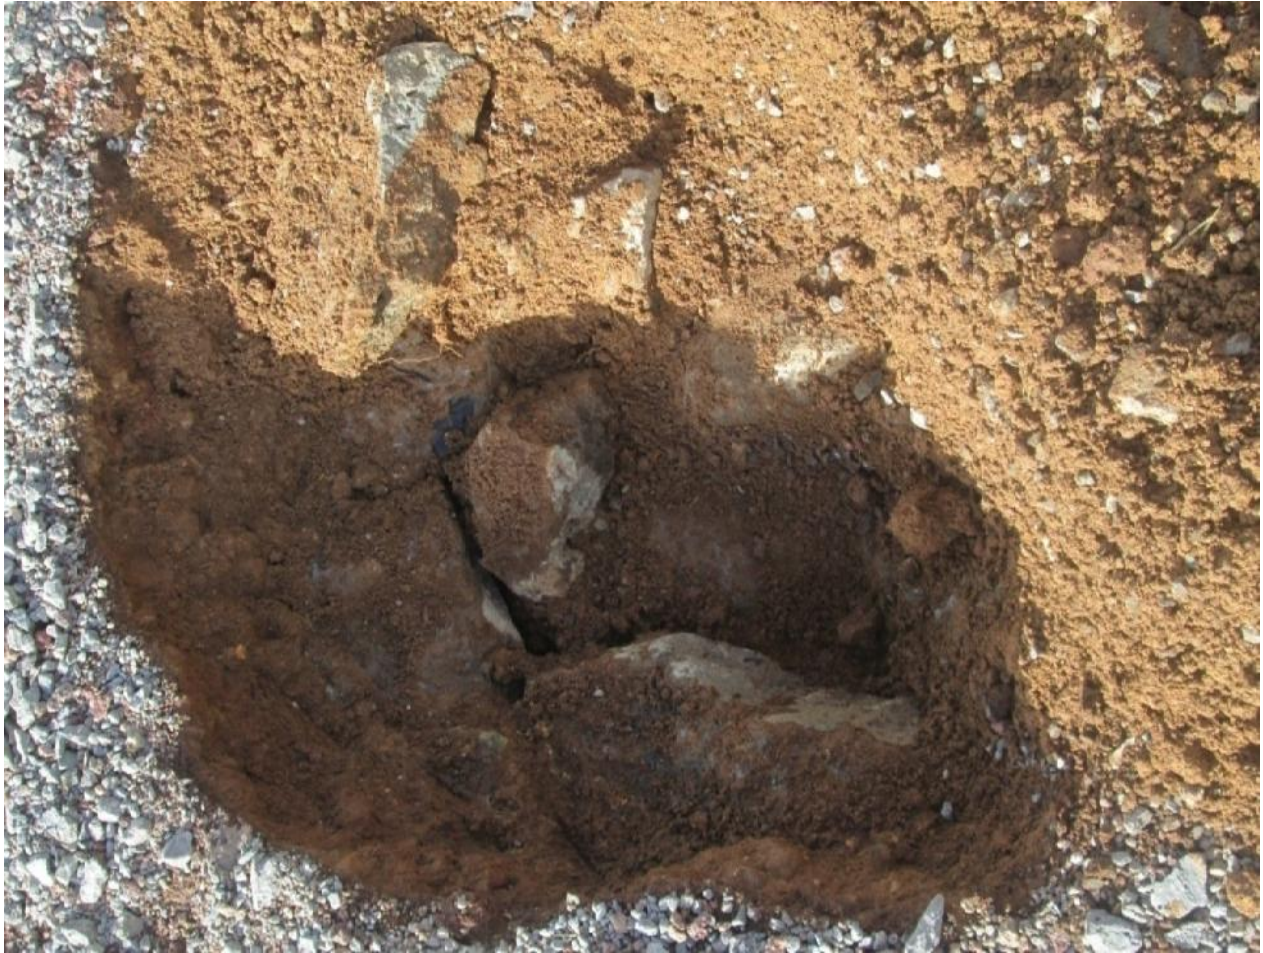
To know the extent of the crack and its origin, excavation of the cracked section of the road were carried out and it was noticed that the crack extends below the replacement materials, even beyond the rock fill. It was seen on some section of the road that, borrow materials were placed directly after treating the top 200 mm thickness of the sub-grade by ripping, removing all loose and oversize material from the surface and compacting to the minimum density requirement. This leads to the rock fill exposed directly to runoff and rainfall, Moreover, there is moisture variation from the underlying subgrade. It was seen around station 24+560 that borrow materials was exposed and seen under the embankment above natural ground elevation. Rock fill were simply placed on cleared surface of the top soil without excavating the natural soil to 60cm replacement depth. Figure below shows the appearance of fill (borrow) materials at the site.

**Figure 4.1 Exposed fill materials where the rock floats on the fine materials below embankment around station 24+560**

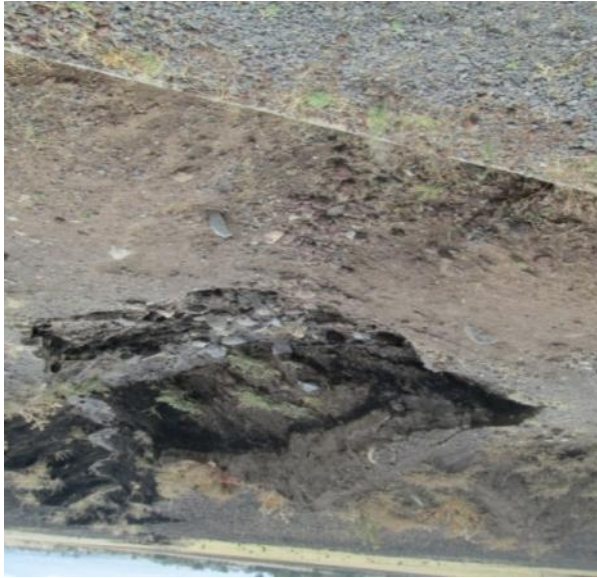
It was seen that drainage structures provided for the road under study are far away from each other and also there are some places that require drainage structures for the relief of the moisture. Lack of the drainage structures produces slide of the road side soil, which leads to erosion as indicated on the figure 4.2 and 4.3 below. The degree of damage occurring from moisture due to lack of drainage structure should be within the acceptable limit so that drainage structures should be designed and placed within acceptable distances where moisture is suspected.

**Figure.4.2 Lack of drainage facility**

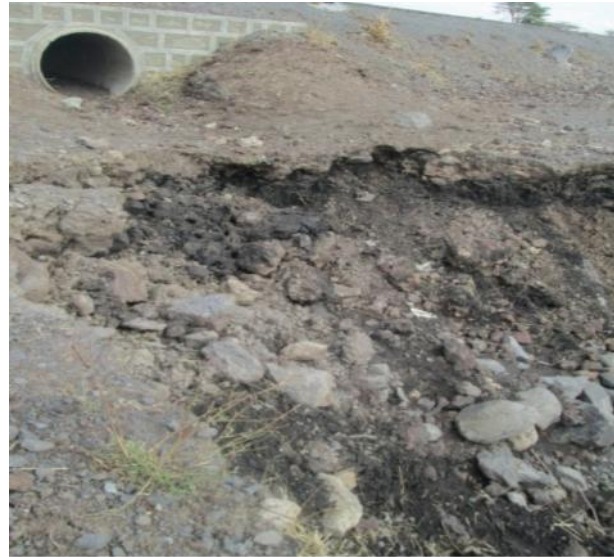
**Figure 4.3 Improper drainage facility**

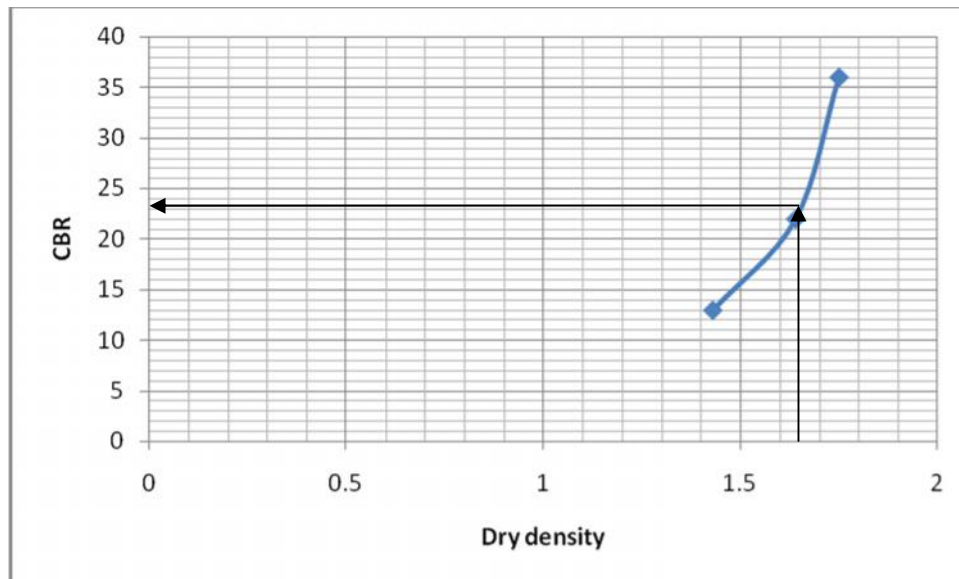
**Figure 5.3 replacement material dry density vs CBR at station 28+400**

$MDD \times 0.95 = 1.66 \text{ g/cc}$  for capping materials at station 28+400, hence CBR at 95% of MDD from the above graph is 23%.

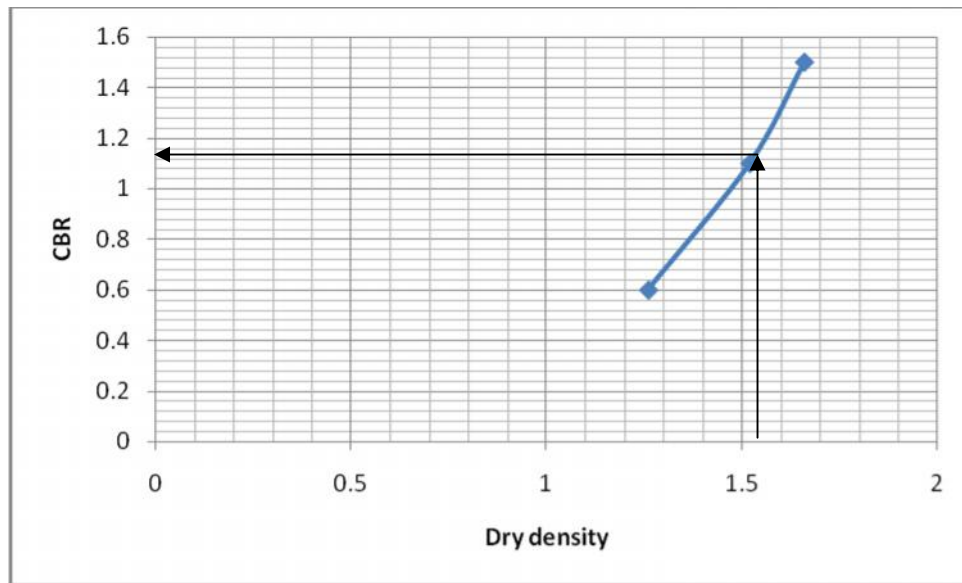
**Figure 5.4 CBR VALUE AT 93% MDD**

The CBR value at 93% of the MDD is 1.18% and hence the design CBR value is 1.18%.

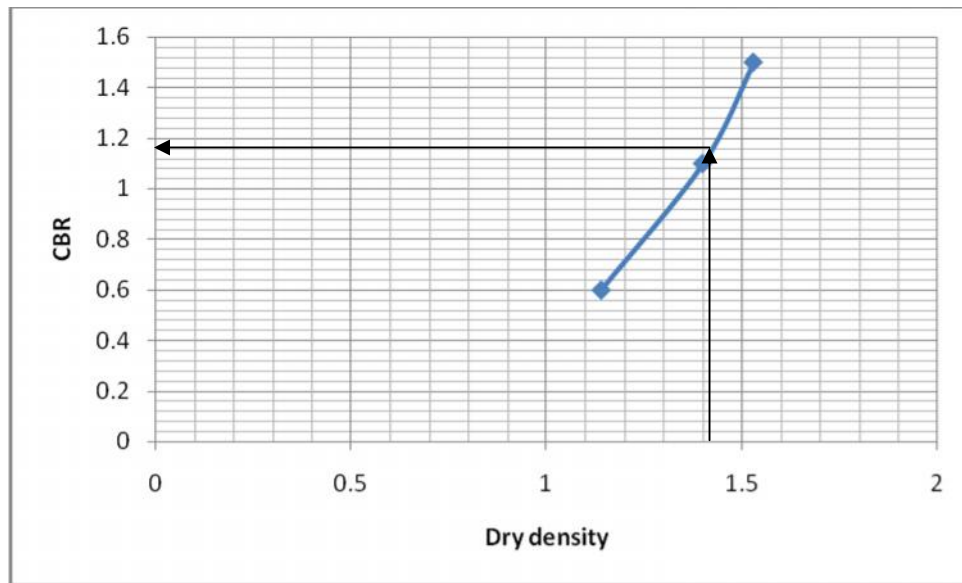
**Figure 5.5 CBR Value at 93% MDD at station 9+656**

The CBR value of 93% of the MDD is 1.19% from figure 5.5 above for station 9+656

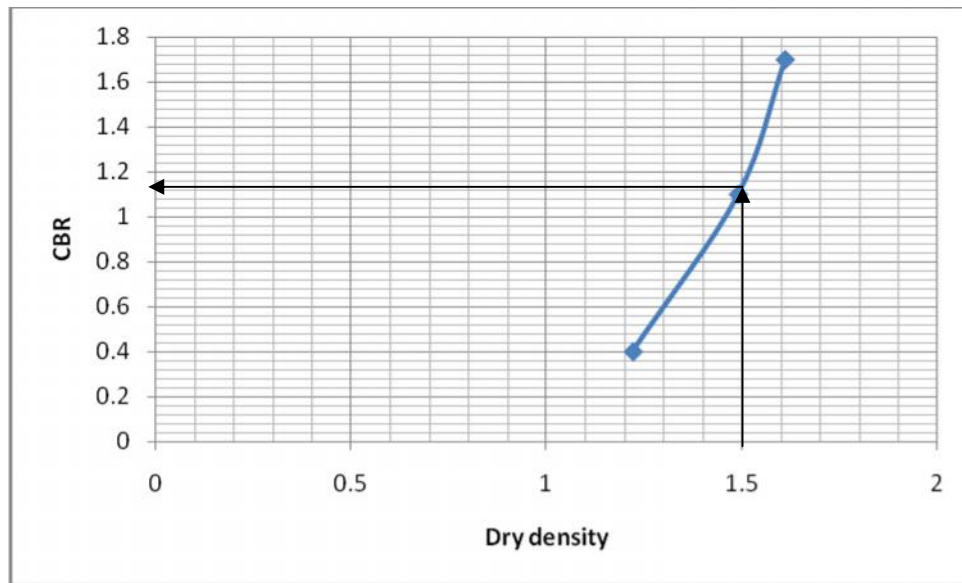
The CBR value of 93% of the MDD is 1.16% from figure 5.6 below for station 24+575.

**Figure 5.6 CBR VS Dry density at station 24+575**

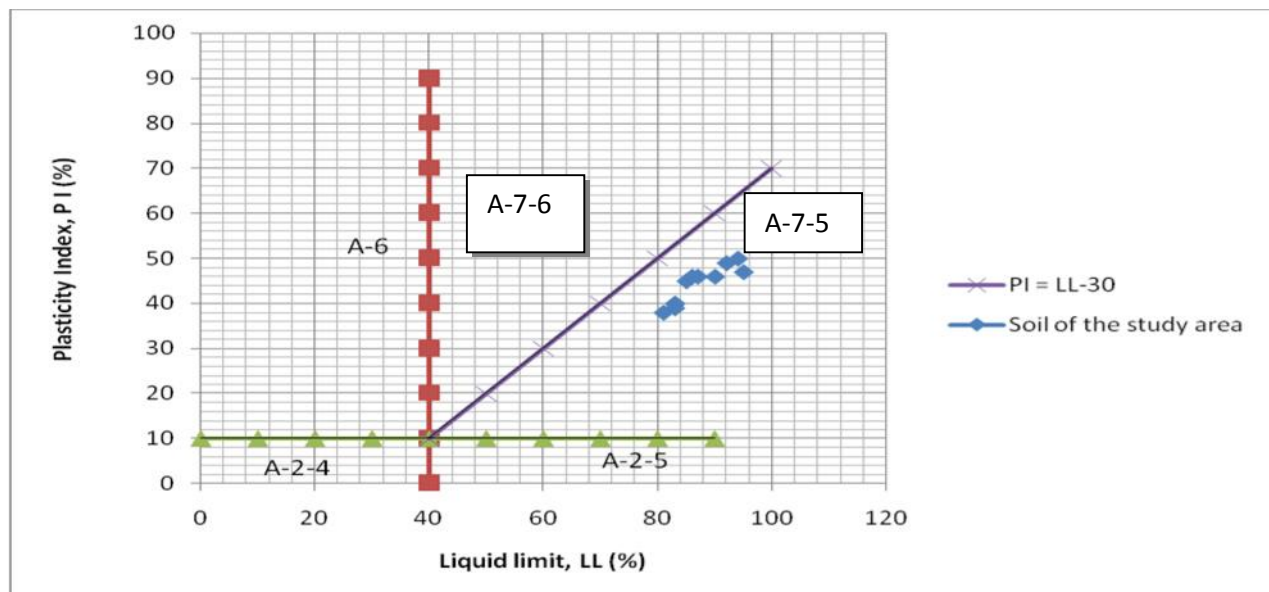
Atterberg limits (liquid limit, plastic limit) were determined according to AASHTO T 89 and 90 standard test method. The results of the Atterberg limits were shown in appendix 1. Measured liquid limit was found in the range of 83% to 94% and plasticity index in the range of 38% to 50%. Based on the Atterberg test results soil classification is made based on AASHTO soil classification system as shown in figure below and classified as A-7-5. This soil groups have high liquid limit and are highly plastic as well as causes considerable volume change upon moisture fluctuation.

Figure 6.1. Plasticity chart for AASHTO classification methods

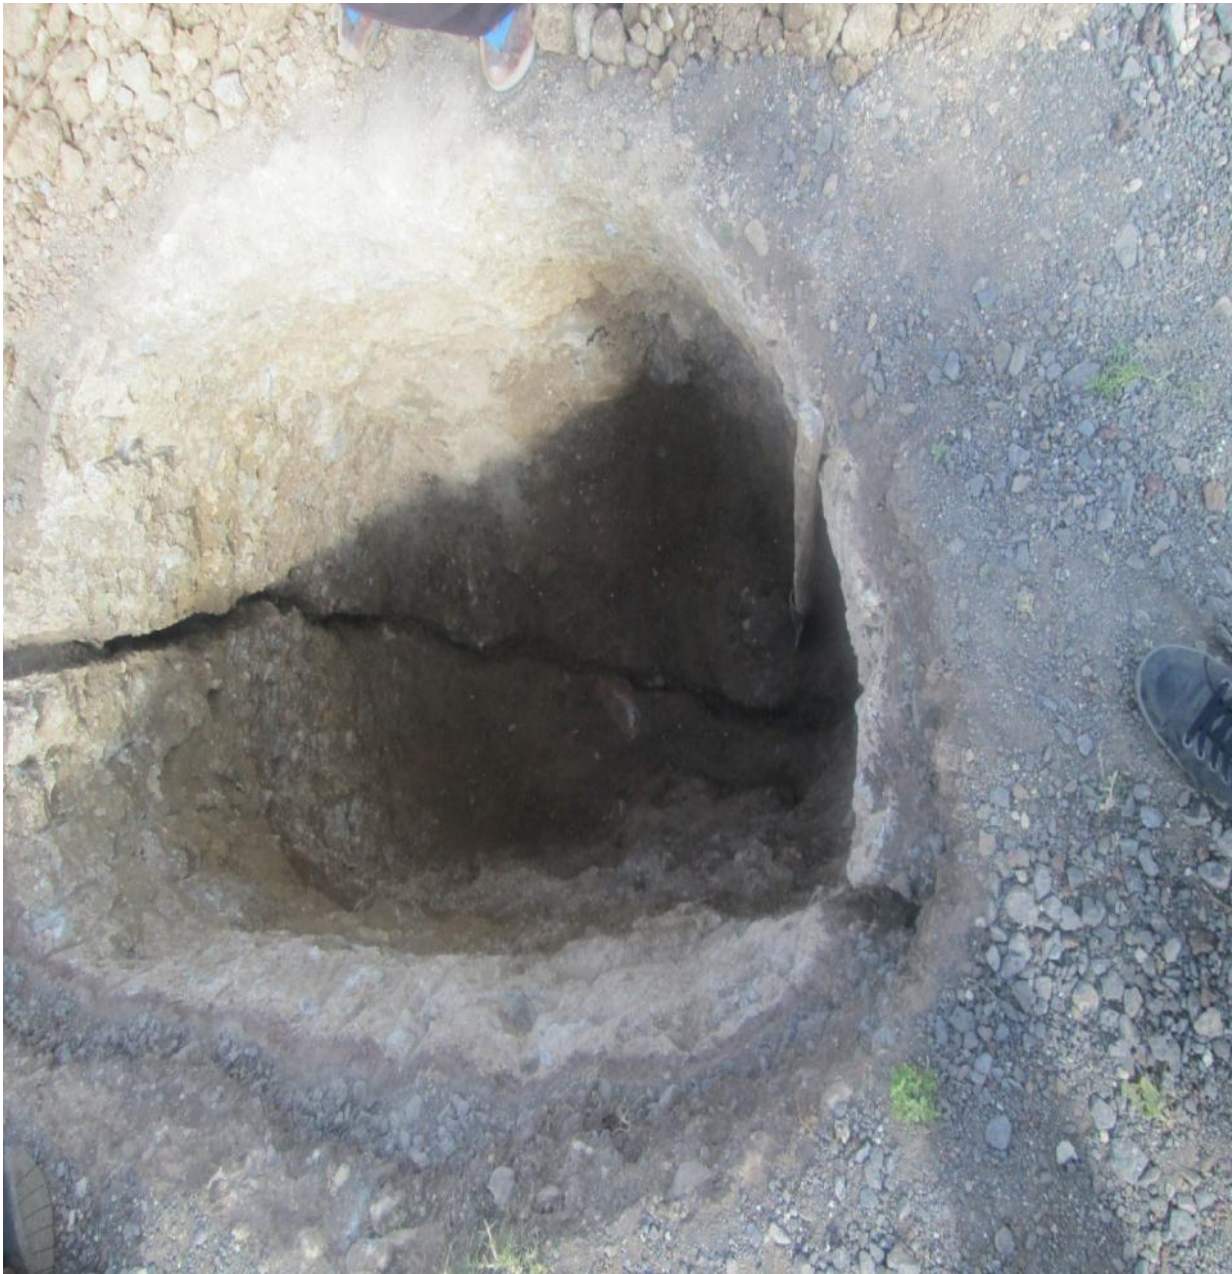
Photo 1 Cracks on the edge at station 24 + 590 – 24 + 610 RHS which extends beyond the rock fill

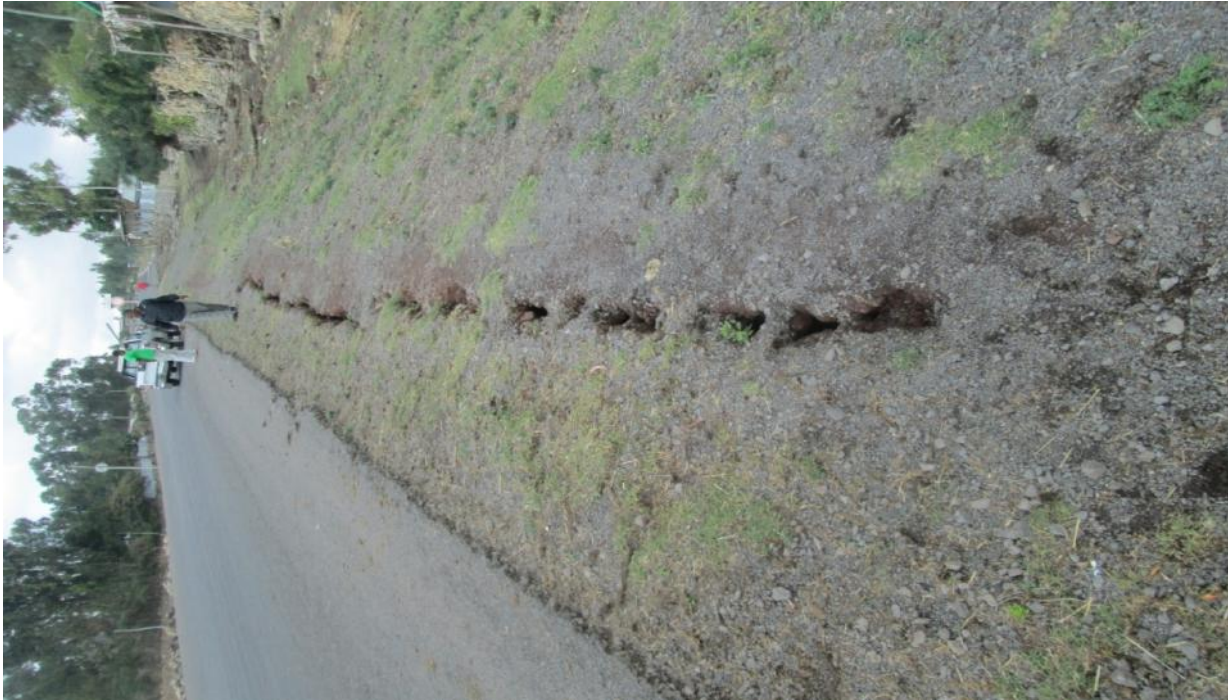
Photo 2 Edge cracks at station 28 + 600 RHS

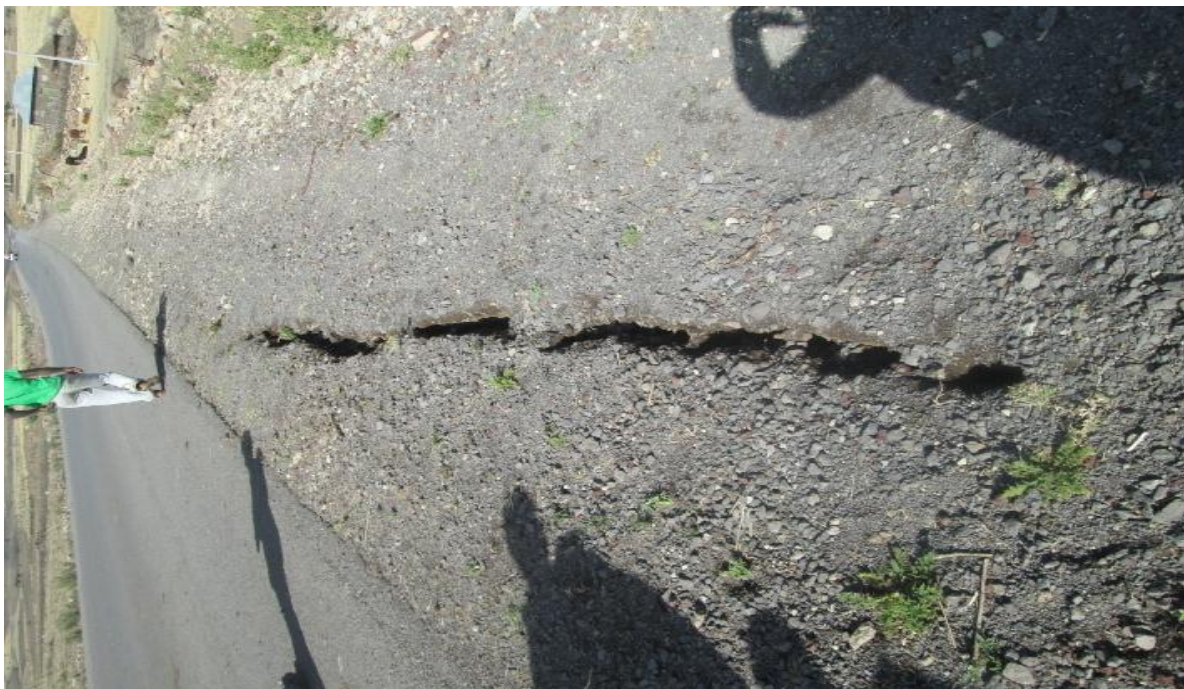
Photo 3 Edge cracks at station 24 + 590 – 24 + 610 RHS

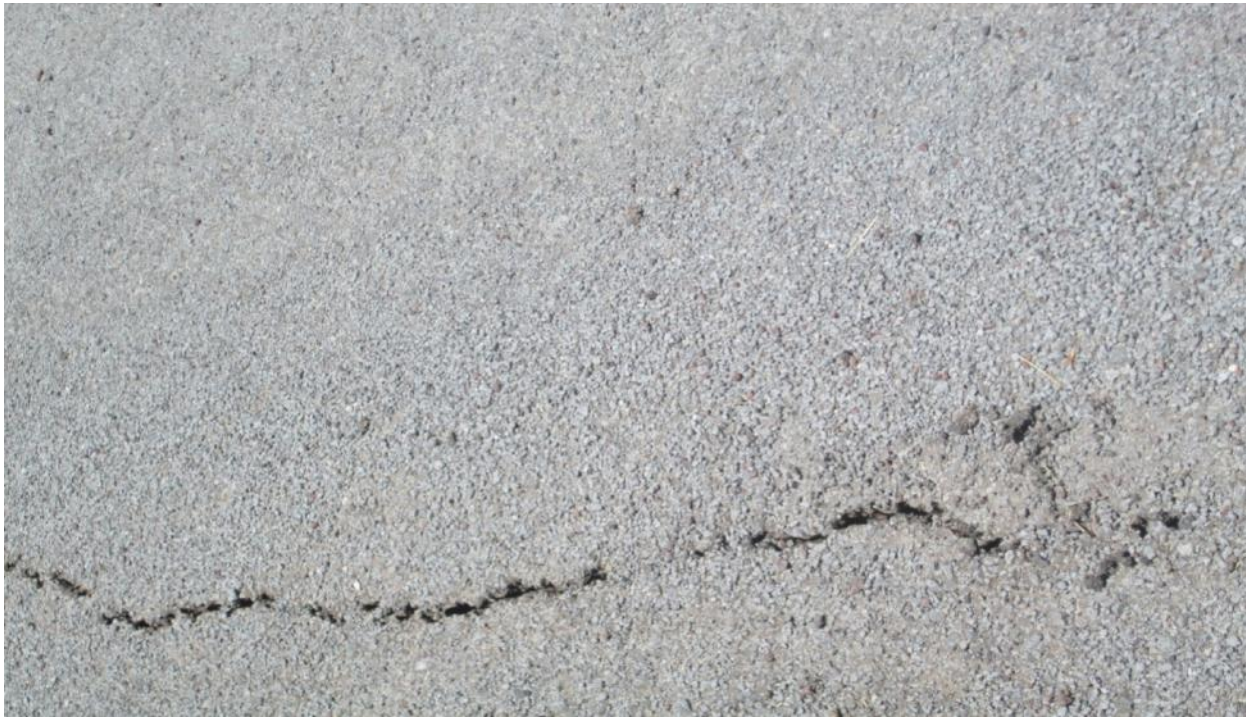
Photo 4 Surface cracks at station 10 + 346 – 10 + 600 LHS

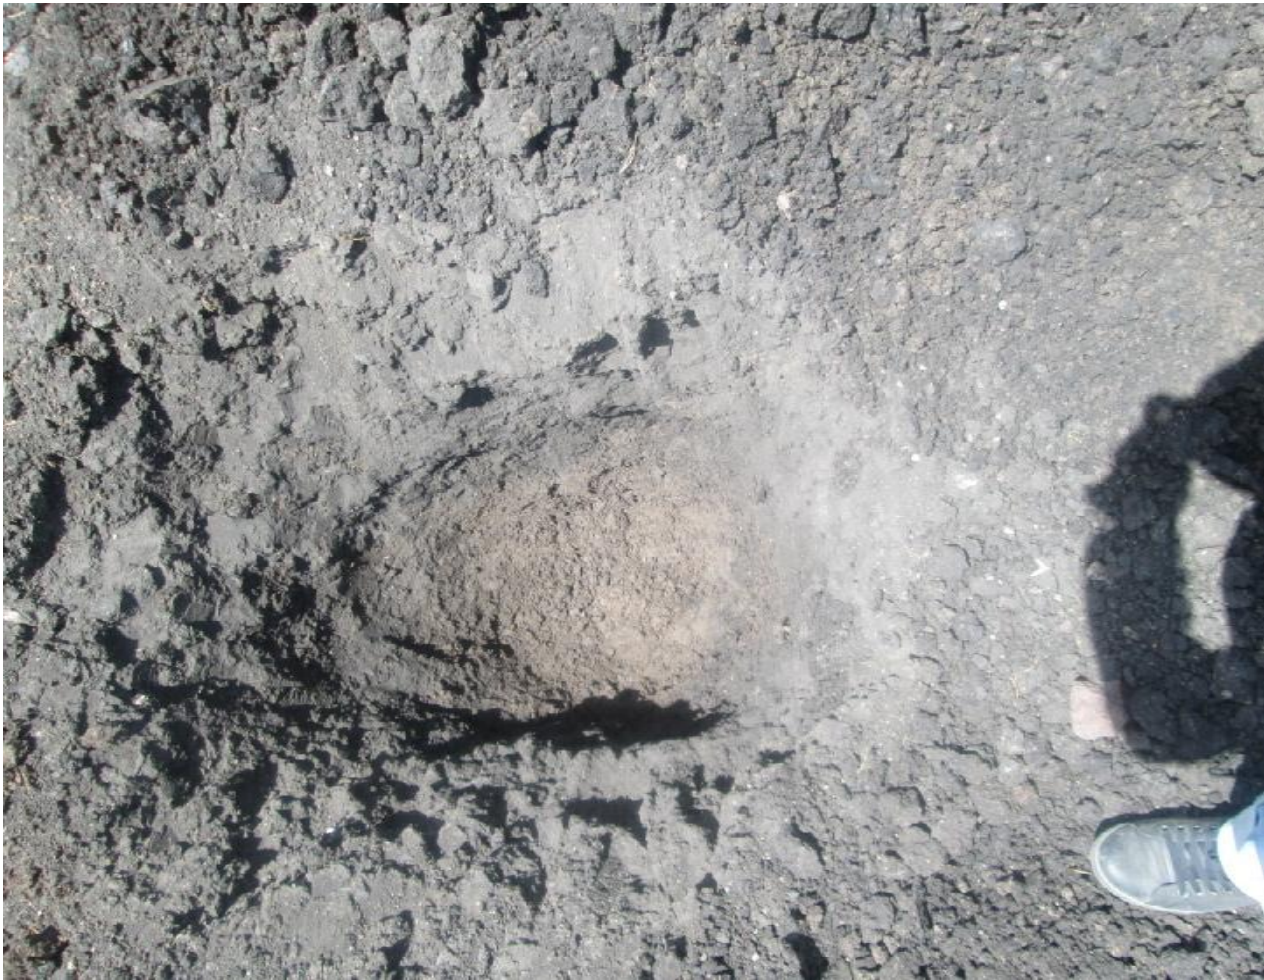
Photo 5 Test pit taken for subgrade at station 10 + 080

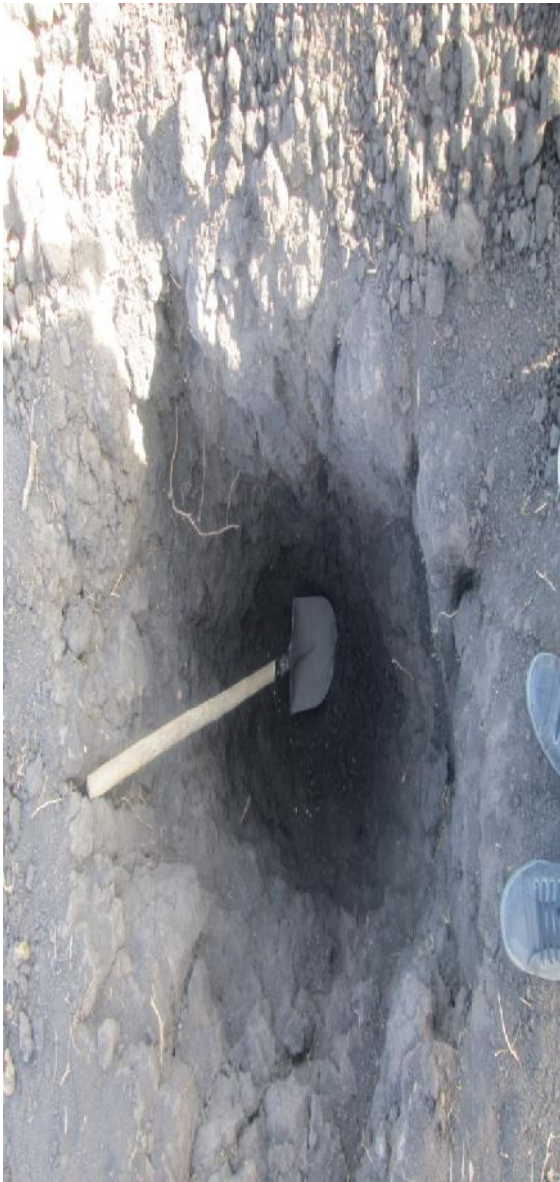
Photo 6 Test pit taken at station 9 + 656

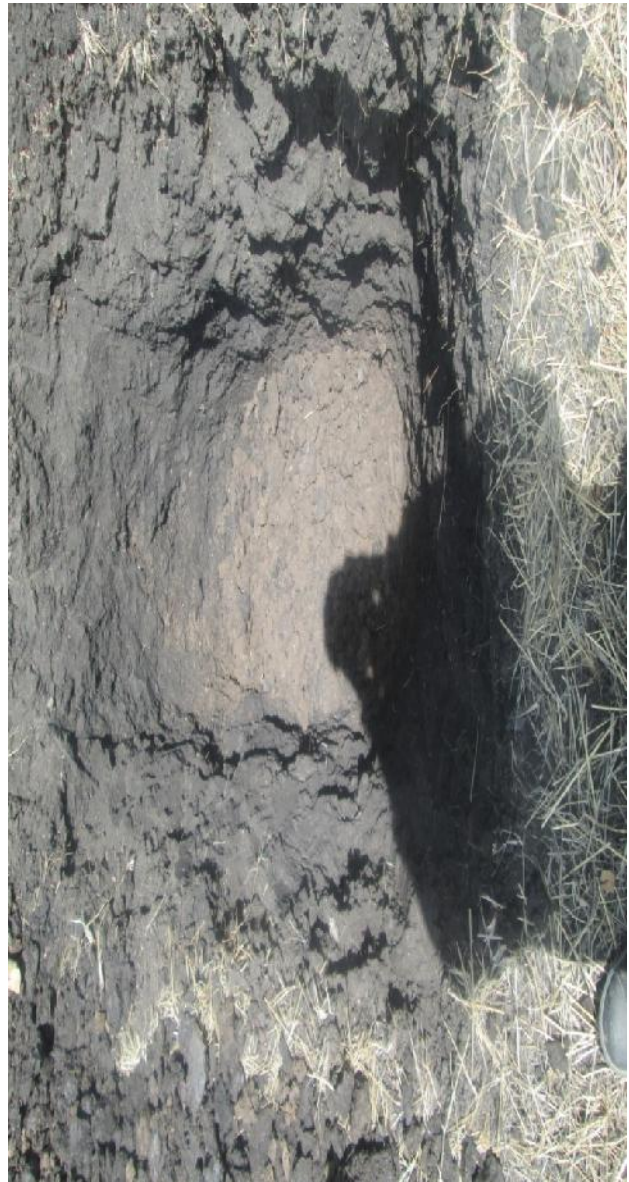
photo 7 Test pit taken for subgrade at 28 + 400

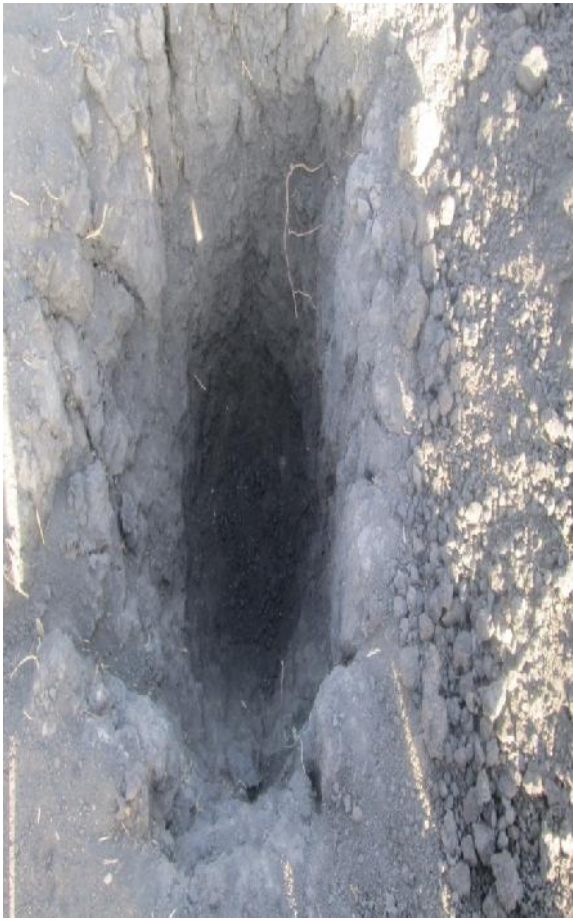
Photo 8 Test pit taken at station 24 + 757

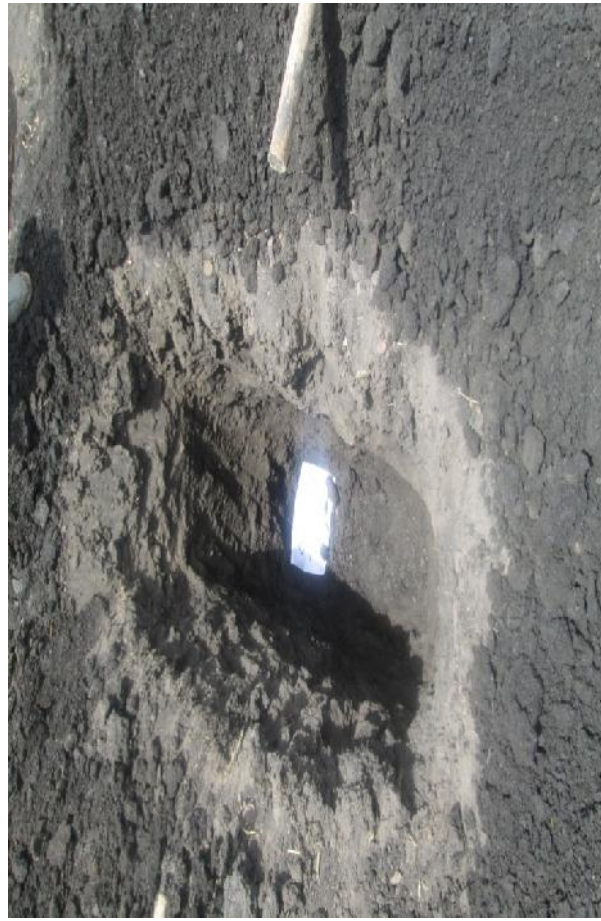
photo 9 test pit taken at station 9 + 656

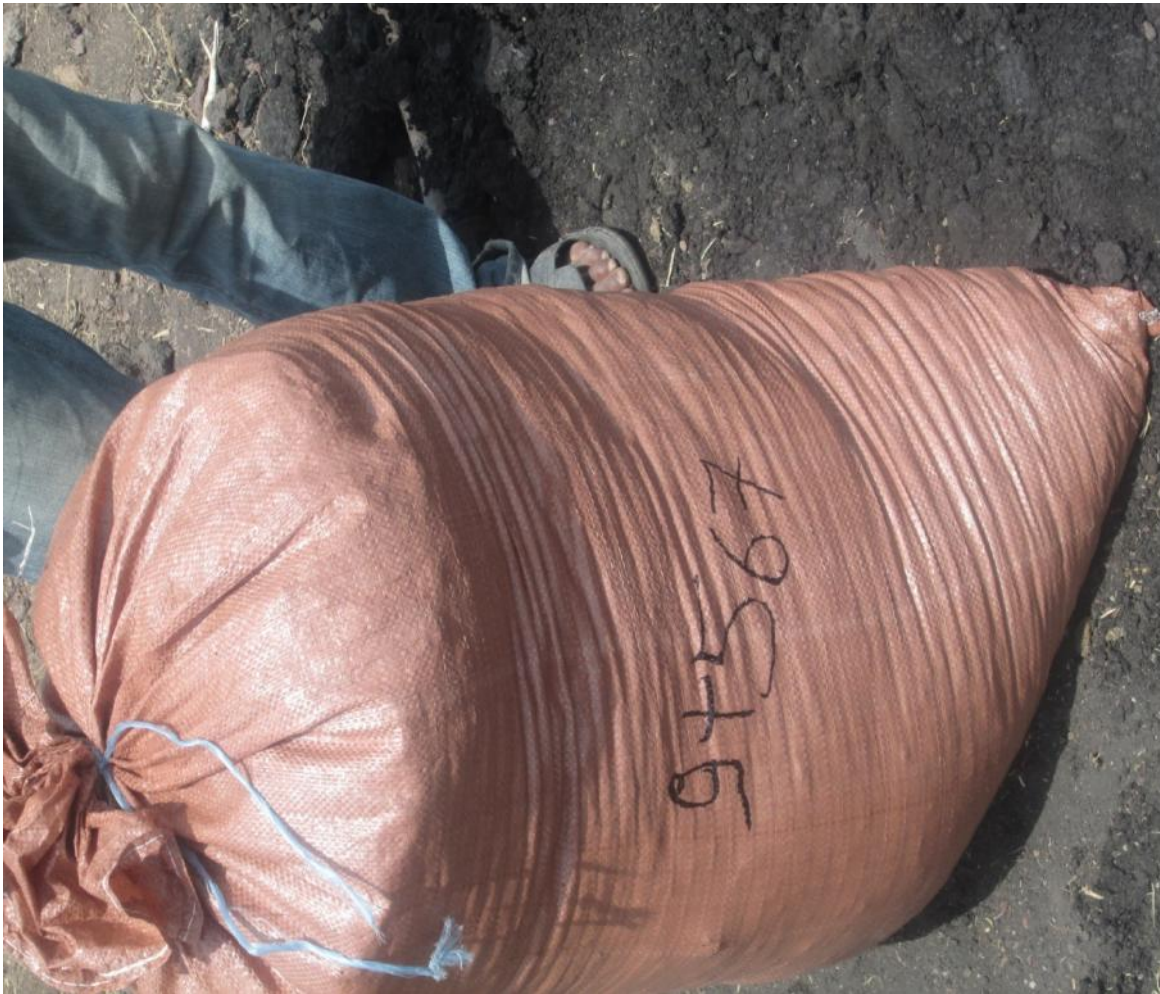
Photo 10 Sample taken for subgrade with its respective sampling station
