**Investigation of the Binding Materials Properties and Assessment of  
Durability Issue in Fasil Ghibbi Palace in Gondar**

**A Thesis Submitted to the School of Graduate Studies of Addis Ababa  
University in Practical Fulfillments of the Requirements of the Degree of  
Master of Science in Civil Engineering**

**By: Eskinder Desta**

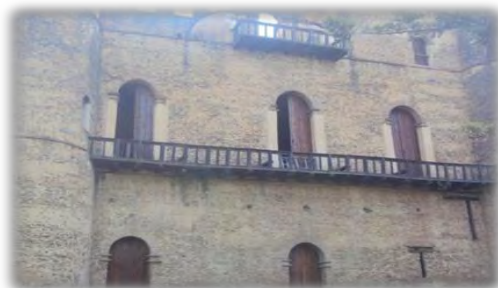
**Figure 1: Buildings in good condition**

The Royal compound lying within 70,000 m.sq, it encompasses six lofty castles and many different purposed buildings like the royal archive, house of the musicians, the lion cage, the horse zoo, the sauna bath, house of the spinners etc. The earliest and grandest of all edifices is that of Emperor Fasiladas, which is 32 meters high and with battlemented square tower (Bureau 2011). Today, these historical structures are in different physical state, some are in relatively good condition, while many are in a deplorable state (see figure 1 and figure 2).

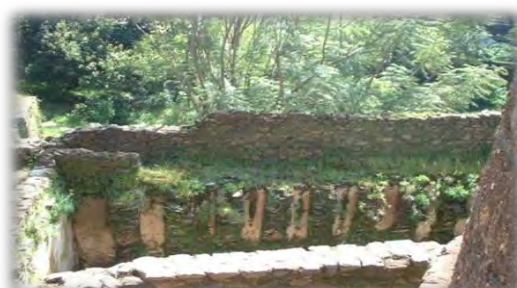
**Figure 2: Buildings in deplorable state**

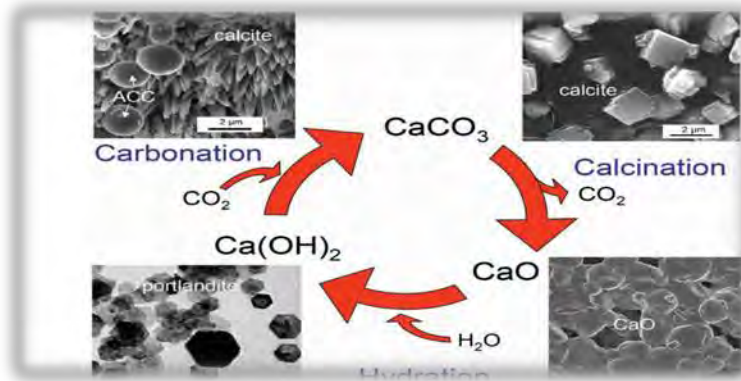
**Figure 3: The lime cycle: Electron microscopy images show reactant and products of the different stages of the cycle.**

According to (C. Rodríguez-Navarro 2002) the lime cycle consists of three stages (Figure 3):

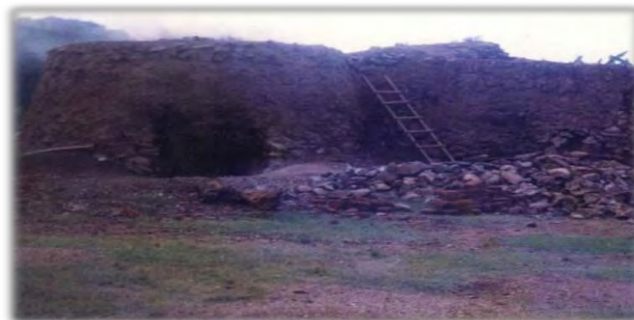
**Figure 4: Calcining of carbonated stone in Uganda traditional vertical shaft kiln**

This practice dubbed calcining serve to derive out the water and carbon dioxide from within the stone. Calcining of carbonate stones takes place in kiln (Ngoma, Characterisation and Consolidation of Historical Lime Mortars in Cultural Heritage Buildings November 2009).

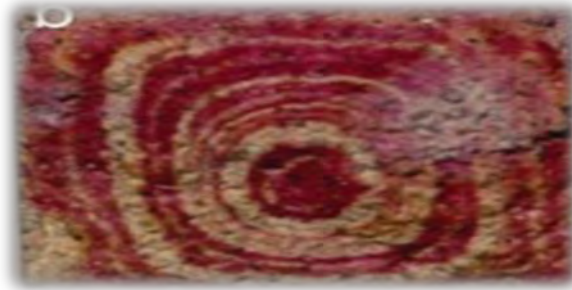
**Figure 6: Section of the prism after 1 year carbonation following phenolphthalein impregnation. The red rings correspond to uncarbonated parts, while the whiter rings are fully carbonated (from Rodríguez-Navarro et al., 2002).**

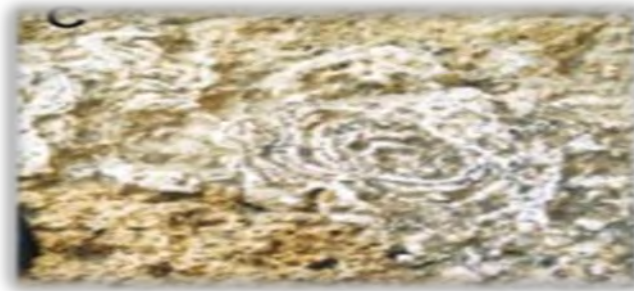
**Figure 7: Example of Liesegang pattern following differential weathering in lime plasters in a historical building (Saint Maria Church, Utrera, Spain) (from Hansen et al., 2008).**

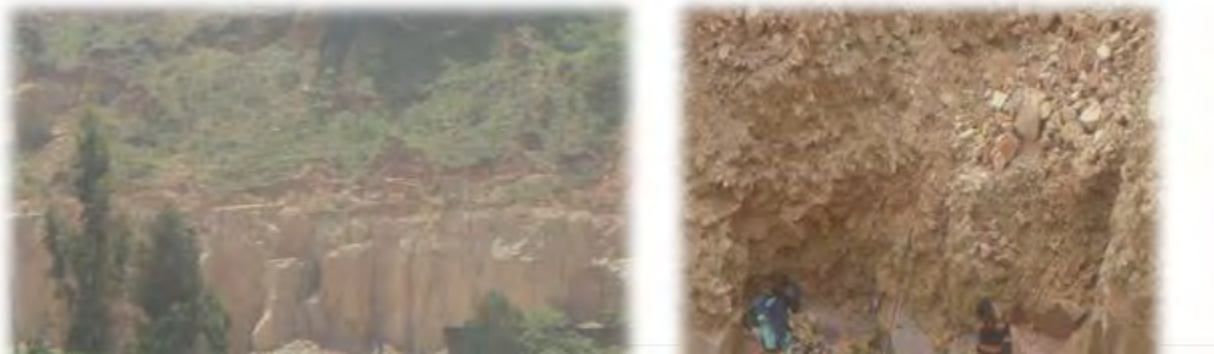
As it is shown in the (figure 11) they drill holes with sophisticated tools, break the stone away with powerful explosives and remove it in large capacity transport vehicles.

**Figure 10: Quarry Site Near to the Plant**

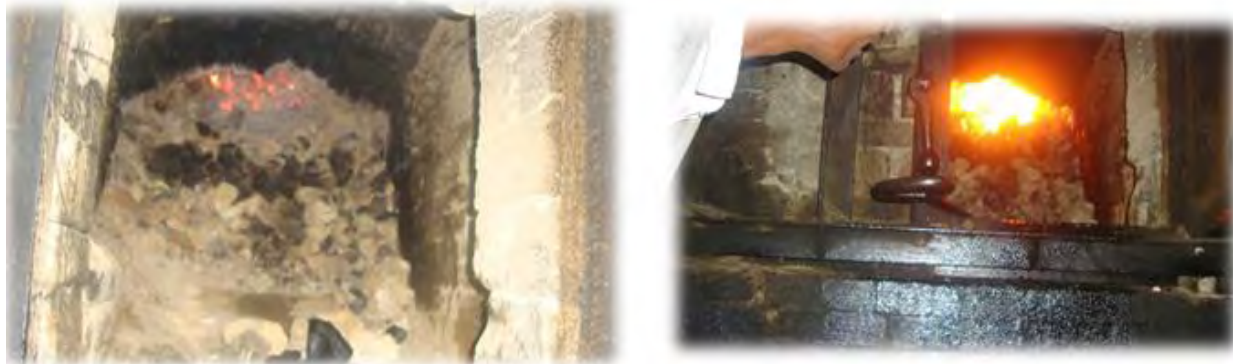
In Senkale Lime production Factory the source of energy is Furness fuel and the calcination process will takes three days in the kin but they don't have a noted data to know the exact burring time and temperature.(See the Figure below)

**Figure 11: Limestone burning kin (Ambo Senkale Lime Factory)**

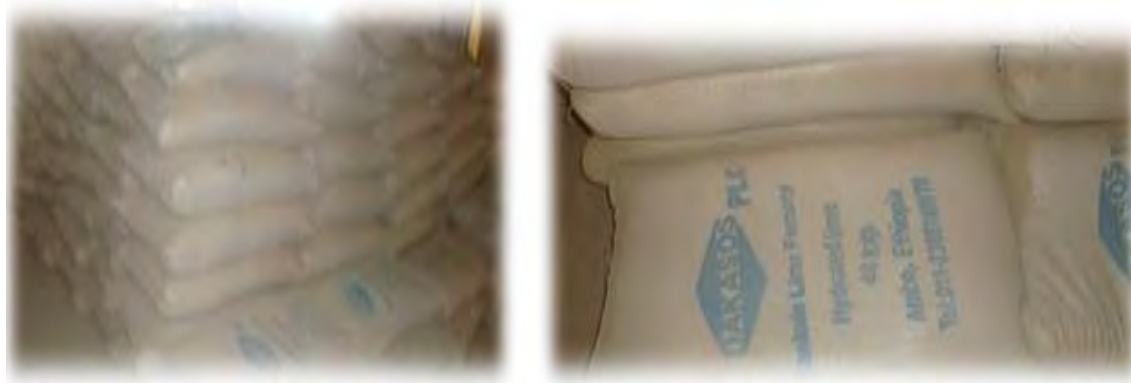
Hydrated lime is normally packed in paper bags for transportation to the customer although bulk tank cars are used for some of the larger consumers. (See figure 13)

**Figure 12: Finished product of Lime**

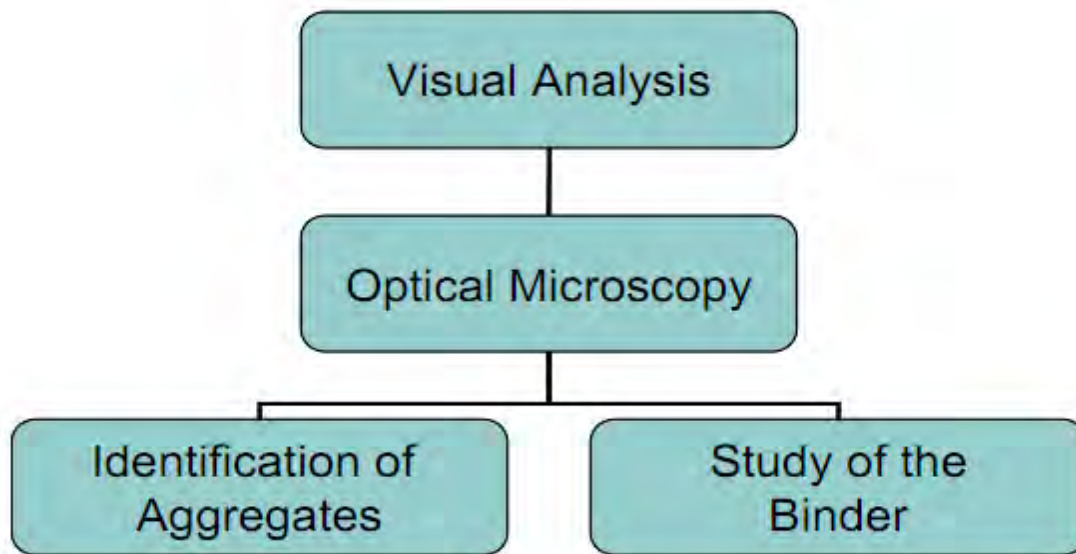
Hypotheses are tested by analyses of the materials. As yet, no standard analytical procedure exists to characterize historical mortars, different approaches and analytical techniques are recommended. The analytical procedure used for characterization of historical mortars is based on Van Balen et al. (1999) proposed approach, which combines several analytical methods currently employed for characterization of historical lime mortars. (Figure 14)

**Figure 13: Analytical Procedure; Van Balen et al. (1999)**

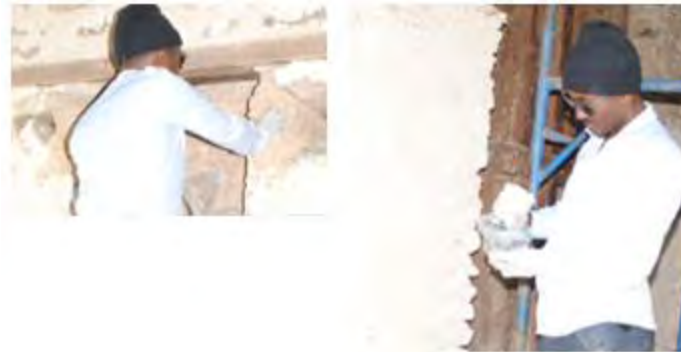
Sample Label: G<sub>1</sub>

**Figure 14: Sample taken from the internal wall**

- ✚ G<sub>1</sub> represent for sample which is taken from the internal wall of the palace, R<sub>1</sub> represent sample which is taken from the restoration sites.
- ✚ Samples are processed using different characterization method and analyzed individually.

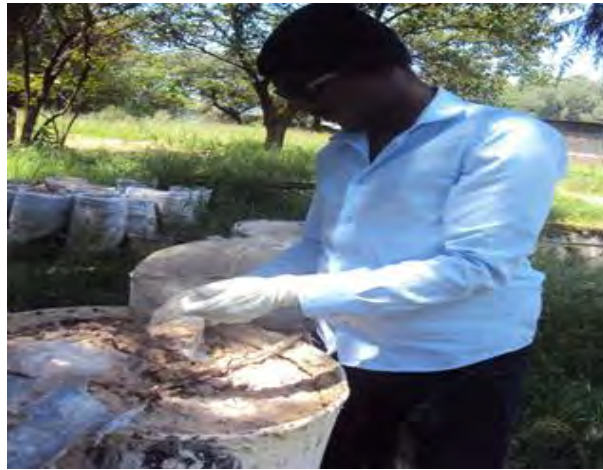
Sample Label: R<sub>2</sub>

**Figure 15: Sample taken from the restoration site**

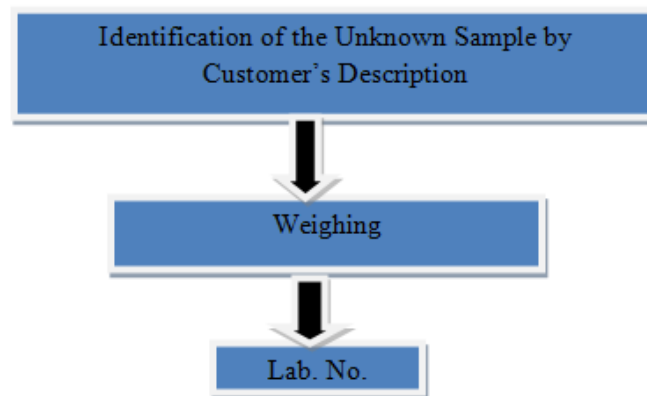
The First step is assigning unique identification for the unknown sample and then weighing the mass whether it is enough for sample extraction process or not, the general steps is summarized in a chart below.

**Figure 16: General Procedure for Silicate Analysis**

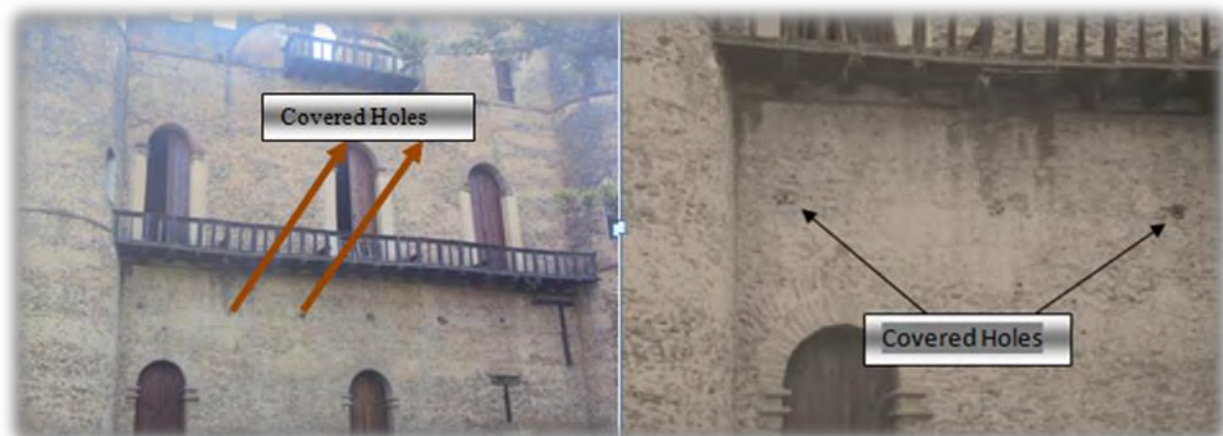
These wooden beams are imported from a place called *Armachiho* or *Dembeca* local name *werk mider*. The holes are positioned within 4 to 5 meter distance from the ground and also found within the same interval for the next level of the wall of the palace.

As it is seen in the (picture 19), it is possible to observe the holes. Meanwhile the holes were covered by the same kinds of stone probably at the end of construction for the aesthetical purposes. However, anyone can physically observe that the covered holes for the wooden beams are visible on different sides of the walls.

**Figure 18: Covered holes for the wooden beams in the main Castel.**

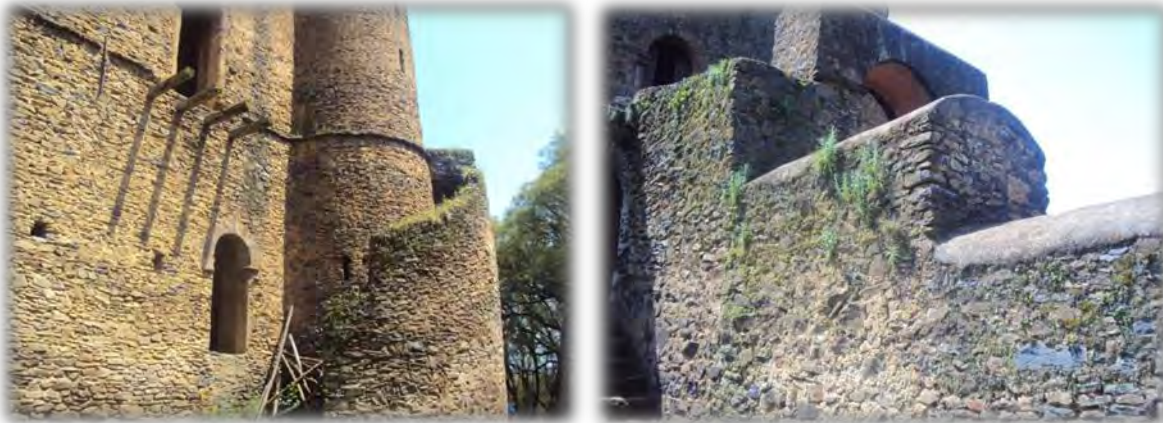
**Figure 19 : Stone masonry Palace building in Gondar, Ethiopia.**

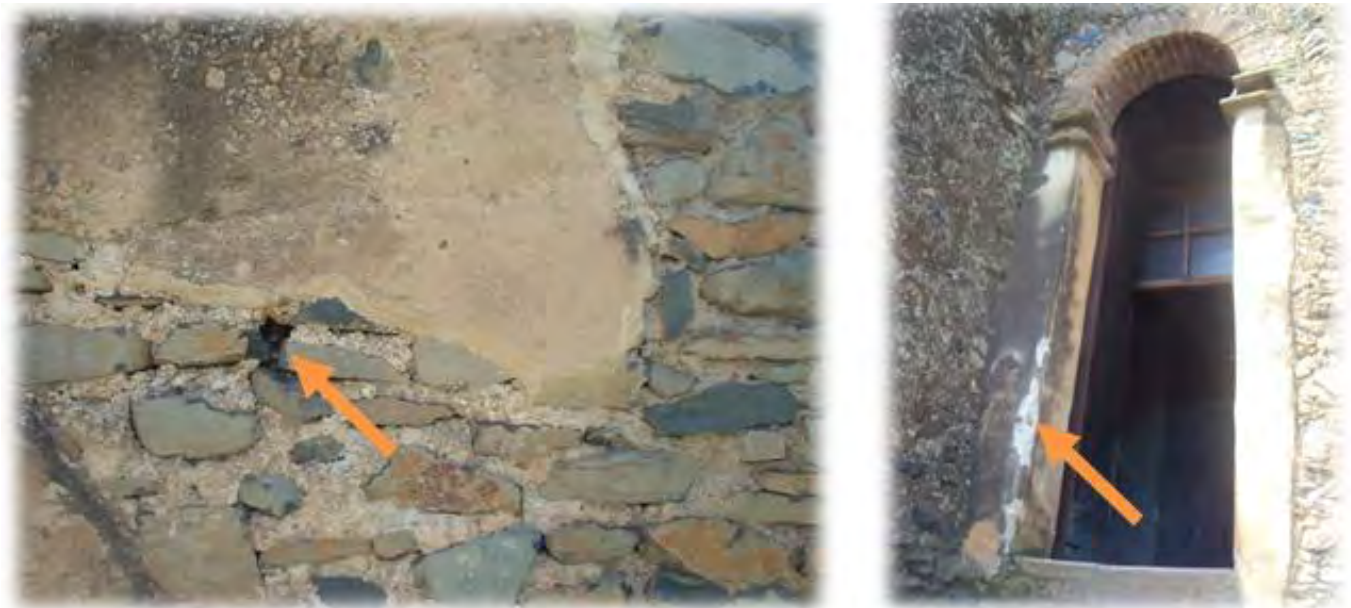
It is well known that various deterioration mechanisms, due to environment interaction with building materials, can occur, in which water always plays a primary role.

**Figure 21: Deterioration of rendering Mortar**

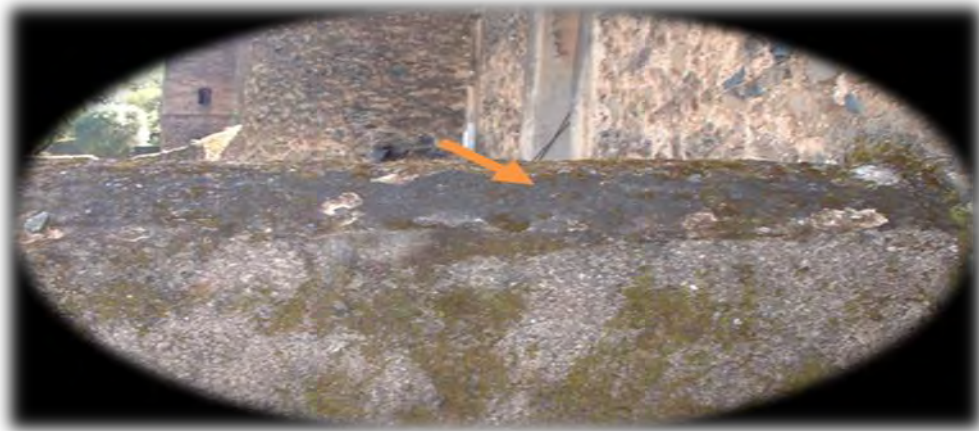
- II. **Chemical causes**: Due to ettringite and/or thaumasite production as a result of the reaction between sulfate salts and hydrated calcium silicates or aluminates which are present in mortars based on hydraulic lime or lime-pozzolanas; and (See the Figure below).

**Figure 22: Mortar deterioration due to Chemical Reaction**

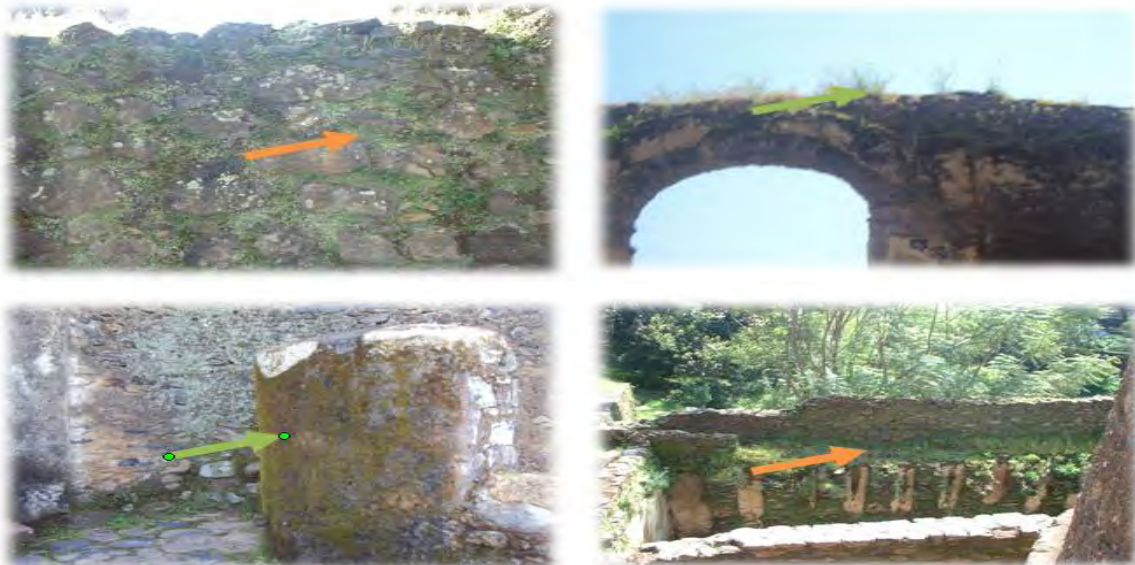
- III. **Biological causes**: As in the case of formation of algae, lichens and fungi. These specific causes have been the chief problem in the external face of the walls.(See the Figure below)

**Figure 23: Mortar deterioration due to Biological Causes**

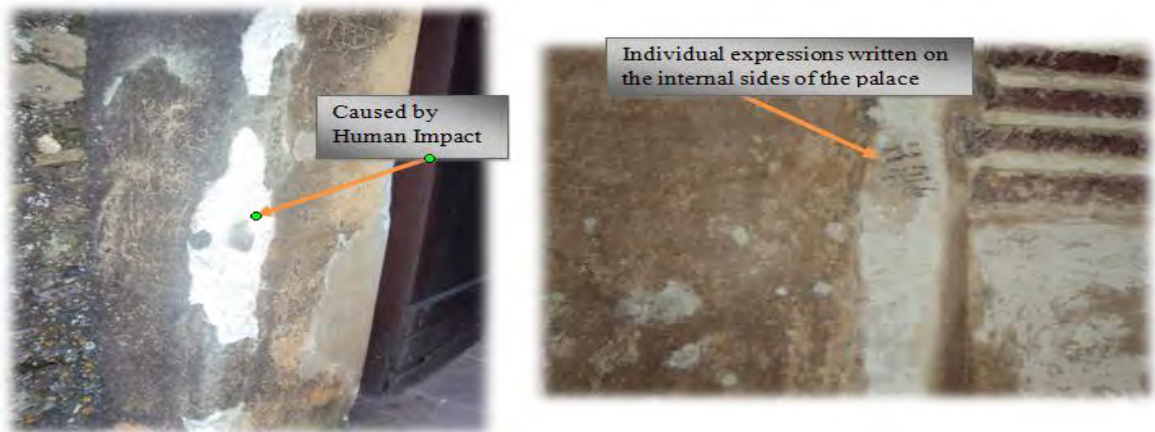
IV. **Mechanical actions**: E.g. impact, overloading, vibration, blasting etc. hence the Royal Palace is located on the center of the city, vibration which is prompt by the nearby traffic load is one of the problem. Proper follow up and care has to be on check points, it is better to limit the number of visitor at a time for proper monitoring and reducing the mechanical impact caused by some irresponsible individuals. .(See the Figure below)

**Figure 24: Mortar deterioration due to Mechanical action**

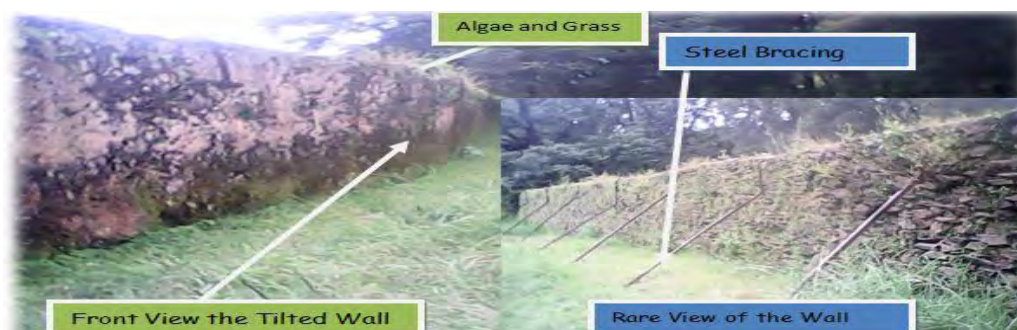
Hence the upper portion of the wall was leaning out of plumb. Masonry damage was the result of aging of the structure and materials, poor water proofing, wrong loading conditions like vibration due to traffic load etc. The destabilization of older walls due to the deterioration of the inner core rubble between the exterior and interior faces of masonry needed proper attention. (See the Figure below)

**Figure 26: Leaning Of the Masonry Wall in the Royal Palace Near to the Main Road**

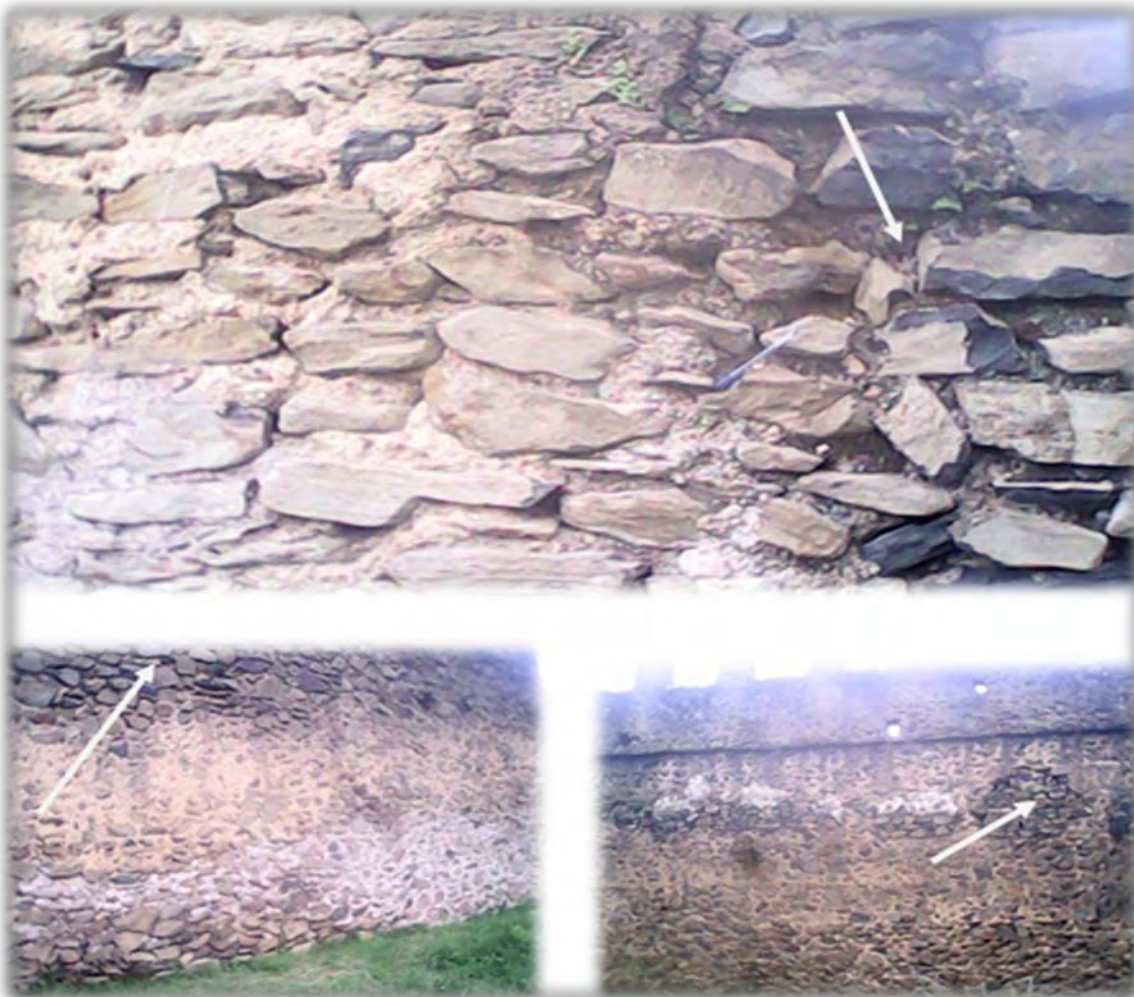
The second dilemma which is related to durability issue of the Royal palace is the loose bondage of mortar in between the masonry stone layer and also the removal of the top pointing surface due to a number of reasons; in addition to the above listed impact mechanical impact caused by human beings should also have to be considered. (See the figure below)

**Figure 27: Some spotted sites which shows critical mortar deterioration**

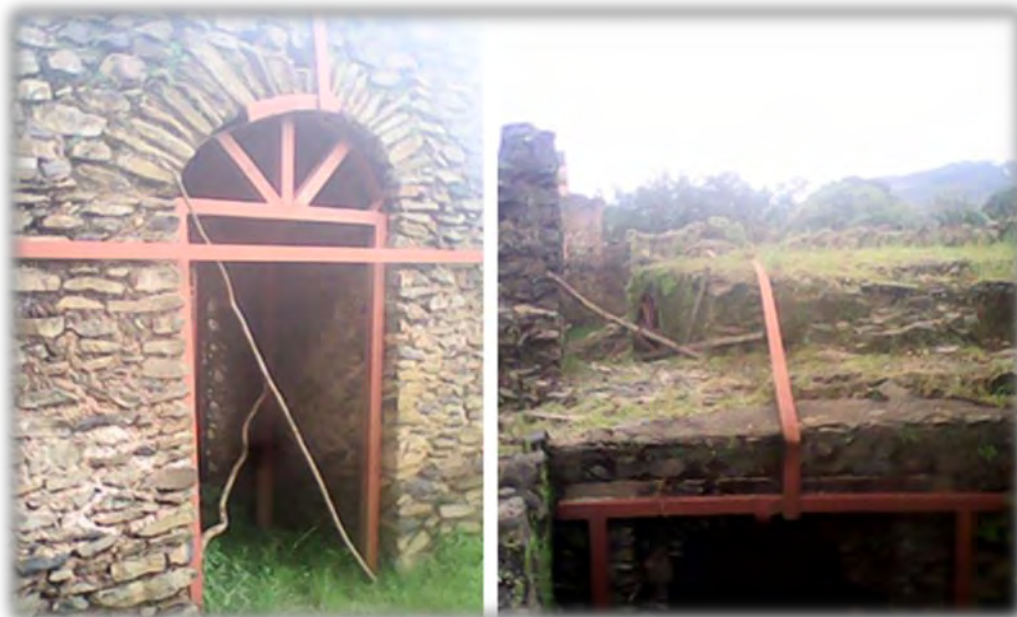
The royal palace administration in collaboration with UNESCO; were trying to maintain the integrity of the wall, by providing a support structure like bracing steel in some specific wall portion of the palace which exhibit major deflection as shown in the figure below.

**Figure 28 : Bracing steel in some specific wall portion**

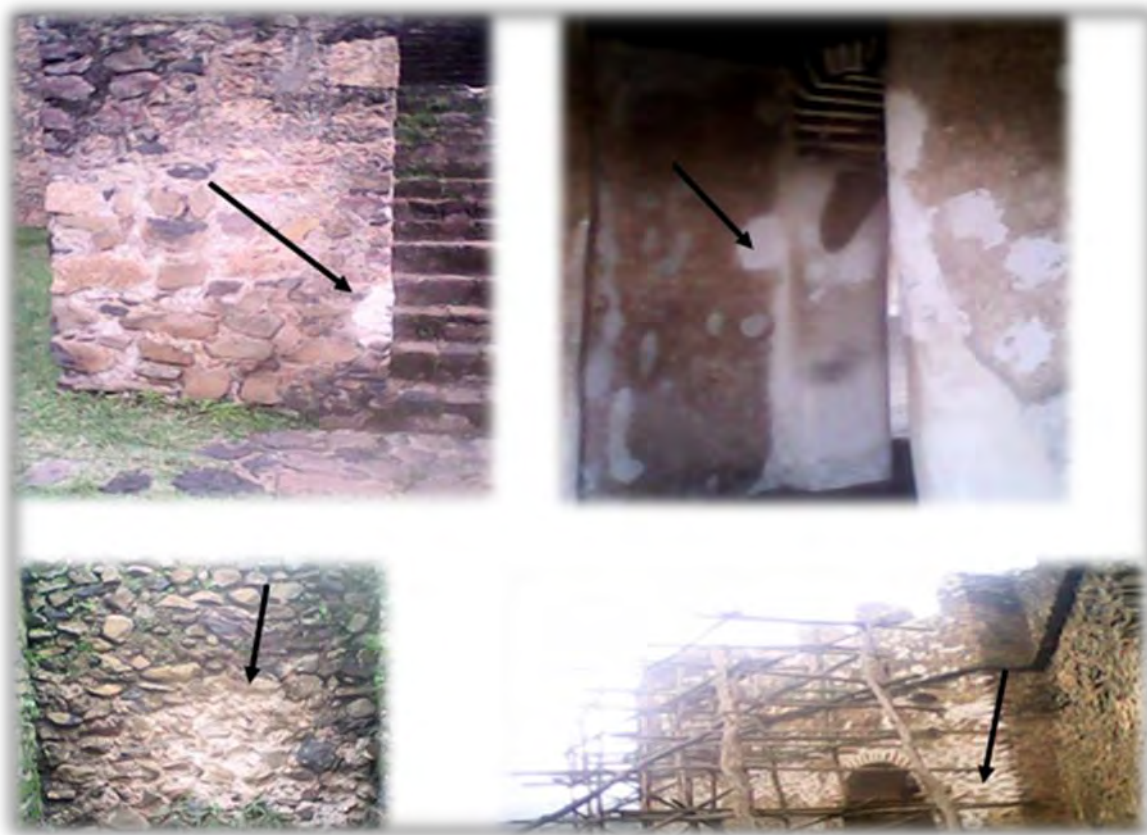
For the deteriorated palace wall, which was originated due to losing its binding mortar; periodic mortar re-pointing is adopted in the Royal palace according to the palace administration effortless treatment work usually done at the end of the rainy season. (Shown in the figure)

**Figure 29: Mortar re-pointing in the internal and external appearance of the palace wall**

Specific procedure was followed during the preparation of re-pointing mortar for the restoration purpose. These procedures were discussed in chapter two.

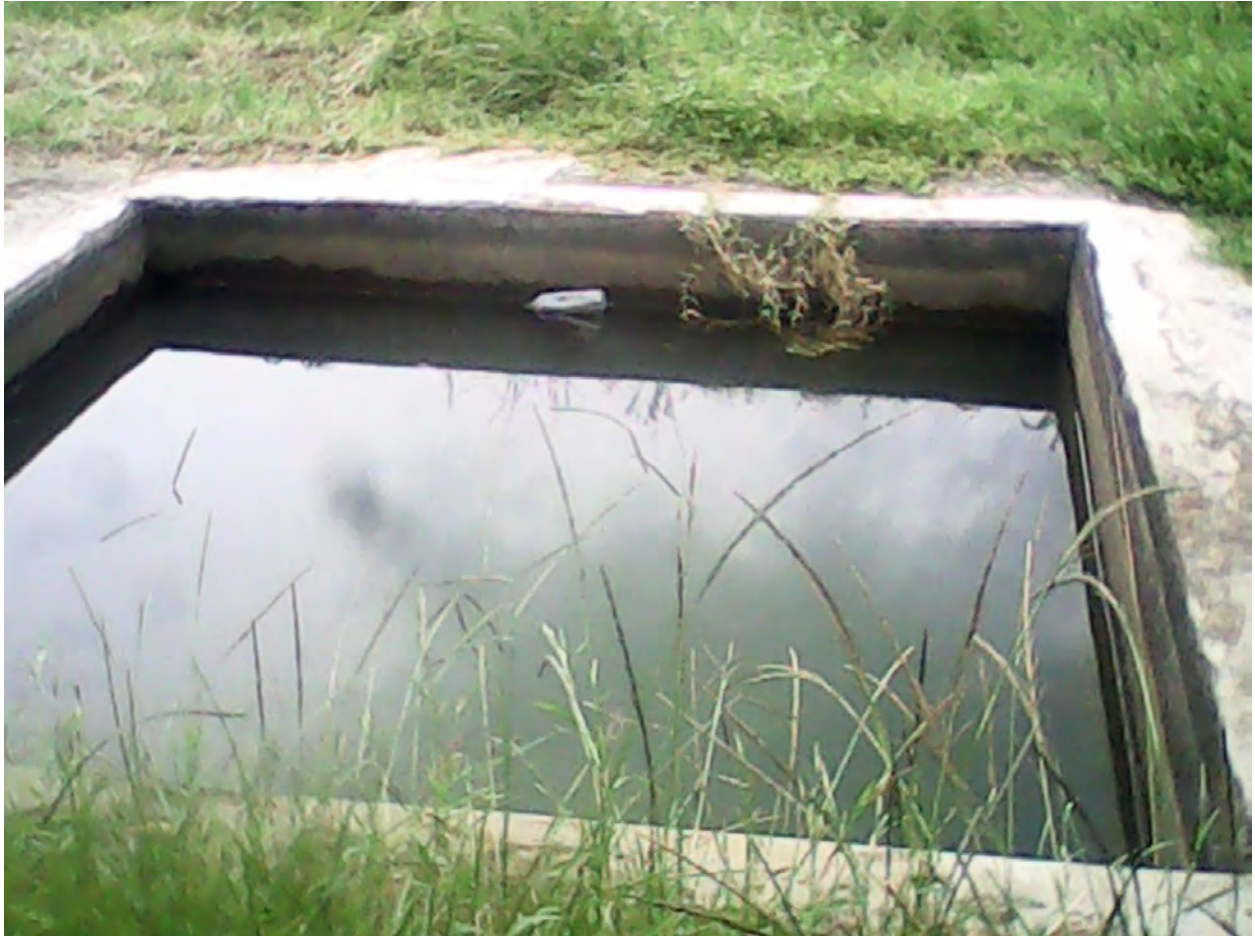
**Figure 6: Hydration Pond in Fasil Ghibbi Palace Restoration Site (Source: Eskinder Desta)**
