Landslide Hazard Evaluation and Zonation in and around Aba-ala town, Northern Ethiopia using Expert Evaluation Techniques.

Nora Yanimio
A Thesis Submitted to
School of Earth Science

In partial Fulfillment of the requirements for
the degree of masters in
Engineering Geology

Addis Ababa University
Addis Ababa, Ethiopia
September, 2020

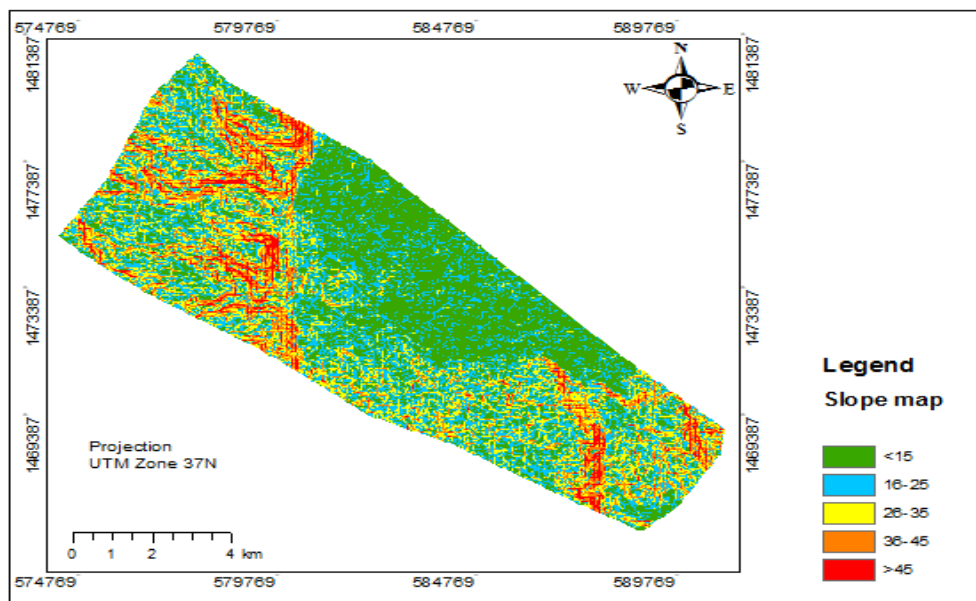
Figure 4.2 slop map of the study area

The slope map of the study area extracted from DEM with the resolution of 20m x 20m from SRTM data using GIS environments. Based on data extracted the slope angle of the study area varies from 0°-72°. According to the classification adopted in Anbalagan 1992 the slope of study area classified into five slope classes' i.e. <15°, 16-25°, 25-36°, 37-45° and >45°.

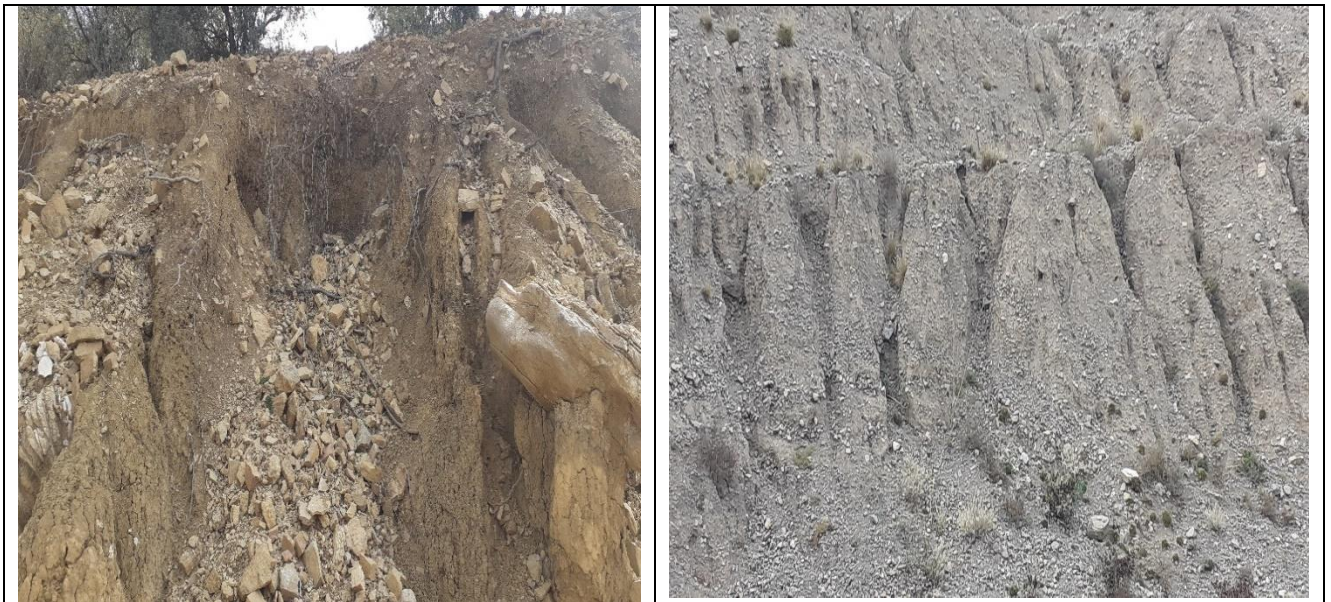
Figure 4.8 residual deposit in the area

The residual deposit in the study area ranges from clay to sand with inclusion of angular boulder, mainly yellowish in color. The residual deposit in the area are mainly deposited in low lying/gentle to moderate steep slopes. The residual deposit in the study area results from weathering of parent rock unit found in the study area (mainly from limestone and shale).

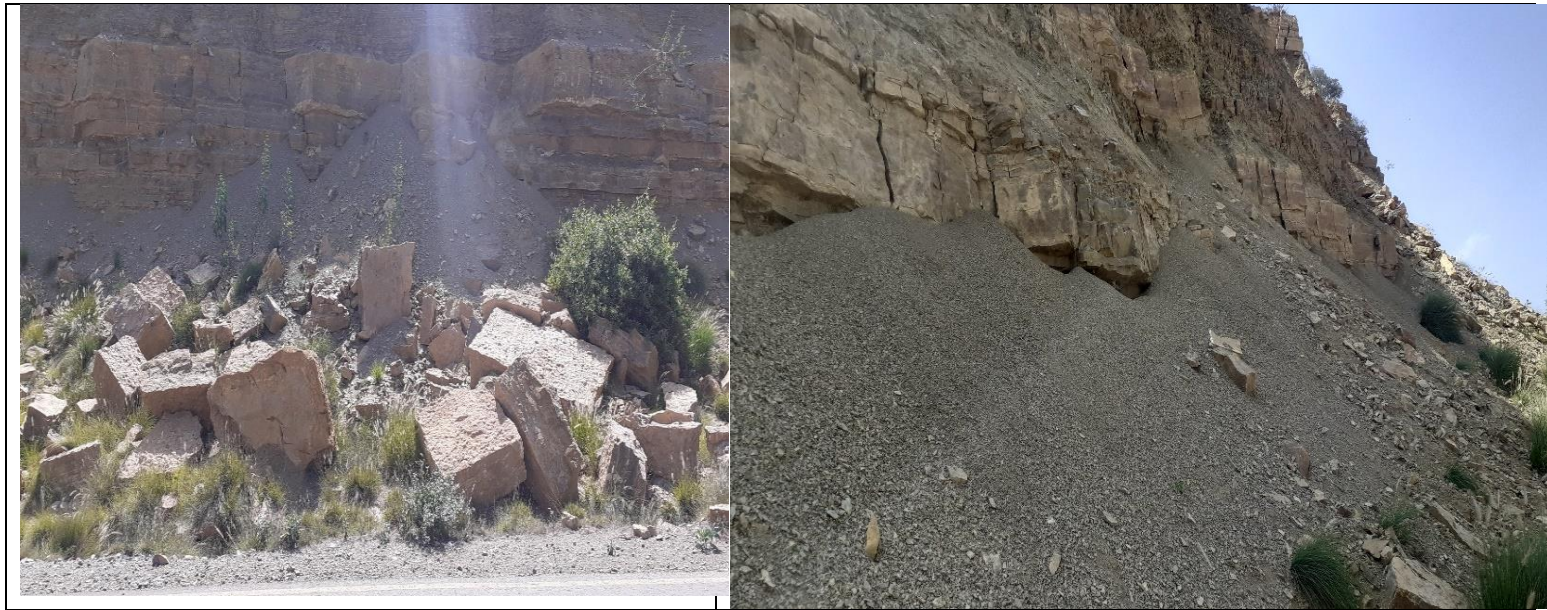
Figure 4.9 Colluvial deposit in area

The colluvial deposits are mainly found along the foot of cliff or at the base of steep slope, these deposit observed along the road cut in the western parts of Aba-ala town on the road running from Abala to Mekelle town. The colluvial deposit in the study area mainly composed from gravel, boulder, and sand soil and they are poorly sorted. The

colluvial deposit in the area shows variation in size of rock fragments, and consists a block of rock and soil that comes from steep slopes. The fragmented rock materials have the origin of limestone and shale rock unit found in the study area.

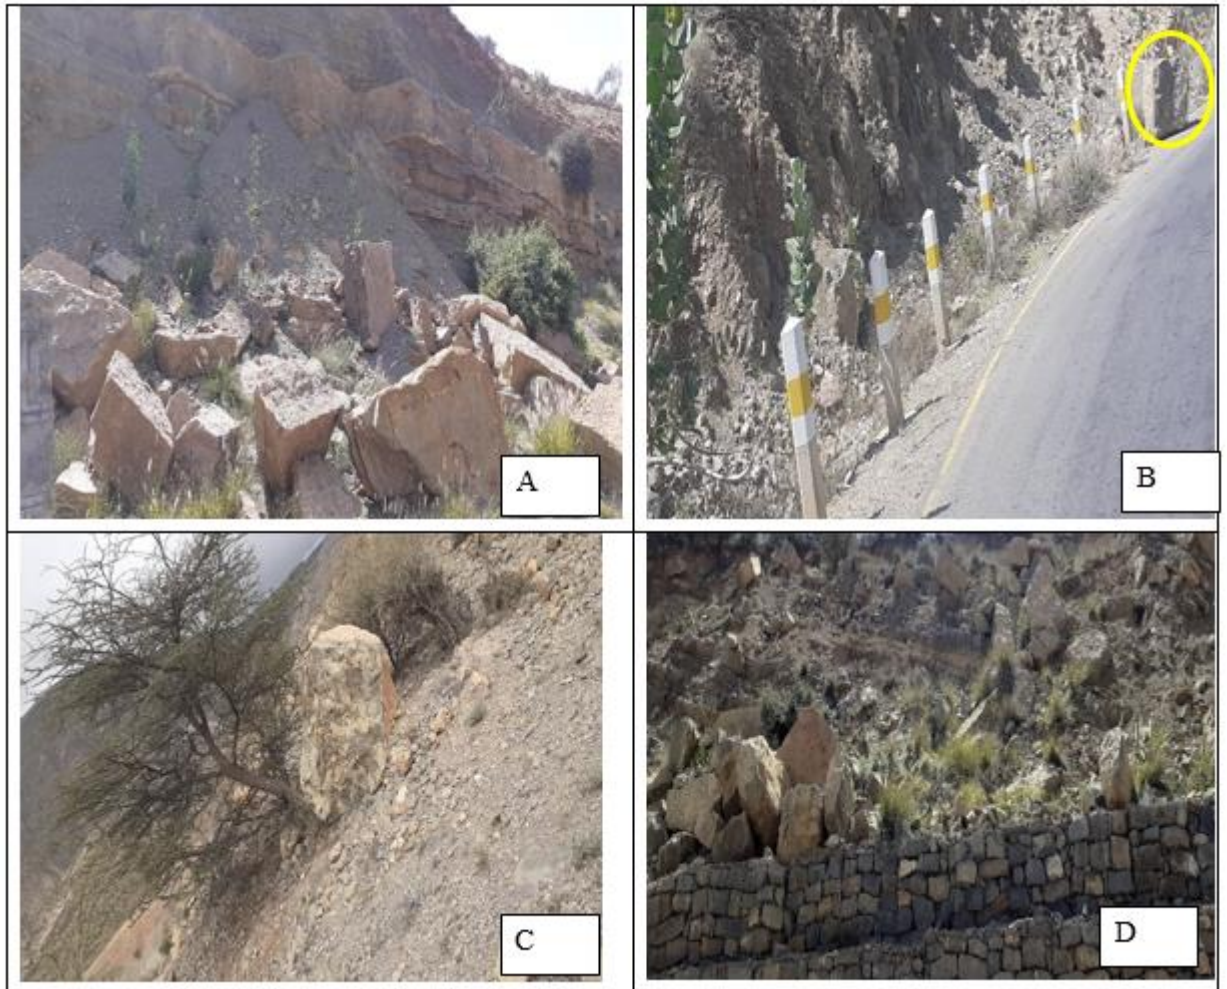
Plate 4.1 block of rock near to the road and on gabion (Rock fall) (A, B, C, D, E and F)
