**METHODOLOGY FOR TRAFFIC SAFETY AUDIT AND  
INSPECTION OF BRIDGES**

**A thesis presented for the partial fulfillment of the requirements for  
the Degree of Masters of Science in Civil Engineering  
(Road and Transport Engineering)**

**Tegegne Eshetu**

**September 2011**

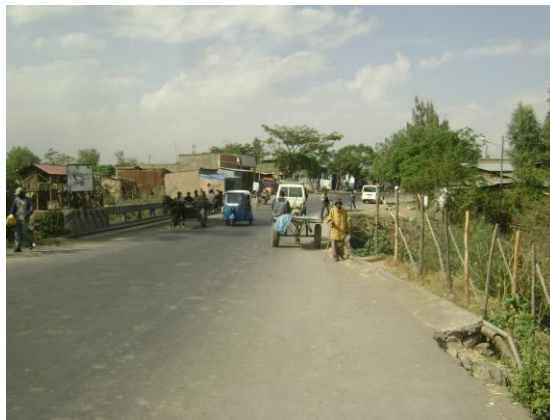
***Figure 1: Meki Bridge accommodating motorized as well as non-motorized users .***

Narrow bridges on horizontal curves can have limited horizontal stopping sight distance past the bridge rail (Figure 1). Operations can be degraded, particularly on bridges on high-speed roadways, because of speed reductions as drivers enter the narrowed cross section as well as a decrease in driver comfort on the bridge.

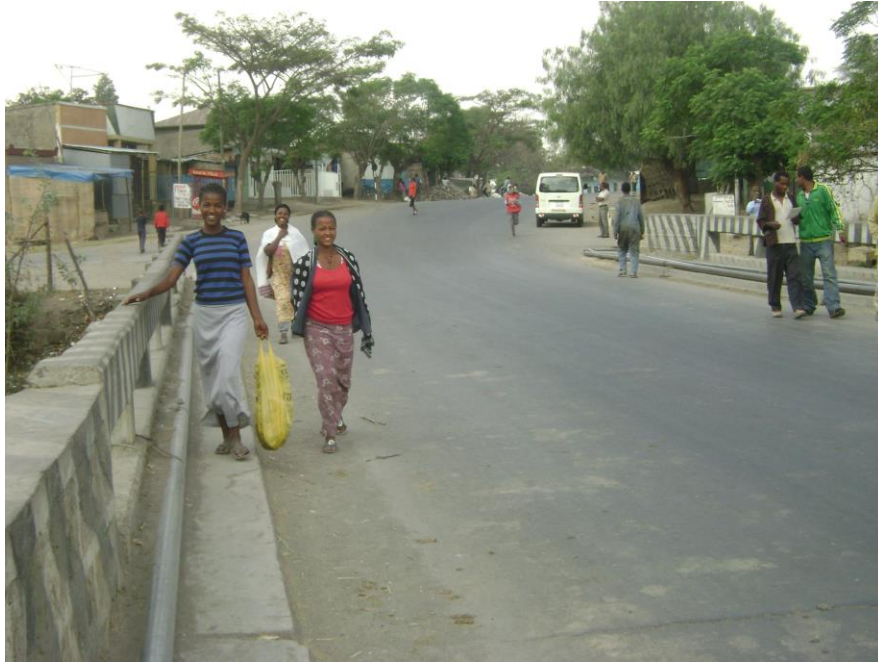
The clear carriageway width is 7.50 meters and the width across parapets is 9.30 meters. No shoulder is provided to both sides of the carriageway. The pedestrian walk way which is provided on the bridge is 0.6m and doesn't meet the minimum walkway requirement for town section bridges. The post and rail on the deck are of concrete construction and are in good condition. The wing walls are made stone masonry and out of the 4 approach wing walls 3 are in good condition. Wing wall at inlet Awassa side completely damaged by traffic as it is situated on sharp bend. The

wearing surface is of hot mix asphalt and in good condition with no pavement marking.

**Figure 11. Photo showing Awassa side Approach Roadway**

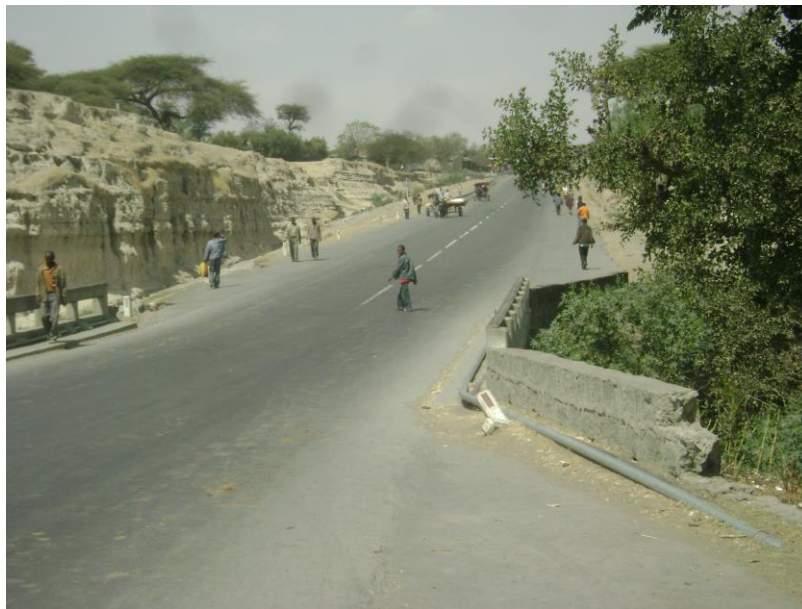
The bridge is located on sag vertical curve. The clear carriageway width is 7.30 meters and the width across parapets is 9.30 meters. No shoulder is provided to both sides of the carriageway. The pedestrian walk way which is provided on the bridge is 0.65m and doesn't meet the minimum walkway requirement for town section bridges. The post and rail on the deck are of concrete construction and are in good condition. The wing walls are made of stone masonry and slanted at about 30 degree from the edge of the roadway and out of the 4 approach wing walls 3 are in good condition. Wing wall at downstream Meki side is completely damaged by traffic. The wearing surface is of hot mix asphalt and in good condition with visible centerline marking and faded edge marking.

*Figure 12. Photo showing Bulbula River Bridge, Modjo side approach*

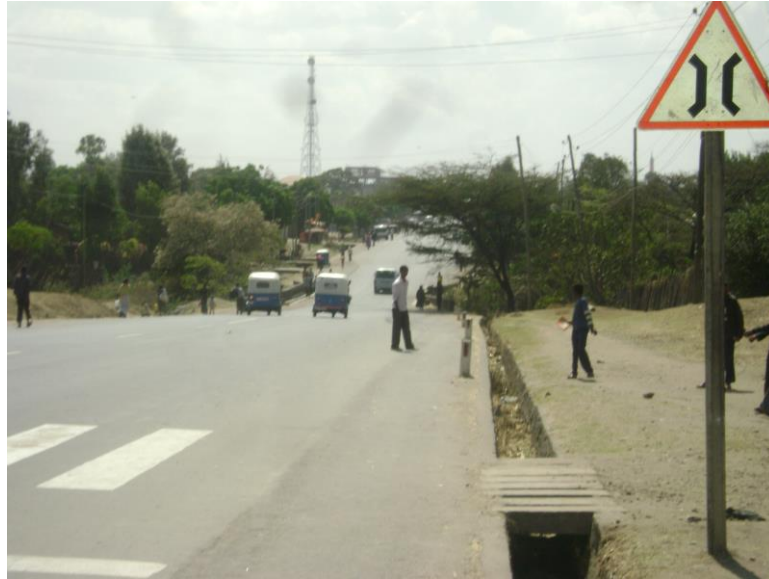
The bridge is located on sag vertical curve. The clear carriageway width is 7.45 meters and the width across parapets is 9.35 meters. No shoulder is provided to both sides of the carriageway. The pedestrian walk way which is provided on the bridge is 0.85m and doesn't meet the minimum walkway requirement for town section bridges. The post and rail on the deck are of concrete construction and are in good condition. The wing walls are made of stone masonry and slanted at about 30 degree from the edge of the roadway and out of the 4 approach wing walls 3 are in good condition. Wing wall at the upstream Modjo side is partially damaged by traffic. The wearing surface is of hot mix asphalt and in good condition with no centerline marking and faded edge pavement marking.

**Figure 13. Approach roadway, Awade 1 bridge**

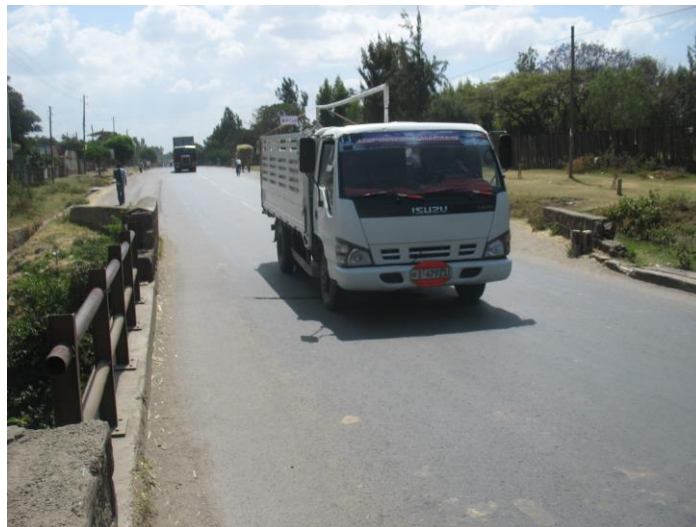
The bridge is located on sag vertical curve. The clear carriageway width is 6.50 meters and the width across parapets is 7.60 meters. No shoulder is provided to both sides of the carriageway. There is no pedestrian walk way on the bridge. The post and rail on the deck are of steel post and pipe rail and are in poor condition. The wing walls are made of stone masonry and slanted at about 30 degree from the edge of the roadway and out of the 4 approach wing walls 3 are in good condition. Parapet at the downstream Modjo side is partially damaged by traffic. The wearing surface is of hot mix asphalt and in good condition with no centerline as well as edge marking.

***Figure 14. Awade Godu bridge damaged post and rail system***

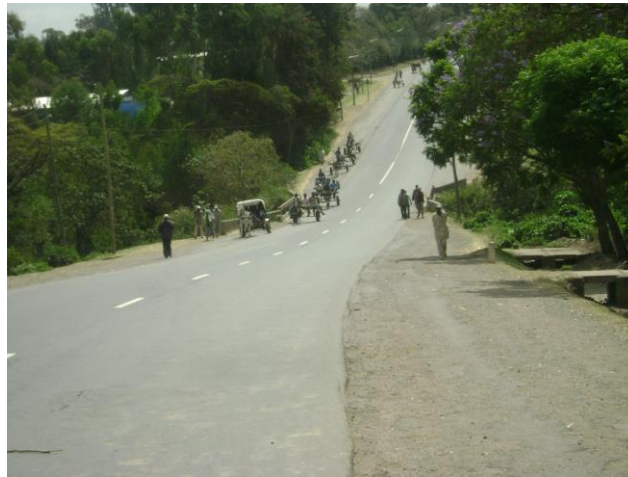
The bridge is located on sag vertical curve. The clear carriageway width is 7.40 meters and the width across parapets is 9.30 meters. No shoulder is provided to both sides of the carriageway. There is no pedestrian walk way on the bridge. The post and rail on the deck are made of concrete and are in good condition. The wing walls are made of stone masonry and slanted at about 30 degree from the edge of the roadway and out of the 4 approach wing walls 3 are in good condition. Wing wall at the downstream Modjo side partially damaged by traffic. The wearing surface is of hot mix asphalt and in good condition with visible centerline marking and faded edge marking.

**Figure 15. Tataba Tinshu River Bridge**

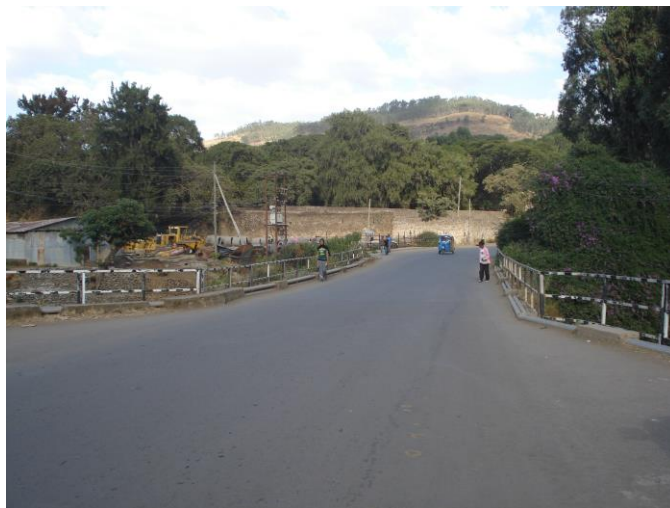
There is an existing Arch bridge on section CD of Gonder by-pass project. The bridge is found to be in bad condition with sever crack on the Arch Barrel. At the moment, the city administration banned heavy vehicles from using the bridge. A team of engineers was mobilized to make a preliminary finding of the existing bridge with respect to structural condition. As usual, the safety aspect of the bridge that is the approach roadway alignment, bridge width and traffic safety feature isn't considered primarily. However, the new bridge will have the same width as the approach roadway width and all the required traffic safety features will be incorporated in the new design.

The purpose of the bridge is to provide at-grade bridge crossing for vehicular traffic, Pedestrians and Cyclists across the section CD of Gonder town.

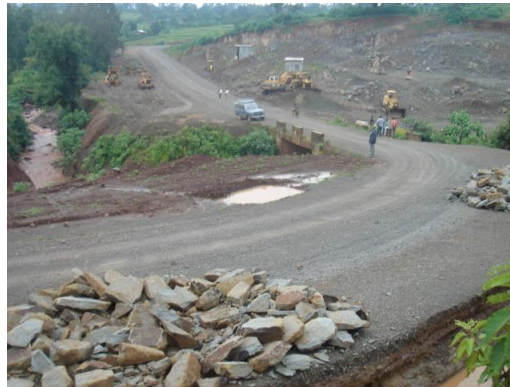
***Problem – Approach Alignment on the Mazoria Side***

This side approach alignment has an adverse geometry on the horizontal alignment. There is a 60m radius sharp curve at about 20m from the bridge end. There is no stopping sight distance provision on this side.
